Tunnel Spillway Performance at Glen Canyon Dam

Philip H. Burgi, Chief, Hydraulics Branch
Melissa S. Eckley, Civil Engineer
Bureau of Reclamation, Denver, Colorado USA

SUMMARY: Colorado River runoff at the 216-m-high Glen Canyon Dam was 180 percent of normal in the summer of 1983. A high reservoir combined with late spring runoff required the use of both 12.5-m-diameter tunnel spillways. Operating these spillways for 2 months eroded 2150 m³ of the concrete liner and foundation rock. The tunnels were repaired, an aeration slot installed, and subsequent tests verified acceptable performance.

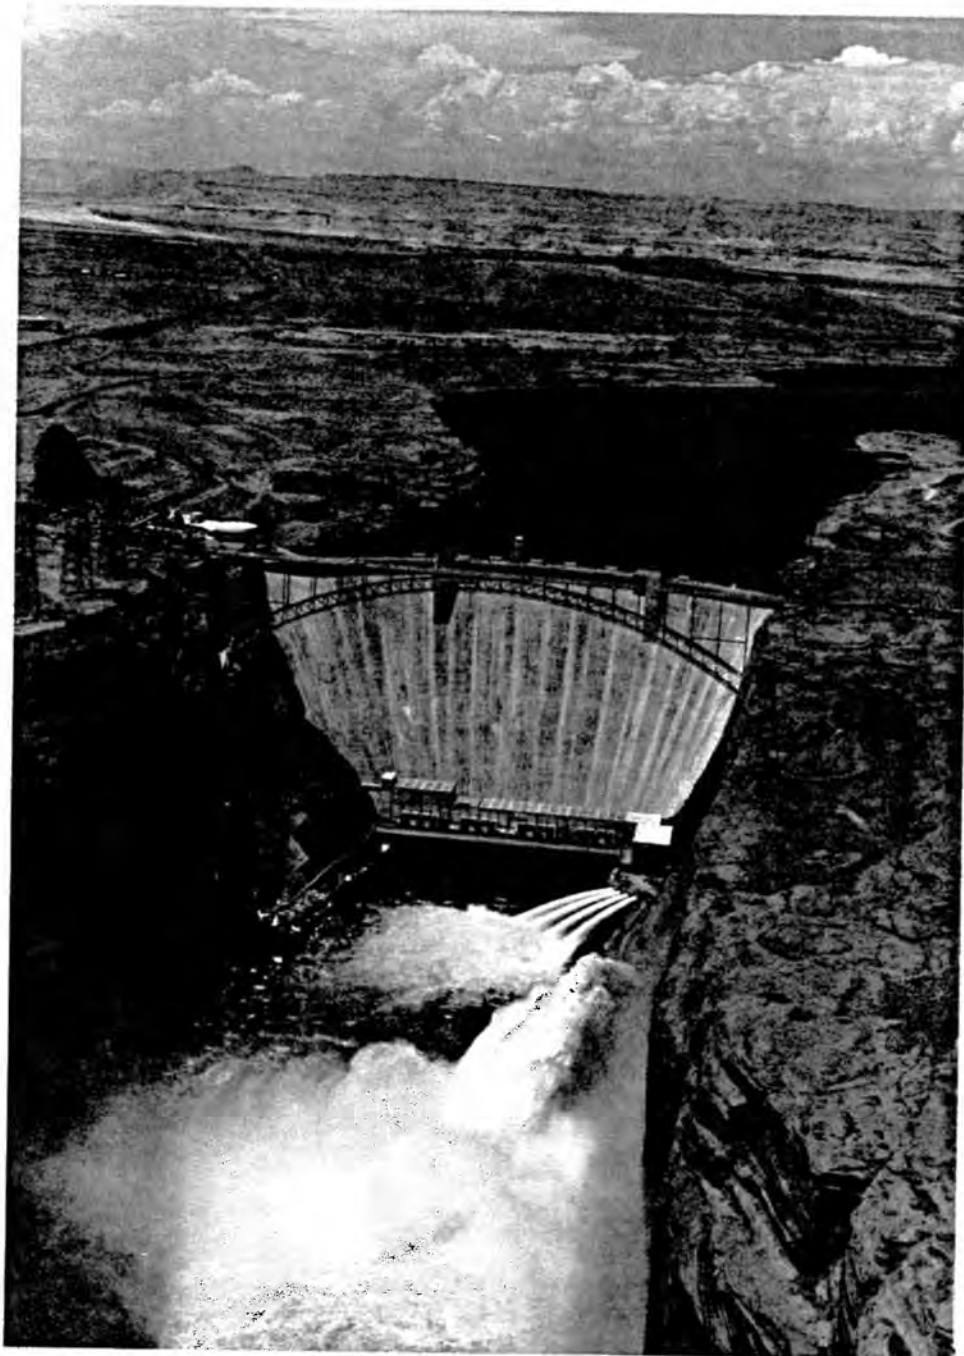
There is a significant temperature gradation at Lake Powell. To avoid severe temperature shock to the downstream fishery during the 1420 m³/s spillway test (figure 6), 470 m³/s of the warmer surface waters were released through the left spillway all night. This warmer flow mixed with the much colder 1000 m³/s powerplant discharge so that the downstream water temperature was slowly raised in preparation for the test.

The maximum measured air velocity in the aerator occurred during the 1420 m³/s test. The air velocity reached 76 m/s. Based on previous experience and theory, the phase 2 duration tests were conducted with an exposure time long enough that minor cavitation damage (holes approximately 150-mm deep) would have resulted without an aeration slot. Although some concrete pop-outs were observed, the frequent tunnel inspections performed throughout the test sequence showed no damage from flow induced cavitation.

Figure 6: - Glen Canyon Dam spillway test - August 12, 1984.
1420 m³/s - left spillway.
28 m³/s - four 2440-mm hollow-jet valves.
