NAVAJO VALVE OPERATOR STUDY

SUBJECT: Failure of Limitorque Valve Operators - Navajo Indian Irrigation Project -  
Laboratory Test Results (Your Memorandum Dated July 11, 1988) (Hydraulic  
Research)

## NAVAJO VALVE OPERATOR STUDY

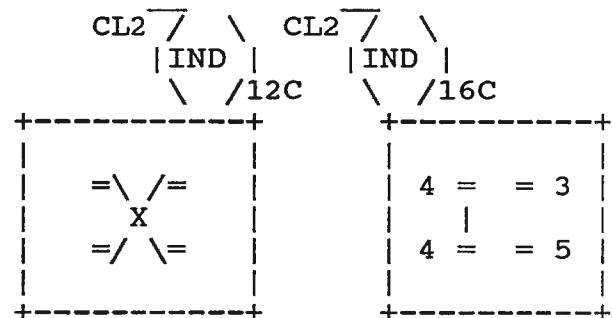
Manual Control Switch

(moisture and turning friction) was the cause of the problems and eventual failure. The damaged control switch could have contributed to the problem, but without knowing when the damage occurred, shipping, supply yard or while installed, this cannot be evaluated.
