ENGINEERING REPORT  
HYDRAULIC INVESTIGATION OF OUTLET  
WORKS AND STILLING BASIN  
TAYLOR DRAW DAM/KENNEY RESERVOIR,  
RANGELY, COLORADO

For  
Water Users' Association No. 1  
Rangely, Colorado

by  
Resource Consultants, Inc.  
402 West Mountain Avenue  
P.O. Box Q  
Fort Collins, CO 80522

January 25, 1991

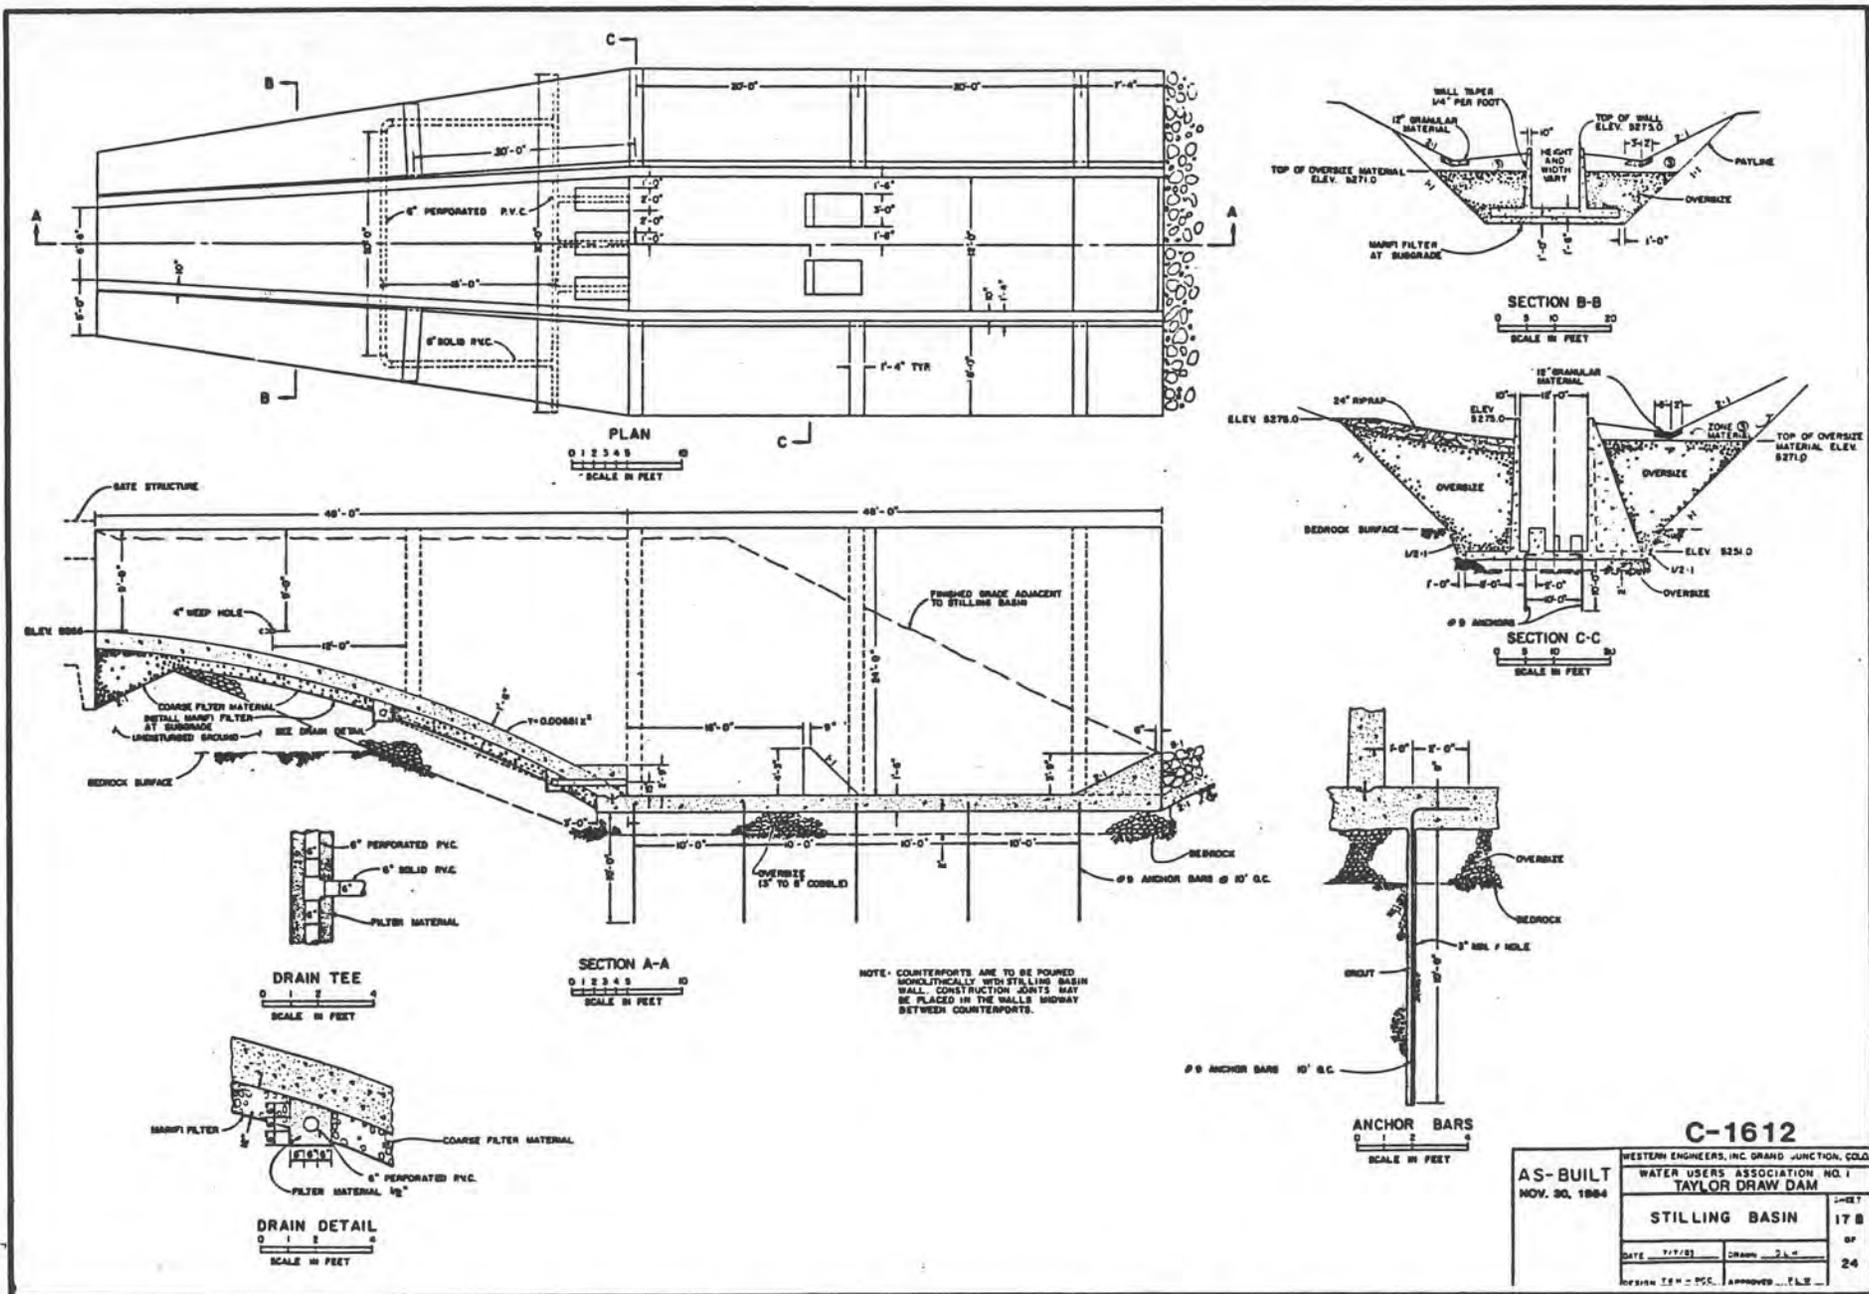
Figure 1.1: AS-BUILT STILLING BASIN PLAN & PROFILE

During an inspection in 1987 it was found that significant damage had occurred to the concrete walls and floor of the stilling basin. The damage was attributed to the abrasive action of rocks churning in the flow. It was suspected that rocks were entering the basin by falling or being thrown into the stilling basin. The basin was dewatered, the concrete was repaired with silica fume concrete, and a cover was placed over the stilling basin. In September 1989, a subsequent inspection by divers revealed that similar damage to the concrete surface had occurred again.

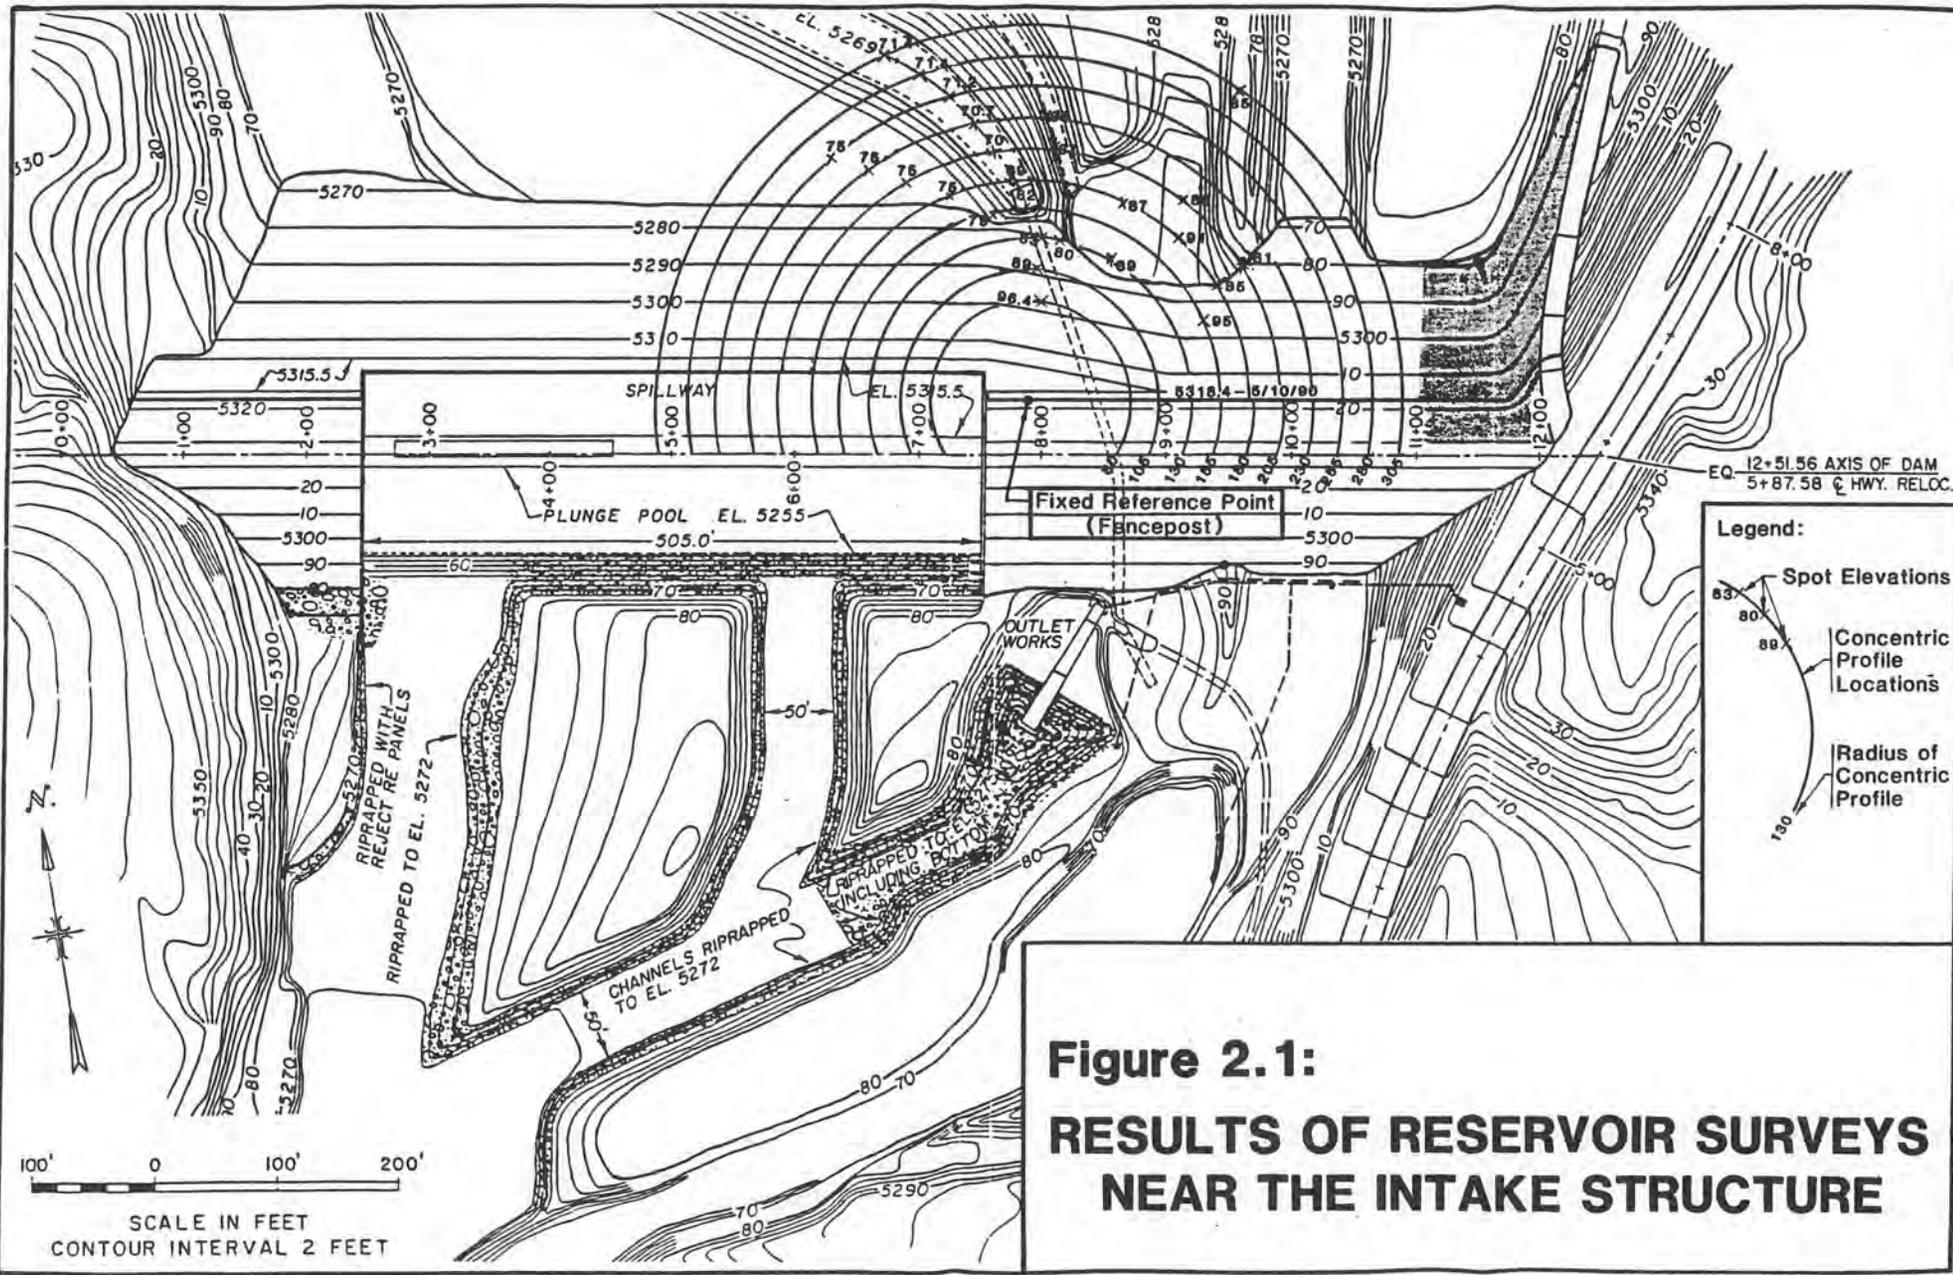
**Figure 2.1:**  
**RESULTS OF RESERVOIR SURVEYS**  
**NEAR THE INTAKE STRUCTURE**

Results of the survey are given in Figure 2.1, with spot elevations at various locations plotted on the as-built topography for the dam. Inspection of these results indicates that 1990 topography matches the as-built topography in all locations, except in the channel approaching the intake structure. At the intake structure the elevation is identical; however, within a short distance upstream sediment deposition up to about 2.5 feet has occurred in the channel.

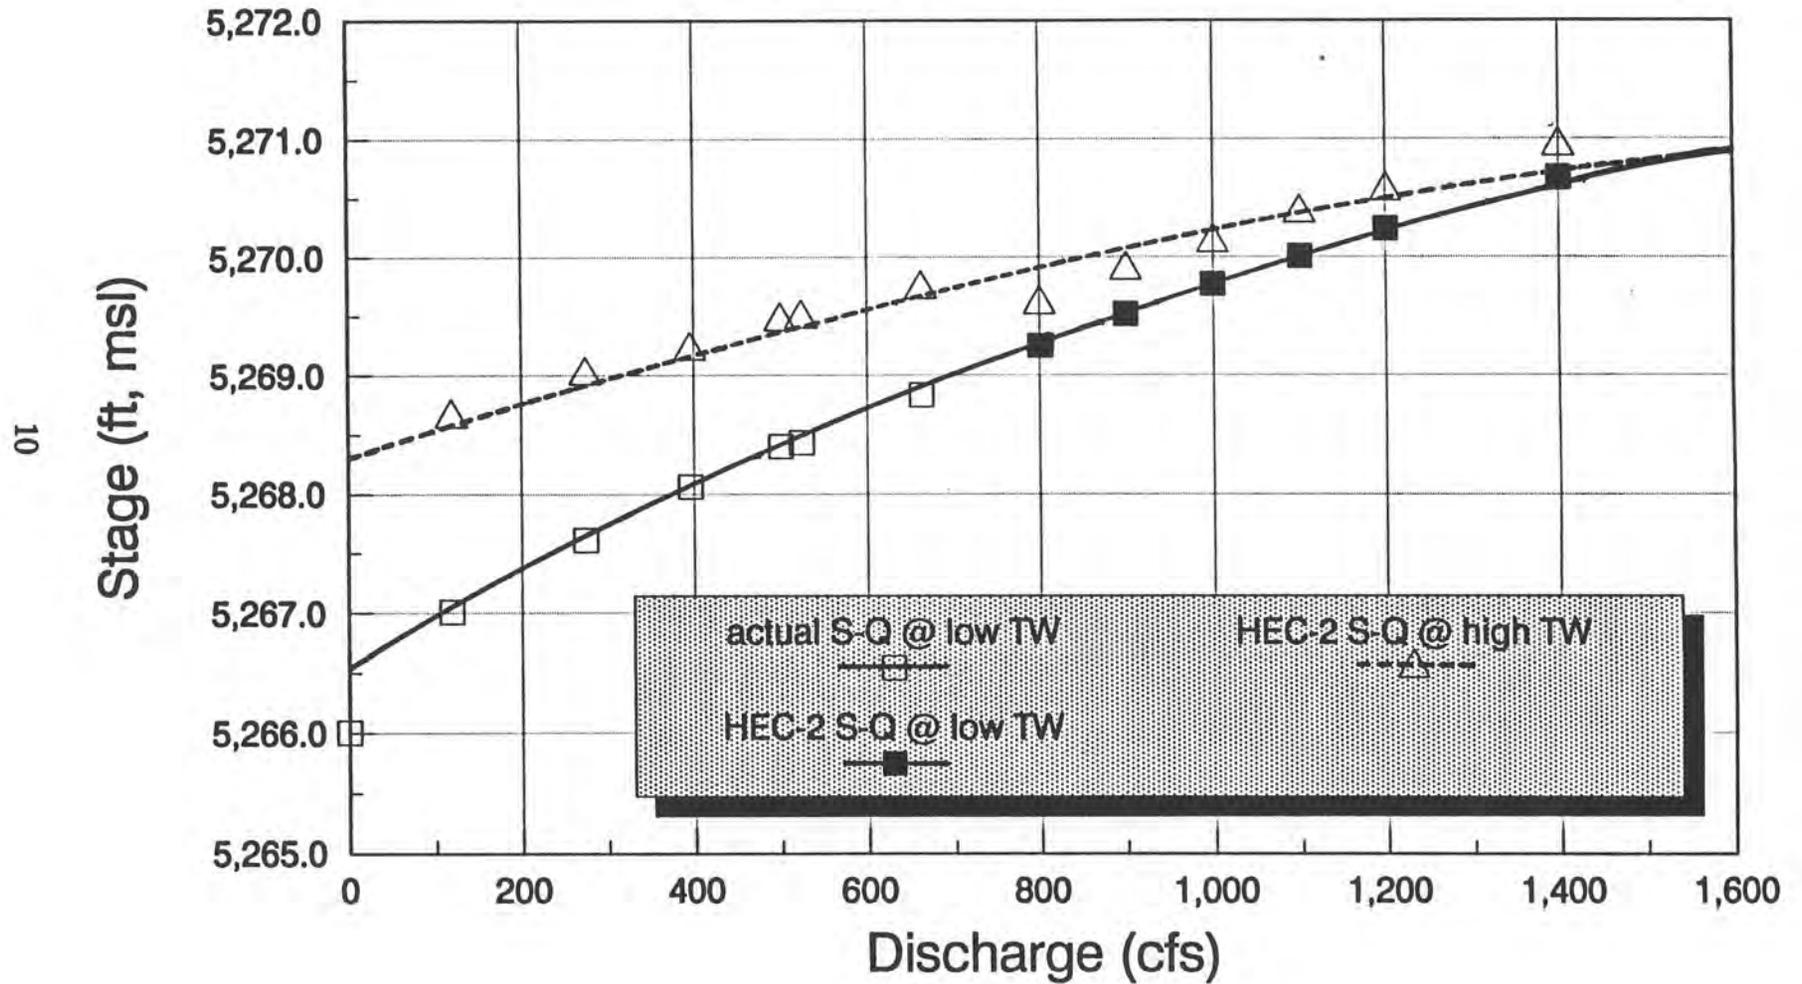
**Figure 2.3**  
**Taylor Draw Outlet Canal**  
**Stage-discharge Relationship**  
**HEC-2 cross section #5**

Results of this analysis are summarized in Figure 2.3. The low tailwater (TW) condition was based on the conditions in the White River the day the measurements were completed, while the high TW condition assumed that the stage on the White River was 2.0 feet higher, which was considered indicative of a significantly greater amount of water passing over the spillway. As would be expected, the influence of the downstream tailwater condition diminished with higher discharge through the outlet works. The band width defined by the low and high tailwater conditions defines the expected operating range of tailwater conditions in the outlet works for given discharges. These results were then used to define expected prototype conditions for the physical model study.

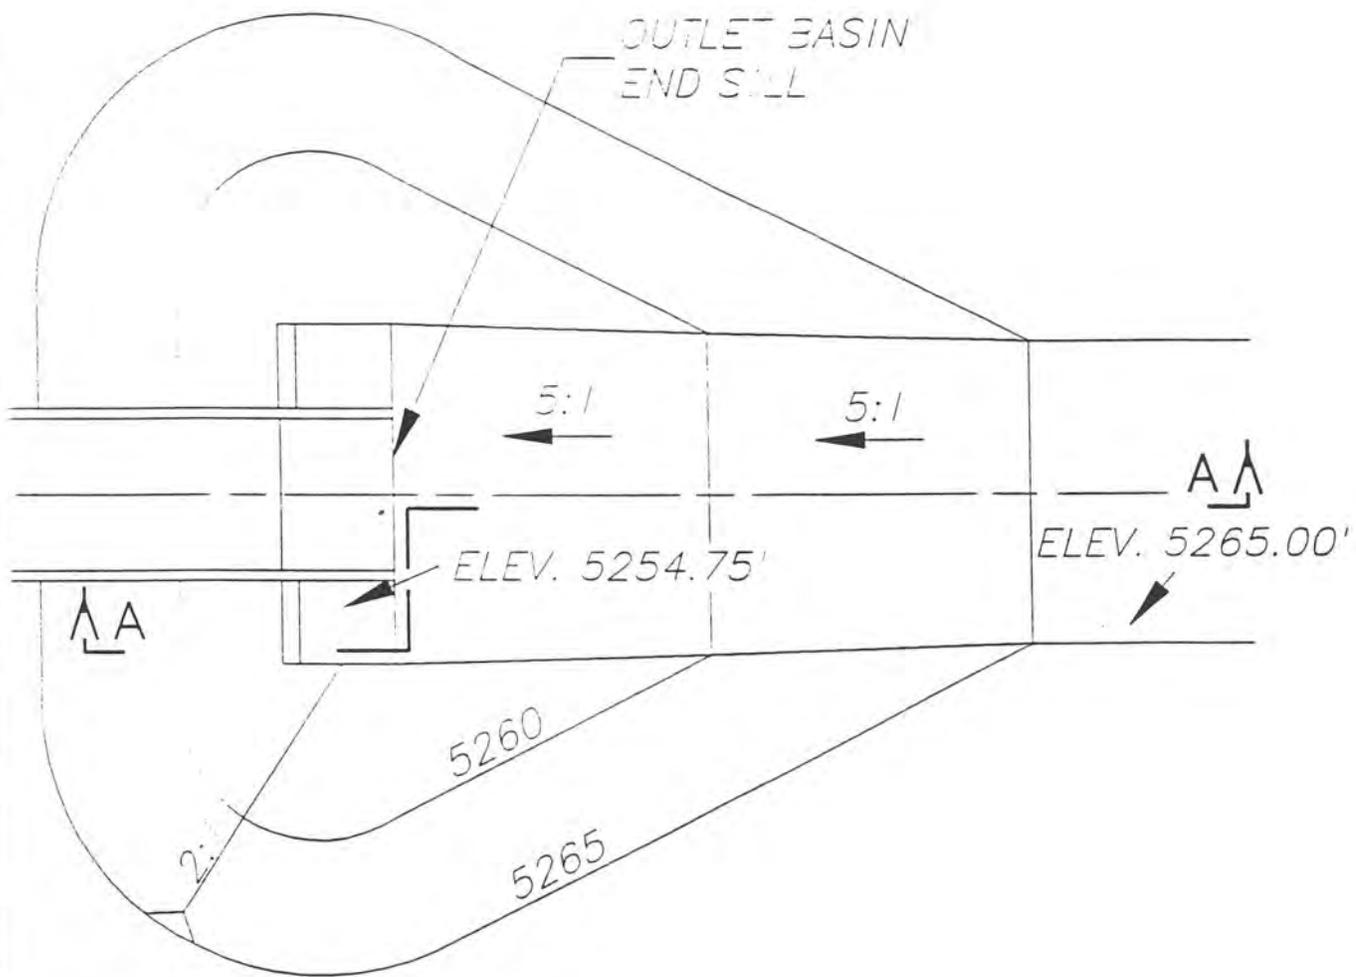
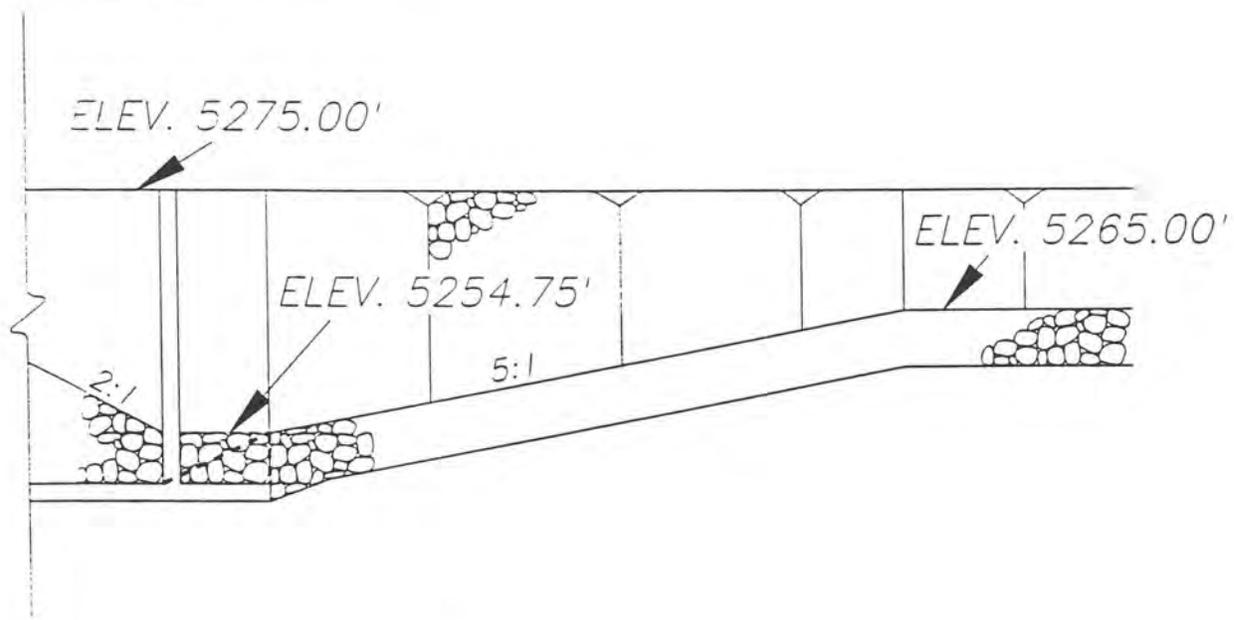
Figure 1. - Riprapped apron downstream of the stilling basin.

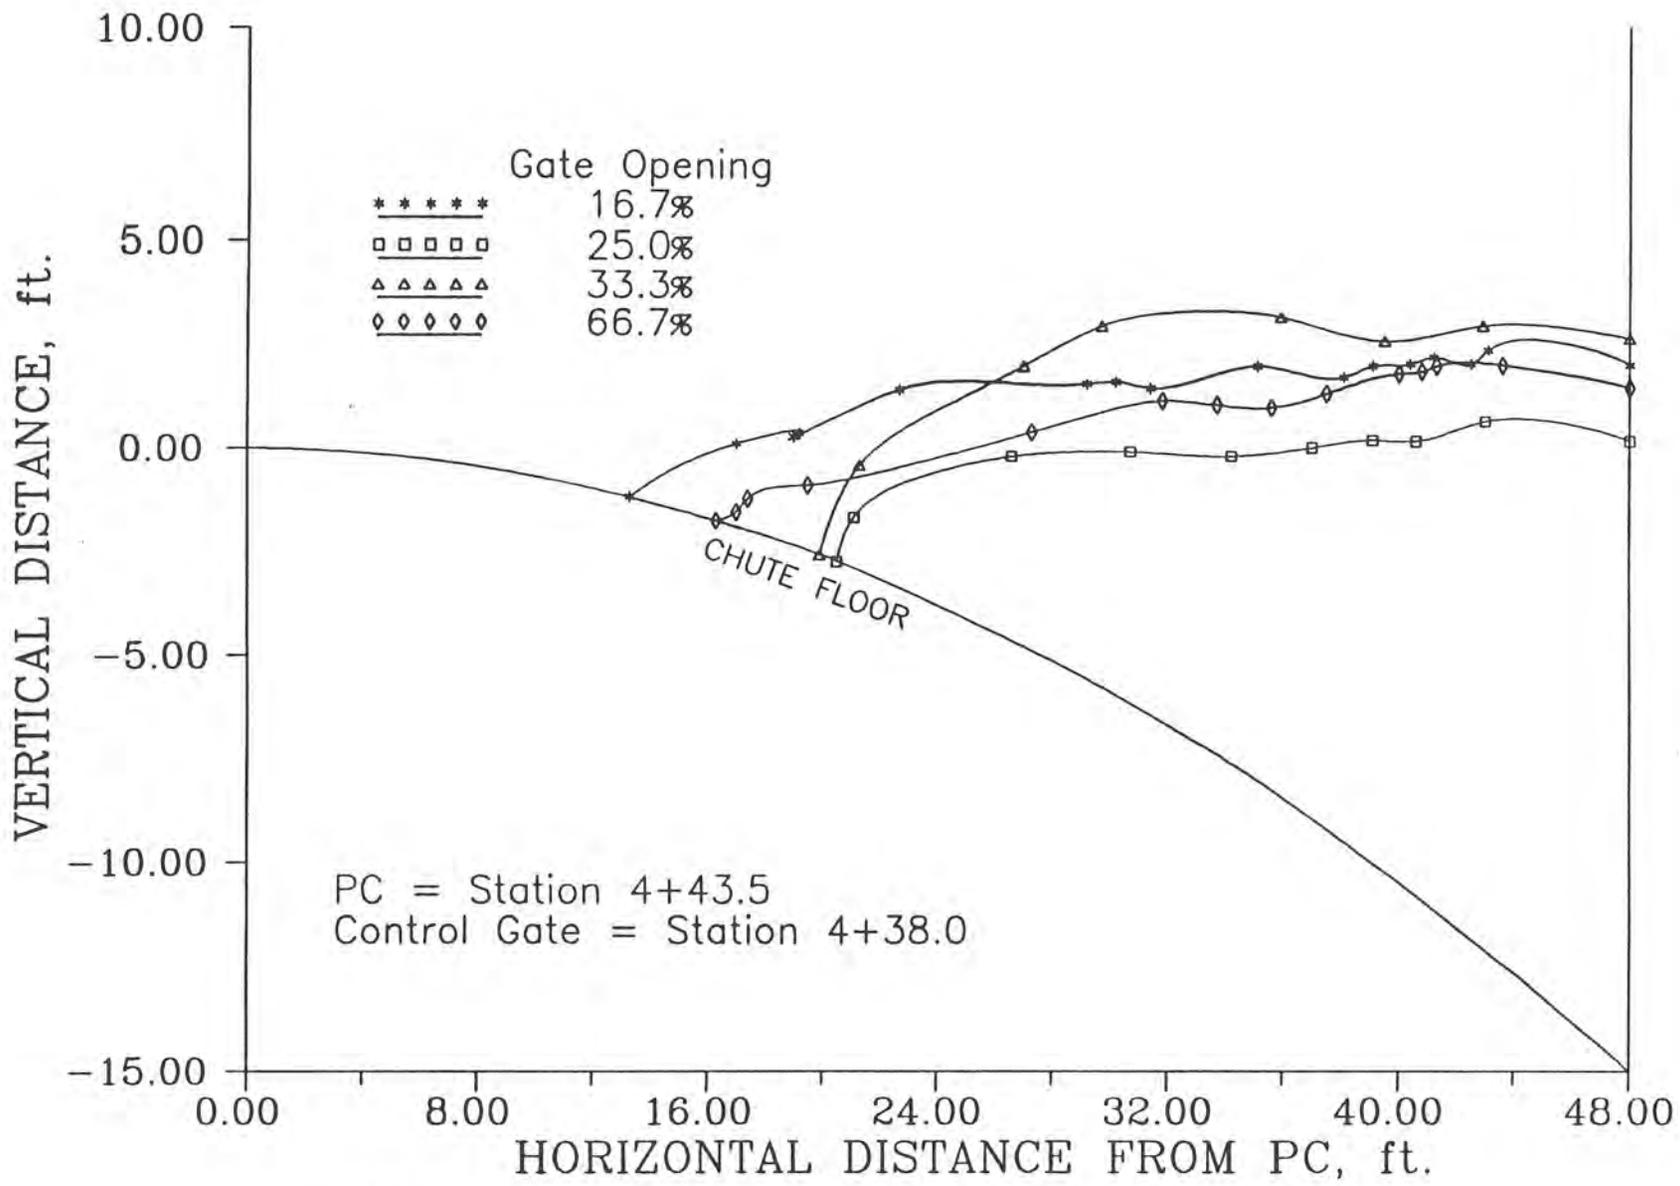
Figure 10 - Location of hydraulic jump on right wall of chute

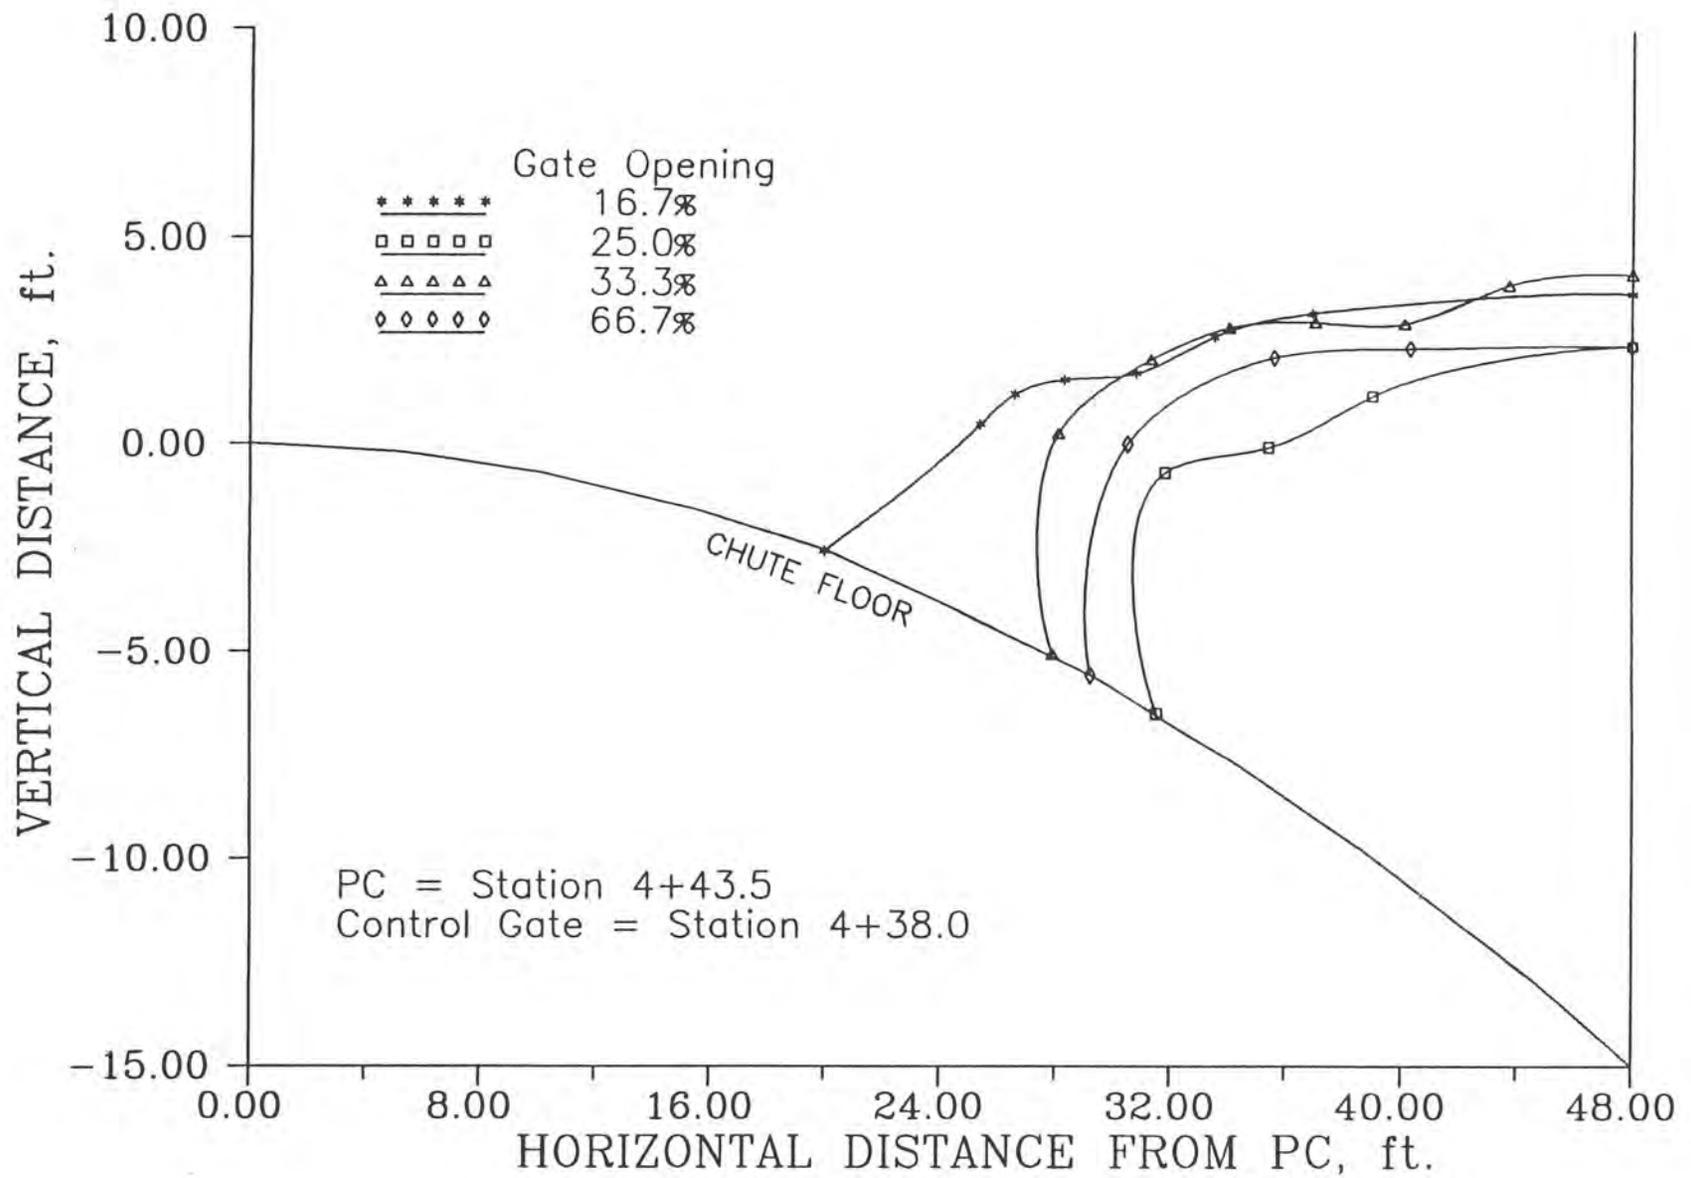
Figure 11. - Location of hydraulic jump on left wall of chute.

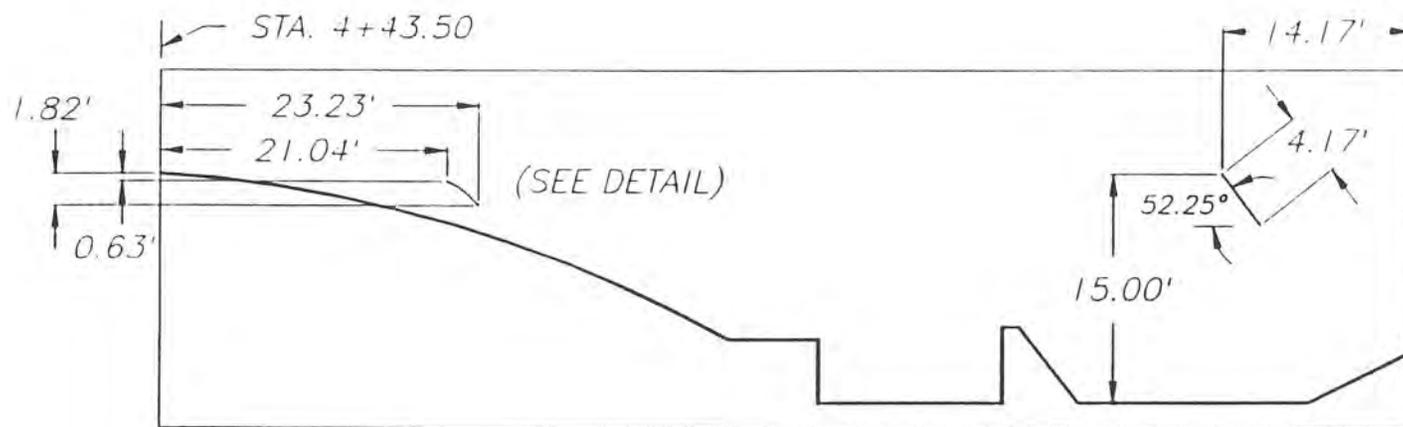
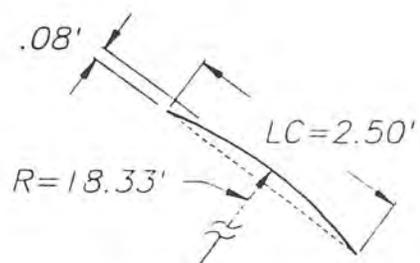
Figure 16. - Position of flow deflectors for the chute and stilling basin

A curved flow deflector was placed in the chute and a second flat deflector was placed downstream in the stilling basin, figure 16. The location and angle of these deflectors were varied to determine if they could be used to adjust the flow profile. The chute deflector was designed to force the flow down along the chute floor and reduce the lateral skewness.

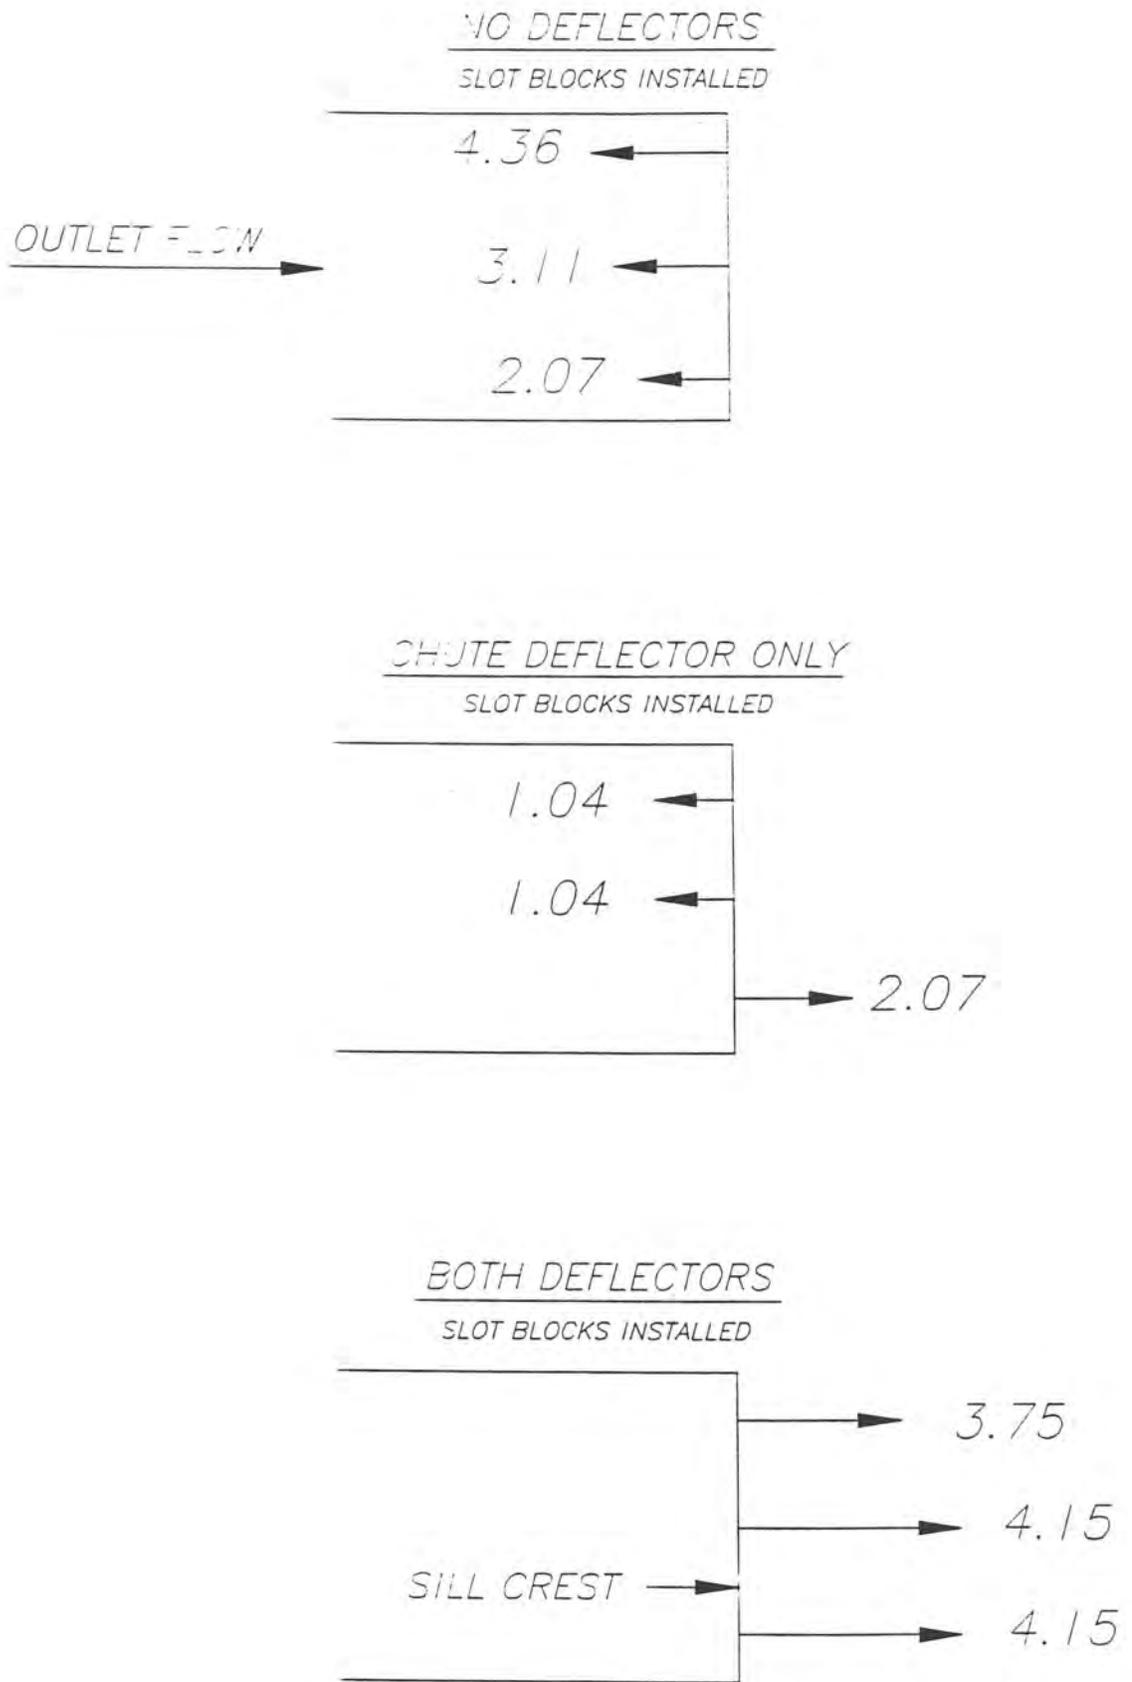
An evaluation of the modifications to the structure were conducted observing material movement and measuring flow velocities over the basin end sill as modifications were added. The basin flow in the as-built draws the most material into the basin at about 25 pct gate opening, therefore a 25 pct gate opening was chosen for velocity measurements. Velocity measurements were made of; (1) as-built with slots upstream of gate filled, (2) filled slots and upstream deflector, and (3) filled slots with both the upstream and downstream deflectors. Velocities were measured just above the interface between sill and the riprap apron. Velocities were measured at three positions across the end sill; near both the basin walls and at the center. A comparison of the velocity measurements are shown in Figure 19. Results of these tests were as follows.

Figure 19. - Velocities measured above the end sill, ft/s
