PAP-646

**STRAIN MEASUREMENT ON THE RUNNER
OF A HYDROELECTRIC TURBINE**

August 1994

**Presented at the ASCE 1994 Symposium on Hydraulic
Measurements and Experimentation, Buffalo, New York**

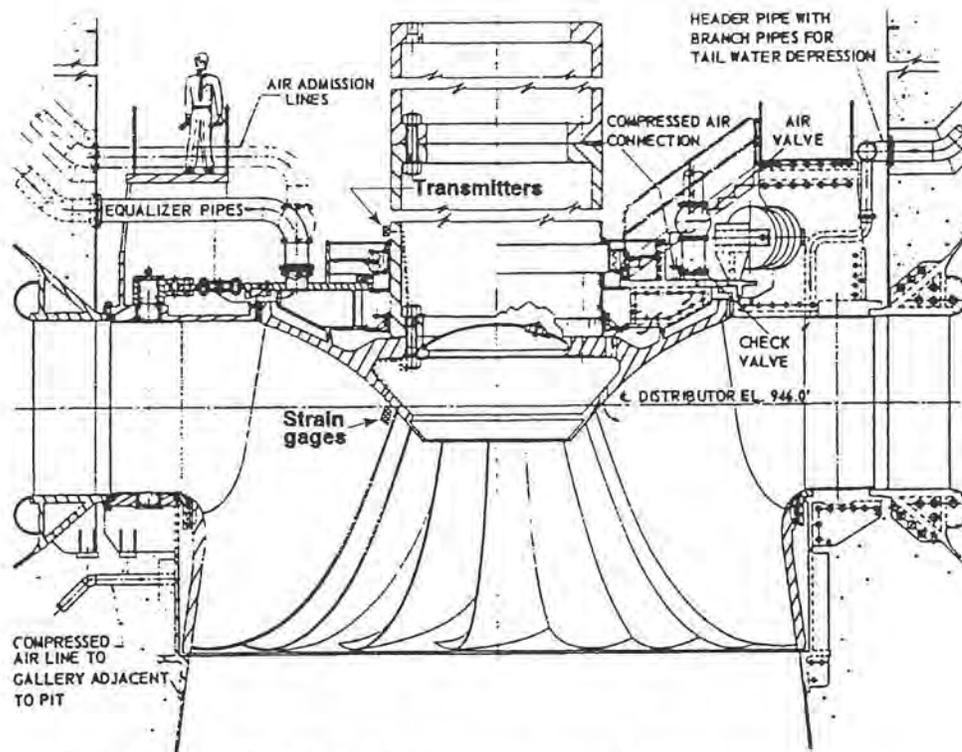
Figure 4: Cutaway of Unit G-23, showing general arrangement.

In addition to the four channels of telemetry, we also recorded unit speed, wicket gate position, and electrical load. The feeds for these inputs were provided by permanent sensors at the powerplant. All signals were recorded on a TEAC RT-111 Digital Audio Tape recorder. Figure 4 shows a cutaway of the turbine, showing the general strain gage and transmitter locations.
