**Terror Lake Hydroelectric Project, Falls Creek Diversion Tunnel
Hydraulic Analysis**

**Terror Lake Hydroelectric Project
Falls Creek Diversion Tunnel
Hydraulic Analysis**

Terror Lake Hydroelectric Project Repair of Falls Creek Diversion Works

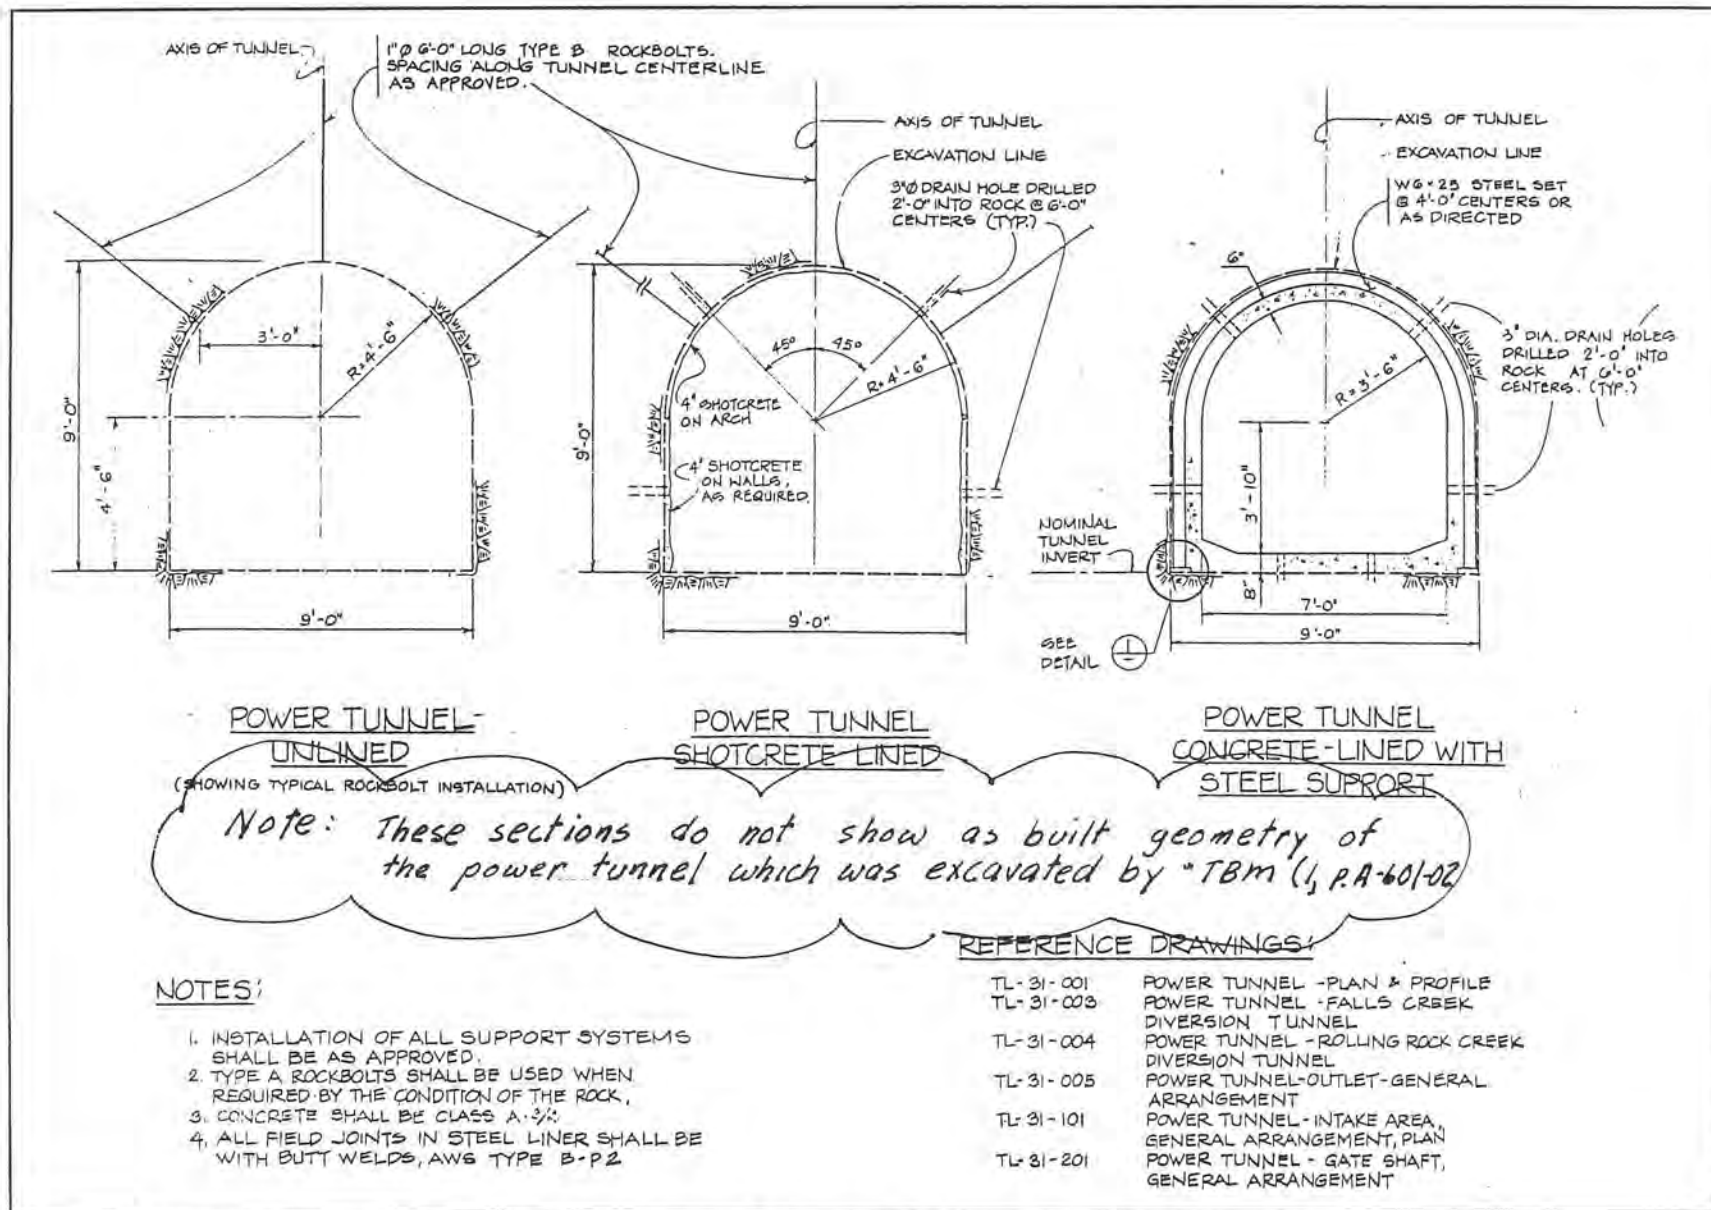
Figure A.3 Typical Sections Falls Creek Diversion (from Kodiak Electric Association, Inc. drawing TL-31-002)

Figure A.3 shows selected typical tunnel sections and notes from drawing TL-31-002. These sections may represent the geometry and support in Falls Creek Diversion Tunnel, but the Power Tunnel was excavated by Tunnel Boring Machine (TBM) so the original sections shown on Figure A.3 do not show the as-built geometry of the Power Tunnel.
