Operation of Glen Canyon Dam Spillways - Summer 1983

Philip H. Burgi 1/, M., ASCE, Bruce M. Moyes 2/, Thomas W. Gamble 3/

**Abstract.** - Flood control at Glen Canyon Dam is provided by a 41-ft (12.5-m) diameter tunnel spillway in each abutment. Each spillway is designed to pass 138 000 ft<sup>3</sup>/s (3907.7 m<sup>3</sup>/s). The spillways first operated in 1980 and had seen very little use until June 1983. In early June the left spillway was operated for 72 hours at 20 000 ft<sup>3</sup>/s (566.3 m<sup>3</sup>/s). After hearing a rumbling noise in the left spillway, the radial gates were closed and the tunnel was quickly inspected. Cavitation damage had occurred low in the vertical bend, resulting in removal of approximately 50 yd<sup>3</sup> (38.2 m<sup>3</sup>) of concrete. Flood flows continued to fill the reservoir. Both spillways were operated releasing a total of 1 626 000 acre-ft (2.0 x 10<sup>9</sup> m<sup>3</sup>) over a period of 2 months. Extensive cavitation damage occurred in both spillways in the vicinity of the vertical bend.

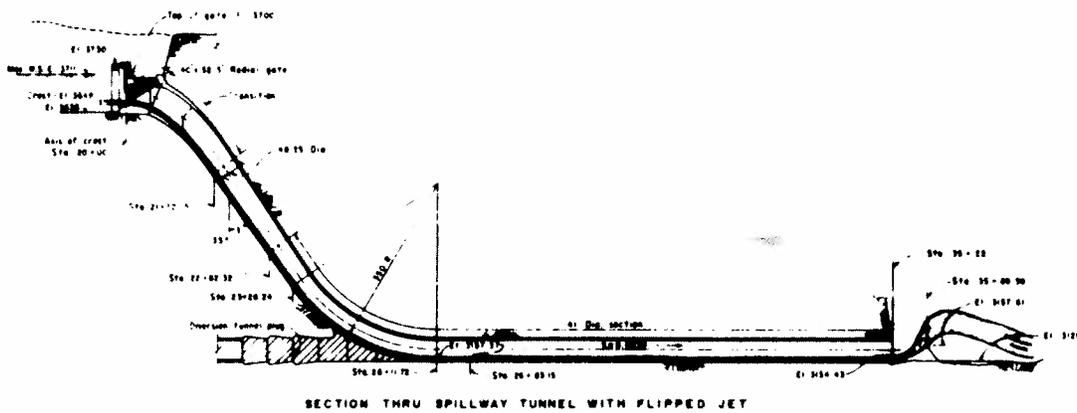
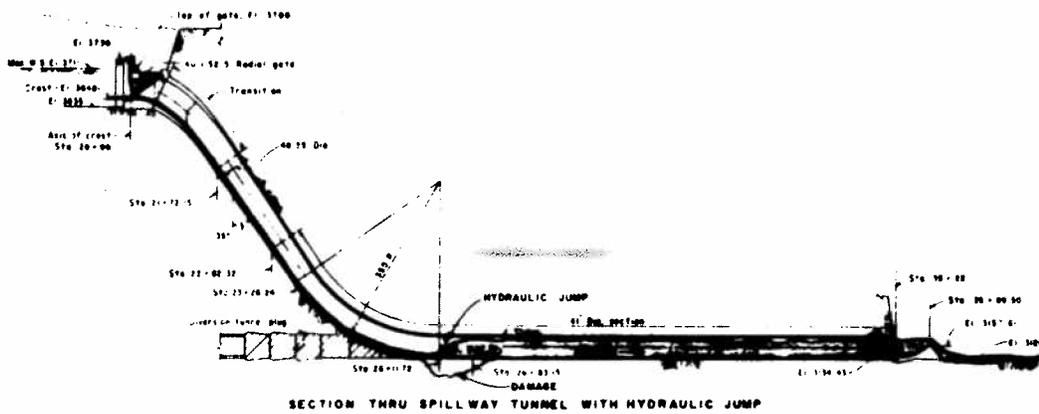
Figure 2b Elevation view of tunnel spillway.

From June 16-23, the discharge through the left tunnel spillway was increased as needed from 12 000 to 23 000 ft<sup>3</sup>/s (339.8 to 651.3 m<sup>3</sup>/s) to ensure a continued flip from the tunnel bucket, figure 2b. This operational plan proved successful and provided an additional 16 days of "productive life" for the right spillway. To increase storage capacity in Lake Powell and continue controlled releases through the spillways, 8-ft (2.4-m) high metal flashboards were designed and used to replace the wooden flashboards on top of the gates. Analysis indicated that 8-ft flashboards would only marginally overstress the gates. This was acceptable on a temporary basis. The metal flashboards provided an additional 1.3 million acre-ft (1.60 x 10<sup>9</sup> m<sup>3</sup>) of storage in Lake Powell. The flashboards proved to be very useful on the downside of the hydrograph when the spillway gates were closed on July 23 with a reservoir El. 3707.8 (EL 1130.0), some 7.8 ft (2.38 m) - 1.25 million acre-ft (1.5 x 10<sup>9</sup> m<sup>3</sup>) - above the top of the gates.

SECTION THRU SPILLWAY TUNNEL WITH FLIPPED JET

SECTION THRU SPILLWAY TUNNEL WITH HYDRAULIC JUMP
