WILLOW CREEK FEEDER SYSTEM

GAME RANGE REACH EROSION CONTROL AND BANK STABILIZATION PLAN

US Department of the Interior
U.S. Bureau of Reclamation

MAY 15, 2000

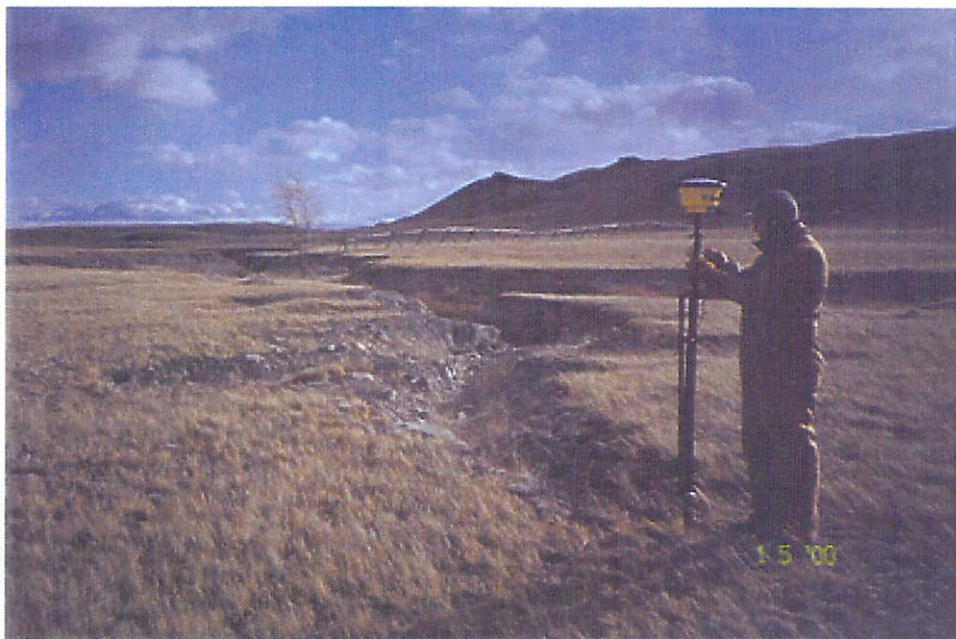
Photograph 0570-23. Gully #1 on left bank near fence at Bottom Reach.

| Photo Station | : 1+60 |

| Upstream Station | : 0+00 |
| Downstream Station | : 2+00 |

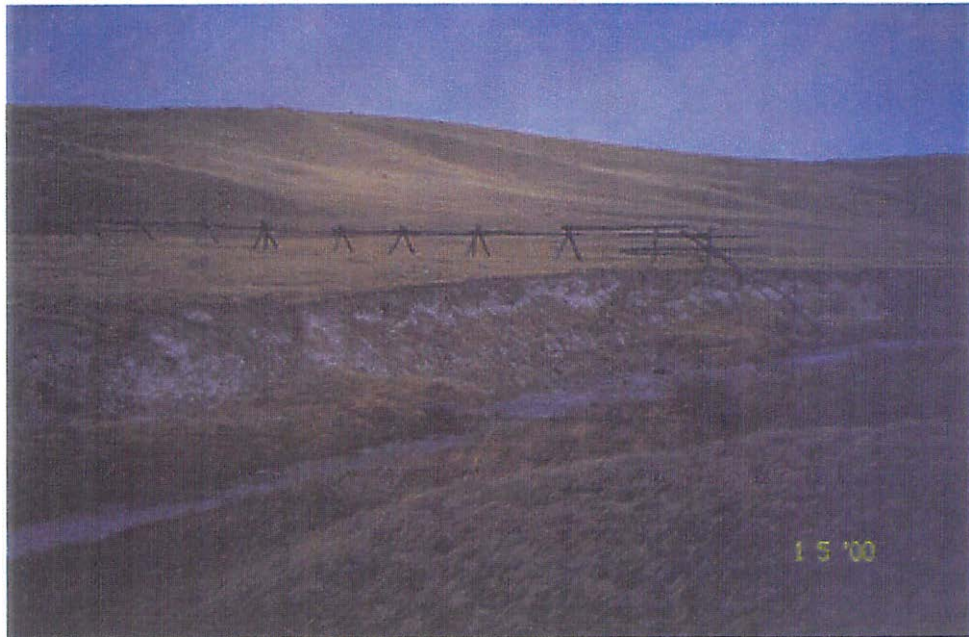
Photograph 0570-21. Left bank looking slightly DS.

| Photo Station | : 1+00 |

| Bank Stabilization | : See Photograph 0570-22. |

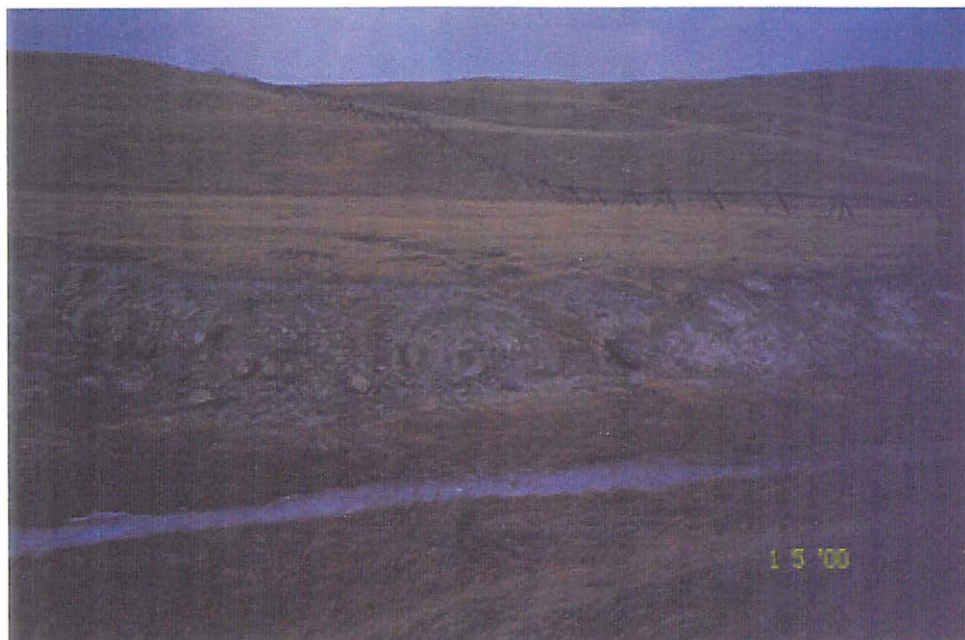
Photograph 0570-20. Left bank from opposite bank. Panned left from Photograph 0570-21.

Photo Station : 1+00
Bank Stabilization : See Photograph 0570-22.

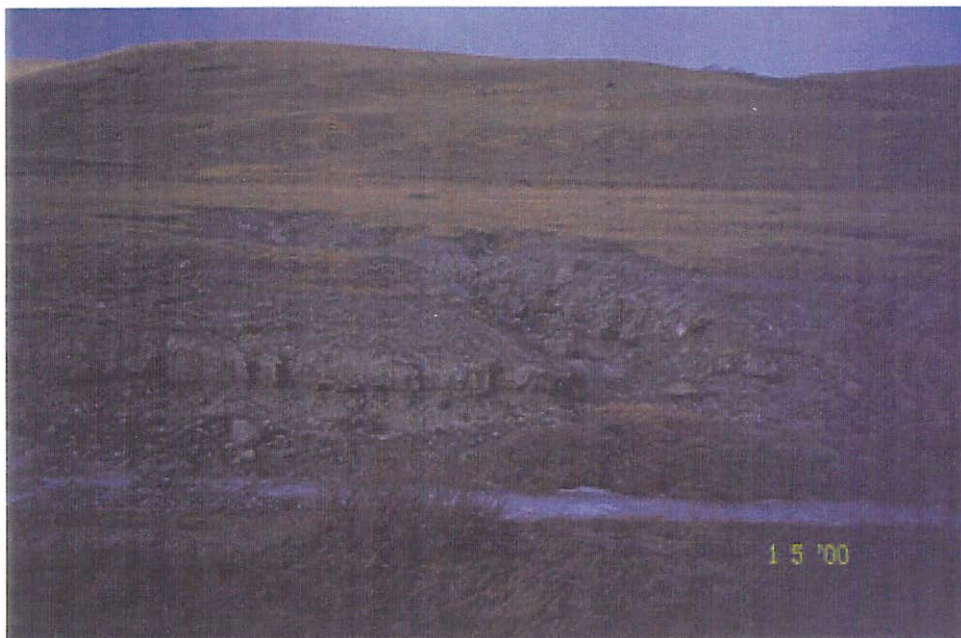
Photograph 0570-19. Left bank from opposite bank. Panned left from Photograph 0570-20.

Photo Station : 1+00
Bank Stabilization : See Photograph 0570-22.

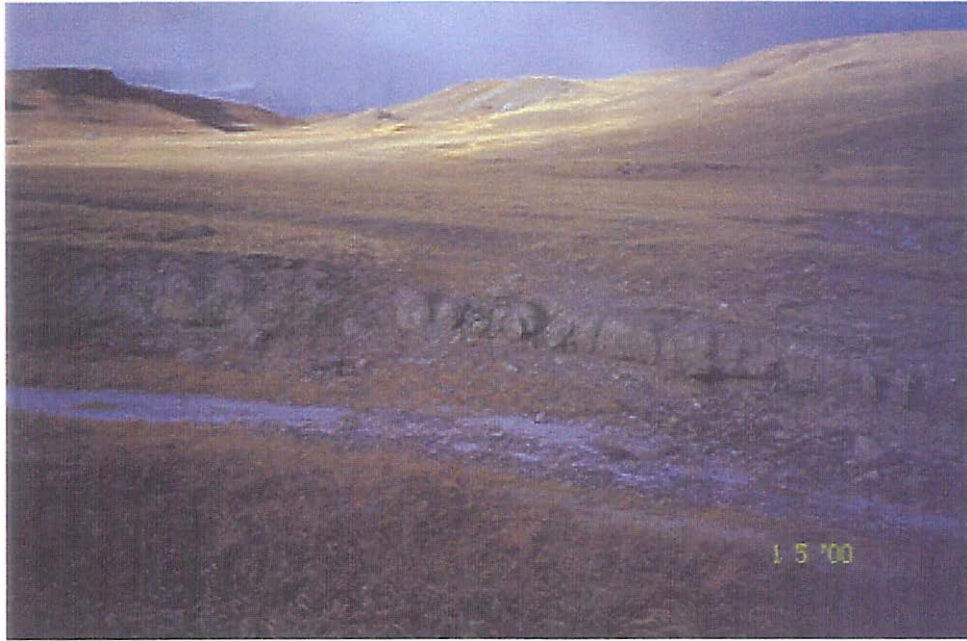
Photograph 0570-18. Left bank looking slightly US from Bottom Reach. Panned left from Photograph 0570-19.

Photo Station : 1+00
 Bank Stabilization : See Photograph 0570-22.

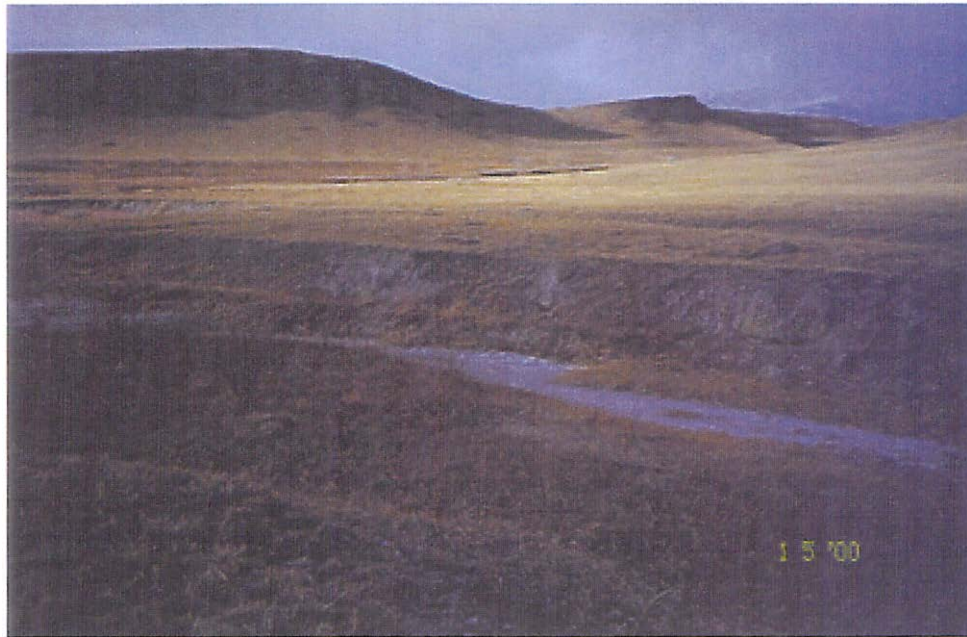
Photograph 0570-17. Left bank looking more US. Panned left from Photograph 0570-18.

Photo Station : 1+00
 Bank Stabilization : See Photograph 0570-22.

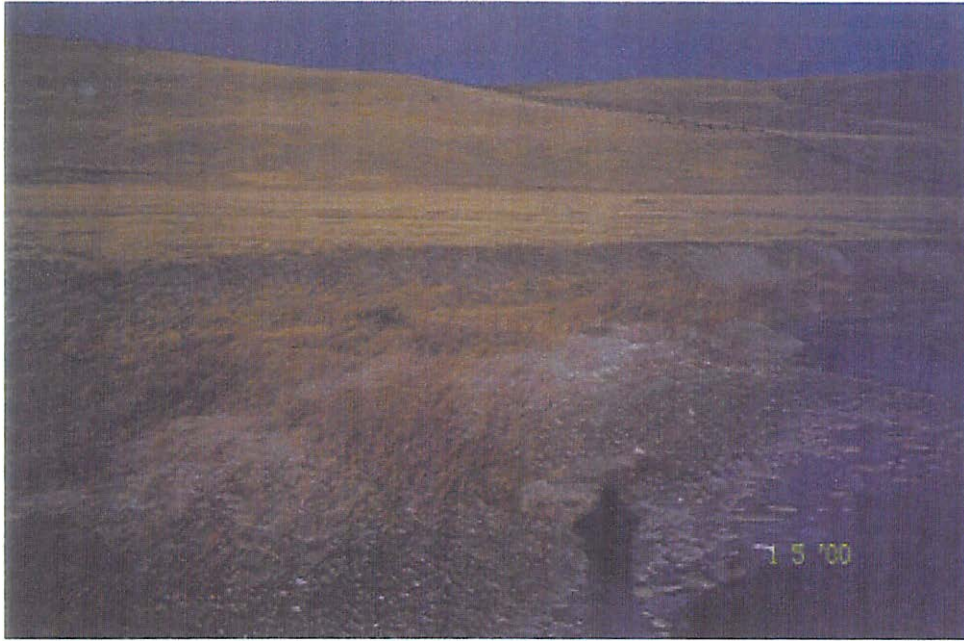
Photograph 0570-16. Left bank looking DS from bottom of Loop #1.

Photo Station : 4+00
Bank Stabilization : None.

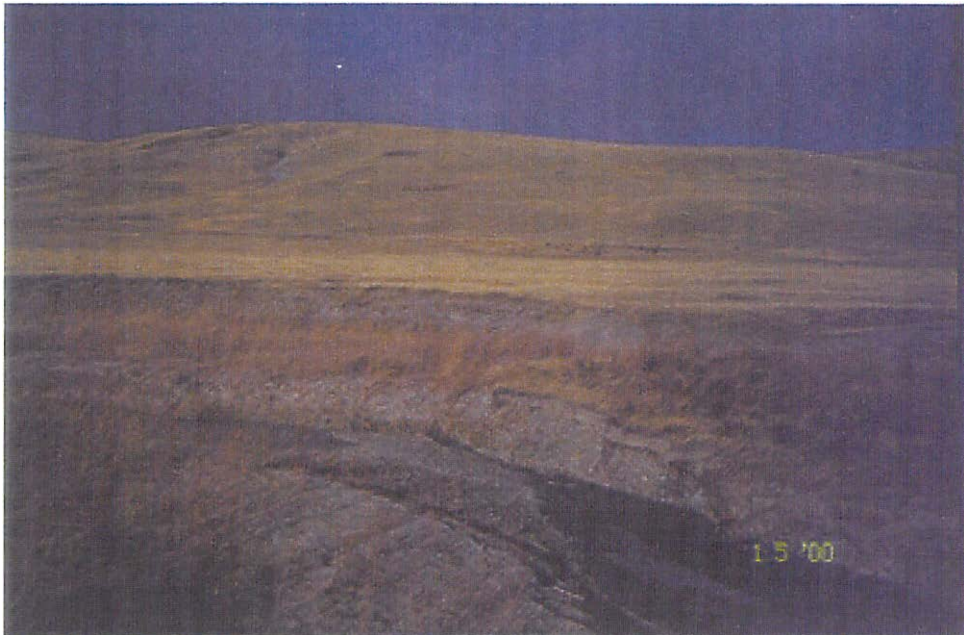
Photograph 0570-13. Left bank looking US at Loop #1. Panned left from Photograph 0570-16.

Photo Station : 4+00
Bank Stabilization : See Photo 0570-11.

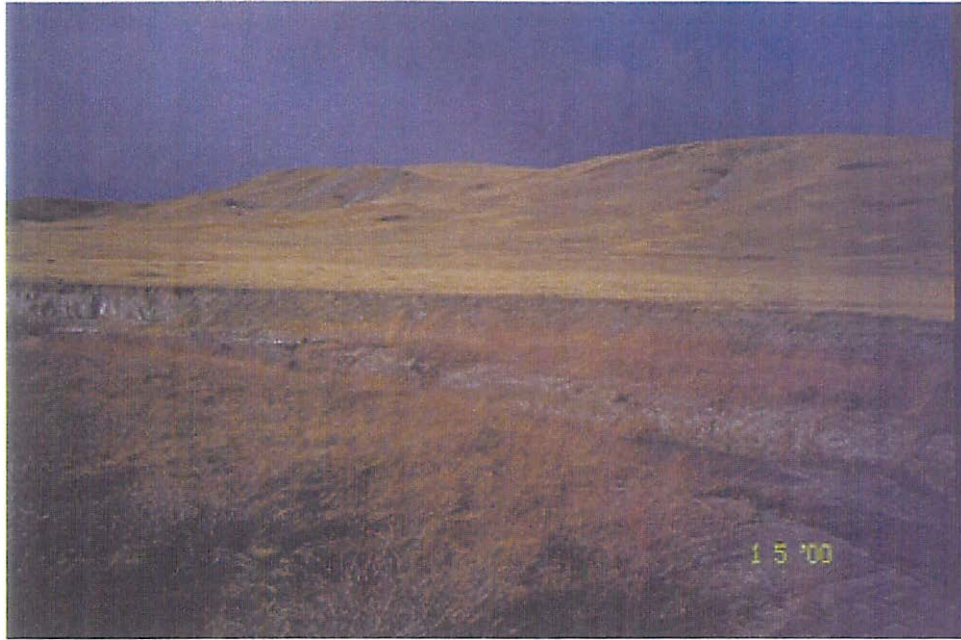
Photograph 0570-12. Left bank looking US of Loop #1. Panned left from Photograph 0570-13.

Photo Station : 4+00
 Bank Stabilization : See Photo 0570-11.

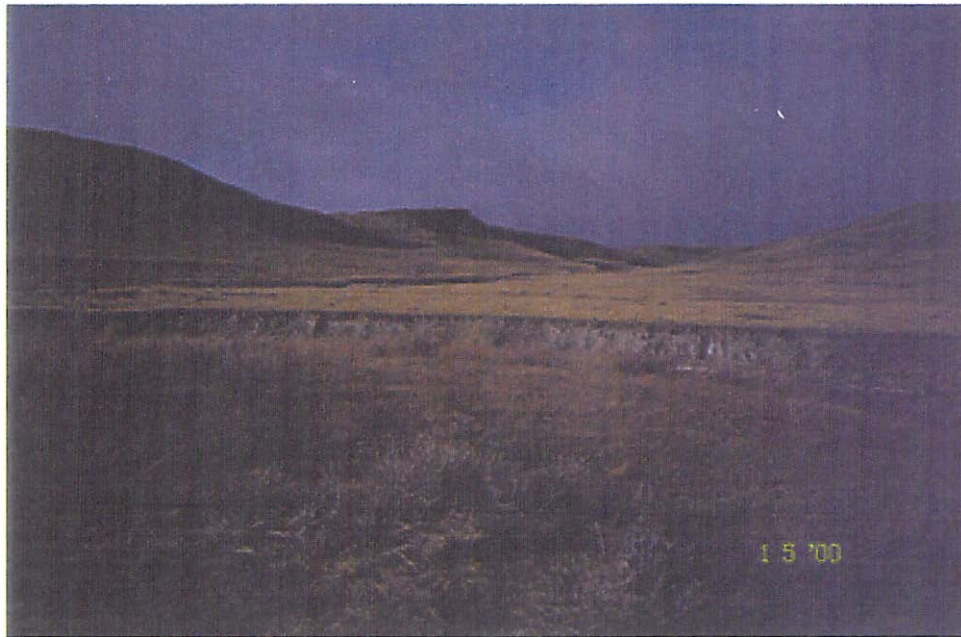
Photograph 0570-11. Left bank looking slightly US at upper Loop #1. Panned left from Photograph 0570-12.

Photo Station : 4+00
 Upstream Station : 8+00
 Downstream Station : 5+40
 Bank Stabilization : Medium priority barbs or longitudinal peaked stone toe protection on left bank
 : Bend Diameter: 160 ft; Channel Width: ~30 ft; Barb Length: 7.5 ft; Barb
 Spacing: 16.3 – 33.8 ft; No. of Barbs: 16 - 8

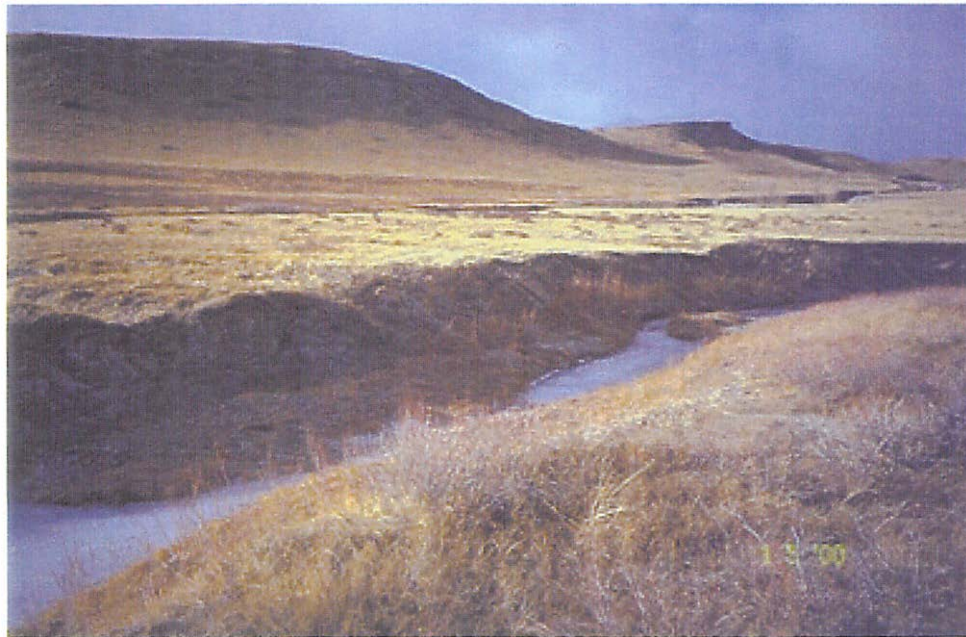
Photograph 0570-08. Left bank looking DS at upper Loop #1.

Photo Station : 9+00
Bank Stabilization : See Photo 0570-11.

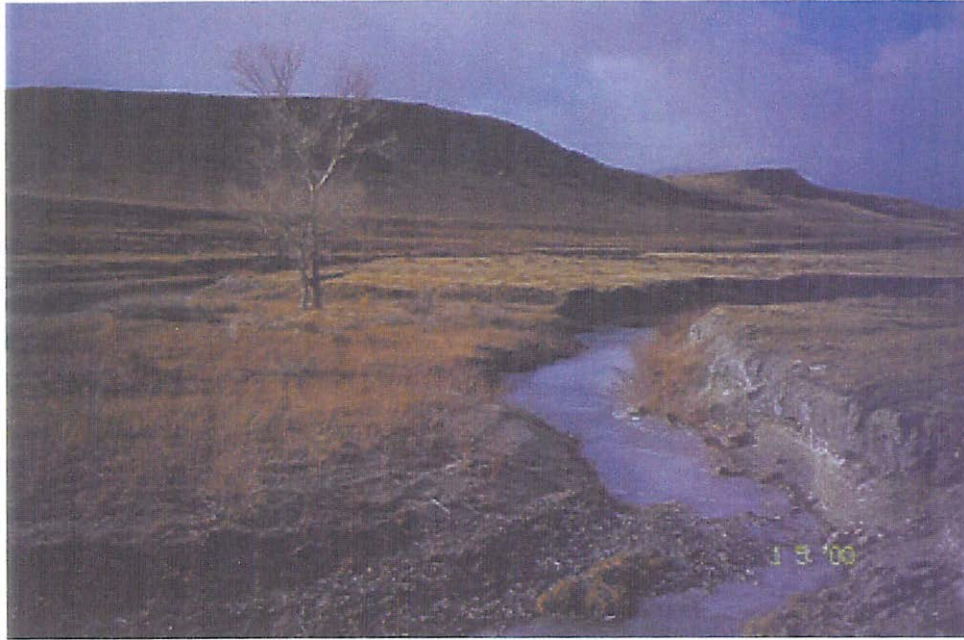
Photograph 0570-07. Both banks looking DS from Loop #2.

| Photo Station | : 10+00 |
| Upstream Station | : 10+75 |
| Downstream Station | : 9+90 |

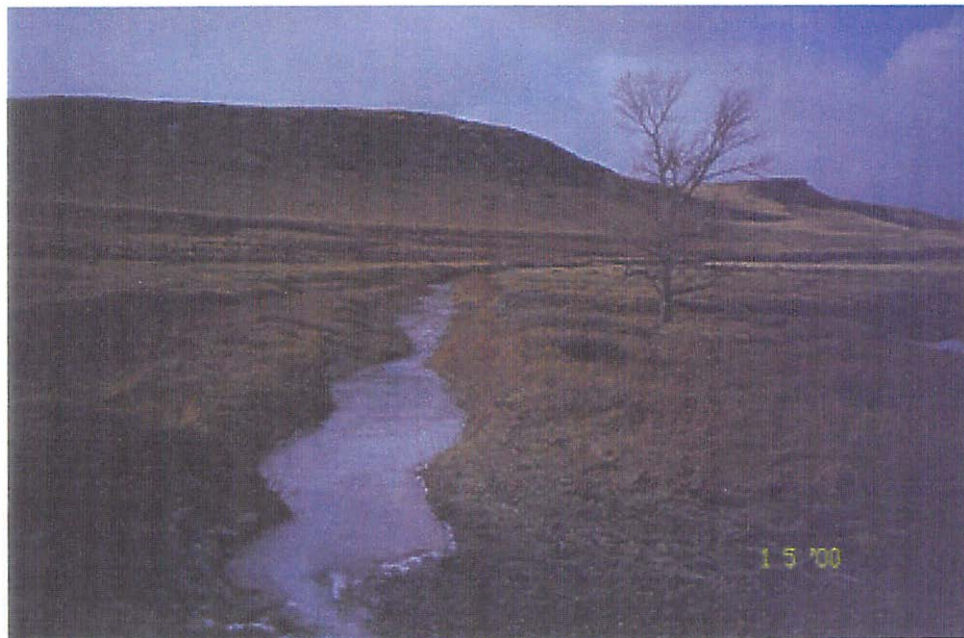
Photograph 0570-06. Looking US from Loop #2. Note riffle.

| Photo Station | : 10+40 |

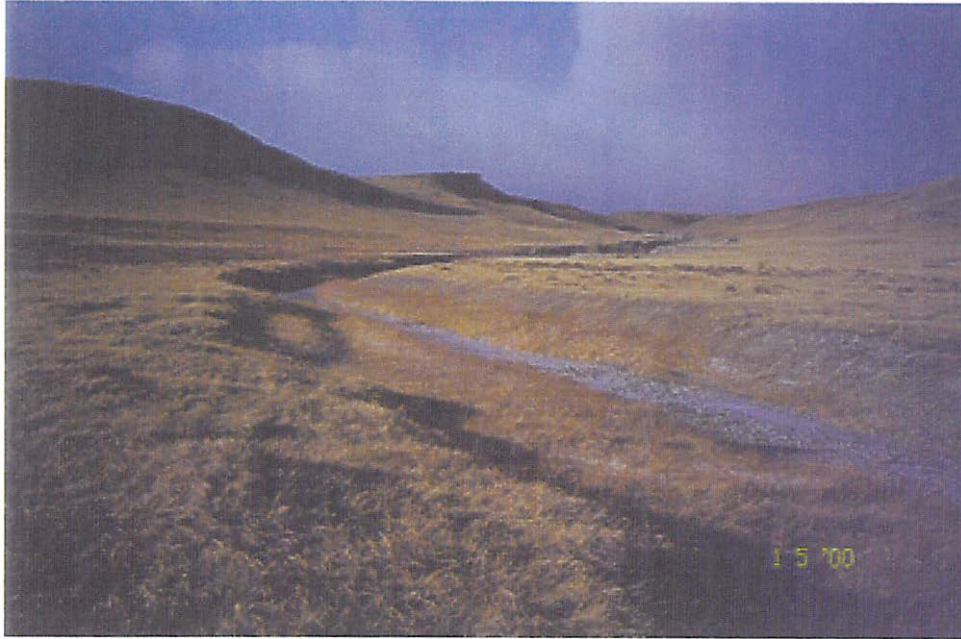
Photograph 0570-05. Looking US opposite riffle in Straight Reach #1.

Photo Station : 11+50
Bank Stabilization : None

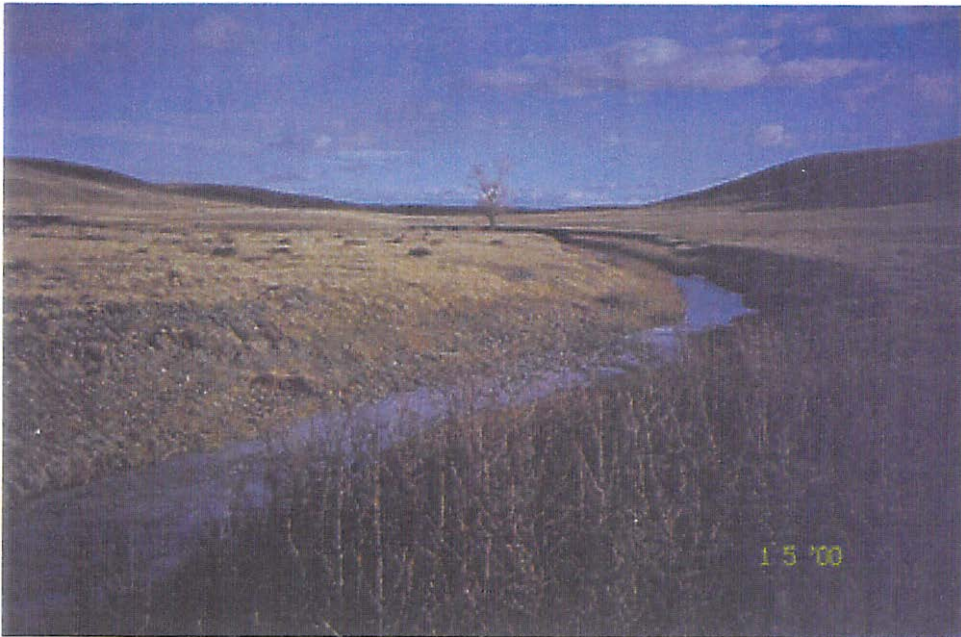
Photograph 0570-04. Looking DS at Straight Reach #1 in Photograph 0570-05 and Photograph 0570-06.

Photo Station : 15+25
Bank Stabilization : None

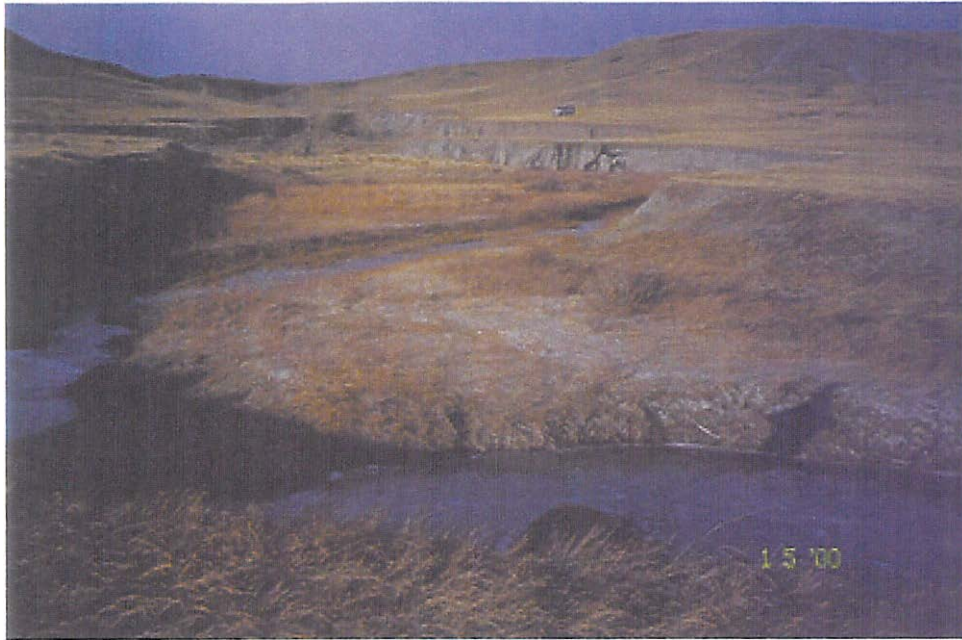
Photo Station : 17+00

Photograph 0570-02. Left bank, looking US from head of Straight Reach #1 on Loop #3. Note vehicle next to BM.

Bank Stabilization : See Photograph 0898-02. Barbs on outside (Right Bank) of Loop #3.

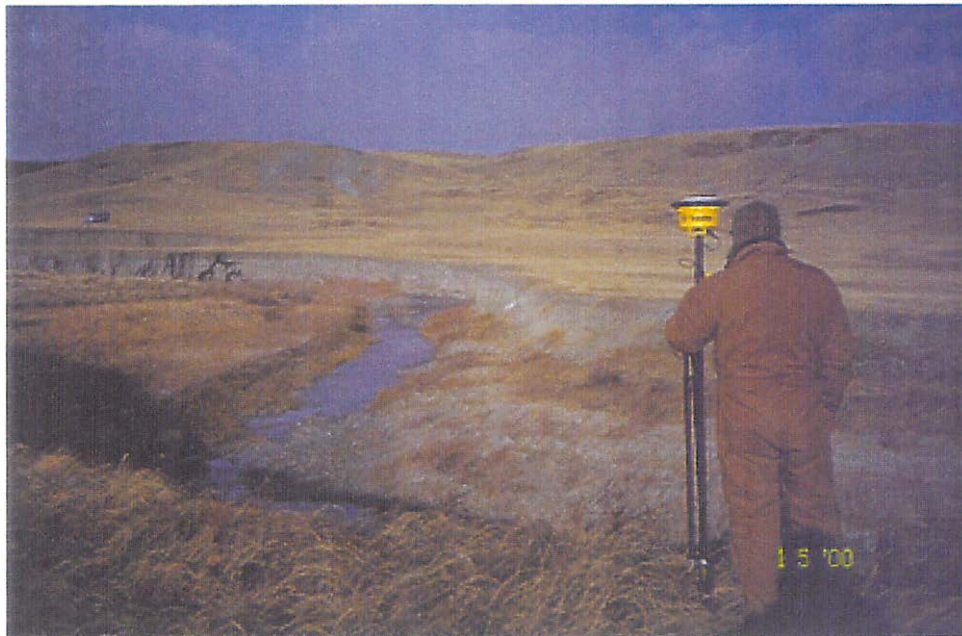
Photo Station : 17+60

Photograph 0570-01. Left bank, looking US at Loop #4. Will Gonzales.

Bank Stabilization : None. See Photograph 0570-26 and Photograph 0570-27.

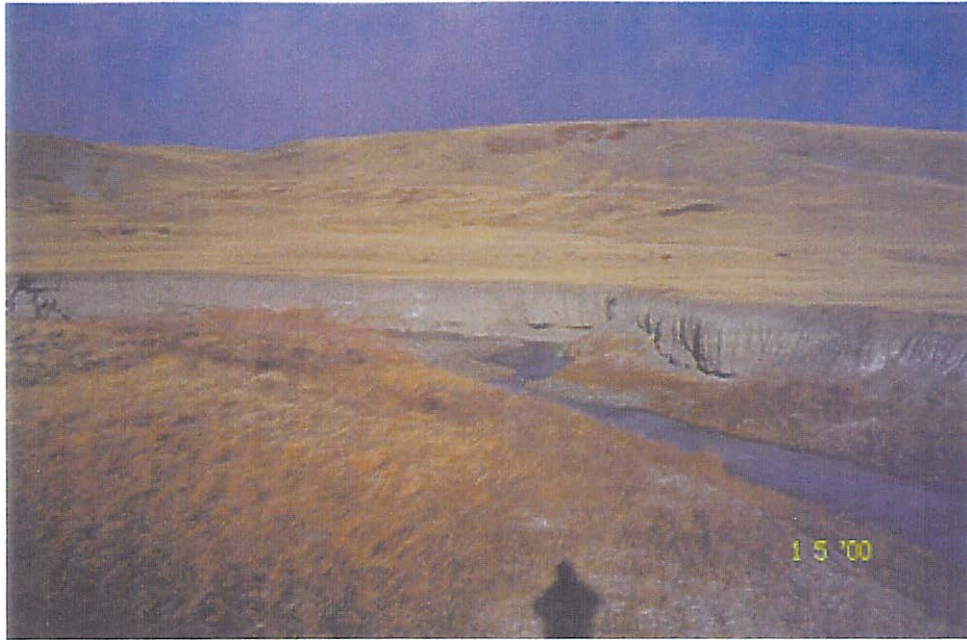
Photograph 0570-26. Left bank, looking US at lower Loop #4.

Photo Station : 18+30
 Upstream Station : 21+20
 Downstream Station : 19+70
 Bank Stabilization : Barbs on left bank.; Bend Diameter : 124 ft; Channel Width: ~30 ft; Barb Length: 7.5 ft; Barb Spacing: 7.9 – 20.8 ft; No. of Barbs: 12 - 6

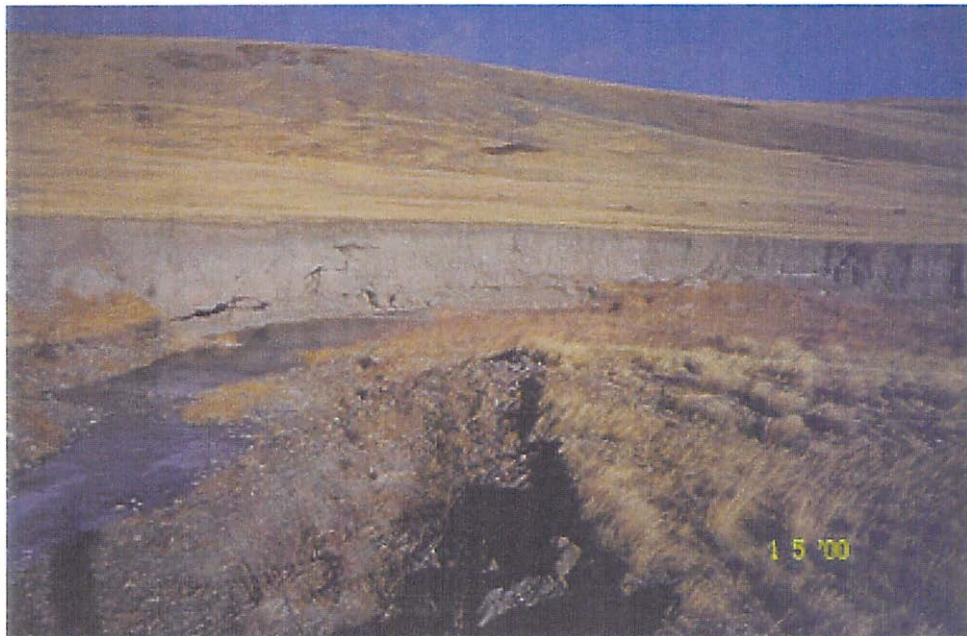
Photograph 0570-27. Left bank, looking DS at upper Loop #4.

Photo Station : 22+00
 Bank Stabilization : See Photograph 0570-26.

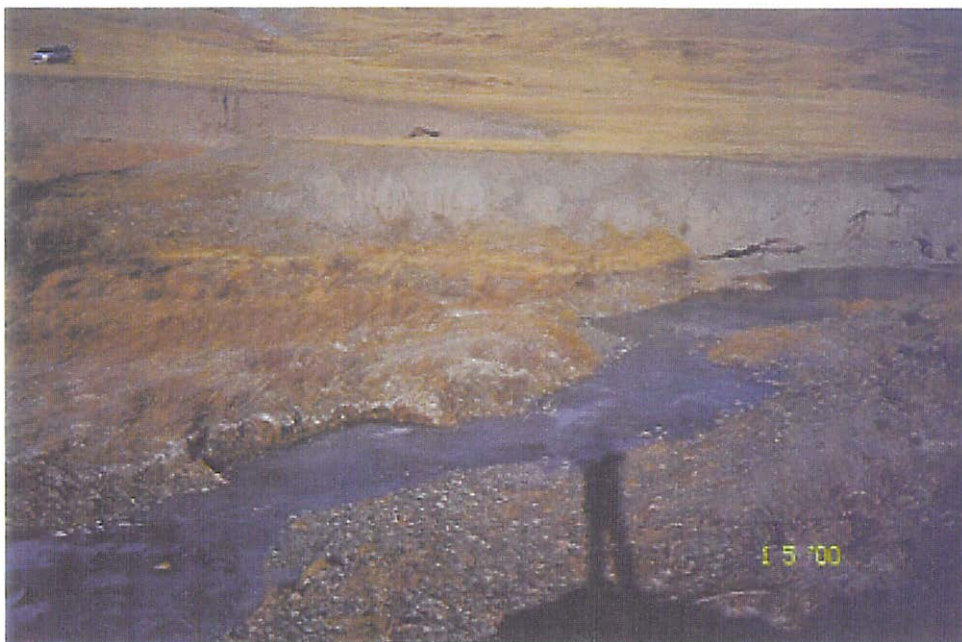
Photograph 0570-28. Left bank, opposite "point," from Loop #5. Panned left from Photograph 0570-27.

Photo Station : 22+00
 Bank Stabilization : See Photograph 0570-26

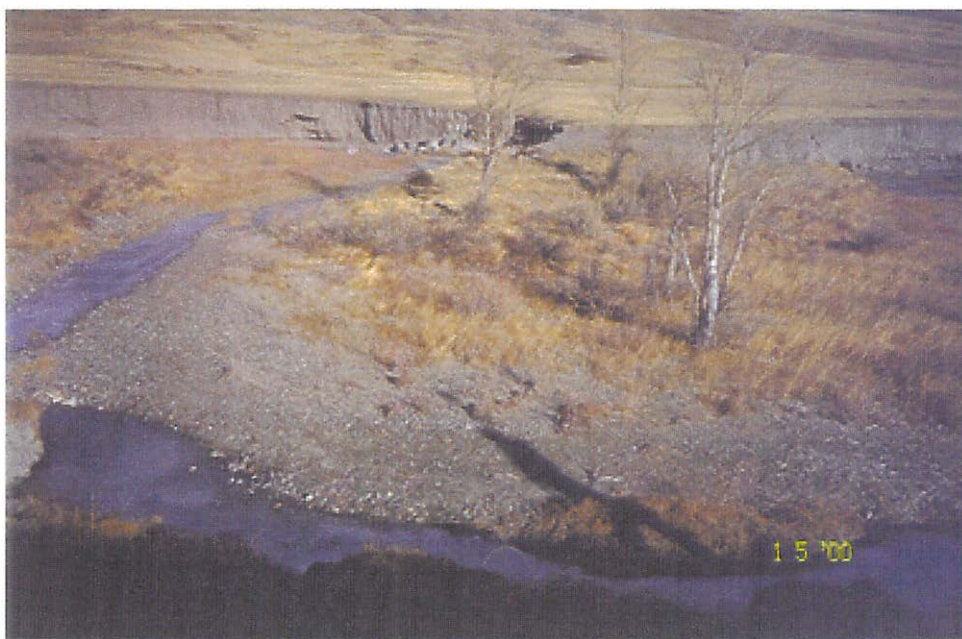
Photograph 0570-30. Left bank and point bar, looking slightly US at lower Loop #6.

Photo Station : 23+60
 Bank Stabilization : Barbs below on right bank of Loop #5. See Photograph 0898-03.

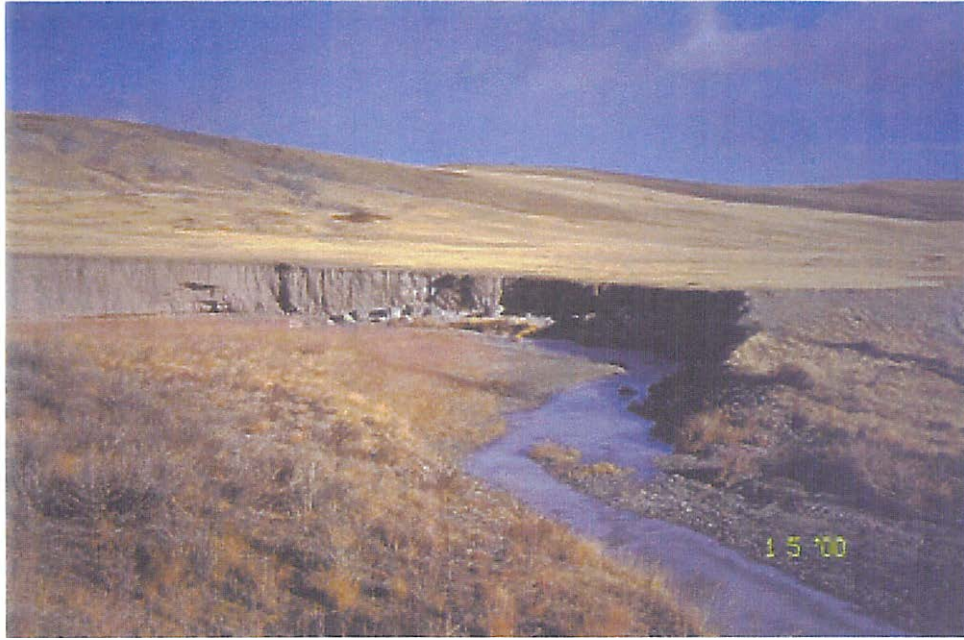
Photograph 0570-31. Left bank looking US at Loop #6.

Photo Station : 24+30
 Upstream Station : 27+70
 Downstream Station : 25+60
 Bank Stabilization : Barbs on left bank of Loop #6; possible Headcut stabilization at lower end of Loop #6; Bend Diameter: 141 ft; Channel Width: ~30 ft; Barb Length: 7.5 ft; Barb Spacing: 14.7 – 31.6 ft; No. of Barbs: 15 - 7

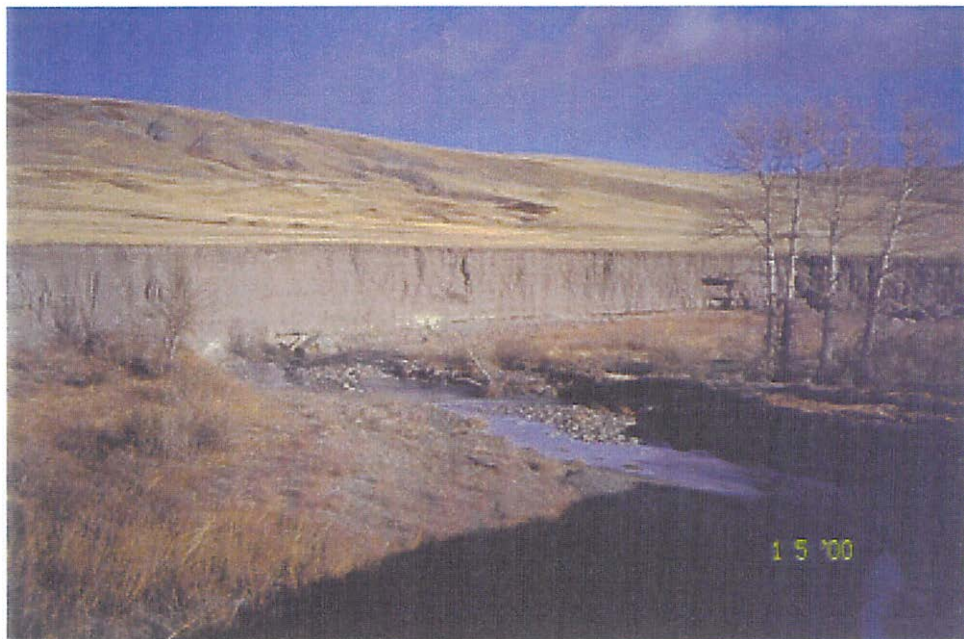
Photograph 0570-32. Left bank looking DS at Loop #6.

Photo Station : 30+20
 Bank Stabilization : See Photograph 0570-31.

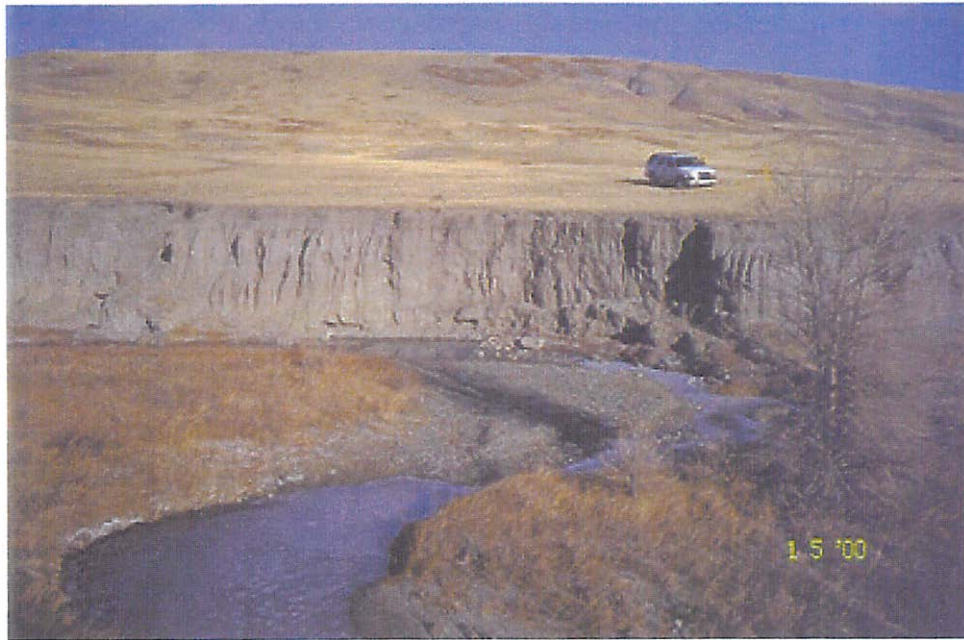
Photograph 0570-33. Left bank looking US at Loop #8 from Loop #7 bank. Panned left from Photograph 0570-32.

Photo Station : 30+20
 Upstream Station : 32+00
 Downstream Station : 31+20
 Bank Stabilization : Longitudinal peaked stone toe protection or barbs on left bank of Loop #8;
 possible headcut stabilization structure at bottom of Loop #8. Bend Diameter:
 72 ft; Channel Width: ~30 ft; Barb Length: 7.5 ft; Barb Spacing: 8.6 – 22.0 ft;
 No. of Barbs: 10 - 4

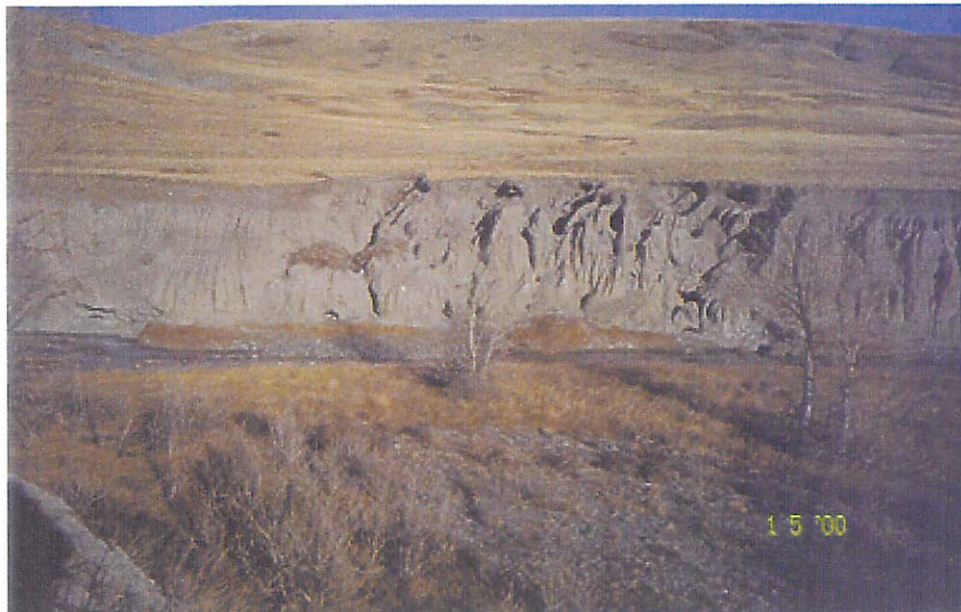
Photograph 0570-34. Left bank looking slightly DS at upper Loop #8.

Photo Station : 32+10
 Bank Stabilization : Medium priority longitudinal peaked stone toe protection on left bank.
 Upstream Station : 34+00
 Downstream Station : 32+00

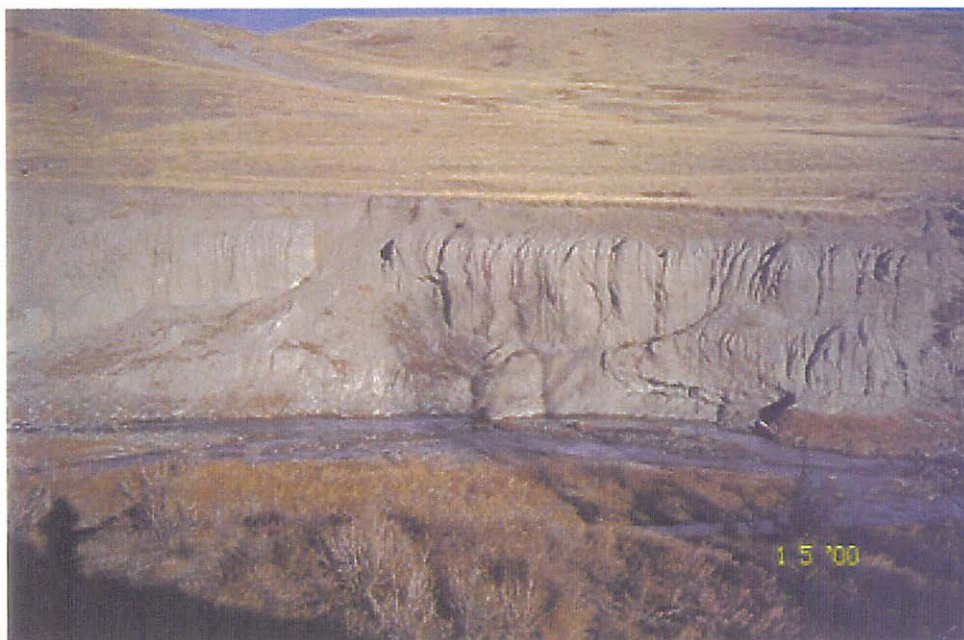
Photograph 0570-35. Left bank opposite Straight Reach #2 above Loop #8.

Photo Station : 33+50
 Bank Stabilization : See Photograph 0570-34.

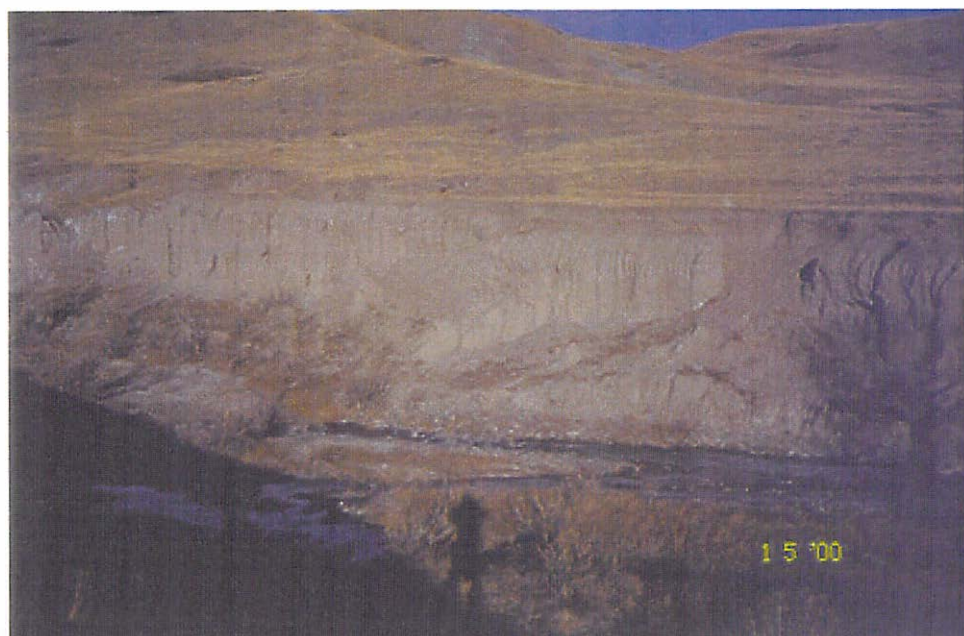
Photograph 0570-36. Left bank looking slightly US from Straight Reach #2 above Loop #8. Panned left from Photograph 0570-35.

Photo Station : 33+50
 Bank Stabilization : See Photograph 0570-34.

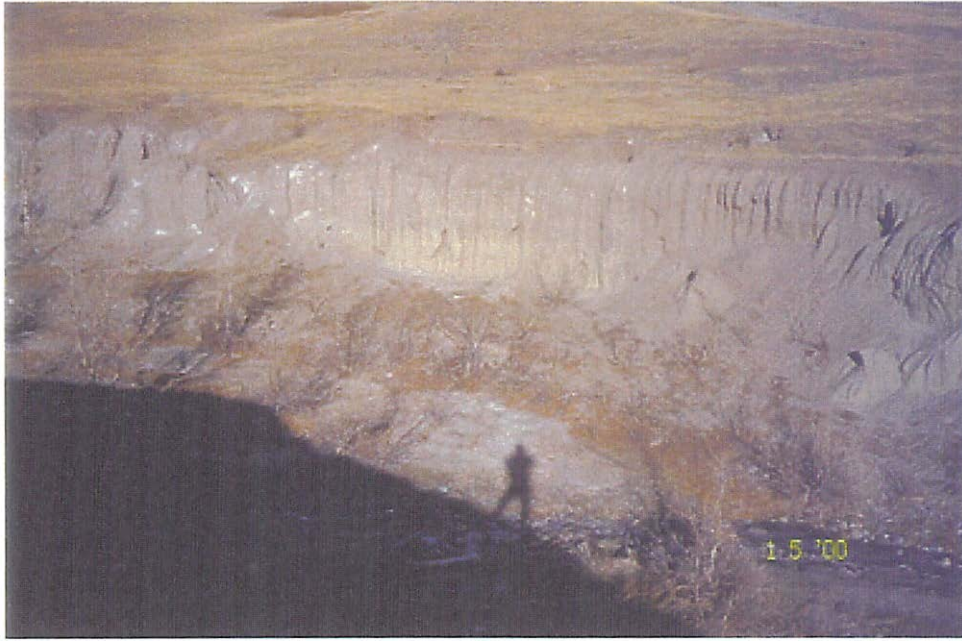
Photograph 0570-37. Left bank, even more US than Photograph 0570-36. Note Gully #2.

Photo Station : 34+20
 Bank Stabilization : Low priority longitudinal peaked stone toe protection on left bank. (Note gully destabilization of left bank.)

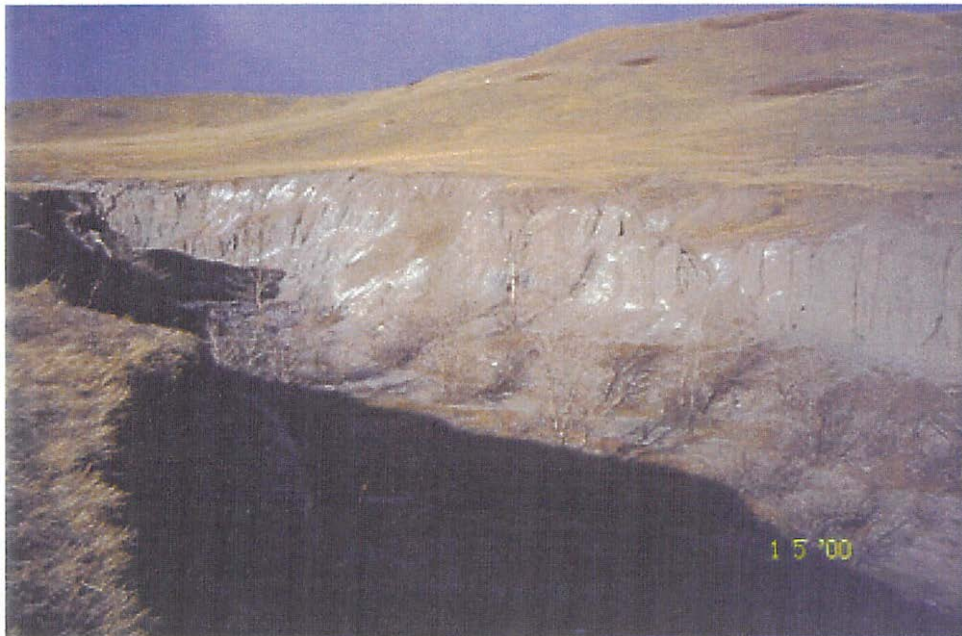
Photograph 0570-38. Looking US at left bank of Bend #1. Panned left and zoomed from Photograph 0570-37. Note Gully #2.

Photo Station : 34+20
 Bank Stabilization : Low priority longitudinal peaked stone toe protection on left bank.

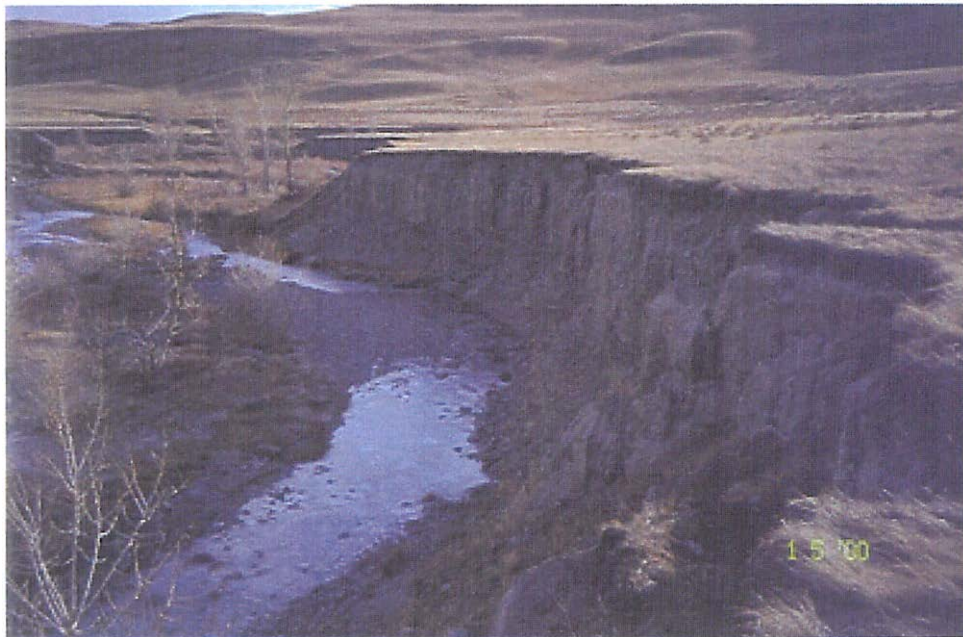
Photograph 0570-40. Right bank, looking DS at Bend #0.

Photo Station : 35+50
 Upstream Station : 35+50
 Downstream Station : 33+50
 Bank Stabilization : Barbs or longitudinal peaked stone toe protection on right bank of Bend #0.
 Bend Diameter: 200 ft; Channel Width: ~30 ft; Barb Length: 15.0 ft; Barb
 Spacing: 47.9 - 52.7 ft; No. of Barbs: 4 - 3

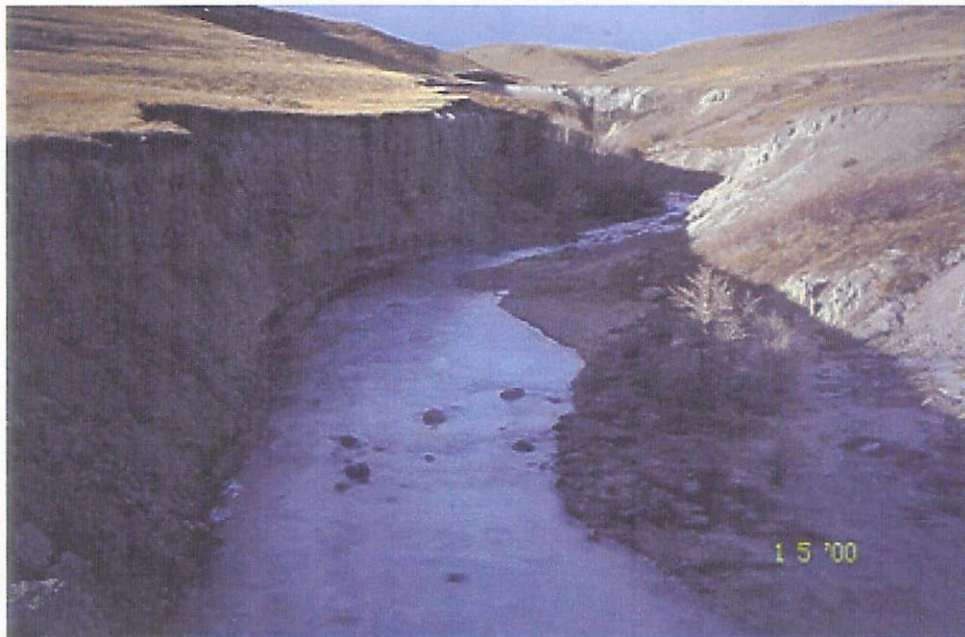
Photograph 0570-42. Both banks looking US at Bend #2. Panned left from Photograph 0570-41.

Photo Station : 35+50
 Bank Stabilization : Longitudinal peaked stone toe protection on right bank. Low priority longitudinal peaked stone protection toe on left bank.
 Upstream Station : 38+00
 Downstream Station : 35+50

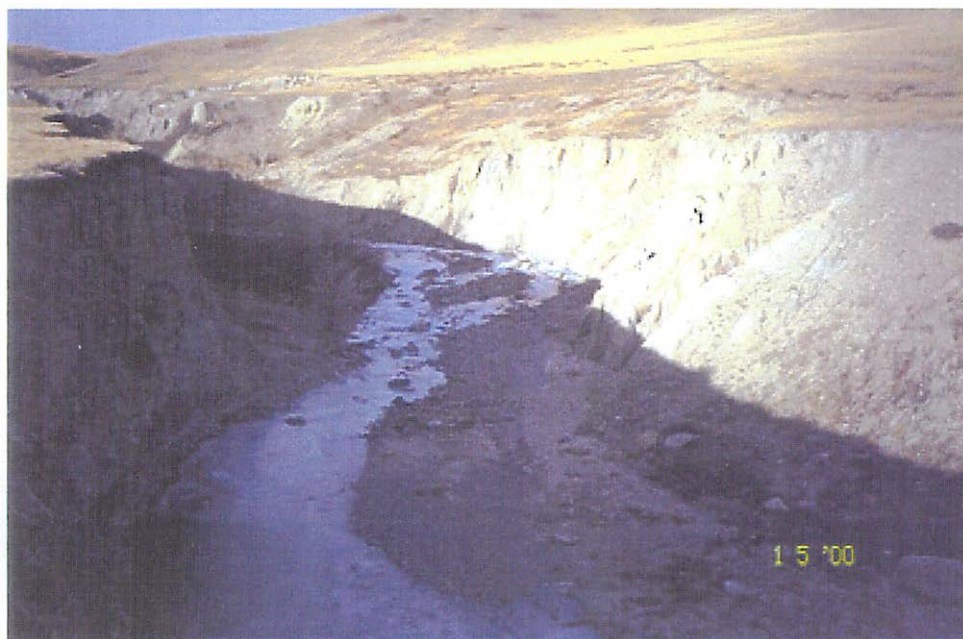
| Photo Station | : 37+30 |

Photograph 0570-44. Both banks, looking US at Bend #3 from Bend #2. Panned left from Photograph 0570-43.

| Bank Stabilization | : Longitudinal peaked stone toe protection on left bank. |
| Upstream Station | : 40+00 |
| Downstream Station | : 38+40 |

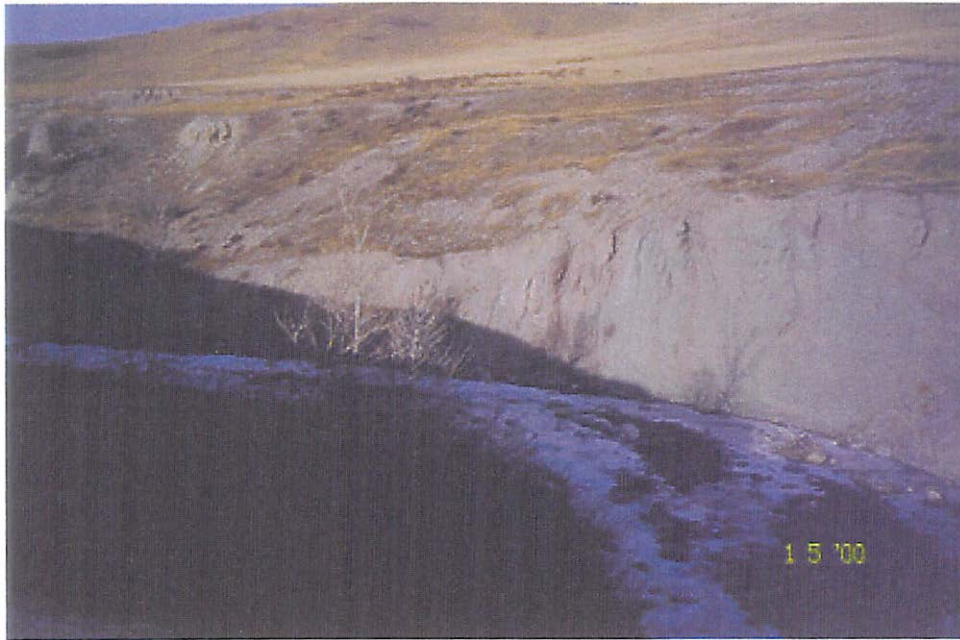
Photograph 0570-45. Left bank, looking US at Bend #3.

Photo Station : 39+70
 Bank Stabilization : See Photograph 0570-44.

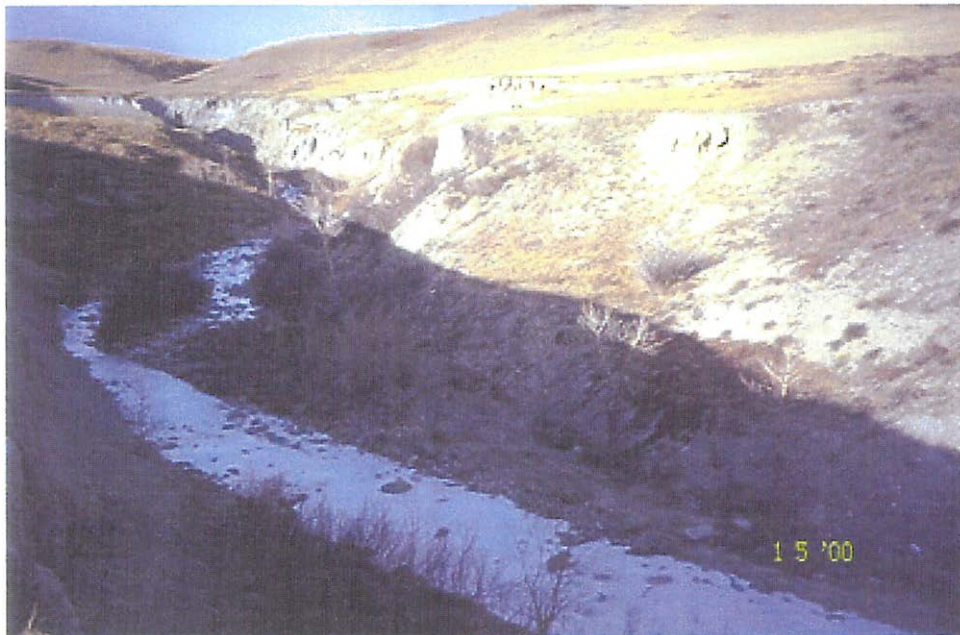
Photograph 0570-46. Left bank, looking US at Bend #4.

Photo Station : 40+80
 Bank Stabilization : Longitudinal peaked stone toe protection on right bank. See Photograph 0898-06; low priority longitudinal peaked stone toe protection on left bank.
 Upstream Station : Left bank: 42+00
 Downstream Station : Left bank: 41+00
