WILLOW CREEK FEEDER SYSTEM

GAME RANGE REACH EROSION CONTROL AND BANK STABILIZATION PLAN

US Department of the Interior
U.S. Bureau of Reclamation

MAY 15, 2000

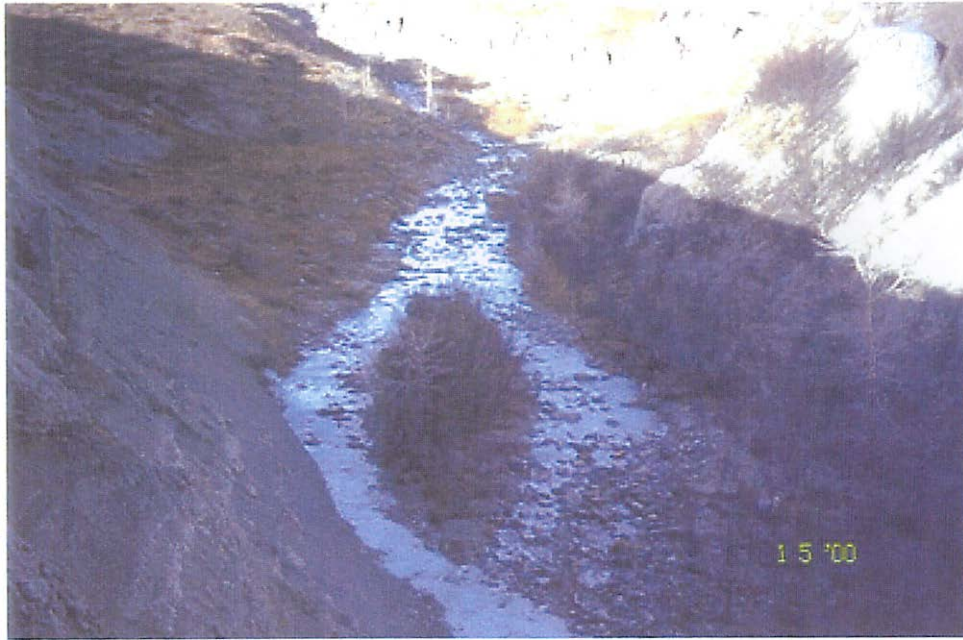
Photograph 0570-47. Both banks, looking US at island in Bend #4.

Photo Station : 41+20
 Bank Stabilization : Right bank – See Photograph 0898-06 (Right bank).

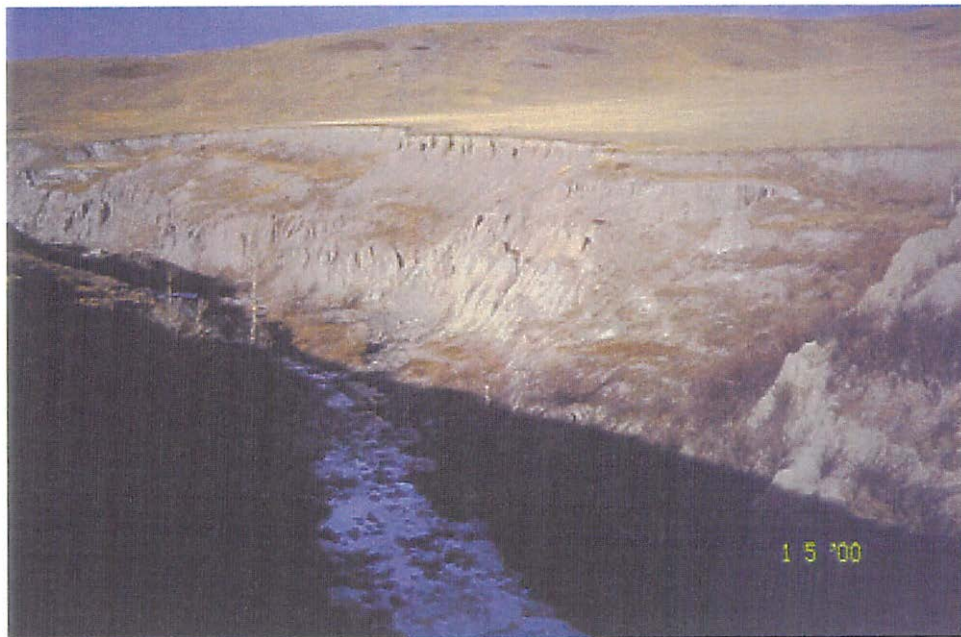
Photograph 0570-48. Left bank looking US at Bend #5.

Photo Station : 41+80
 Bank Stabilization : Longitudinal peaked stone toe protection on left bank.
 Upstream Station : 47+00
 Downstream Station : 43+00

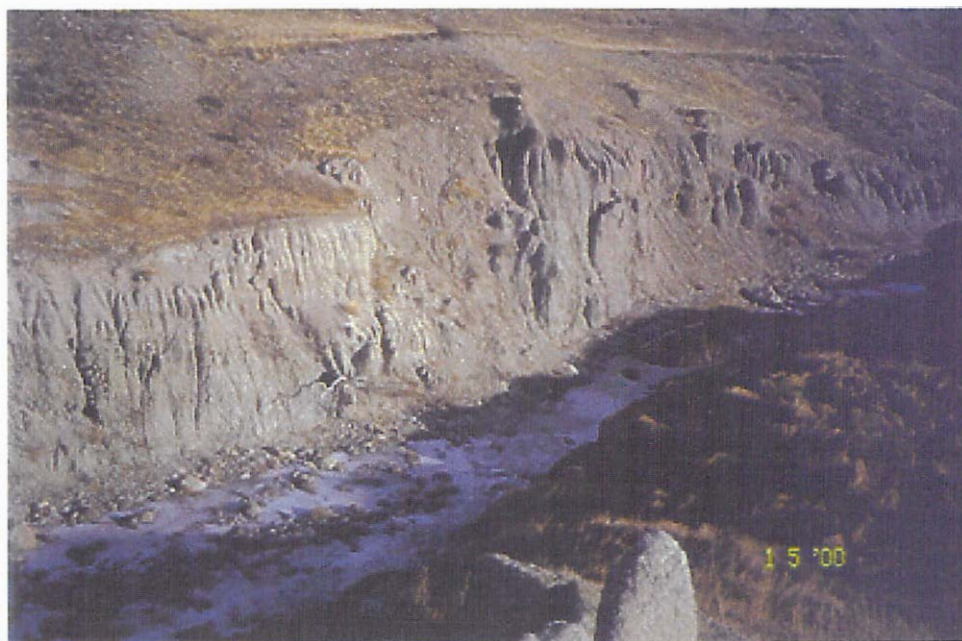
| Photo Station | : 46+90 |

Photograph 0570-50. Left bank, looking DS at Straight Reach #4. Panned left and down from Photograph 0570-49.

| Bank Stabilization | : See Photograph 0570-49. |

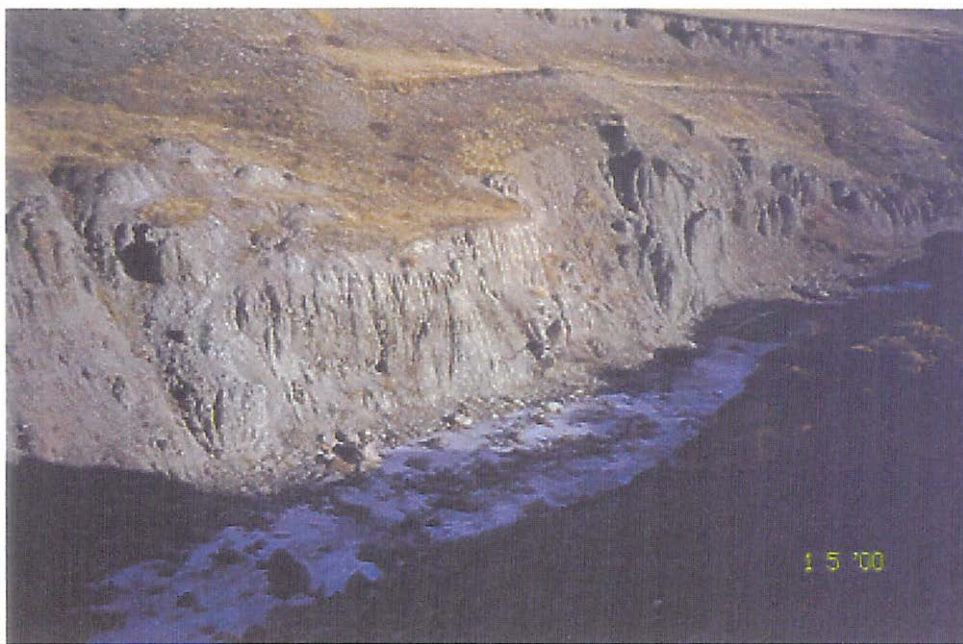
Photograph 0570-52. Same as Photograph 0570-50. After changing film rolls.

Photo Station : 46+90
 Bank Stabilization : See Photograph 0570-49.

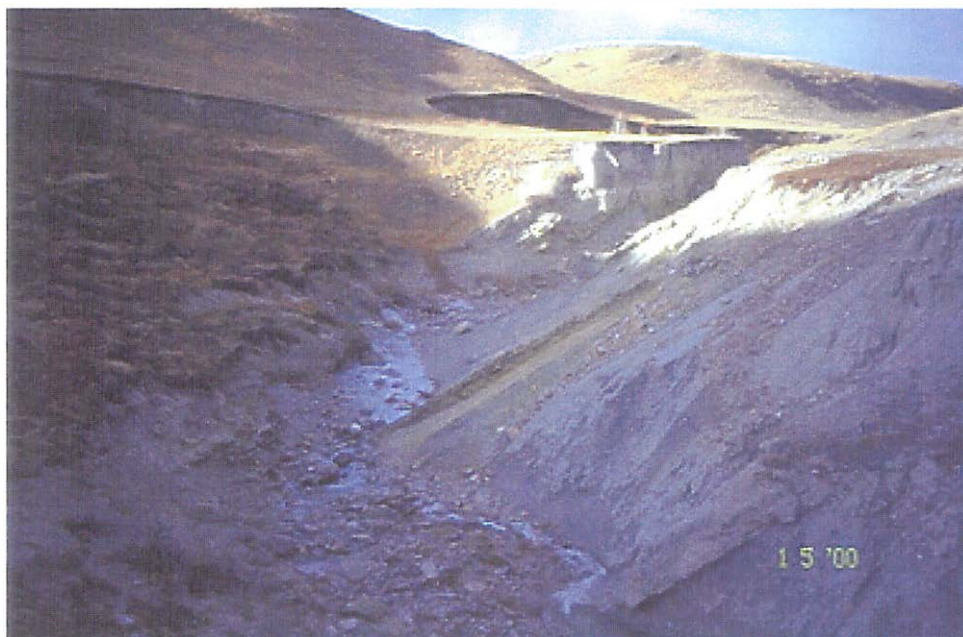
Photograph 0570-53. Looking US at Bend #8, exit of "Kayak" chute.

Photo Station : 47+20
 Bank Stabilization : Longitudinal peaked stone toe protection on right bank. Left bank see Photographs 0570-49 to 52.
 Upstream Station : 50+50
 Downstream Station : 49+00

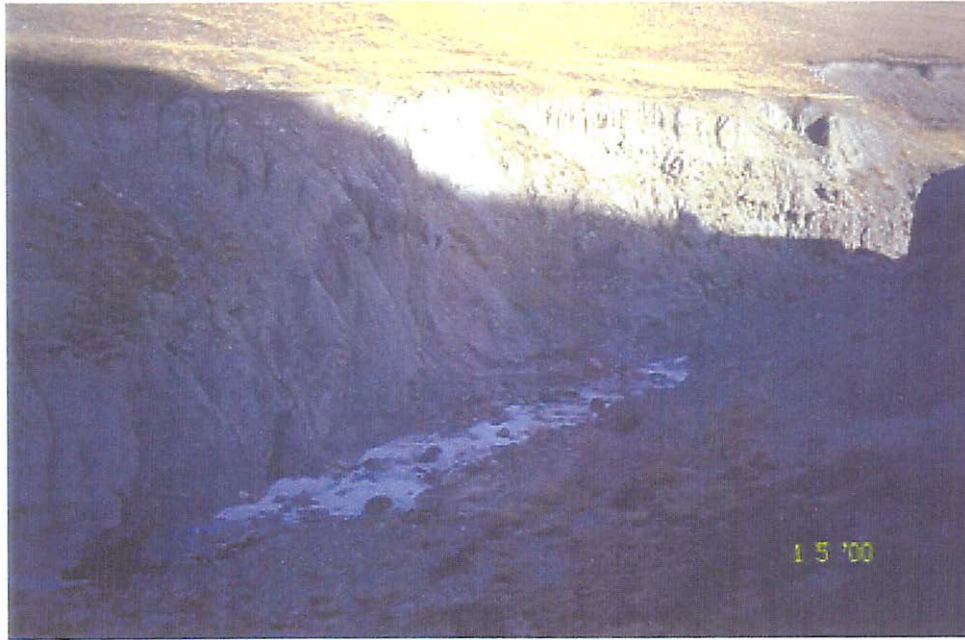
Photograph 0570-54. Looking DS at Bend #8.

Photo Station : 48+80
Bank Stabilization : See Photographs 0570-49 to 53.

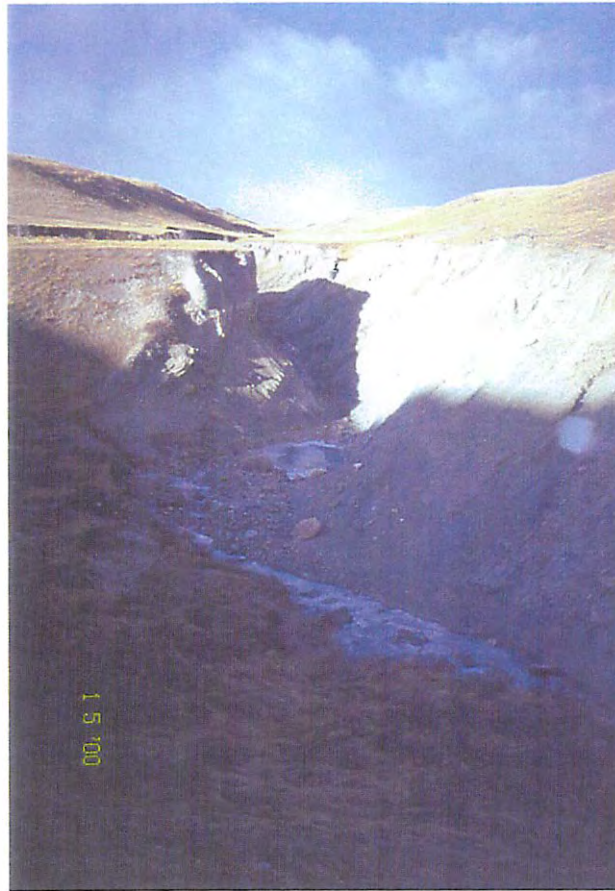
Photo Station : 48+80

Photograph 0570-55. Looking US at "Kayak" stilling basin. Panned left and US from Photograph 0570-54.

Bank Stabilization : See Photographs 0570-49 to 54.

Note : Longitudinal peaked stone toe protection on both banks downstream of "Kayak." No treatment in "Kayak" with the possible exception of headcut stabilization or stilling basin at the foot of "Kayak."

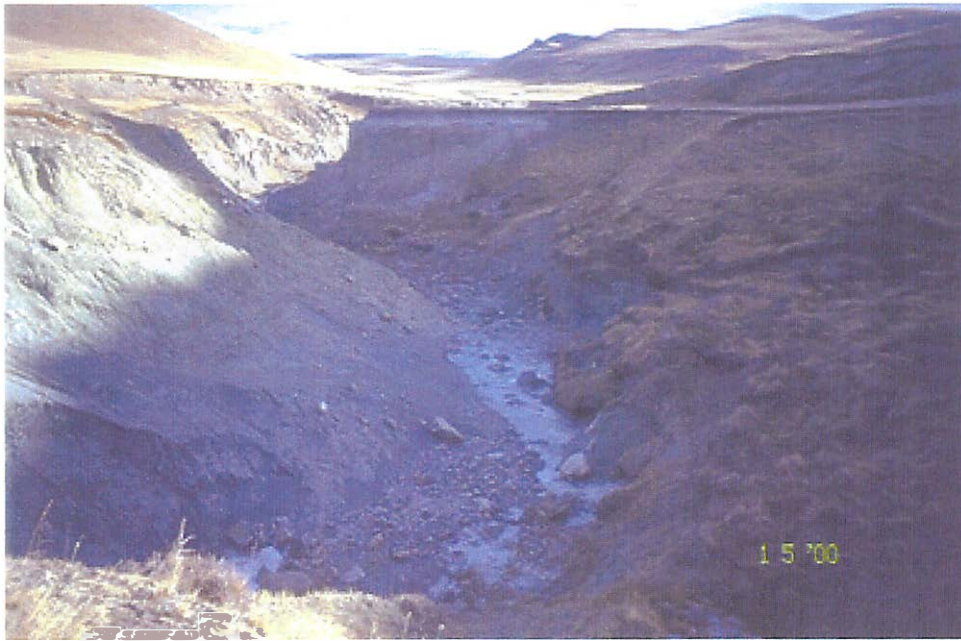
Photograph 0570-57. Looking DS at Straight Reach #4 below "Kayuk" stilling basin.

Photo Station : 50+80
Bank Stabilization : See Photographs 0570-49 to 56.

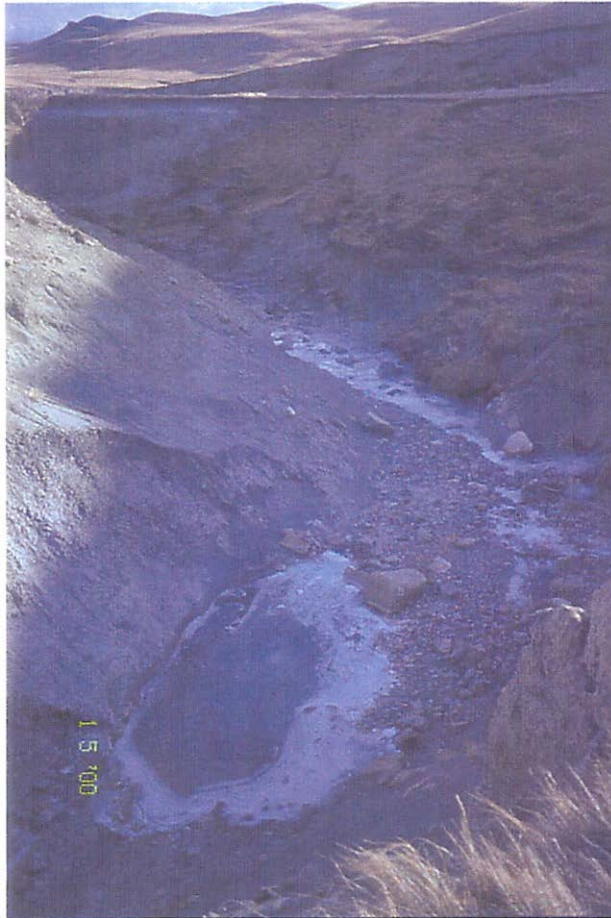
Photograph 0570-58. Looking DS at "Kayak" scour hole. Panned down from Photograph 0570-57.

Photo Station : 50+80
Bank Stabilization : See Photographs 0570-49 to 57.

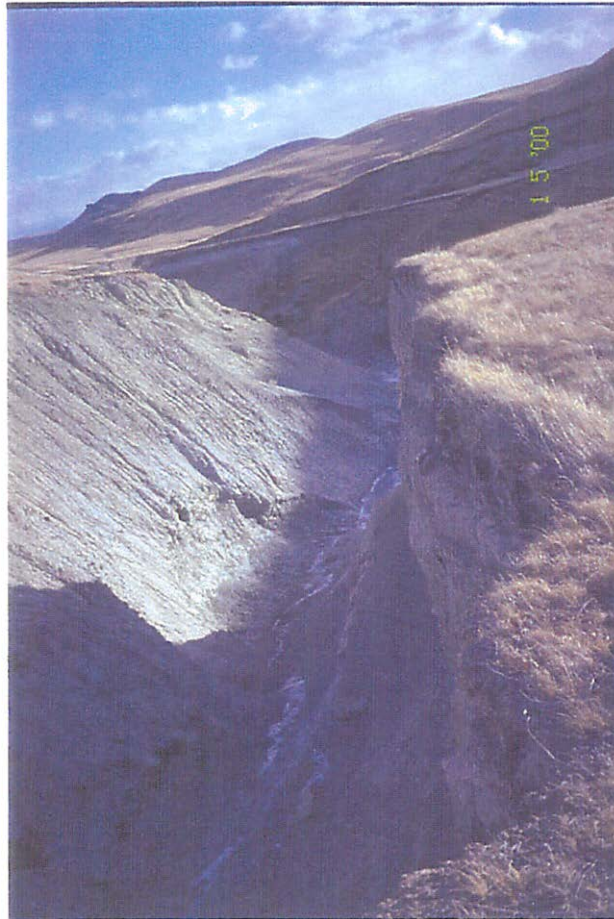
Photograph 0570-59. Looking DS at "Kayak" chute.

Photo Station : 51+70
Bank Stabilization : See Photographs 0570-49 to 58.

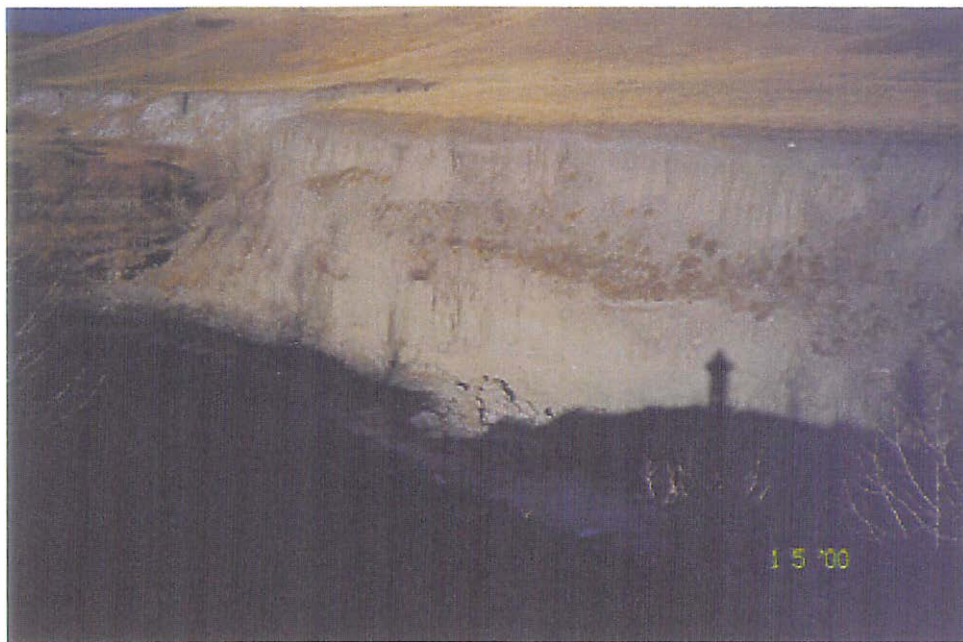
| Photo Station | : 51+70 |

Photograph 0570-60. Left bank US of "Kayak." Panned left and US from Photograph 0570-59.

| Bank Stabilization | : Longitudinal peaked stone toe protection on left bank. |
| Upstream Station | : 53+70 |
| Downstream Station | : 51+80 |

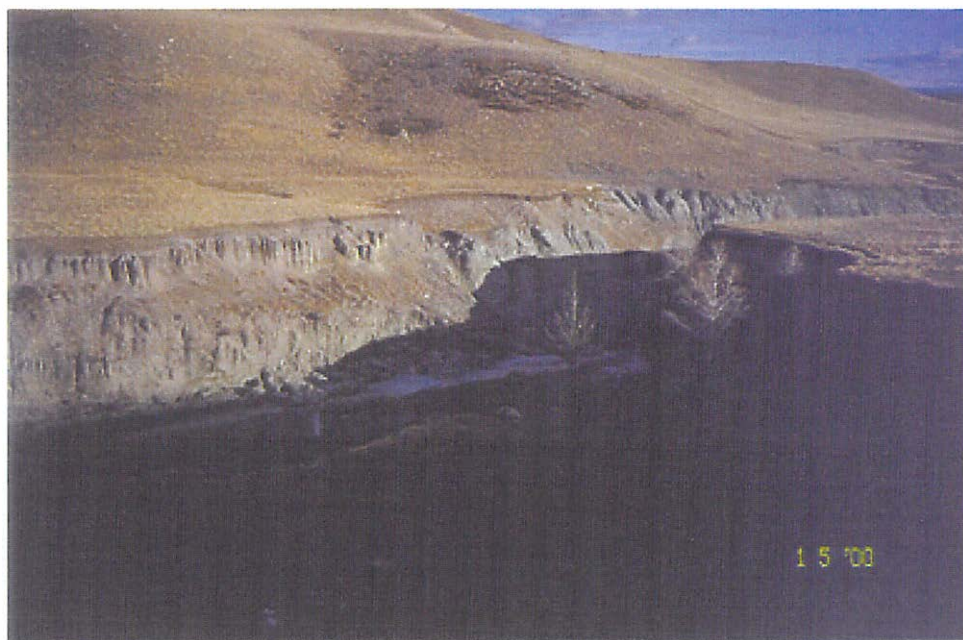
| Photo Station | : 53+70 |

Photograph 0570-61. Left bank entrance to "Kayak."

| Bank Stabilization | : See Photograph 0570-60. |

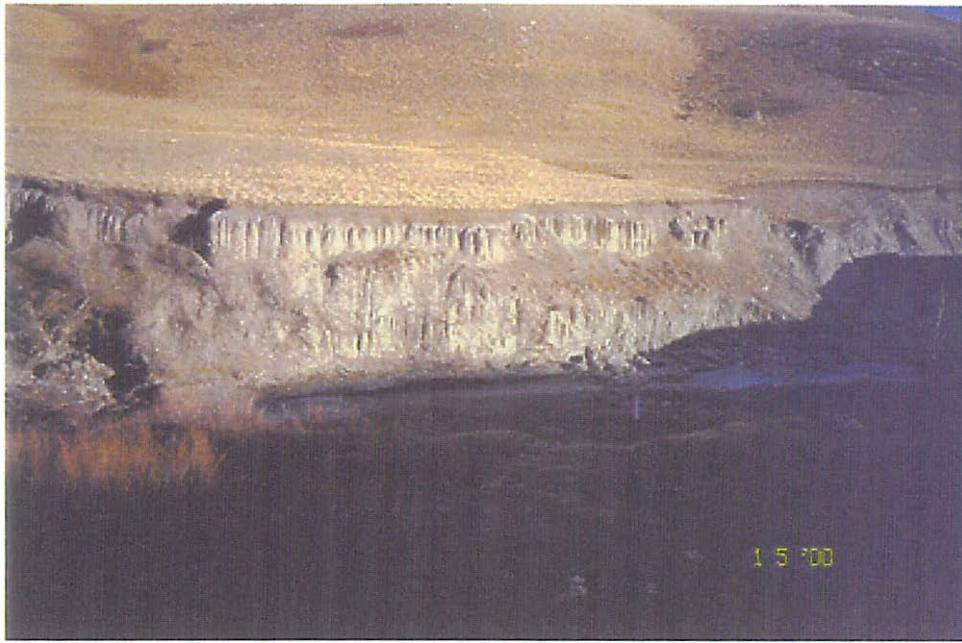
Photograph 0570-62. Left bank. Panned left from Photograph 0570-61.

Photo Station : 53+70
 Bank Stabilization : See Photograph 0570-60.

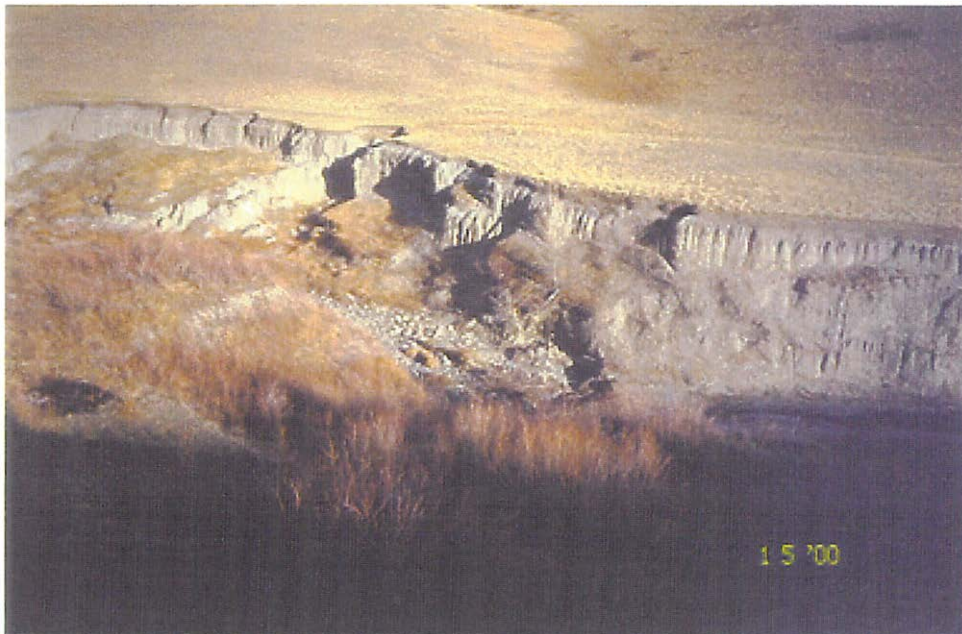
Photograph 0570-63. Left bank. Panned left from Photograph 0570-62.

Photo Station : 53+70
 Bank Stabilization : See Photograph 0570-60 for downstream left bank in this photograph.

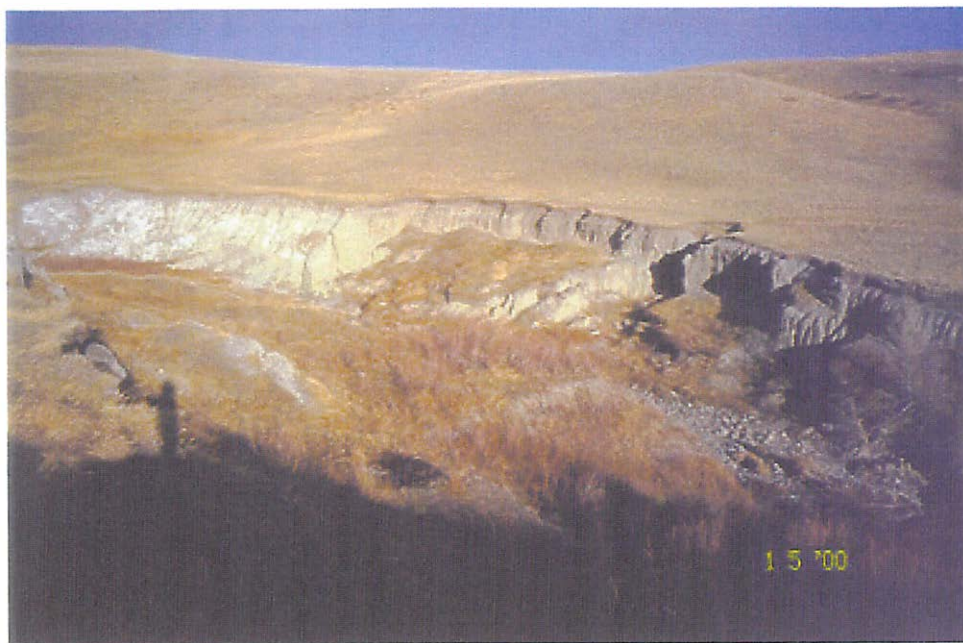
| Photo Station | : 53+70 |

Photograph 0570-64. Left bank. Panned left from Photograph 0570-63.

| Bank Stabilization | : Low priority longitudinal peaked stone toe protection on left bank |
| Upstream Station | : 56+00 |
| Downstream Station | : 54+00 |

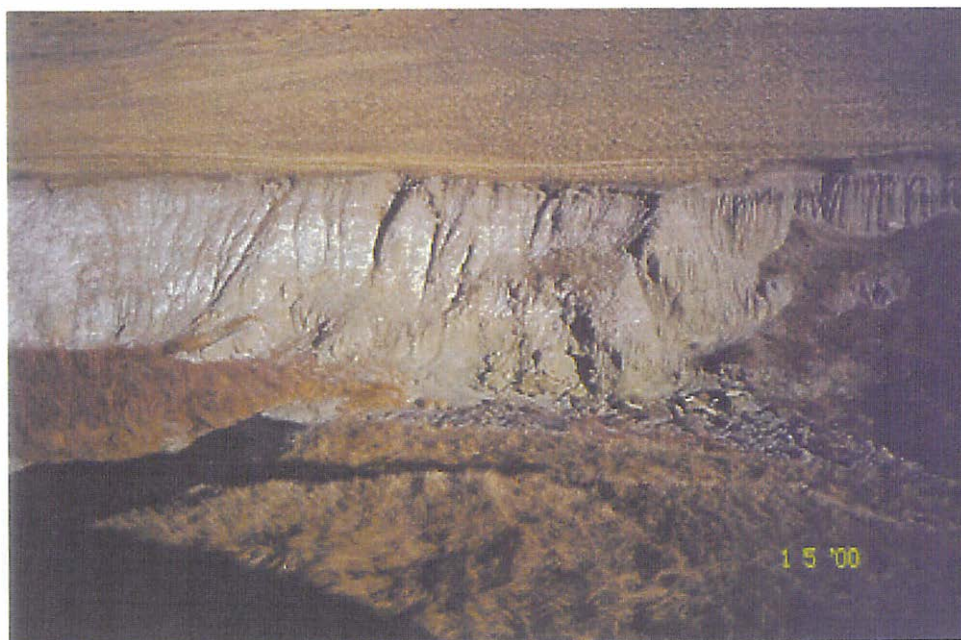
| Photo Station | : 56+90 |

Photograph 0570-65. Left bank opposite Bend #14.

| Bank Stabilization | : Medium priority longitudinal peaked stone toe protection on left bank. |
| Upstream Station | : 57+20 |
| Downstream Station | : 56+80 |

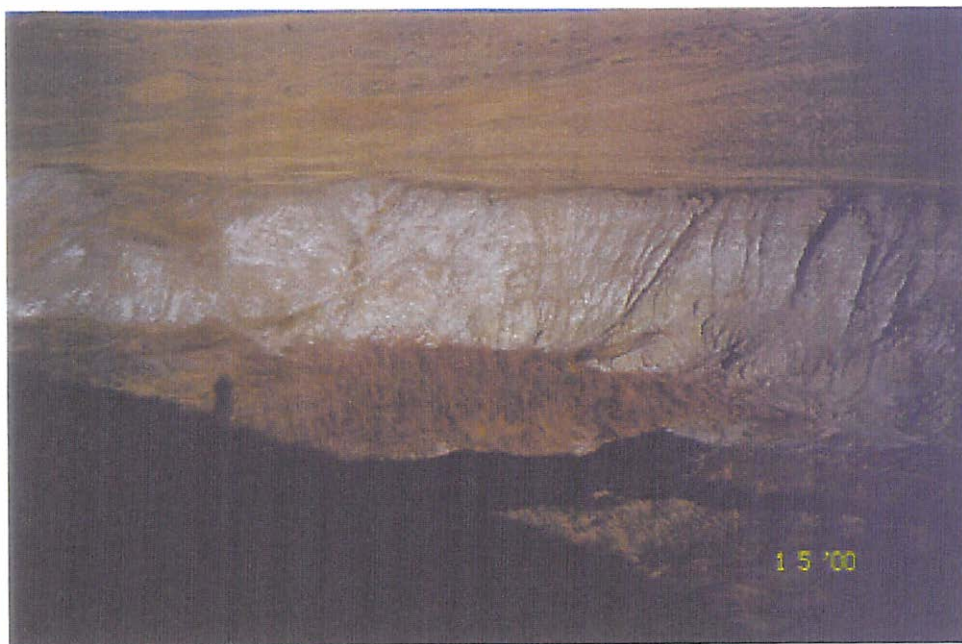
Photograph 0570-66. Left bank. Panned left from Photograph 0570-65.

Photo Station : 56+90
Bank Stabilization : None.

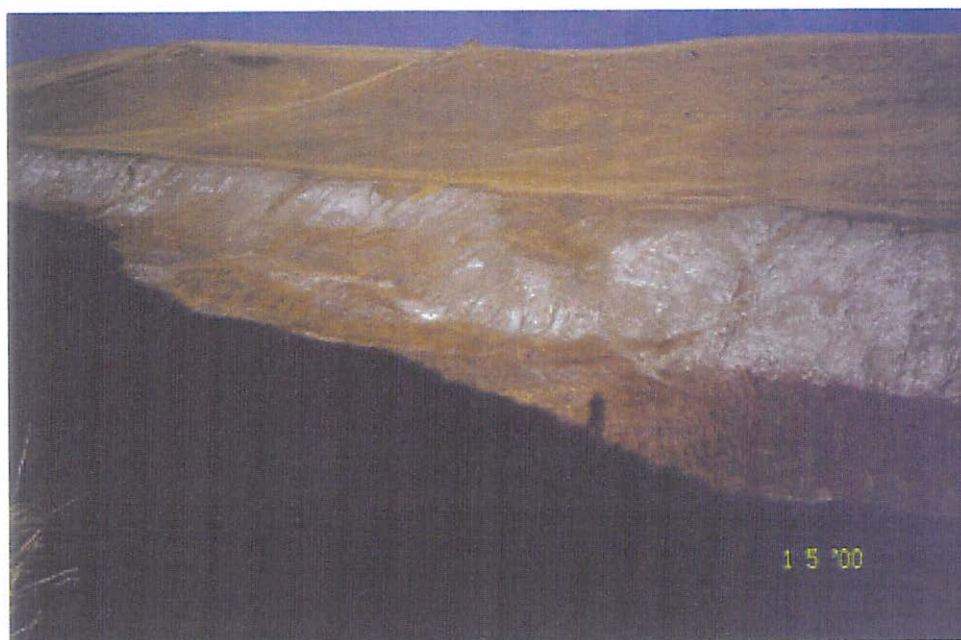
Photograph 0570-67. Left bank looking into Straight Reach #5. Panned left from Photograph 0570-66.

Photo Station : 56+90
Bank Stabilization : None.

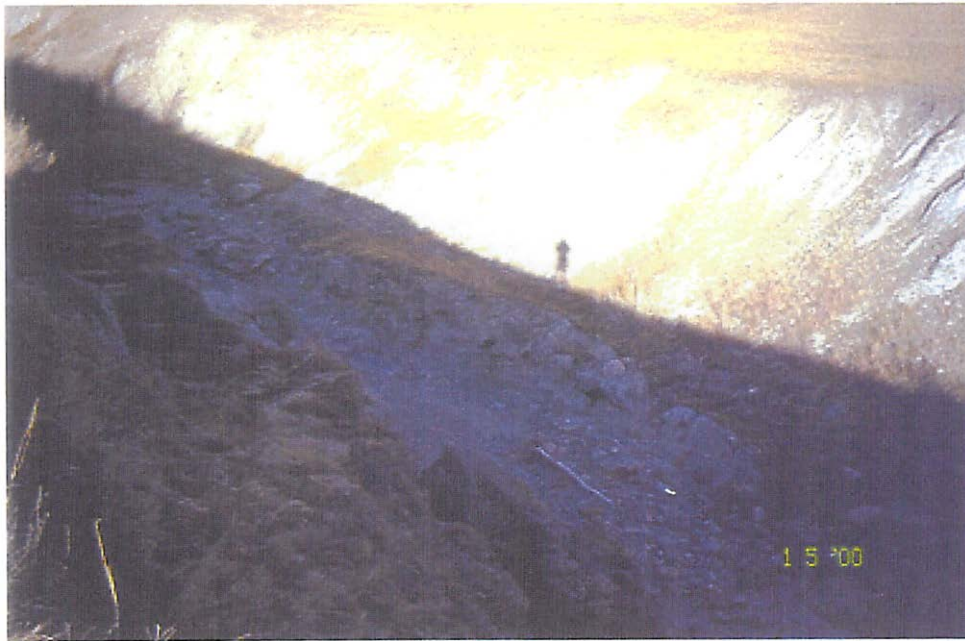
Photograph 0570-70. Left bank, looking US into Straight Reach #5.

Photo Station : 59+40
Bank Stabilization : None.

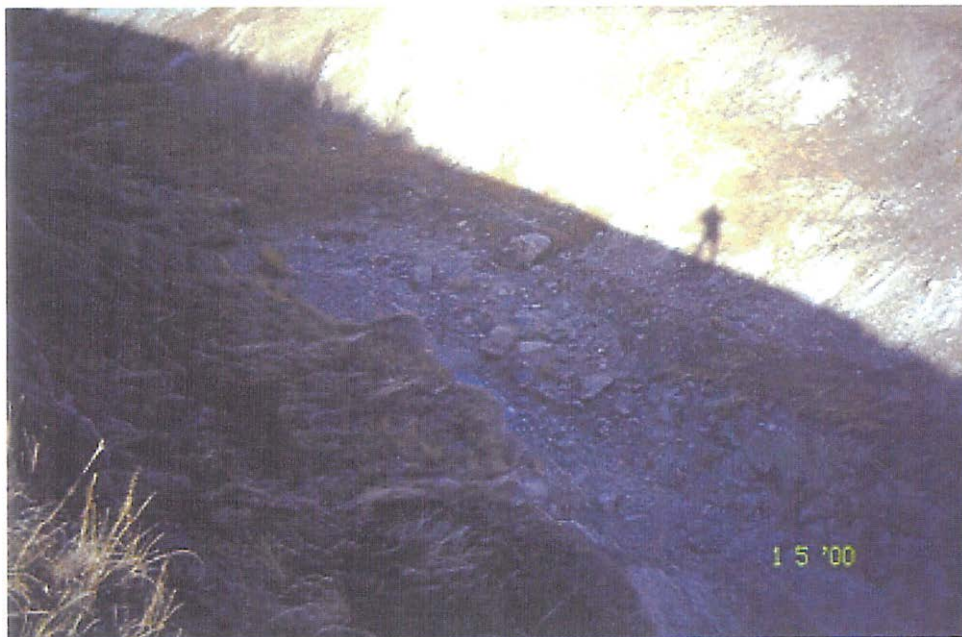
Photograph 0570-71. Left bank looking US into Straight Reach #5.

Photo Station : 60+10
Bank Stabilization : None.

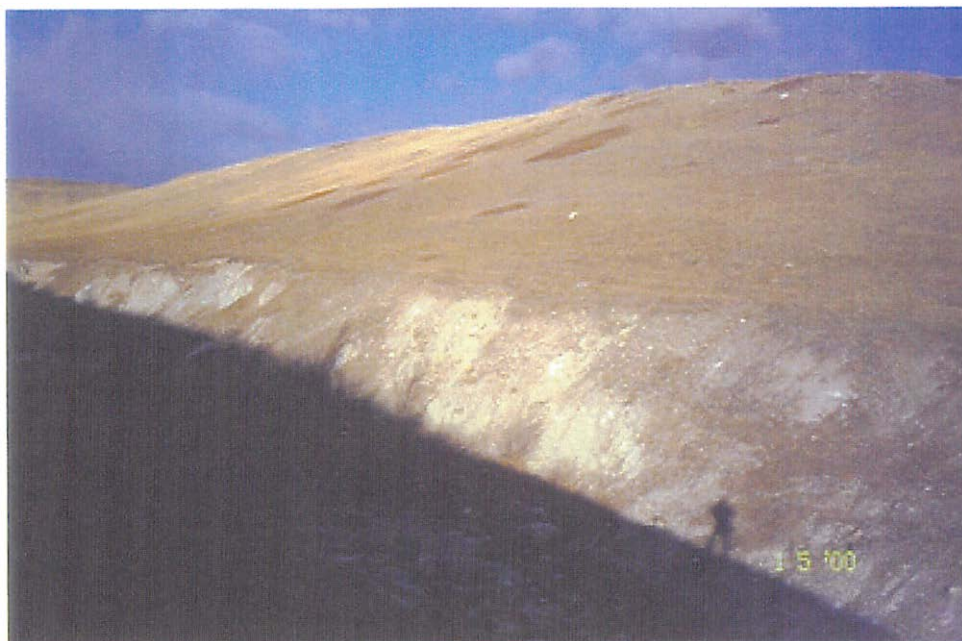
Photograph 0570-72. Left bank looking US. Panned US and left from Photograph 0570-71. Lower chute of Bend #15. Note vehicle tracks on left bank.

Photo Station : 60+10
Bank Stabilization : None.

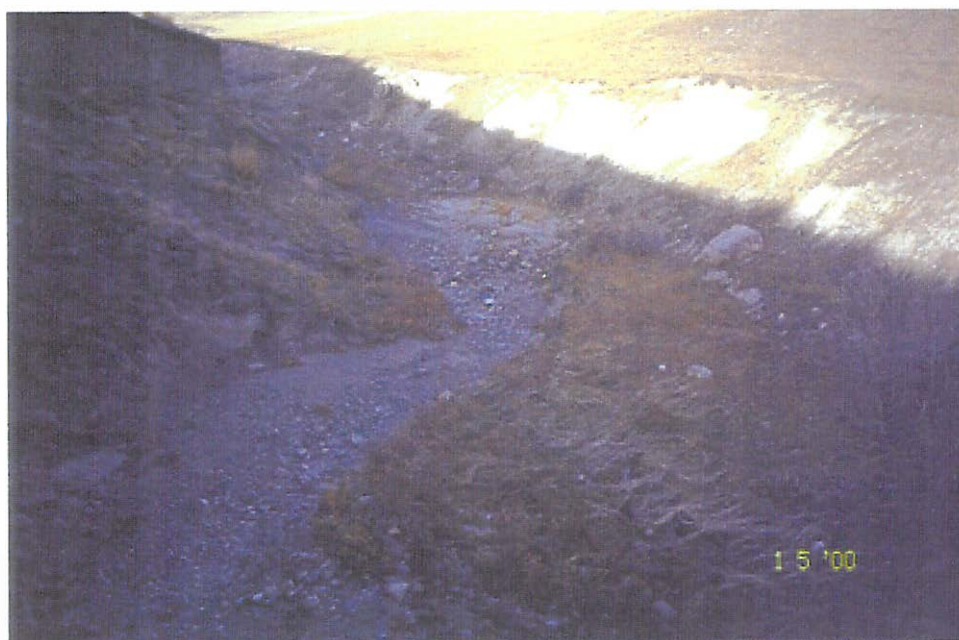
Photograph 0570-74. Right bank in Bend #15 and left bank US of Bend #15.

Photo Station : 61+30
Bank Stabilization : Longitudinal peaked stone toe protection on left bank opposite of Bend #15.
Upstream Station : 62+00
Downstream Station : 61+50

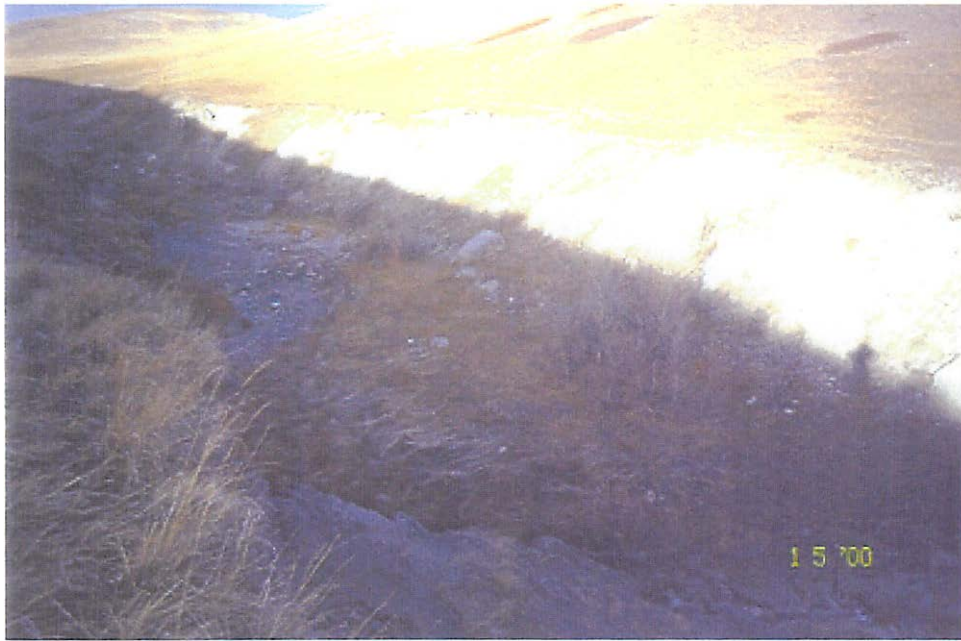
Photograph 0570-75. Left bank US of Bend #15.

Photo Station : 61+00
 Bank Stabilization : See Photograph 0570-74.

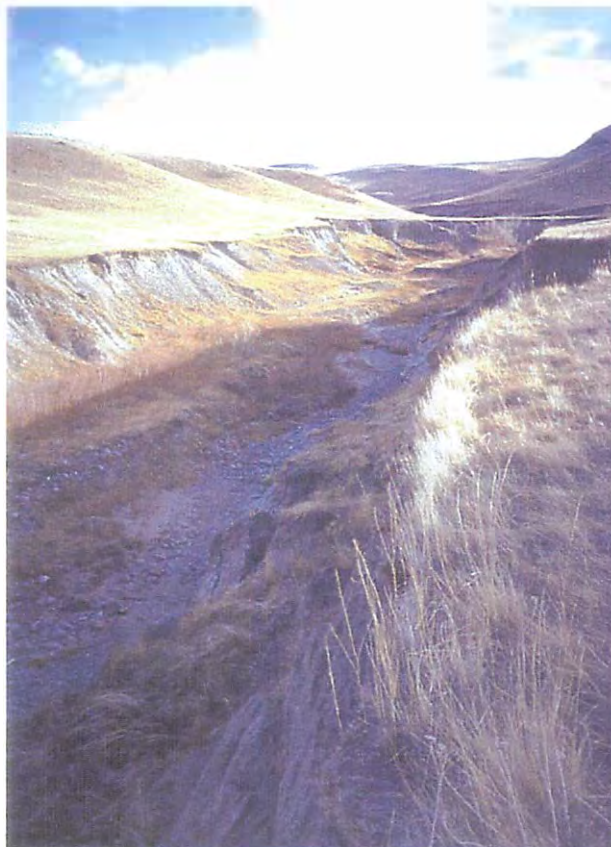
Photograph 0570-51. Panoramic looking DS. Out of sequence. Good perspective of "no-man's-land."

Photo Station : 67+50 (Our best guess)
 Bank Stabilization : None on left bank between 62+00 and 67+50. (Visible left bank in photo.)

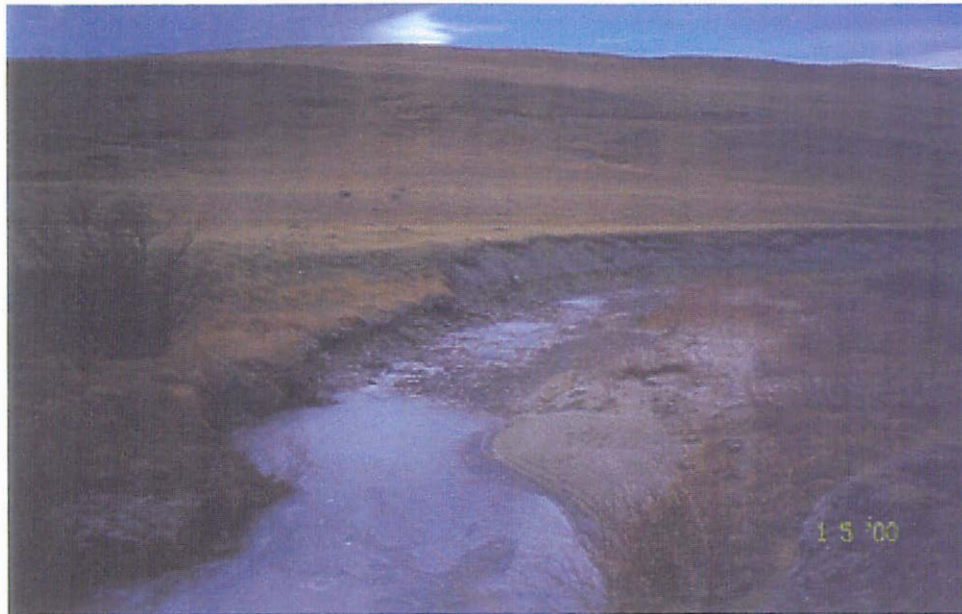
Photograph 0898-01. Right bank looking US at bottom of Loop #1.

Photo Station : 1+00
Bank Stabilization : Medium priority longitudinal peaked stone toe protection on right bank.
Upstream Station : 4+00
Downstream Station : 3+00

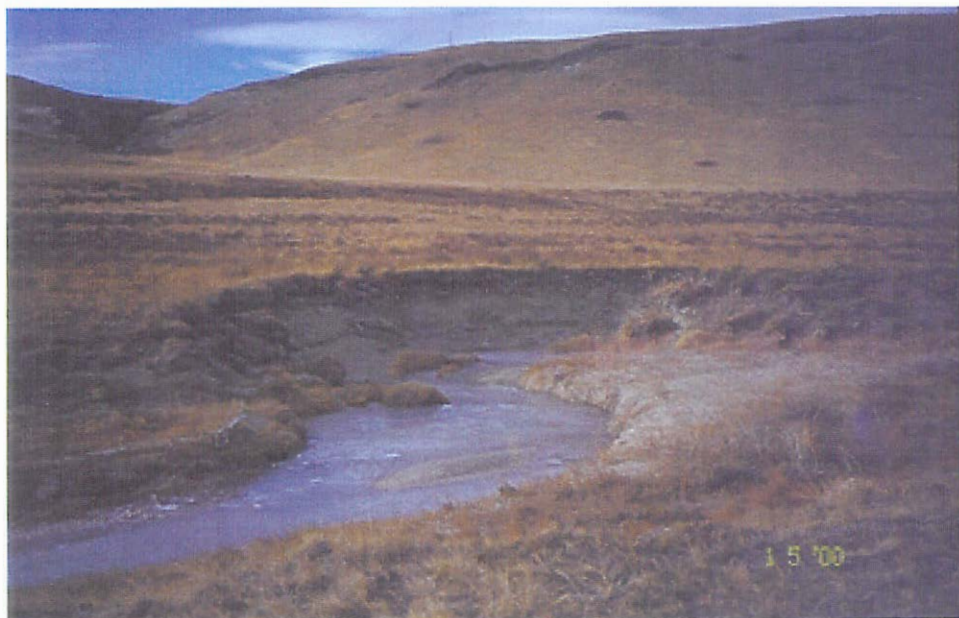
Photograph 0898-02. Right bank looking US at Loop #3.

Photo Station : 16+70
Upstream Station : 18+00
Downstream Station : 17+30
Bank Stabilization : Medium priority longitudinal peaked stone toe protection or barbs on right bank (outside of Loop #3). Bend Diameter: 65 ft; Channel Width: ~30 ft; Barb Length: 7.5 ft; Barb Spacing: 7.9 – 20.8 ft; No. of Barbs: 9 - 4

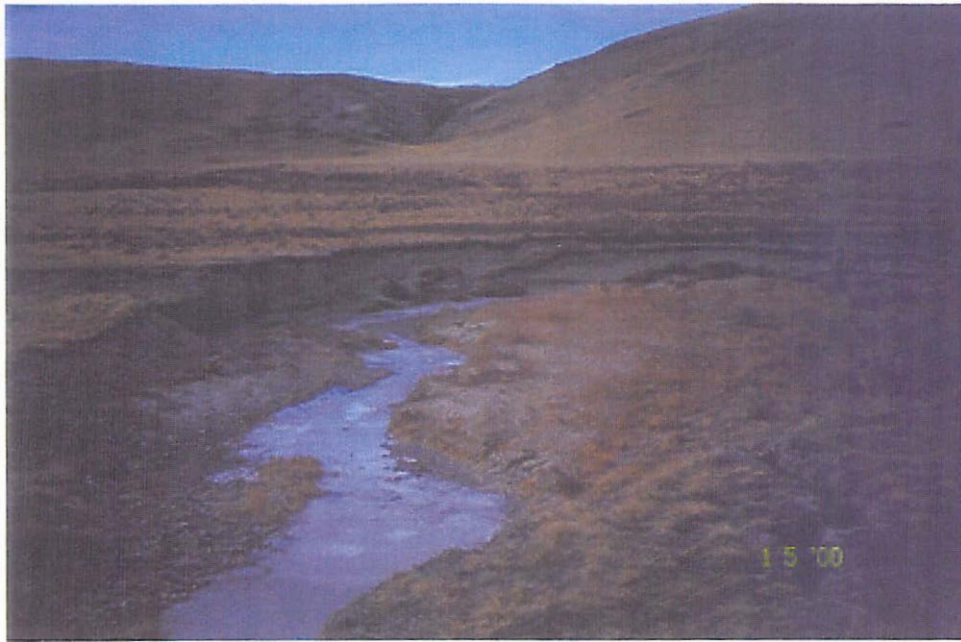
Photograph 0898-03. Right bank looking US at Loop #5.

Photo Station : 20+60
 Upstream Station : 24+50
 Downstream Station : 22+50
 Bank Stabilization : Barbs on right bank (Loop #5). Bend Diameter: 113 ft; Channel Width: ~30 ft; Barb Length: 7.5 ft; Barb Spacing: 12.3 – 28.1 ft No. of Barbs: 17 - 8

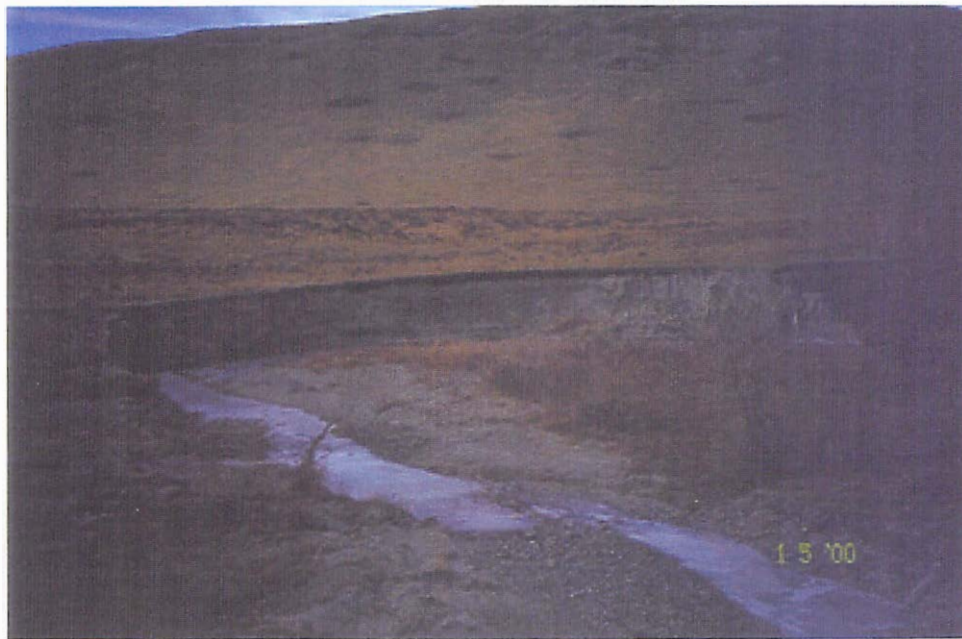
Photograph 0898-04. Right bank looking US at Loop #7.

Photo Station : 27+60
 Upstream Station : 30+20
 Downstream Station : 29+00
 Bank Stabilization : Barbs on right bank (Loop #7). Bend Diameter: 100 ft; Channel Width: ~30 ft; Barb Length: 7.5 ft; Barb Spacing: 11.2 – 26.3 ft; No. of Barbs: 11 - 5

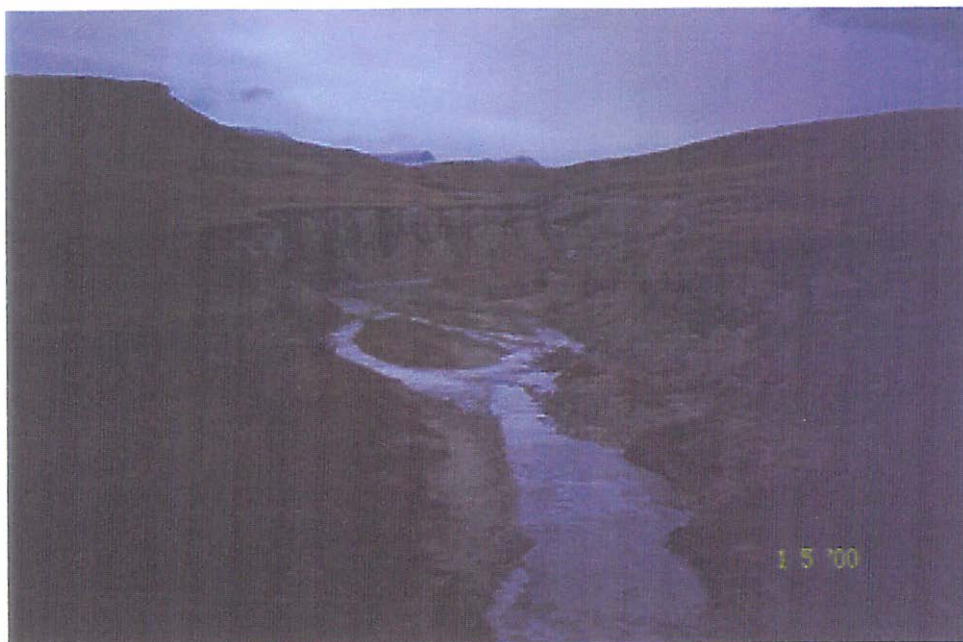
Photograph 0898-05. Looking US at Straight Reach #2, above benchmark.

Photo Station : 31+40
 Bank Stabilization : Right bank, see Photograph 0570-40.

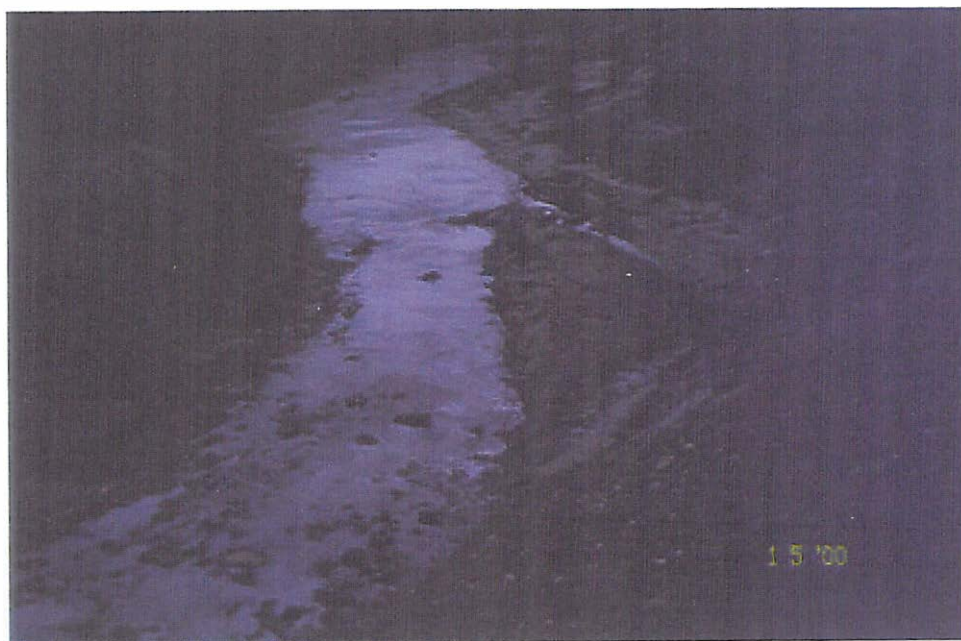
Photograph 0898-06. Right bank looking US at Bend #4.

Photo Station : 38+90
 Bank Stabilization : Longitudinal peaked stone toe protection on right bank.
 Upstream Station : 41+50
 Downstream Station : 38+90

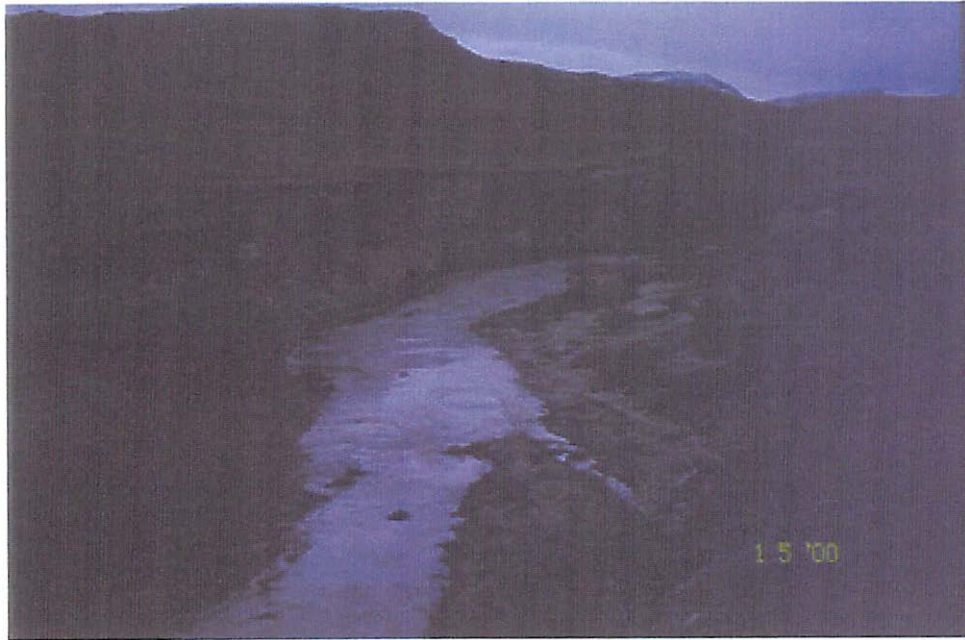
Photograph 0898-07. Right bank looking US at Bend #4. Panned up from Photograph 0898-06.

Photo Station : 38+90
 Bank Stabilization : Longitudinal peaked stone toe protection on right bank. See Photograph 0570-43 and Photograph 0898-06.

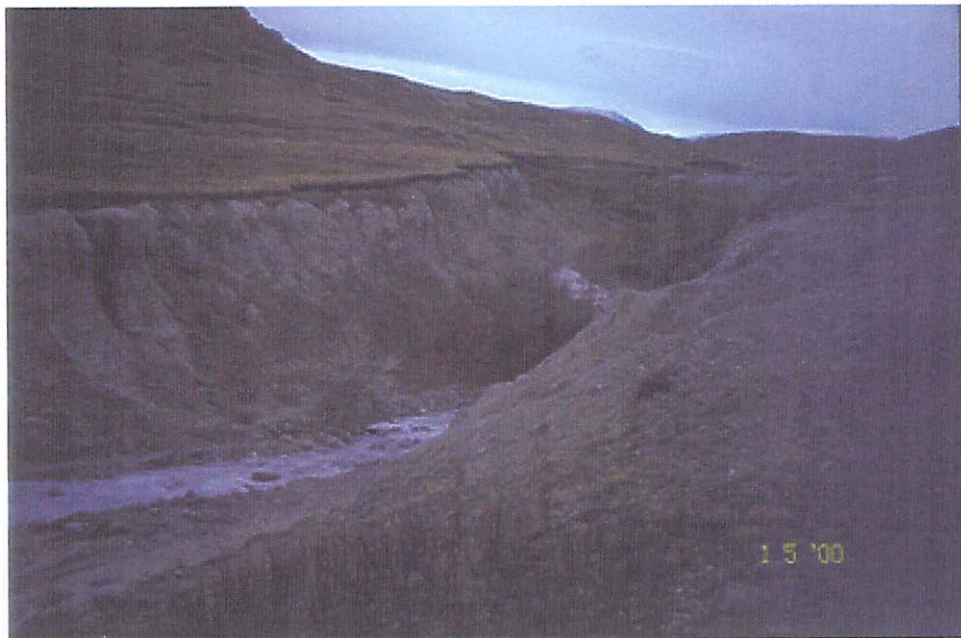
Photograph 0898-08. Right bank looking US at riparian area in Bend #5.

Photo Station : 40+30
 Bank Stabilization : Low priority longitudinal peaked stone toe protection on right bank.
 Upstream Station : 42+50
 Downstream Station : 41+50

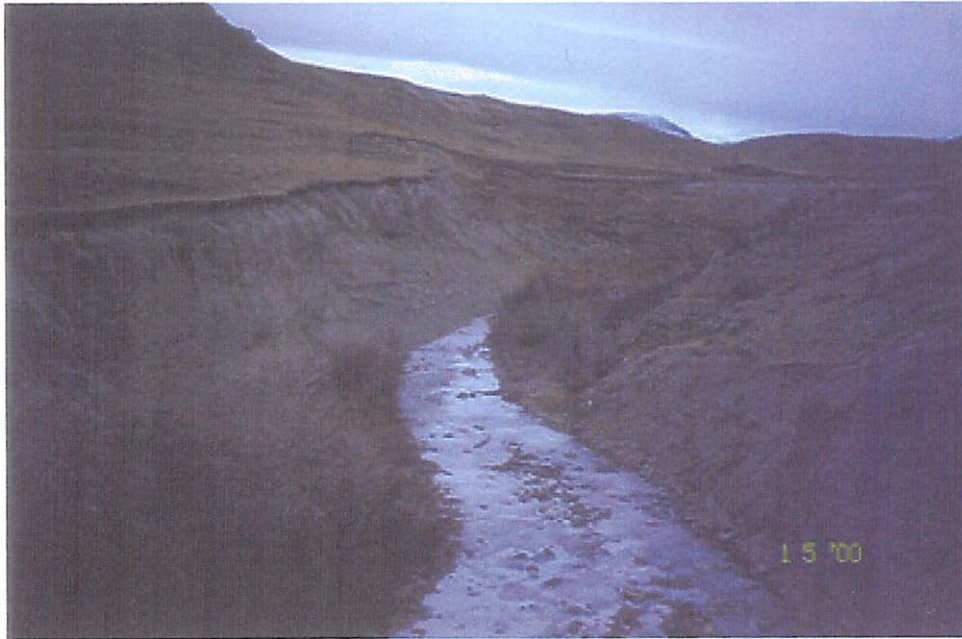
Photograph 0898-09. Right bank looking US at upper Bend #5.

| Bank Stabilization | : Longitudinal peaked stone toe protection on right bank. |

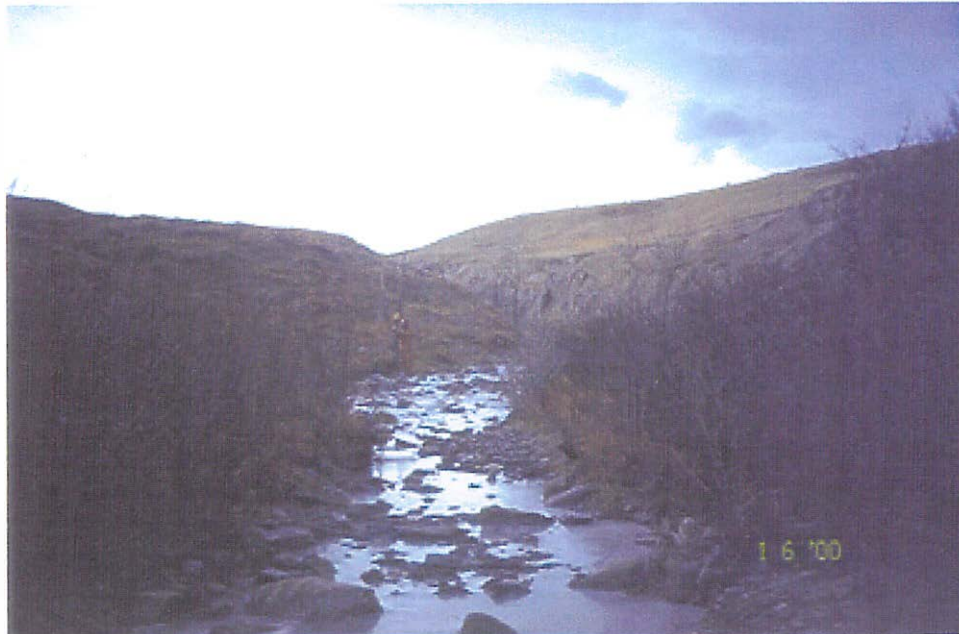
Photograph 0898-10. Both banks looking US at Straight Reach #3. Will Gonzales.

| Bank Stabilization | : None. |

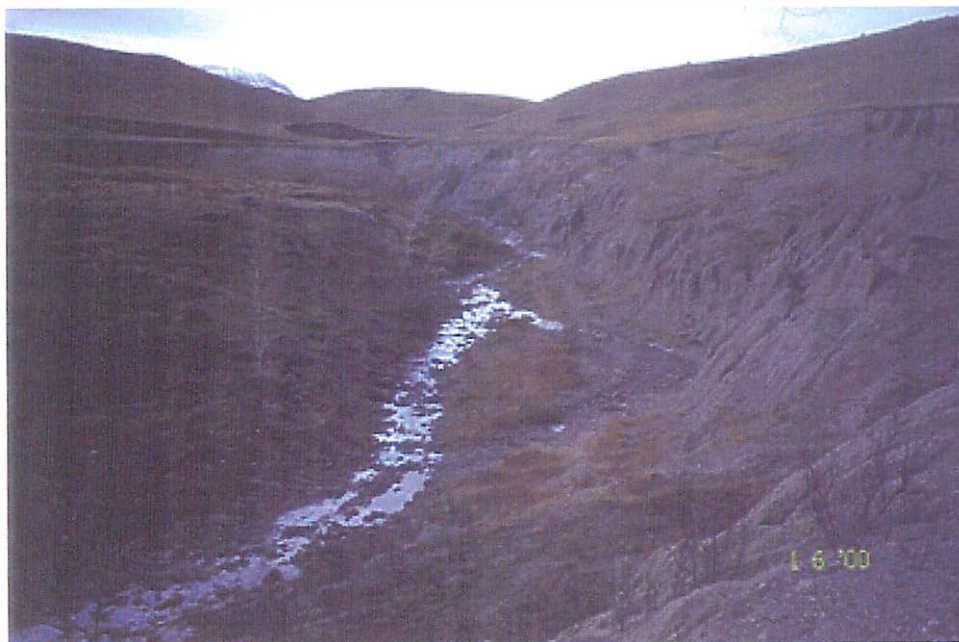
Photograph 0898-12. Right bank looking US at Bend #6. Downstream slide on left.

| Bank Stabilization | : Longitudinal peaked stone toe protection on right bank. Left bank see Photograph 0570-48. |
