WILLOW CREEK FEEDER SYSTEM

GAME RANGE REACH EROSION CONTROL AND BANK STABILIZATION PLAN

US Department of the Interior
U.S. Bureau of Reclamation

MAY 15, 2000

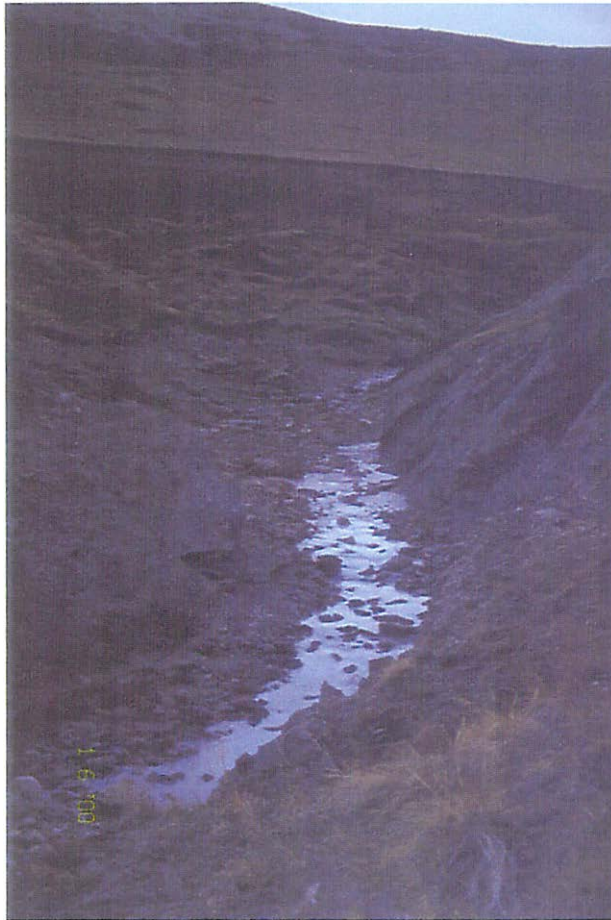
Photograph 0898-15. Both banks looking US at Bend #6. Downstream slide on left.

Bank Stabilization : None, except mine rock from channel and revet both banks.

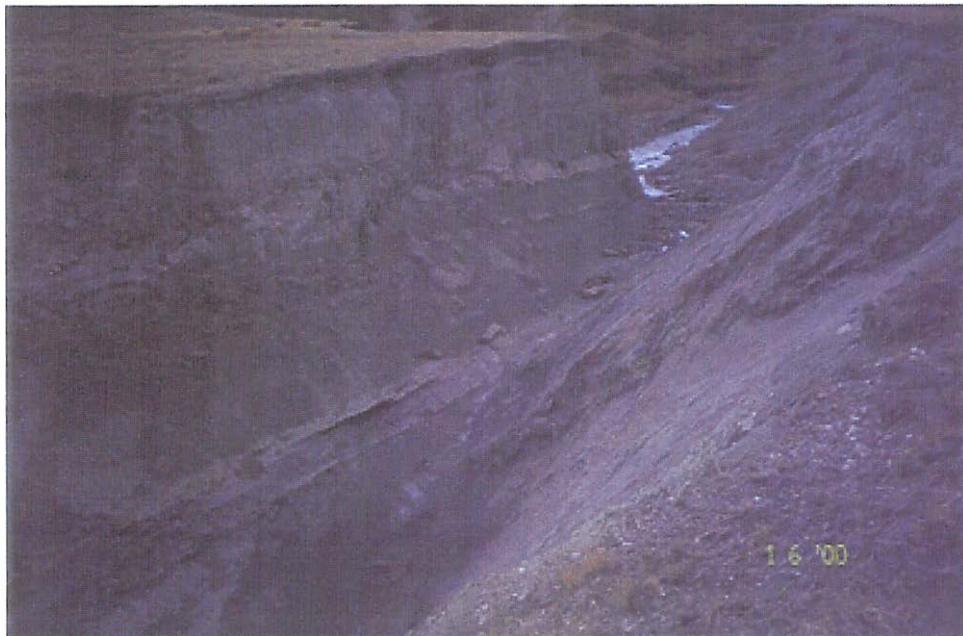
Photograph 0898-19. "Kayak."

Photo Station : 50+00
 Bank Stabilization : None.

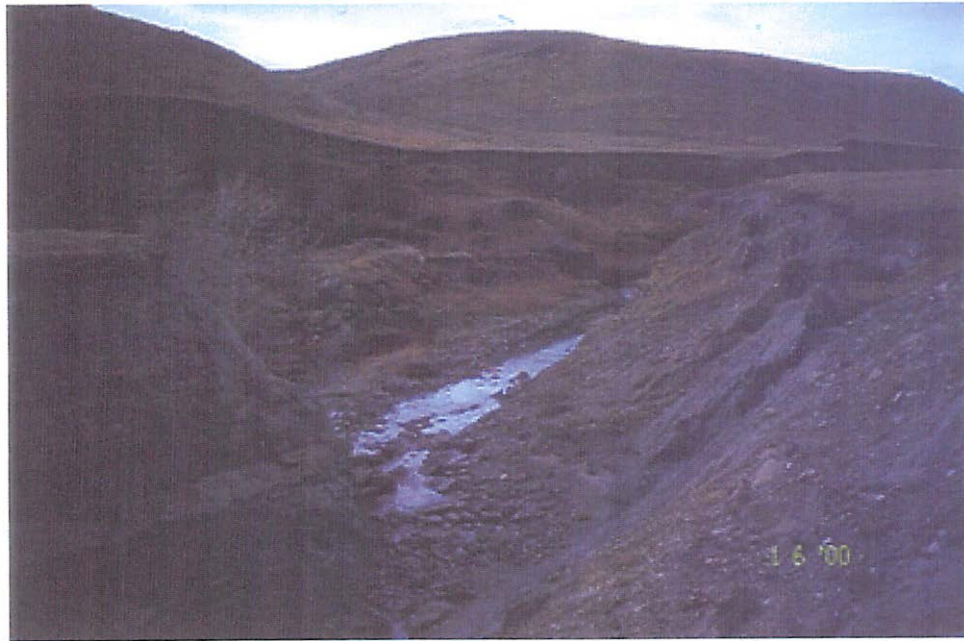
Photograph 0898-20. Right bank US of "Kayak" entrance, lower Bend #10.

| Bank Stabilization | : None. Rebuild headcut stabilization structure at entrance to "Kayak" with rock from channel and right bank. This protects right bank (cupola) immediately to the right at upstream of "Kayak." See Photograph 0898-22. |

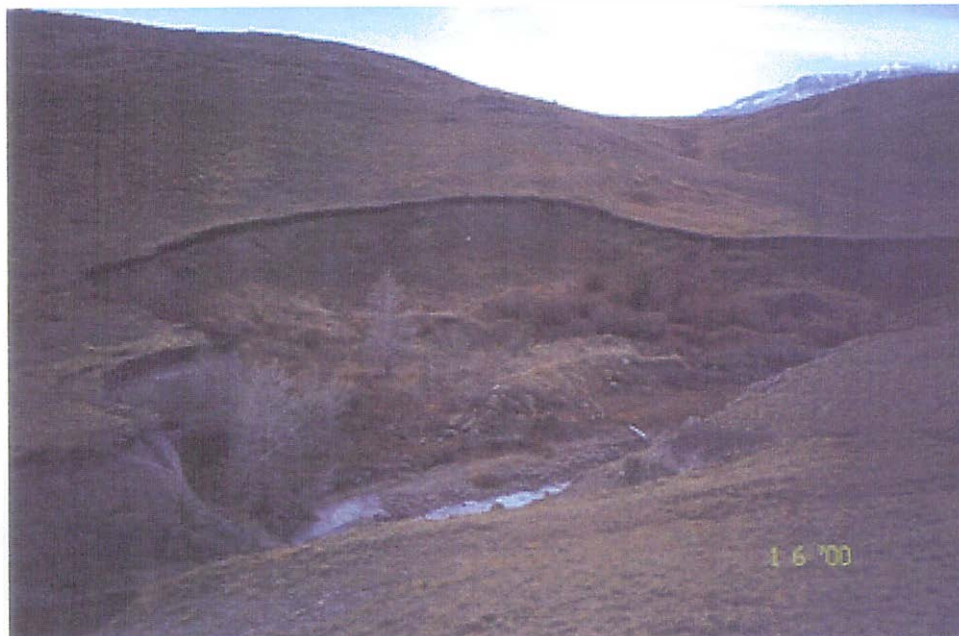
Photograph 0898-21. Right bank, Bend #11. Upper slide.

| Bank Stabilization | : See Photograph 0898-20. |

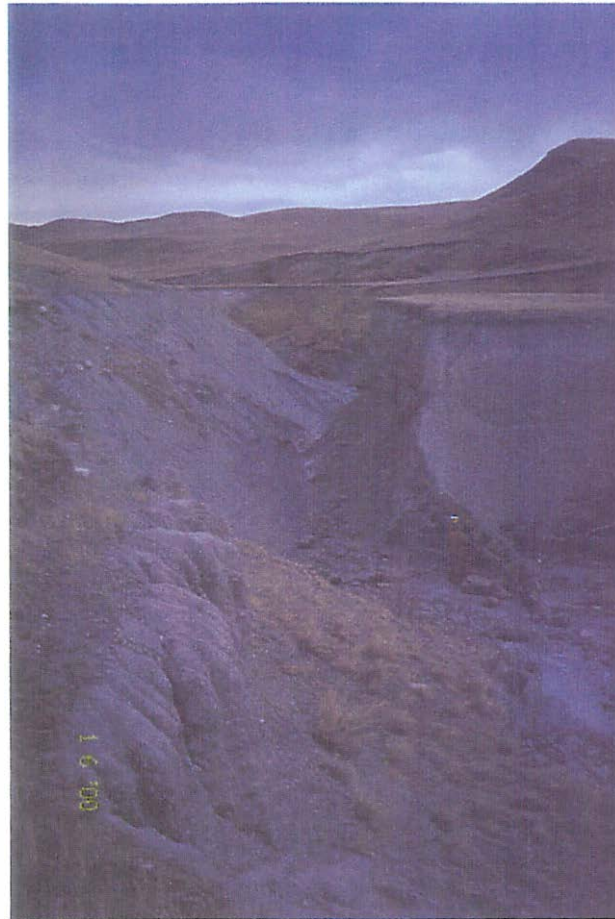
Photograph 0898-22. View looking downstream into "Kayak." Will Gonzales.

Bank Stabilization : Headcut stabilization structure at entrance to "Kayak." See Photograph 0898-20.

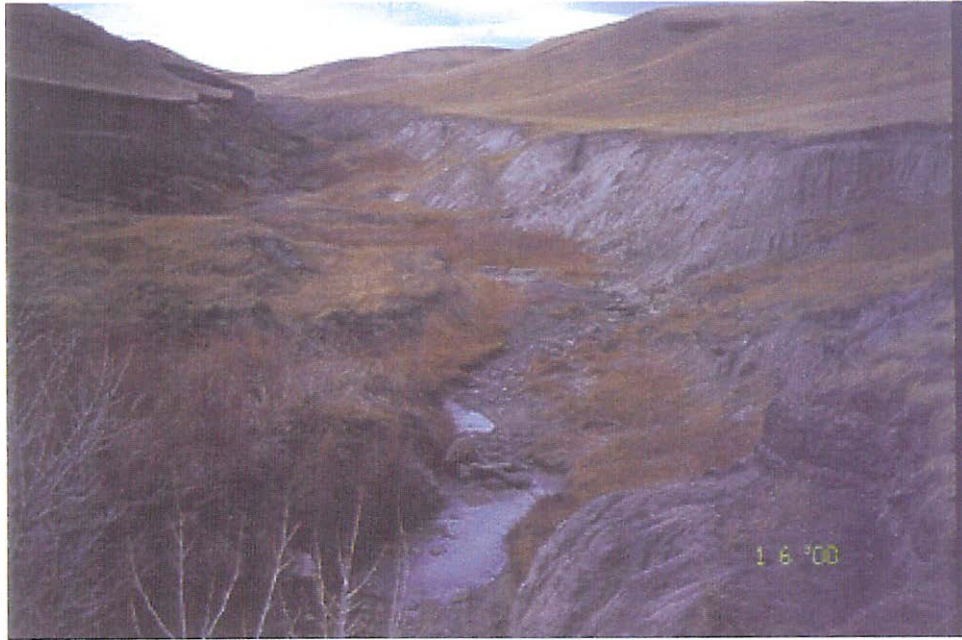
Photograph 0898-24. Both banks looking US at Bend #12 then Straight Reach #5. Note view upstream showing potential access along left bank for construction equipment. Probability low that vehicles could access along upper bank. Access in channel adequate for tracked vehicles only.

Photo Station : 54+60
Bank Stabilization : None.

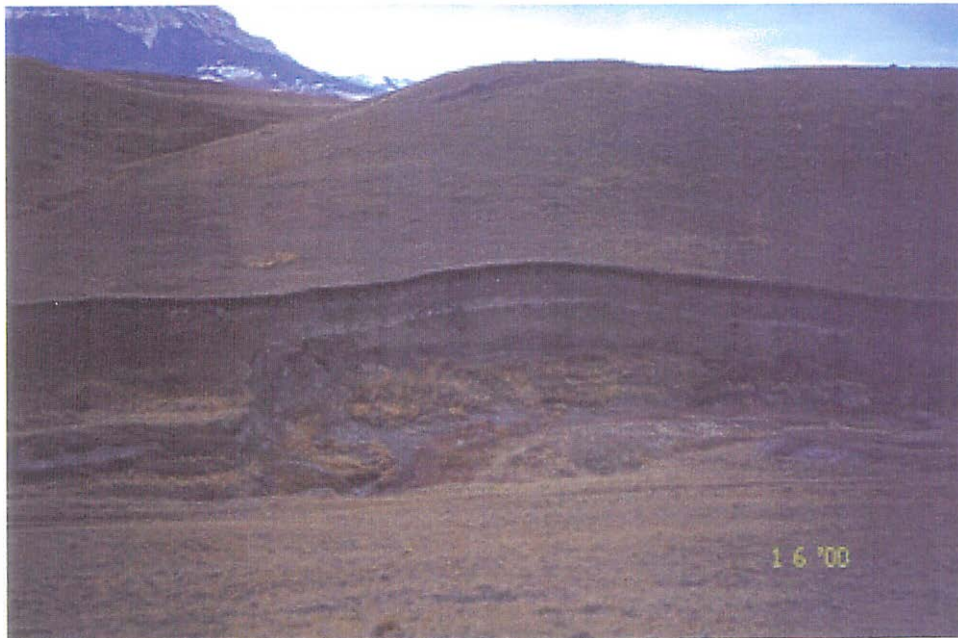
Photograph 0898-25. Right bank opposite Bend #13 & #14.

Photo Station : 55+90
Bank Stabilization : Medium priority longitudinal peaked stone toe protection on right bank. High priority headcut stabilization structure at 56+00.
Upstream Station : 61+10
Downstream Station : 56+00

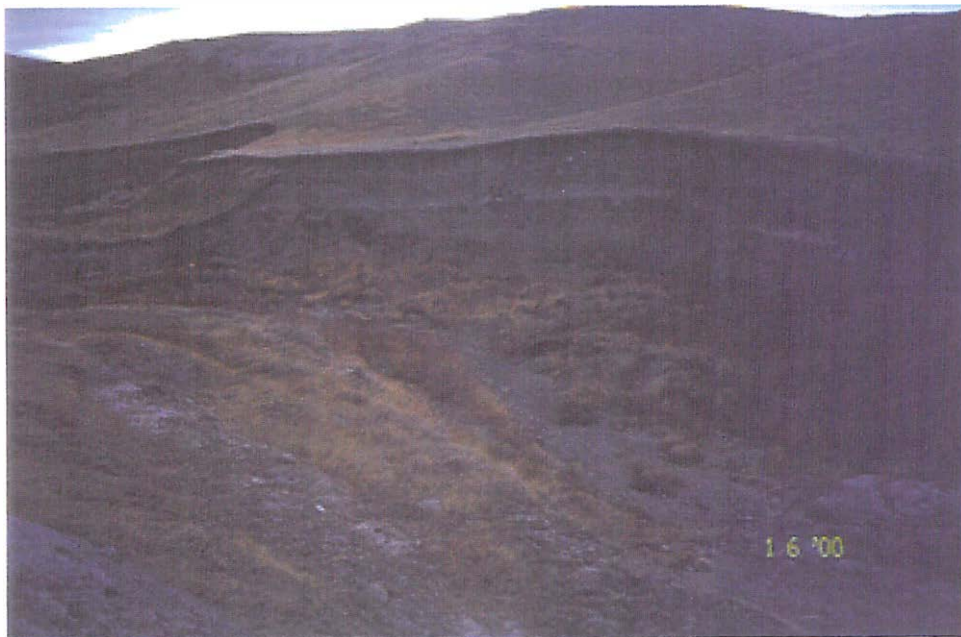
Photograph 0898-28. View looking DS of Photograph 0898-25 and Photograph 0898-26.

Bank Stabilization : See Photographs 0898-25 and 27.

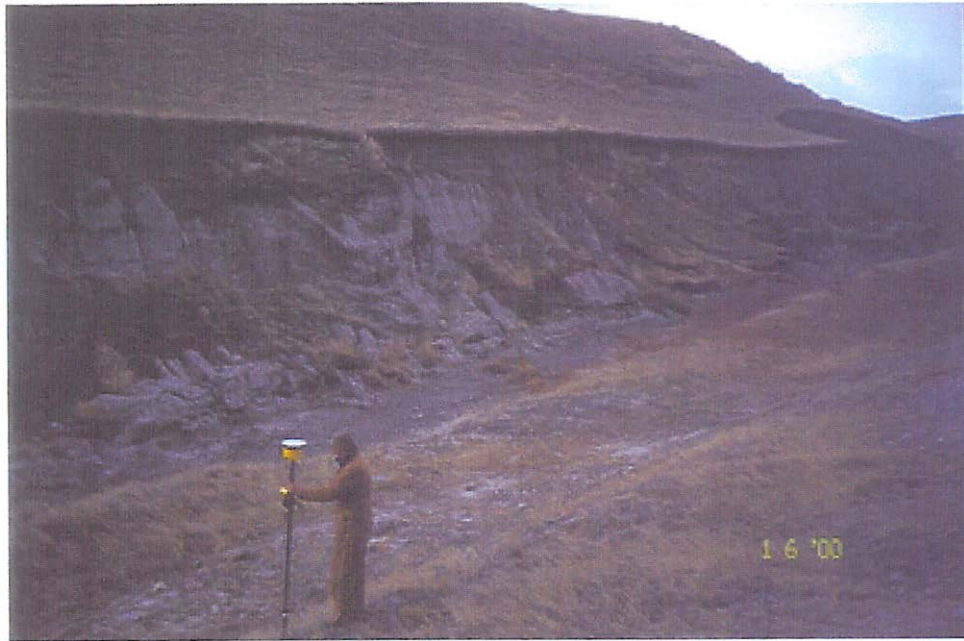
Photograph 0898-29. Right bank looking US at Straight Reach #5. Panned right from Photograph 0898-28.

Photo Station : 57+10
 Bank Stabilization : Medium priority longitudinal peaked stone toe protection on right bank. See Photograph 0898-25.

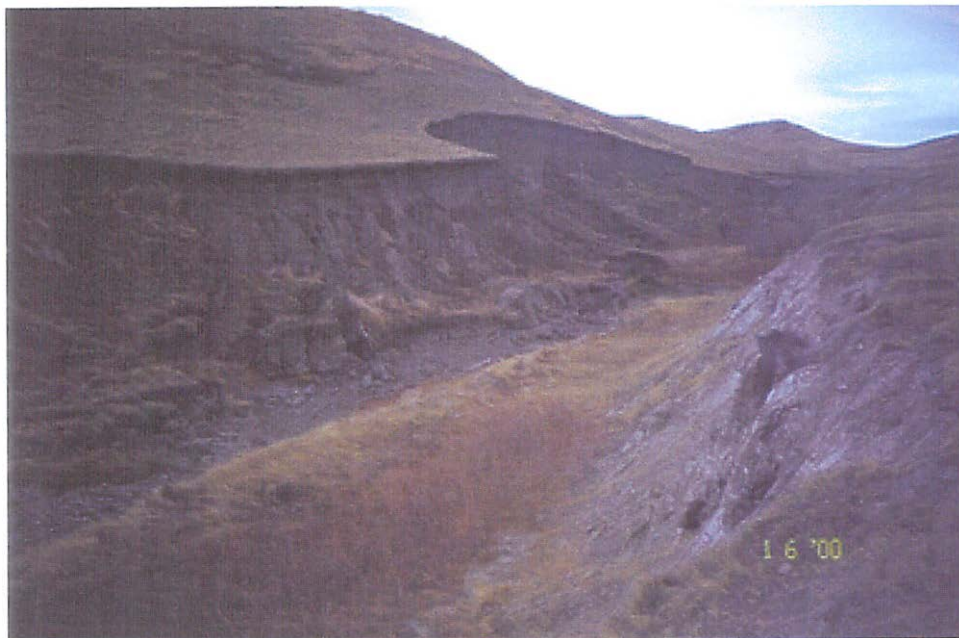
Photograph 0898-30. Right bank looking US at Straight Reach #5.

Photo Station : 59+10
 Bank Stabilization : See Photograph 0898-25.

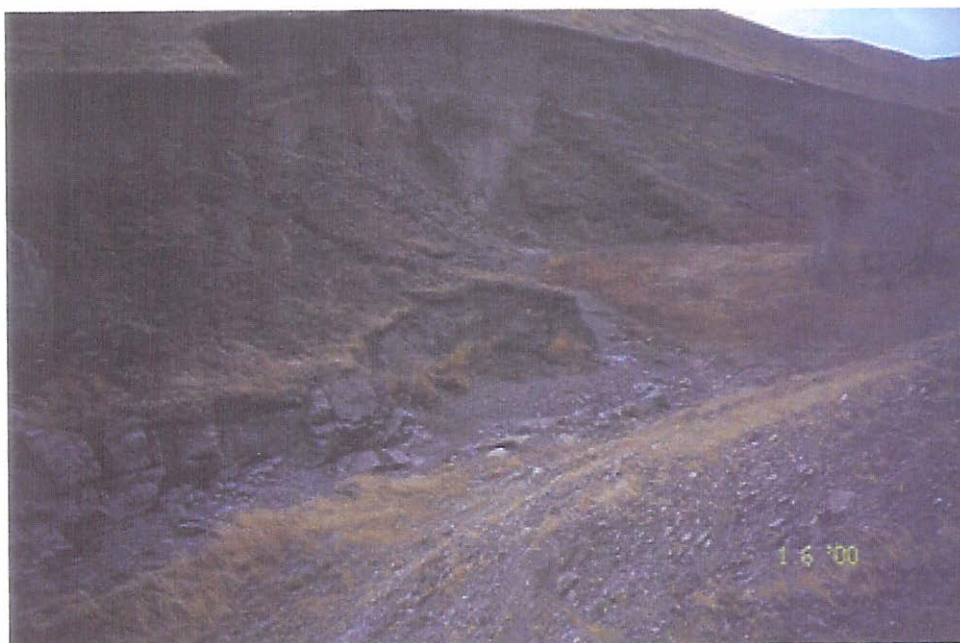
Photograph 0898-31. Right bank looking US at Bend #15.

Photo Station : 60+90
 Bank Stabilization : See Photograph 0898-25.

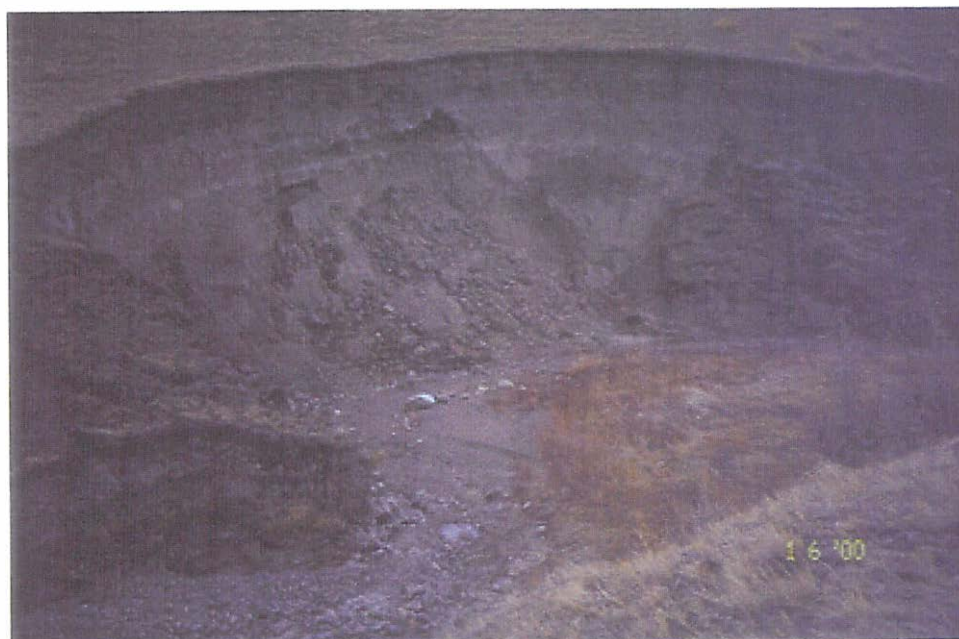
Photograph 0898-32. Right bank of Bend #15.

Photo Station : 61+10
 Bank Stabilization : Longitudinal peaked stone toe protection on right bank.
 Upstream Station : 62+20
 Downstream Station : 61+10

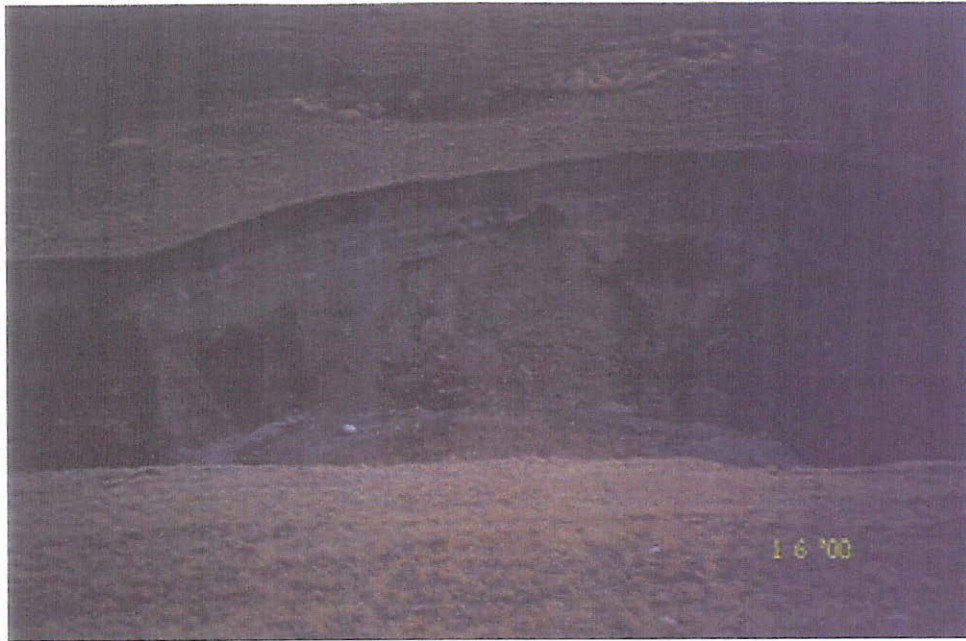
Photograph 0898-33. Right bank of Bend #15.

Photo Station : 62+00
 Bank Stabilization : See Photograph 0898-32.

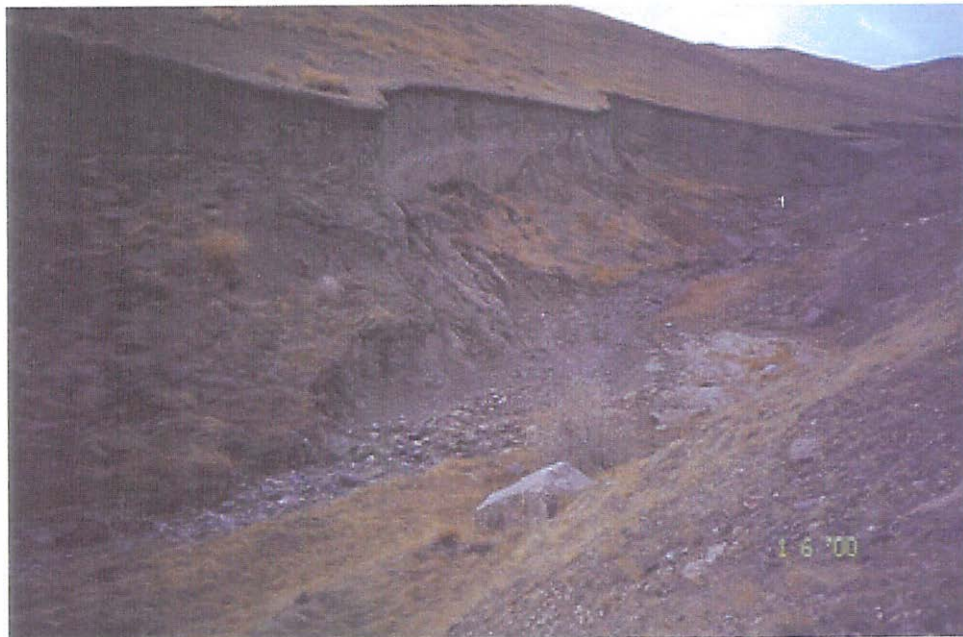
Photograph 0898-34. Right bank looking US at Straight Reach #6 and Bend #16.

Photo Station : 62+50
 Bank Stabilization : Paired barbs using available rock in channel for energy dissipation.
 Upstream Station : 66+30
 Downstream Station : 62+20

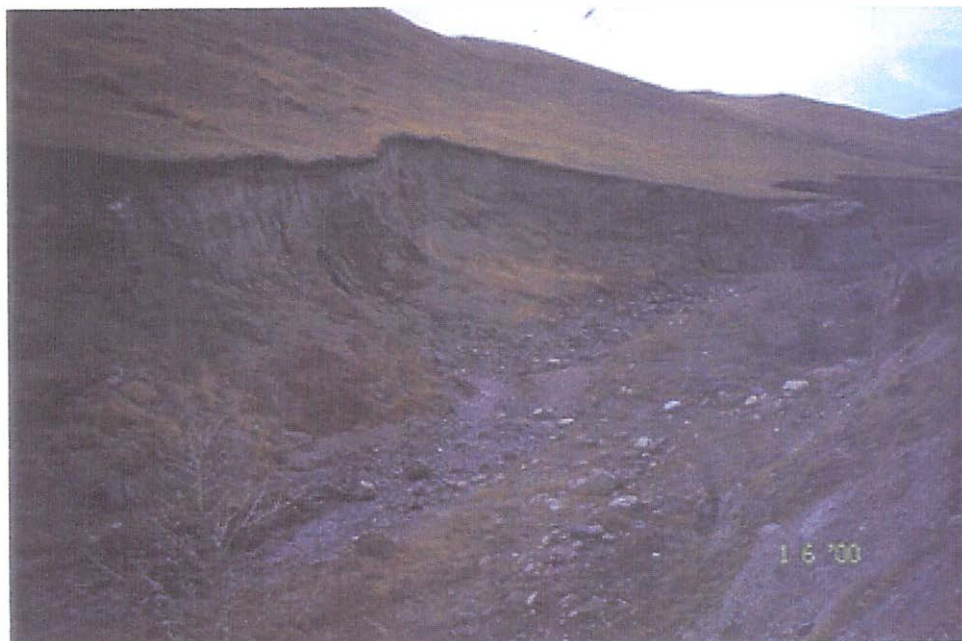
Photograph 0898-35. Right bank looking US from Straight Reach #6 to Bend #16.

Photo Station : 63+00
 Bank Stabilization : See Photograph 0898-34.

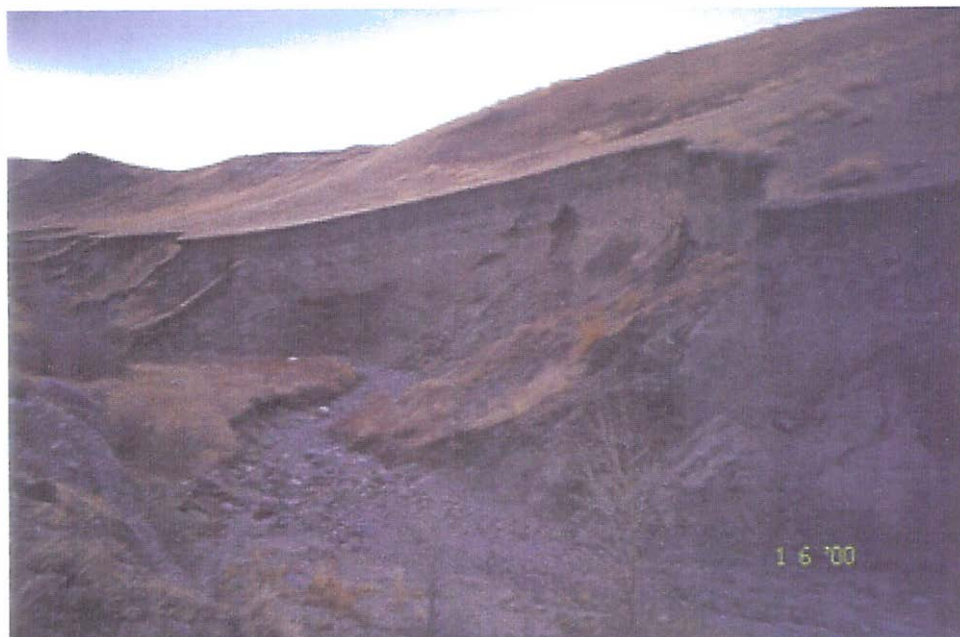
Photograph 0898-51. Right bank looking DS at Bend #15. (Overlaps)

Photo Station : 63+00
 Bank Stabilization : See Photograph 0898-34.

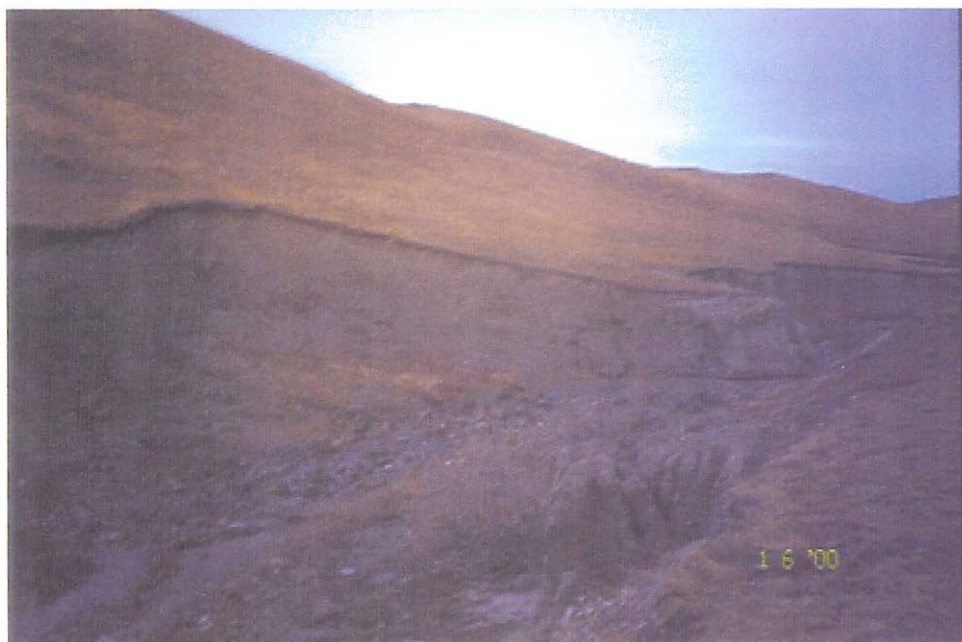
Photograph 0898-52. Right bank looking US at Bend #16. (Similar to Photograph 0898-35)

Photo Station : 63+50
 Bank Stabilization : See Photograph 0898-34.

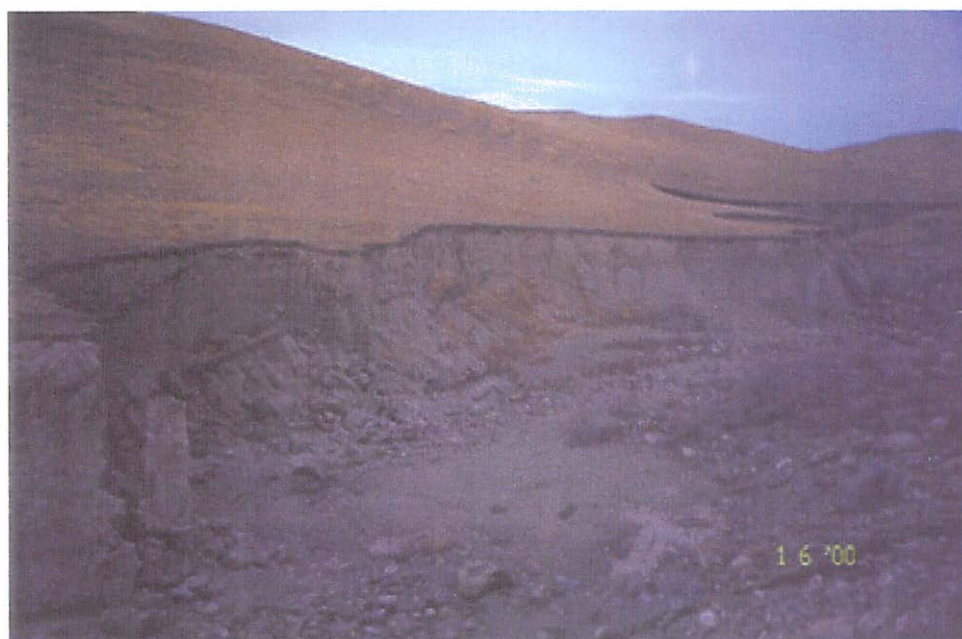
Photograph 0898-53. Right bank looking US at Bend #18.

Photo Station : 66+30
 Bank Stabilization : Longitudinal peaked stone toe protection on right bank. Potential headcut stabilization structure at 66+30.
 Upstream Station : 68+00
 Downstream Station : 66+30

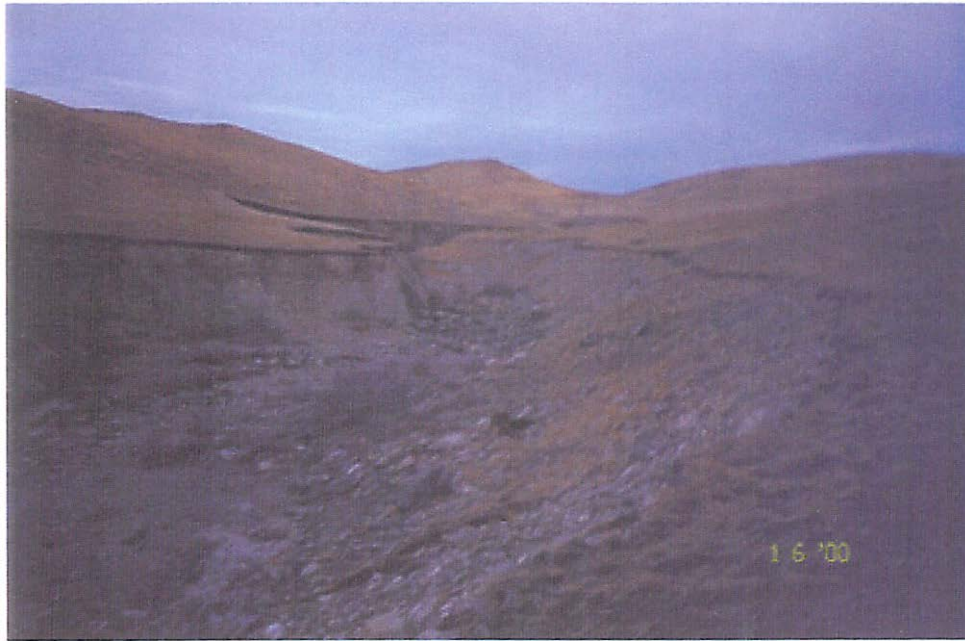
Photograph 0898-54. Right bank panned right from Photograph 0898-53 looking US at Bend #19.

Photo Station : 66+30
 Bank Stabilization : See Photograph 0898-53.

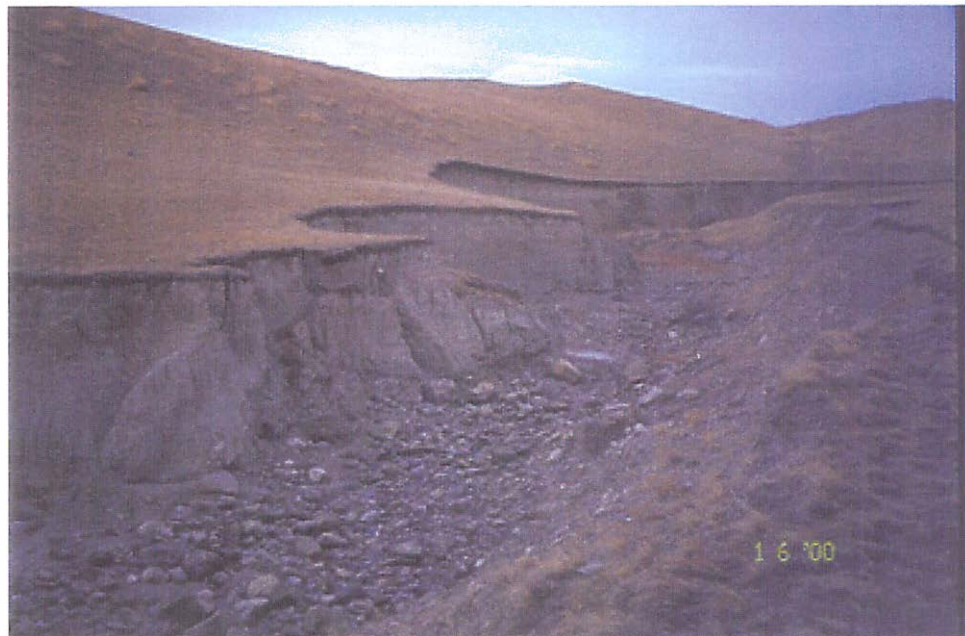
Photograph 0898-55. Right bank looking US at Bend #19 (foreground) and Bend #20 (middle).

Photo Station : 67+90
 Bank Stabilization : See Photograph 0898-53. Potential headcut stabilization structure.
 Upstream Station : 68+75
 Downstream Station : 68+00

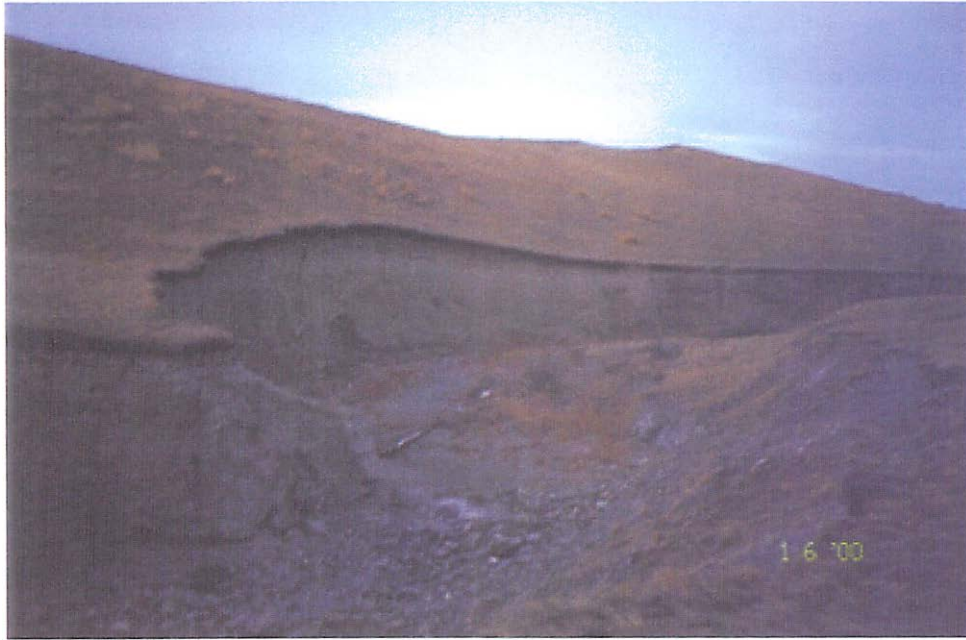
Photograph 0898-56. Right bank looking US at Bend #21.

| Bank Stabilization | : High priority longitudinal peaked stone toe protection on right bank. |

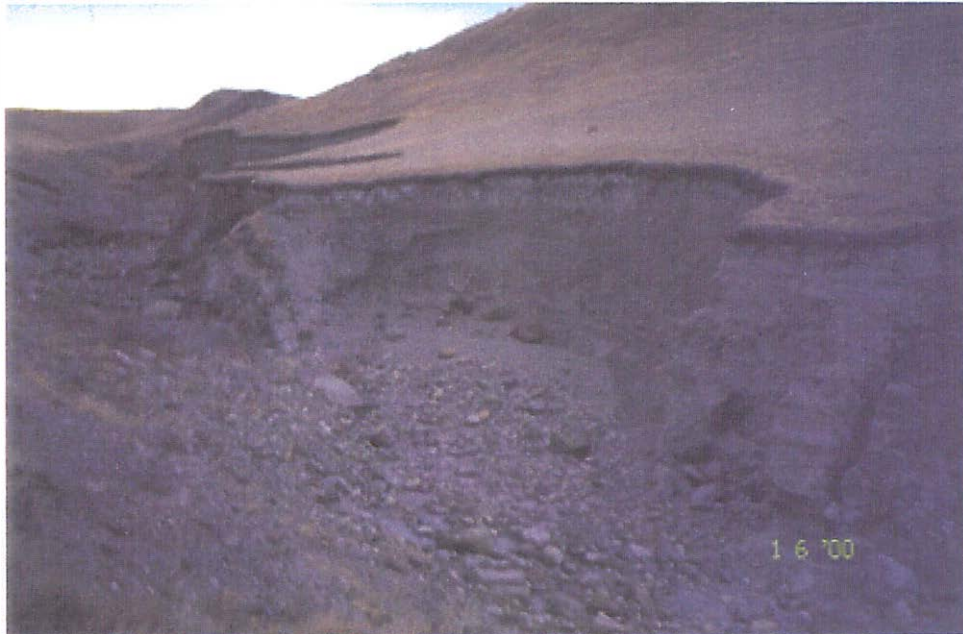
Photograph 0898-57. Right bank looking DS into Bend #20.

| Bank Stabilization | : See Photograph 0898-53. |

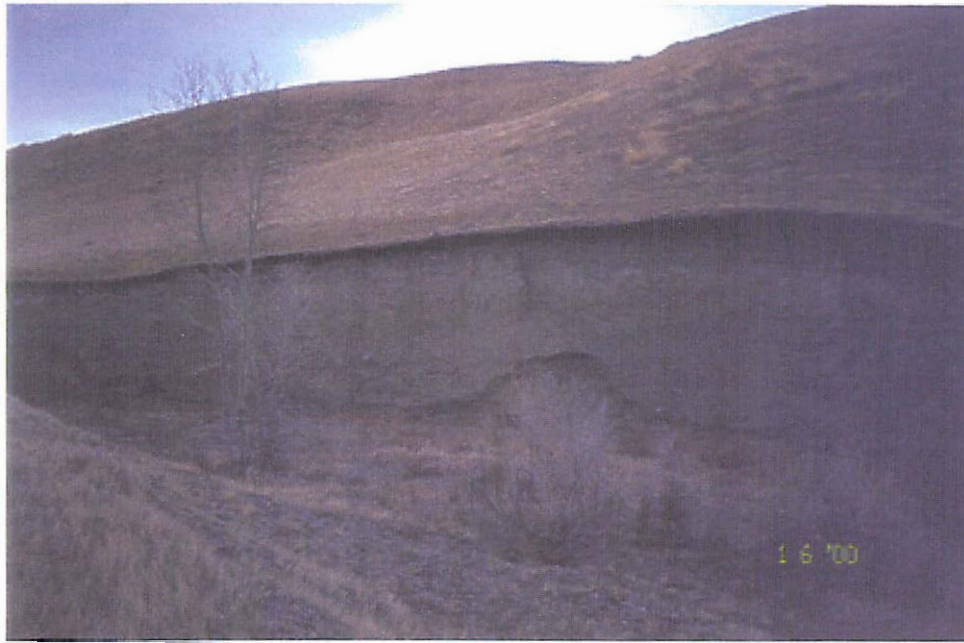
Photograph 0898-58. Right bank looking DS into middle of Bend #21.

Photo Station : 72+70
 Bank Stabilization : Photograph 0898-56.

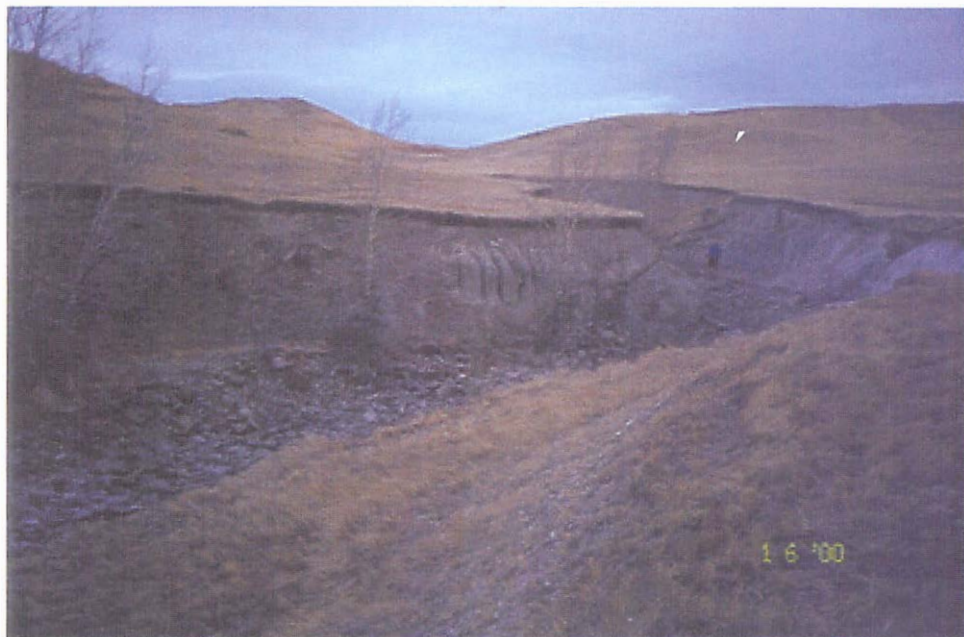
Photograph 0898-59. Right bank looking US into upper Bend #21. Panned right from Photograph 0898-58.

Photo Station : 72+70
 Bank Stabilization : None. Potential longitudinal peaked stone toe protection using rock in channel.

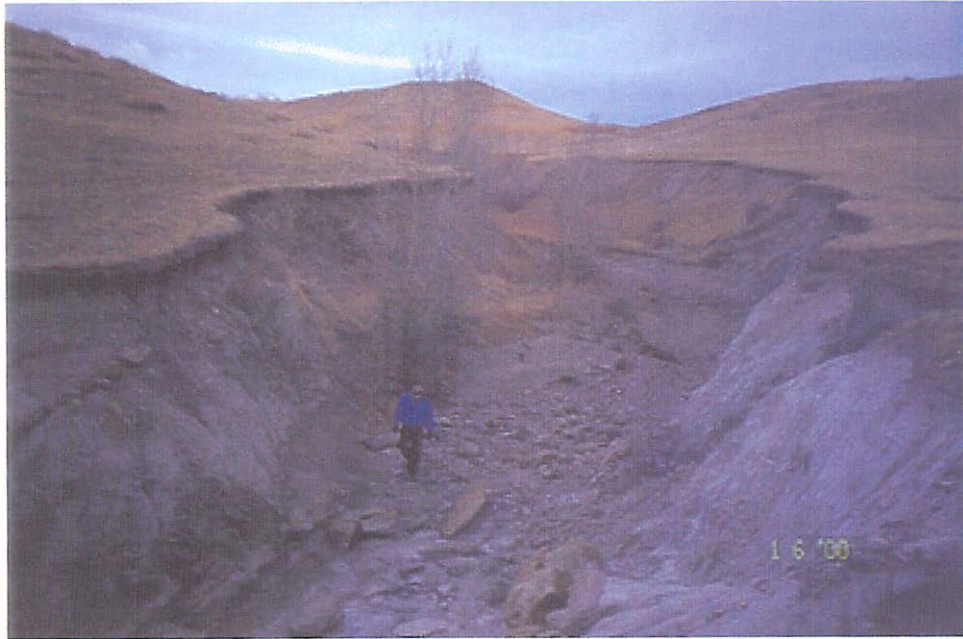
Photograph 0898-60. Both banks looking US at upper end of Bend #21, into Straight Reach #7. Will Gonzales.

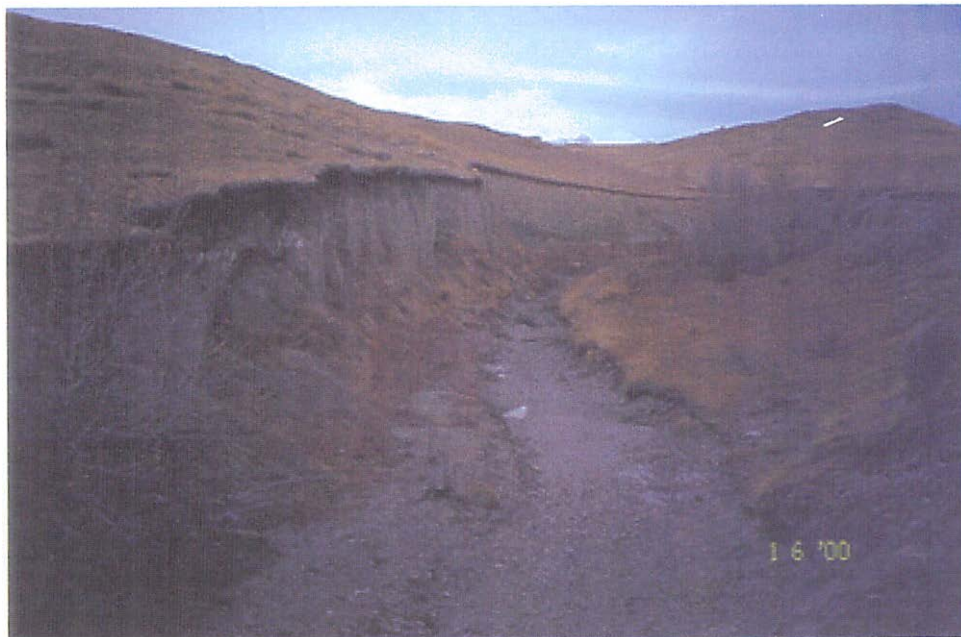
Photograph 0898-61. Right bank looking US into Bend #22.

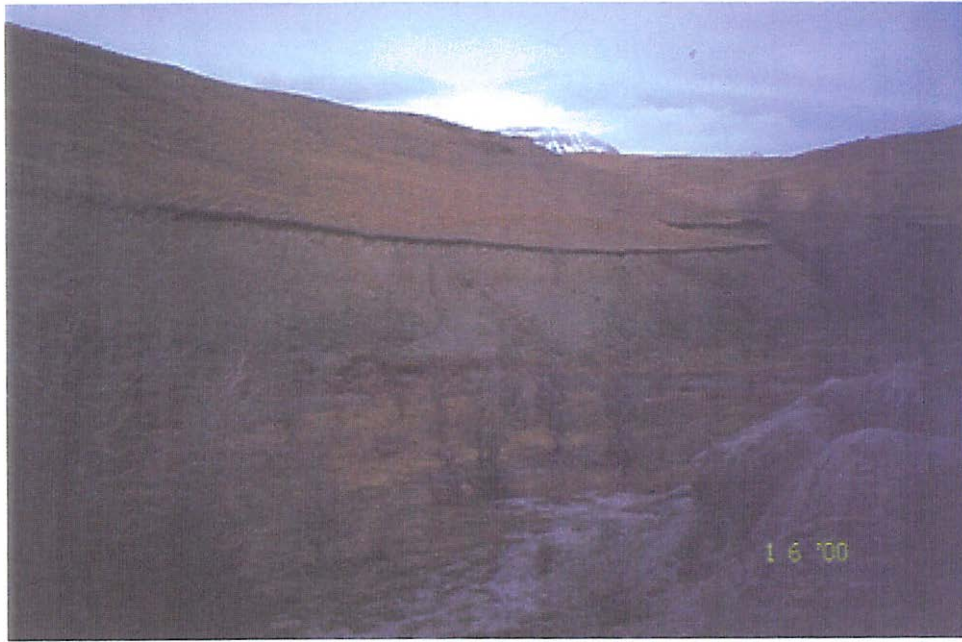
Photograph 0898-62. Right bank looking US into Bend #22.

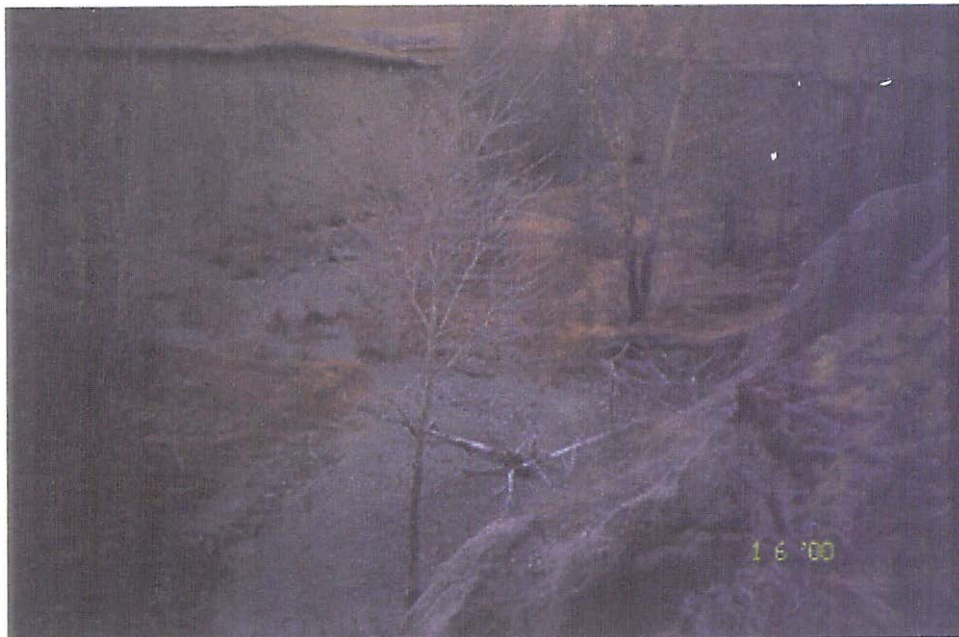
Photograph 0898-63. Left bank looking US into Bend #23.

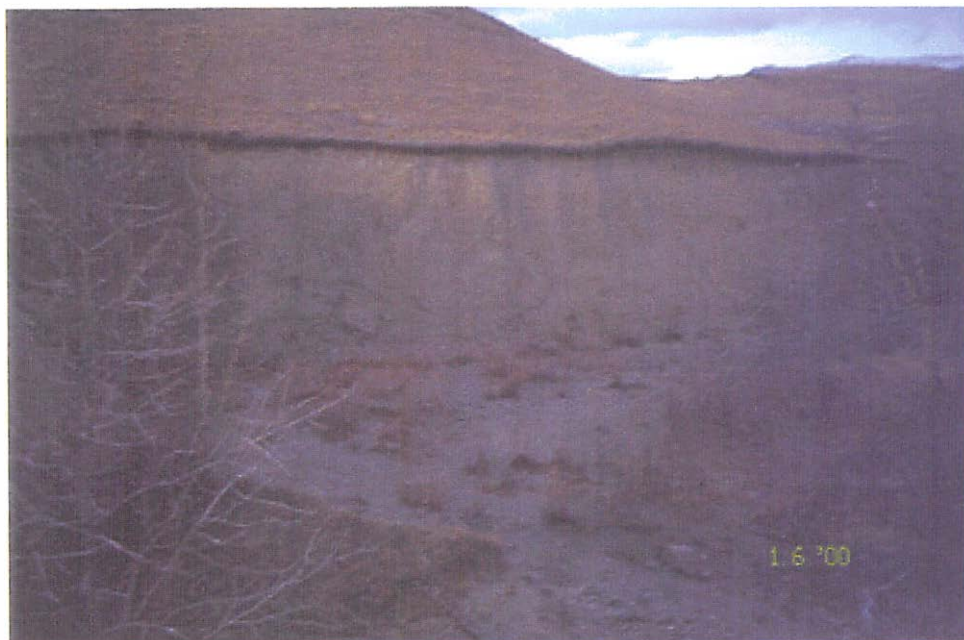
Photograph 0898-64. Right bank looking US into Bend #24.

Photo Station : 80+90
 Bank Stabilization : See Photograph 0898-63.

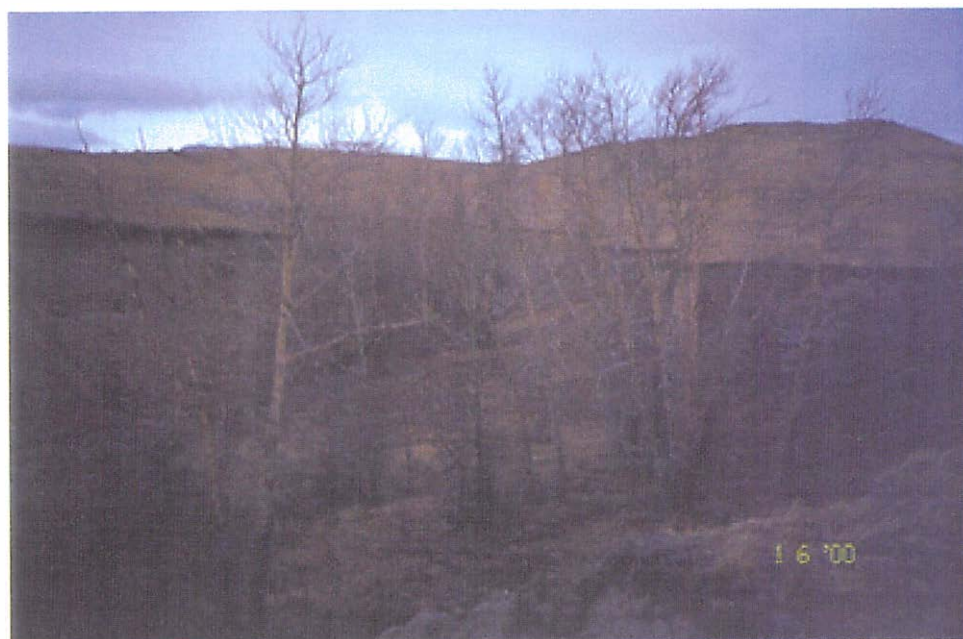
Photograph 0898-65. Riparian area on left bank US of Bend #24. Panned right from Photograph 0898-64.

Photo Station : 80+90
 Bank Stabilization : None.

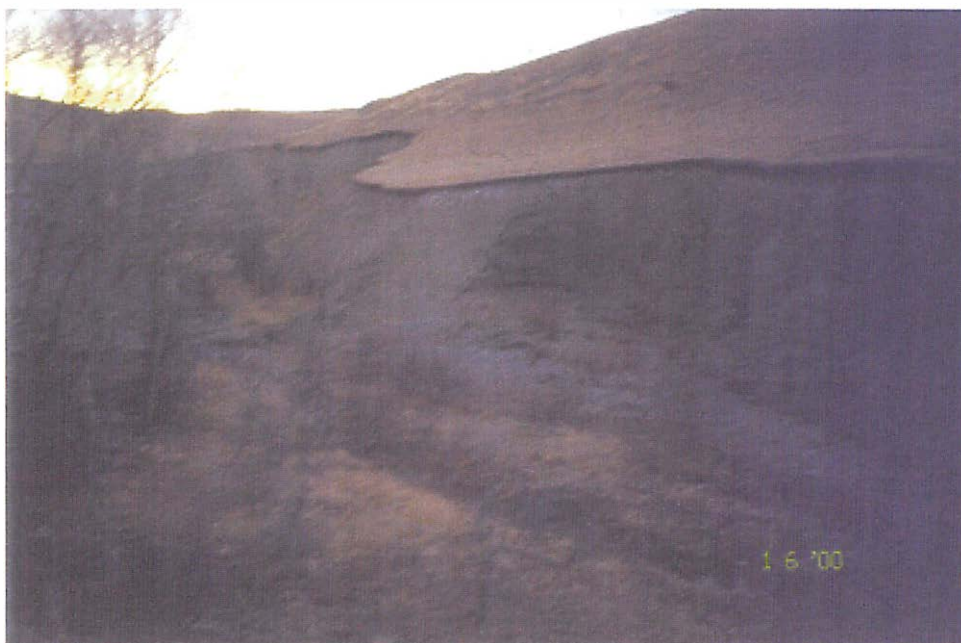
Photograph 0898-66. Right bank looking DS into Bend #24.

Photo Station : 82+80
 Bank Stabilization : See Photograph 0898-63.

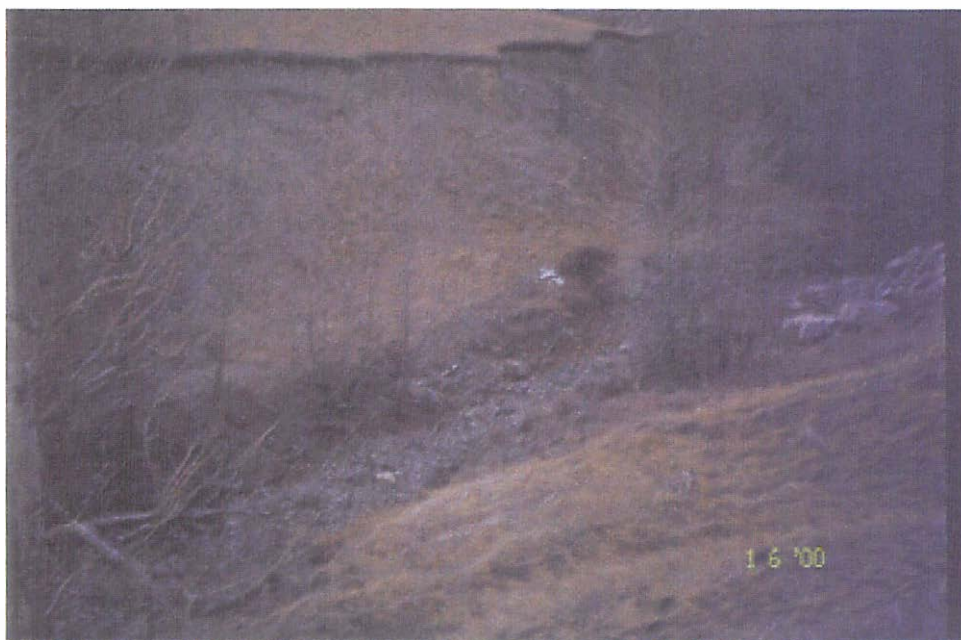
Photograph 0898-67. Both banks looking into Straight Reach #8. Panned right from Photograph 0898-66.

Photo Station : 82+80
 Bank Stabilization : None.

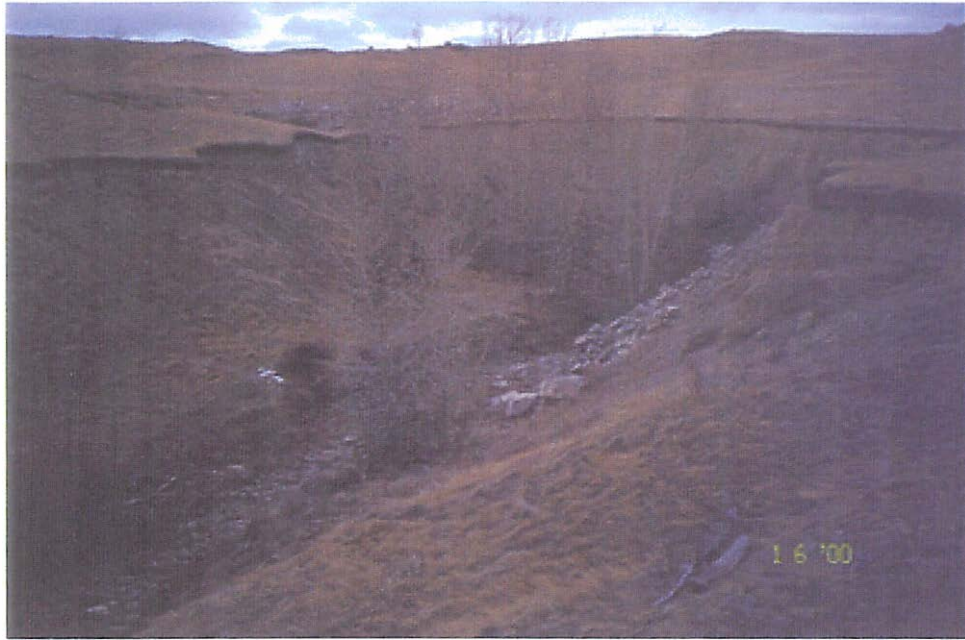
Photograph 0898-68. Both banks into Bend #26. Panned right from Photograph 0898-67.

Photo Station : 82+80
 Bank Stabilization : None. Salvage rock on left bank.

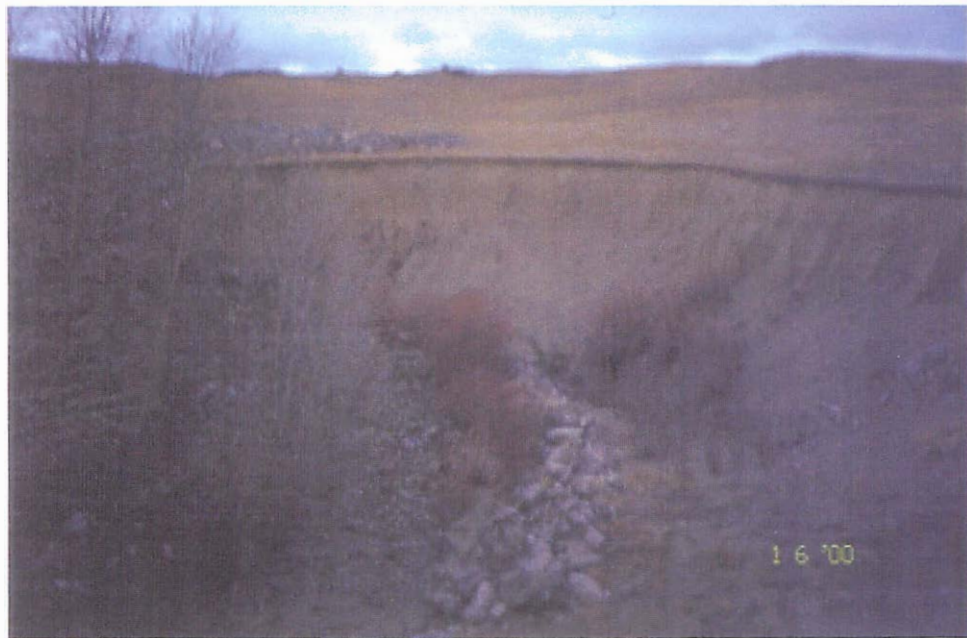
Photograph 0898-71. Left bank and riparian area created behind longitudinal peaked stone toe protection. Panned up from Photograph 0898-70.

Photo Station : 84+20
 Bank Stabilization : See Photograph 0898-70.

| Reference | Photo(s) | Bank | Begin Sta. | End Sta. | Length ft | Priority | Type | No. | Volume (Tons) |
|---|---|---|---|---|---|---|---|---|---|
| Bend #26 | 0898-69,70,71 | B | 84+00 | 85+00 | 100 | 1 | LPSTP repairs | | 0 |

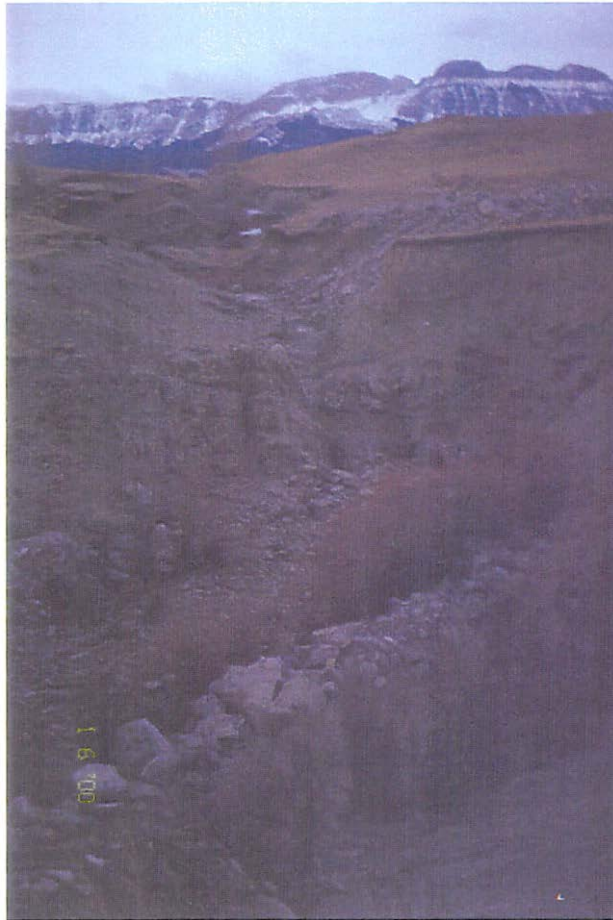
Photograph 0898-72. Headcut.

Photo Station : 85+00 (Estimated)
Bank Stabilization : None.
