WILLOW CREEK FEEDER SYSTEM

GAME RANGE REACH EROSION CONTROL AND BANK STABILIZATION PLAN

US Department of the Interior
U.S. Bureau of Reclamation

MAY 15, 2000

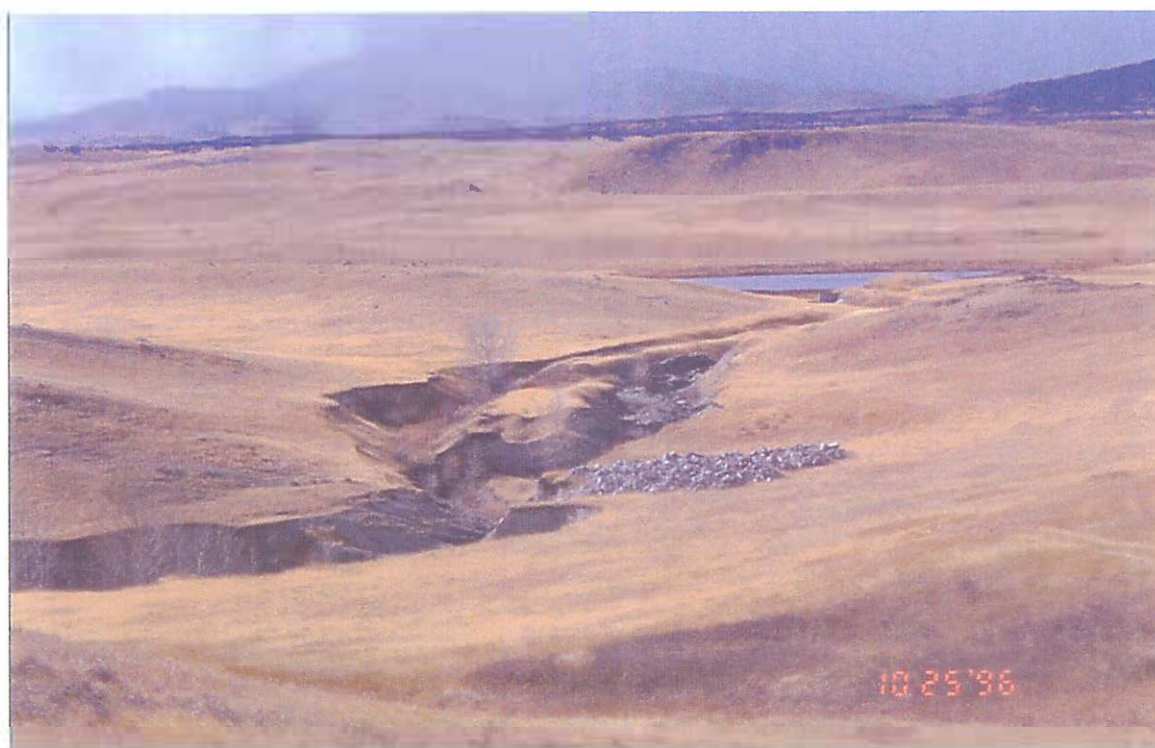
There is an existing stockpile, Stockpile Site #1, of minus-36 inch angular rock, acceptable for longitudinal peaked stone toe protection, barbs, and headcut stabilization at the upper end of the Game Range Reach. Figure 19 shows the stockpile. The surface area of the stockpile, measured by GPS, is roughly 10,400 ft². The height of the stockpile is roughly 3.5 feet. The estimated volume of the stockpile is 1,350 cubic yards or roughly 1,800 tons. The LPSTP, barbs, and headcut stabilization structures require roughly the same size and gradation of rock. The maximum, or D₁₀₀, size is 42 inches. The median, or D₅₀, size is 30 inches. The practical minimum size, or D₁₀, is two inches. This gradation is well-graded yet massive, and is similar to rock designs on Muddy Creek, Montana, Blue River, Colorado, Sun River, Montana, Hilton Creek, California, and others.

Figure 19. Rock stockpile at upper end of Game Range Reach.

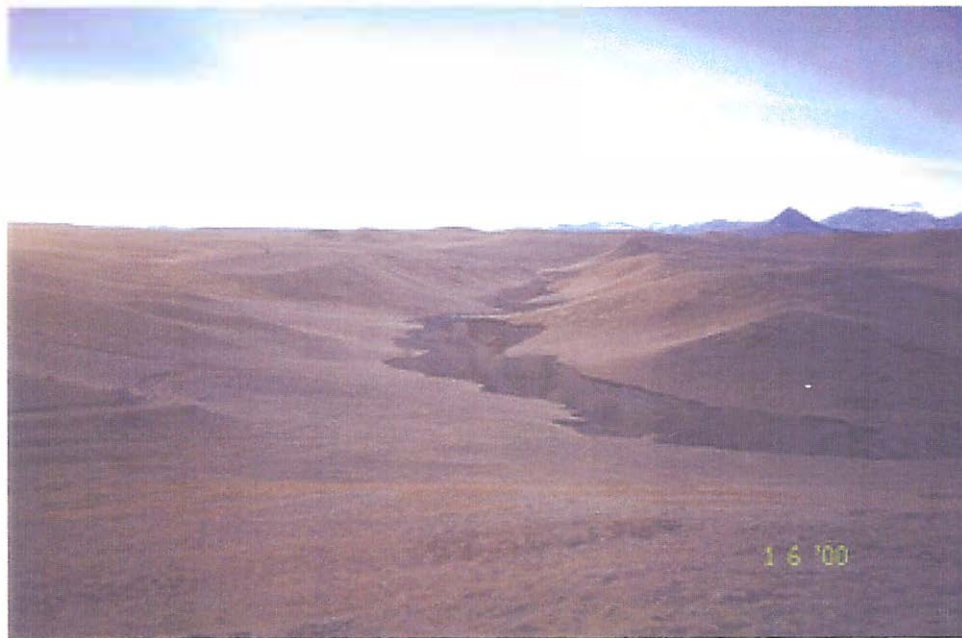
Photograph 0898-49 pictures the view looking downstream along the Game Range Reach. The road pictured in the right side of the photograph originates at the county road along the north end of the Game Range Reach of the feeder system. Construction access on this road along the left bank is good from Station 85+00 downstream to roughly Station 69+00. Rubber wheeled and tracked vehicles could use this existing road to dump rock over the bank to the construction sites. The terrain becomes too steep below roughly 69+00 (maybe as low as 65+00) to safely traverse loaded trucks. The road is partially graded, and near 69+00 reduces to two wheel tracks.

Photograph 0898-49. Panoramic view looking downstream from knoll.

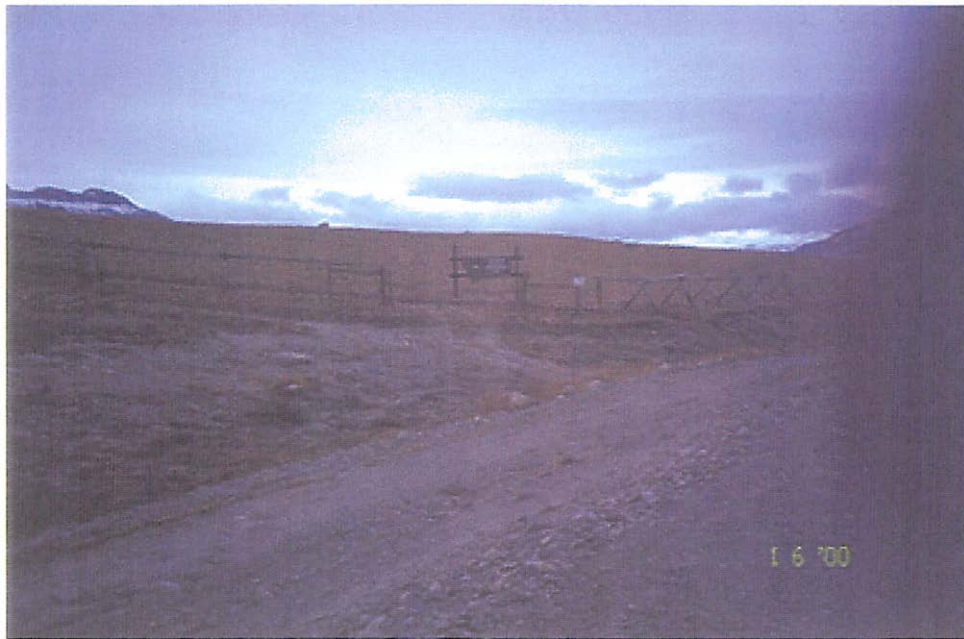
Photograph 0898-75. Lower entrance into game range.

Photograph 0898-49 shows a view facing downstream from roughly the location of the "S1" label on Figure 20. Photograph 0898-75 shows the gate along the county road at the downstream boundary of the Game Range Reach, just above the "F" label on Figure 20.

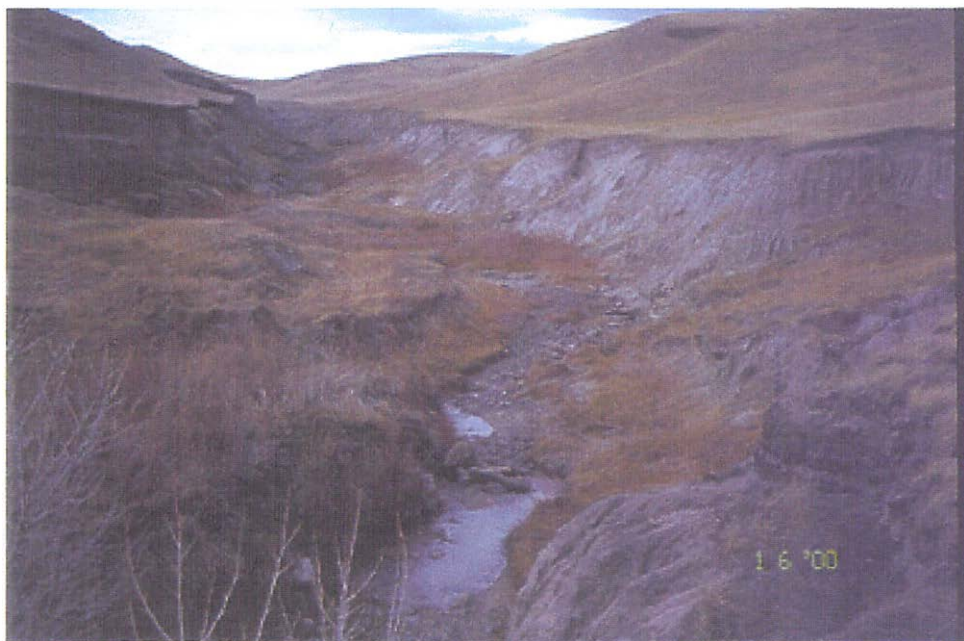
Photograph 0898-24, taken at roughly Station 54+60, shows the middle area, around the "Kayak" feature. From roughly Station 54+00 to 69+00, 1,500 feet, access will be very difficult from both the top-of-bank and within the channel. Rubber wheeled vehicles will not be able to traverse the left bank because the terrain is too steep. Tracked vehicles can traverse the channel up-to or down-to the "Kayak" location.

Photograph 0898-24 (54+60). Both banks looking US at Bend #12 and Straight Reach #5. Note view upstream showing potential access along left bank for construction equipment. Low probability that those vehicles could traverse upper left bank. Access in channel adequate for tracked vehicles only.

However, transporting the required volumes of rock material will be difficult. We advise receiving construction advice from the Greenfields Irrigation District or another contractor, in coordination with Montana Fish, Wildlife & Parks on access in the middle area of the Game Range Reach.

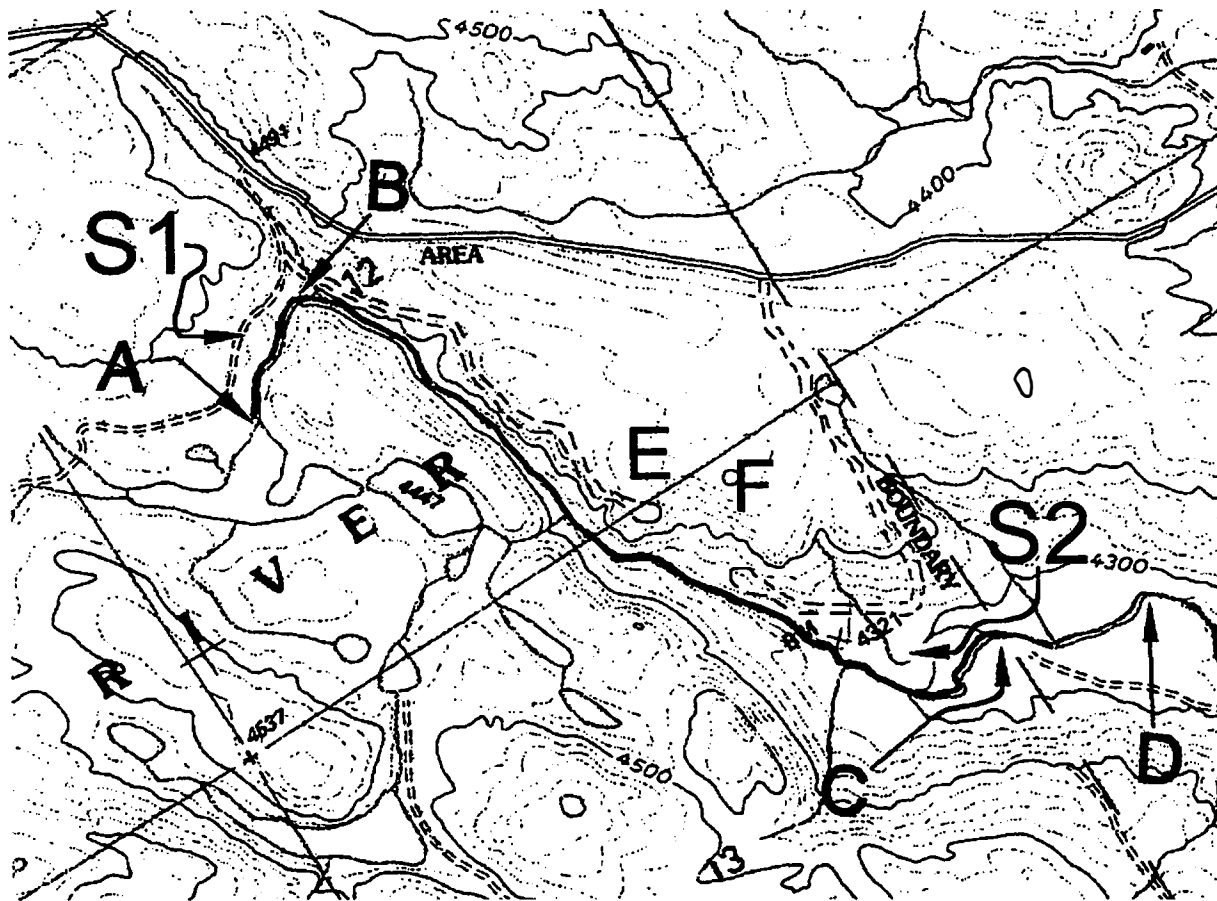
Figure 20 shows the existing and proposed access routes to the Game Range Reach. The reach extends from "B" to "C." Stockpiles are at "S1" and "S2." Existing two-wheel track extends from "B" to "E." Proposed new two-wheeled track extends from "F" along the boundary along the downstream end of the

Game Range Reach to the county road. Area between "E" and "F" slopes towards the canal, making it very difficult to traverse without extensive grading. There may be other preferable routes that can be determined in cooperation with Greenfields Irrigation District and Montana Fish, Wildlife, and Parks.

Figure 20. Access to the Game Range Reach.
