Technical Memorandum No. Hv-D8560-2001-1

Lower Colorado
Boulder Canyon
Hoover Dam Penstock System
Evaluation of tie rods at the A-1 penstock junction,
Upper Arizona Penstock

U.S. Department of the Interior
Bureau of Reclamation

October 2001

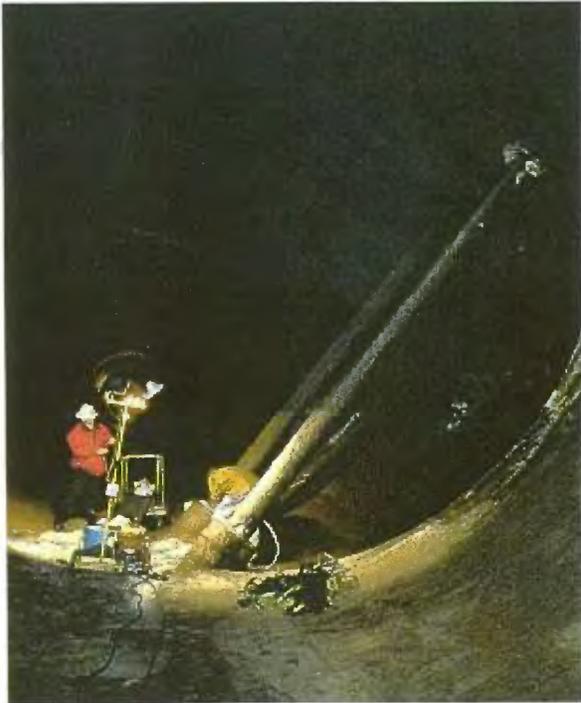
Figure 1.- Tie rods at the junction of the A-1 penstock lateral.

Eight-350 ohm weldable strain gages were installed on the tie rods of the A-1 lateral junction at Hoover Dam (figure 1) during the week of January 22, 2001. Prior to traveling to Hoover Dam, steel fittings were machined (figure 2) to accept molded epoxy pass-through connectors manufactured by PAVE (figure 3). These connectors are designed and have been tested at pressures up to 450 lb/in² with no visible leakage.

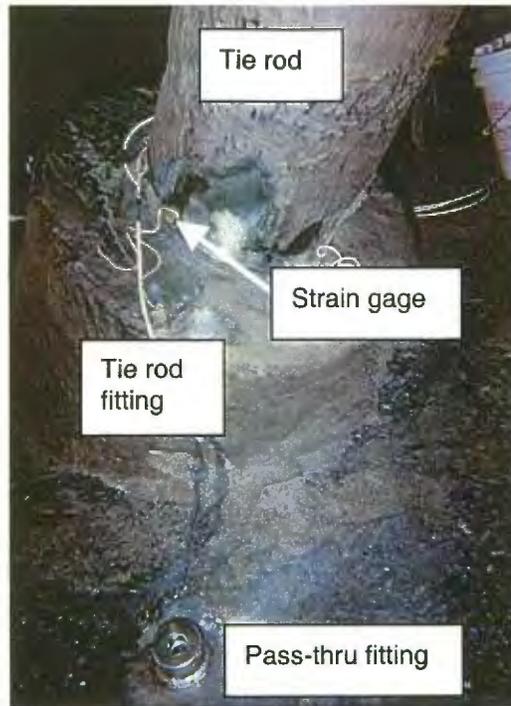
One-half inch diameter holes were lanced through the 2-1/2 inch-thick penstock walls on the invert of the penstock near the tie rod fittings. The pass-through connector fittings were then welded to the inside of the penstock, figure 4. A weldable plug fitting was located over the hole on the exterior of the penstock to provide long-term sealing and shut off should a leak occur. The coal-tar epoxy coating was chipped away in the areas that gages were placed. Additional grinding was necessary in the area that strain gages were mounted along with the areas

Figure 4: Fitting welded in place on interior of penstock near base of tie rod on the A-1 lateral. Gages are in place, 90-degrees apart, at a location where the rod is threaded into the base fitting.

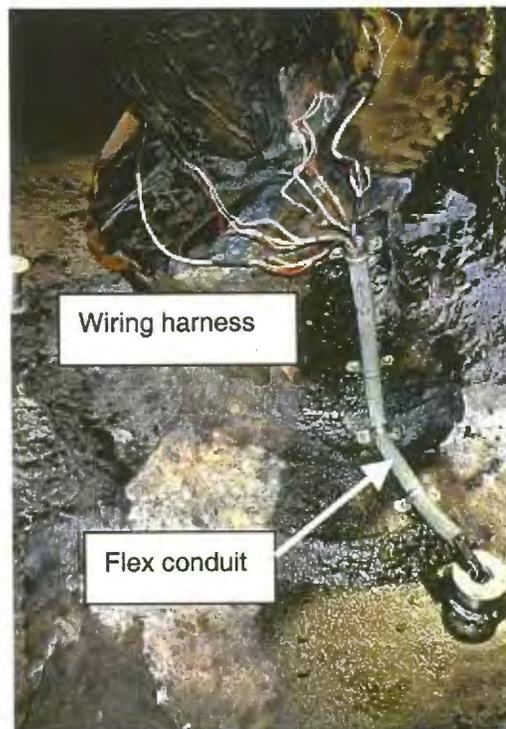
where wire paths were routed. The pass-through wiring harness was put through a section of flexible conduit and attached to the penstock surface by conduit clamps (figure 5).

Figure 5: Strain gage wiring connected to pass-through wiring harness. Note flex-conduit to provide mechanical protection for wiring.

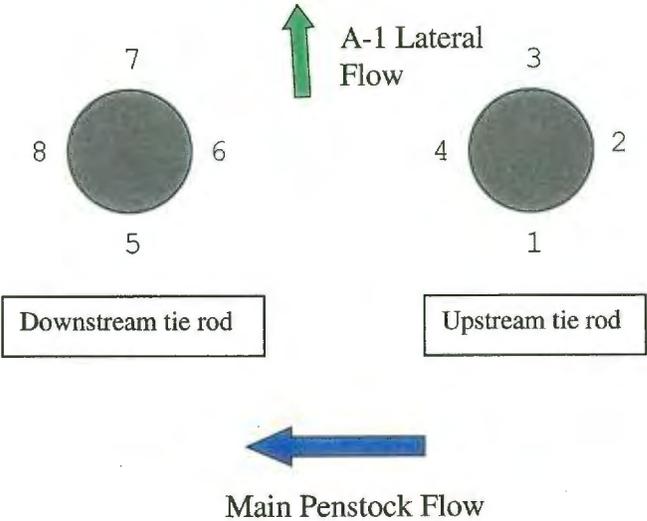
Figure 6: Numbering system and locations for tie rod strain gages.

Four strain gages were attached 90-degrees apart around the circumference of each tie rod, near the base. The gages were oriented in the axial direction of the tie rod and in planes that are parallel and perpendicular to the flow in the main penstock, fig. 6. We measured the location of the centerlines of the active gage in a slightly different manner for each tie rod. The upstream tie rod had exposed threads where it joined the base fitting and the centerline was measured up from the beginning of the threads. The downstream tie rod did not have exposed threads so the centerline was measured up from the top face of the lower fitting. The measurements probably have an accuracy of about 1/8-inch due to the variable coating thickness on the rod and fitting.

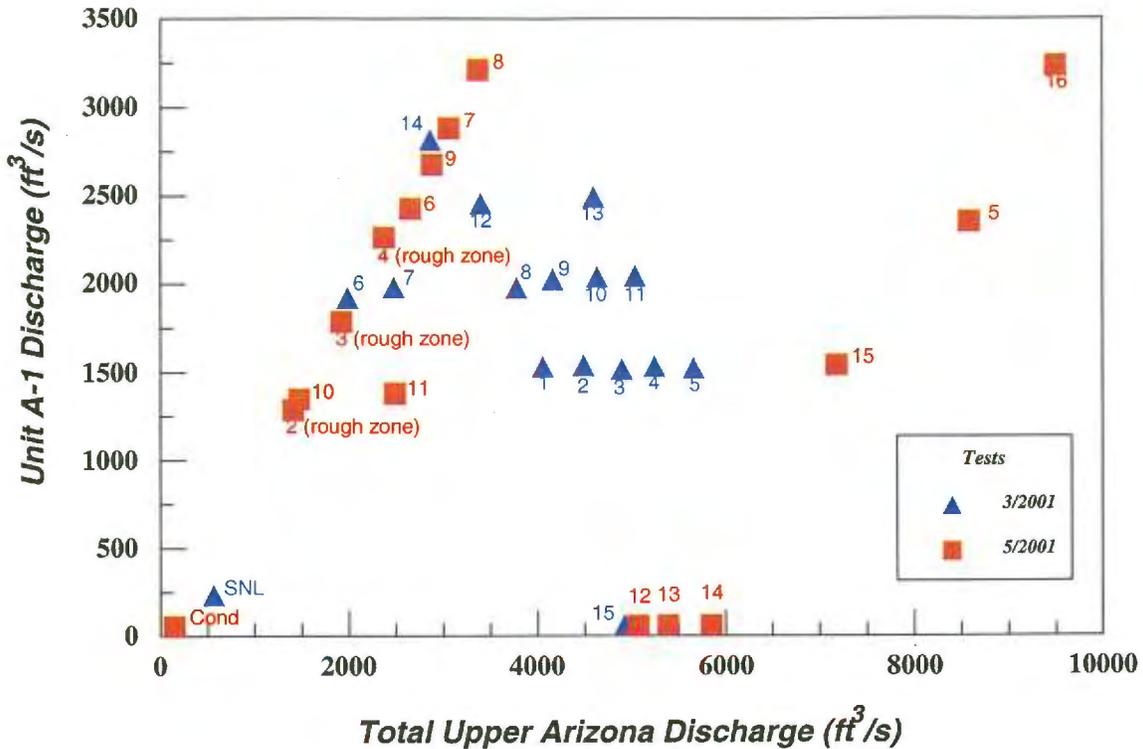
Figure 7.-Summary of all test runs as a function of A-1 flow versus total flow.

A summary of the test runs as a function of flow in A-1 versus total Upper Arizona penstock flow is shown on figure 7.

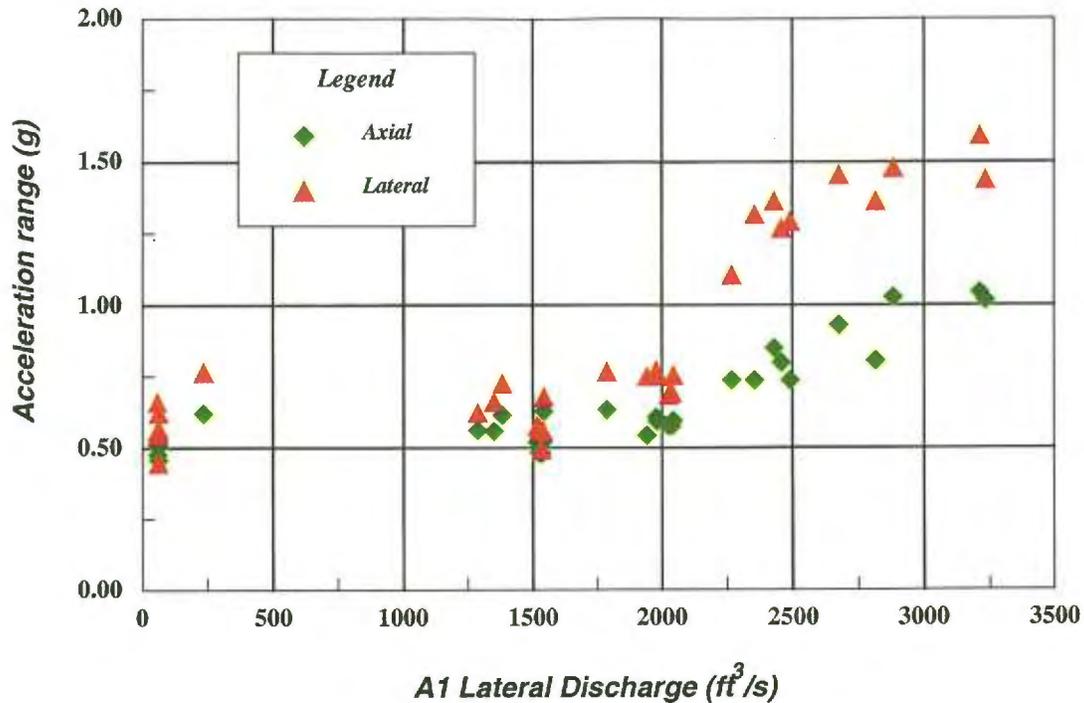
The accelerometer data provided information concerning the magnitudes and frequency of vibrations on the stiffening plate located external to the penstock at the tie rod ends. Accelerometers were located both on the axis perpendicular to the tie rods and also along the axis of the tie rods. As you might expect, the magnitudes along the axis of the tie rods were smaller due to the higher stiffness in that direction. Figure 8 shows both lateral and axial accelerometer responses as a function of the flow down the A-1 lateral. Test data from both the March and May tests are shown on this plot. These same data did not correlate well with total discharge. Data from the accelerometers showed no significant differences in amplitude or frequency of the vibration signal as both A-1 and N-6 were moved through the rough zone. The accelerometers did not show many lower frequencies, with the first significant frequency peak usually occurring at 48 Hz (blade passing frequency of the runner). No significant increase in vibration was noted at the N-6 junction between 100 MW and 130 MW and in fact test data collected at 90 MW showed the highest vibration amplitudes.

Figure 8.- Range (max-min) of acceleration versus A-1 lateral discharge for sensors located on the external stiffening plate in the axial and lateral directions.

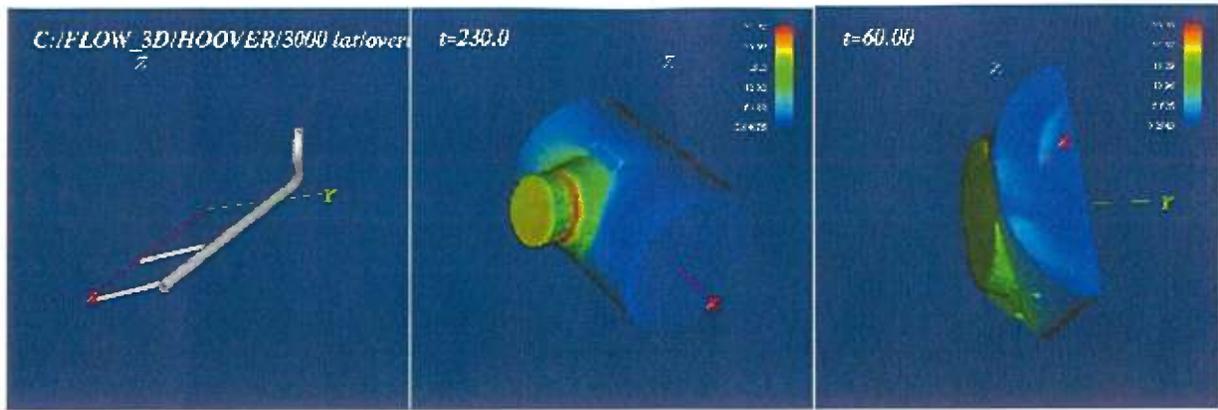
As a result of some of the uncertainties concerning stress magnitudes from the testing, we carried out a math modeling effort to look at flow patterns and loadings in the vicinity of the tie rods. FLOW-3D, a three-dimensional finite volume hydrodynamic model was run for 3 different conditions at the A-1 lateral junction. Initial runs looked at a large part of the penstock system in order to generate the appropriate boundary conditions for a finer, more detailed model. In all, three iterations of the geometry were used to achieve the final results. Figure 11 shows the three geometries that were modeled. Three flow conditions were modeled that related to actual test conditions that were performed in March 2001, 1) 3000 ft³/s down the A-1 lateral and no flow down the penstock, 2) 4900 ft³/s flowing down the penstock and no flow down the A-1 lateral, and 3) a flow split between the A-1 lateral and penstock that totaled 4164 ft³/s. Some samples of the flow fields illustrating colored velocity contours are shown in Figures 12a-c. These snapshots show the complexity of the flow field around the tie rods, and show the three different flow conditions cited above for a slice at about mid-level through the lateral. Results showed that the loading on the tie rod is not uniform top to bottom. Table 2 shows results from the model for forces on the tie rod due to flow-induced drag for the three cases modeled. The CFD results give forces attributed only to drag, no loadings due to hydrostatic pressure or pipe flexure were included. Unfortunately, the numbers generated by the mathematical model did not explain the high magnitudes of stresses measured during the prototype testing.

Figure 11.-Three successively more detailed models were used to generate data with Flow-3D.

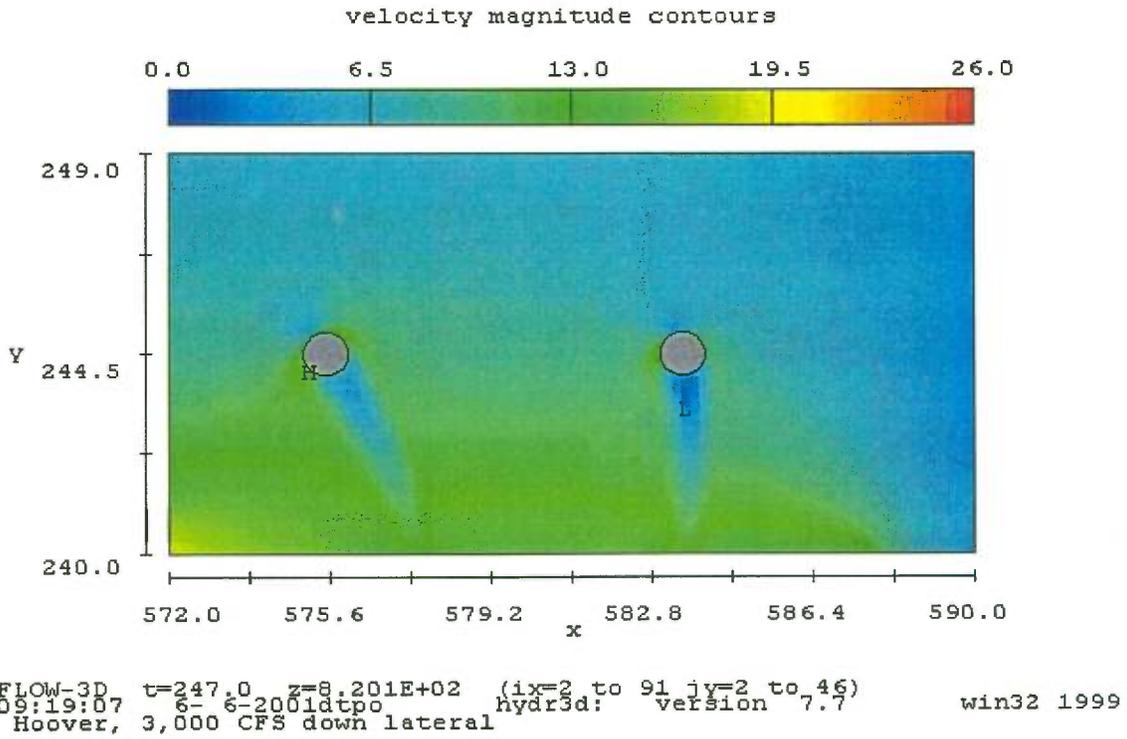
Figure 12a.- Flow-3D output showing velocity contours for the condition of 3000 ft³/s, flowing down the A1 lateral.

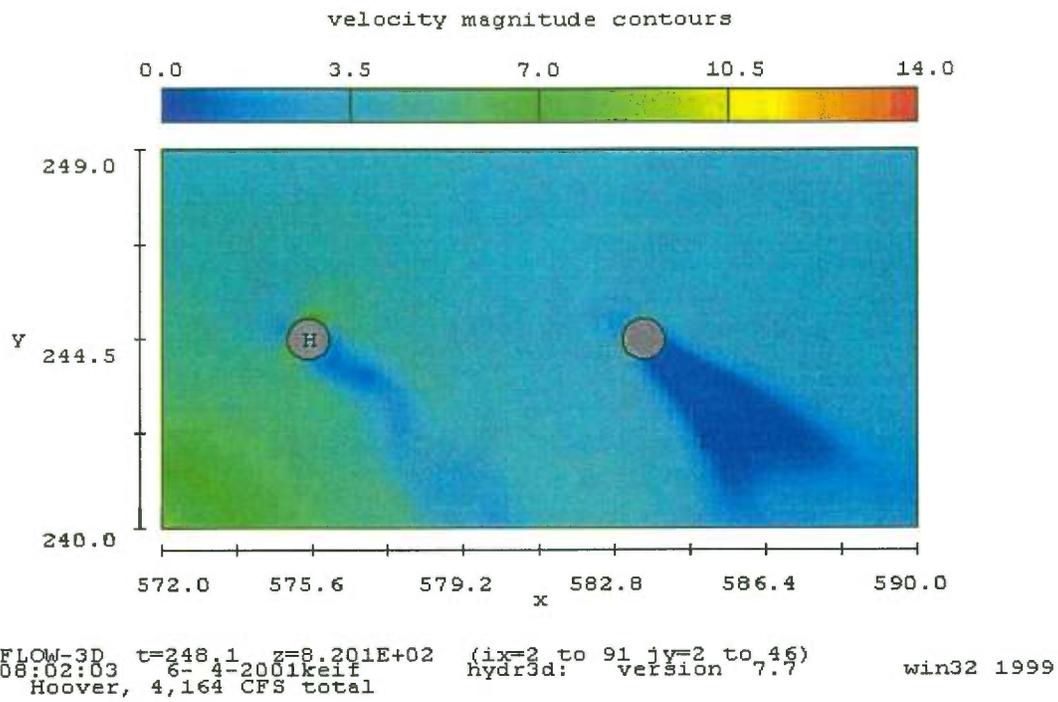
Figure 12b.- Flow split condition, 4164 ft³/s total discharge.

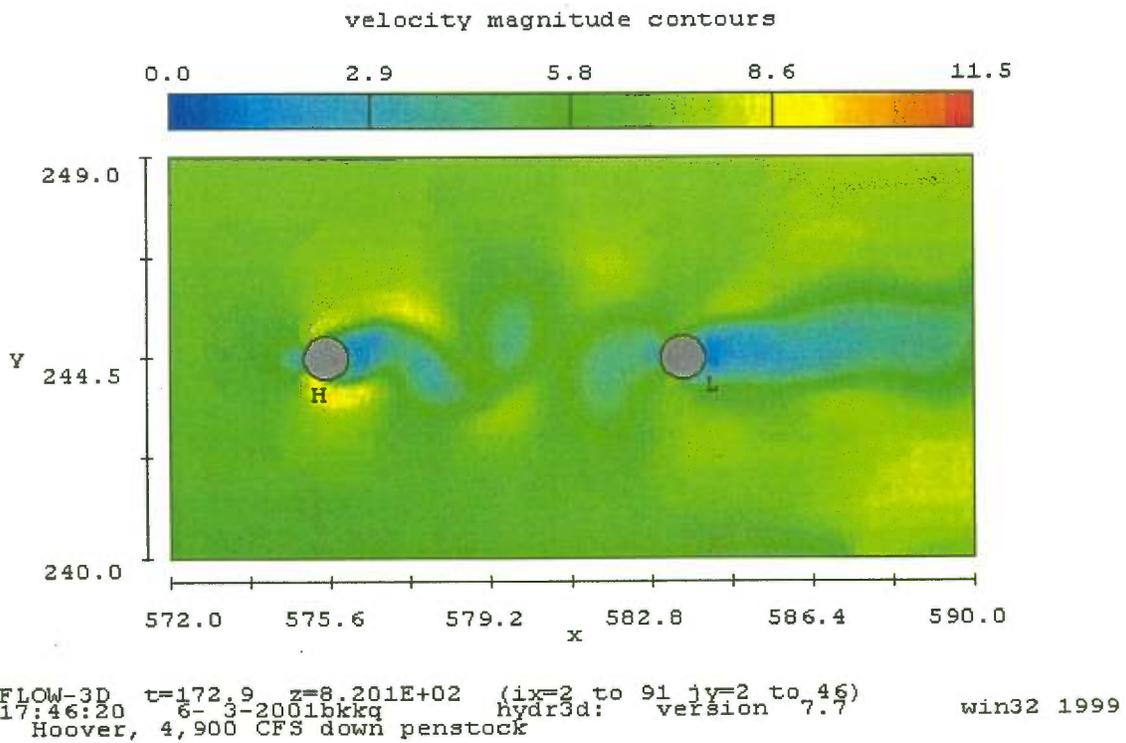
Figure 12c.-All flow past the A1 lateral, 4900 ft³/s total.

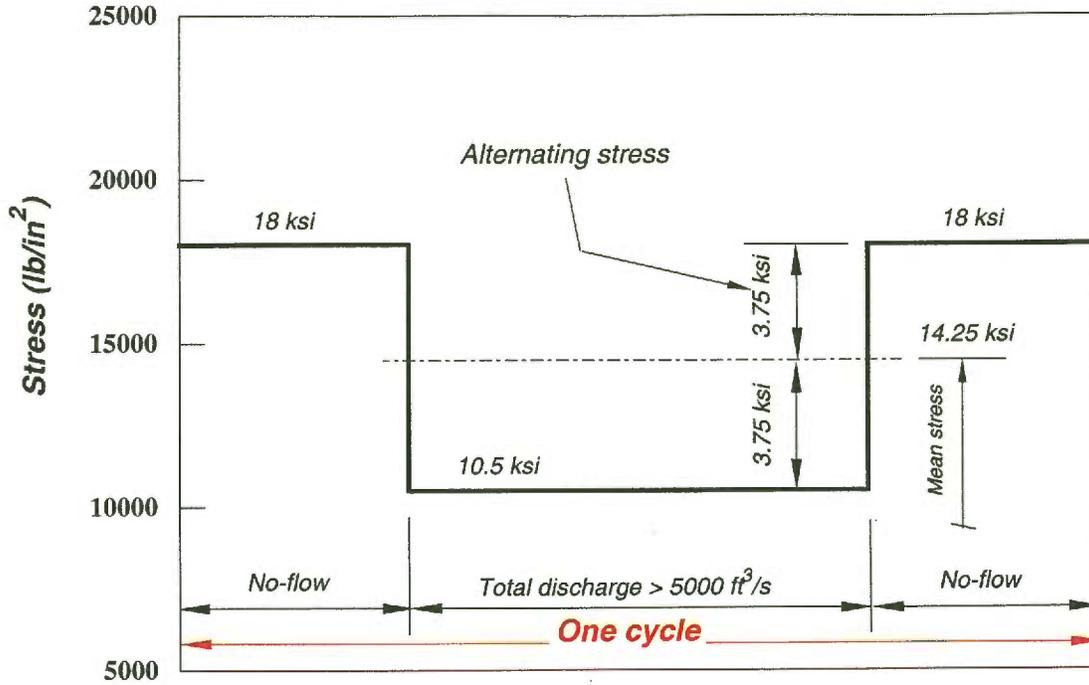
Figure 15.- Stresses at downstream tie rod location 8

Data from the March 13, 2001 test showed the maximum stress at 5 was -15 ksi, and at 8 was -7.5 ksi. Assuming no bending at 8, the axial stress is -7.5 ksi and the bending stress at 5 is -7.5 ksi. Details of these operating cycles are shown in fig. 14, 15, and 16 for the locations 5, 8, and 7 respectively.

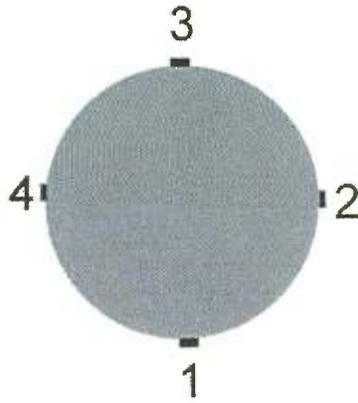
Figure 18.- Cross section of the upstream tie rod, see figure 6 for flow orientation.

Upstream Tie Rod: The no-flow stress conditions will be assumed to be the same as those described for the downstream tie rod. Test data from March 13, 2001, showed a maximum stress of -20 ksi, occurring at location 1 (fig. 18). At location 4, the axial stress was -7.5 ksi, which resulted in a bending stress of -12.5 ksi at location 1.

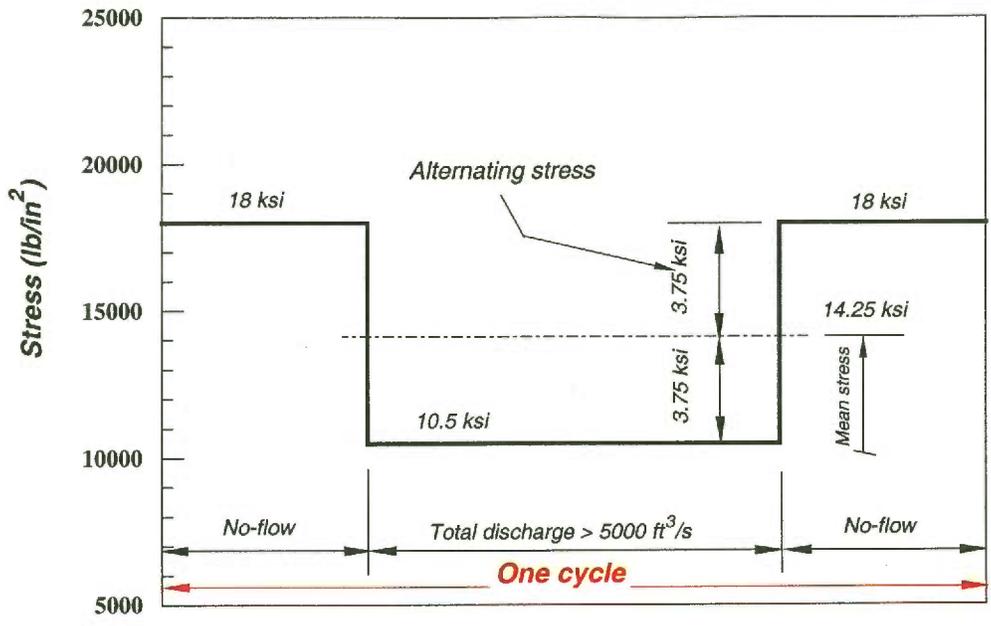
Figure 20.- Stresses at upstream tie rod location 4.

The three stress cycles for the upstream tie rod locations are shown on figs. 19-21.
