Swim-Thru Fishway Evaluation Project

Swim-Thru Fishway¹ Evaluation Project²

**U.S. Department of the Interior
Bureau of Reclamation
Technical Service Center
Water Resources Research Laboratory
Denver, Colorado
WRRL Report PAP-940**

September 2004

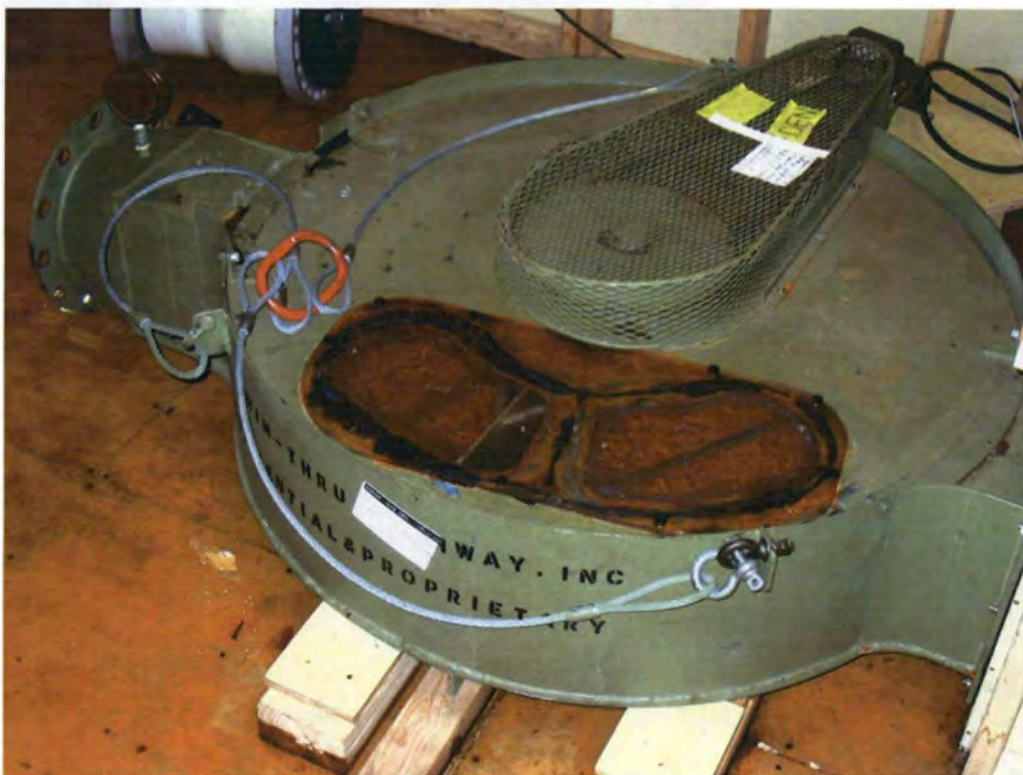
The rotary valve tested in the evaluation study is shown in figure 2. The valve was 4 ft in diameter and 1 ft high. The fish entrance was 10 in. wide by 11 in. high. The exit was a 10 in. diameter pipe. The internal rotor had three straight vanes supported by a center shaft. A Plexiglas insert mounted in the fish pass top provided a window for viewing inside the chamber during operation. Flow passes continuously through the valve as the vanes rotate. The amount of flow passing through the fish pass is dependent on the total head across the valve, volume of the valve and the clearances between the valve vanes and the chamber. The clearance between the vanes and the chamber floor could be adjusted by moving a high density polyurethane strip mounted on the bottom edge of each vane. No clearance adjustment was available along the top and side of the vanes. The measured clearances between the vanes and the chamber body were about 0.10 inches along the top, 0.08 inches on the sides and 0.07 inches on the bottom. Vane clearances were not changed during testing. Each vane also contained a 1 in. diameter hole with a one way flap valve. The flap valve allowed flow through the hole when the vane was moving against the flow and closed when the vane was moving in the flow direction. The rotary valve is powered by an overshot water wheel, figure 3. The water wheel uses water piped from the upstream barrier to drive the wheel.

Figure 2 – Photograph of Swim-Thru Fishway tested at WRRL.

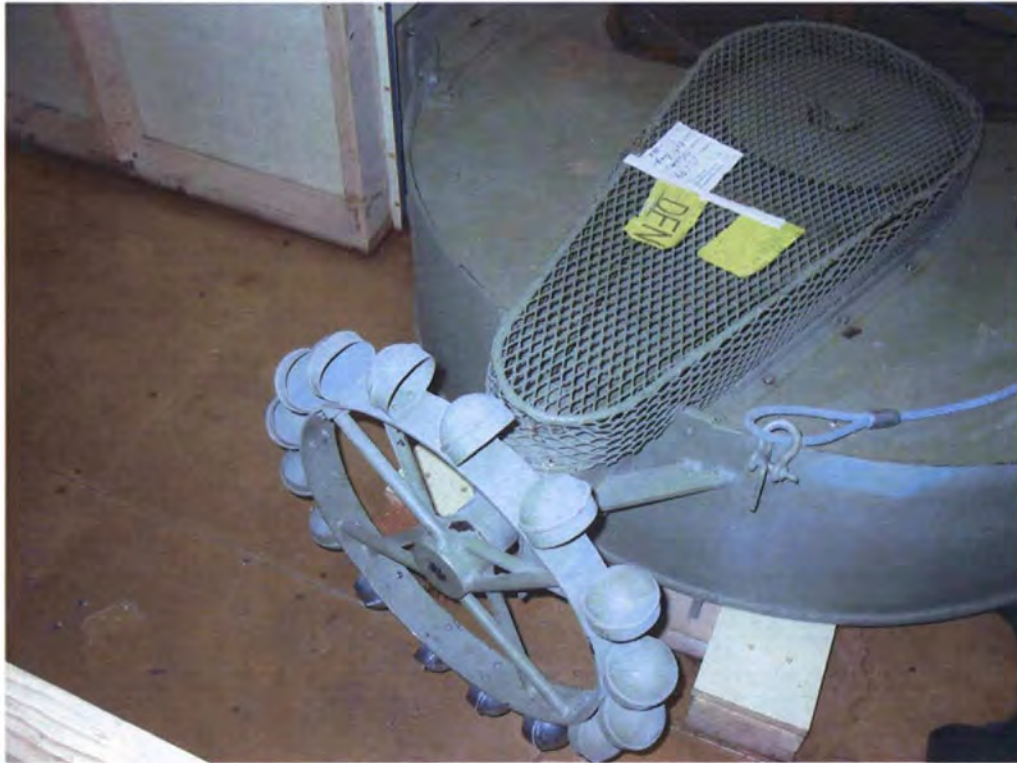
Figure 3 - View of overshoot water wheel.

- For some installations an undershot paddle wheel drive similar to those used on small drum screens may be a better option than the overshot wheel. It may also be possible to incorporate an auto reversing drive that reverses the direction of the rotary vane if it stops rotating. This would allow the rotary vane to backup if debris became wedged between the vane and chamber wall.

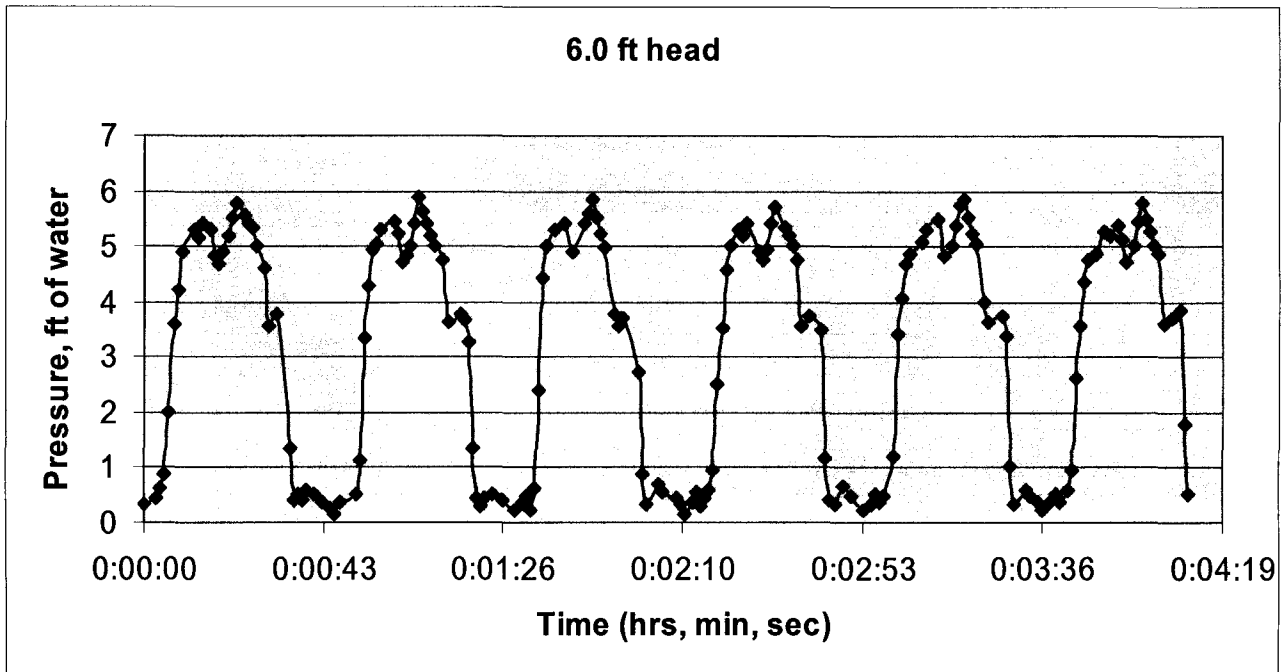
set by adjusting flow delivered to the fish pass. Tests were conducted at differential pressures across the valve of 2.0, 2.5, 3.6 and 5.5 ft. Differential pressures can be thought of as barrier height. Tests were planned for higher differential pressures; however, at upstream pressures above about 6 ft the vanes scraped the lid of the fish pass chamber. It appeared deflection in the top of the chamber was sufficient to cause loss of clearance between the outer edges of the vanes and the chamber lid. All tests were conducted at a rotational speed of about 1.35 rpm. The rotational speed was chosen based on the ability of the gear motor to drive the rotary vanes smoothly through a full cycle. Drive torque was not measured during the tests. However, loading on the drive motor clearly changed as a function of vane rotational position. During the tests, the fish pass entrance was submerged 0.5 ft by tailwater resulting in a flow depth in the entrance channel of about 1.7 ft., figure 9. Figures 10, 11, 12 and 13 give the results of the pressure measurements. The pressure response to the valve rotation was similar in all tests. The peak and valley of each cycle show a pressure change that is likely due to a vane passing the entrance or exit openings. When a vane crosses an opening the total head across the system is broken across two vanes instead of three vanes. The pressure curves shown will change if vane clearances are adjusted. For the valve configuration tested, the relationship between flow and total differential pressure is given in figure 14. For example, a differential pressure of 5 ft of water across the fish pass equates to a flow of 1.8 ft³/s flow.

Figure 13 - Expanded view of pressure changes in fish passage chamber during valve rotation. The upstream pressure head was 6.0 ft and the total differential head was 5.5 ft.

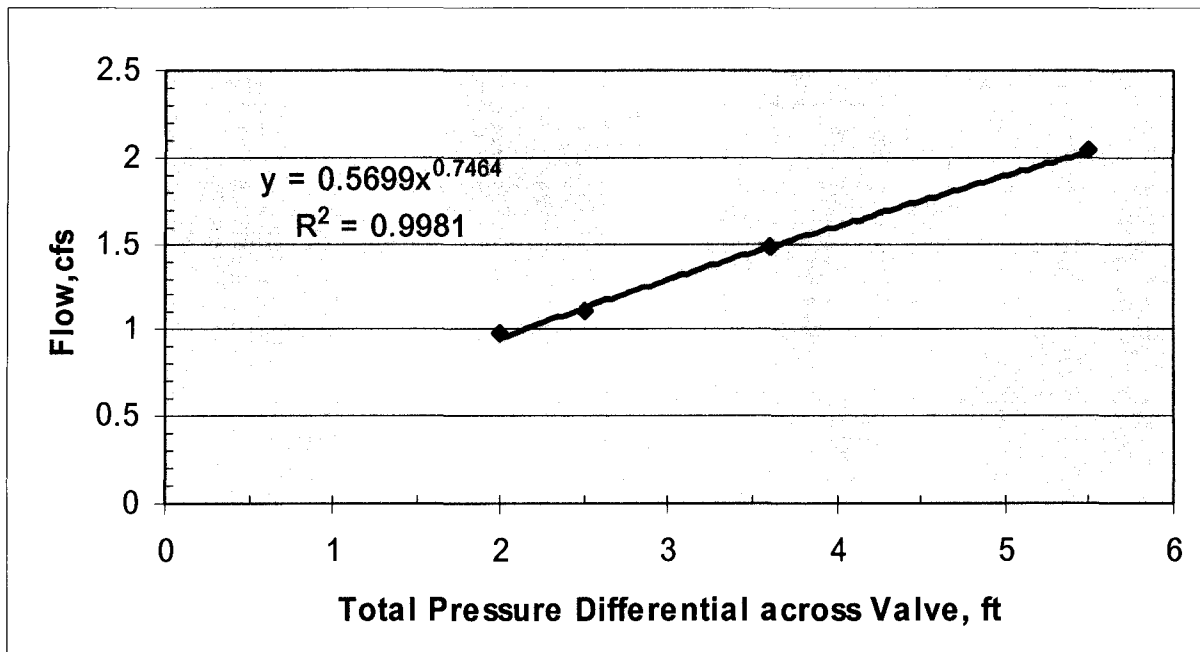
Figure 14- Relationship between total differential pressure across rotary valve and fish passage flow.

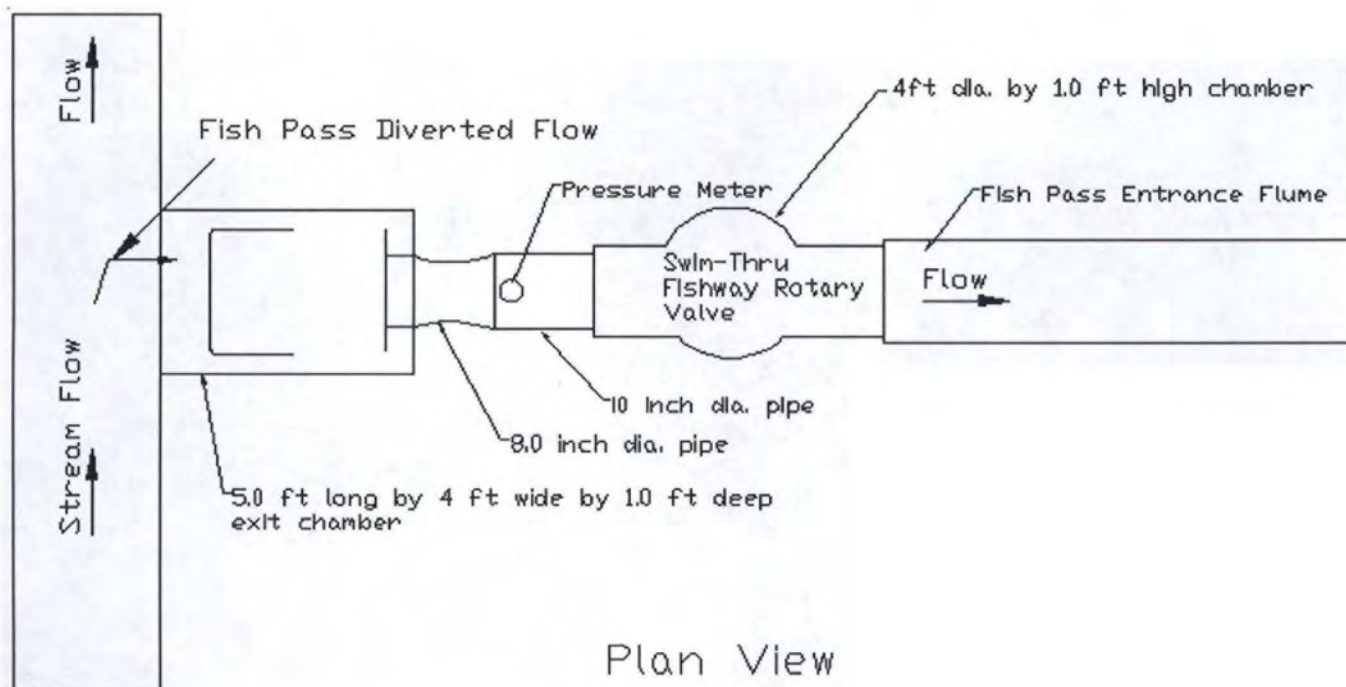
The model was changed to closer simulate a typical fish pass installation for the biological tests. The pump used for the first phase of tests was replaced by a flume that carried water past the fish pass exit similar to a fish pass located on the abutment of a small run-of-river dam, figure 15. A fish pass exit structure designed by Swim-Thru Fishway was mounted perpendicular to the upstream flume, figure 16. The exit structure serves as an interface between the stream and the exit pipe upstream of the rotary valve. During construction we noted the pipe flange on the exit structure was for an 8 inch pipe flange instead of a 10 inch flange used on the rotary valve. Because the tests were not designed to evaluate fish passage efficiency, we reduced the exit pipe from 10 inch to 8 inch to match flanges. This increased flow velocity in the exit pipe by about 56 percent.

Figure 15- Schematic of model test apparatus for biological evaluation.

- Where feasible, consider exiting the fish pass directly into a vertical shaft. Experience with Borland fish locks and vertical shaft fish locks support using a vertical shaft design to improve fish passage. A vertical shaft could be a steel or concrete culvert mounted vertically with concrete poured around the base and the rotary valve flanged 90 degrees to the vertical shaft. The vertical shaft or pipe should be open on top with expanded metal grating to exclude large debris. A vertical shaft exit will increase light at the rotary valve exit and expand the flow area immediately at the rotary valve exit. Both conditions should encourage fish to exit the rotary valve.

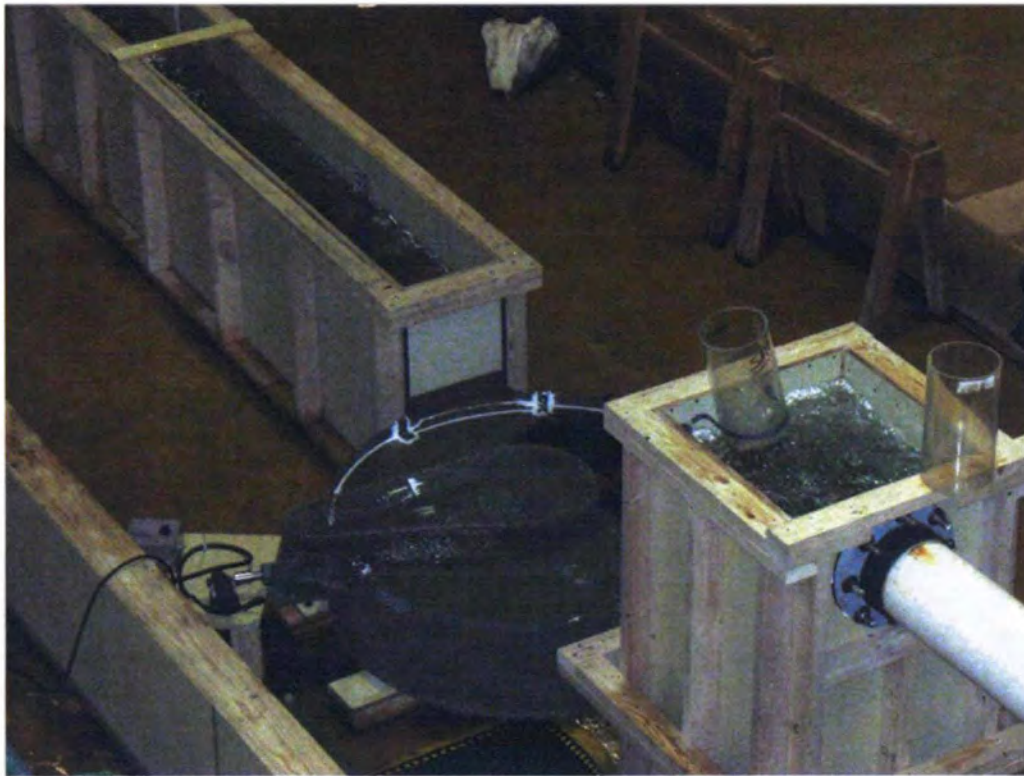
The rotary valve was disassembled and the reinforcement bars were cut off the vanes. The vanes were then ground smooth at the point of attachment. The support rods were not required for structural support when operating the valve at the three to four foot head level tested in the laboratory. In addition to removing the support rods, two other recommendations listed in the initial study were implemented. A 1/16 inch thick rubber flap was mounted to the back side of each vane along the bottom, side and top. The thin rubber seals allowed better control of flow past the vanes while enabling the vane to rotate without the metal part of the vane scraping the chamber top or bottom, see photograph 2 (addendum). Another recommendation implemented was the addition of a vertical wet well at the exit of the rotary valve, photograph 3 (addendum). The wet well concept was implemented in the laboratory tests as it allowed for observation of fish at the exit of the rotary valve.

Photograph 3– View of model showing wet well at the upstream exit of the rotary valve. Plastic tubes shown on at the surface of the wet well were used to view fish exiting the valve.
