Technical Memorandum No. EVMAA-8668460-2008-1

## **El Vado Dam Middle Rio Grande Project, New Mexico**

**Issue Evaluation — Service Spillway – Operational Testing &  
Dynamic Analysis**

**August 2008**

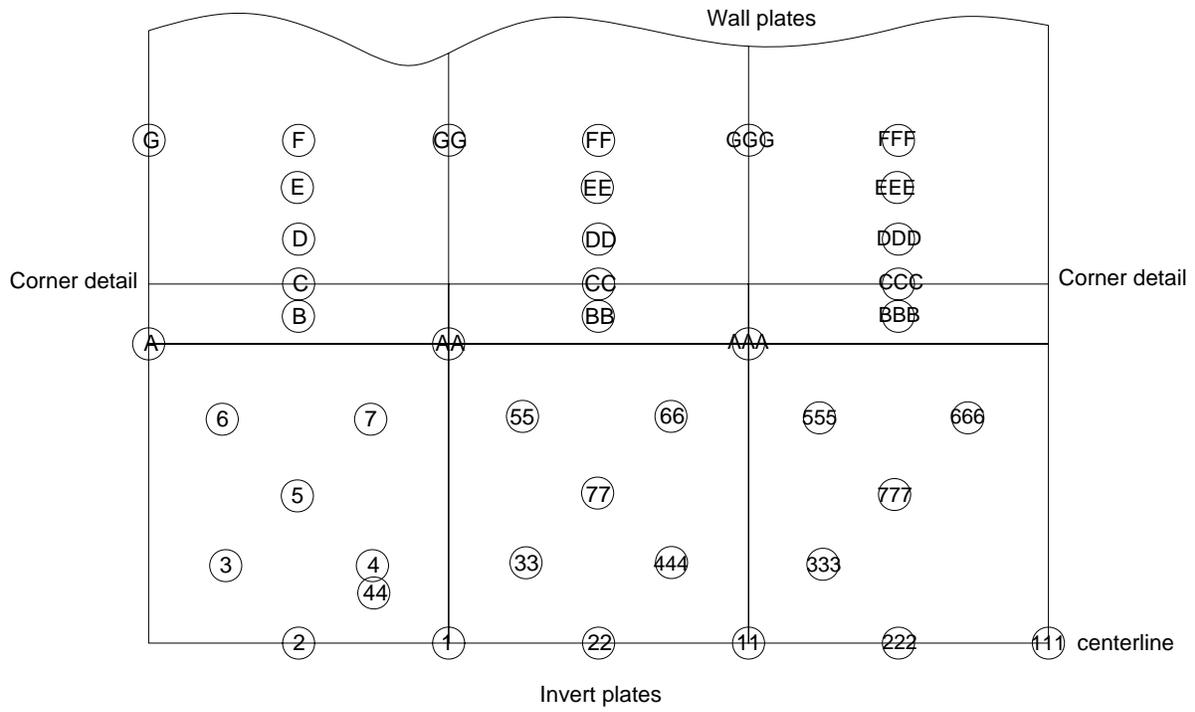
**Figure 3: Developed view of accelerometer positions for the modal survey, location 1 and 2. Location 3 is a single 100-in by 100-in plate represented by one third of the figure above.**

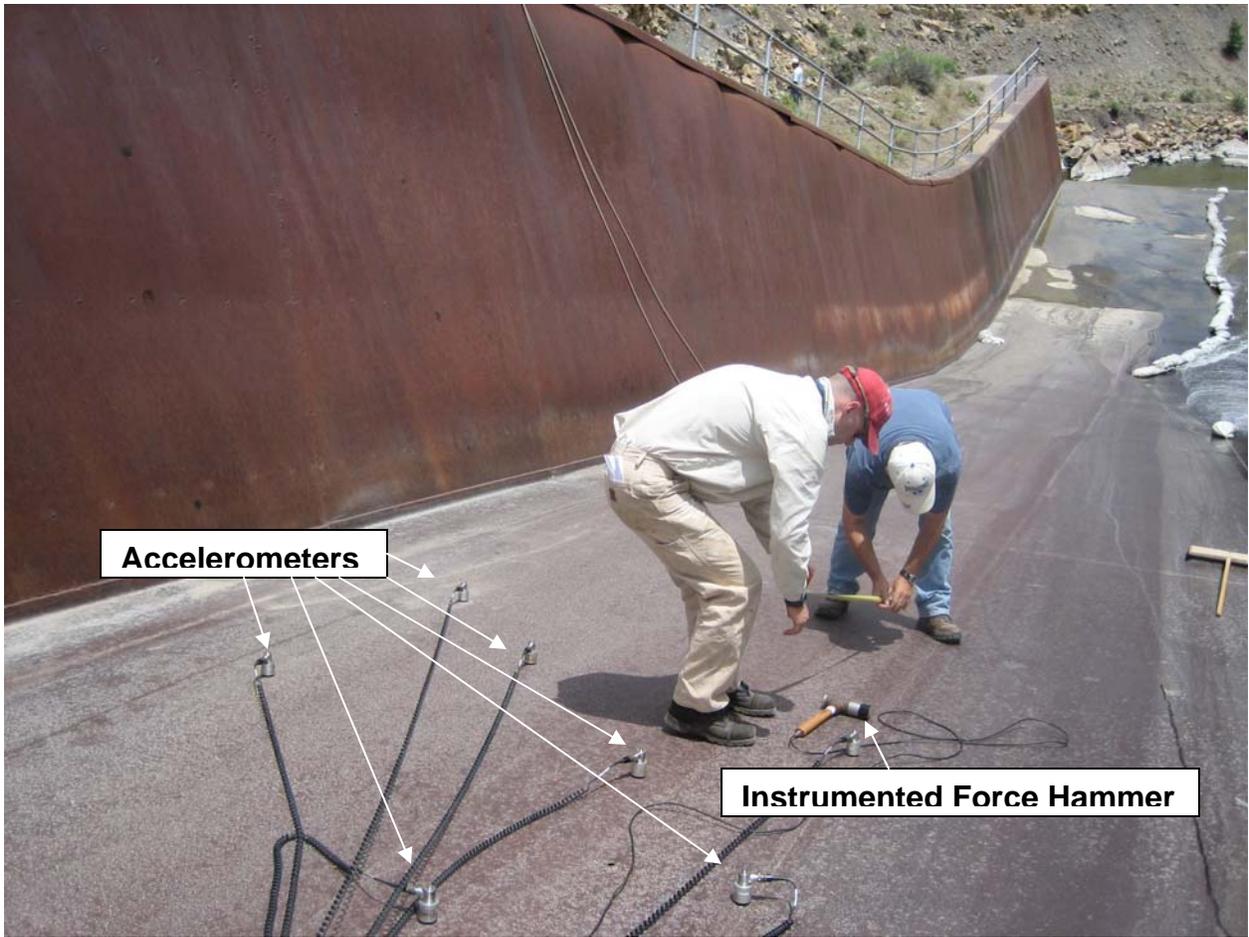
**Figure 4: Placement of accelerometers on invert plates for impulse/response modal testing.**

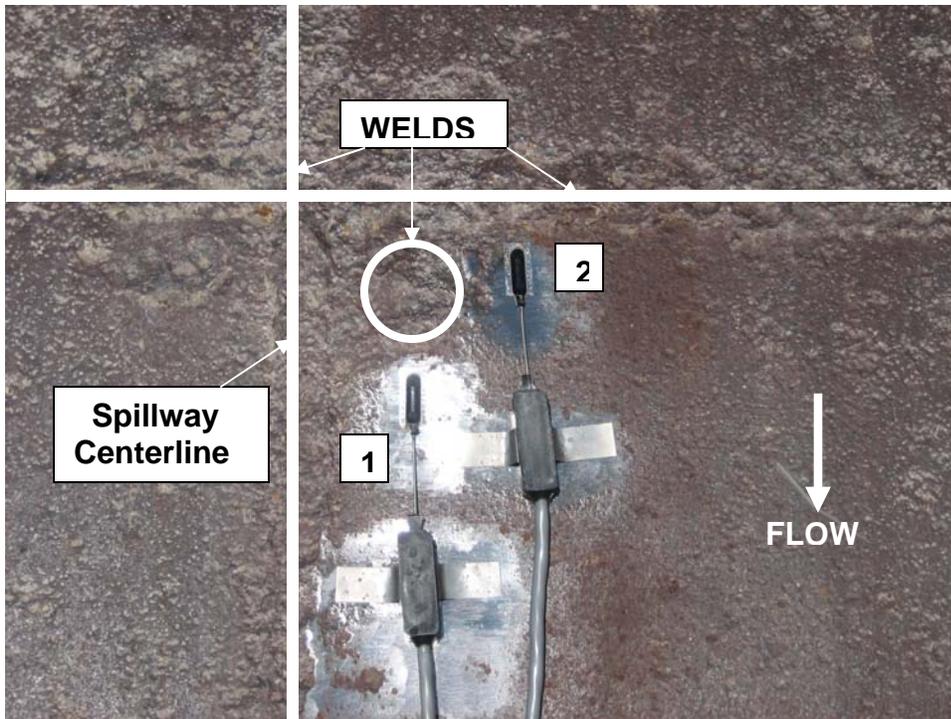
Figure 5: Strain gages 1 and 2 at Location 1, near spillway centerline.

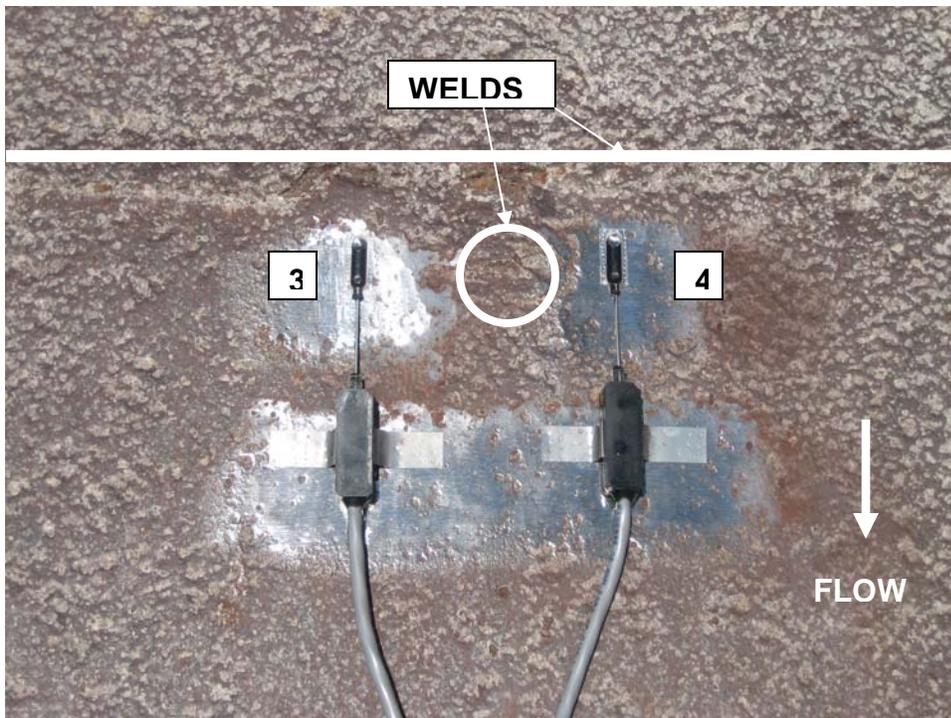
Figure 6: Strain gages 3 and 4 at Location 1 near midspan of left invert plate.

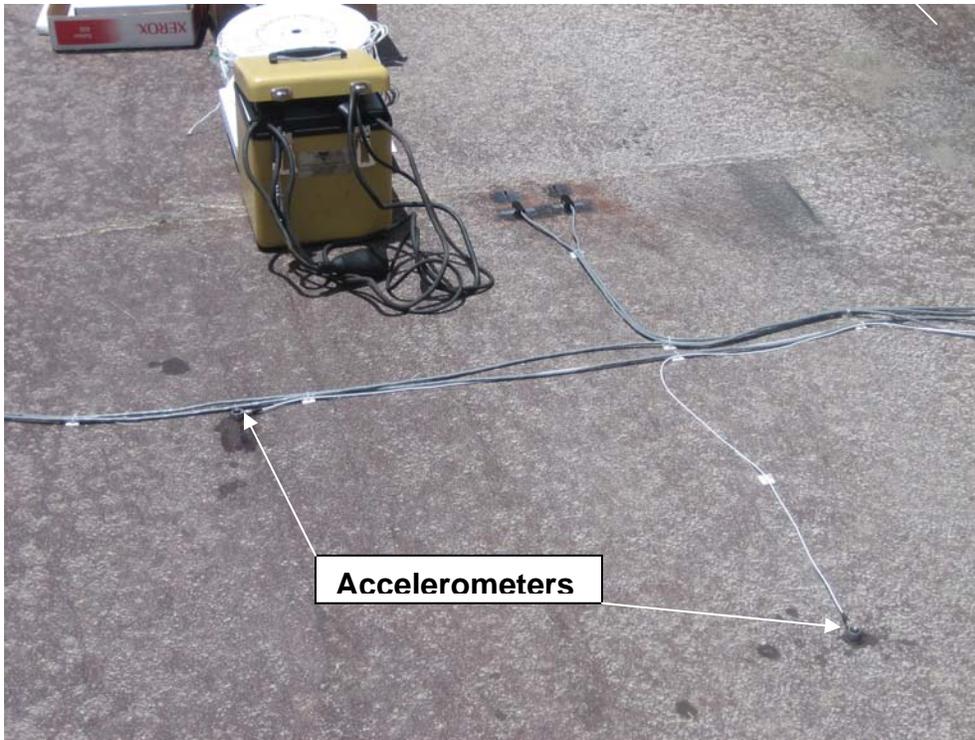
**Figure 7: Accelerometers were attached directly to invert plate using a threaded stud.**

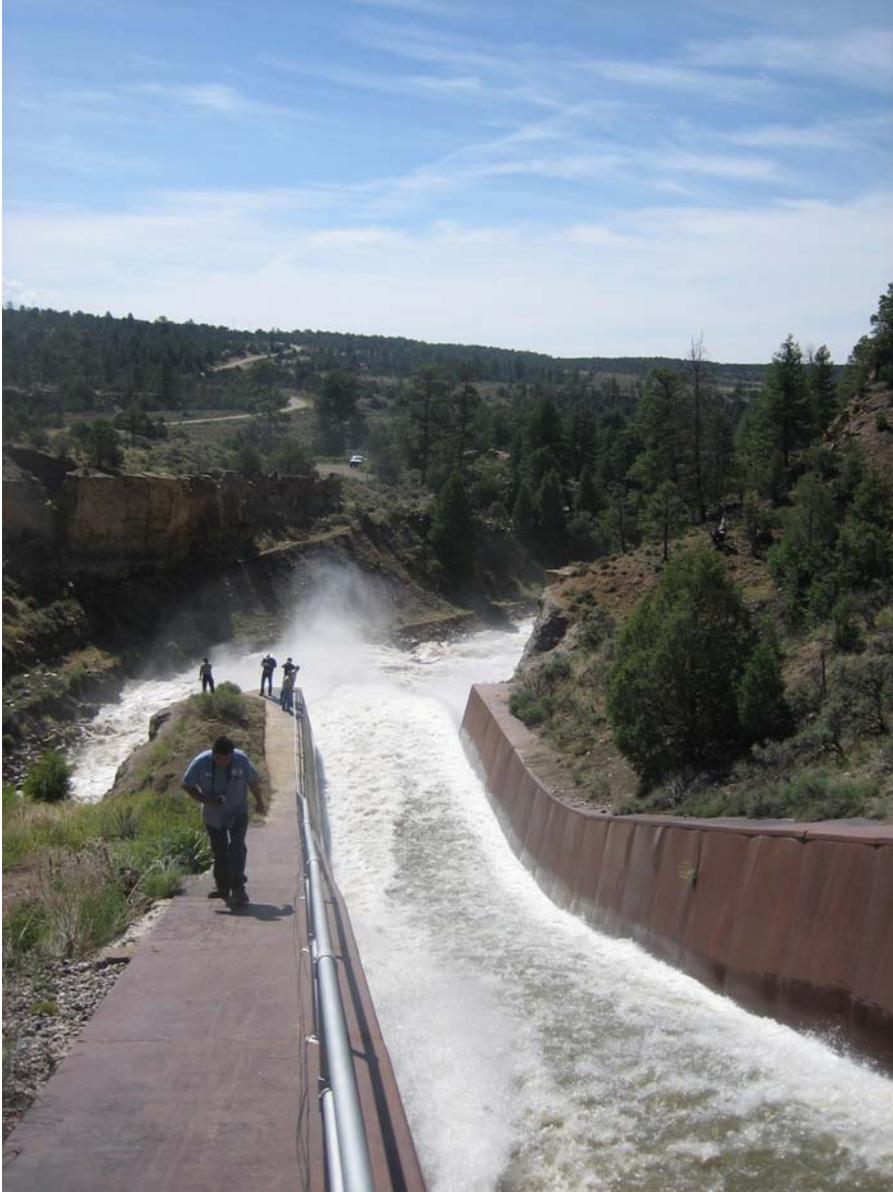
**Figure 9: Flow of  $2700 \text{ ft}^3/\text{s}$  passing by location 1, note sidewall accelerometers above water level.**
