**ENGINEERING EVALUATION OF THE RED BLUFF RESEARCH
PUMPING PLANT ON THE SACRAMENTO RIVER IN NORTHERN CALIFORNIA:
1995-1998**

**A Summary Report
Red Bluff Research Pumping Plant
Report Series: Volume 6**

September 1999

**U.S. Department of the Interior
Bureau of Reclamation**

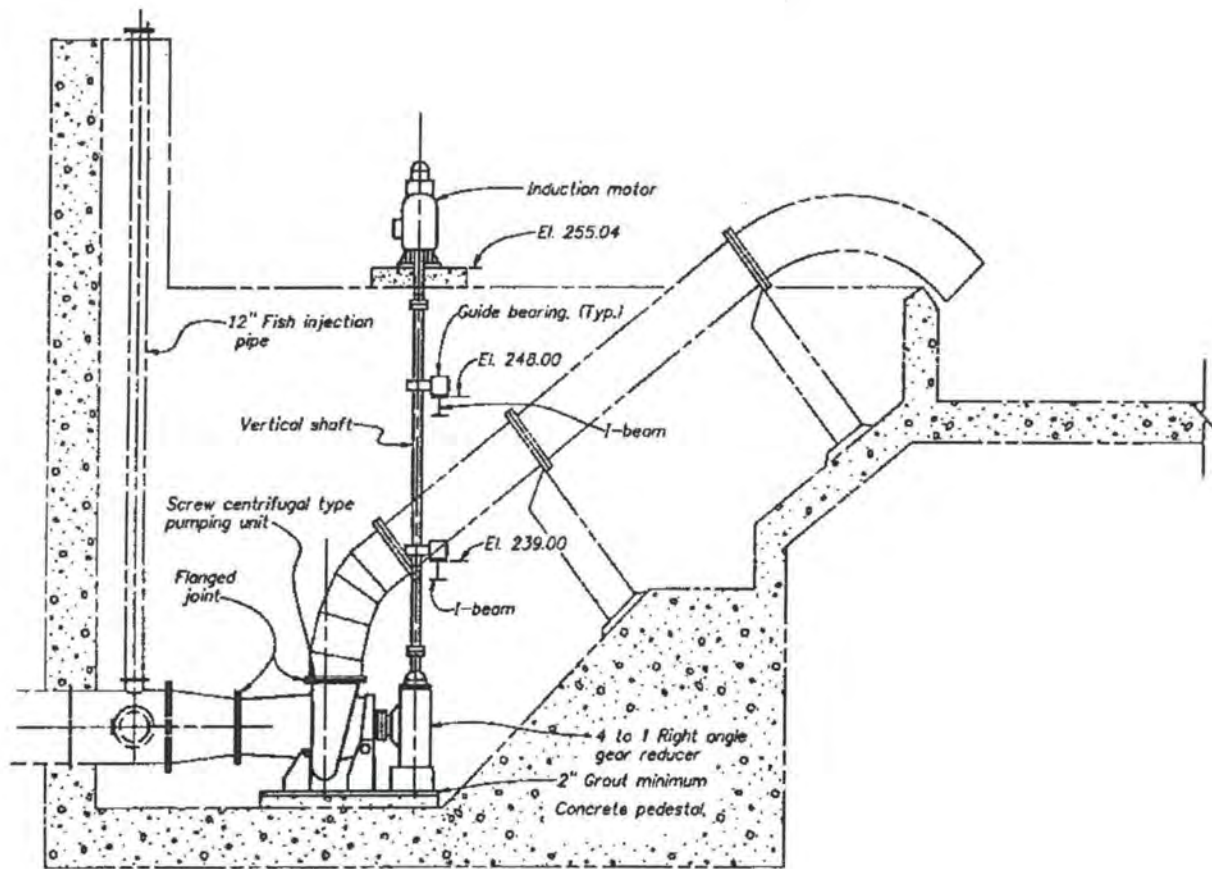
Figure 24. Wemco-Hidrostal centrifugal pump installation. *The Wemco-Hidrostal centrifugal pump installation at Red Bluff Research Pumping Plant*

centrifugal pump was used to begin the biological evaluations. The pump operation was initially very smooth; however, over the course of only 254 hours, shaft runout and pump noise forced the pump to be shut down on September 14, 1995. Upon inspection of the pump, it was discovered that the impeller had shifted radially along the pump shaft impinging the impeller on the intake manifold. A broken shaft had caused the pump to seize, figure 26. The impeller was shipped to the manufacturer's plant in Salt Lake City, UT, where it was discovered to be extremely out of balance. A new shaft was

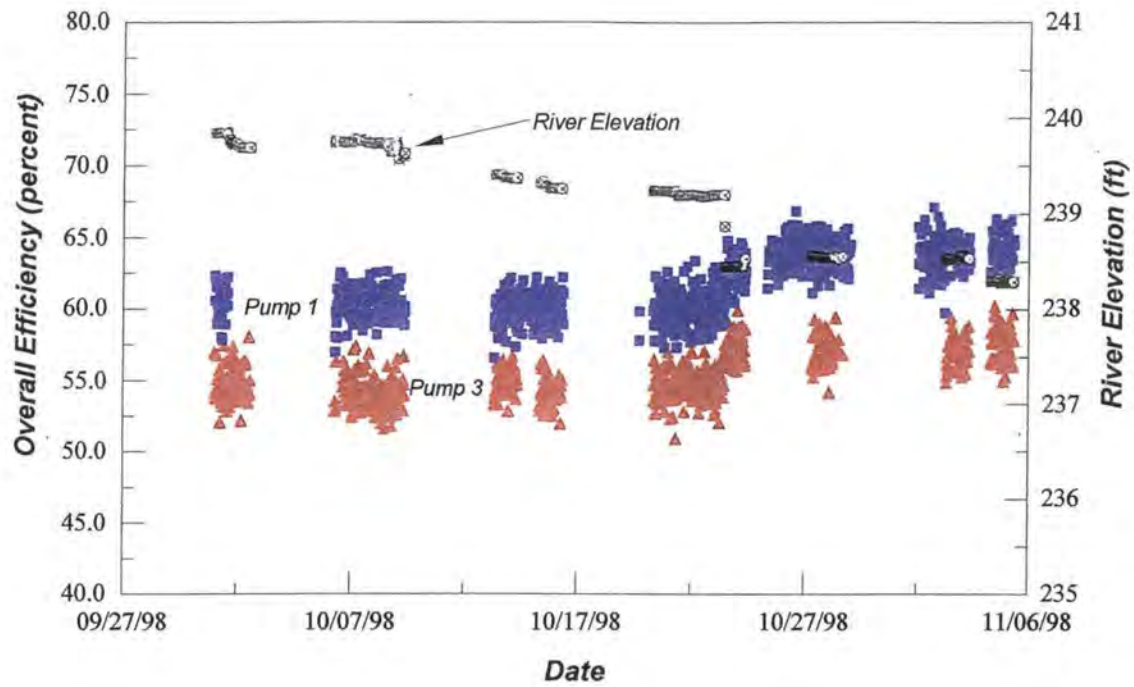
Water-to-wire efficiencies have been calculated for pumps 1 and 3, for the period October - December 1998, figure 28. The pumps were not operated from mid-November thru the end of the year, so the data are limited. Data are stored on a 30 minute interval. Efficiency values are quite low considering typical manufacturer's claims of 90-percent efficiency for the Archimedes pumps and 75-80 percent efficiencies for the Wemco-Hidrostral pump. These claims are of course for pump efficiency only, not including hydraulic, motor, bearing, and drive losses. In addition, for the Archimedes pumps, no data are available for a sealed inlet condition where the suction head is above the lower centerline setting of the pump.

Figure 28. Overall efficiencies for 1998. Overall efficiencies for Pumps 1 and 3 at the Red Bluff Research Pumping Plant for the last quarter of 1998.

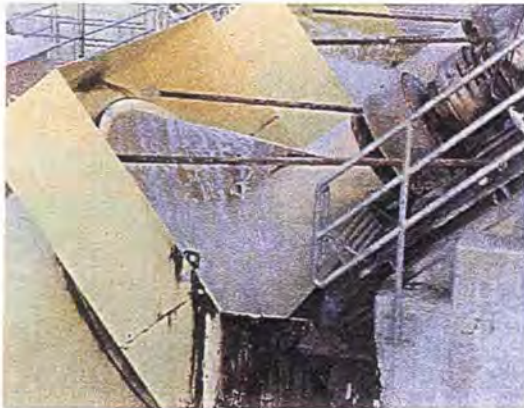
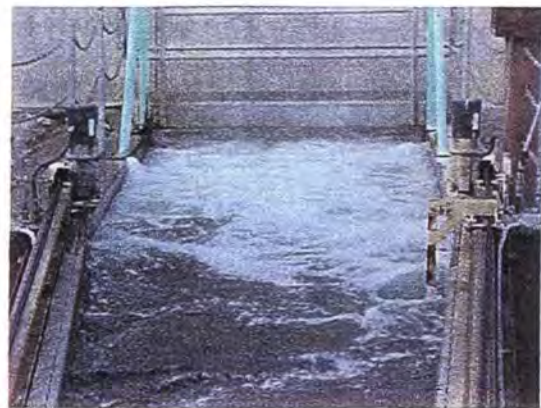
The pumps discharge into an enlarged rectangular channel section. The Archimedes pumps dump the contents of each flight into the head end of the channel at a rate of 79.5 cycles/min when the pumps operate at full speed. A discharge of 90 ft³/s requires that about 68 ft³ of water be carried in each flight segment at the maximum speed of the pumps. The first 17 ft of the channel in which the Archimedes pumps dump into is covered by the concrete mounting block that supports the pump motors and couplings, figure 30. The initial 7 ft of the channel is a modified trapezoidal shape which transitions into a rectangular channel over the next 14.25 ft. The vertical fish screens begin 1 ft into the rectangular section. The Wemco-Hidrostral centrifugal-helical pump discharges at a similar position in the channel although the outlet is offset and not centered on the channel, figure 31. The off-center discharge impacts on the transitional fillet at the bottom of the channel causing a back and forth sloshing to occur for a considerable distance down the channel.

Figure 30. Archimedes pump discharge. Discharge area for the Archimedes pumps. Left photo shows the end of the pumps while the right photo shows the discharge channel after about 17 ft of channel length.

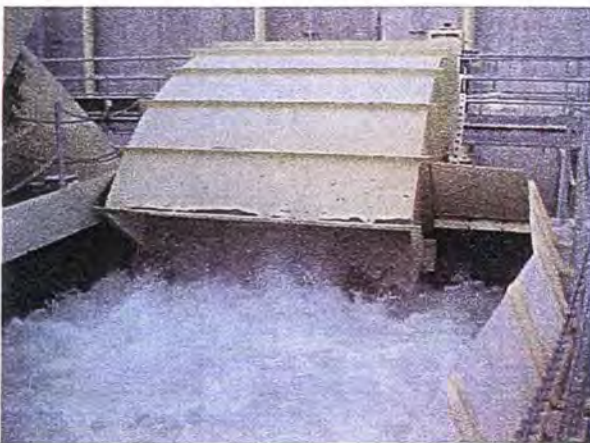
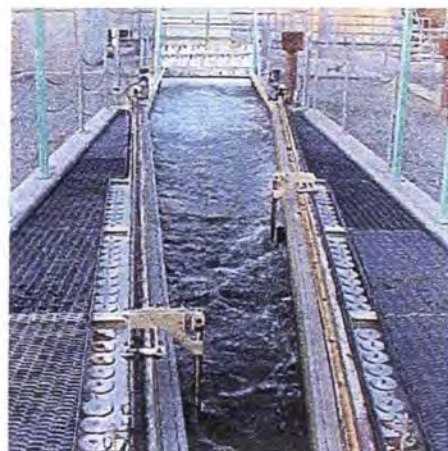
Figure 31. WEMCO-Hidrostal pump discharge. Wemco centrifugal-helical pump discharging about 80 ft³/s into screening channel. Left photo shows offset discharge to channel. Right photo shows channel and a portion of the vee screen structure.

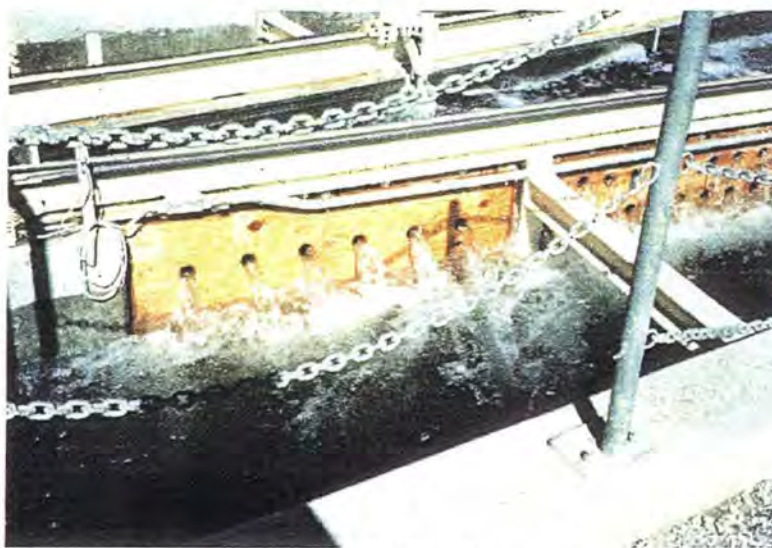
The first attempt at baffling was with fixed area baffles constructed of plywood and bolted to the backside of the downstream half of each side of the structure, figure 34. These were installed in July 1995. The screen panels closest to the bypass entrance were baffled with 10% open area, the next ones upstream at 25%, and the final baffles were at 50% open area. The upstream 3 panels on each side of the screen structure remained unbaffled. The baffling as a function of the complete screen area was 64 % open.

Figure 34. Temporary plywood baffles. *Plywood sheets with holes cut out created temporary baffles behind the wedge-wire screens.*

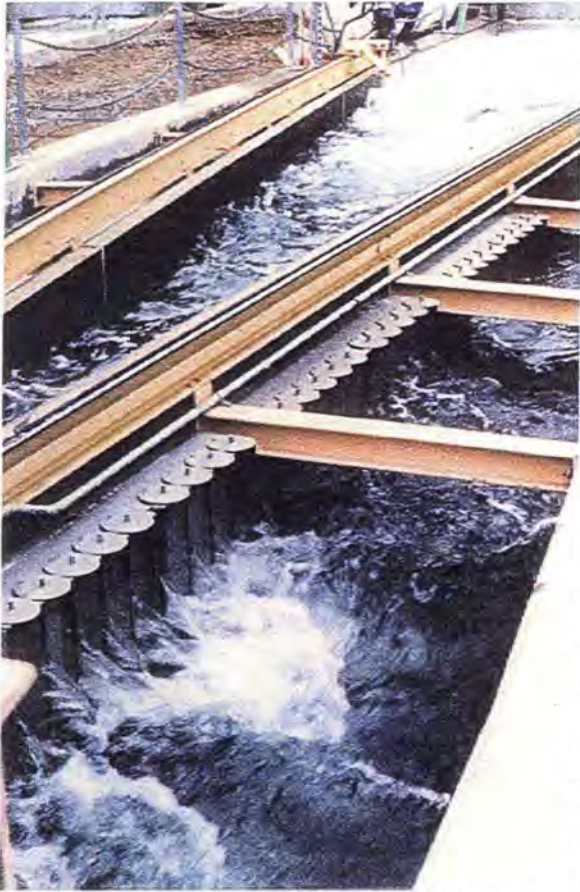
Figure 36. Adjustable baffles. *Adjustable porosity baffles cover the downstream half of the screen area in each bay.*

1996, figure 36. Several iterations of baffle adjustments were made between the baffle installation and summer 1997, with a complete set of measurements on all three pumps completed in July 1997. Some improvement in the velocity distribution and magnitude of approach velocities was accomplished, however, as baffles were closed off, the higher magnitude velocities migrated upstream to the first screen panel which was not baffled. Modification of the velocity distribution also helped lessen the strength of the eddy in front of the bypass entrance. Depending on the time of year and the debris load entering the screen structures, a moderate improvement in overall uniformity was achieved due to the “self-baffling” of the screens with debris. Deciduous tree leaves were especially effective in covering areas of high approach velocity on the wedgewire screens. In addition to the baffle modifications, an adjustable inverted weir was installed shortly after the adjustable baffles, at the bypass entrance. This weir had only a very localized effect on the bypass velocity and is generally recommended that it not be used, however, it does help maintain the water surface within the screen structure.

The early fish injection experiments also pointed out the problem with the velocity field entering the bypass, as many fish would hang up in front of the bypass entrance in the eddy zone created by the bypass ramp. Adjustable porosity baffles were constructed and replaced the *partial* temporary baffles in September

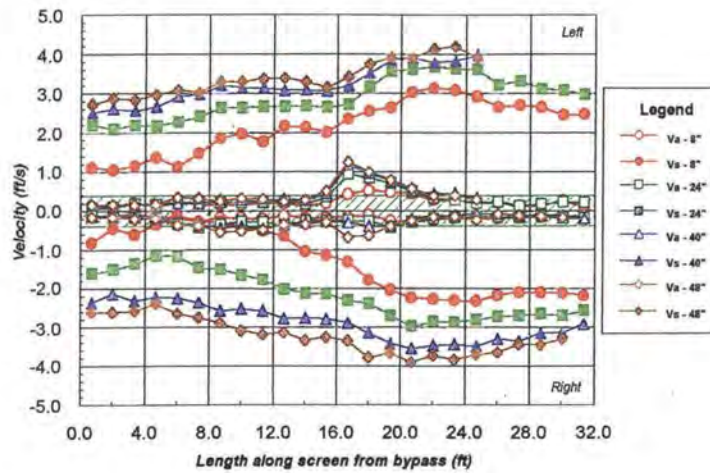
Detailed velocity measurements of the flow field in front of the wedgewire screens with the adjustable baffles in place were performed once again in the summer of 1998. Measurements were performed on pump 2, an Archimedes pump operating at 26.5 rev/m. Results show that the approach velocities near the bypass entrance were within criteria, however, just upstream from the beginning of the baffles, high approach velocities still exist, figure 37. The uniformity of the velocity field was also slightly variable, especially side to side. It became clear that it was necessary to baffle all the screen panels to affect the entire velocity field. Plywood baffles with a 25-percent open area were installed behind the remaining unbaffled screen panels. The measurements were repeated and showed much improvement in both magnitude and uniformity, figure 38. In general, the approach velocities met the 0.4 ft/s criteria at almost all points measured. The area in which criteria is exceeded is most likely due to the influence of surface waves impacting the wedgewire screen. The waves are noticeable in the Archimedes pump

Figure 37. Velocity measurements for partially baffled screens. ADV measurements for partially baffled screens of pump 2, $Q=87 \text{ ft}^3/\text{s}$. Measurements are for various depths above the channel bottom.

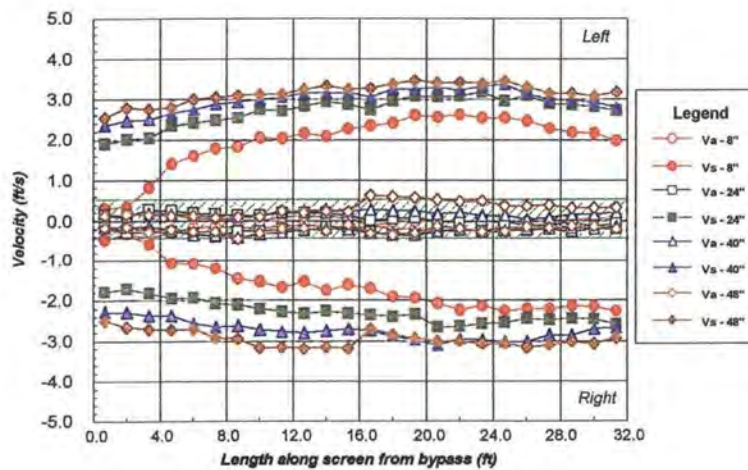
Figure 38. Velocity measurements for fully baffled screens. ADV measurements for fully baffled screens of pump 2, $Q=87 \text{ ft}^3/\text{s}$. Measurements are for various depths above the channel bottom.

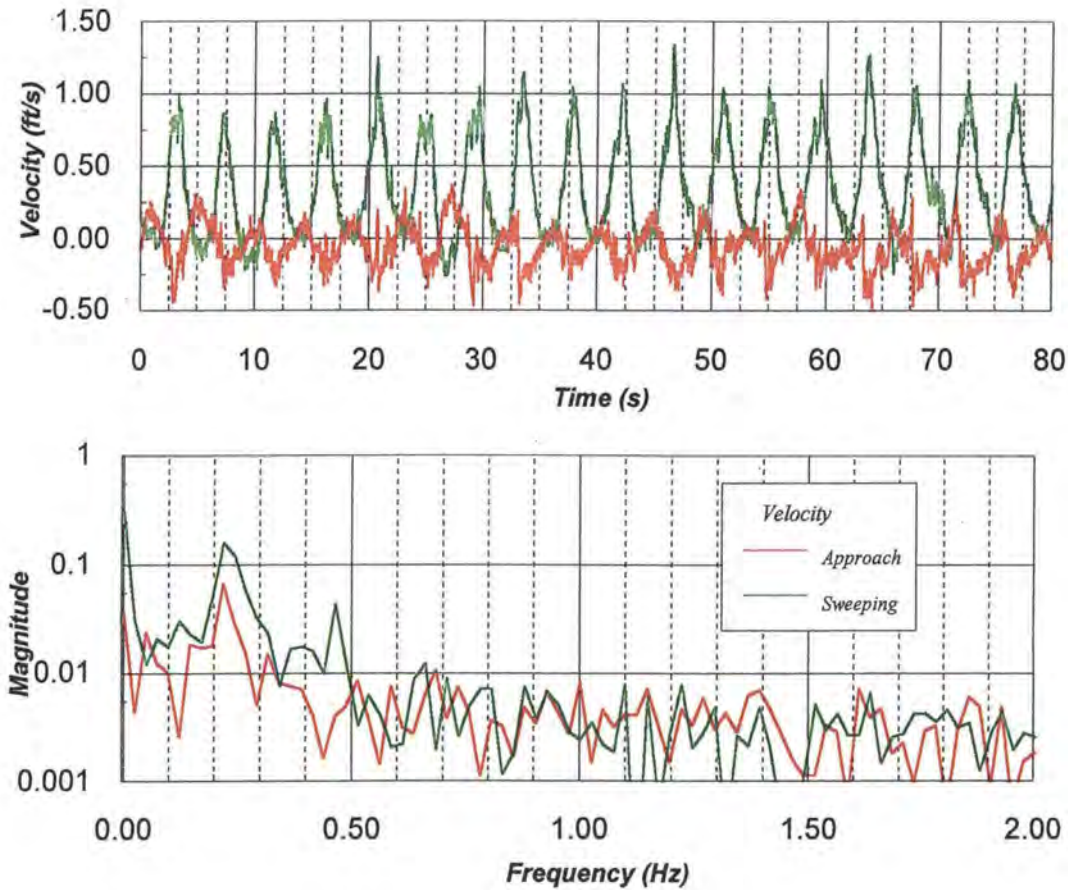
channels and the frequency is a function pump speed. At maximum speed (26.5 r/min) the dumping frequency of the flights is 1.325 Hz, and while not noticeable in the actual velocity traces, the water surface is definitely not smooth. As the rotational speed of the pump is slowed down using the variable frequency drive, the waves or pulsing action of the flow does become noticeable in the actual approach and sweeping velocity measurements, figure 39.

Figure 39. Velocity measurements with the Archimedes pump rotating at 4.42 r/min. Time series and frequency information of the approach and sweeping velocity components from pump No. 2, operating with the VFD at 10 Hz, giving a rotational speed of 4.4167 r/min and a dumping frequency of 0.22 Hz, $Q=12 \text{ ft}^3/\text{s}$.

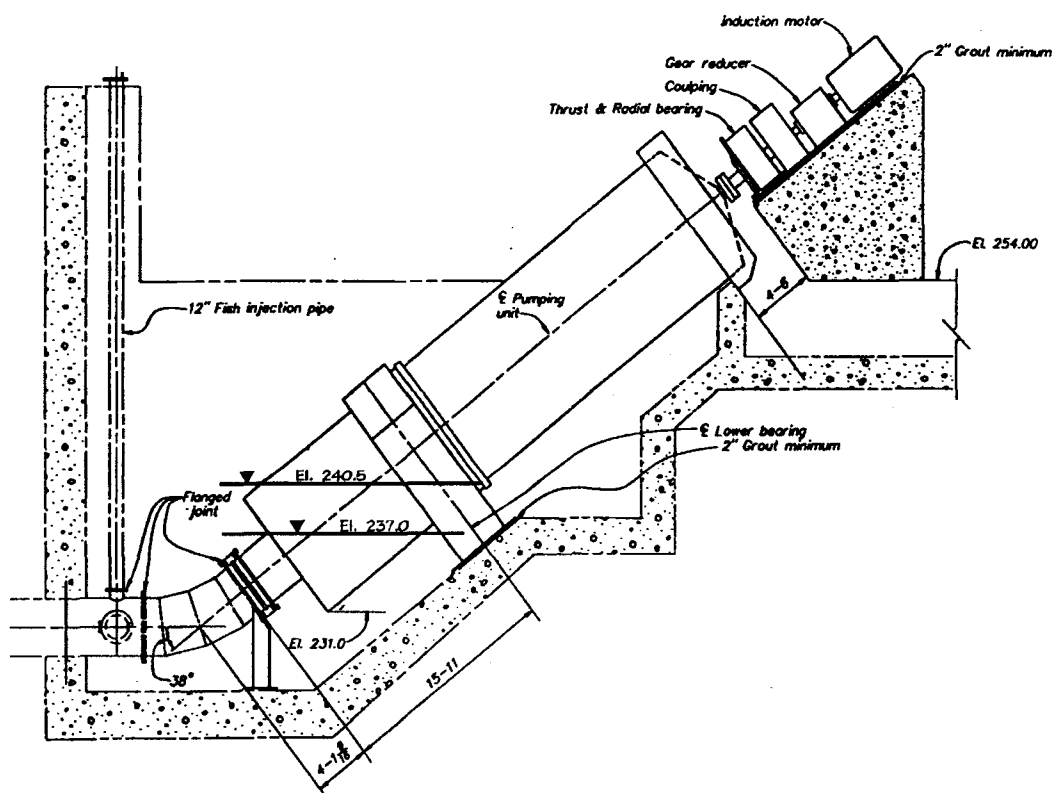
The major design issues with the Archimedes pump involved the rotating seal at the inlet to the pump and the design of the internal flights. Most of the additional problems including failures of couplings and bearings were due to the initial installation being well out of alignment. The rotating seal provided by the pump manufacturer failed within hours of the startup. After several months of trying to work with the manufacturer, Reclamation finally designed and installed a seal which has been performing very well. There has been little or no maintenance required, and leakage was minimal. Cracking of the pump's internal flights was the other major design issue. This problem was a result of both an overload and poor workmanship of the flight-to-flight welds. The cracking began at an abrupt contour change and the beginning of a weld. This type of junction typically has a large stress concentration factor. In addition to this workmanship issue, finite element modeling showed that the size material used for the flights were inadequate. Reinforcing plates were added to each side of the flights over a portion of the pump's length. Through this modification as well as the weld repairs and stop-drilling, most of the cracking has stopped. The setting of the pump elevation in the structure may be a major cause of the cracking due to the high static water loading inside the pump. The lack of experience with a variable water surface at the inlet to the Archimedes pump raises the question as to whether a higher pump elevation setting should have been used. Figure 43 shows the minimum and maximum design water surfaces and how they relate to the pump setting.

Figure 43. Elevation setting of the Internalift Archimedes pumps. Design settings for the Archimedes pumps at RBRPP. Note specified minimum and maximum water surface elevations for pumping, actual maximum was actually closer to 245.
