TECHNICAL MEMORANDUM

Bureau of Reclamation

Cavitation on Stepped Spillways – Lab Studies of Damage Potential

DATE: December, 29, 2010

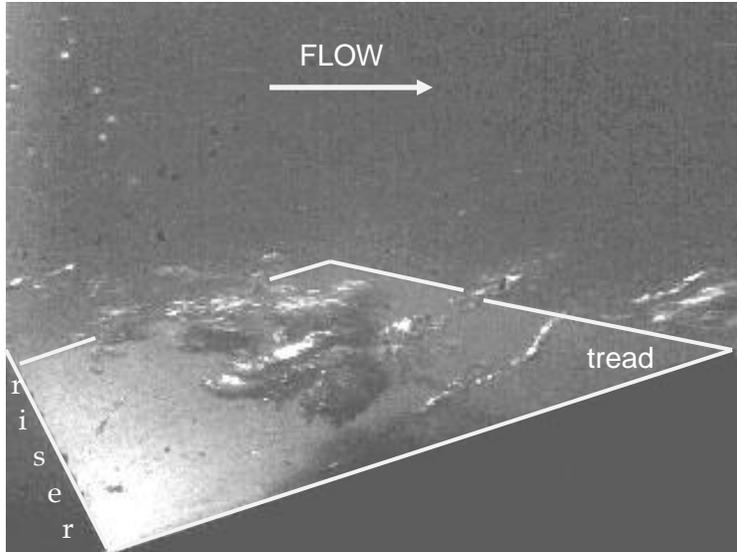
a) Mild slope, LAPC tests at $s = 0.31$ (flow from left)

Figure 3: Steps within the LAPC, captured from high-speed video running at 2000 frames/s. Mild slope appears with the step tread at 21.9-degrees to the horizontal – such that a line connecting the step tips is horizontal. In the steep slope picture, the camera was rotated to provide a horizontal tread.

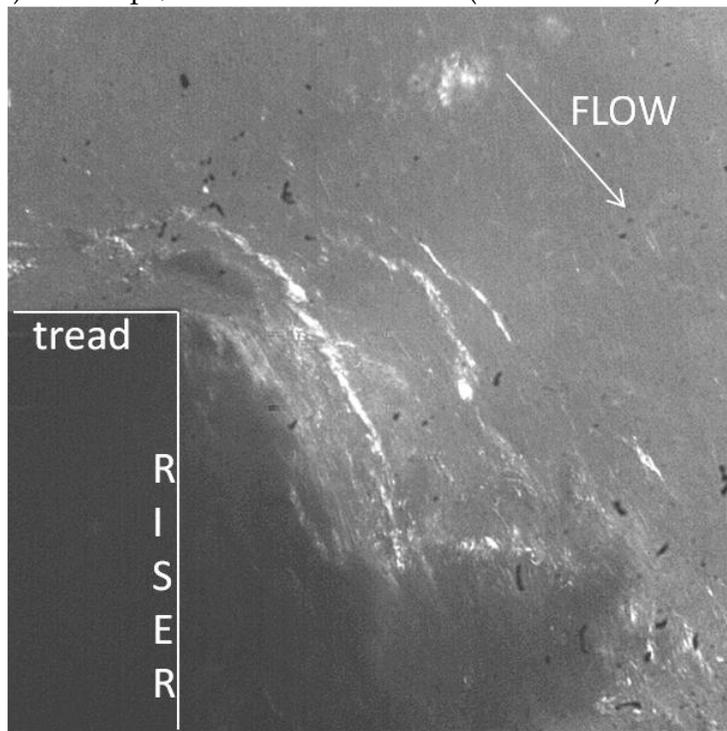
a) Steep slope, LAPC tests at $s = 0.32$ (flow from top left)
