Hydraulic Laboratory Technical Memorandum PAP-1102

Canal Lining Drawdown Tests for the Brock Reservoir Inlet Canal

May 2014

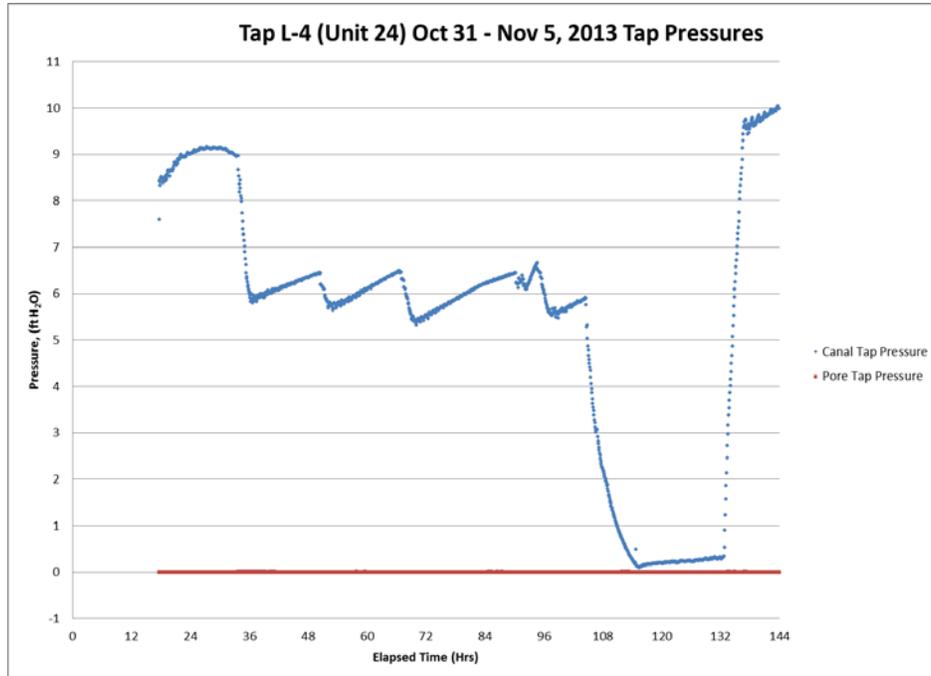
Figure 12. Tap L-4 Measured Pressures

Figures 9, 10 & 11 presenting data from the R-1, R-2 and L-3 sites respectively, show that during the minimum canal level period when the canal bubbler taps at these locations were above the water level, the canal tap pressure readings were the same as the pore tap pressure. Figures 12 & 13 presenting data from the L-4 and L-5 sites show that during the minimum canal level the canal tap pressures are higher than the pore tap pressures (presumed to be atmospheric pressure). This is consistent with the observed position of the canal tap levels at the respective sites which remained slightly submerged during the minimum water level period.

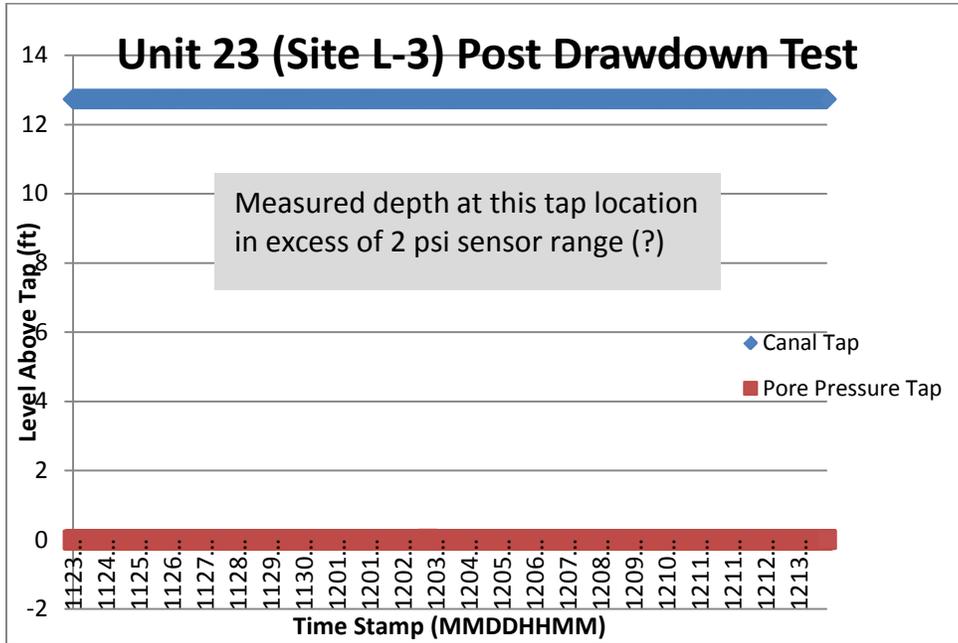
Figure 16. Site L-3 Post Test Data

A comparison of drawdown test plots and post test plots for the respective sites – Figures 9 & 14 for the R-1 site; Figures 10 & 15 for the R-2 site; Figures 11 & 16 for the L-3 site; Figures 12 & 17 for the L-4 site; and Figures 13 & 18 for the L-5 site – show that for each of the sites other than the L-3 site, the range of canal pressures in the post test data set are similar to pressures recorded as the canal was refilled at the end of the drawdown test. For the L-3 site the post-test data set is showing a pressure almost 3 ft. H₂O greater than the refill canal pressure seen in Figure 11. A clogged bubbler orifice might explain the recorded canal tap pressures at this site.
