## St. Mary Diversion Dam – Case Study of a 100 year Old Diversion

### ABSTRACT

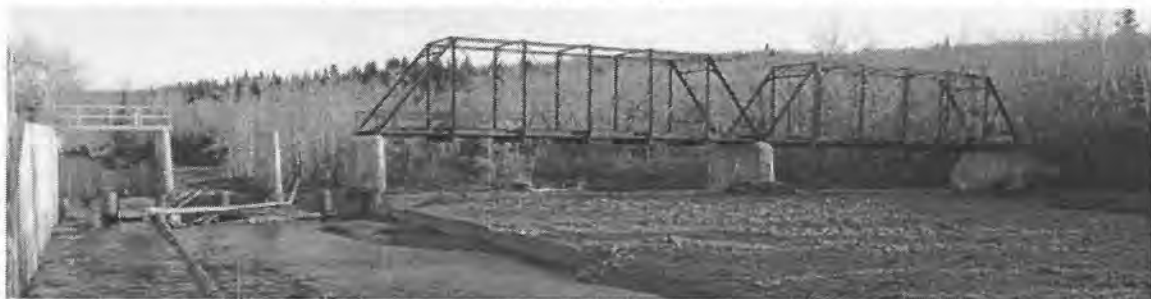
Figure 3. Existing St. Mary Dam Diversion weir, sluiceway and abandoned bridge during low flow fall season (view is from upstream left bank)

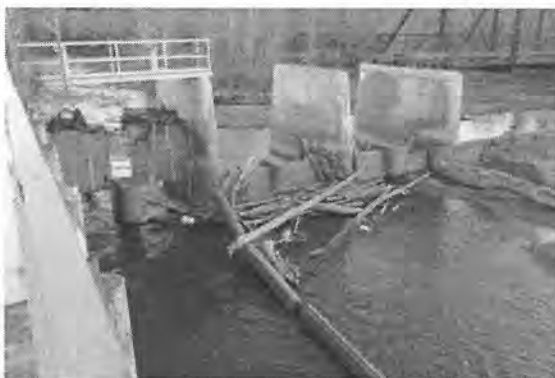
Figure 4. St. Mary Diversion sluiceway gates (view is from upstream left bank, standing on top of the headworks structure)

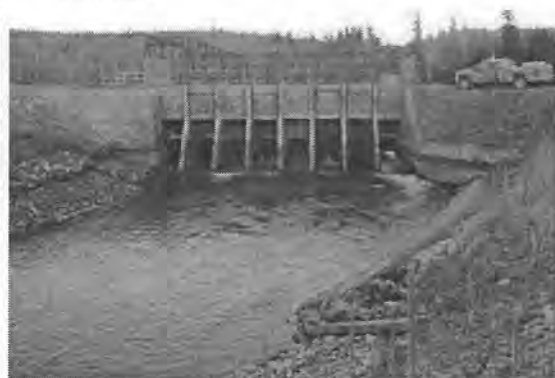
Figure 5. St. Mary Diversion headworks structure (view of from downstream of the headworks, flow is towards reader)
