Hydraulic Laboratory Technical Memorandum, PAP-1222

# Evaluation of Canal Flow Measurement System for the Indian Unit

## Yuma Project, Reservation Division Lower Colorado Region

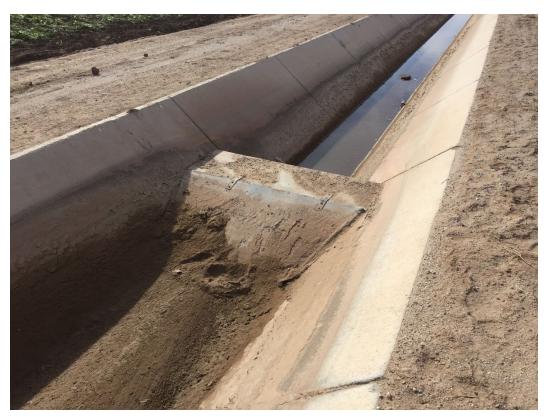
A ramp flume on the Supai Canal translates a single canal depth into flow. It is a prefabricated flume structure that was existing prior to the initial TSC equipment installation in 2019(Figure 4). During the 2022 site visit, the ramp flume was filled with sediment, preventing flow measurement through the flume (Figure 5). Although the battery was no longer holding a charge, both the bubbler and RTU seemed to function. Depth measurements from the RTU, however, were incorrect.

Figure 4. Supai canal ramp flume shown during dewatering.

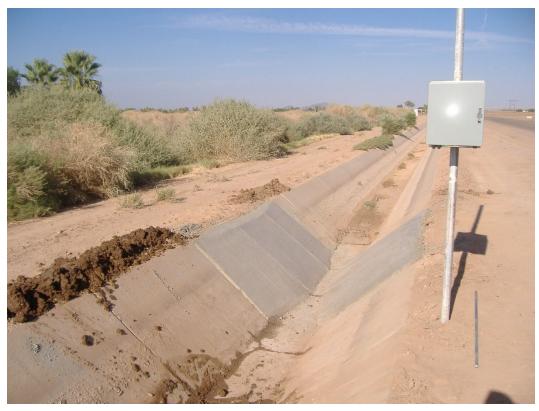
TSC fabricated a long-throated flume for the Pueblo Site in 2019 (Figure 6). During the 2022 site visit, excessive sediment with plant growth was found both upstream and downstream of the flume (Figure 7), leaving the flume incapable of reliably measuring flow. The battery was no longer holding a charge and the RTU was completely non-responsive, regardless of the solar power. Further investigation revealed corrupted firmware.

Figure 6. Pueblo canal long-throated flume pictured shortly after its construction in 2019.
