HYDRAULIC MODEL STUDIES OF AERATION DEVICES FOR YELLOWTAIL DAM SPILLWAY TUNNEL, PICK-SLOAN MISSOURI BASIN PROGRAM, MONTANA

**D. M. Colgate
Engineering and Research Center
Bureau of Reclamation**

December 1971

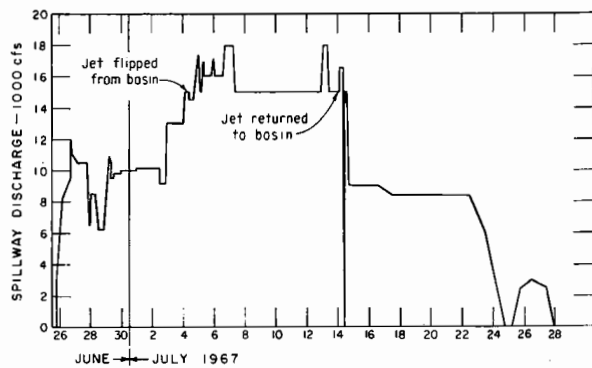
Figure 2. Yellowtail Dam spillway releases between June 26 and July 28, 1967.

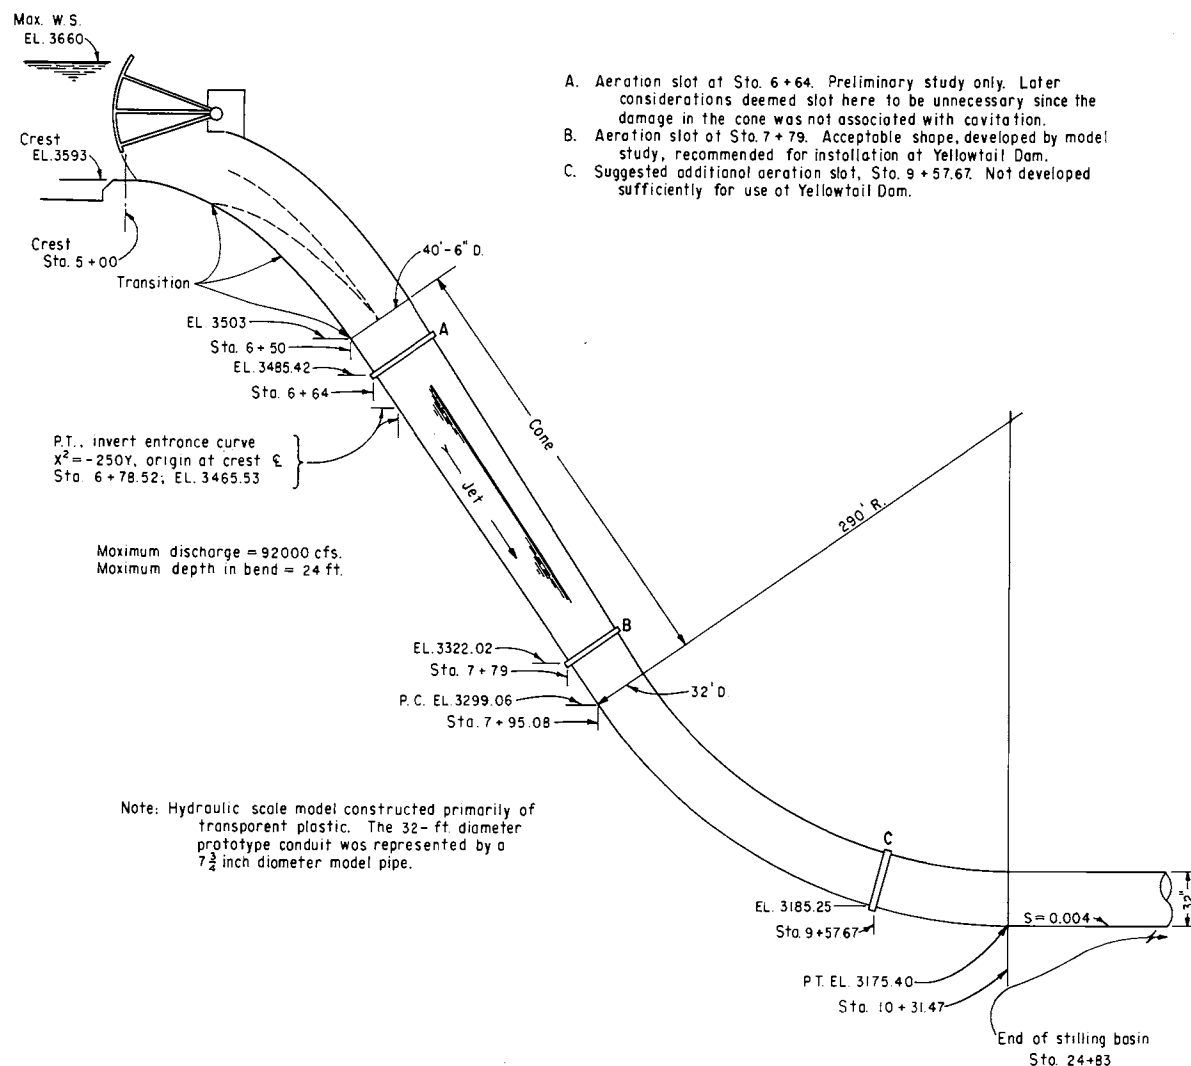
Figure 6. Yellowtail Dam tunnel spillway.

A model study was needed to evaluate various air entrainment devices to determine the optimum design to be installed during repairs to the Yellowtail Dam spillway tunnel. Therefore, a 1:49.5 scale model of the tunnel was constructed in the Bureau of Reclamation's Hydraulics Branch laboratory (Figures 6 and 7).

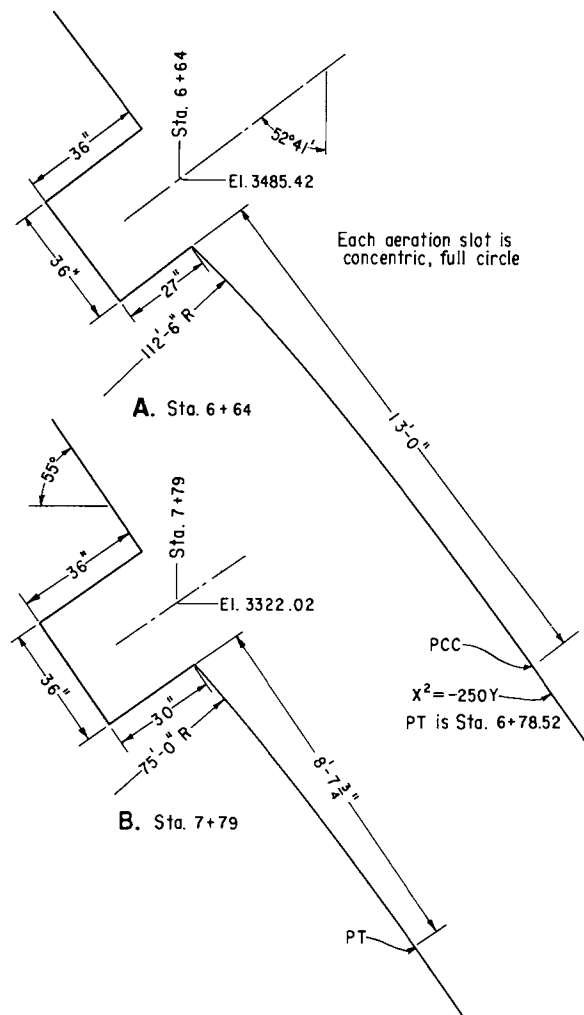
Figure 7. Preliminary aeration slots.

The preliminary aeration slot at Station 7+79 was uniform in cross section for the entire circumference of the tunnel (Figure 7B). Although air was entrained in the flowing water for low flows, the edges of the jet near the water surface impinged on the downstream edge of the slot for discharges greater than about 5,000 cfs. As the discharge increased, more of the jet impinged on the downstream edge of the slot and greater amounts of water entered the slot. As more water entered the slot, the amount of air entrained in the flowing water decreased. Air entrainment in the flowing water stopped entirely at a spillway discharge of about 50,000 cfs.

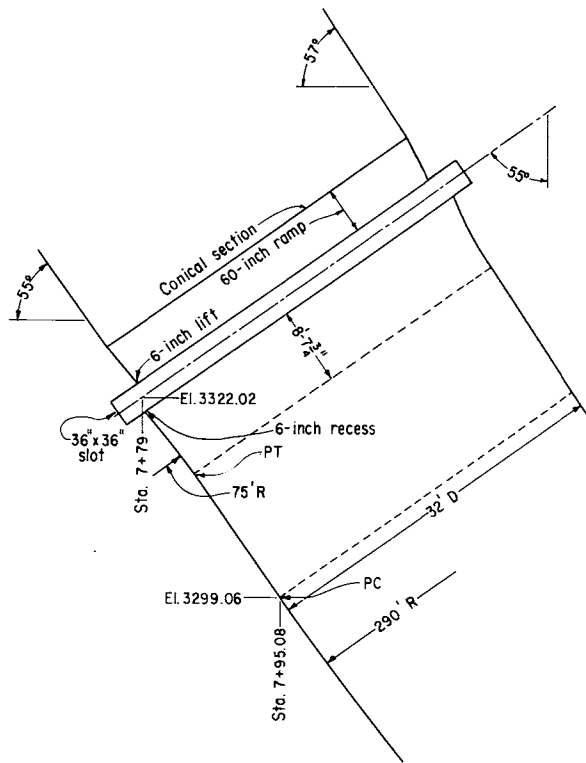
Figure 10. Conical nozzle, 6-inch lift, 60-inch ramp.

7+79 where the tunnel diameter was 33 feet. The nozzle exit was concentric with the tunnel, 32 feet in diameter, and the cone extended 5 feet upstream from the slot (Figure 10). Air was entrained in the jet and the slot remained free of water for all discharges. However, a large fin of water formed on either side of the tunnel where the jet from the nozzle impinged in the bend. The fins became progressively larger and arched higher with increasing discharge until, at a discharge of 6,000 cfs, the side fins extended to the crown of the tunnel. For discharges greater than 40,000 cfs, the water folded over the top of the jet and choked the tunnel. This study indicated that the nozzle shape or a ramp-type lift upstream from an air slot would permit the jet to entrain air for all discharges, but modifications were needed to prevent side fins from choking the tunnel at the higher discharges.

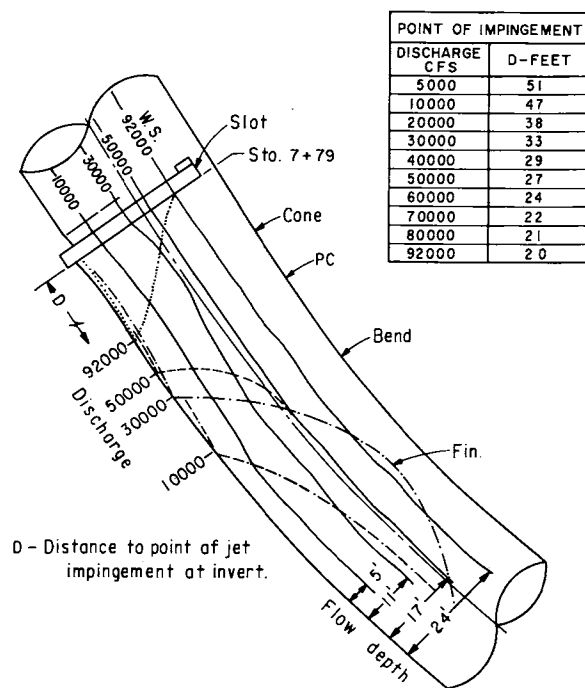
The lift, or ramp, forced the jet away from the tunnel flow surface and over the aeration slot, and the jet remained free for a considerable distance downstream before it impinged on the tunnel invert. The distance to the point of jet impingement on the tunnel invert reached a maximum of 52 feet downstream from the aeration slot at a discharge of 4,000 cfs. This distance decreased as the flow depth and discharge increased and was 20 feet for a discharge of 92,000 cfs (Figure 12). This type of impingement will not damage smooth concrete surfaces.

The impingement of the jet on the tunnel invert downstream from the aeration slot caused side fins to form. For discharges less than 50,000 cfs these side fins swept uninterrupted up the walls of the tunnel past the contracted jet. The maximum side fins, which occurred at a discharge of 30,000 cfs, were not objectionable and did not reach the top of the tunnel (Figure 13). Since the lift diminished as it neared the tunnel springline, the upper portion of the jet was subjected to less contraction than the lower portion. Consequently, the upper elements of the jet impinged on the walls of the tunnel farther upstream and at a much smaller angle, as the discharge and flow depth increased. For discharges greater than 30,000 cfs, the upper portion of the jet interfered with and reduced the side fins, and for discharges greater than 50,000 cfs, the side fins were entirely contained by the upper portion of the jet (Figure 14).

Figure 12. Trace of side fins and jet impingement point. Recommended aeration slot.

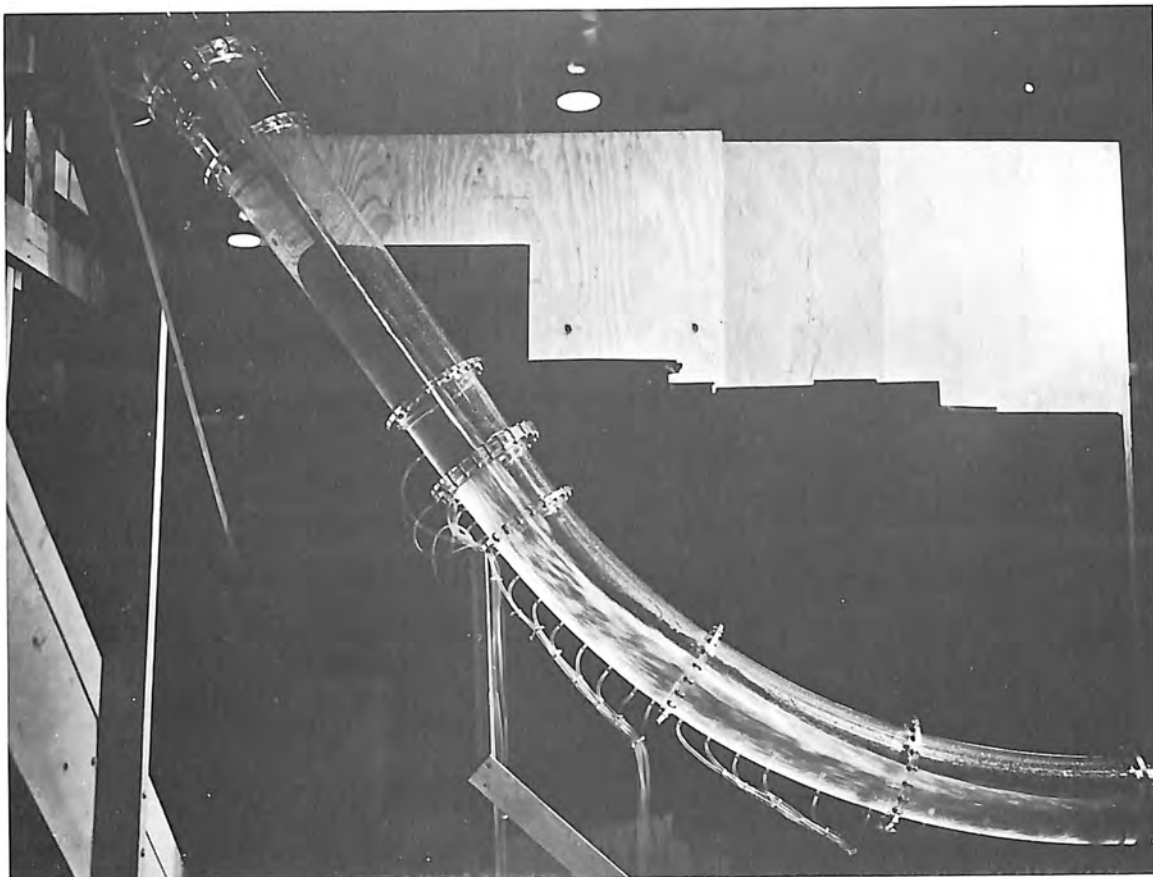
bend (Figure 15). However, it was not known whether the amount of air remaining adjacent to the tunnel flow surfaces in the downstream portion of the bend would be sufficient to prevent cavitation damage. The relationship between model and prototype with respect to entrained air is unknown. As a further precaution against cavitation damage, it appeared that air should be reintroduced into the jet at some station upstream from the P.T. of the bend.

Figure 15. Overall view of the spillway model. Recommended aeration slot at Station 7+79. The slot at Station 6+64, upper left, has been closed. Air entrained at the aeration slot continues throughout the bend. Mixing tends to reduce the air near the flow surfaces in the downstream portion of the bend. Photo P459-D-68808

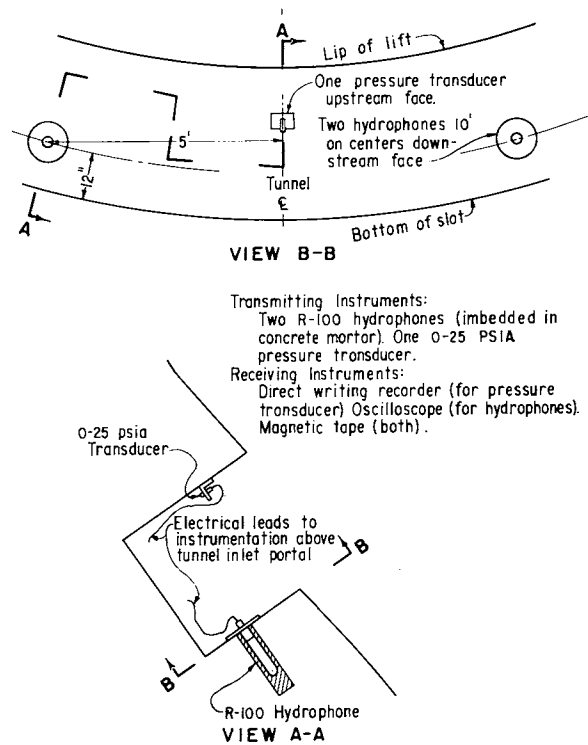
Figure 18. Prototype instrumentation.

tunnel. Electronic surveillance was supplied by two hydrophones and one pressure transducer installed in the aeration slot prior to the start of the first spillway test (Figure 18). The hydrophones were embedded in the concrete in the downstream face of the slot to indicate any change in vibration and the pressure transducer was installed in the slot to monitor the slot pressure during the extended tunnel operation.
