**BUREAU OF RECLAMATION
TECHNICAL SERVICE CENTER
DENVER, COLORADO**

TRAVEL REPORT

Subject: Travel to North Dakota to view Missouri River pump intake sites

DKAO Pump Intake Project
Discussion Notes from 10/16-20/06 Site Visit
And from Post-Visit 10/31/06 Staff Meeting:
Attachment A to Travel Report for October 16-20, 2006 Site Visit

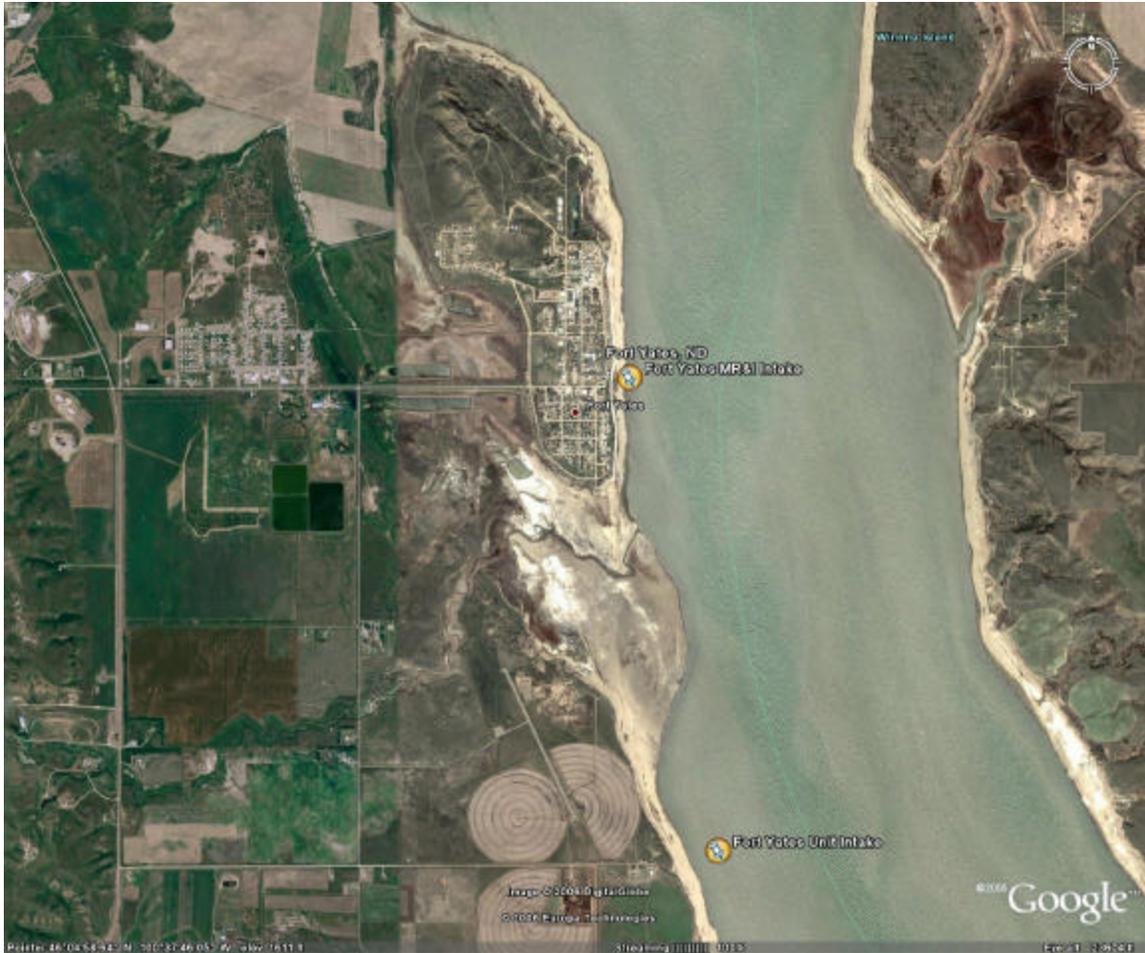
Problem: The fixed intake failed when the river channel shifted due to declining reservoir levels which moved sediment downstream. An off-channel sump was constructed and is being used as the intake for the MR&I water system. The channel is unstable and shifting due to fluctuating water levels (Oahe reservoir to Missouri river system), shifting river channels, sedimentation of intake sites, and low water levels.

Figure 1. Aerial photo of Fort Yates municipal and irrigation intakes (courtesy Google).

- At the municipal water intake, an infiltration gallery should be considered. Historical drill logs indicate that there may be an existing sand/gravel layer sufficient to provide groundwater flow. Several options are available for infiltration galleries to improve their production. If placing gallery pipe in sand and gravel layers is not feasible, then gallery pipe can be placed in open cut trenches, then backfilled with appropriately sized gravel and sand to allow groundwater flow and provide a base level of filtration. Multiple gallery pipes could be extended underneath the river from a central collection well, providing backup sources and increasing gallery production. Whether a directionally drilled or cut and fill placement method is used, fine sediments (silts and clays) can deposit in the sand/gravel surrounding the gallery pipe over time, choking the water inflow. To maintain sufficient inflow, an infiltration gallery can be designed with back-flushing capability to periodically remove fine sediment from the filter layer surrounding the pipe. The water demand for Fort Yates is relatively low (1,200 to 1,400 gpm; 2.7 to 3.2 cfs), increasing the potential of an infiltration gallery as a reliable and consistent water supply.

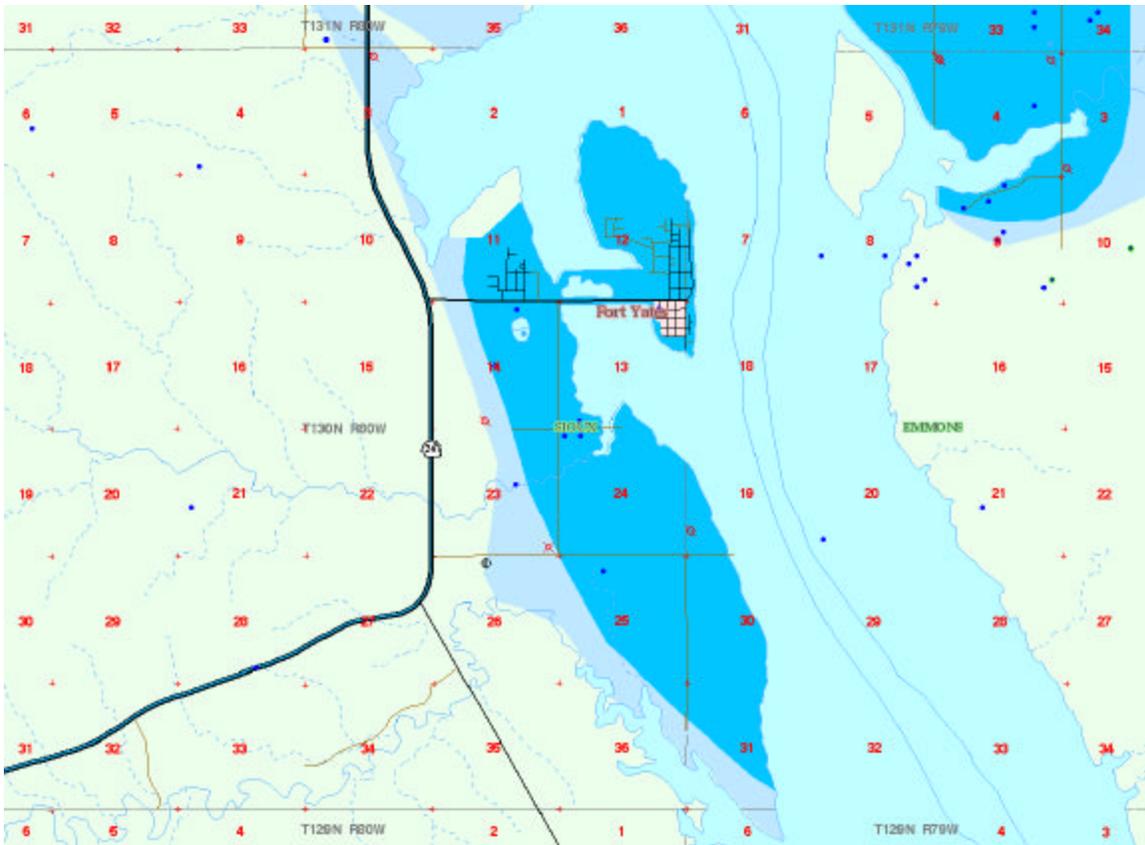
The locations of some of the wells and test holes are plotted on Figure 4. Not all of the drill logs evaluated are plotted on Figure 4, but it shows the proximity of the intakes to the historical river channel and reservoir boundaries.

Figure 4. NDSWC map of Fort Yates area showing well locations (courtesy NDSWC).

- Further exploration of groundwater in the Fort Yates area is warranted. Preliminary examination of existing data indicates potential for developing groundwater sources for municipal and irrigation water supply. Tapping into existing groundwater sources could provide a reliable water supply in high and low water conditions and eliminate most concerns associated with

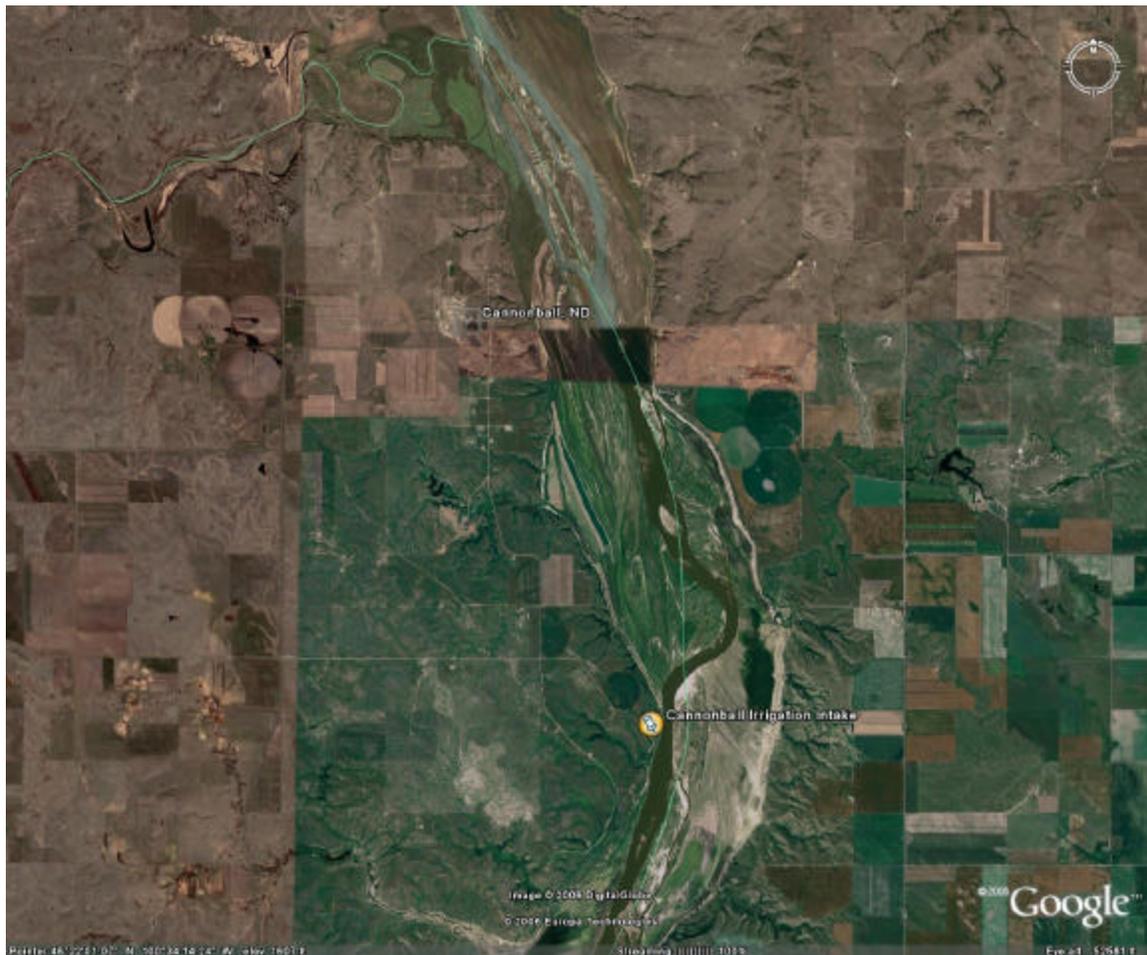
Problem: The fixed intake failed when the river channel shifted due to declining reservoir levels which moved sediment downstream. The Tribe is currently using a portable pump as the main river channel is close to the pumping plant. The Tribe would like to construct one intake which will operate in both high and low water conditions. Their consultant has proposed constructing an expensive H structure in the channel which will allow the intake to be moved vertically but not horizontally.

Figure 6 and Figure 7 provide aerial views of the Cannonball intake site and surrounding area. The Missouri River narrows at the upstream end of the straight reach containing the intake, increasing flow velocity and depth, and raising sediment transport capacity there.

Figure 6. Aerial photo of Cannonball Irrigation Unit intake site (courtesy Google).

- If the river remains in its current low flow channel along the right bank, portable intakes appear to be the best option here. The river at this site is relatively stable and close to the irrigation pumps. While the vertically adjustable intake proposed by Morrison and Maierle may solve most of the problems at this site, the estimated \$1,000,000 price tag seems excessive. Perhaps a less expensive solution could be found that would be just as effective. During discussions of potential alternatives, the possibility of installing an inclined intake on the existing concrete ramp at the Cannonball site (Figure 5) was presented. Inclined rails or a track system could be installed on the concrete slope. A portable intake could travel up and down the rails, following the water surface as it rises and falls. Flexible pipe would be connected to the intake to maintain a connection to the pumps while the intakes were adjusted.

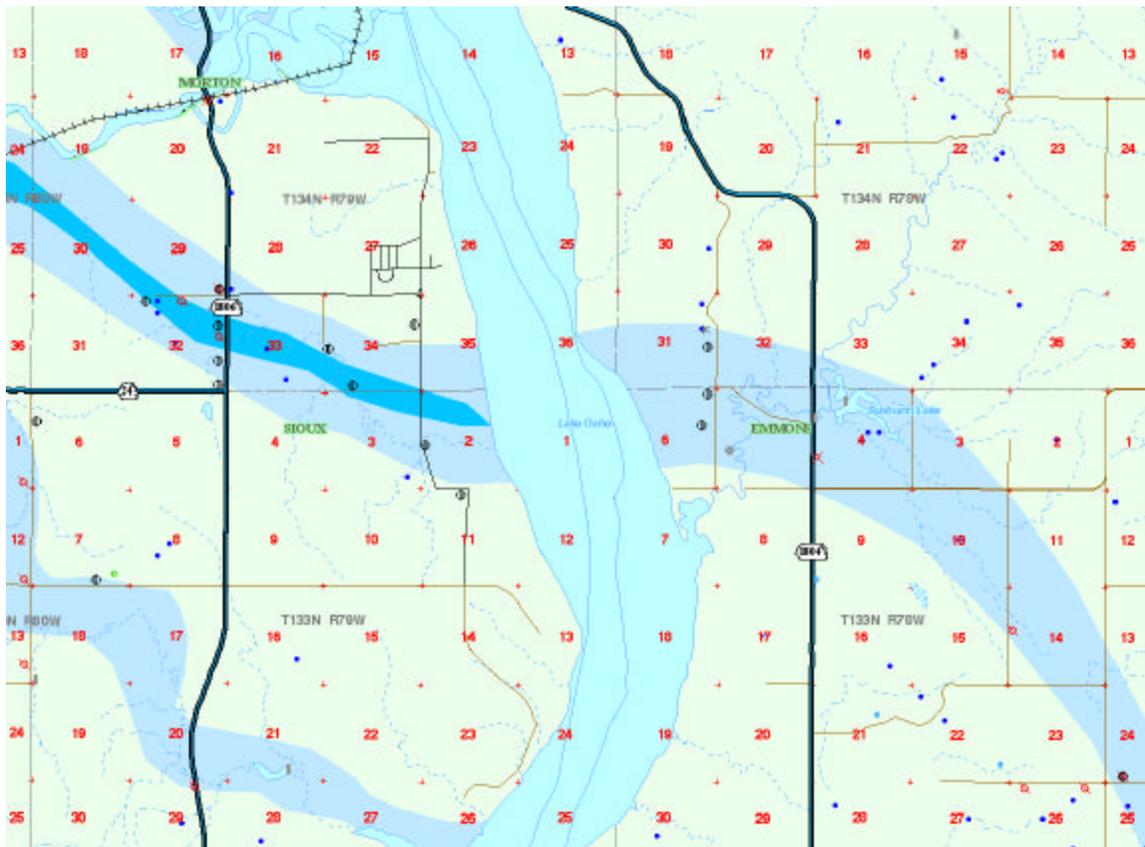
Figure 7 maps the original Missouri River channel before Oahe Dam closed. The historical channel was straight and against the right bank at the current Cannonball Intake site. When Lake Oahe dropped, the river returned to the historical channel. Upstream of the intake, a sharp bend has developed and the river has migrated away from the historical channel, but the channel at the intake appears to be relatively stable. Recent aerial photos do not show significant downstream migration of the bend since 1995 and show additional vegetation growth in the floodplains, further stabilizing the low flow channel.

Figure 7. NDSWC map of Cannonball Irrigation Unit intake area showing historical channel.

As the reservoir level rises and falls, the delta location changes with the head of the pool. If the upstream end of the pool stalls in the Cannonball area due to hydrological conditions or dam operation, there is potential for significant sediment deposit to occur at the intake site. Delta deposition could bury a permanent, stationary intake.

Conversely, dropping reservoir levels can result in erosion of the river channel through reservoir deposits. Erosion of the channel bed at the intake could undermine Cannonball Irrigation Unit infrastructure, causing structural failure of the intake.
