TR-2017-01

Travel to Senator Wash Pump-Generation Plant to observe penstock vibrations

TRAVEL REPORT

Date: May 3, 2017

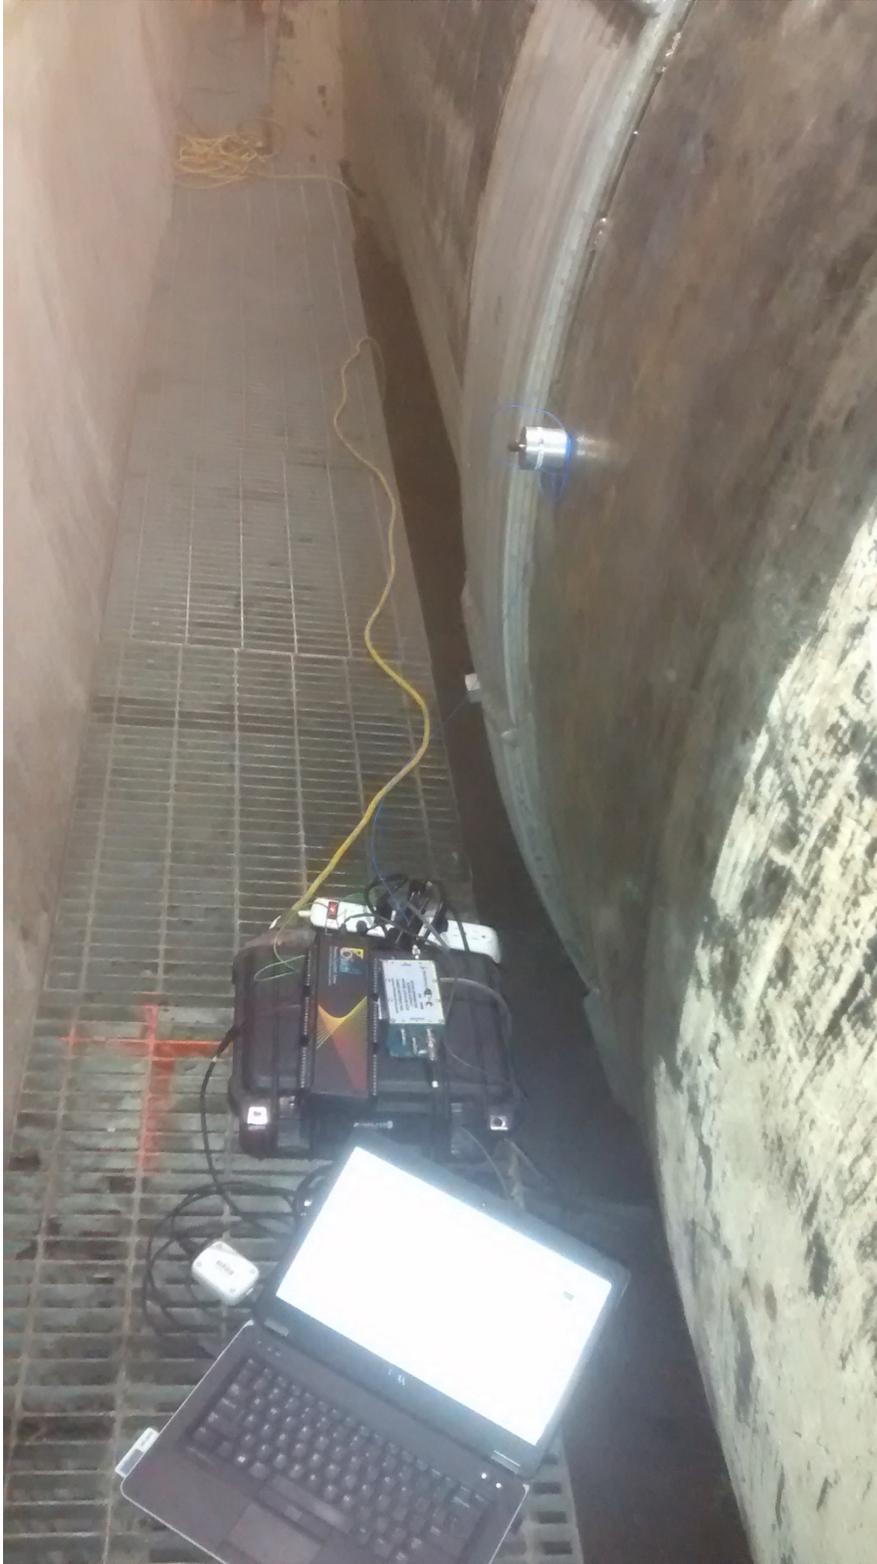
Figure 2 Photo of the accelerometer mounted on the penstock, on the reservoir side of the expansion joint during tests on March 21st.
