Dams and Public Safety

A Water Resources
Technical Publication

U.S. DEPARTMENT OF THE INTERIOR
Bureau of Reclamation

**By
Robert B. Jansen**

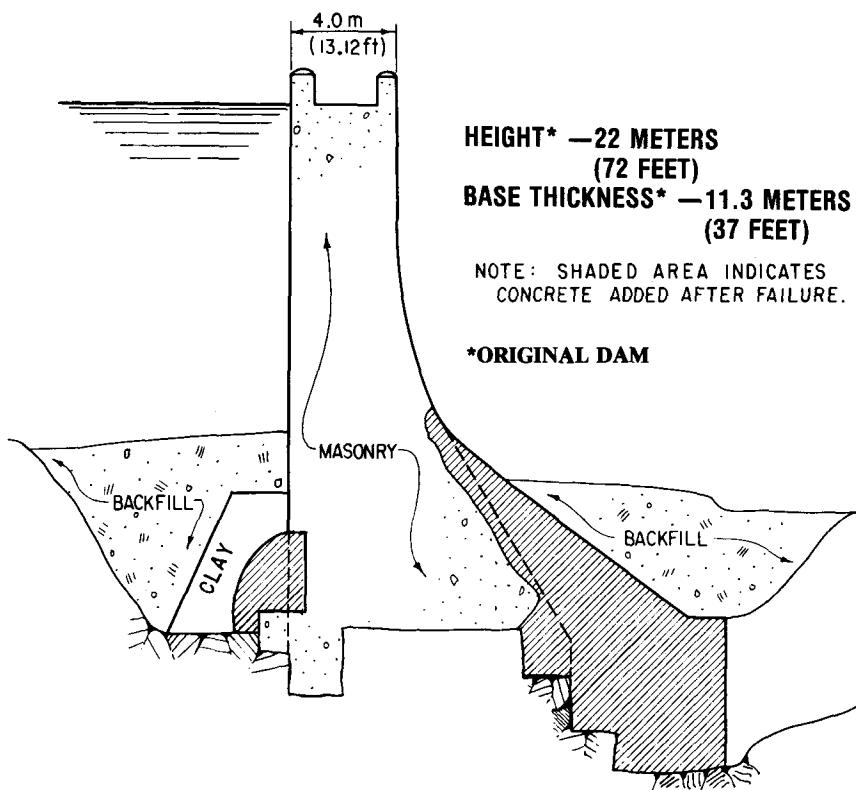
Figure 4-2.—Bouzey Dam, cross section. P-801-D-79347.

The Bouzey Dam (fig. 4-2) was located on L'Avière, a tributary of the Moselle River near Epinal in Vosges Province in France. It failed on April 27, 1895. The designers of the dam evidently disregarded the "middle-third" principle, which states that on any horizontal plane within a gravity dam, the resultant of forces should act within the middle third. This was to ensure that the stress would be compressive at all points on that plane. The rule assumed a linear variation of stress, which is now recognized as only a crude approximation.

In the fall of 1885, about 1½ years after the mishap, the reservoir was drained. Inspectors then learned that there were many cracks in the upstream face, with one break extending 91 meters (300 feet) horizontally. Evidently, cracking had also severed the dam from its cutoff wall, which extended into the foundation at the heel. This crack at the base was then covered by a longitudinal block of masonry, which in turn was sealed with puddled clay. The downstream toe was extended outward and downward by addition of a masonry mass which roughly doubled the dam's base thickness. It gave a flatter slope to the lower downstream face, keying into the original mass at about midheight. The cracks in the old masonry were

grouted, and drains were installed. The remedial program was finished in September 1889.

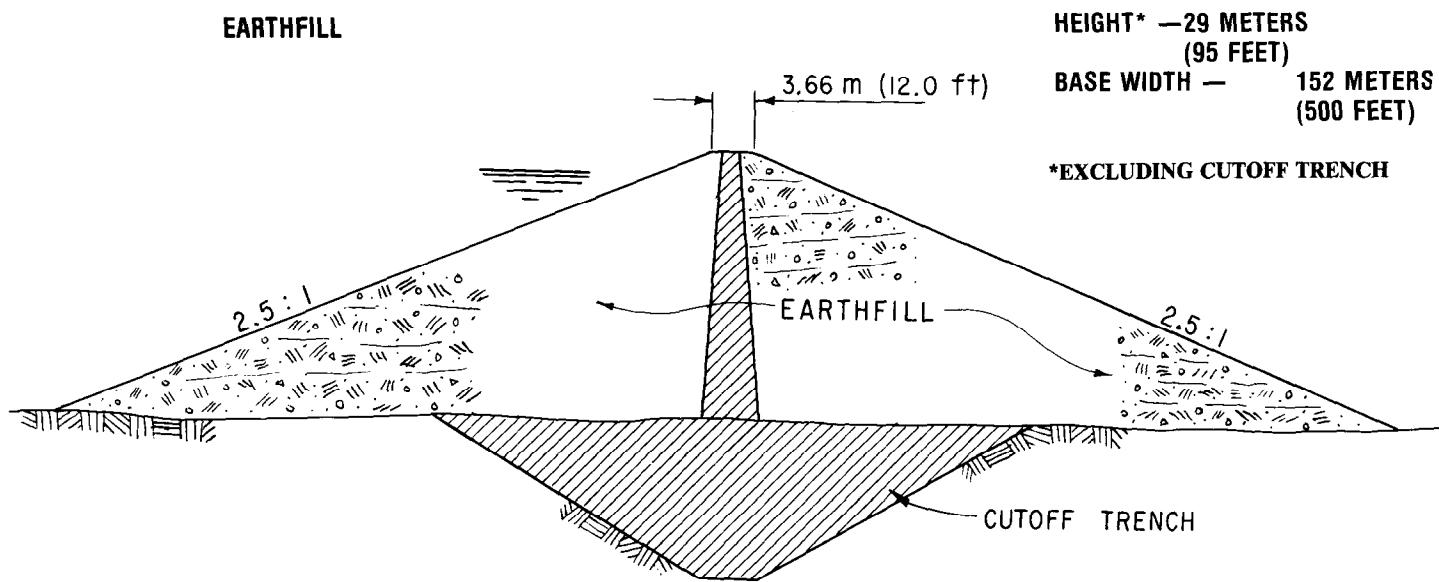
Figure 4-3.—Bradfield Dam, cross section. P-801-D-79348.

Disaster struck the Bradfield Dam (fig. 4-3) — or Dale Dike — near Sheffield, England, on the evening of March 11, 1864. The breaching of this

embankment loosed a flood which swept into the valley with such velocity that any effective warning of the populace was impossible. As a consequence, 238 people died.

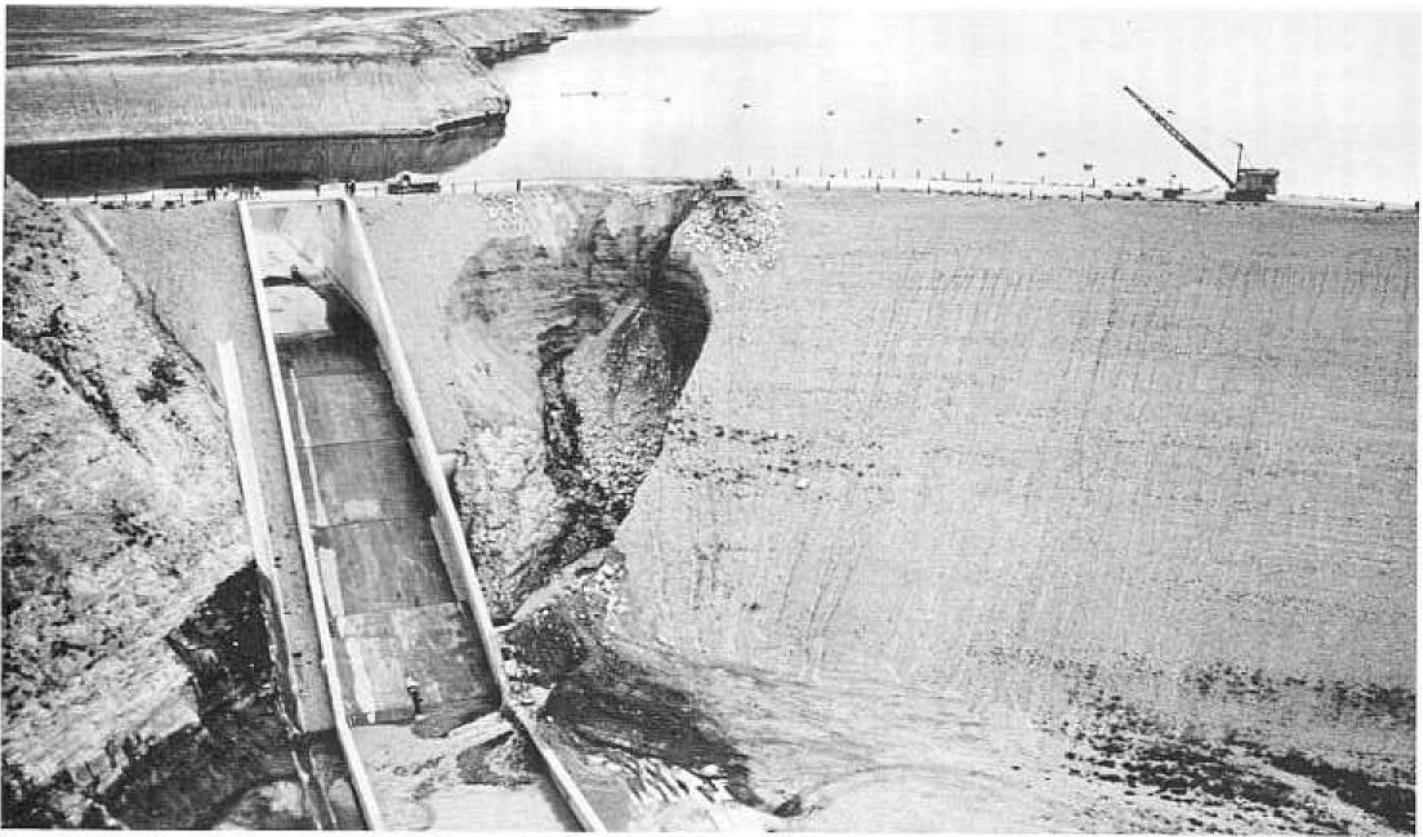
Figure 4-4.—Fontenelle Dam (P154-400-1501). P-801-D-79349.

In September 1965, during filling of the reservoir at the Bureau of Reclamation's Fontenelle Dam (fig. 4-4), a 39.6-meter (130-foot) high earthfill structure completed in 1964 on the Green River in Wyoming, seepage through joints in the shales and sandstones of the right abutment caused deep erosion which seriously endangered the dam. Quick action by the operations crews narrowly prevented a disaster. This event demonstrated the hazards of relying on single rather than redundant seepage defenses. In the case of Fontenelle Dam, the lone defense in the abutment was a single-line grout curtain. Remedial work included broadening and extending the grout curtain by additional lines of grout holes.

The Fontenelle Dam accident had several contributing factors. When the embankment remnant in the distressed area was excavated to foundation, cracks were found in the sedimentary rock (sandstone, shale, siltstone). There also was reported to be sandy core material at the foundation contact. The postemergency investigation also produced evidence that in some places the grout injected during construction had not traveled far enough to seal foundation cracks completely.

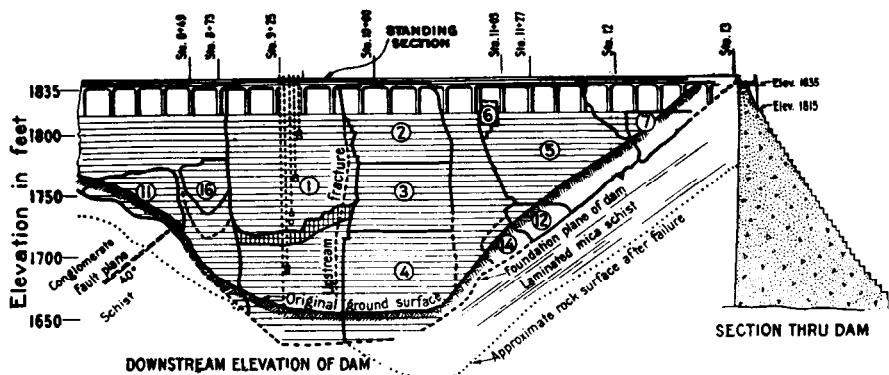
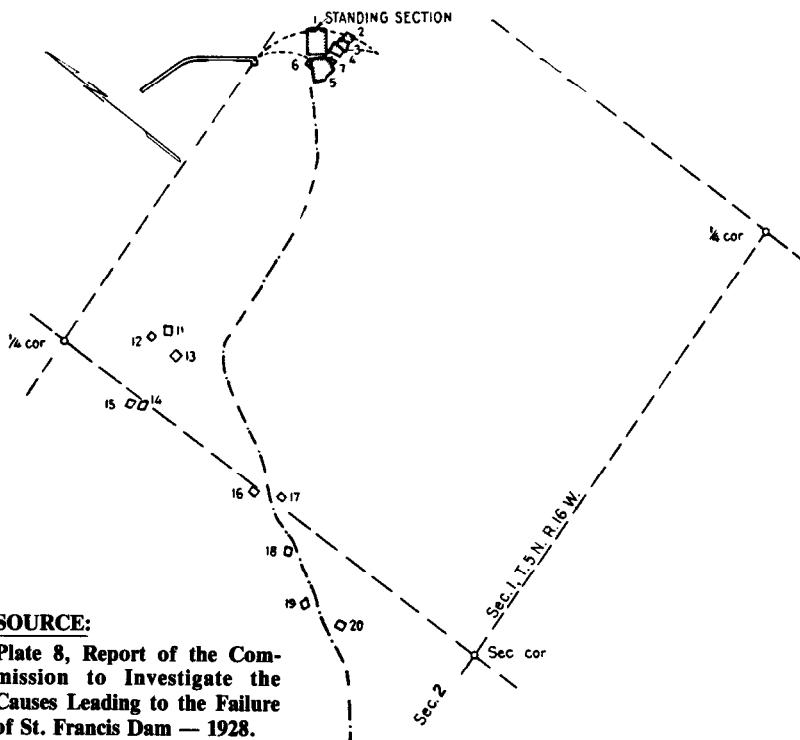
ST. FRANCIS DAM
DISTRIBUTION OF FRAGMENTS

A survey of the remaining portion of the west wingwall showed that it had risen as much as 91 millimeters (0.3 foot). Downslope from the wall, in the lower part of the west abutment, the conglomerate was washed away to a depth of as much as 9 meters (30 feet), and on the east side of the standing monolith the schist was cut to an estimated maximum depth of 12 meters (40 feet).

A huge slide was active on the east abutment for at least 2 weeks following the disaster. This was a manifestation of even greater movement within the mountain. Cracks were discovered 61 meters (200 feet) farther up the slope, indicating the total magnitude of dislocation of the rock mass.

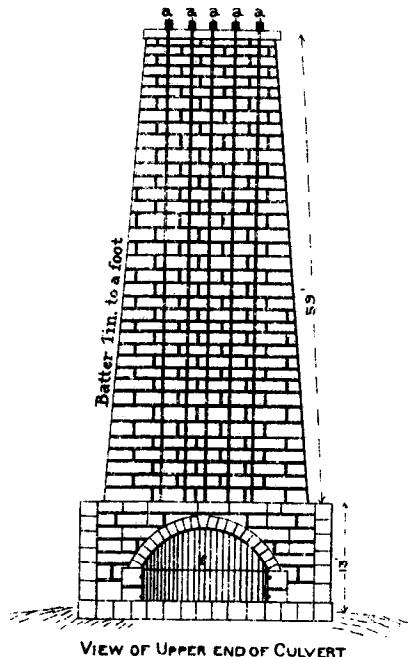
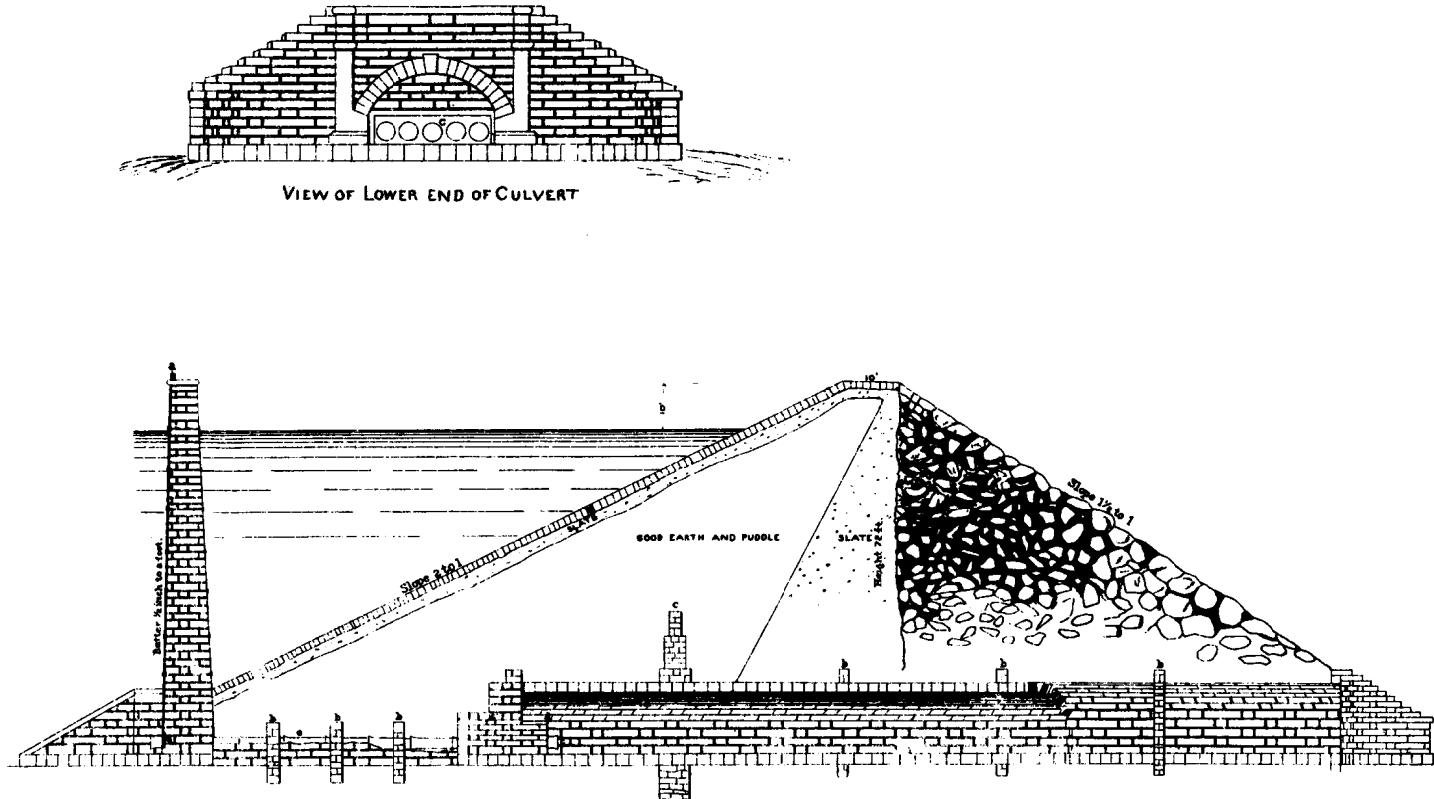
Figure 4-15.—South Fork Dam, cross sections (1 of 2). P-801-D-79360.

On May 31, 1889, a major catastrophe occurred in the Allegheny Mountains of Pennsylvania, when the South Fork Dam (fig. 4-15), about 14 kilometers (9 miles) above Johnstown, suddenly broke and loosed a flood down the narrow valley of the Conemaugh River. A large part of the city of Johnstown was ruined, and 2,209 people died.

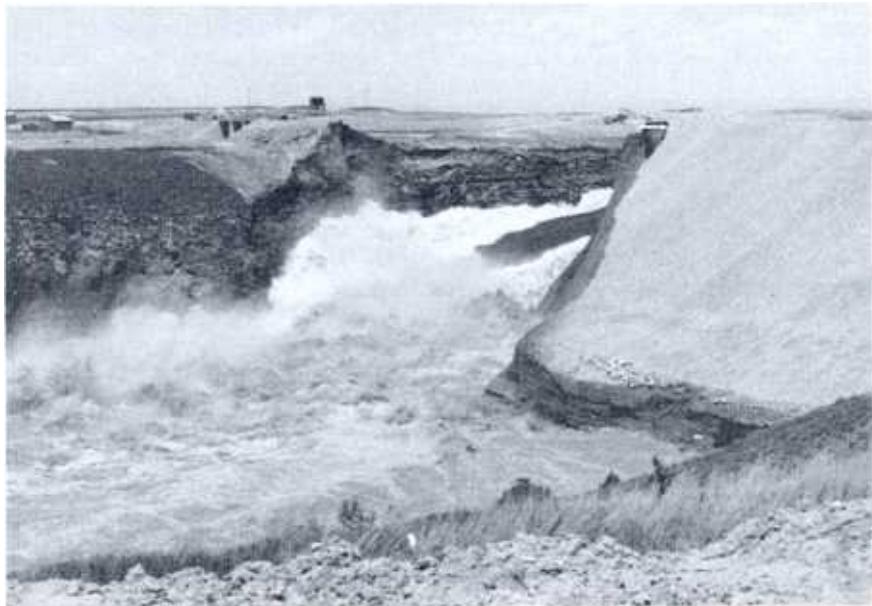
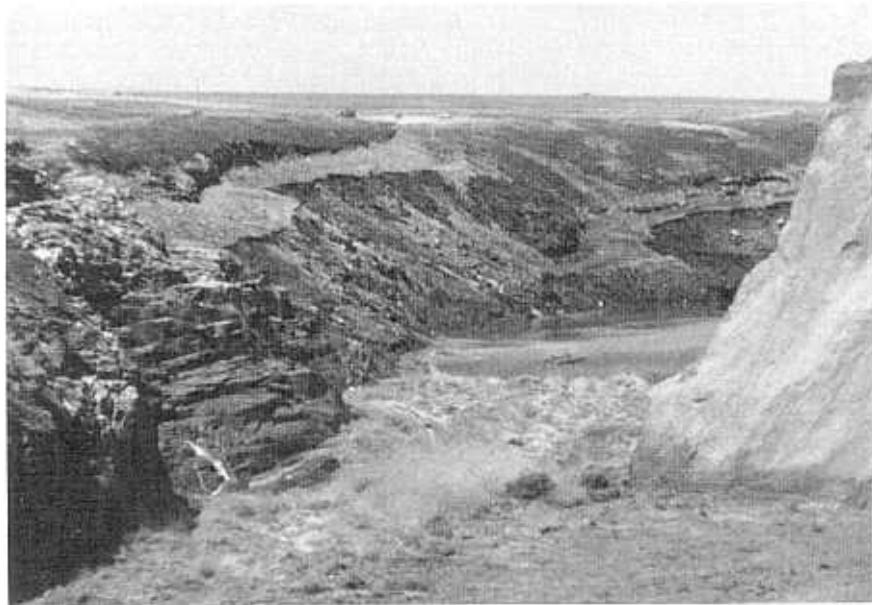
Figure 4-16.—Teton Dam failure sequence, June 5, 1976—Continued.

The Bureau of Reclamation's Teton Dam failed on June 5, 1976, during initial impoundment when the reservoir was nearly full (figs. 4-16, 4-17, and

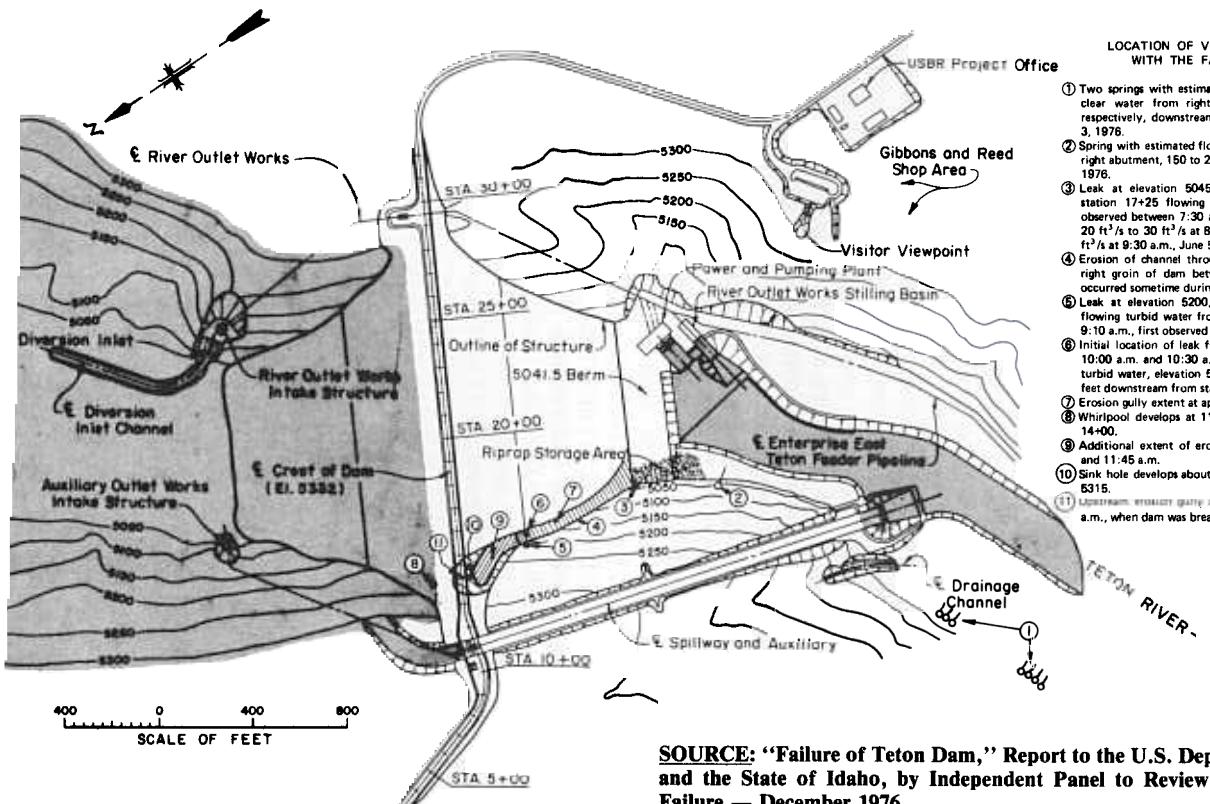
Figure 4-20.—Teton Dam, prefailure leakage — location of visual events. P-801-D-79372.

During the night of June 4, water evidently flowed down the right groin from about elevation 1585 (5200) inasmuch as a shallow damp channel was noticed early on the morning of June 5. Shortly after 7 a.m. when the first observations (see figs. 4-20 and 4-21) were made on June 5, muddy water was flowing at about 0.6 to 0.8 cubic meter (20 to 30 cubic feet) per second from talus on the right abutment at about elevation 1538 meters (5045 feet), and a small trickle of turbid water was flowing from the right abutment at elevation 1585 meters (5200 feet). Both flows were at the junction of the embankment and the abutment, referred to as the groin, and both increased noticeably in the following 3 hours.

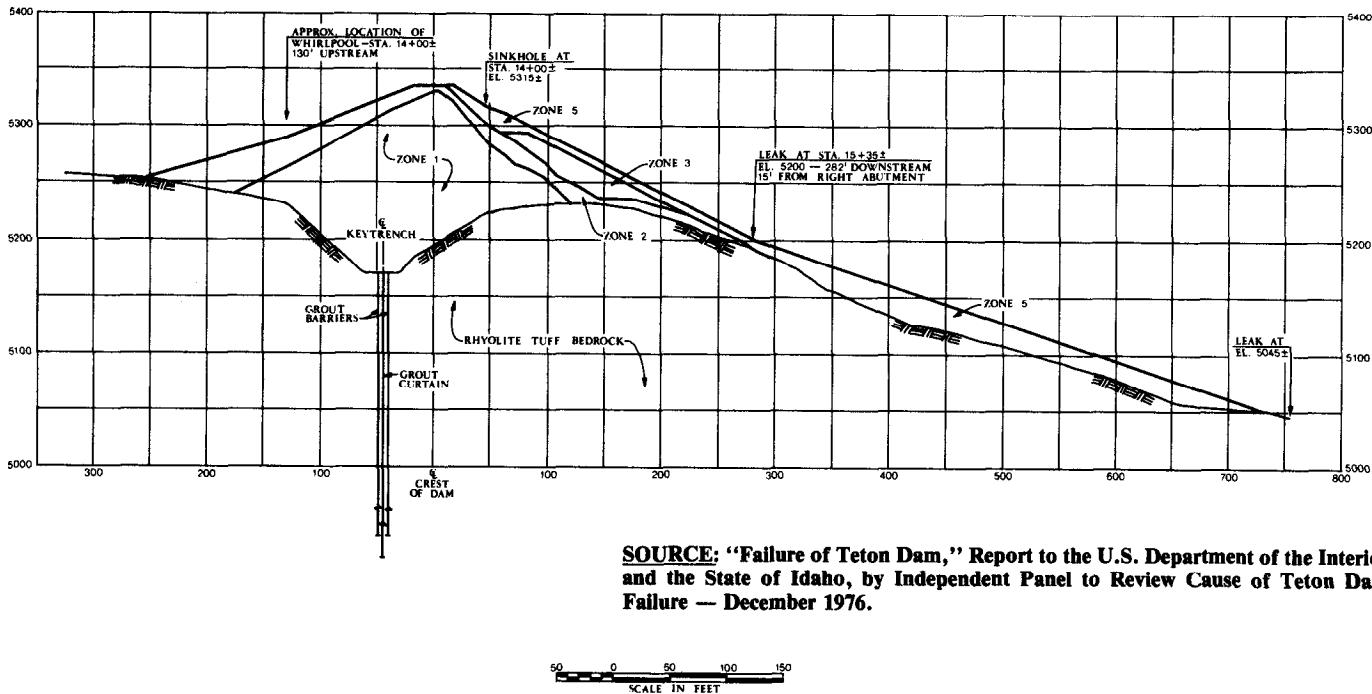
Figure 4-21.—Teton Dam, section along approximate path of failure. P-801-D-79373.

Beneath the level of the base of the key trench, the rock was also jointed and pervious, as judged by water tests in exploratory drill holes and by grout takes in the curtain. Since the curtain was confined to the key trench, there is no doubt that the rock at depth, upstream of the curtain, was pervious, although possibly less so than that in the upper 21 meters (70 feet). Inspection of the face of rock remaining along the right abutment after the erosion by the escaping floodwaters disclosed many open joints below key trench level, some partially filled with grout, both upstream and downstream of the grout curtain.

Ponding tests conducted by the Independent Panel demonstrated that water could flow readily beneath the grout cap at several locations near the failure zone. Water tests in drill holes on the center line of the grout curtain

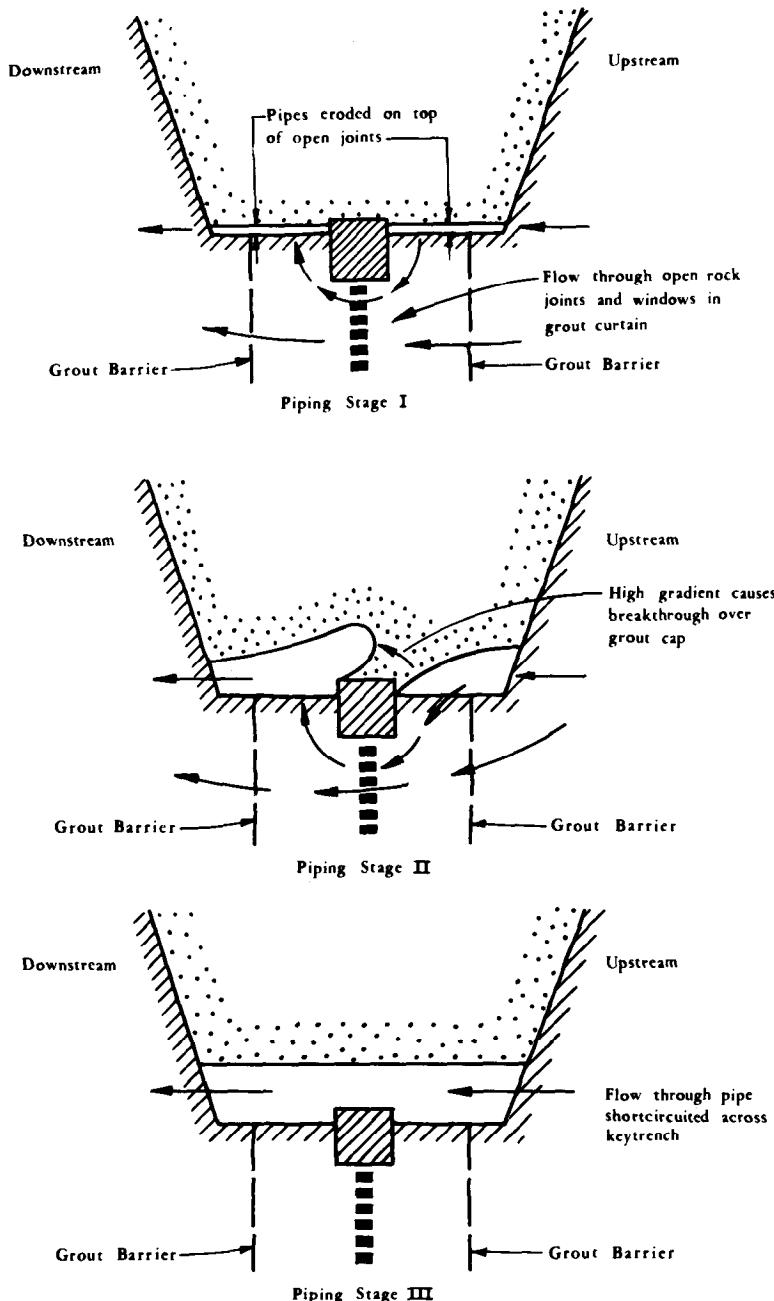
EROSION DIAGRAMS

During the night of June 4, however, the leakage began to exceed the capacity of the pervious materials, whereupon it emerged at elevation 1585 meters (5200 feet) and flowed briefly down the surface, where dampness and slight erosion were noted along the groin the next morning. Early in the morning, as flow continued to increase, muddy springs appeared at both elevation 1537.7 meters (5045 feet) and 1585.0 meters. Soon the spring at elevation 1585 meters was seen to be the mouth of an erosion tunnel extending along the rock at the base of the earthfill close to the groin. Progressive erosion led to continued increase in size of the tunnel until finally at about 10:30 a.m., the water pressure was great enough to break suddenly and violently through the zone 2 fill and erupt on the face of the dam. Thereafter, the tunnel became a gully, working headward first up the groin and then along the initial passage through the key trench. The gully ex-

SOURCE: "Failure of Teton Dam," Report to the U.S. Department of the Interior and the State of Idaho, by Independent Panel to Review Cause of Teton Dam Failure — December 1976.

In its summary, the Independent Panel concluded that the physical conditions were fully satisfied for water flowing under high pressure to attack the lower part of the key trench fill along open joints, some of which were found to transmit water freely through the grout curtain, particularly through the upper part near the grout cap. The attack was fully capable of quickly developing an erosion tunnel across the key trench. Arching at local irregularities, loose zones of fill at re-entrants, and local cracking may have contributed to the success of the attack and determined the precise location. Conditions were favorable for escape of the water and eroded solids into the joints of the rock downstream, for discharging the water against and along the interface of the right abutment of the dam and the embankment, and for development of the erosion features that ultimately breached the dam.

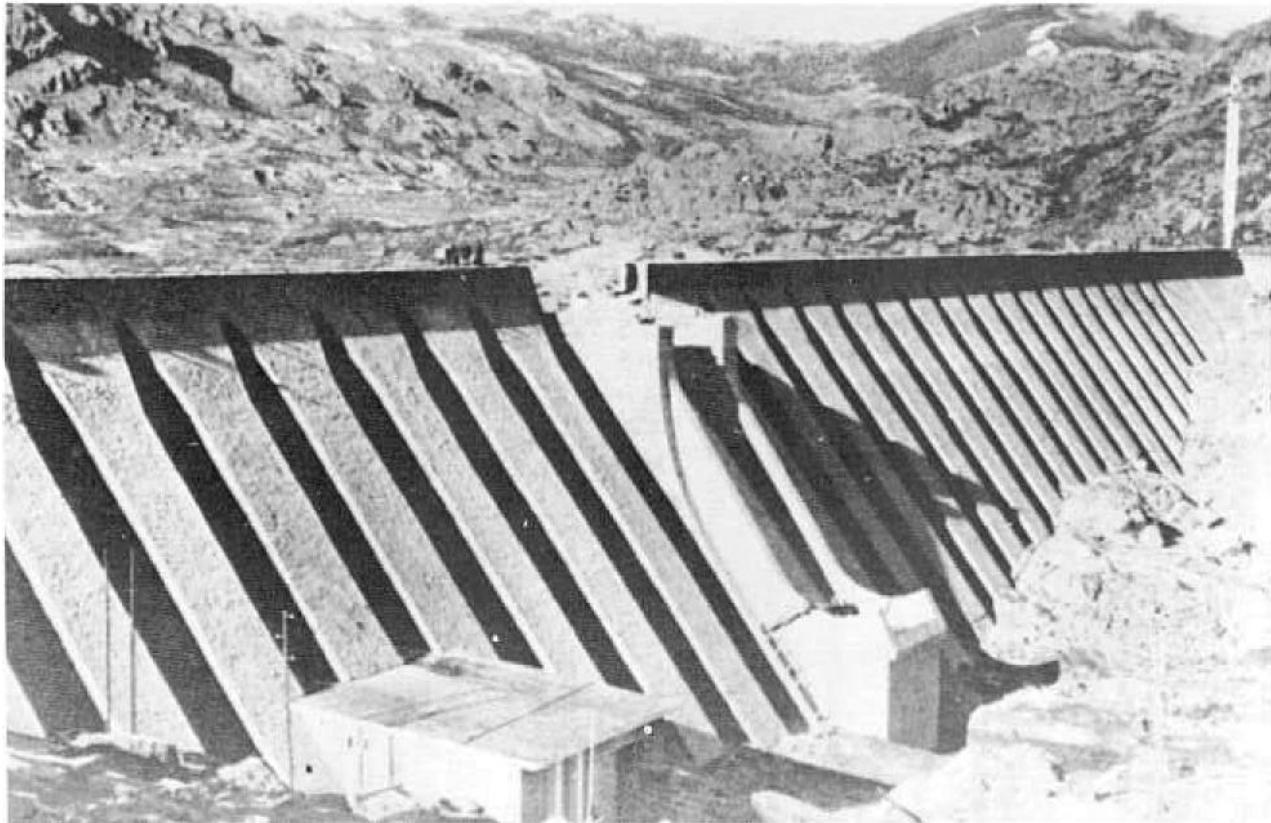
Failure of the Vega de Tera Dam (fig. 4-27 and 4-28) on January 10, 1959, caused the deaths of 144 people. This 34-meter (112-foot) high slab-and-butress structure in the district of Zamora in northwest Spain collapsed suddenly during the night. The flood released from its full reservoir destroyed the mountain village of Rivadelago 5 kilometers (3 miles) down the Tera River, a tributary of the Río Duero.

The Vega de Tera Dam, constructed in the period from 1954 to 1957, was a straight barrier with masonry buttresses and concrete slabs. Its builders followed the practice of suspending work during winter. As a result of inadequate preparation of joints on resumption of placement, poor bond was

Figure 4-27.—Vega de Tera Dam before failure (Courtesy, Comité Nacional Español, ICOLD). P-801-D-79379.
