REC-ERC-71-48

LABORATORY INVESTIGATIONS OF COMBINED VERTICAL FLOWMETER AND FLOW CONTROLLERS USED FOR IRRIGATION WATER DELIVERY

D. B. Garduno
R. A. Dodge
Engineering and Research Center
Bureau of Reclamation

December 1971

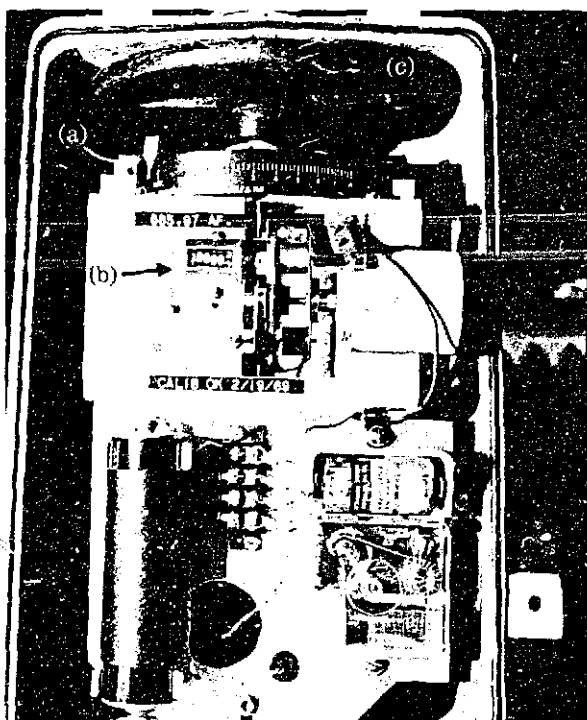
Figure 2. Horizontal scale and pointer of used field-modified device. Discharge pointer (a). Totalizer dials (b). Set point handwheel (c). Photo PX-D-70502

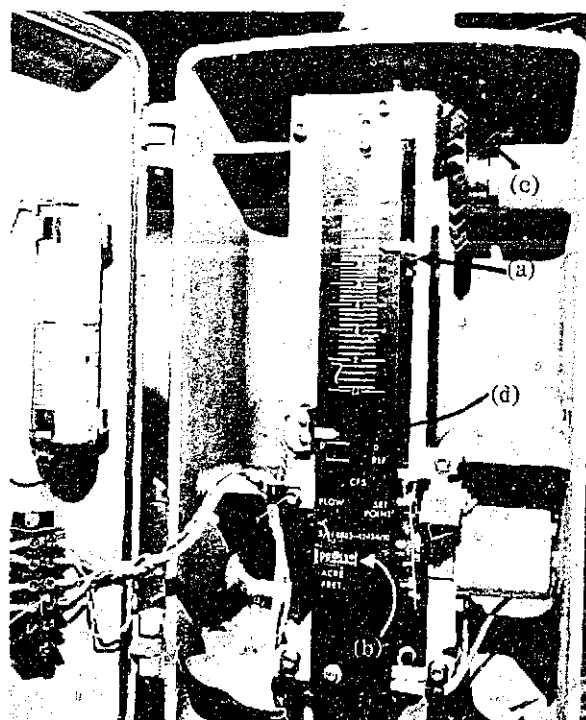
Figure 3. Vertical following pointer of newer-version device. Set point indicator (a). Totalizer dials (b). Set point hand crank and gear drive (c). Discharge indicator (d). Photo PX-D-70501

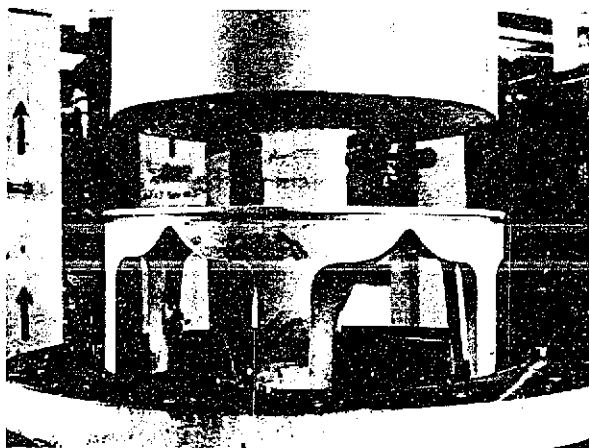
Figure 4. Sleeve valve with shaped flow control orifices. Photo PX-D-70499

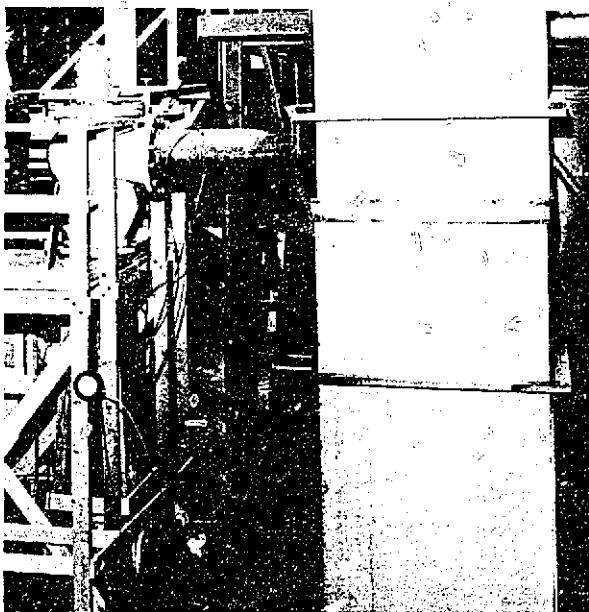
Figure 5. Laboratory installation of flowmeter and flow-controller—Used field-modified device. Photo PX-D-70494

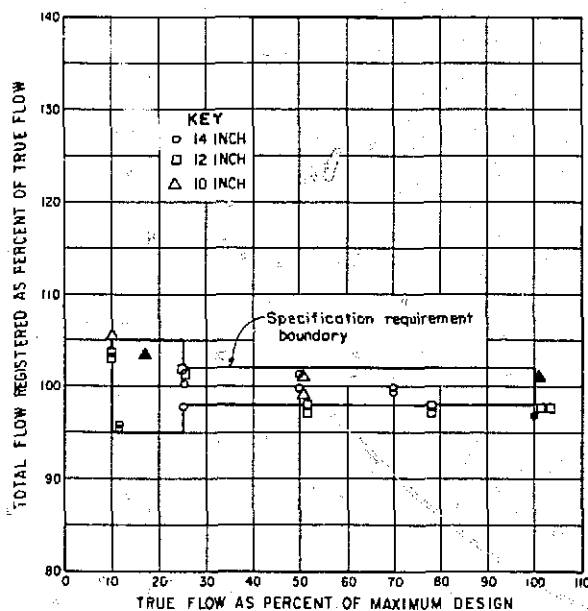
The used field-modified devices operating near 50 percent discharge, totalized flow in a 20 percent band ranging from 96 percent to 116 percent registration, Figure 6. The solid data points represent double data points. All the new devices complied with the totalization specifications. The specifications require plus or minus 5 percent from 10 to 25 percent maximum and plus or minus 2 percent from 25 percent to maximum discharge. These requirements are demarked by the areas bounded by the heavy lines in Figures 6 and 7. Laboratory measurement of discharge was measured to plus or minus 1 percent. The totalization time interval was also selected to produce a plus or minus 1 percent discharge accuracy due to the relative effects of the precision of dial reading. The remainder of the error was due to the devices themselves. Some of the data scatter shown for the field-modified devices was due to including data obtained from the 12-inch (30.5-cm) meter that was improperly prepared for shipping and was found to be damaged.

Figure 7. Totalization accuracy of newer-version devices.

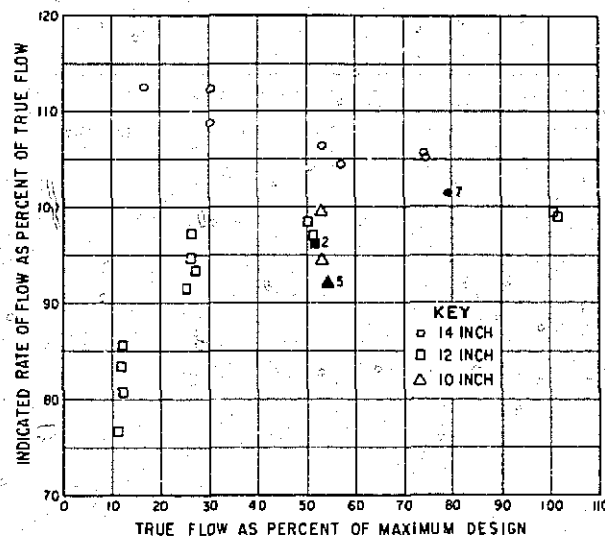
The field-modified devices operating near 50 percent maximum design discharge indicated flow in a 15 percent band, ranging from 92 to 107 percent of true

Figure 8. Rate of flow indication accuracy of the used field-modified devices.

flow, Figure 8. The new meters operating near 50 percent of maximum discharge fell in a 6 percent band ranging from 93 to 99 percent of true flow, Figure 9. The solid data points with numbers in Figures 8 and 9 represent multiple data points. It should be remembered that the laboratory discharge measurements are only accurate to within plus or minus 1 percent.

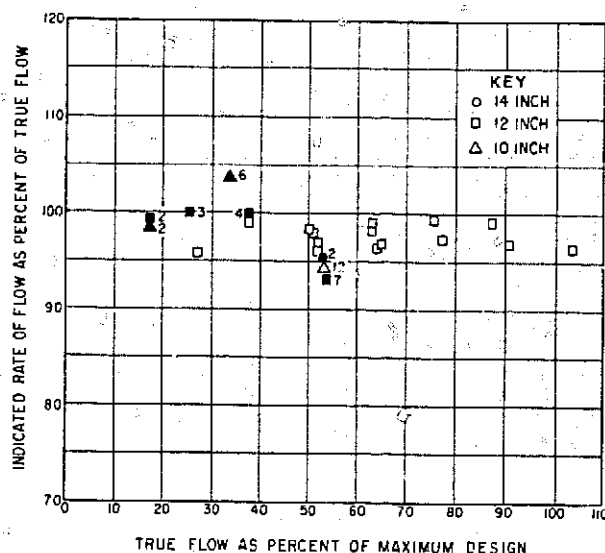
Figure 9. Rate of flow indication accuracy of the newer-version devices.

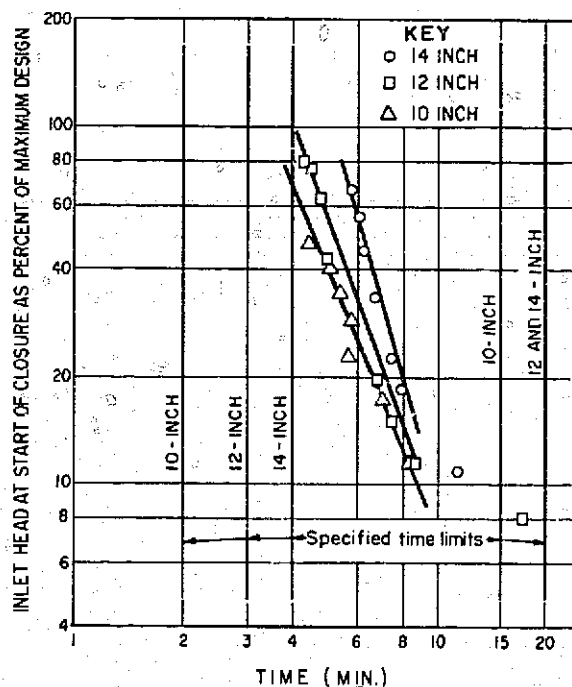
Only the data for the field-modified 14-inch (35.6-cm) device fully complied with the specified closing time limits after the closure cycle was accepted internally, Figure 10. The vertical lines demark specified upper and lower specified closing time limits for the three sizes of devices. The solid data points represent double data points. One of the data points for the field-modified 10-inch (25.4-cm) device was out of specified range and two of the data points for the field-modified 12-inch (30.5-cm) devices that was properly shipped were out of specified range. However, all the data for the new version devices were within specified range after the closure cycle was accepted internally, Figure 11.

Figure 11. Closing characteristics of the newer-version devices.

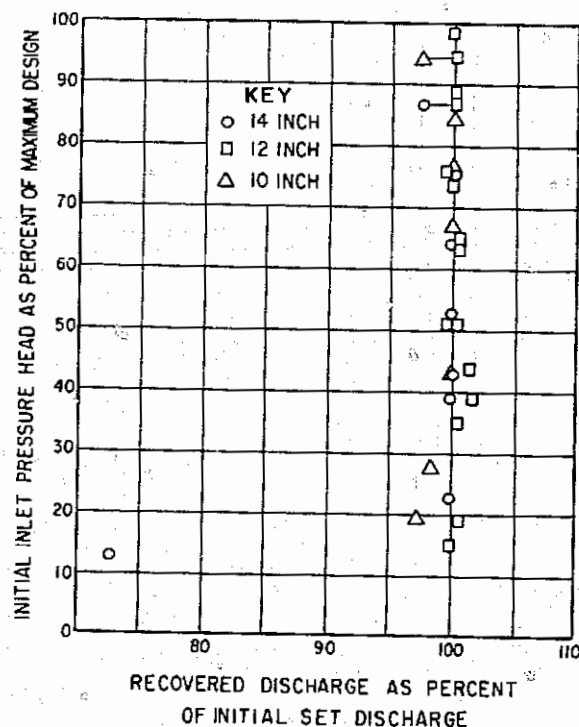
approaching 20 percent of maximum design head. These tests were performed with discharges set near 50 percent maximum and/or normal flow. These recovery data are plotted in Figures 13 and 14. It should be remembered that the laboratory discharge measurement was accurate to within plus or minus 1 percent.

Figure 13. Discharge recovery after pressure decreases—Used field-modified devices.

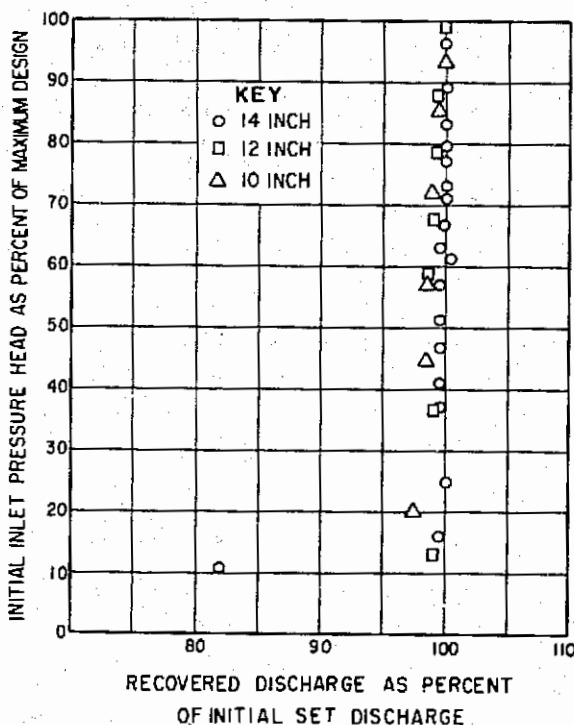
Figure 14. Discharge recovery after pressure decreases—Newer-diversion devices.
