# **ALKALI-SILICA REACTIVITY IN FIVE DAMS IN SOUTHWESTERN UNITED STATES**

**July 1985**

**S. Department of the Interior  
Bureau of Reclamation**

1. REPORT NO. <b>REC-ERC-85-10</b>		3. RECIPIENT'S CATALOG NO.	
4. TITLE AND SUBTITLE <b>Alkali-Silica Reactivity in Five Dams in Southwestern United States</b>		5. REPORT DATE <b>July 1985</b>

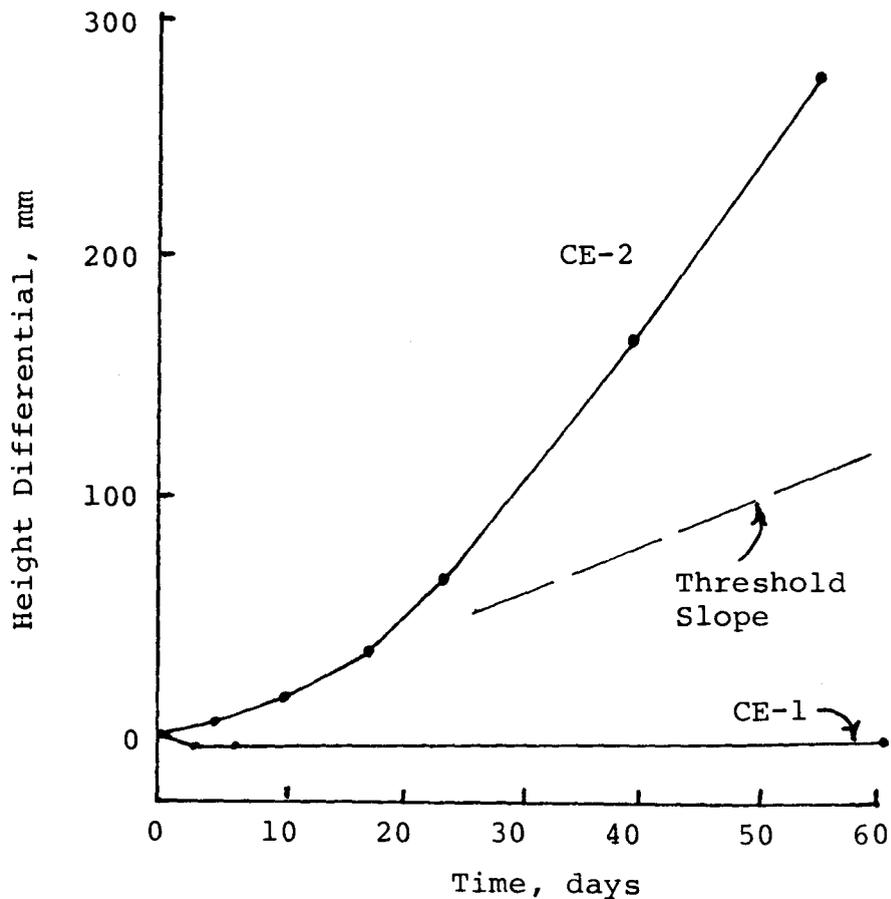
FIG. A6 - RESULTS OF OSMOTIC CELL TESTS FOR AGGREGATE FROM COOLIDGE DAM

NO.	LOCATION	DESCRIPTION	FLOW RATE, mm/DAY
CE-1	3 to 5 in. from exterior end of core CE, taken into west face of right buttress, 4 ft up from ground level.	Dense crystalline, purple-red andesite porphyry, 3-in. particle. No evidence of previous reactivity.	<0.0
CE-2	Same core as above. Particle located 1 to 3 in. from external surface.	Somewhat weathered and porous, purple-red andesite porphyry. 2-1/2-in. particle size. No evidence of previous reactivity.	7.3

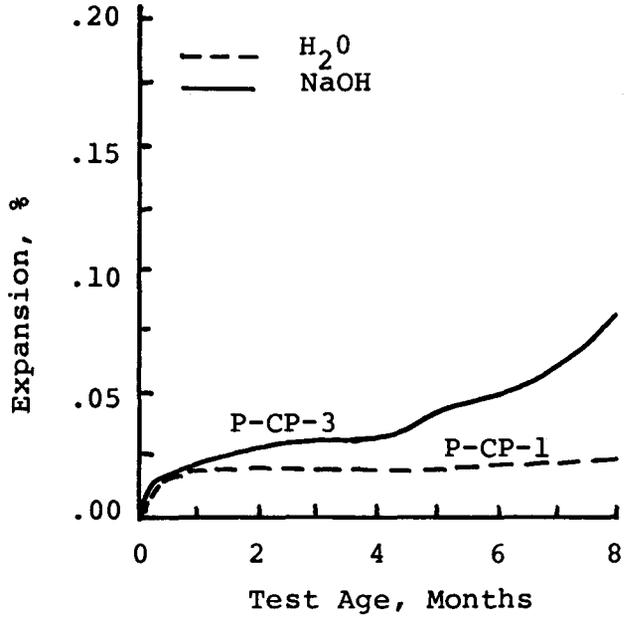
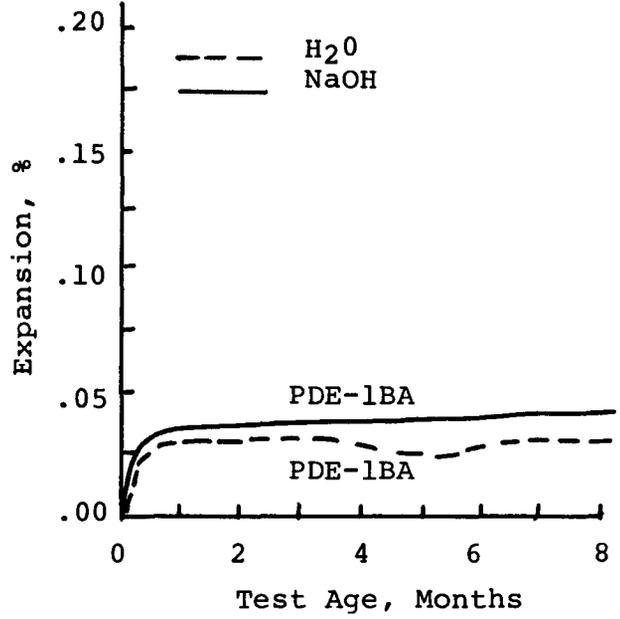
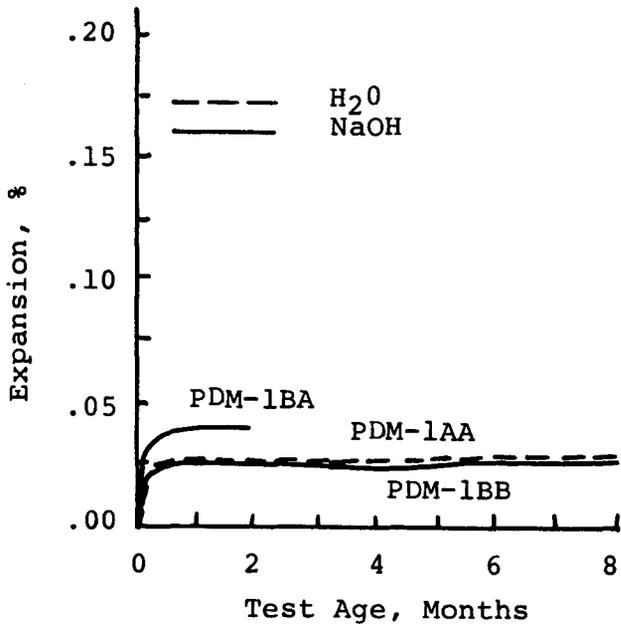
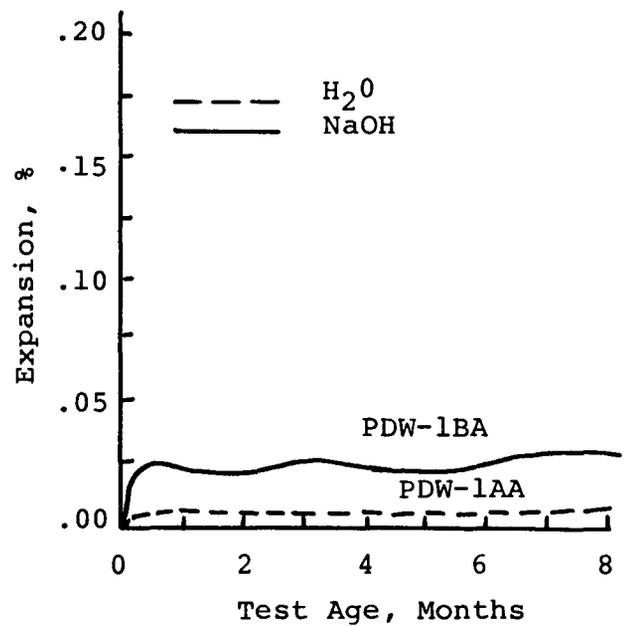
FIG. D5 - LENGTH CHANGES OF PARKER DAM CORES IMMERSSED IN WATER OR IN NaOH SOLUTION AT 100°F

Core No.	Core Length	Location	Depth in.	Test Sol'n	Percent Length Change									
					7D	14D	1 Mo.	2 Mo	3 Mo.	4 Mo.	5 Mo.	6 Mo.	7 Mo.	8 Mo.
P-CP-1	10 in.	From core stockpile.	Not known	H <sub>2</sub> O	.015	.011	.014	.021	.020	.022	.022	.022	.025	.025
P-CP-3	10 in.		NaOH	.016	.018	.018	.029	.031	.033	.042	.047	.065	.082	
PDE-1AA	6 in.	"Monument" at east end of wall along roadway on dam.	12-18	H <sub>2</sub> O	.025	.025	.038	.030	.032	.028	.025	.027	.030	.028
PDE-1BA	9 in.		NaOH	.031	.034	.036	.037	.038	.037	.039	.038	.040	.040	
PDM-1AA	9 in.	Sidewalk near roadway, east side of west spillway.	0-9	NaOH	.026	.027	.028	.028	.029	.083	.029	.026	.029	.029
PDM-1BA	9 in.		0-9	NaOH	.036	.039	.040	.043	Broken		--	--	--	--
PDM-1BB	9 in.		12-21	NaOH	.024	.030	.029	.029	.031	.024	.024	.027	.030	.031
PDW-1AA	9 in.	Sidewalk near roadway, 60 ft west of west column of superstructure.	12-21	H <sub>2</sub> O	.008	.002	.003	.005	.006	.007	.005	.006	.005	.005

PDW-1BA	6 in.		11-17	NaOH	.027	.022	.022	.025	.030	.025	.023	.025	.028	.028

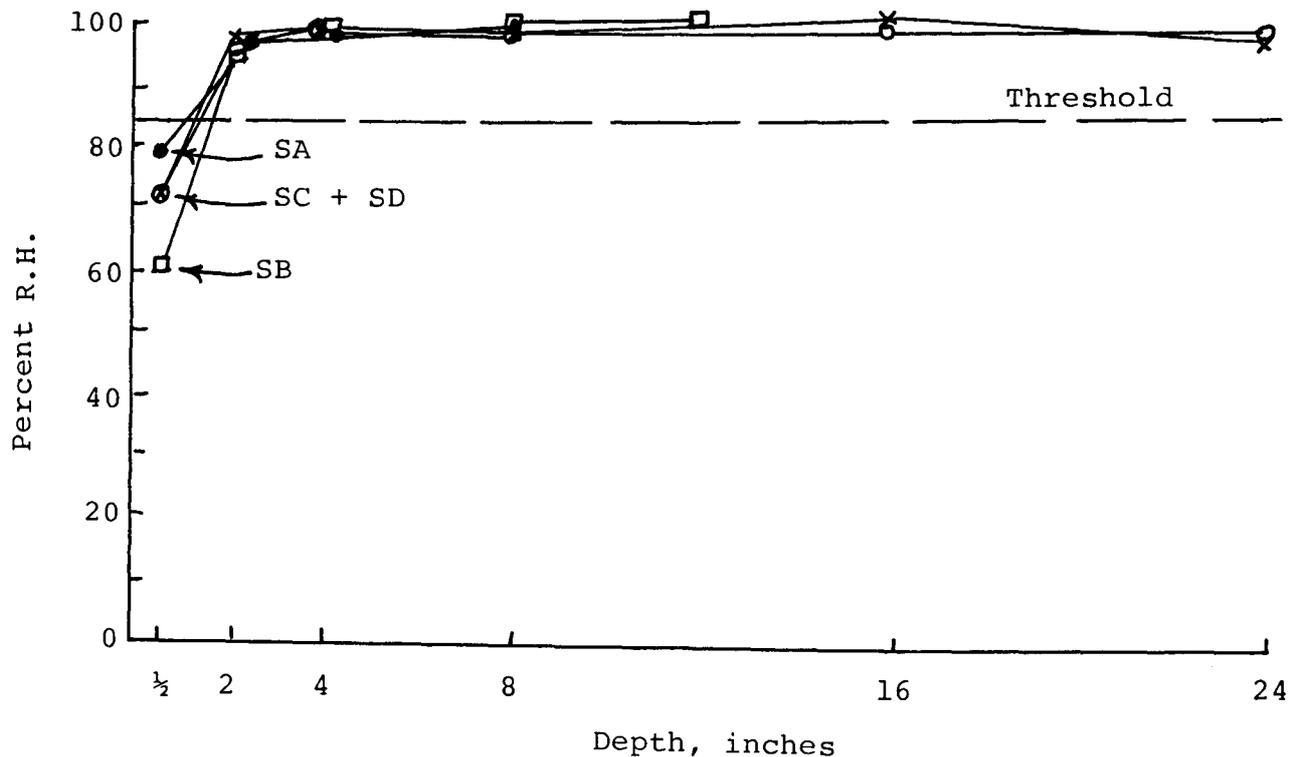
FIG. E1 - RELATIVE HUMIDITY DATA FOR STEWART MOUNTAIN DAM

SAMPLE	LOCATION	DEPTH IN.	R.H.* %
SA	Sampled vertically into concrete curb along roadway, top of dam, 2-1/2 ft east of post No. 5 from west end. Partial bitumen coating on curb.	1/2 to 1	80
		2 to 2-1/2	97
		4 to 4-1/2	98
		8 to 8-1/2	98
SB	Sampled vertically into roadway at top of dam, 150 ft east of right thrust block.	1/2 to 1	60
		2 to 2-1/2	96
		4 to 4-1/2	99
		8 to 8-1/2	100
		12 to 12-1/2	100
SC	Sampled vertically into roadway on top of dam, 400 ft from right thrust block.	1/2 to 1	73
		2 to 2-1/2	98
		4 to 4-1/2	99
		8 to 8-1/2	98
		16 to 16-1/2	100
		24 to 24-1/2	99
SD	Sampled vertically into top of right thrust block, on roadway.	1/2 to 1	72
		2 to 2-1/2	98
		4 to 4-1/2	98
		8 to 8-1/2	99
		16 to 16-1/2	98
		24 to 24-1/2	100

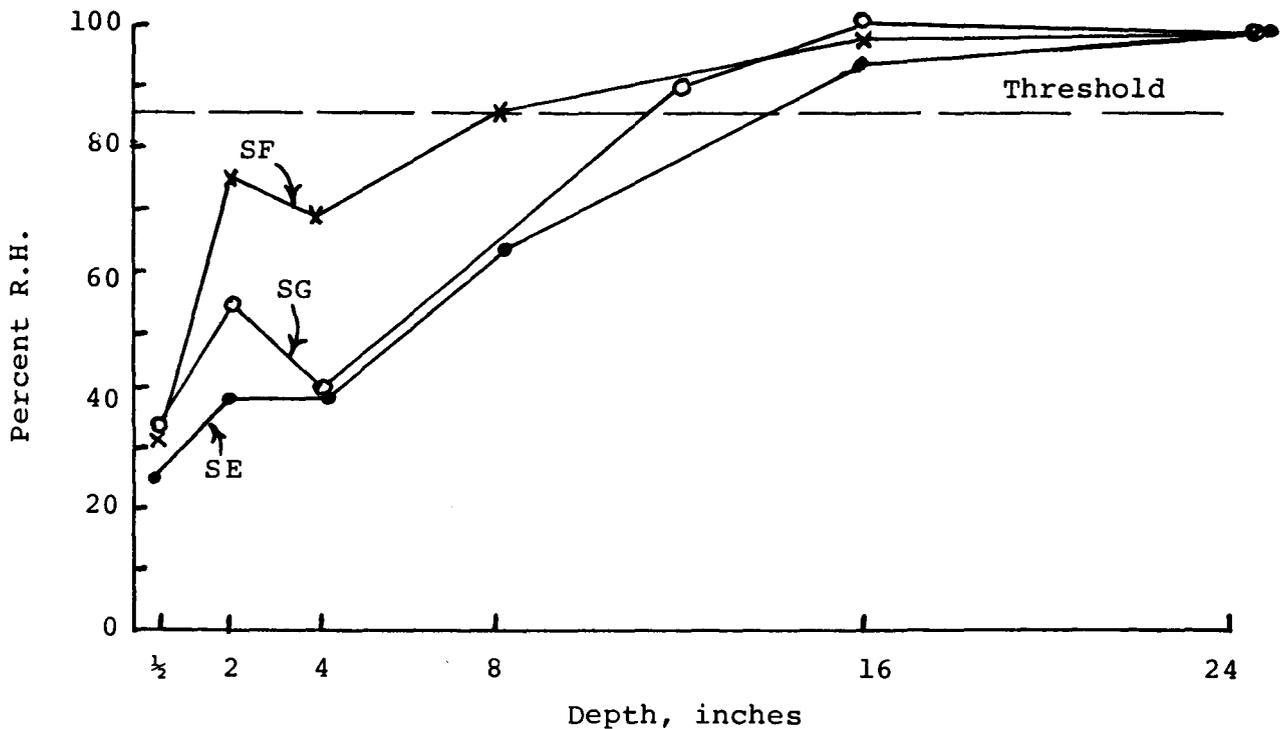
FIG. E2 - RELATIVE HUMIDITY DATA FOR STEWART MOUNTAIN DAM

SAMPLE	LOCATION	DEPTH IN.	R.H.* %
SE	Sampled horizontally into downstream face of dam, on powerhouse roof, 3-1/2 ft above roof.	1/2 to 1	25
		2 to 2-1/2	39
		4 to 4-1/2	39
		8 to 8-1/2	64
		16 to 16-1/2	94
		24 to 24-1/2	98
SF	Sampled horizontally into downstream face of dam, over 54-in. penstock at landing on east side of powerhouse.	1/2 to 1	30
		2 to 2-1/2	75
		4 to 4-1/2	68
		8 to 8-1/2	86
		16 to 16-1/2	97
		24 to 24-1/2	98
SG	Sampled horizontally into right thrust block, 17-1/2 ft from nose of block, 3-1/2 ft above roadway at ground level.	1/2 to 1	36
		2 to 2-1/2	54
		4 to 4-1/2	39
		12 to 12-1/2	90
		16 to 16-1/2	100
		24 to 24-1/2	98

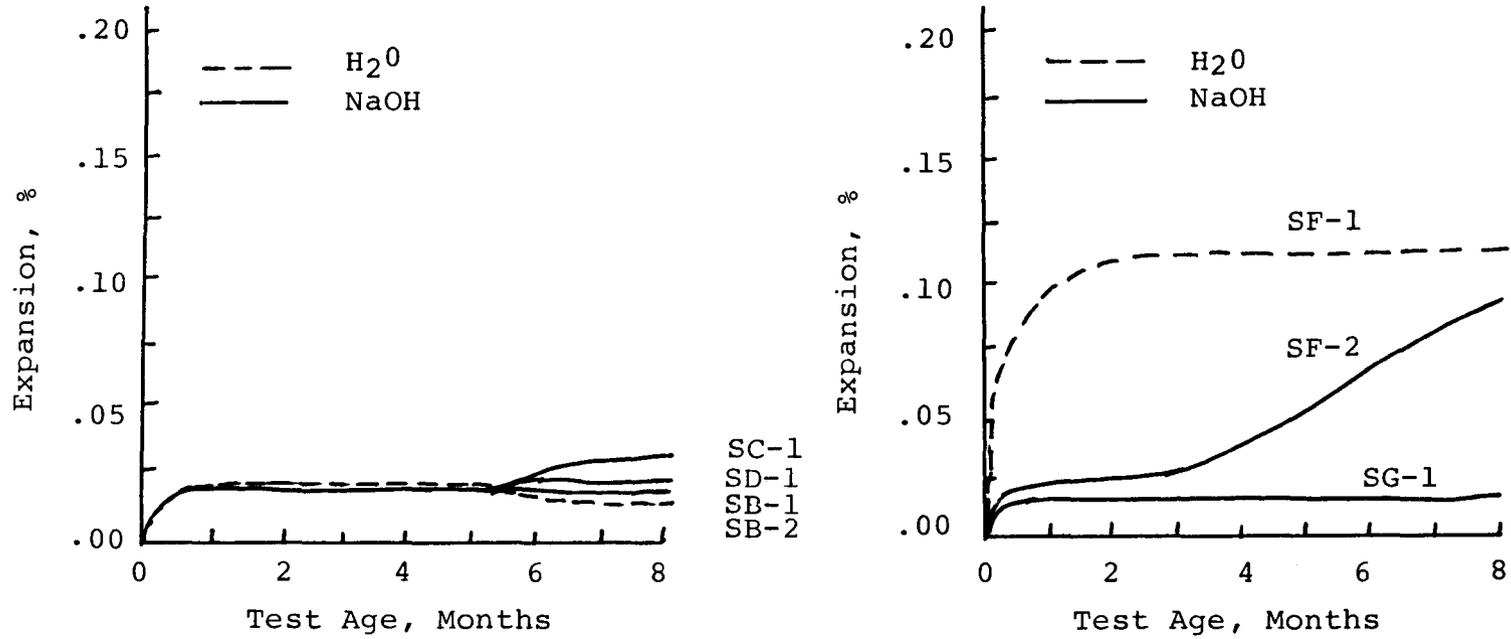
FIG. E5 - LENGTH CHANGES OF STEWART MOUNTAIN DAM CORES IMMERSSED IN WATER OR IN NaOH SOLUTION AT 100°F

Core No.	Core Length	Location	Depth in.	Test Sol'n	Percent Length Change									
					7D	14D	1 Mo.	2 Mo	3 Mo.	4 Mo.	5 Mo.	6 Mo.	7 Mo.	8 Mo.
SB-1	9 in.	Roadway, top of dam, 150 ft from right thrust block.	12-21	NaOH	.017	.013	.018	.017	.019	.018	.019	.013	.016	.016
SB-2	6 in.		5-11	H <sub>2</sub> O	.018	.017	.018	.018	.020	.018	.013	.013	.013	.013
SC-1	9 in.	Roadway on top of dam, 400 ft from right thrust block.	13-22	NaOH	.017	.018	.018	.017	.019	.019	.020	.028	.032	.036
SD-1	6 in.	Roadway on right thrust block.	0-6	NaOH	.012	.010	.013	.015	.018	.023	.017	.027	.023	.024
SF-1	6 in.	Face of dam, on landing above 54-in. penstock.	3-9	H <sub>2</sub> O	.065	.077	.100	.118	.125	.127	.125	.125	.127	.127
SF-2	9 in.		13-22	NaOH	.001	.017	.018	.023	.020	.034	.046	.067	.083	.092
SG-1	9 in.	Right thrust block 3-1/2 ft above roadway at ground level.	6-15	H <sub>2</sub> O	.027	.027	.028	.030	.028	.029	.030	.027	.028	.028

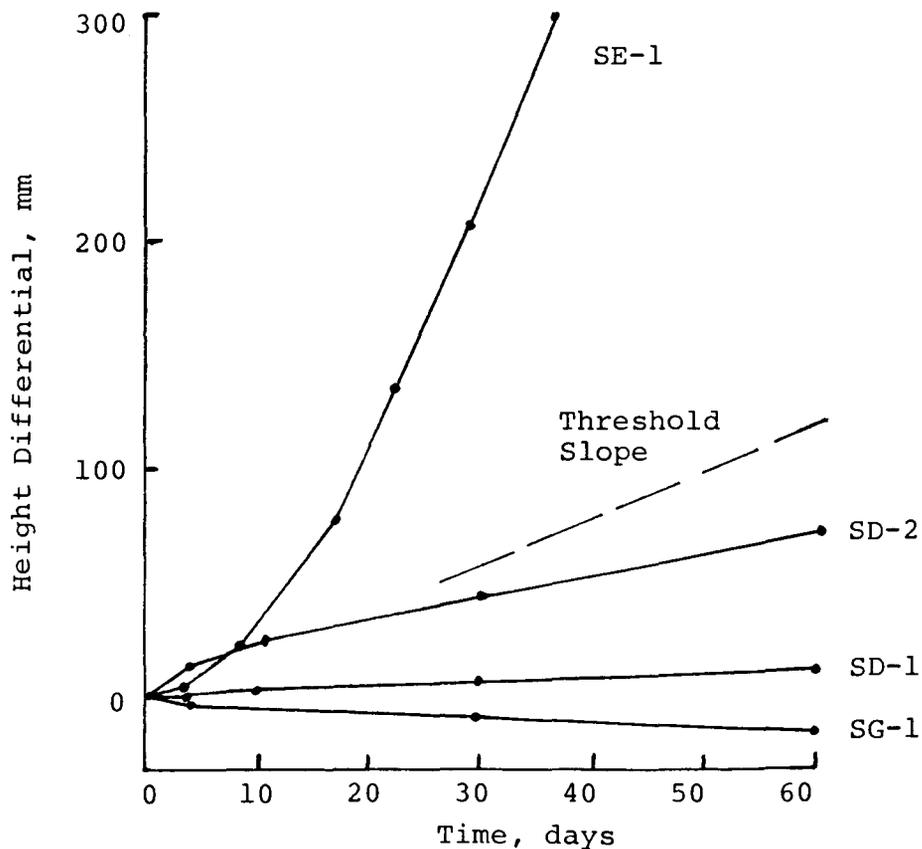
FIG. E6 - RESULTS OF OSMOTIC CELL TESTS FOR AGGREGATE FROM STEWART MOUNTAIN DAM

NO.	LOCATION	DESCRIPTION	FLOW RATE, mm/DAY
SD-1	At 8-1/2 in. depth from exterior end of core DH-SD, taken on roadway on right thrust block.	Quartzite, 3 in. particle size. No evidence of reactivity.	0.3
SD-2	At 12-16 in. depth from exterior end of core DH-SD, taken on roadway on right thrust block.	Dense, reddish, brown granite, 3 in. particle size. No evidence of reactivity.	0.9
SE-1	At 26-30 in. depth from exterior end of core DH-SE, taken into face of dam, on powerhouse roof, 3-1/2 ft above roof.	Reddish-purple andesite, 4 in. particle. Reaction rims, some microcracking, minor gel reaction product.	10.2
SE-1	At 15-18 in. depth from exterior end of core, taken into right thrust block, 17-1/2 ft from nose of block, 3-1/2 ft above roadway at ground level.	Black rhyolite, 2-1/2" particle, contains reaction rim, but no interval microcracks or gel reaction product.	<0.0
