**REC-OCE-70-51**

# **EVALUATION OF MATERIALS FOR CAVITATION RESISTANCE**

**A Progress Report**

**F. E. Causey  
Engineering and Research Center  
Bureau of Reclamation**

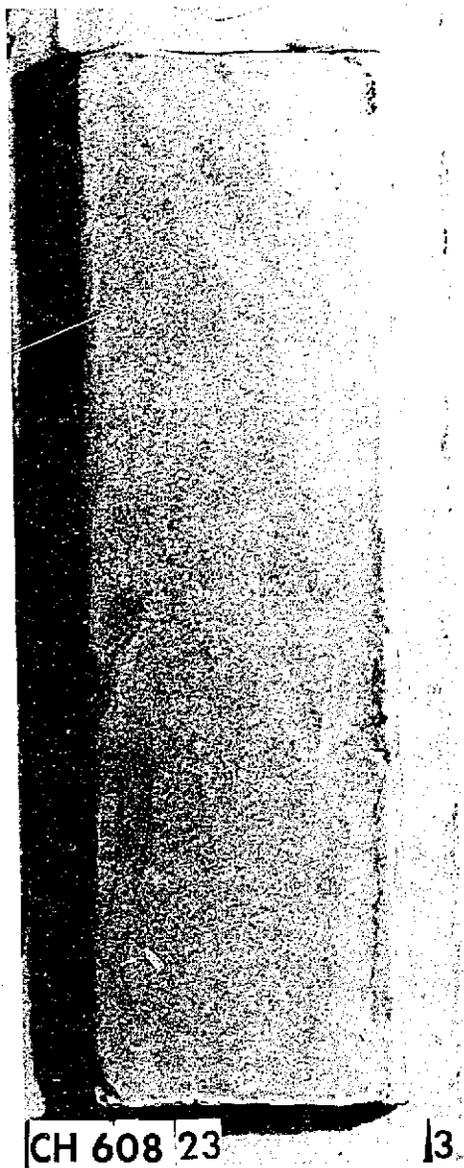
Figure 13. Specimen No. 3—Epoxy polyamide.

B. After 14 hours, the epoxy failed as shown above. It is believed that a poorly finished surface caused early failure. Photo PX-D-67955

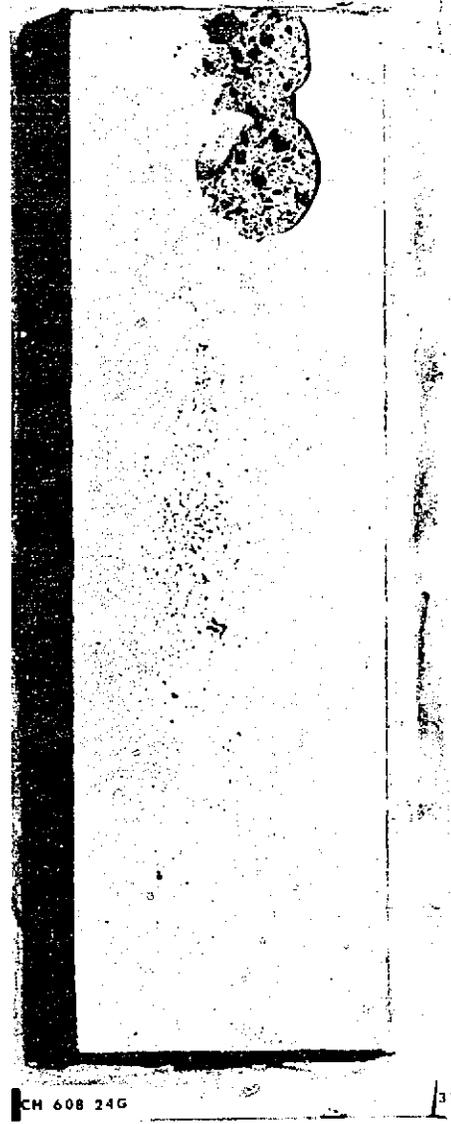
Figure 14. Specimen No. 3T—Epoxy polyamide.

B. After 49 hours, cavitation had chipped away  
a large area at the top and scoured the middle  
of the sanded fillet epoxy to failure. Photo  
PX-D-25534

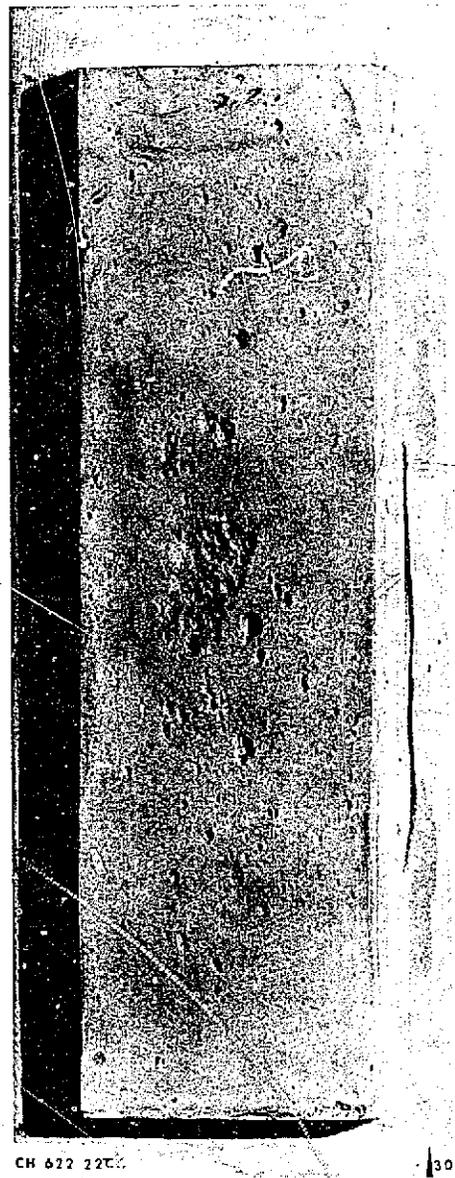
Figure 18. Specimen No. 30—Epoxy polyamide.

B. After 21 hours, the holes increased in size to  
cause partial failure of the coating. Photo  
PX-D-67965

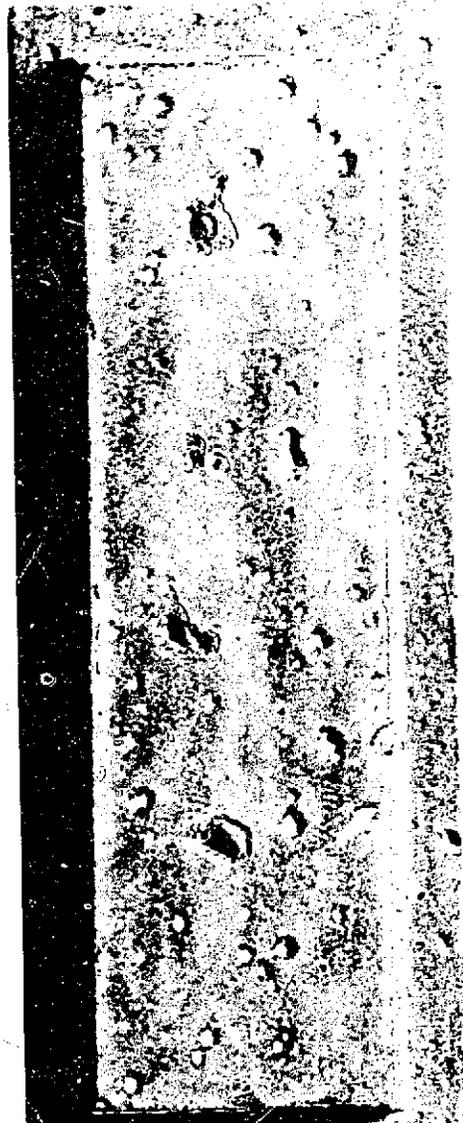
Figure 21. Specimen No. 7—Epoxy polysulfide.

B. Epoxy failed after 7 hours of testing. Photo PX-D-67971

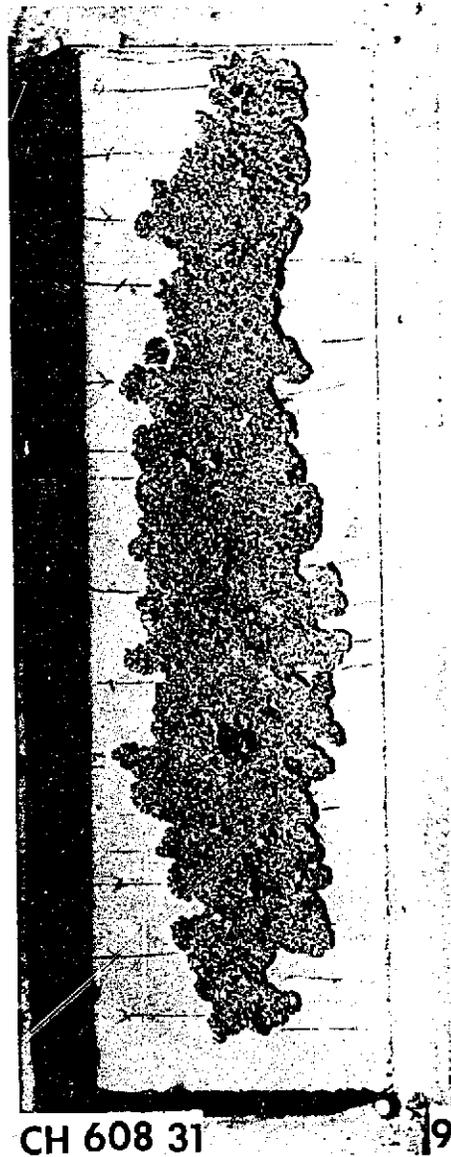
Figure 23. Specimen No. 9—Epoxy polysulfide.

B. The epoxy crack sealer failed after 7 hours testing. Photo PX-D-67975

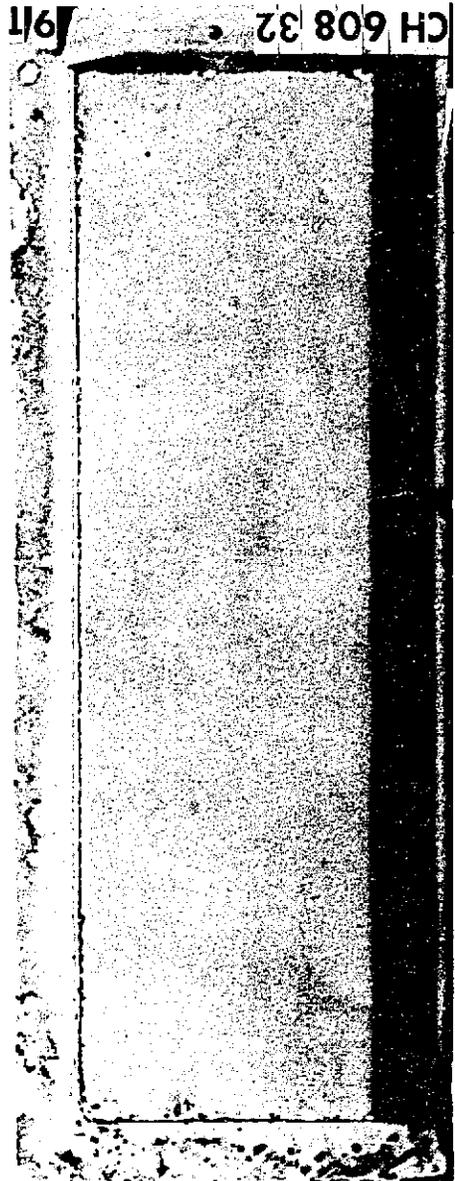
B. The epoxy was 75 percent damaged after 7 hours testing. Photo PX-D-67977

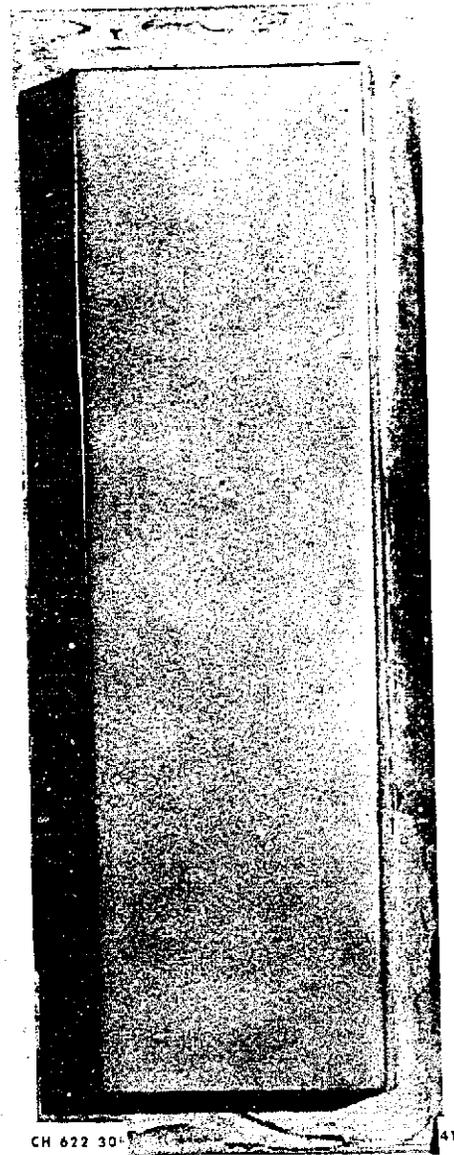
Figure 25. Specimen No. 41—Epoxy polysulfide.

B. After 14 hours test, there appeared to be little change from 7 hours test. Some pinpoint holes occurred. Photo PX-D-67979

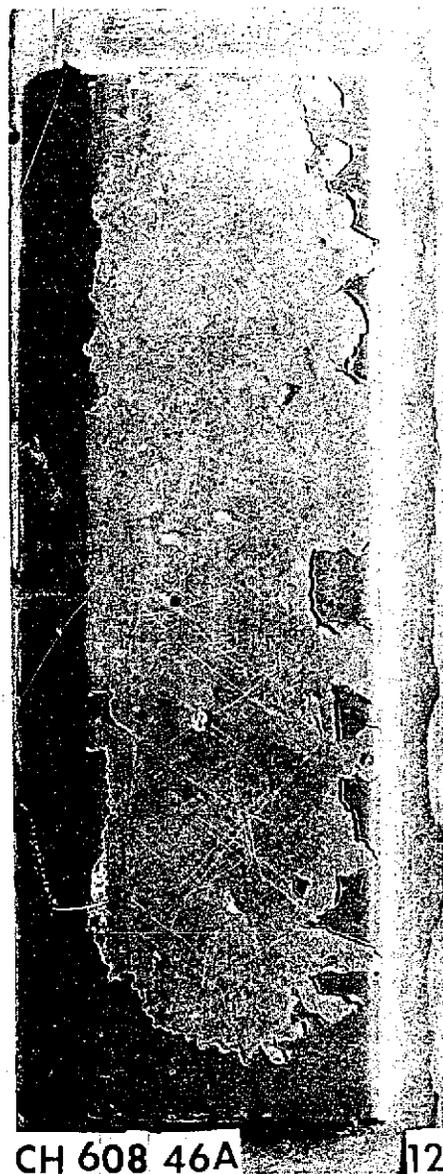
Figure 29. Specimen No. 12—Epoxy.

B. After 7 hours testing 95 percent of the  
finish coat was peeled off. Photo PX-D-67987

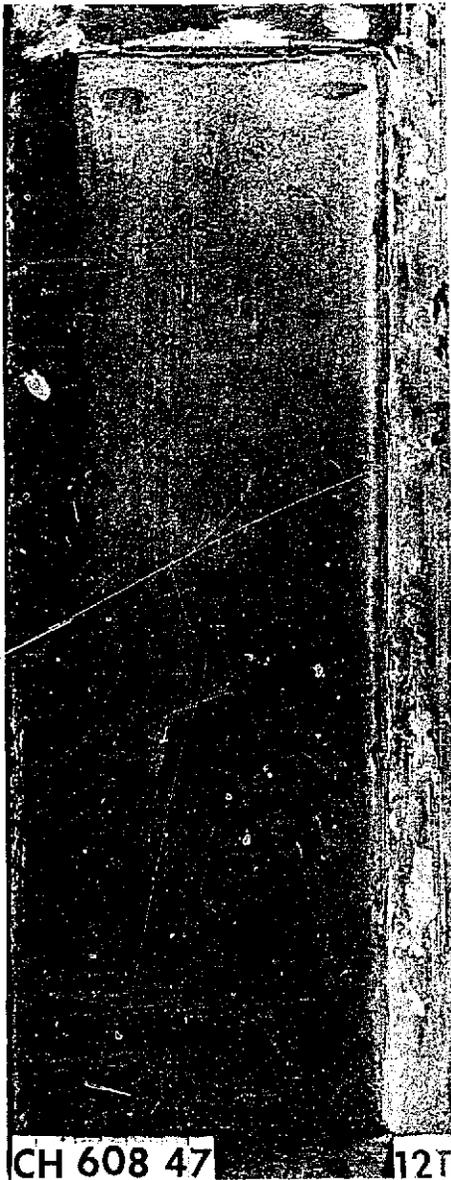
A. Epoxy resin before test. Photo PX-D-67988

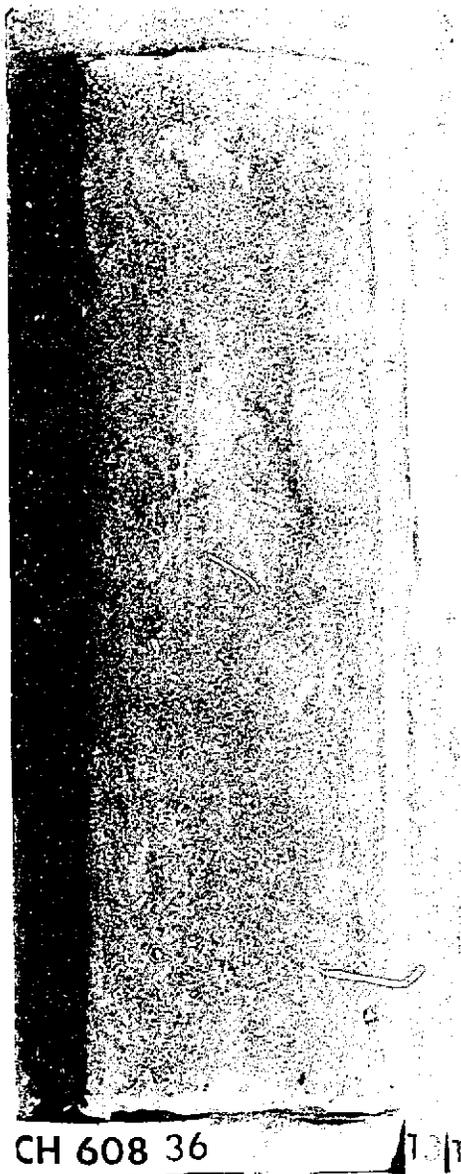
Figure 30. Specimen No. 12T—Epoxy.

A. Epoxy before test. Photo PX-D-67990

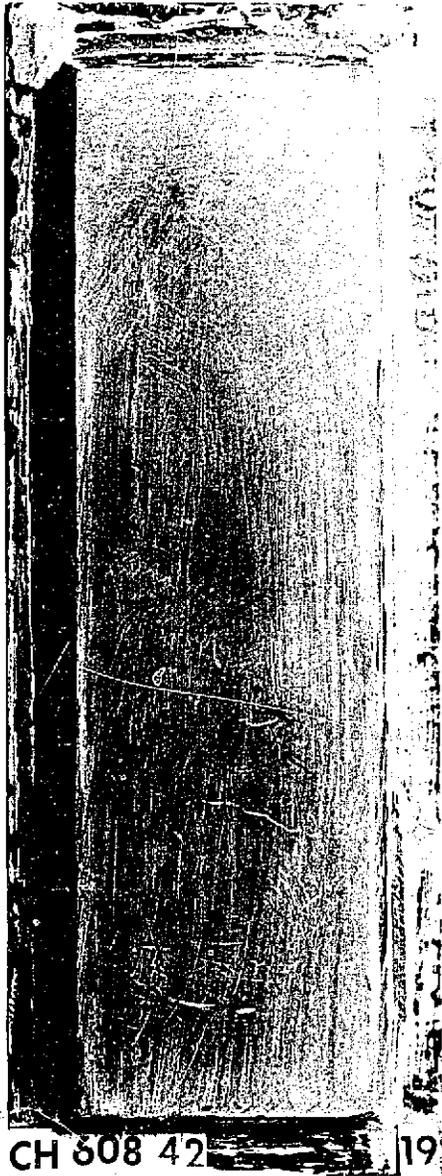
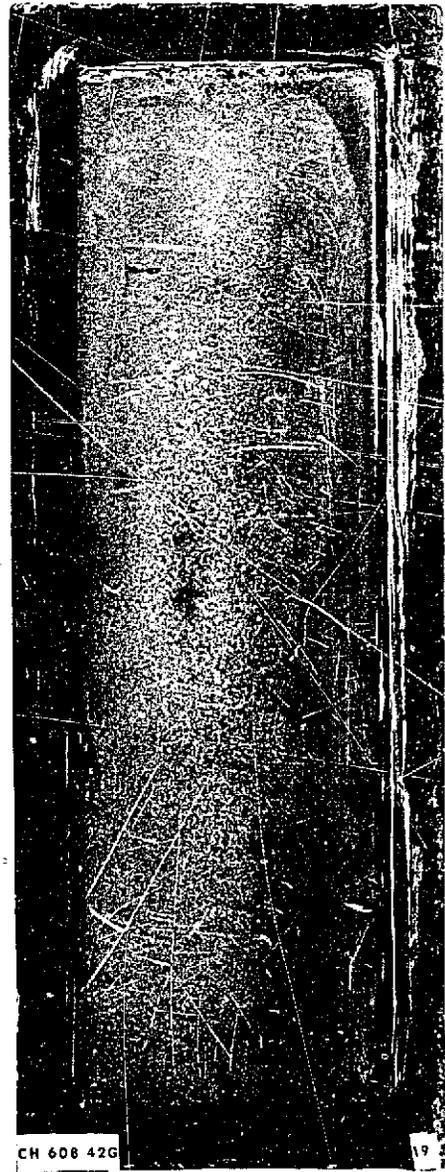
Figure 31. Specimen No. 13T—Epoxy.

A. A trowel-on epoxy that was ground smooth, before testing. Photo PX-D-67992

B. After 50 hours, damage has continued to the base specimen causing partial failure. Photo PX-D-67993

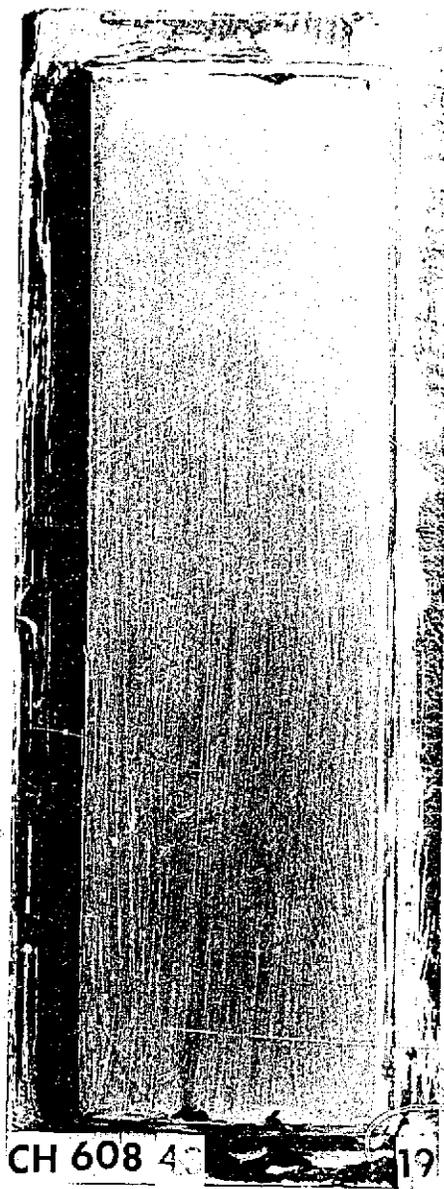
Figure 32. Specimen No. 19—Epoxy.

A. A trowel on epoxy that was ground smooth, before testing. Photo PX-D-67994

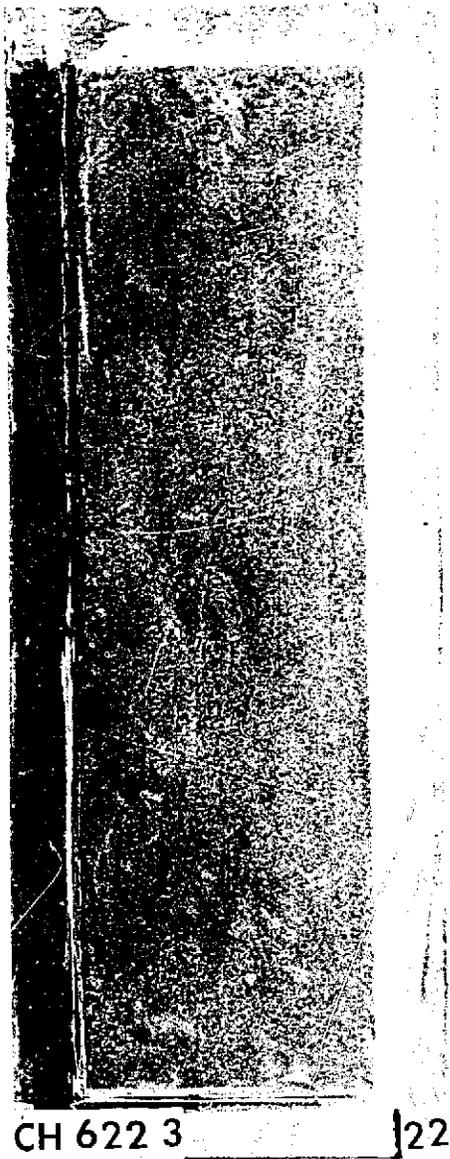
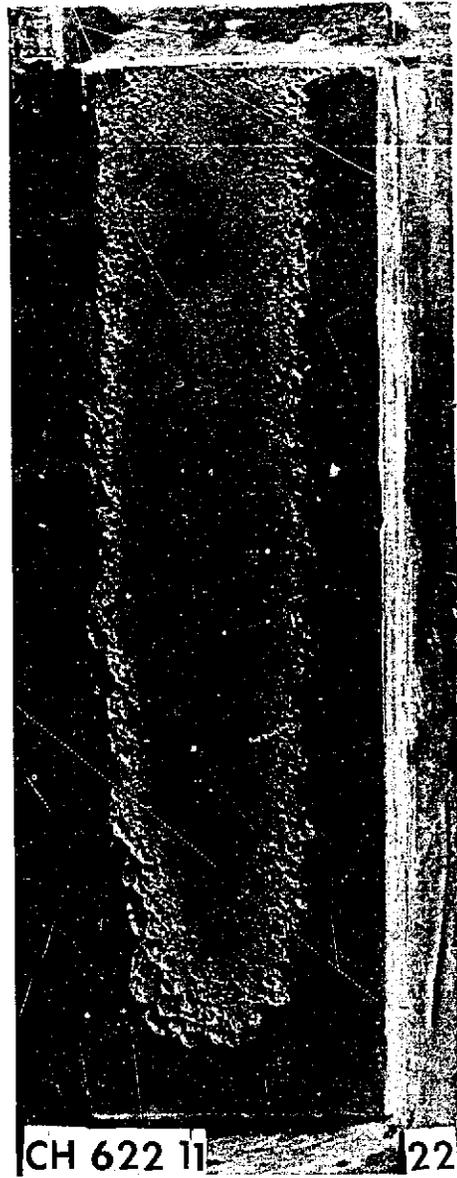
Figure 33. Specimen No. 19T-Epoxy.

A. Epoxy before test. Photo PX-D-67996

B. 60 percent of the coating is eroded from the base steel specimen after 24 hours testing. Photo PX-D-67997

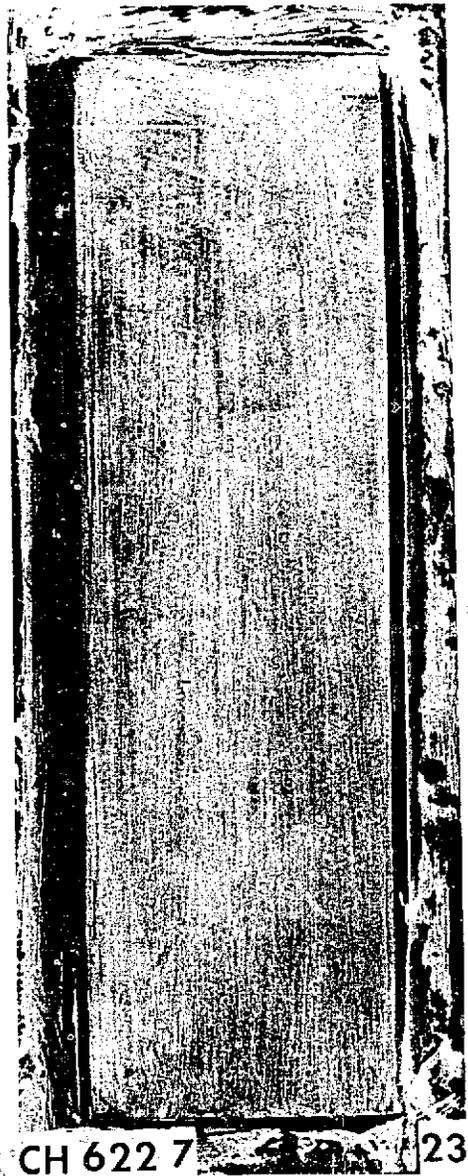
Figure 34. Specimen No. 22—Epoxy.

A. Epoxy coating before test. Photo PX-D-67998

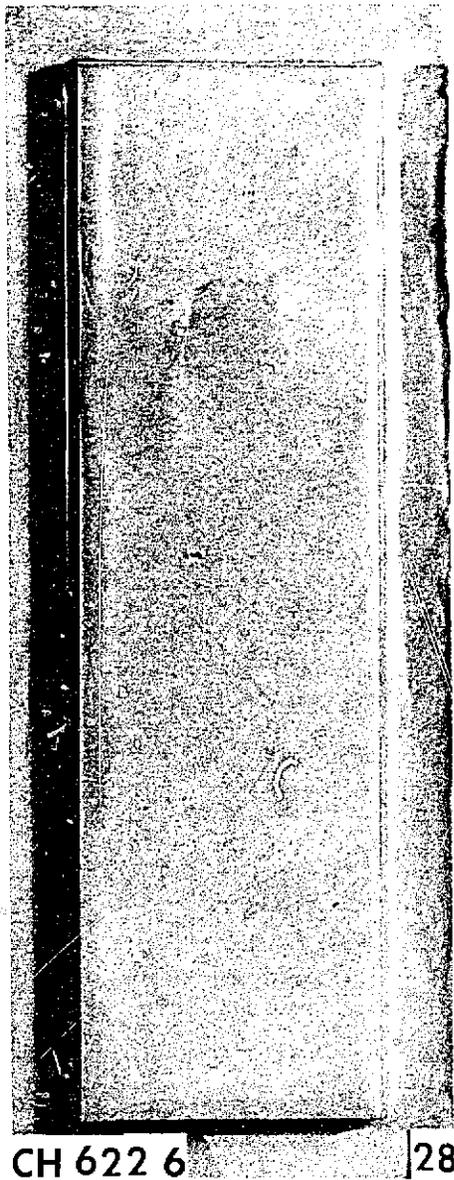
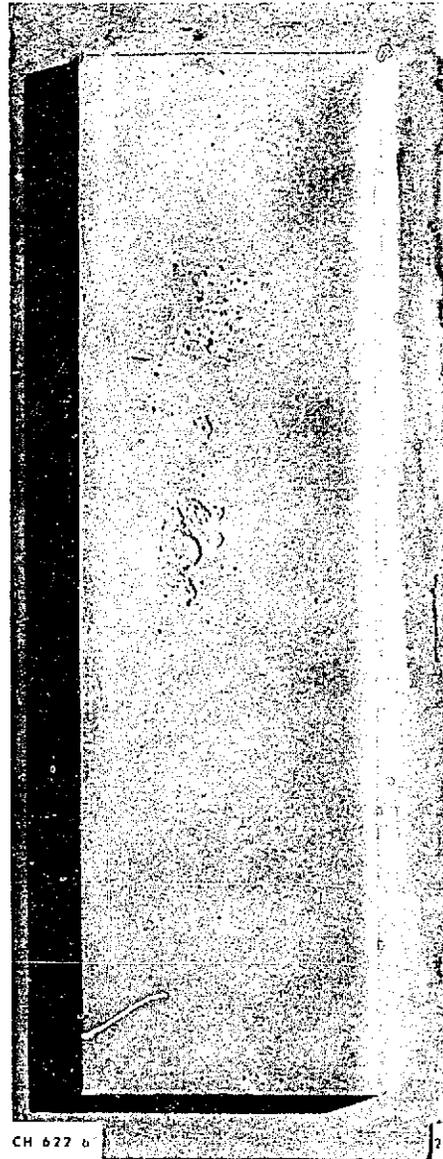
Figure 35. Specimen No. 23—Epoxy.

A. Epoxy before testing. Photo PX-D-68000

B. After 53 hours, pinpoint holes occurred on the coating surface particularly in a spilled area, and increased in size until they caused failure. Photo PX-D-68001

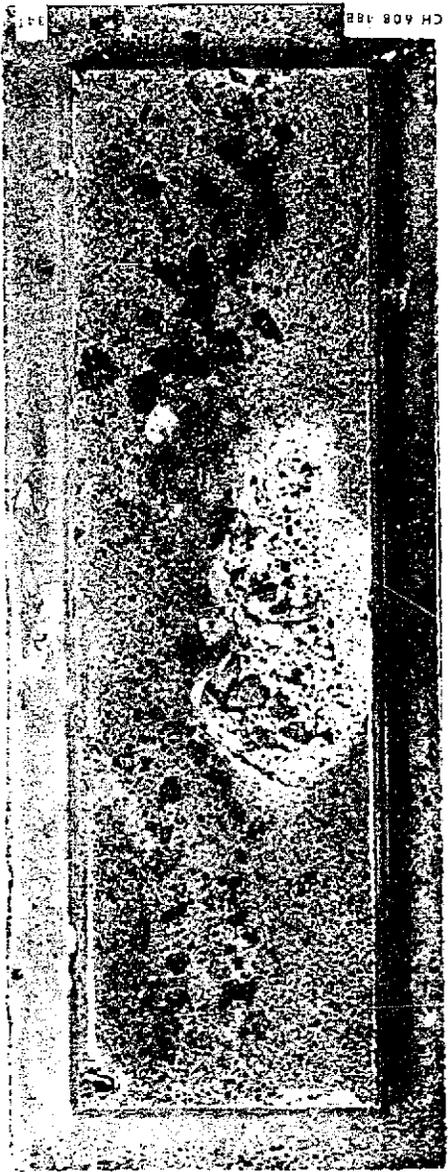
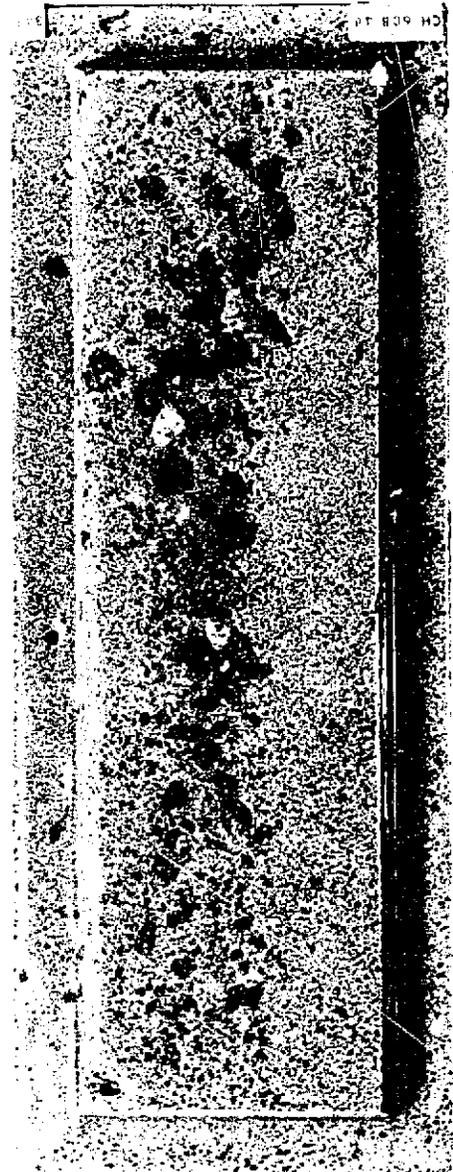
Figure 36. Specimen No. 28—Epoxy.

B. After 7 hours, the epoxy resin failed from severe damage. Photo PX-D-68003

A. Epoxy resins before test. Photo PX-D-68002

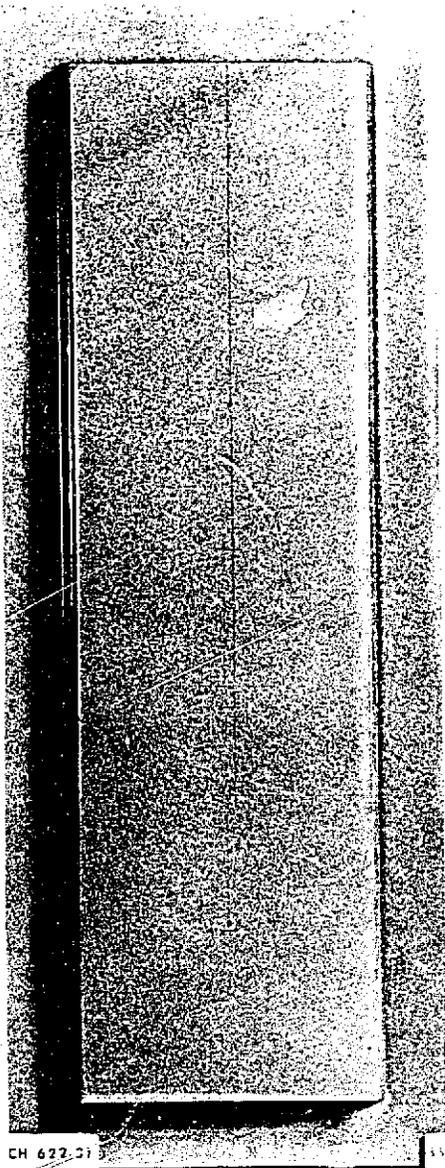
Figure 37. Specimen No. 34T-Epoxy.

A. Epoxy resin before test. Photo PX-D-68004

B. After 15 hours, holes had become evident. Photo PX-D-68005

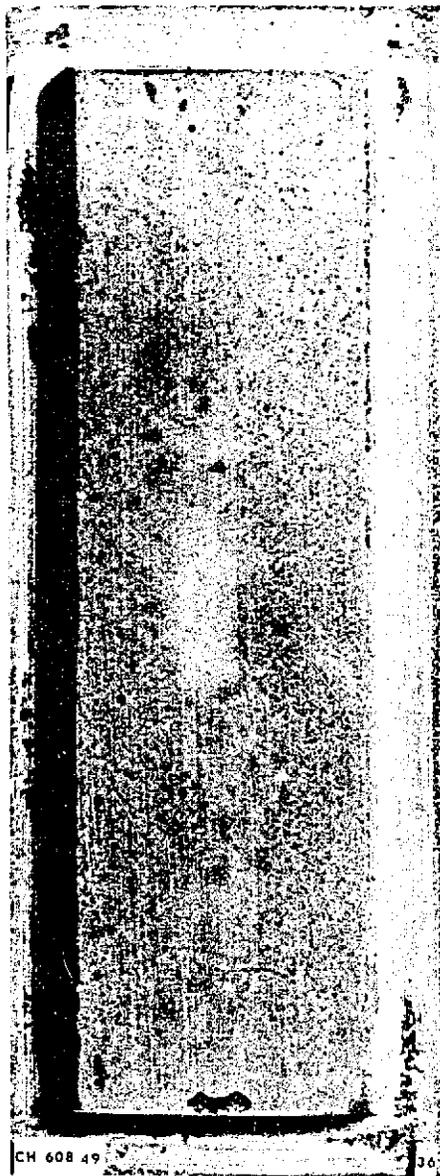
Figure 39. Specimen No. 36T—Epoxy resin  
before test. Photo PX-D-68006

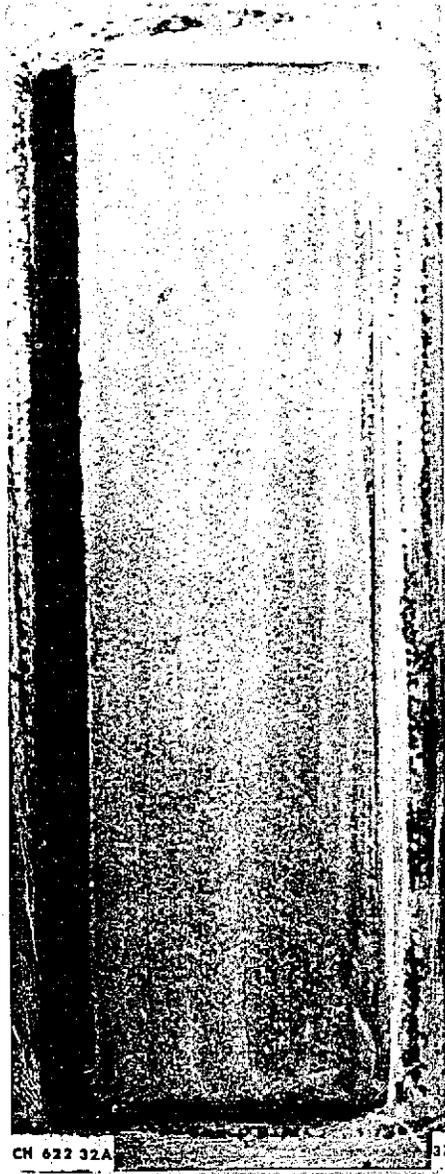
Figure 40. Specimen No. 37—Epoxy before exposure. Photo PX-D-68007

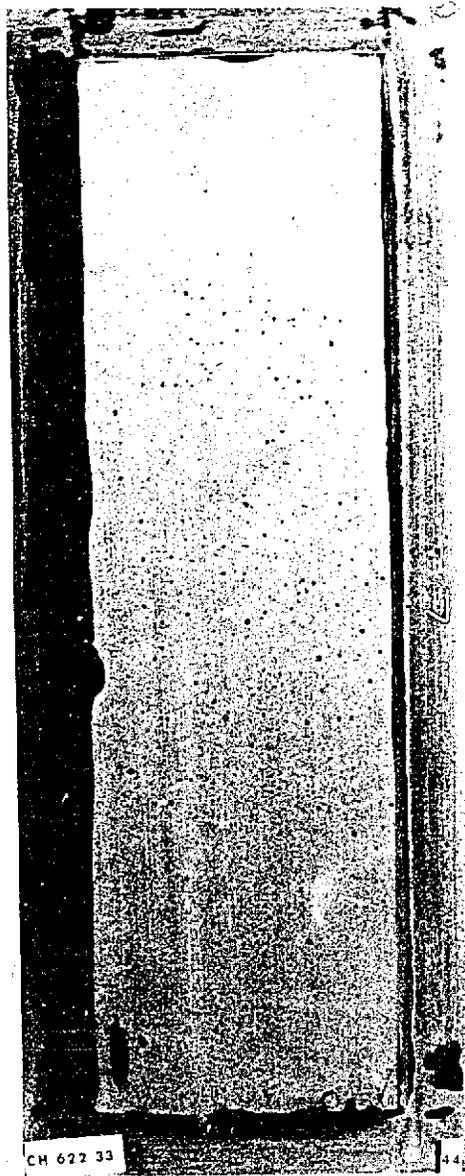
Figure 41. Specimen No. 44—Epoxy before test. Photo PX-D-68008

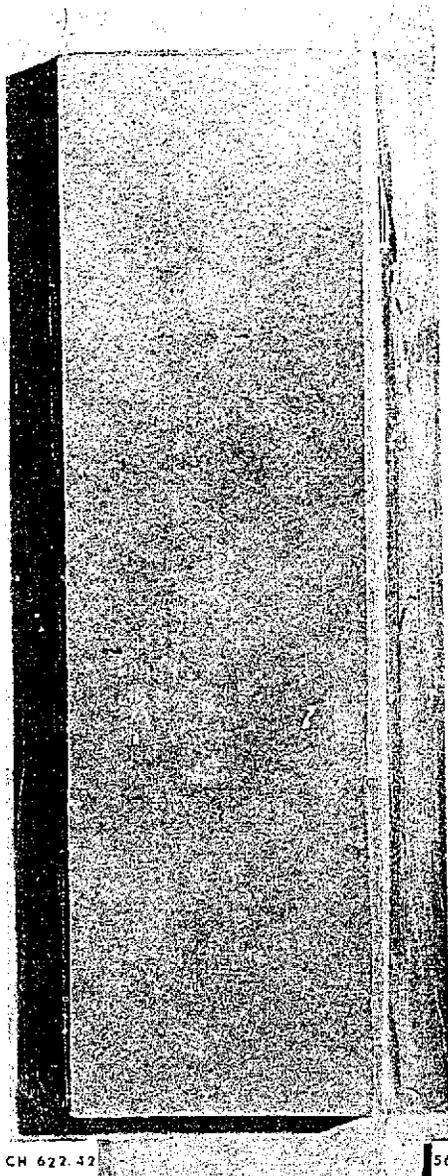
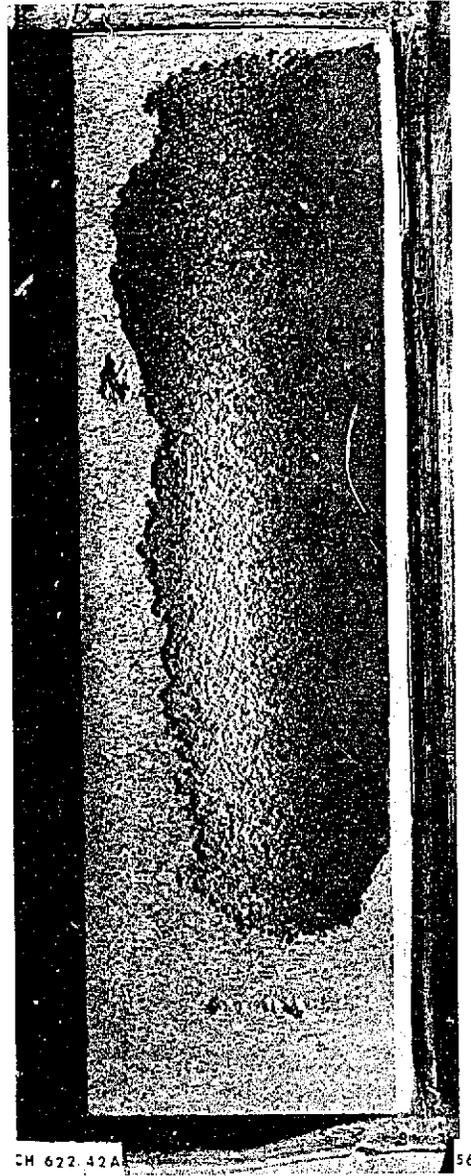
Figure 42. Specimen No. 56—Flexible epoxy patching compound.

A. Flexible epoxy before test. Photo PX-D-68009

B. After 8 hours, 33 percent of the flexible epoxy had peeled off. Photo PX-D-68010

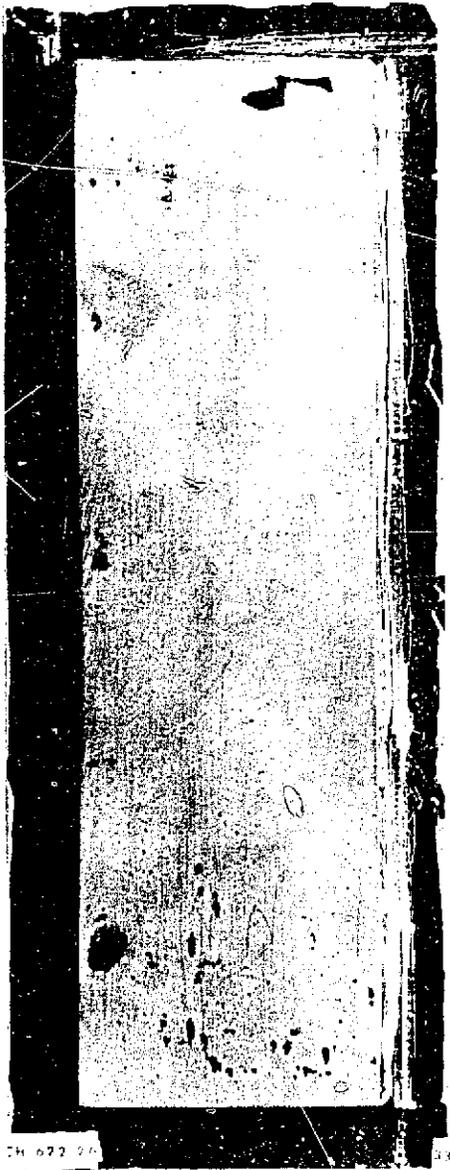
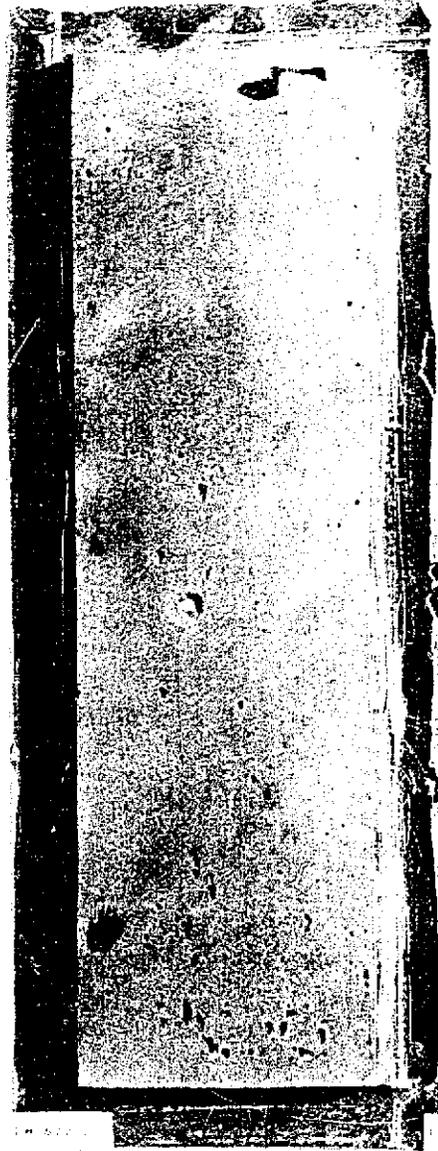
Figure 49. Specimen No. 33—Steel-filled epoxy polyamide.

A. A steel-filled epoxy polyamide before exposure. Photo PX-D-68021

B. The holes continued to increase in size and number causing partial failure after 21 hours. Photo PX-D-68022

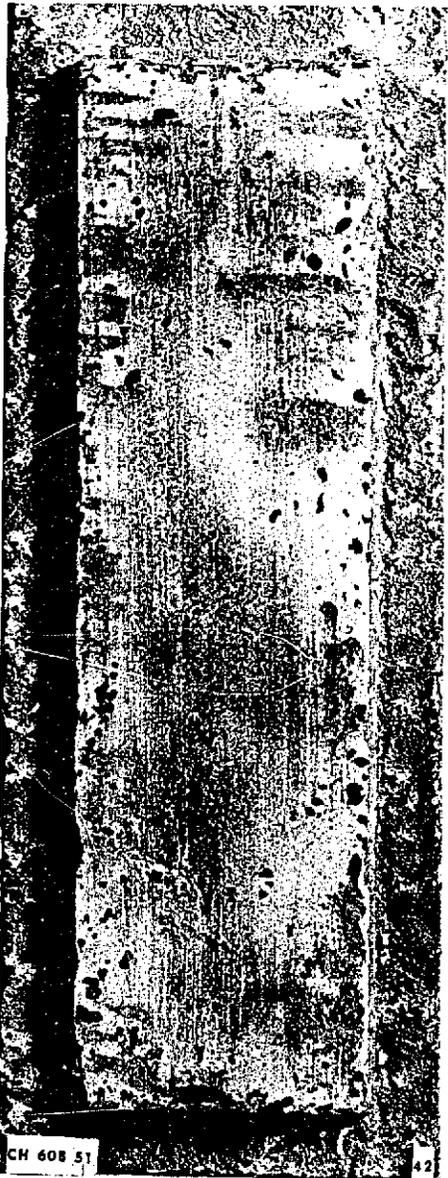
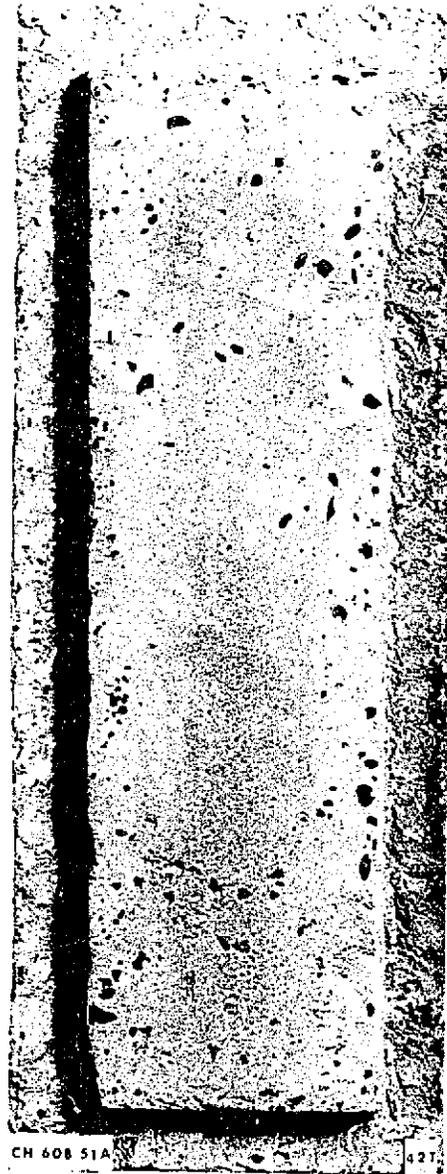
Figure 51. Specimen No. 42T—Sand-filled epoxy polysulfide.

Specimen No. 42T, a sand-filled epoxy polysulfide applied to concrete failed in 7 hours' testing. See Figure 51.

A. Sand-filled epoxy polysulfide before test.  
Photo PX-D-68025

B. Sand-filled epoxy polysulfide after 7 hours  
test. Photo PX-D-68026

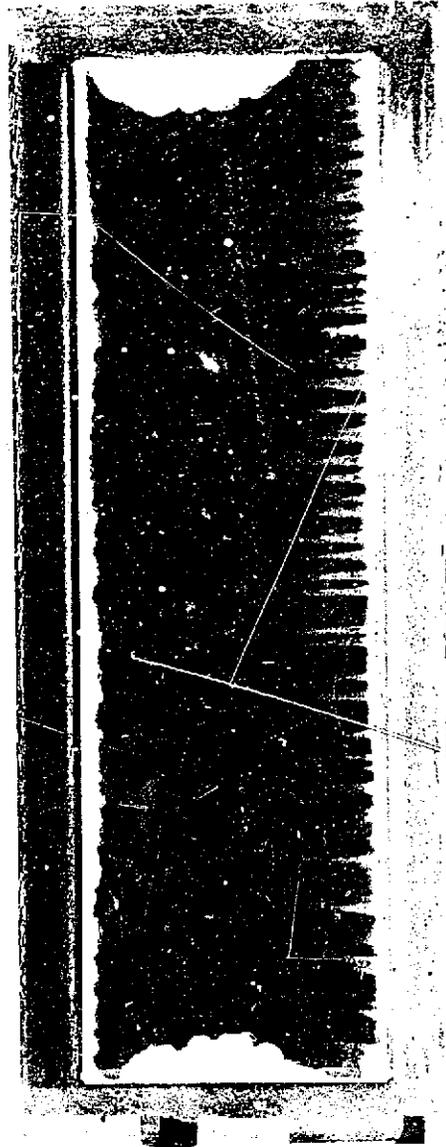
Figure 59. Specimen No. 60—Polyurethane.

B. After 1,738 hours, damage in the upper center of the coating to the base steel specimen occurred and test was stopped. Photo PX-D-68039

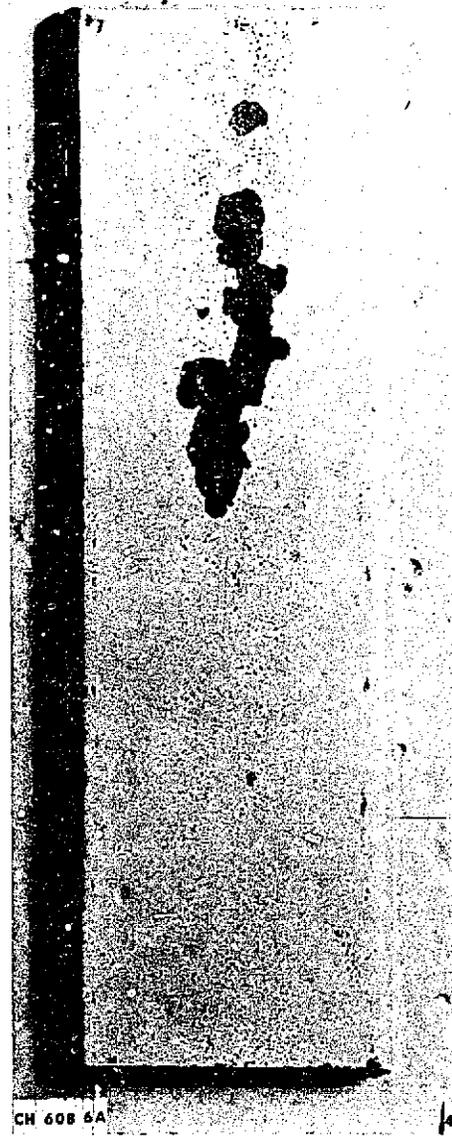
Figure 60. Specimen No. 4—Epoxy modified phenolic.

Two specimens coated with epoxy modified phenolic were tested and proved unsatisfactory. The specimen numbers are 4 and 21. See Figures 60 and 61 for times of failure.

B. After 7 hours, the epoxy modified phenolic failed. Photo PX-D-68041

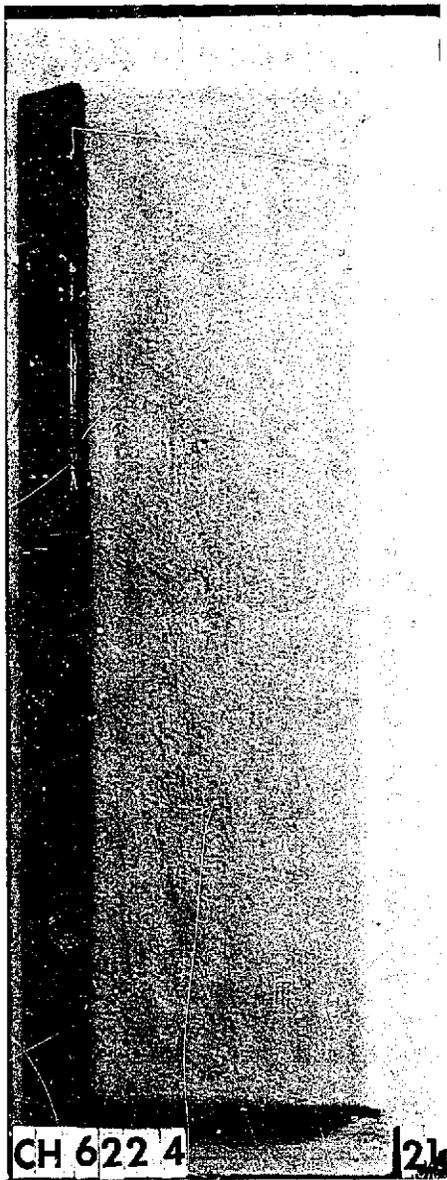
A. Epoxy modified phenolic before exposure.  
Photo PX-D-68042

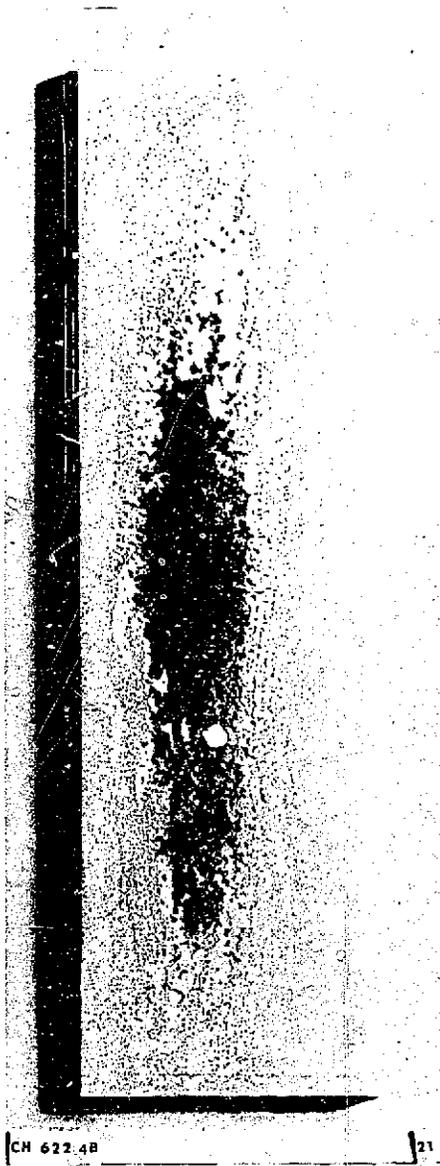
Figure 61. Specimen No. 21—Epoxy modified phenolic.

B. The epoxy modified phenolic had peeled  
from the steel and failed after 14 hours testing.  
Photo PX-D-68043

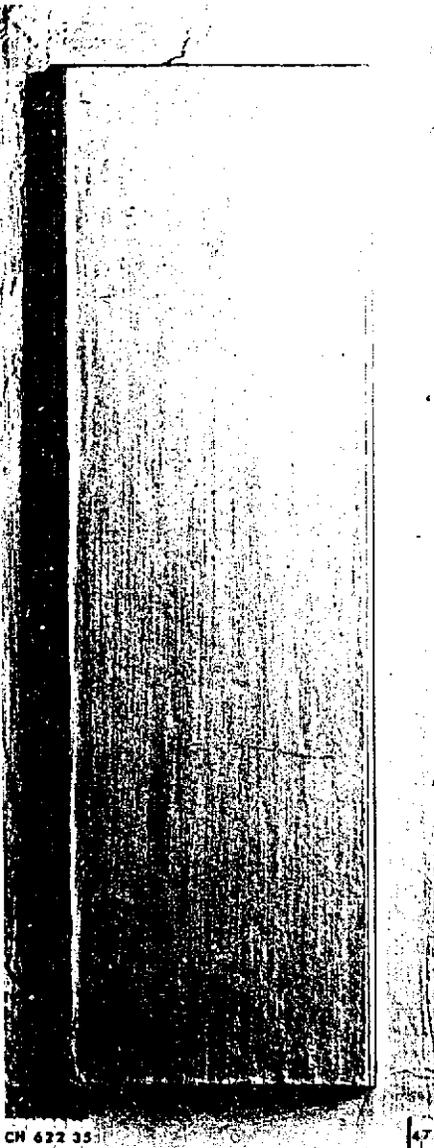
Three vinyl-coated specimens were tested and found unsatisfactory. The specimen numbers are 47, 48, and 66. Specimens No. 47 and 48 are six-coat vinyl resin systems and No. 66 is a fused vinyl. See Figures 63, 64, and 65 for times of failures.

Figure 63. Specimen No. 47—Vinyl (VR-6 with aluminum seal coat) before test. Photo PX-D-68045

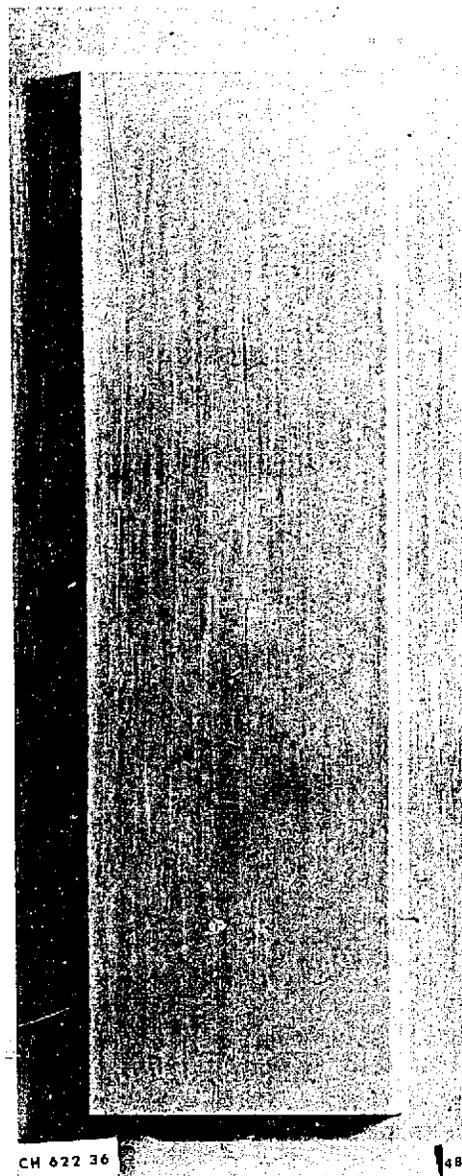
Figure 64. Specimen No. 48—Vinyl coating  
(VR-6 with a gray seal coat) before exposure.  
Photo PX-D-68046

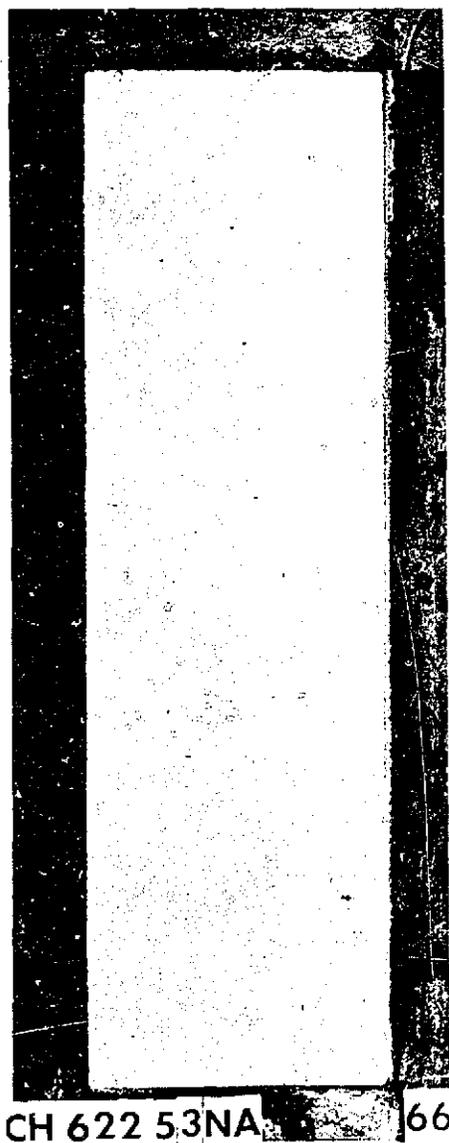
Figure 65. Specimen No. 66—Vinyl.

A. Fused vinyl before exposure. Photo PX-D-68047

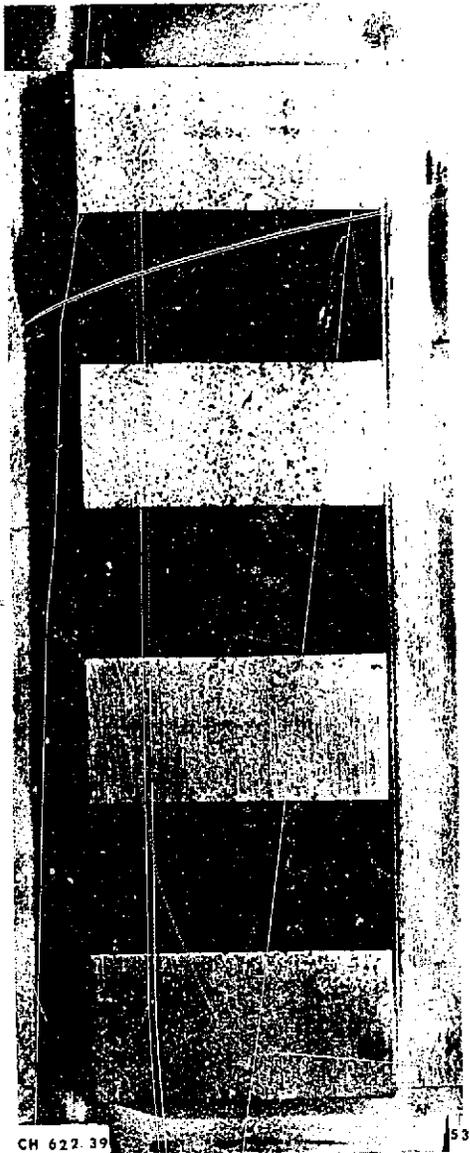
Figure 66. Specimen No. 53—Steel-filled epoxy.

A. Plastic steel in cut areas before test. Photo PX-D-68049

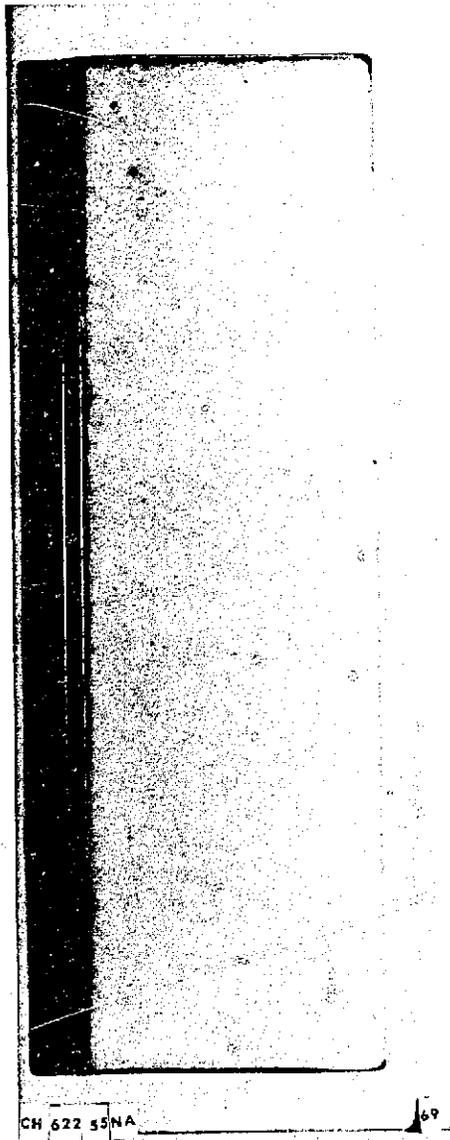
A. Sprayable neoprene-urethane coating on steel before test. Photo PX-D-68055

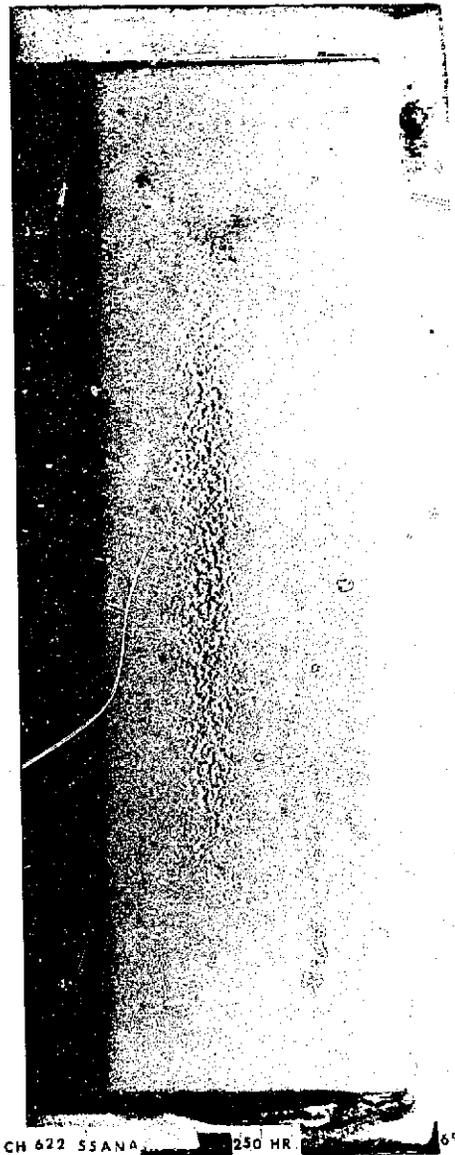
Figure 69. Specimen No. 69—Neoprene-urethane rubber.

Neoprene-urethane rubber, Specimen No. 69, applied on steel performed satisfactorily for 250 hours. See Figure 69.

B. After 250 hours, the coating developed some pinpoint holes in the surface. Photo PX-D-68056

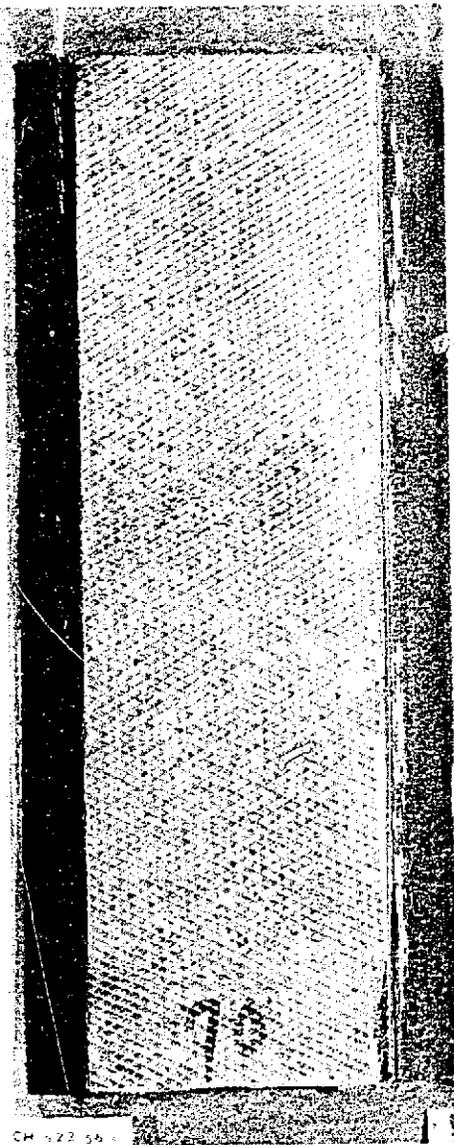
A. Tan gum rubber 1/16 inch thick on steel substrate before test. Photo PX-D-68057
