**REC-OCE-70-51**

# **EVALUATION OF MATERIALS FOR CAVITATION RESISTANCE**

**A Progress Report**

**F. E. Causey  
Engineering and Research Center  
Bureau of Reclamation**

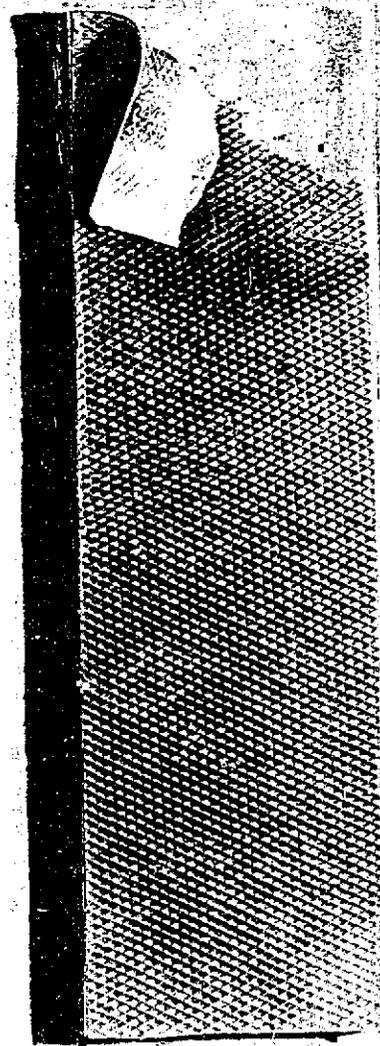
Figure 70. Specimen No. 70—Gum rubber.

Three specimens had gum rubber of three thicknesses bonded to them by an adhesive. These are Specimens No. 70, 1/16 inch (0.16 cm); 71, 1/8 inch (0.32 cm); and 72, 1/4 inch (0.63 cm) thick. The two thinner pieces of rubber had bond failures. Specimen No. 72 had delamination failure in 126 hours on one edge. See Figures 70, 71, and 72 for types of failure.

B. After 7 hours of testing, there was a bond failure between adhesive steel and rubber. Photo PX-D-68058

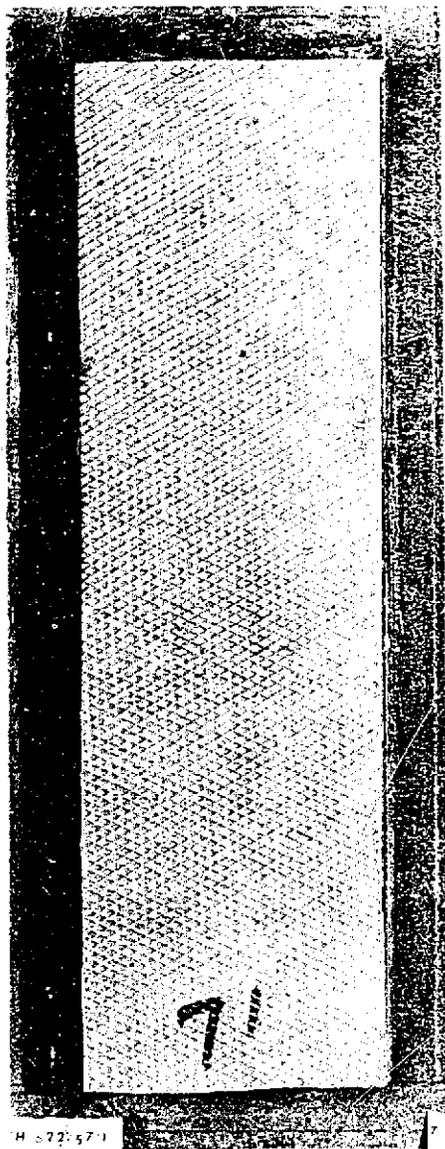
Figure 71. Specimen No. 71—Gum rubber.

A. Tan gum rubber one-eighth inch thick on steel substrate before test. Photo PX-D-68059

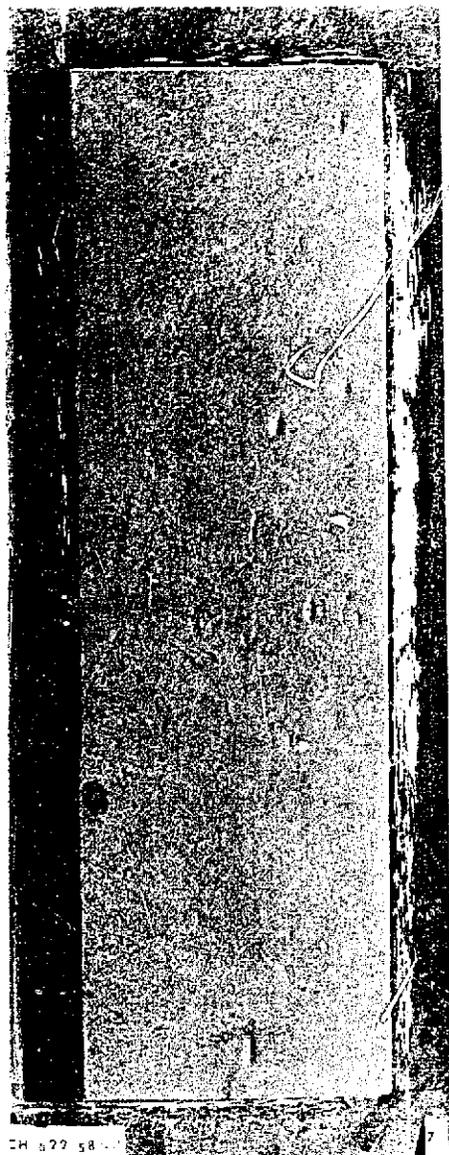
A. Tan gum rubber one-fourth inch thick on steel substrate before test. Photo PX-D-68061

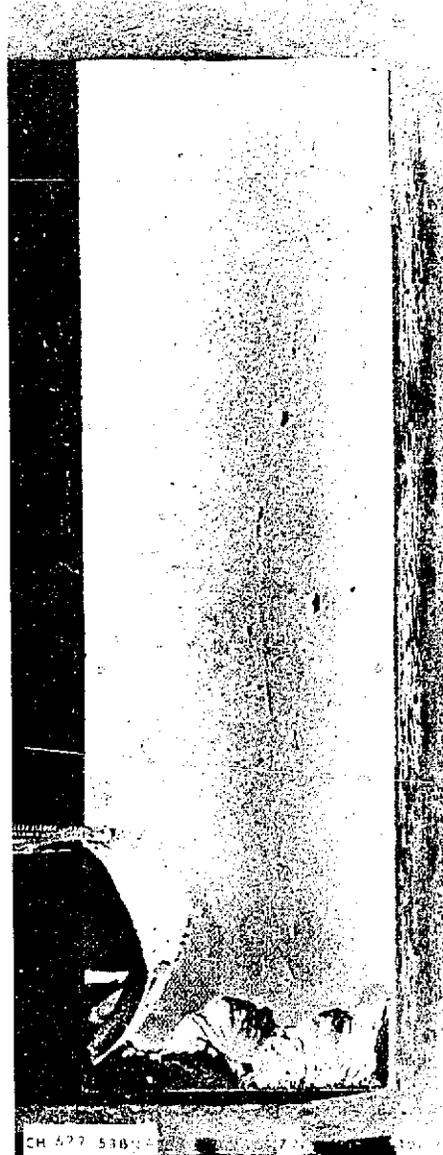
Figure 2. Specimen No. 72—Gum rubber.

B. After 126 hours of testing, bond, delimitation and peel caused the failure of this gum rubber. Flap shown raised and clamped to illustrate disbond and tearing. Photo PX-D-68062

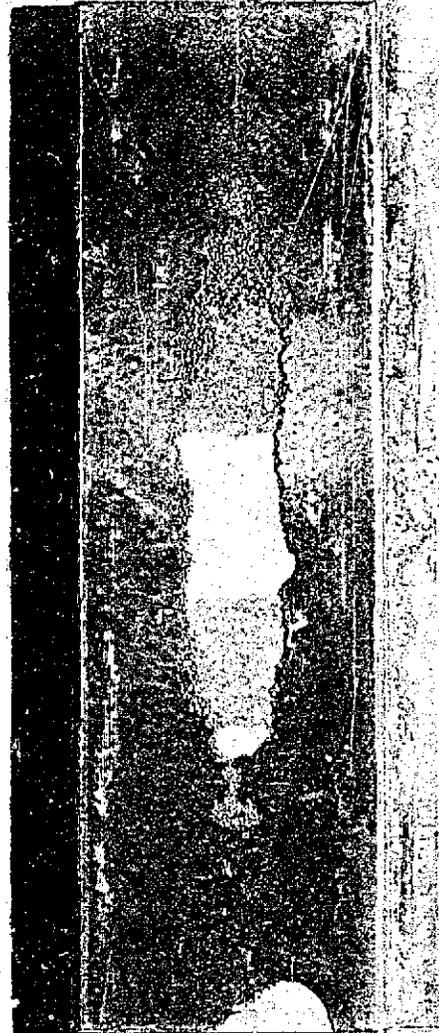
Figure 73. Specimen No. 67—Chlorinated polyether.

Specimen No. 67, a fused chlorinated polyether over a welded stainless steel patch in the steel substrate, failed in 8 hours. Figure 73 shows the failure.

B. After 6 hours, the holes became one long eroded area down the middle of the specimen, 4 by 1 inches. Photo PX-D-68064
