GR-86-2

ANALYSIS OF UTILIZATION OF GROUT AND GROUT CURTAINS — HOOVER DAM

*February 1986
Engineering and Research Center*

*U.S. Department of the Interior
Bureau of Reclamation
Division of Research and
Laboratory Services
Concrete and Structural Branch*

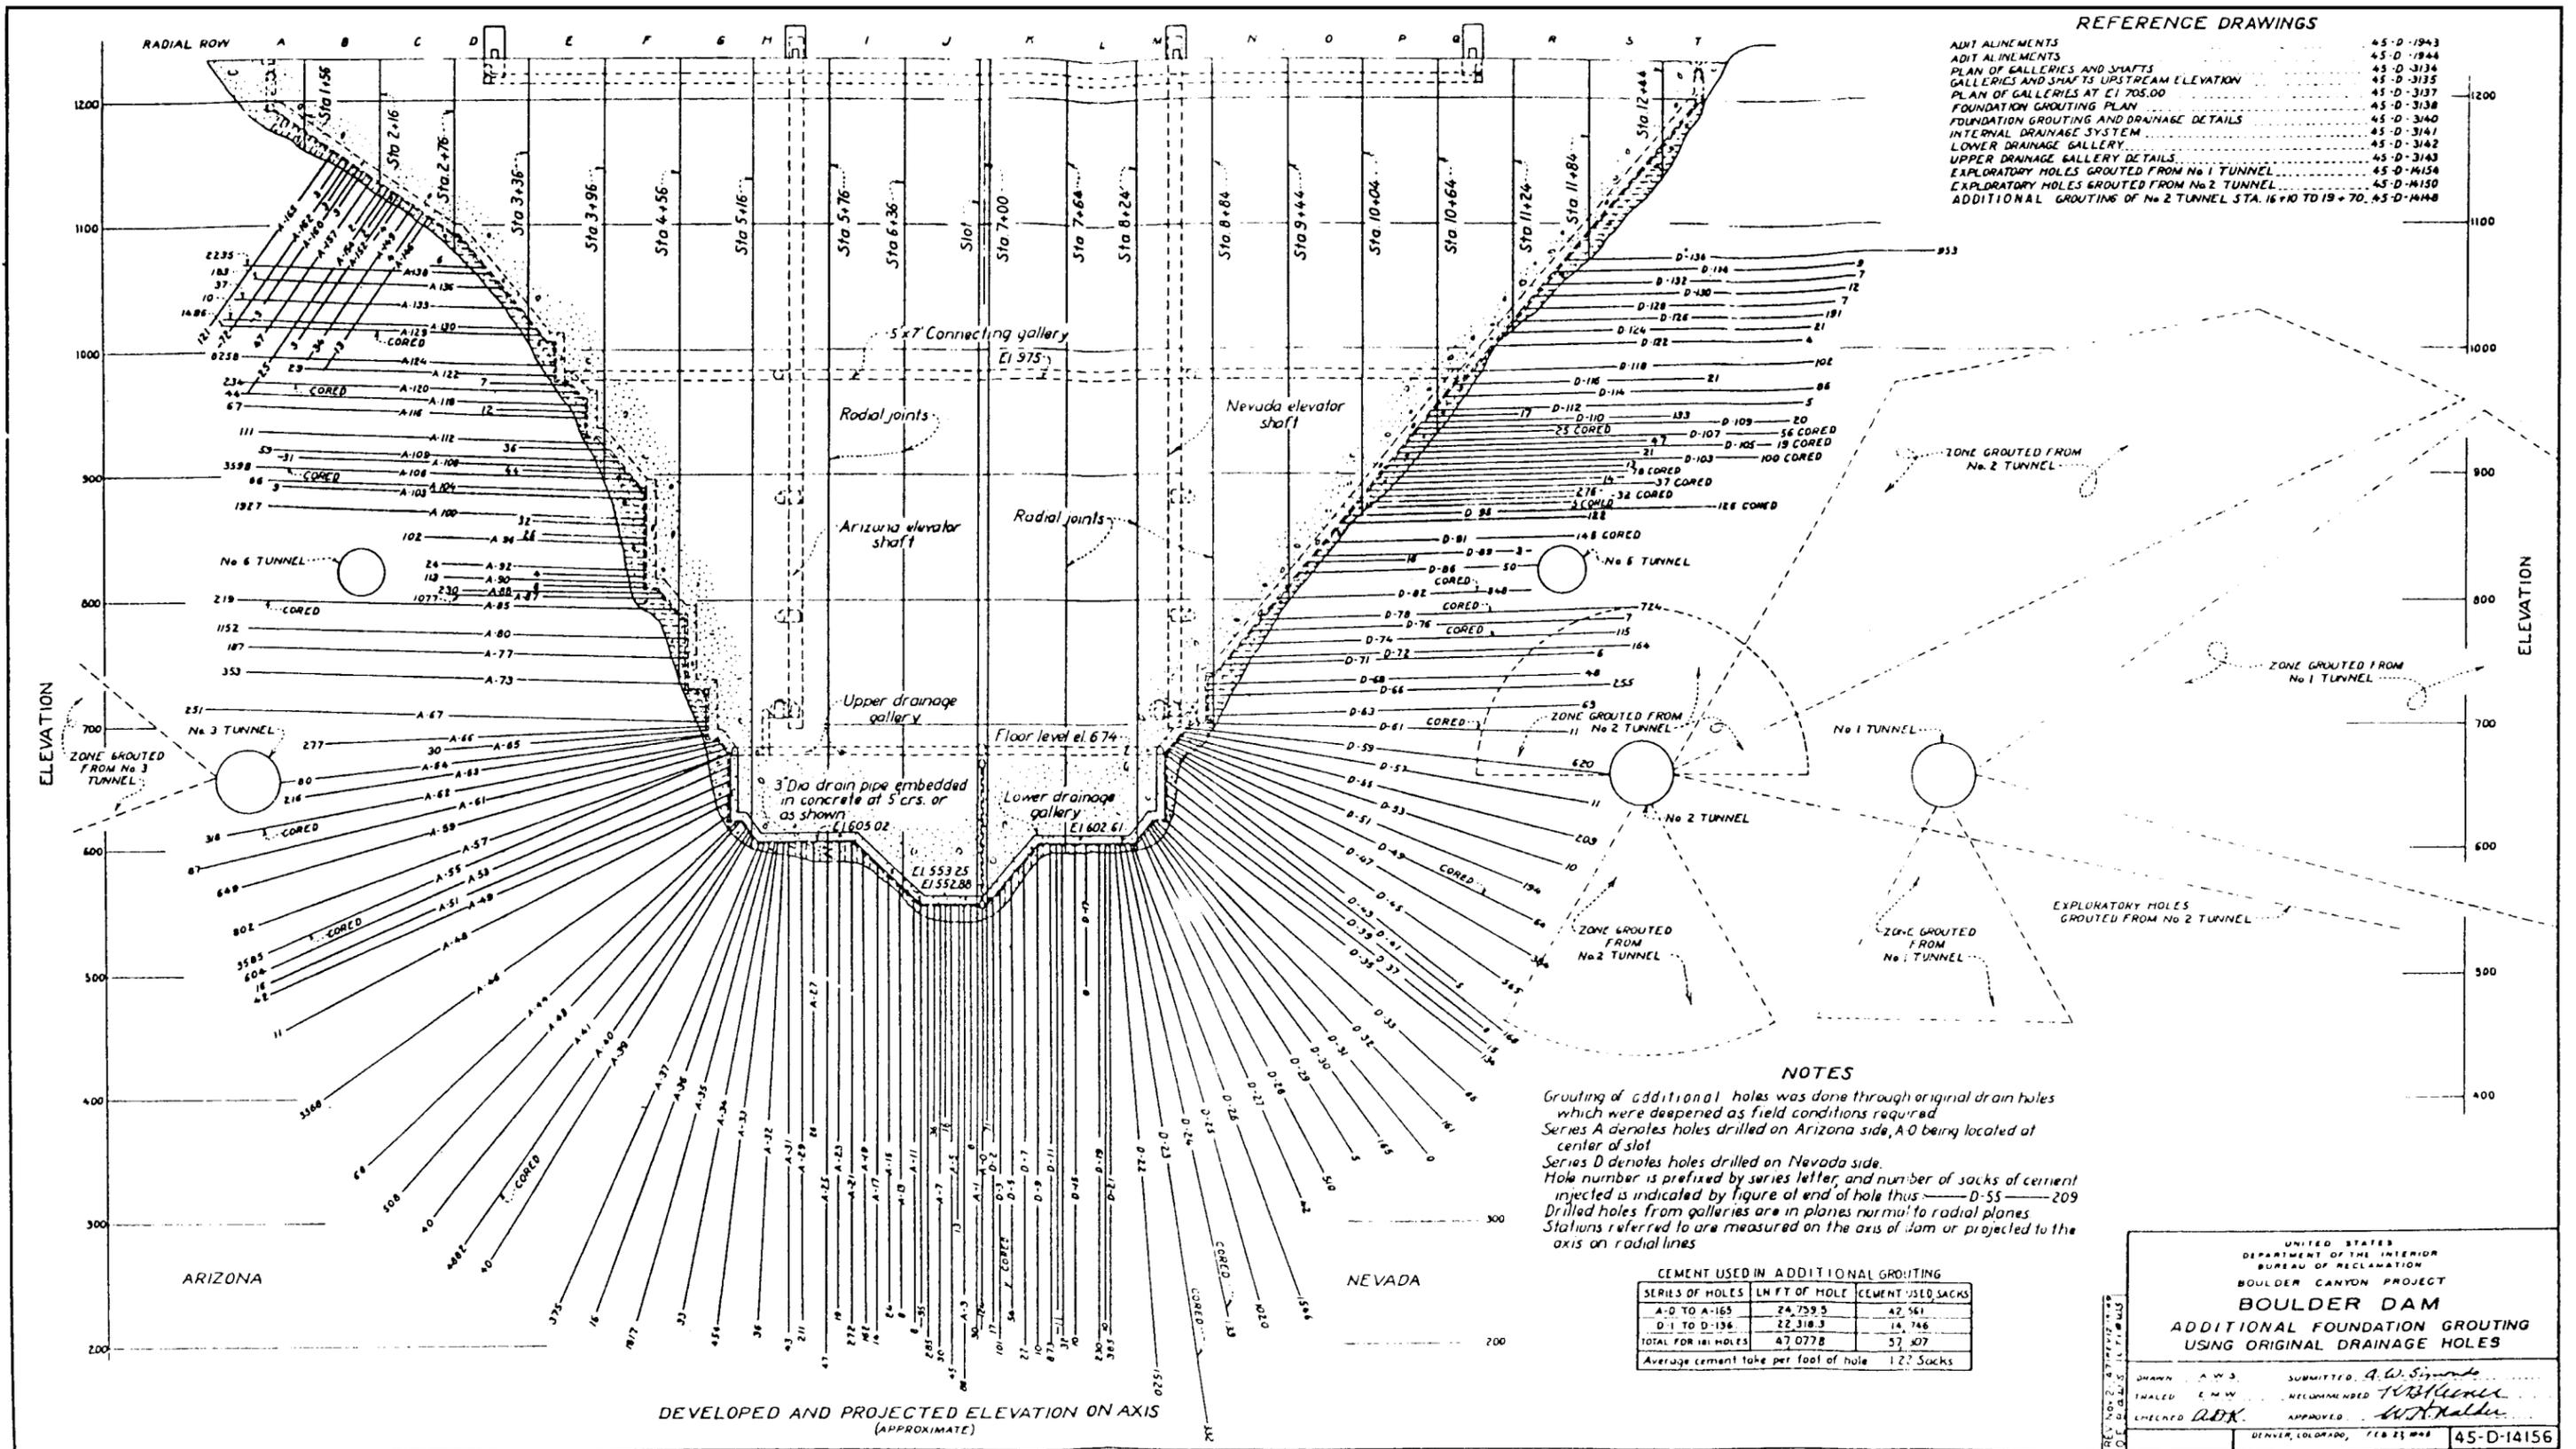
The initial work started in October, 1938, with drilling of 15 drain holes from the El. 616 gallery of the powerhouse into the foundation near the downstream toe of the dam. See figure 14. These drains penetrated 5 feet into rock and did lower the uplift pressures in line C but not in line B. Attempts were made without success to regrout nine Nevada A holes that penetrated the fault zone between El. 840 and El. 940. Drilling of alternate drain holes on 10-foot centers (which had not been drilled during the original construction) between Stations 5+46 and 8+04 in the El. 553 drainage gallery disclosed mud seams extending beneath the river channel at El. 525. Broken rock was found at El. 500±, and a large flow of water was encountered at El. 405. It was decided to deepen the original drain holes and to convert them into a grout curtain and to later install a new drainage system downstream. Twenty-five of the new grout holes were core drilled which gave considerable additional information on the foundation conditions. Hole D-23 was drilled to a depth of 479.8 feet and was the deepest hole drilled. As shown on figure 15, many of the holes were drilled to 400 feet into rock and most of the holes in

the canyon bottom were over 300 feet deep, which was more than twice the depth of the original holes.

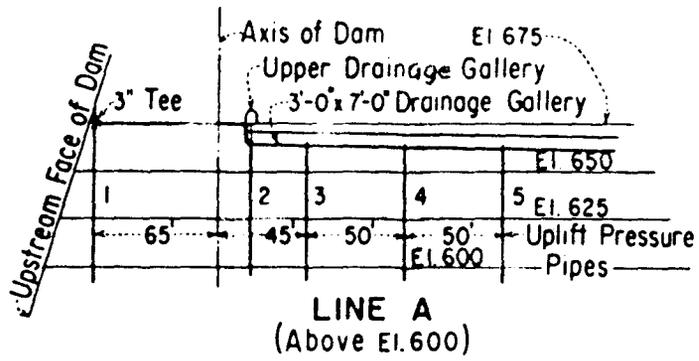
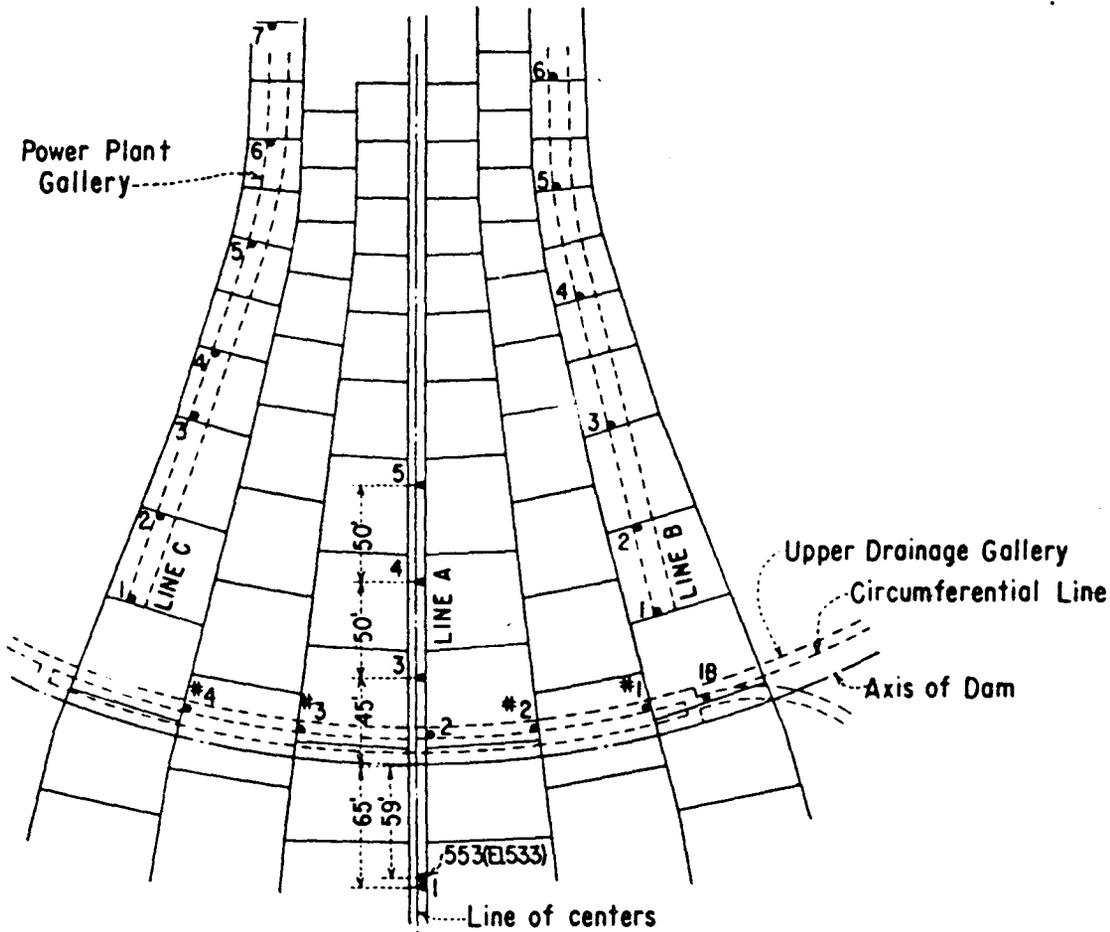
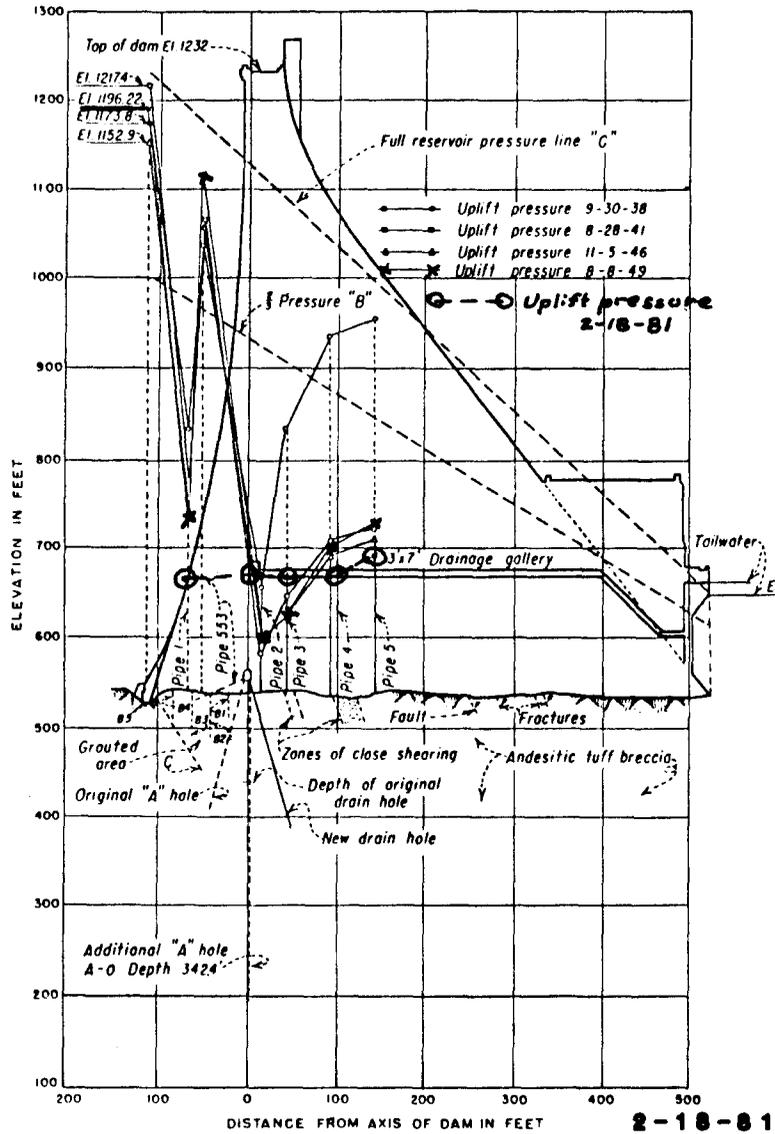
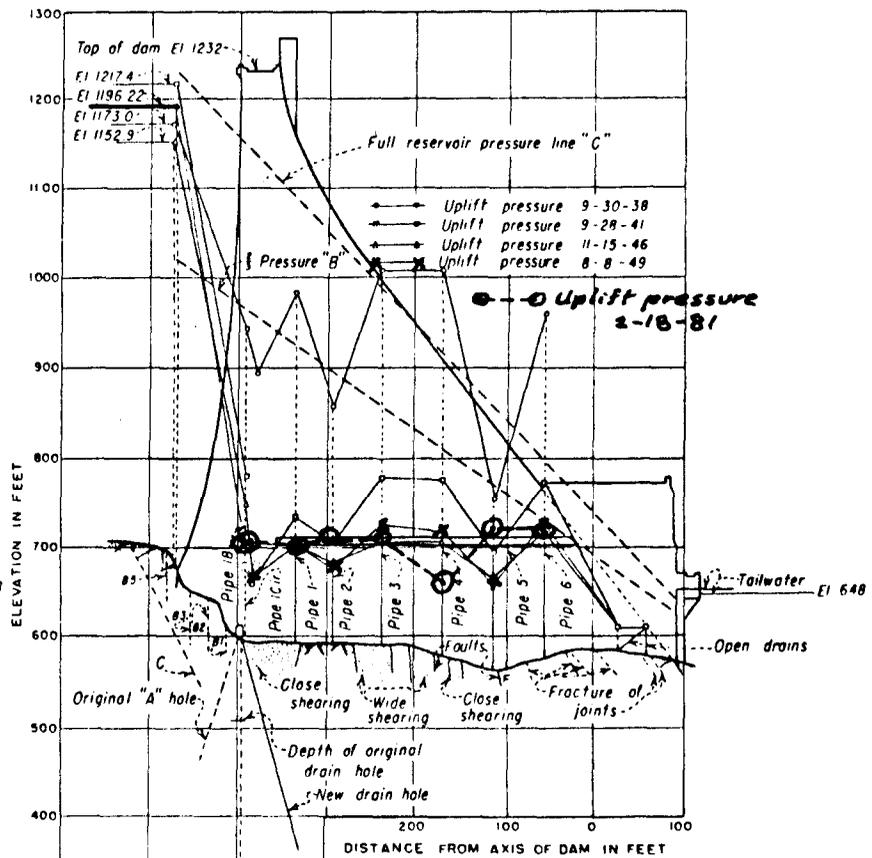
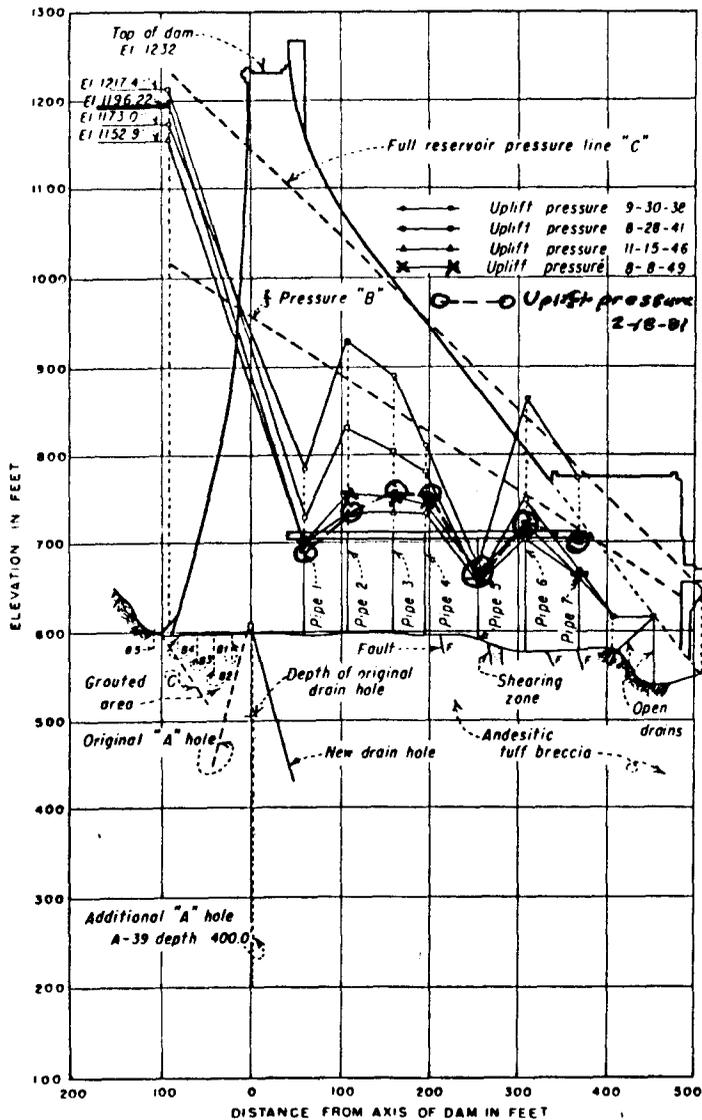
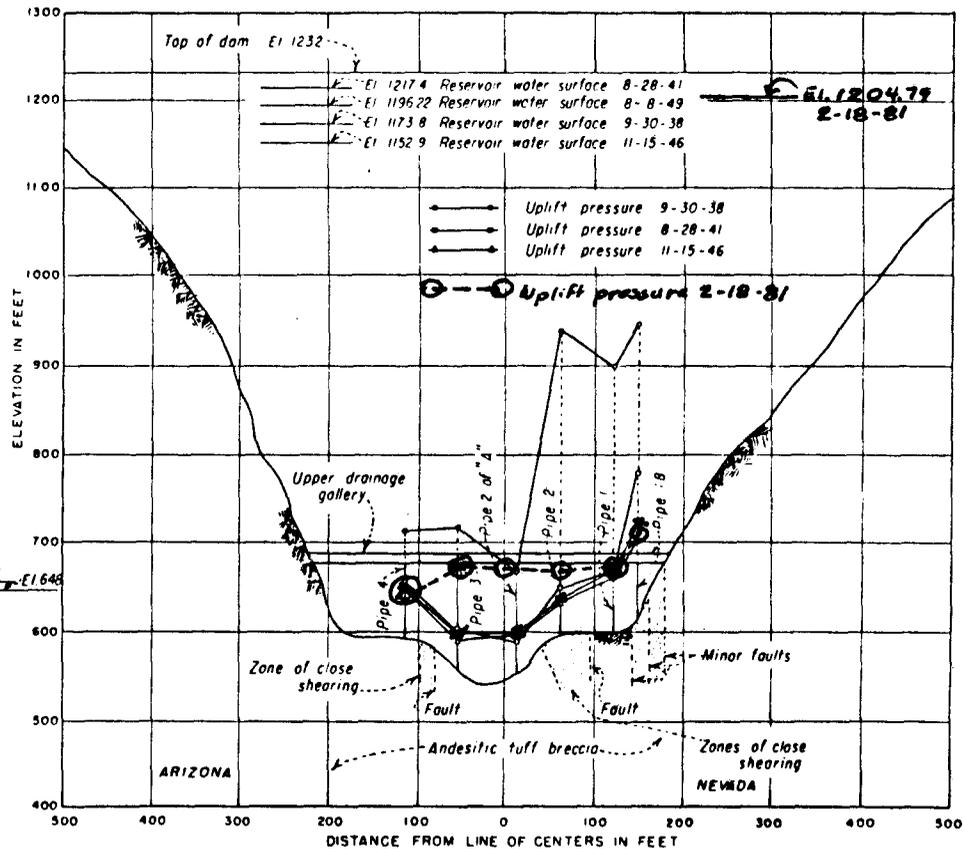
UNITED STATES
DEPARTMENT OF THE INTERIOR
BUREAU OF RECLAMATION
BOULDER CANYON PROJECT
BOULDER DAM
**REDUCTION IN UPLIFT PRESSURE GRADIENT
DUE TO ADDITIONAL GROUTING AND DRAINAGE**

31. Original grouting. Uplift pressures and leakage into the drainage galleries and penstock tunnels were excessive during initial filling operations in 1937 and 1938. Seepage also developed above the powerhouse on the Nevada side and at other points downstream. The increasing uplift pressure on the base of the structure particularly along sets B and C was of the greatest concern. The locations of the uplift pressure pipes are shown on figure 19 and the uplift pressures for September 30, 1938, are shown on figures 20 and 21.

A review of table 1 indicates that much of the reduction in uplift was accomplished in 1939, 1940 and 1941 by a combination of grouting and drainage. These reductions are shown on the plots for September 28, 1941, on figures 20 and 21. Although some further reduction in the uplift pressures was accomplished after 1941, the work primarily reduced the amount of seepage which was in itself very important.

33. Current status of uplift pressures and seepage. The uplift pressures for February 18, 1981 are plotted on figures 20 and 21. The reservoir water surface on February 18, 1981 was at

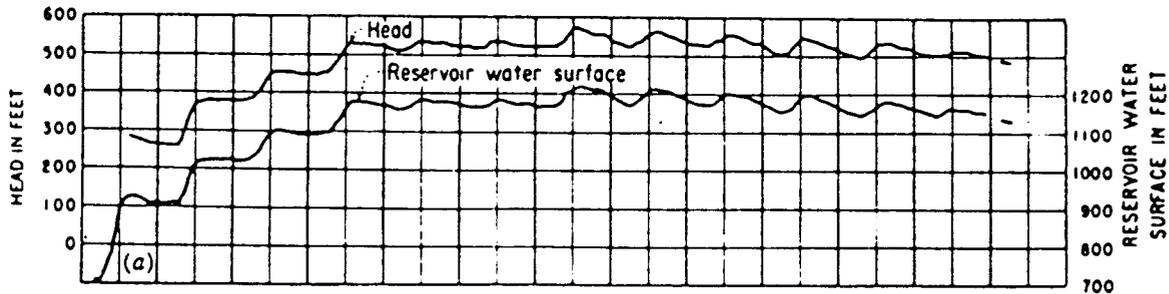
UPLIFT PRESSURES AT BASE, LINE B

Figures 22 and 23 were reproduced with ASCE's permission from figures 12 and 13 of Keener's⁽¹¹⁾ paper on uplift pressures. These plots are extremely valuable because they indicated even during the early stages of filling that all holes along line B had relatively high readings in percentage of head. Of particular concern were readings for holes 3 and 4 which were located 161 feet and 230 feet, respectively, downstream from the dam axis; and of even more concern was the readings from hole 6 which was

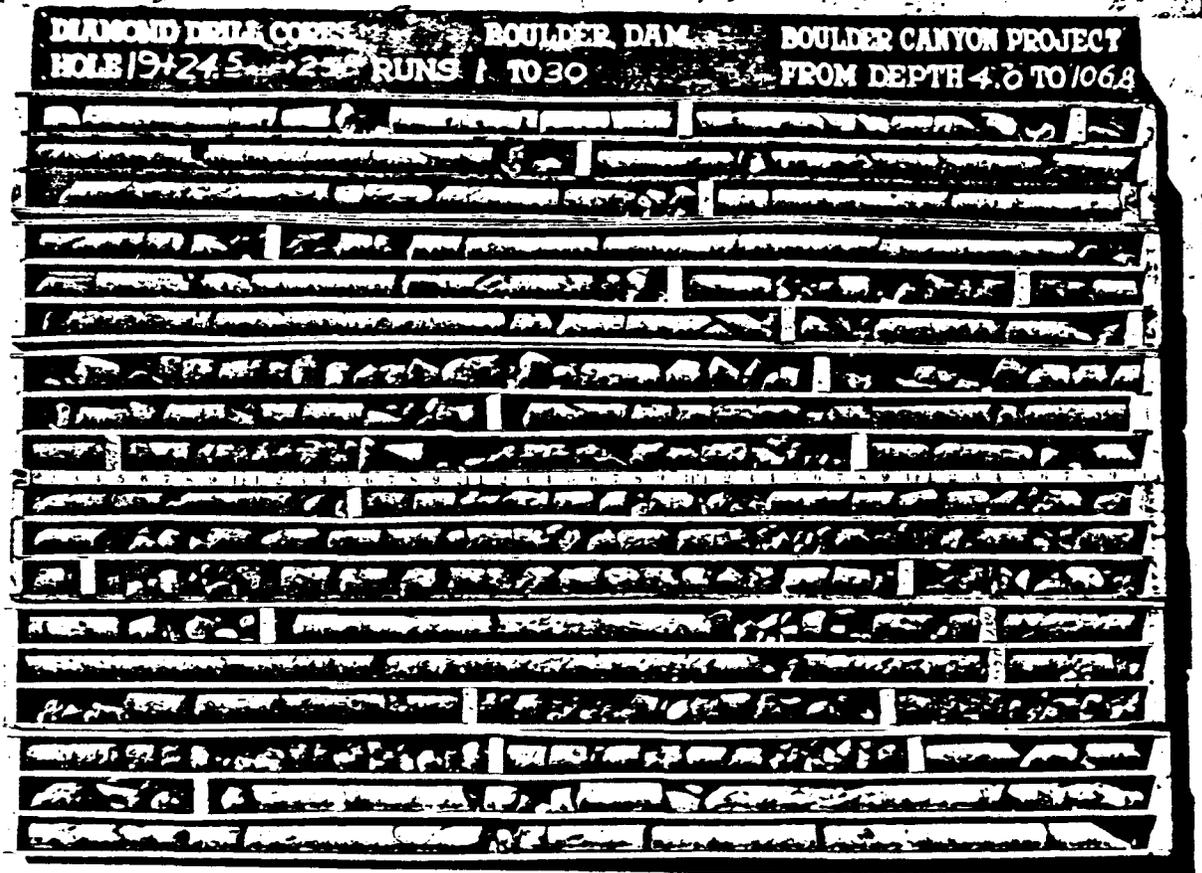
* Exploratory Hole # 19/24.5 /250

Extensive voids and areas of poor rock with high water flows were also found in the Nevada abutment. For instance, an exploratory hole drilled from Station 19+24.5 in tunnel No. 2 on the Nevada side (see figure 14) at an upward angle of 25° had poor and broken rock from a depth of 8 feet to 107 feet as shown on figure 27. The collar of this hole is located near the tips of holes drilled from the dam galleries. The hole made water for its full depth with large flows encountered at depths of 555, 610 and 680 feet. A seam of grout was encountered between depths of 630.5
