GR-86-3

ANALYSIS OF UTILIZATION OF GROUT AND GROUT CURTAINS — KORTES DAM

*February 1986
Engineering and Research Center*

***U.S. Department of the Interior
Bureau of Reclamation
Division of Research
and Laboratory Services
Concrete and Structural Branch***

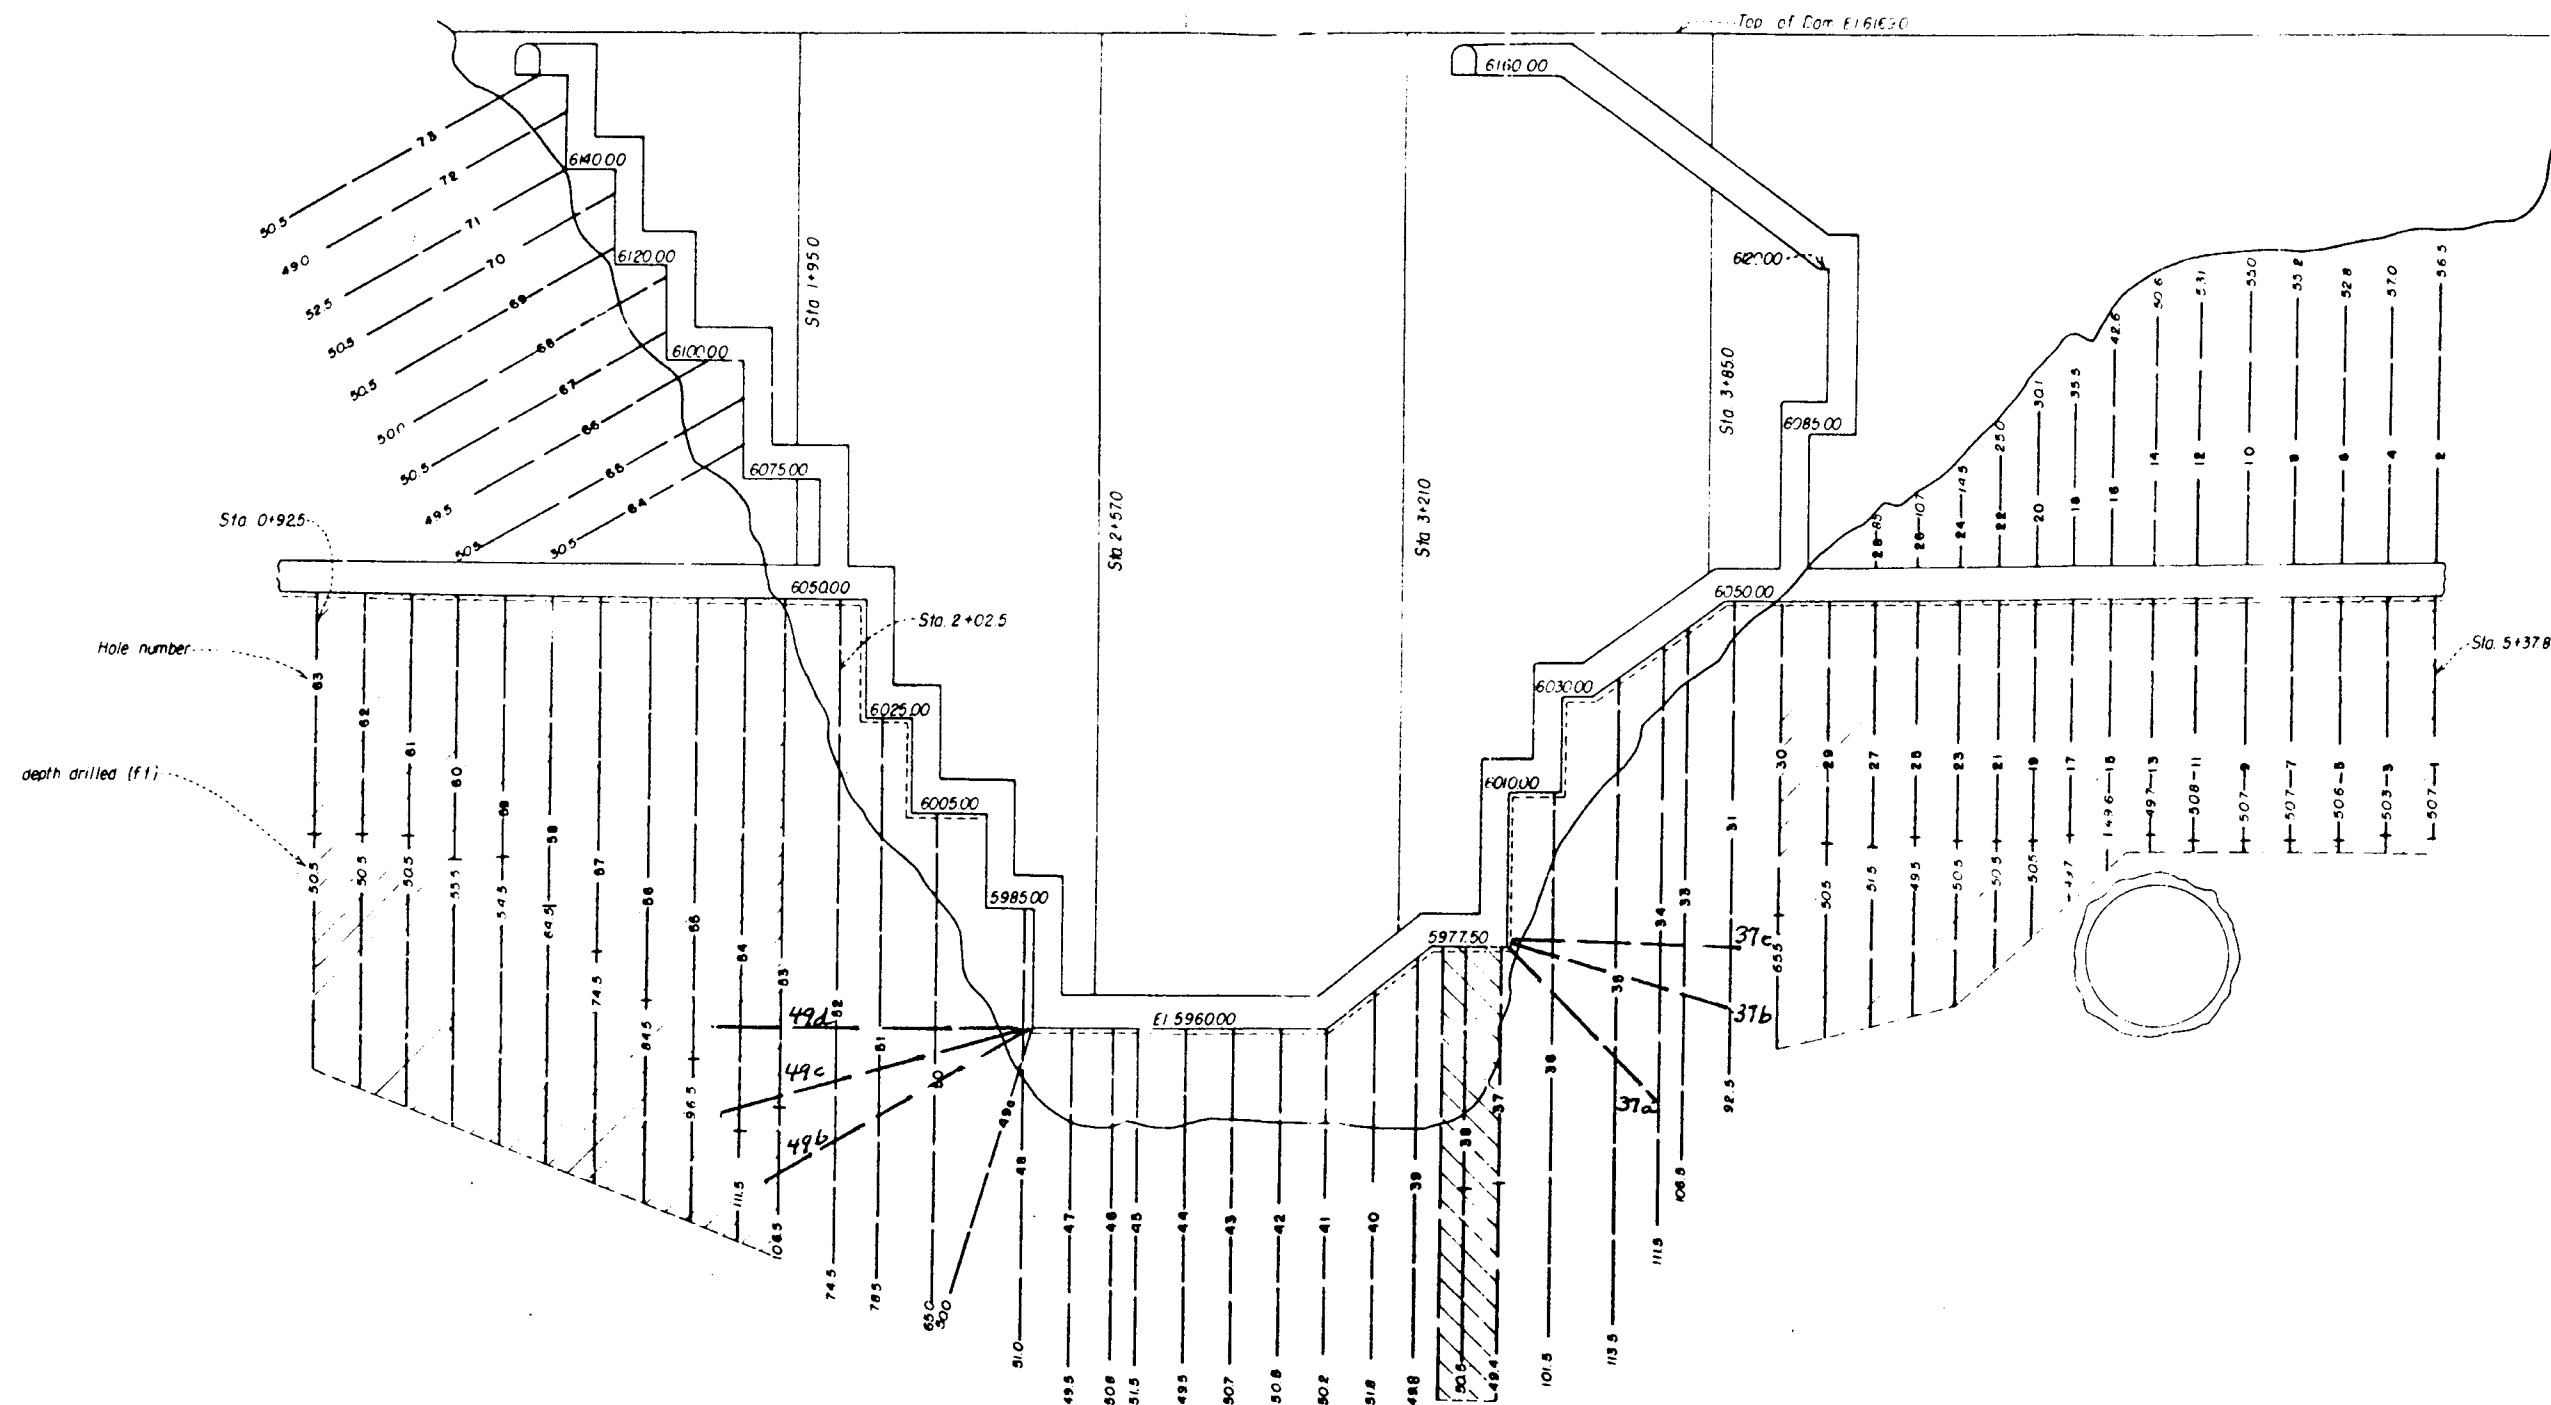
KORTES DAM
FOUNDATION DRAINAGE

10. Foundation drainage holes. The drainage holes were drilled in a direction perpendicular to the axis but inclined downstream 10 degrees from vertical. The drainage holes in the upper part of the abutment were drilled 30 degrees downward from horizontal as shown on figure 15. Drainage holes were also drilled from the foundation tunnels on both abutments. On the right abutment, drainage holes were drilled upward and downward from the drainage tunnel. See figure 9 on page numbered 17 in appendix A.

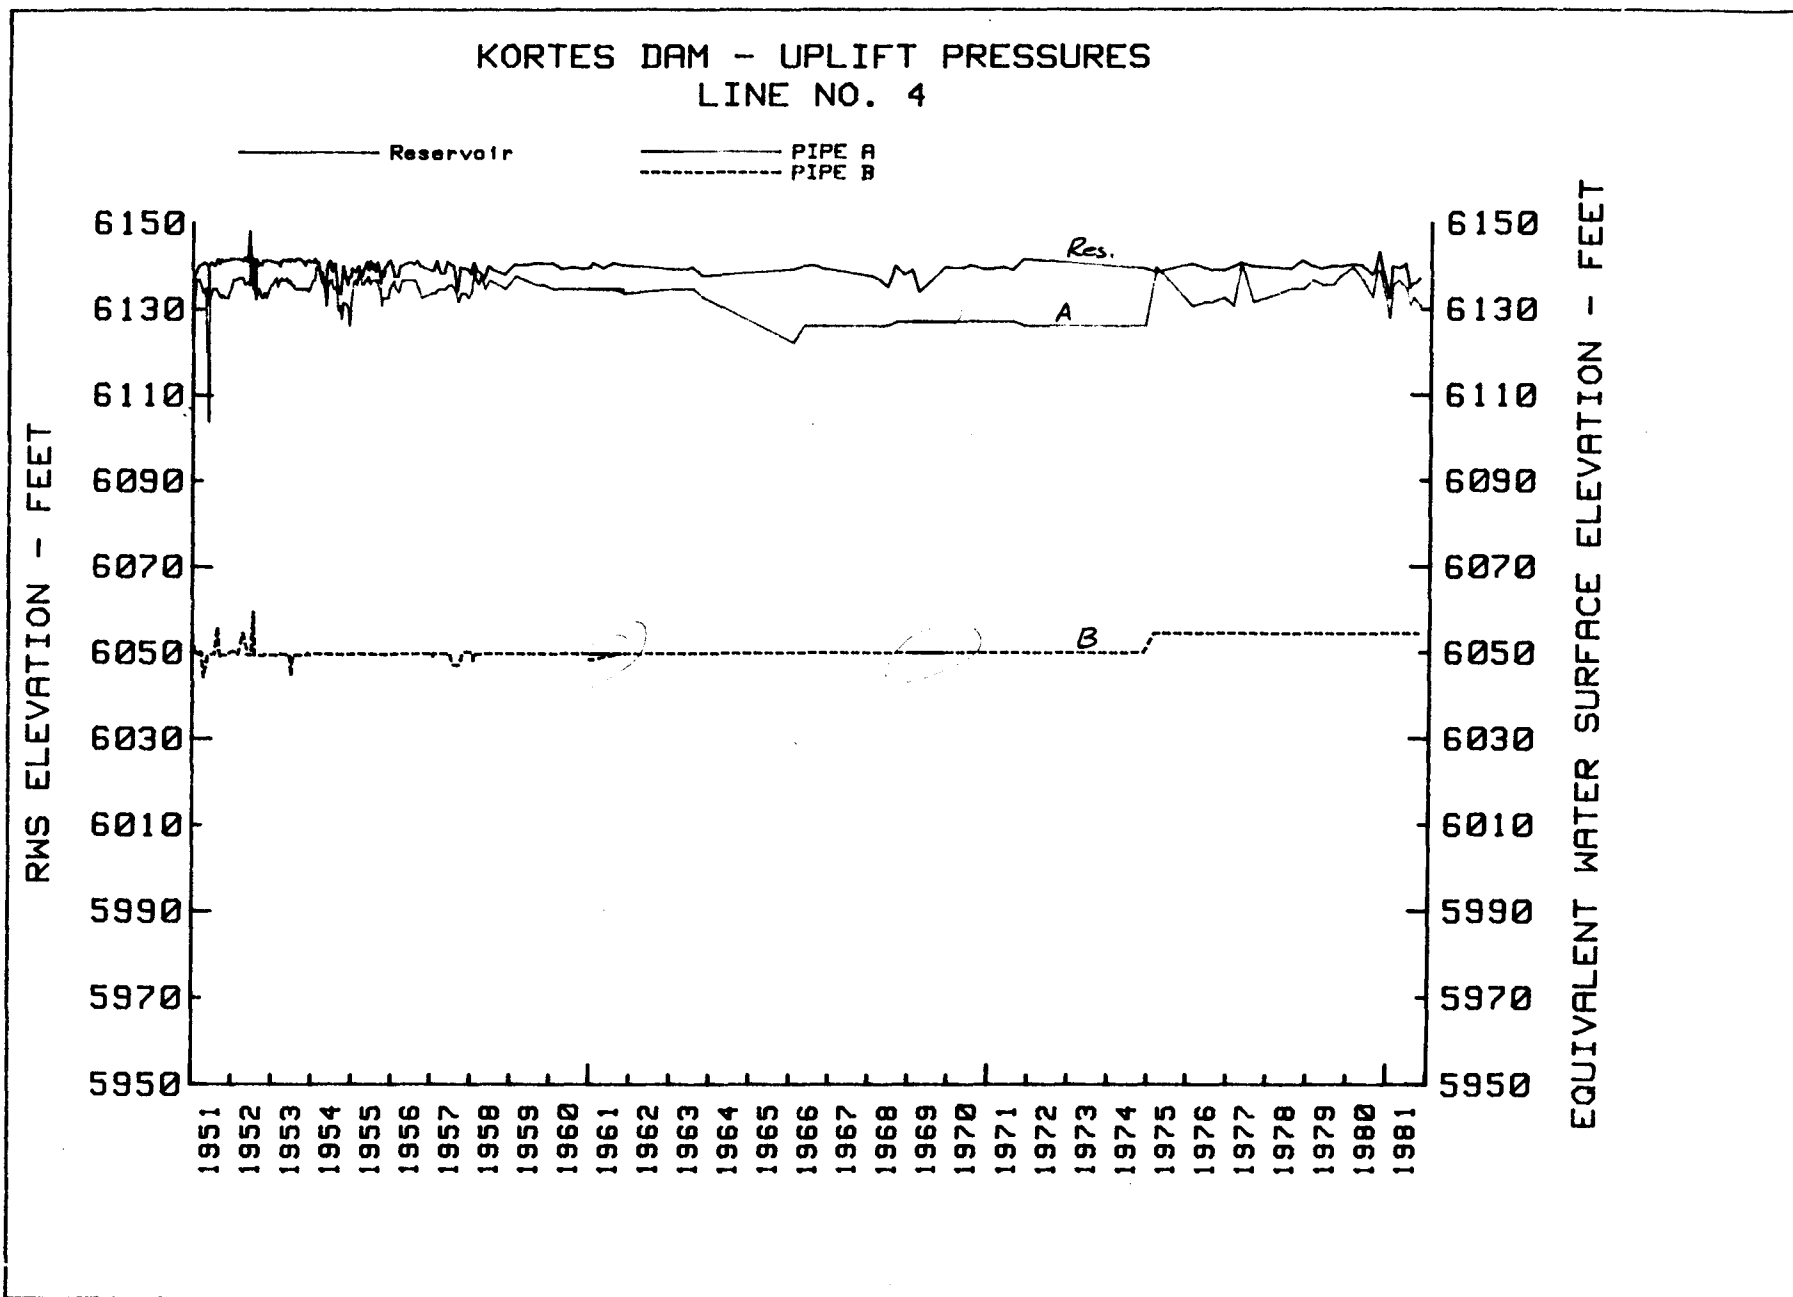
FIGURE 21

(b) Uplift. Uplift was recognized as a problem during the initial filling in 1951. The uplift, particularly at the B pipes, was found to be higher than the values used in design and the uplift was increasing with time under a constant head. The layout of the uplift measurement system is shown on figure 17, and the uplift pressures for the period of 1951-1981 are plotted on figures 18 through 21.

evaluation of the effects of grouting and drainage on the dam uplift cannot be made. Assuming that the available data is correct, it is concluded that the grouting has reduced the seepage volume sufficiently but that the drainage system has not reduced the uplift pressures sufficiently near the downstream toe of the dam. An additional line of drainage holes is needed along the downstream toe to reduce the hydrostatic uplift line below the face of the dam. The drains would have to be insulated at the surface to prevent freezing in the winter time.

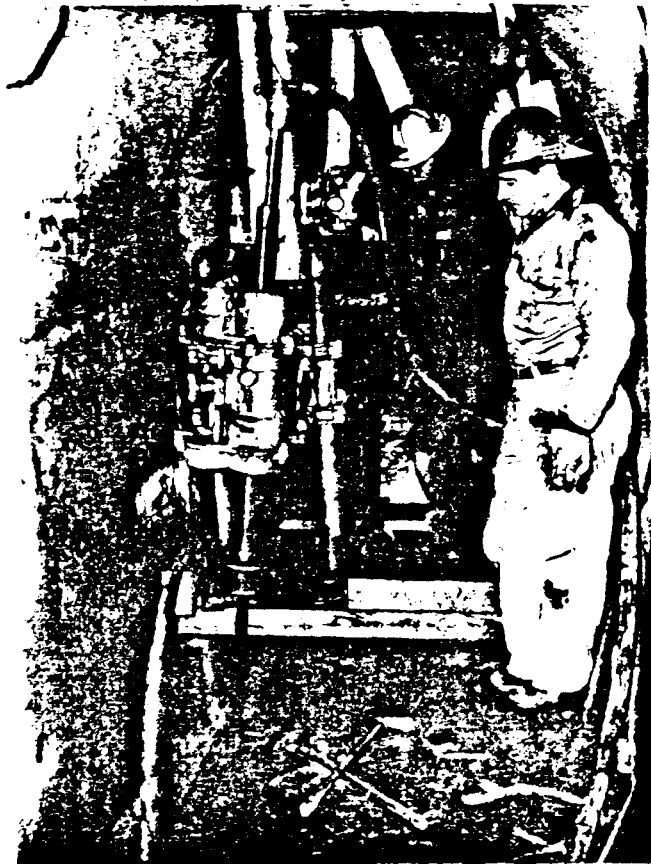
Figure 10. --Drilling curtain grout holes in gutter of the foundation gallery in the dam. 405-728.
