# ANALYSIS OF UTILIZATION OF GROUT AND GROUT CURTAINS — HUNGRY HORSE DAM

*February 1986*  
*Engineering and Research Center*

*U.S. Department of the Interior*  
*Bureau of Reclamation*  
*Division of Research and*  
*Laboratory Services*  
*Concrete and Structural Branch*

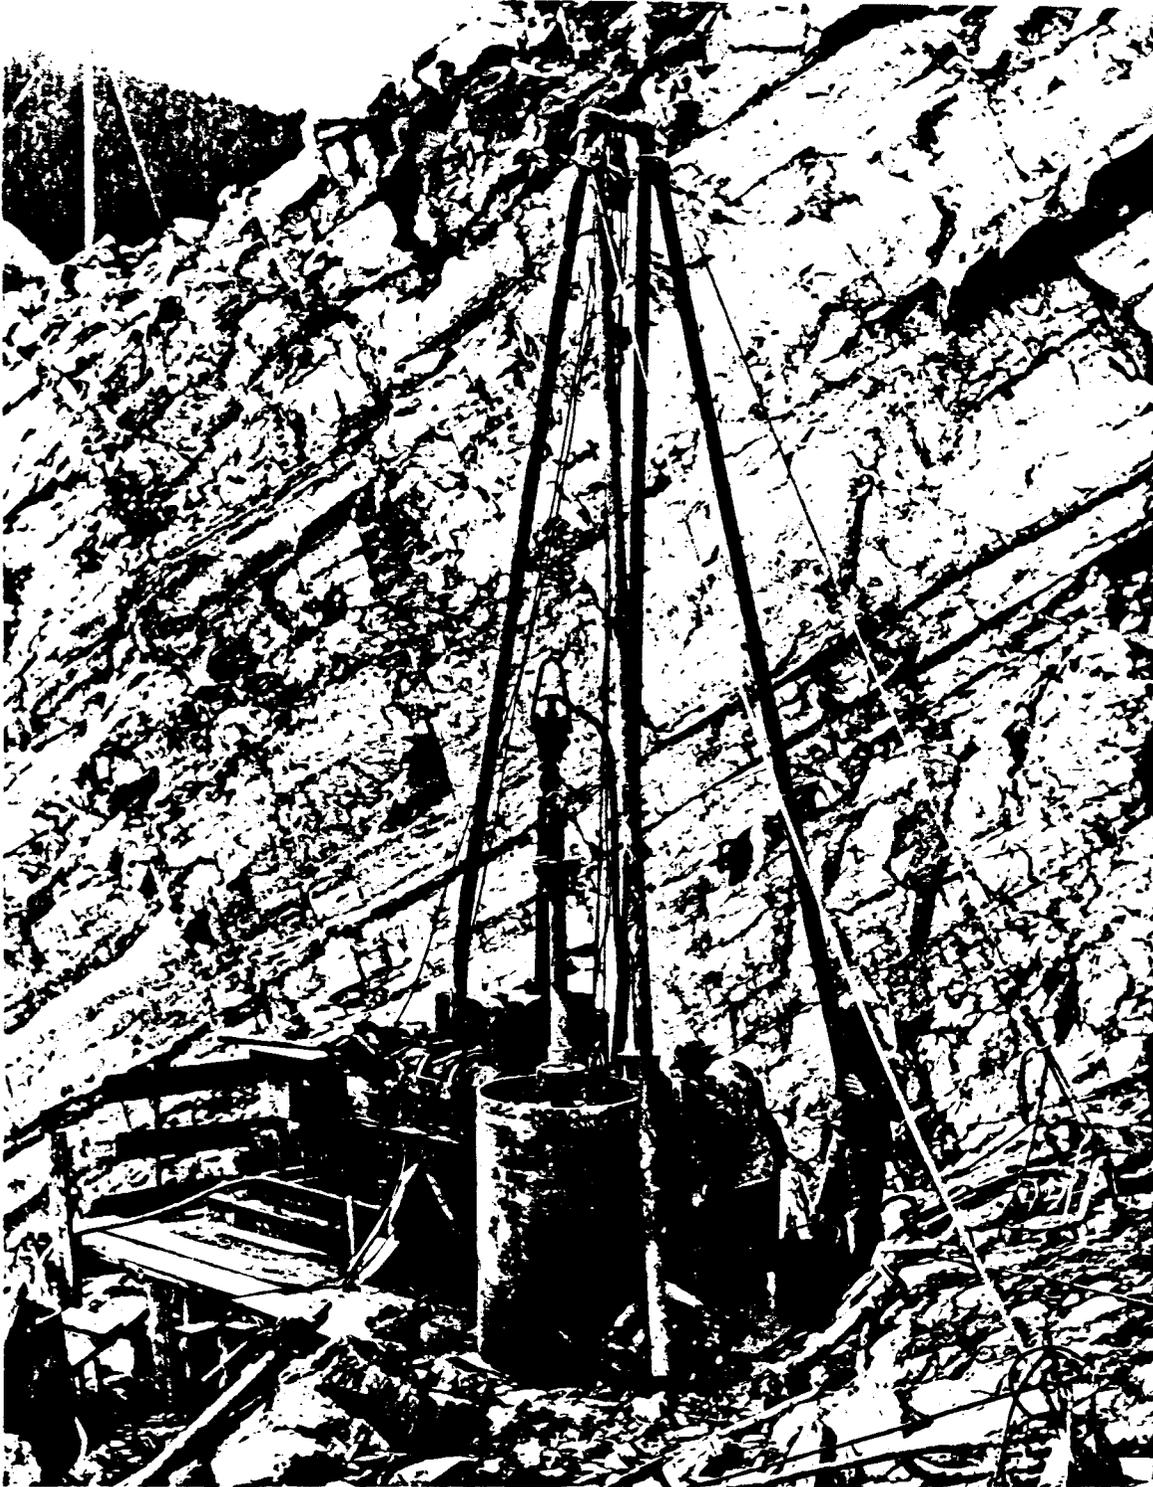
Figure 15 Calyx drill boring 36-inch diameter holes for purpose of inspection of clay seams in left abutment dam foundation rock. P447-105-1943, November 28, 1949.

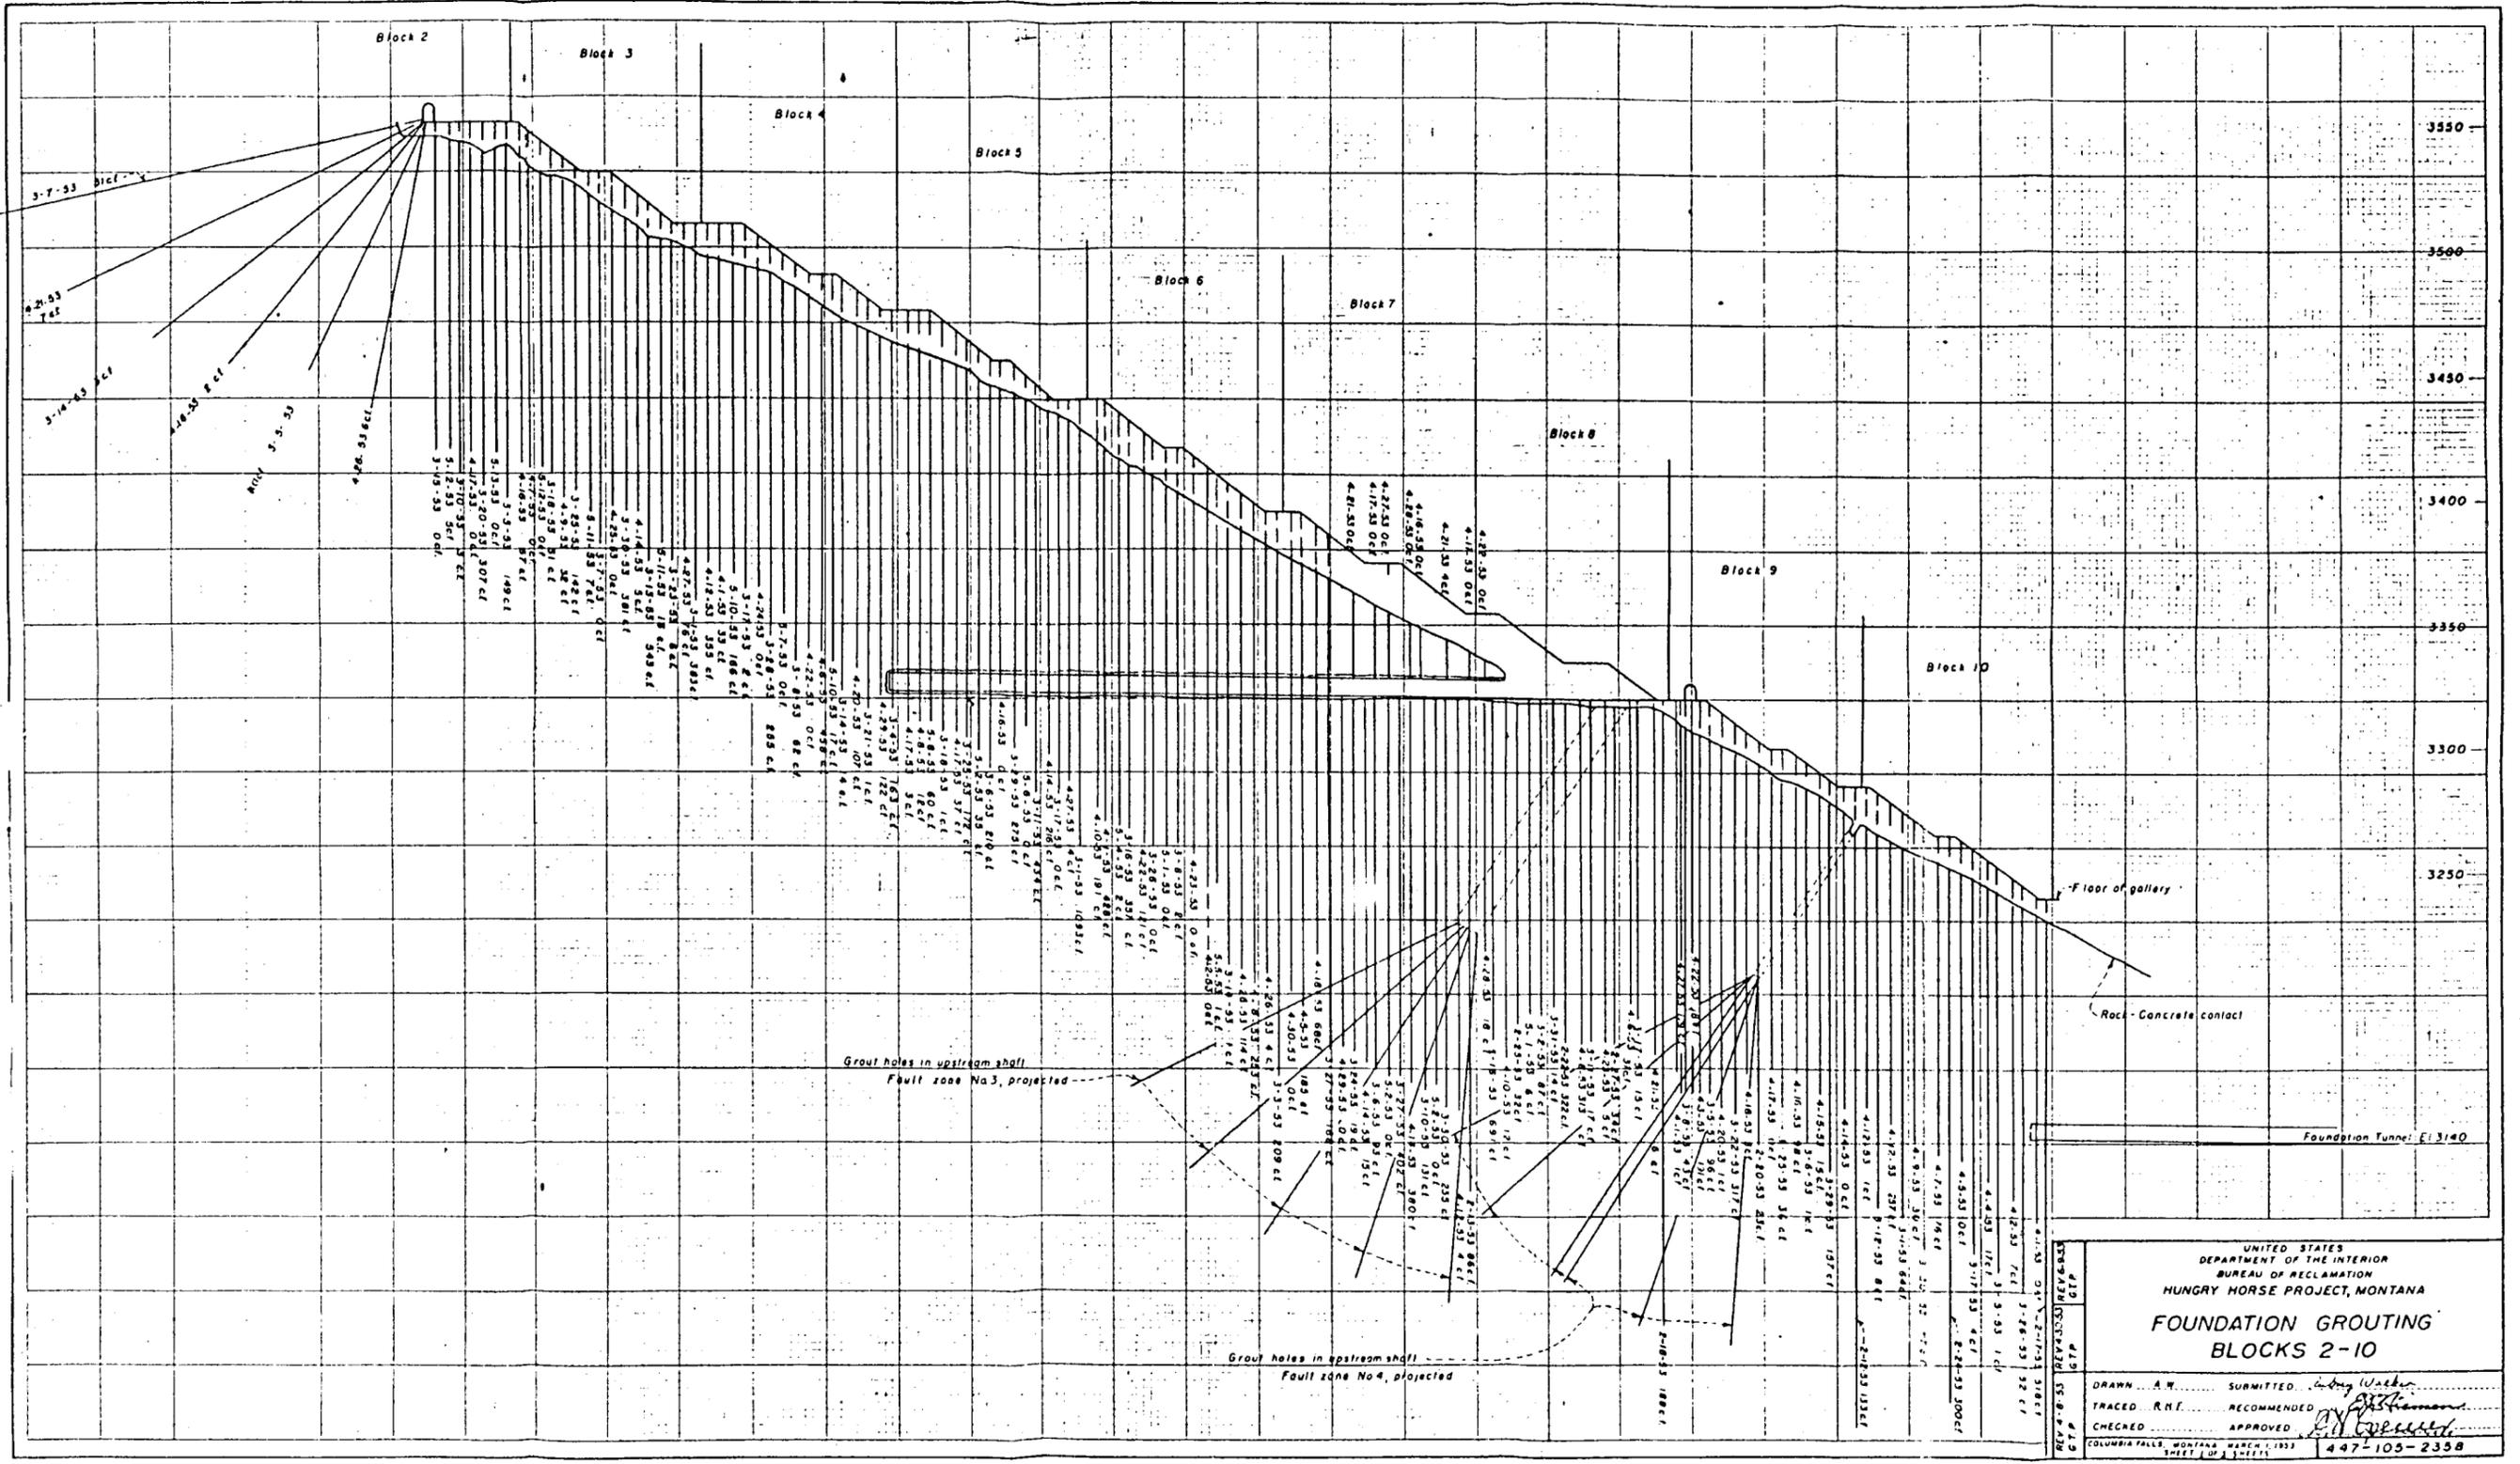
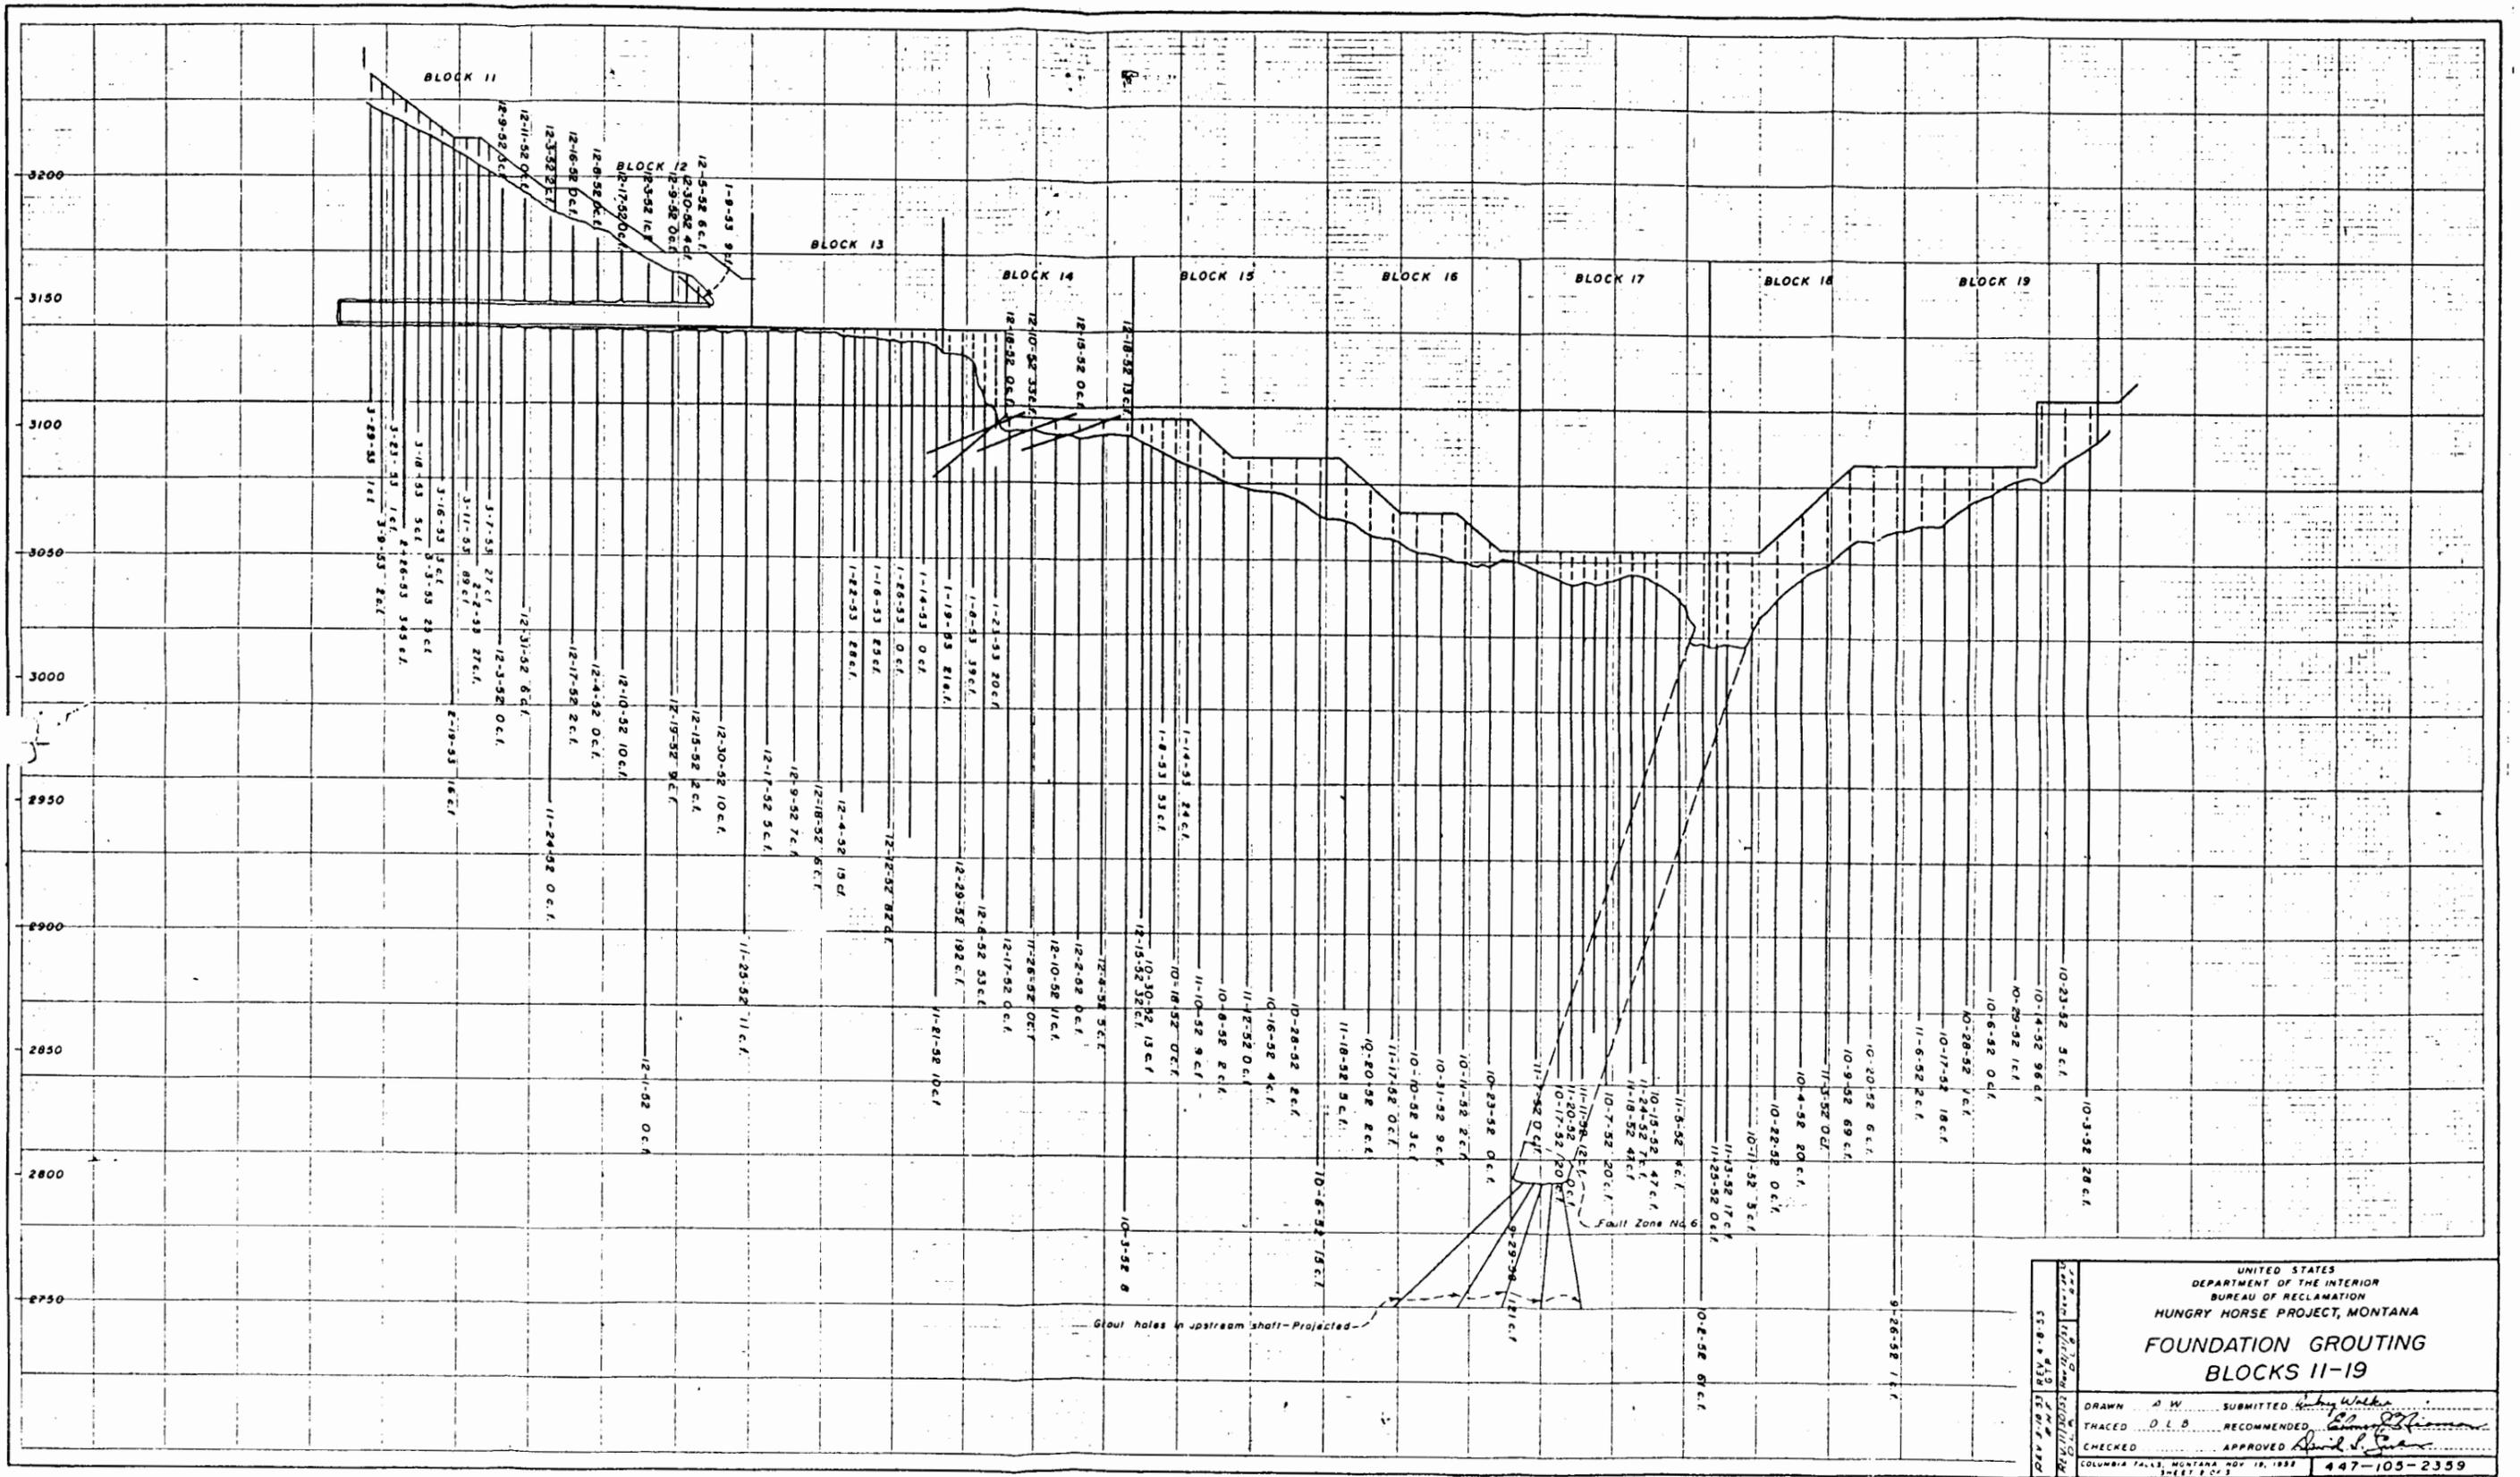
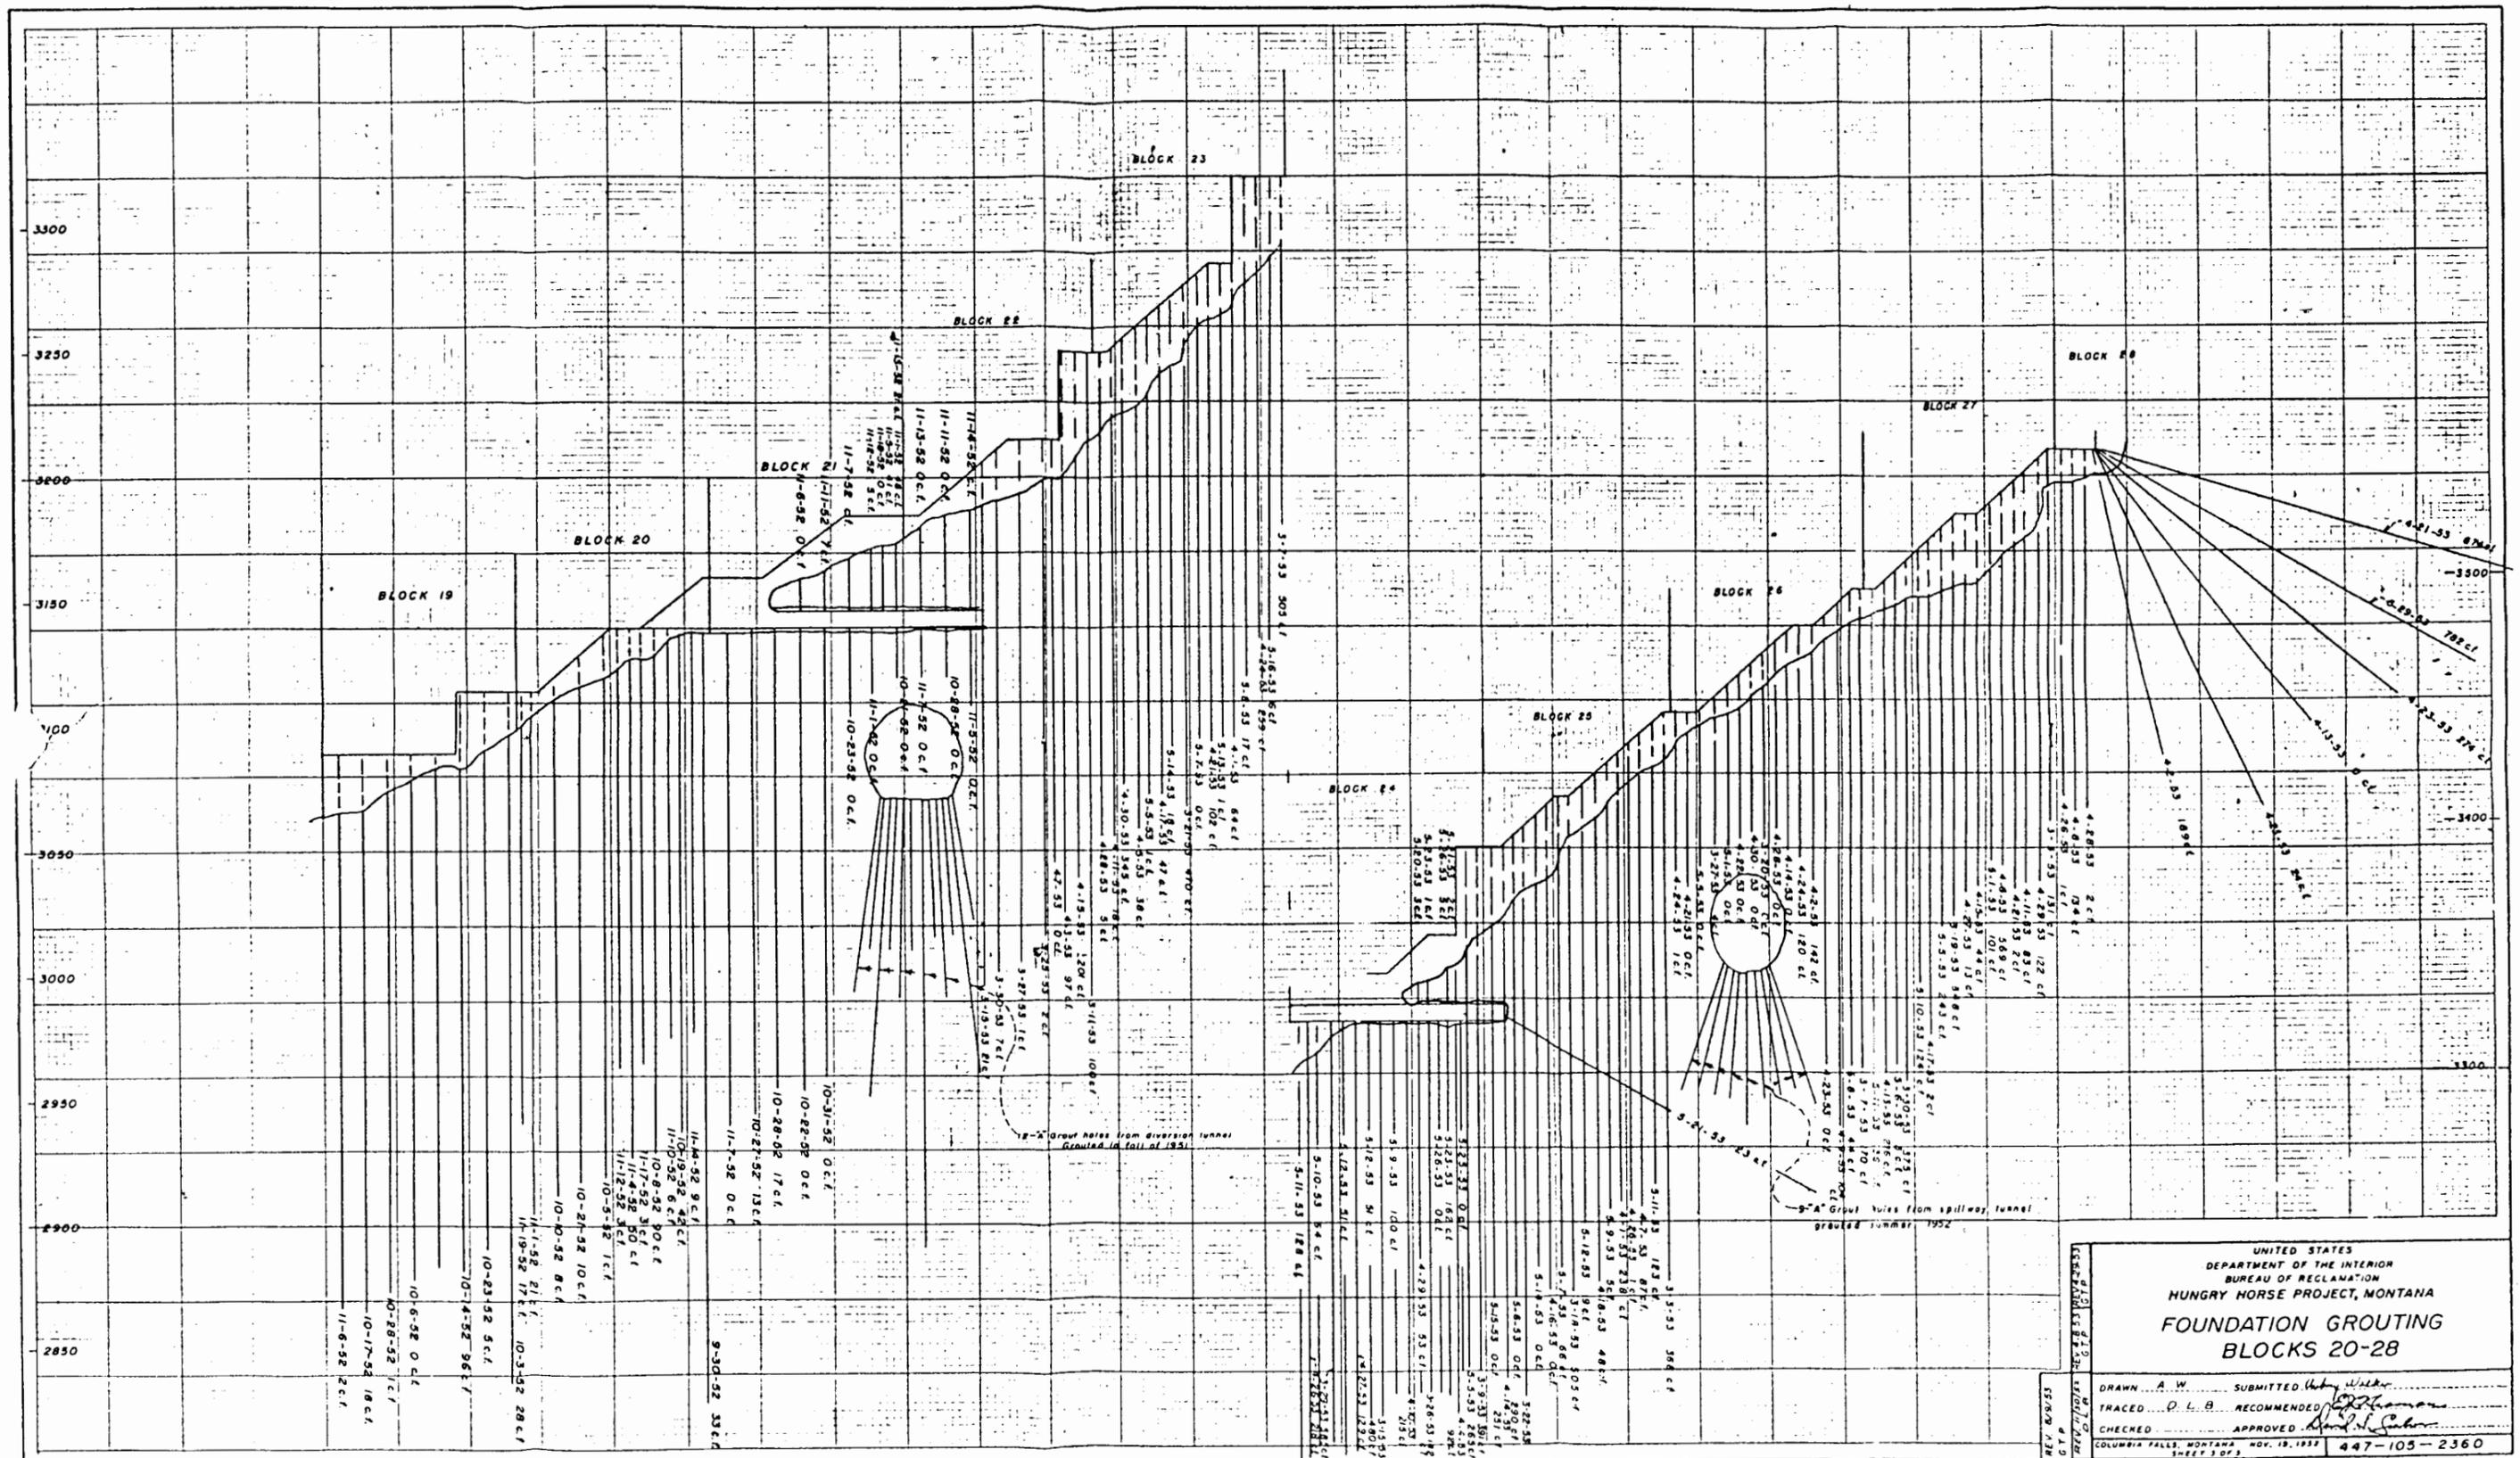
(3) The primary cutoff curtain consisted of a single line of "A" holes drilled through pipes in the drainage gallery. The holes were inclined upstream at 12 degrees so that the base of the grout curtain was located on the vertical projection of the heel of the dam. The depth of "A" holes varied from 110 to 310 feet and the average depth of the holes was 157 feet. Grouting was by the split-spacing method from an initial spacing of 160 feet (primary holes) to a final spacing of 10 feet. The plan was to drill the 5-foot-spaced holes only if deemed necessary, on the basis of grout take in the holes on 10-foot spacing. The ascending-stage grouting method was used with packers. The profile of the "A" holes is shown on figures 27, 28 and 29.

(b) Specifications. The specifications were complete in regard to the general performance of the work. However, the specifications did not include requirements for: (1) the expected range of water-cement ratios; (2) water-pressure tests for each zone and the test time; (3) minimum size and capacity of equipment and pumps; (4) minimum size of the grout pipe within the packer; (5) final backfilling of completed holes; (6) storage of a sufficient quantity of cement at or near the grout plant to insure that grouting operations would not be held up by lack of cement; and (7) a placing unit (agitator sump and pump) at an elevation approximately that of the hole collar where the elevation difference between primary grout plant and the hole collar may result in gravity pressure higher than the maximum allowable pressure.

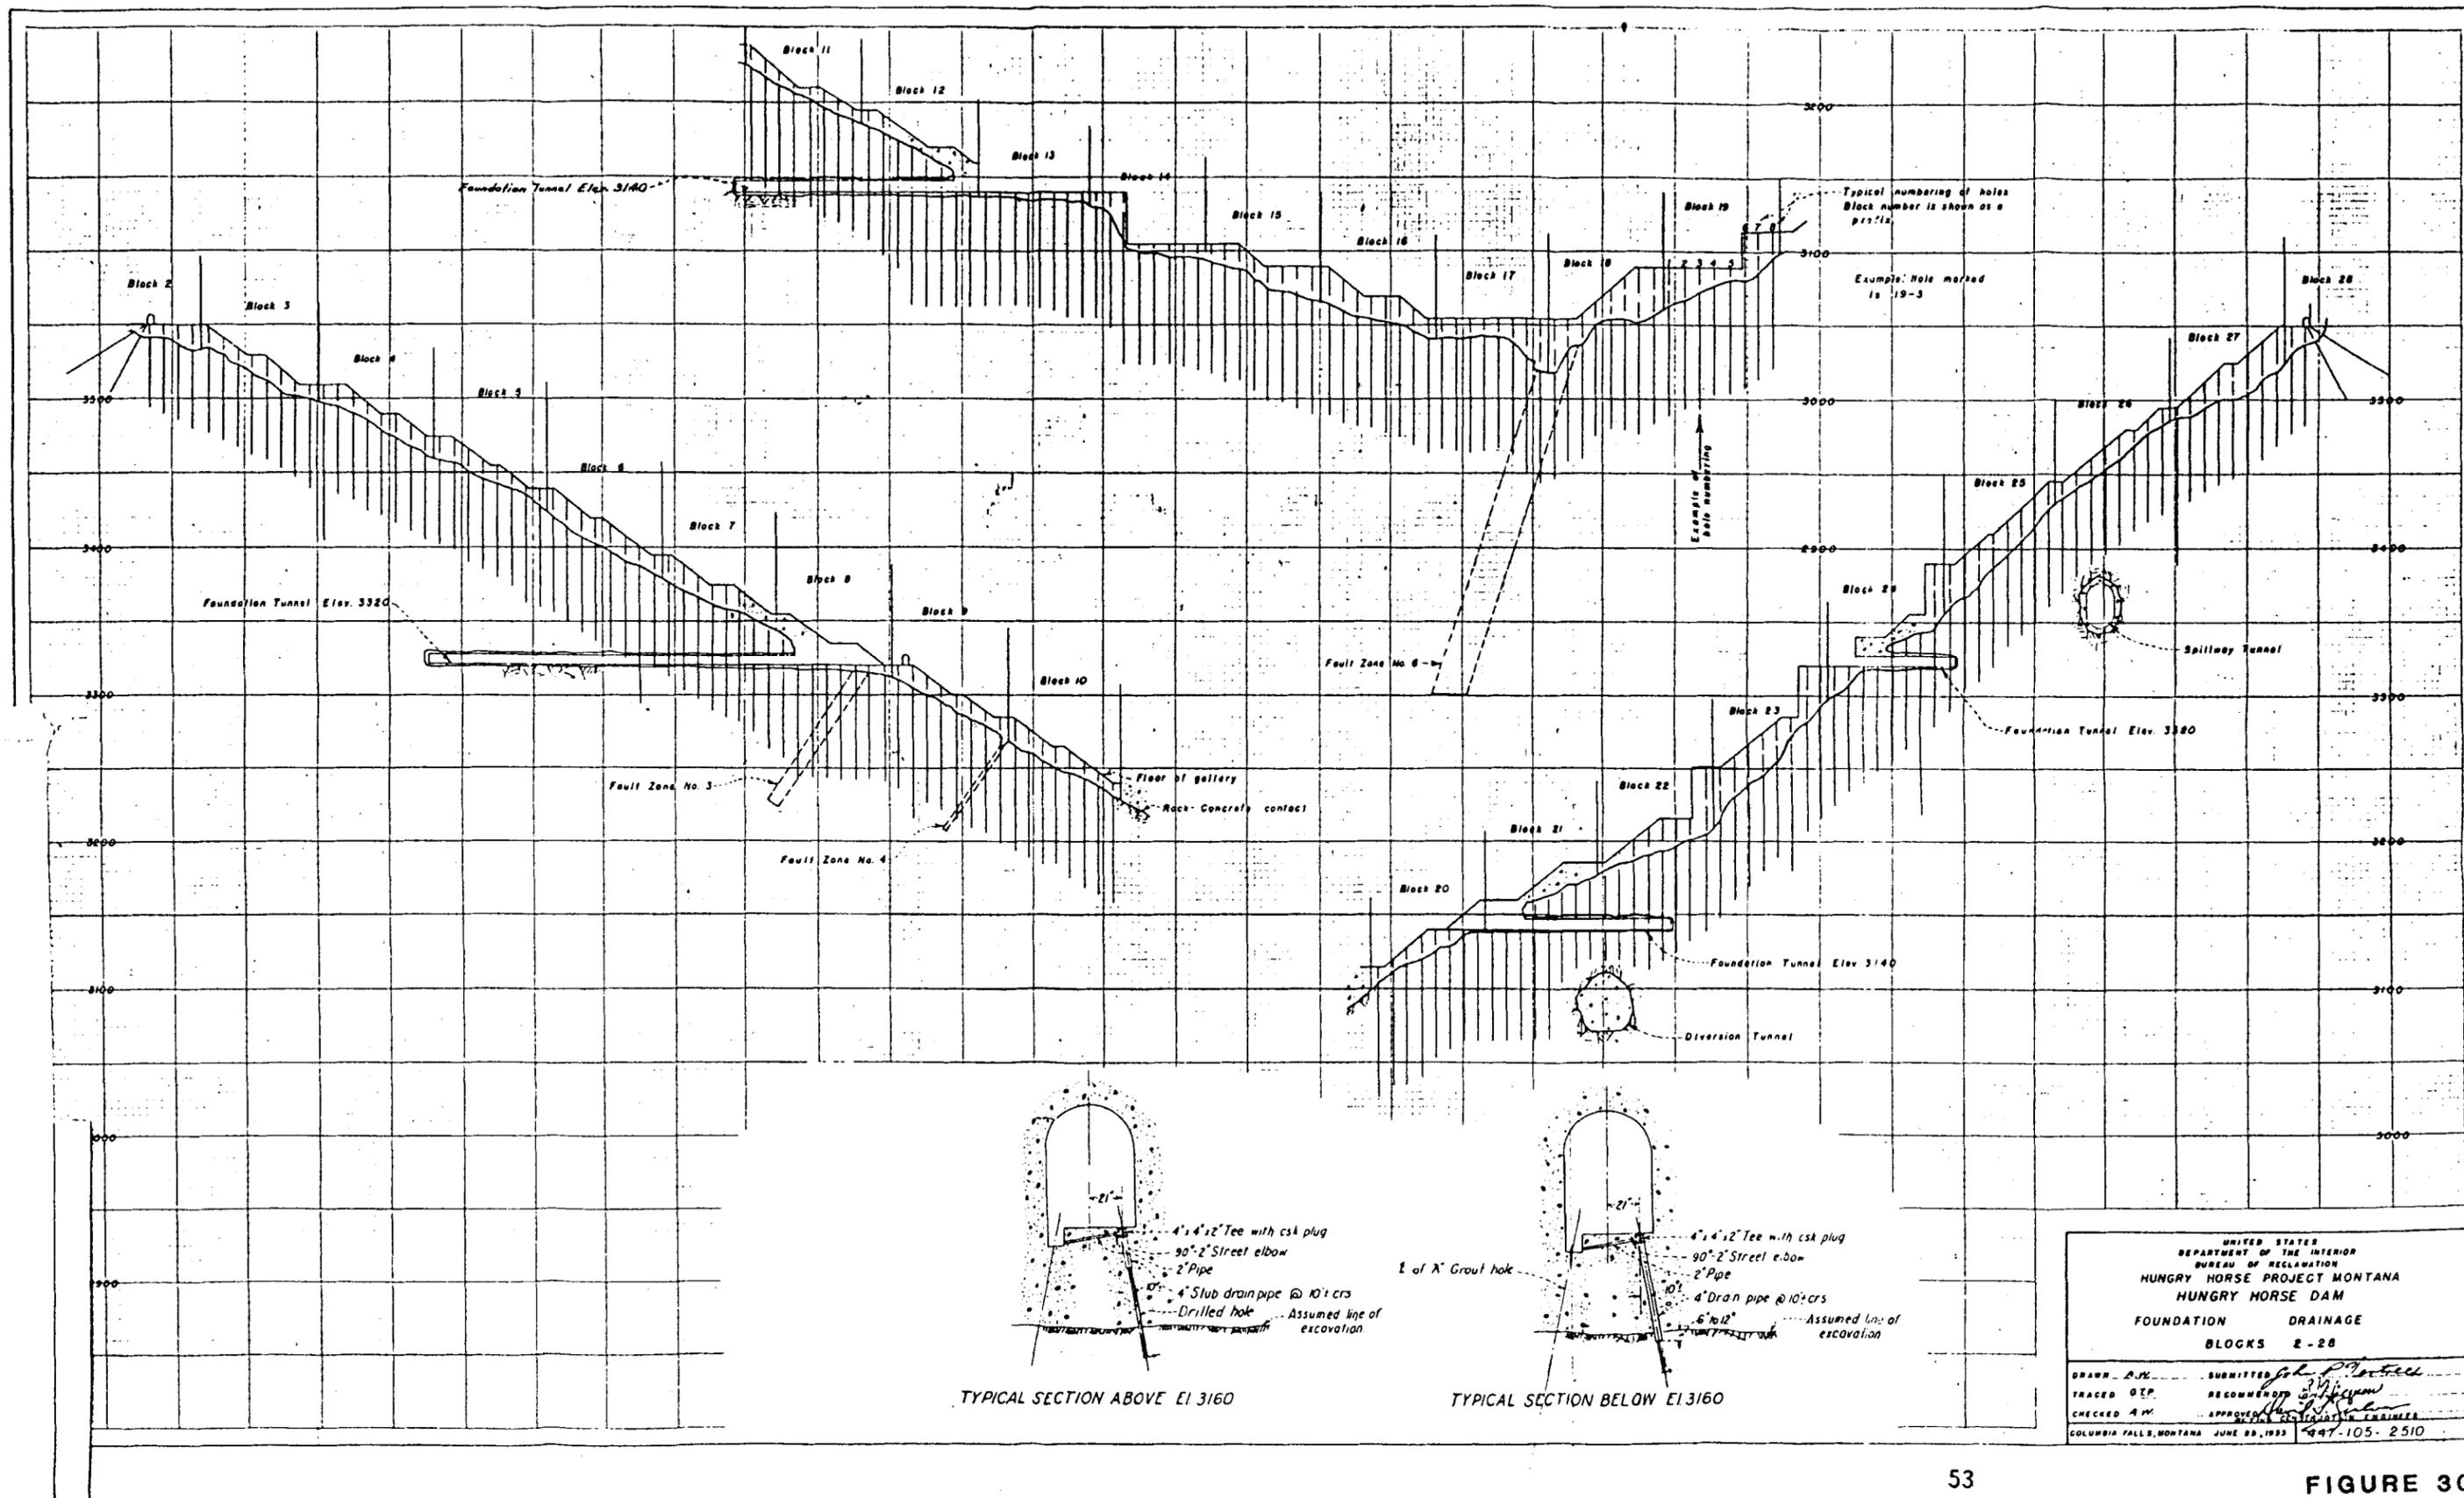
UNITED STATES  
DEPARTMENT OF THE INTERIOR  
BUREAU OF RECLAMATION  
HUNGRY HORSE PROJECT MONTANA  
HUNGRY HORSE DAM  
FOUNDATION DRAINAGE  
BLOCKS 2-28

8. Foundation drainage. The profile of foundation drainage holes is shown on figure 30. Based on the limited data available from the explorations, the drainage holes penetrated through the zone of high-water takes and into the zone of low-water takes.

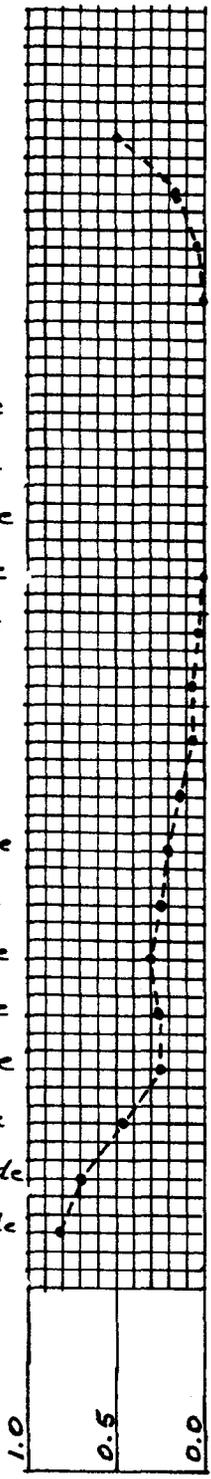
**UPLIFT OF DAM RESULTING FROM 'A' HOLE GROUTING**  
**TRACED FROM PAGE 27 OF 'GROUTING**  
**REPORT ON THE HUNGRY HORSE DAM'**

APPARENT UPLIFT IN INCHES

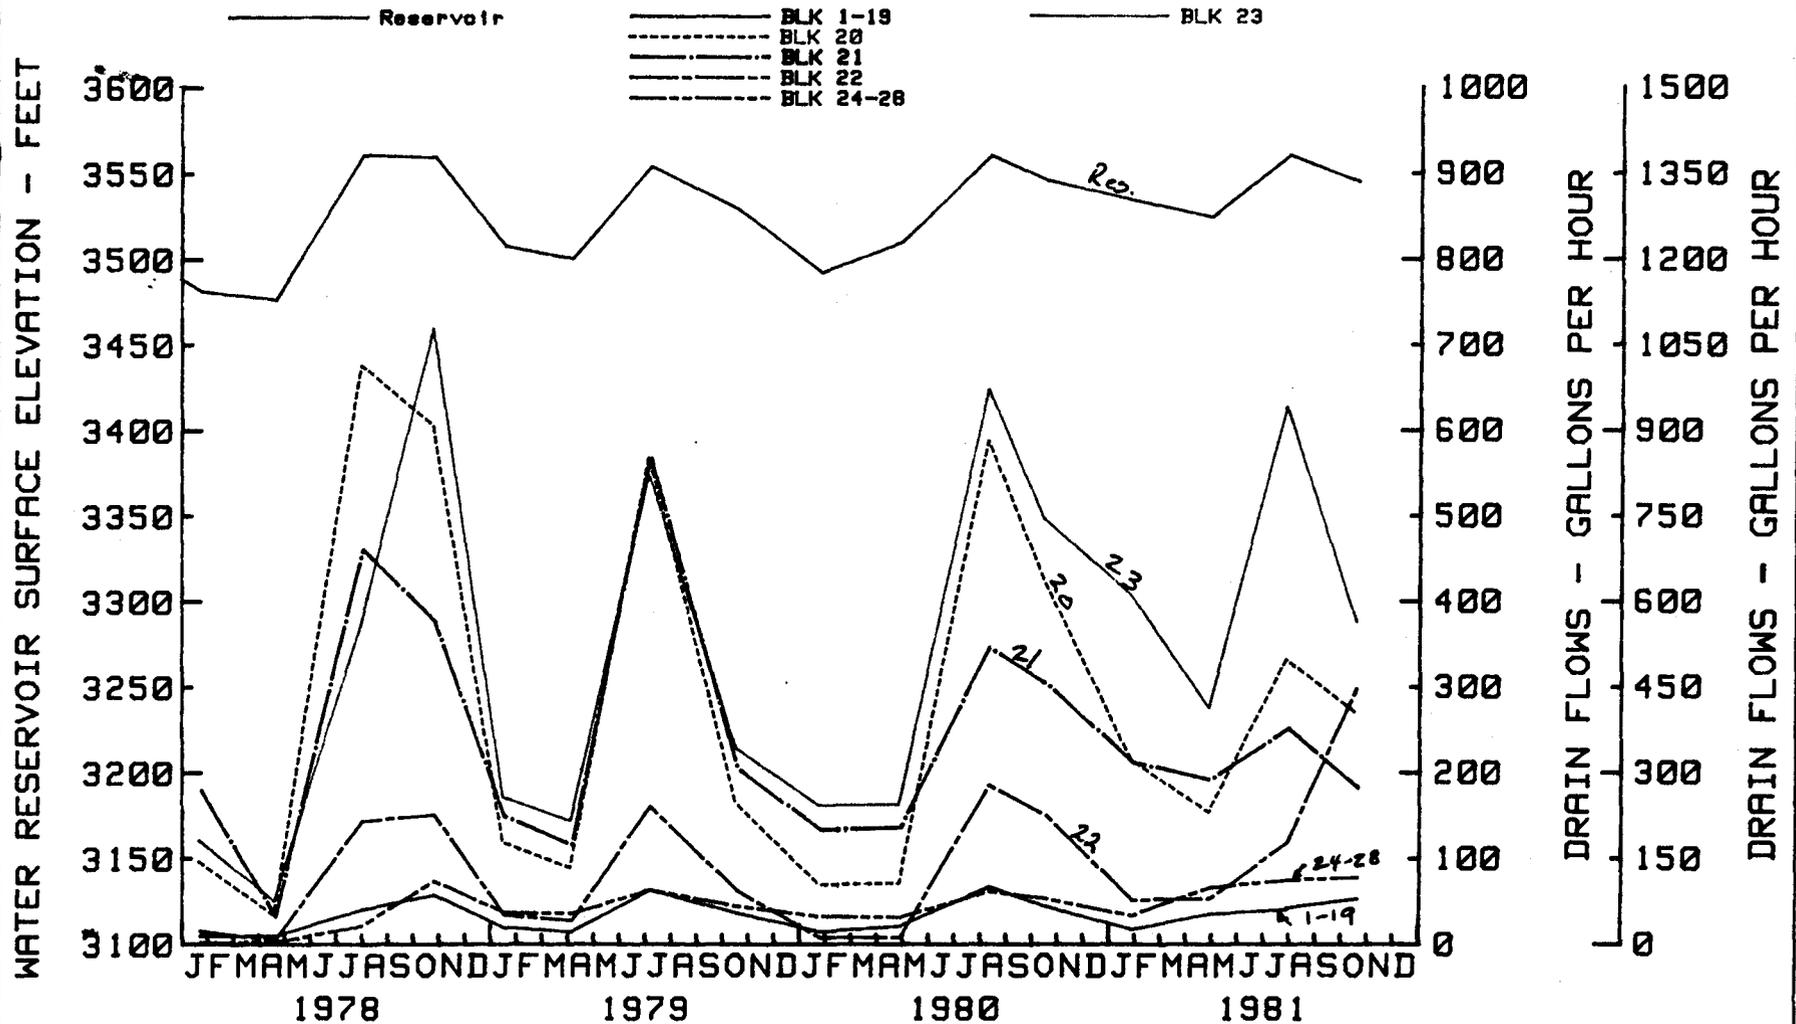
# HUNGRY HORSE DAM FOUNDATION DRAIN HOLES -- WATER FLOW

(a) Seepage. Plots of the flows from the foundation drain holes are presented on figure 35. The data indicate that the overall volume of drain flows is relatively low for a dam of this height. However, the plots indicate large fluctuations in the flows from blocks 20, 21, 22 and 23 when the reservoir level changes back and forth from about El. 3,500 to El. 3,560. For instance, the flow from block 23 increased in 1980 from a flow of 170 gph at a reservoir level of El. 3,490 to 650 gph at a reservoir level of El. 3,560. On a hydraulic head increase of 26 percent, the drain flow increased 382 percent. This increased flow probably includes seepage through the upstream construction joints and may not be related to foundation seepage. A letter<sup>(6)</sup> dated December 31, 1959 from the Regional Director to Assistant Commissioner and Chief Engineer, subject: "Water Leakage into the block 24 elevator and shaft and inspection gallery at elevation 3,550 -- Hungry Horse Dam etc." states in part: "Construction joints in blocks 3, 6, 8, 21 and 23 leak at the floor level when

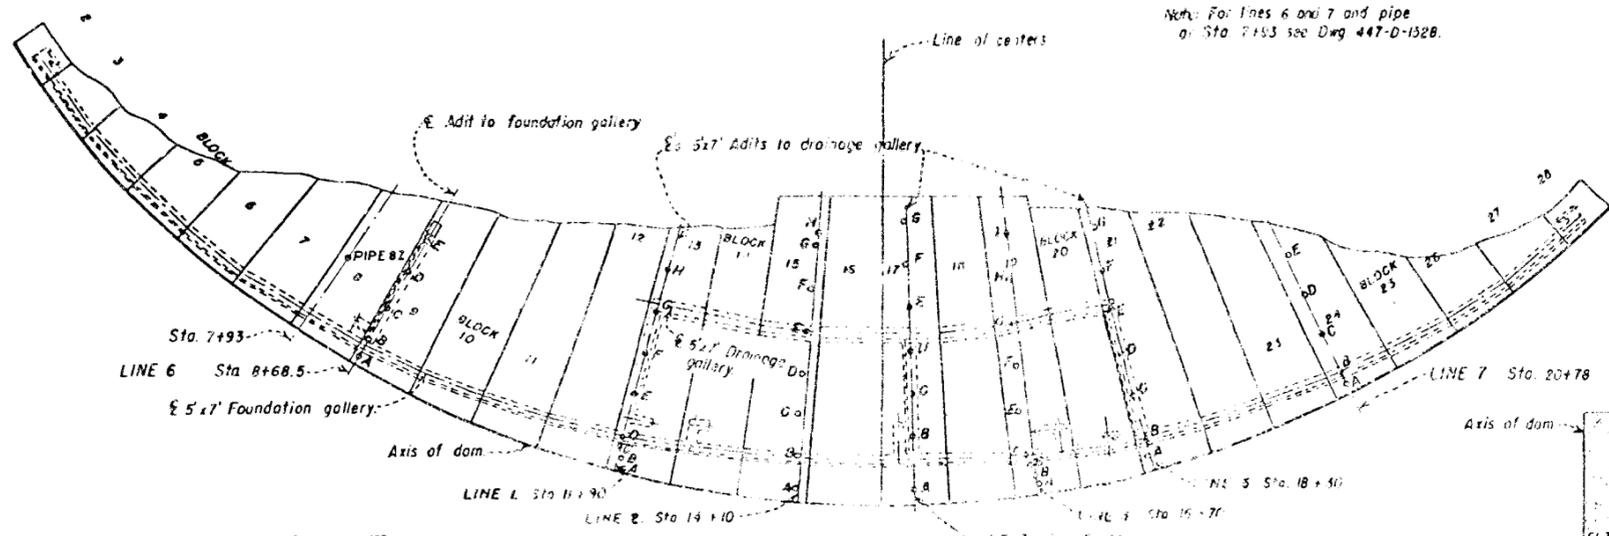
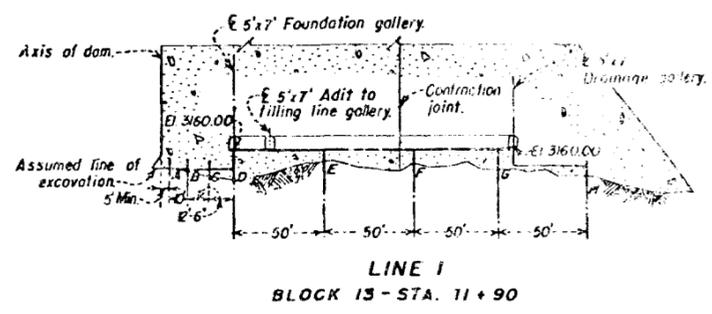
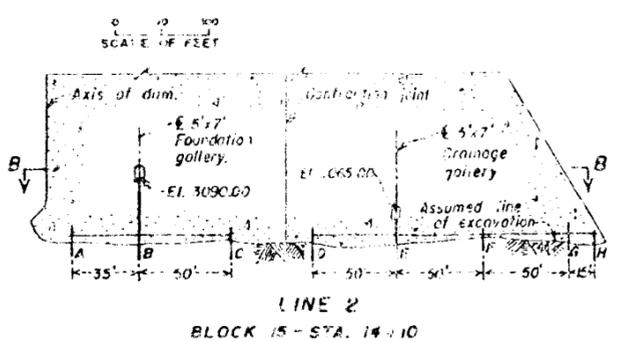
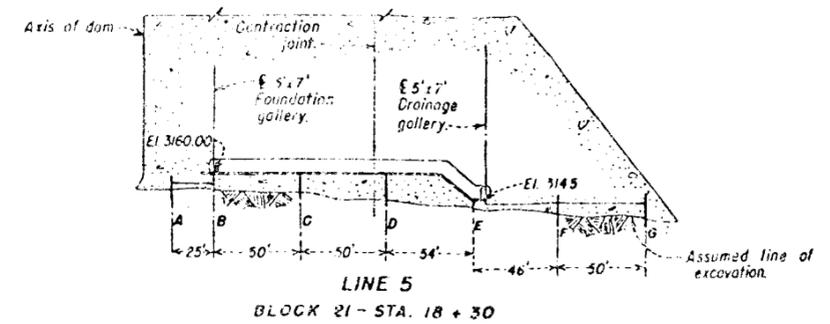
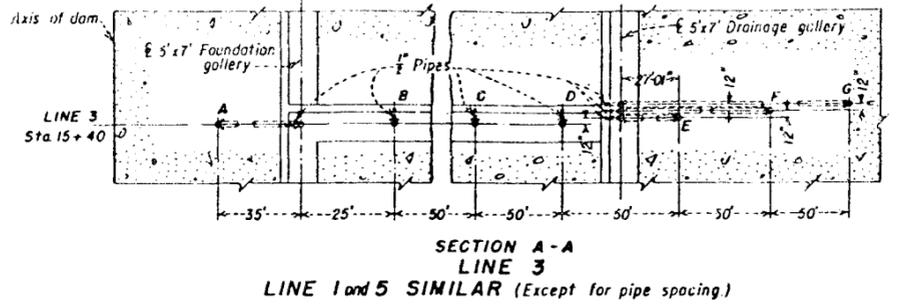
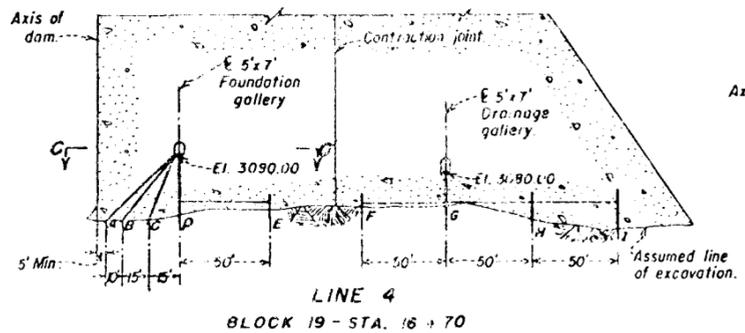
FIGURE 36

(b) Uplift. The plan and sections of the uplift pressure pipes are shown on figure 36. The data from the uplift pipes for the years 1965 through 1981 are plotted on figures 37 through 43, and the data for October 20, 1981 are plotted on sections through the dam for lines 1 through 7 on figures 44 through 50. These plots indicate a very high drop in uplift pressure from the most upstream pipe (A) to the pipes immediately at and downstream of the foundation galleries. Uplift pressures beneath the downstream half of the dam are very low.
