# ANALYSIS OF UTILIZATION OF GROUT AND GROUT CURTAINS — HUNGRY HORSE DAM

*February 1986*  
*Engineering and Research Center*

*U.S. Department of the Interior*  
*Bureau of Reclamation*  
*Division of Research and*  
*Laboratory Services*  
*Concrete and Structural Branch*

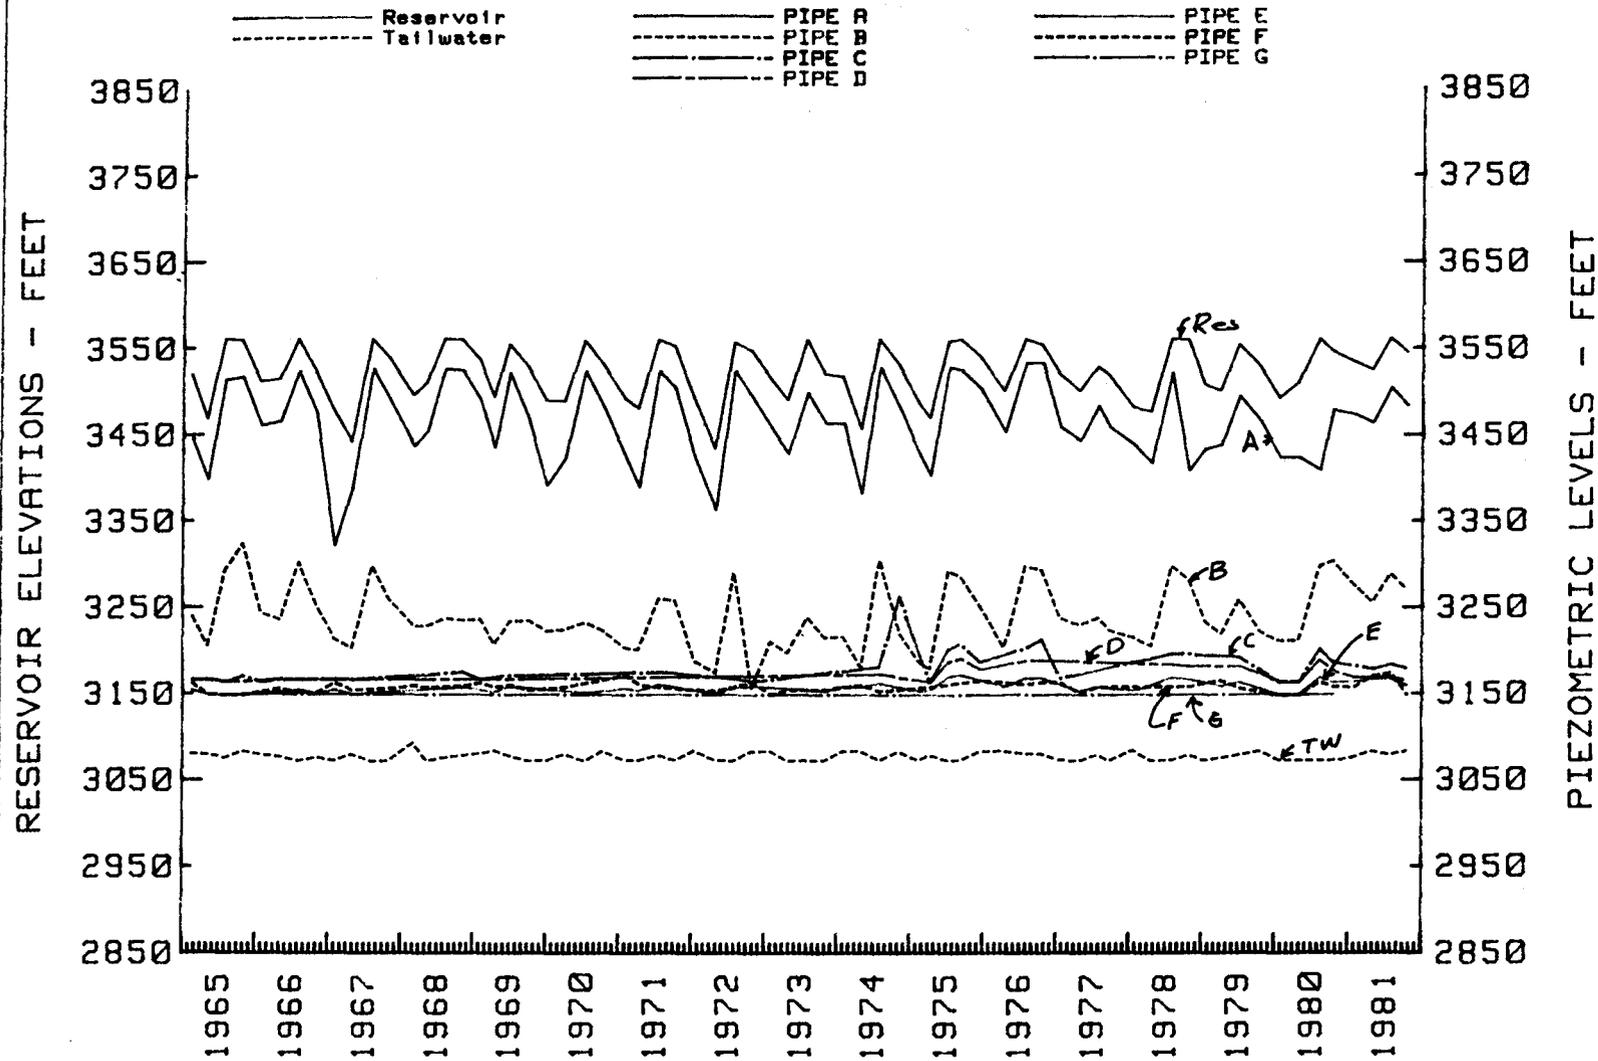
FIGURE 41

# HUNGRY HORSE DAM - UPLIFT PRESSURES LINE 5

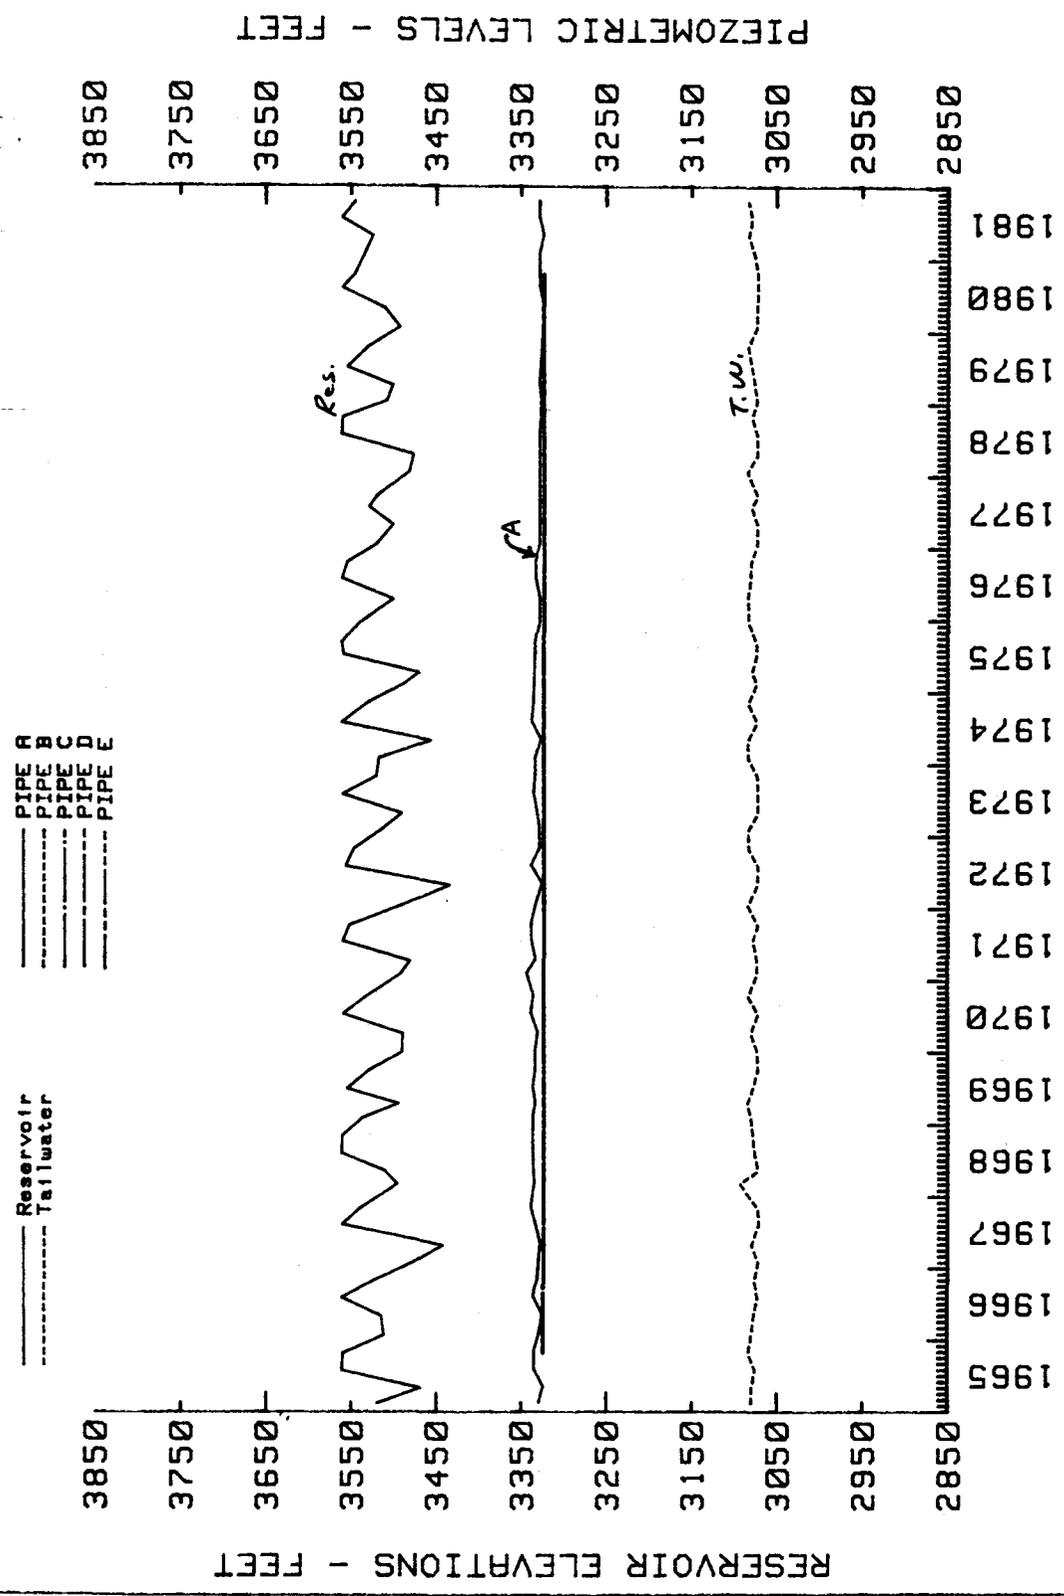
FIGURE 42

### HUNGRY HORSE DAM - UPLIFT PRESSURES LINE 6

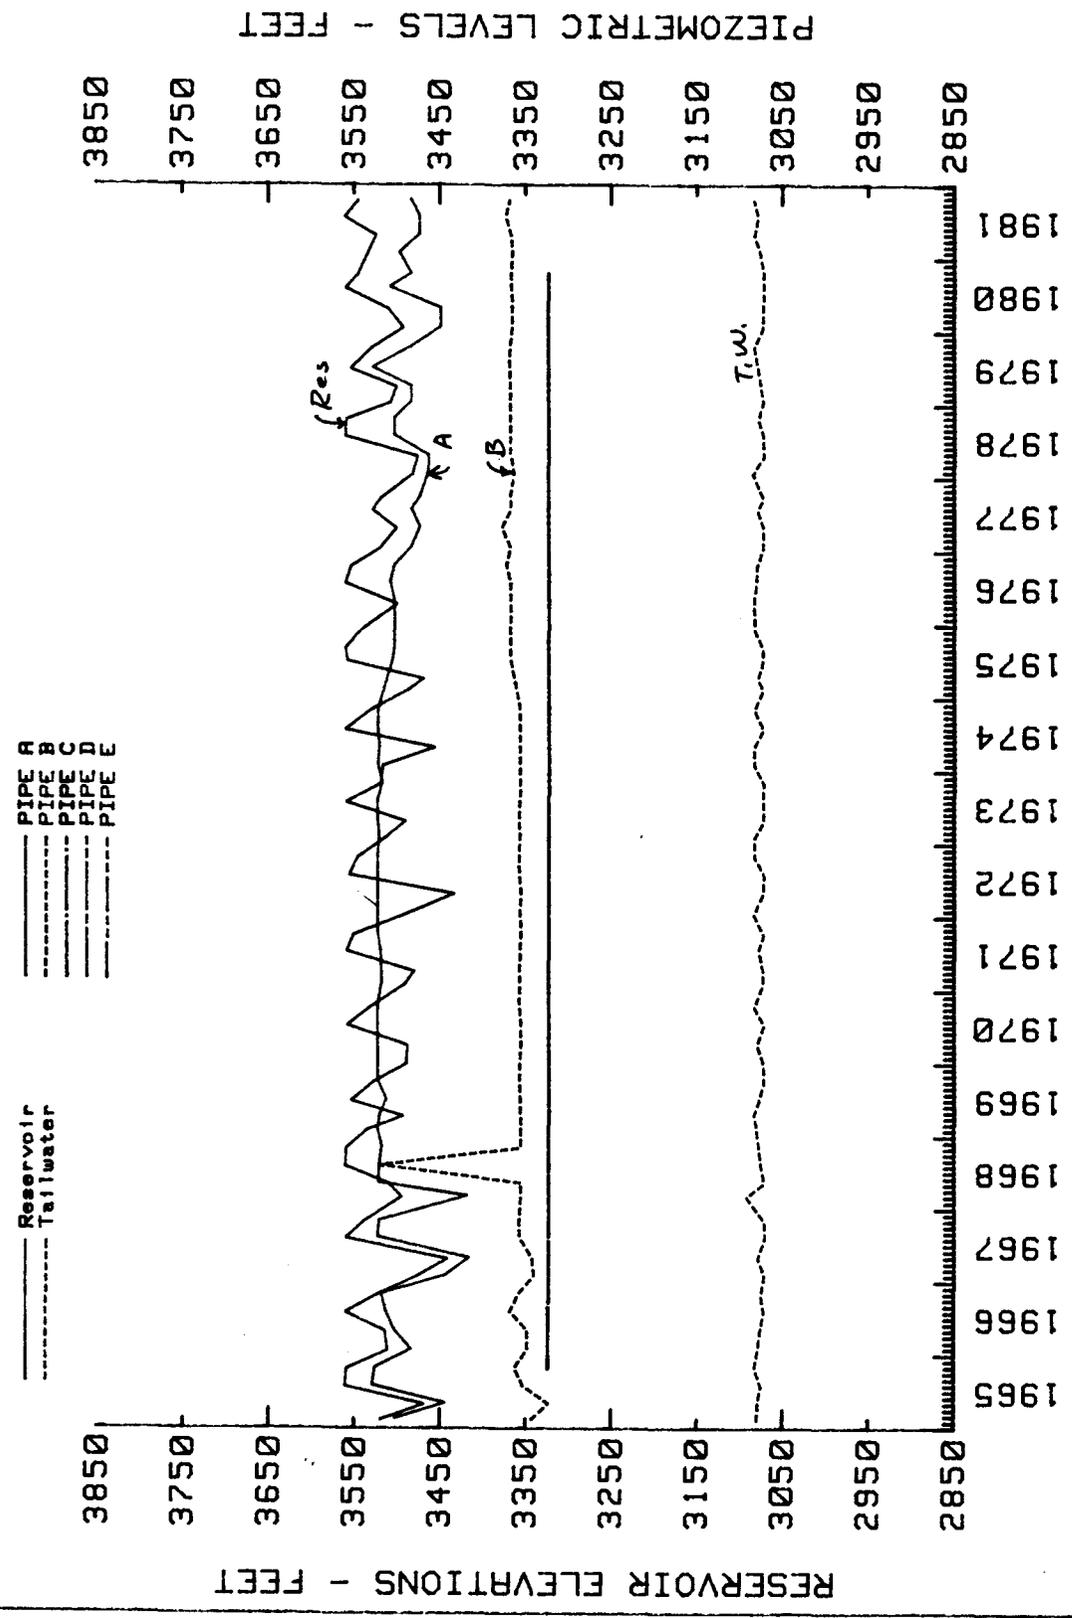
FIGURE 43

HUNGRY HORSE DAM - UPLIFT PRESSURES  
LINE 7

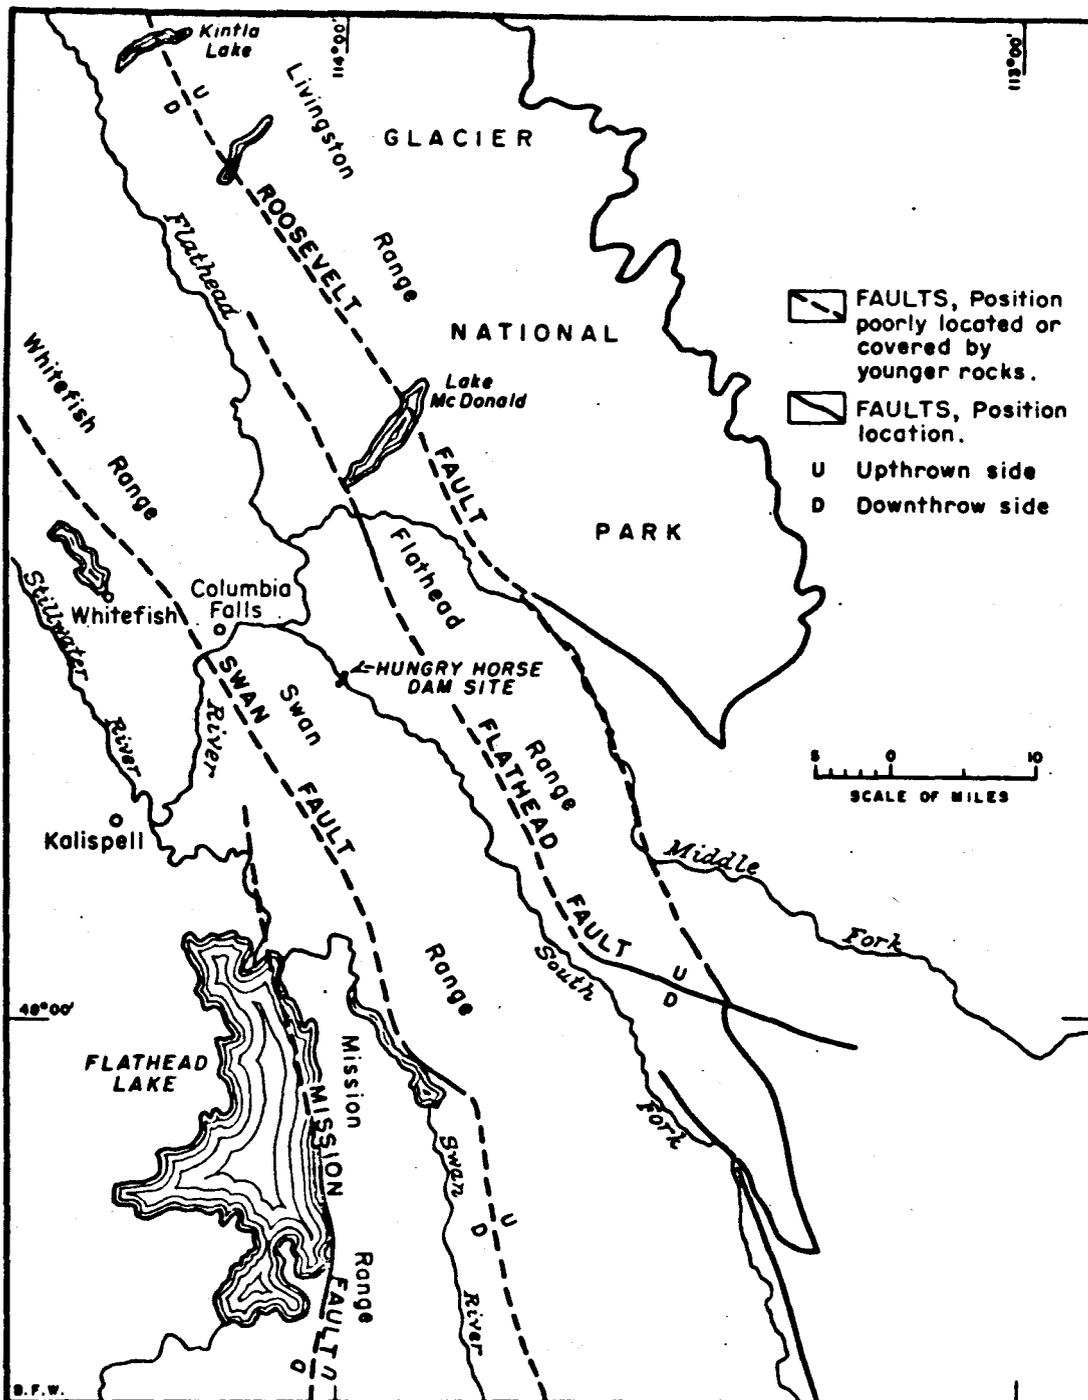
11. Structural Geology. - Several major faults exist in the Hungry Horse area, as shown on figure 4. During the Tertiary period, mountain building forces uplifted and folded the rocks in northwestern Montana, then broke them along steeply dipping thrust faults. These stresses built up until the deformed and stonger Belt Series of rocks were thrust eastward over the younger and weaker Mesozoic rocks of the Great Plains region. The structural valleys and uplifted mountain blocks which trend north-northwest were developed by these thrust faults. These faults dip northeast at an angle of  $60^{\circ}$  to  $80^{\circ}$ , and the displacement varies from 10,000 to 30,000 feet.

Figure 4. --Sketch showing the location of the major faults in the vicinity of Hungry Horse Dam site.

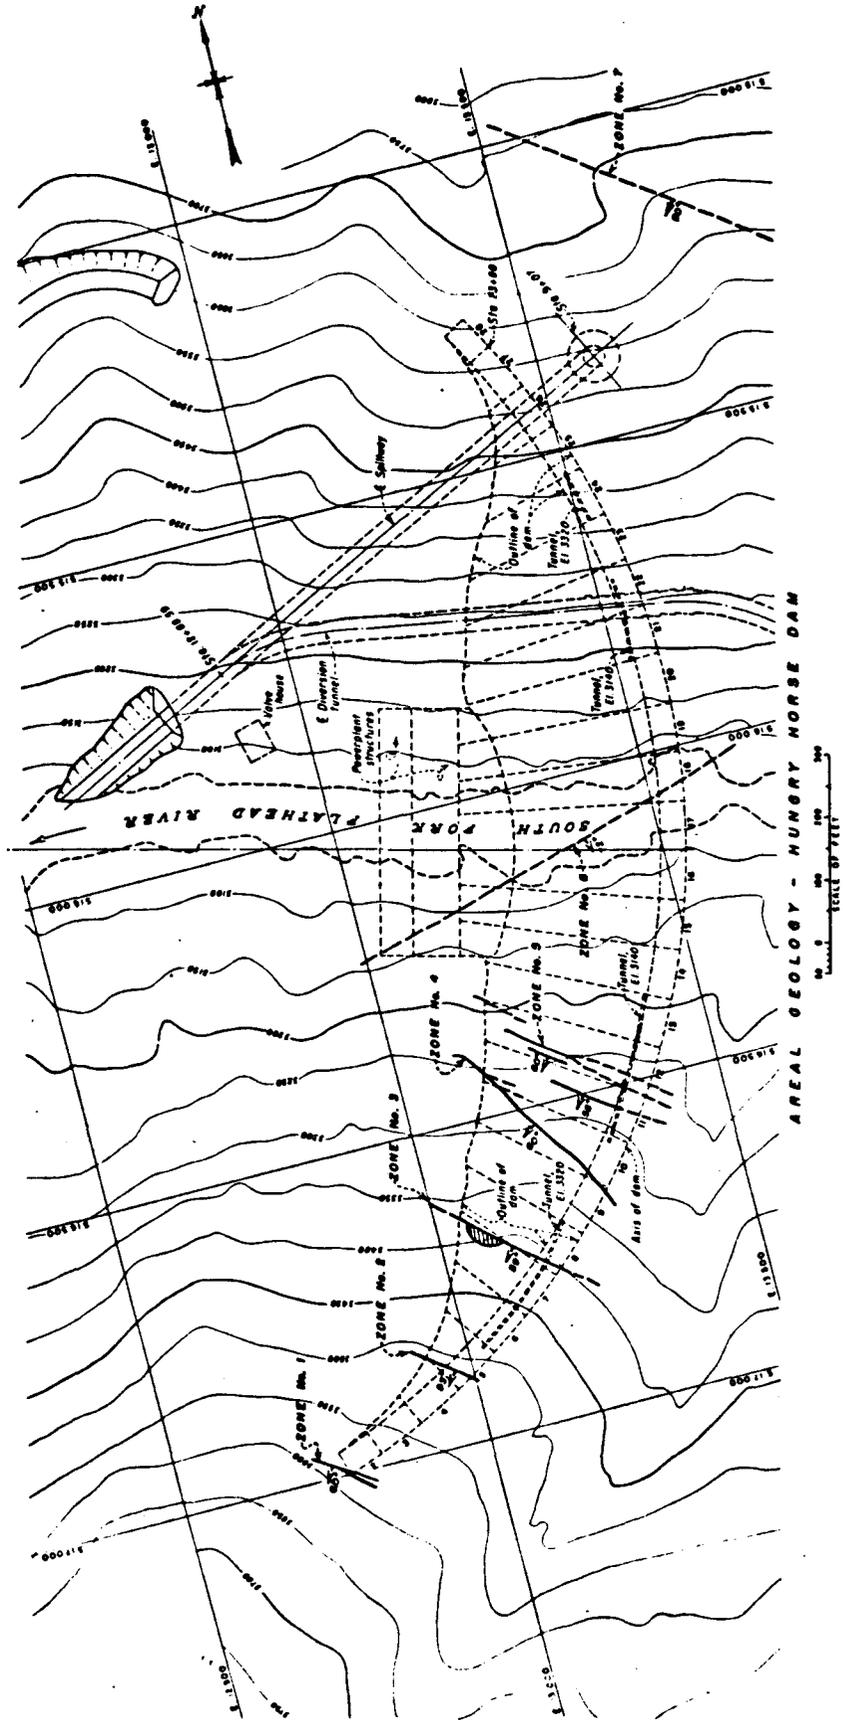
18. Faults. - Figure 7 shows the location of faults on an areal map of the dam. In the original exploration for the dam, only one fault, later called fault zone No. 6, was discovered and thoroughly explored by diamond drill cores. During stripping of the foundation six other faults were uncovered. Of these faults, No. 3 in blocks 7 and 8, No. 4 in blocks 9 to 11, and No. 6 in blocks 15 to 18 were large enough to require cutoff shafts and trenching of the zones where they crossed the foundation. Fault zones No. 1 in block 2, No. 2 in block 5, and No. 5 in block 12 were minor faults and required only trenching of the zone. There was no evidence of recent movement along any of these faults. The excavation and grouting of the faults is summarized under the chapter on grouting. A brief description of the faults as disclosed during investigation and later treatment follows:

Figure 7. --Areal geology of the selected dam site.
