# **ANALYSIS OF UTILIZATION OF GROUT AND GROUT CURTAINS — HERON DAM**

*February 1986  
Engineering and Research Center*

*U.S. Department of the Interior  
Bureau of Reclamation  
Division of Research and  
Laboratory Services  
Concrete and Structural Branch*

1. REPORT NO. GR-86-7		2. GOVERNMENT ACCESSION NO.		3. RECIPIENT'S CATALOG NO.	
4. TITLE AND SUBTITLE 3 Analysis of Utilization of Grout and Grout Curtains-Heron Dam 3			5. REPORT DATE 4 February 1986 4

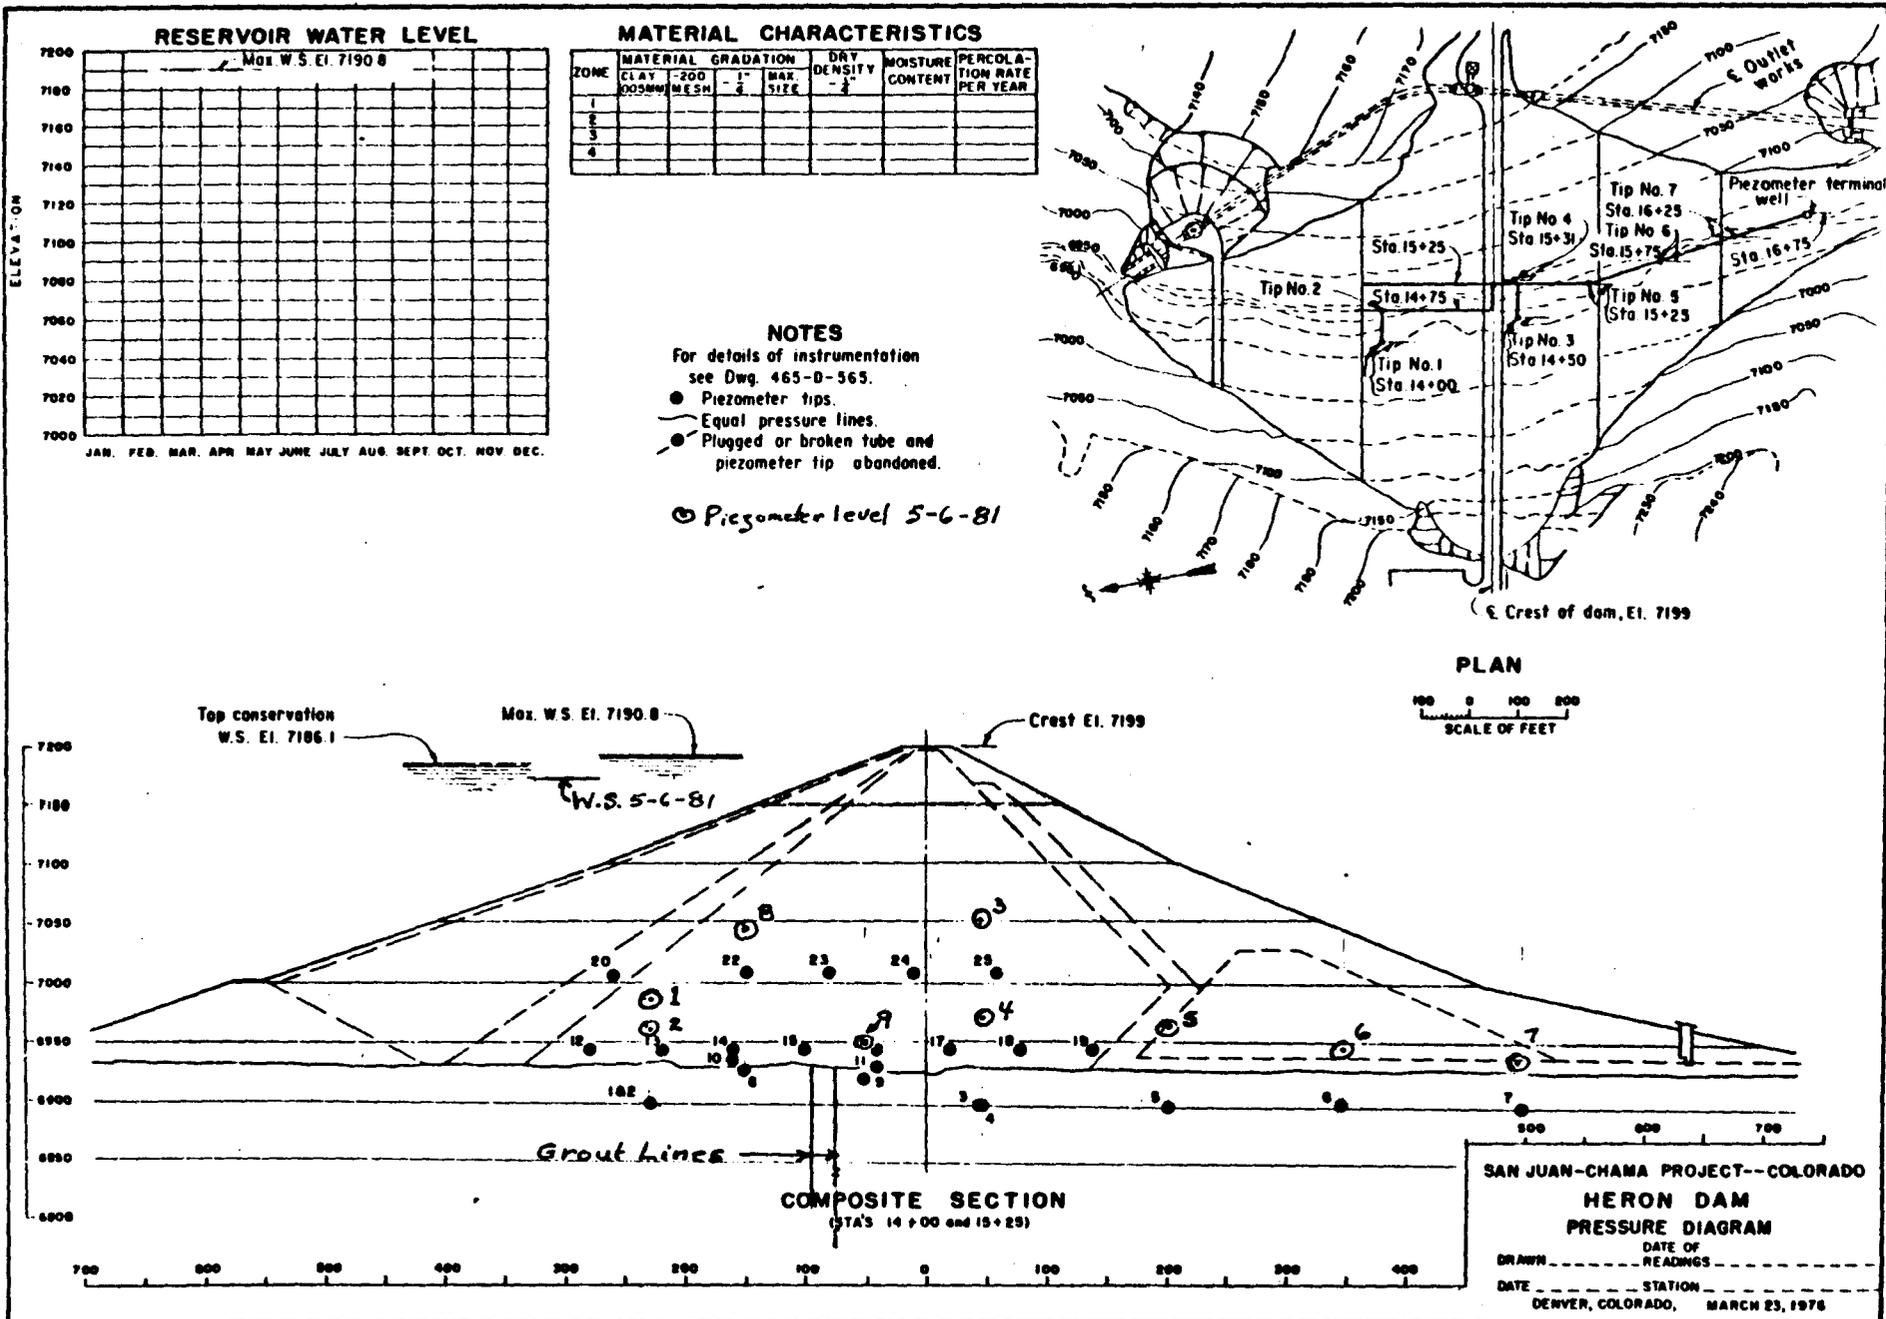
FIGURE 8

(d) Piezometric pressures - dam. It is reported that only the foundation piezometers have repeatable readings. A plot of the readings for May 6, 1981, are shown on figure 8. The scaled reading for the reservoir water surface for that day was El. 7,172 feet. As no tailwater was shown on the computer

The general trend of the deep piezometers is a gradual reduction in piezometric level from upstream to downstream with no particular drop at the grout curtain, which is what should be expected in the relatively tight rock found in the valley bottom.

It is concluded that there is insufficient data to prove or disprove whether the grout curtain has any effect on the piezometric levels in the foundation rock.

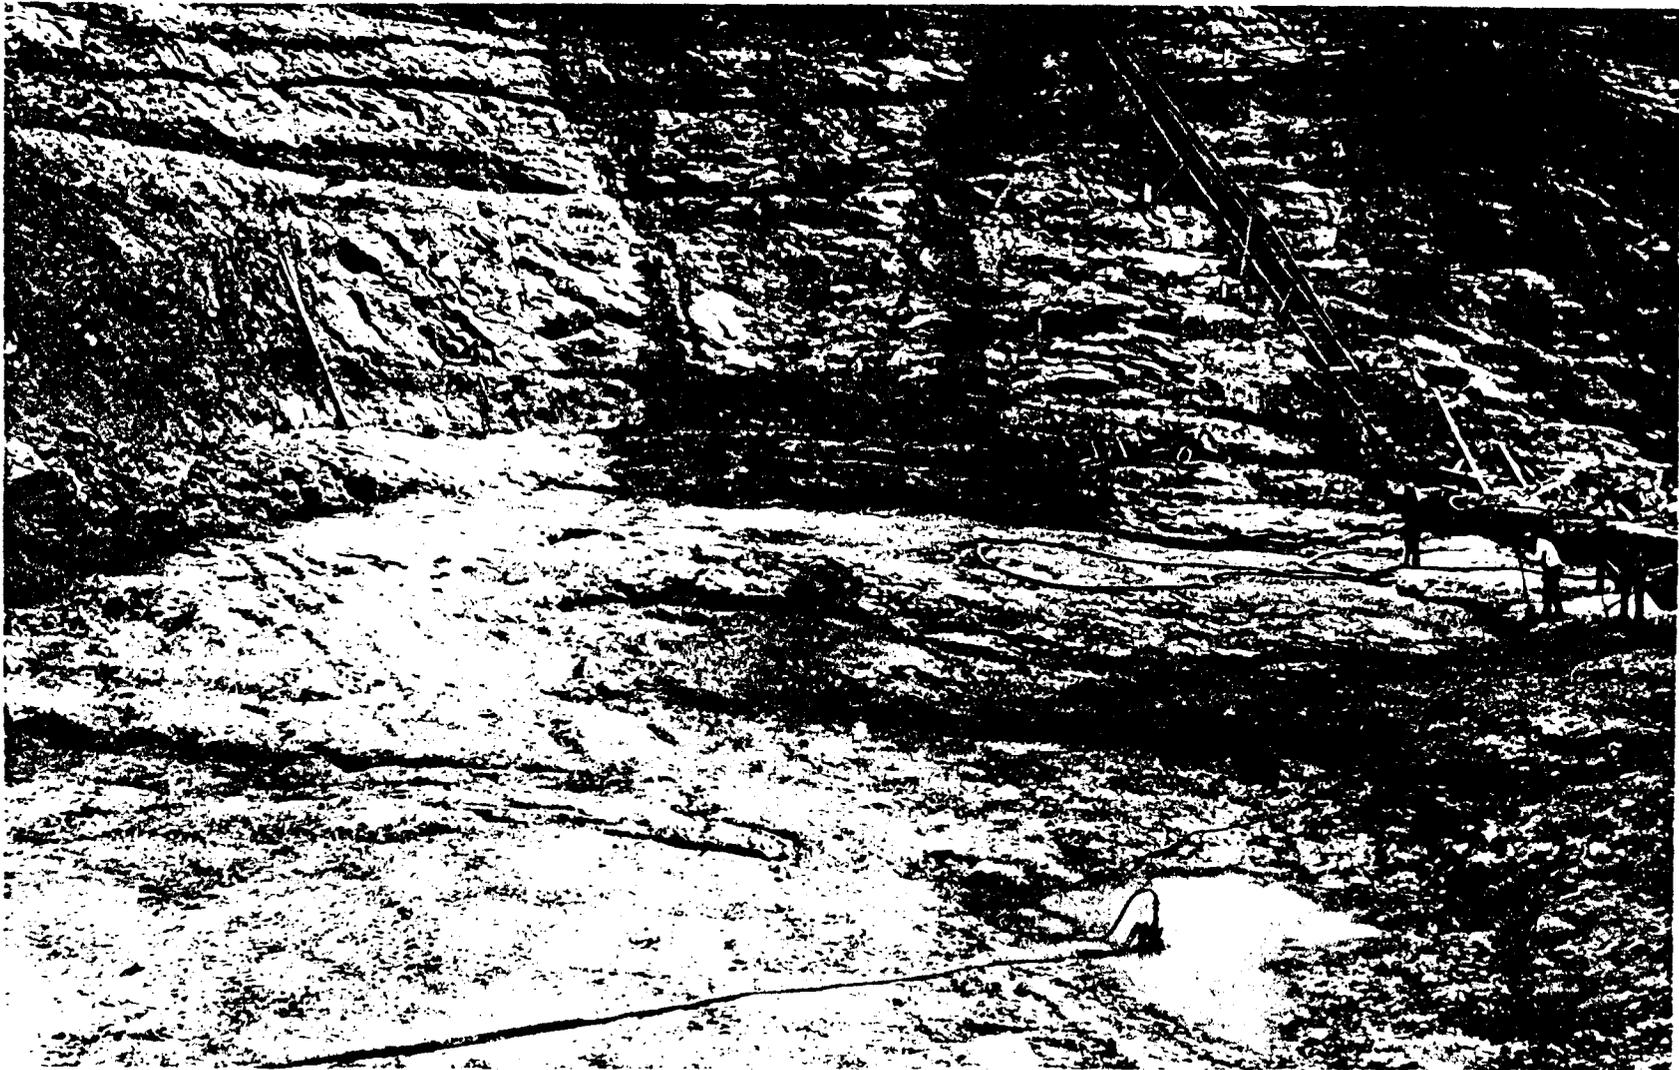
Figure 21

P465-523-2345NA Heron Dam and Relocation of State Highway No. 95--San Juan-Chama Project--  
Colorado-New Mexico Heron Dam embankment foundation following final cleanup and prior to  
placing Zone 1 material downstream of the grout cap and against the right abutment. The  
ladder on the slope is above the grout cap.  
Specifications No. DC-6558 Universal Constructors, Inc.  
9-3-69 Bureau of Reclamation Photo by D. Manning

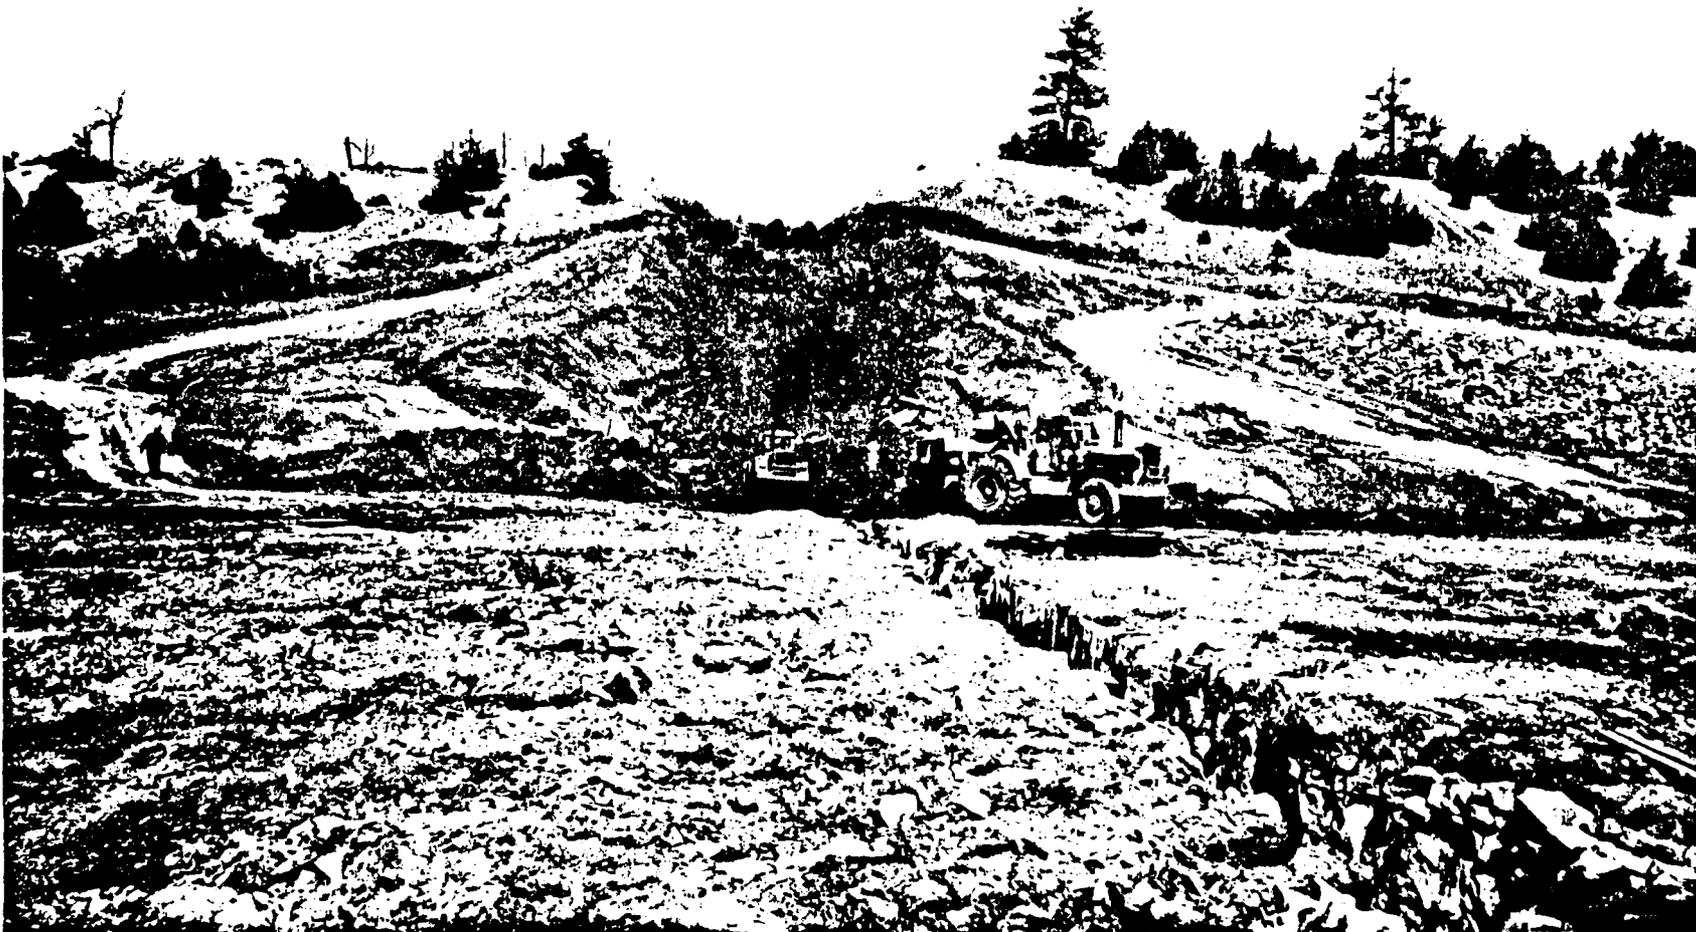
P465-523-1742NA Heron Dam and Relocation of State Highway No. 95--San Juan-Chama Project--  
Colorado-New Mexico Looking west at a section of the excavated grout cap trench on the  
dike. Foundation trench excavation is under way in the background between Stations  
21+00 and Station 27+00.  
Specifications No. DC-6553 Universal Constructors, Inc.  
4-30-63 Bureau of Reclamation Photo by D. Manning

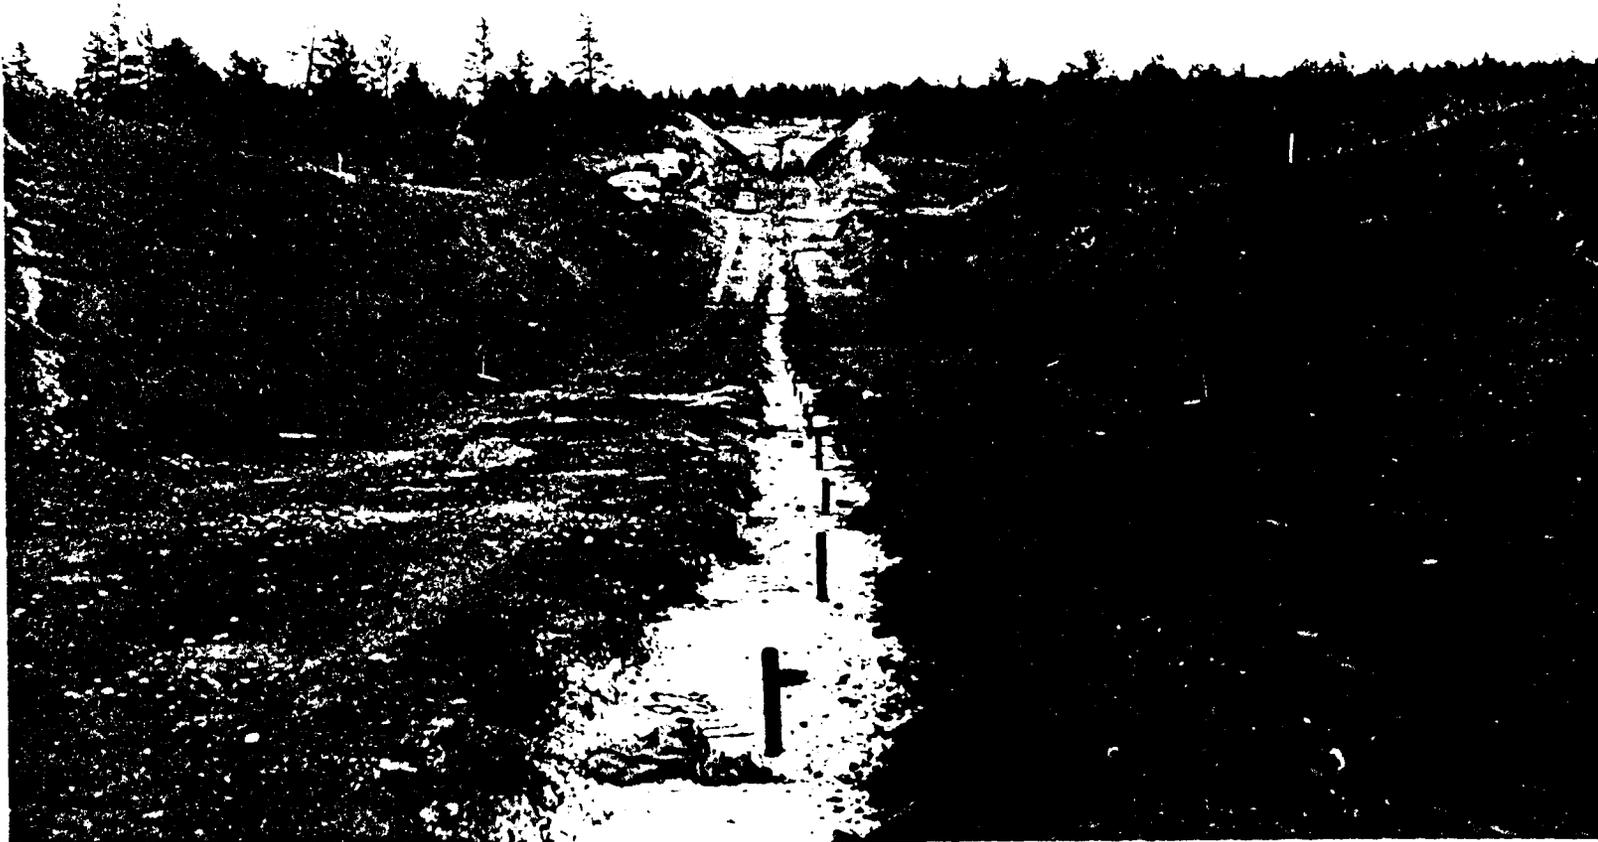
P465-528-1830NA Heron Dam--San Juan-Chama Project--Colorado-New Mexico View of the grout cap and foundation trench of the dike section looking southeast from station 11+60. Specifications No. DC-6553 Universal Constructors Inc. 7-2-68 Bureau of Reclamation Photo by K. Cooper

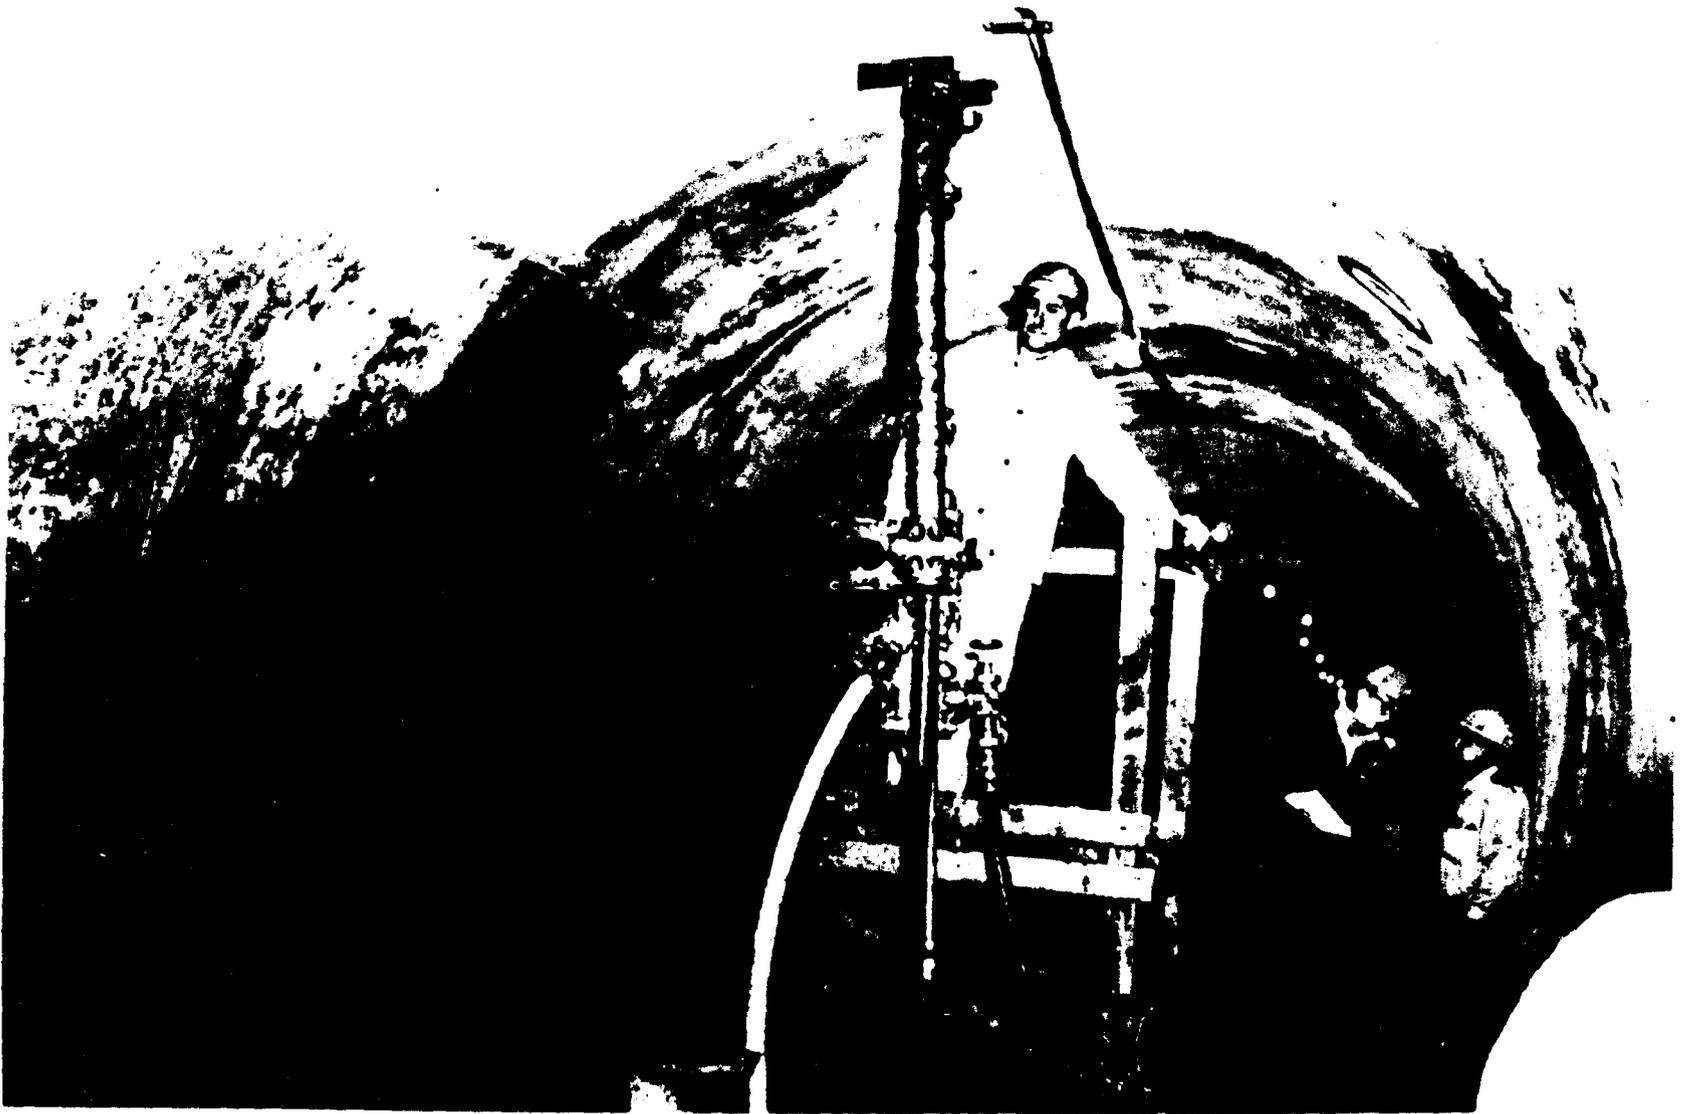
Drilling was accomplished with Chicago Pneumatic No. 65 drills mounted on a 4-inch diameter pipe and equipped with clamps designed to clamp onto a 2-inch or 3-inch diameter pipe nipple (Photograph No. P465-528-2214NA), and Reich (Chicago-Pneumatic) Model C-350 crawler mounted drills. The Reich drills were an all hydraulic drilling unit with a top drive rotary head. Diamond plug bits and drag bits were generally used for drilling the sandstone and shale members, respectively, (Photograph Nos. P465-528-1851NA, -1852NA, -2627NA, and -2628NA).

P465-528-2214NA Outlet Works Tunnel-Heron Dam--San Juan-Chama Project--Colorado-New Mexico  
Mike Figarelle, an employee of Keltner Drilling Company drills a grout hole with a Chicago  
Pneumatic No. 65 drill in Heron Dam Outlet Works Tunnel.  
Specifications No. DC-6558 Keltner Drilling Company, sub-contractor  
5-14-69 Bureau of Reclamation Photo by D. Manning

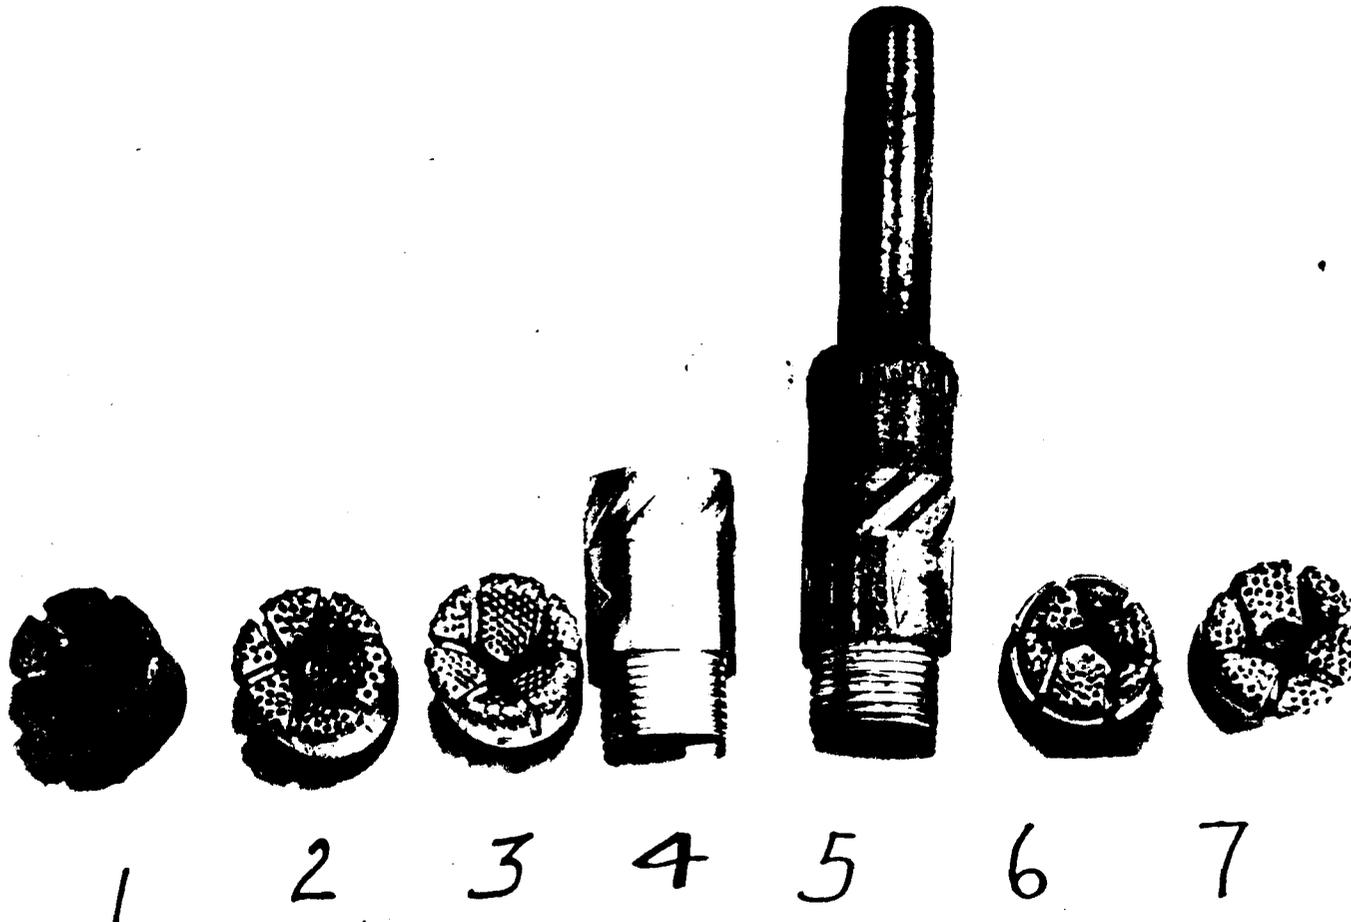
P465-528-2627NA Heron Dam--San Juan-Chama Project--Colorado-New Mexico Drill bits used by Layne Texas on Heron Dam. (1) AX bit (Christensen #A5506) - Drilled 2,833 L.F. "H" Grade diamonds 5 stones per carat. (2) AX bit (Christensen #C2285) "A" Grade diamonds 5 stones per carat. Diamond wt 26.36 carats. (3) AX bit (Christensen #24520) "H" Grade diamonds. 8 stones per carat. (4) AX Resmer Shell B Grade diamonds. 15 stones per carat. Diamond wt 5.50 carats. (5) EX to AX hole opener bit with pilot. (6) AX bit outer edge shoved off after drilling steel. (7) AX bit small crystals of pyrite were found in water ways which caused center of bit to be cored out. Specifications No. DC-6558 Layne Texas Company, sub-contractor 8-19-70 Bureau of Reclamation Photo by D. Manning

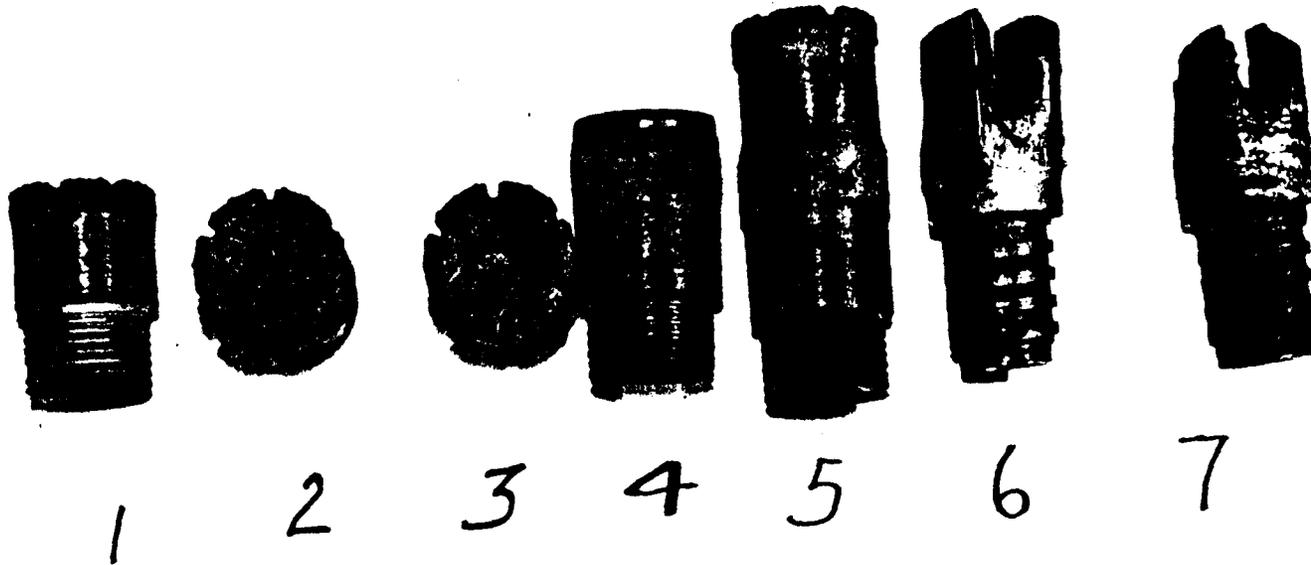
P465-528-2628NA Heron Dam--San Juan-Chama Project--Colorado-New Mexico Drill bits used by Layne Texas on Heron Dam. (1) thru (3) Typical used AX diamond bits. (4) Typical used AX Reamer Shell. (5) Typical used AX bit with reamer shell. (6) New AX three-way drag bit. (7) Used AX three-way drag bit.  
Specifications No. DC-6558 Layne Texas Company, sub-contractor  
8-19-70 Bureau of Reclamation Photo by D. Manning

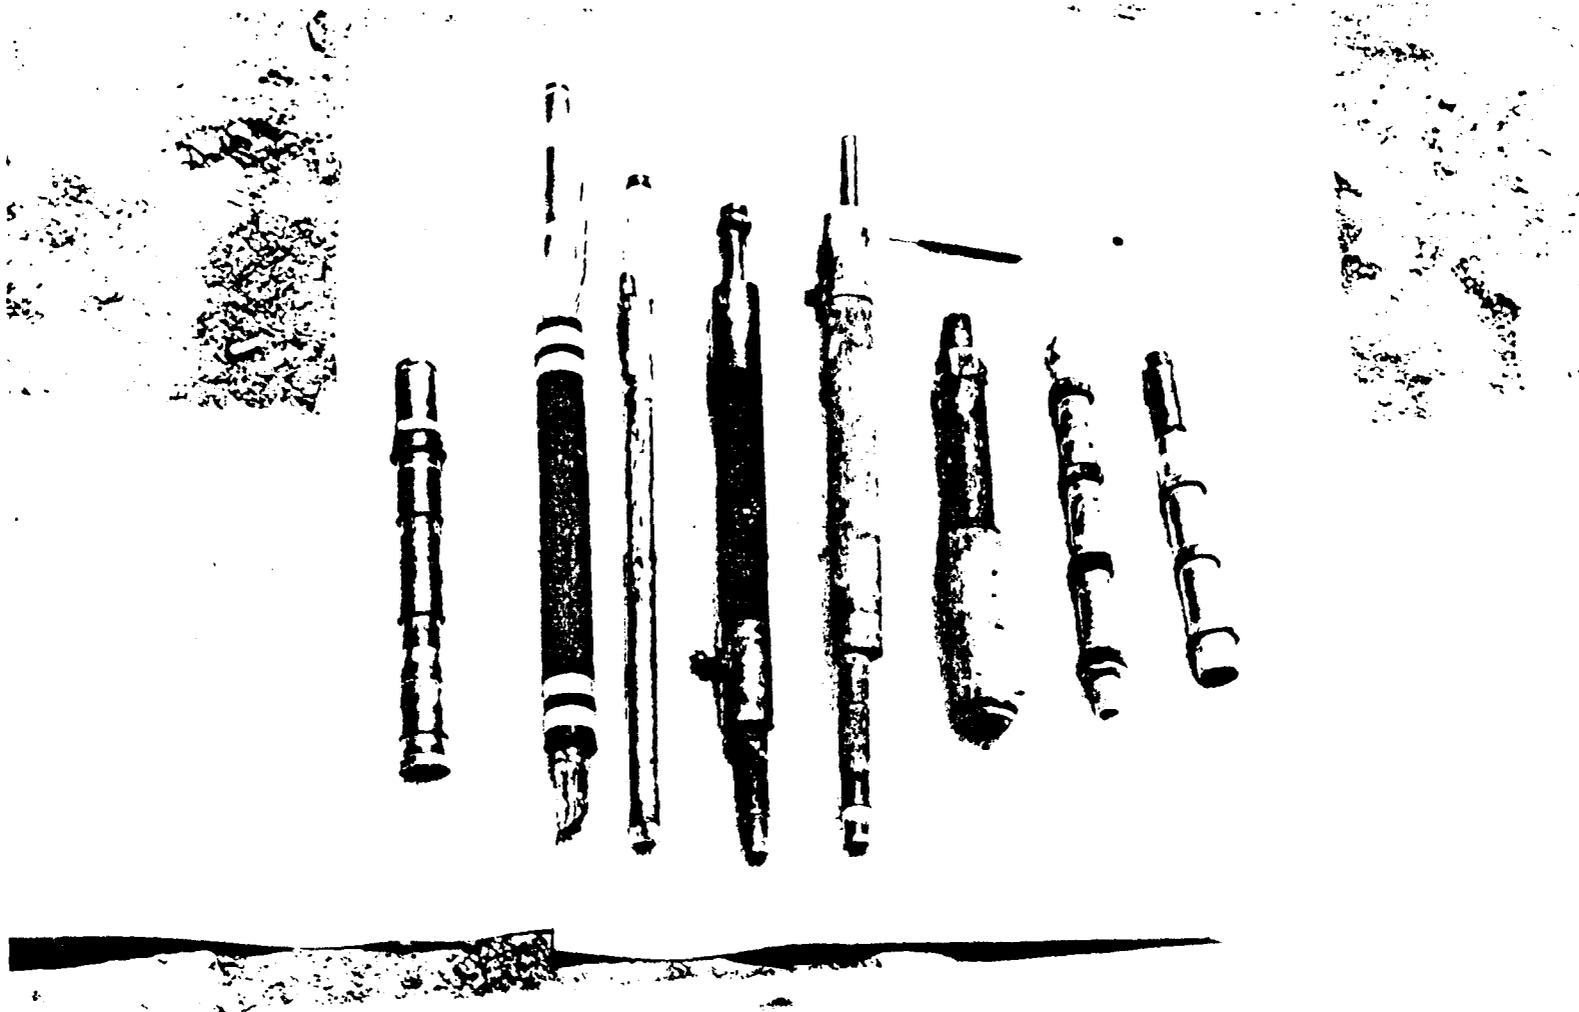
Commercial pneumatic packer frames manufactured by the Damco Manufacturing Company, Dallas, Texas, were used exclusively by the subcontractor from August 1968 to October 1969 (Photograph No. P465-528-2639NA). The disadvantage of these packers was that the AX (2" diameter) packer had only a 3/8-inch diameter opening through the packer. This small opening severely choked flow through the packer. A test run was made to demonstrate to the subcontractor how the small 3/8-inch pipe through the packer restricted the flow of water at different pressures. For instance, total volume was restricted to 11.2 cubic feet in 5 minutes with 88 psi water pressure.

P465-528-2639NA Heron Dam--San Juan-Chama Project--Colorado-New Mexico Packers used by Layne Texas Company on Heron Dam. (1) AX Leather cup packer 1" I.D. (2) AX Shop constructed pneumatic packer 3/4" I.D. (3) AX Shop constructed pneumatic packer w/o rubber element 3/4" I.D. (4) AX Pneumatic (Damco) packer 3/8" I.D. (5) Same as No. 4. (6) AX Squeeze packer 1/2" I.D. (7) EX Leather cup packer 1/2" I.D. (8) Ex Leather cup packer 3/4" I.D.

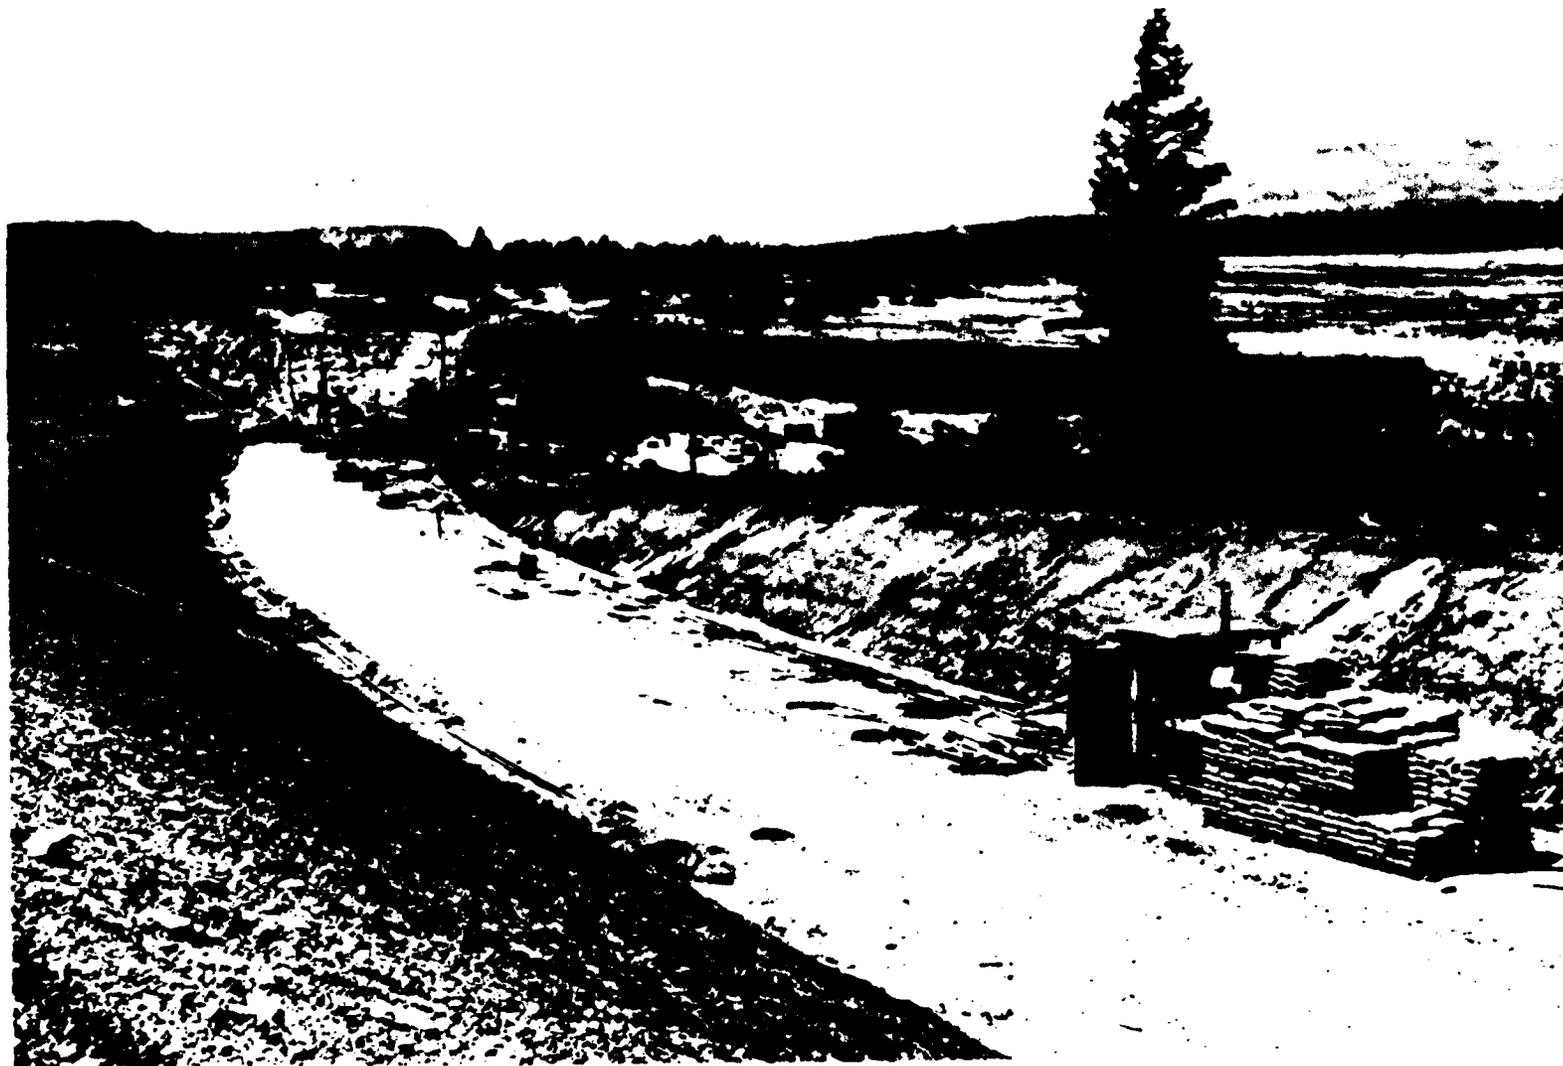
Drilling of the first hole on the 1,000-foot extended curtain on the left abutment was started in April 1970, and drilling and grouting operations continued until completion in July 1970 (Photograph No. P465-528-2566NA). Drawing No. 465-D-372 illustrates the general layout of the grout hole pattern. This pattern was generally followed except that between Station 18+29 and Station 20+54 back, the curtain was constructed upstream of the access shaft and gate chamber to give added protection to these facilities.

P465-528-2566NA Heron Dam--San Juan-Chama Project--Colorado-New Mexico General view of the 1,000 foot extended grout curtain on the left abutment of Heron Dam. Grout plant in the foreground is located at station 26+25.  
Specifications No. DC-6558 Layne Texas Company, sub-contractor  
4-11-70 Bureau of Reclamation Photo by D. Manning
