Sedimentation Survey
of
SHERIDAN COUNTY STATE LAKE
KANSAS

JANUARY 1950

UNITED STATES DEPARTMENT OF THE INTERIOR

BUREAU OF
RECLAMATION,
REGION 7

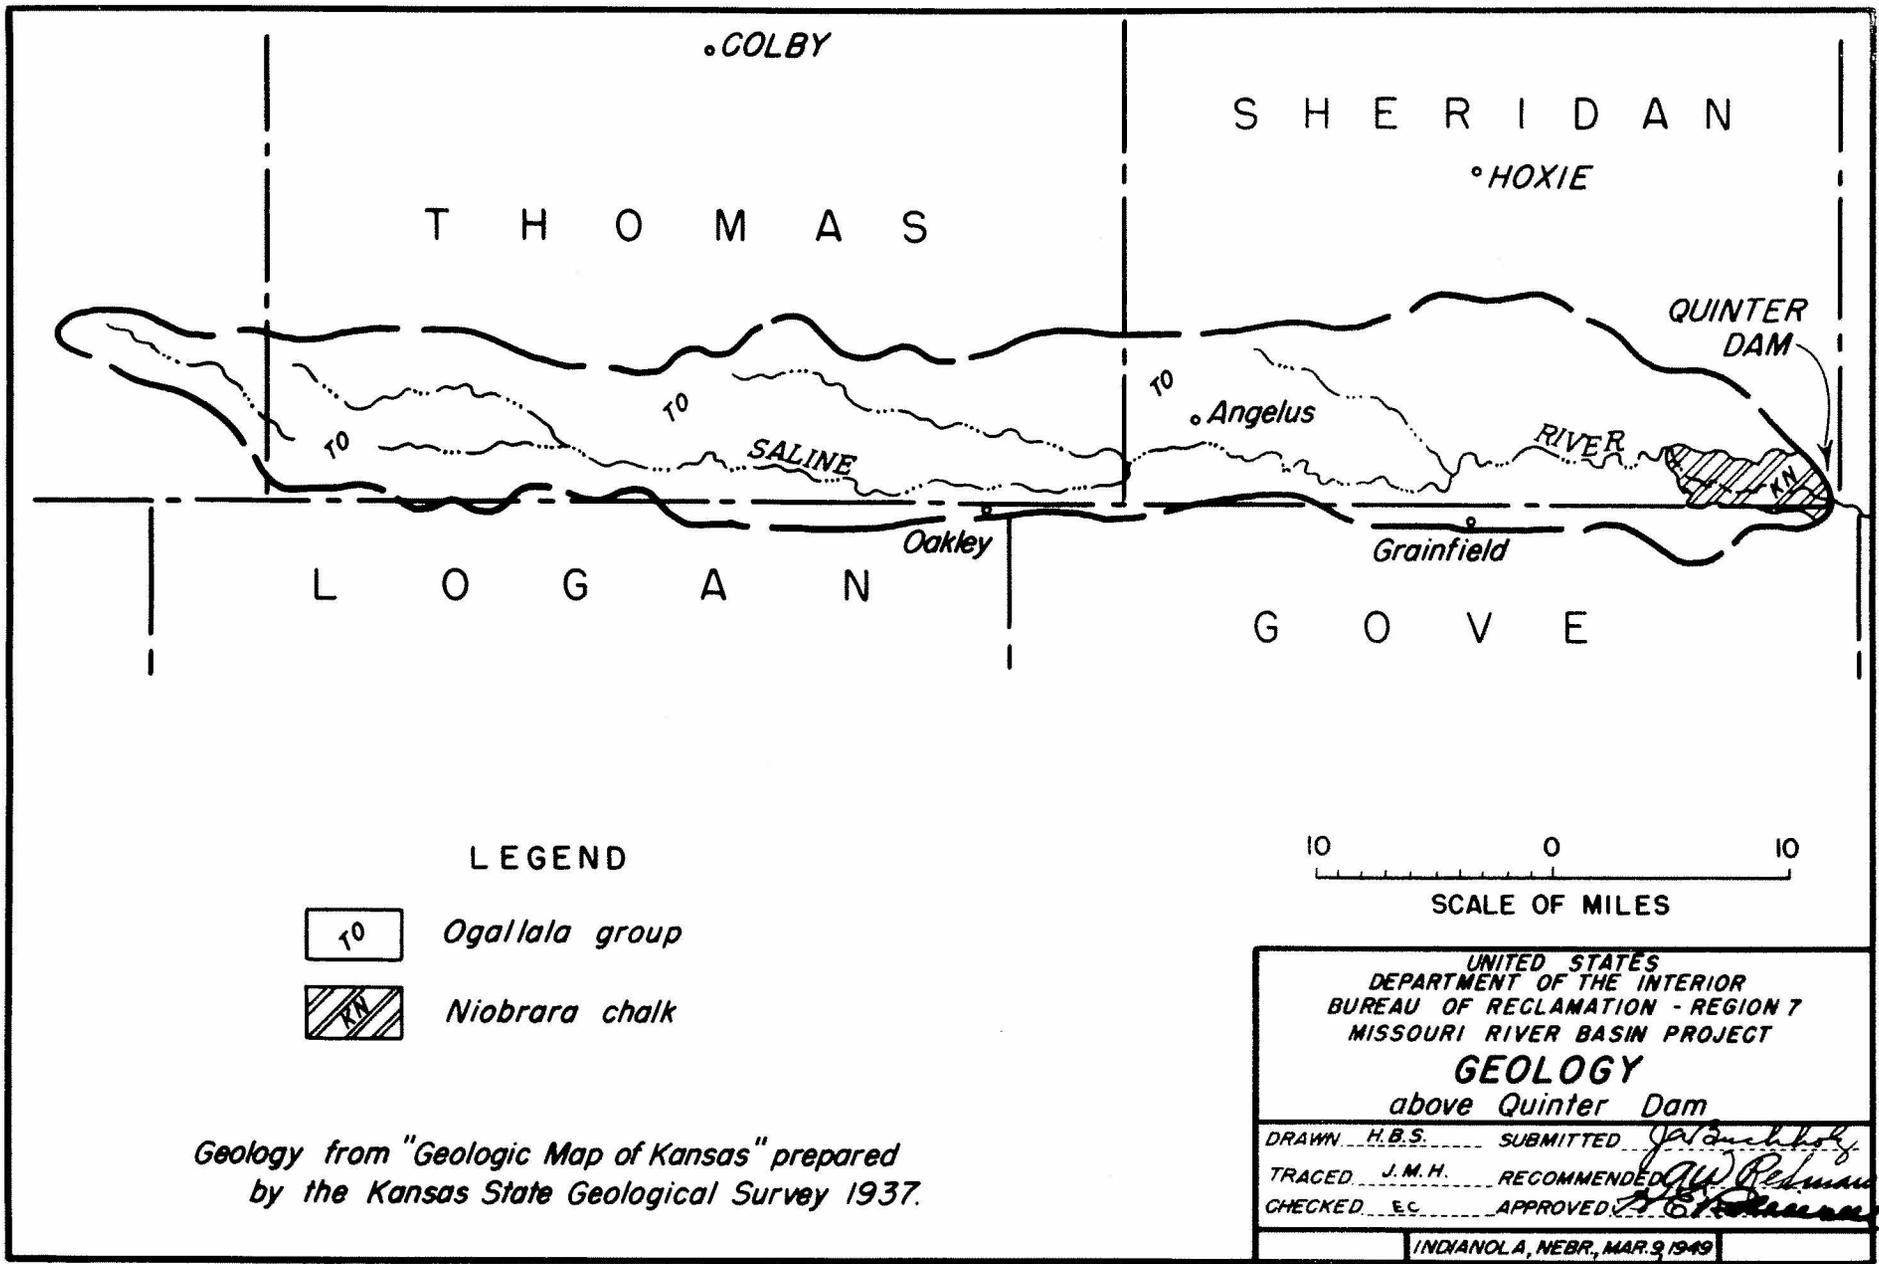
FIGURE 7

The geology of the drainage area is shown on Figure 7. Over 95 percent of the area is of the Ogallala group, the remainder is Niobrara chalk in the vicinity of the reservoir.

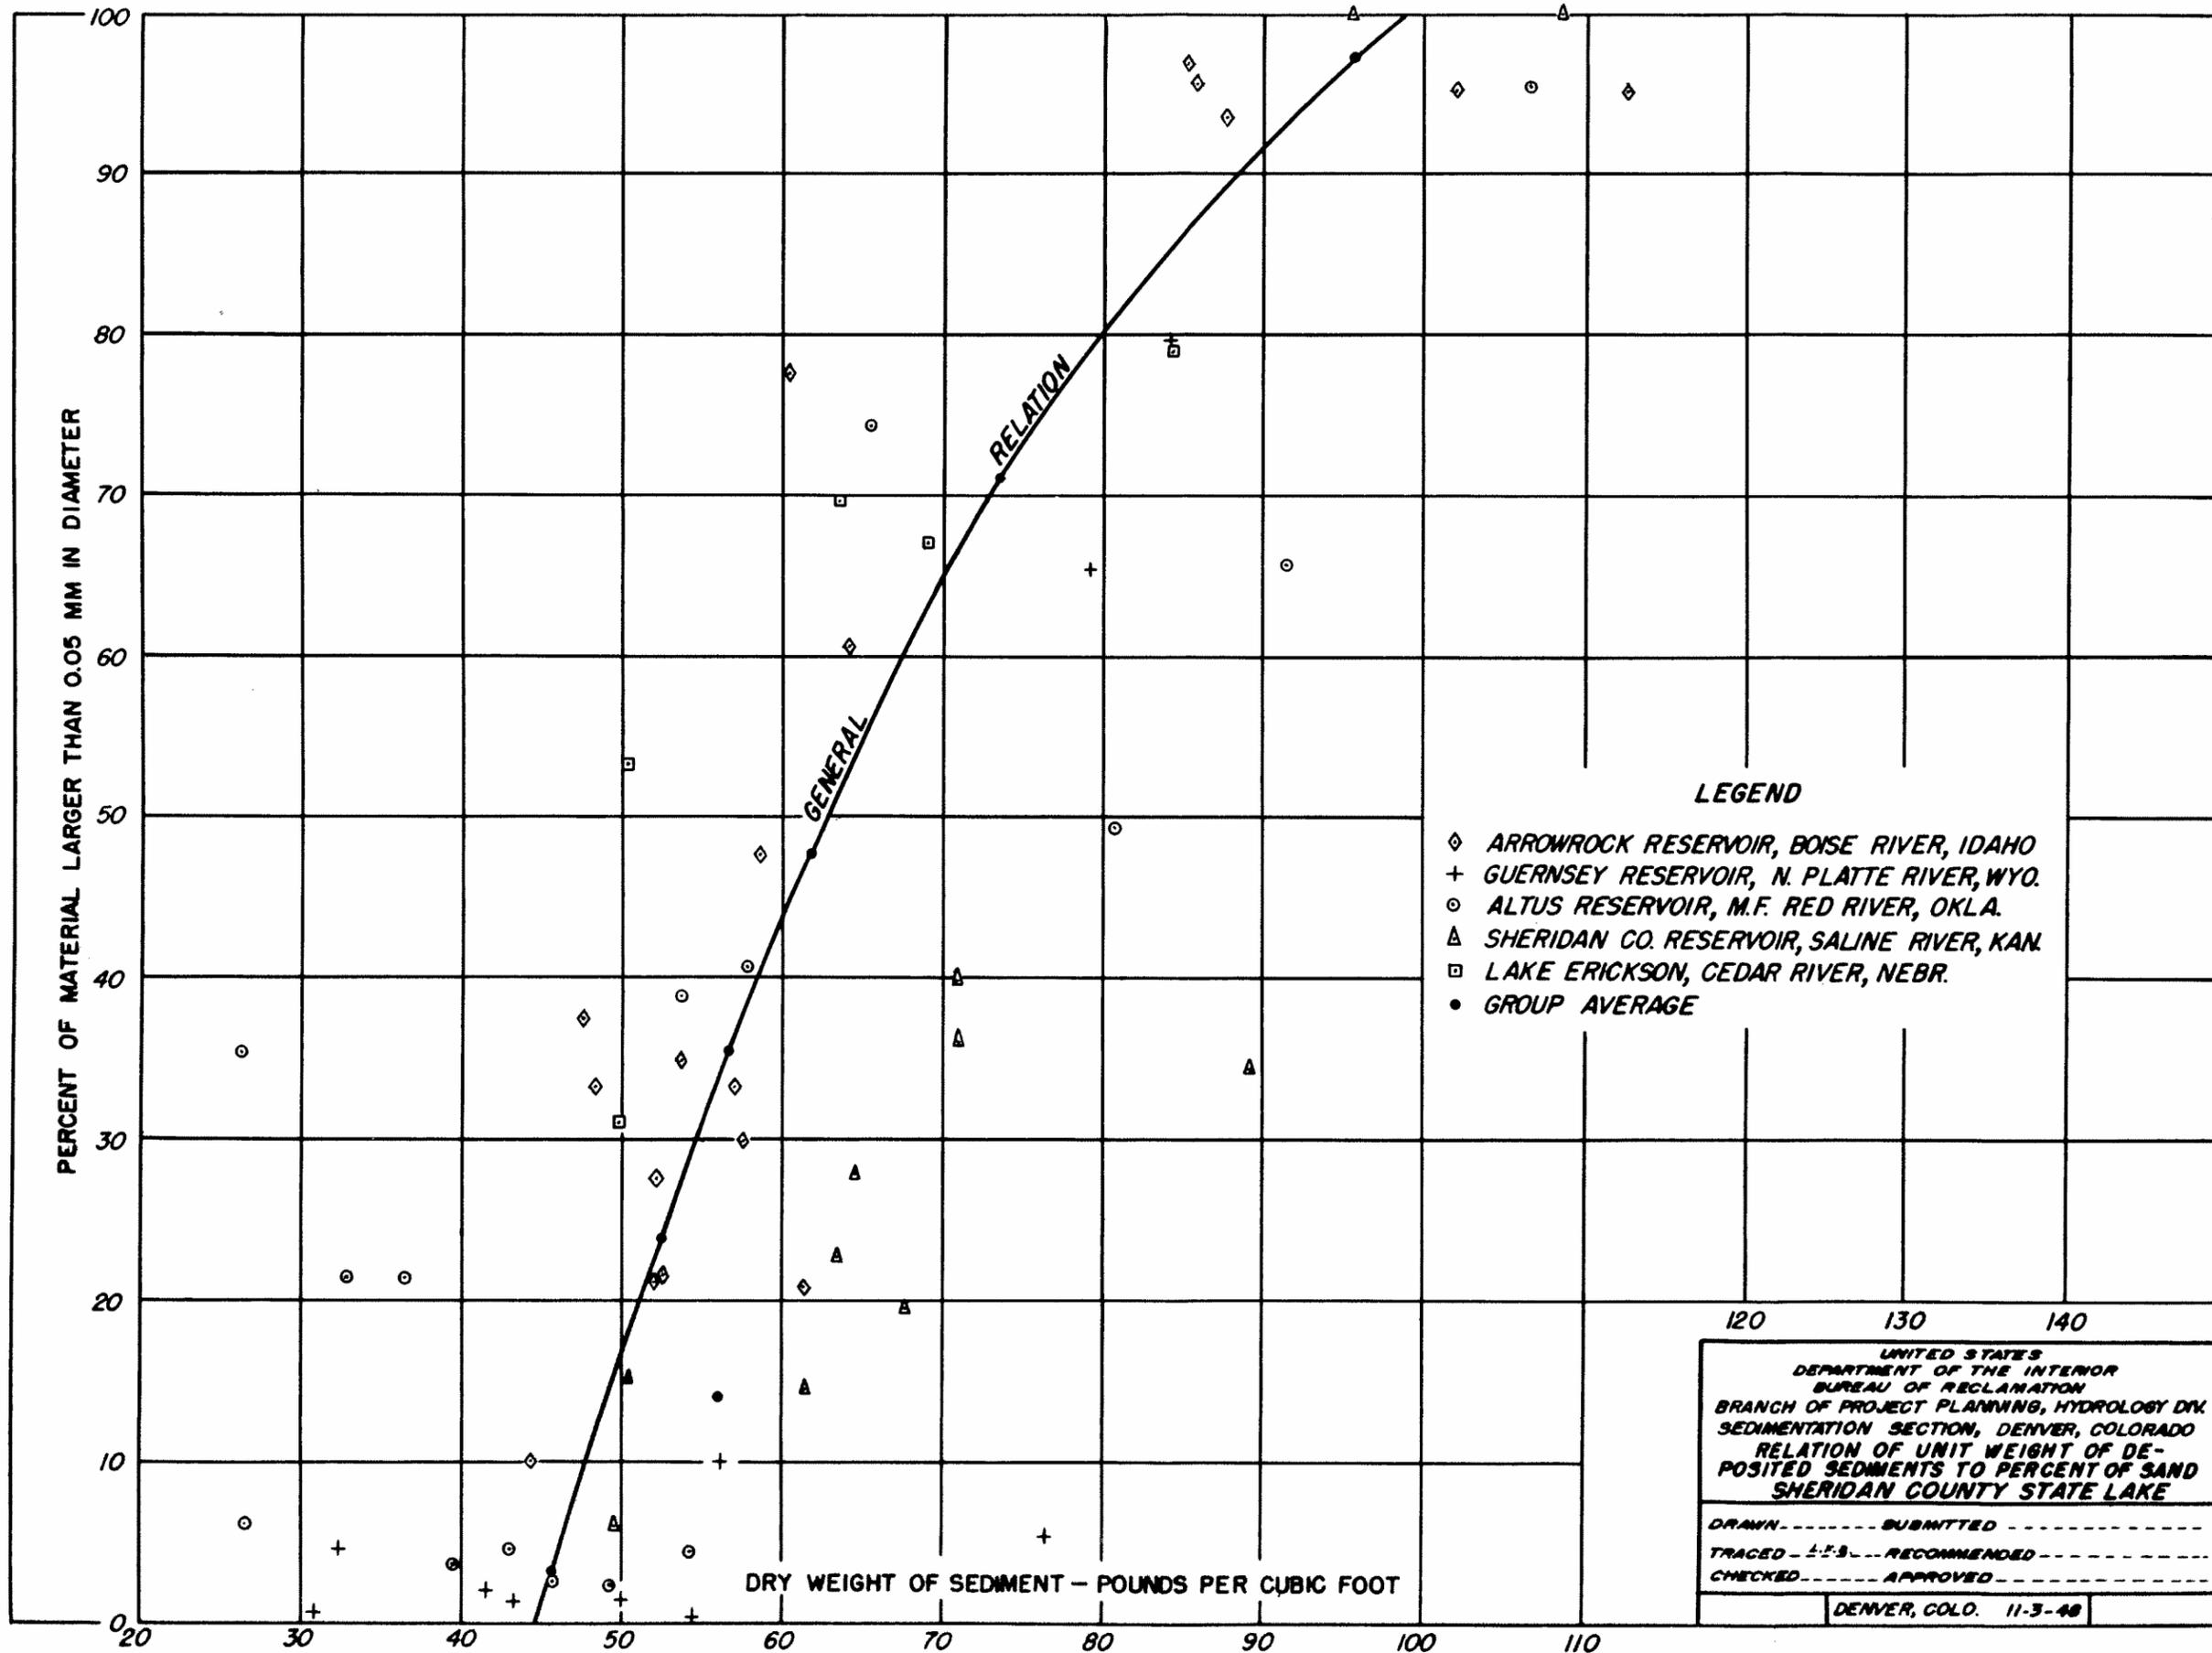
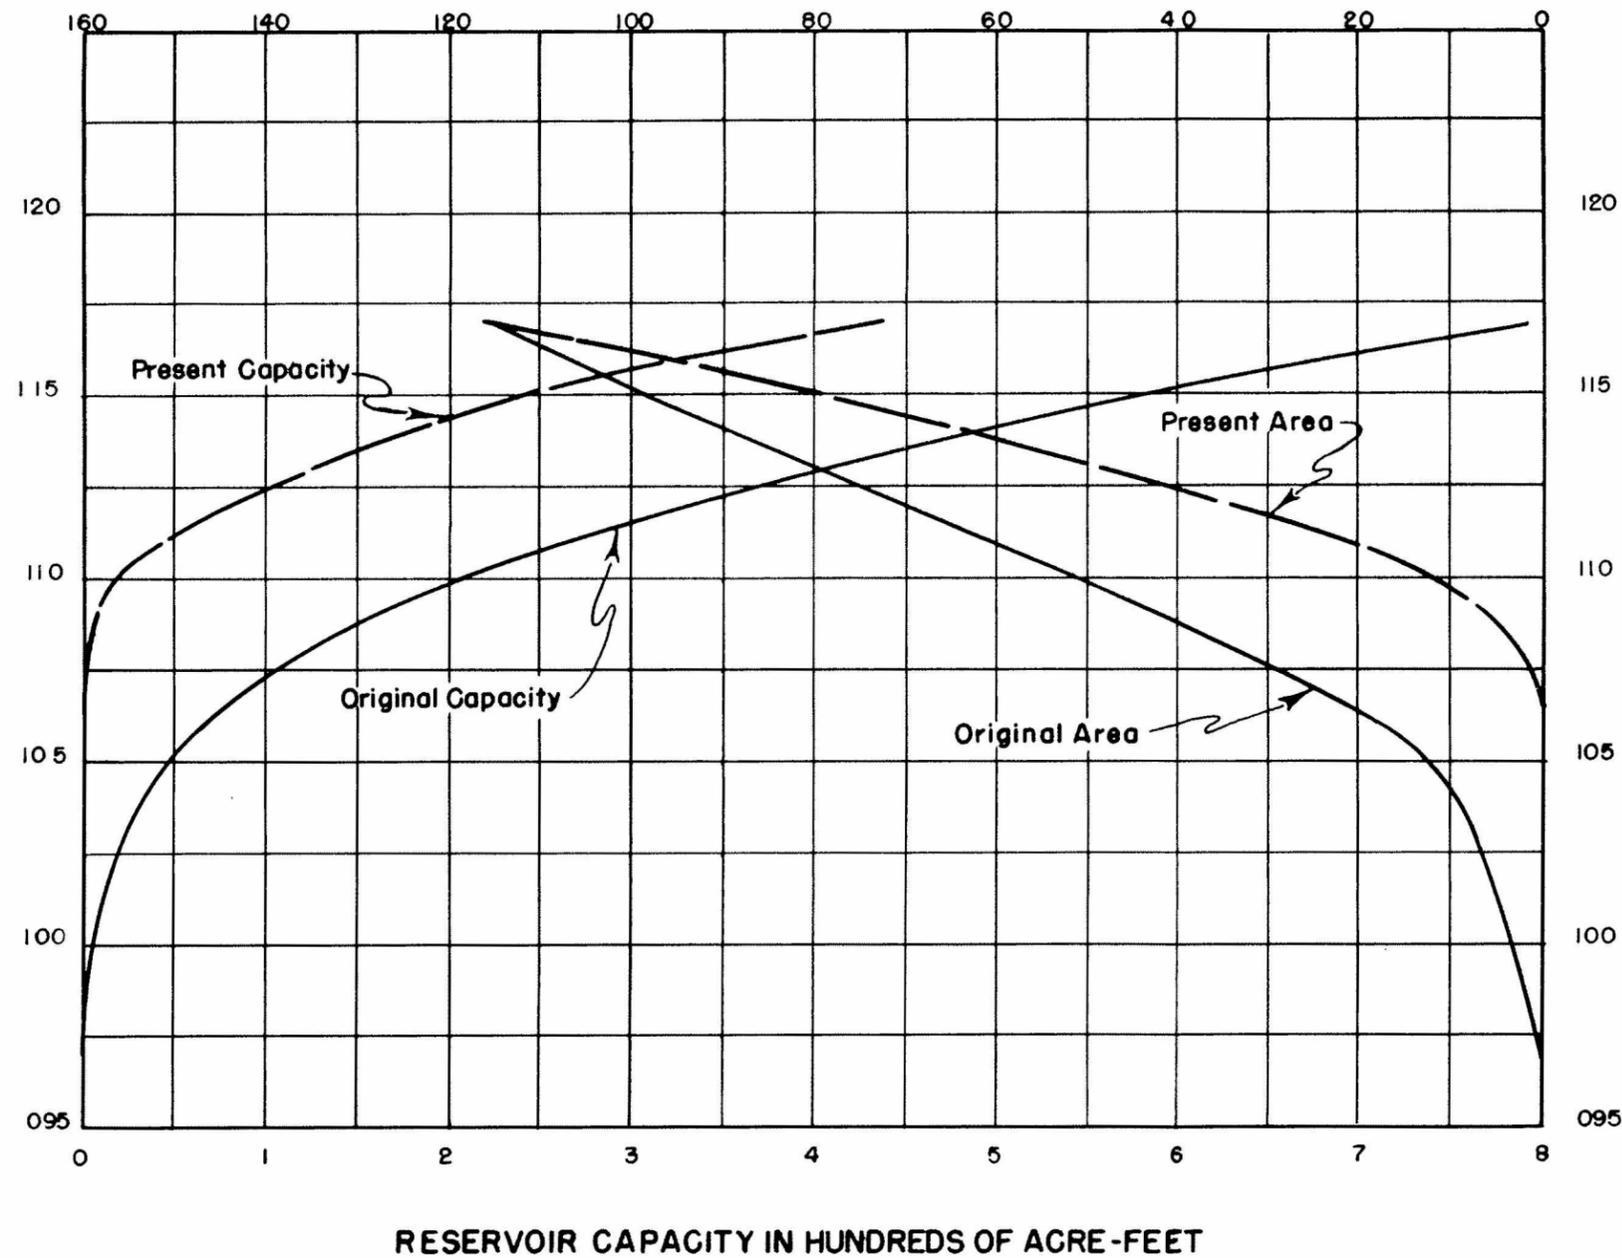
The repair of the dam in 1936 reduced the capacity of the reservoir to 777 acre-feet with an area of 116 acres at elevation 117. In June 1948 the capacity at that same elevation was 436 acre-feet with an area of 116 acres.

^{a/} Volume of earthfill, 16.25 acre-feet, placed over face of original Dam must be deducted from total capacity.
