RECLAMATION

Evolution of the Bends at RM 110

Department of the Interior
Bureau of Reclamation

February 2006

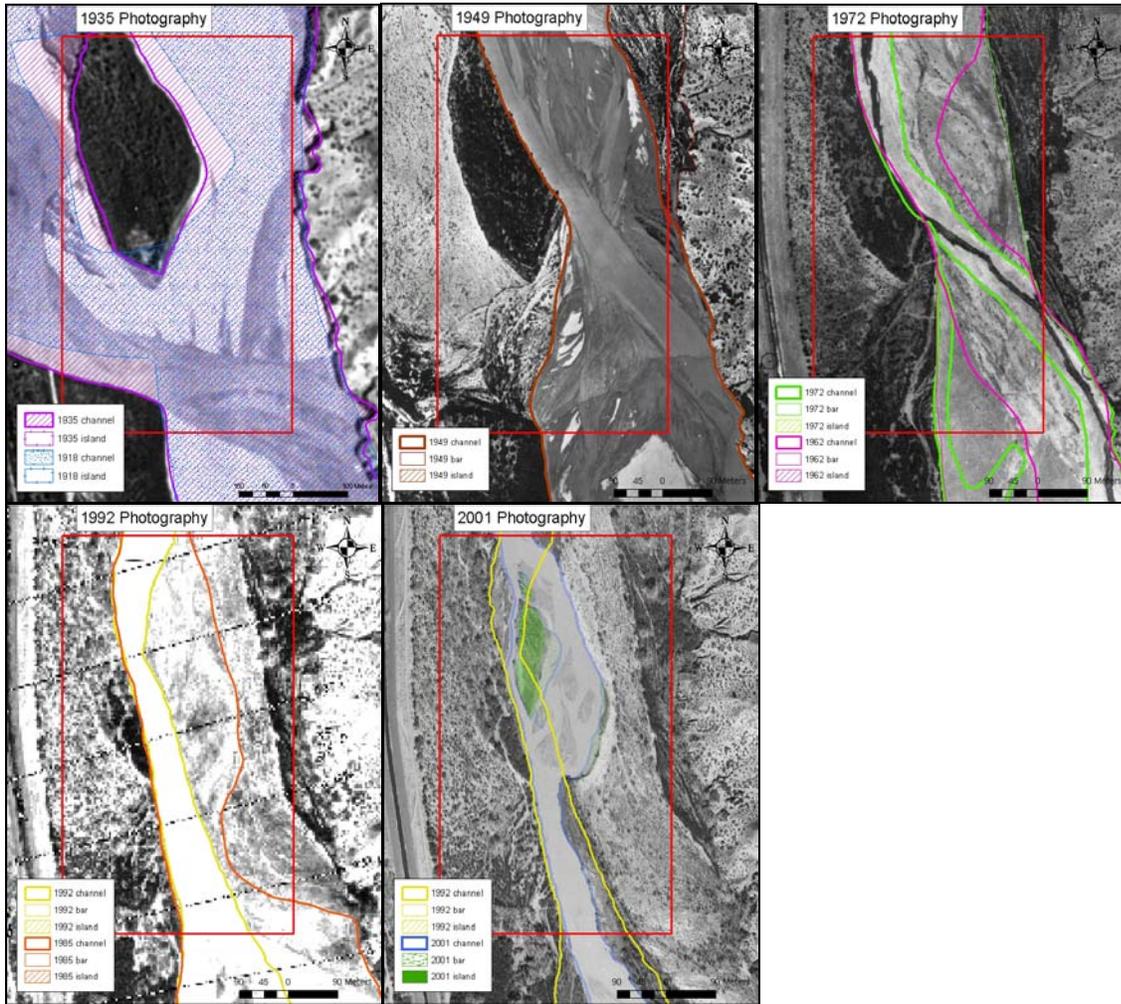
Historical Channels at RM 110

The tall terrace along the eastern bankline is sparsely vegetated and composed of loosely consolidated sand/silt material (a.k.a., sugar sand). Based on the 1949 and 1962 aerial photographs, this surface was active channel in 1949 but abandoned by 1962. As a result of the loose sediment structure in the tall eastern bank, the river easily erodes it. However, the active floodplain appears to resist erosion as a hook has formed at the end of the bend (Figure 3). This resistance also retards the downstream migration of this large eastern bend. In order for the bend to migrate, it must first ‘rip-out’ the floodplain vegetation/surface. Field observations in 2005 reveal that the river eroded this floodplain surface from the east, thereby flanking it. Based on these data, high flows are most likely to cause bend migration at

The western bank sediments are older than those found on the eastern bank, but still appear to be composed predominantly of sand (Figure 5); the 1935 photography shows most of this area as being active channel. At present, the bank height is 8-10 feet above the current channel (Figure 2). Near the downstream end of the
