UNITED STATES
DEPARTMENT OF THE INTERIOR
BUREAU OF RECLAMATION

HYDRAULIC MODEL STUDIES
OF THE SPILLWAY AND OUTLETS
FOR THE FRESNO DAM
MILK RIVER PROJECT

Hydraulic Laboratory Report No. 177

JULY 6, 1945

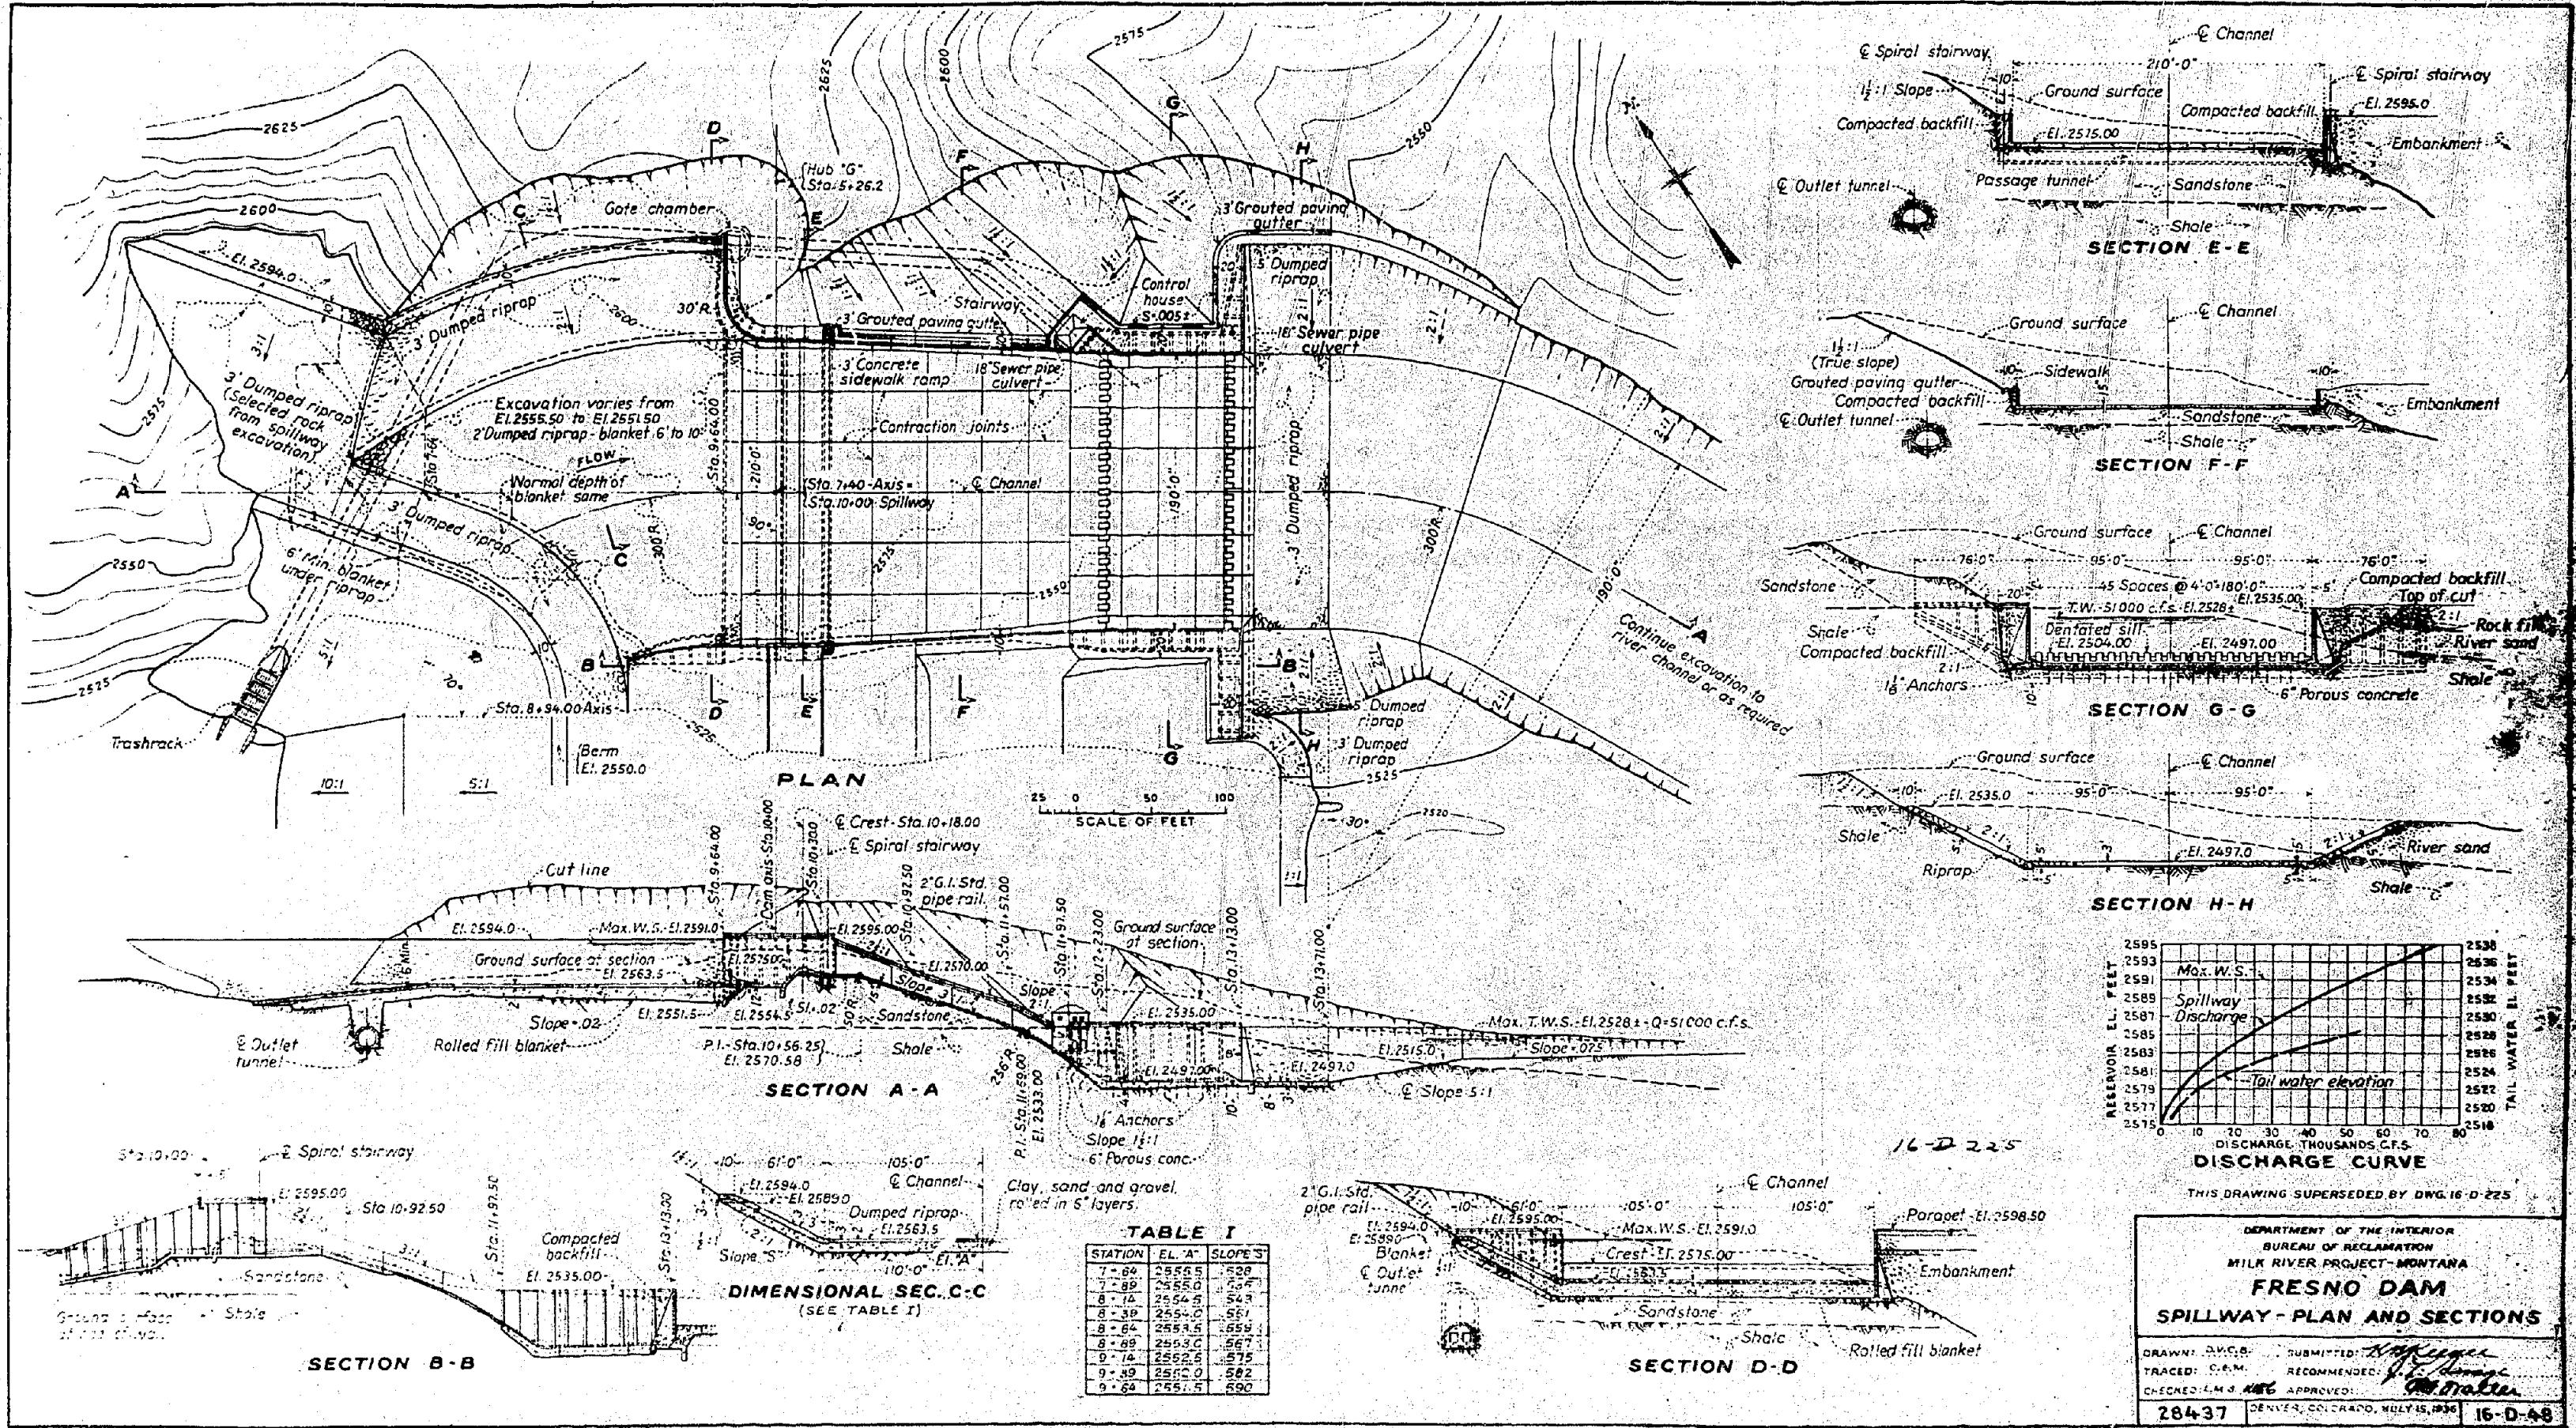
FIGURE 2

The concrete-lined uncontrolled spillway with an approach channel, crest, chute, and stilling pool in the left abutment of the dam will serve to convey floodwaters safely past the dam (Figure 2). The spillway has a design capacity of 51,000 second-feet with a total drop of 63 feet.

The shallow approach channel is riprapped and transitions are provided at each end of the spillway to produce smooth flow over the uncontrolled crest. The chute width converges from 210 feet at the crest to 190 feet at the stilling pool entrance. The pool, for dissipating the energy in the spillway flow, is rectangular in cross-section with a constant width of 190 feet.

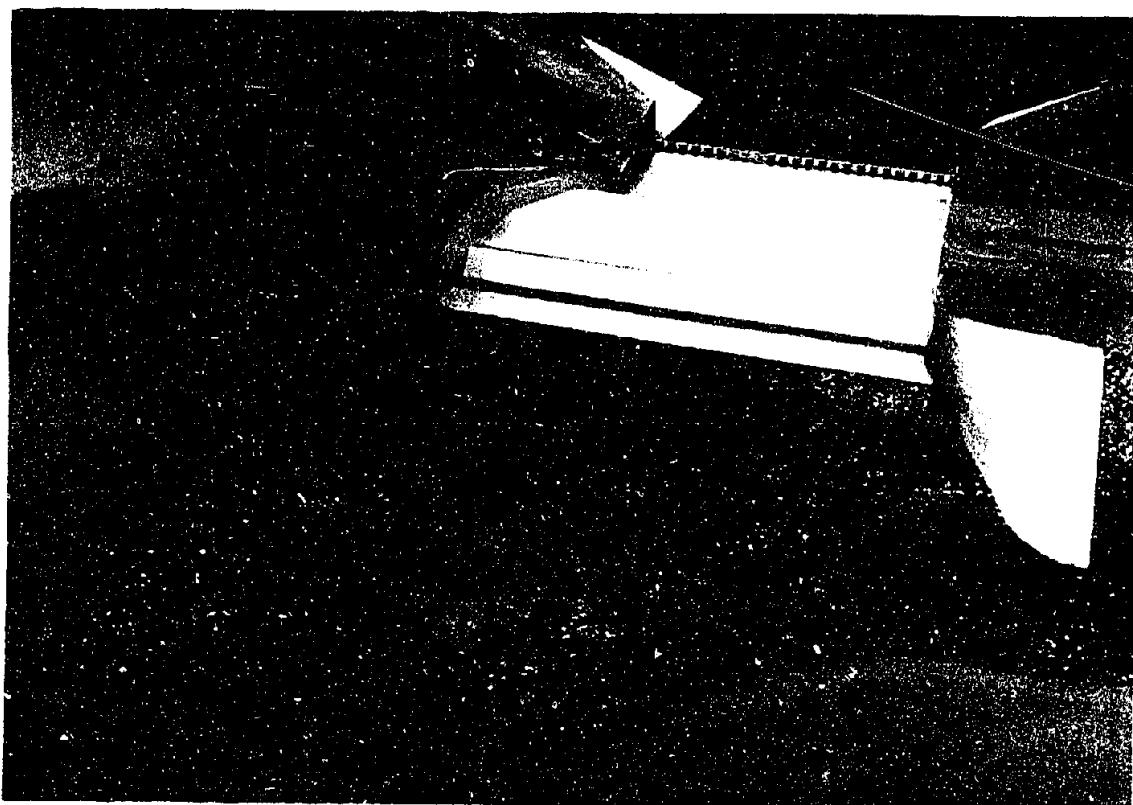
FIGURE 5

A - Looking downstream

B - Looking upstream

1:60 MODEL OF FRESNO DAM SPILLWAY WITH
RECOMMENDED DESIGN FEATURES INCLUDED

The model, with all recommended features included, is shown on Figures 5 and 6.

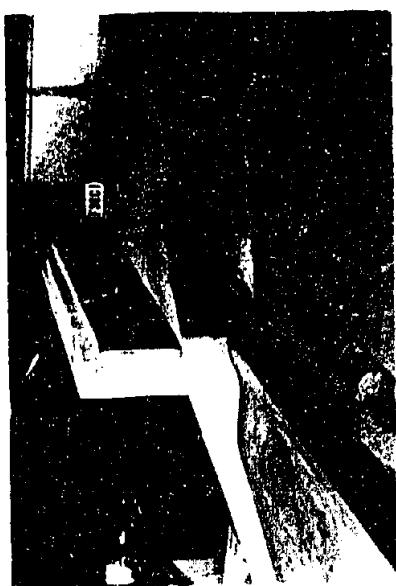
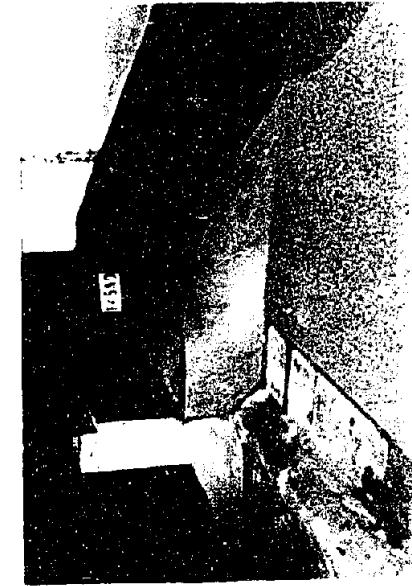
FIGURE 12

Before run

A - Discharge 51,000 second-feet
Design 11

Erosion
Design 11

B - Discharge 51,000 second-feet
Test 12

FLOW CONDITIONS AND EROSION IN APPROACH CHANNEL OF 1:60 MODEL OF THE
FRESNO DAM SPILLWAY - DESIGNS 11 AND 12 OF WARPED RIGHT WING WALL.

Another warp was constructed in an attempt to eliminate the objectionable features of the previous designs. The surface shape was generated by passing a straightedge along two screed lines while keeping it normal to the spillway centerline (design 12, Figure 10). The hydraulic conditions with this wall were similar, but slightly less severe than for the original design (Figure 12B), and was therefore unsatisfactory.

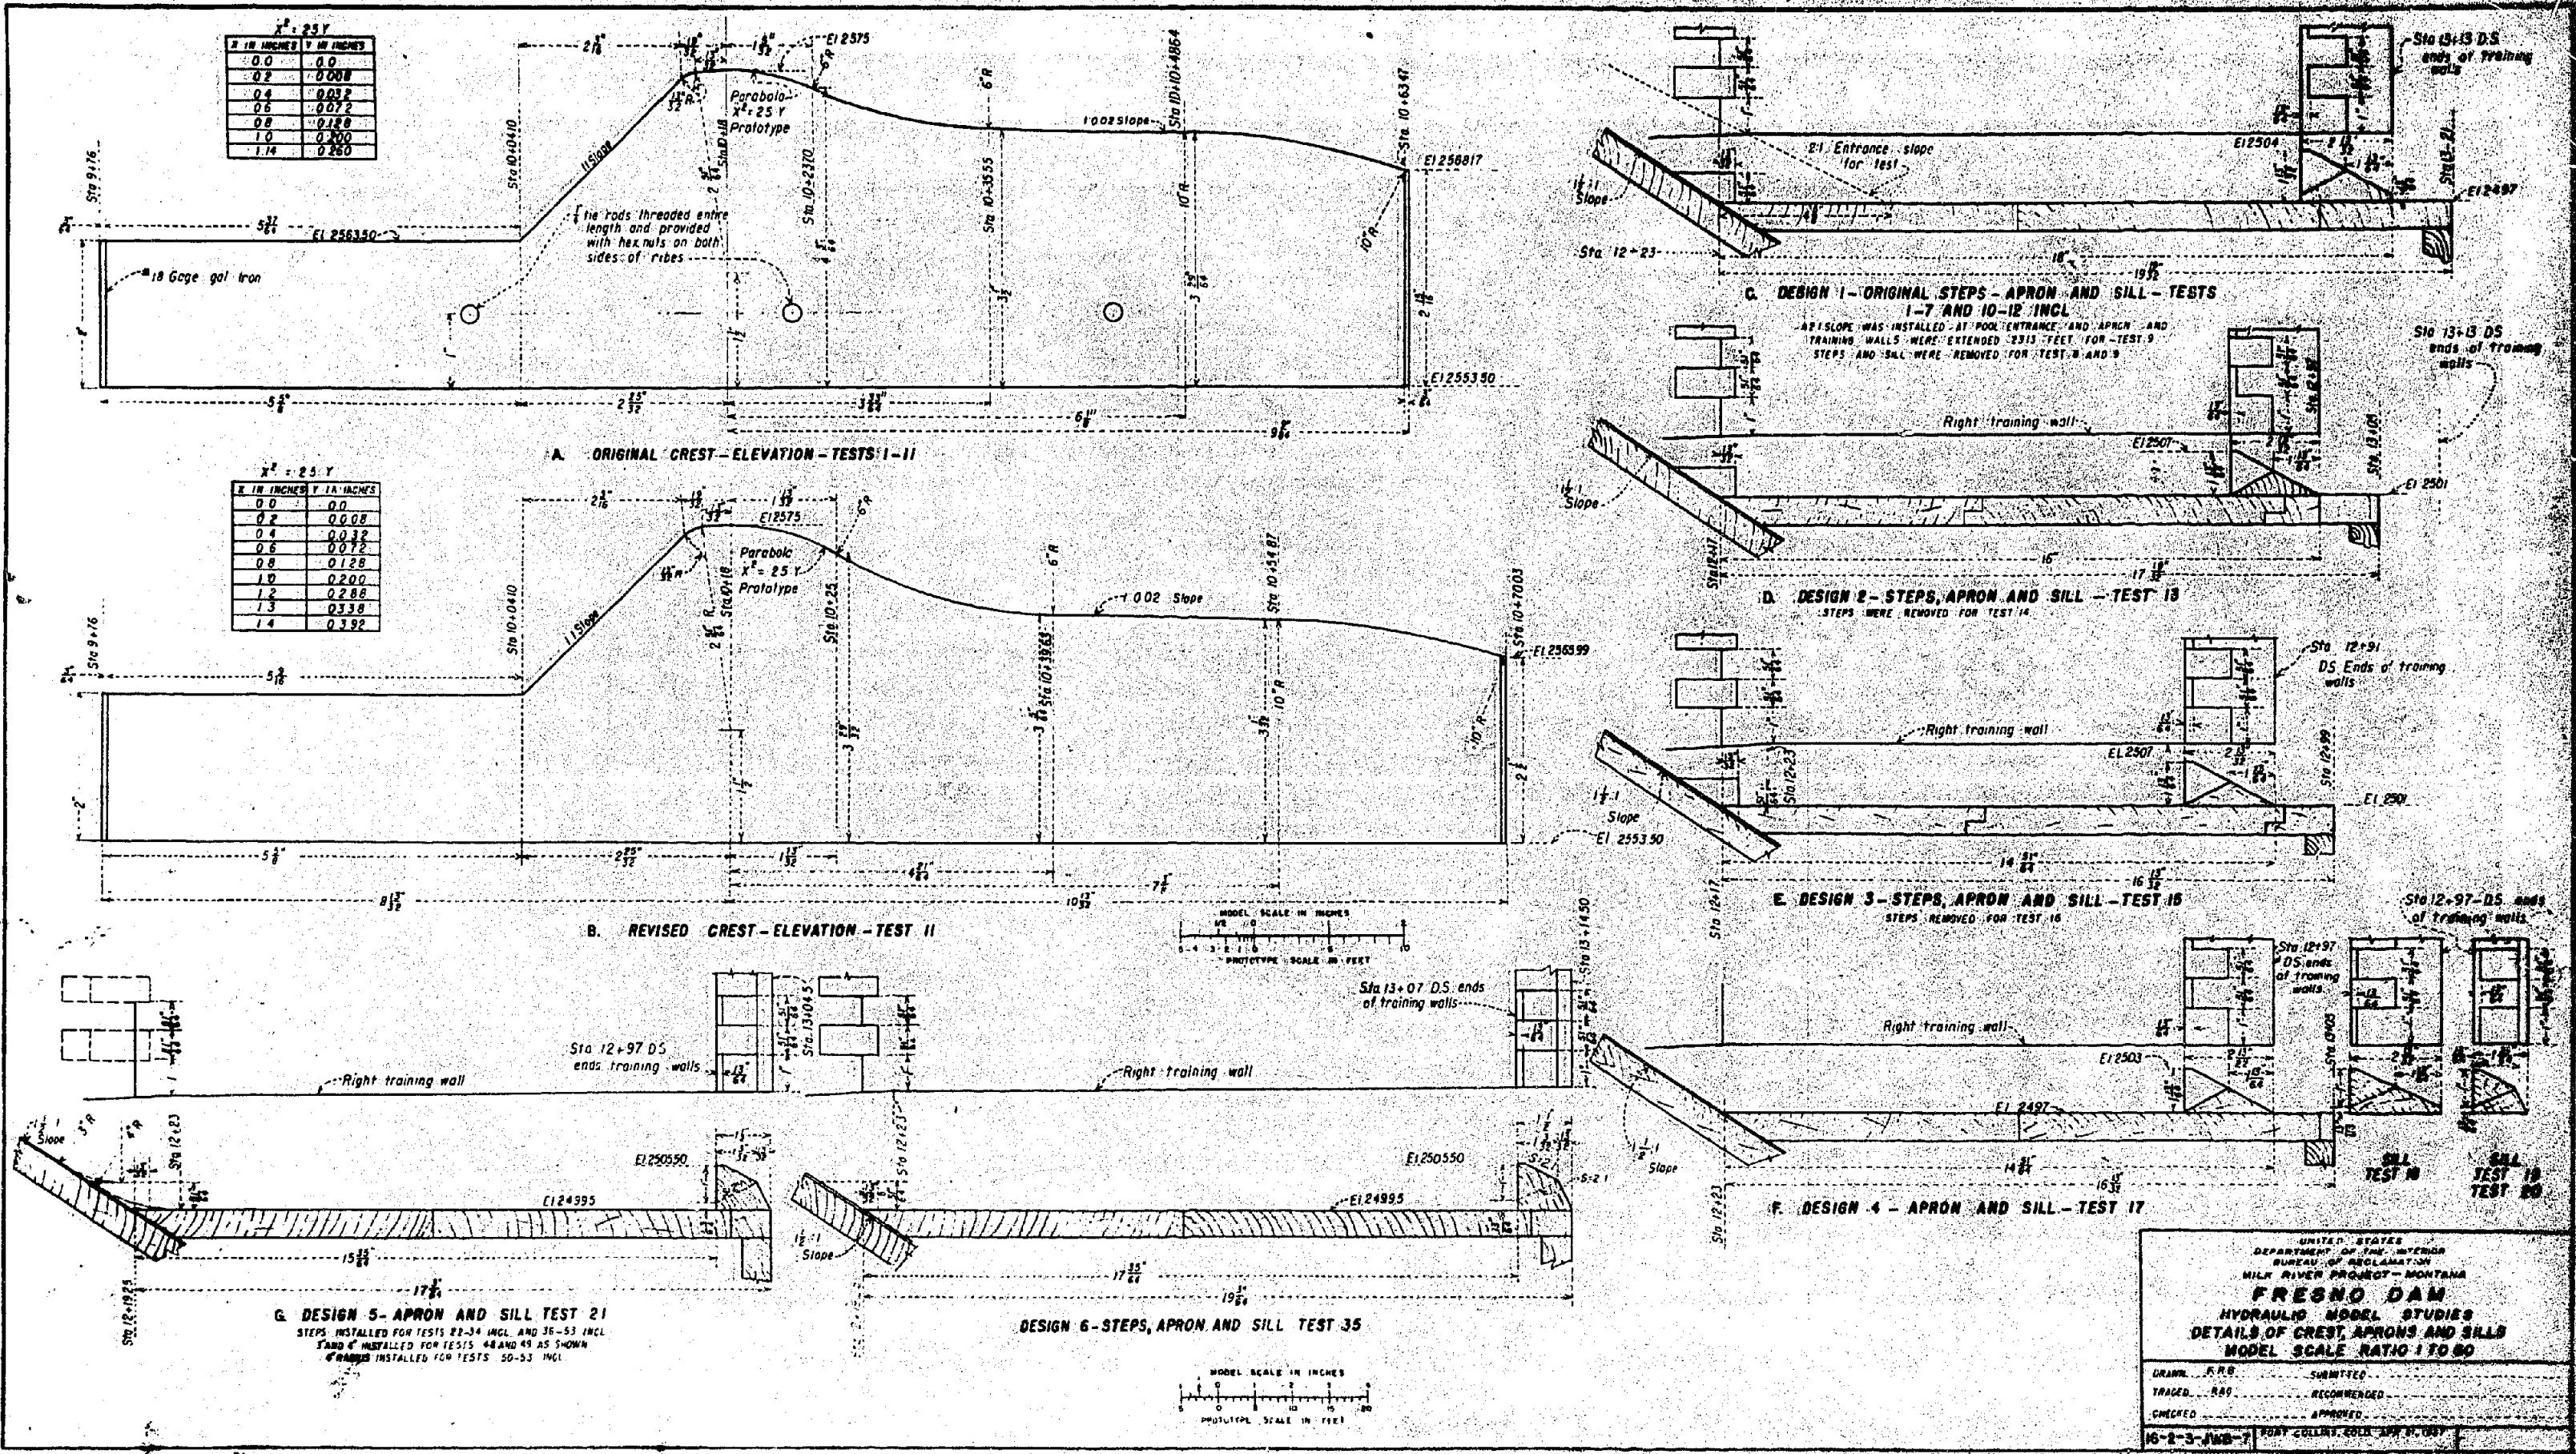
UNITED STATES
DEPARTMENT OF THE INTERIOR
BUREAU OF RECLAMATION
MILK RIVER PROJECT - MONTANA
FRESNO DAM
HYDRAULIC MODEL STUDIES
DETAILS OF CREST, APRONS AND SILL
MODEL SCALE RATIO 1 TO 50
DRAWN BY: SUBMITTED BY:
TRACED BY: RECOMMENDED BY:
CHECKED BY: APPROVED BY:
16-2-3-AWB-1
FORT COLLINS COLORADO, U.S.A.

Original Crest Design. The original crest (Figure 13A), with the original right wing-wall, was calibrated to ascertain the spillway capacity with the reservoir at elevation 2591.0. The discharge was found to be 47,000 second-feet or 4,000 second-feet less than the desired capacity of 51,000 second-feet. The reason for the low discharge was investigated when computations indicated an additional 18 feet of crest length would be necessary to obtain the 4,000 second-feet. It was believed that the swirling jet, which formed at the right end of the spillway with this design wing-wall, contributed to the difference. The design of the wall was revised, but the increase in flow was slight, making the capacity 47,500 second-feet. The estimated additional length of crest required to increase this quantity to 51,000 second-feet was 15 feet. When the change in the wing-wall design failed to increase the spillway discharge substantially, the possibility of submerged flow over the crest was investigated. Pressures and water surface profiles were taken along the center line of the crest (Figure 14). The water surface profiles directly downstream from the crest revealed that the flow did not completely attain the shape of a free jet, and that the pressures, which were above atmospheric, were excessive at the apex of the crest for large spillway discharges. These characteristics indicated that the difference in elevation of the crest and the chute floor immediately downstream was insufficient to prevent interference with the flow over the crest. With this in mind, a lower floor design was incorporated in the model and comparable data obtained.

Final Crest Design. The floor of the chute was lowered approximately two feet (Figure 13B). This increased the capacity of the crest to 51,400 second-feet with the reservoir at elevation 2591.0. The flow over the crest followed a path nearer that of a free jet and the pressures on the crest were decreased noticeably (Figure 15).

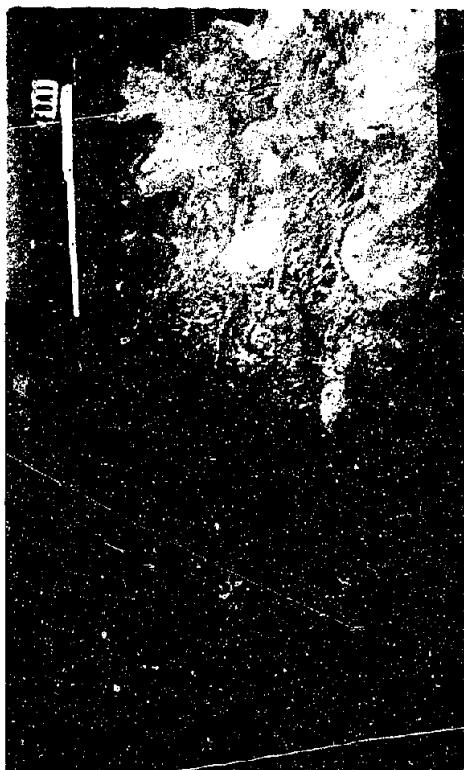
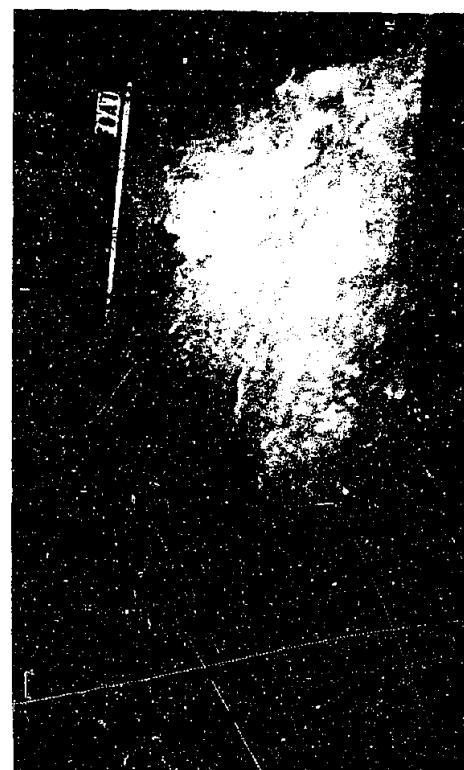
FIGURE 16

Normal tailwater

A - Pool entrance with 1:1 slope

Tailwater 6 feet below normal

B - Pool entrance with 2:1 slope

FLOW CONDITIONS IN STILLING POOL OF 1:60 MODEL OF FRESNO DAM SPILLWAY
EFFECT OF ENTRANCE SLOPE ON POOL ACTION. NO SILL OR STEPS ON APRON.

Stilling Pool Design 1 (Original Design). In the preliminary tests, the slope of the pool entrance was changed from 1-1/2:1 to 2:1 in order to determine the effect of the different entrance slopes on the formation of the jump. No noticeable difference occurred (Figure 16), so all subsequent tests were made with the 1-1/2:1 sloped entrance. With the steps and sill removed for these tests, an efficient appearing jump formed on the apron for 51,000 second-feet. This resulted even though the jump-height curve, which was computed without considering friction losses, was three feet above the tailwater elevation for this discharge (Figure 17). Apparently the decrease in velocity caused by friction compensated for the lack of tailwater depth, and the erosion immediately downstream from the end of the apron affected a deepening of the pool which supported the formation of the jump. Since the pool length was less than three times the tailwater depth necessary to form a jump at a discharge of 51,000 second-feet, it was believed that some type of sill should be placed on the apron. After the steps and a sill were installed (design 1, Figure 13C), unequal distribution of flow was noted in the spillway chute, with deeper water on the left side than on the right. This condition, which was very noticeable at the maximum discharge, was attributed to the direction of the flow approaching the crest and was not considered serious.

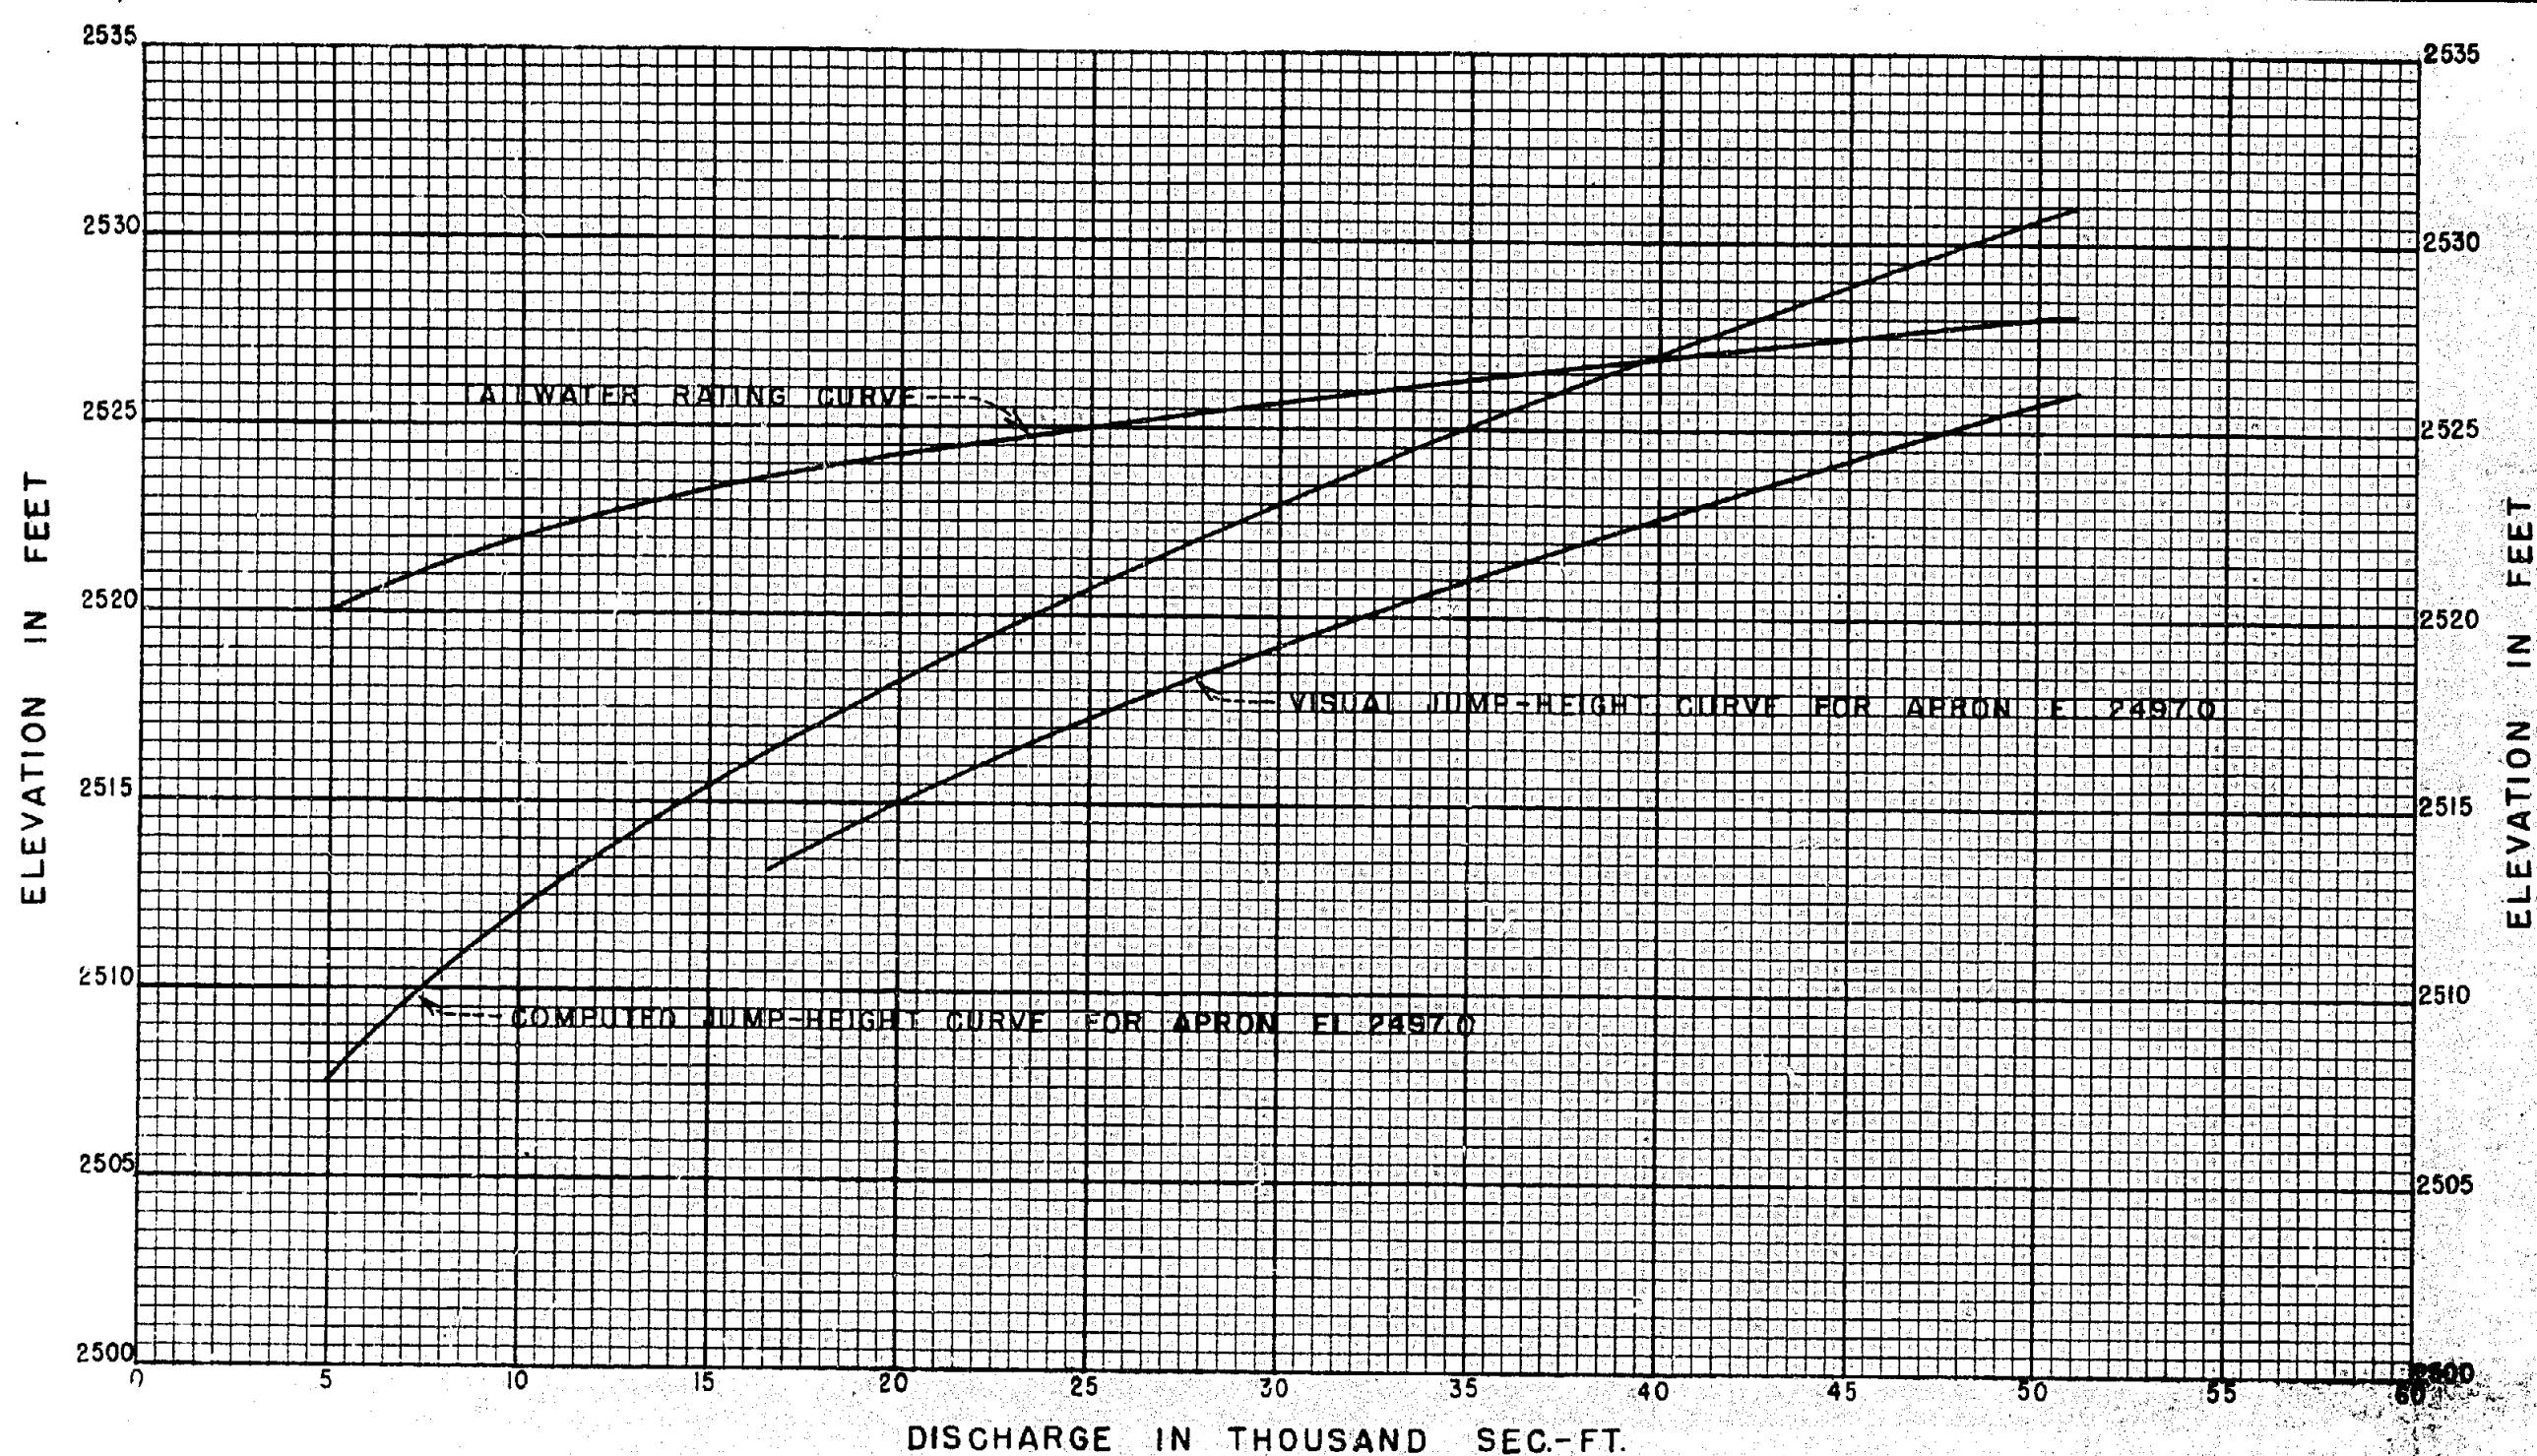
FIGURE 17

UNITED STATES DEPARTMENT OF THE INTERIOR BUREAU OF RECLAMATION MILK RIVER PROJECT-MONTANA	
FRESNO DAM	
HYDRAULIC MODEL STUDIES	
JUMP-HEIGHT AND T.W. EL. CURVES	
MODEL SCALE RATIO 1:60	
DRAWN, R.R.B.	SUBMITTED.....
TRACED, A.H.W.	RECOMMENDED.....
CHECKED.....	APPROVED.....
162-3 JWB-4 DENVER, COLORADO 3-19-67

A study of the relation between the tailwater rating curve and the theoretical jump-height curve (apron elevation 2497) shows deeper tailwater than necessary to form a good jump for discharges below 40,000 second-feet, and a depth too shallow for greater discharges (Figure 17). However, a jump-height curve obtained by varying the

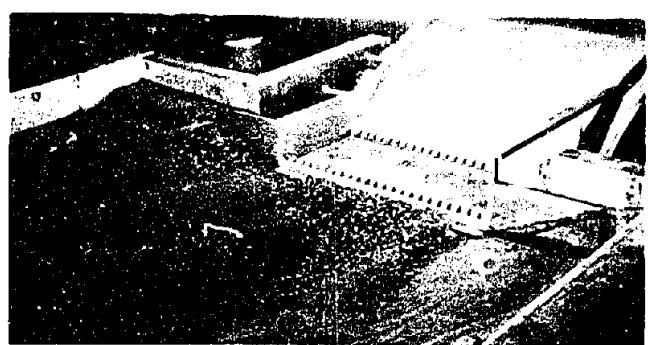
FIGURE 18

A - Normal tailwater

B - Tailwater 6.6 feet below normal

Discharge 30,000 second-feet

C - Normal tailwater

D - Tailwater 1.1 feet below normal

Discharge 51,000 second-feet

Before test

After test

FLOW CONDITIONS AND EROSION IN STILLING POOL OF 1:60 MODEL OF FRESNO DAM SPILLWAY. ORIGINAL DESIGN - 98-FOOT APRON WITH STEPS AT ENTRANCE, 7-FOOT SILL PLACED WITH UPSTREAM EDGE 20 FEET FROM END OF APRON

A prominent roll appeared at the water surface over the sill and the jump seemed somewhat drowned at all discharges (Figures 18, 19C, and E), (normal tailwater). Even so, a return flow immediately downstream from the left wing wall of the pool washed away the 2:1 rip-rapped slope (Figure 18F). The drowned condition was ascribed to the high sill and stepped apron.

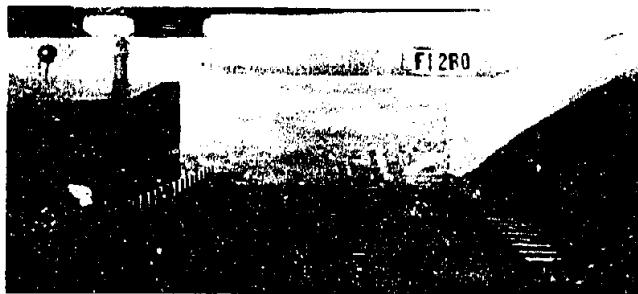
FIGURE 19

A - Side view of pool

FLCW CONDITIONS IN STILLING POOL OF 1:60 MODEL OF FRESNO DAM SPILLWAY
ORIGINAL DESIGN - 98-FOOT APRON WITH STEPS AT ENTRANCE; 7-FOOT STILL
PLACED WITH UPSTREAM EDGE 20 FEET FROM END OF APRON.

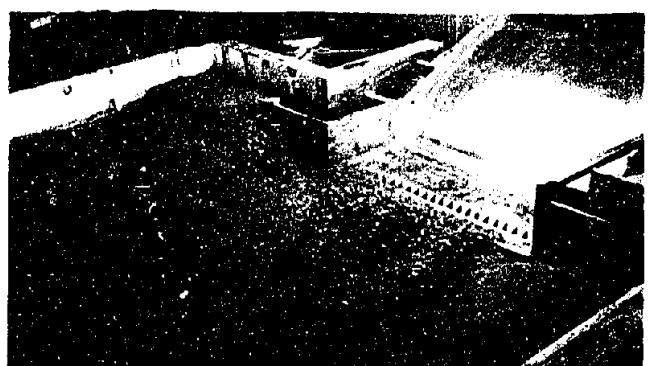
b - Erosion caused by 51,000 second-feet

Design 2 - Steps on apron

c - Discharge 51,000 second-feet

d - Erosion caused by 51,000 second-feet

Design 3 - No steps on apron

FLOW CONDITIONS AND EROSION IN STILLING POOL OF 1:60 MODEL
OF FRESNO DAM SPILLWAY - POOL DESIGNS 2, 3, AND 4.

Stilling Pool Design 2. When the floor was raised four feet, shortened 10 feet, and the 7-foot sill replaced by one 6 feet high (design 2, Figure 13D), the pool became rough at 51,000 second-feet (Figure 20A). More erosion occurred at the apron cutoff wall than on the original design, but the 2:1 slope downstream from the left wing-wall was only slightly disturbed (Figure 20B). A shorter apron was indicated for the next test.

difference in the condition of the 2:1 excavated slope downstream from the wing-walls. It was necessary to raise the tailwater 1.7 feet to obtain the most desirable jump. The jump was nearly swept off the apron when the steps were removed from the upstream end of the pool to determine their effectiveness. More impact was noted on the sill and the height of the roll over the sill was increased (Figure 20C). This design was considered inadequate because it was necessary to raise the tailwater 4.4 feet to form a satisfactory jump. As it seemed desirable to obtain a satisfactory design which did not include the steps on the apron, the pool floor was lowered for the next test.

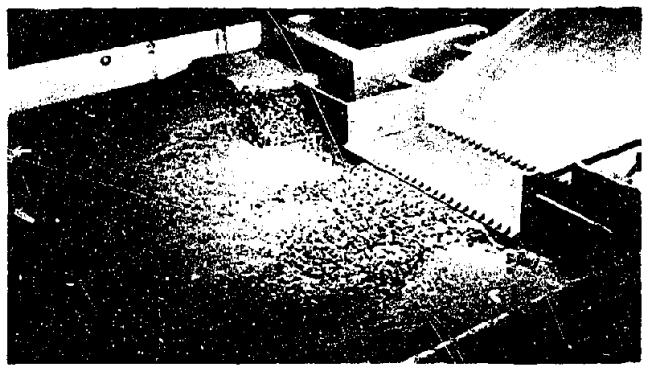
FIGURE 21

A - Discharge 51,000 second-feet

B - Erosion caused by 51,000 second-feet

Design 4 - Truncated sill - no steps on apron

C - Discharge 51,000 second-feet

D - Erosion caused by 51,000 second-feet.

Design 5 - Truncated sill - no steps on apron

E - Discharge 51,000 second-feet

F - Erosion caused by 51,000 second-feet.

Design 5 - Truncated sill - steps on apron

FLOW CONDITIONS AND EROSION IN STILLING POOL OF 1:60
MODEL OF FRESNO DAM SPILLWAY - POOL DESIGNS 4 AND 5.

Stilling Pool Design 4. With the pool floor lowered to elevation 2497.0 and the apron length of 82 feet kept constant (design 4, Figure 13F), there was a noticeable decrease in erosion (Figure 20F). In all the tests discussed in the previous paragraphs, the deepest erosion along the cutoff wall at the end of the apron occurred immediately downstream from each end of the sill. The same conditions, noted previously in tests on a model of the Bull Lake Spillway, had been improved somewhat by the use of a sill having dentals, instead of spaces, adjacent to the training walls. The dentals on the Fresno sill were therefore arranged in a similar manner (design 4, test 18, Figure 13F). Only a slight improvement was noted. However, this improvement seemed desirable, so a sill of this type was used for all subsequent tests. The persistent roughness of the pool seemed to indicate that the apron was too short, but as it was not economical to lengthen the walls or the floor, the sill was truncated and moved downstream so that the upstream edge was at the same station as the ends of the training walls (design 4, test 19, Figure 13F). Although the appearance of the jump changed but slightly by this lengthening (Figure 21A), the erosion was considerably decreased, and this sill was recommended for use on the Fresno Spillway.

The maximum depth of scour was slightly below elevation 2497 (the pool floor) at the downstream corners of the apron, and material was deposited against the sill between these areas (Figure 21B). The excavated slope downstream from the left wing-wall of the stilling pool was destroyed.

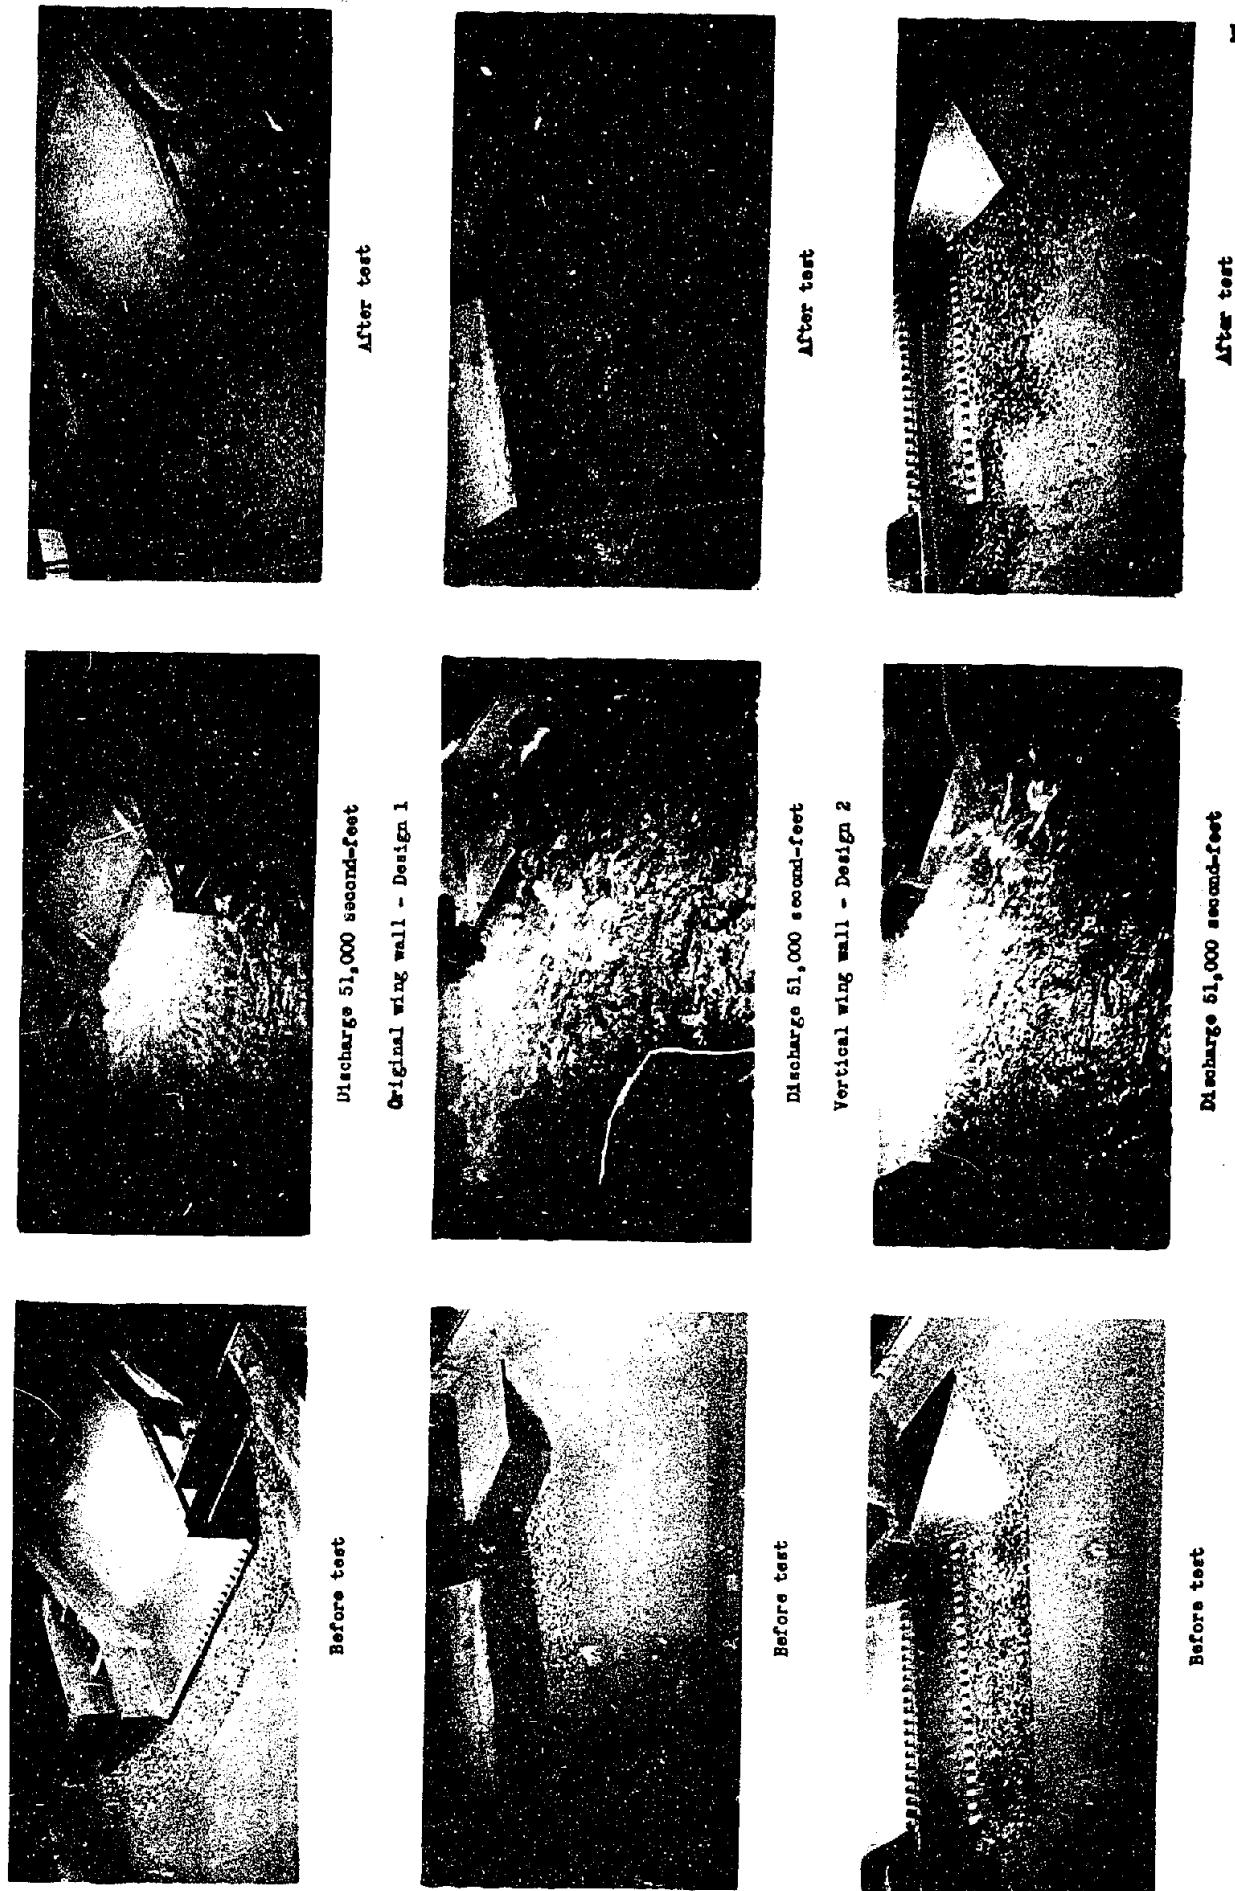
FIGURE 23

FLOW CONDITIONS AND EROSION DOWNSTREAM FROM APRON OF 1:60 MODEL OF
FRESNO DAM SPILLWAY WING WALL - DESIGNS 1, 2, AND 3.

Downstream Wing-wall, Design 2. A vertical wall was extended 71.5 feet downstream at an angle of 20 degrees with the training wall, thence parallel to the end of the apron into the bank (design 2, Figure 22). This eliminated the erosion at the cutoff wall (Figure 23B), but an eddy, forming immediately downstream from the wing-wall, destroyed the 2:1 excavated slope and eroded a deep hole at the corner of the wall. A warped wall similar to that used on the Pilot Knob Wasteway was considered.

Downstream Wing-wall, Design 3. A warped wall was extended from vertical at the end of the main training wall to a 2:1 slope at a point 60 feet downstream from the end of the apron. The bottom streamward edge was level at elevation 2499.5, and extended downstream perpendicular to the end of the apron (design 3, Figure 22). The riprap along the streamward and downstream edges was moved by currents until both were exposed to a depth varying from 4 to 6 feet (Figure 23C). The eddy near the bank at the downstream edge of the wall was very small, so it was concluded that the riprapped surface was too steep. Most of the riprap moved from this area had rolled to the foot of the slope. The wall was altered in an attempt to prevent the erosion at its edges.

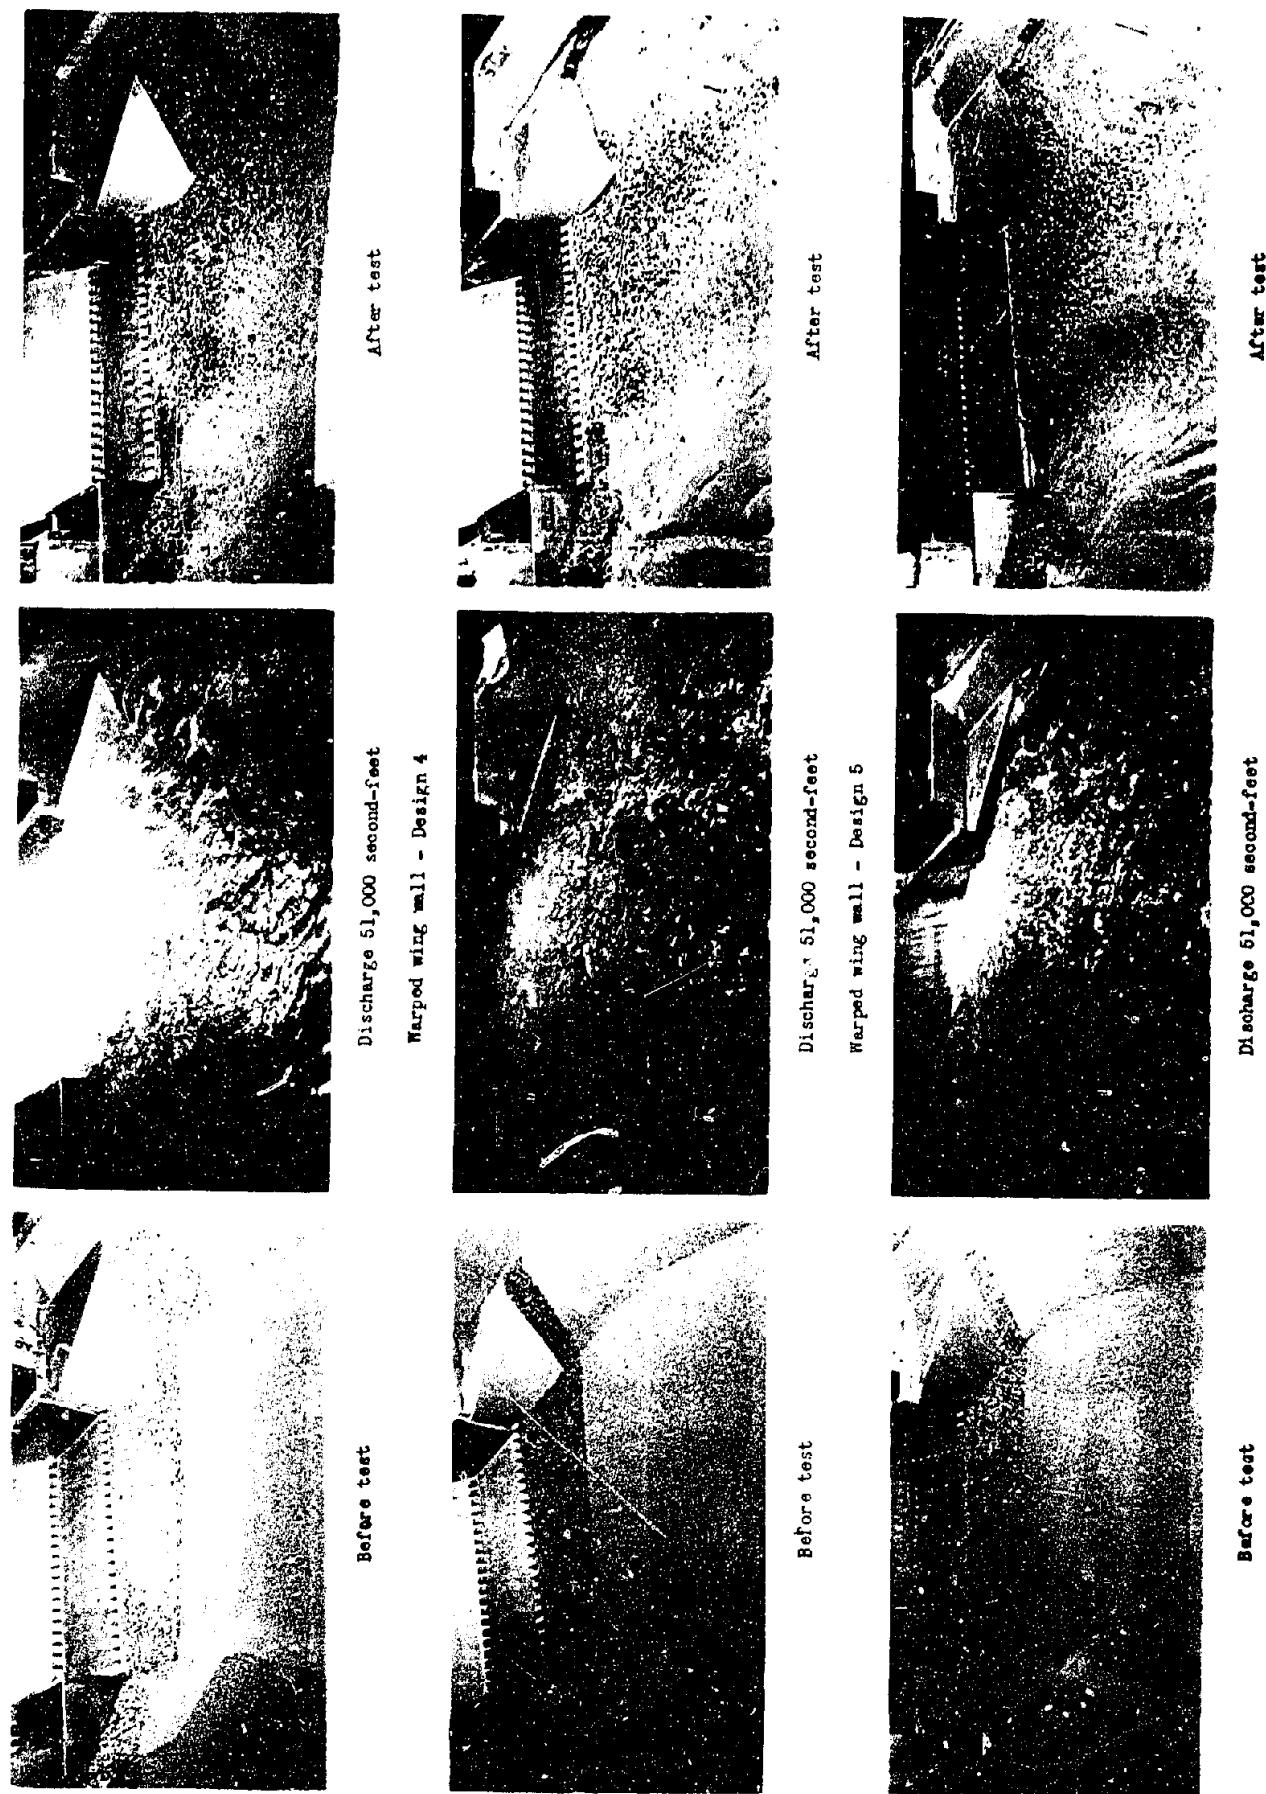
FIGURE 24

FLOW CONDITIONS AND EROSION DOWNSTREAM FROM APRON OF 1:60 MODEL
OF FRESNO DAM SPILLWAY WING WALL - DESIGNS 4, 5, AND 6.

Downstream Wing-wall, Design 5. The wall was extended from vertical at the downstream end of the training wall to a 1-1/2:1 slope at a point 60 feet downstream from the apron (design 5, Figure 22). The right edge flared outward at an angle of 5 degrees with the training wall. The flow conditions appeared the same as for design 5, but the erosion along the edges of the wall was considerably increased (Figure 24B).

Downstream Wing-wall, Design 6. The edge at the base of the warp was flared 10 degrees outward from the training wall and the downstream edge placed on a 2:1 slope (design 6, Figure 22). The flow conditions were similar to those for the designs previously tested and were considered satisfactory (Figure 24C). However, the erosion was practically the same as for design 3 and the warp was again altered.

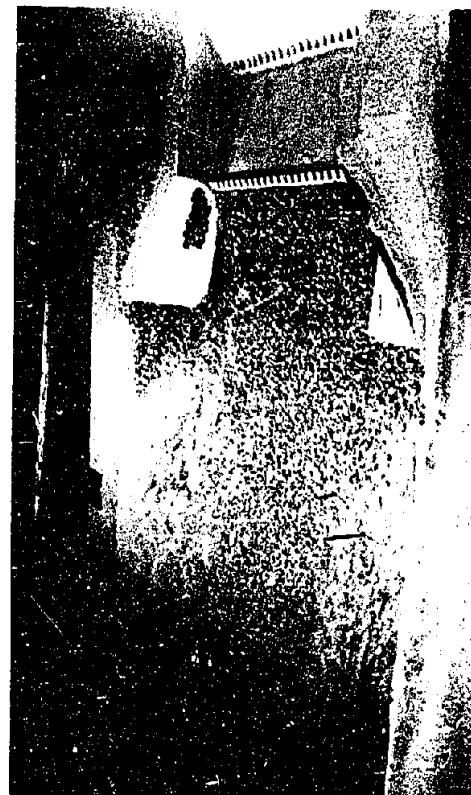
FIGURE 28

A - Maximum discharge over spillway and through tunnels

B - Erosion caused by maximum discharge over spillway and through tunnels.

C - Erosion caused by maximum discharge over spillway and through tunnels.

D - Both tunnels discharging full capacity

FLOW CONDITIONS AND EROSION DOWNSTREAM FROM APRON OF 1:60 MODEL OF
FRESNO DAM SPILLWAY - ALL RECOMMENDED FEATURES INCLUDED.

Return flow was apparent downstream from both wing-walls, however, it was much more pronounced downstream from the left wall causing excessive erosion, damaging the 2:1 riprapped slope (Figure 28B).
