* * * * * HYDRAULIC LABORATORY REPORT NO. 185 * * * * *

* * * * * MODEL TESTS OF GILA VALLEY CANAL HEADWORKS
* * * * * AND
* * * * * BALL CHECK VALVES FOR THE DESILTING BASIN * * * * *

* * * * * IMPERIAL DAM
* * * * * ALL-AMERICAN CANAL PROJECT * * * * *

Subject: Model tests of Gila Valley Canal Headworks and Ball Check
Valves for the Desilting Basins - Imperial Dam - All-American
Canal Project.

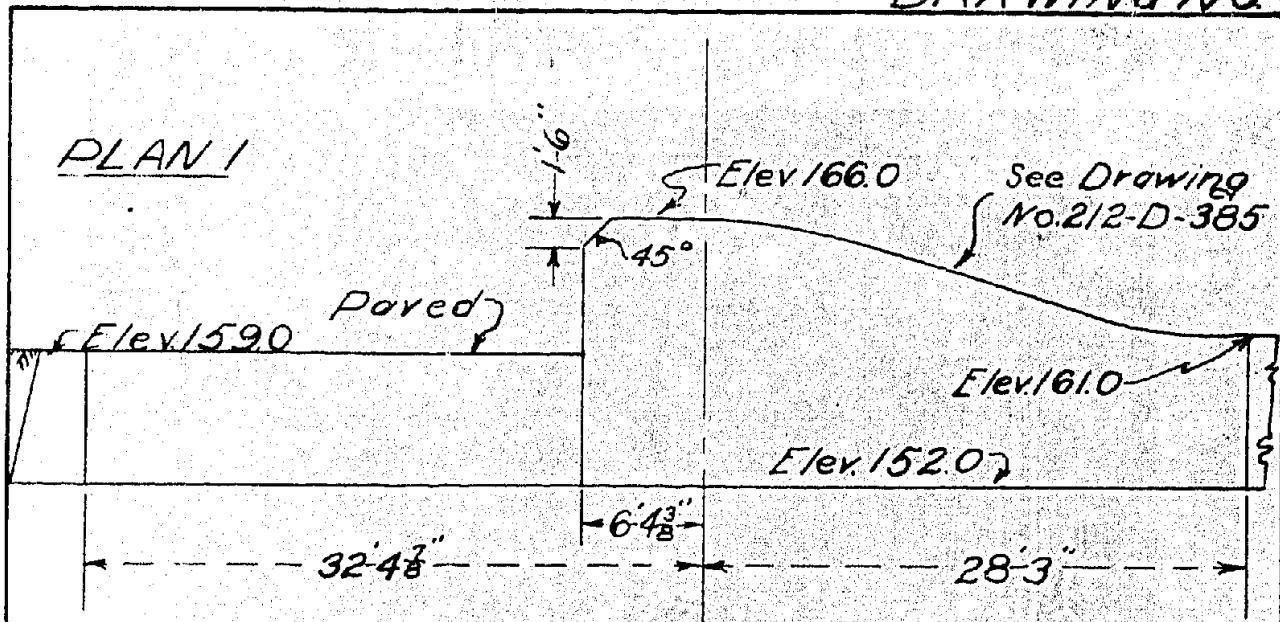
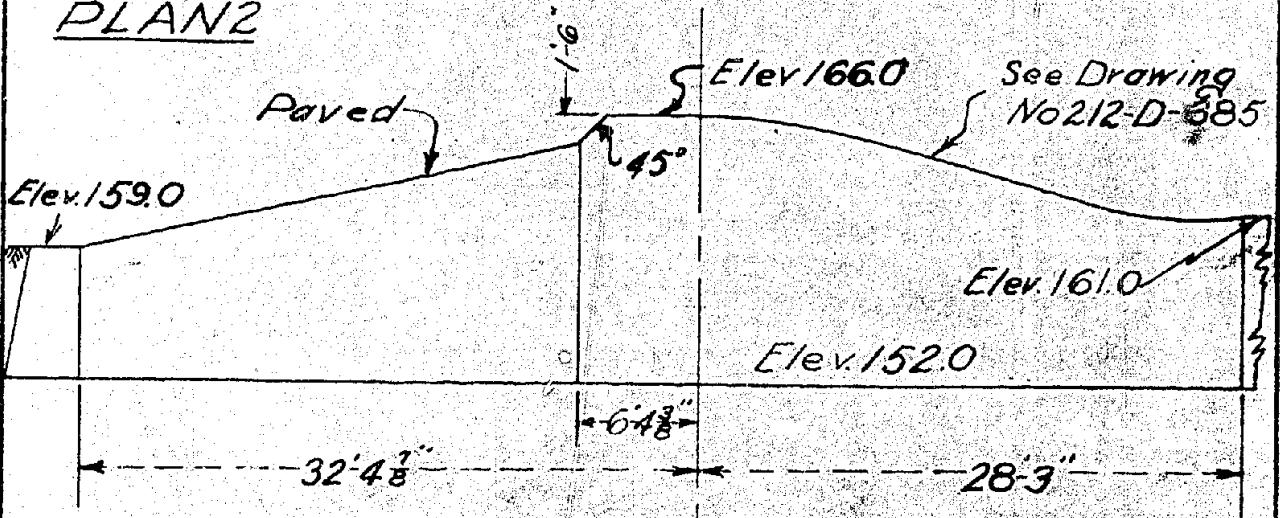
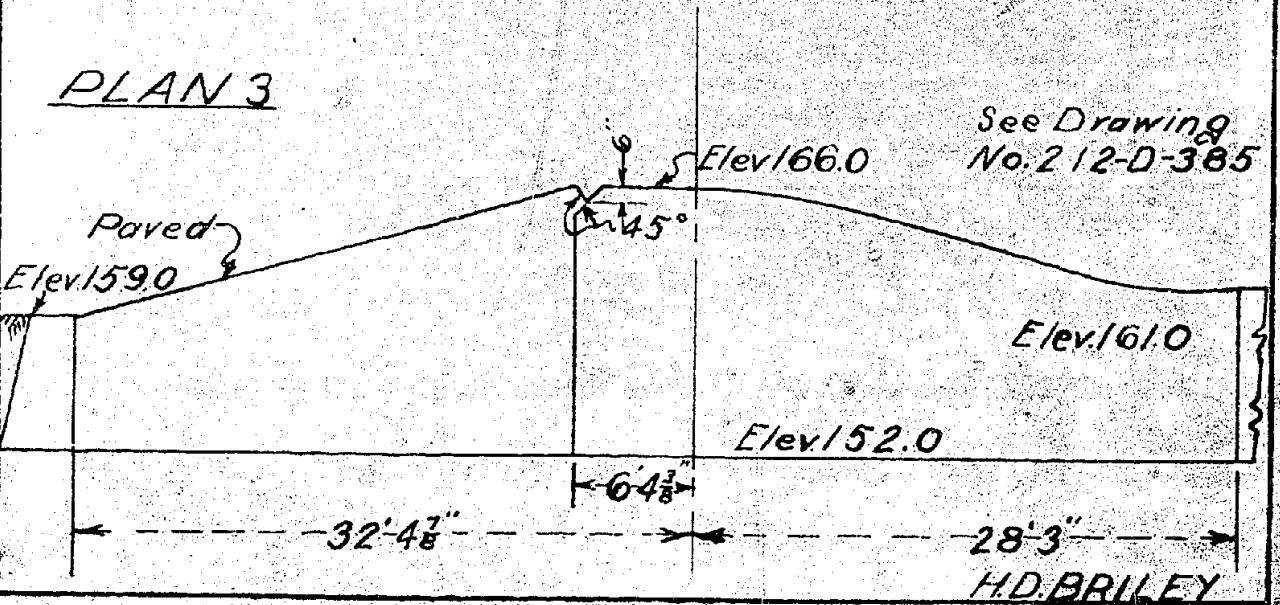
DRAWING NO. 4

PLAN 1

PLAN 2

PLAN 3

2. Improvement of Inlet Gate Crest. Preliminary runs on the original design of the crest of the inlet structure plan 1, figure 4, had indicated that very bad entrance conditions existed under the lip of the gate when these gates were opened only a small amount and the water in the desilting basin was low, figure 5. Consequently, runs were made on this design and on the several proposed changes by raising the water surface in the desilting basin by one-foot steps beginning at elevation 161.0 and ranging to elevation 179.5. The adverse condition consisted of a shooting jet of water which broke

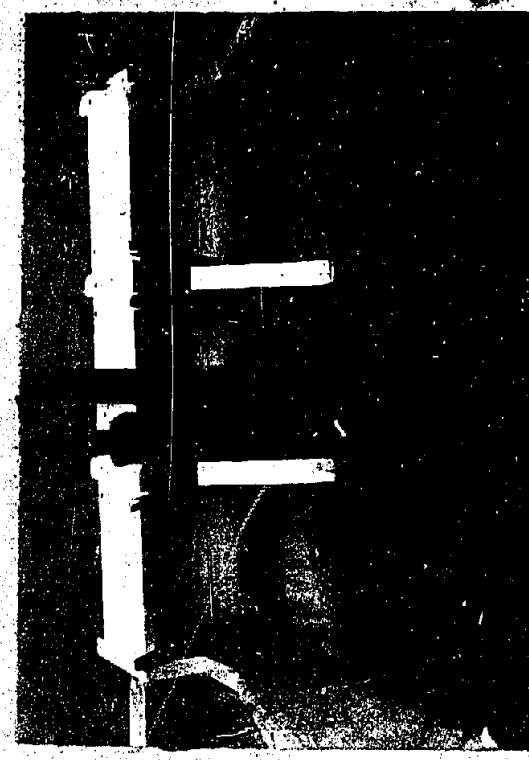
Figure 6

Plan 1 - High Tailwater
Flow Conditions

Plan 2 - Low Tailwater

Flow Conditions

Medium Tailwater

Flow Conditions - Plan 2

High Tailwater

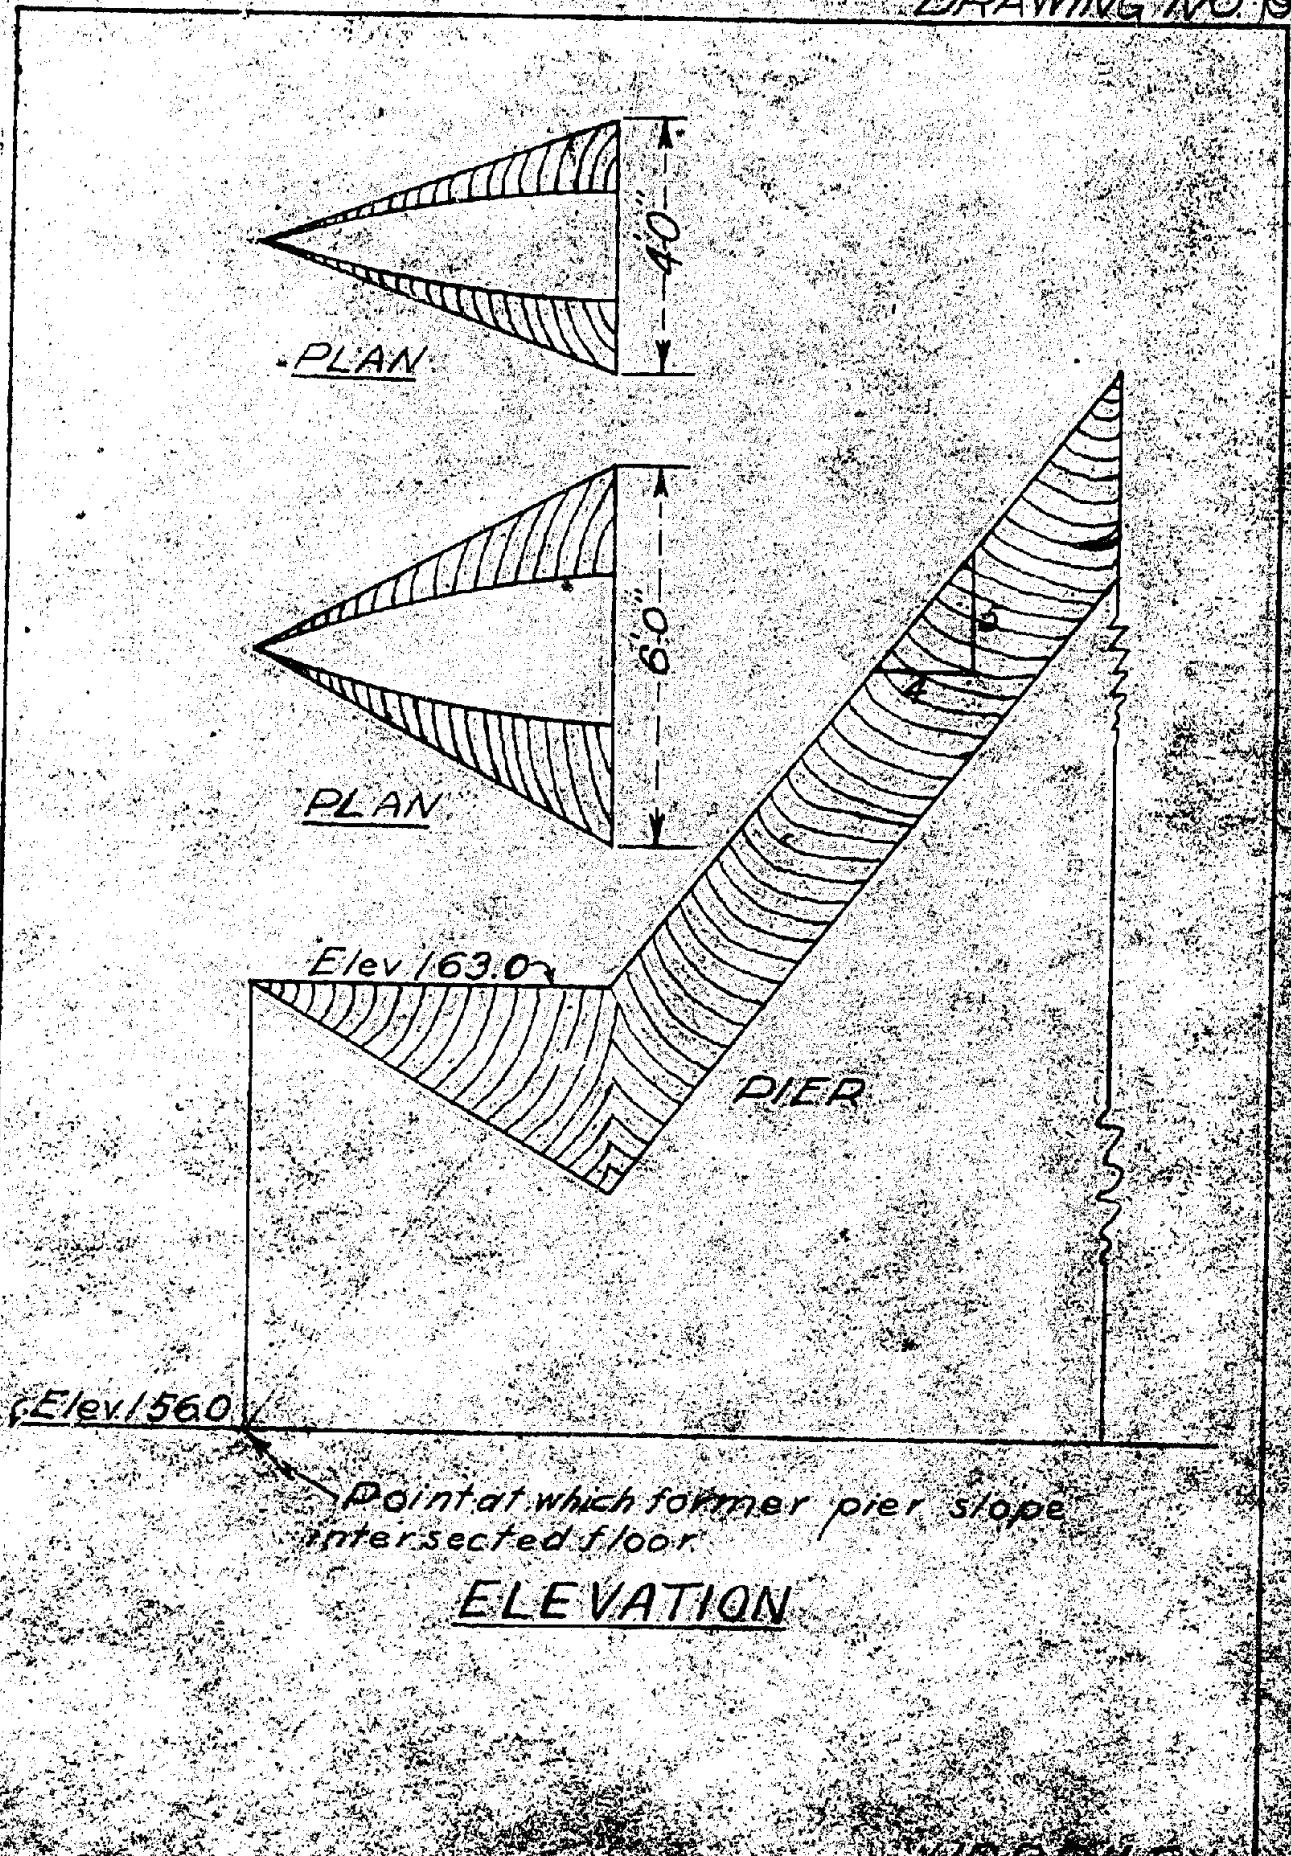
DRAWING NO 9

ELEVATION

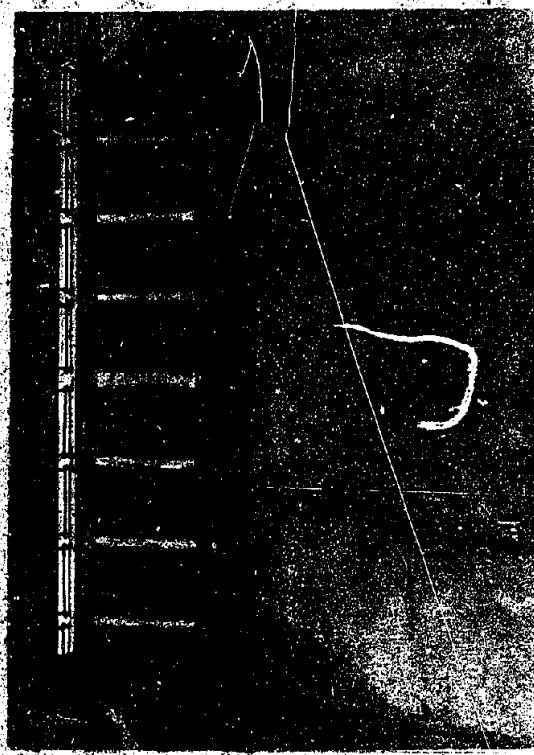
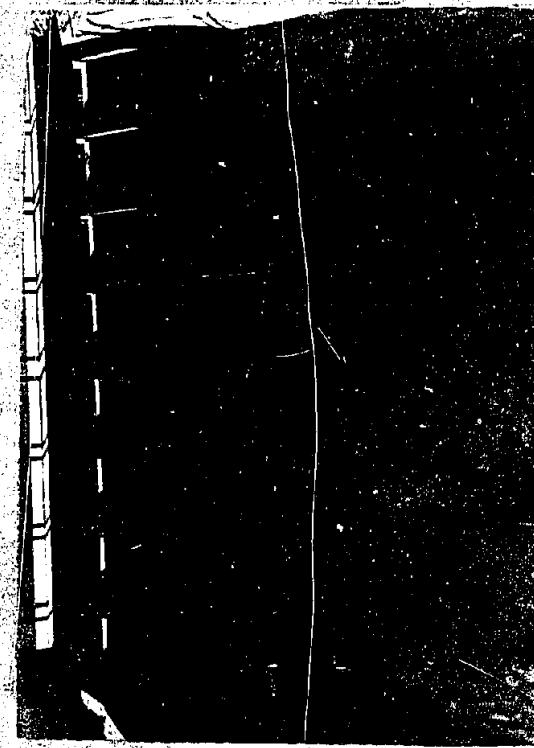
Figure 10

No pier shape - Looking Downstream

Flow conditions - Looking Downstream

Flow conditions around one pier
SLUICEMAT STRUCTURE - IMPROVED DESIGN

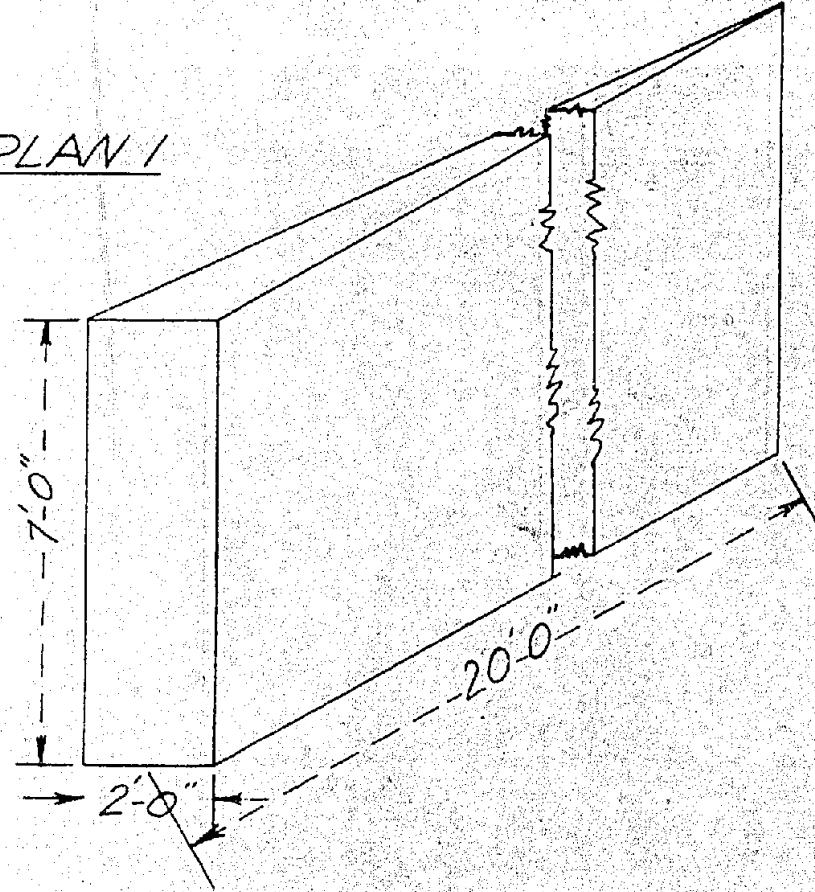
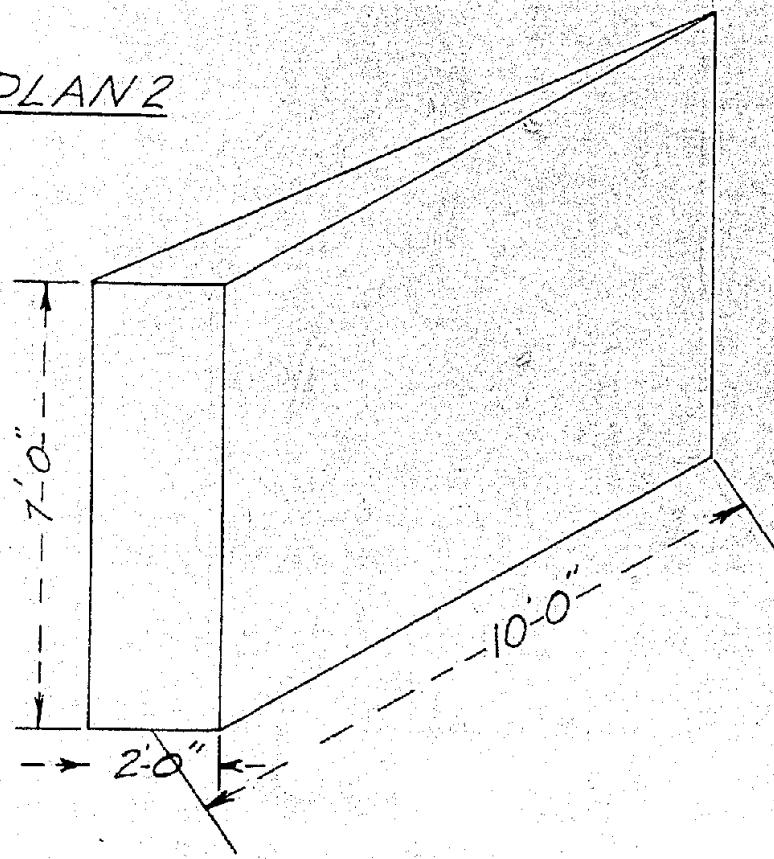
DRAWING NO. 12

PLAN 1

PLAN 2

would conform better to the general shape of the structure. With this thought in mind the next section tested was of the same general shape but only 10 feet in length, plan 2, figure 12. This addition did not give quite as good results as the longer section but since it conforms more to the general shape of the structure it is considered satisfactory, figure 11.

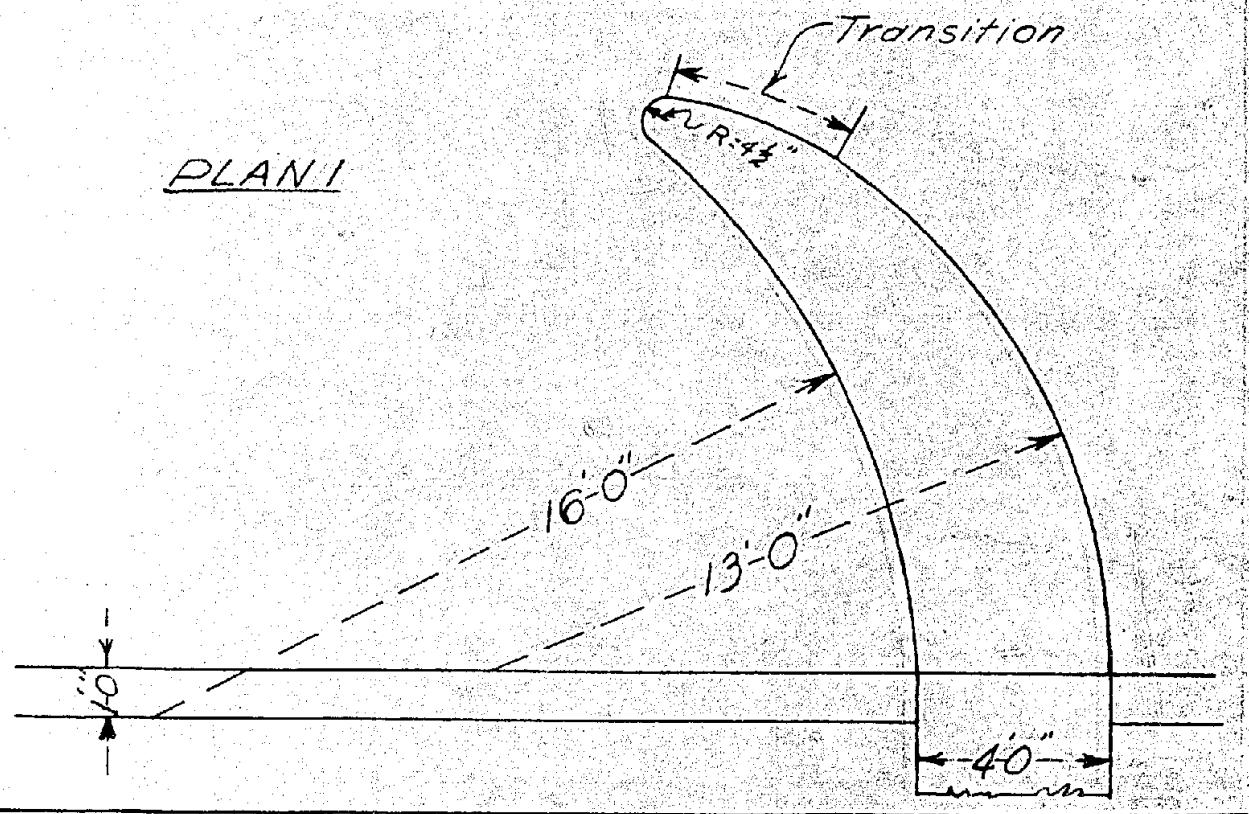
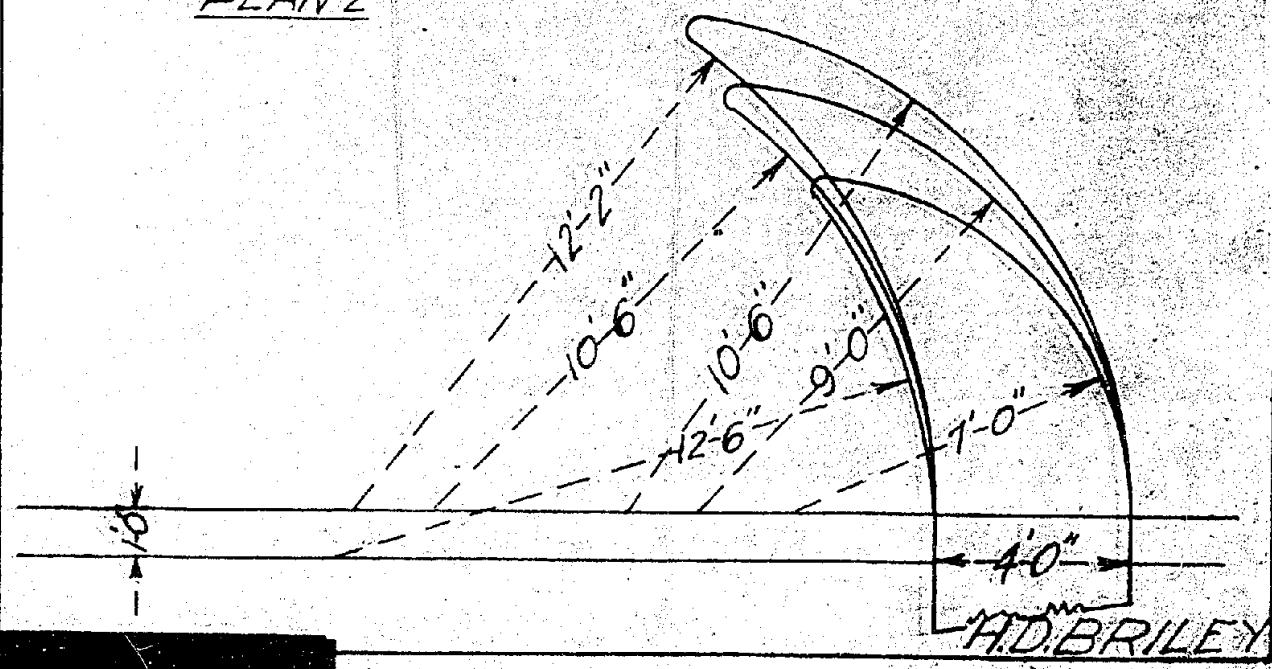
PLAN 1

PLAN 2

The water surface in the desilting basin was held at elevation 179.5. The first attempt to improve the conditions in the channel consisted of shortening the three pier tails on the right, plan 2, figure 13. Some improvement was noted in the flow, especially between the second and third gates from the right, figure 14, and some of the whirl was quieted in the canal channel. There was also an evident drop in head

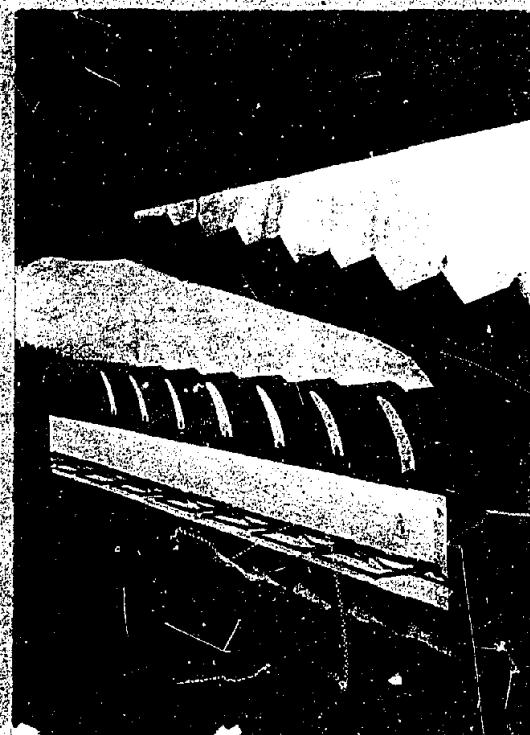
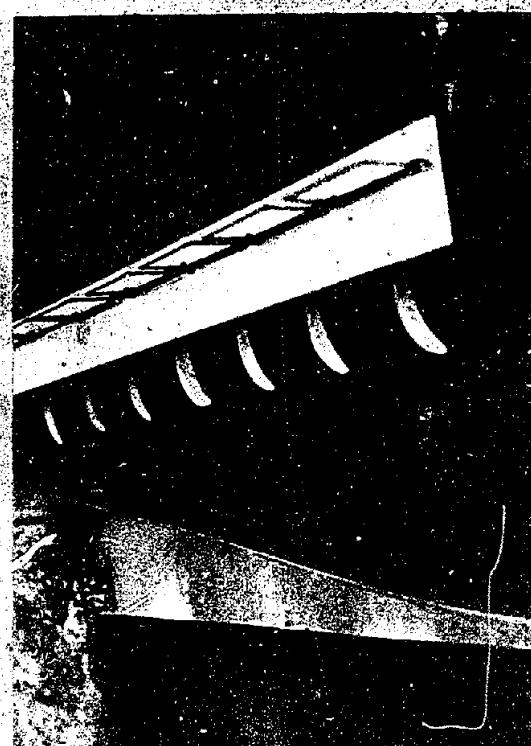
Figure 14

View from right

Flow Condition - Plan 2

View from left

Flow Condition - Plan 1

PIER TAILS ON SLUICEWAY STRUCTURE

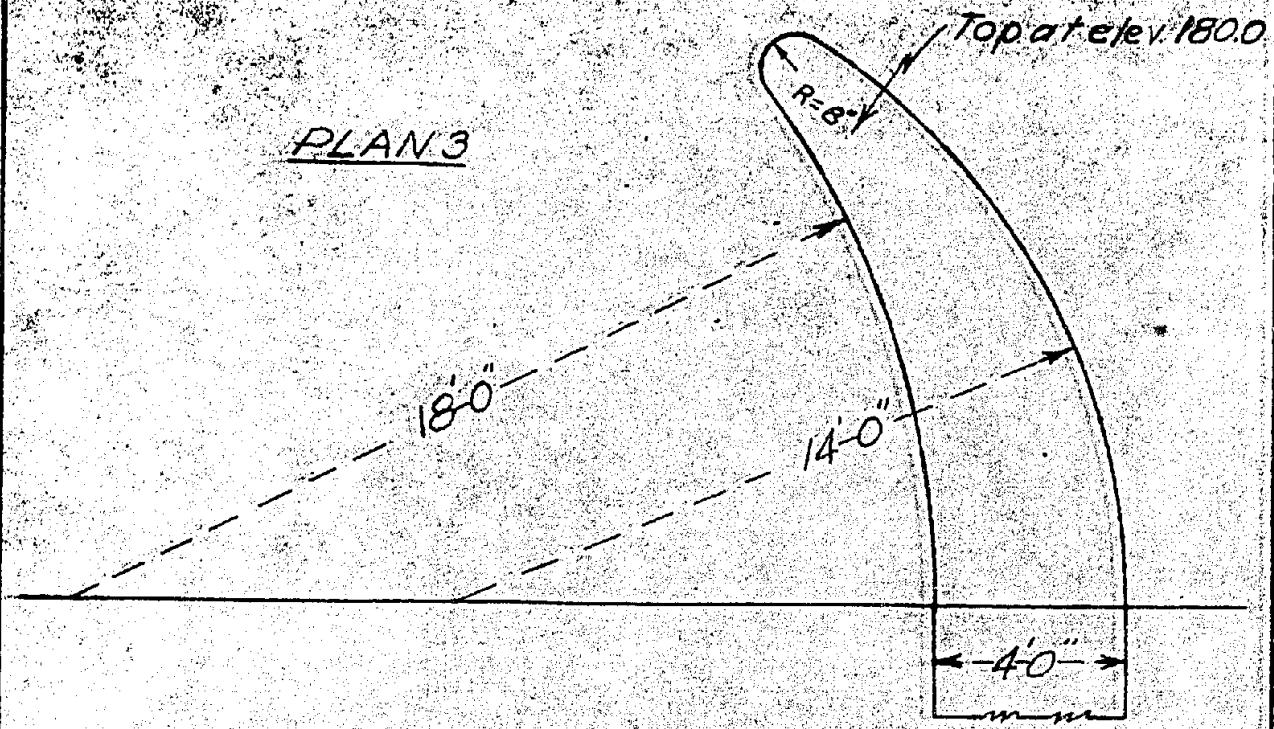
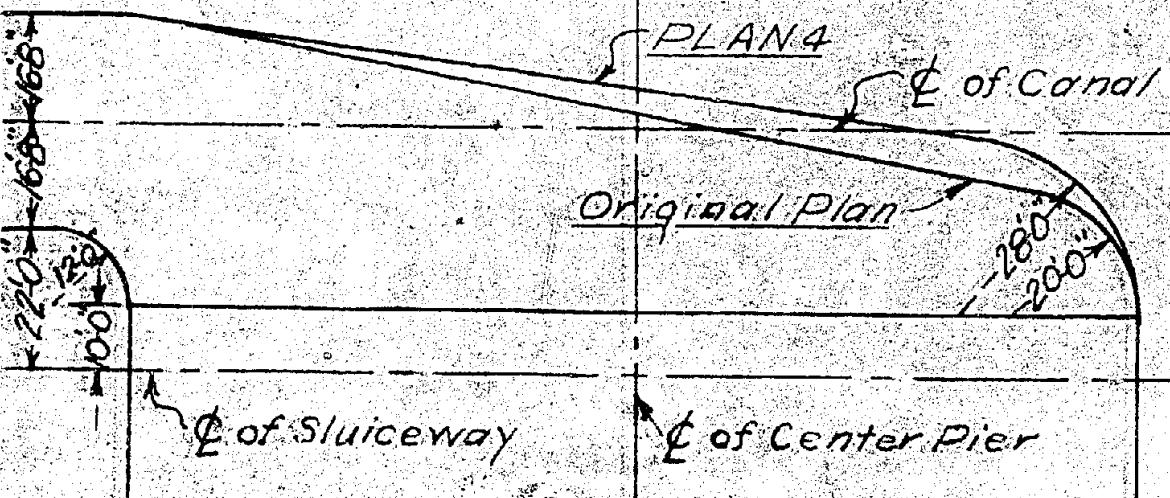
PLAN 3

PLAN 4

from right to left in the canal below the sluiceway but generally the flow conditions were not appreciably improved. All of the pier tails were removed and new ones of the shape shown on plan 3, figure 15, were installed. Flow conditions in the channel were improved, especially below the three right openings, figure 16. Flow distribution in the channel above the transition to the earth section of the canal was improved but there was still considerable drop in head between the two ends of the canal section. Observed conditions indicated that it would not be practical to make the pier tails straighter because the direction imparted to the water entering the channel would then be undesirable. With further changes on this point impractical, attention was directed to moving the canal wall farther downstream. This wall was moved until the opening between it and the right pier tail was practically equal to the width of the gate opening, plan 4, figure 15. This change made a very noticeable improvement in the conditions in the channel and the distribution in the transition upstream from the earth section. The drop-in head between the two ends of the canal section was also reduced. There was a slight surface roll below the three left gates. Throughout these tests it had been noticed that with flow over the gates the water surface in the canal was above the bottom of the beam across the top of the gate openings. Since the bottom of this beam was at elevation 179.0 and the water surface in the desilting basin was at elevation 179.5, the opening acted as an orifice. Improved conditions of flow were obtained by raising the bottom of this beam to elevation 180.0. Distribution before entrance into the earth section was very good and the drop in head between the two ends of the structure was reduced.

The formation of a slight roll below each gate was noted. The jet from each of the gates was visible to the center of the channel and then became evenly distributed in the canal. These three changes, namely, change in shape of pier tails, plan 3, figure 15, new position of canal wall, plan 4, figure 15, and raising the bottom of the beam above the gates, have combined to improve the distribution of flow and entrance conditions in the canal.

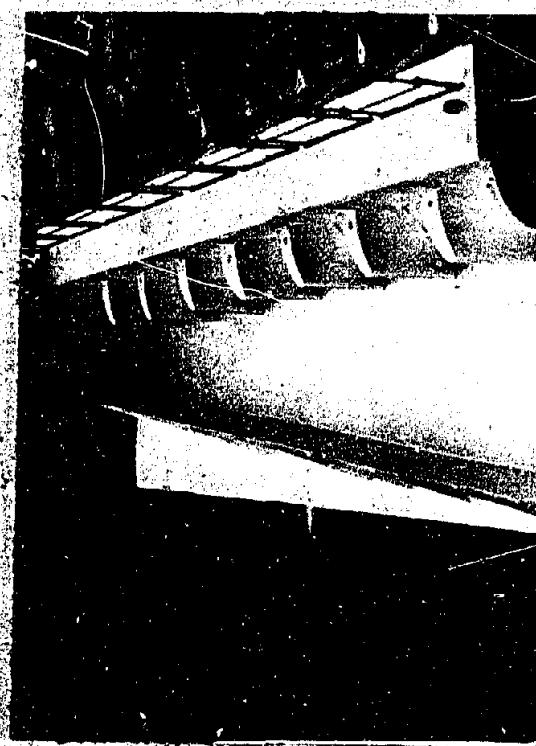
Figure 16

Flow Conditions - Plan 3

Structure - Plan 4

Flow Conditions - Plan 4

Flow Conditions - Bottom of Beam
above Gates at Elevation 180.0
PIER TAILS ON SLUICeway STRUCTURE

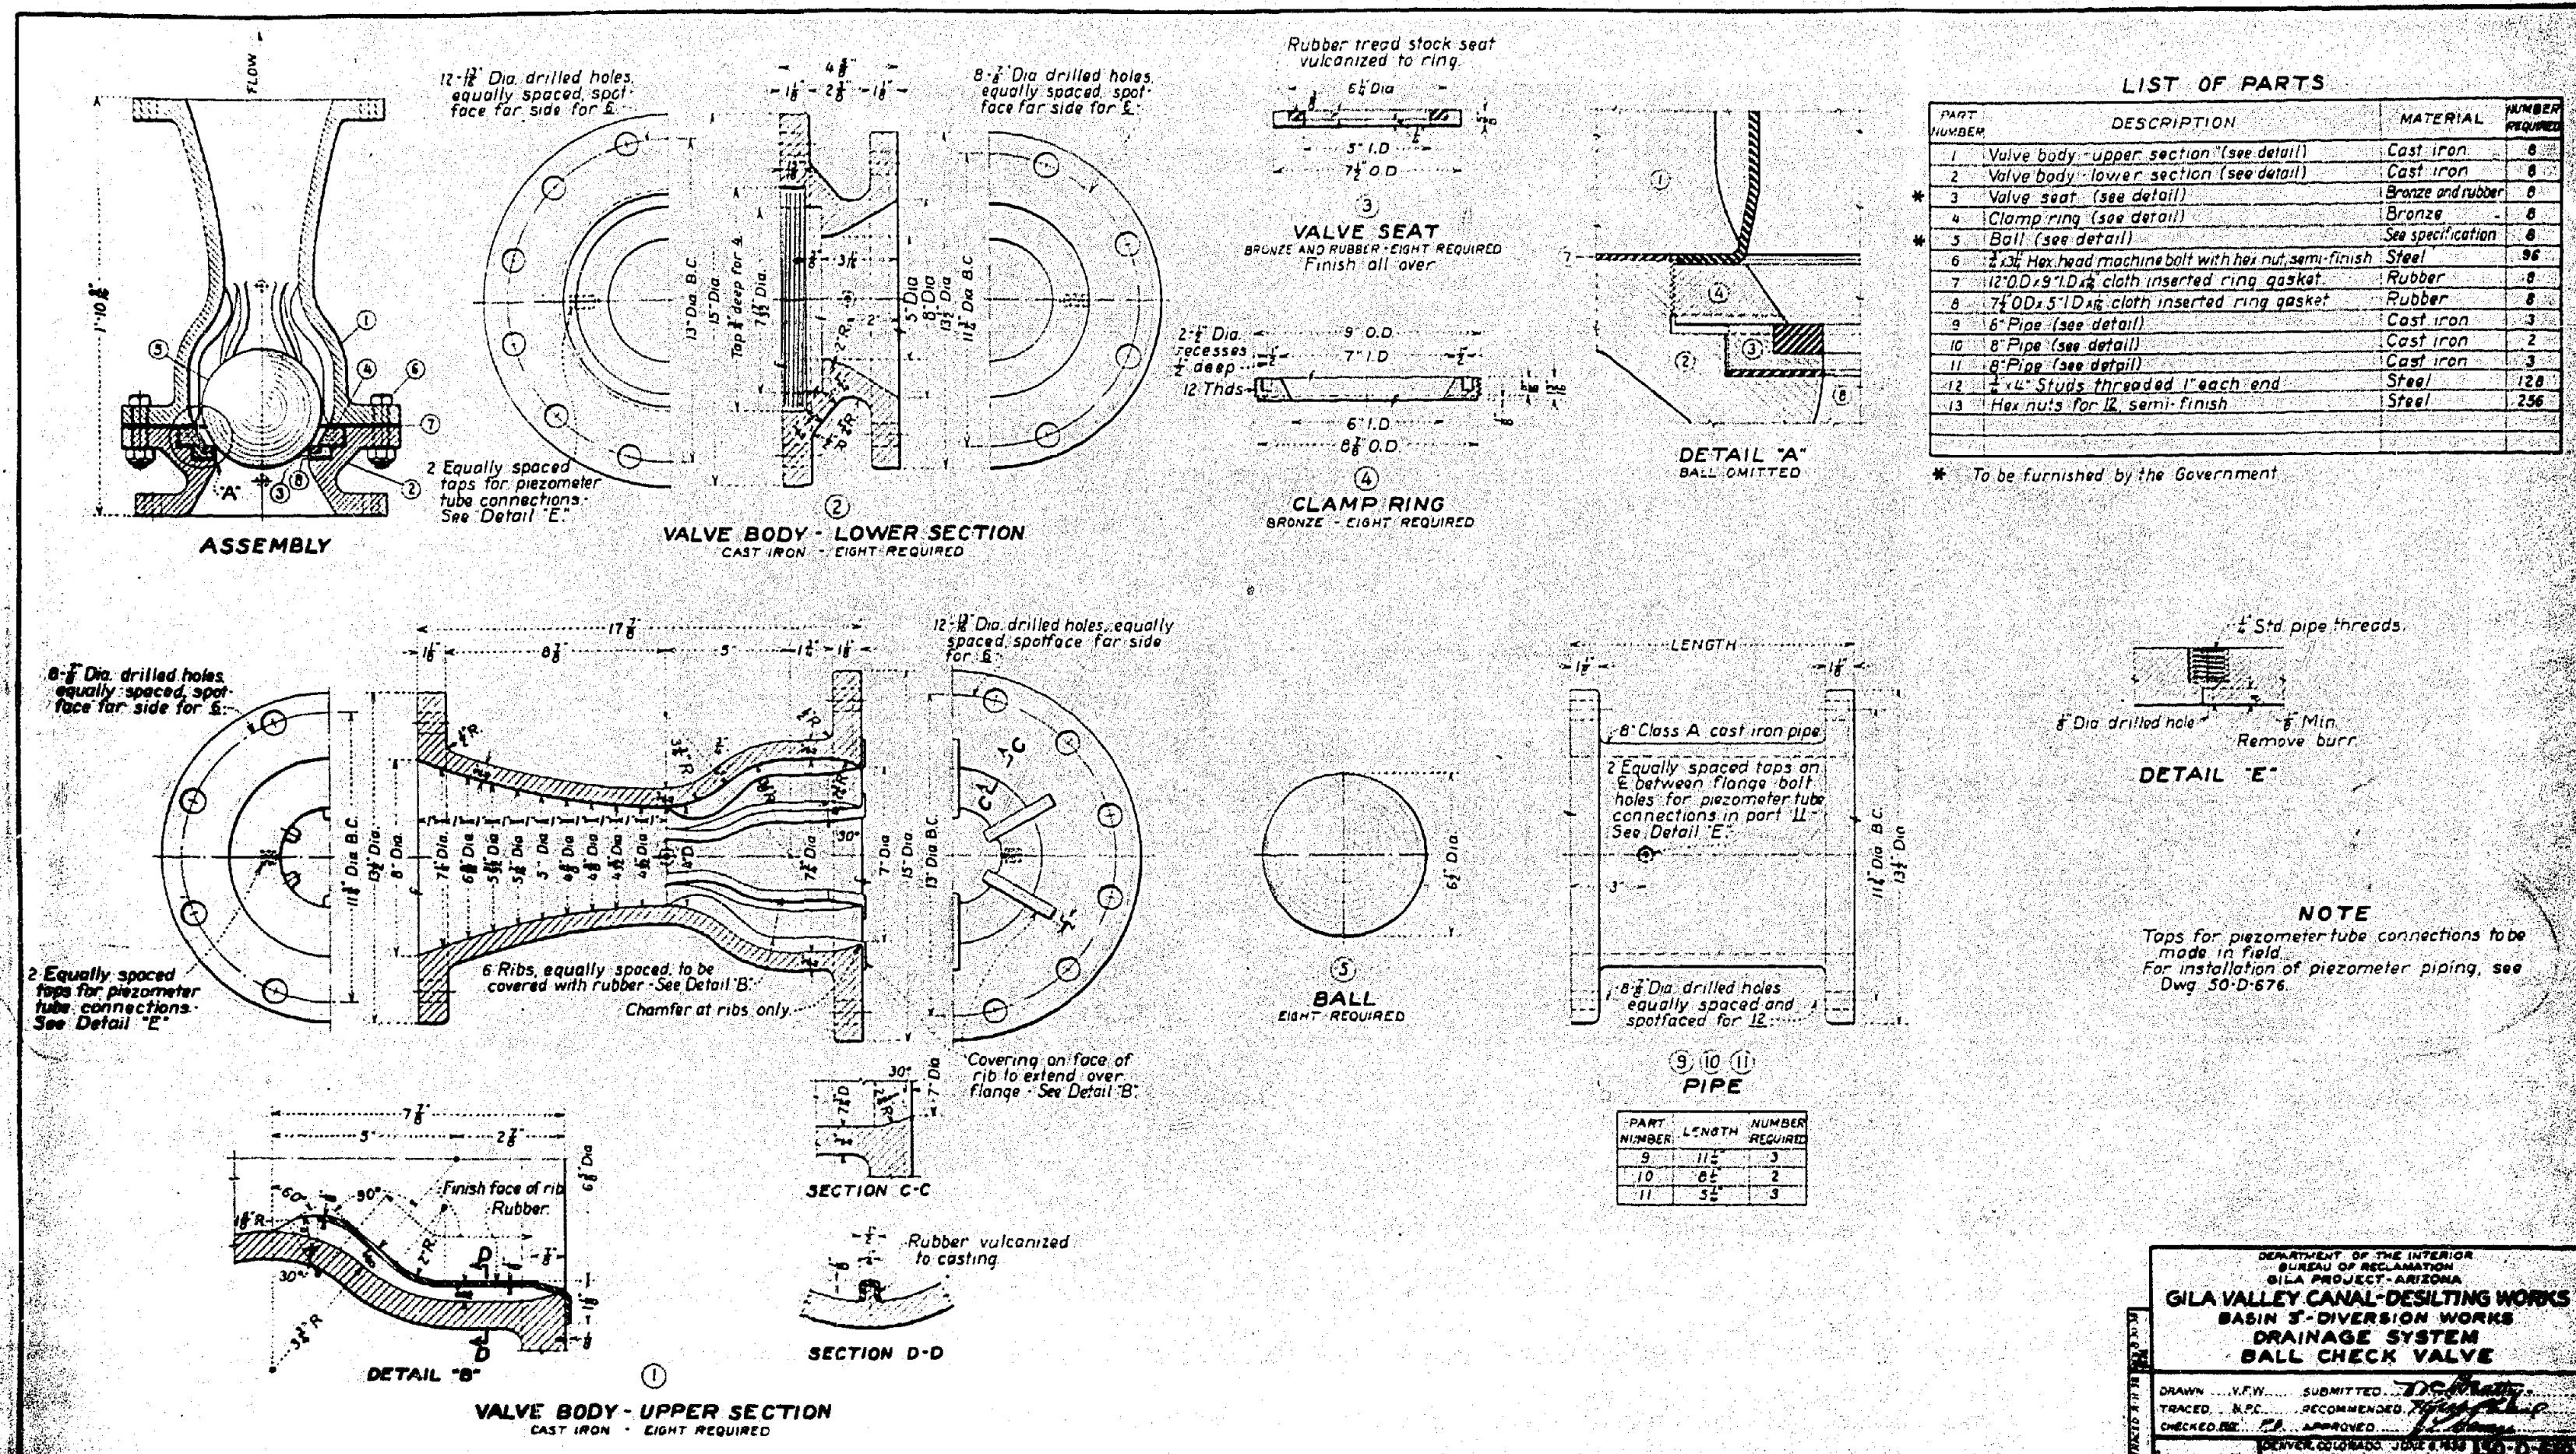
FIG. 18.

the ball be smaller than that below it for all open positions. The final design of the valve, figure 18, is such that, with the ball in the open position, there is a progressive decrease in cross-sectional area from inlet to outlet, with the resulting increase in velocity and decrease in pressure head.

Operation of the final valve at discharges below 0.46 second-foot resulted in no vibration of the valve and such a slight motion of the ball that its presence could be detected only by the fluctuation of the mercury columns of piezometer connections. During small flows, the ball is lifted only a small distance above the seat so that the cross-sectional area of flow between the ball and the seat is smaller than that above the ball, which results in an unbalanced pressure system similar to that developed in the original valve. Obviously, this condition can never be completely eliminated. The range of discharge over which the ball has motion can be reduced by further reducing the cross-sectional area through the valve, but, since this increases the loss and consequently reduces the discharge through the valve, and because the motion of the ball in the revised design was not considered excessive, this design was adopted.

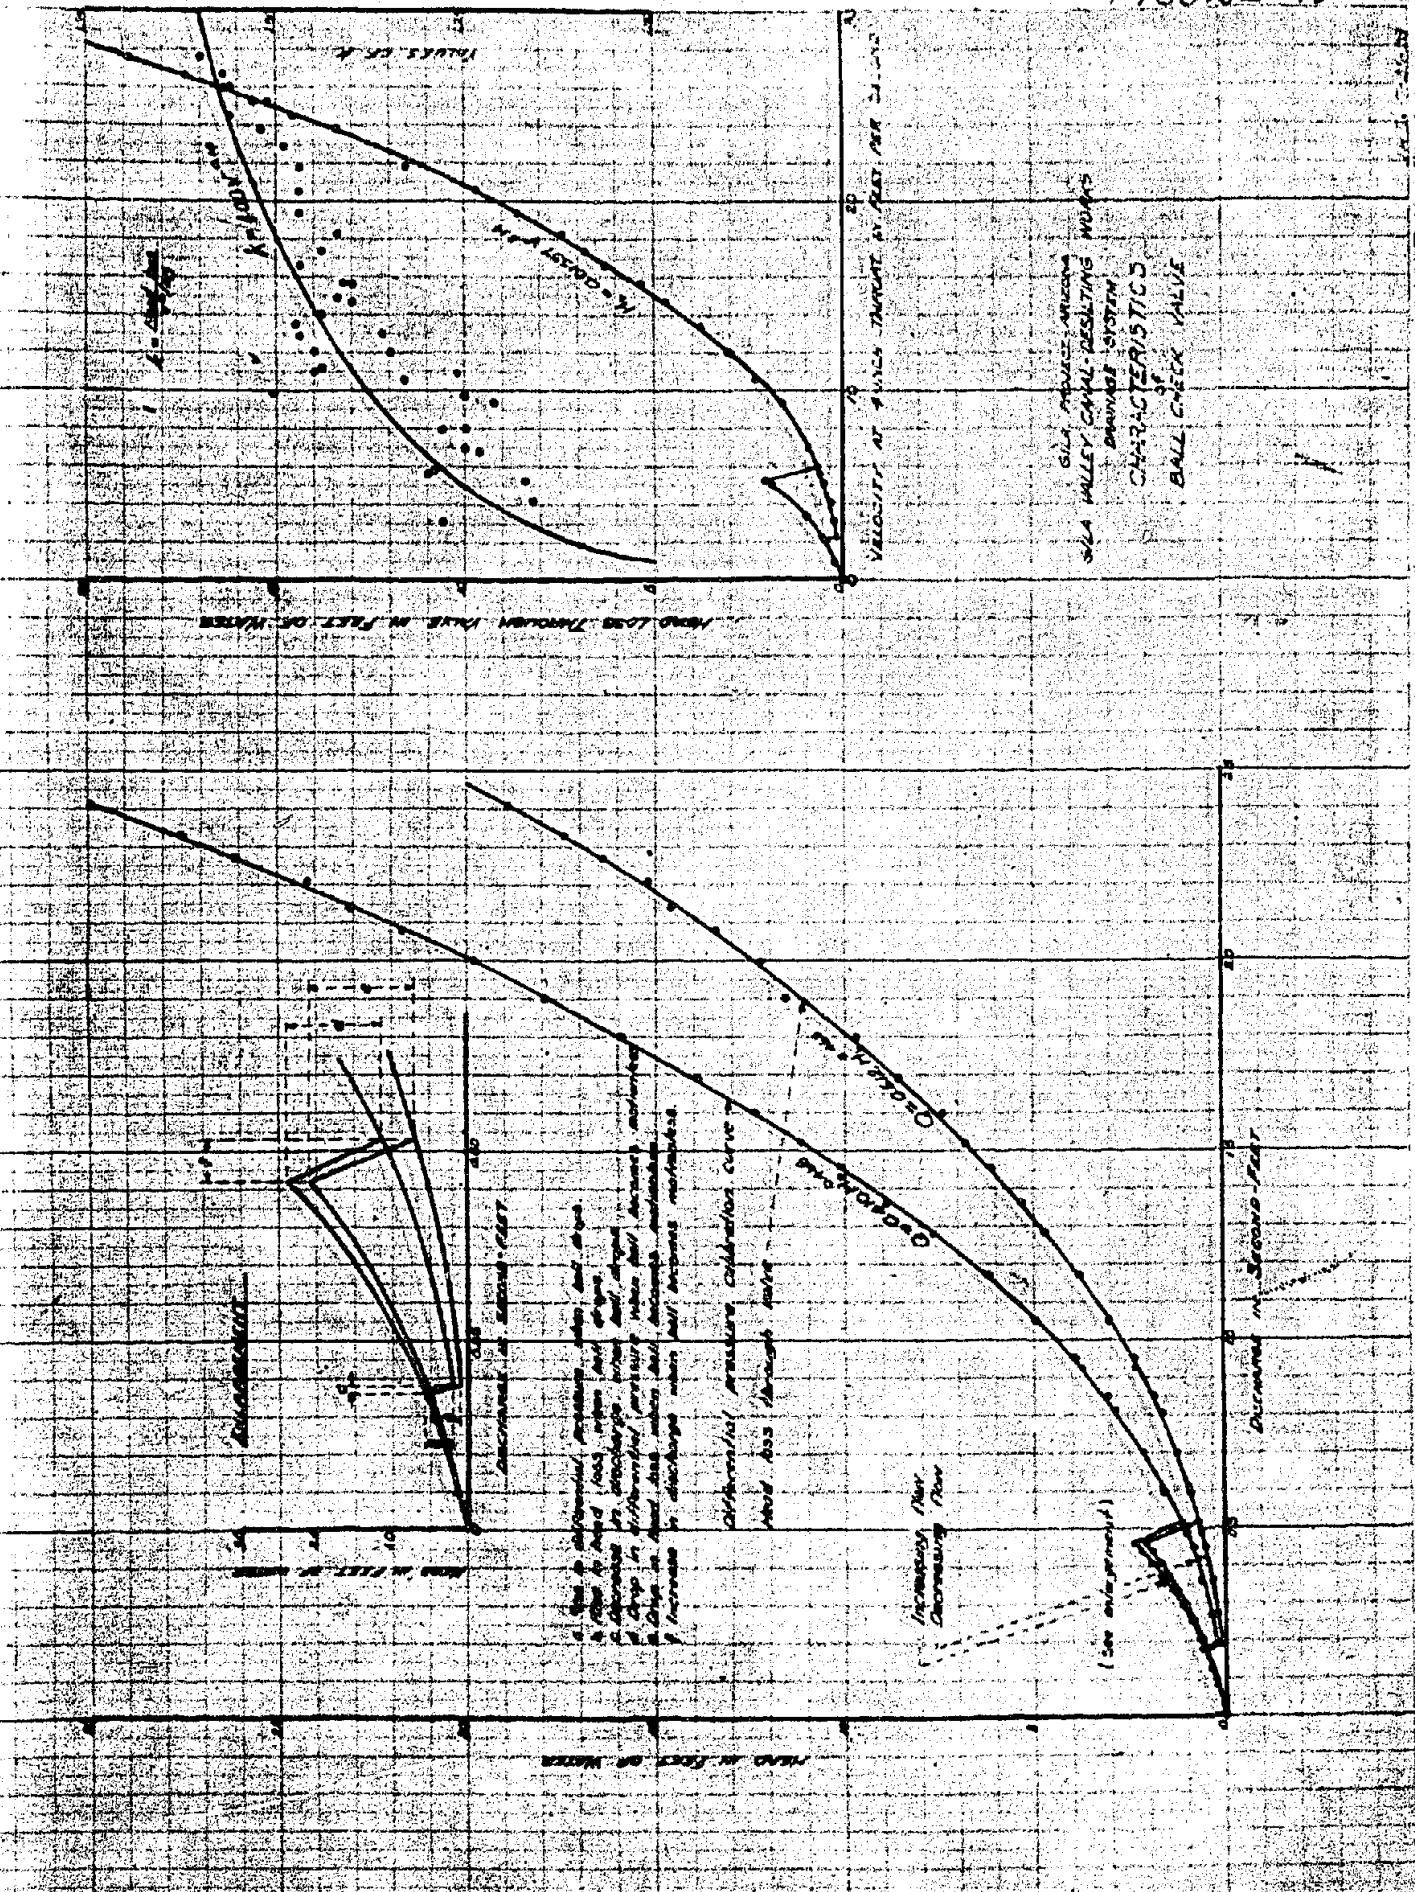
FIGURE 19

10. Calibration of the Final Design of Valve. Figure 19 shows the characteristics of the ball check valve for discharges up to about 2.5 second-feet. The head loss through the valve in the 1 to 1 scale model was measured by 1/8-inch inside diameter piezometer openings located at quarter points in planes A and D, figure 18. A large differential pressure for rating purposes was obtained from diametrically opposite openings at location B and C. A slightly greater differential was obtained by using piezometers at point A in the 8-inch pipe instead of at

The increased resistance to flow when the ball is in motion is clearly shown by the lower portion of the curves of figure 19. As the flow increases, the ball is in motion up to a discharge of 0.46 second-foot and a loss of head of 2.05 feet, at which point the ball is held motionless against the guide vanes, with an accompanying decrease in head loss and corresponding increase in discharge. The head loss plotted against discharge then follows a smooth curve whose equation is

where Q is the discharge through the valve and H_L is the head loss between A and D. As the flow decreases from the maximum, the discharge-head loss relationship is the same for increasing flow and is given by equation (1) until a discharge of 0.19 second-foot and a head loss of 0.10 foot are reached, at which point the ball drops from its stationary position and assumes a very slow motion. The head loss immediately increases to that value found with the ball in motion during increasing discharge. During increasing flow, the ball remains in motion over a greater range of discharge than during decreasing flow because a greater difference in pressure between the top and bottom of the ball is required to stop its motion than is required to start it again.

Assuming that the flow through each valve is half that through the 12-inch pipe, then the corresponding maximum value of differential pressure as found from piezometers at B and C is found from the curve on figure 19. The rate of lowering the water surface in the settling basin is thus defined by this maximum allowable difference between piezometers at B and C.

The walls of the settling basin were designed for a pressure of 1.15 feet of water at the top and 2.6 feet at the bottom, and the wall thickness varies uniformly from top to bottom. Computations indicate that the check valves of line I will operate with the balls in motion (on the higher loss curve of figure 19) until the total head causing flow becomes 2.3 feet of water. At the heads above 2.3 feet, the

It must be kept in mind that the values of "allowable differential pressure" as measured at the valve between piezometers B and C (taken from the curves of figure 19) are based on computed values of discharge through the valves. Should the actual values of losses be greater than those assumed for computation purposes, then the computed values of discharge and the corresponding allowable differential pressures are too high. For complete safety of operation, either field measurements of the losses in line I should be made, or provisions made for measuring the head, due to ground water, on the walls and floor in the area drained by line I.
