Hydraulic Laboratory Report No. 2.83

Technical Memorandum No. 389

SATURATION OF EXISTING EARTH DAMS

MEMORANDUM TO CHIEF DESIGNING ENGINEER
SUBJECT: SATURATION OF EXISTING EARTH DAMS

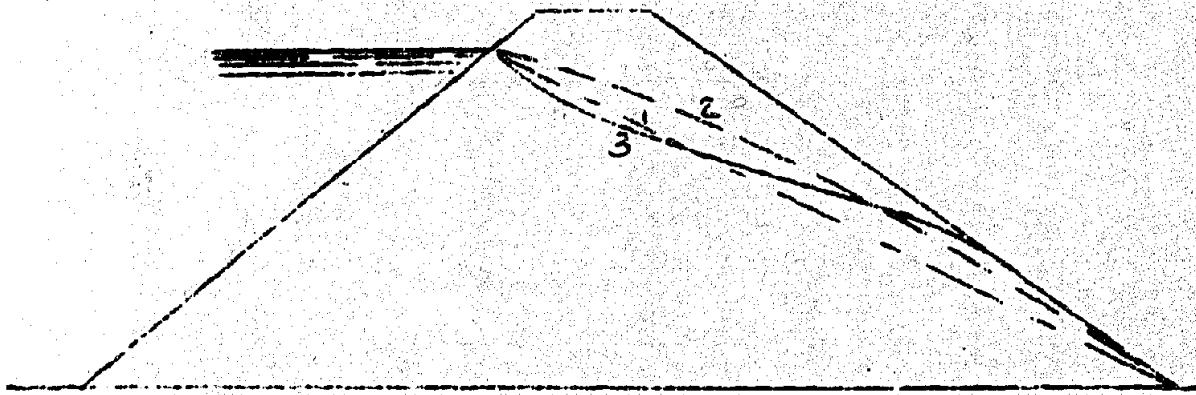
The following sketch indicates roughly the saturation line of a homogeneous earth dam on an impervious foundation as it might be estimated by several analytical methods. They will be soon to be at considerable variance.

1. Straight line - First approximation generally employed.
2. Single curve concavo upward - Turneaure & Russell
"Public Water Supplies" (1913).
3. Triple curve - Prof. N. N. Pavlovsky¹ and Dr. Leo Casagrande².

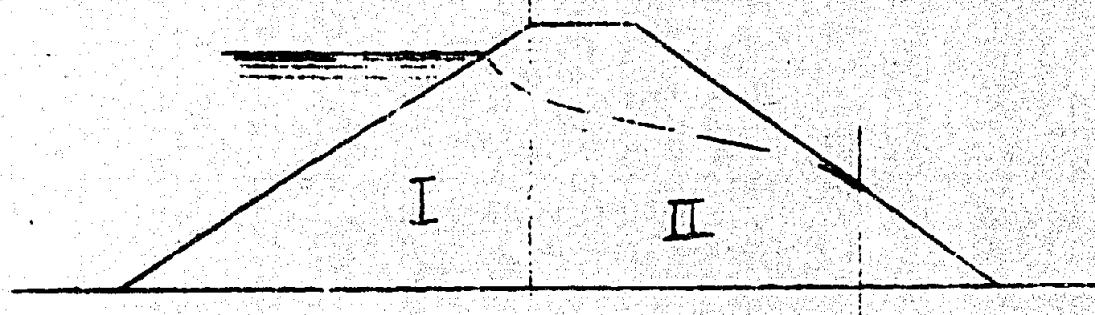
The saturation line of a homogeneous dam on an impervious foundation is shown by Prof. N. N. Pavlovsky in his analytical treatment of the subject¹ and demonstrated by Engineer Davidenkov in the laboratory with sand and sand-clay models² to be of about this shape:

In section I water enters the dam perpendicular to the face; in section II the curve drops but gently and then drops sharply again when approaching the downstream slope. It has nothing in common with a straight line.

This curve will be seen to be roughly approximated in some of the cases which follow.

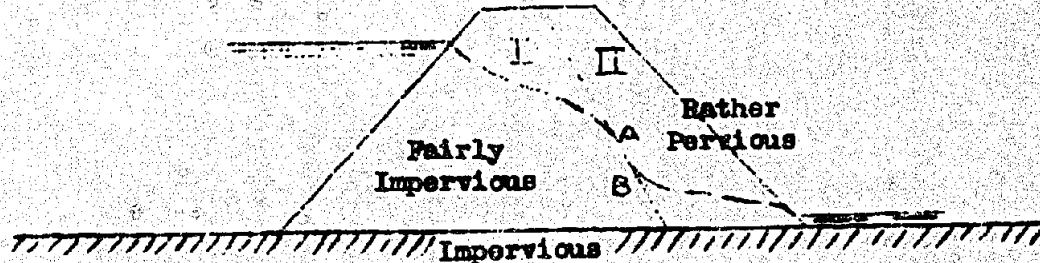
b. Drains. No matter where they are located drains appear to induce flow in their direction. Witness Coquille Dam (plate 41), Borov Elect. Co. Dam (plate 46), and Boz-Su Dam (plate 43). Where a drain is used it is seen that a drop in saturation line does not necessarily indicate presence of impervious material. As another example consider the following:

Here the porous material II is capable of carrying away on a relatively flat slope all of the water that the impervious material I will pass. In this case the steep slope of the "saturation line" from A to B indicates nothing but free flow down the face of the impervious section. If II were rock rip-rap the curve beyond B would be practically flat.

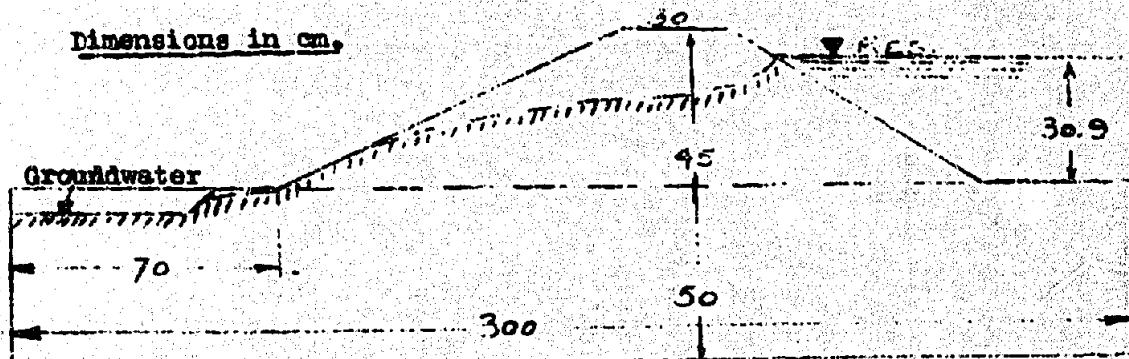
c. Porous foundation. A porous foundation tends to lower the saturation line and increase the seepage flow. However Davidonkov* showed by experiment with models of sand that the saturation line

"cut the downstream slope even when the level of ground water was fixed at some distance from the dam."

This point appears to be contradicted by plates 9, 33 and 34. It would be interesting to know more regarding data gathered at these dams.

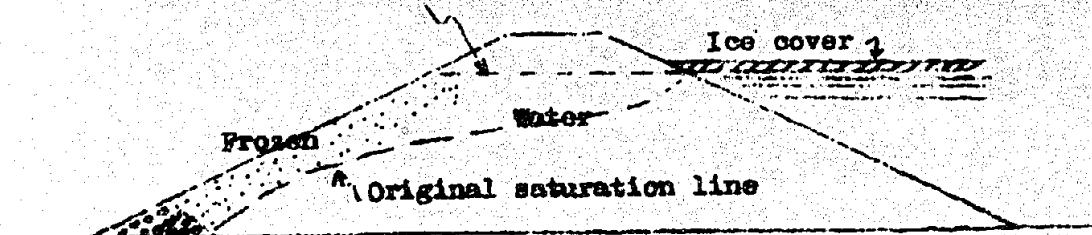
Saturation line after
bank and drain have frozen

When a drain at the downstream toe of a dam freezes the saturation line is raised. Engineer Davidonkov* in speaking of Russian Dams says that "the phenomenon has not been studied but it appears of great importance. In case the outgoing current of percolating water is frozen the saturation line will go up until the motion of the water through the dam stops and the latter appears saturated with water up to the level of the lower surface of the ice cover at the upper face.

In springtime when the downstream slope is thawing, the outcoming streams of water possess considerable gradients which can seriously threaten stability of the dam." Drains well buried are not apt to freeze.

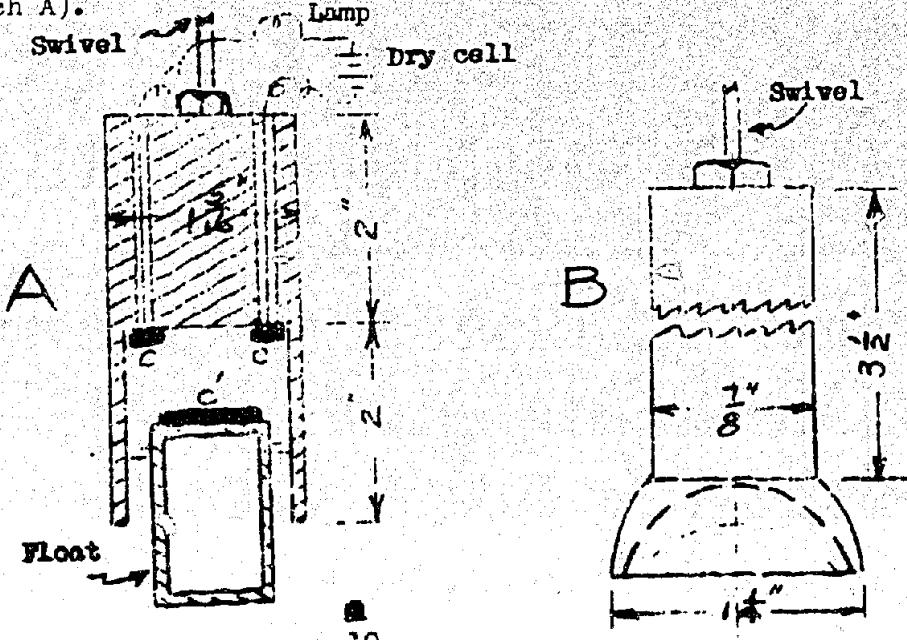
sketch "in which a float, suspended in a metal cylinder, is let down by a twin electric cable with its terminals connected one to the float and the other to the cylinder. As soon as the float touches the water the contact points of the float and the cylinder come together and an electric circuit is closed which rings a bell or lights a lamp." (See sketch A).

d. A bell sounder method (sketch B) also used by Mr. Khosla consists of a solid brass rod $\frac{7}{8}$ " diameter and $3\frac{1}{2}$ " long ending in an inverted cup or hollow hemisphere and suspended from the steel tape by a swivel. "Directly the cup touches the water surface a definite sound is produced which cannot be mistaken or drowned, even in the roar of water shooting over the weir crest". Readings can be
*This cup was used in shallow wells in India when uplift pressures under barrages were being studied.
accurate up to $1/16$ of an inch but $1/8$ " may be taken as normal accuracy." Mr. Khosla deems this method simplest, most direct, and most accurate. These advantages foster collection of useful data.

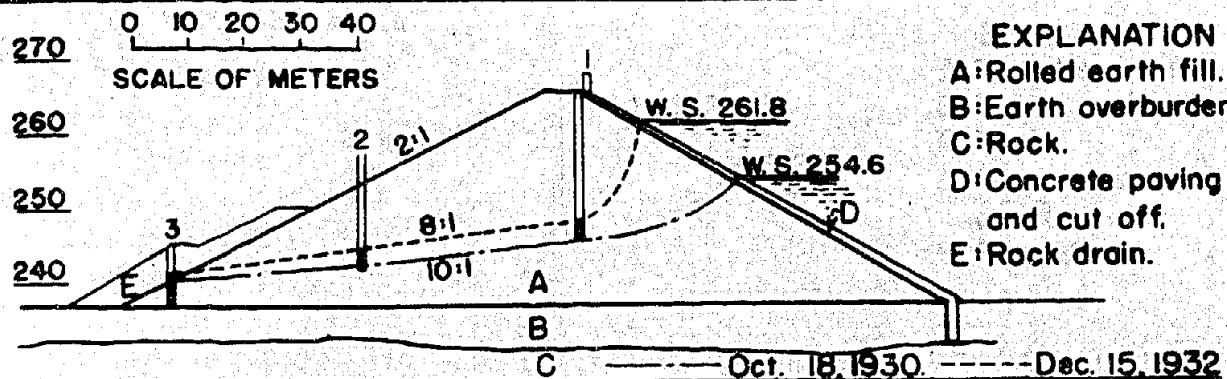
DON MARTIN DAM STA. 8+50
MEXICOCOMISION NACIONAL DE IRRIGACION
ESTADOS UNIDOS MEXICANOS
(ANDREW WEISS)

A: Rolled earth fill.
B: Earth overburden.
C: Rock.
D: Concrete paving
and cut off.
E: Rock drain.

Concentration of impervious material at the upstream face will cause a great drop to occur there. Don Martin Dam (plates 2 & 3) is faced with a fairly tight concrete paving; the drop is experienced in passing through (or through the cracks of) this paving. The relatively porous earth of the dam body causes proportionately small loss of head.

Because seepage flow is not always perpendicular to the axis of the dam the saturation line obtained by observations at one section cannot in general be applied to a section some distance away. This can be seen by comparing plates 2 and 3 of Don Martin Dam and the three sections shown of the Kreibitzbach Dam (plate 9). Upon the choice of sections will largely depend the accuracy of the obtained saturation surface.

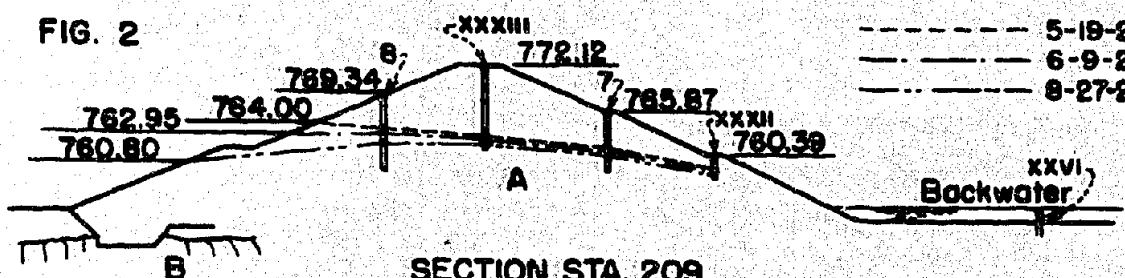
FIG. 2

1. Fig. 2- Water forced into the dam during high reservoir level flows away toward both faces of the dam when the reservoir level drops.
2. Fig. 3- Low water stage in pipe VII is explained by the fact that this pipe extends down into the permeable material below the dam and acts as a collecting funnel draining toward the bottom. Seepage along the axis of dam from the adjacent hillsides may also influence the level of water in the wells to a limited extent.

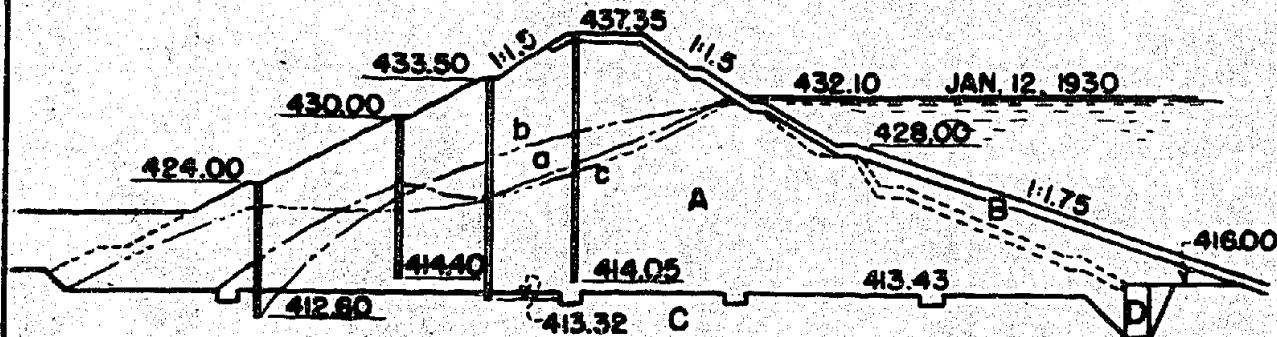
KREIBITZ DAM
CZECHOSLOVAKIAFIRST CONGRESS ON LARGE DAMS
STOCKHOLM, SWEDEN 1933
REPORT VOL. IV, PAGE 153

This dam was completed in 1924. It is carefully founded on sand-stone and is lined on the upstream side with a cut-off of concrete with a filler of tamped loam. On the upstream face the dam carries an impervious layer of heavy binding soil. Mechanical analyses of the materials in the dam are indicated on the analysis sheet which follows. After failure of the Weisse Desse Dam this dam was also investigated and strengthened. The Relative Permeability D_w of this dam compares favorably with that of both the Weisse Desse and Schwarze Desse. The material comprising the main body of the dam is of course more permeable than that in the upstream face. (See chart).

- A: Clayey loam sand.
 B: Impervious heavy binding soil.
 C: Sandstone.
 D: Double concrete wall with
 filler of tamped loam.

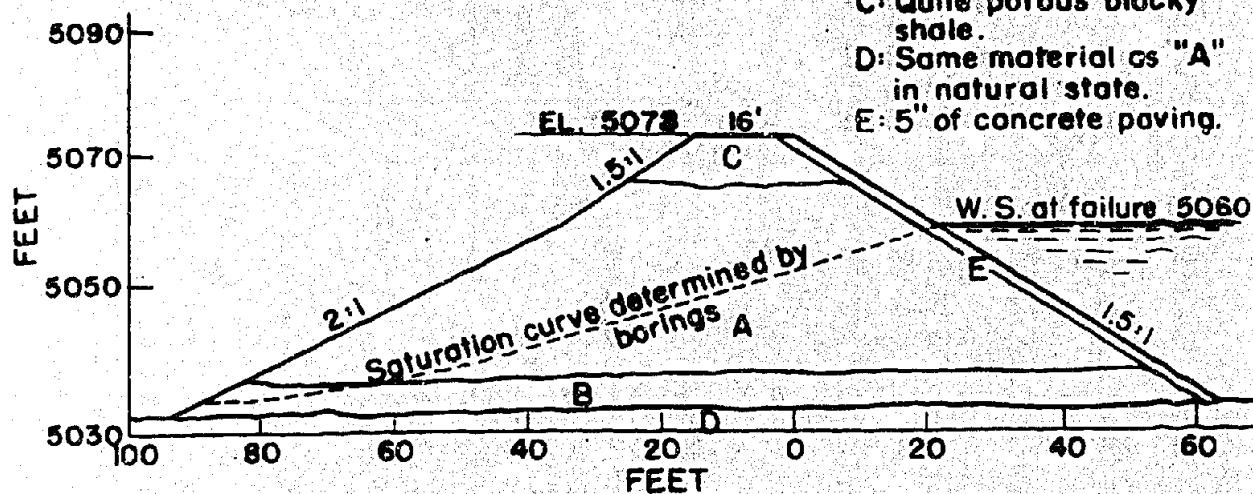
- A: Sandy loam and clayey material placed dry in 4 foot lifts.
- B: Same material as "A" damp and packed well.
- C: Quite porous blocky shale.
- D: Same material as "A" in natural state.
- E: 5" of concrete paving.

Three-foot lifts were specified in building the dam, but four-foot lifts were found after failure with water 13 feet below top of the dam. Failure is attributed to settlement caused by erosion around an 8-foot reinforced arch outlet which passed under the dam at its maximum section.

d. Pipe laid in the dam. Horse Creek Dam (plate 11) furnishes an example of failure allegedly caused by seepage along the outside of a concrete conduit laid perpendicular to the axis under the dam at its maximum section. An observation pipe, if driven through the impervious earth of the dam body and into a drain or underlying porous strata will act as a collecting chamber or funnel inducing flow down to the drain. The dip in saturation surface indicated at the Schwarze Desse Dam (plate 5) illustrates this point.

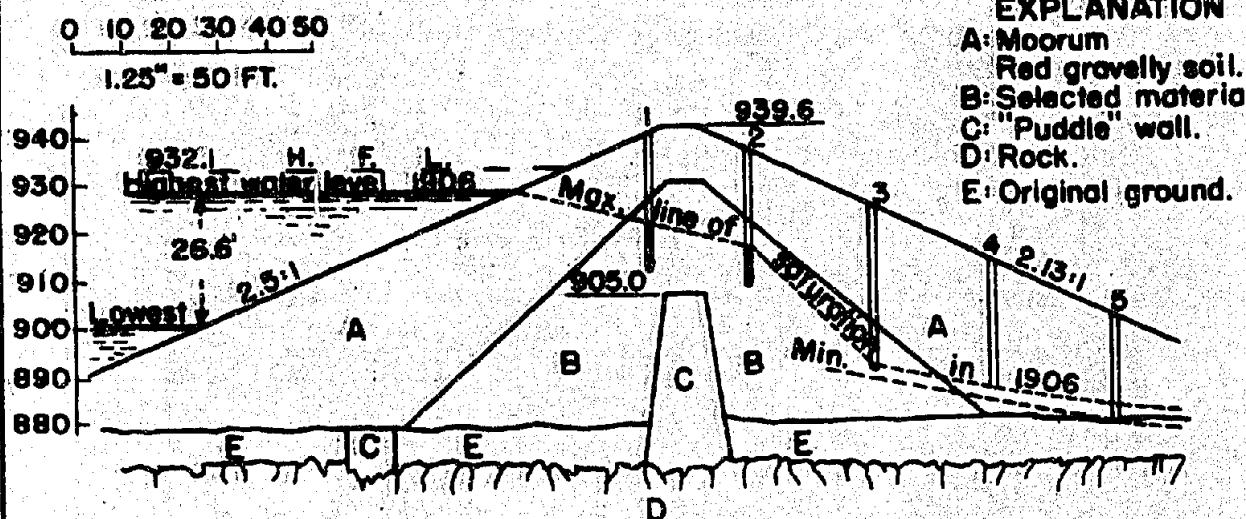
MUKTI RESERVOIR EMBANKMENT
INDIABUCKLEYS IRR. H&B.
PAGE 383

- A: Moorum
- Red gravelly soil.
- B: Selected material.
- C: "Puddle" wall.
- D: Rock.
- E: Original ground.

a. Core Walls and Facings. Water in percolating through soil encounters great resistance to flow and so suffers loss of head. The denser the soil the greater is this loss of head. Thus in a dam featuring a clay puddle or other form of relatively impervious core the saturation line is found to be steeper through the core wall than it is in the relatively porous material on either side of it. See Gatun Type II (plate 26), Wachusett South Dike (plate 32), Mukti Reservoir Embankment (plate 15), and Unkal Reservoir Embankment (plate 19).

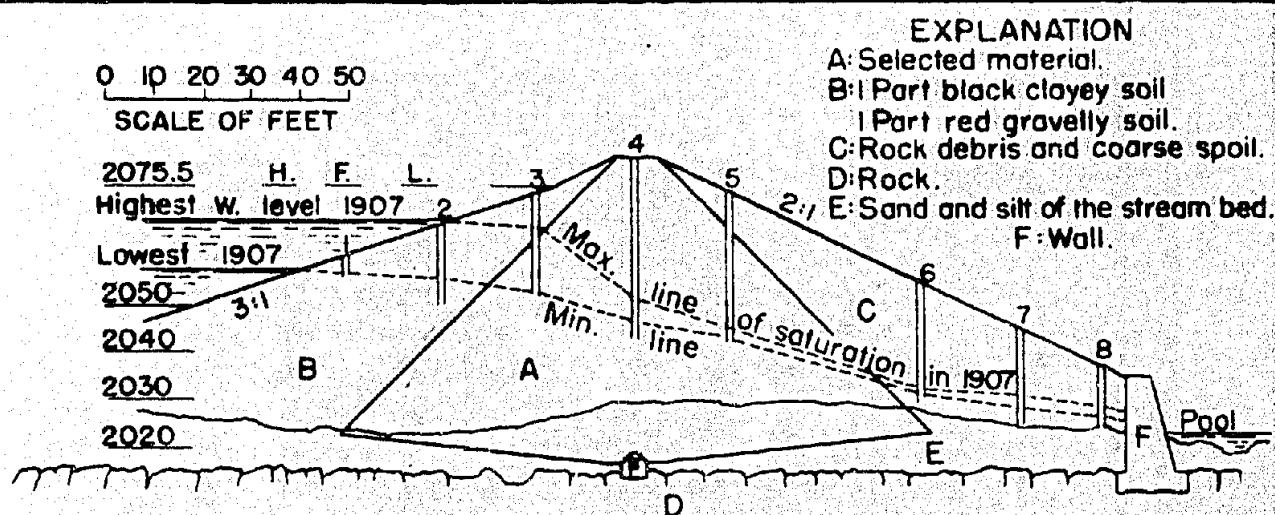
UNKAL RESERVOIR EMBANKMENT
INDIABUCKLEYS IRRIGATION H'B'K.
PAGE 383

- A: Selected material.
- B: Part black clayey soil.
- C: Part red gravelly soil.
- D: Rock.
- E: Sand and silt of the stream bed.
- F: Wall.

This dam is part of the Hubli Water Works in India. Selected core material was consolidated by cart travel. A low cut-off wall (F) joins this material to the rock foundation.

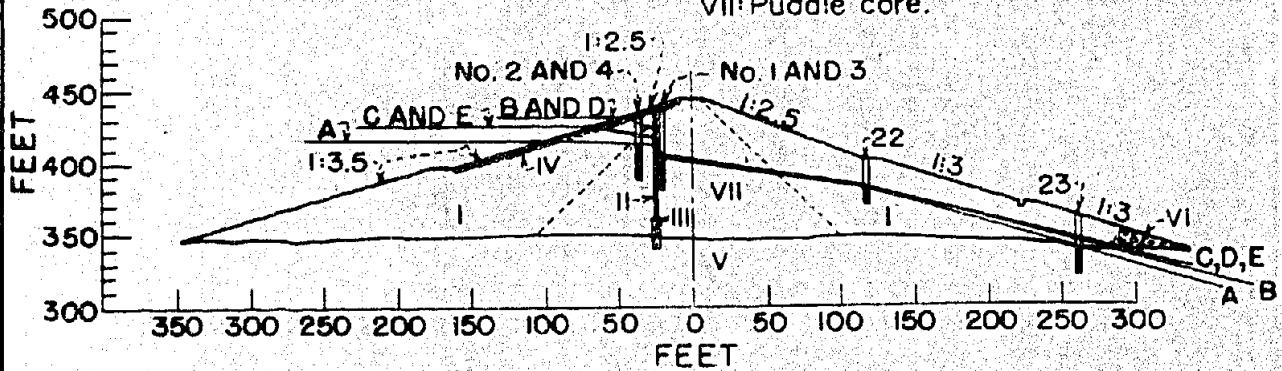
The reinforced concrete base of the core-wall was founded on ledge rock to about sta. 600. At this point it was no longer practical to follow the ledge, as it dipped down below the glacial drift at a sharp angle. From this point east a core-wall trench 6 to 10 feet deep with vertical sides (braced when necessary) was dug about 3 feet wide in the glacial drift and filled with concrete to form the base of the core-wall. On the main dam the reinforced concrete core-wall was carried about 10 feet above the original surface.... The core-wall was continued to above high water line throughout the length of the dam by means of timber as described above." The dam was built by the hydraulic sluicing method and puddle-core samples taken from a "chimney" built into the core indicated effective sizes ranging from 0.005 to 0.015 mm.

Dimensions in feet.

- I : Earth fill.
 - II : 6" Wakefield core-wall, timber
 - III : 24" Reinforced concrete core-wall.
 - IV : Rip rap.
 - V : Glacial drift.
 - VI : Rock grain.
 - VII : Puddle core.

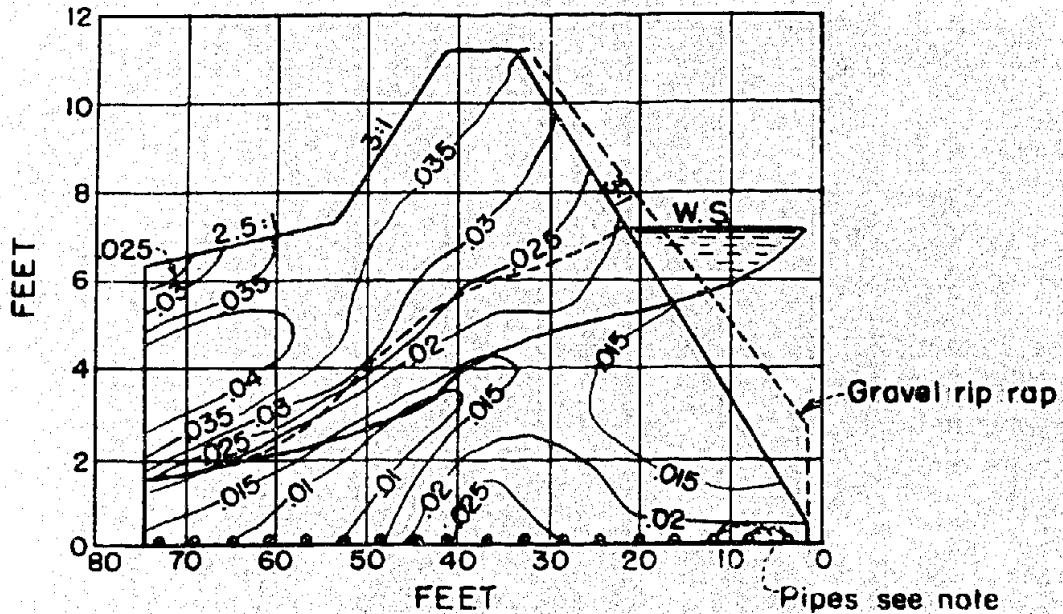
GATUN, PANAMA
EXPERIMENTAL DAM TYPE ITRANS. AM. SOC. C. E. 1924
VOL. LXXXVII, P. 97

At intervals of 4 feet, 1-1/2-inch, galvanized pipe perforated with one-fourth-inch holes were placed across the tank near the bottom, the ends being threaded, and passed outside the tank. These pipes were covered with wire gauze and later with a little fine gravel. Each of the projecting ends of these pipes was held with locknuts outside the tank. On the east side these pipes were capped so that they could be used for drainage or for flushing out the pipes if they became clogged with sand. On the west side of a T-branch was screwed

NOTE: 18- $\frac{1}{2}$ " perforated pipes spaced at approximately 4' centers laid across the bottom.

Records for Type I are complete, but only the final curve for Type II is shown in the report. Speaking of tests on Type I it is stated: "All of the curves (showing the building up of pressures within the dam as time went on) show a marked change near the center of the dam. This distortion corresponds nearly with the slope on which the soft material was pumped out as mentioned above. The line for Type II shows just the kind of distortion that would be expected with a fairly tight core wall."

It is felt that the solid black line indicated on the above sketches might not be correctly interpreted. It is the line of pressures along the bottom of the dam caused by the percolating water. Obviously it is not strictly the saturation line of the dam because of the way the pipes were laid. By a procedure outlined on a succeeding page the line of saturation may be approximately obtained from this line. The approximate saturation line is shown above as a dotted line. Type II, the one adopted, is drawn undistorted to show approximately the difference in position between these two lines.

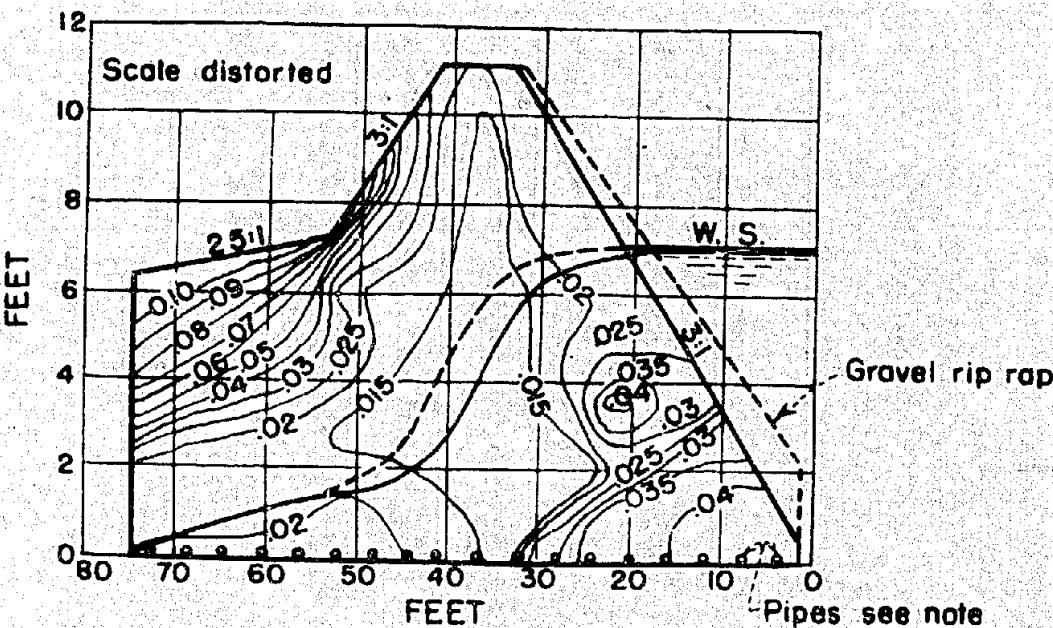
GATUN, PANAMA
EXPERIMENTAL DAM TYPE 2TRANS. AM. SOC. C. E. 1924
VOL. LXXXVII, P. 97

NOTE: 18-1/2" perforated pipes spaced at approximately 4' centers laid across the bottom.

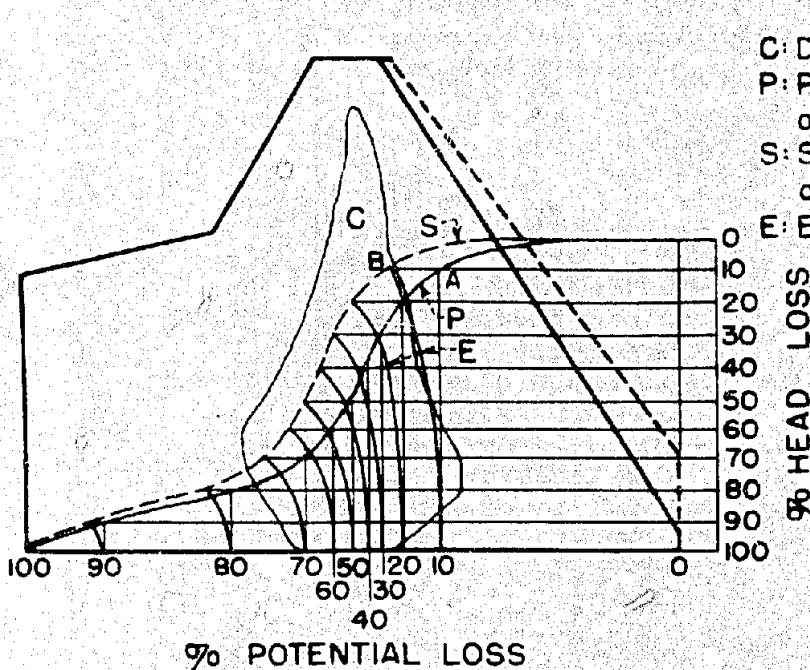
GATUN DAM, TYPE 2
EXPLANATION OF METHOD OF OBTAINING SATURATION LINE FROM DATA GIVEN

- C: Dist. of finest material.
- P: Piezometer line at base of dam. (Saville)
- S: Saturation line of dam approximately. (Author)
- E: Equipotential lines.

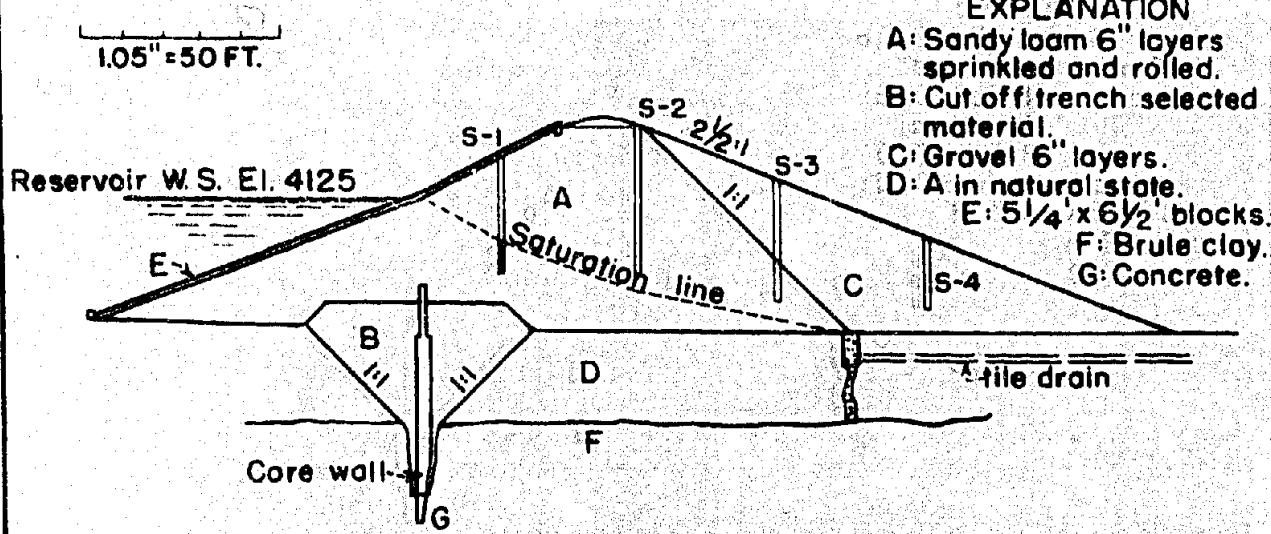
MINATARE DAM
NORTH PLATTE PROJECT SEC. AT STA. 27+50
DWG. NO. 20-C-166

Drawing No. 20-C-166 shows the above cross-section with exception of the saturation line. This line was drawn in from observations made by Mr. Hinds on April 8, 1922. Pipes extending into the foundation were located at four other sections but are not shown in the above sketch. The chart shown below was plotted from original data furnished by Mr. T. W. Parry. Saturation wells were located at one section only.

While constructed on a foundation of Brule clay, the dam has no Brule clay in it.

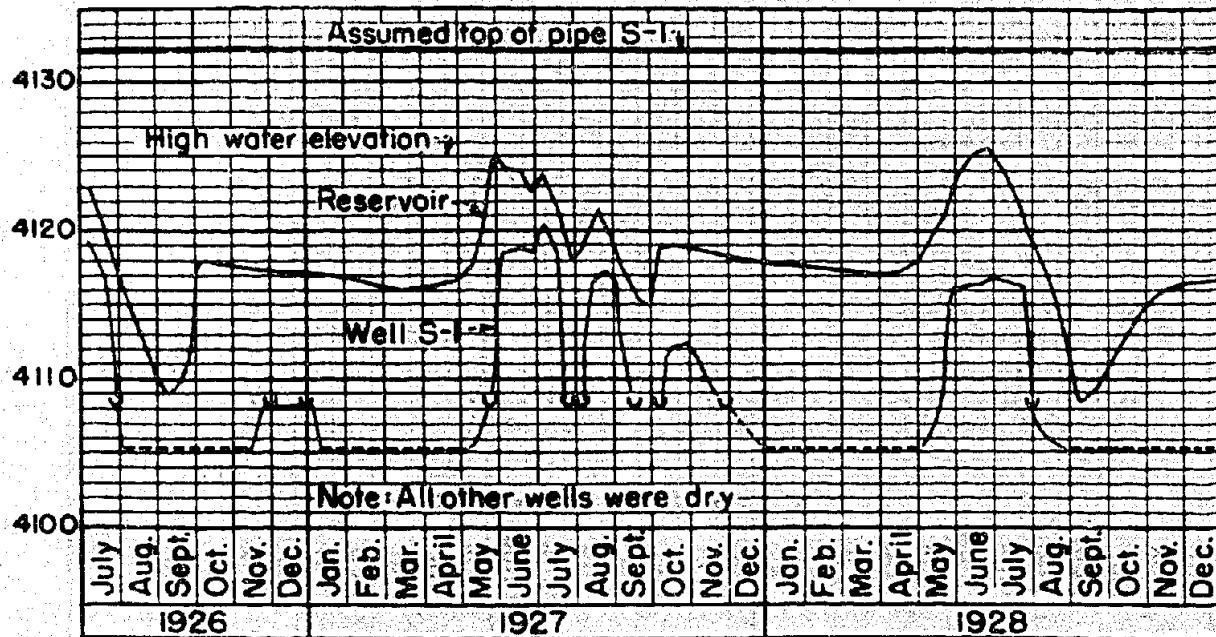
**EL E V A T I O N O F W A T E R
I N R E S E R V O I R A N D I N "S A T U R A T I O N W E L L S"***

- Indicates "trace of water in well".
- - - - - Indicates "well is dry".

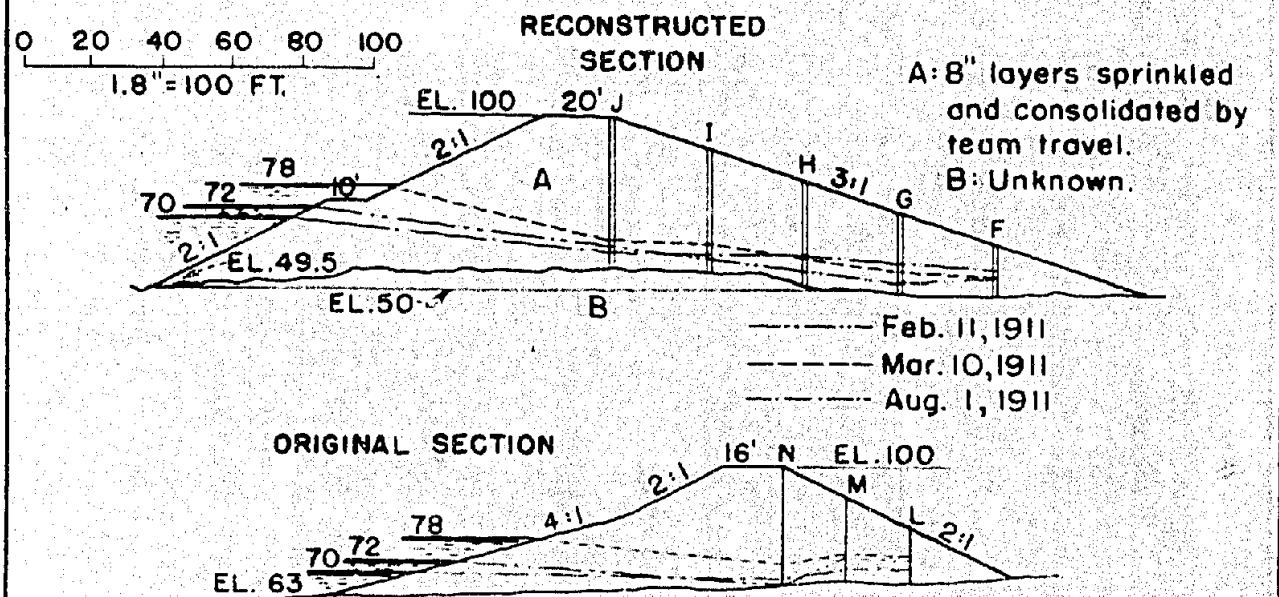
JUMBO DAM
COLORADOE. N. OCT. 12, 1911
PAGE 447

This dam partially failed in 1910 and the damaged part was reconstructed. Both sections are shown above; they are 100 feet apart. In rebuilding the dam practically the same materials were used, but the downstream slope was flattened.

From the more complete records given in the article (and which were not included here) it is apparent that the reservoir level fluctuated considerably over a short time and remained at one elevation hardly long enough to allow a saturation line to become established. Ground water or seepage along the dam from some other section may have caused the rise indicated at M and L. What happens to the water after it passes points F and L is not known.

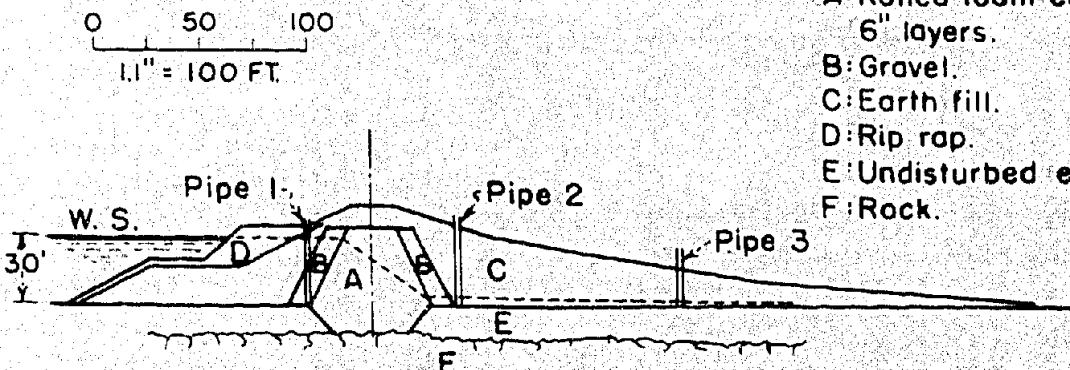
- A: Rolled loam cut off
6" layers.
B: Gravel.
C: Earth fill.
D: Rip rap.
E: Undisturbed earth.
F: Rock.

This is a well-constructed dike which incorporates many interesting features in its design.

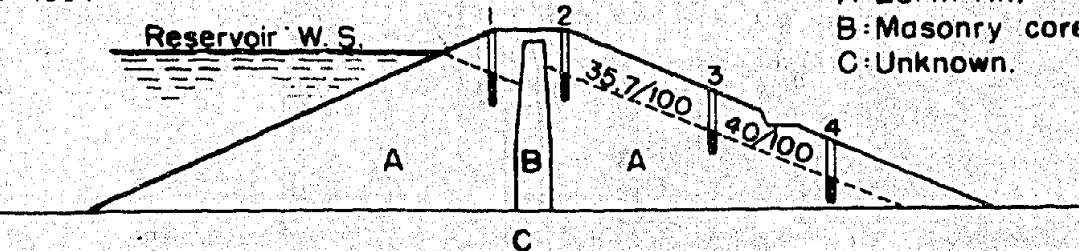
ISTHMIAN CANAL COMM. REPORT 1908
PLATE 136

The peculiar position of the saturation line shown here may be the result of a misinterpretation of the data. The original sketch shows the level in pipe No. 2 slightly lower than that in No. 1 so that a line joining the two levels would have some slope downstream. This would mean a relatively pervious core wall. The disappearance of the saturation line into the foundation would indicate a pervious soil. No more accurate data is at hand.

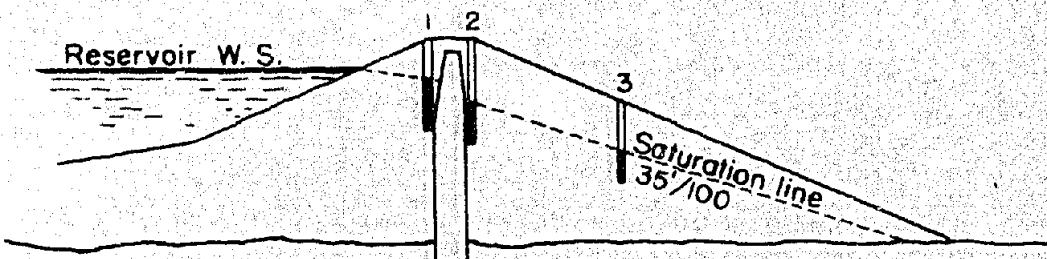
This dam was completed in January 1896 and filled in April 1896. No data on kind or placing of materials is available although the core wall is very likely masonry.

The saturation line is fairly steep and indicates a fairly impervious bank. The line indicated may not be the maximum possible with this reservoir level. Its disappearance into the foundation indicates a porous material there. Just what position the line occupies downstream from well 3 is problematical.

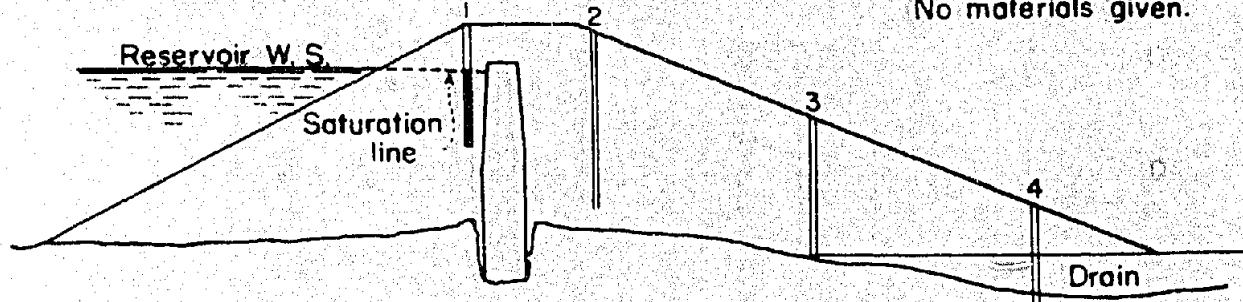
ISTHMIAN CANAL COMM. REPORT 1908
PLATE 136

This dam was completed and filled in 1896. The core wall may be masonry. The drain is probably broken rock.

Indications point to an impervious core-wall and foundation and a well drained downstream embankment. Data gathered subsequently should be interesting.

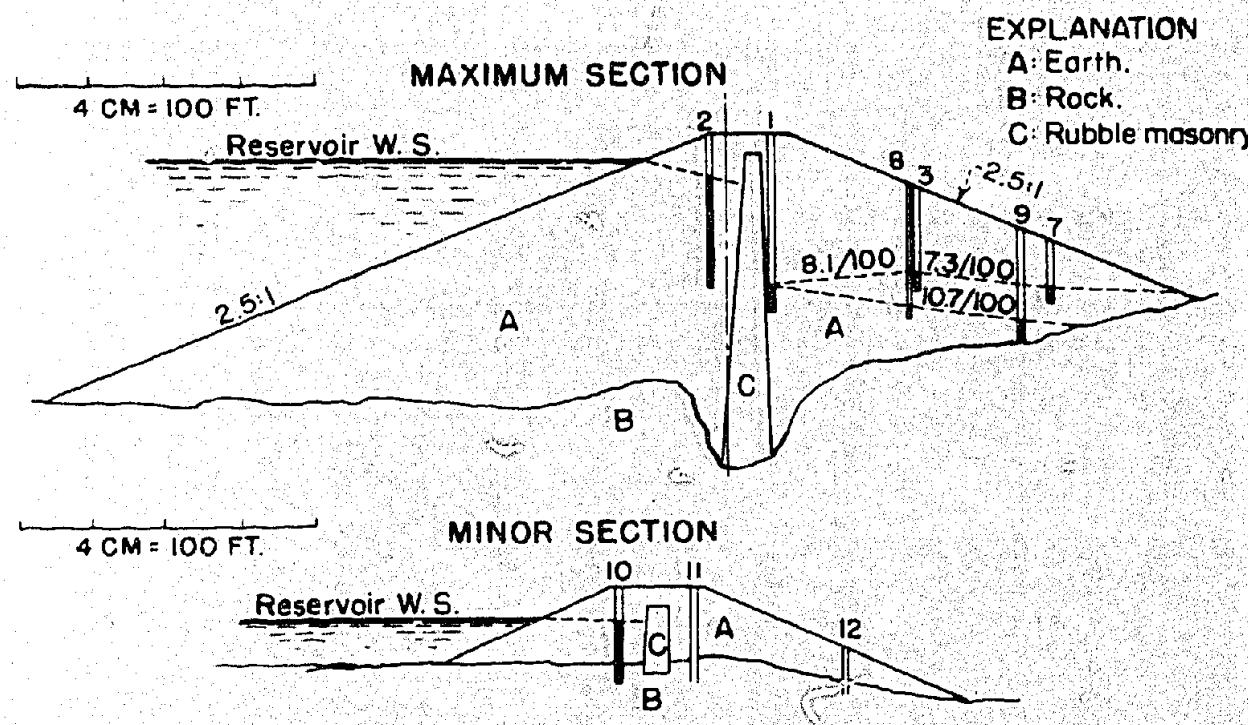
TITICUS DAM

It is not stated what kind of hole was bored to obtain the saturation line. The core wall seems to be impervious. "No percolating water was found in the downstream portion of the dam"; the water there is said to be ground water because when permitted to flow away by a drop in ground water table it flows away on a relatively flat gradient. The embankment appears very porous.

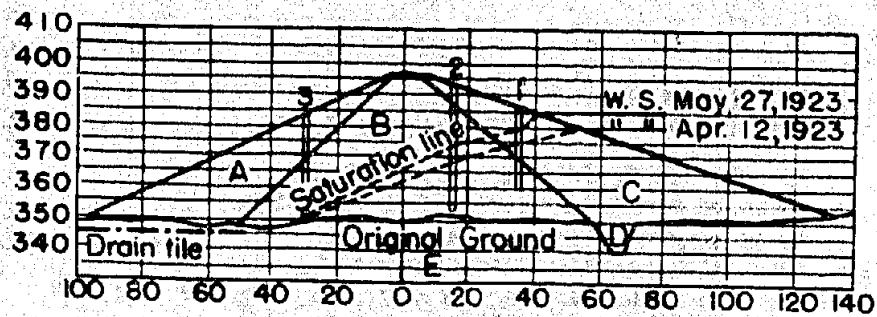
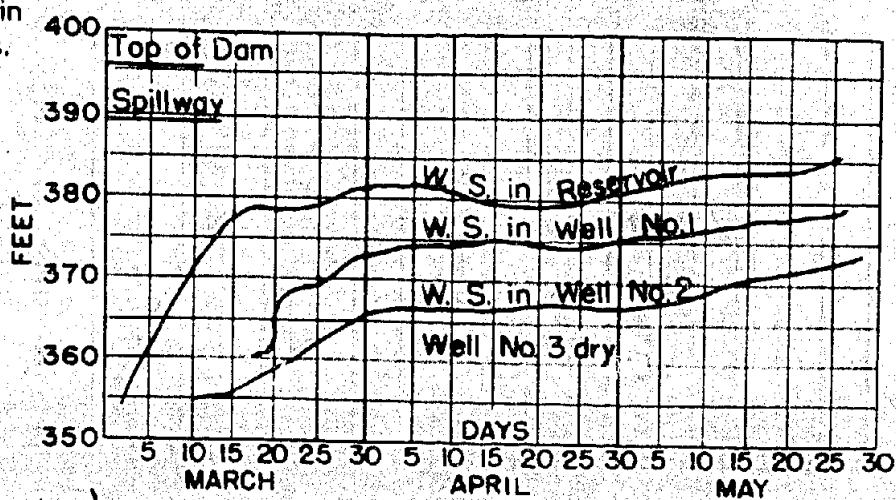
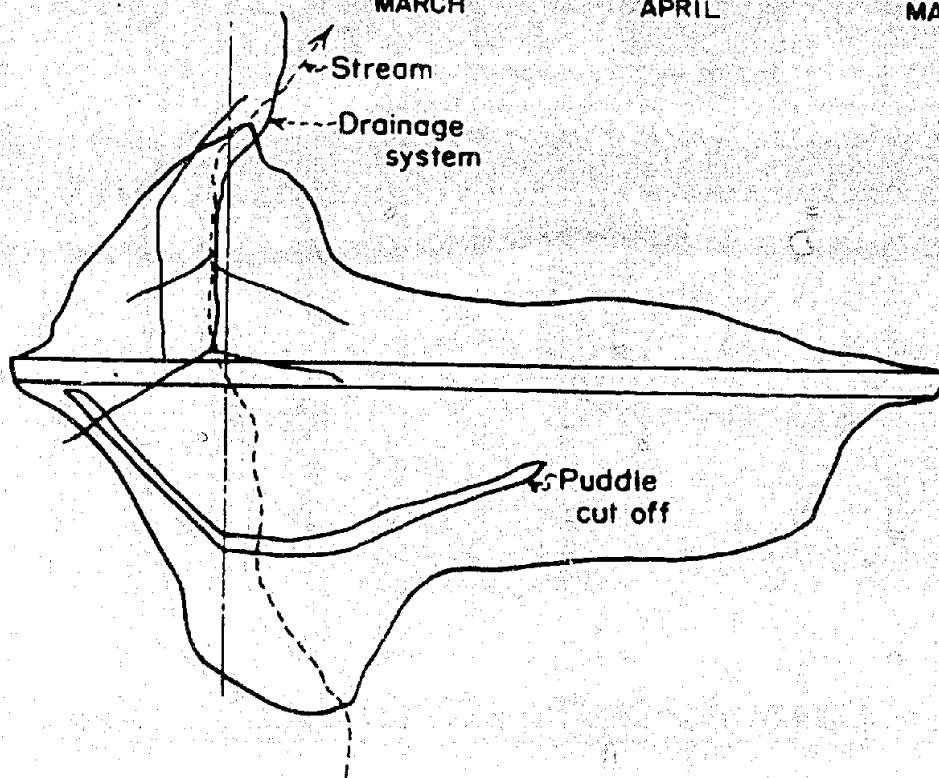
X-D-1137

This dam was built on a clay foundation and provided with a puddle clay core wall laid in a crescent shape concave upstream. A system of tile drains was laid in the foundation material as shown on the plan view of the dam at the bottom of the page of sketches.

Six wells were driven at the maximum section. Three were perforated pipe for observing the saturation line and three were not, the latter being used to measure hydrostatic pressure in the foundation material. "Measurements were taken every few days for three months and are plotted above. The 2-inch perforated pipes (shown in the sketch) were equipped with well points and perforated to within 10 feet of the surface of the dam."

Reservoir level was rising throughout the test. "No water has been observed to date (1924) in well No. 3. Seepage has never exceeded 40 gals. per minute and all of this seepage comes from the drainage system under the dam."

- A: Quarried sandstone spread in layers not over 3 feet thick.
- B: Borrow pit material sprinkled and rolled in not over 1 foot layers.
- C: Borrow pit clay sprinkled and rolled in not over 6 inch layers.
- D: Puddle of clay, sand and gravel deposited in water and mixed by poling.
- E: Alluvial material.

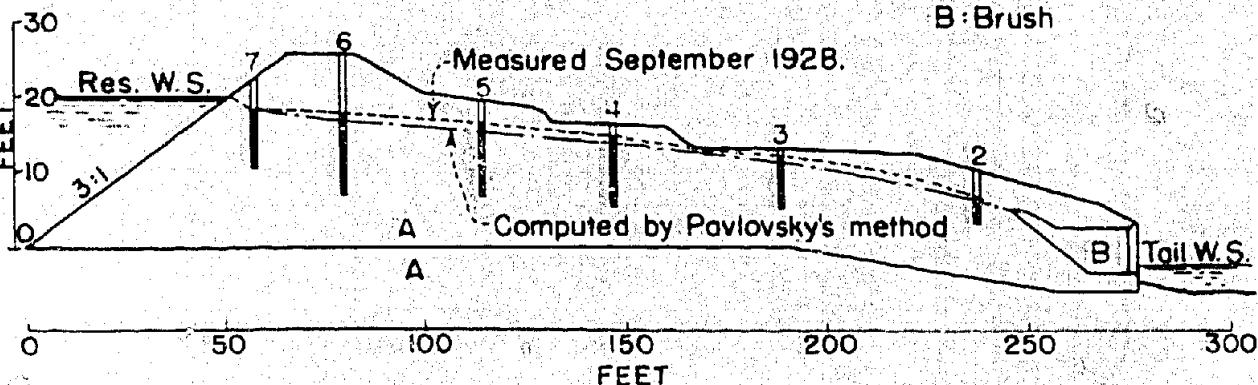
BOROV ELECT. CO. DAM
U.S.S.R."HYDRAULIC ENGINEERING" (RUSSIAN)
MOSCOW, JUNE 1933, PAGE 24

A: Pure quartz sand
See mech. analysis

B: Brush

Sand was used in this dam and a brush drain was relied upon to keep the saturation line within the structure of the dam. The foundation is also sand.

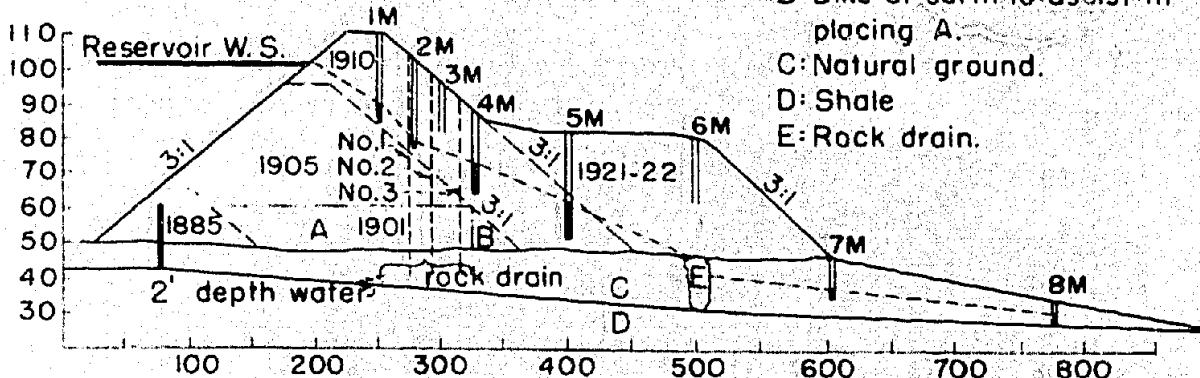
- A: Clay placed hydraulically.
- B: Dike of earth to assist in placing A.
- C: Natural ground.
- D: Shale
- E: Rock drain.

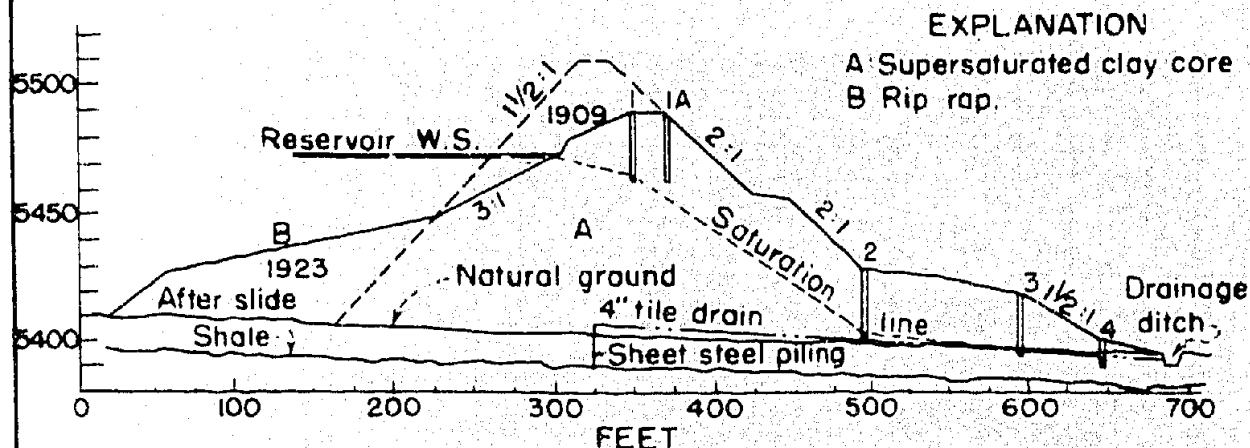
STANLEY LAKE DAM
COLORADOLAKESIDE CONST. CO. REPORT, JULY 1, 1923
PLATE F-3-81

This dam has been redesigned and reconstructed after partial failure so often that even a fair idea of the distribution of material in it is difficult to obtain. The Engineering News Record gives a fairly complete picture of the "Case of the Standley Lake Dam", but this article and the reference in the Lakeside Construction Co. report differ in the placing of the 4" tile drain at the base of the dam. A slight slip occurred in 1912 and a major slide in 1916. The dam was repaired after each slip. Failure was attributed to sudden lowering of the reservoir level and consequent flowing of the saturated clay core. "Later after further movement (of the upstream slope) which increased the height of the vertical face there appeared opposite sta. 32/35 a pronounced seepage at elevation 5450. Water ran from the vertical face in a small stream and at three other points (along the dam) similar conditions prevailed." (E.N.R. May 32, 1917. P.444) "Out of 21 tell-tale wells driven into the outer slope in August 1914 water showed in 9. Out of these water showed to any extent only in 2 when examined in Feb. 1917. Those showing water were scattered among the dry wells", (Editor E.N.R.)

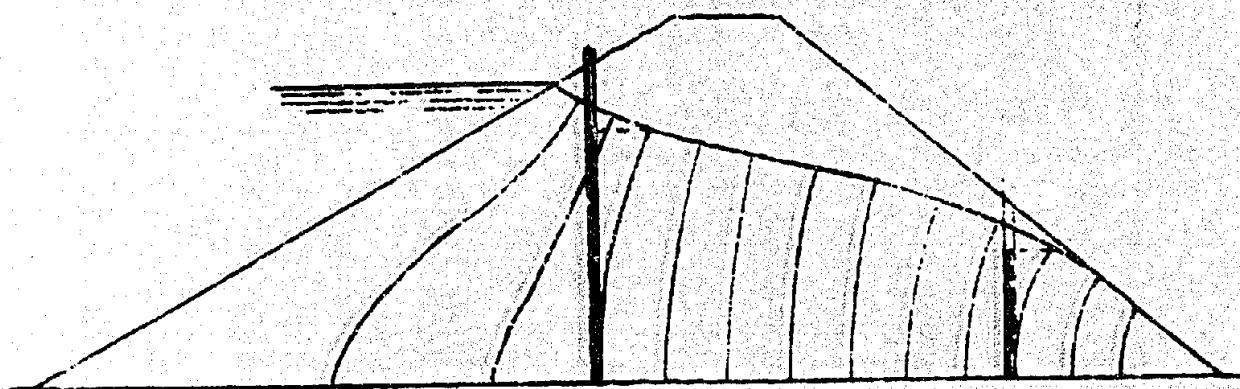
H. LEVEL INDICATED BY AN IMPERFORATE PIPE

A pipe open only at the ends will record the hydrostatic head on the water at the end of the pipe. This level will be lower than the saturation line as shown.

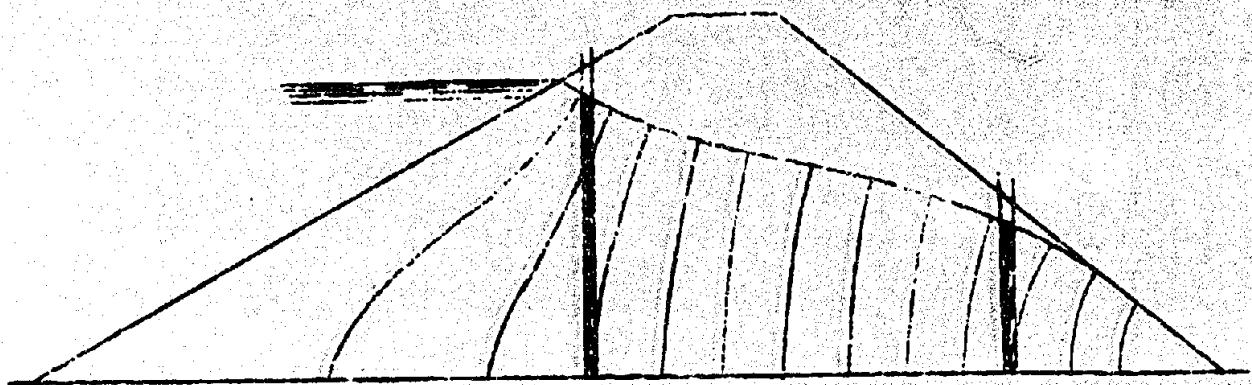
LEVEL INDICATED BY A PERFORATED PIPE

A perforated pipe integrates the pressures in the vertical and more nearly approximates the saturation line. There is an effect of inducing flow down the pipe due to the fact that the potential of water at the top is greater than at the bottom of the pipe, but just how important this effect is is not as yet known.
