Hydraulic Laboratory Report No. 2.83

Technical Memorandum No. 389

SATURATION OF EXISTING EARTH DAMS

MEMORANDUM TO CHIEF DESIGNING ENGINEER
SUBJECT: SATURATION OF EXISTING EARTH DAMS

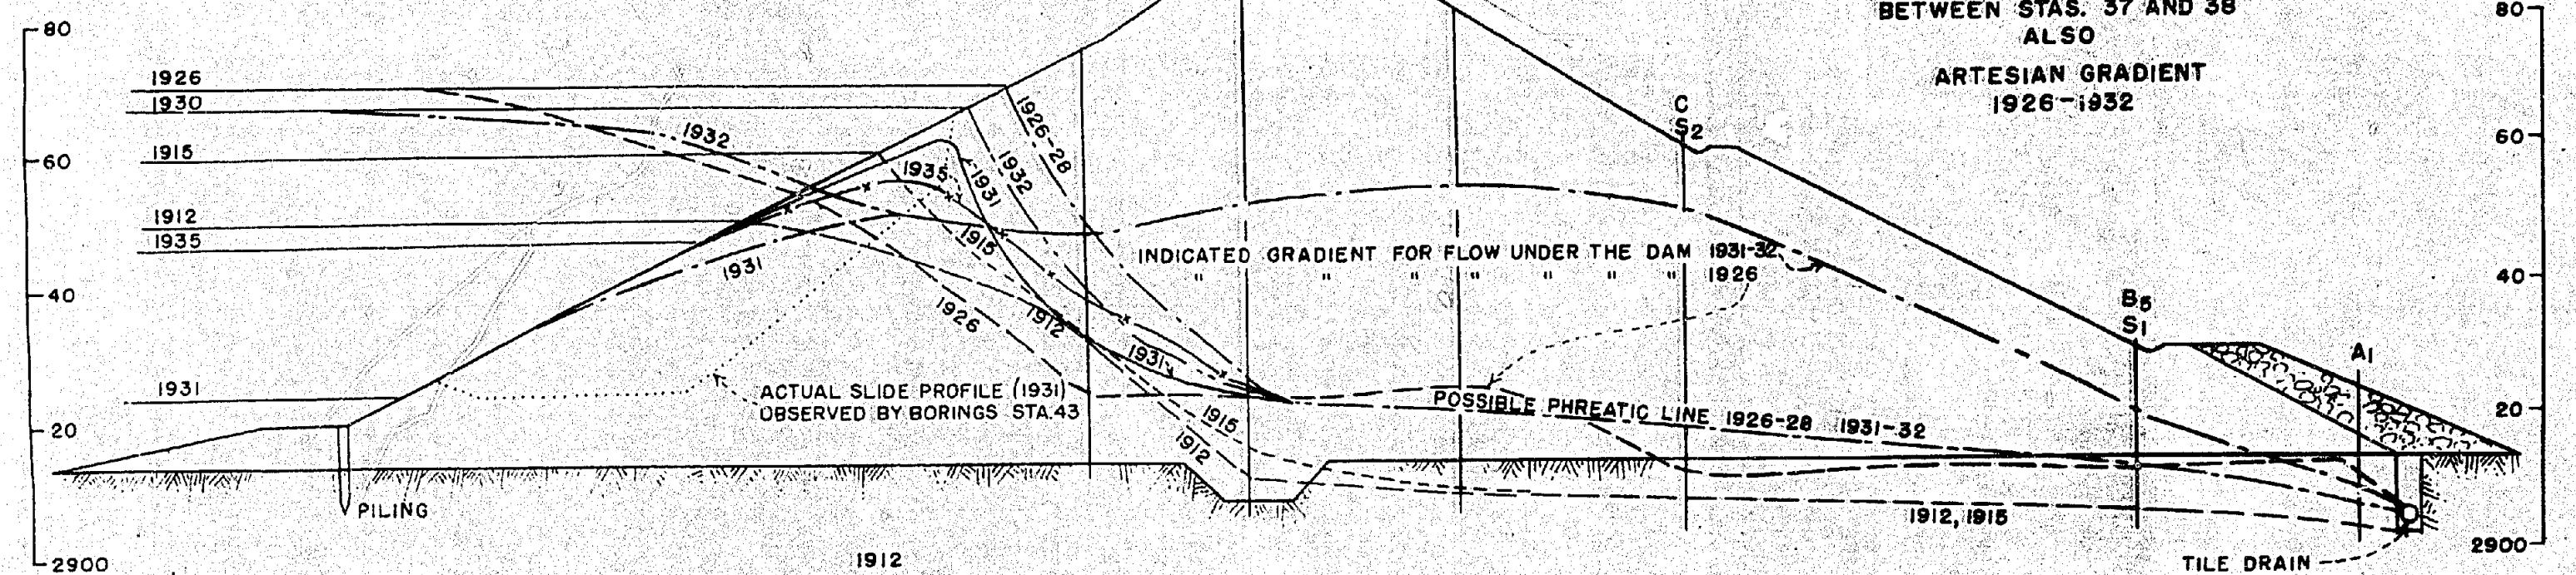
PLAN AND CROSS SECTION
BETWEEN STAS. 37 AND 38
SHOWING LOCATION AND DEPTH
OF ORIGINAL OBSERVATION WELLS.

"In the latter part of the year 1911 a series of wells was drilled in the embankment between stations 36 and 39 for the purpose of determining the plane of saturation and obtaining data on its movements. A wash-boring apparatus was used in sinking the wells through the completed embankment, after which they were cased with 2" w.i. pipe, open at the bottom but not perforated. A plug in the upper end excludes surface water, rain, etc. In all, 34 wells were sunk in this section, ranging in depth from 10 to 90 feet. Their location and depths are shown on the drawing." The water surface readings were accurate to about 0.1 ft.

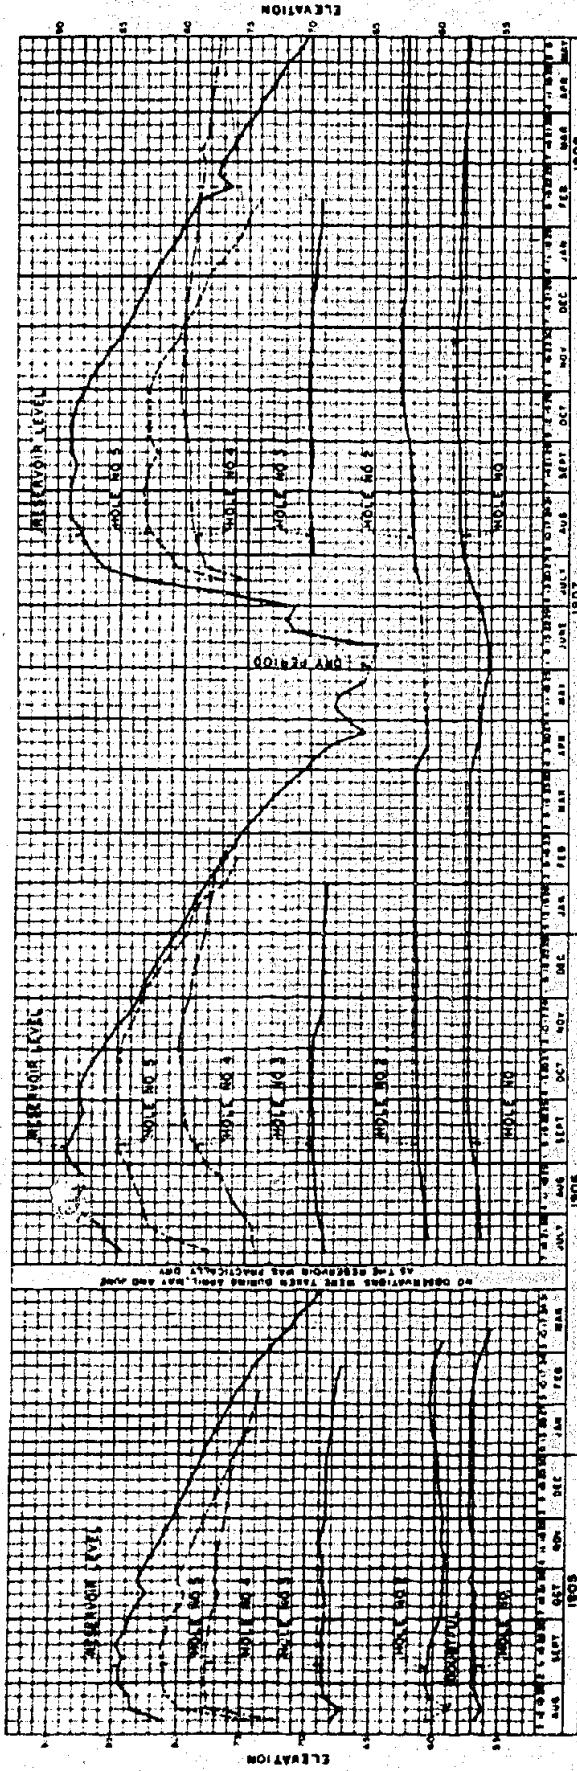
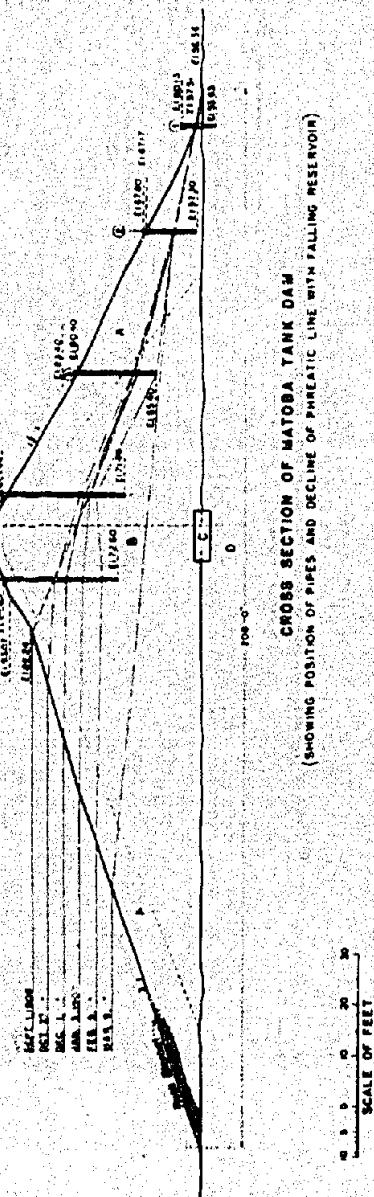
MATOBIA TANK DAM INDIA

RECORD OF WATER LEVELS IN RESERVOIR AND RIVER

CROSS SECTION OF MATOBA TANK DAM
 (SHOWING POSITION OF PIPES AND DECLINE OF PHREATIC LINE WITH FALLING RESERVOIR)

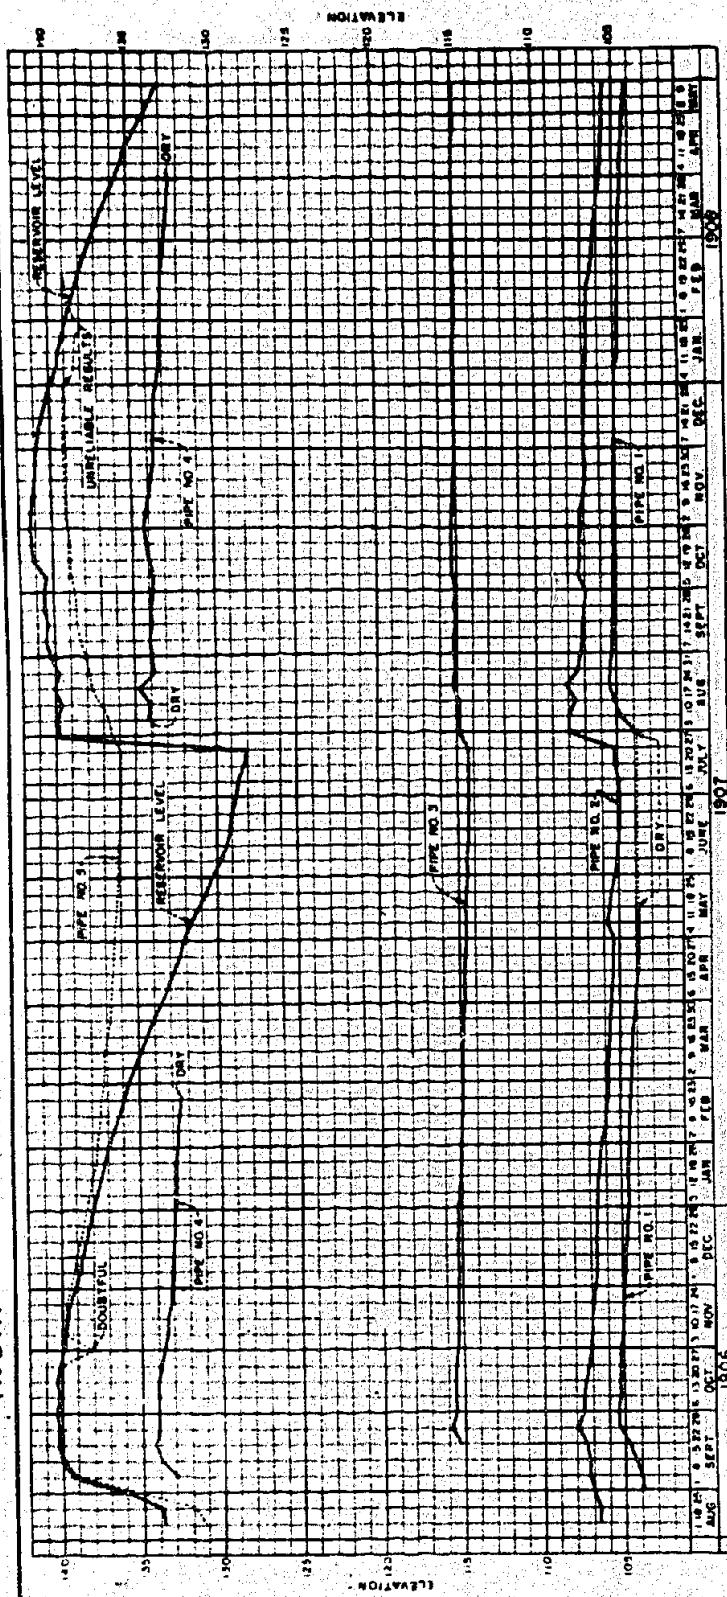
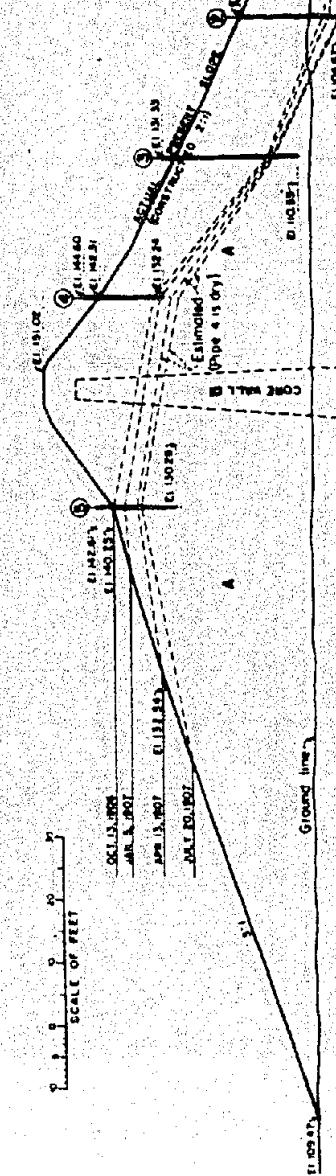
PASHAN TANK DAM
INDIA

RECORD OF WATER LEVELS IN RESERVOIR AND PIPES

FIG. 8
CROSS SECTION OF PASHAN TANK DAM
(SHOWING POSITION OF PIPES AND DECLINE OF PIPE LINE WITH LOWERING RESERVOIR)

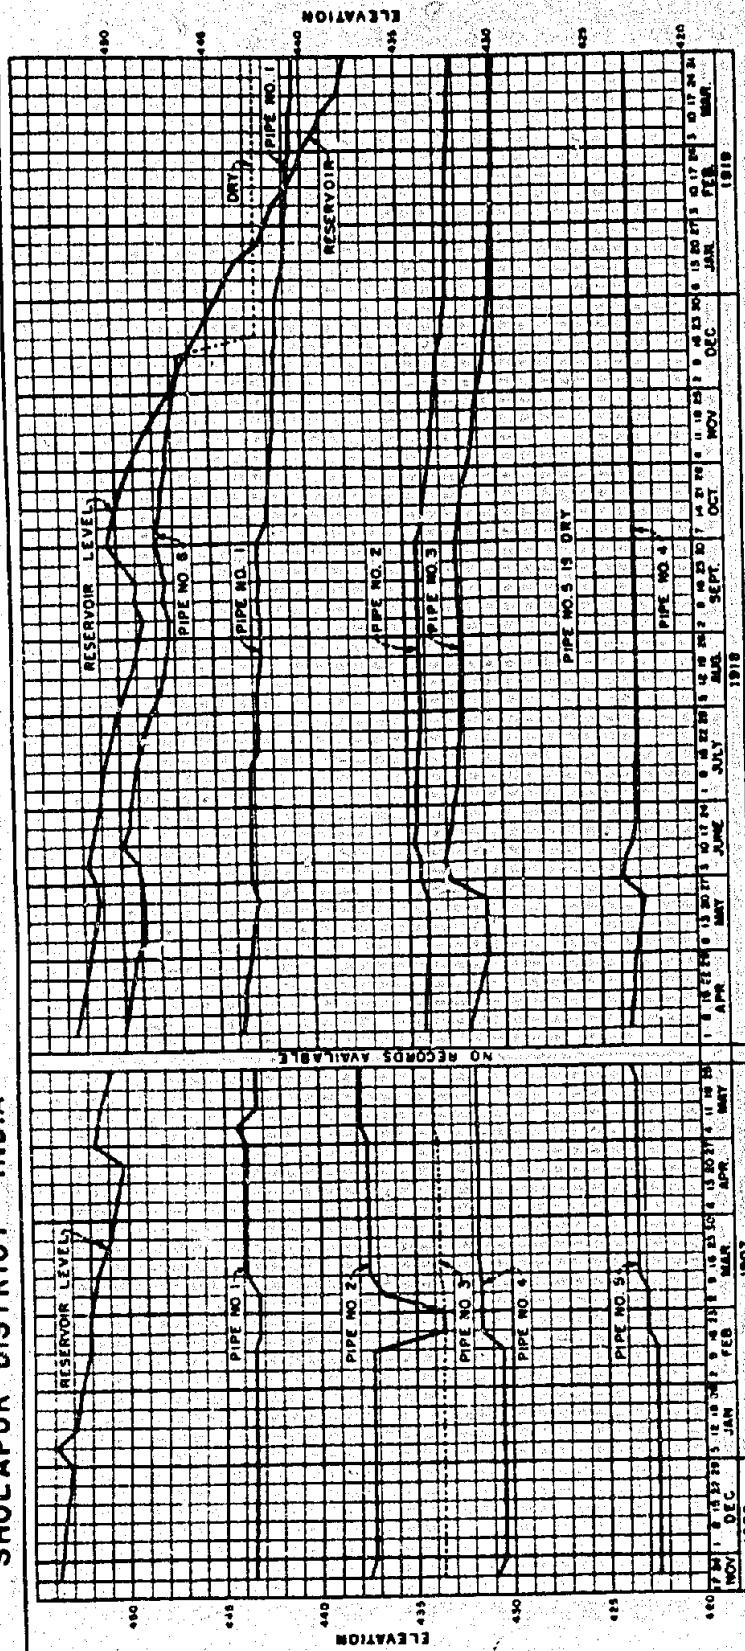
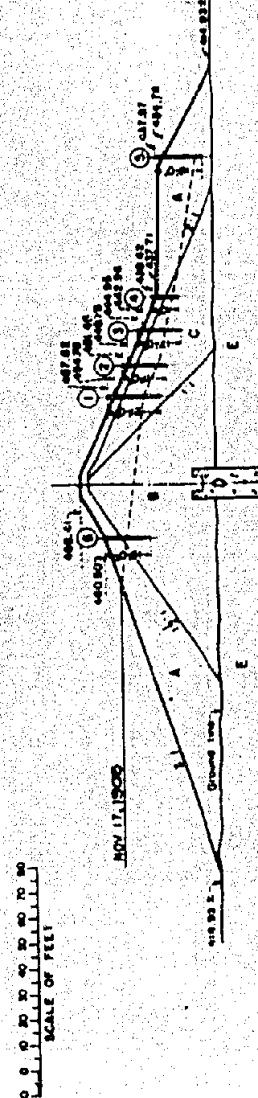
**WADSHIVNE TANK DAM
SHOLAPUR DISTRICT - INDIA**

CROSS SECTION OF WADSHIVNE TANK DAM (1909)
(SHOWING POSITION OF PIPES FOR OBSERVING LINE OF SATURATION)

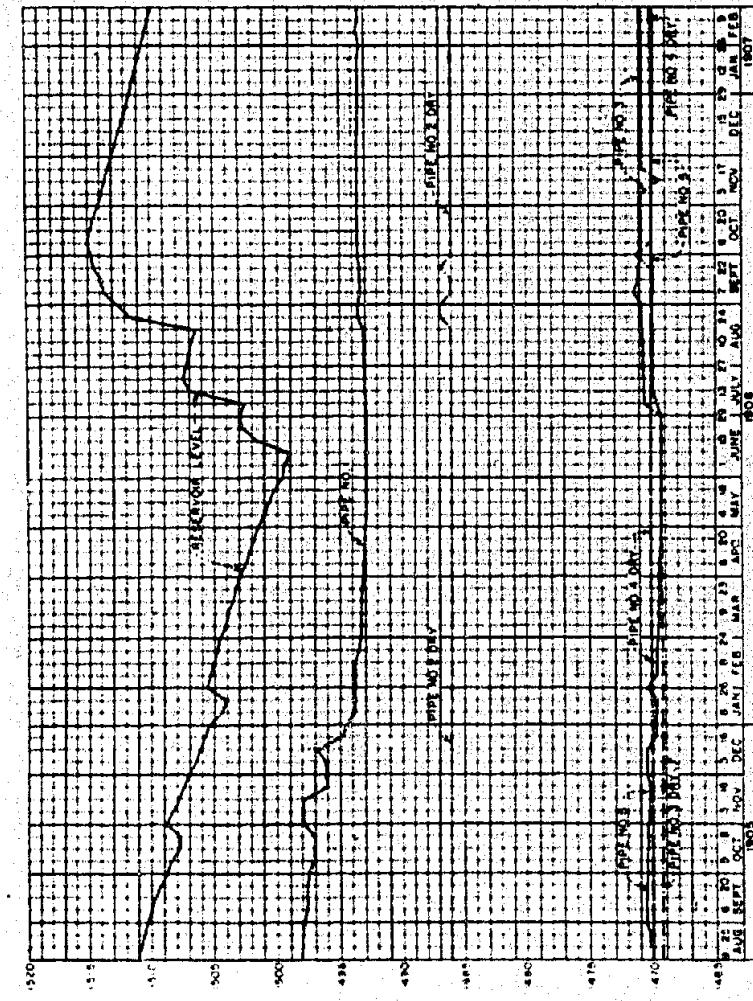
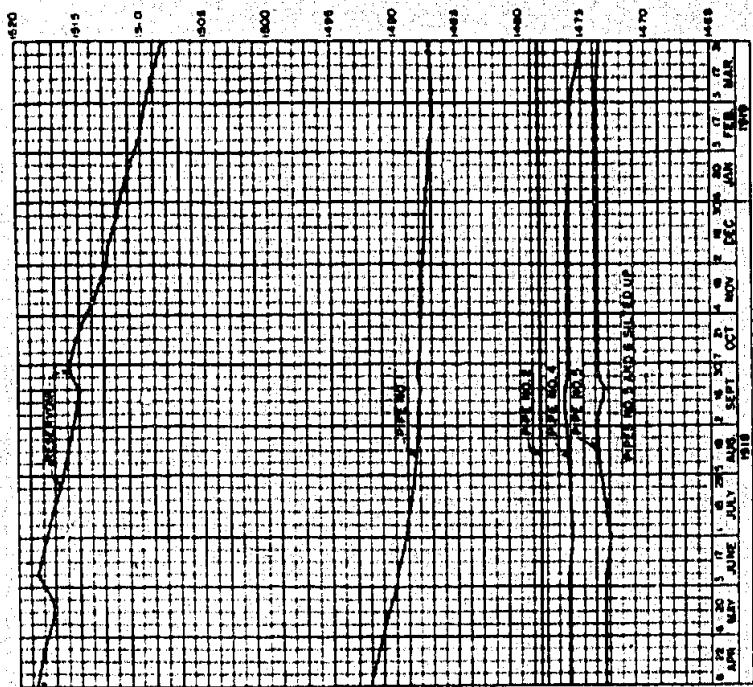
EKRUK TANK DAM
SHOLAPUR DISTRICT INDIA

- A. Earth laid in 3 inch layers.
- B. Puddle trench.
- C. Murum.
- D. Hard Murum.

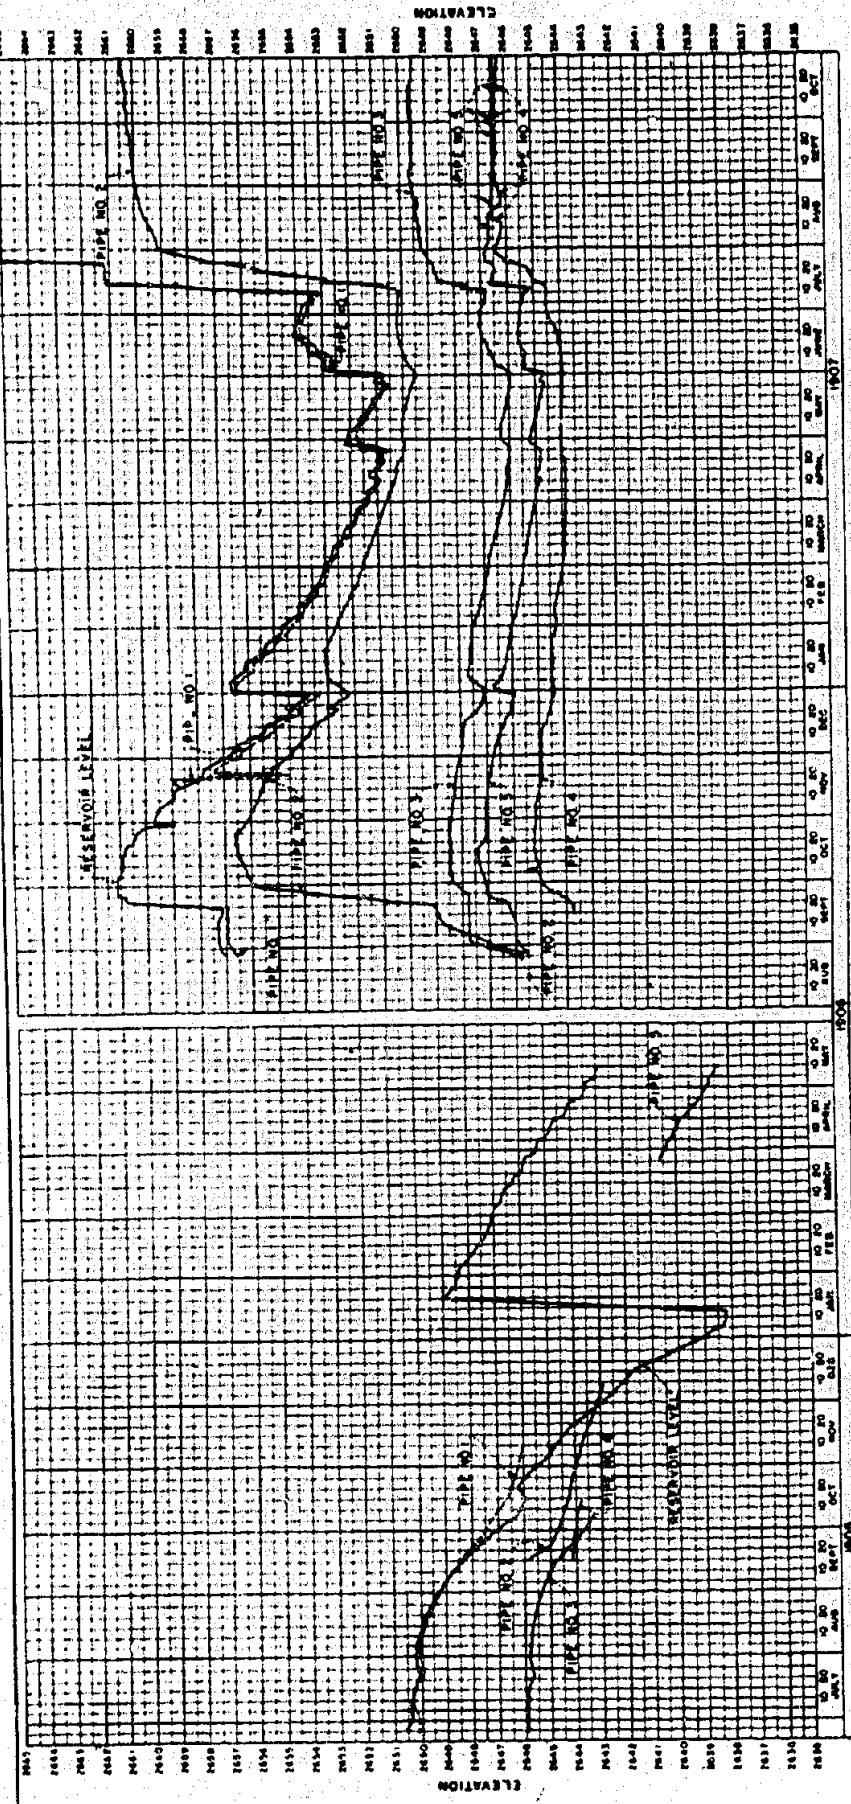
RECORD OF WATER LEVELS IN RESERVOIR AND PIPES

"This is one of the best embankments in the Deccan and has never given trouble. The interior is reported to be of selected earth and the outer portion both upstream and downstream of moorum, whilst the foundations are rock.

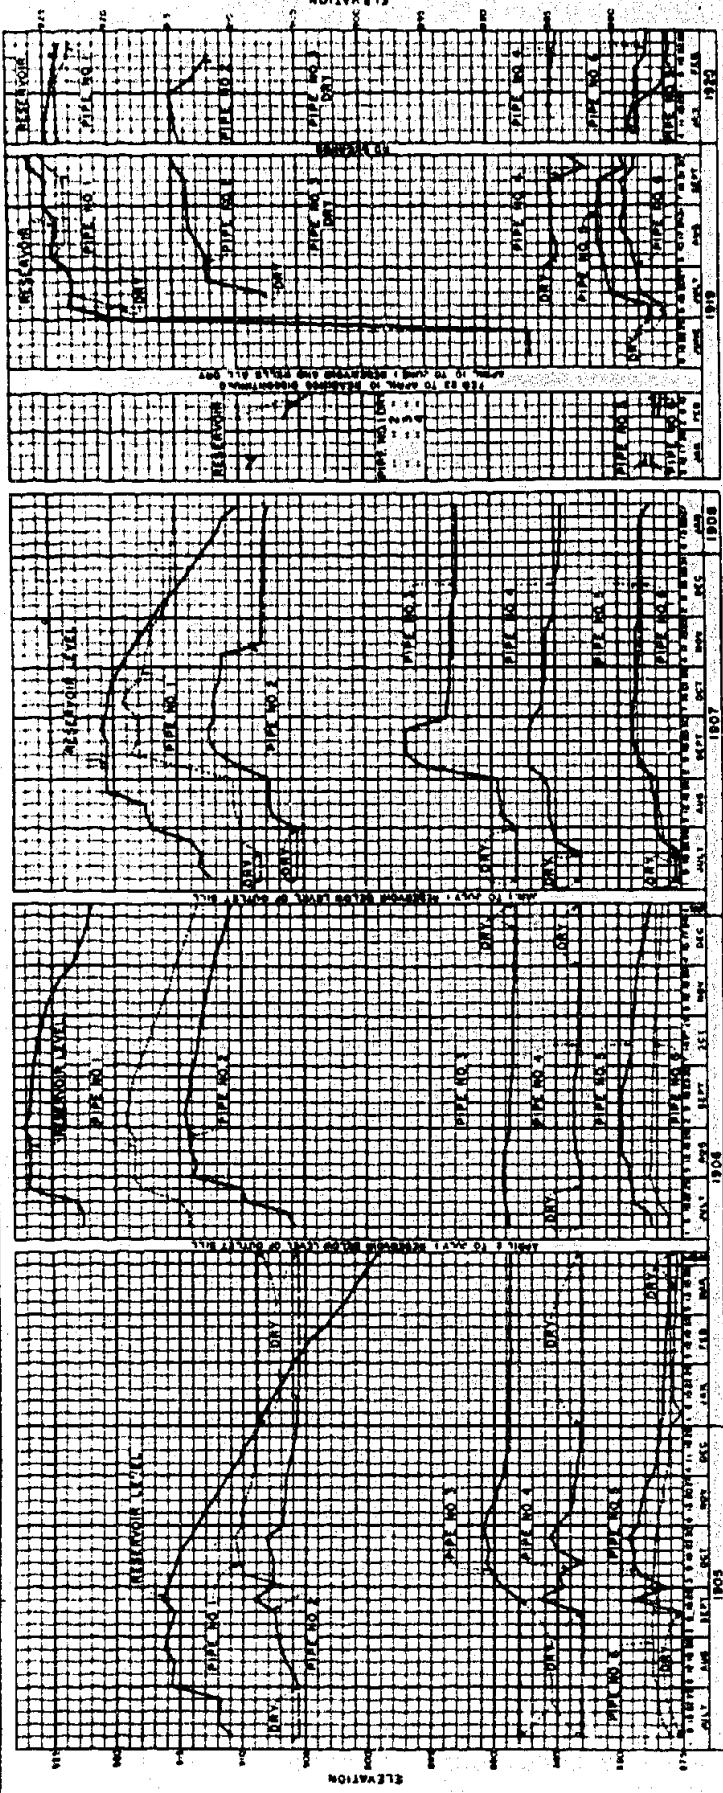
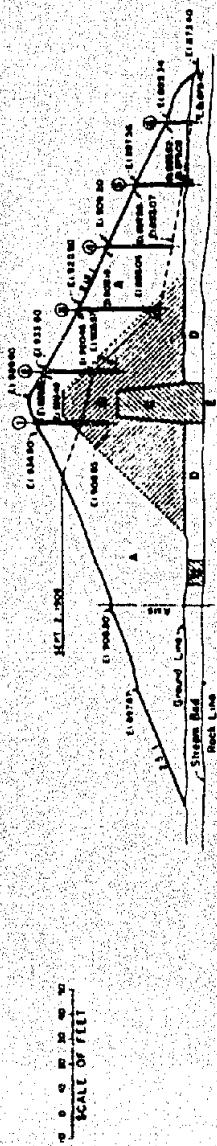
CROSS SECTION OF MUKTI TANK DAM
 (SHOWING POSITION OF PIPES FOR GATE FLOW LINE OF SATURATION)

Sent. 22 - Oct. 6, 1906. Pipe No. 8 - Saturated earth at given level. Pipe No. 1 - Mouth of pipe is close to the ground. Rainwater must have entered through pinholes in the pipe to cause abnormal rise.

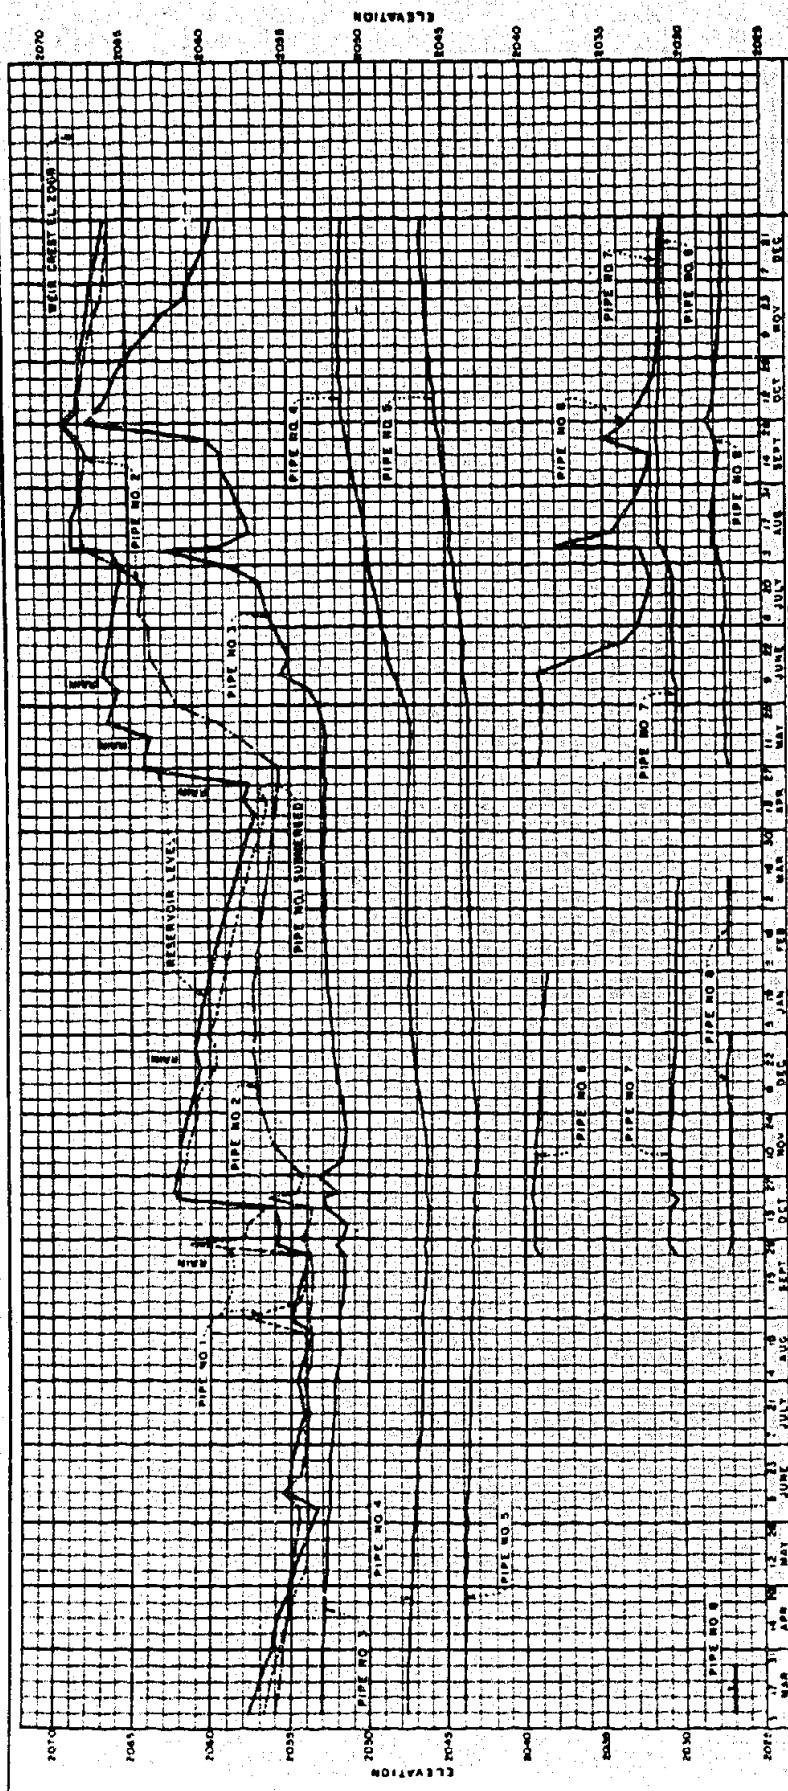
RECORD OF WATER LEVELS IN RESERVOIR AND PIPES

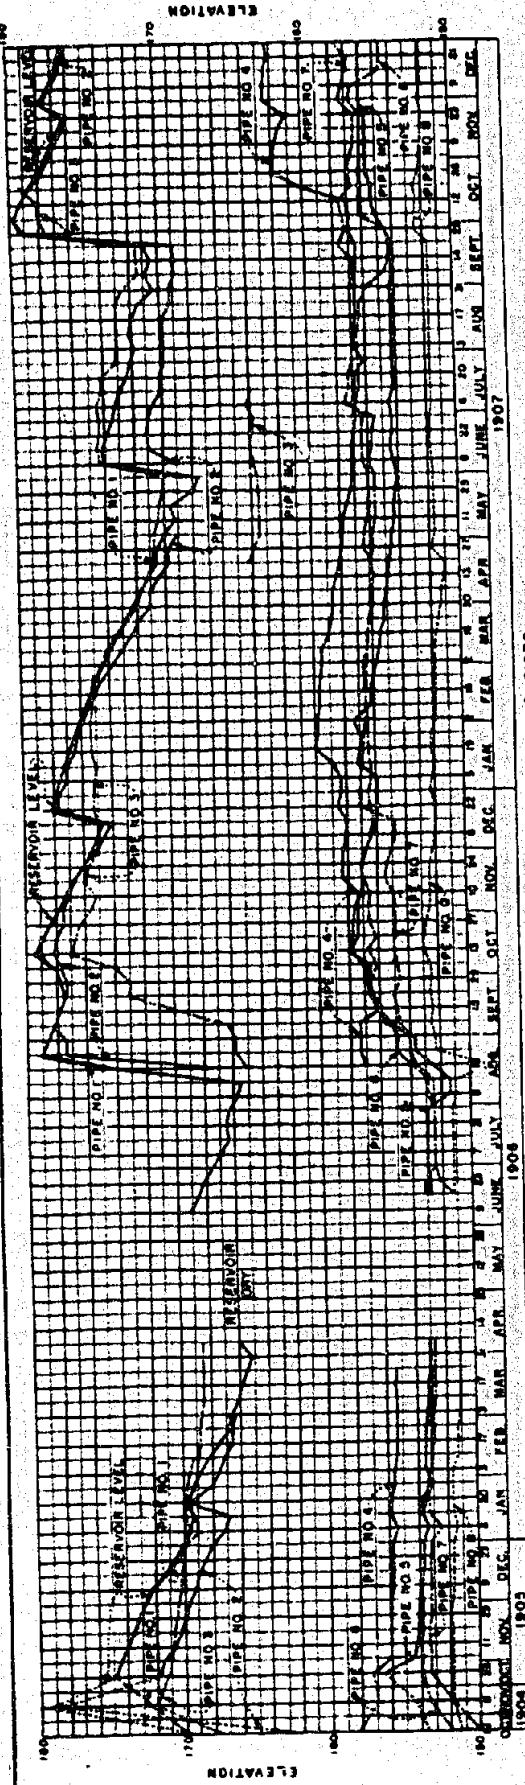
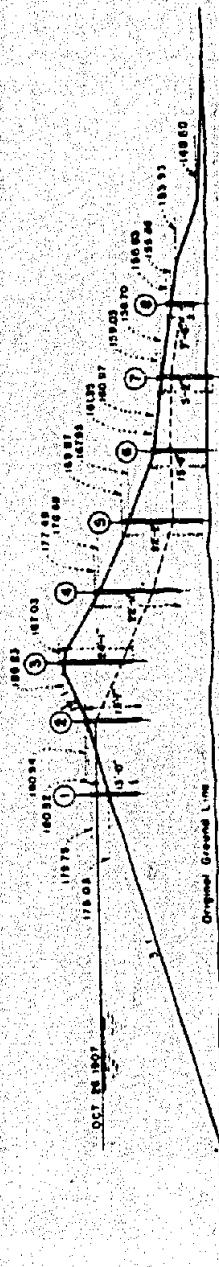
PLATE 64

LEVELS AS PER SANCTIONED DESIGN	
TOP OF DAM	3 TO 1 UP TO UPSTREAM SLOPE 1/4 TO 1, ABOVE CONCRETE SLOPE 2 TO 1 UP TO DOWNSTREAM SLOPE 1/4 TO 1, ABOVE THICKNESS AT BASE (in ft) —
EL. 8100	EL. 8100 EL. 8200 EL. 8200 EL. 8200 EL. 8200 500 FT

EXPLANATION
MATERIAL VERY LIKELY MURUN
CONSOLIDATED BY CART TRAVEL

CROSS SECTION OF MEDLER TANK DAM
 [SHOWING POSITIONS OF PIPE FOR OBSERVING LINE OF SATURATION]

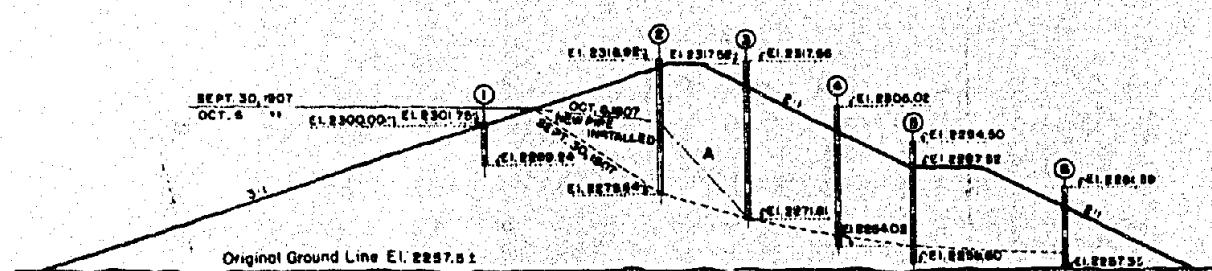
A. Clayey material - Earth and Murum mixed.

B. Murum

CROSS SECTION OF MAYNI TANK DAM
SHOWING POSITION OF PIPES FOR OBSERVING LINES OF SATURATION

A curious fact in these Maynt Tank figures is the sudden change in the levels recorded for pipe No. 2 in October of 1907. This rise in water level is due to the bank being disturbed by digging a pit 10 feet diameter to put in a new pipe. Mud was found at 2,300 level.

It is not quite clear from the above comments whether "mud" was found at elevation 2300 before or after October 6, 1907. If before, some clue is given as to relative height of saturation line above phreatic line.

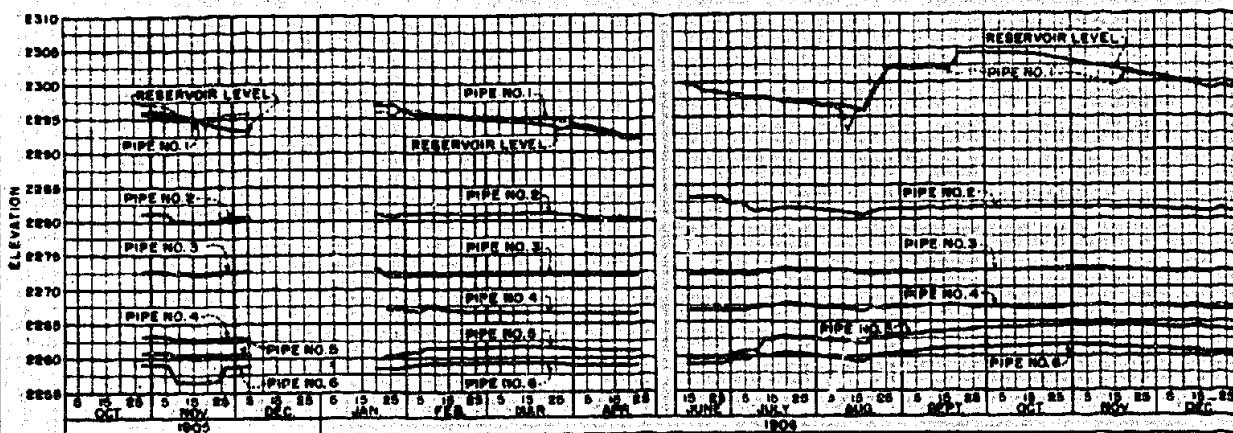
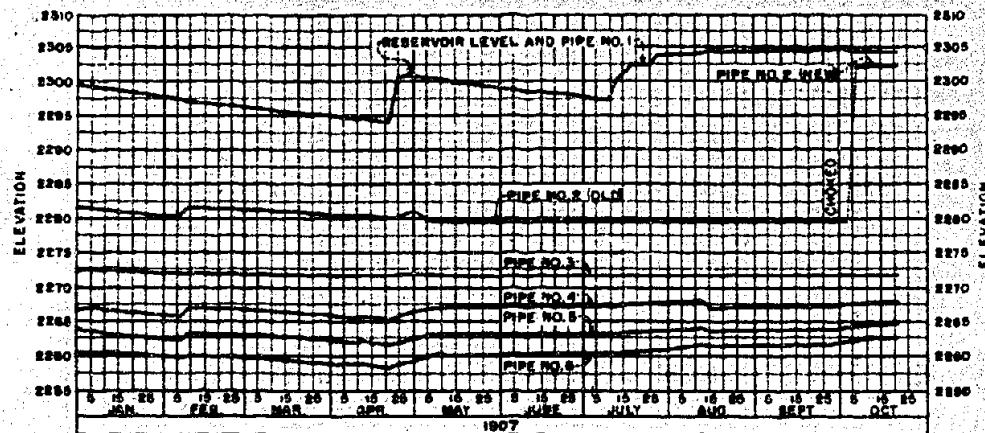
RECORD OF WATER LEVELS IN RESERVOIR AND PIPES.

The Superintending Engineer, at an inspection, verified the levels in this particular pipe No. 2 and found them as reported and the pipe not choked.

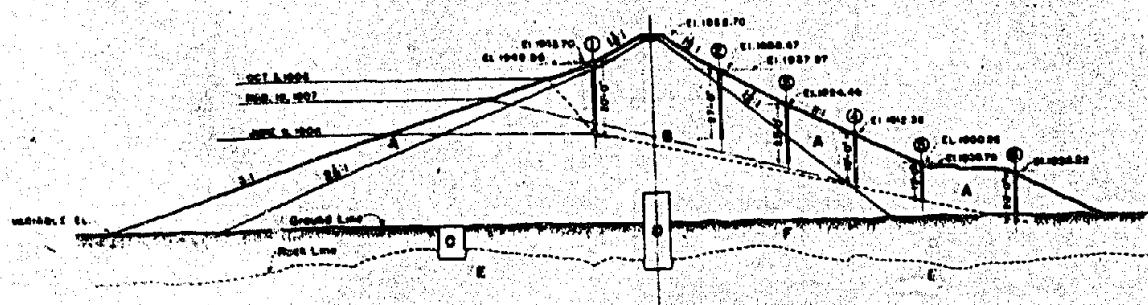
EXPLANATION
 A. Mixture of Earth and Maran
 B. Backfilled Soil
 C. Cut-off Trench
 D. Concrete Wall
 E. Rock
 F. Not Known

CROSS SECTION OF MHASWAD TANK DAM
(SHOWING POSITION OF PIPES FOR OBSERVING LINE OF SATURATION)

Commenced in 1826 and completed in 1905, this 63-foot dam is now used for domestic water and irrigation. The bank is of black soil and moorum, provided with a concrete core wall faced front and rear with a muddle trench. The foundation is sand, gravel, and boulders overlying moorum and the Deccan trap rock. The average annual rainfall is 27 inches, with a maximum 24-hour rain of 5.40 inches on 9-23-24.

The top phreatic line in the sketch is based on the assumption that the heart material is the most impervious. The high level indicated at well 2 may be due to some special cause other than normal seepage.

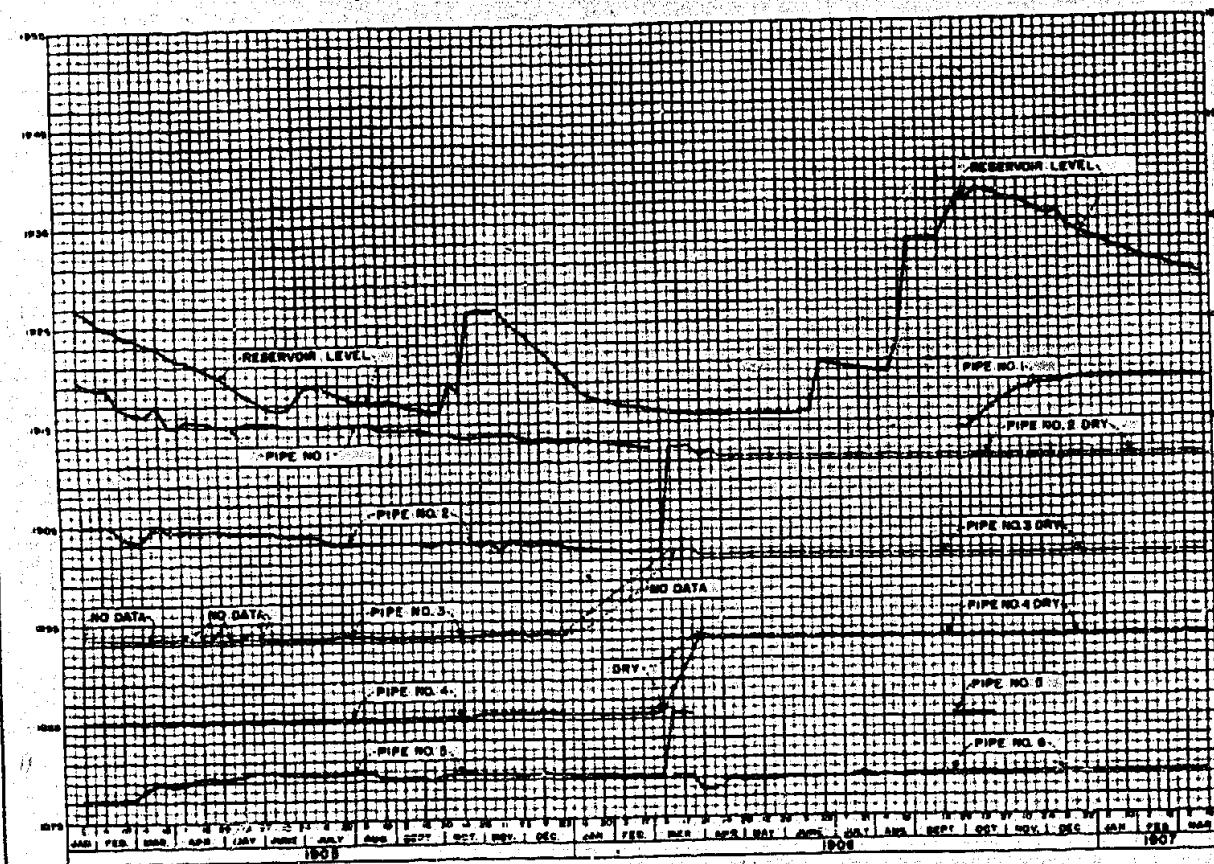
RECORD OF WATER LEVELS IN RESERVOIR AND PIPES

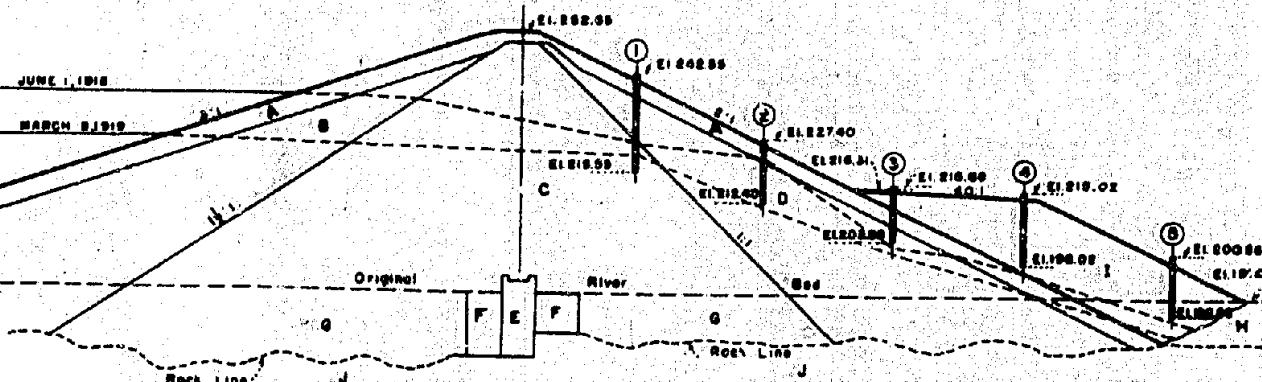
- A MURUM CASINO
 - B SELECTED MATERIAL 1ST CLASS
1 BLACK SOIL TO 1 MURUM
 - C HEARTING 1 BLACK SOIL TO 1 MURUM
 - D SELECTED MATERIAL 2ND CLASS
1 BLACK SOIL TO 1 MURUM
 - E CONCRETE TRENCH
 - F PUDDLE
 - G NATURAL GROUND EARTH
 - H SAND, GRAVEL, LOOSE STONES, ETC
 - I BERM MATERIAL NOT STATED
 - J ROCK

**CROSS SECTION OF PATHRI TANK DAM
SHOWING POSITION OF PIPES**

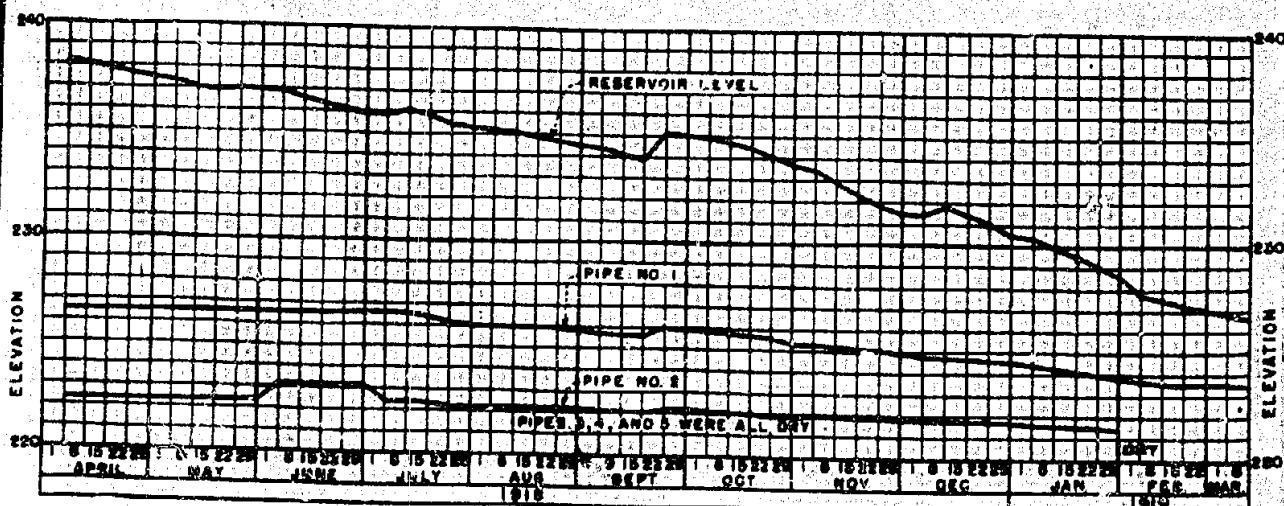
RECORD OF WATER LEVELS IN RESERVOIR AND PIPES

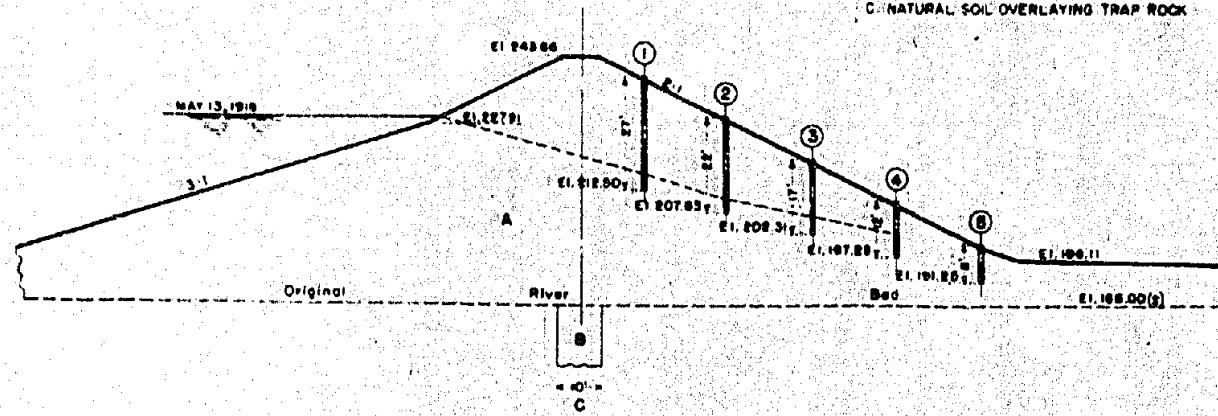
EXPLANATION
A: MIXTURE OF EARTH AND MURUM.
B: PUDDLE TRENCH.
C: NATURAL SOIL OVERLAYING TRAP ROCK.

CROSS SECTION OF ASHTI TANK DAM

This 58-foot embankment was begun in 1876 and was completed in 1883. It is used for irrigation. Built of earth and muckum, on a foundation of sand and trap rock, it is provided with a concrete core with puddle trench below ground level. The location of the concrete core wall is not indicated. Annual rainfall is 23 inches; the maximum 24-hour rain recorded 5.50 inches on 8-27-32.

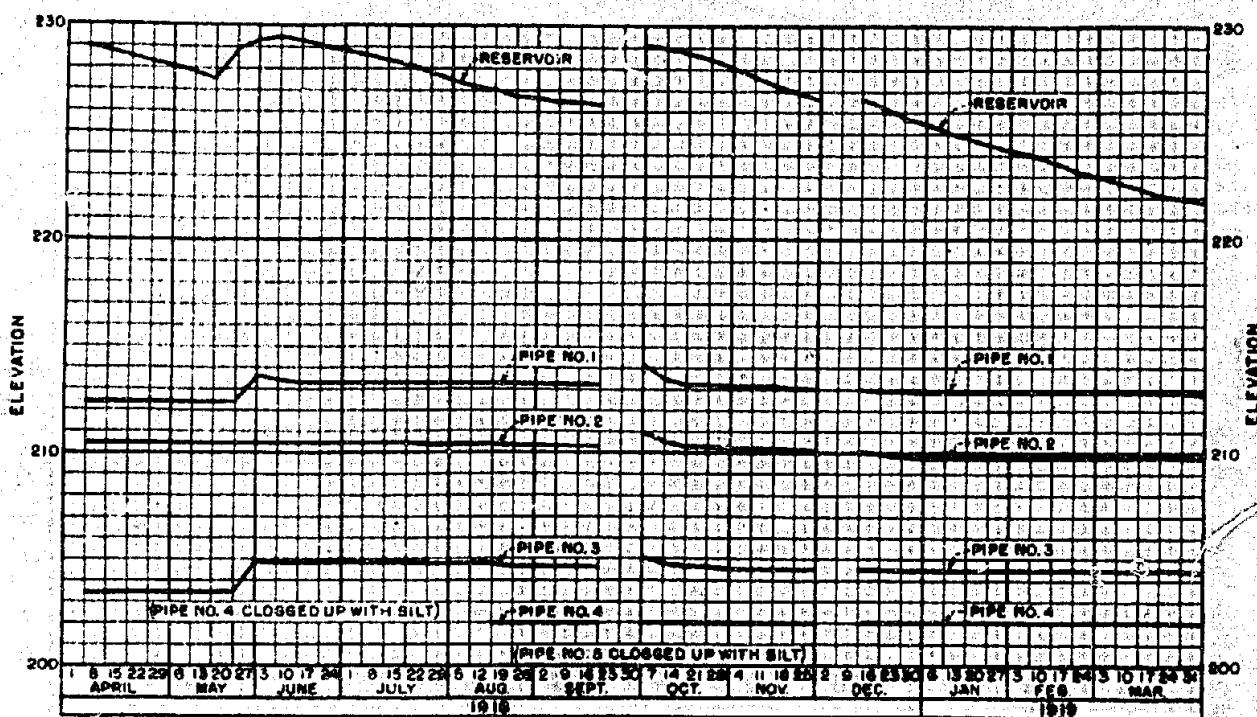
RECORD OF WATER LEVELS IN RESERVOIR AND PIPES

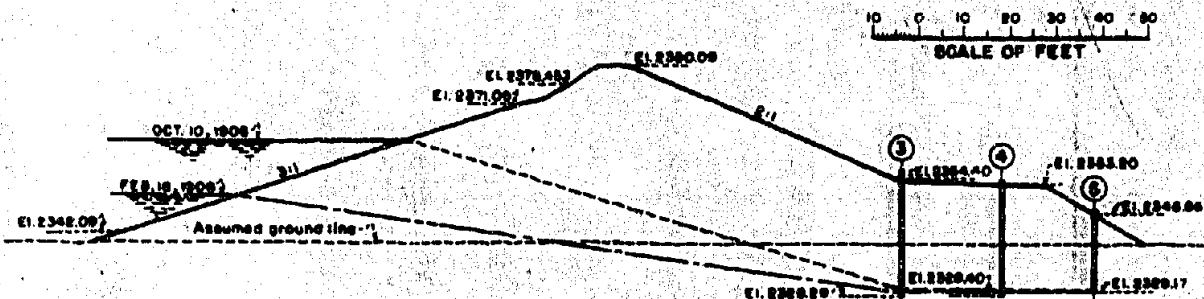
CROSS SECTION OF PINGLI TANK DAM
SHOWING POSITION OF PIPES FOR OBSERVING LINE OF SATURATION
NO INFORMATION AS TO POSITION OF PIPES 1 AND 2

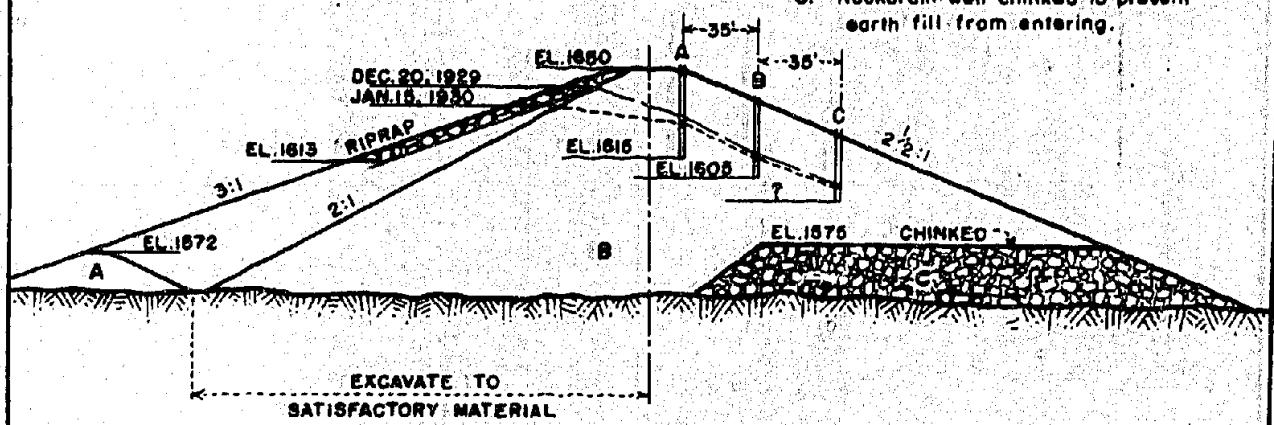
- A. Preliminary diversion fill
- B. ?
- C. Rockdrain well chinked to prevent earth fill from entering.

This dam is included because it affords a case in which sloughing of the downstream slope is experienced even in the presence of a large rock-fill drainage section. Had the drain become temporarily clogged for any reason, say by freezing, the downstream slope might readily have become sufficiently saturated to cause sloughing.

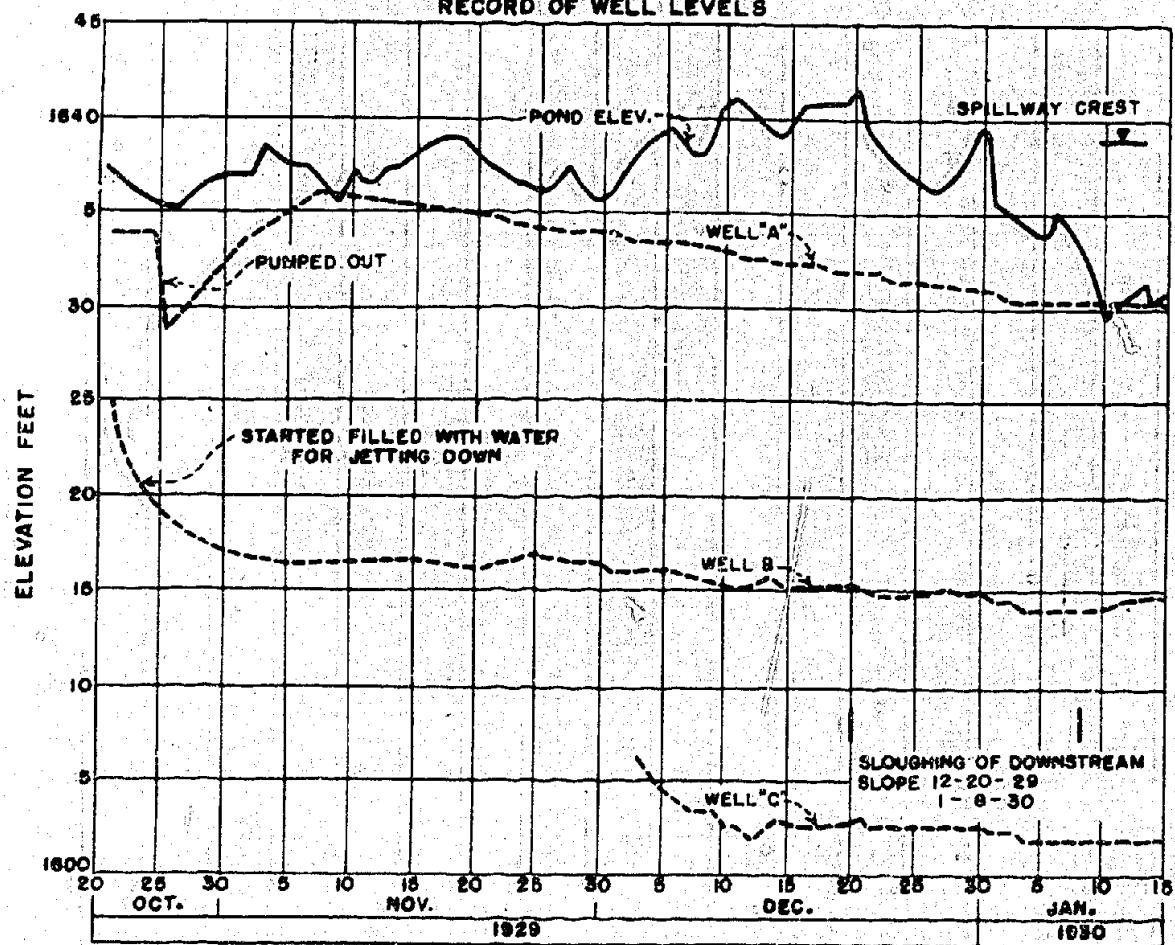
RECORD OF WELL LEVELS
