HYDRAULIC MODEL STUDIES RELATING TO
THE REDESIGN OF THE SPILLWAY AND
POWERHOUSE FOR THE DAVIS DAM

Hydraulic Laboratory Report Hyd. 232

Bureau of Reclamation
Denver, Colo.

July 15, 1947

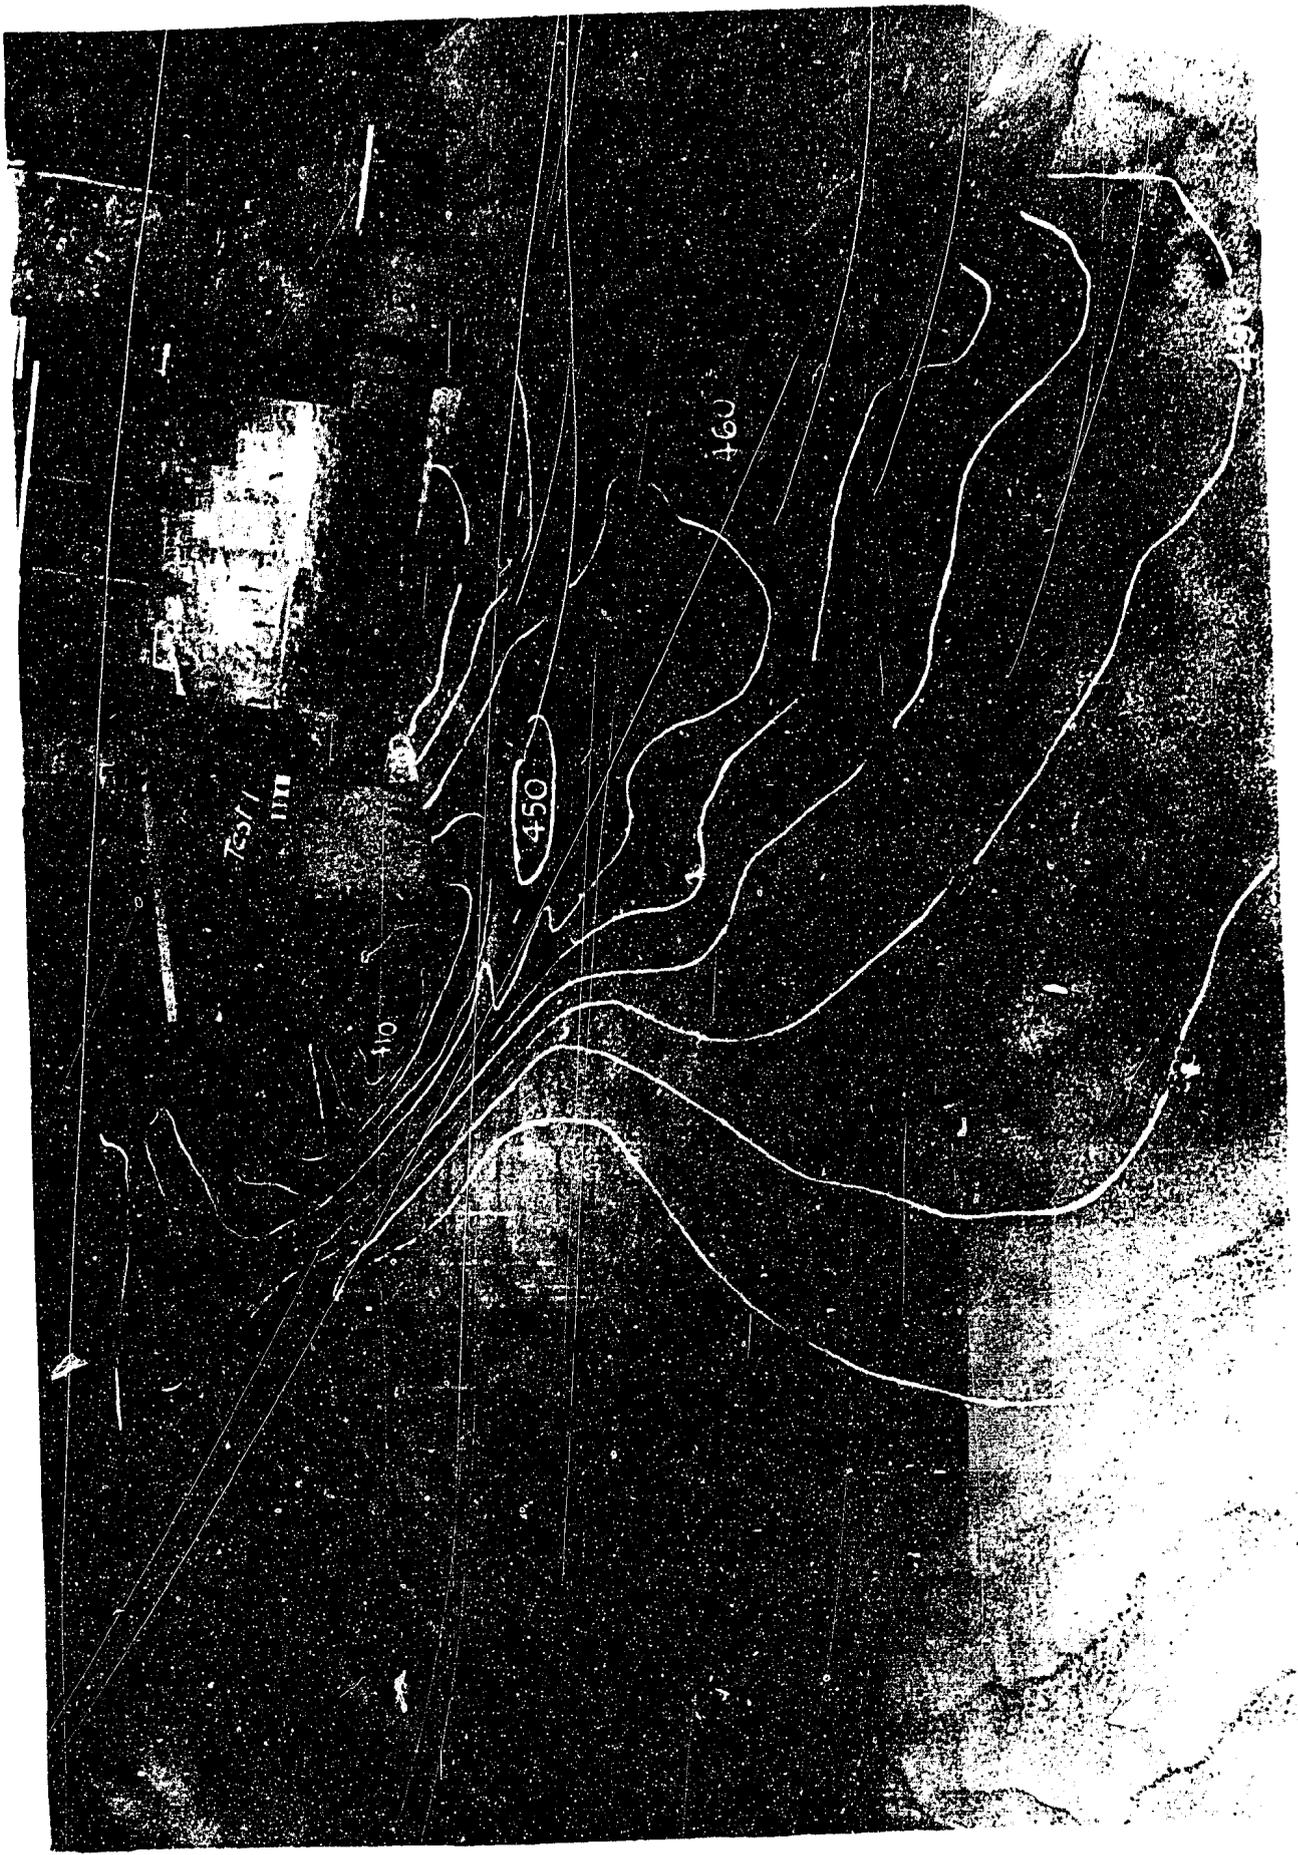
Results of Erosion Test are shown below

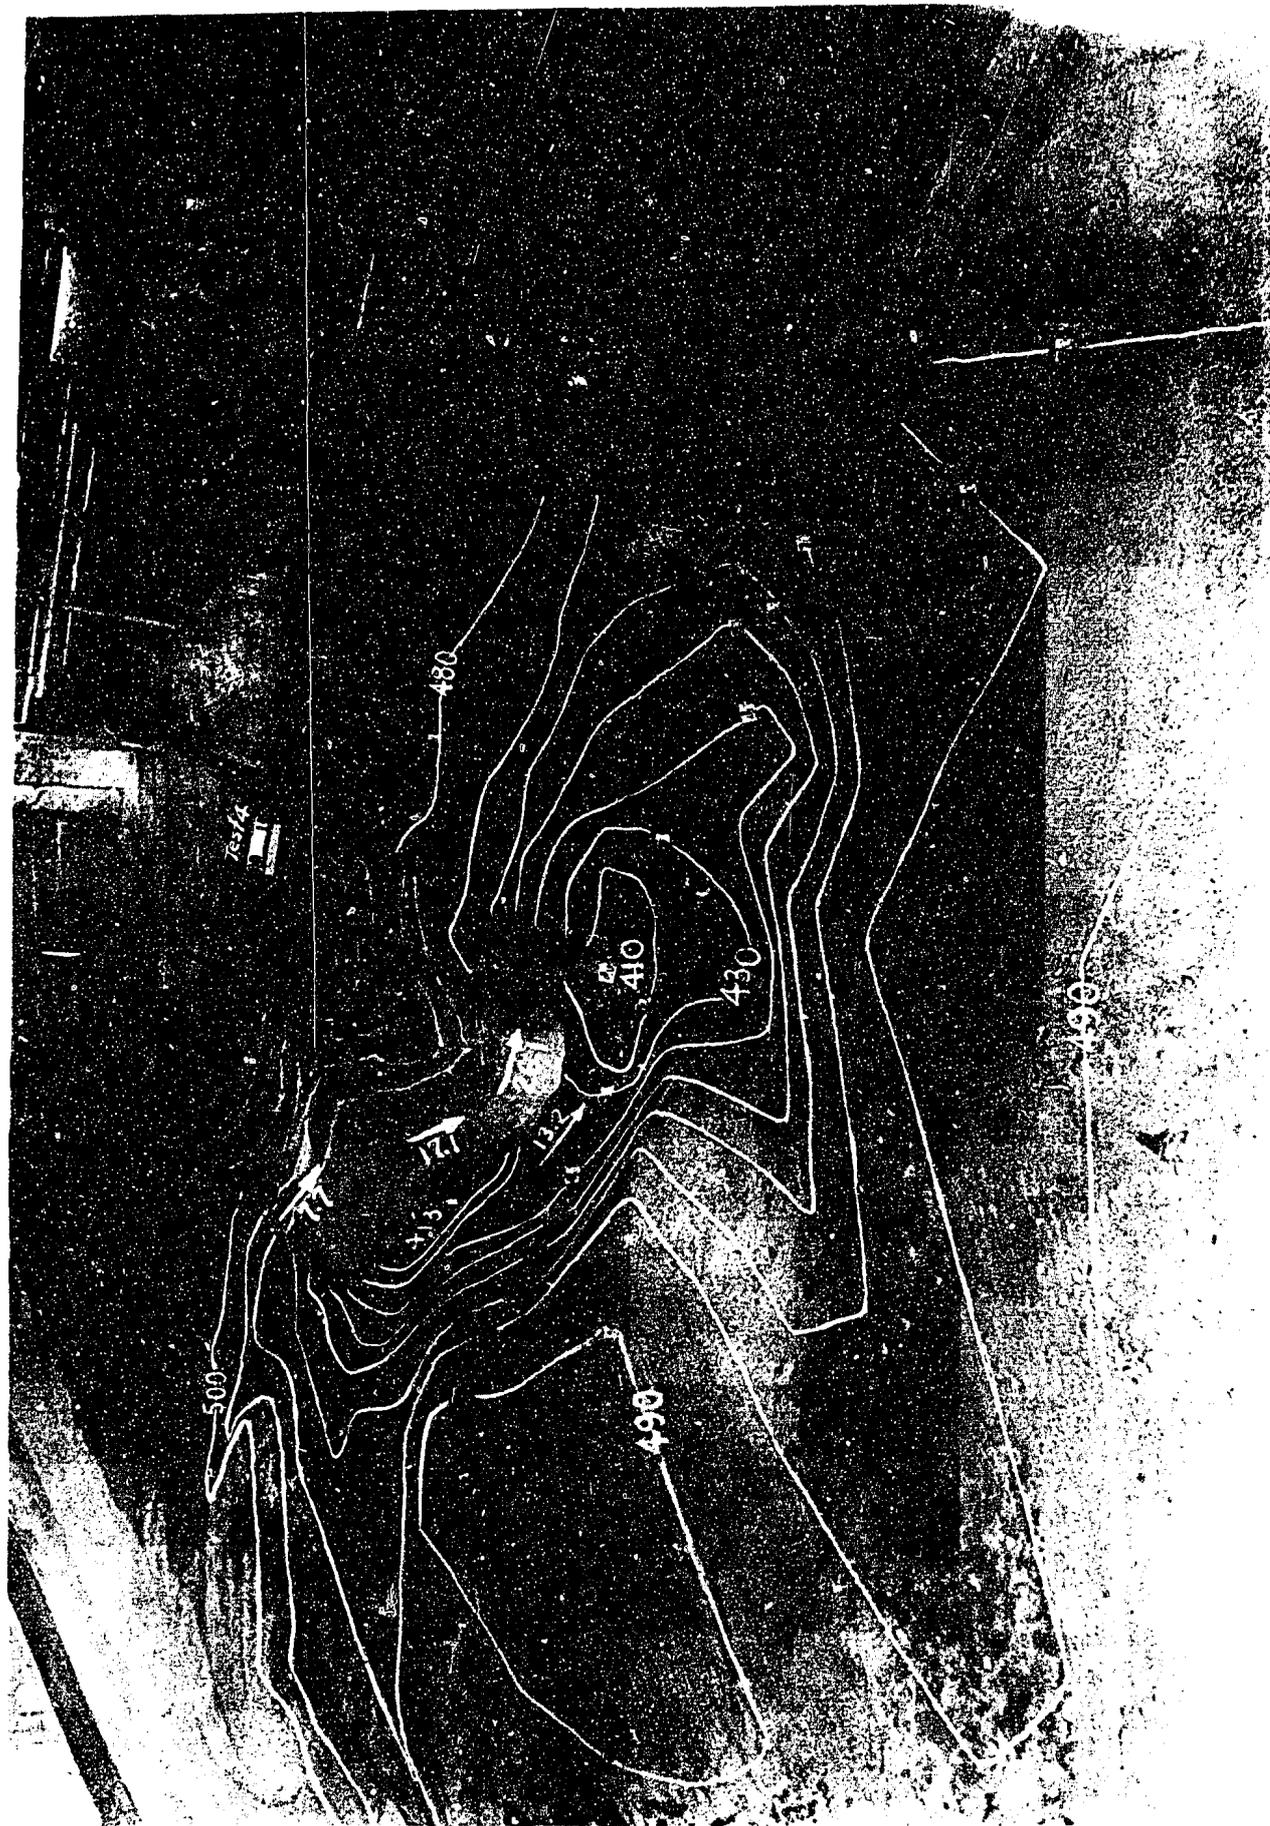
Test No. 5

Same as Test No. 3 but with ultimate tallwater at El. 515.75. Erosion for this test was considerably greater along rock on right side and 10 feet deeper at lowest point.

Discharge - 175,000 sec.-ft.
Tallwater - Ultimate - El. 515.75
Time of Test - 8 hrs.

Results of the erosion test are shown below.
