HYDRAULIC MODEL STUDIES OF THE
CHERRY CREEK DAM OUTLET WORKS AND
THE PROPOSED IRRIGATION INLET
CHERRY CREEK PROJECT, COLORADO

Hydraulic Laboratory Report Hyd. 241

APRIL 29, 1948

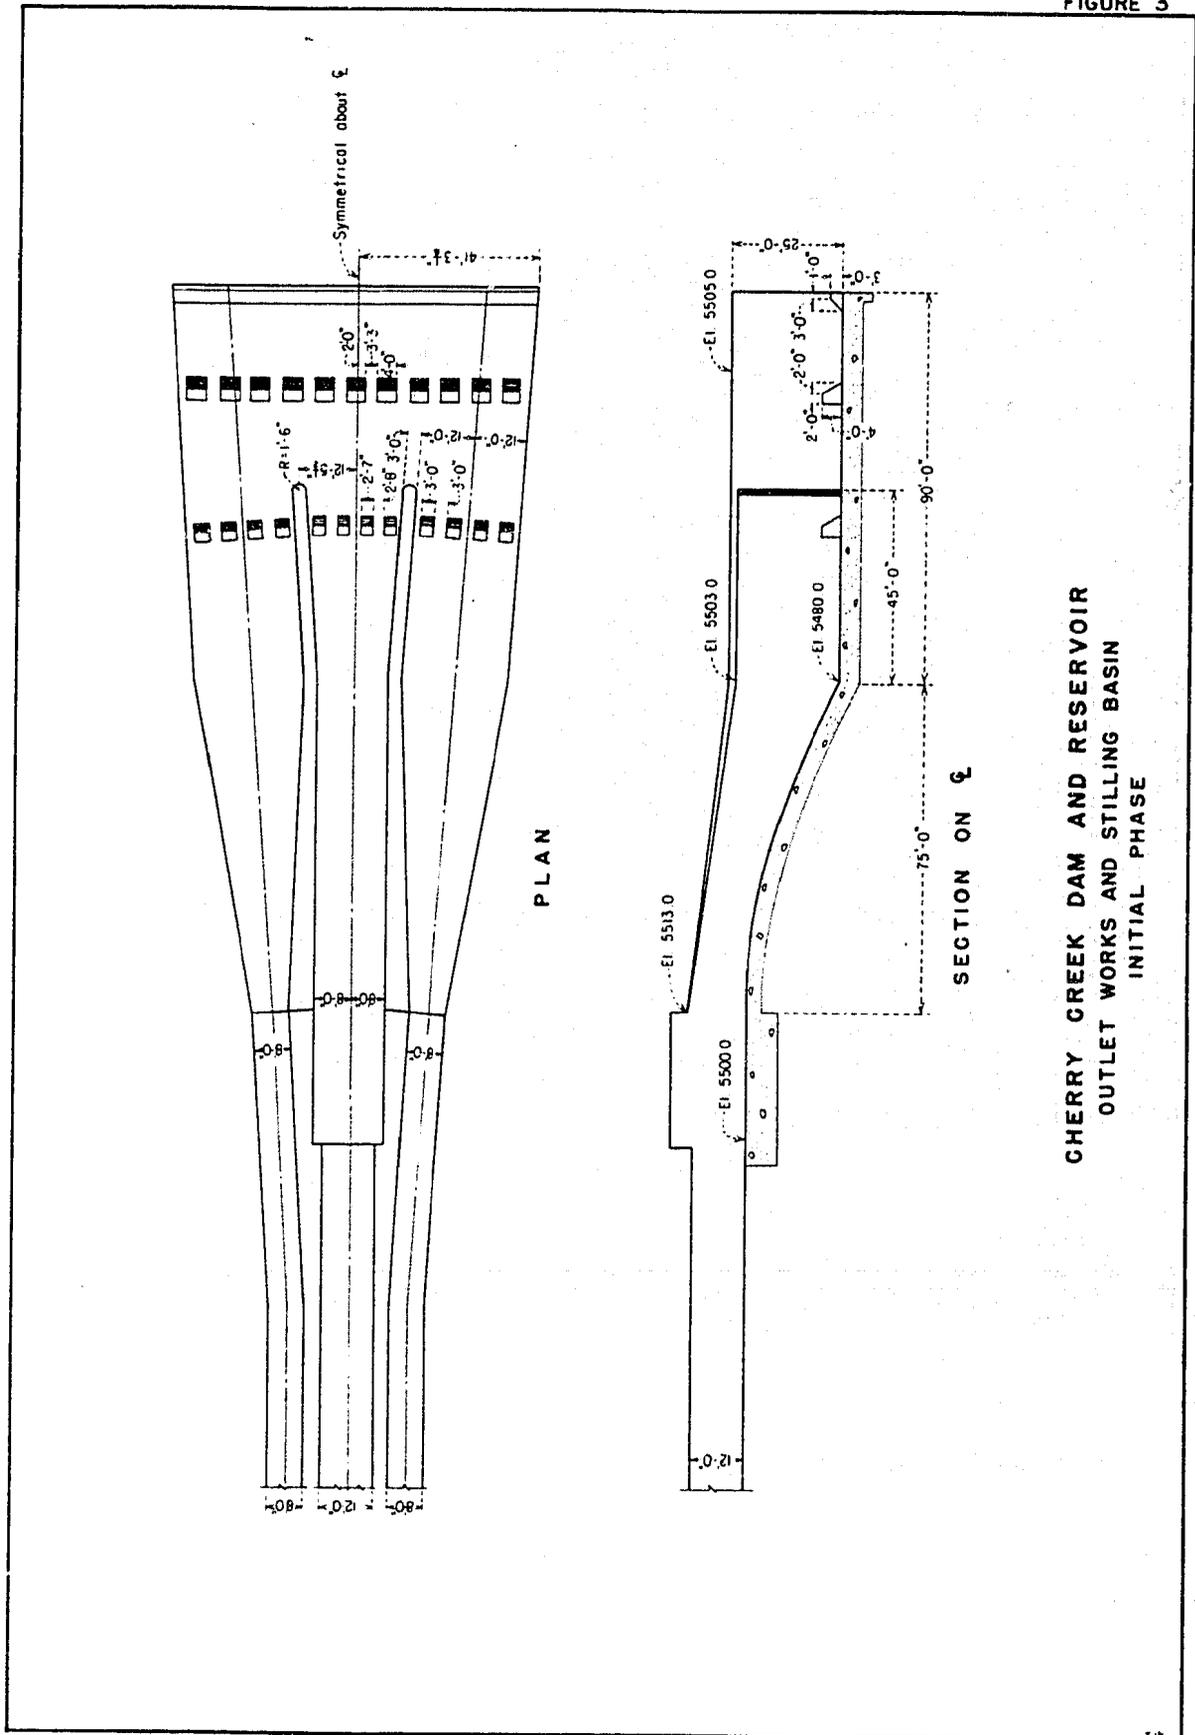
FIGURE 3

CHERRY CREEK DAM AND RESERVOIR
OUTLET WORKS AND STILLING BASIN
INITIAL PHASE

As the outlet works was to be constructed in two phases, the stilling-basin studies were made in two parts. In its initial phase, Figure 3, the primary purpose of Cherry Creek Dam is for flood control with a maximum total discharge through the three conduits of 6,000 second-feet at reservoir elevation 5535. The conduits are controlled by slide-gates located near the upstream end. Operation of the model, Figures 7 and 8, showed that the design of the outlet works, in general, was satisfactory.

Baffle piers. During the tests on the initial and final phases of the stilling-basin it was noted that the original baffle piers were not fully effective because they were located too far downstream, Figure 3. In order to evaluate the effectiveness of the piers in this original position, the model was operated with all baffles removed. Flow at the downstream end of the stilling-basin appeared the same whether or not the baffles were in place. Scour was slight after one hour of operation at 6,000 second-feet, Figure 13. The only discernible difference in the erosion pattern was the absence of the sand deposits on the downstream end of the apron with the baffles removed.

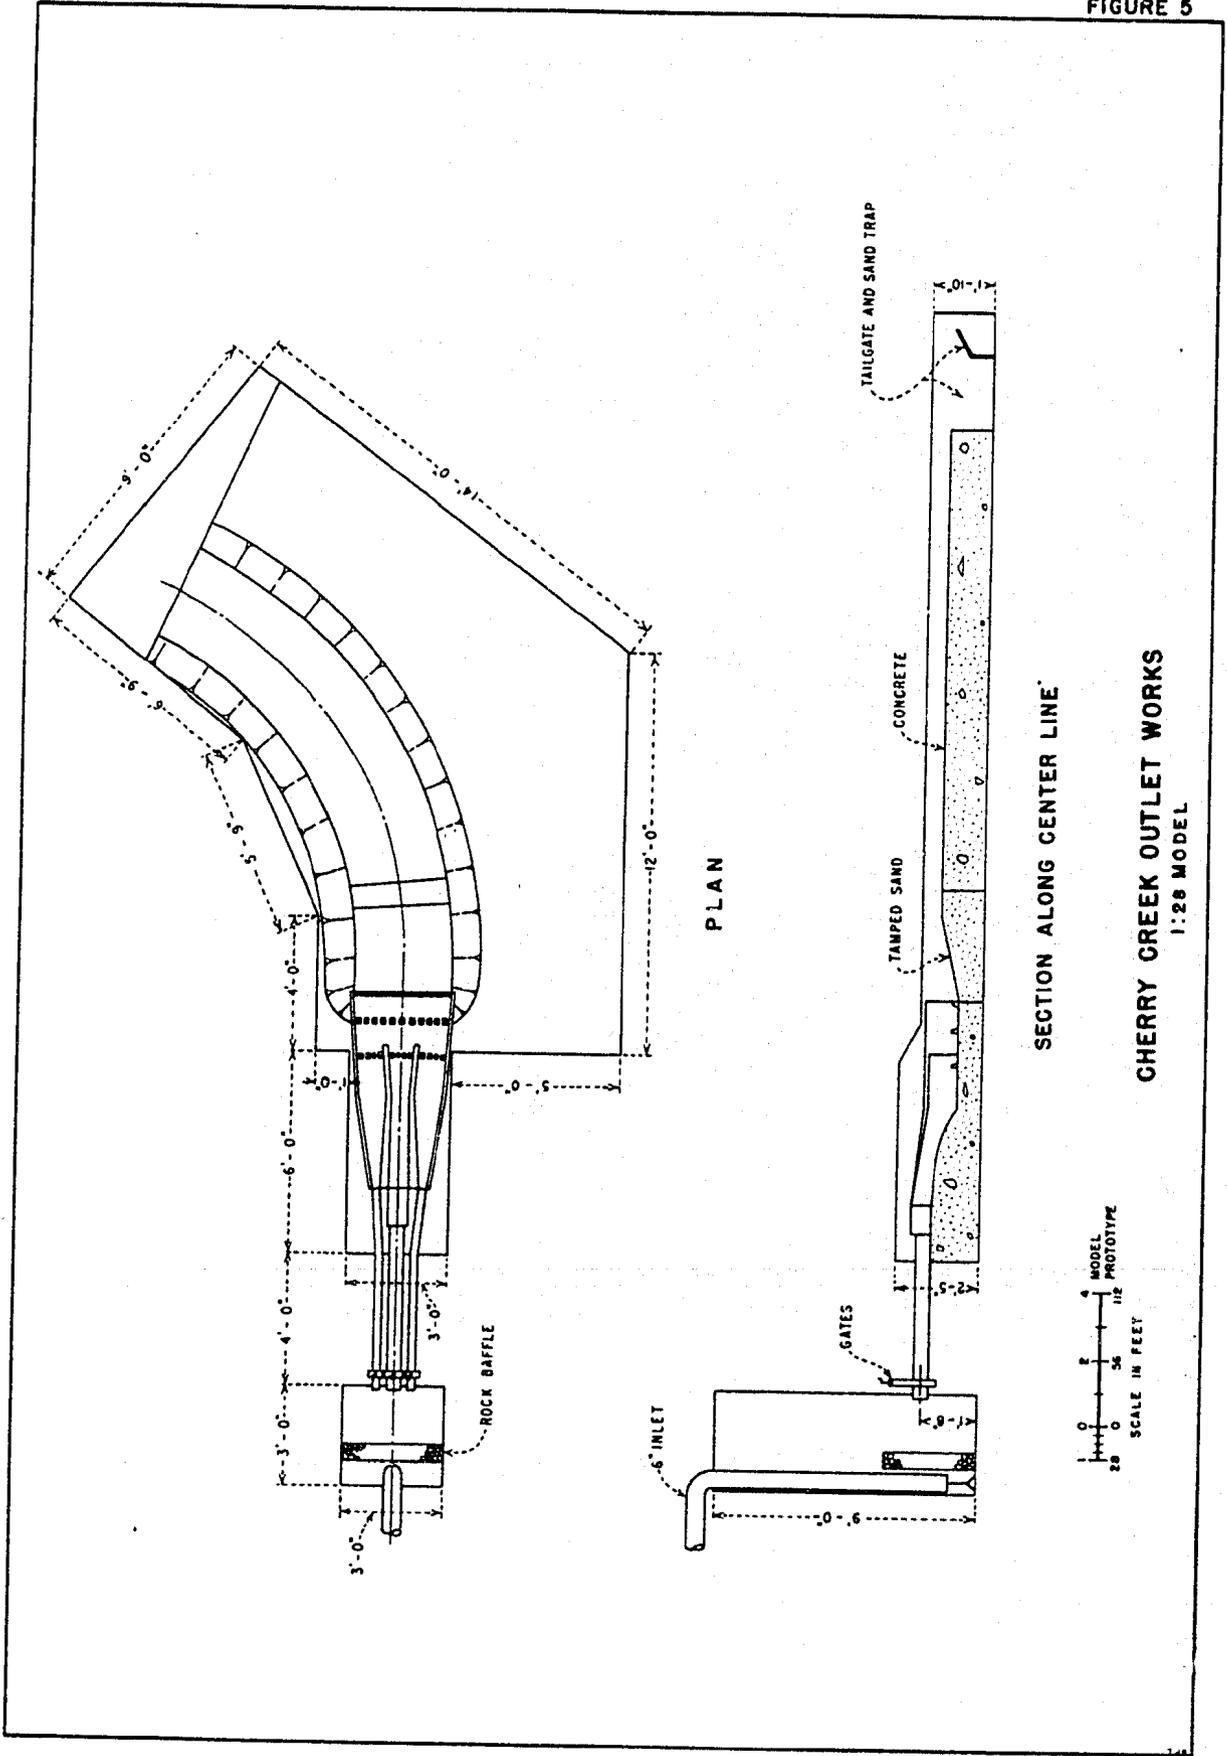
FIGURE 5

SECTION ALONG CENTER LINE
CHERRY CREEK OUTLET WORKS
1:28 MODEL

The model, Figures 5, 6A, and 6B, was contained in a wooden headbox and tailbox lined with sheet metal. The three outlet conduits were constructed of sheet metal and were provided with brass slide-gates at the upstream end. Because the studies were concerned only with the outlet ends, the conduits were made shorter than the true scale lengths. However, proper model-prototype relationship of velocities at the conduit portals was obtained for any discharge by appropriate settings of the slide-gates and the water surface elevation in the headbox.

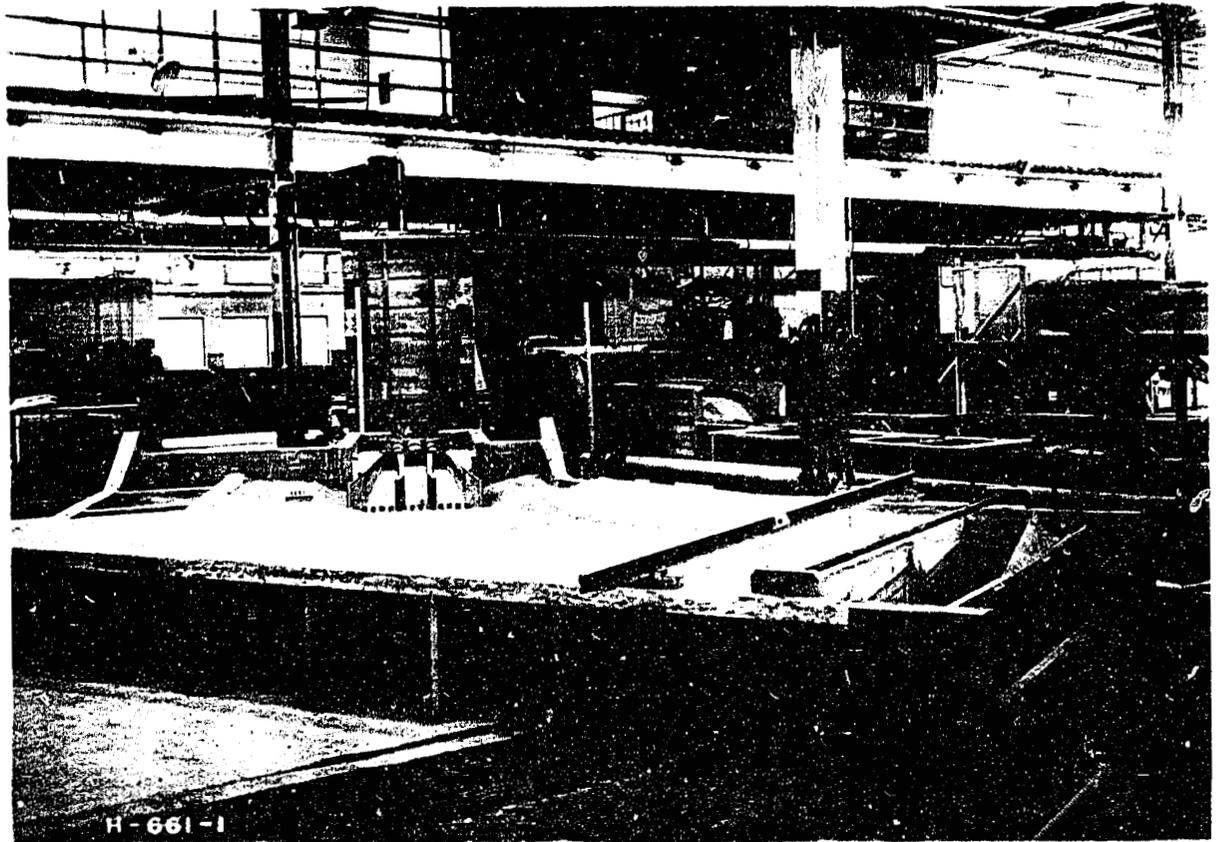
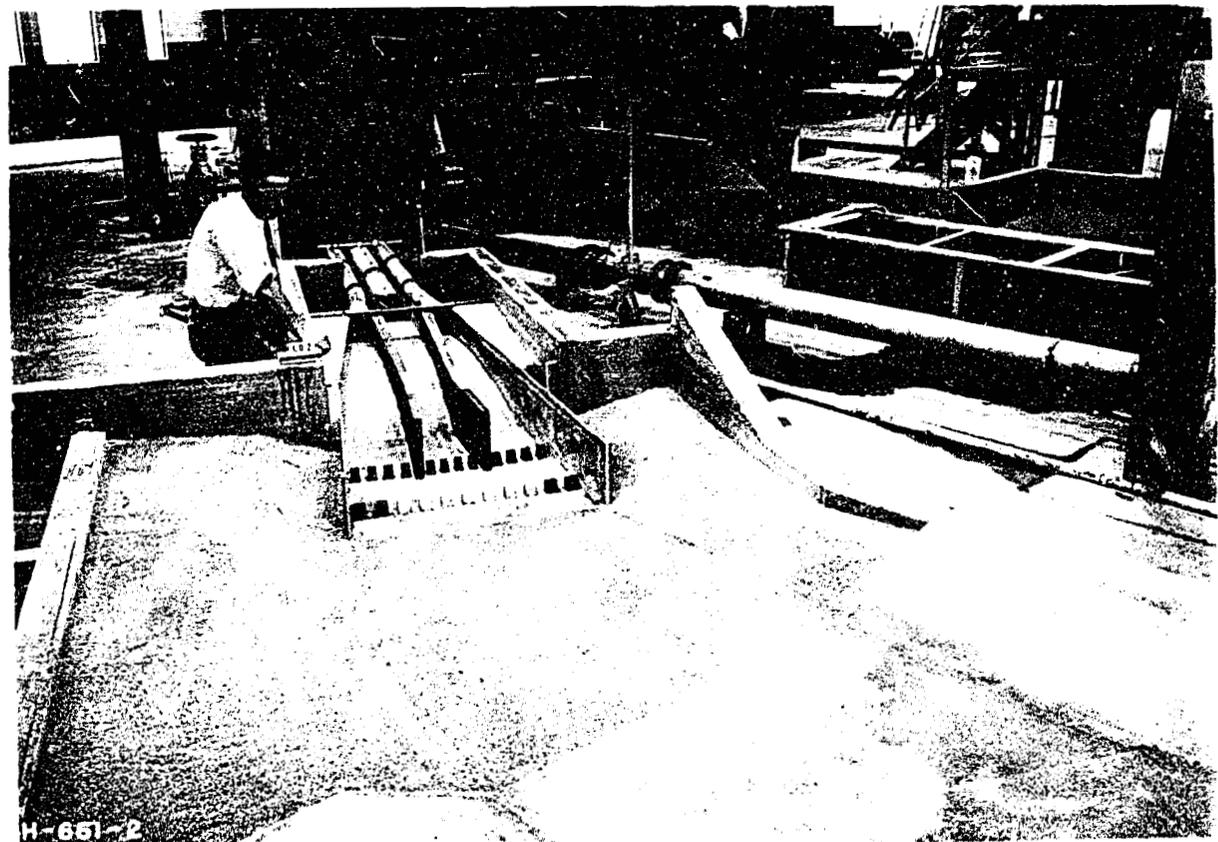
A. Completed model

E. Stilling-basin

MODEL, CHERRY CREEK OUTLET WORKS, ORIGINAL DESIGN, INITIAL PHASE

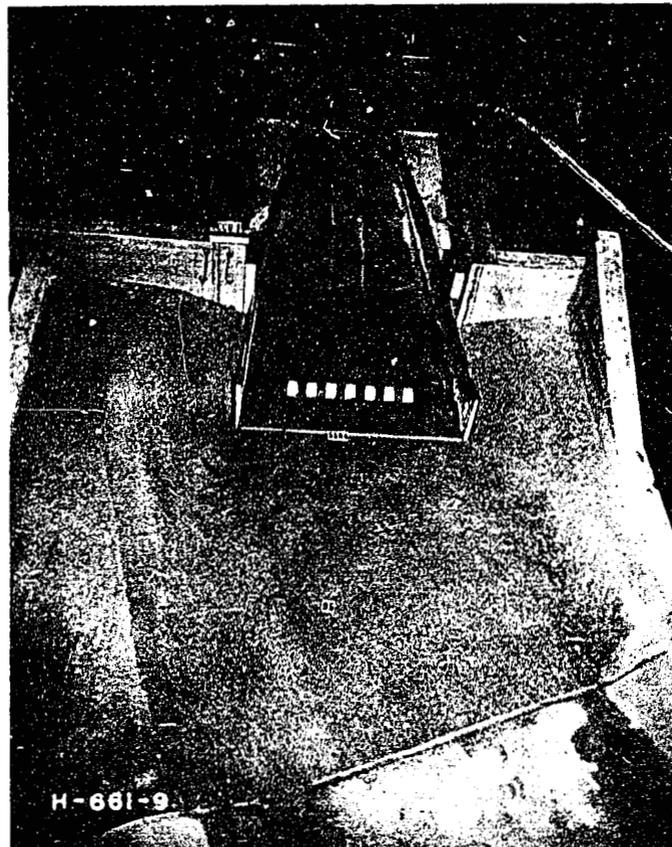
FIGURE 9

Scour after 1 hour operation 3 conduits discharging
6,000 second-feet, tailwater elevation 5502.8

1:28 MODEL, CHERRY CREEK STILLING-BASIN, ORIGINAL DESIGN, INITIAL PHASE

Scour was observed for the four flow conditions of Figures 7 and 8, and a record test was made, Figure 9, of the scour after operating one hour at 6,000 second-feet and tailwater elevation 5502.8, the most severe condition. Very little movement of the channel bed material resulted. Figure 9 shows two small deposits of sand on the downstream end of the apron close to the centerline of flow from each outside conduit. This was probably carried by bottom currents from around the end of each training wall. Erosion close to the end sill and at the end of the training walls was negligible.

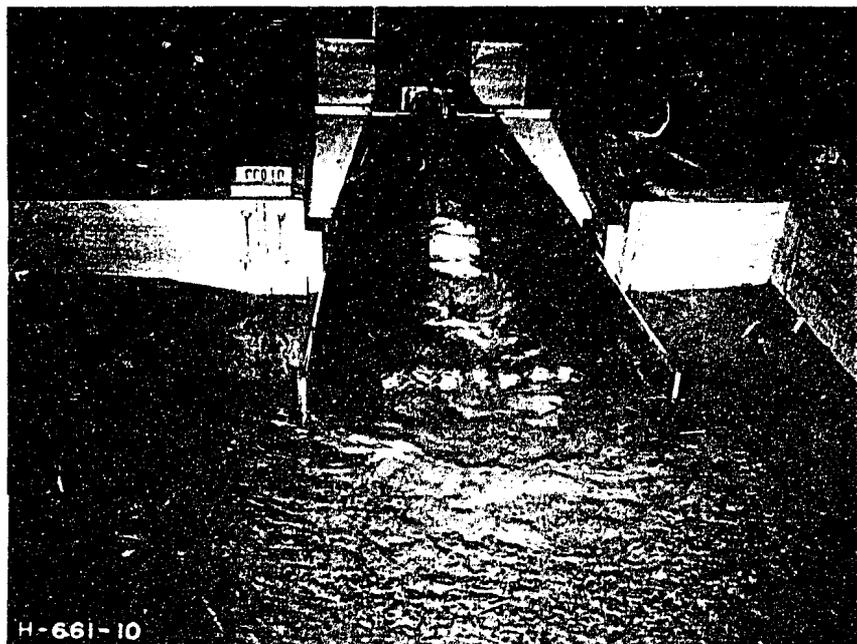
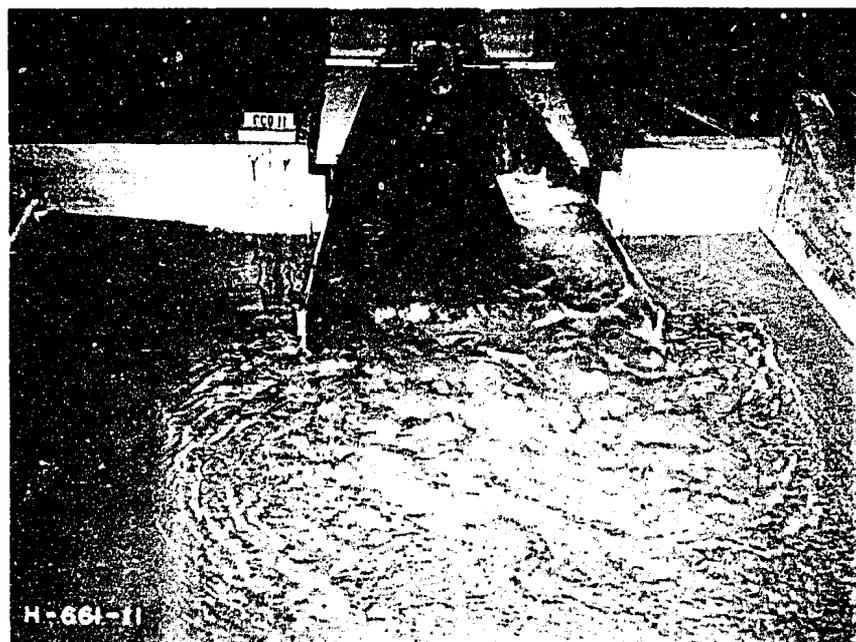
A. Hollow-jet valve discharging 1,500 second-feet

B. Left conduit discharging 2,275 second-feet

1:28 MODEL, CHERRY CREEK STILLING-BASIN, ORIGINAL DESIGN, FINAL PHASE

Final phase. The center conduit was modified and an 84-inch hollow-jet valve was installed on the downstream end for the tests on the final phase, Figure 4. The maximum flow of 1,500 second-feet from the hollow-jet valve is shown in Figure 10A. Figure 10B shows one outside conduit discharging 2,275 second-feet. In Figure 11A both outside conduits are shown operating with a total flow of 6,000 second-feet and Figure 11B shows all conduits discharging a total of 9,400 second-feet. Three conduits discharging a total flow of 6,000 second-feet is shown in Figure 12A. The higher reservoir head in the final phase resulted in greater velocities from the conduits than occurred in the initial phase, but operation was still satisfactory. Stilling-basin action with the maximum discharge of

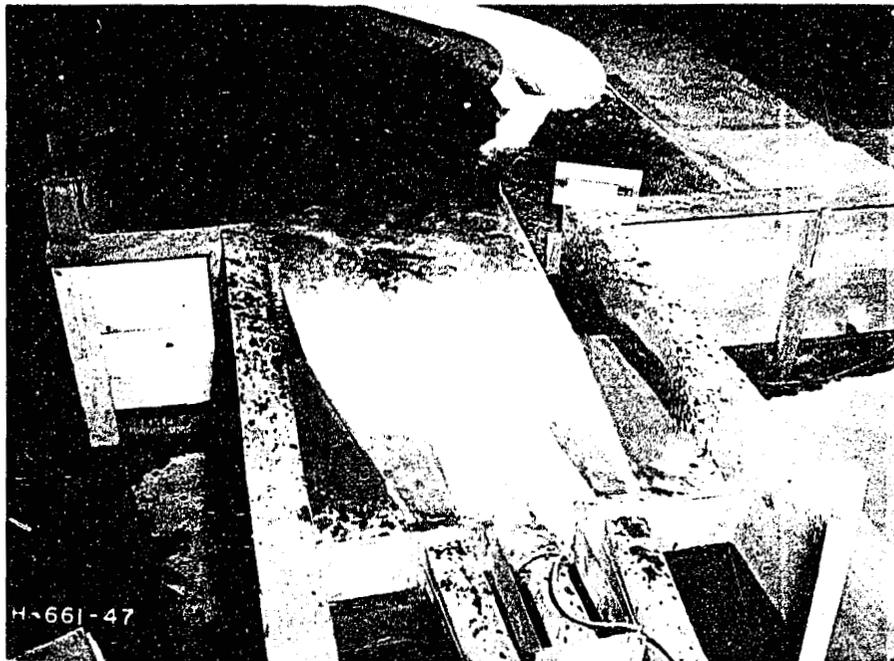
A. All conduits discharging - 9,400 second-feet

B. Scour after 1 hour operation, 3 conduits discharging
9,400 second-feet. Tailwater 5505.3

1:28 MODEL, CHERRY CREEK SPILLING-BASIN, RECOMMENDED DESIGN

Recommended stilling-basin. Since the performance of the original stilling-basin was satisfactory for both the initial and final phases of operation, the original design of this basin is recommended for field construction except for the shape and location of the baffle piers. The recommended basin is shown in Figure 14, and operation is shown in Figure 15, A & B. Scour after one hour operation at 6,000 second-feet is shown in Figure 16. Action of the stilling-basin for all conduits flowing a total of 9,400 second-feet is shown in Figure 21. Scour, Figure 21B, after one hour operation at 9,400 second-feet is similar to that for a discharge of 6,000 second-feet except that there are no sand deposits on the apron. Greatest depth of scour, elevation 5481, occurred just downstream from the end sill.

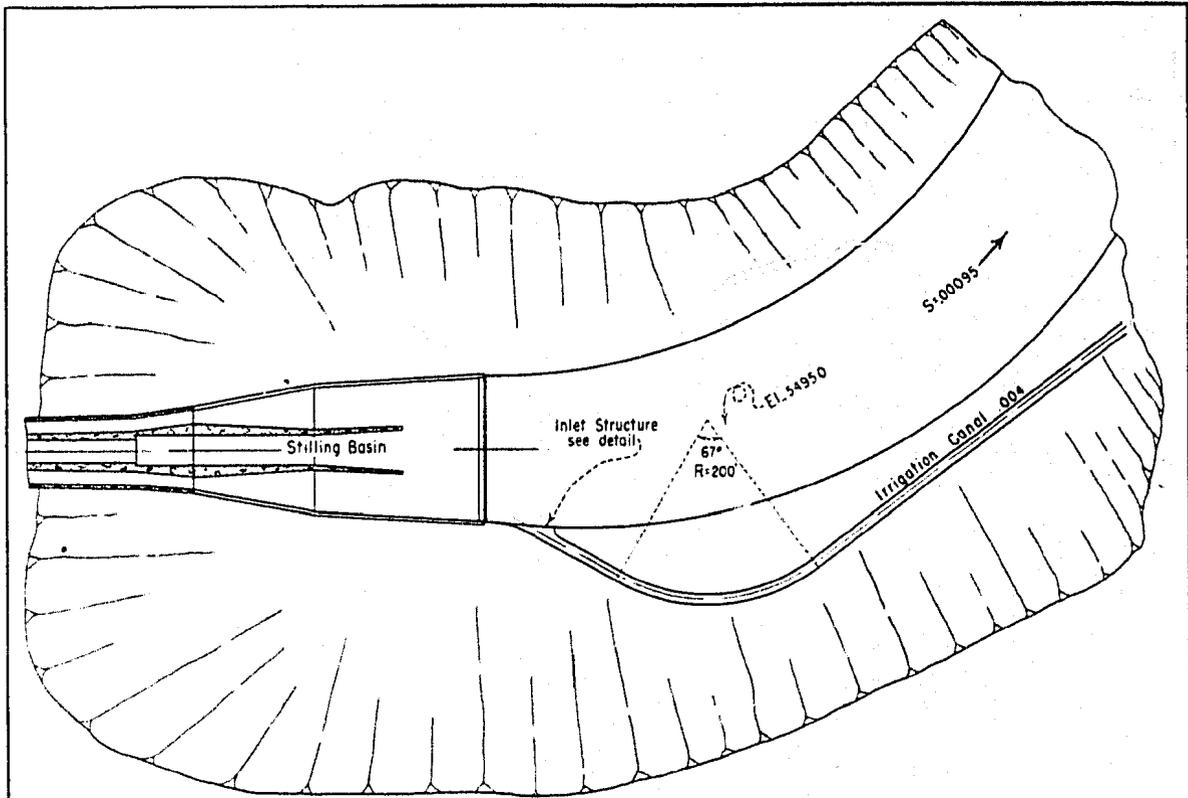
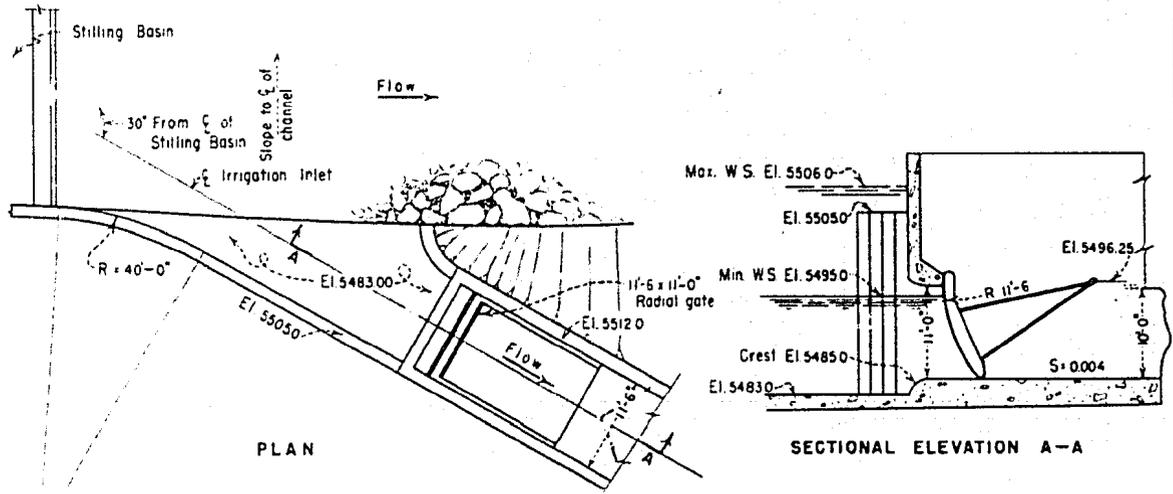
GENERAL PLAN

PLAN

SECTIONAL ELEVATION A-A

DETAIL OF INLET STRUCTURE

CHERRY CREEK DAM AND RESERVOIR
IRRIGATION INLET STRUCTURE

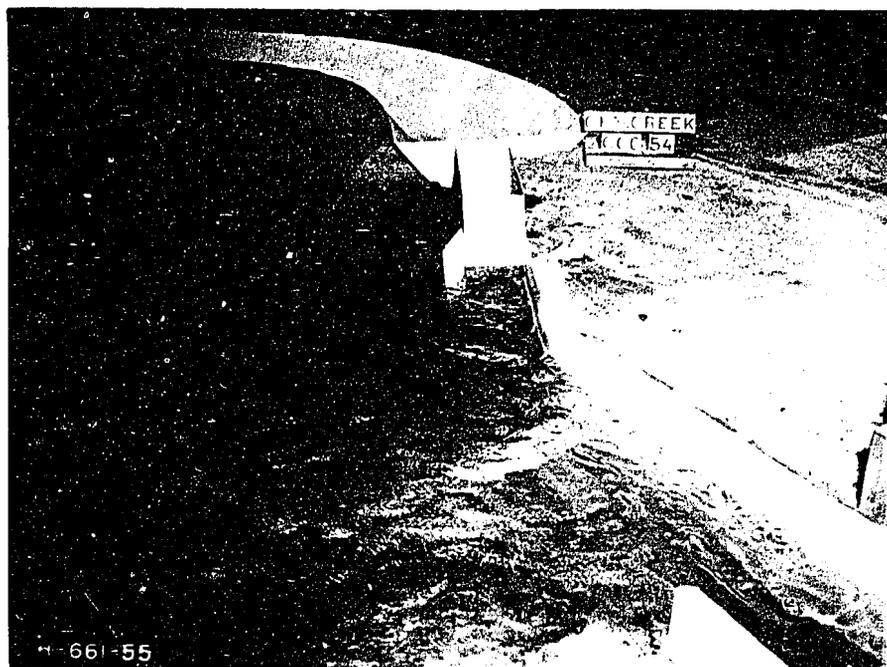
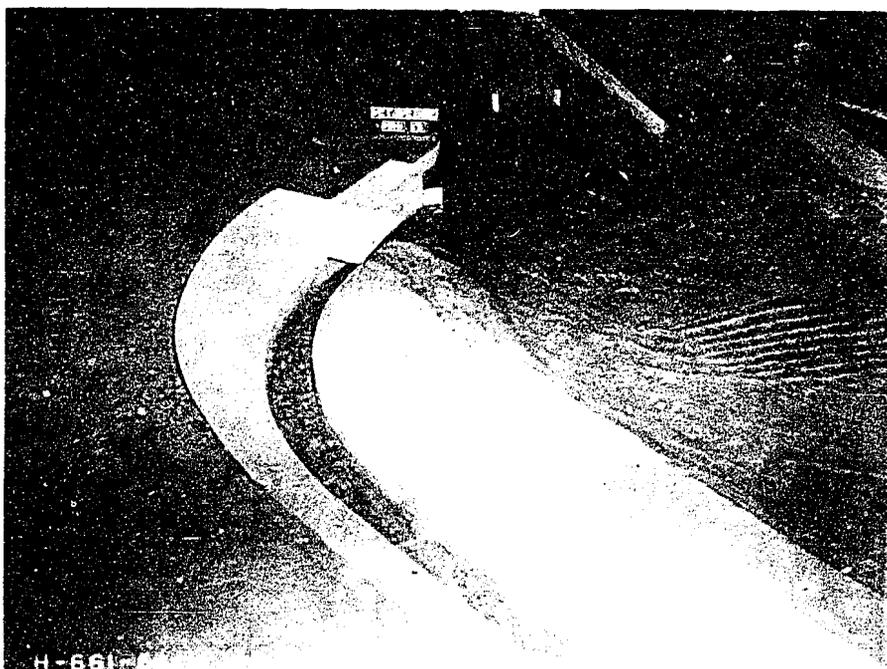
A. Flow conditions at entrance

B. Flow conditions in the canal

CANAL DISCHARGE 750 SECOND-FEET - 4-FOOT GATE OPENING. HOLLOW-JET
VALVE DISCHARGING 1,500 SECOND-FEET, TAILWATER ELEVATION 5497.6

1:20 MODEL, CHERRY CREEK IRRIGATION INLET

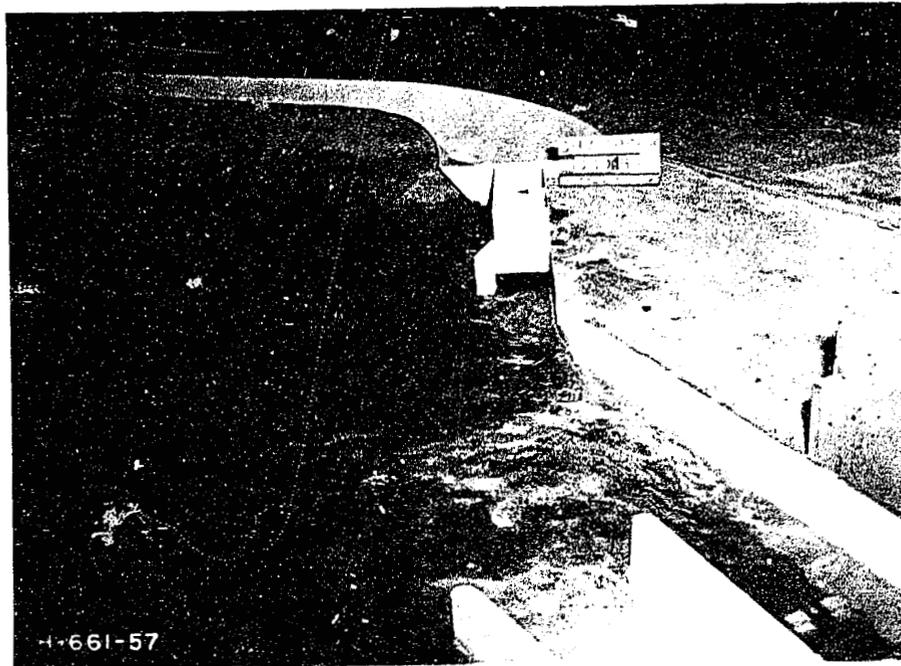
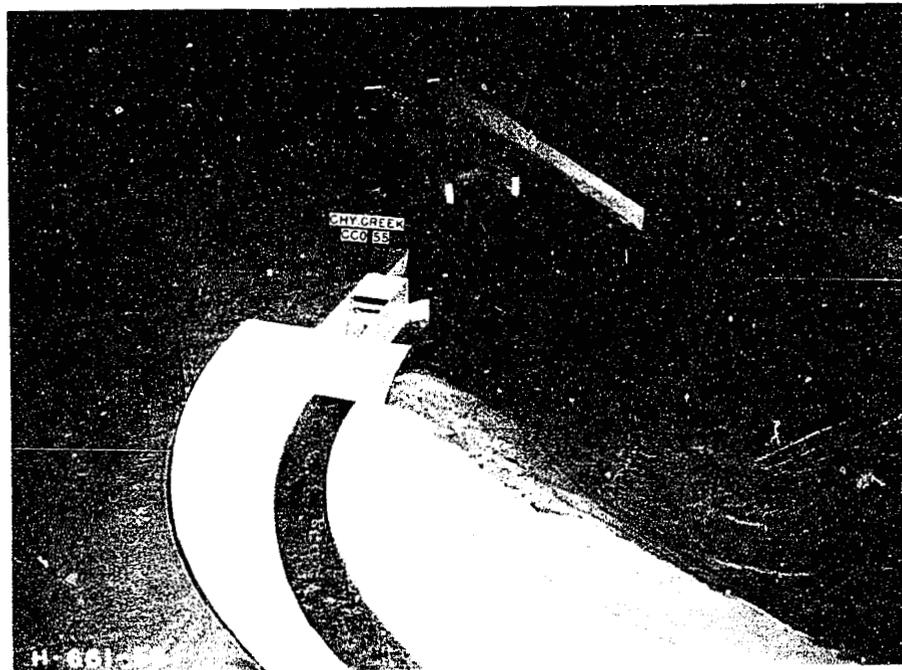
A. Flow at entrance is affected slightly by contraction

B. Flow in canal is concentrated along outside of bend

CANAL DISCHARGE 1,200 SECOND-FEET - GATE FULLY OPEN. HOLLOW-JET VALVE DISCHARGING 1,500 SECOND-FEET, TAILWATER ELEVATION 5496.3

1:28 MODEL, CHERRY CREEK IRRIGATION INLET

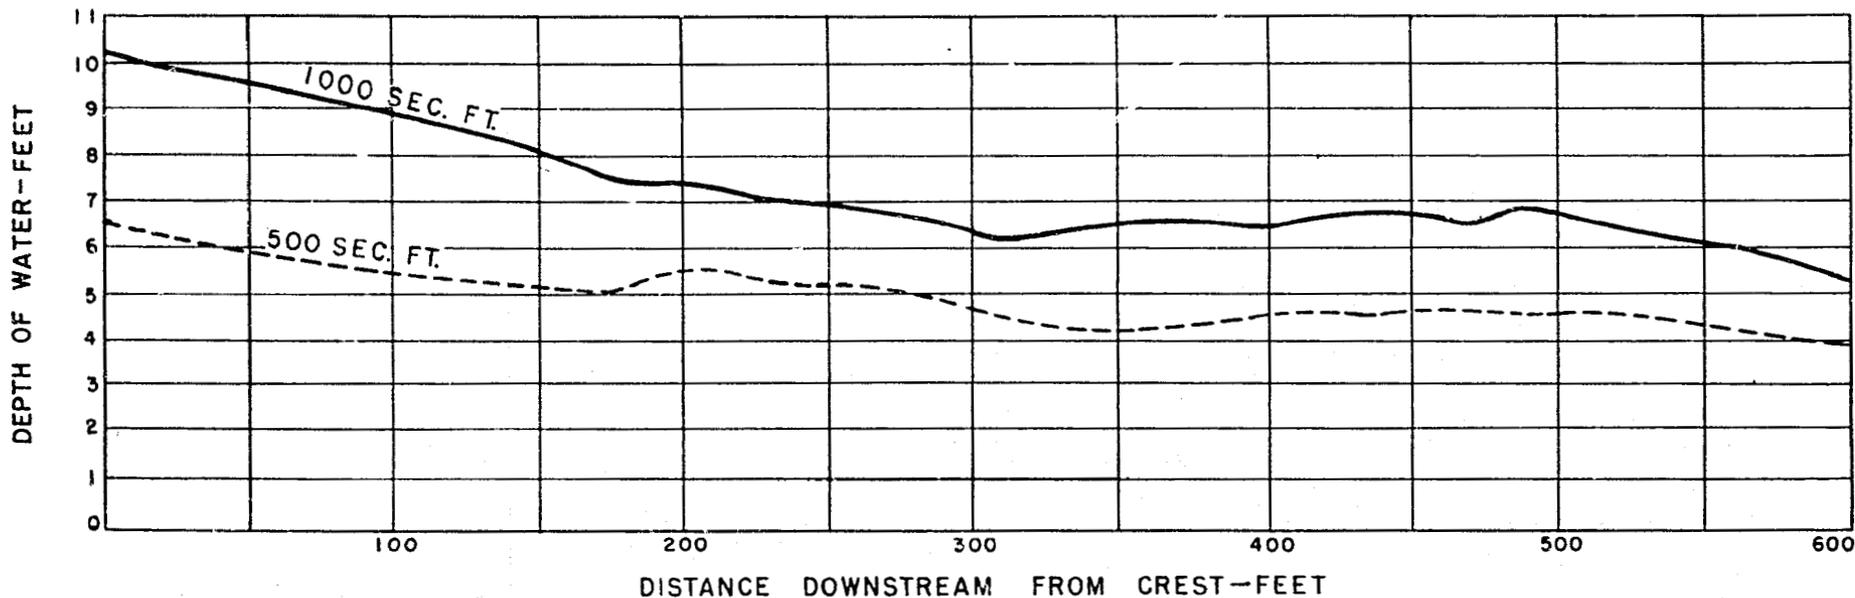
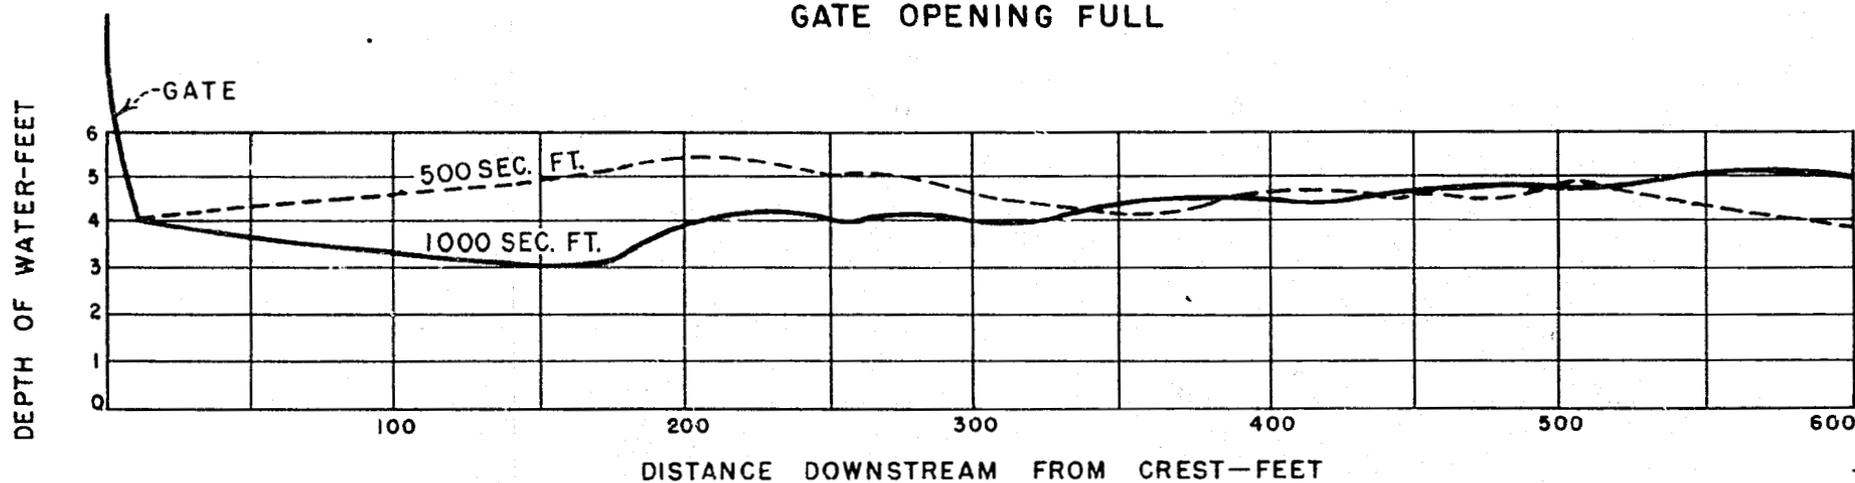
WATER SURFACE PROFILES IN IRRIGATION CANAL
CHERRY CREEK DAM.. 1:28 MODEL
