HYDRAULIC MODEL STUDIES FOR THE
MODIFICATION OF HORSESHOE DAM SPILLWAY

Report to Leeds, Hill and Jewett, Consulting Engineers
by
A. J. Peterka

Hydraulic Laboratory Report No. 248

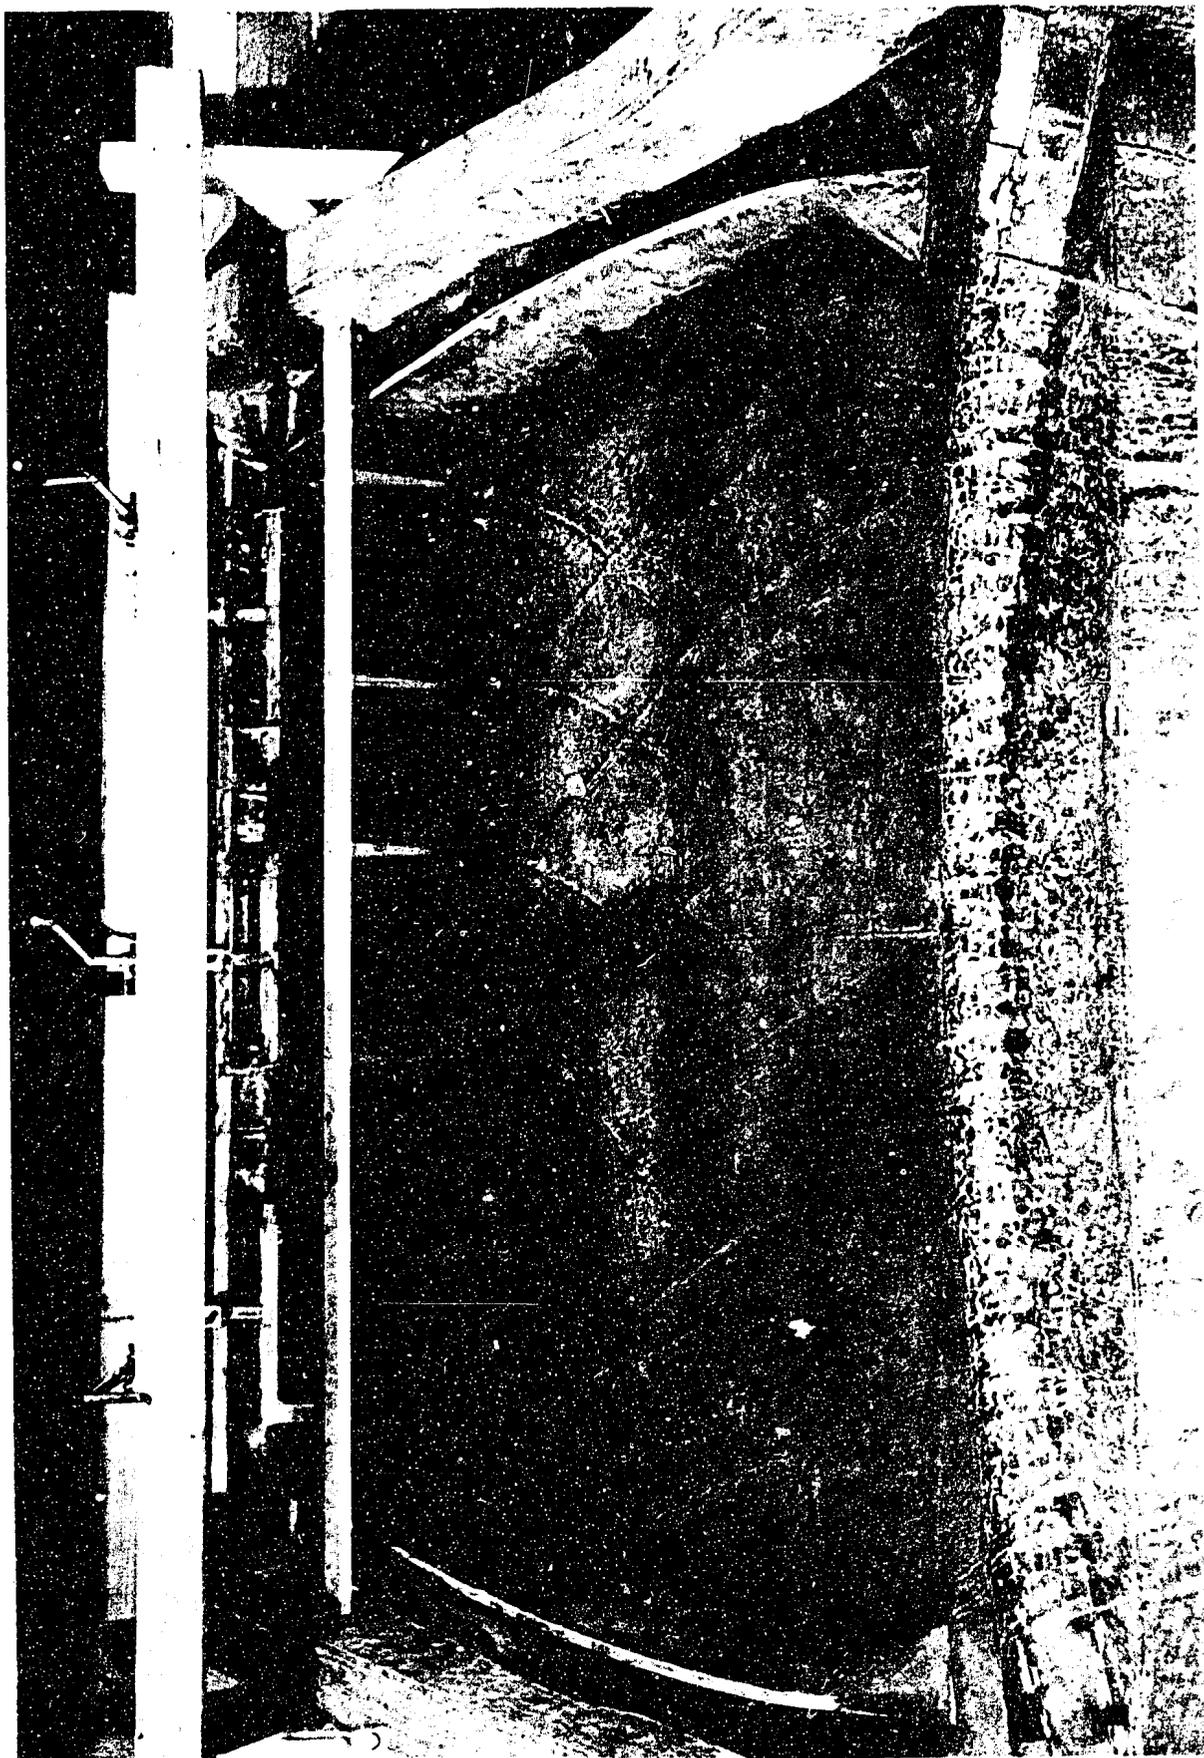
Figure 5

The diamond pattern on the spillway originates at the downstream end of the piers. Discharge 10,000 second-feet.

Tests with the piers in place indicated that pronounced diamond-shaped wave patterns were formed between the piers, Figure 4, and the patterns persisted over the entire spillway area, Figures 5, 6, and 7. At no time, however, was there a tendency toward overtopping the downstream spillway training-walls. For all heads, discharges, and gate openings with the gates operated uniformly, flow conditions were entirely satisfactory. Although the model scale, 1:60, was too small for the model to indicate splash, it is believed that no significant amount of splashing will occur.
