UNITED STATES  
DEPARTMENT OF THE INTERIOR  
BUREAU OF RECLAMATION

# HYDRAULIC MODEL STUDIES OF FALCON DAM

Hydraulic Laboratory Report No. Hyd. 276

JULY 31, 1950

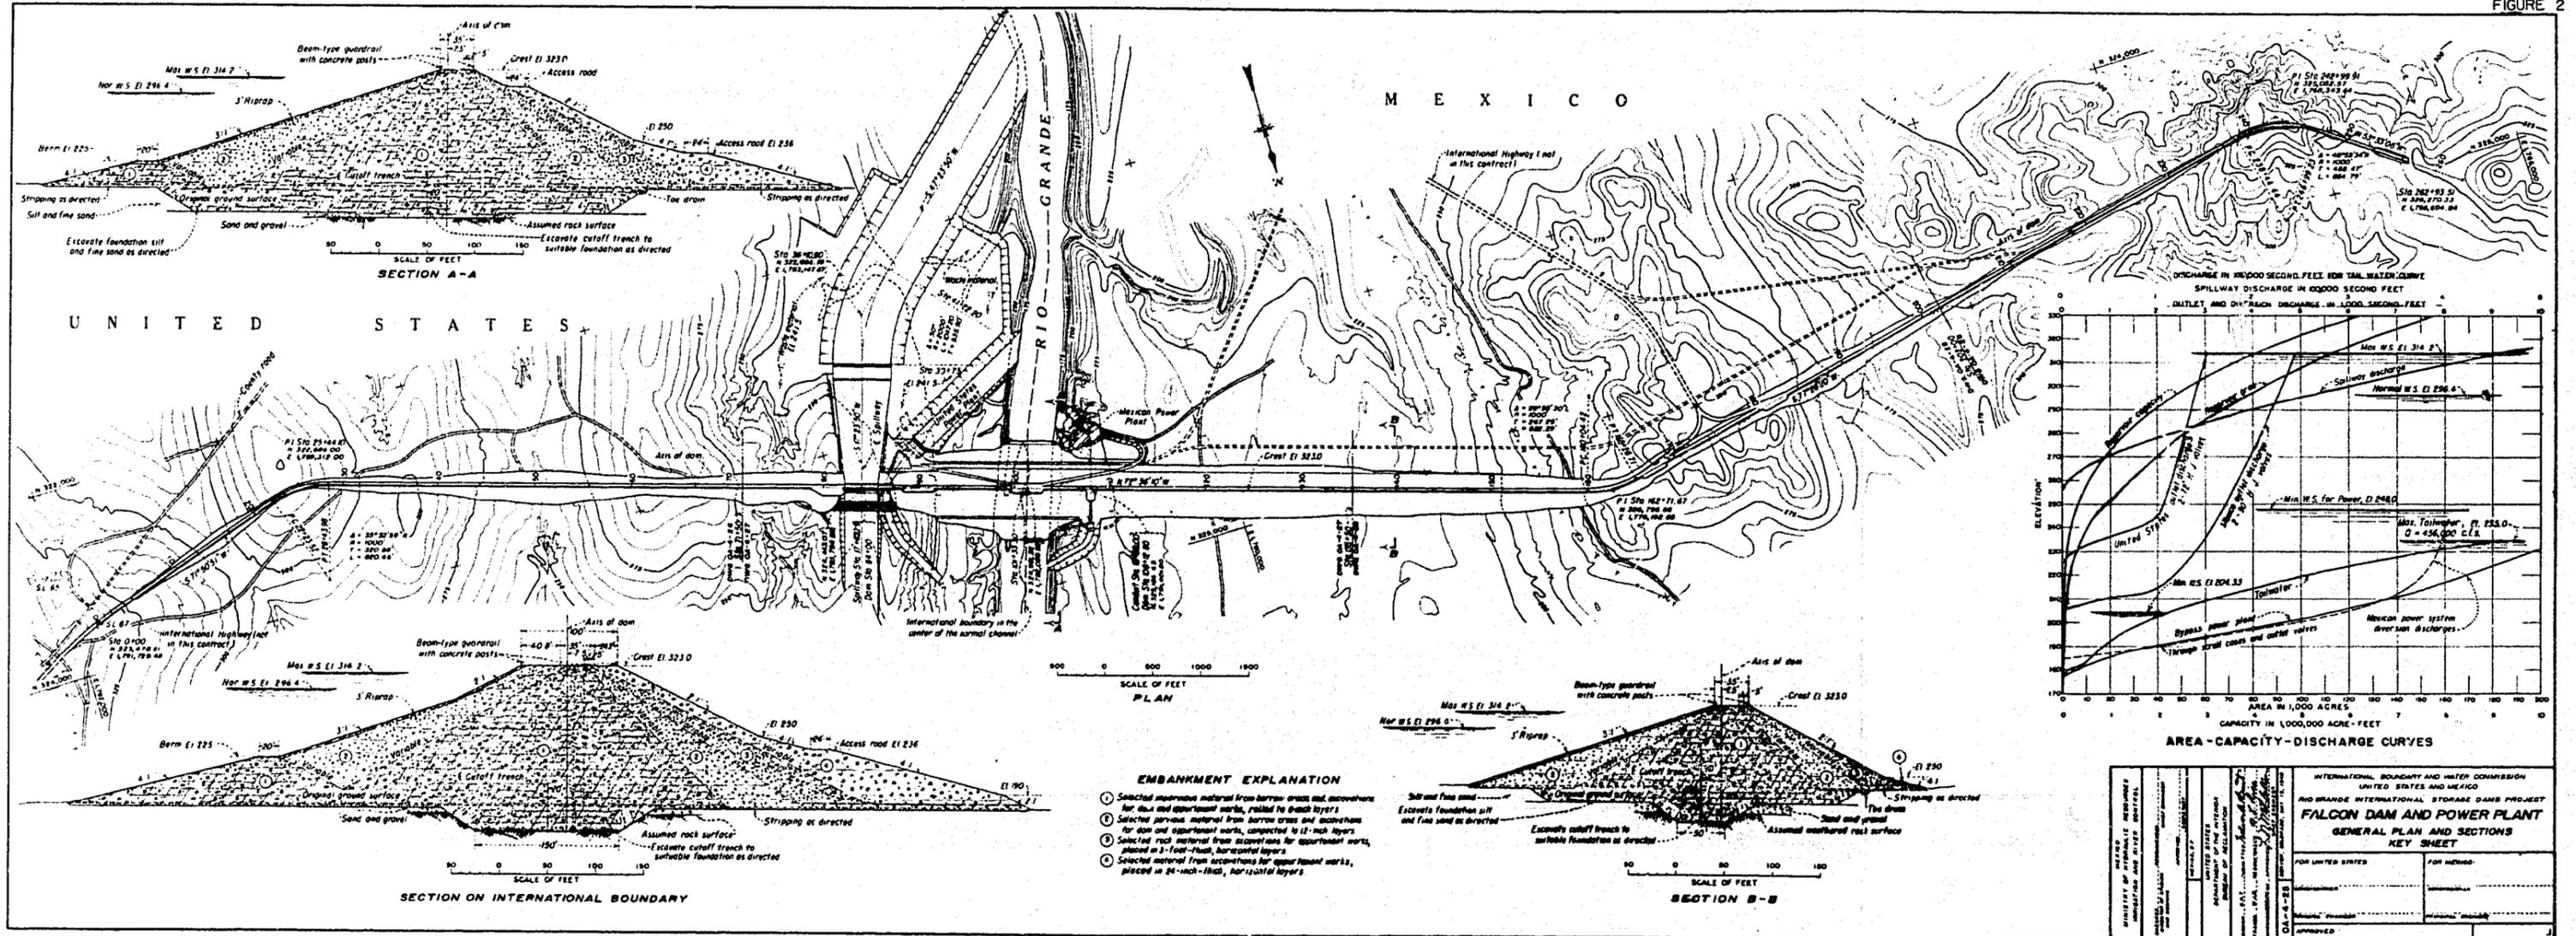
INTERNATIONAL BOUNDARY AND WATER COMMISSION UNITED STATES AND MEXICO	
RIO GRANDE INTERNATIONAL STORAGE DAMS PROJECT	
FALCON DAM AND POWER PLANT	
GENERAL PLAN AND SECTIONS	
KEY SHEET	
FOR UNITED STATES	FOR MEXICO
DESIGNED BY: [Blank]	DESIGNED BY: [Blank]
CHECKED BY: [Blank]	CHECKED BY: [Blank]
APPROVED BY: [Blank]	APPROVED BY: [Blank]

Falcon Dam, located 72 miles southeast of Laredo, Texas, is an earth fill structure approximately 24,300 feet long, rising 150 feet above the present bed of the Rio Grande, Figure 2. Two power plants of similar design are located on either side of the river channel immediately downstream from the dam, and each house has an outlet works utilizing two hollow-jet valves, Figures 3 and 4. The valves in the Mexican outlet works are 90 inches in diameter; those in the United States outlet works are 72 inches in diameter. A chute-type spillway, Figure 3, located on the United States side of the river is equipped with six 50-foot by 50-foot rectangular leaf gates on the crest. At the downstream end of the spillway is a horizontal stilling basin 600 feet wide and 180 feet long with chute blocks at the upstream end and a dentated sill at the downstream end.

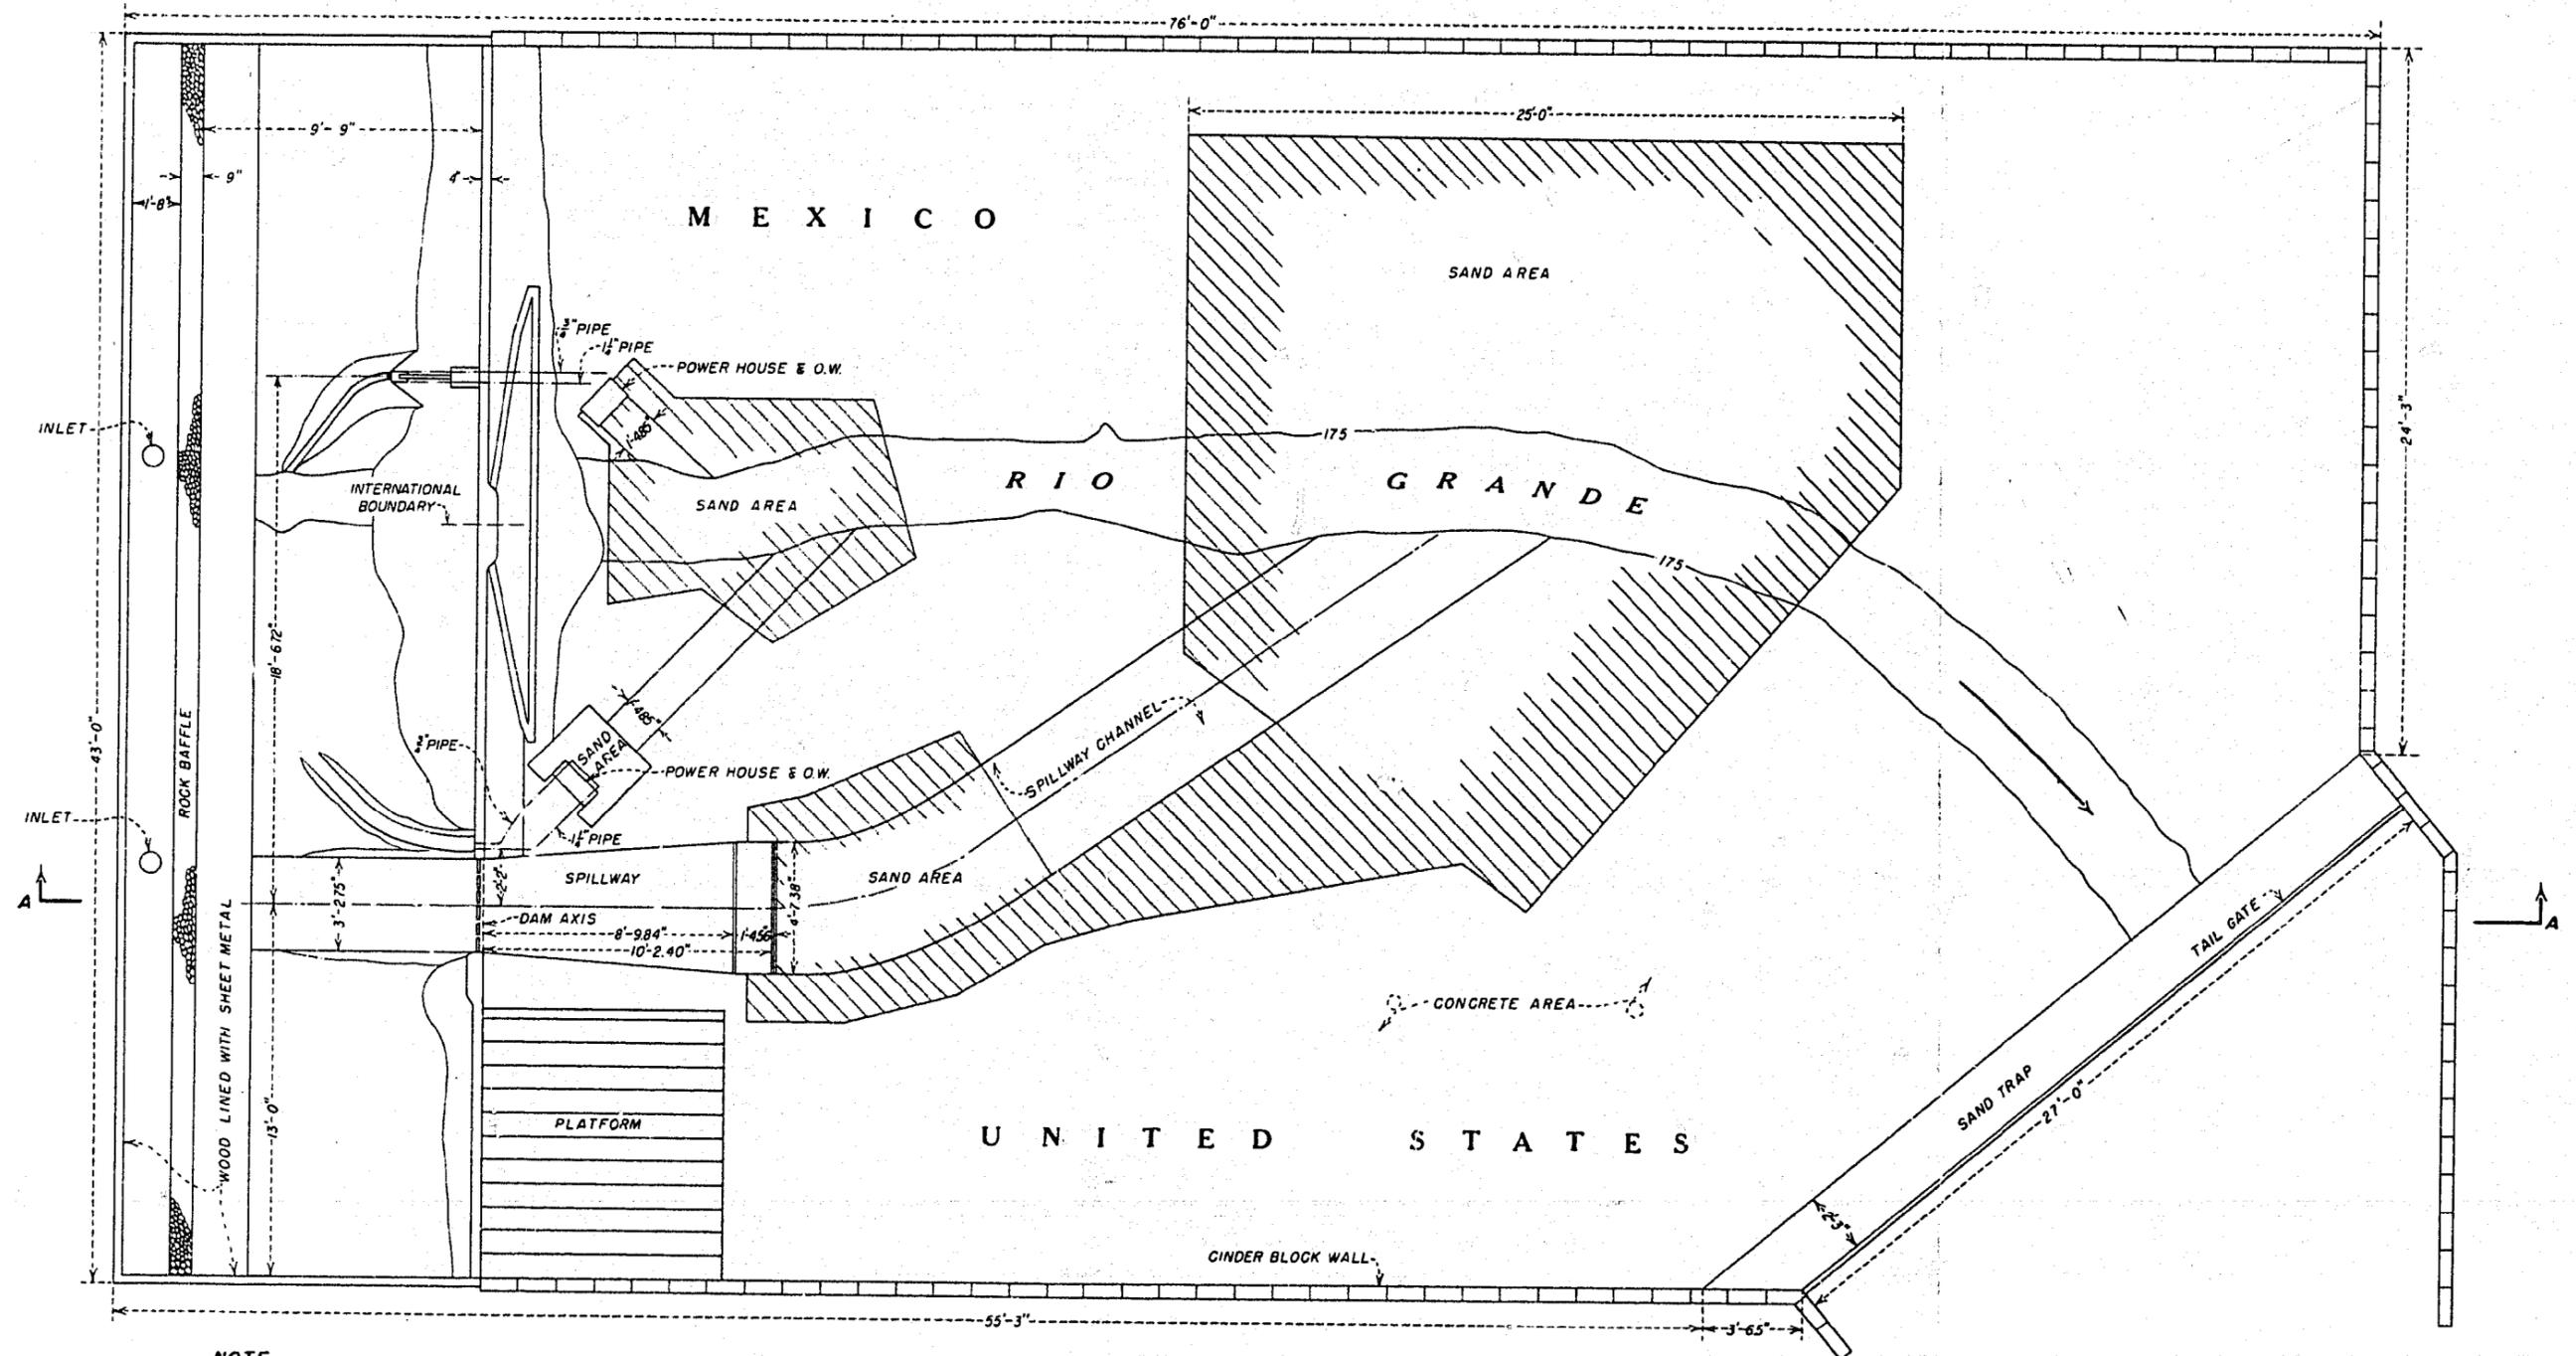
P L A N

NOTE  
GATES AND PIERS ON SPILLWAY  
CREST NOT SHOWN

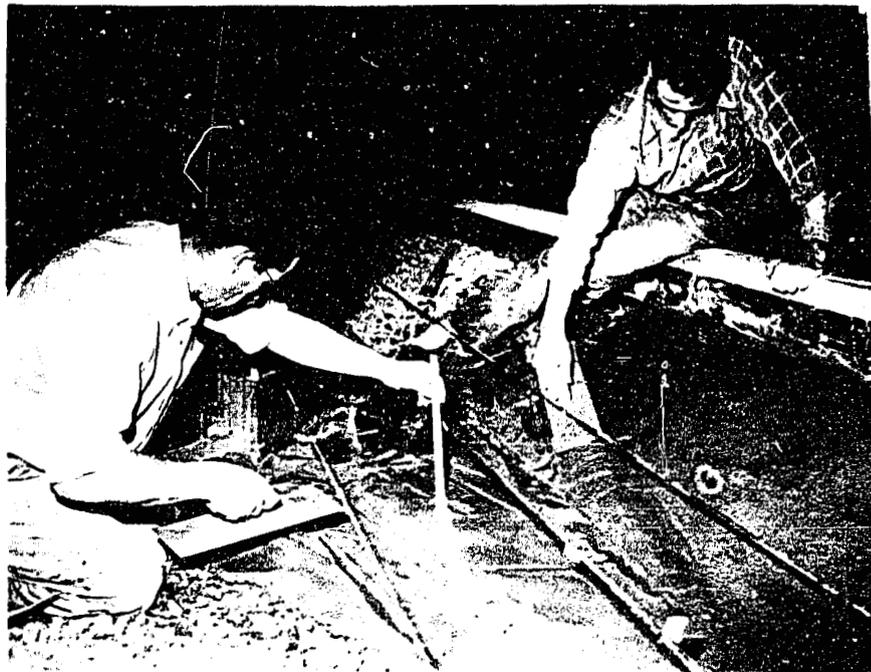
1-130 Composite Model  
FALCON DAM

A. Placing topography in concrete. The cords are at fixed elevations and are used as references in forming the topography.

B. Placing topography in concrete. The area in the foreground will be filled with fine sand.

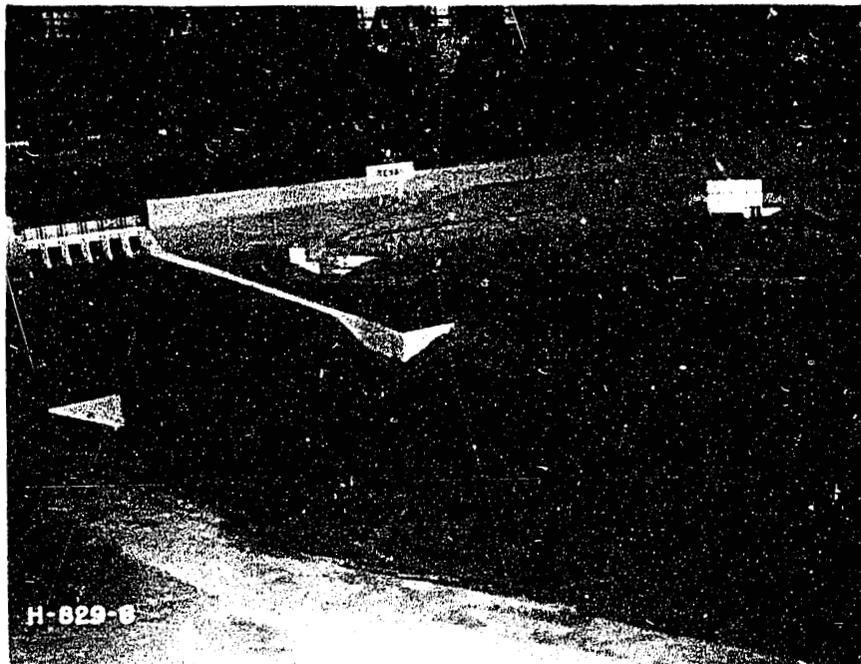
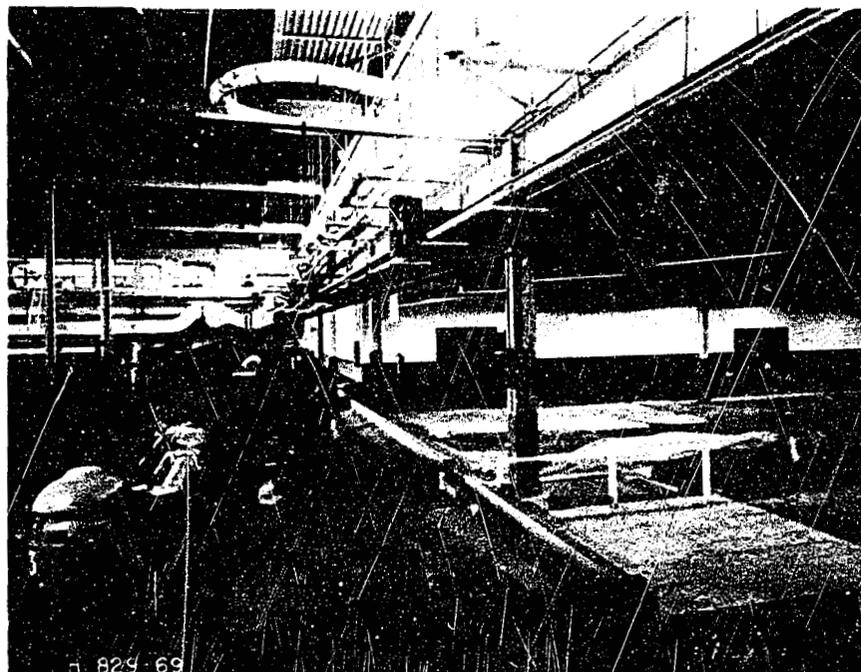
A. The spillway as originally constructed, prior to operation. Note the demarcation between the sand (lighter area) and the concrete.

B. The reservoir area. Water is supplied by the pump in the foreground. Note rock baffle at the left, and the gages in the foreground.

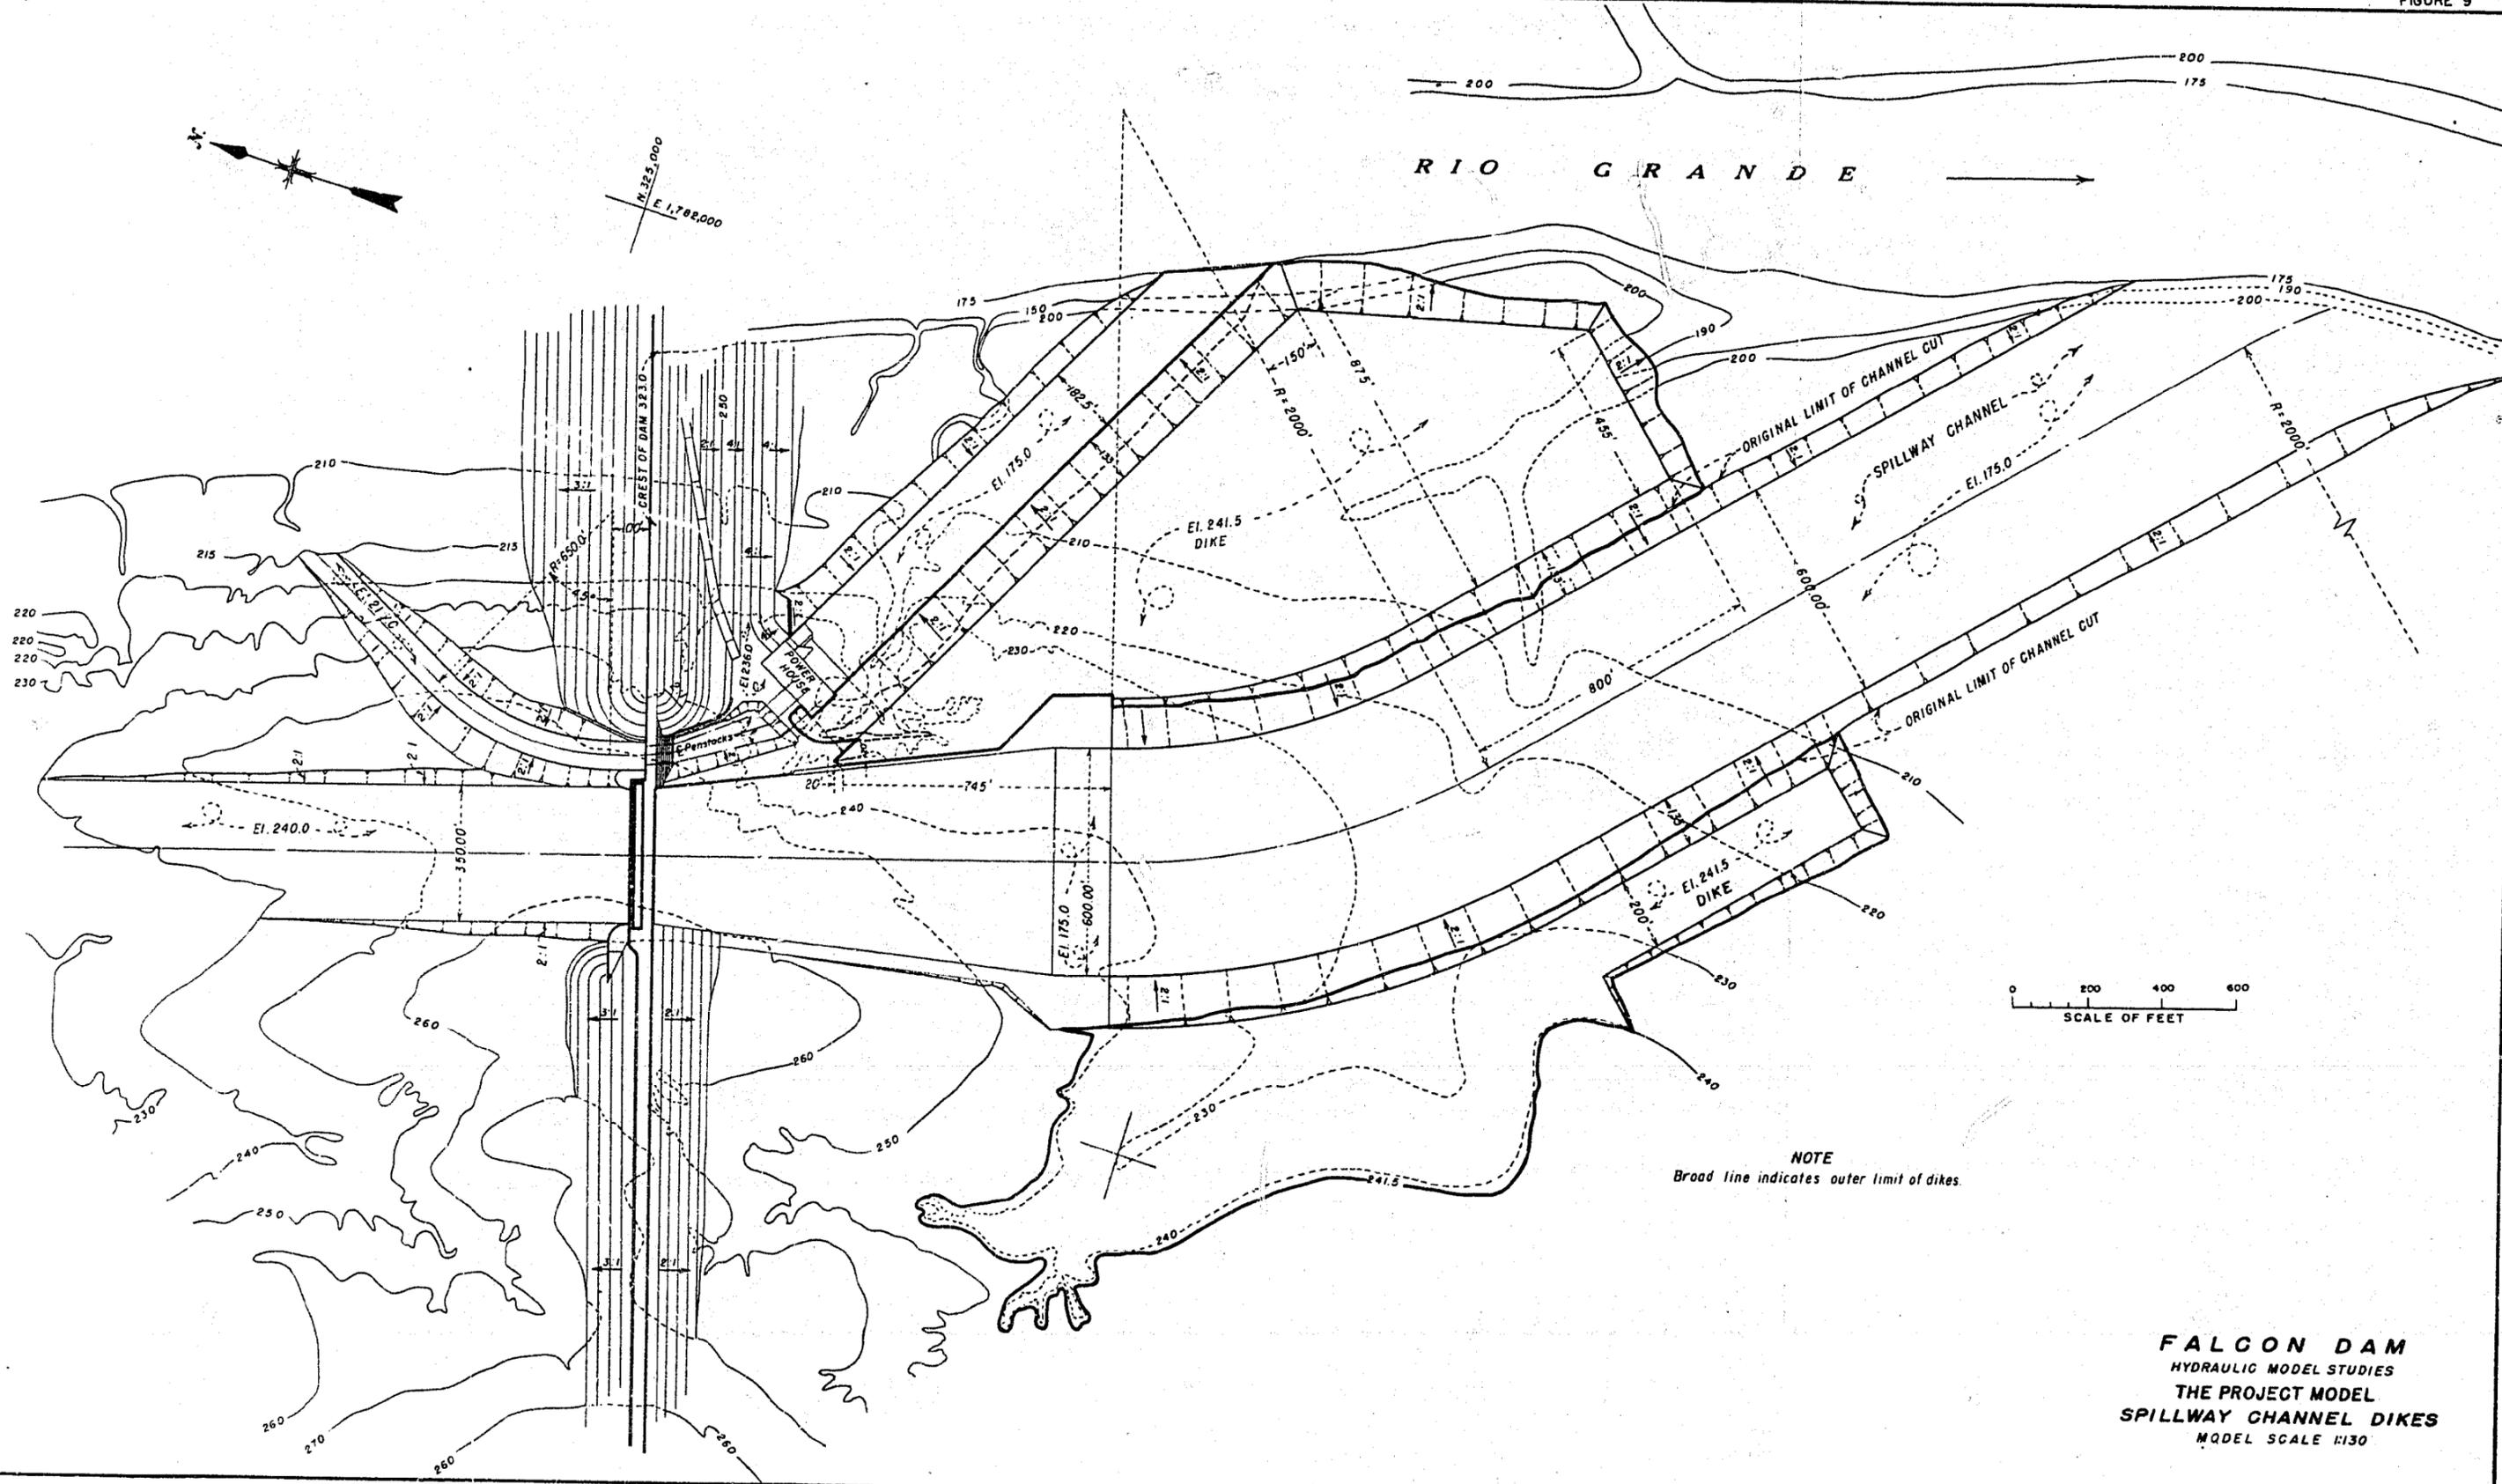
NOTE  
Broad line indicates outer limit of dikes.

**FALCON DAM**  
HYDRAULIC MODEL STUDIES  
THE PROJECT MODEL  
SPILLWAY CHANNEL DIKES  
MODEL SCALE 1/30

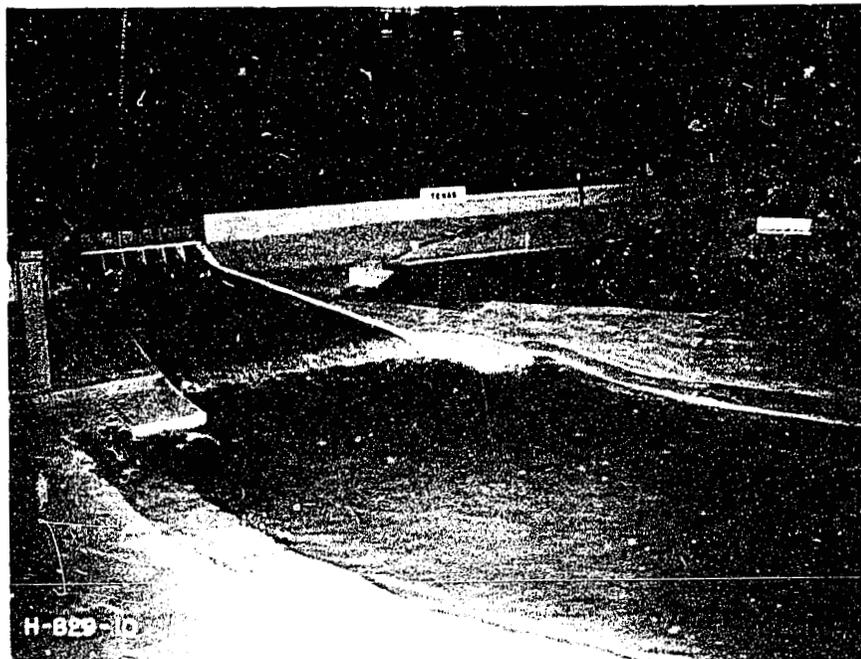
A. The spillway and spillway channel.

B. The stilling basin.

THE SPILLWAY---PRELIMINARY DESIGN. DIS-  
CHARGE OF 456,000 CFS WITH ALL GATES  
FULLY OPEN.

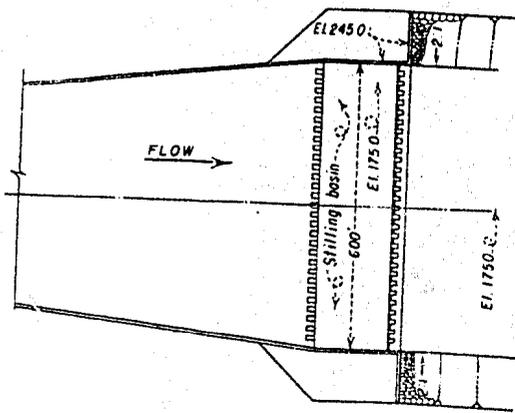
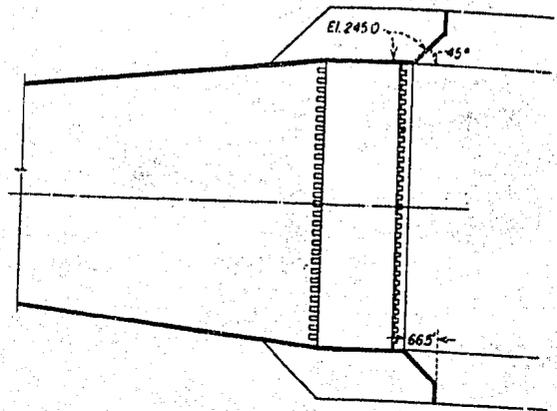
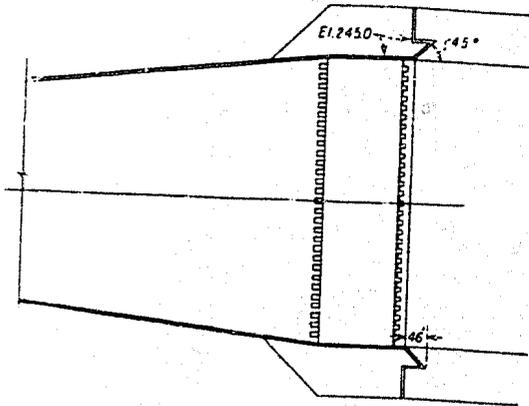
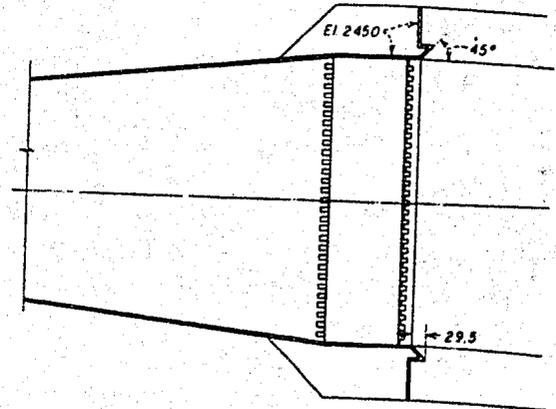
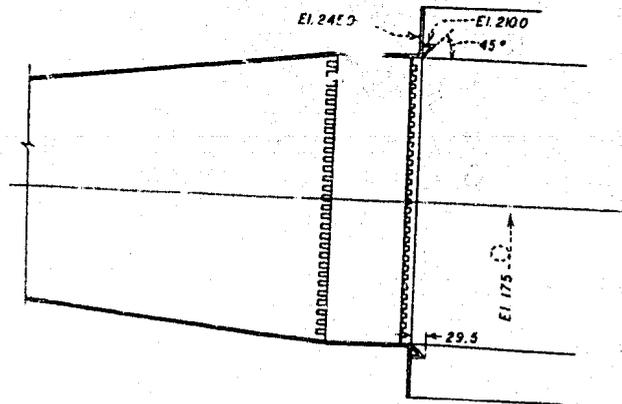
PRELIMINARY DESIGN

DESIGN S-2

DESIGN S-3

DESIGN S-4

DESIGN S-5

**FALCON DAM**  
 HYDRAULIC MODEL STUDIES  
 SPILLWAY  
 WING WALL DESIGNS  
 MODEL SCALE 1:130

For Design S-4, the spur wall length was reduced to 29.5 feet as this was the width of the footings of the training walls. Tests on this shorter wall resulted in less satisfactory erosion patterns than were found for the longer wall of Design S-3. The shorter wall evidently provided less braking action on the induced eddies at the apron corners and resulted in slightly more erosion along the walls and end of the apron. After a 2-hour test at maximum discharge, the cut-off wall below the end sill was exposed approximately 2 feet, Figure 14A. However, this increase in erosion was considered relatively minor, and it was believed that, in the prototype, this wall would provide sufficient protection from undermining. Since riprap will be placed in the prototype areas subject to erosion (the same areas where fine sand was used in the model) the depth of erosion should be less severe in the prototype.

Design S-5 used the same length and type of spur wall as Design S-4, but the wall was only one-half as high, the top being placed at elevation 210. At maximum discharge and tail water elevation the top was 25 feet below the water surface. A 2-hour scour test with the maximum discharge of 456,000 cfs produced a deep hole immediately downstream from the right end of the basin, along the right spur wall. This hole was 35 feet deep, as shown in Figure 14B. The erosion was very similar to that which occurred with 90° wing walls. To determine the reasons for this erosion, dye streams were used to trace the flow lines. It was found that because the wall was below the water surface an eddy current circulated over the top of the wall, Figure 15. A vertical current also traveled down the inside face of the wall at high velocity causing the erosion noted above. Since the wall was found to be of no value in providing protection from excessive erosion, it was given no further consideration.

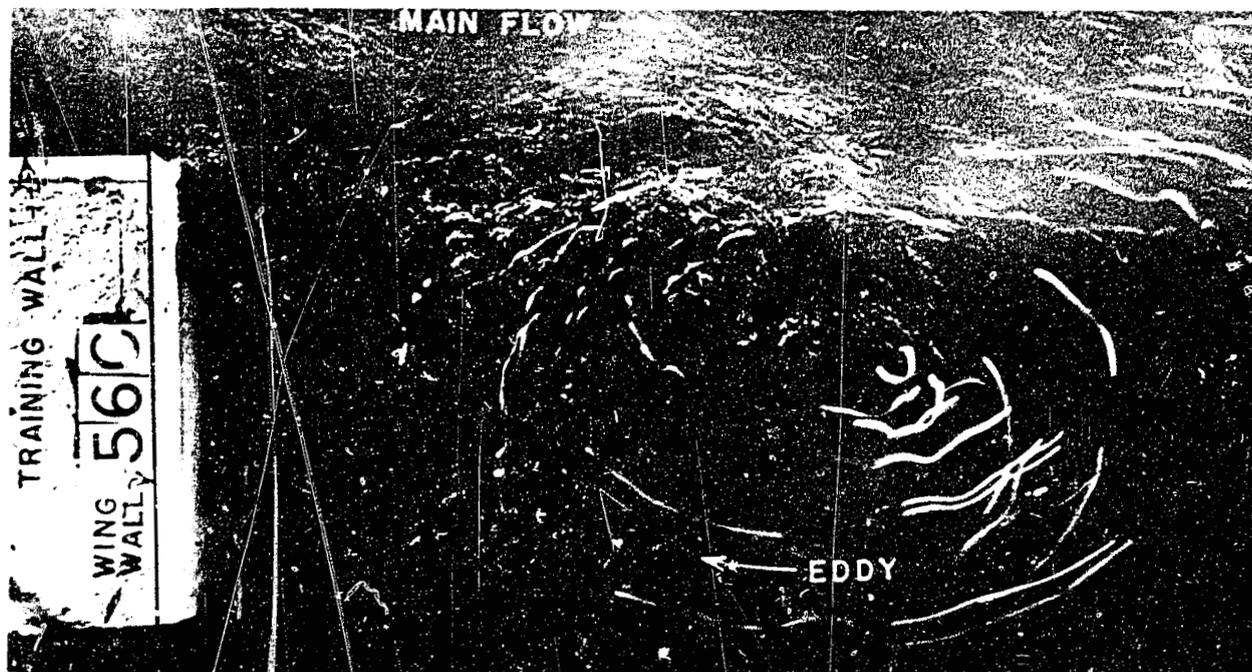
A. Erosion below the stilling basin after a discharge of 456,000 cfs for 2 hours. All gates open. Note the deep hole at the end of the stilling basin.

B. Eddy in area immediately downstream from right end of stilling basin.  $Q = 456,000$  cfs. It is believed that this eddy was the cause of the severe erosion shown above.

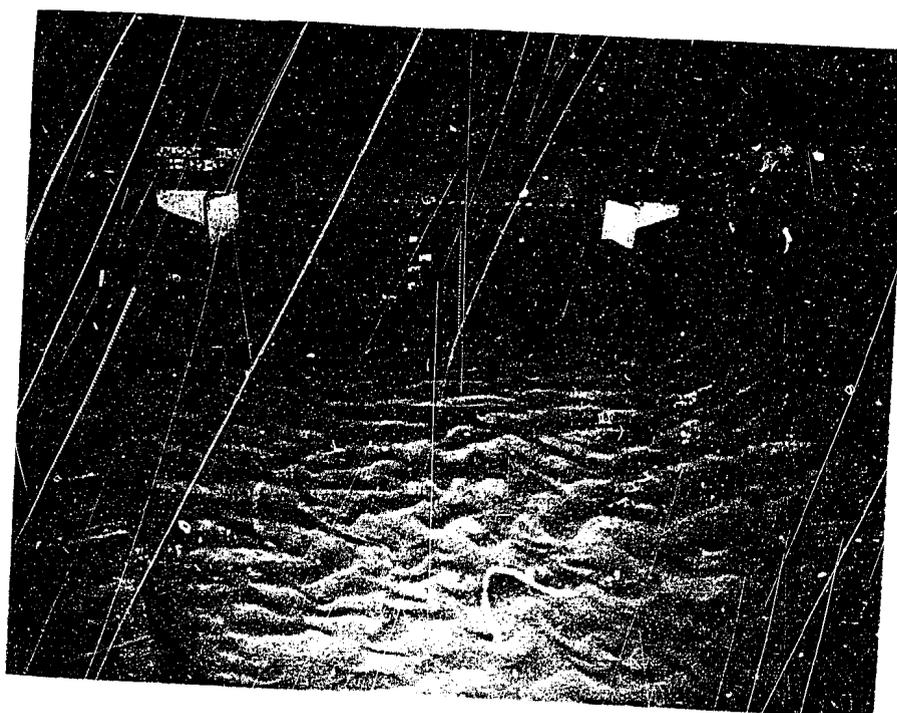
A. Design S-2. Erosion after a discharge of 456,000 cfs for 2 hours. All gates fully opened.

B. Design S-3. Erosion after a discharge of 456,000 cfs for 2 hours. All gates fully opened. Note the reduction in erosion from previous designs.

THE SPILLWAY. EROSION BELOW THE STILLING BASIN.

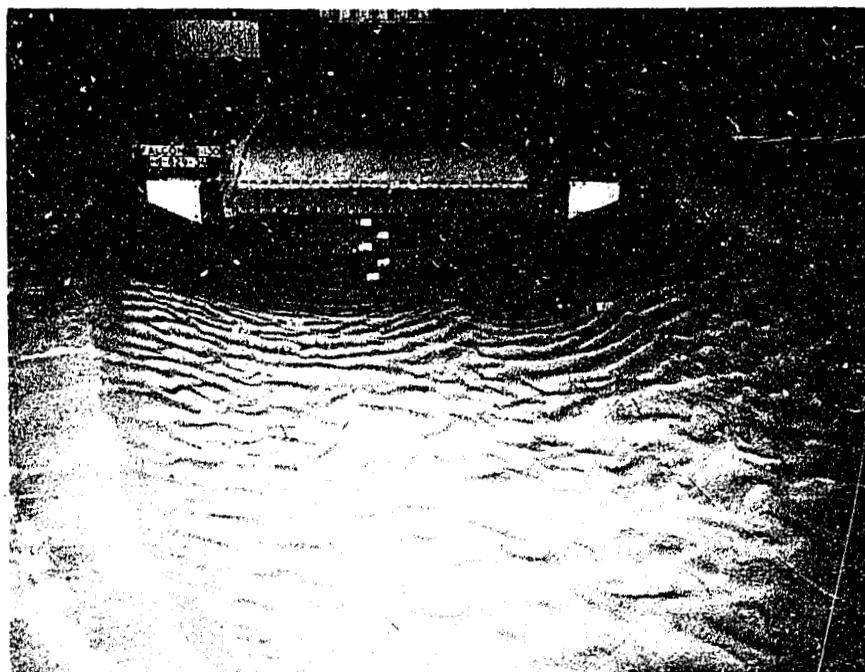
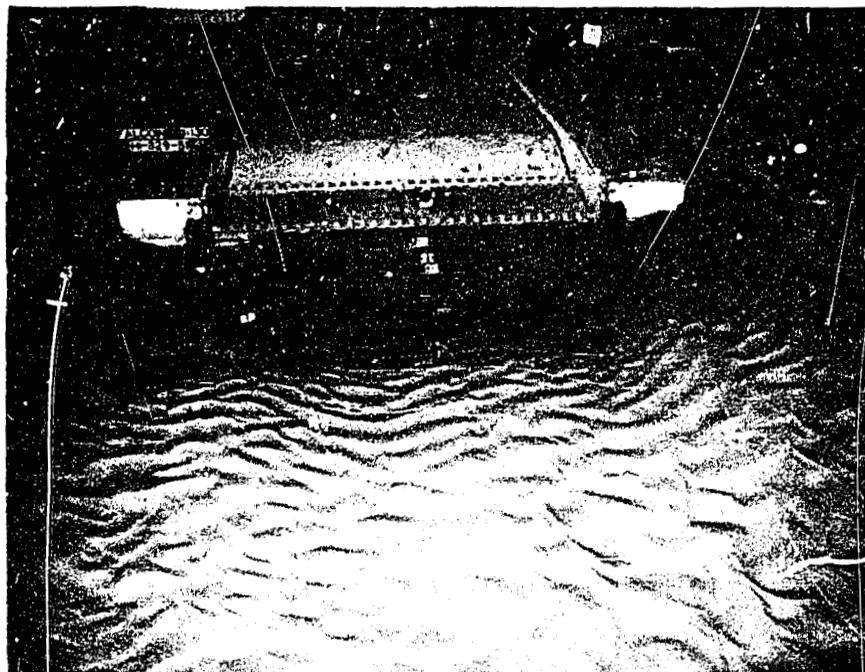
A. Design S-4. Erosion after a discharge of 456,000 cfs for 2 hours. All gates fully opened. Erosion at apron corners is negligible.

B. Design S-5. Erosion after a discharge of 456,000 cfs for 2 hours. All gates fully opened. Note the similarity of erosion with this design to that obtained with the preliminary design.

THE SPILLWAY. EROSION BELOW THE STILLING BASIN.

To verify the results of the erosion tests, independent corroborative tests were run using Designs S-4 and S-5. Results of these check tests compared closely with those obtained for the original tests. A photograph of the confirming test for Design S-5 is included in this report, as Figure 16. The similarity of these erosion patterns, obtained for two independent tests using identical procedures, operating conditions, and walls may be seen by comparing Figure 14B with the check test, Figure 16.

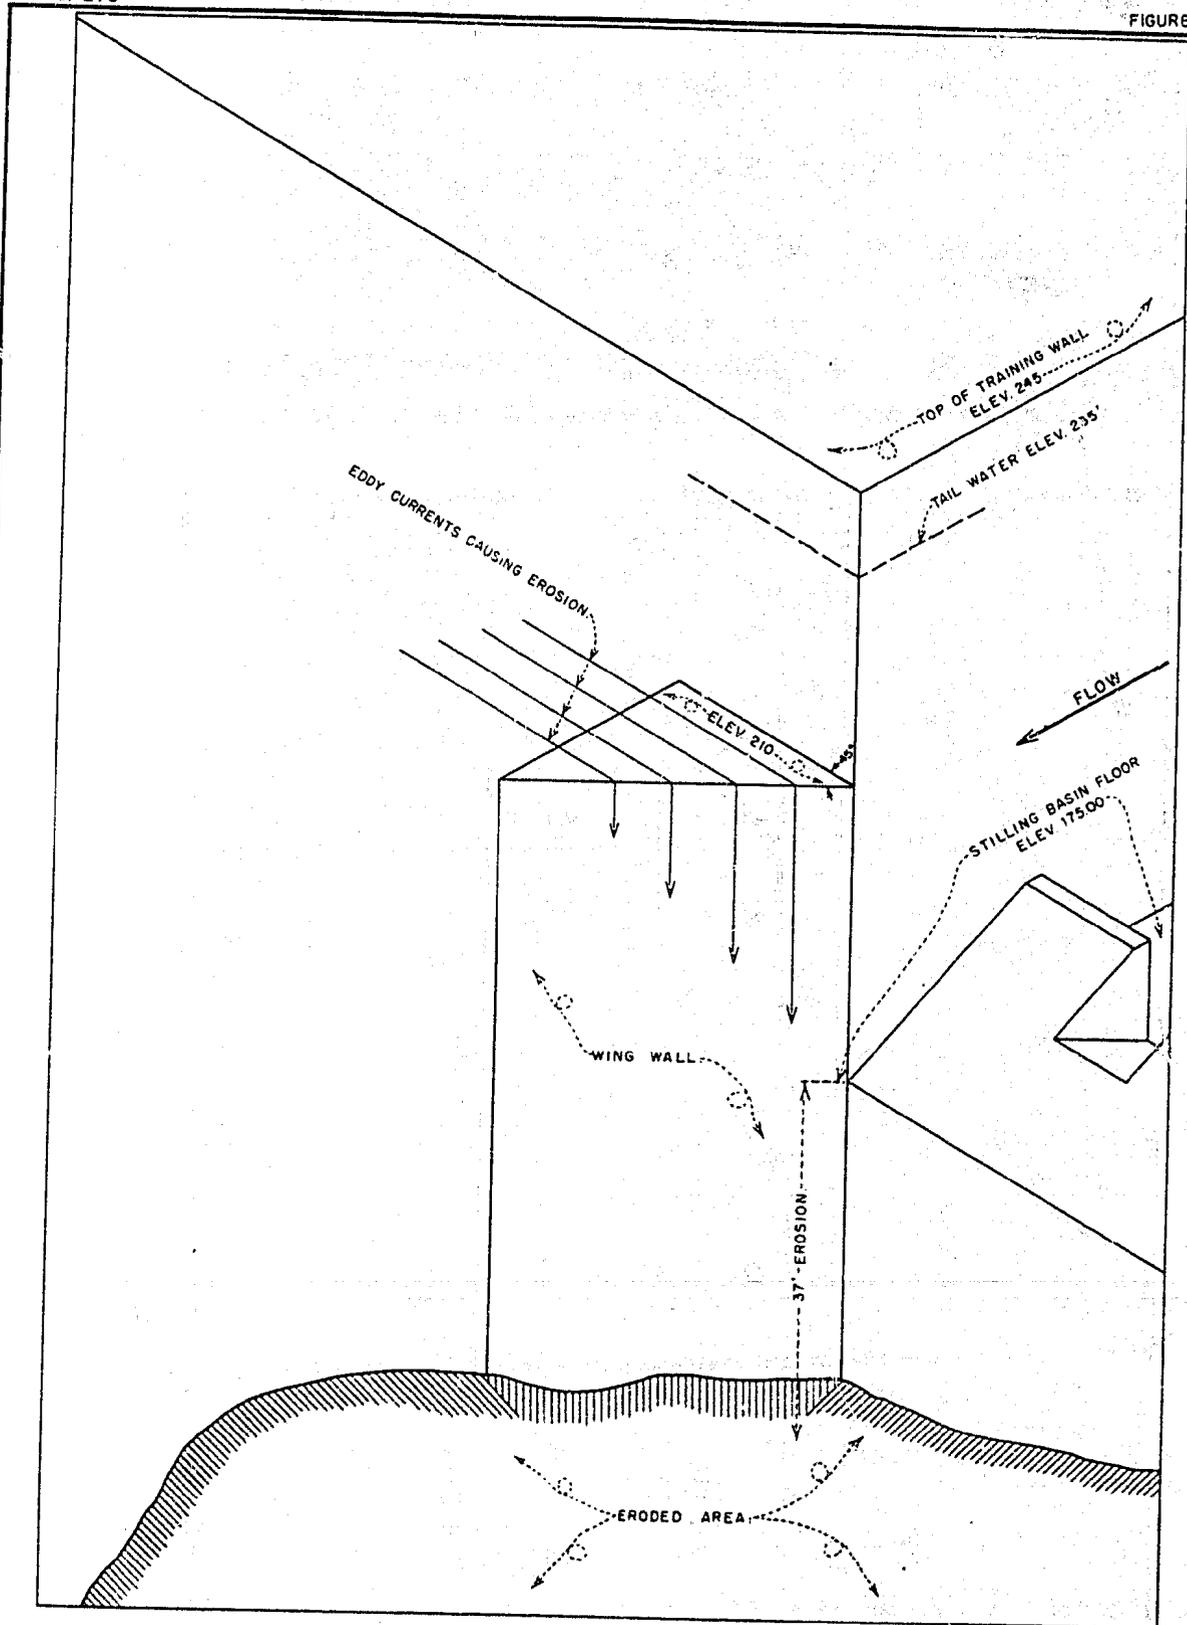
FALCON DAM  
HYDRAULIC MODEL STUDIES  
SPILLWAY  
EROSION CURRENTS WITH  
LOW WING WALL  
MODEL SCALE 1/30

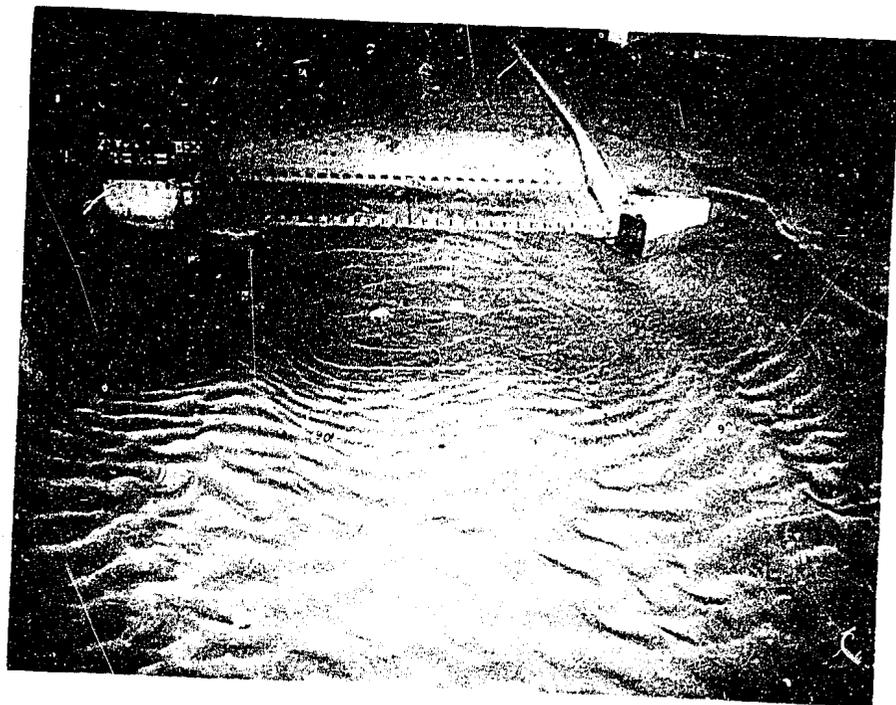
Results of a second erosion test with Design S-5. Erosion after a discharge of 456,000 cfs for two hours. Compare with Figure 14B.

THE SPILLWAY. DESIGN S-5. EROSION BELOW THE SPILLWAY.

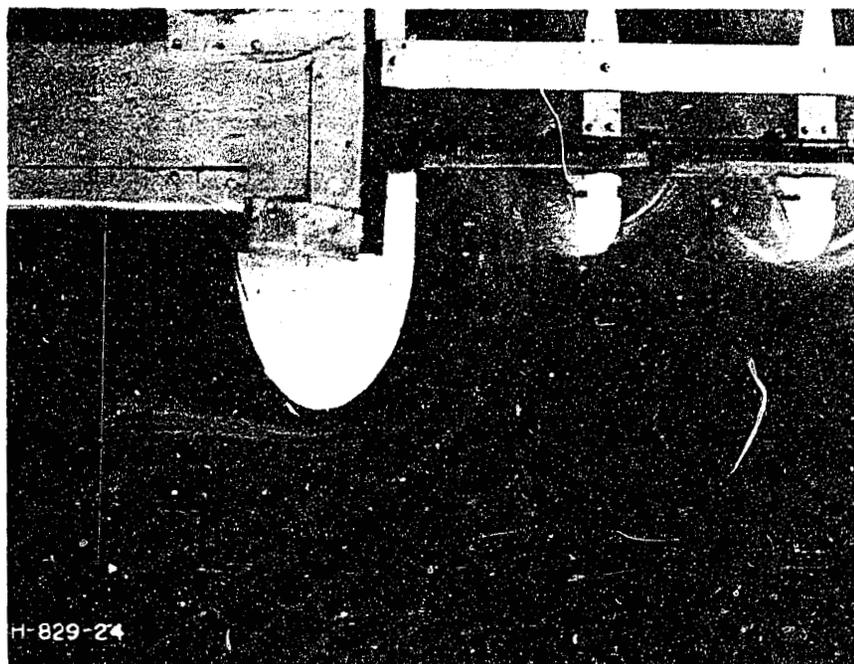
A. Drawdown at both piers.

B. Currents about the left approach pier. Preliminary design. Note how the flow tends to leave the face of the pier next to the spillway.

THE SPILLWAY. CONTRACTION AT THE APPROACH.  
456,000 CFS BEING DISCHARGED.

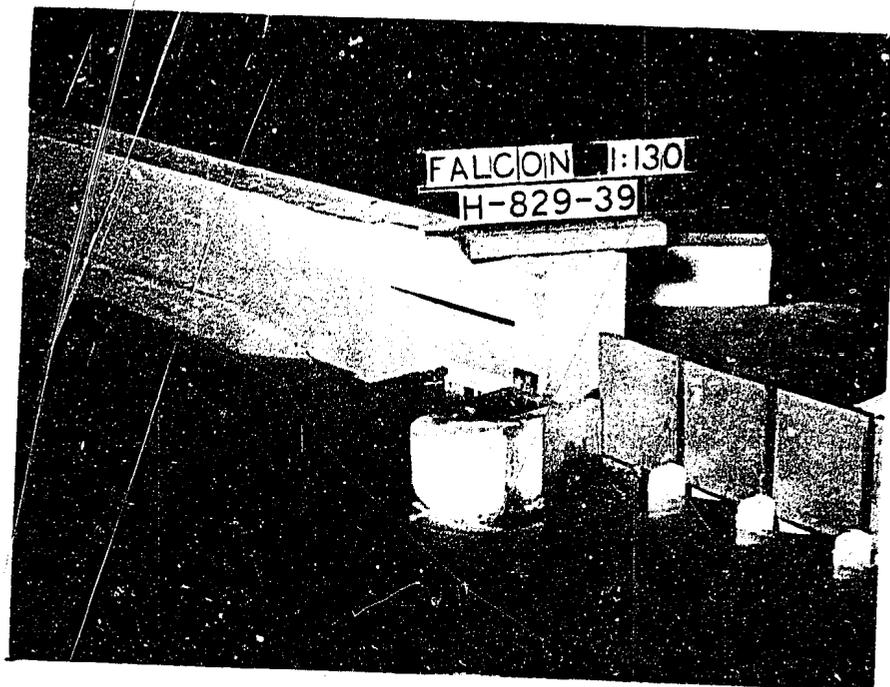
A. Excessive contraction causes a depressed water surface or drawdown along the pier. Note that the elevation of the water surface dips, then rises again before the crest is reached.

B. Currents about the pier. Note the eddy on the left, in front of the powerhouse intake. The powerhouse is not discharging.

THE SPILLWAY. DESIGN 8-6--LEFT APPROACH PIER 100 FEET LONG.  
456,000 CFS BEING DISCHARGED.

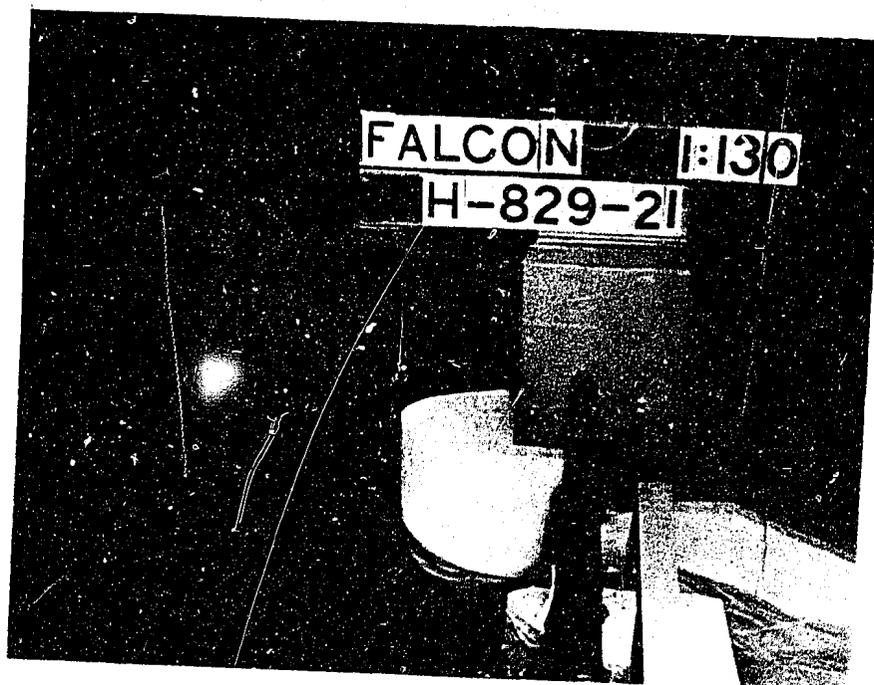
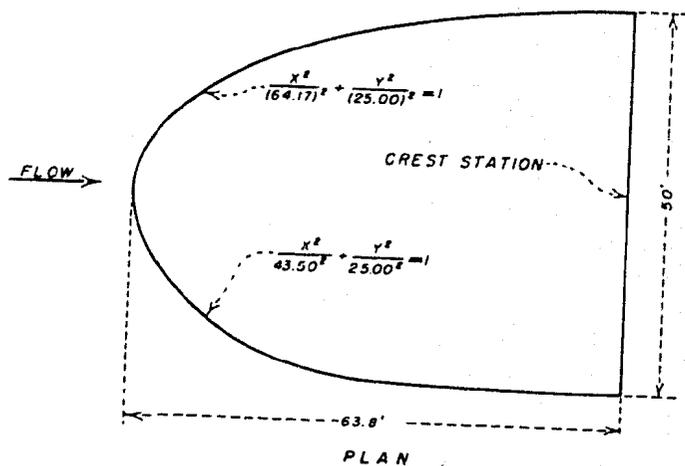
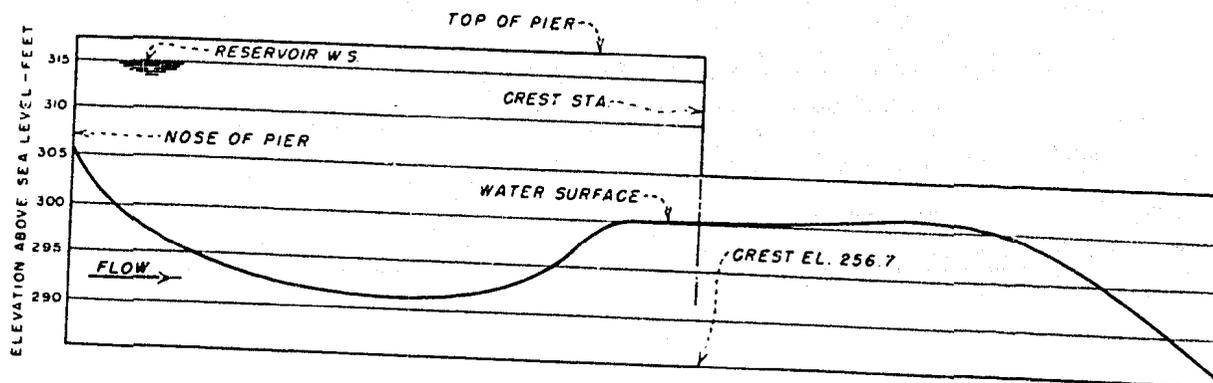
DRAWDOWN DURING OPERATION - Q = 456,000 C.F.S.

COEFFICIENT OF DISCHARGE = 336

PLAN AND PERFORMANCE DATA

PROFILE OF DRAWDOWN-SPILLWAY SIDE - Q = 456,000 C.F.S.  
 LEFT APPROACH PIER-PIER DESIGN "A"
