UNITED STATES  
DEPARTMENT OF THE INTERIOR  
BUREAU OF RECLAMATION

# HYDRAULIC MODEL STUDIES OF FALCON DAM

Hydraulic Laboratory Report No. Hyd. 276

JULY 31, 1950

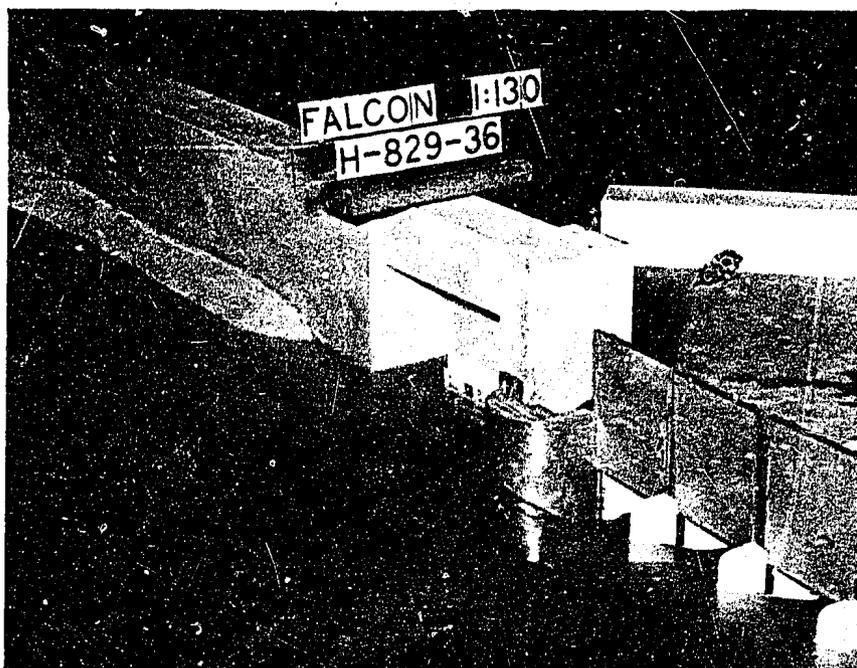
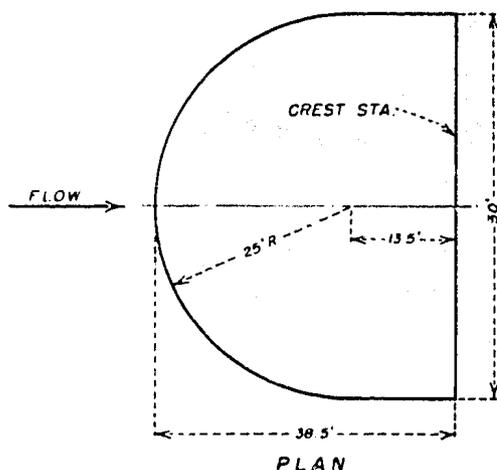
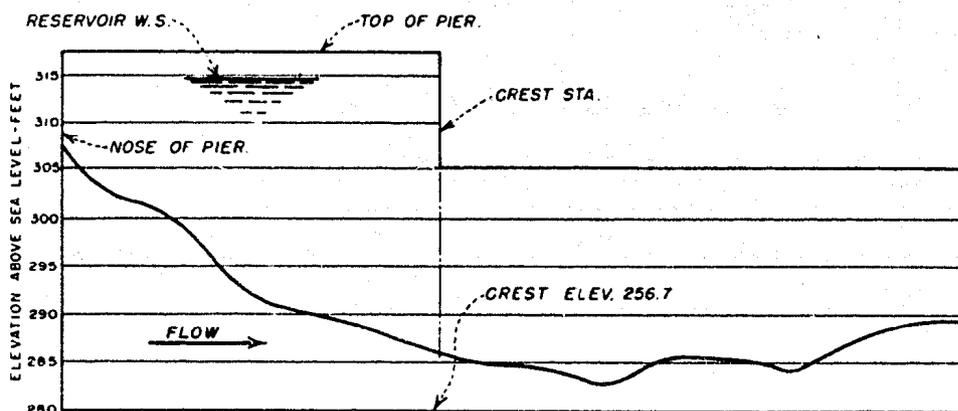
DRAWDOWN DURING OPERATION -  $Q = 456,000$  C.F.S.

COEFFICIENT OF DISCHARGE = 3.34

PLAN AND PERFORMANCE DATA

LEFT APPROACH PIER - PIER DESIGN "B"

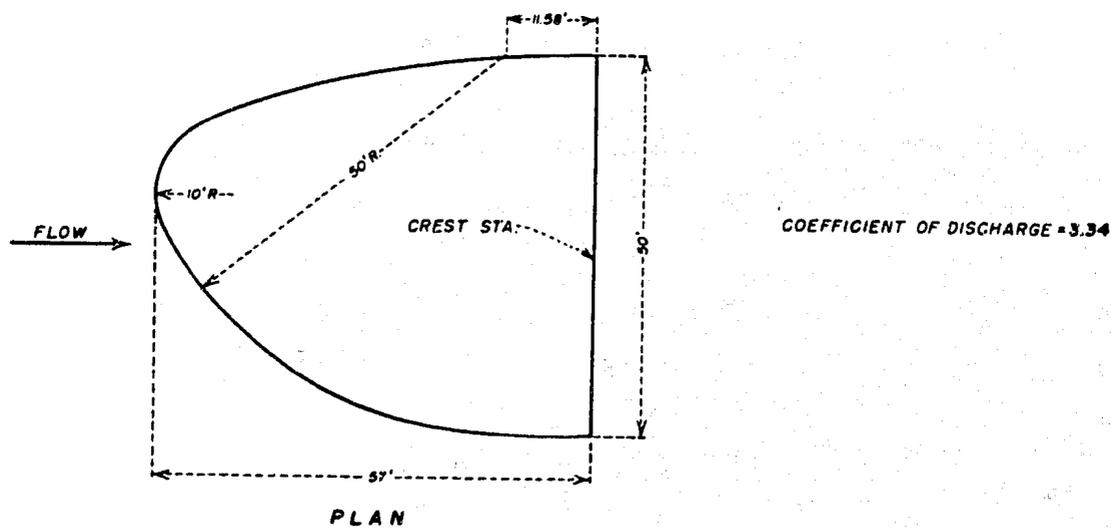
DRAWDOWN DURING OPERATION -  $Q = 456,000$  C.F.S.

PLAN AND PERFORMANCE DATA

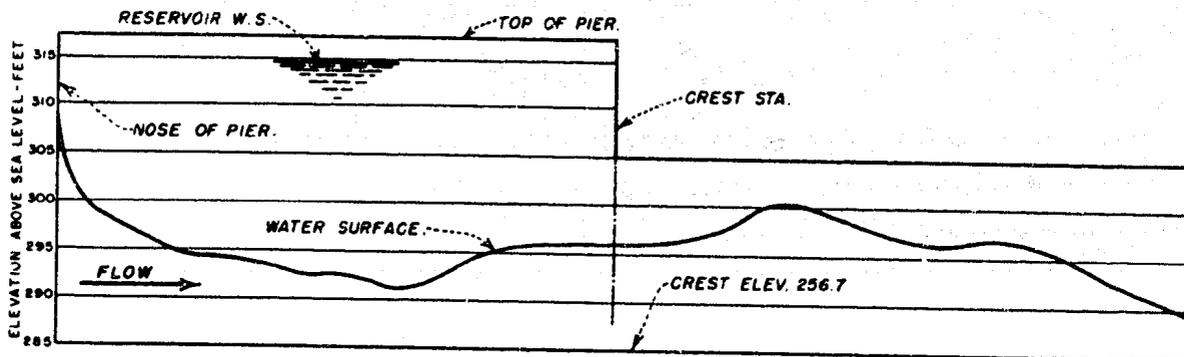
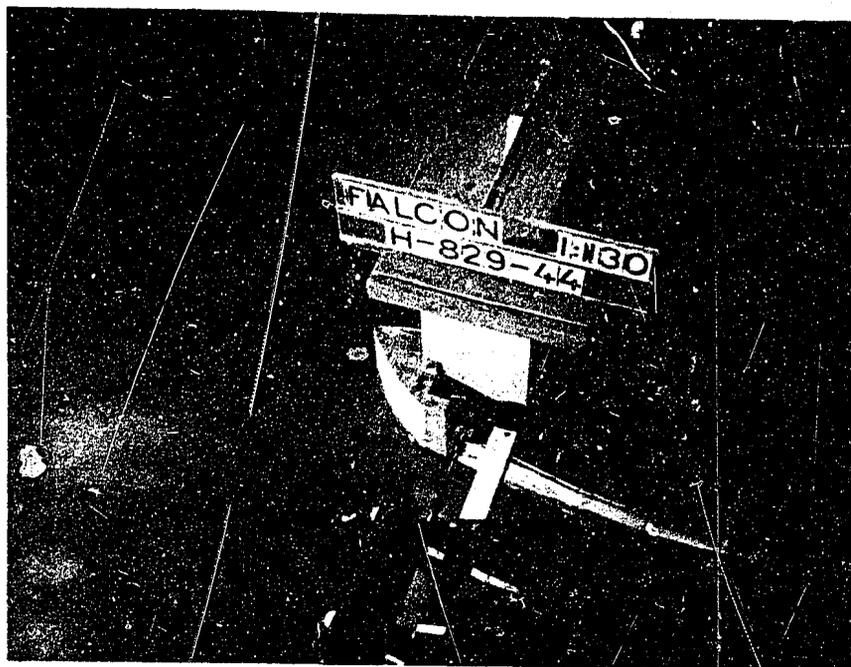
LEFT APPROACH PIER - PIER DESIGN "C"

PROFILE OF DRAWDOWN - SPILLWAY SIDE  $Q = 456,000$  C.F.S.

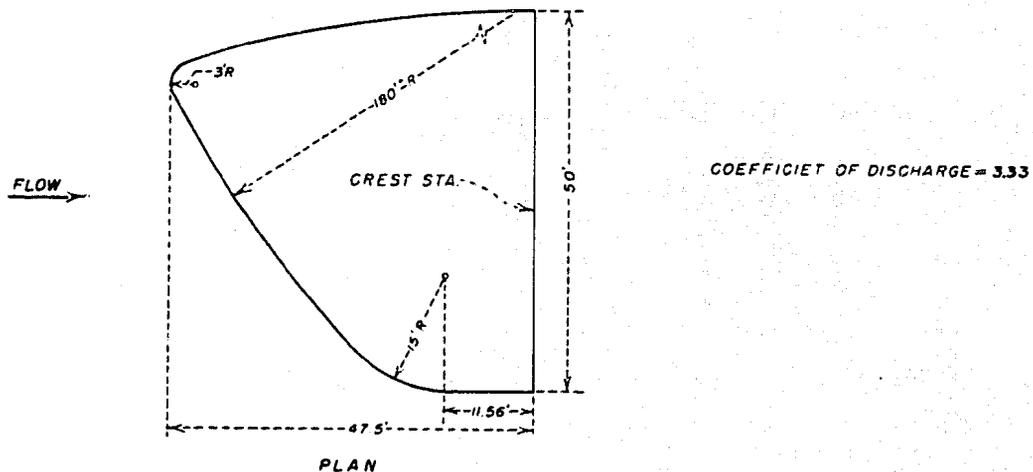
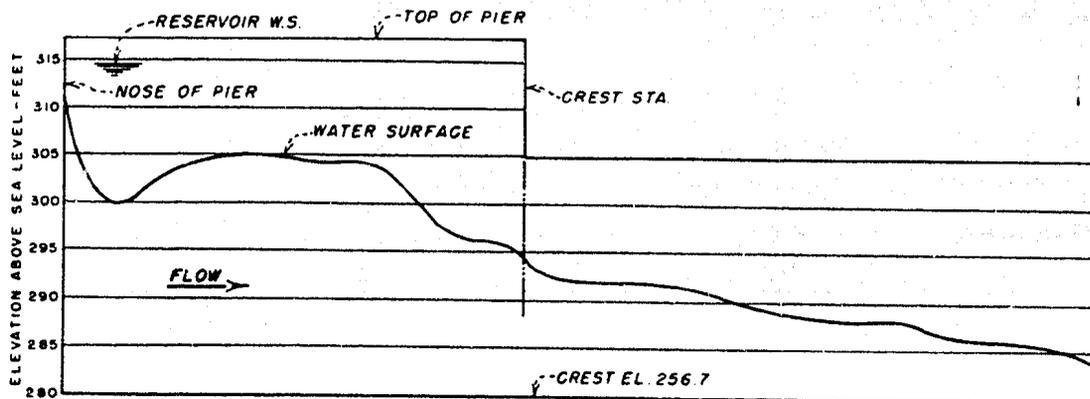
LEFT APPROACH PIER - PIER DESIGN "D"

DRAWDOWN DURING OPERATION -  $Q = 456,000$  C.F.S.

PLAN AND PERFORMANCE DATA

PROFILE OF DRAWDOWN - SPILLWAY SIDE  $Q = 456,000$  C.F.S.

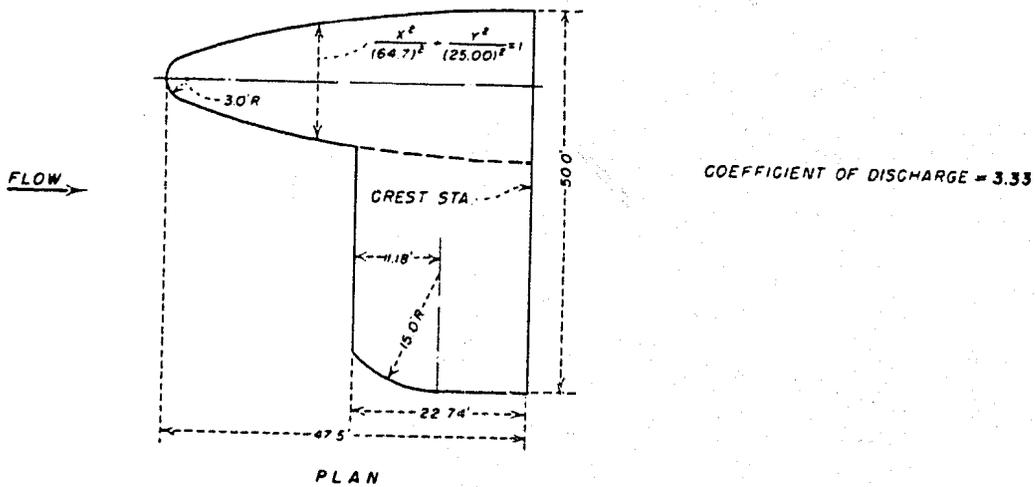
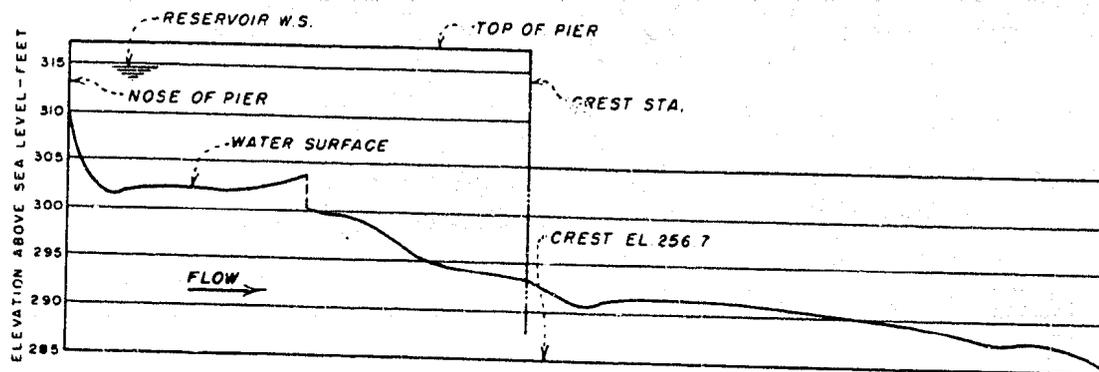
PROFILE OF DRAWDOWN—SPILLWAY SIDE Q=456,000 G.F.S.  
LEFT APPROACH PIER—PIER DESIGN "E"

DRAWDOWN DURING OPERATION—Q=456,000 G.F.S.

PLAN AND PERFORMANCE DATA

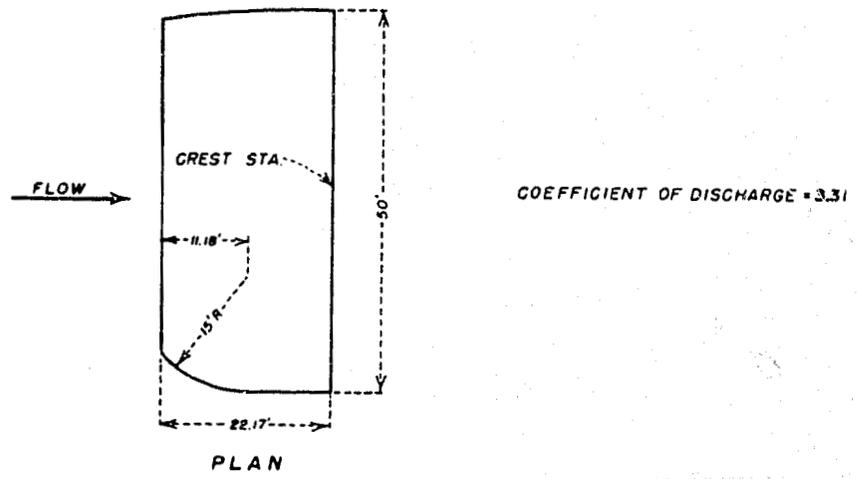
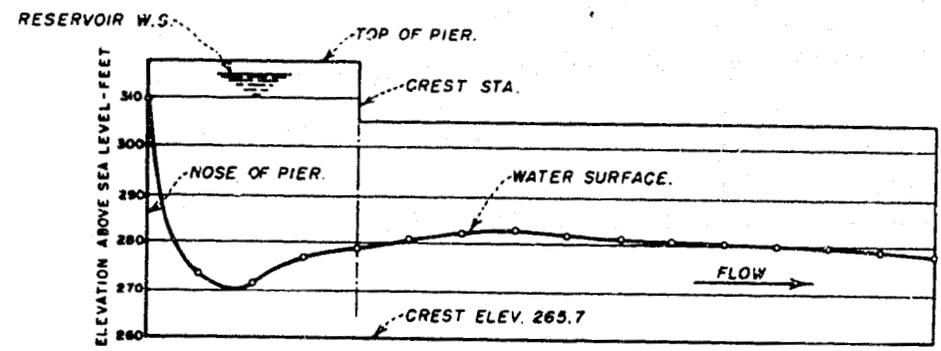
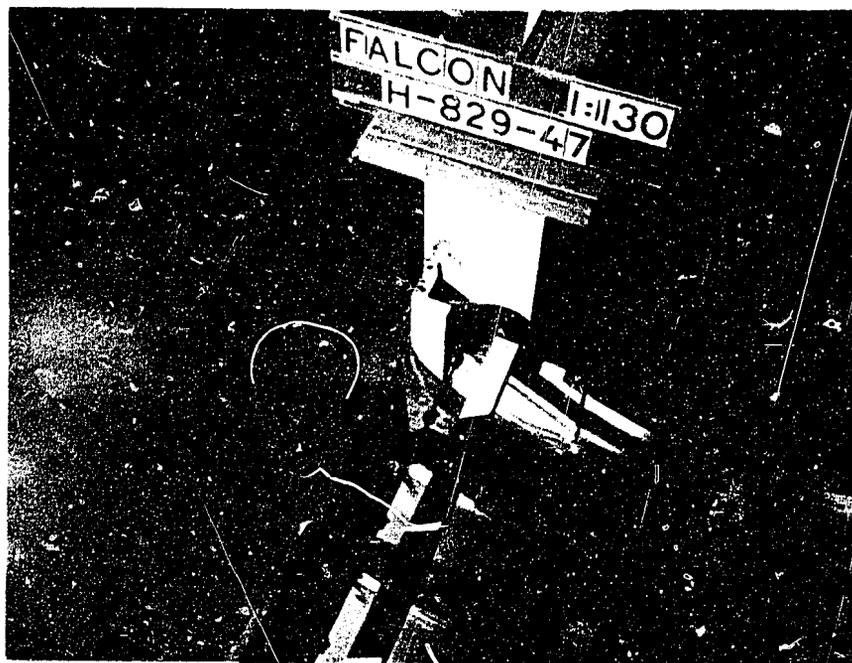
LEFT APPROACH PIER - PIER DESIGN "F"

DRAWDOWN DURING OPERATION -  $Q = 456,000$  C.F.S.

PLAN AND PERFORMANCE DATA

PROFILE OF DRAWDOWN - SPILLWAY SIDE  $Q = 456,000$  C.F.S.

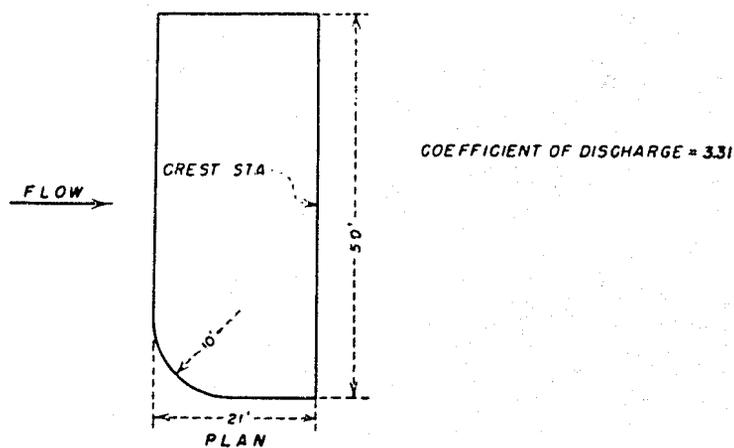
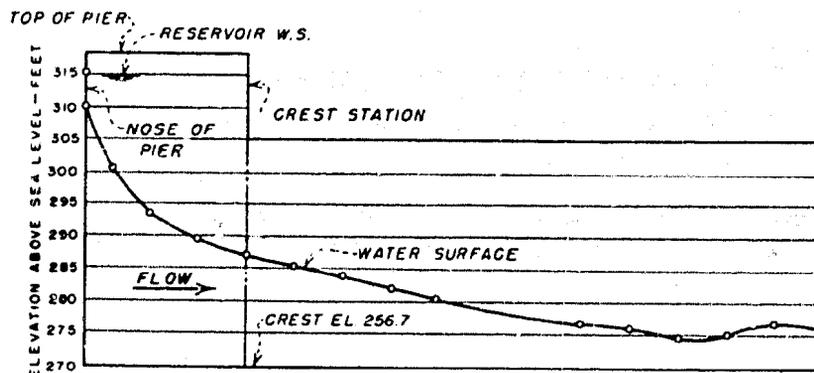
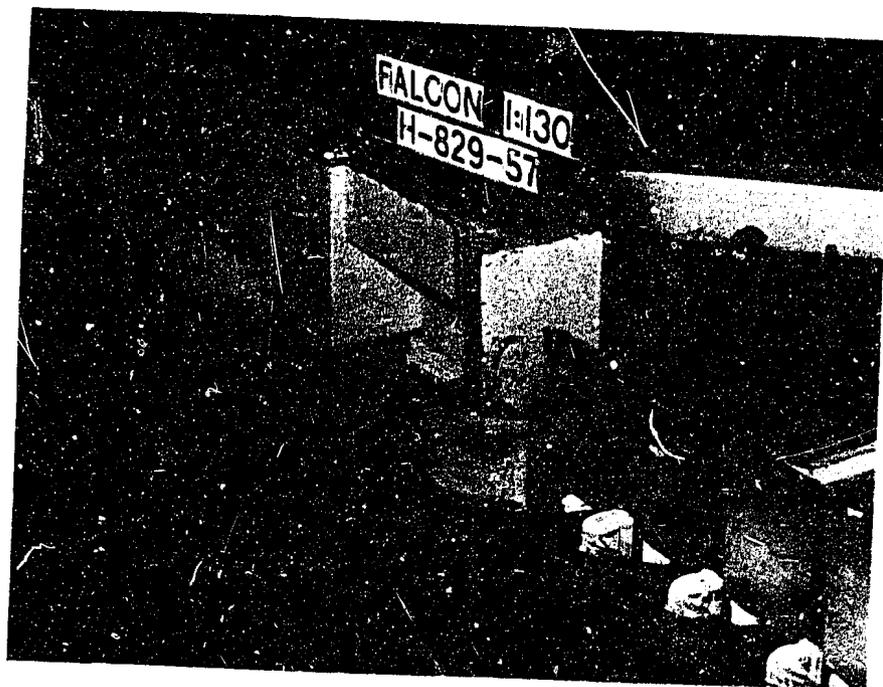
LEFT APPROACH PIER - PIER DESIGN "G"

DRAWDOWN DURING OPERATION -  $Q = 456,000$  C.F.S.

PLAN AND PERFORMANCE DATA

PROFILE OF DRAWDOWN - SPILLWAY SIDE  $Q = 456,000$  C.F.S.

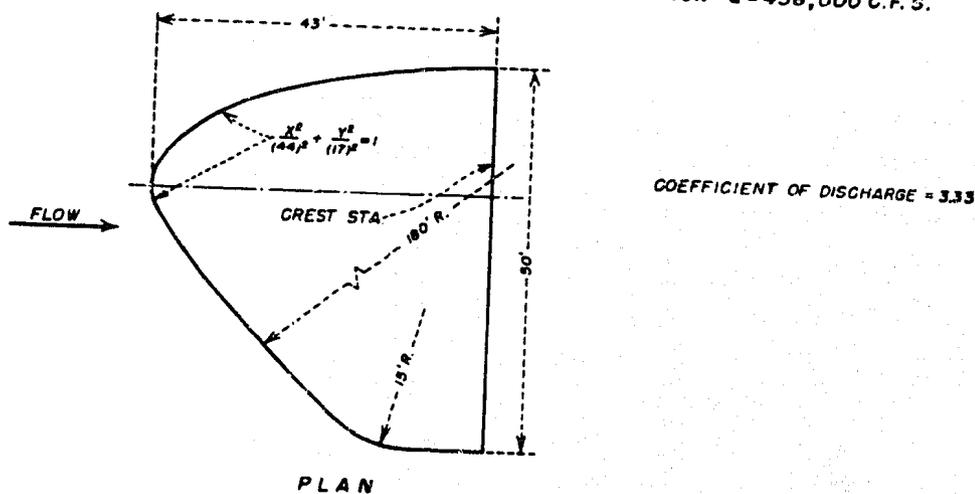
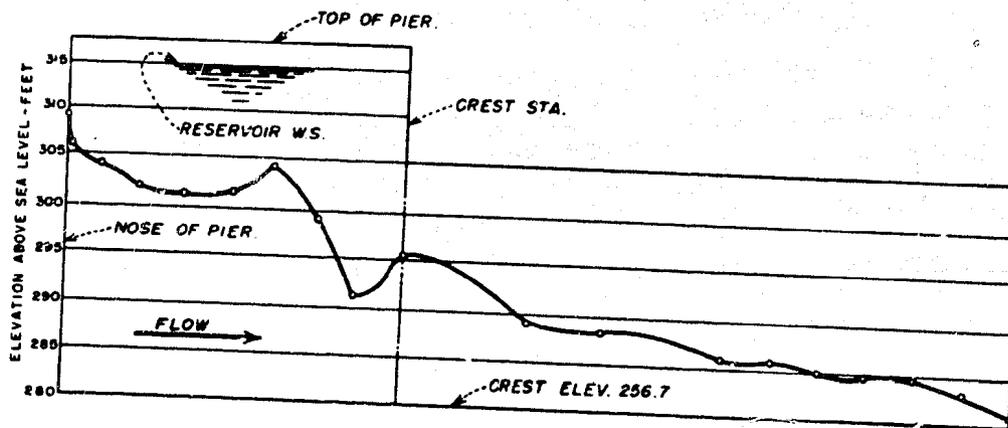
LEFT APPROACH PIER - PIER DESIGN "H"

DRAWDOWN DURING OPERATION - Q = 456,000 C.F.S.

PLAN AND PERFORMANCE DATA

PROFILE OF DRAWDOWN-SPILLWAY SIDE - Q = 456,000 C.F.S.

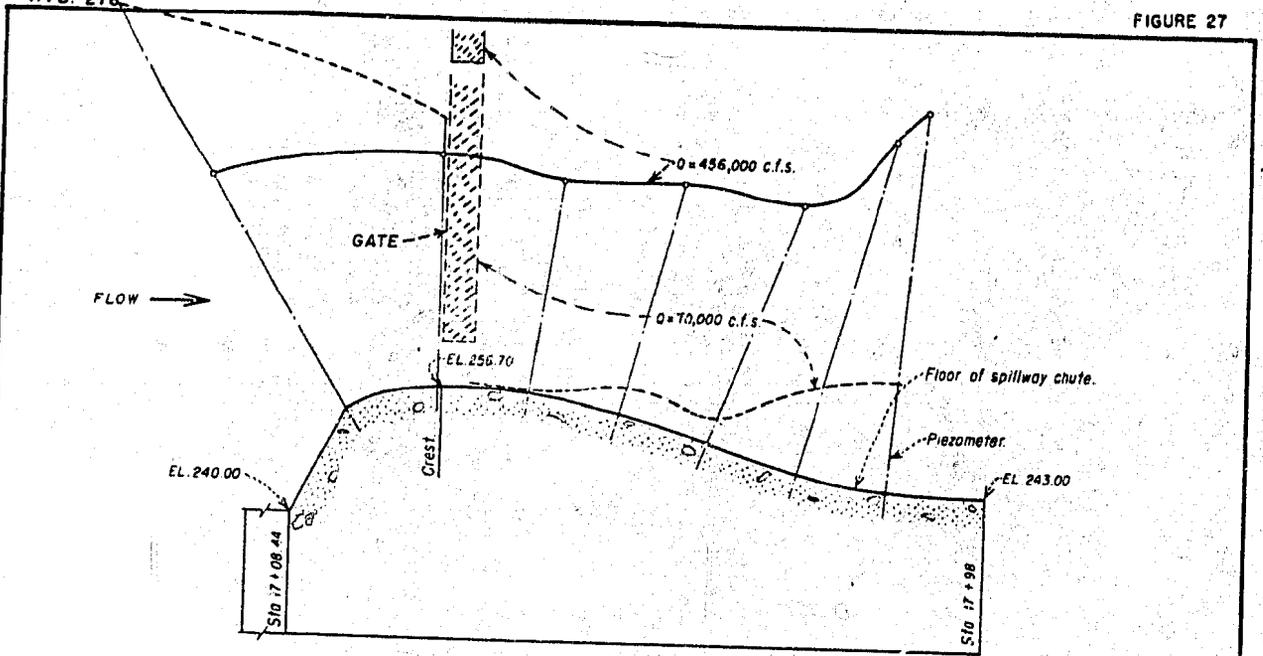
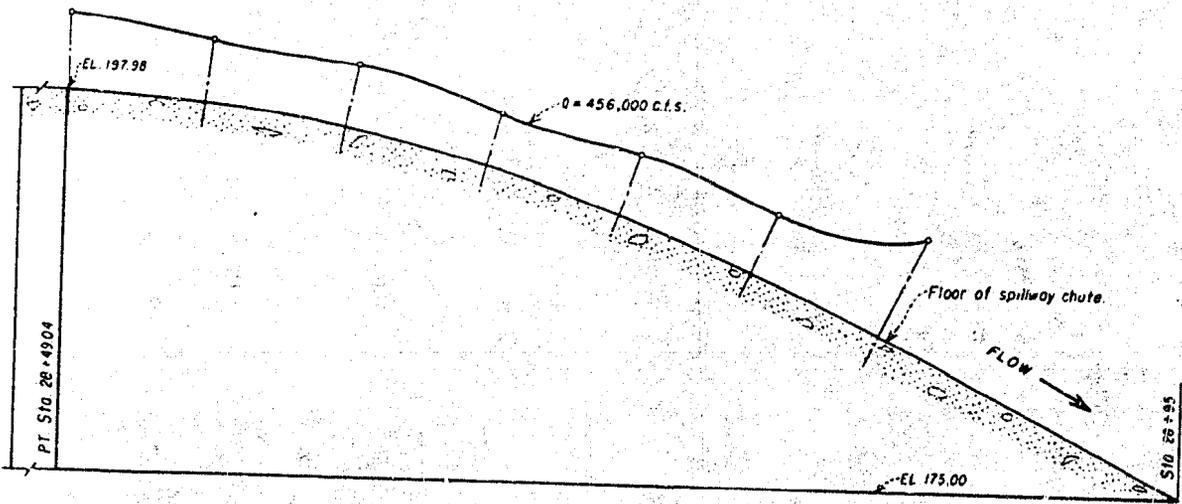
**NOTE**

Pressures are in feet of water, with the chute floor being the zero line. Pressures above the line are above atmospheric pressure. All pressures remained above atmospheric for the complete range of discharges.

**FALCON DAM**  
HYDRAULIC MODEL STUDIES  
SPILLWAY  
PIEZOMETRIC PRESSURES  
MODEL SCALE 1:130

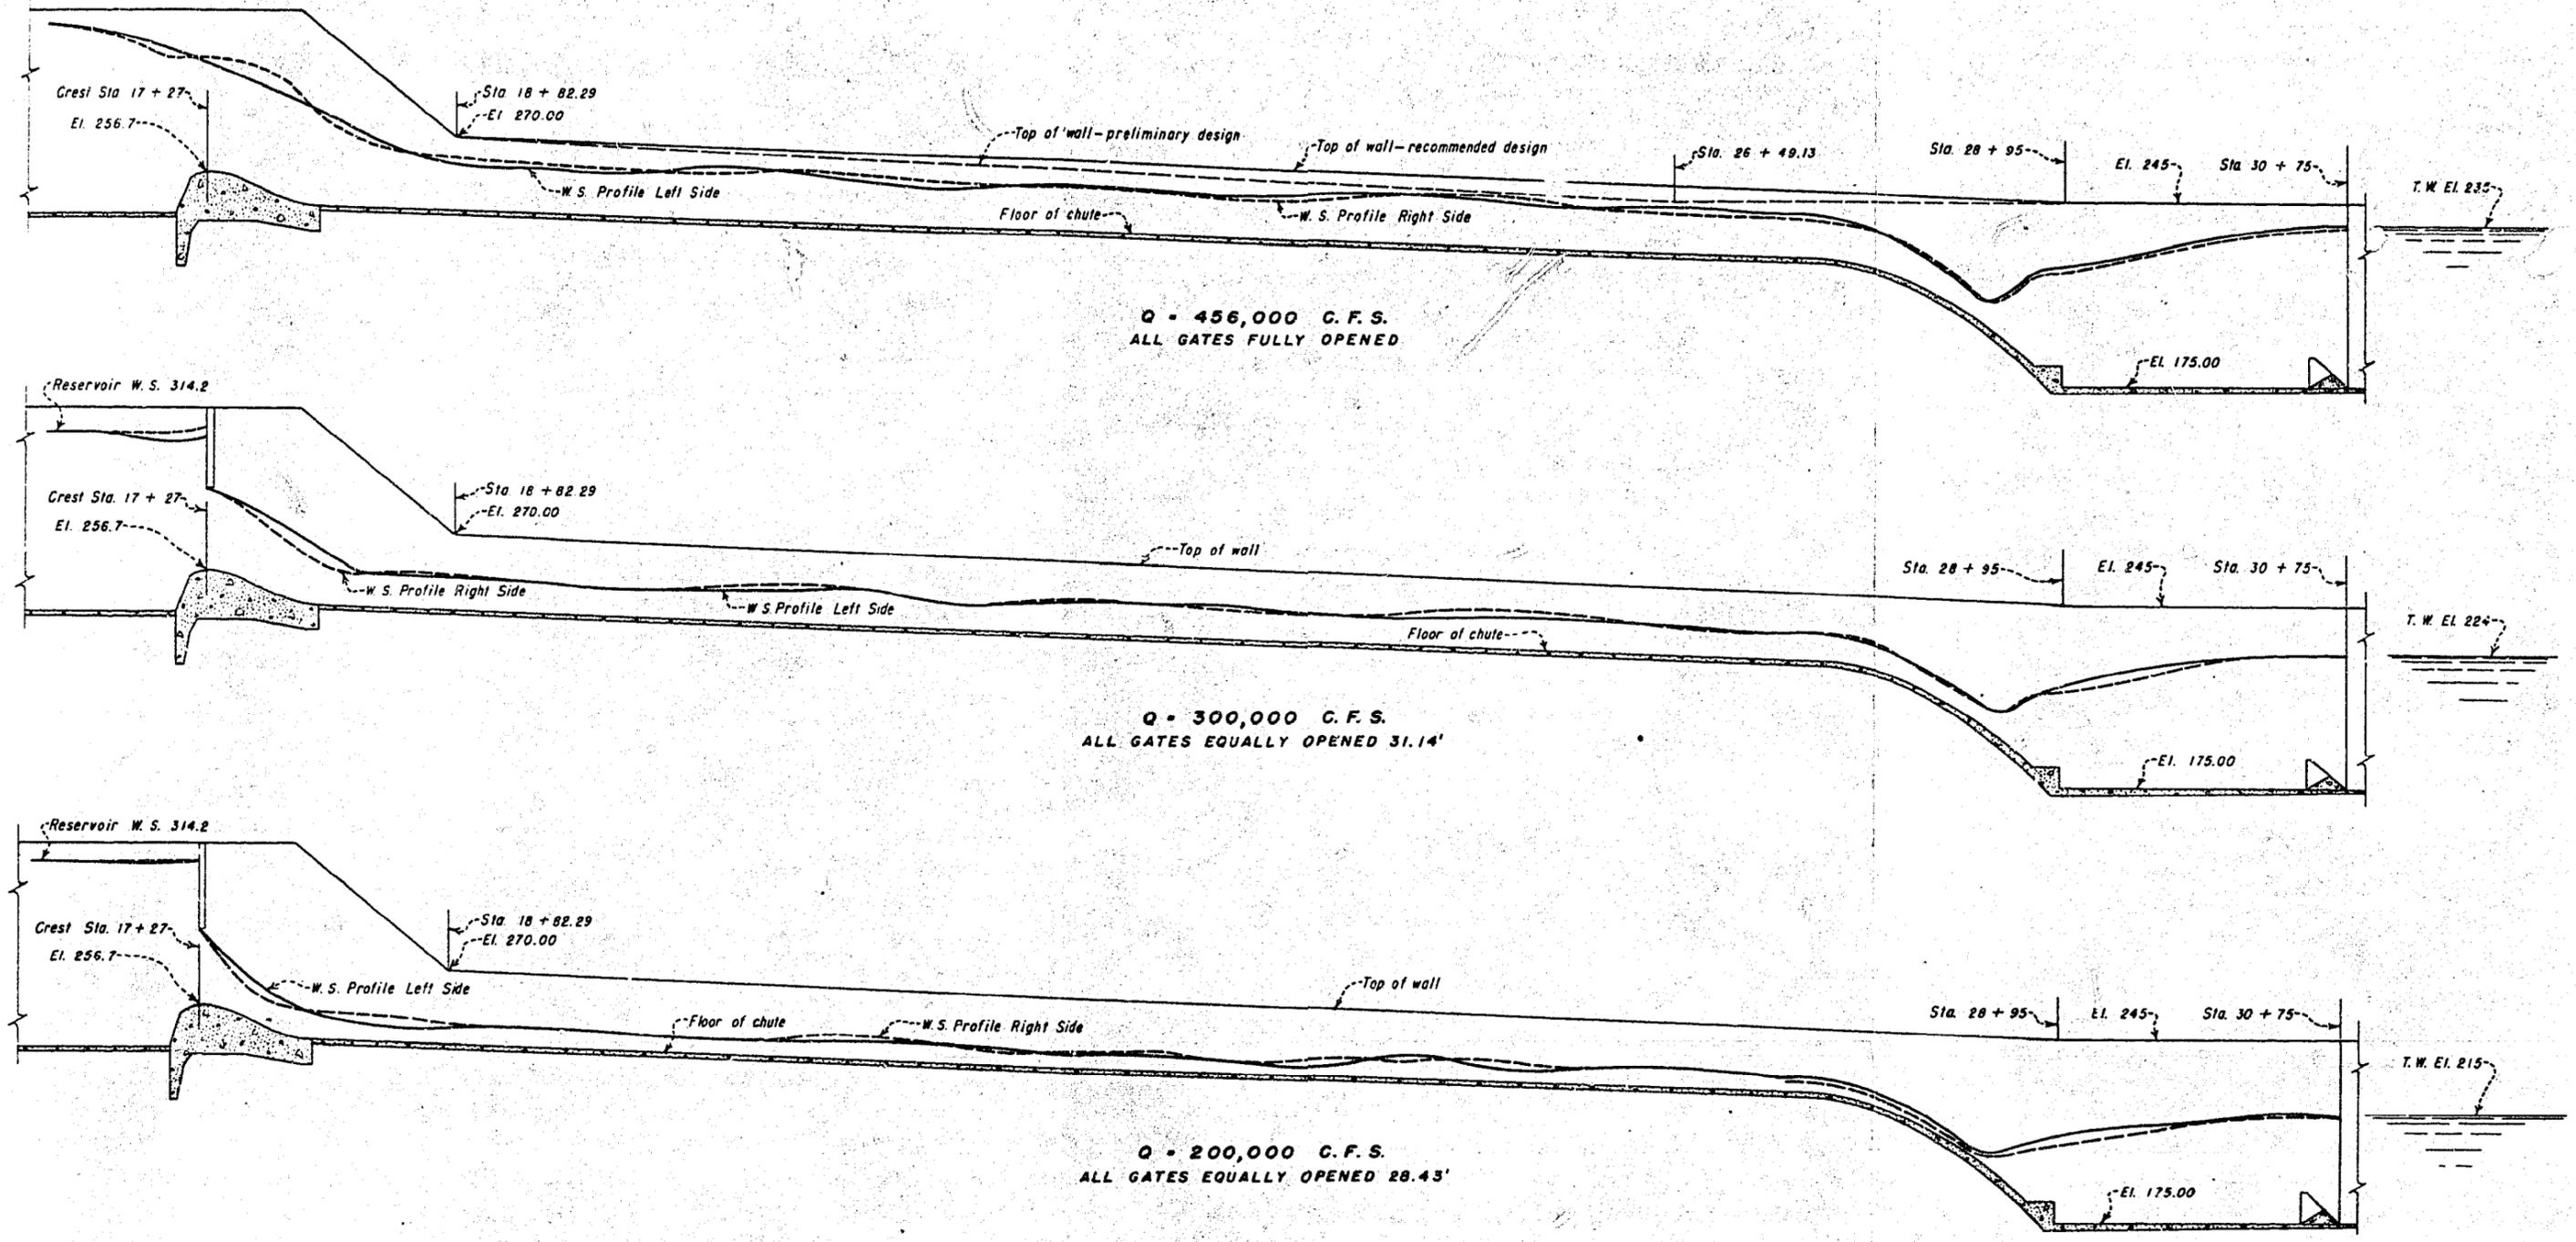
**FALCON DAM**  
HYDRAULIC MODEL STUDIES  
SPILLWAY RECOMMENDED DESIGN  
WATER SURFACE PROFILES  
MODEL SCALE 1:30

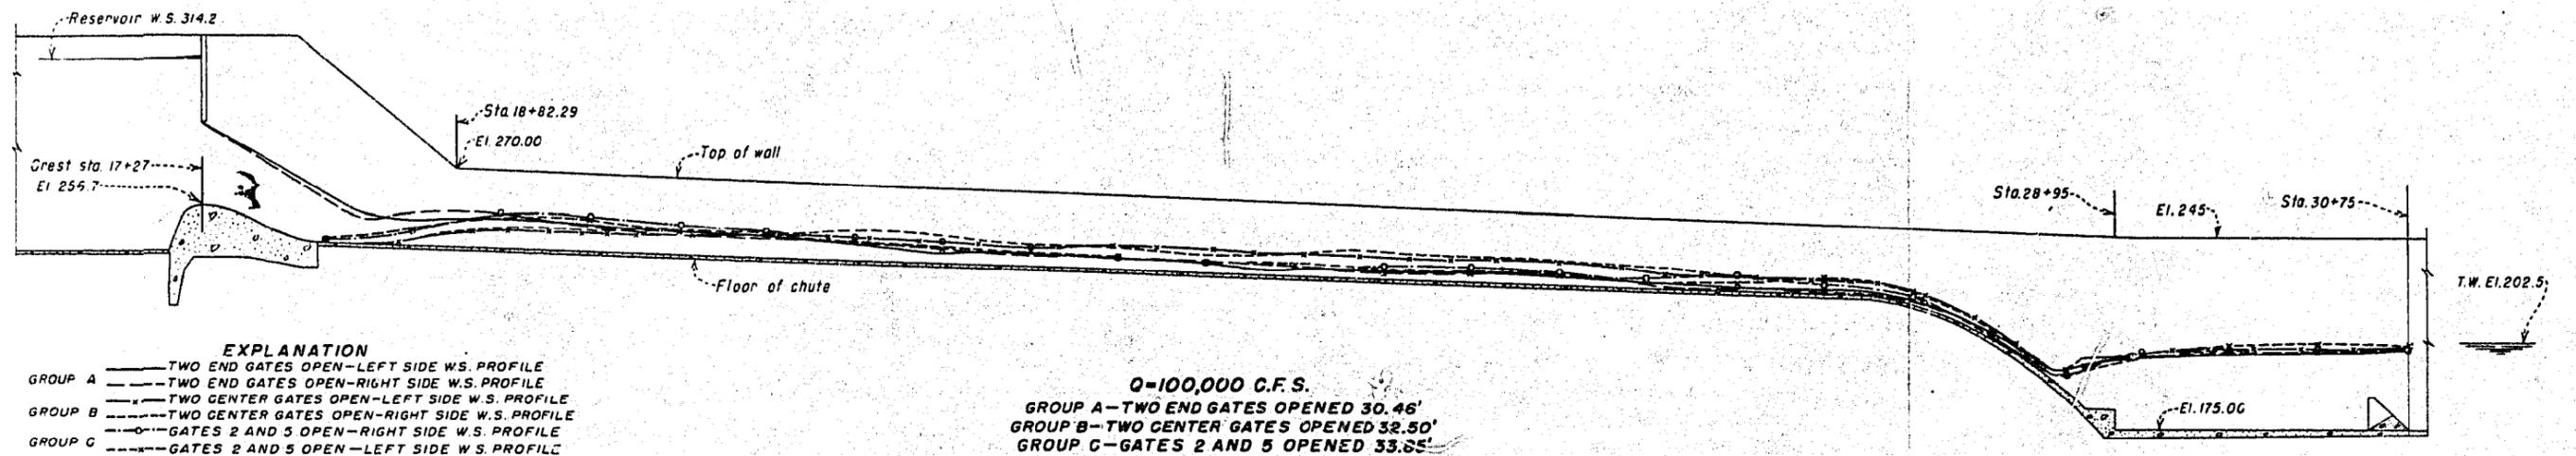
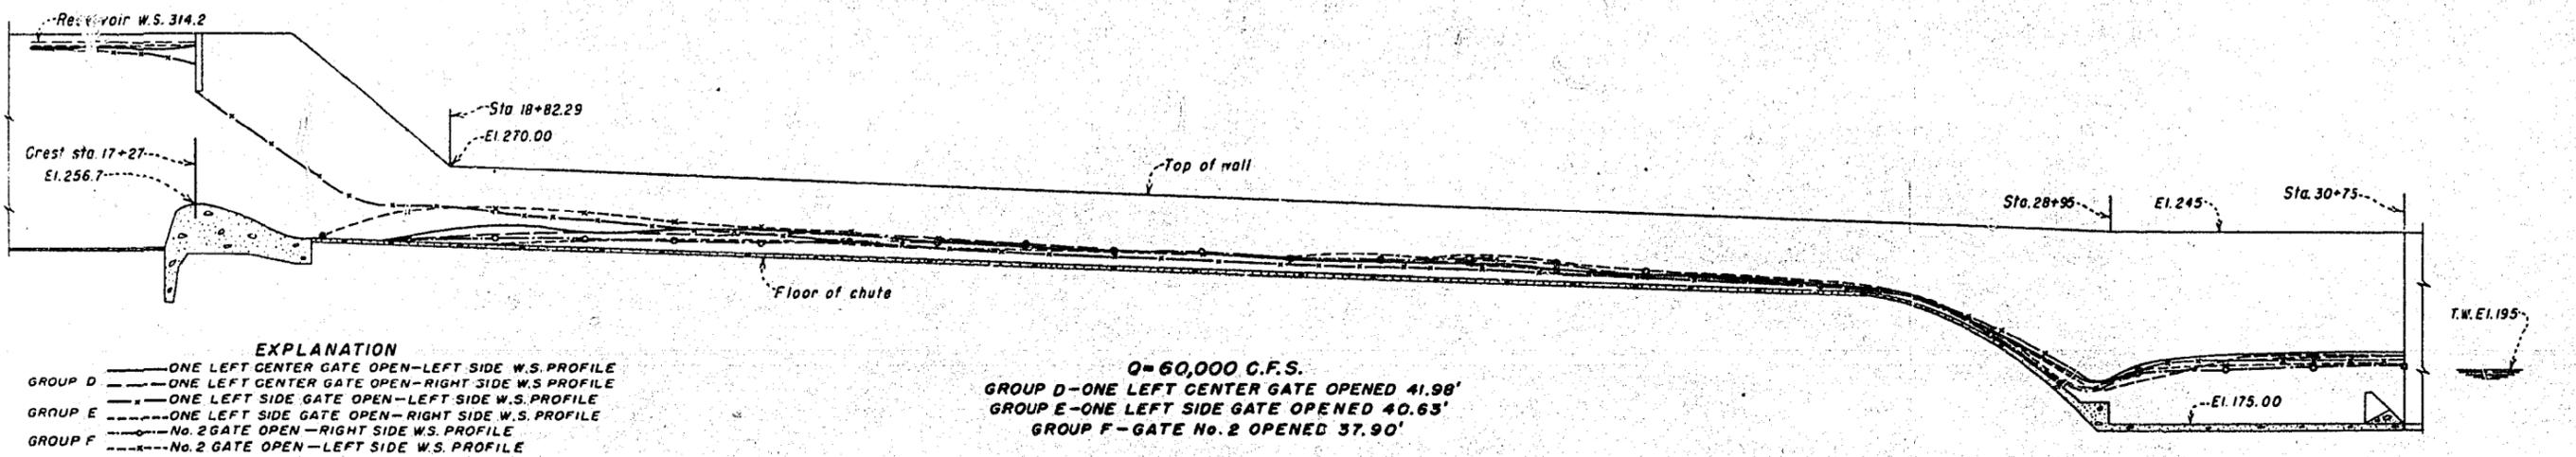
**FALCON DAM**  
 HYDRAULIC MODEL STUDIES  
 SPILLWAY—RECOMMENDED DESIGN  
 WATER SURFACE PROFILES  
 MODEL SCALE 1:130

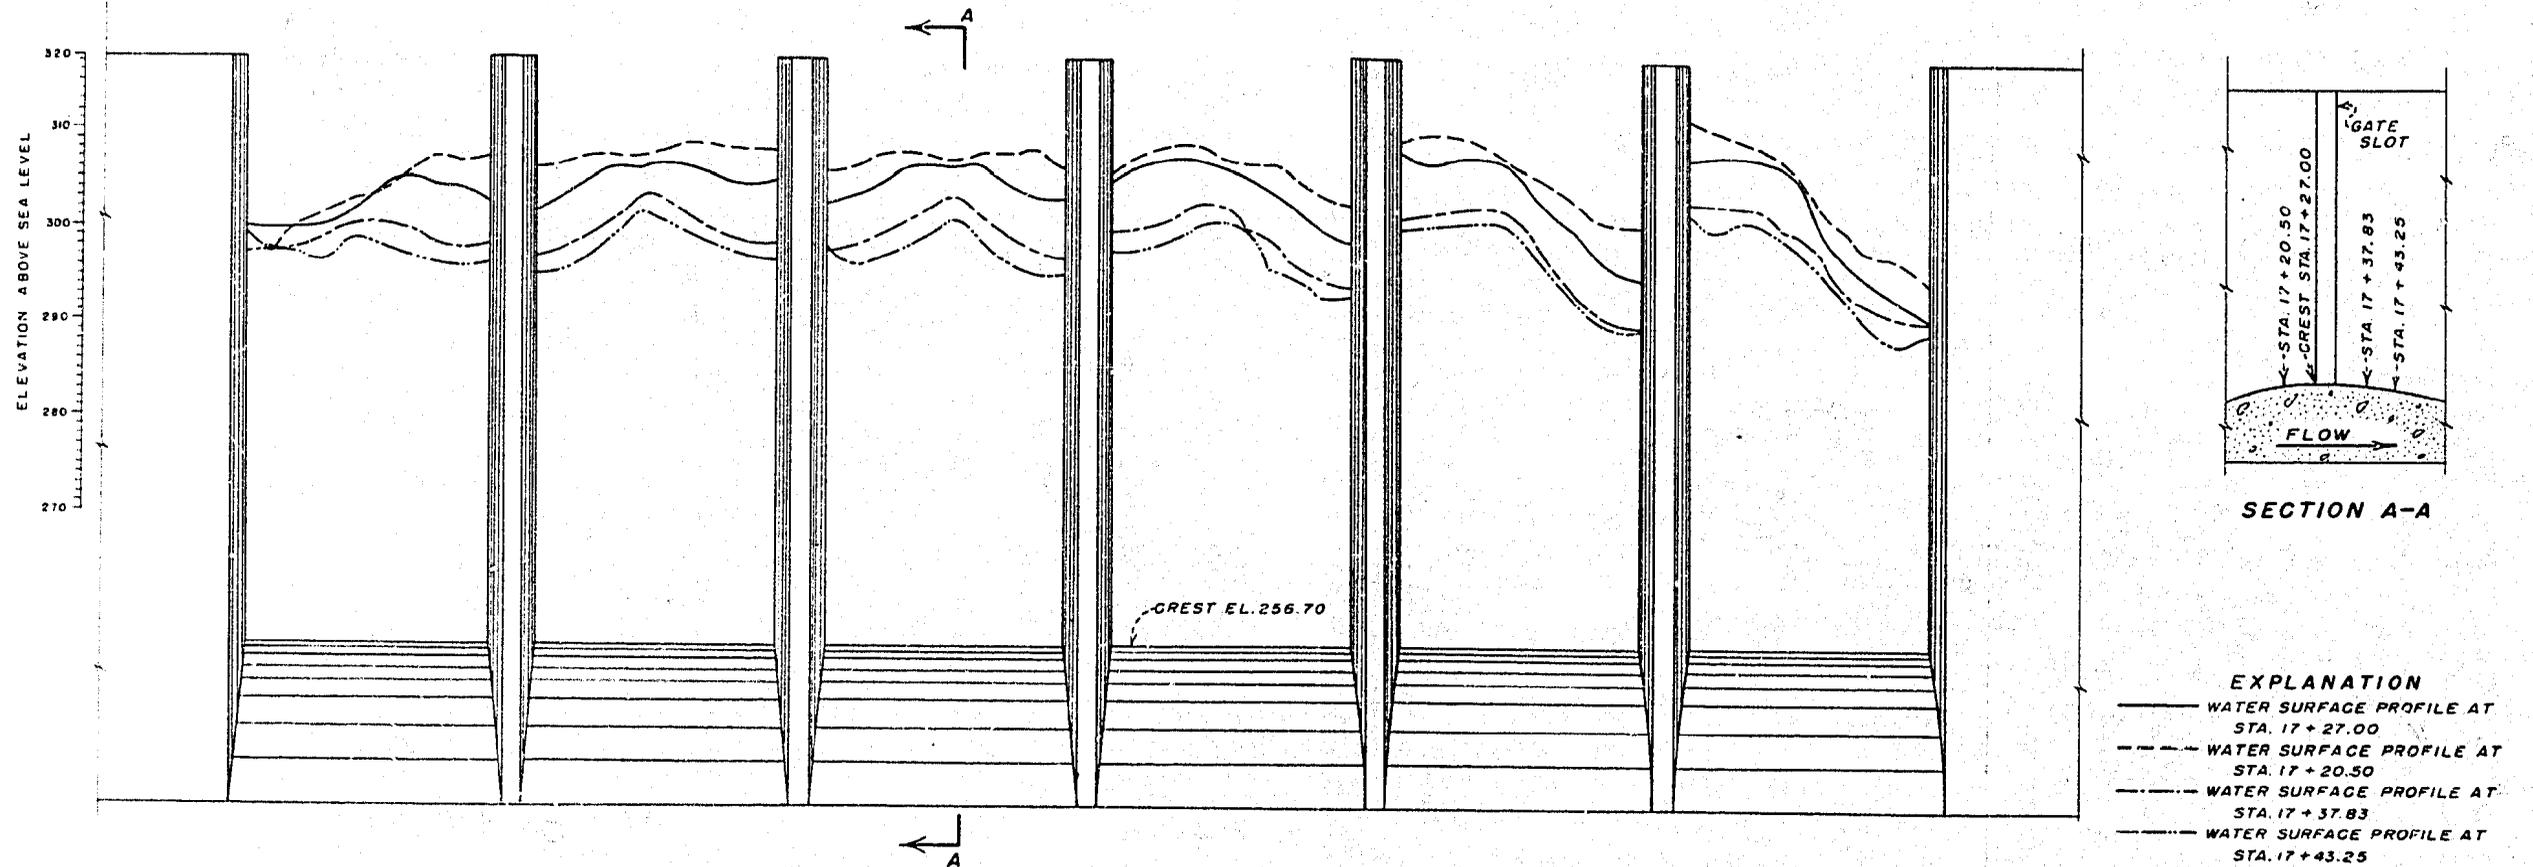
**NOTES**  
 1. VERTICAL SCALE IS TWO TIMES HORIZONTAL SCALE  
 2. FOR ALL PROFILES Q = 456,000 C.F.S.

UPSTREAM VIEW OF SPILLWAY CREST

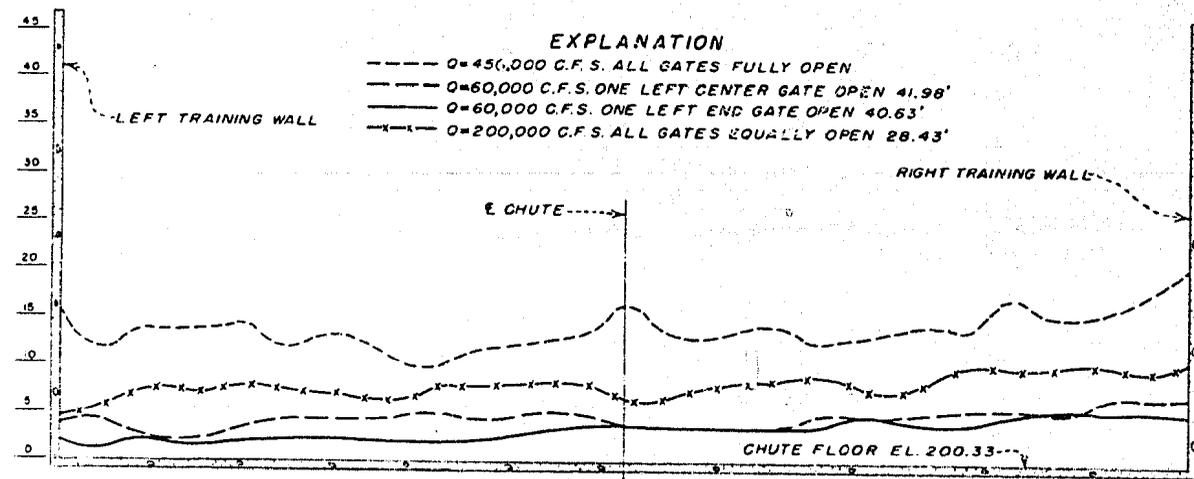
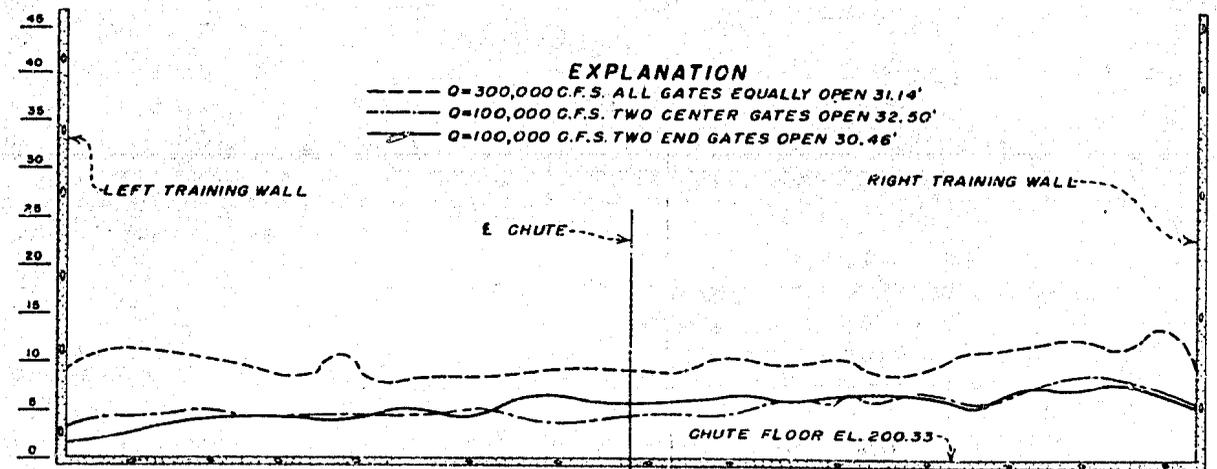
PROFILES AT STATION 28 + 43

**NOTE**  
 STA. 28+43, WHERE THESE PROFILES WERE MEASURED IS JUST UPSTREAM FROM THE UPPER LIMIT OF THE HYDRAULIC JUMP AT MAXIMUM DISCHARGE

**FALCON DAM**  
 HYDRAULIC MODEL STUDIES  
 SPILLWAY—RECOMMENDED DESIGN  
 WATER SURFACE PROFILES  
 MODEL SCALE 1:130

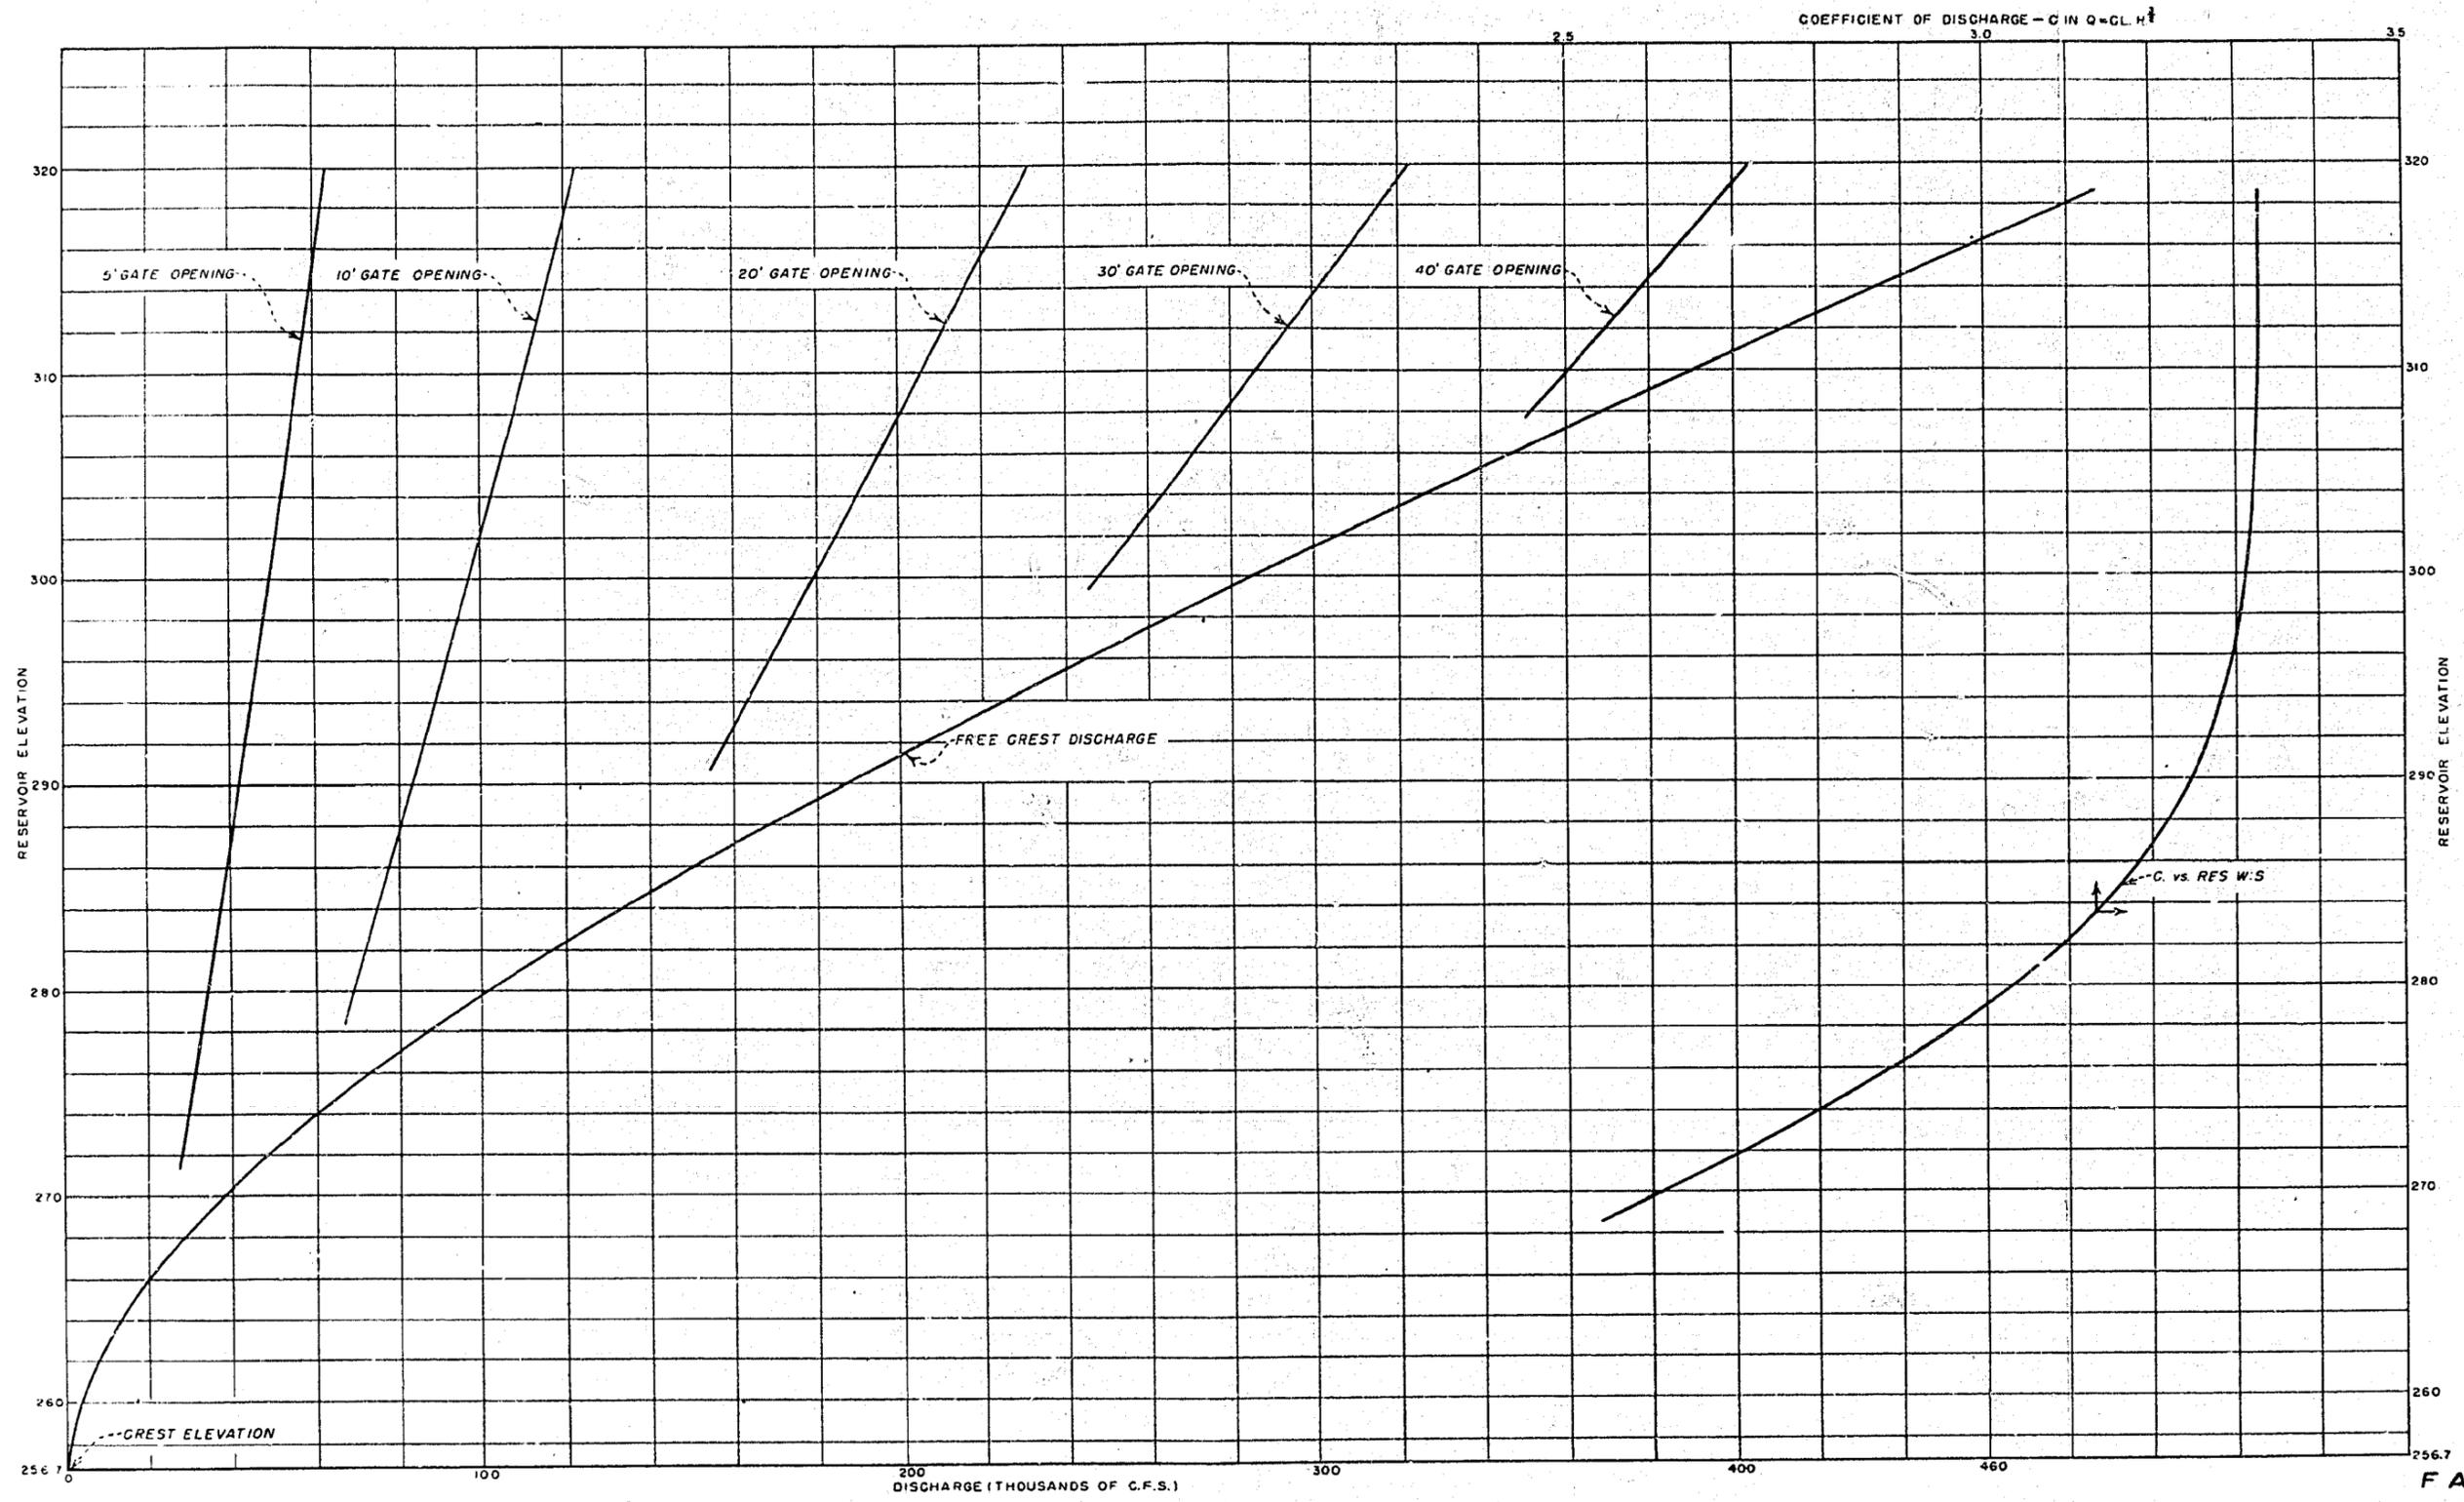
NOTE  
 ALL GATES OPENED EQUALLY  
 SIX 50' X 50' LEAF GATES

FALCON DAM  
 HYDRAULIC MODEL STUDIES  
 SPILLWAY—RECOMMENDED DESIGN  
 DISCHARGE CURVES  
 MODEL SCALE 1:130
