UNITED STATES  
DEPARTMENT OF THE INTERIOR  
BUREAU OF RECLAMATION

# HYDRAULIC MODEL STUDIES OF FALCON DAM

Hydraulic Laboratory Report No. Hyd. 276

JULY 31, 1950

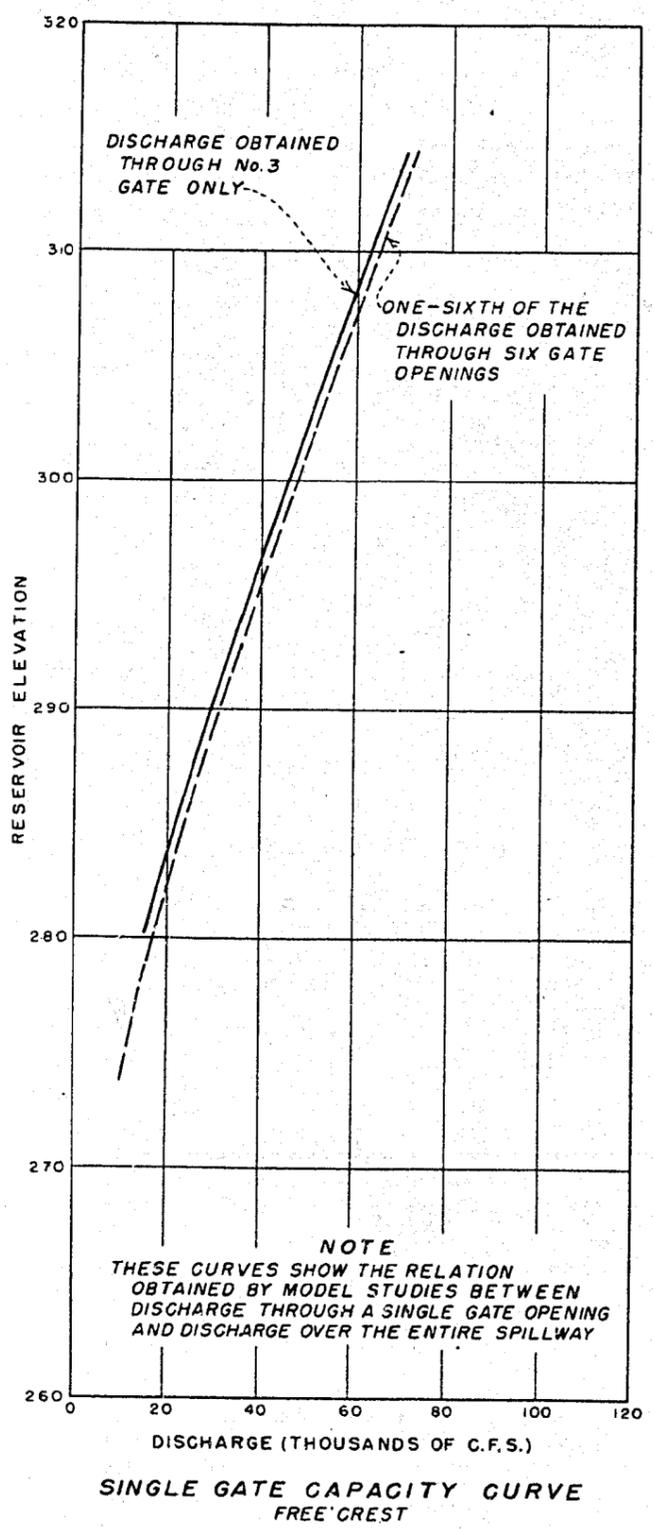
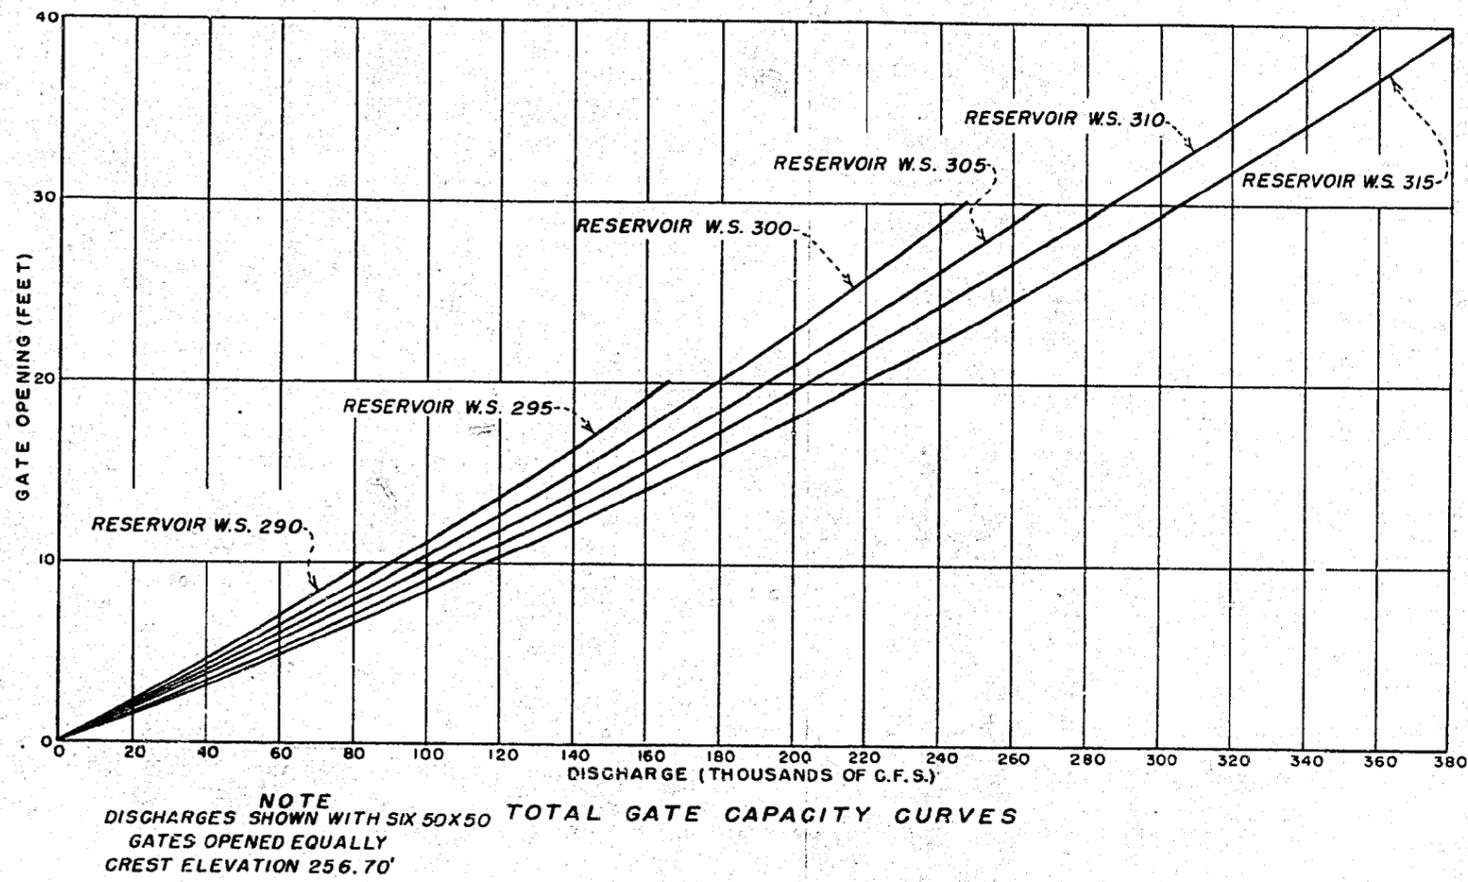
FALCON DAM  
HYDRAULIC MODEL STUDIES  
SPILLWAY-RECOMMENDED DESIGN  
DISCHARGE CURVES  
MODEL SCALE 1:130

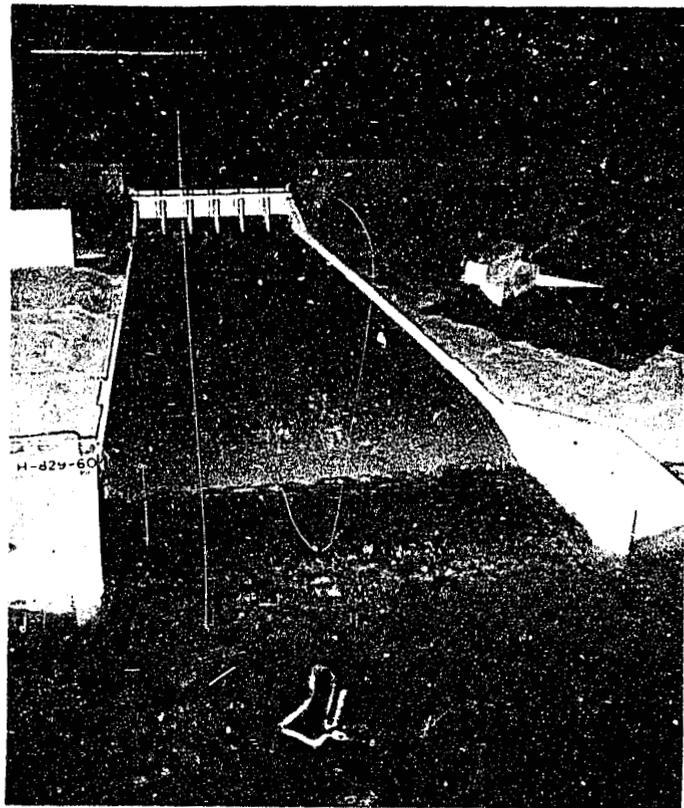
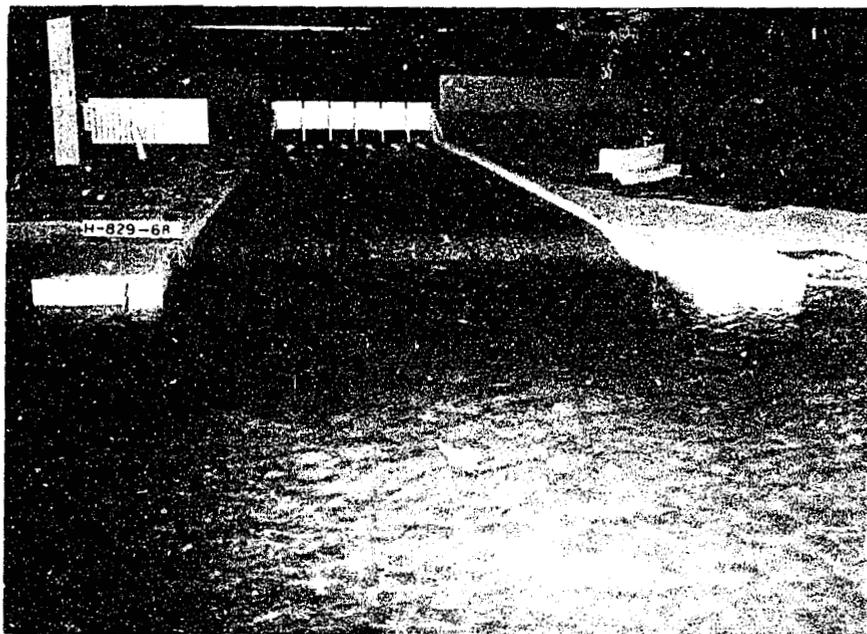
Figure 33  
Hyd. 276

100,000 cfs being discharged with all gates open 8 feet and the reservoir water surface at elevation 314.2.

200,000 cfs being discharged with all gates open 19 feet and the reservoir water surface at elevation 314.2.

THE PROJECT MODEL. DISCHARGE OVER THE SPILLWAY WITH PARTIAL GATE OPENINGS.

Flow in the spillway chute was satisfactory at all discharges, as shown in Figures 33, 34, 35, and 36. At high discharges, the flow spread evenly in the chute and showed no tendency to overtop the training walls. At lower discharges the flow was also spread evenly over the spillway, if the gates were opened equally, Figures 33A and B. If the gates were not opened equally, standing waves formed in the chute, but they were not sufficiently high to be of concern and they had only a minor effect on the performance of the stilling basin, Figures 35 and 36. The stilling basin also performed well at all discharges; even with unsymmetrical gate openings, the jump remained well up on the slope of the chute. Figure 37 shows the entire model operating with a spillway discharge of 456,000 cfs.

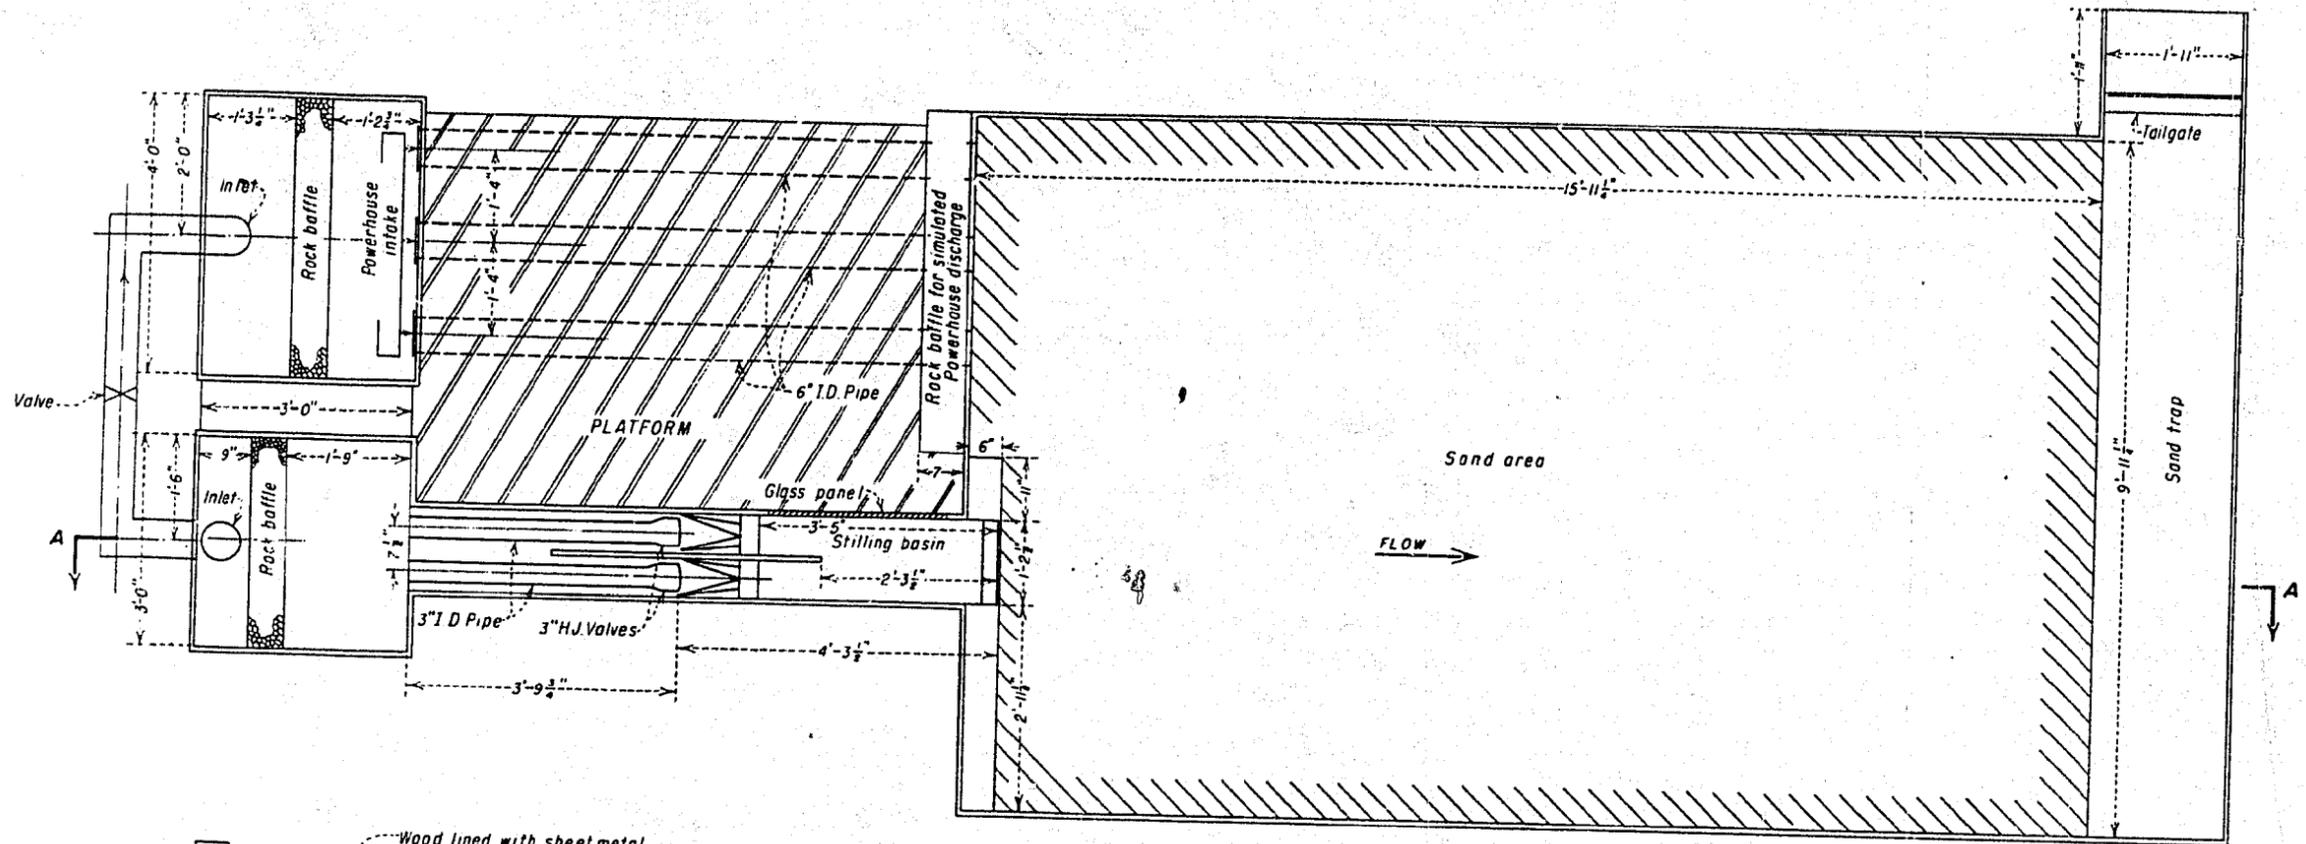
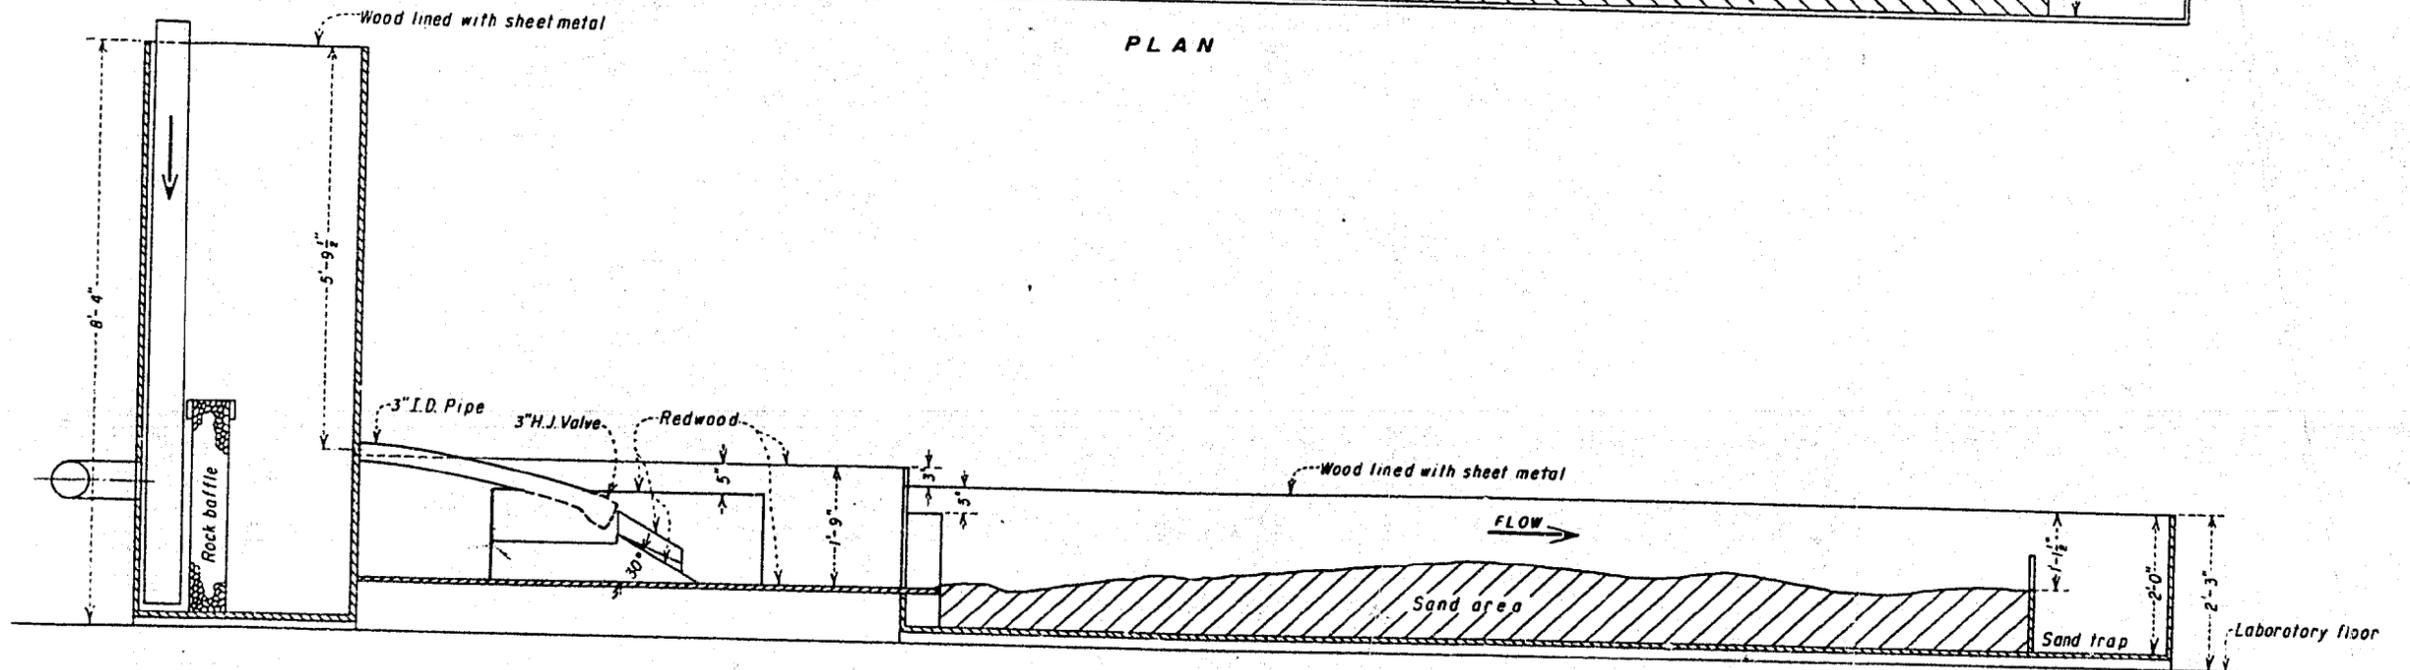
PLAN

SECTION A-A

**FALCON DAM**  
 HYDRAULIC MODEL STUDIES  
 MEXICAN OUTLET WORKS  
 MODEL ARRANGEMENT  
 MODEL SCALE 1:30

Included in the model (Figure 65) were two hollow-jet valves with approach conduits, a head box, a stilling basin, approximately 250 feet of downstream channel and a tail box equipped with an adjustable gate. No provisions were made to duplicate the powerhouse tailrace, as tests on the Mexican outlet works had shown that hydraulic conditions were no worse with the powerhouse discharging.

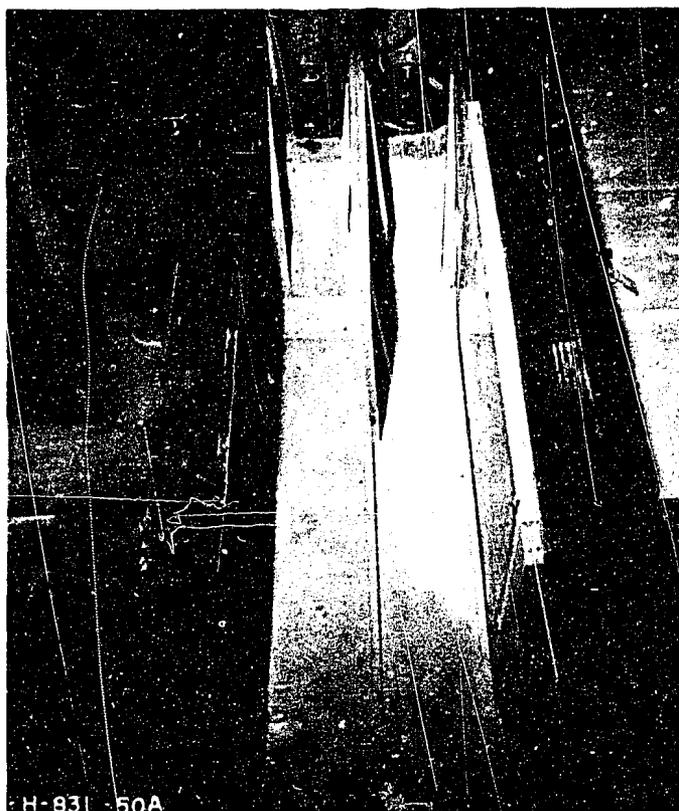
Figure 39  
Hyd. 276

B. The stilling basin. Note the valves, the inclined floor, the converging walls, the fillets, the horizontal floor, and the end sill. This is the recommended design.

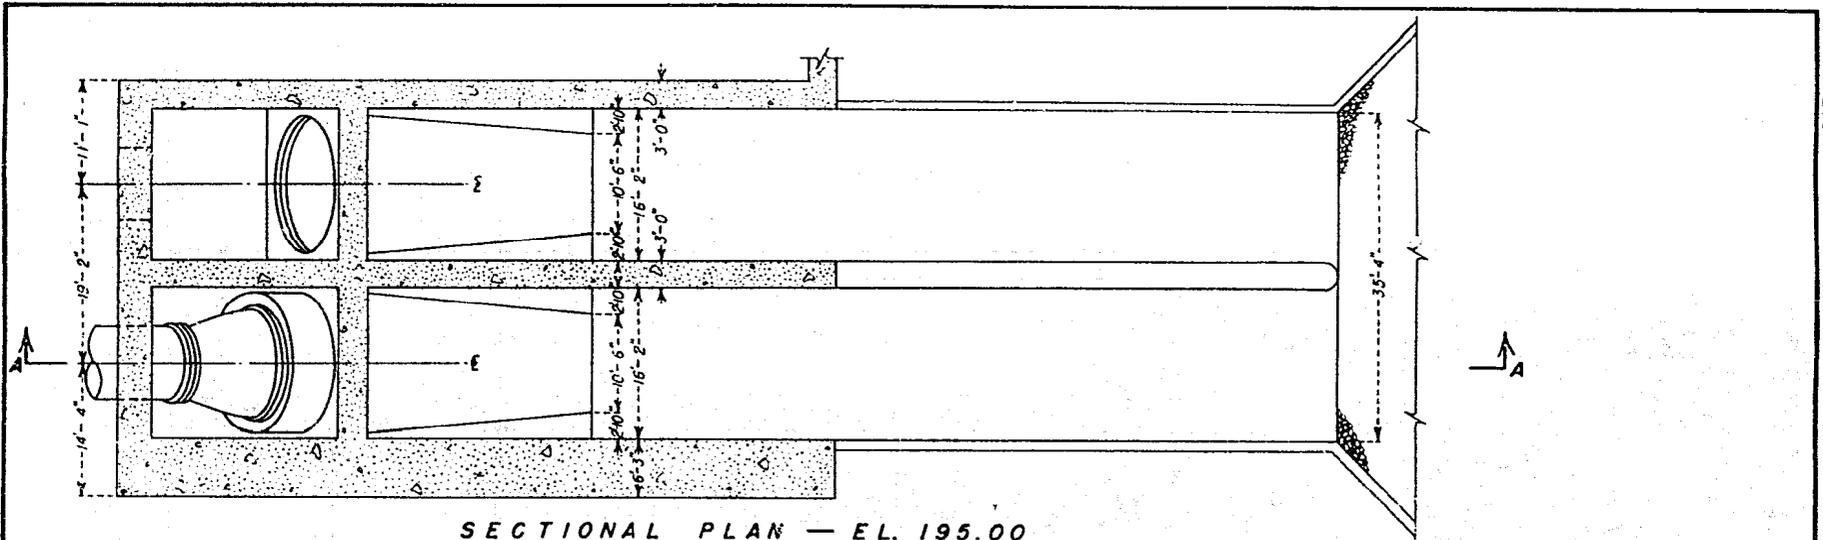
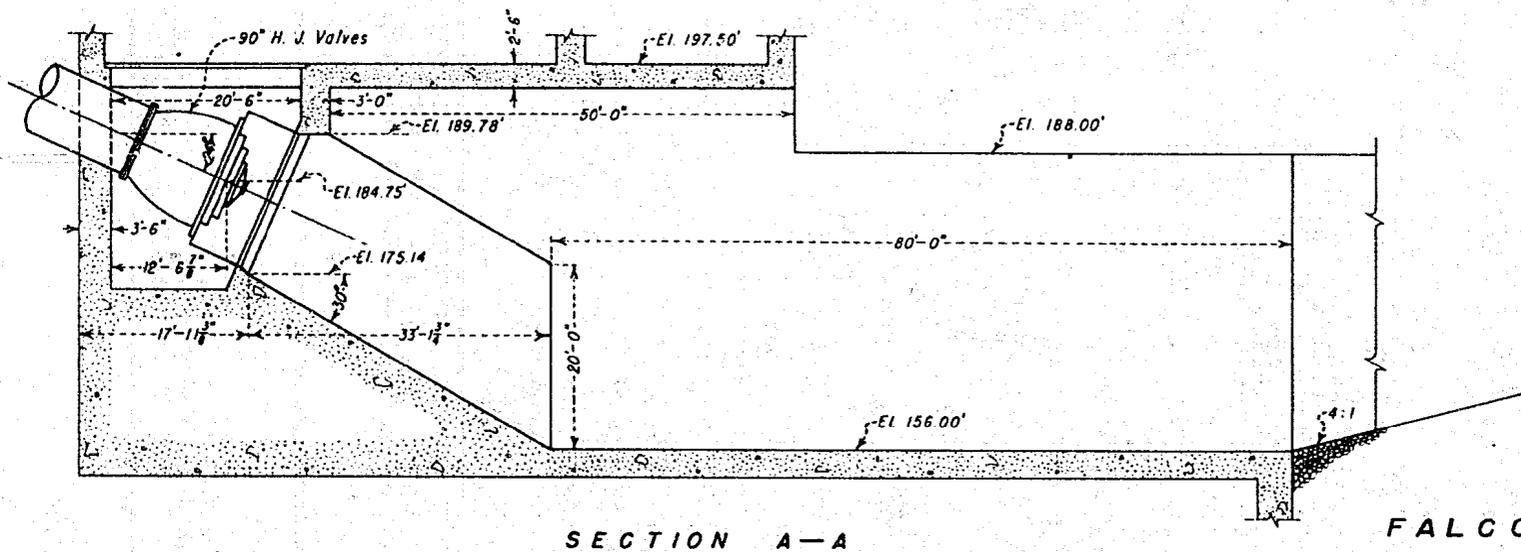
**FALCON DAM**  
 HYDRAULIC MODEL STUDIES  
 MEXICAN OUTLET WORKS  
 PRELIMINARY DESIGN  
 MODEL SCALE 1:30

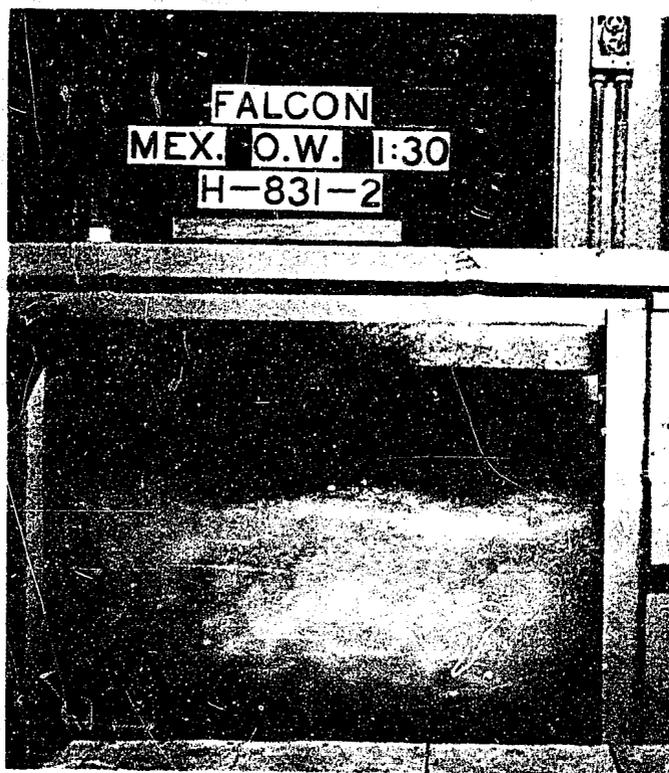
Figure 43  
Hyd. 276

B. Action in the basin. 4,570 cfs discharging through both valves.

THE MEXICAN OUTLET WORKS. PRELIMINARY DESIGN. OPERATION WITH THE POWER PLANT DISCHARGING 5,400 CUBIC FEET PER SECOND.

Tests with and without the power plant operating showed very little difference in performance, Figures 41 and 43. With the power plant discharging the wave action below the stilling basin was slightly reduced, Figure 43, while the erosion was slightly greater at the left side of the stilling basin and slightly less at the right side. Since there was no appreciable difference with or without the power plant discharge, and since the tests could be made more rapidly without it, most of the subsequent testing was done without the power plant discharging.

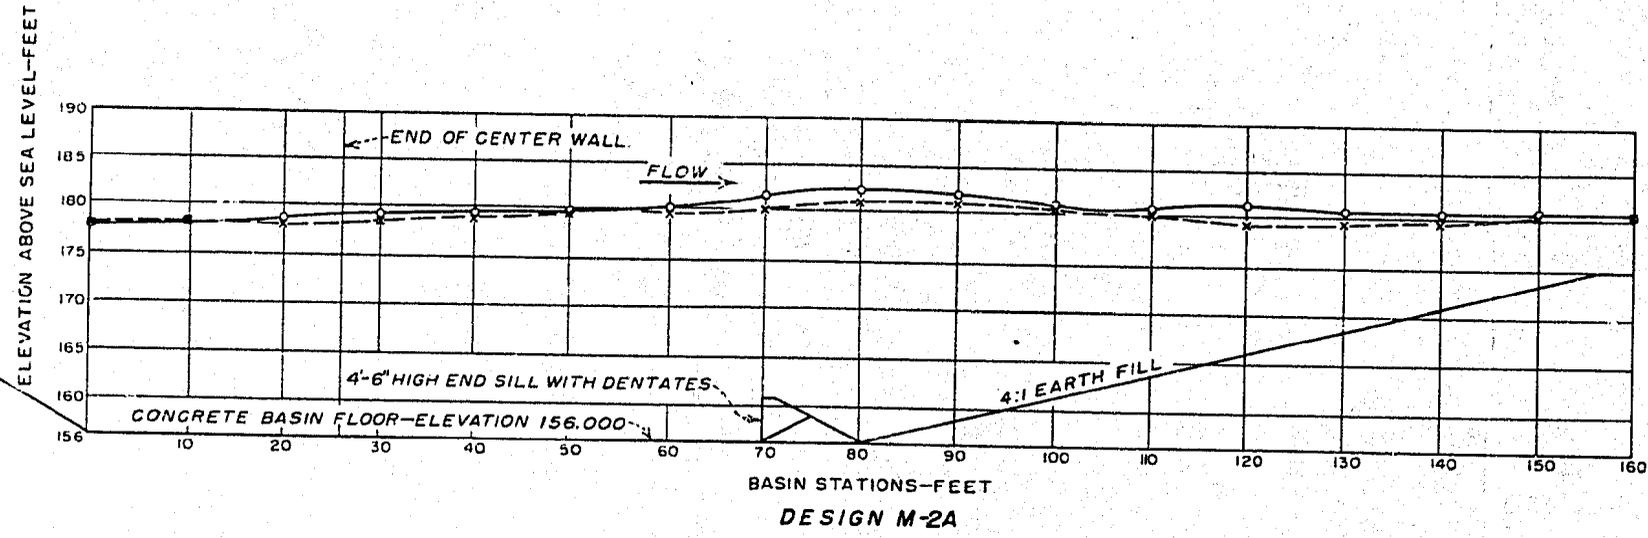
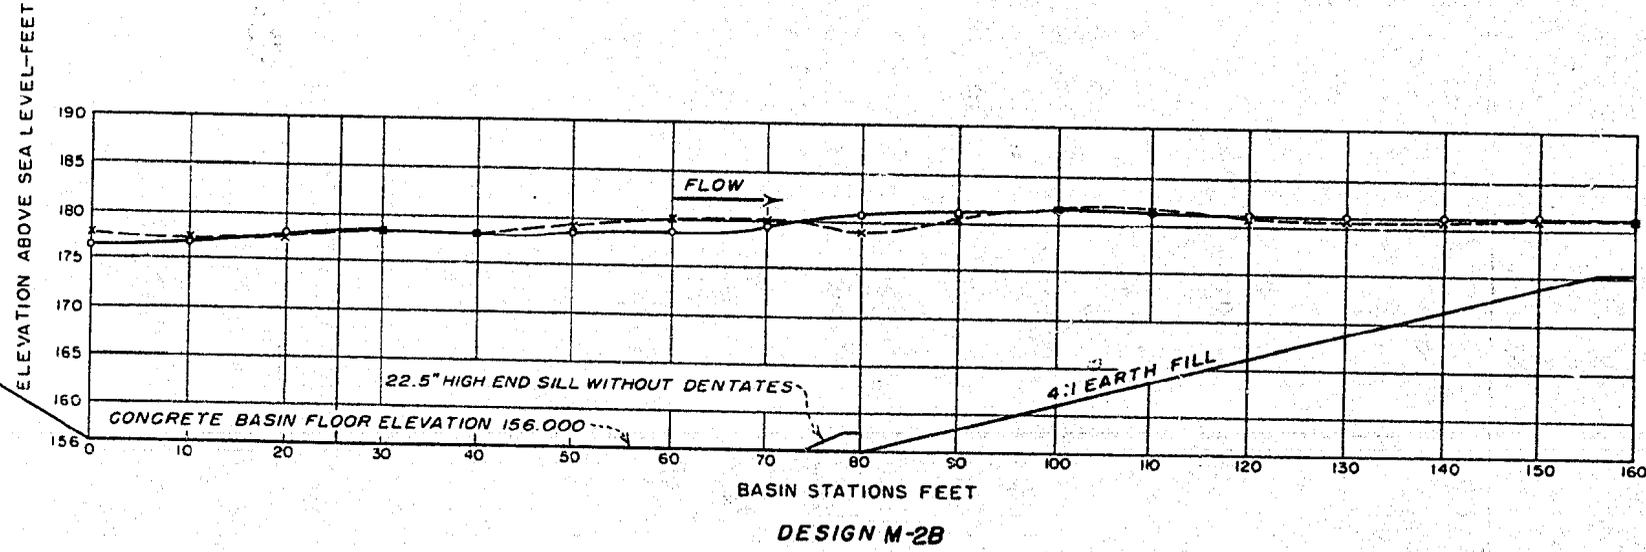
————— Q=4570 C.F.S. BOTH VALVES OPEN—PROFILE ALONG LEFT WALL.  
 - - - - - Q=2400 C.F.S. LEFT VALVE OPEN—PROFILE ALONG LEFT WALL

**FALCON DAM**  
 HYDRAULIC MODEL STUDIES  
 MEXICAN OUTLET WORKS  
 STILLING BASIN DESIGNS  
 MODEL SCALE 1:30

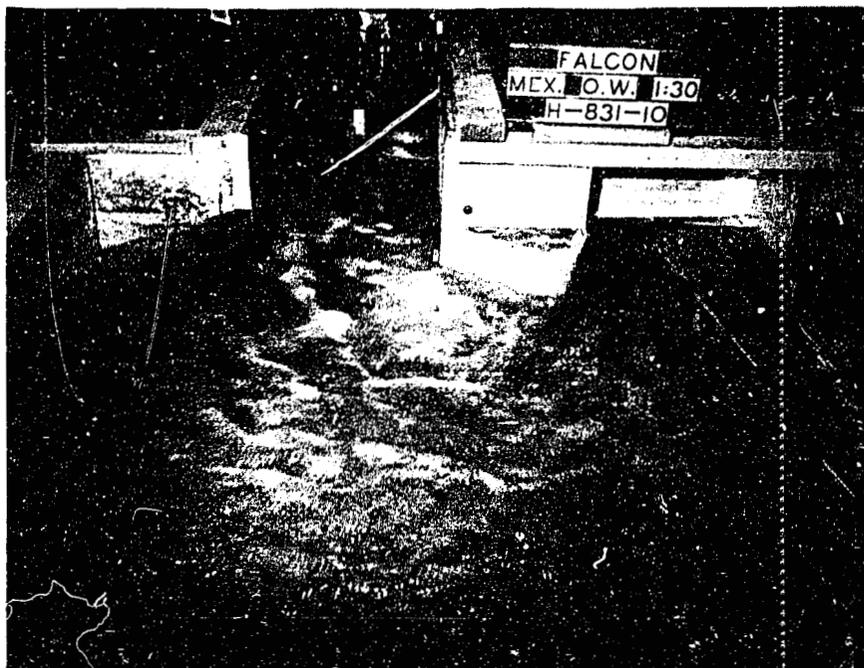
A. One valve discharging-- $Q = 2,400$  cfs.

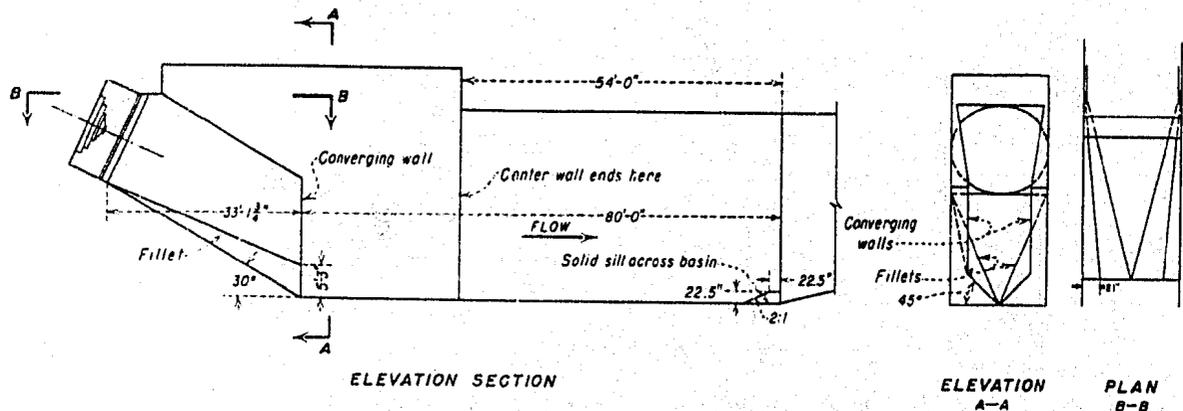
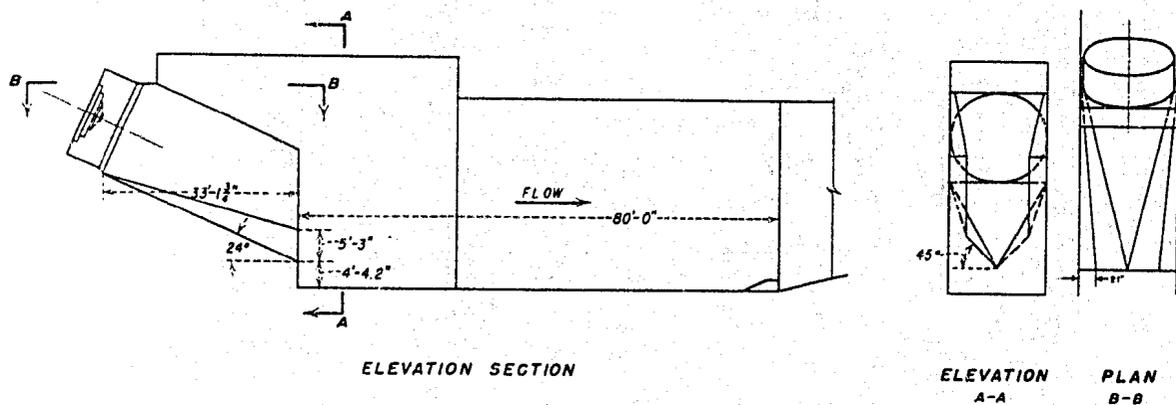
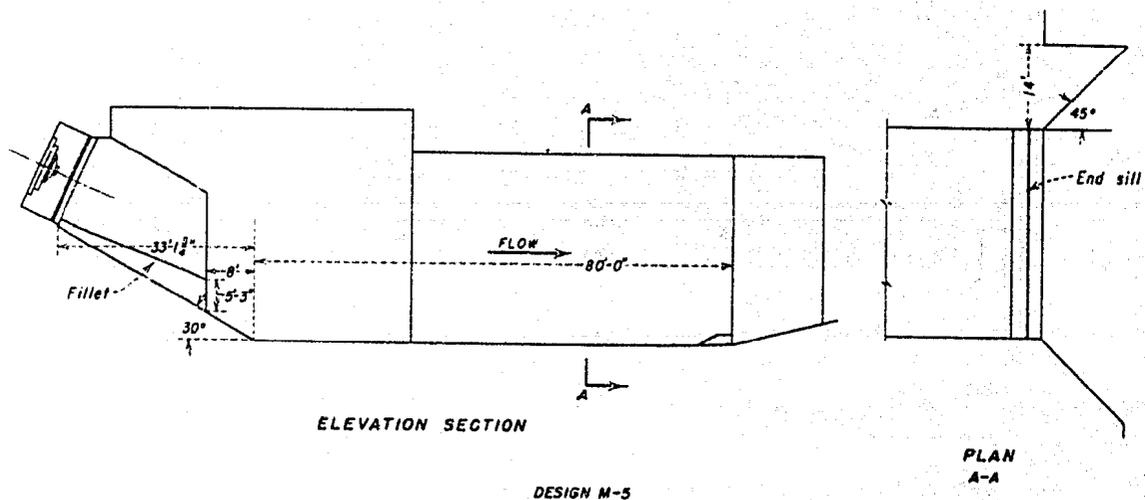
FALCON DAM  
 HYDRAULIC MODEL STUDIES  
 MEXICAN OUTLET WORKS  
 STILLING BASIN DESIGNS  
 MODEL SCALE 1:30

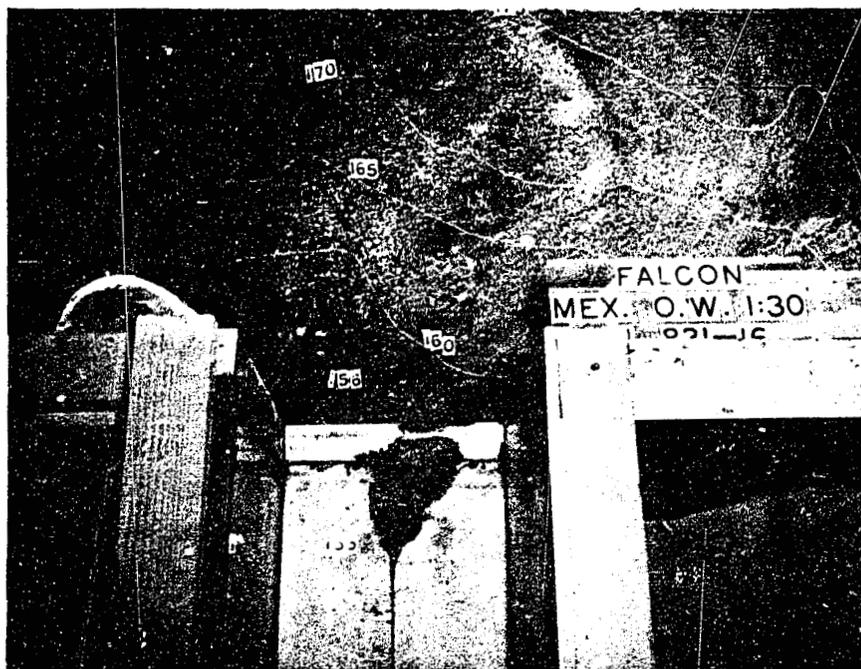
B. Erosion after a discharge of 2,400 cfs for 1 hour through left valve. Note sand deposited in basin.

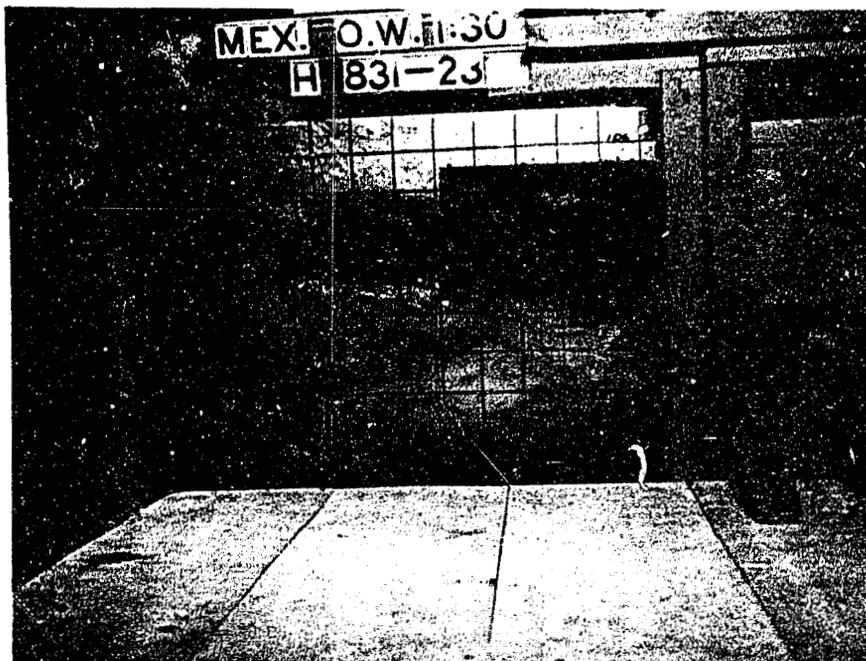
A. Design 4. Slope of inclined approach to basin  $24^{\circ}$ . Note slope of water surface from left to right.  $Q = 4,570$  cfs, both valves discharging. Flow from right to left.

THE MEXICAN OUTLET WORKS---DESIGNS M-4 AND M-5.  
WATER SURFACES IN THE STILLING BASIN.

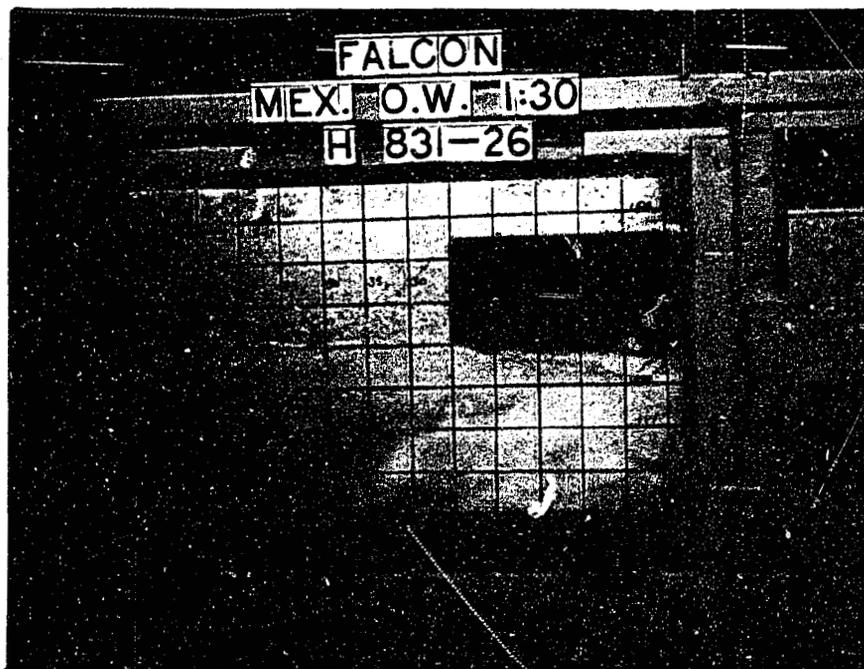
B. Design 5. Slope of inclined approach to basin  $30^{\circ}$ . Surface of water has approached the horizontal.  $Q = 4,570$  cfs, both valves discharging.

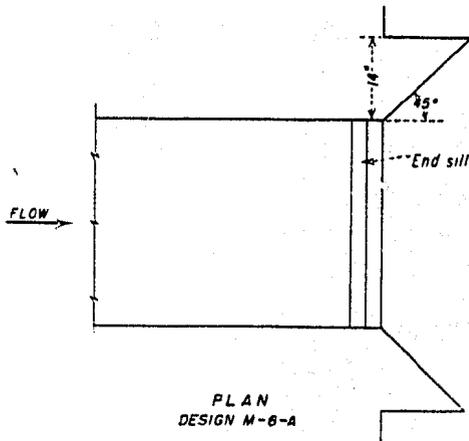
PLAN  
DESIGN M-6-A

DESIGN M-6  
UPSTREAM SECTION OF  
BASIN IS THE SAME AS  
DESIGN M-5

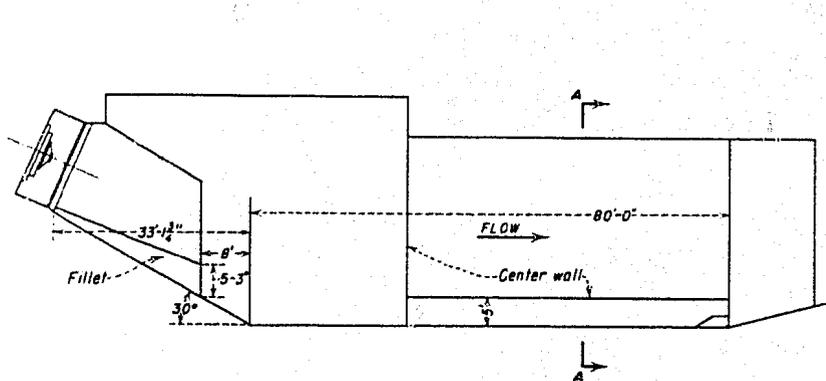
ELEVATION SECTION

DESIGN M-7

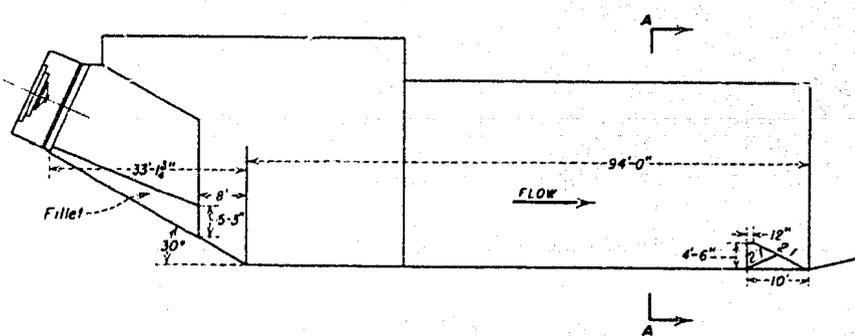
ELEVATION SECTION

DESIGN M-8

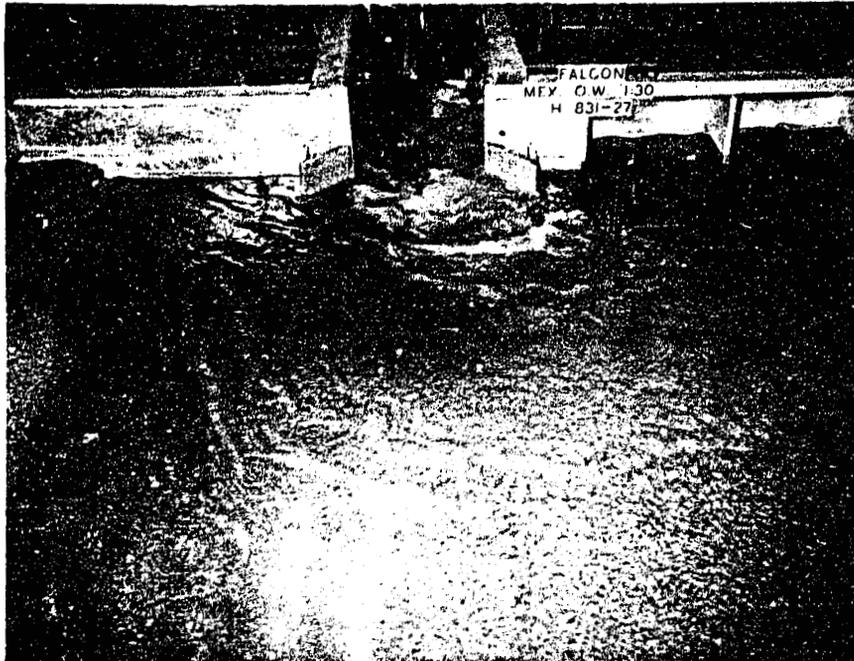
A. One valve discharging 2,400 cfs

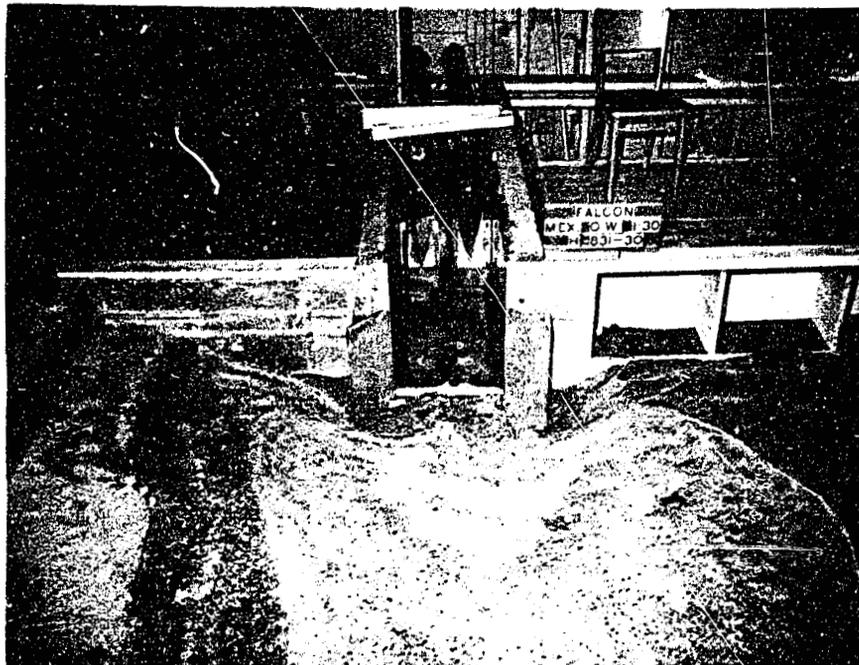
B. Erosion after a discharge of 2,400 cfs for 1 hour through left valve. Note that the erosion is below the elevation of the basin floor.

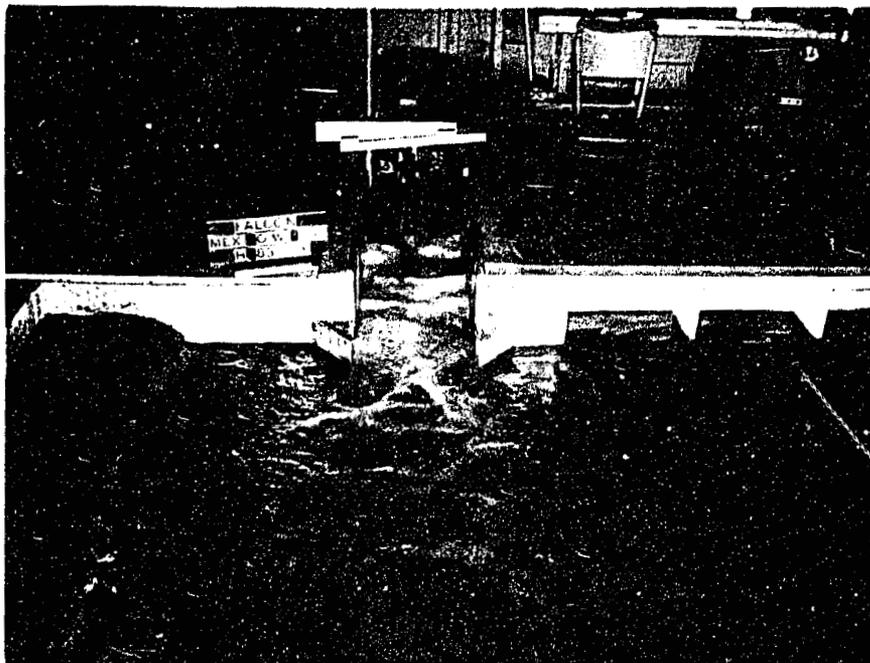
A. Action of the stilling basin. Both valves discharging--  
 $Q = 4,570$  cfs.

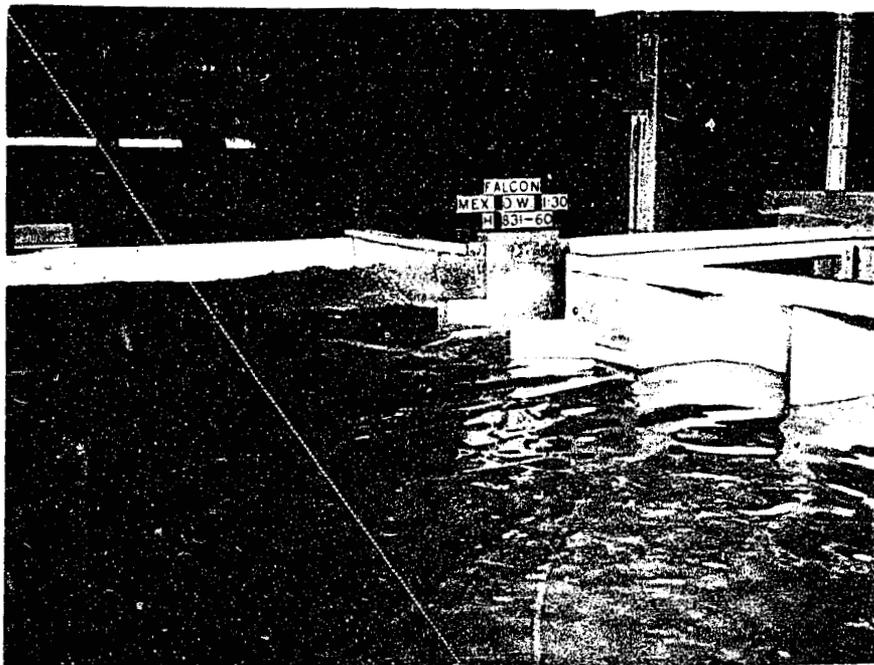
B. Water surface downstream from the basin. Both valves  
discharging-- $Q = 4,570$  cfs.

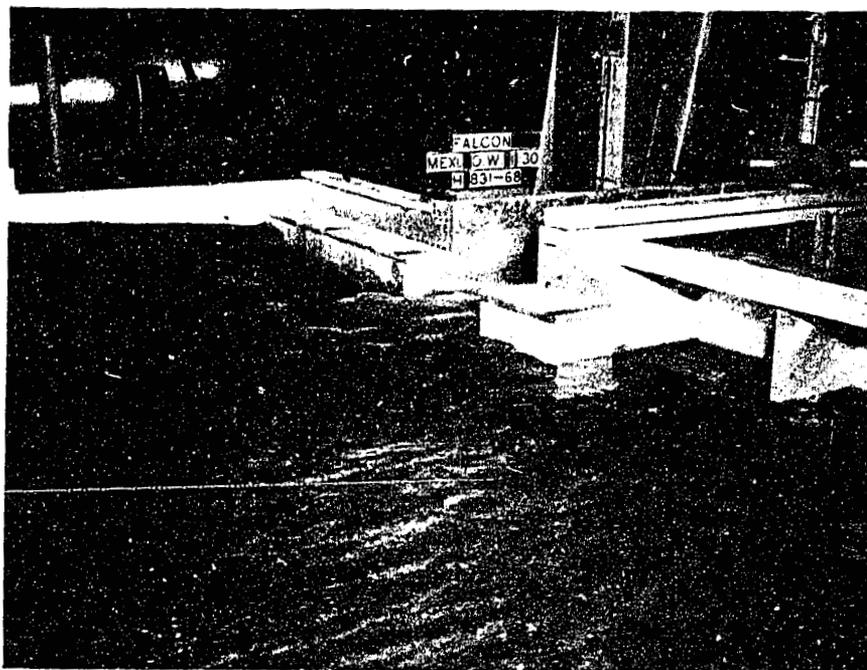
A. Water surface downstream from the stilling basin. Both valves discharging a total of 4,570 cfs.

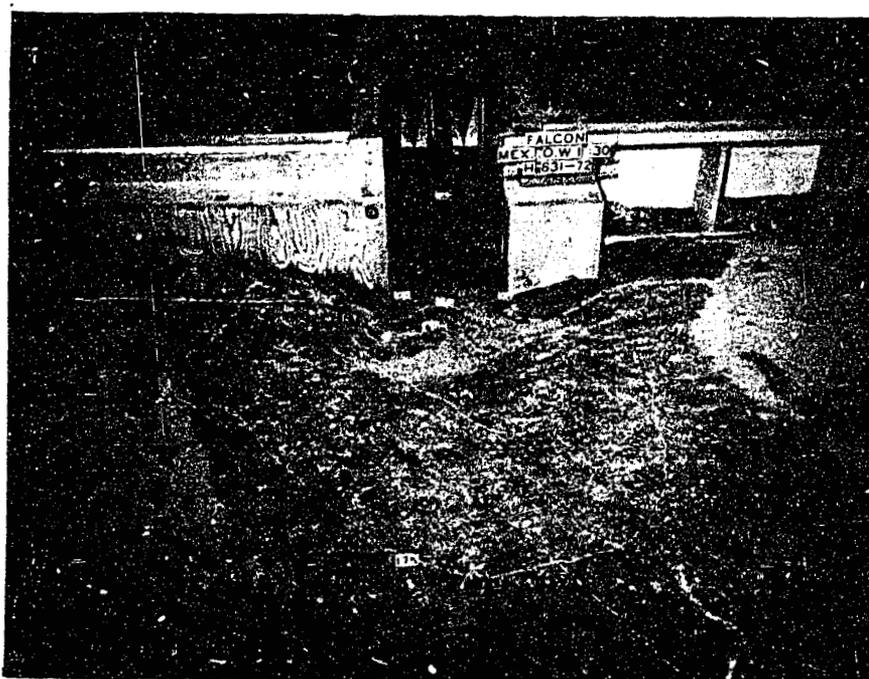
B. Erosion after a discharge of 4,570 for 1 hour through both valves.

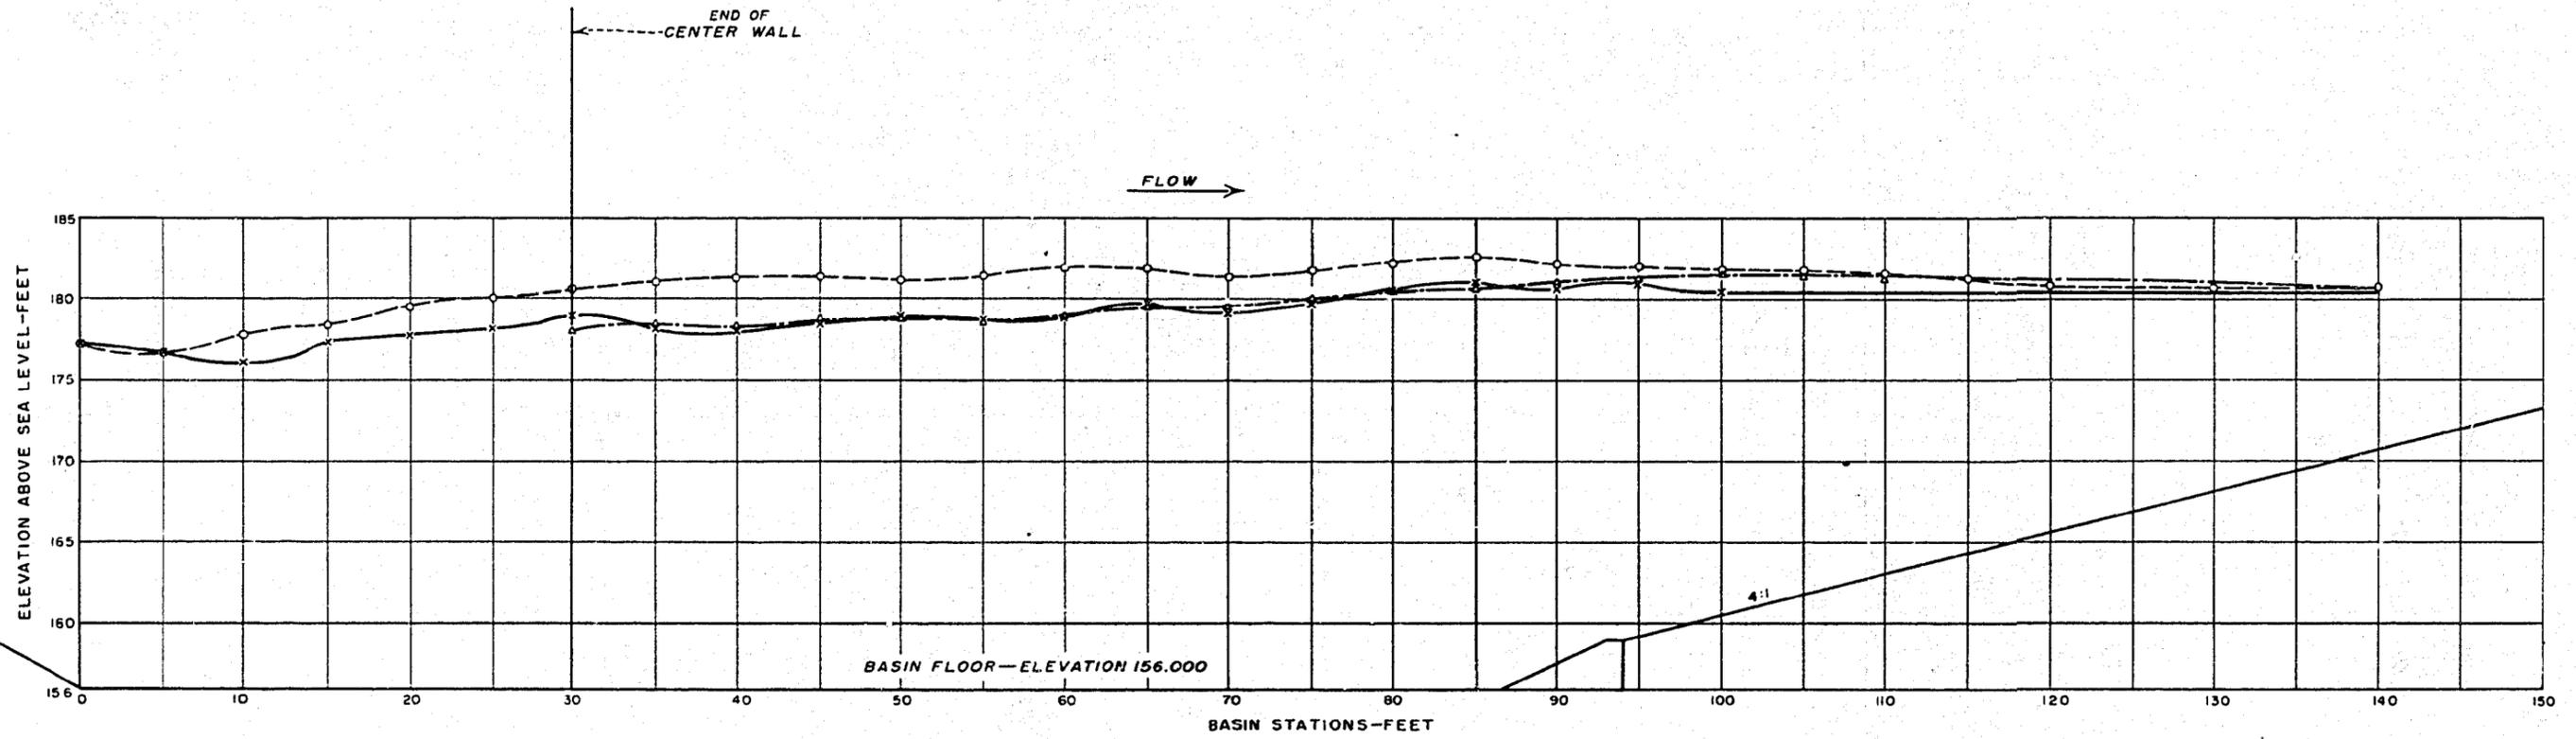
——— Q=4570 C.F.S. BOTH VALVES OPEN—PROFILE ALONG LEFT WALL  
 - - - Q=2400 C.F.S. LEFT VALVE OPEN—PROFILE ALONG LEFT WALL  
 - · - Q=4570 C.F.S. BOTH VALVES OPEN—PROFILE ALONG CENTERLINE OF BASIN.

**FALCON DAM**  
 HYDRAULIC MODEL STUDIES  
 MEXICAN OUTLET WORKS  
 WATER SURFACE PROFILE—RECOMMENDED DESIGN  
 MODEL SCALE 1:30
