UNITED STATES  
DEPARTMENT OF THE INTERIOR  
BUREAU OF RECLAMATION

# HYDRAULIC MODEL STUDIES OF FALCON DAM

Hydraulic Laboratory Report No. Hyd. 276

JULY 31, 1950

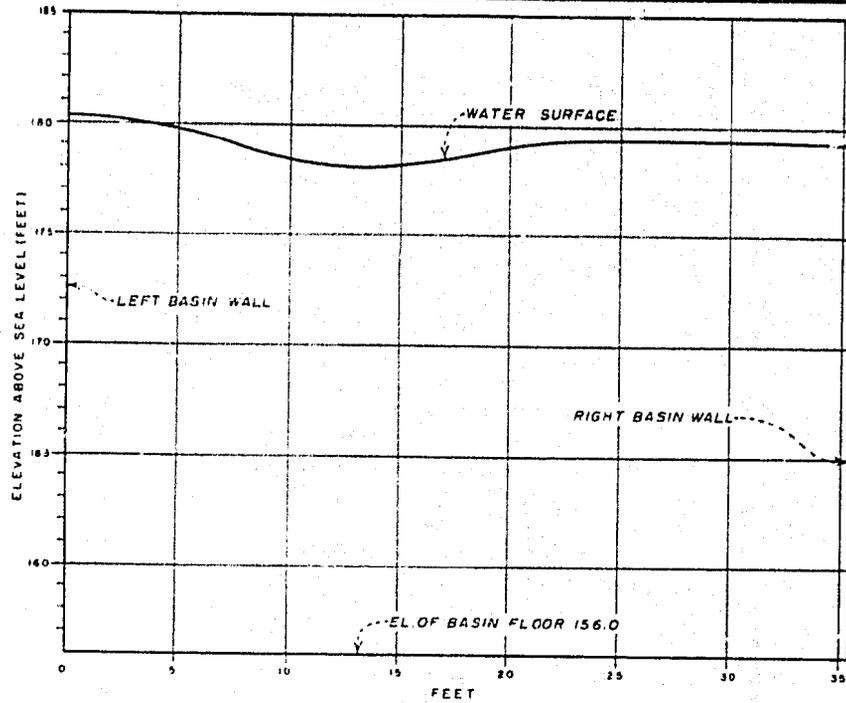
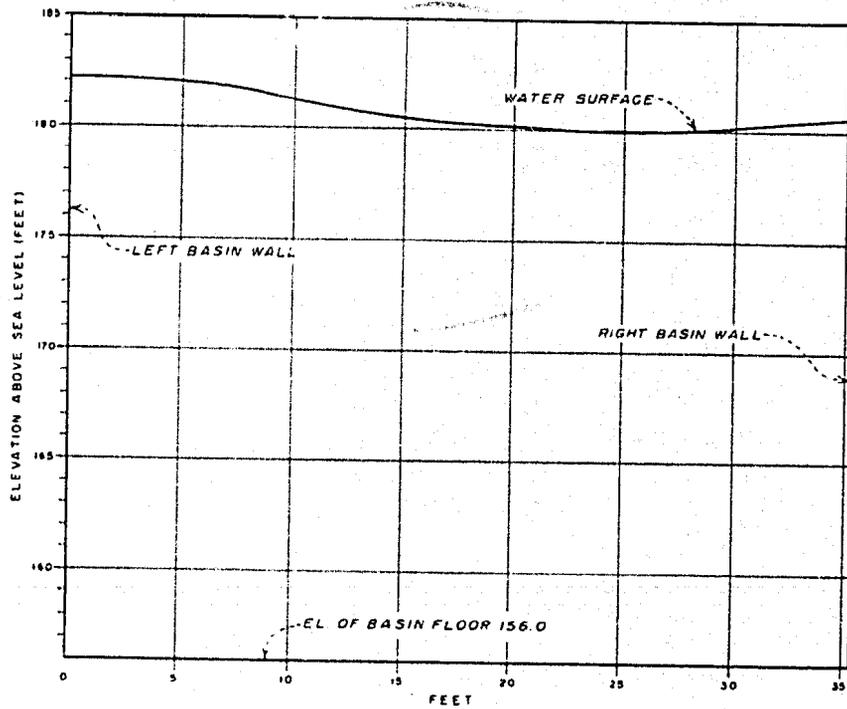
PROFILE AT END OF CENTER WALL

PROFILE AT END OF STILLING BASIN

NOTE  
 Q = 2,400 C.F.S.  
 LEFT VALVE ONLY DISCHARGING

FALCON DAM  
 HYDRAULIC MODEL STUDIES  
 MEXICAN OUTLET WORKS  
 TRANSVERSE WATER SURFACE  
 PROFILES IN STILLING BASIN  
 MODEL SCALE 1:30

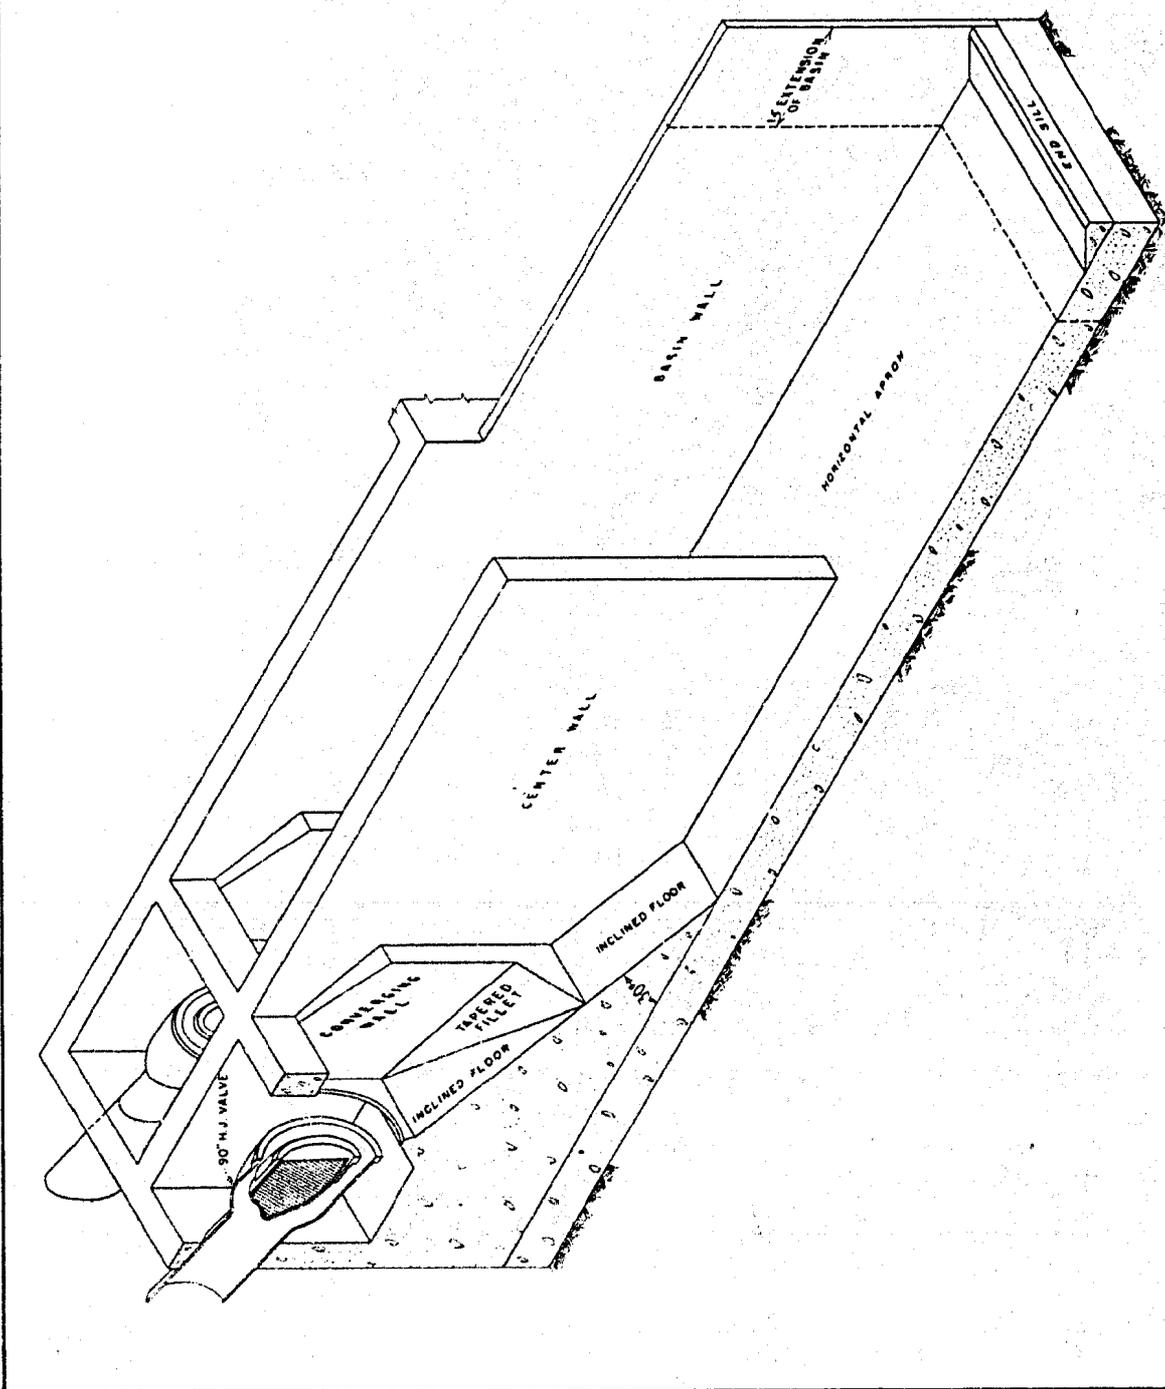
FALCON DAM  
HYDRAULIC MODEL STUDIES  
MEXICAN OUTLET WORKS  
STILLING BASIN FEATURES  
MODEL SCALE 1:30

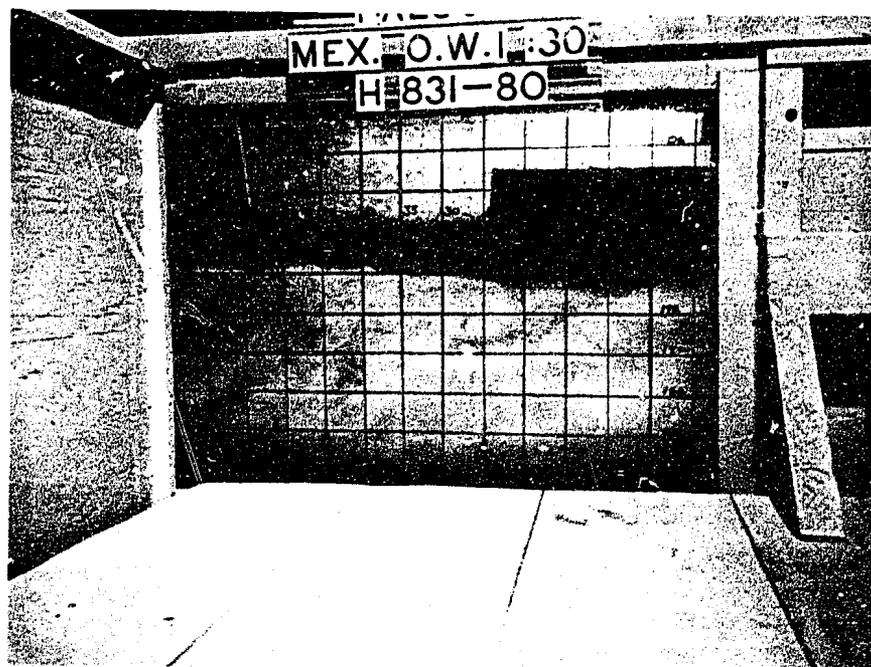
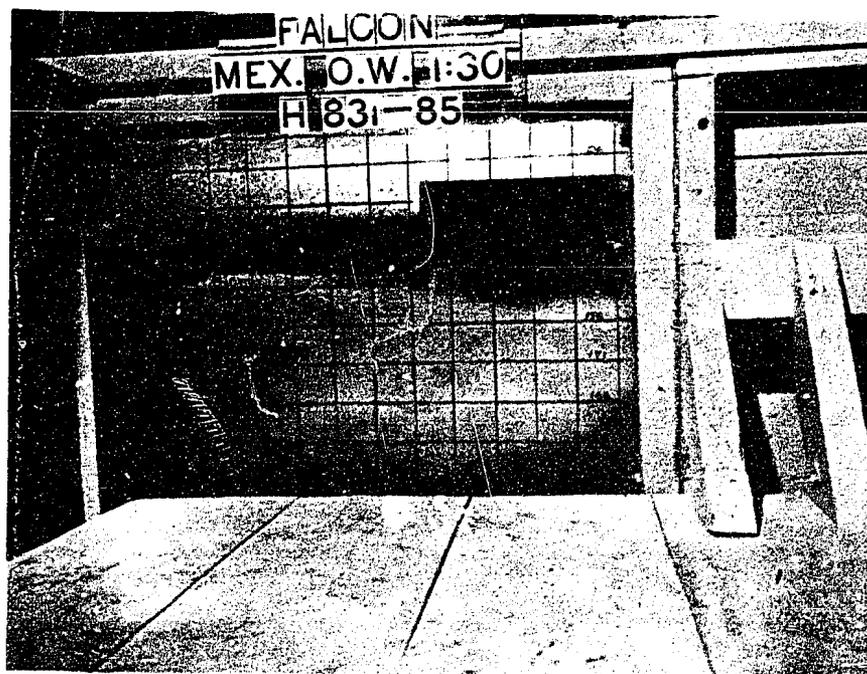
A. The left valve discharging 2,400 cfs.

B. Both valves discharging 4,570 cfs.

THE MEXICAN OUTLET WORKS--RECOMMENDED DESIGN.  
WATER SURFACES IN THE STILLING BASIN

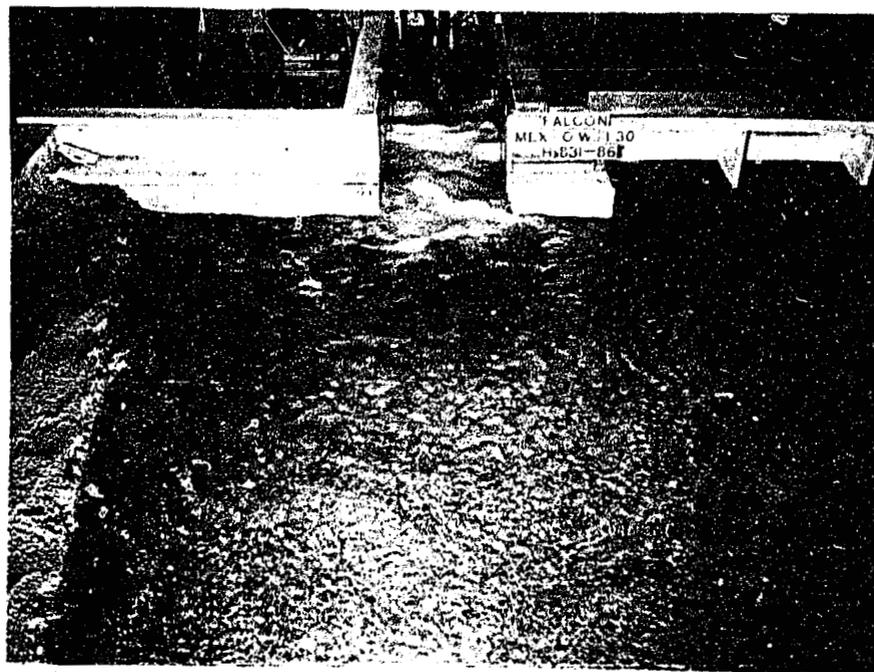
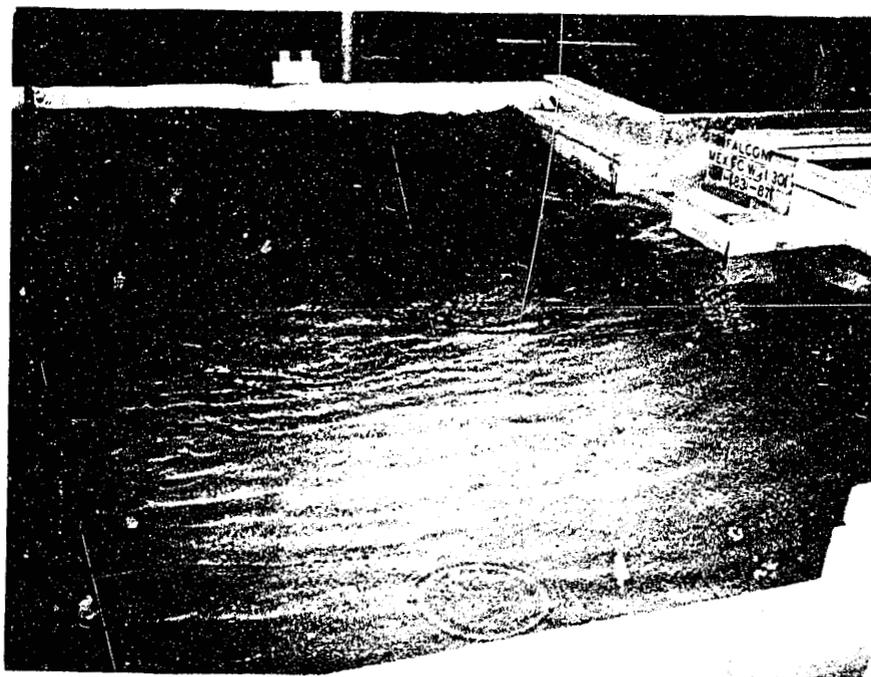
A. Action in the basin..

B. Flow in the channel.

MEXICAN OULET WORKS.--RECOMMENDED DESIGN.  
4,570 CFS, BOTH VALVES DISCHARGING.

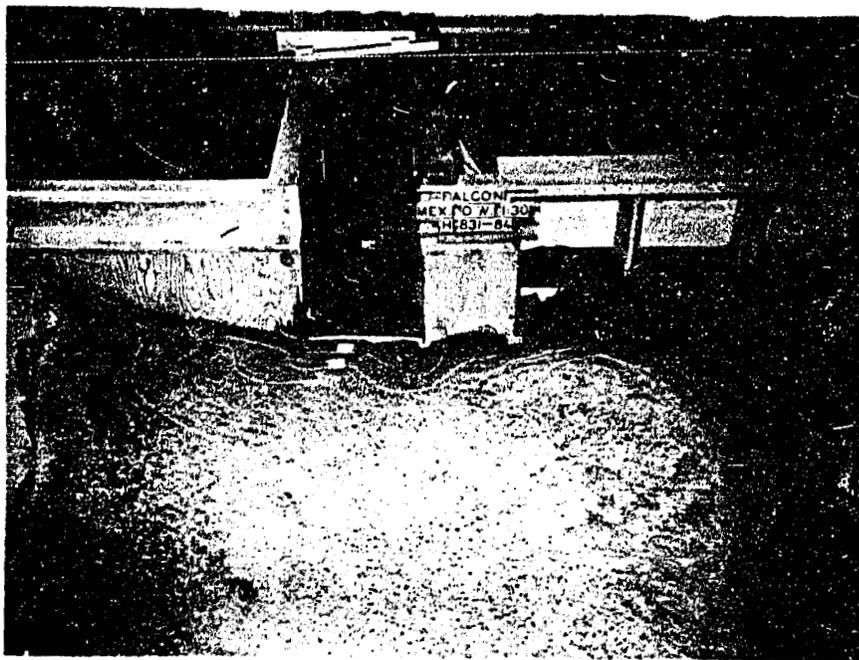
A. Erosion after a discharge of 2,400 cfs for 1 hour through left valve.

B. Erosion after a discharge of 4,570 cfs for 1 hour through both valves.

THE MEXICAN OULET WORKS.--RECOMMENDED DESIGN.  
EROSION DOWNSTREAM FROM STILLING BASIN.

There was no severe erosion, downstream from the basin, Figures 64A and B, for any condition tested. After two valves had discharged a total of 4,570 cfs for 1 hour, the maximum erosion was still 1 foot above the floor of the basin. After a discharge of 2,400 cfs through one valve for 1 hour, the erosion depth was found to be the same as for two valves operating. Although a small amount of sand was carried

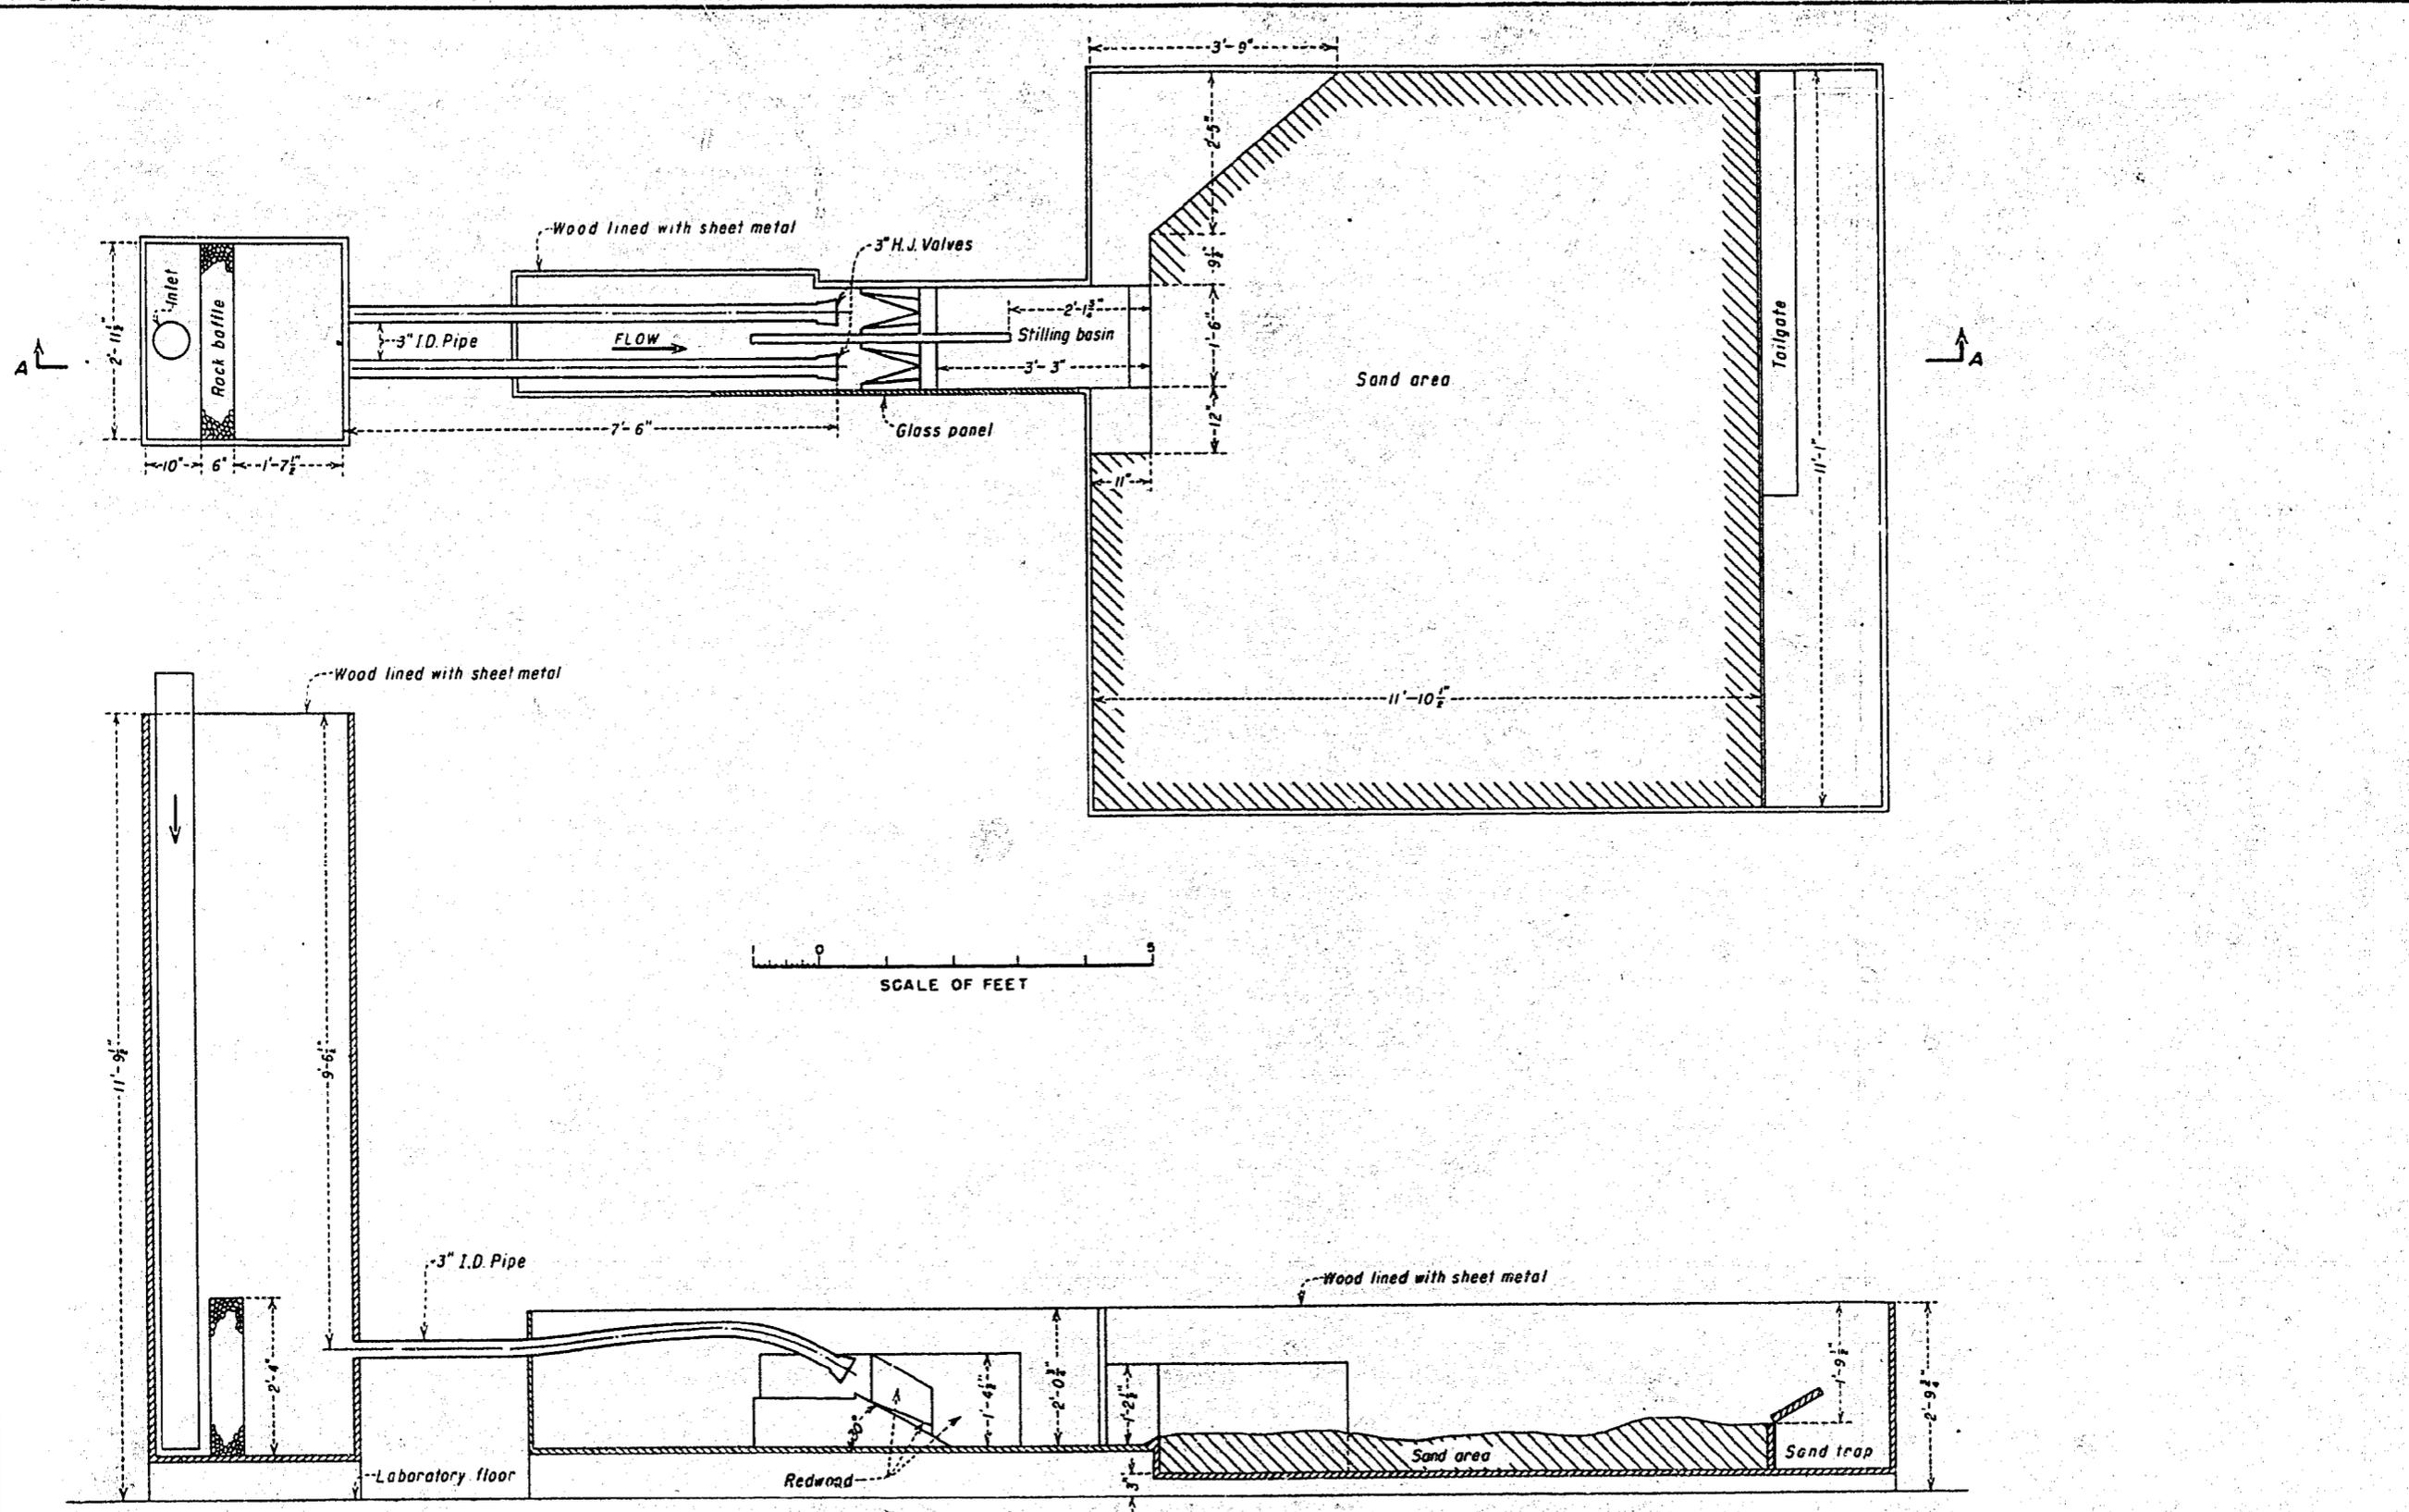
SECTION A-A

FALCON DAM  
 HYDRAULIC MODEL STUDIES  
 UNITED STATES OUTLET WORKS  
 MODEL ARRANGEMENT  
 MODEL SCALE 1:24

Included in the model (Figure 65) were two hollow-jet valves with approach conduits, a head box, a stilling basin, approximately 250 feet of downstream channel and a tail box equipped with an adjustable gate. No provisions were made to duplicate the powerhouse tailrace, as tests on the Mexican outlet works had shown that hydraulic conditions were no worse with the powerhouse discharging.

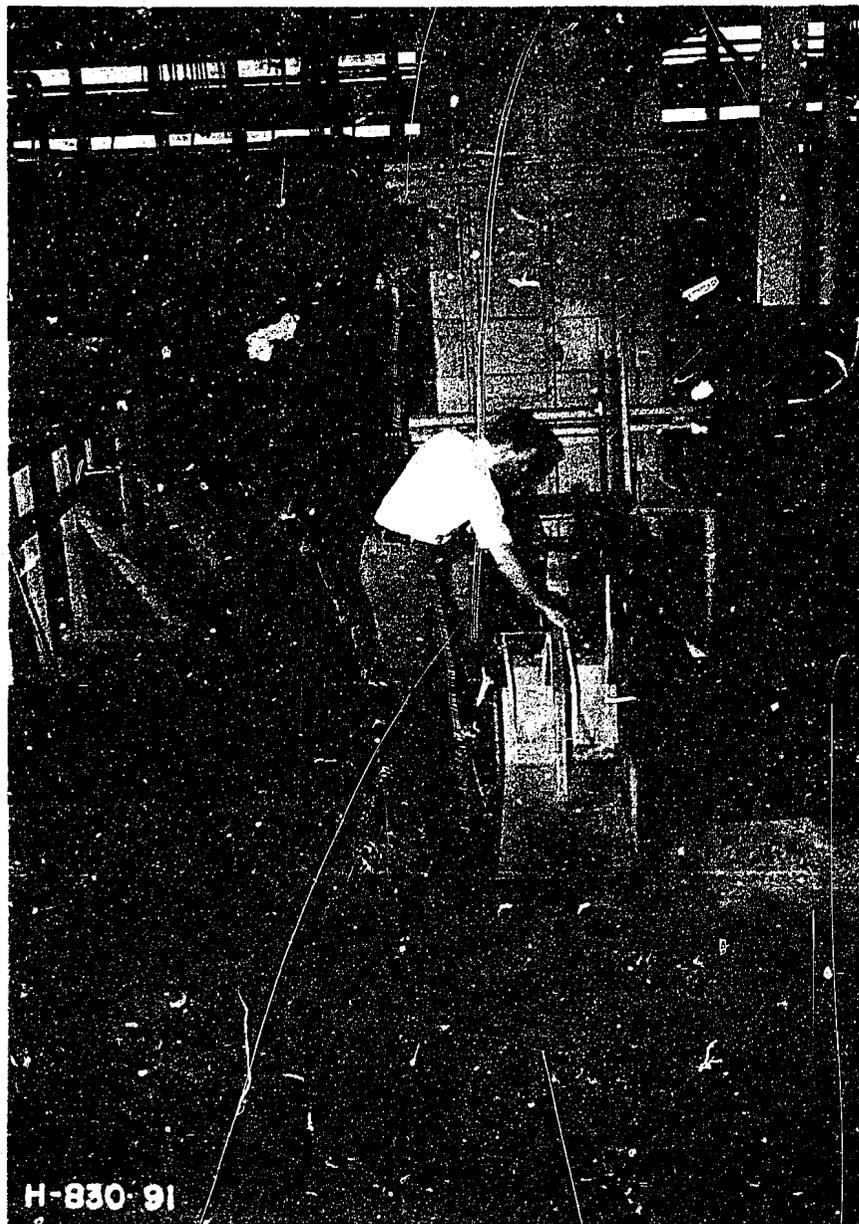
Note the two valves, the horizontal floor, the wing wall arrangement, and the sand in tailrace channel.

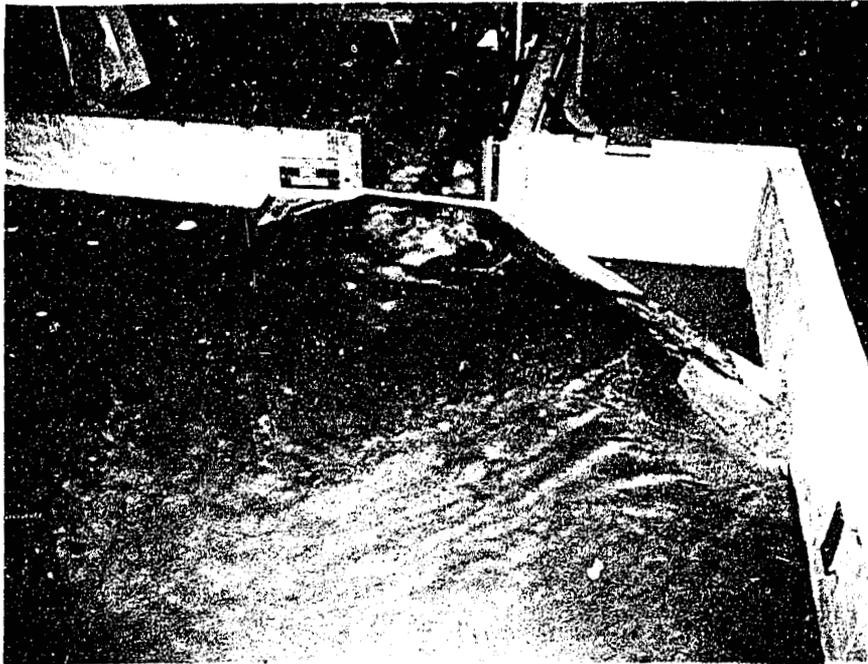
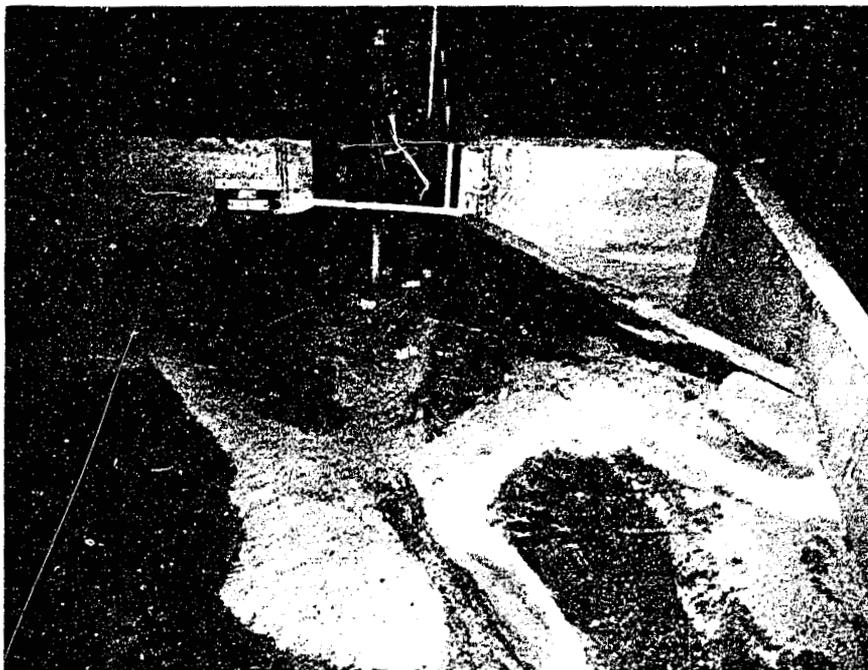
A. Operation of stilling basin. Both valves discharging a total of 2,920 cfs. Note violent water surface.

B. Erosion after a discharge of 2,920 cfs through two valves for 1 hour.

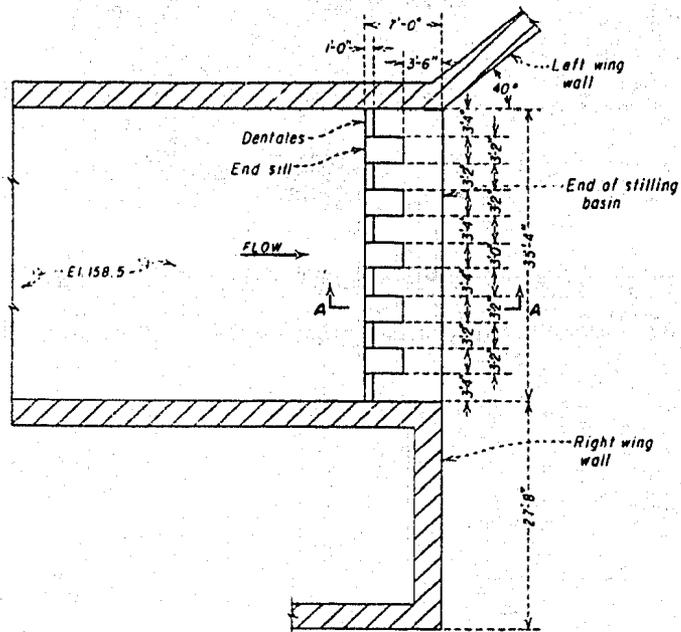
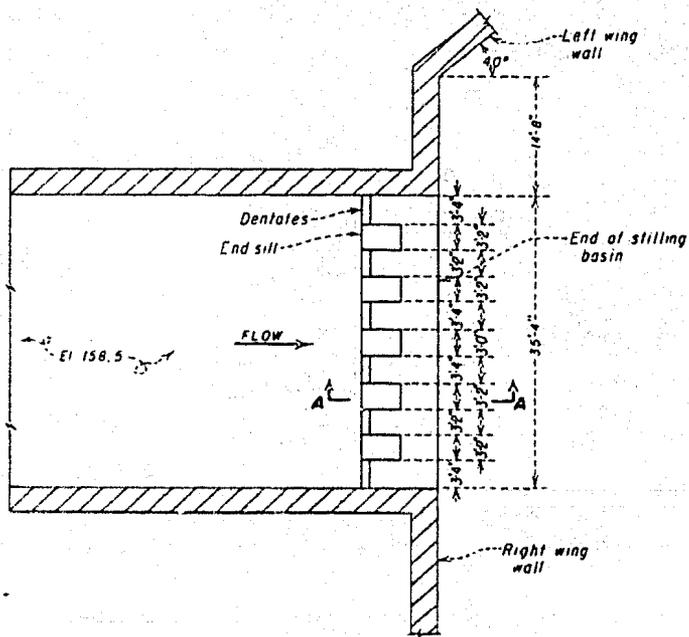
SECTIONAL PLAN  
DESIGN A-2

SECTIONAL PLAN  
DESIGN A-3

Note Upstream end of basin and basin length same as recommended design

**FALCON DAM**  
HYDRAULIC MODEL STUDIES  
UNITED STATES OUTLET WORKS  
STILLING BASIN DESIGNS  
MODEL SCALE 1:24

In Design A-3 the 40° wing wall was changed to a 90° wing wall, 14 feet 8 inches long at the end of the left side of the basin, as shown in Figure 70. Tests on this wall arrangement showed that the eddy previously noted was not directed back into the basin, Figure 72A, but tended to stay downstream. As a result the amount of sand returned to the basin was reduced considerably, as shown in Figure 72B.

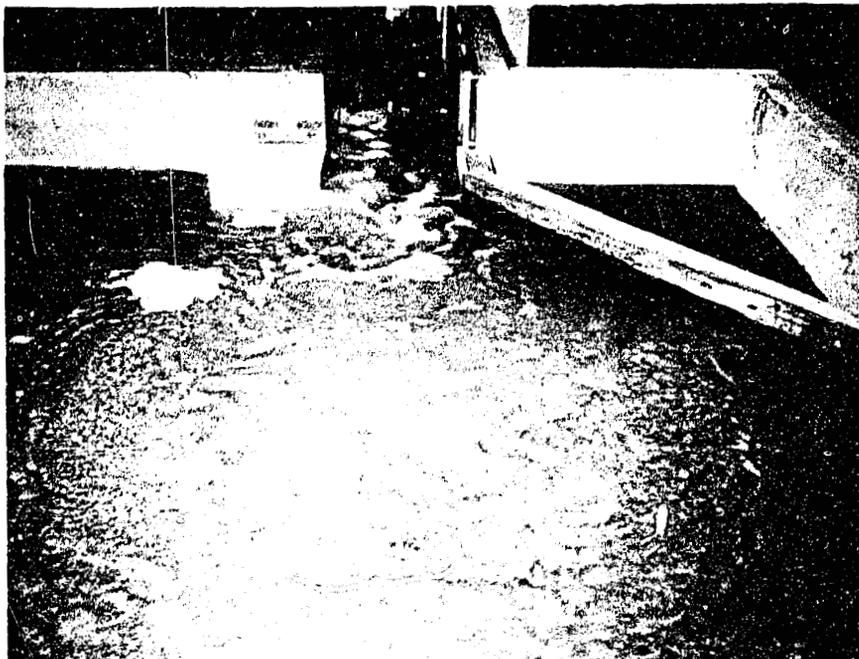
A. Operation of stilling basin. Right valve discharging 1,600 cfs.

B. Erosion after discharge of 1,600 cfs through right valve for 1 hour. Note sand deposited in basin.

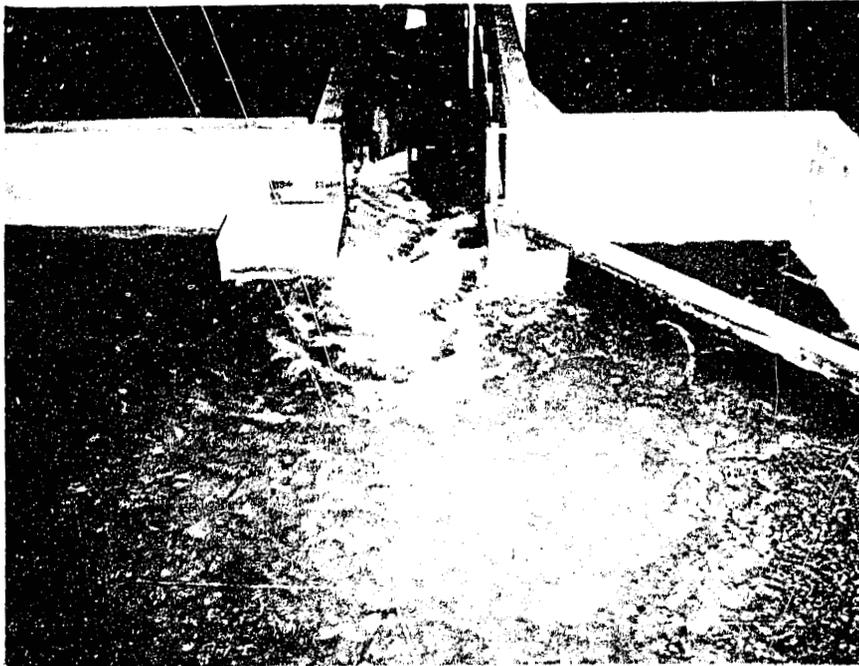
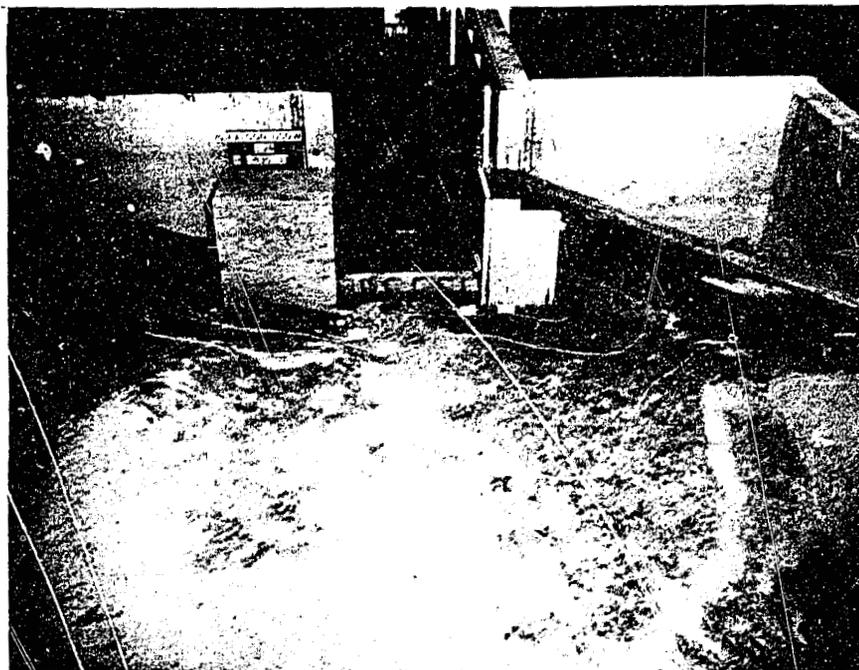
A. Operation of stilling basin. Right valve discharging 1,600 cfs.

B. Erosion after a discharge of 1,600 cfs for 1 hour through right valve. Note reduction in sand deposited in basin.

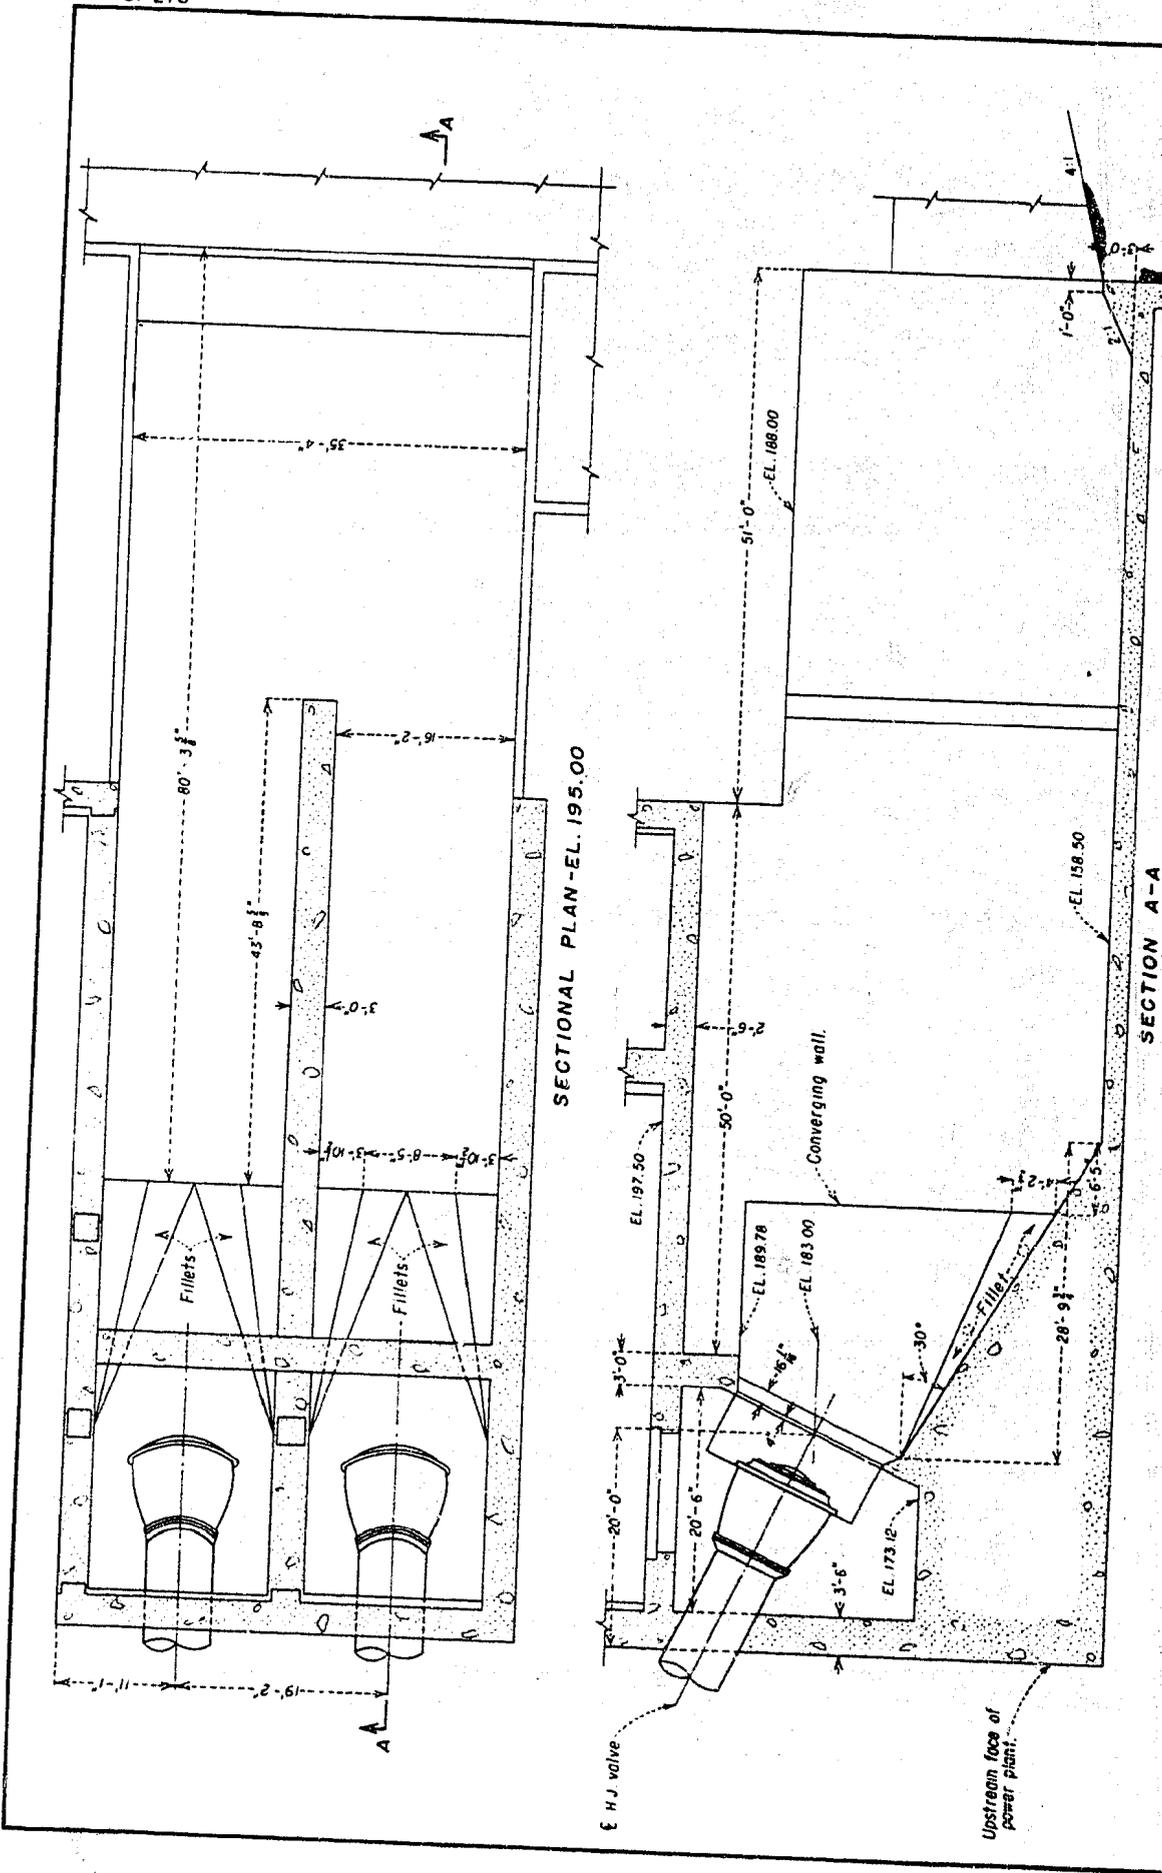
**FALCON DAM**  
 HYDRAULIC MODEL STUDIES  
 UNITED STATES OUTLET WORKS  
 RECOMMENDED DESIGN  
 MODEL SCALE 1:24

The recommended design was similar to Design A-3, but an end sill 3 feet high was installed on the end of the apron. This sill was

previously found to be satisfactory for the Mexican outlet works and also improved Design A-3. The recommended design is shown in Figure 73. Tests on this design showed satisfactory operation both with one valve, Figures 74A and B and 75A, and with two valves, Figures 75B and 76A and B. With both valves operating the water surface downstream from the basin was relatively quiet. No severe erosion occurred downstream in the basin. After 1 hour the maximum scour was to elevation 158, or 0.5 foot below the basin floor which occurred 5 feet downstream from the end of the apron, Figure 77A.

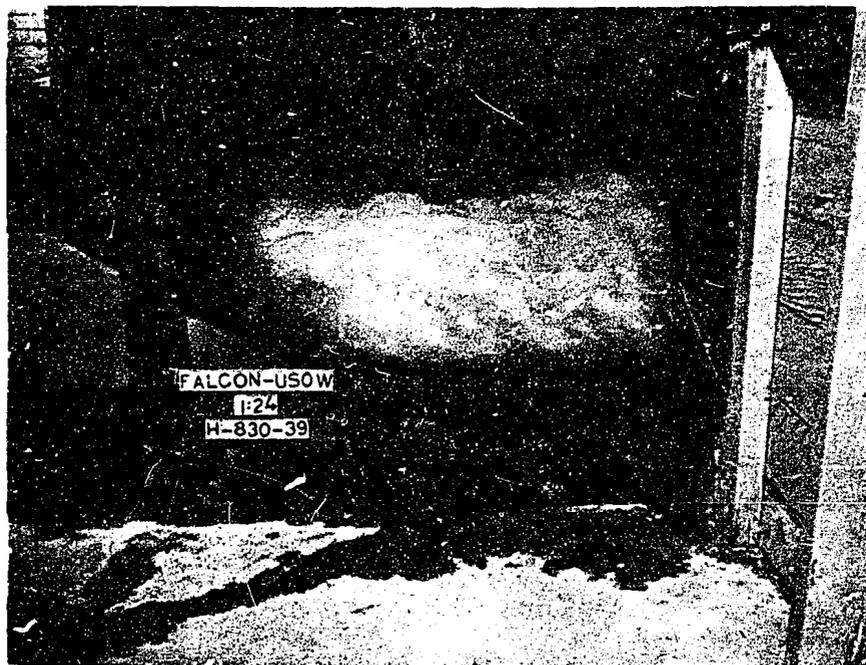
A. Both valves discharging a total of 2,920 cfs.  
Tailwater elevation 180.8.

B. Both valves discharging total of 2,920 cfs.  
Note how the flow travels along the floor.

THE UNITED STATES OUTLET WORKS. RECOMMENDED DESIGN.  
OPERATION OF STILLING BASIN.

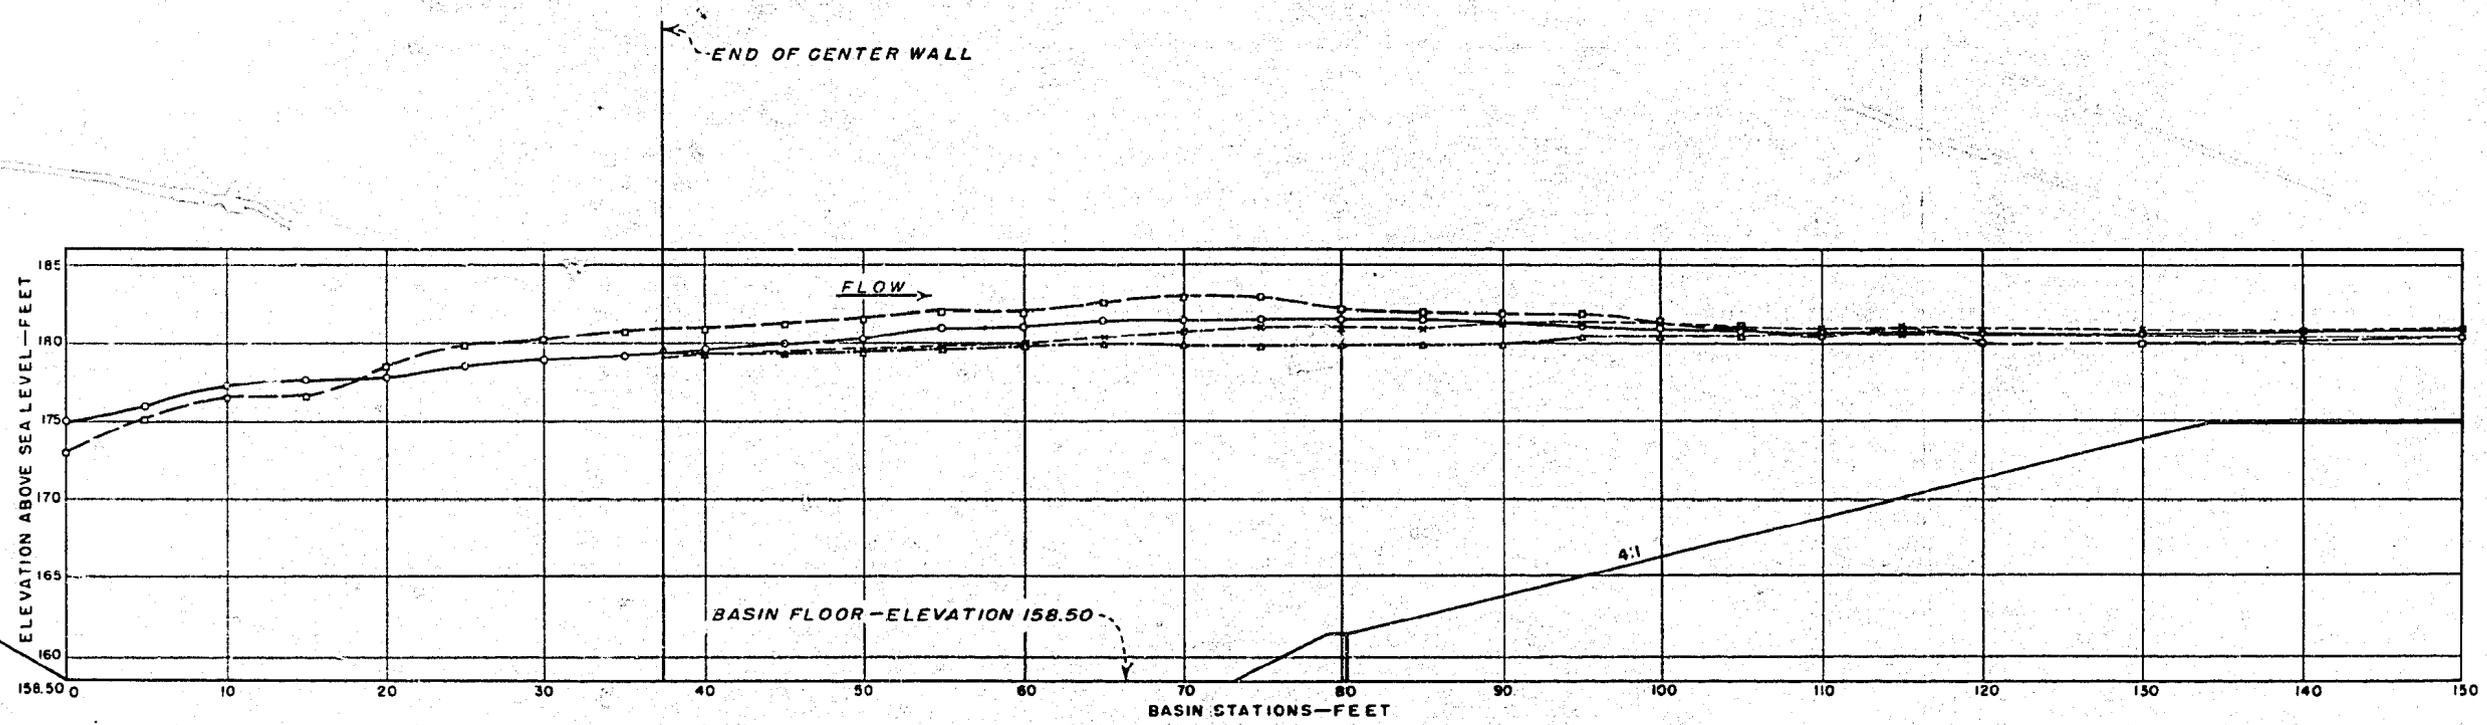
- Q=2920 C.F.S. BOTH VALVES OPEN—PROFILE ALONG RIGHT WALL
- -○- - Q=2920 C.F.S. BOTH VALVES OPEN—PROFILE ALONG CENTERLINE OF BASIN
- Q=1600 C.F.S. RIGHT VALVE OPEN—PROFILE ALONG CENTERLINE OF BASIN
- -□- - Q=1600 C.F.S. RIGHT VALVE OPEN—PROFILE ALONG RIGHT WALL

FALCON DAM  
 HYDRAULIC MODEL STUDIES  
 UNITED STATES OUTLET WORKS  
 WATER SURFACE PROFILES  
 RECOMMENDED DESIGN  
 MODEL SCALE 1:24

Water surface profiles were taken, both transversely and longitudinally for maximum discharge with one and both valves operating, Figures 78 and 79. These profiles show the relatively level water surface in the basin for the most critical operating conditions.

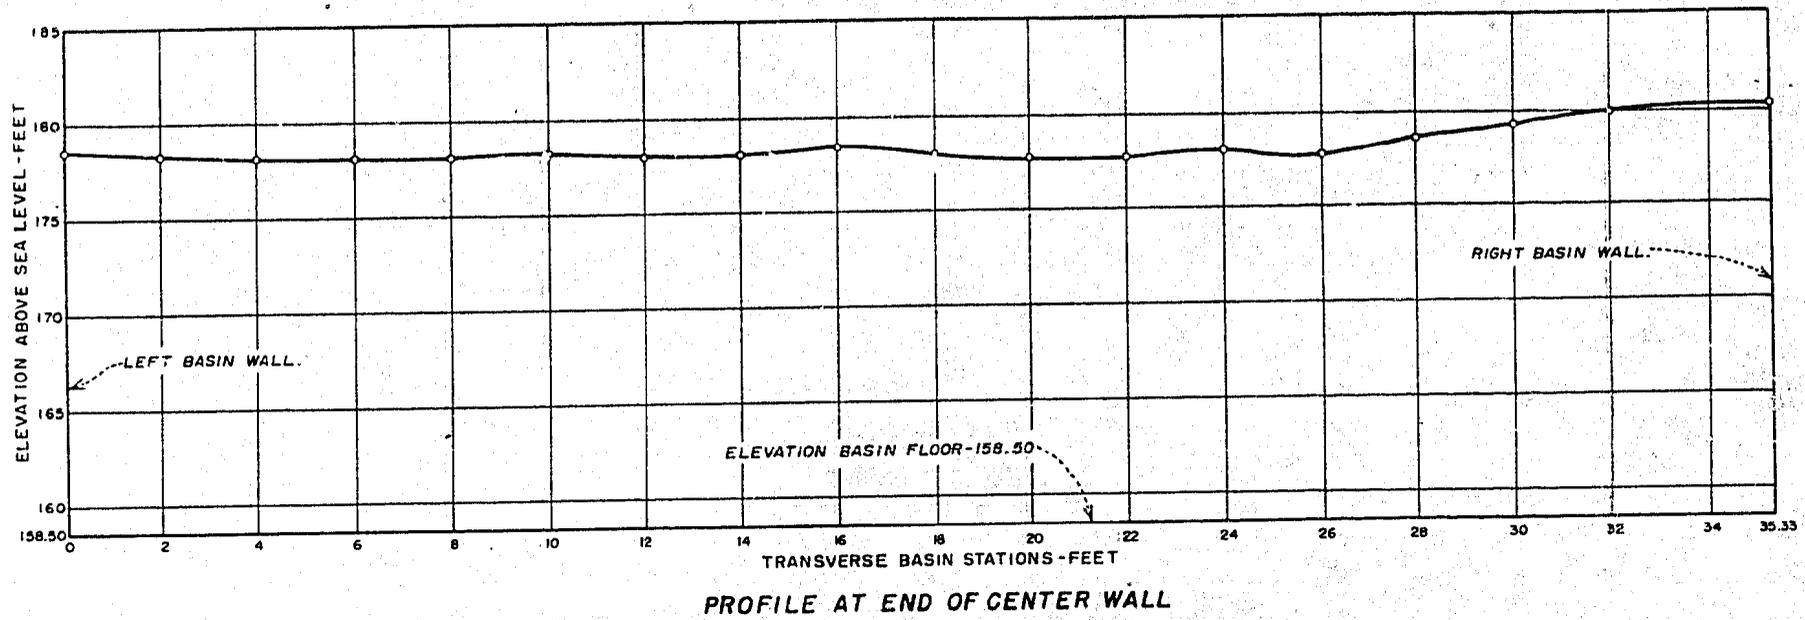
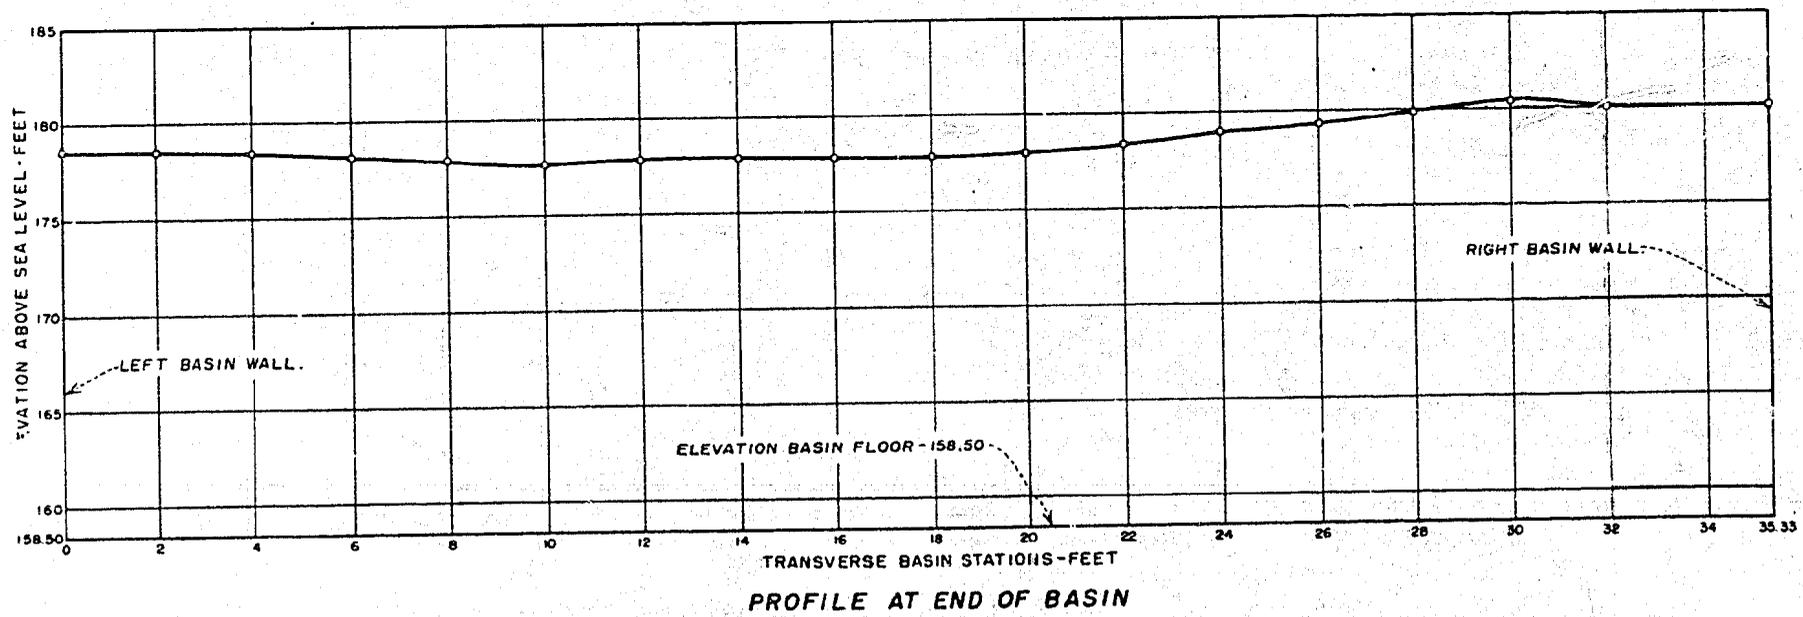
**NOTE**  
 Q = 1600 CFS - RIGHT VALVE ONLY DISCHARGING.

**FALCON DAM**  
 HYDRAULIC MODEL STUDIES  
 UNITED STATES OUTLET WORKS  
 TRANSVERSE WATER SURFACE  
 PROFILES IN STILLING BASIN  
 MODEL SCALE 1:24
