UNITED STATES
DEPARTMENT OF THE INTERIOR
BUREAU OF RECLAMATION

MEMORANDUM TO CHIEF DESIGNING ENGINEER
SUBJECT: HYDRAULIC MODEL STUDIES FOR THE
DESIGN OF CANAL CHUTES

HYD 3.6
TECHNICAL MEMORANDUM NO. 458

MILL COULEE CANAL CHUTE DROP - STA. 259 + 35

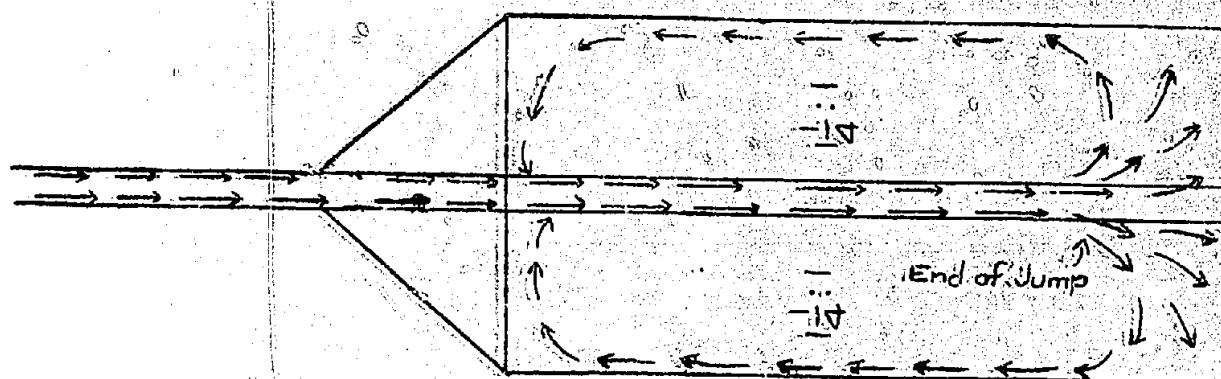
This chute has an objectionable feature from a hydraulic standpoint. It is practically impossible to obtain a good stable hydraulic jump in a trapezoidal pool which has side slopes as flat as $1\frac{1}{2}:1$ and especially so when the width of the chute is small compared with the width of the pool. The sketch below demonstrates the action which is inevitably found in stilling pools of this general shape.

The narrow jet of water issuing from the chute does not spread; consequently, the jump is effective only in the center of the pool. Due to the difference in elevation between the tailwater and the water surface at the front of the jump, a continual flow in an upstream direction persists on both sides of the pool as there is no force present to oppose it. The potential energy innate in the tailwater causes a portion of the water leaving the jump to part in opposite directions, turn, and flow back along the sides of the pool.

This water again contacts the jet which is entering the pool, goes thru the jump, and a portion of it again returns by way of the sides of the pool to recontact the jet. As a result, the water in the pool assumes a constant whirling motion in both directions as indicated by the sketch.

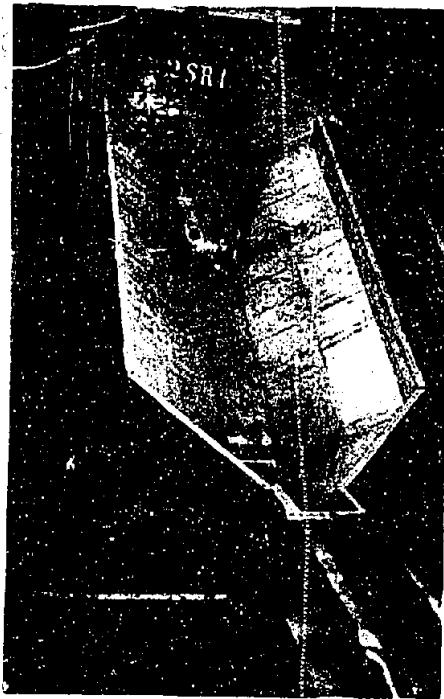
A. VIEW OF STILLING POOL AND
LOWER PORTION OF CHUTE.

Photographs of the original design are shown in views A and B, plate 1. Photograph A shows the model as originally designed, and photograph B shows the stilling pool in operation for the maximum discharge and corresponding tailwater. The purpose of the "nubbins" on the sloping floor at the downstream end of the pool was to aid in keeping the jump in the pool at low tailwater depths. Notice in photograph B that the jump is only effective in the center of the pool. Also notice the water flowing back on each side of the jump. Test 2-1 (figure 4) shows a profile of the water surface in the pool measured along the center line. The beginning and end of the roller is indicated in this and the following profiles. The beginning of the roller was located from inspection and the end was located by dropping a chip of wood on the water until a point was found at which it was carried in either direction. Velocity measurements were taken on the center line of the pool by means of a pitot tube, and these results are plotted to scale on the profile drawings. The photographs in some cases are of more value than the plotted profiles as they show the general action over the entire pool, while the profiles indicate conditions on the center line where the action is at its best.

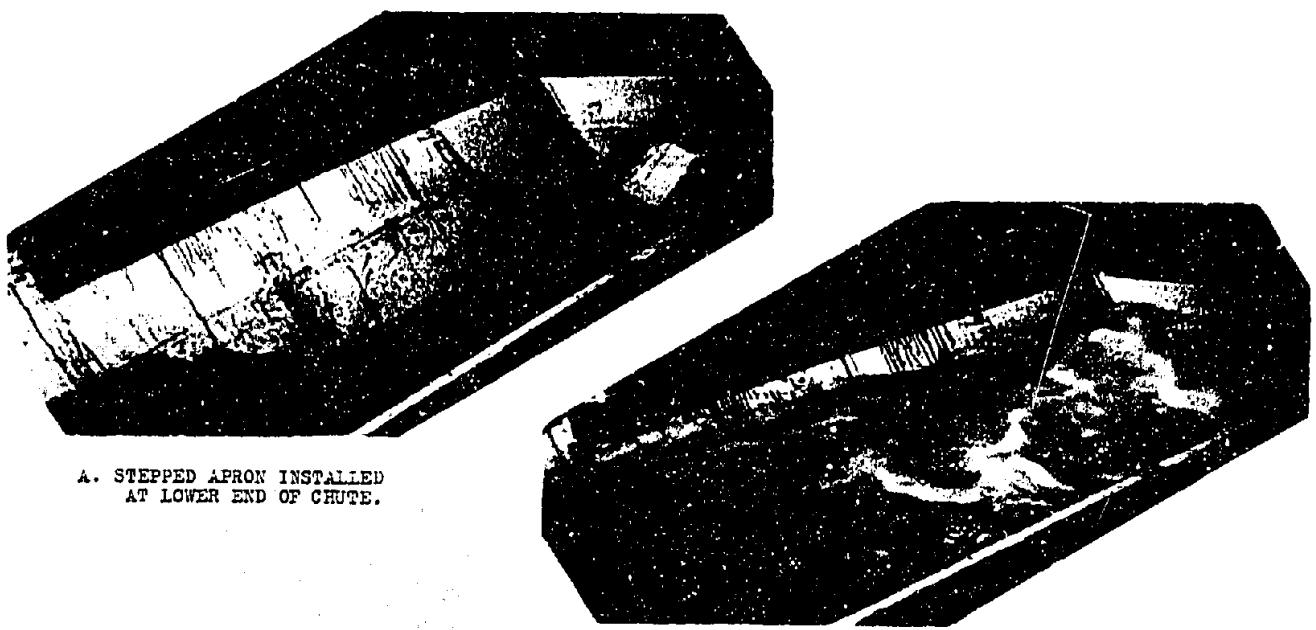
A. STEPPED APRON INSTALLED
AT LOWER END OF CHUTE.

B. DISCHARGE 139 SECOND-FEET.
STEPPED APRON 0.83 FOOT
ABOVE POOL FLOOR.

In another attempt to spread the jet and in this case lift it off the floor, a stepped apron was built into the lower end of the chute as shown in test 1-1 (figure 5) and photograph A (plate 2). The downstream end of the apron was 1.0 foot above the pool floor. A very good velocity distribution was obtained with this stepped apron but, contrary to expectations, the length of the roller was exceptionally long. Photograph C (plate 2) shows this pool in action for the maximum discharge. Notice that the jump is still confined to the center of the pool and that all efforts so far made have failed to prevent the back flow near the sides.

Two other stepped aprons were tried in tests 4-1 and 5-1 (figure 5). The lower ends of these were 0.83 and 0.62 feet, respectively, above the pool floor. Photograph B (plate 2) was taken of the pool during test 4-1 and photograph D was taken during test 5-1. There is a negligible difference between these tests as can be observed from the profile plots. The length of jump is shorter in the latter two tests than in test 1-1, but the velocity distribution in the center of the pool using the highest apron is preferable.

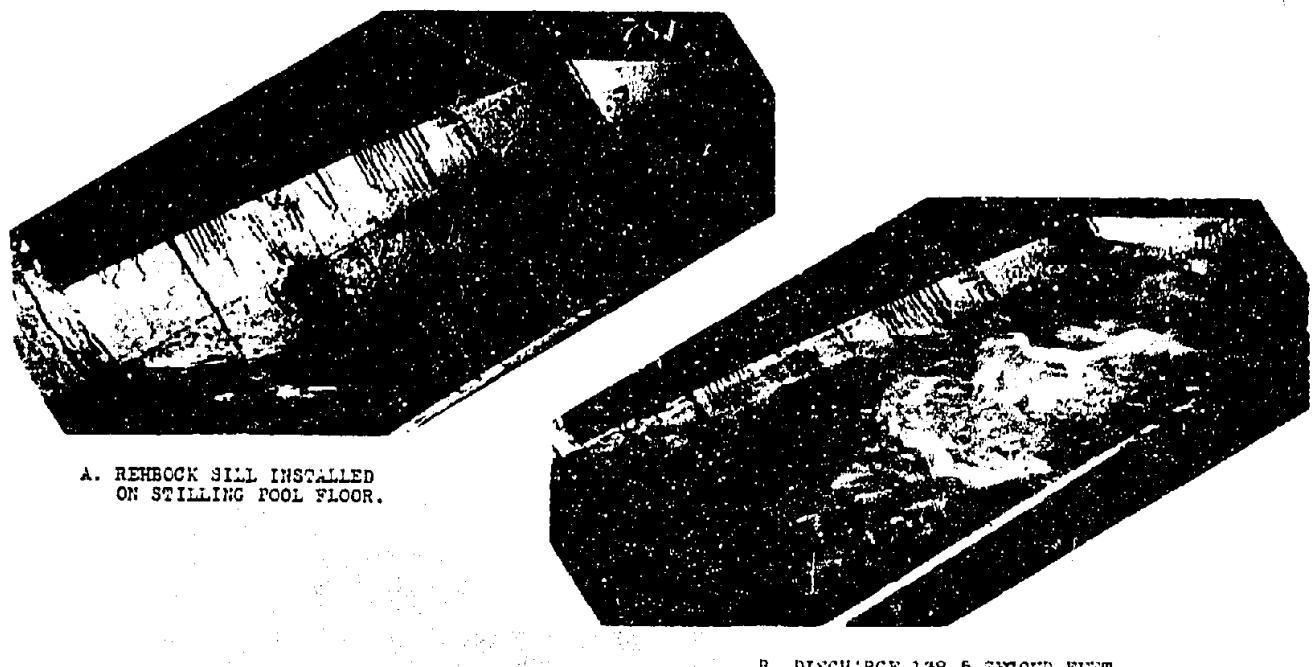
A. REHBOCK SILL INSTALLED
ON STILLING POOL FLOOR.

B. DISCHARGE 138.5 SECOND-FEET.
REHBOCK SILL INSTALLED.

The false slope was removed and a small Rehbock sill was installed on the pool floor at station 266+03.40 as shown in test 7-1, figure 4. The sill was very effective in improving the velocity distribution and energy dissipation in the center of the pool, but the same back flow conditions existed along the side walls. Photograph A (plate 3) shows the sill installed, and photograph B shows the pool for a discharge of 138.5 c.f.s.

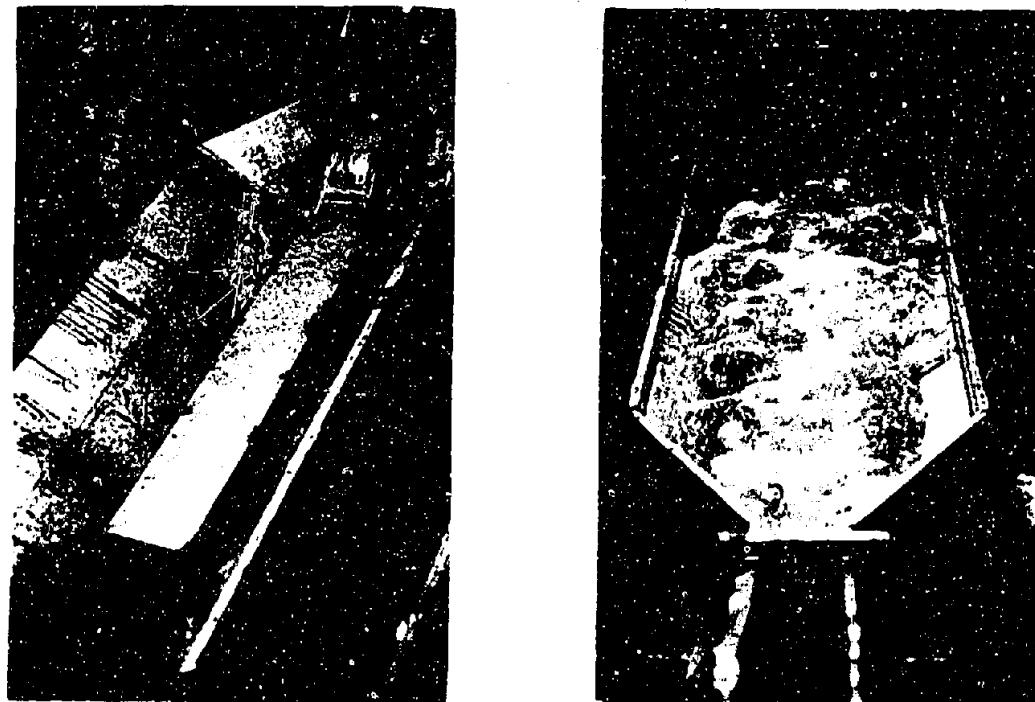
C. FALSE FLOOR INSTALLED
0.83 FOOT ABOVE
ORIGINAL POOL FLOOR.

D. DISCHARGE 138.5 SECOND-FEET.
FALSE FLOOR INSTALLED.

In another attempt to improve pool conditions, a false floor was installed 0.83 feet above the original pool floor as shown on the profile for test 6-1 (figure 6) and in photograph C (plate 3). Photograph D shows the pool in action for maximum discharge with the false floor installed. A slight improvement was noticeable but pool conditions in general were materially unchanged.

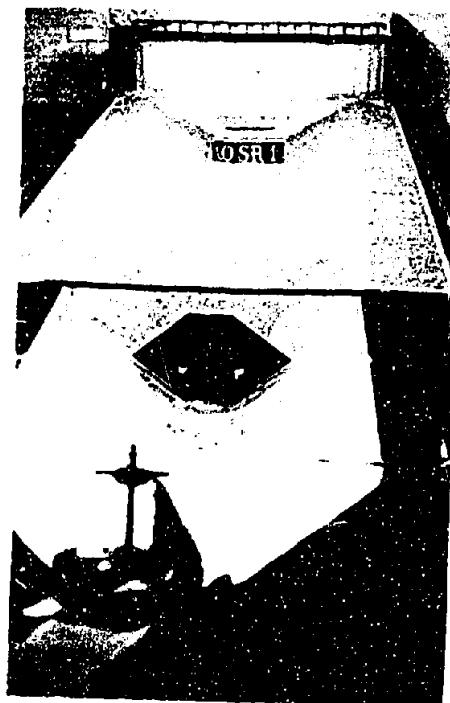
C. ONE OF THE BAFFLE WALLS
TRIED.

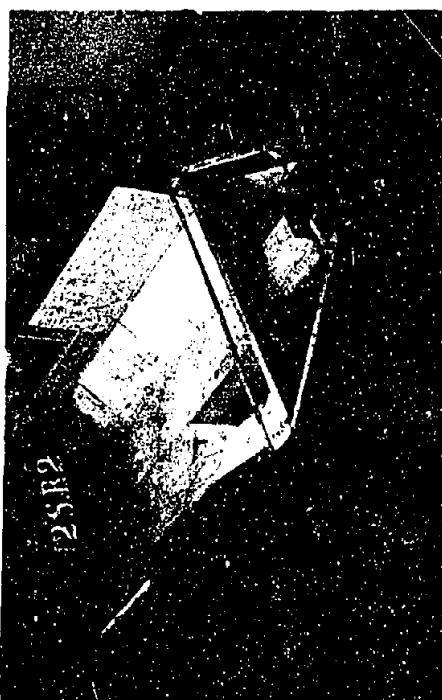
D. BAFFLE BOX INSTALLED IN MODEL.

A fifth design somewhat similar to the last one was a baffle box which is shown as sketch B on figure 8. Photograph C (plate 5) shows this box built into the model. The purpose of the box was to turn the jet of water issuing from the chute back on itself and then change the direction of flow. There were six windows in the box but most of the water squirted out of the two farthest downstream as can be seen in photograph D, plate 5. These two jets were so concentrated that it was necessary to nail pieces of sheet metal on the sides of the channel to keep the water from shooting out of the pool. A portion of the two downstream windows was then blocked off and the box performed somewhat better. Considerable disturbance however, was again produced when the tailwater depth was decreased.

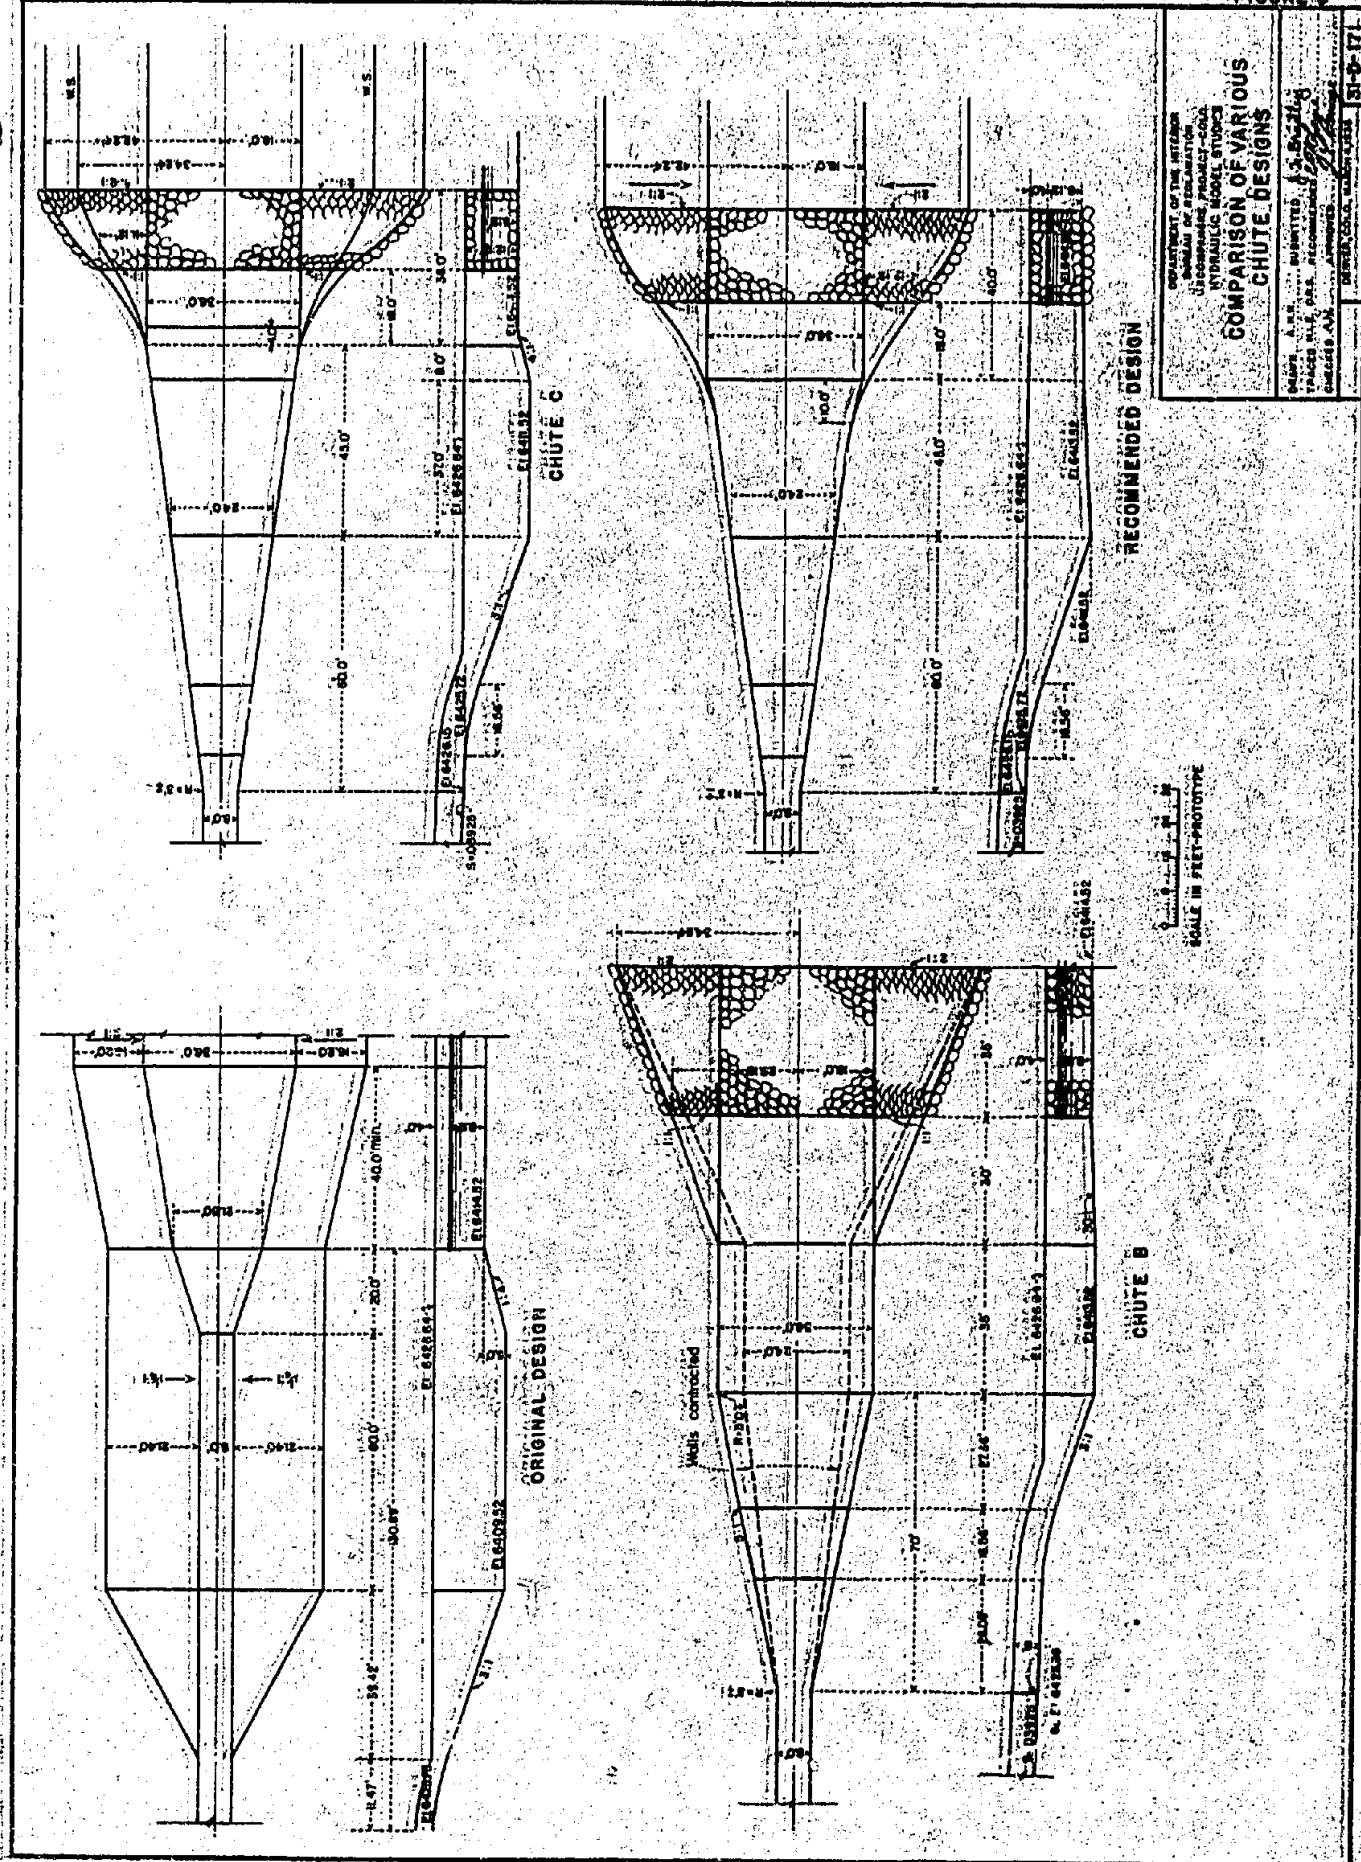
FIGURE 9

HYDRAULIC MODEL STUDY
COMPARISON OF VARIOUS
CHUTE DESIGNS

A chute drop was designed to replace a series of drops which have become excessively worn on the South Uncompahgre Canal. A model of the original design which is shown in prototype on figure 9 was constructed and tested in the laboratory. As can be observed from the drawing, the general shape of this chute drop was very similar to the one previously described on the Mill Coulee canal. The results were also very similar to those obtained on the Mill Coulee chute.

Acting upon the failure to obtain the desired results on this and the previously described models, together with suggestions made by the laboratory force, a redesigned chute was submitted for testing. A drawing of the new design is shown as chute B, figure 9. In this case, the chute and stilling pool were rectangular in section throughout. Model tests showed the chute proper to flare too rapidly and the stilling pool to be too wide. As a result, the depth of flow in the sloping chute varied from maximum at the center to practically nothing at the sides, and the jump was much more effective in the center of the stilling pool than near the sides. The pool was subjected to some whirling motion and the jump lacked stability. In spite of these flaws, this chute exhibited a considerable improvement over the original design.

The pool was then contracted from a width of 36 feet to 24 feet and the flare of the chute was reduced accordingly by installing false side walls in the model as indicated by the dotted lines in Design B, figure 9. The spread of the jet in the chute was much more uniform and pool conditions were greatly improved. These encouraging results led up to another design which proved to be very satisfactory.

This third design which was presented for model studies is shown as chute C on figure 9. The flare of the chute was gradual and in this case, it continued thru to the end of the stilling pool. The chute and pool remained rectangular in cross section. The pool floor for this design was in two forms; namely, that shown in Design C (figure 9) and an alternate pool floor shown as "The Recommended Design" in the same figure. The two worked equally well but the alternate design proved to be the favorite because of structural reasons. The advantages of a chute drop of this type are:

The model of the chute known as the "Recommended Design" in figure 9 was very satisfactory (with or without a sill) and it is believed that this design will prove very satisfactory under all conditions encountered in the field. The bureau constructs a number of canal chutes each year, and for this reason it is felt that the model studies on these small structures have been justifiable. A comparison of the costs of the original and recommended designs for the Uncompahgre chute drop showed very little difference, while the difference in the hydraulic action in the two was remarkable.

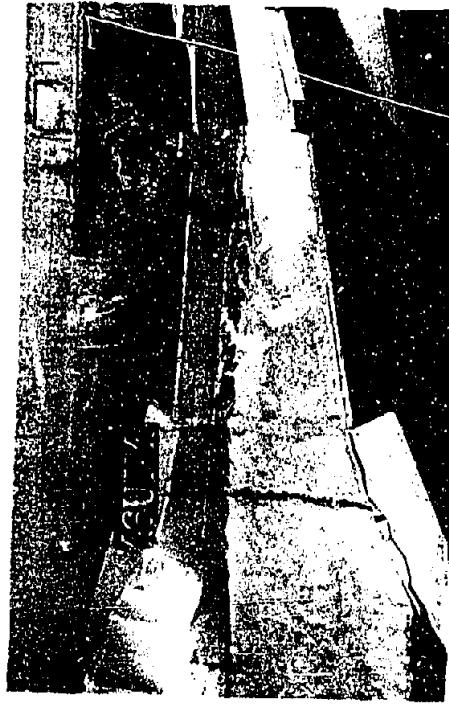
D. RECTANGULAR SILL 1.5 FEET HIGH INSTALLED.
DISCHARGE 331 SECOND-FEET.
TAILWATER ELEVATION 6418.9.

Test 16 (figure 14) was made at a discharge of 331 c.f.s. and a tailwater elevation of 6418.9 with a rectangular sill 1.5 feet high and 2.0 feet wide placed with the downstream edge at station 33+58.85. A photograph of the pool taken during this test is shown as D on plate 9. The sill raised the water surface slightly but made possible a jump which was stable in character and very effective in its action.

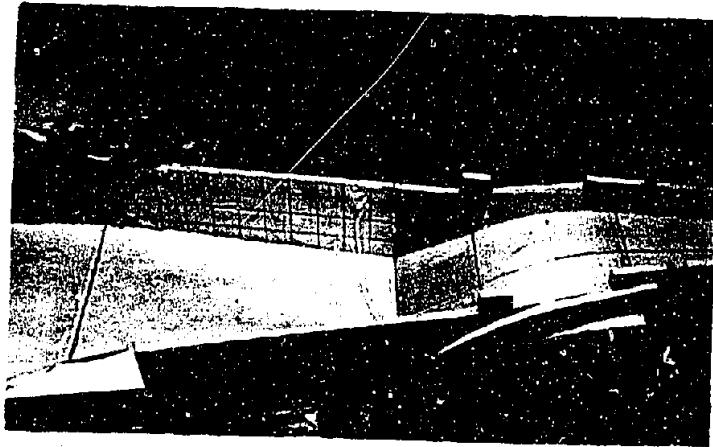
A. SLOPE OF CHUTE INCREASED.

Two attempts were made to increase the slope at the lower end of the chute in order to observe the effect this would produce on conditions in the pool. The profiles for tests 17-1 and 18-1 on figure 14 indicate these slopes. Photograph A (plate 10) shows the model revised to represent the steepest slope tried and photograph B shows the chute in operation at the maximum discharge. Test 17-1 (figure 14) shows a profile of the water surface for this slope. It can be observed both from the profile and the photograph that the jet actually sprung clear of the floor when this steepest slope was used. Notice the fins near the side walls in photograph B. Pool conditions were practically unchanged and therefore were not plotted.

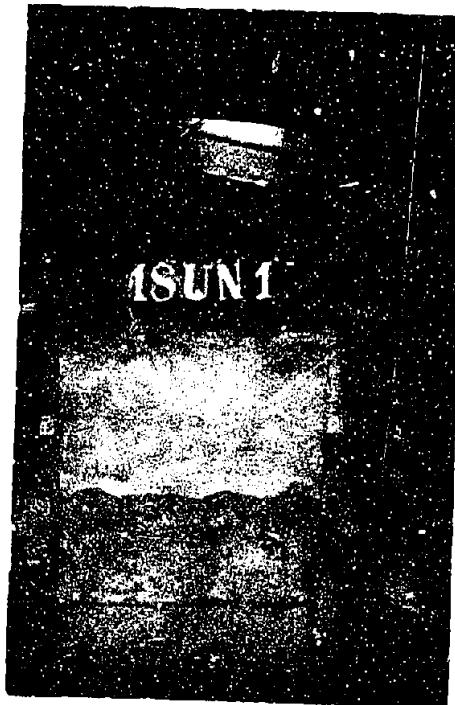
C. INTERMEDIATE CHUTE SLOPE.
DISCHARGE 930 SECOND-FEET.

Test 18-1 (figure 14) shows a profile of the water surface using an intermediate slope and photograph C (plate 10) shows a view taken during this test. Notice in photograph C that the fins were still present in the chute. This slope also proved to be slightly excessive.

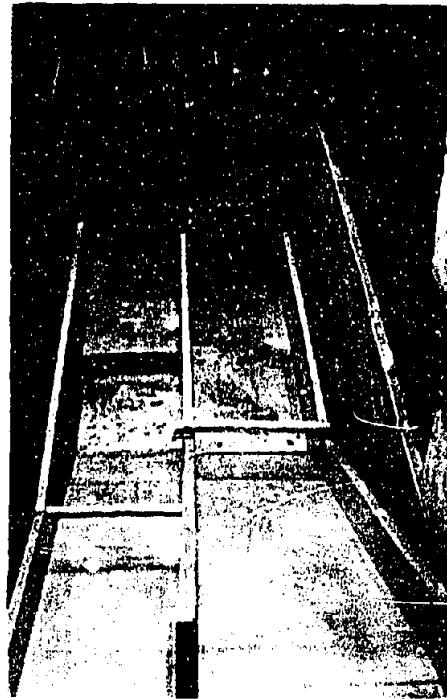
A. SET-UP

Test 3 was somewhat similar to the one just described except a sharp break was made in the pool floor. A portion of the floor of chute B was dropped $2\frac{1}{8}$ inches as shown in figure 15. Photograph A (plate 12) shows the layout and photograph B shows the two chutes in operation for a tailwater depth of $4\frac{7}{16}$ inches. Notice that the jump has left the pool in chute A but chute B is operating very nicely. For a tailwater depth of $3\frac{1}{4}$ inches, which was the lowest tried in this test, the jump in chute B remained in the pool.

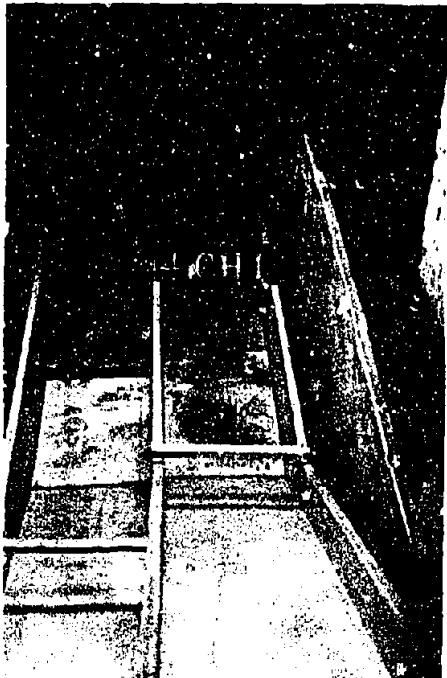
C. SET-UP.

Test 4 was very similar to test 3 except in this case a portion of the pool floor was dropped 1 inch. Photograph C (plate 12) shows the layout for this test and photograph D shows chutes A and B operating with a tailwater depth of $5\frac{1}{2}$ inches. Chute B was more effective in its action for a depth of $4\frac{1}{4}$ inches. The tailwater was dropped to a depth of 2 inches before the jump showed any tendency toward leaving the pool while in chute A, the jump was swept out at a tailwater depth of 5 inches. Notice in the last two tests that the downstream end of the roller was directly above the break in the floor. Also observe the superiority of this type of pool with a sharp break in the floor to the one in test 2 where the change in elevation is gradual.
