SUBJECT: HYDRAULIC MODEL STUDIES FOR THE DESIGN

THE ISLAND PARK DAM SPILLWAY

TECHNICAL MEMORANDUM NO. 478

August 10, 1935

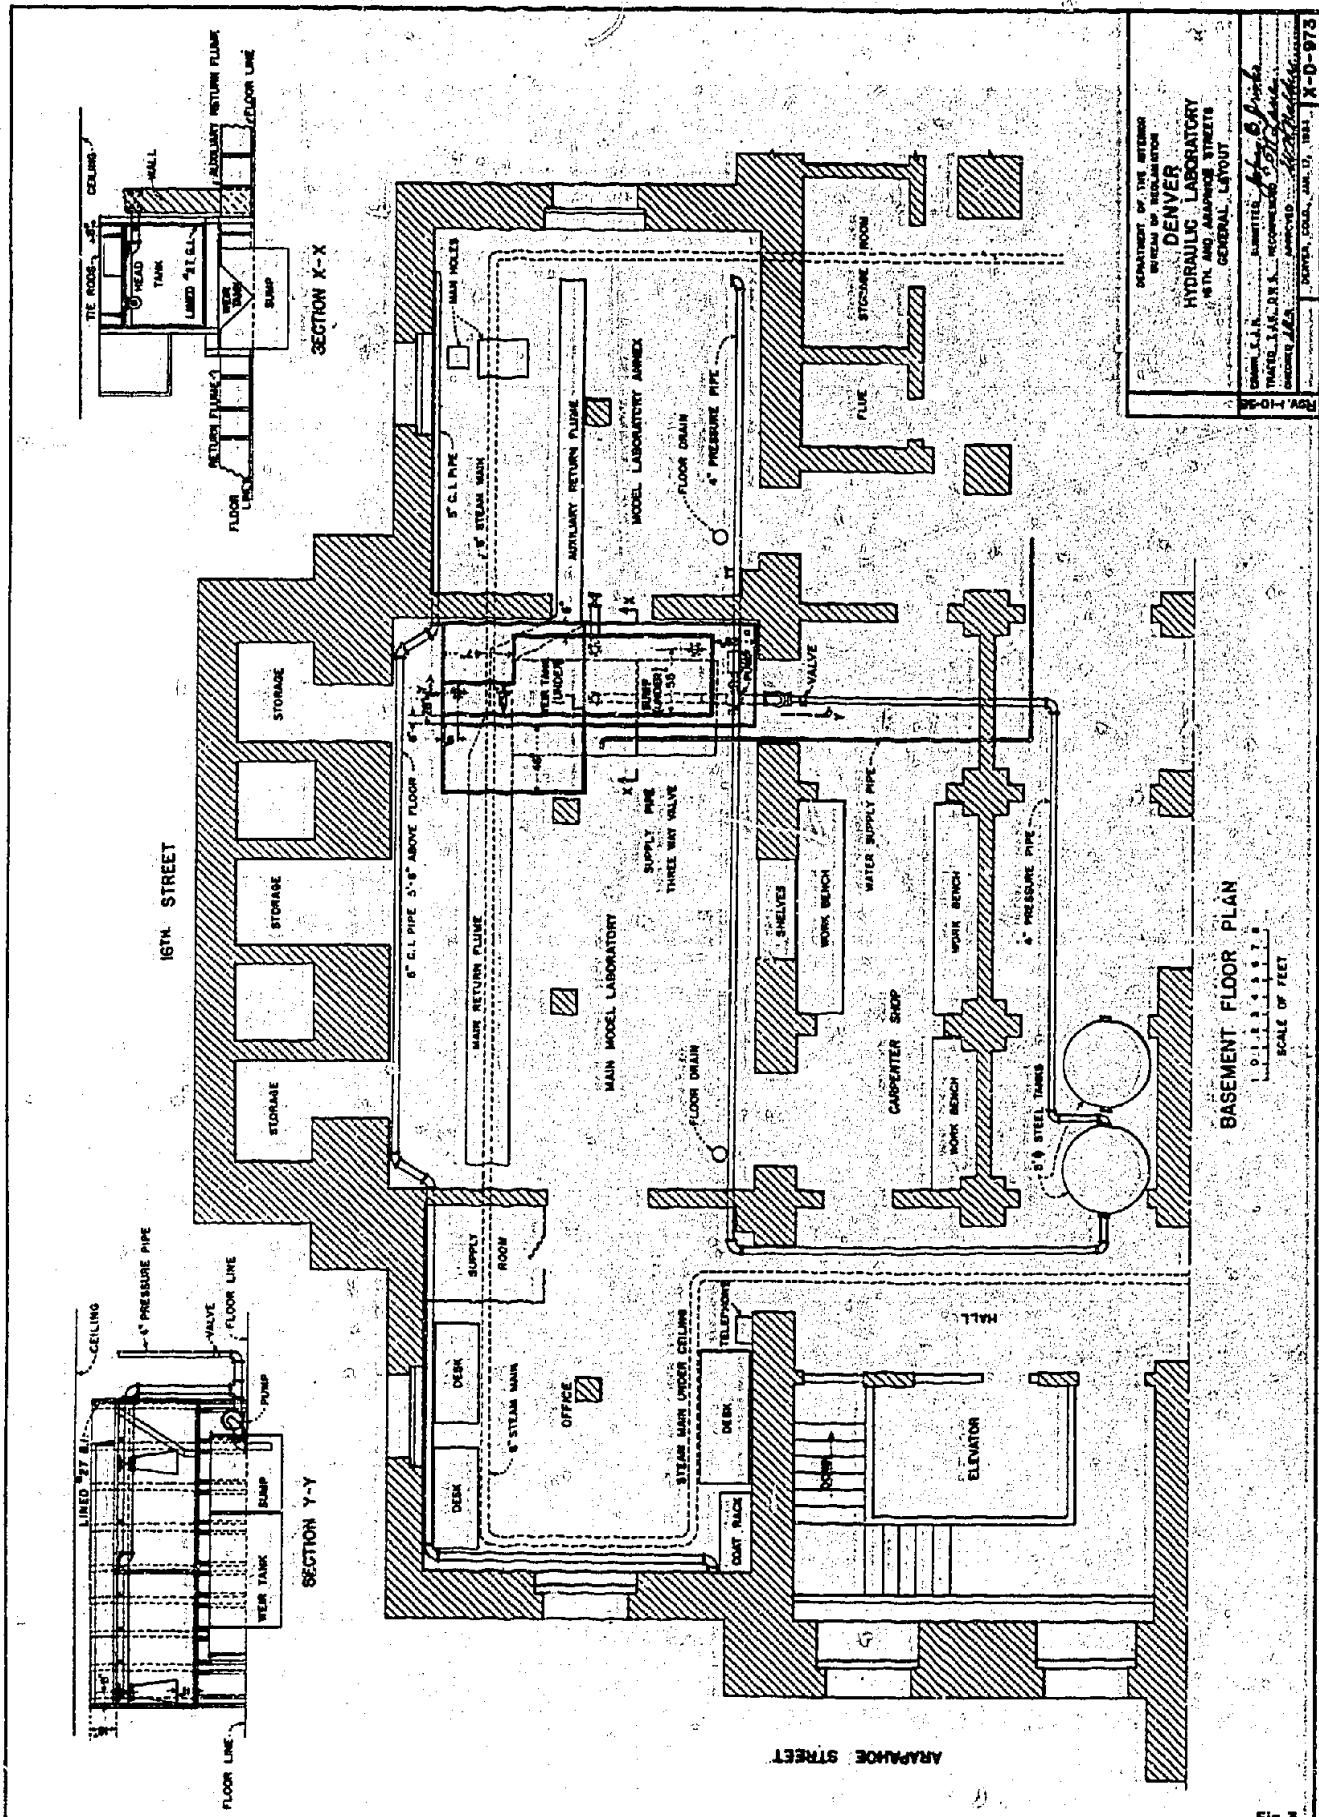
Fig. 3

A model of the Island Park Spillway was constructed and tested in the laboratory located in the basement of the Old Custom House in Denver. A plan of the laboratory is shown in figure 3.

Water for supplying the models is measured over a 90° V notch weir located in the end of a weir tank 6 by 12 by 4 feet deep, which is partially below the laboratory floor. From here a 6-inch centrifugal pump having a capacity of 3 c.f.s. raises the water up into a constant level tank located as high as the ceiling of the laboratory will permit. A stationary skimming weir makes it possible to maintain a constant head of water on this tank. The water flows from the constant level tank through calibrated gate valves, and large expanding cones into two head reservoirs, located directly below the constant level tank. Water is then supplied to the models directly from these head reservoirs. With this arrangement, two models can be operated simultaneously. The overflow section of the Island Park model was constructed in one of these head reservoirs. After passing through the model, the water collected in a sheet metal flume and flowed back to the weir tank. In this way, the water was continuously remeasured and recirculated. The head on the measuring weir was observed by two hook gages.

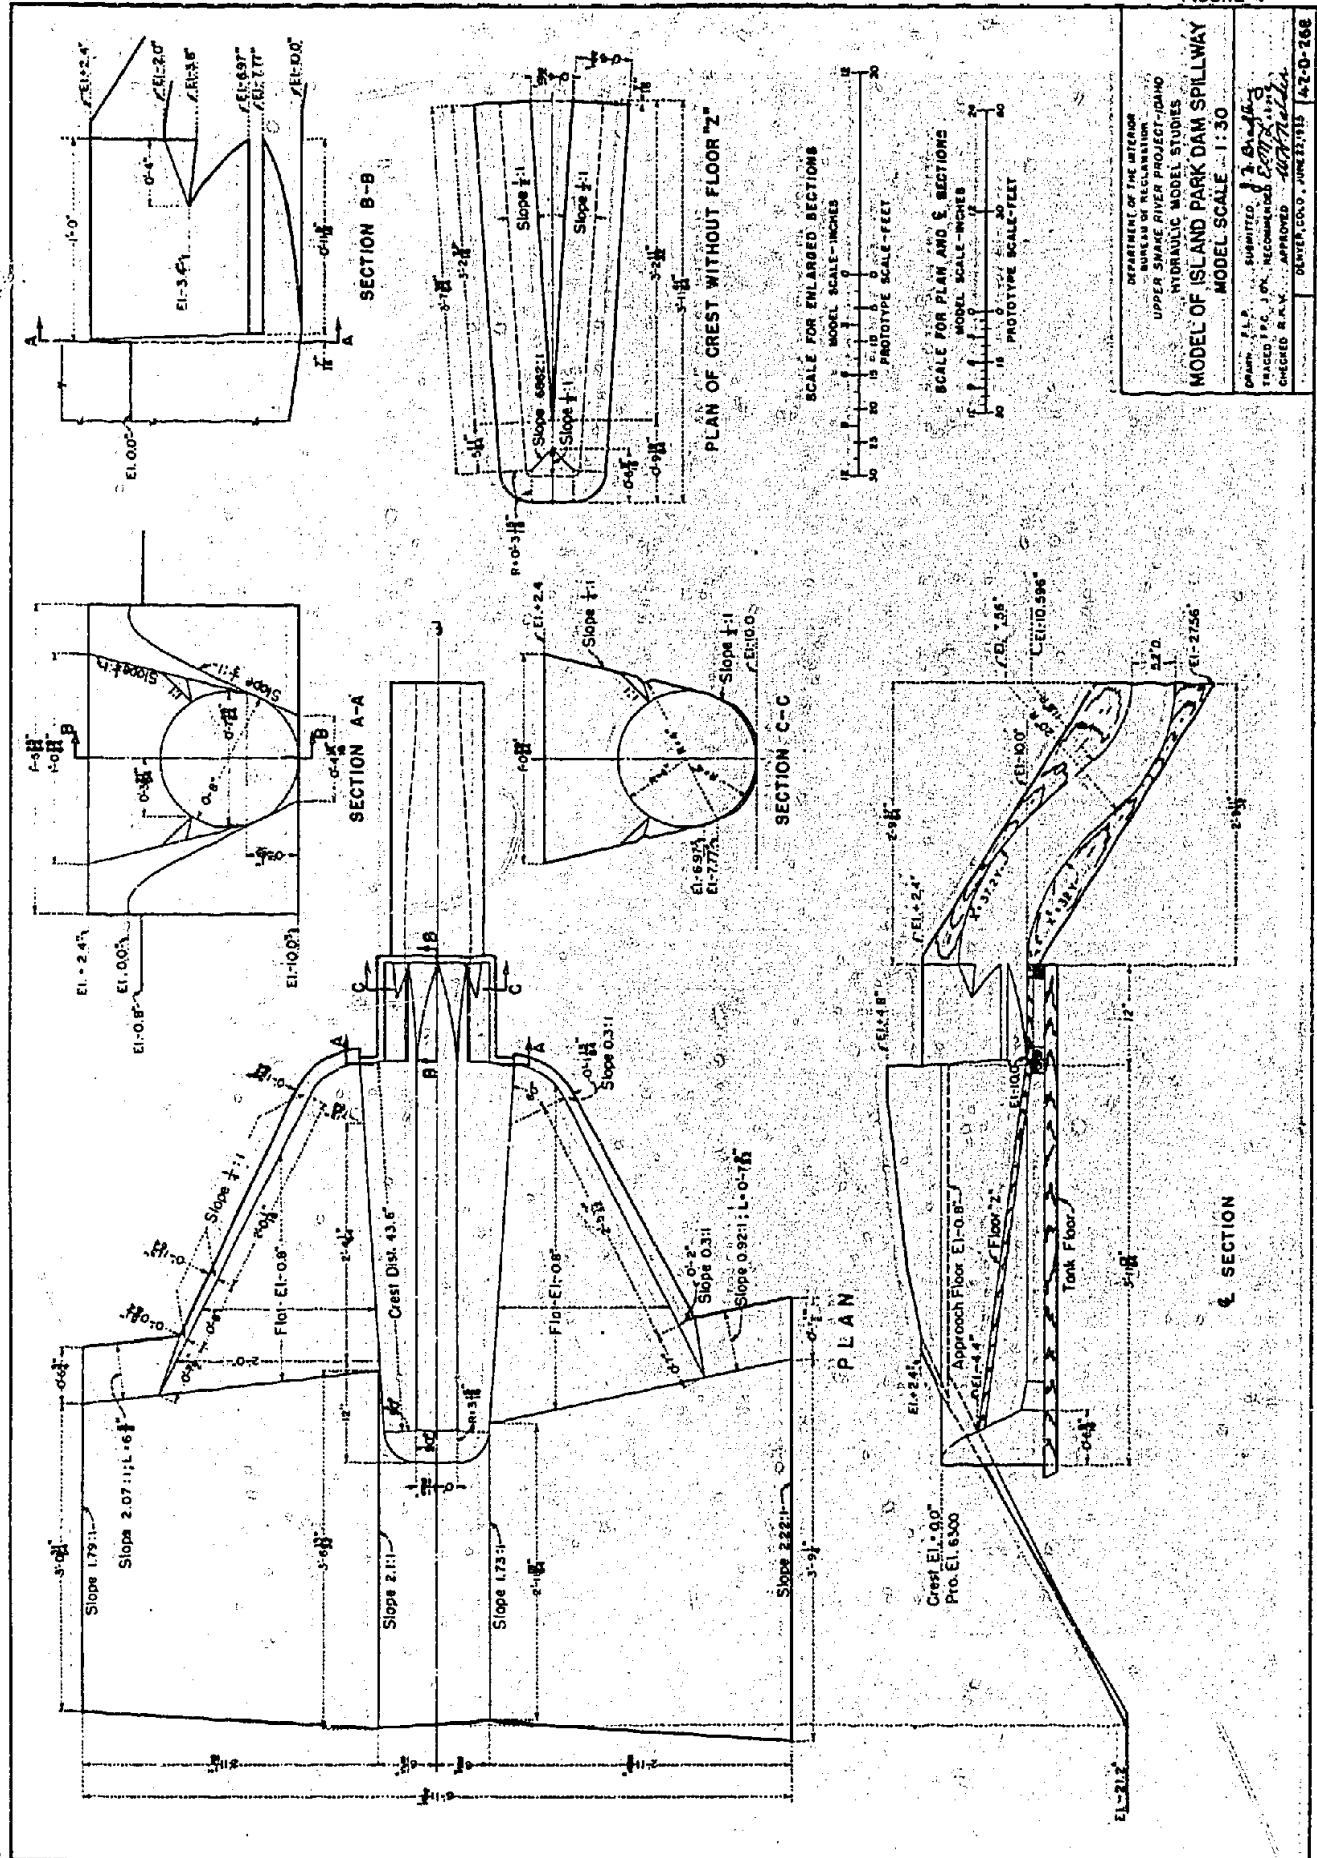
FIGURE 4

A model of the Island Park spillway was made to a scale of 1:30. A drawing of the model is shown in figure 4. The overflow section was constructed by bending a piece of sheet metal around heavy metal ribs so that the resulting shape was true to scale and then soldering the sheet to the ribs. The two warped surfaces at the upstream end of the channel were moulded in place with plaster of paris. The metal ribs were mounted on small galvanized

iron angles and the whole made a very rigid and accurate model. The metal channel floor was constructed lower than specified so that an auxiliary wooden floor could be placed in various positions above it. The approach to the overflow crest which was made to scale was constructed of wood and covered with light sheet metal.

The converging chute which led from the downstream end of the overflow channel to the 13-foot circular tunnel was carved in a laminated block of wood. Pieces of 1- by 12-inch white pine boards were marked and sawed so that the greater part of the material to be removed was removed before the boards were assembled into a block. The pieces were then glued and screwed together so that the block was in two halves. Photograph A (plate II) shows the chute at this stage of construction. The remainder of the material to be removed was then dug out with the aid of gouges and templates to the final shape. The two halves were then bolted together. A portion of the top of the chute was made removable for observation purposes. The irrigation outlets were built into the lower end of the chute block. Photograph B (plate II) shows one half of the chute block completed with one of the irrigation outlets installed.

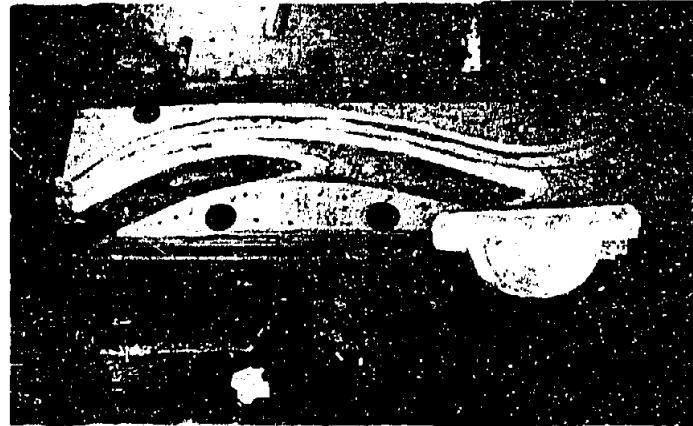
A. METHOD OF CONSTRUCTION
OF CHUTE

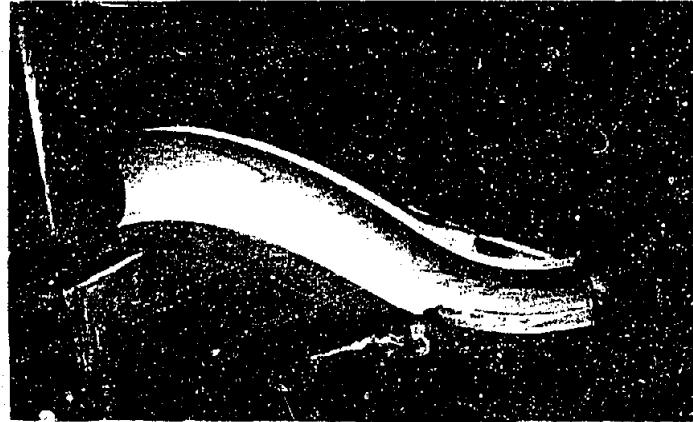
B. ONE-HALF OF CHUTE COMPLETED

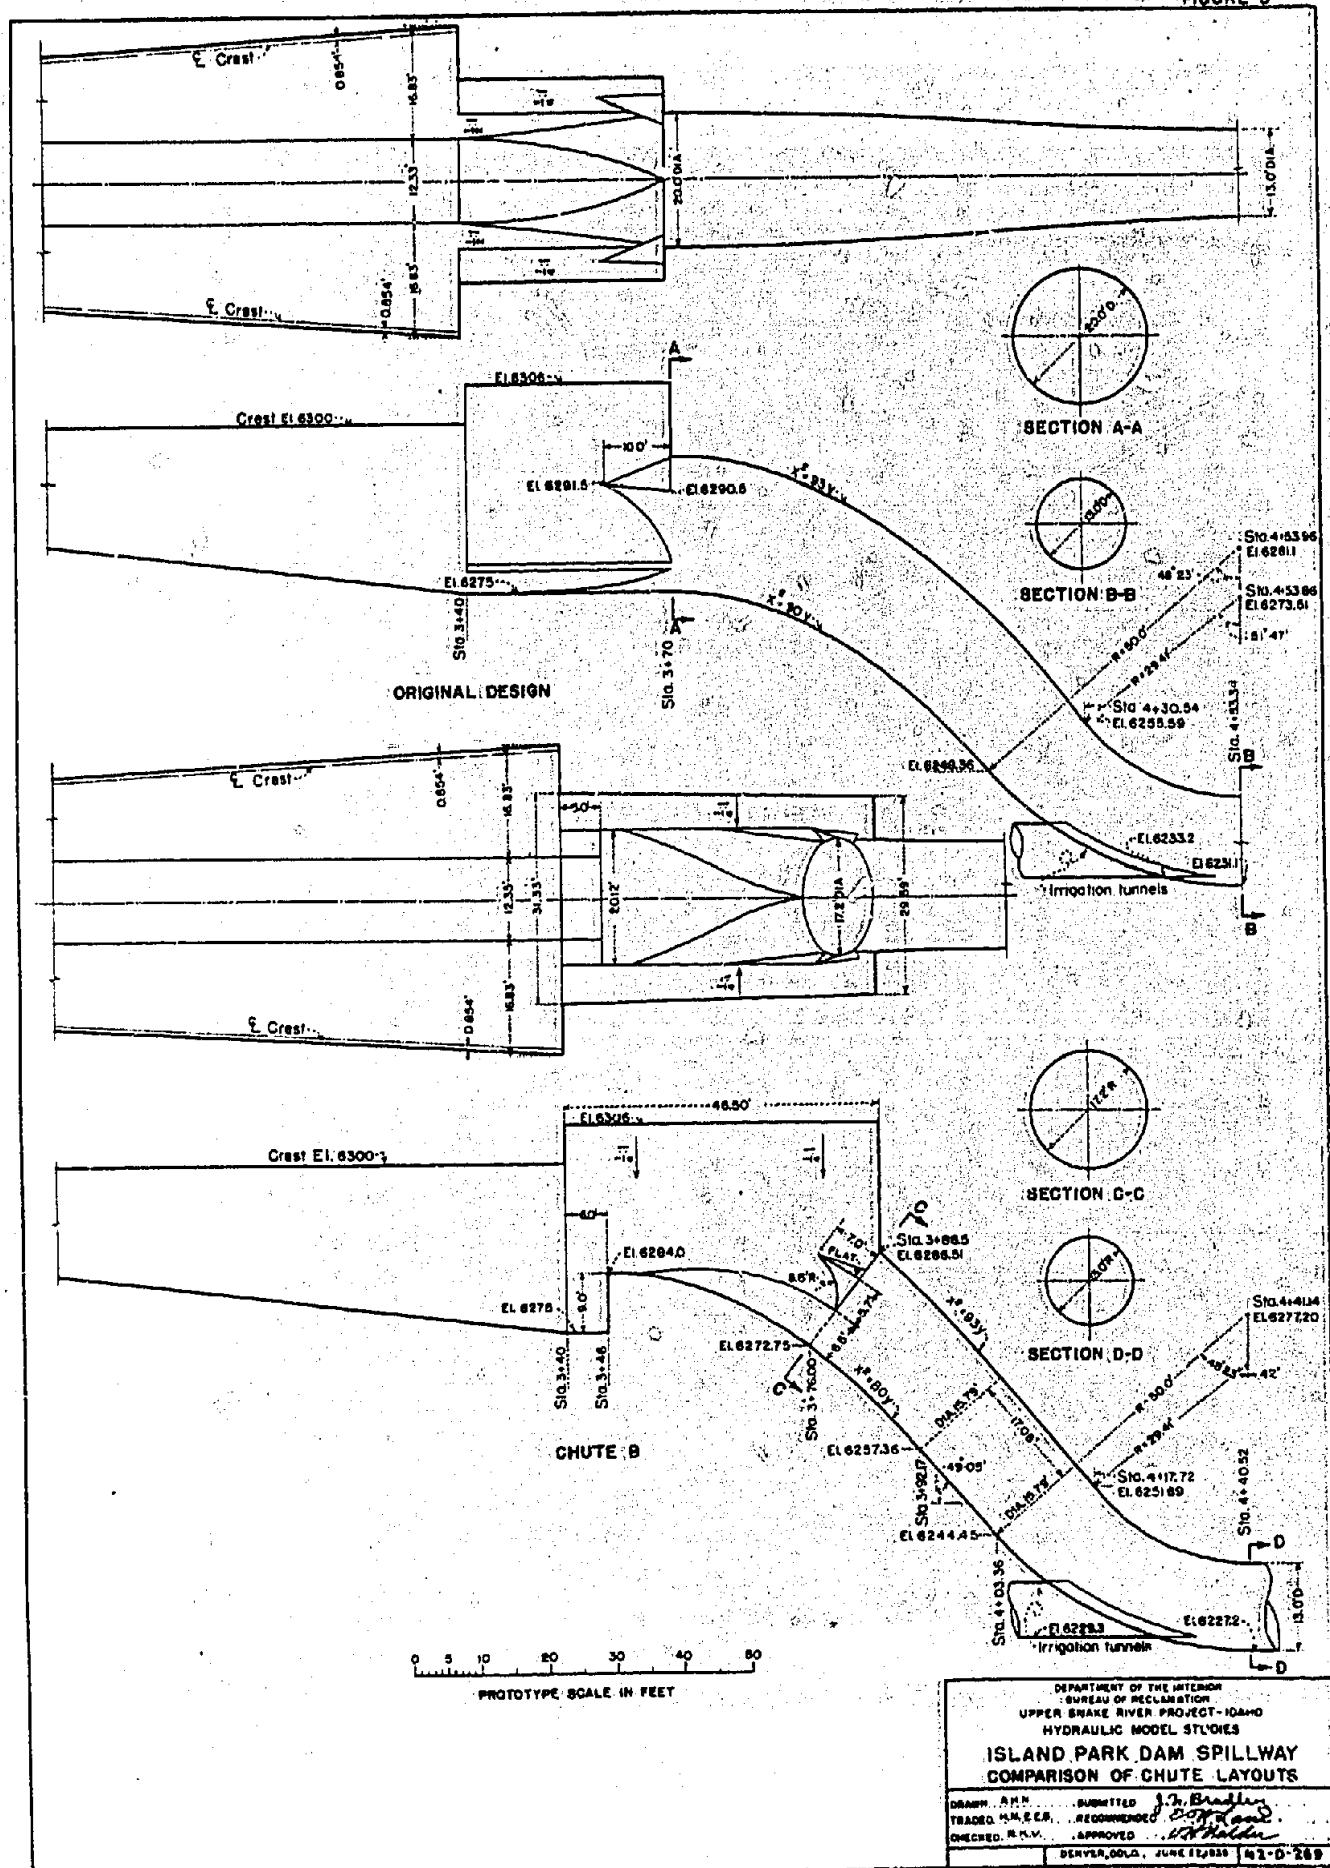
FIGURE 5

The chute was next revised to agree with the sketch designated as "chute B" on figure 5. Notice that the chute now commences at station 3+46.0 and at this point it is 9 feet above the floor of the channel section. The slope of the invert down to station 3+92.17 is identical with the original. The shape of the chute from station 3+46.0 to station 3+76.0 however, was changed to that shown for chute

B on figure 5; As the 13-foot constant diameter tunnel was lowered approximately 4 feet and the upper portion of the chute was raised 9 feet, it was necessary to add a tangent section from station 3+92.17 to station 4+03.36. The remainder of the chute from the latter point downstream was the same as in the original design. Raising the chute portal 9 feet increased the depth of water in the overflow channel considerably. It was found however, that this was not objectionable as the overflow crest was not submerged and the added depth of water in the channel reduced the boil and splash at the upstream end. Flow in the chute, although an improvement over the original design, was still not acceptable. The water surface at the portal was higher along the sides than in the center with the result that a large fin from each side would fold in toward the center as the water started down the chute. This created a very irregular water surface together with a considerable amount of splashing and noise. Splashing was still prevalent at the lower end of the chute.

A sketch of the original design of the overflow channel is shown in layout 1 (figure 7) and a drawing of the original chute is shown on figure 5. Photograph A (plate I) is a view of the complete model; photograph C (plate II) is a closer view of the overflow section showing a portion of the original circular chute; and photograph B (plate I) shows the original spillway in operation at the maximum discharge of 5,000 c.f.s. These pictures were taken with the chute cover removed. Note the splashing at the lower end of the chute in photograph B (plate I).

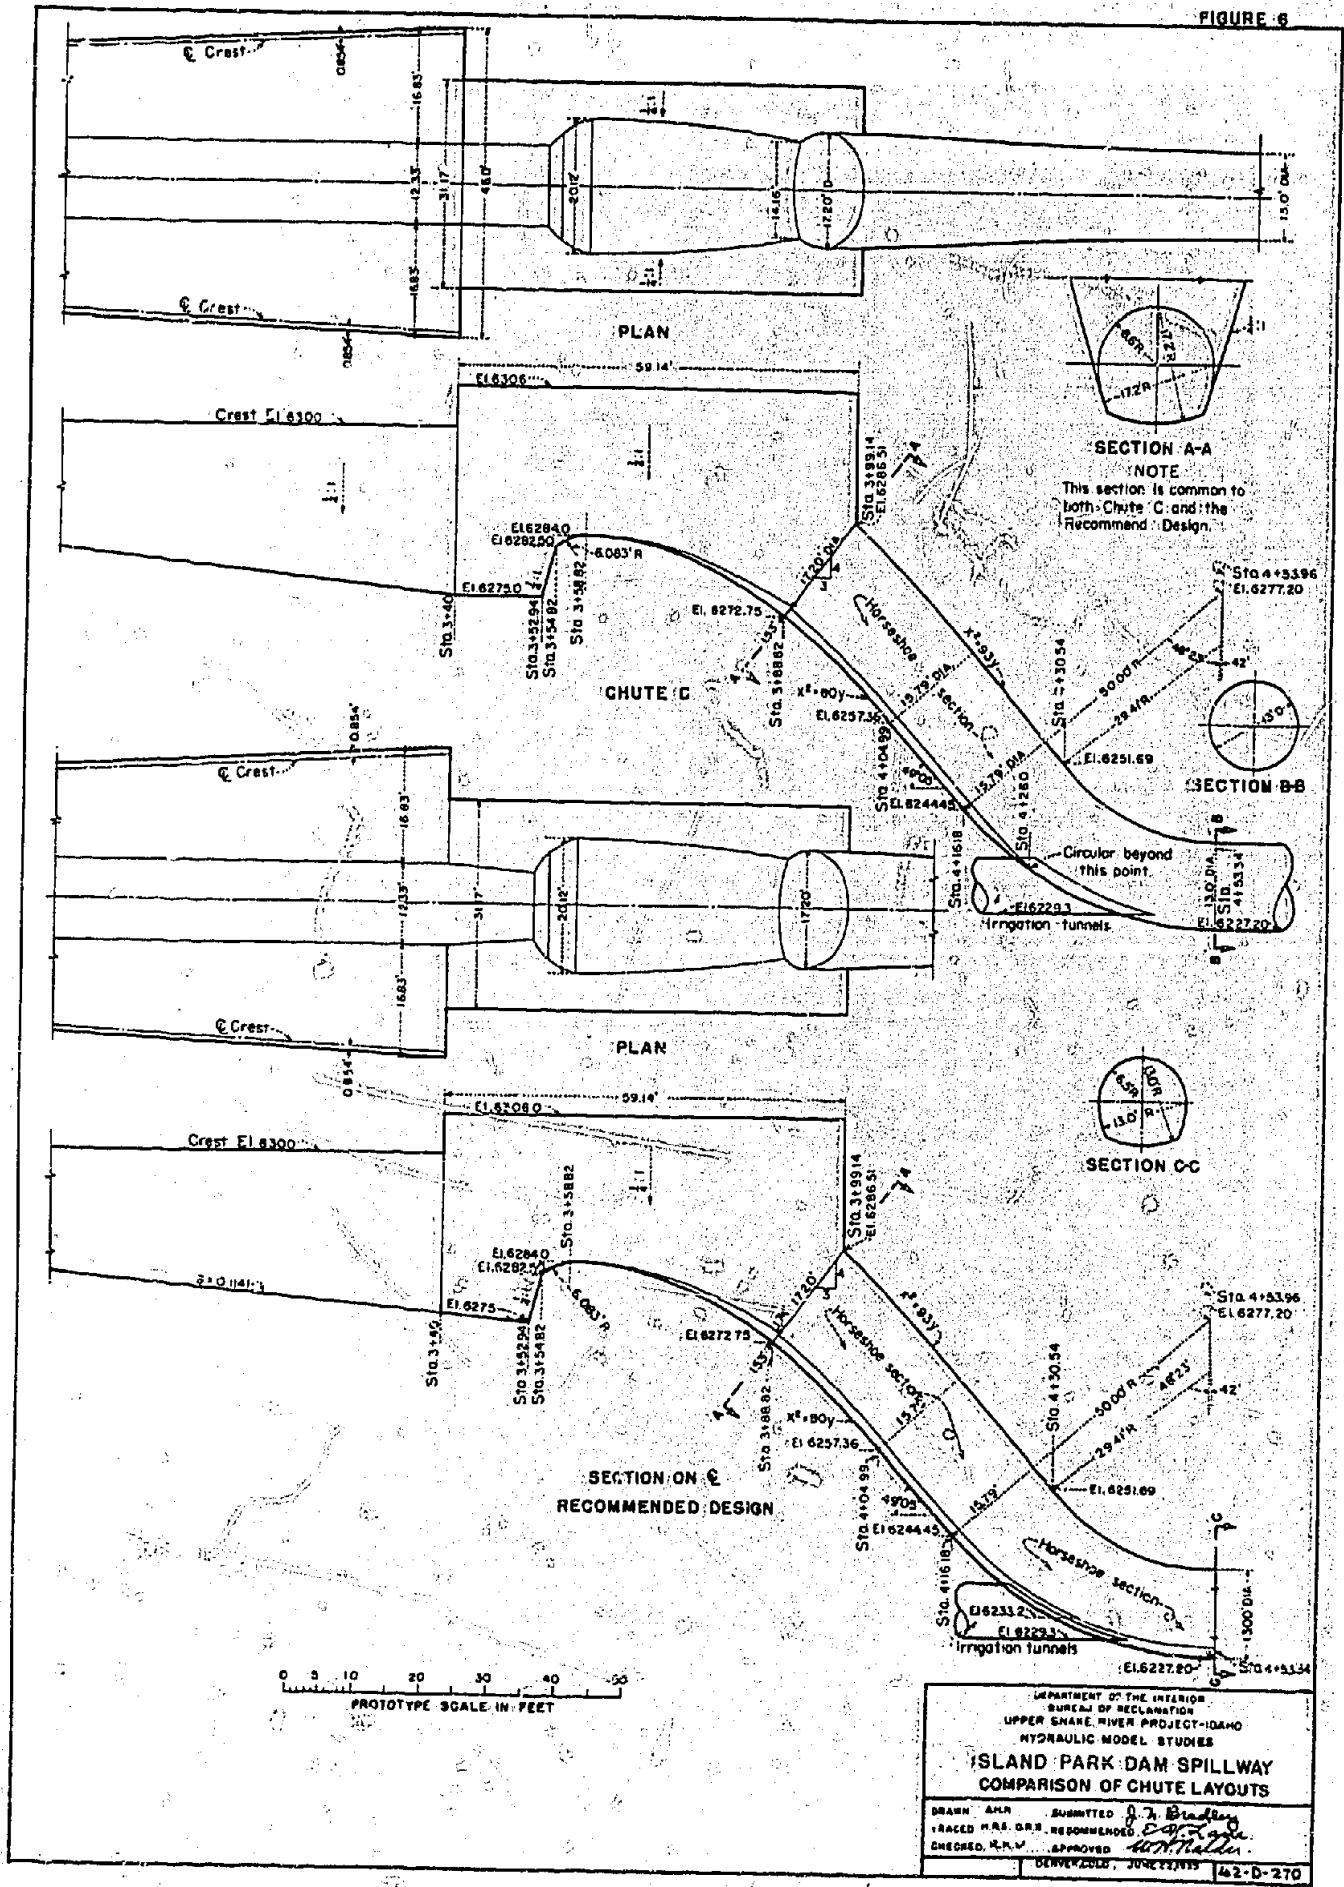
FIGURE 6

In spite of the improvement in flow in the upper part of the spillway, a certain amount of splashing was still present at the lower end of the chute. In a further effort to correct this undesirable condition, the horseshoe section was continued down to the end of the chute or station 4+53.34. The transition from the horseshoe to the circular section in this case was incorporated in the upstream end of the 13-foot constant diameter tunnel. This revision remedied the splashing and very satisfactory flow existed throughout the spillway. A drawing of the recommended chute is shown in figure 6 and the corresponding channel layout is shown as no. 16 on figure 9.

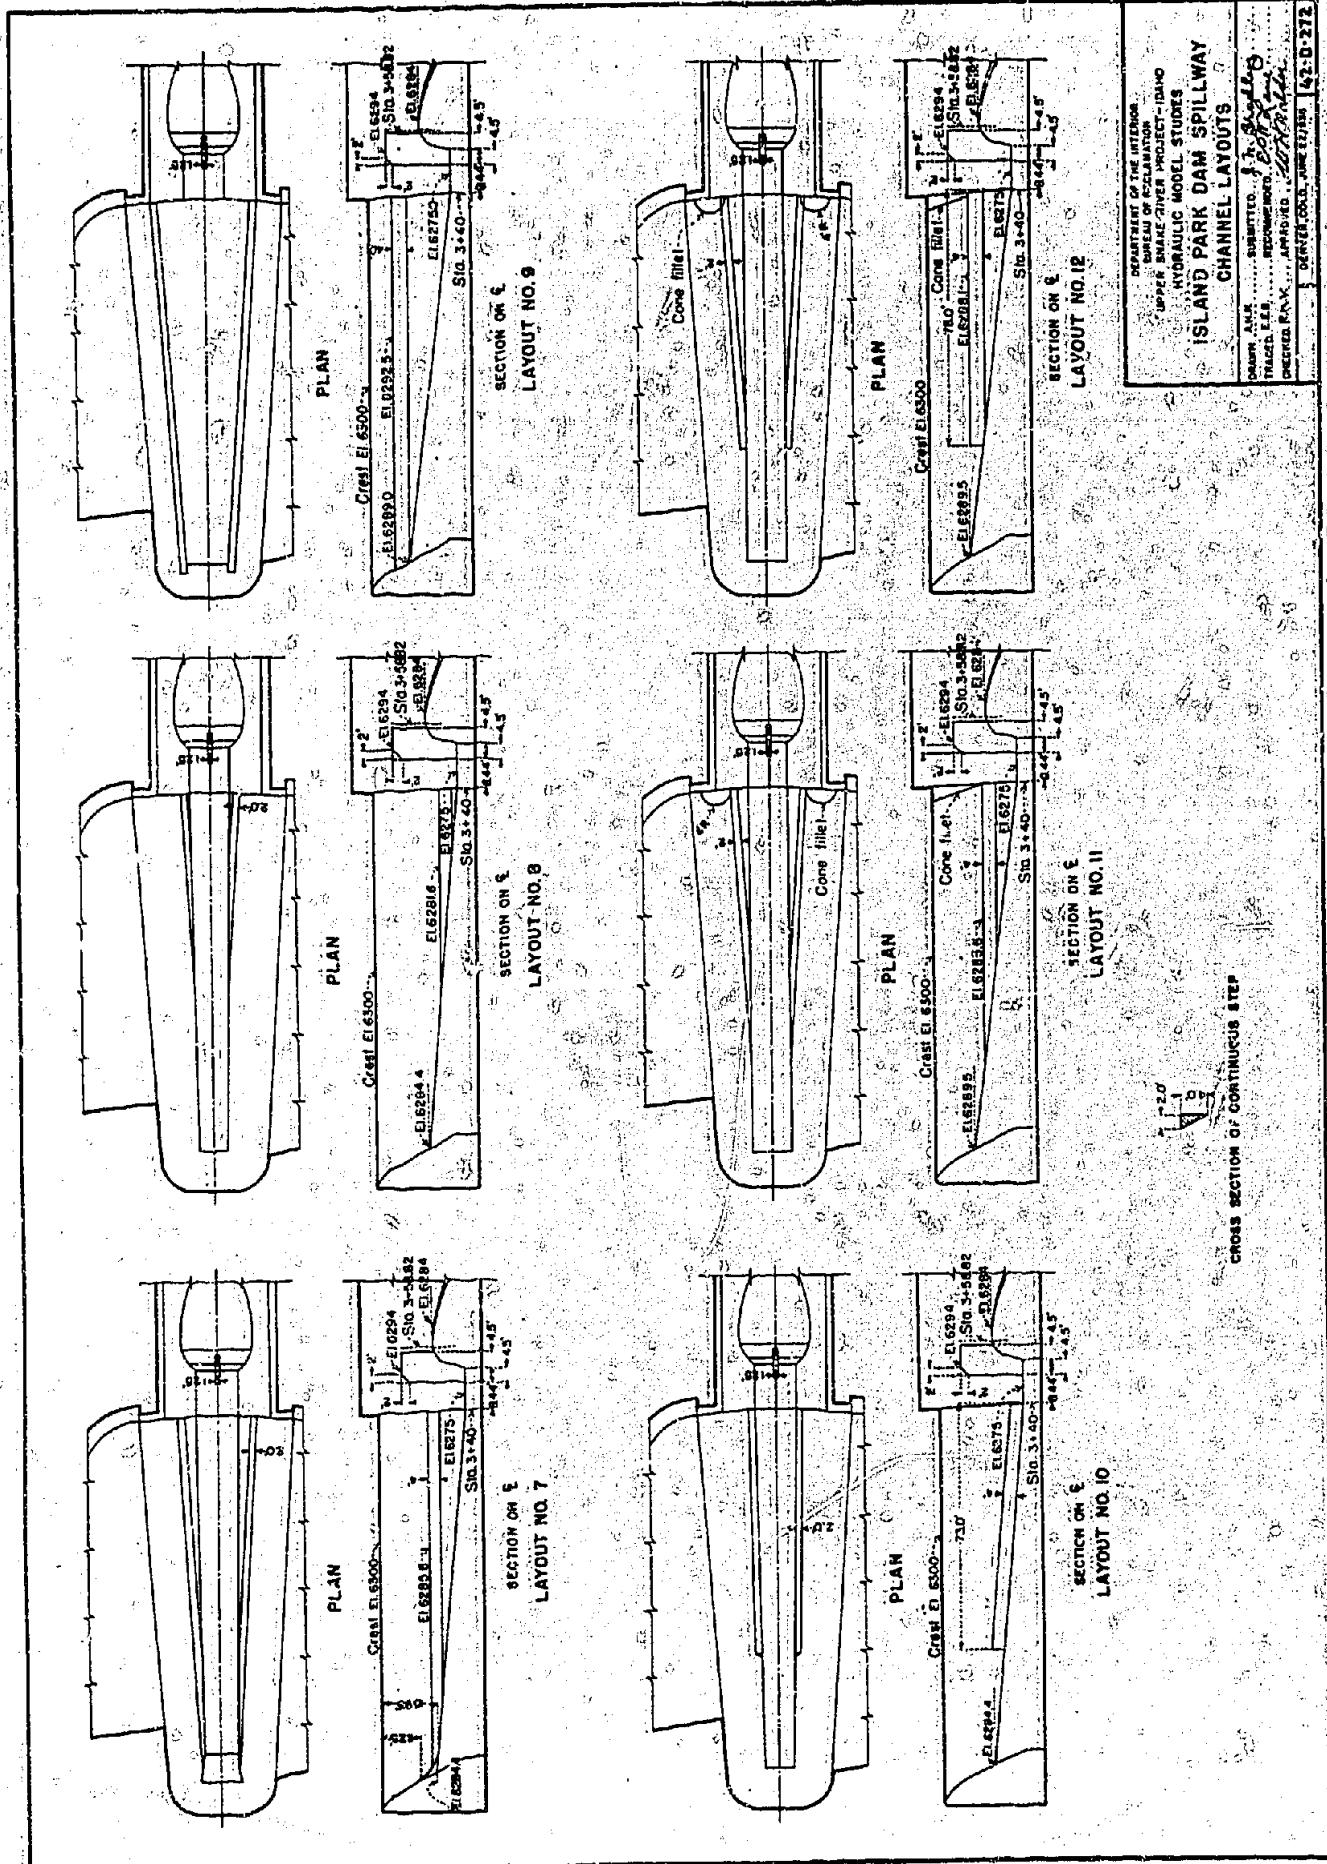
FIGURE 9

In an endeavor to improve the flow in the chute, rectangular sills of different heights were installed in various positions in the trapezoidal section connecting the channel with the chute. Sketch A (figure 9) illustrates one of these trials. These sills failed to improve the flow in the chute. The lower sills were ineffective, and the higher ones flooded the overflow channel.

A portion of the trapezoidal channel section was then filled in with a piece of sheet metal as shown in sketch C (figure 9). The same slight improvement in flow conditions was noticeable with this layout which thus exhibited the possibility of moving the entire chute upstream and eliminating a portion of the trapezoidal channel section.

In layouts 7 to 15, inclusive, on figure 8 and 9, various step arrangements were tried in combination with the dividing wall at the chute portal. Also, the slope and shape of the channel floor was varied throughout these tests. In general, the layouts in which the steps extended the full length of the crest produced the best flow conditions in the channel and down the chute. In other words, layouts 7, 9, and 14 were the best of the group with layout 14 the most satisfactory of the three. It should be noted that in some of the later layouts including number 14, the upstream 30 feet of channel floor was constructed level at elevation 6285.3. It was found that this revision reduced considerably the boil and splash caused by the water flowing over the upstream end of the crest.

in layouts 11, 12, and 13 for the purpose of eliminating the sharp corners in this location. These produced a negligible effect on the flow in the chute.

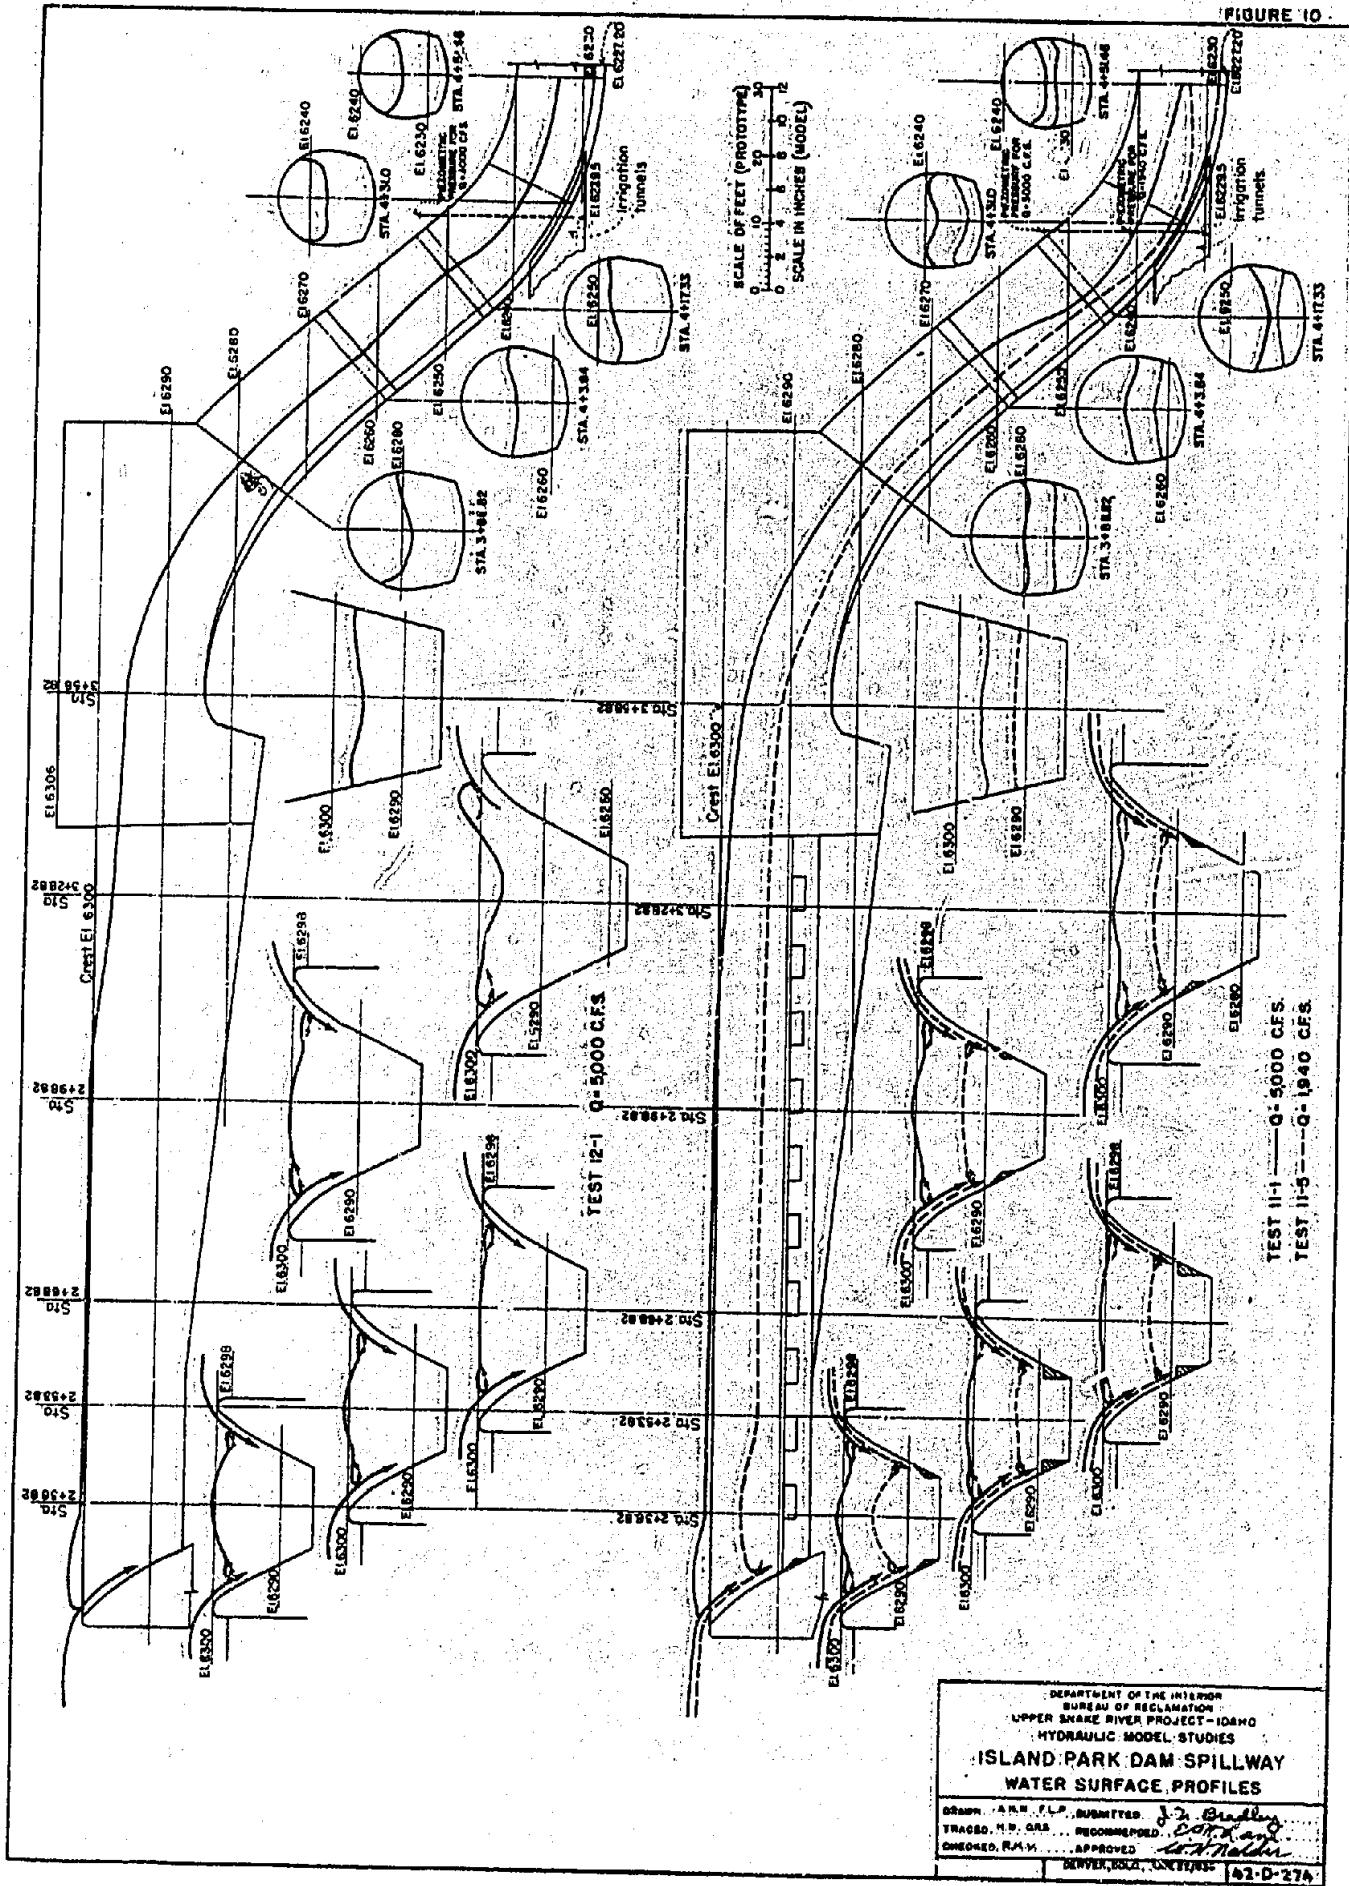
FIGURE 10.

Water surface profiles and sections which were taken in the channel and down the chute on the recommended design are shown plotted on figure 10. In order to show that the steps on the overflow crest are indispensable for good flow conditions, the upper profile was obtained with the steps removed and the lower profile was measured with the steps installed. For the maximum discharge of 5,000 c.f.s., very little difference existed between the two in the shape of the water surface in the overflow channel. Naturally, the water surface was slightly higher in the layout with the steps installed. Flow down the chute however, varied considerably for the two. The sections in the chute for the test with the steps installed are much more regular and symmetrical than for those obtained from the test made with the steps omitted. The sections hardly do justice in showing the difference. The photographs on plate IV were taken during the tests with the steps removed and those on plates V and VI were taken of the recommended design with the steps installed. Notice the difference in the flow down the chute in photograph C (plate IV) and photograph D (plate V). The steps on the overflow crest make a remarkable improvement in the flow. It might have been possible to omit them had the slope of the chute been decreased. This, however, was not done for structural reasons. The sudden sag in the profile lines in the lower portion of the chute on figure 10 was produced by the unusually large irrigation outlets. A profile and some sections are also shown on the lower plot for a discharge of 1940 c.f.s.

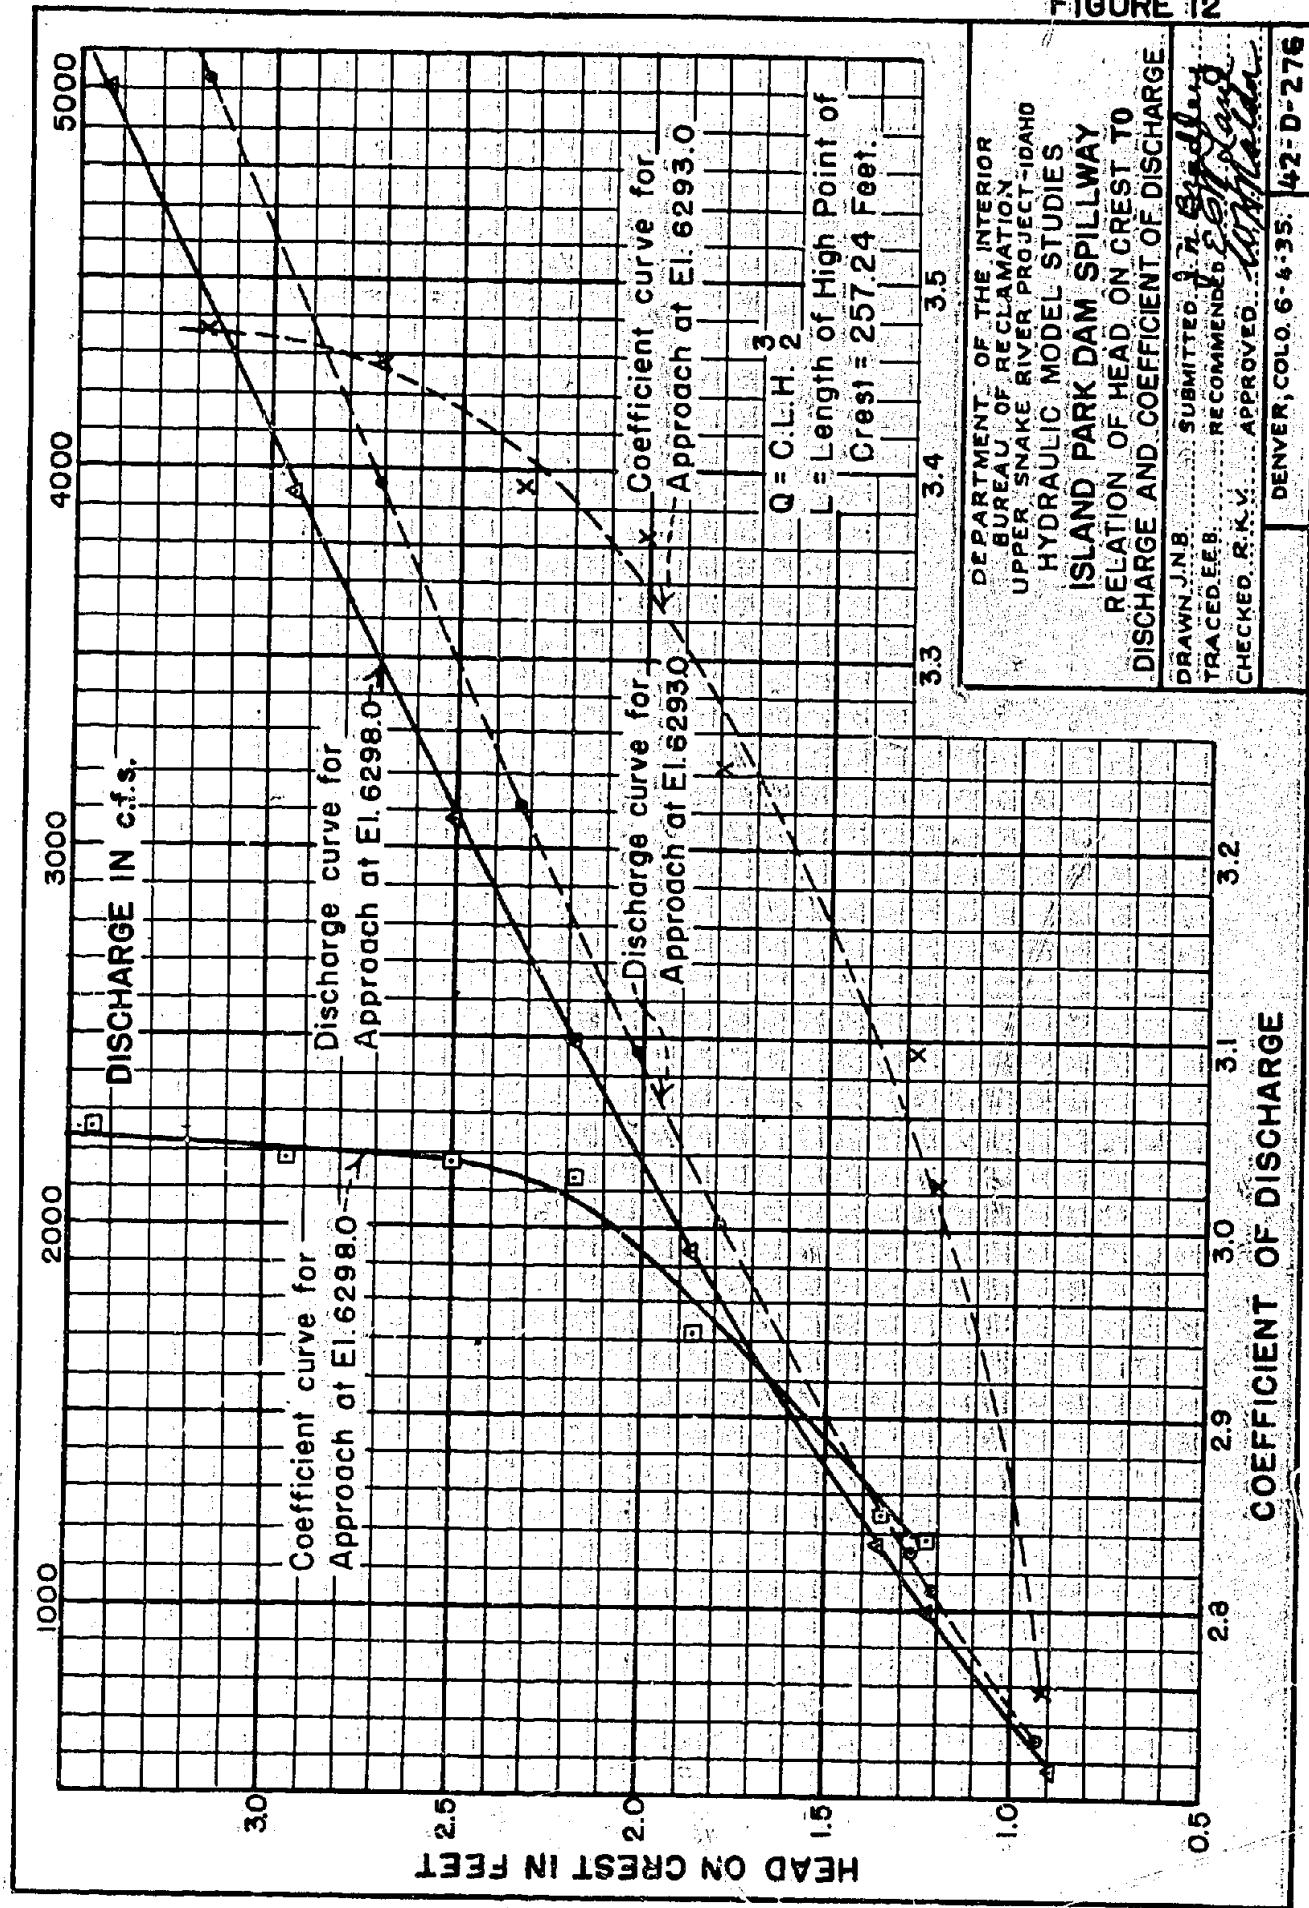
FIGURE NO. 12

As originally designed, the approach to the overflow crest was to be excavated to 2 feet below the crest or elevation 6298.0 and the width of approach was to be as shown in figure 2. The head discharge relation obtained from runs made on this layout is plotted as a full line on figure 12. A head of 3.48 feet on the crest was required to get the maximum discharge of 5,000 c.f.s. over the spillway. The coefficients of discharge for the above runs were computed from the formula $Q = CLH^{3/2}$ where L is the length of the high point on the crest or 257.24 feet (measured on the model and converted to prototype). The coefficient curve for this layout is also plotted as a full line on figure 12. For maximum discharge, the coefficient of discharge is about 3.045.

During a series of experiments on approach studies, the head discharge relation was again determined for various discharges with the approach floor dropped to 7 feet below the crest or elevation 6293.0. One of the dotted lines on figure 12 shows this relation and the other is the coefficient of discharge curve for this layout. For a head of 3.0 feet on the crest there is a difference of 500 c.f.s. in the discharge using the approach floor at the two elevations. With the approach floor at elevation 6293.0, a head of only 3.20 feet is required on the crest for a maximum discharge and this gives a coefficient of discharge of 3.470.

The above comparison illustrates the importance of a well designed approach to a spillway of this type. As providing a minimum head on the crest was not important in this particular case and as the expense was much less for the higher approach, the floor was left at elevation 6298.0 in the final design as shown in figure 2.
