HYDRAULIC STUDIES OF THE SKI-JUMP SPILLWAY
FOR CLEVELAND DAM
GREATER VANCOUVER WATER DISTRICT
VANCOUVER, BRITISH COLUMBIA, CANADA

Hydraulic Laboratory Report No. Hyd-369

May 19, 1953

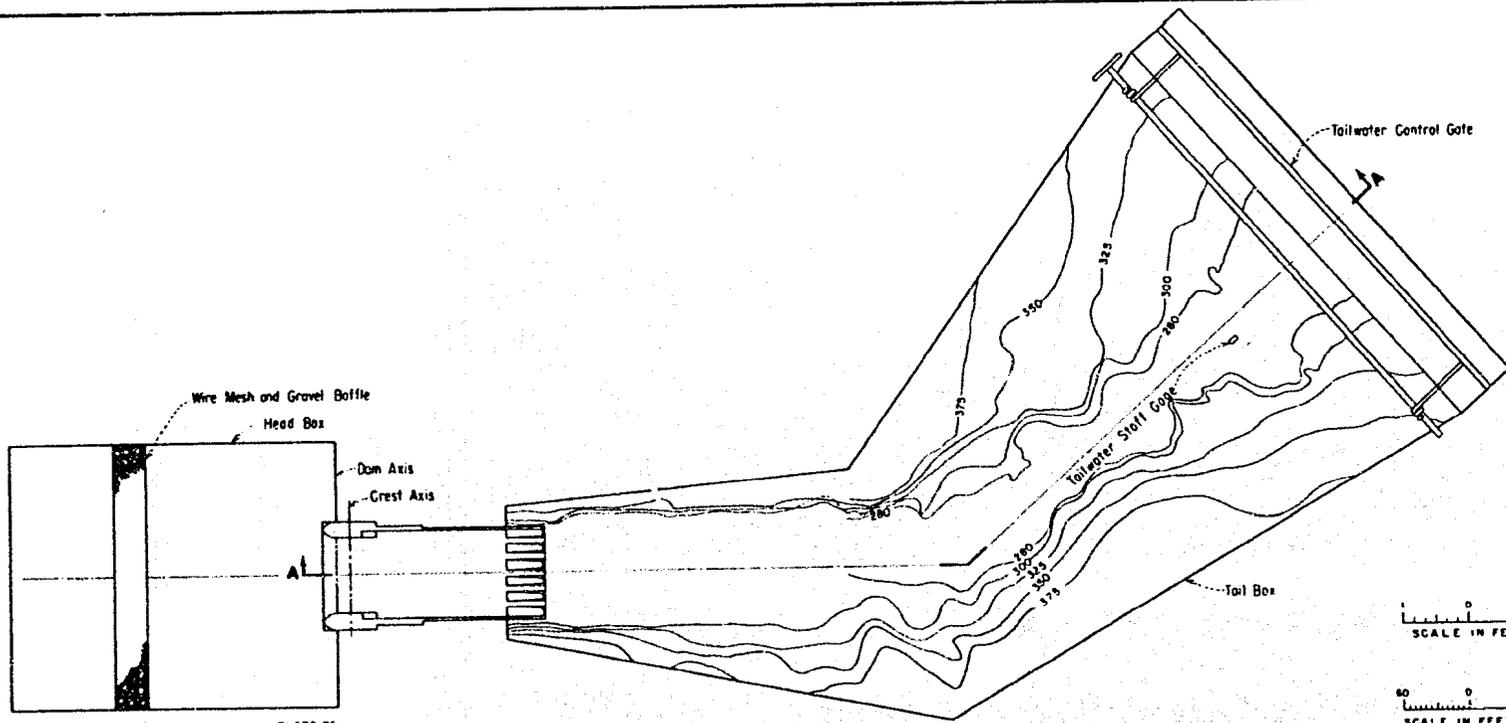
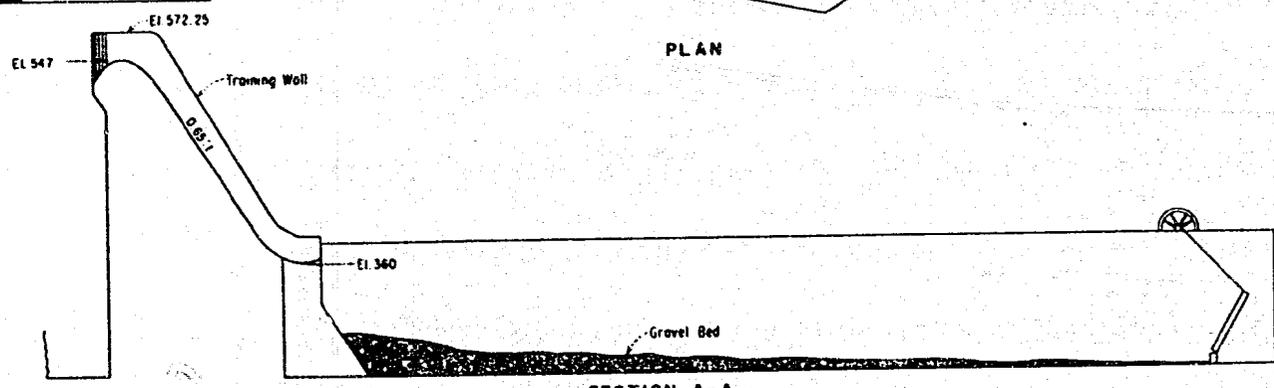
FIGURE 1
 REPORT NO. 288

SECTION A-A
 SPEATER VANCOUVER WATER DISTRICT
 VANCOUVER B.C.
CLEVELAND DAM
 MODEL PLAN AND SECTION
 MODEL SCALE 1:60

The model is shown schematically on Figure 1. Sections of the prototype spillway are shown on Figure 2. A 4- by 5- by 8-foot deep head box made of sheathing and sheet metal lined was used to represent the spillway approach. The crest was set in the box so an inside edge of the box represented the upstream face of the dam. The spillway was constructed in three parts. The crest and piers were made as a unit of sugar pine. The straight portion of the chute and training walls were made of plywood. The ski-jump bucket and training walls were made of sugar pine. Special shaped blocks were individually glued to the surface of a plain curved bucket to form a slotted bucket. The blocks could be removed for study of the plain bucket. The chute was attached to the crest with a mortise joint, and the ski-jump bucket was secured with screws and glue to the face of the chute. All parts of the spillway were given a coat of glyptol base paint as waterproofing.

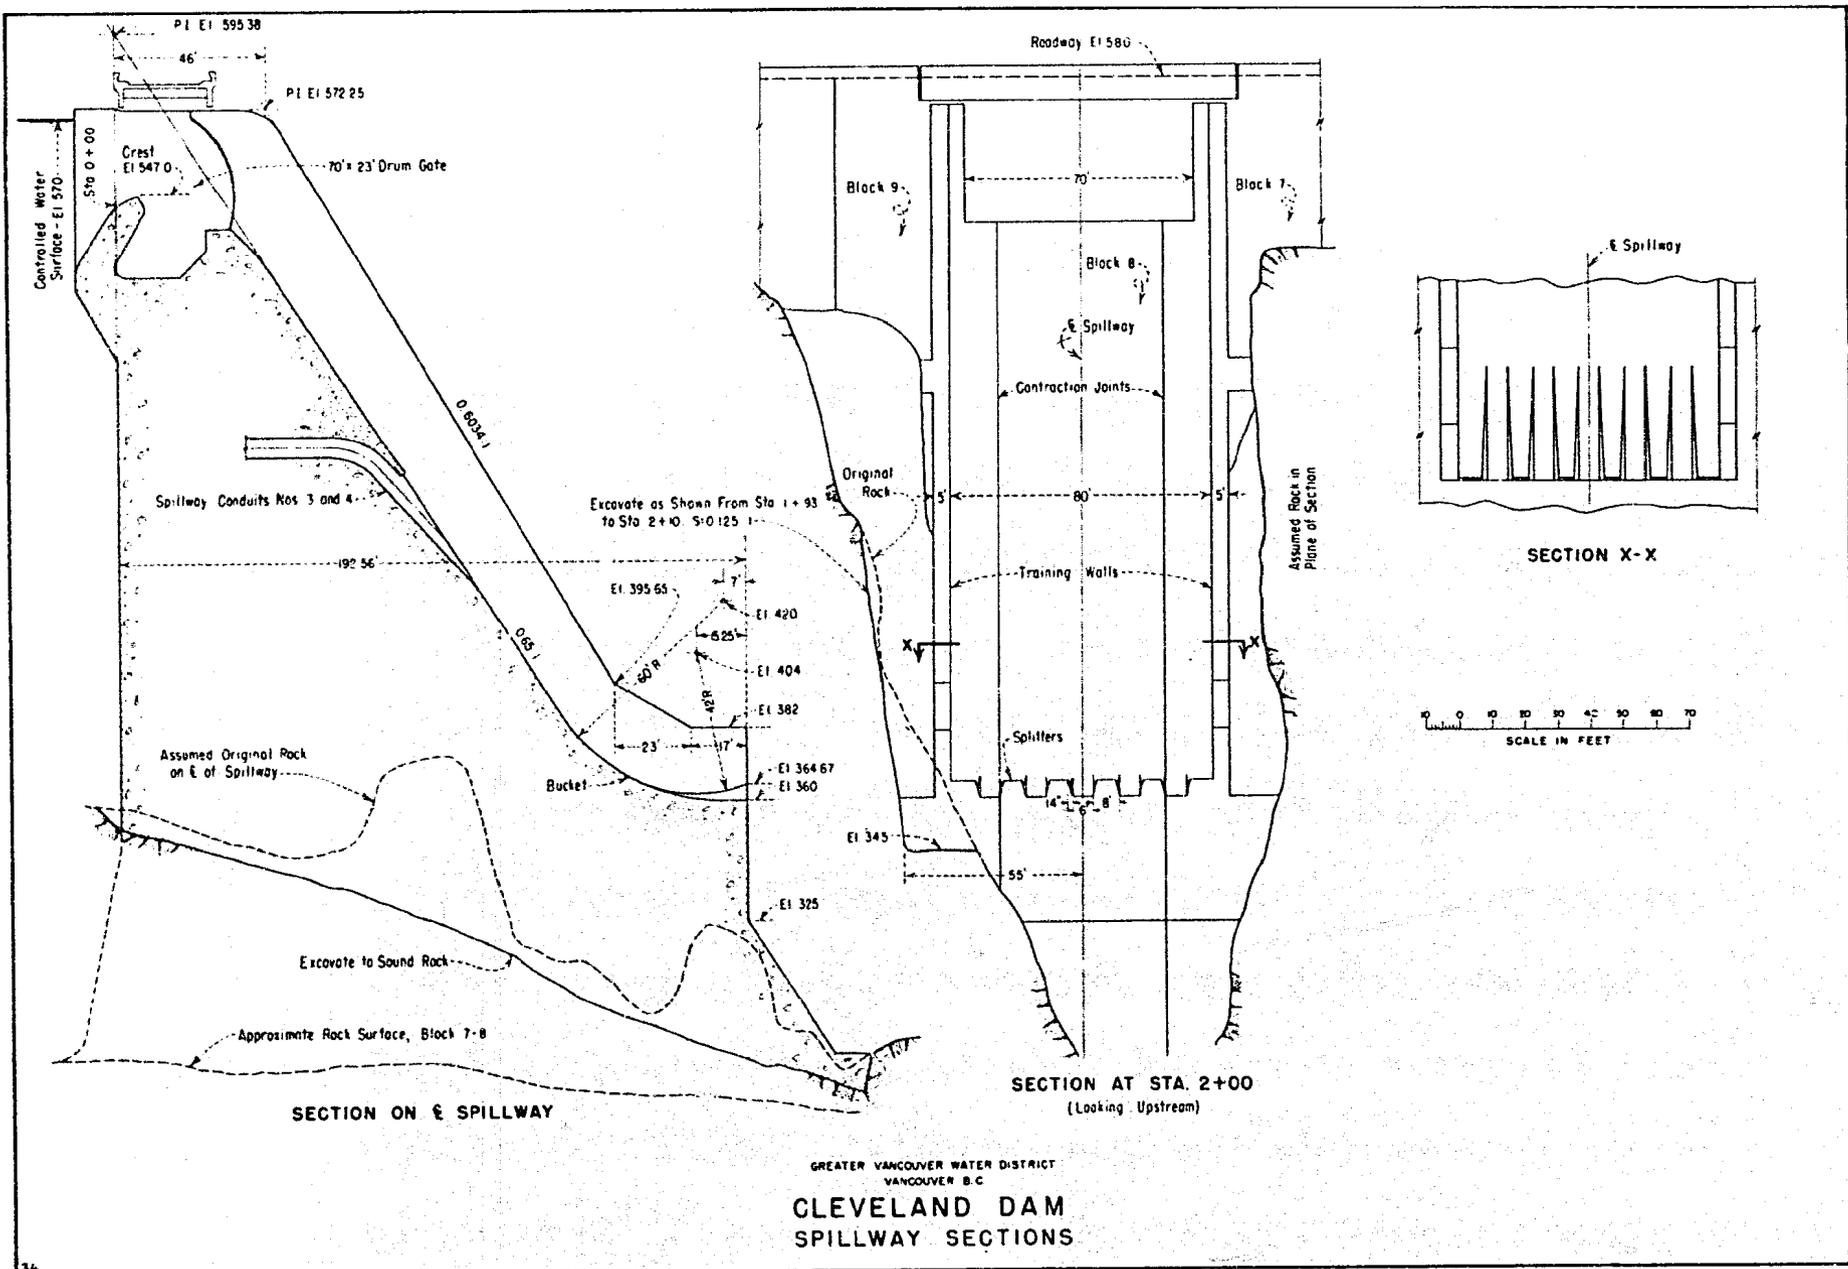
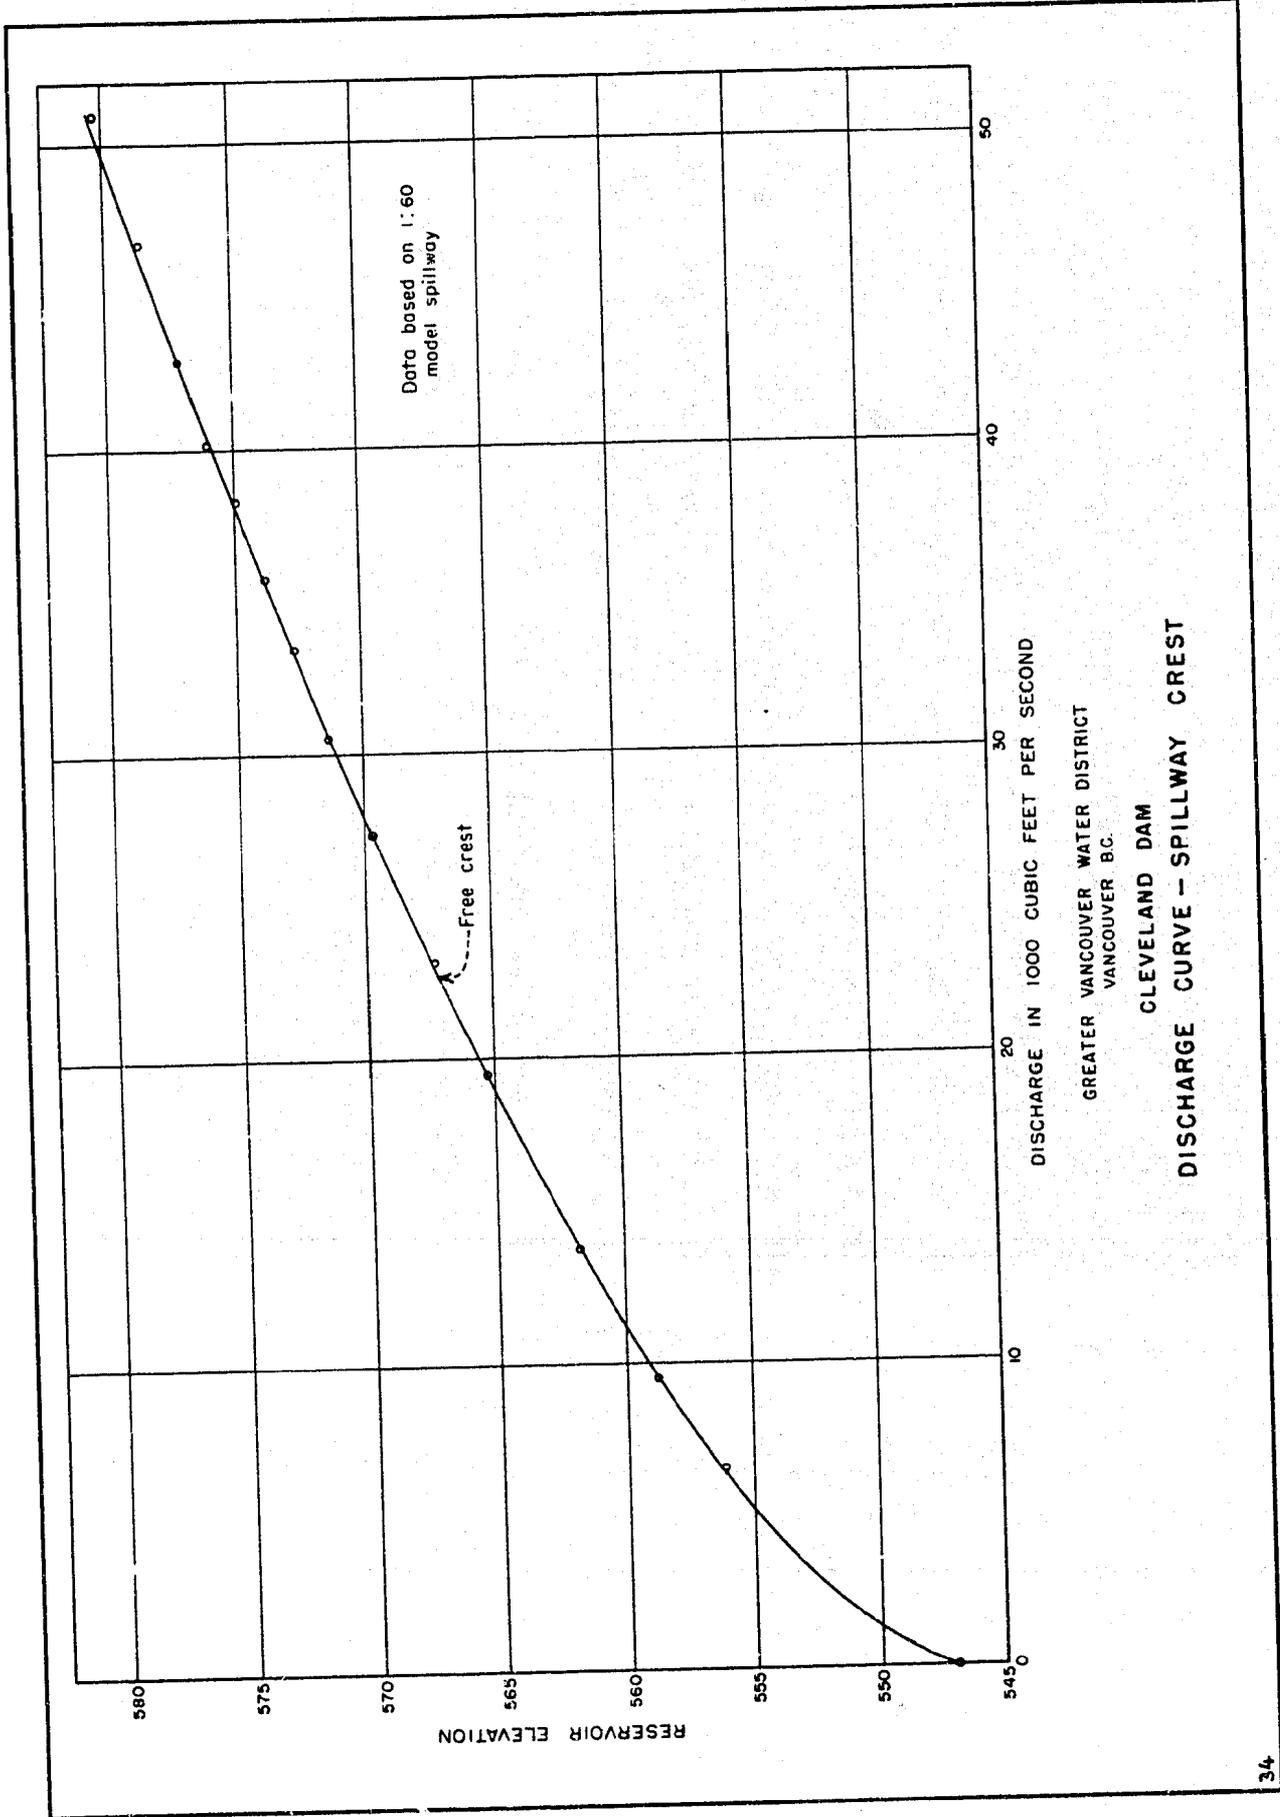
GREATER VANCOUVER WATER DISTRICT
VANCOUVER B.C.
**CLEVELAND DAM
SPILLWAY SECTIONS**

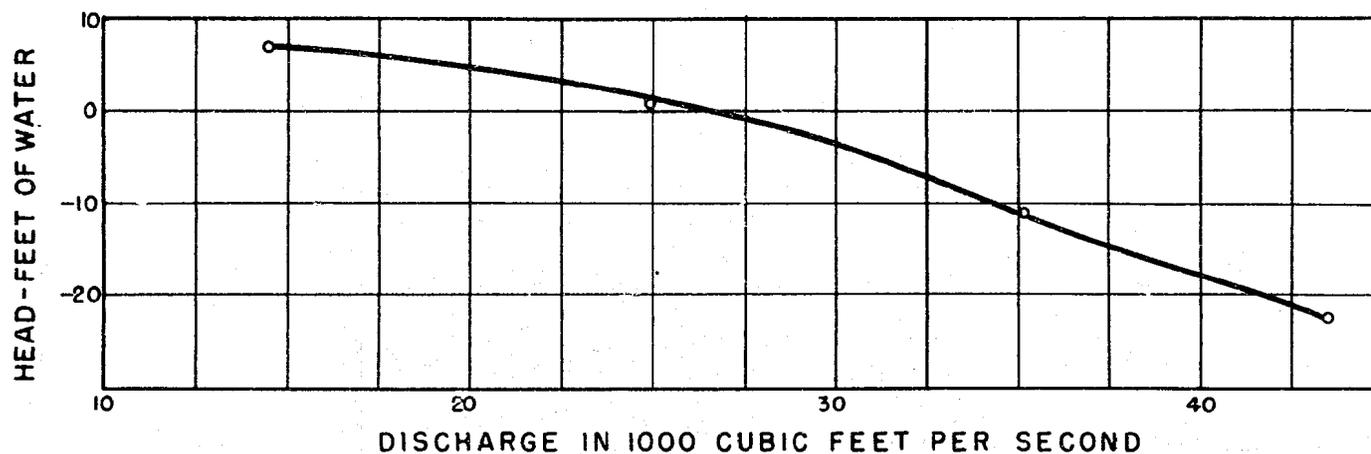
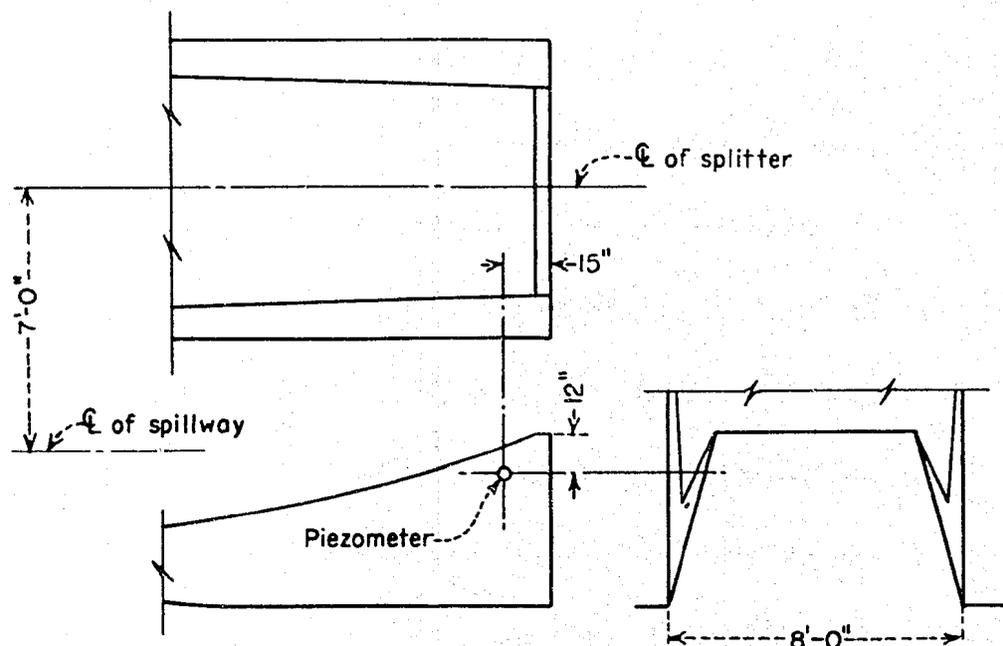
PIEZOMETER LOCATION

GREATER VANCOUVER WATER DISTRICT
VANCOUVER B.C.
CLEVELAND DAM
PRESSURE ON EDGE OF
BUCKET FLOW SPLITTER
MODEL SCALE 1:60

A limited study was made of the pressure on one of the edges of a bucket flow splitter. This test was planned after the model had been constructed, and only one piezometer was placed in the critical area near the edge of the splitter because of the difficulty of inserting tubes in wood. Location of the piezometer and the pressure curve for various discharges are given on Figure 4. Subatmospheric pressure occurred at high discharges. Low pressures can be expected along the splitter edges, with probable cavitation damage prevailing at smaller discharges than is indicated by the curve.

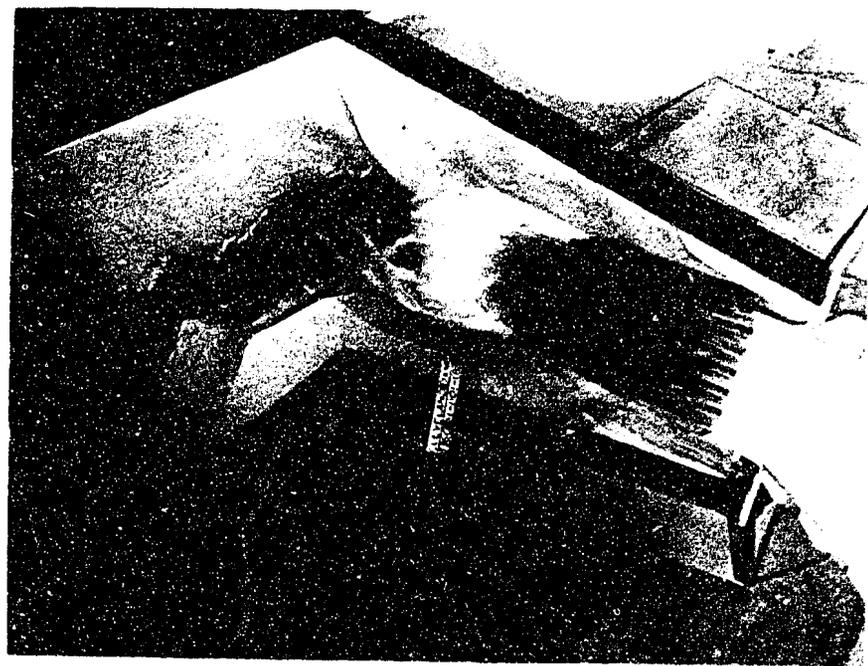
A. 15,000 cfs discharge
Tail water el. 299

B. 25,000 cfs discharge
Tail water el. 307

Greater Vancouver Water District
Vancouver, B.C., Canada
Cleveland Dam ski-jump spillway
Plan views of downstream river channel
with flows of 15,000 and 25,000 cfs

1. In general the spillway flow conditions were acceptable, particularly at the smaller discharges.
2. The ski-jump bucket slotted to form flow splitters, satisfactorily deflected the water into the river channel downstream away from the toe of the dam at all flows (Figures 9 through 14).

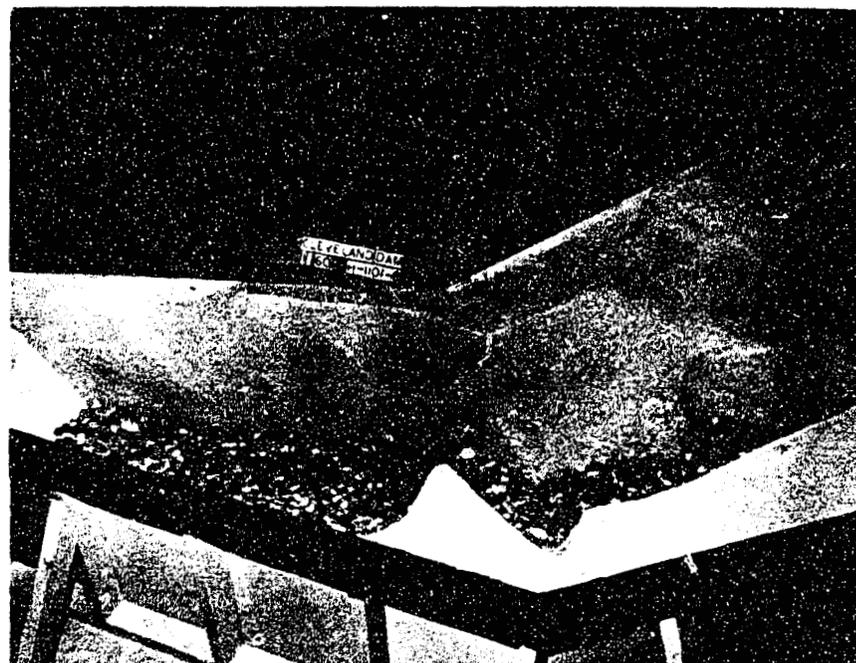
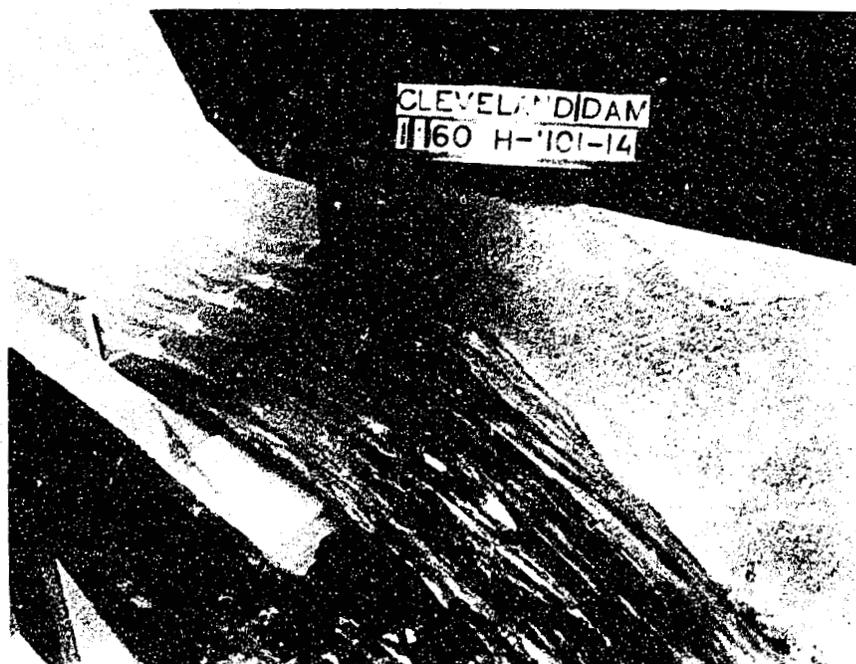
A. No discharge

B. 5,000 cfs discharge
Tail water el. 288

View of left side in ski-jump area
with flows of 0 and 5,000 cfs

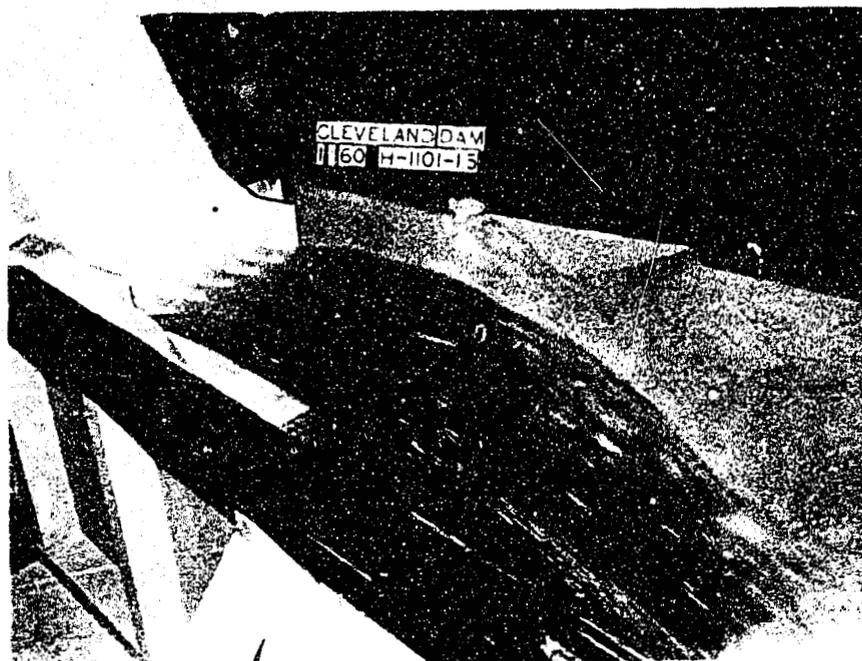
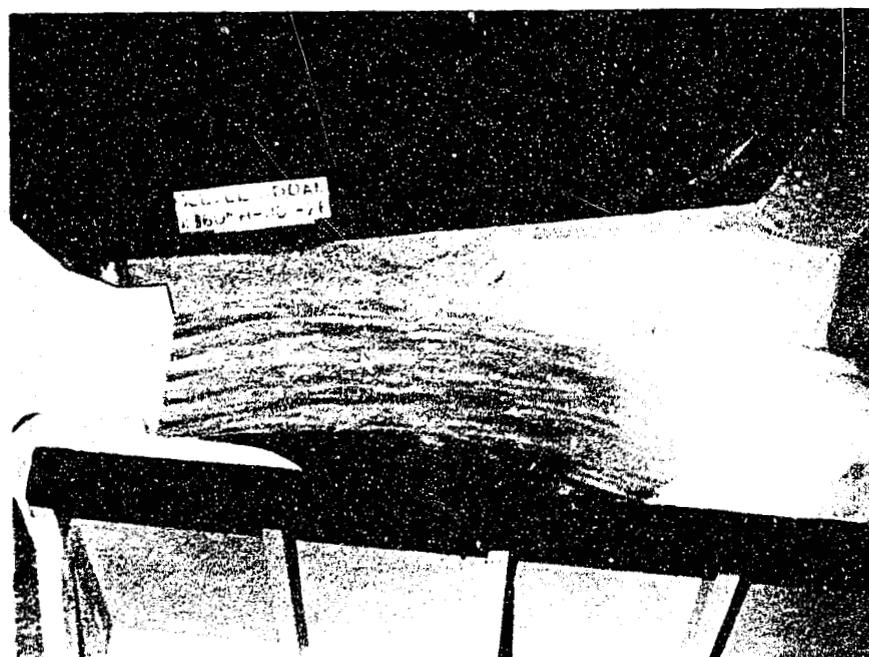
A. 15,000 cfs discharge
Tail water el. 299

B. 25,000 cfs discharge
Tail water el. 307

View of right side in ski-jump area
with flows of 15,000 and 25,000 cfs

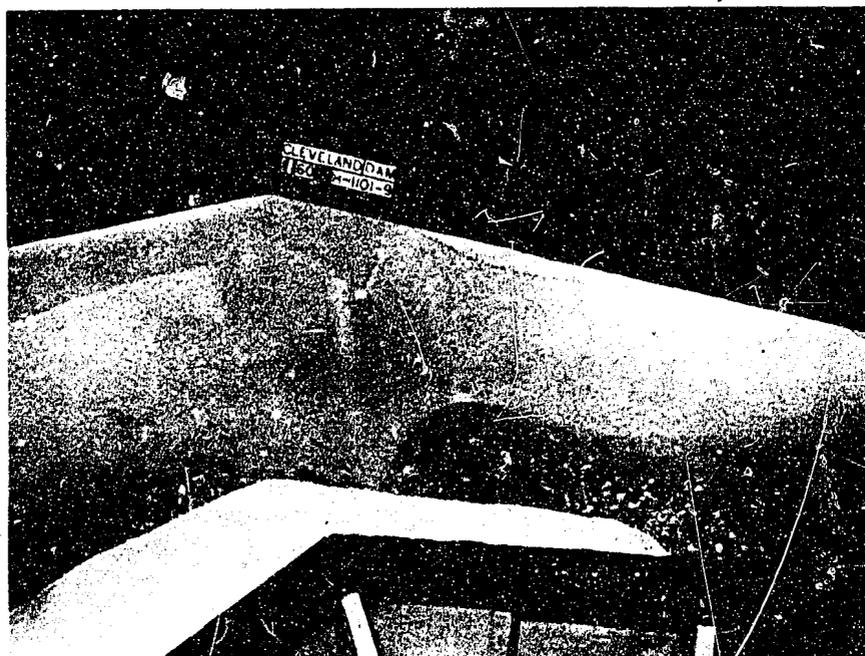
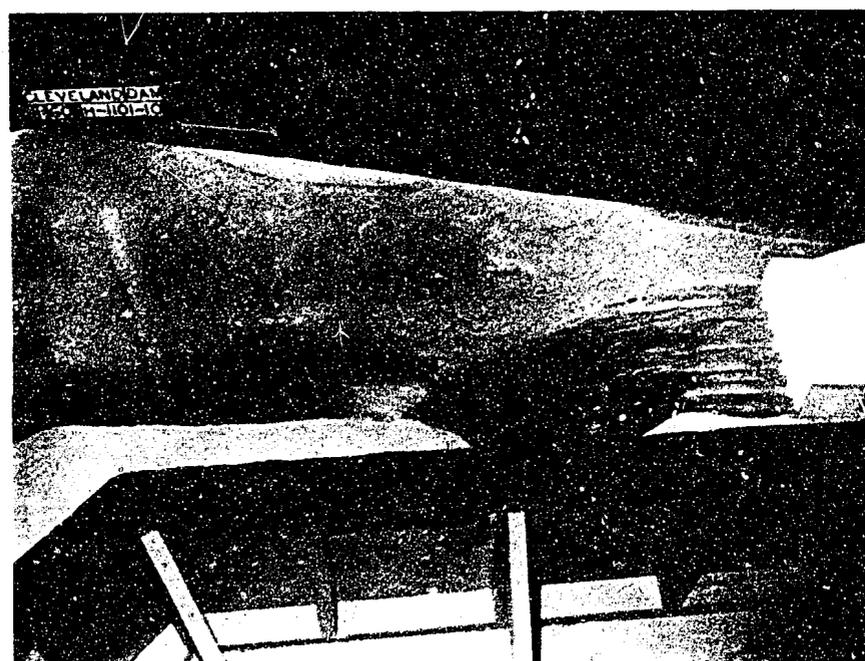
A. No discharge

B. 5,000 cfs discharge
Tail water el. 288

View of right side in ski-jump area
with flows of 0 and 5,000 cfs

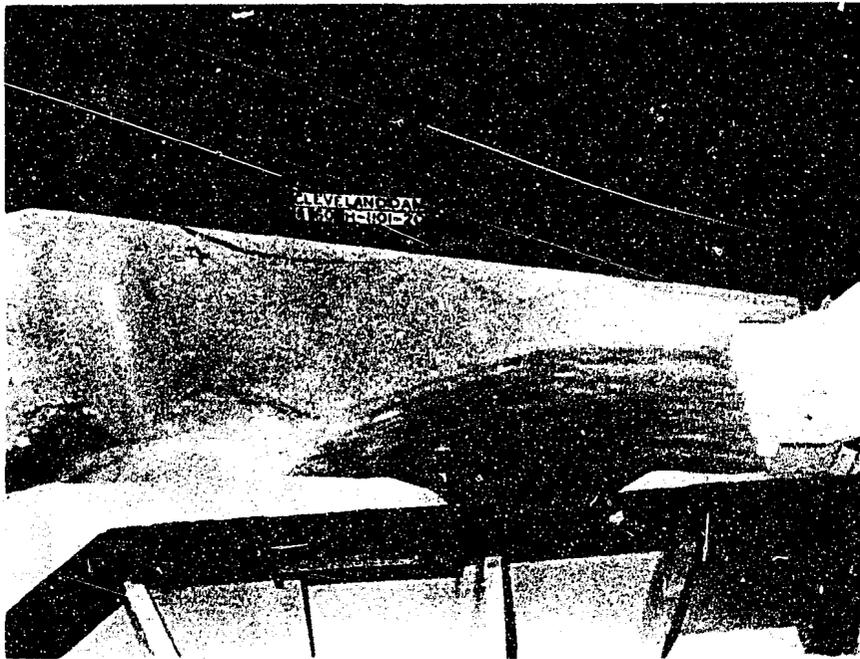
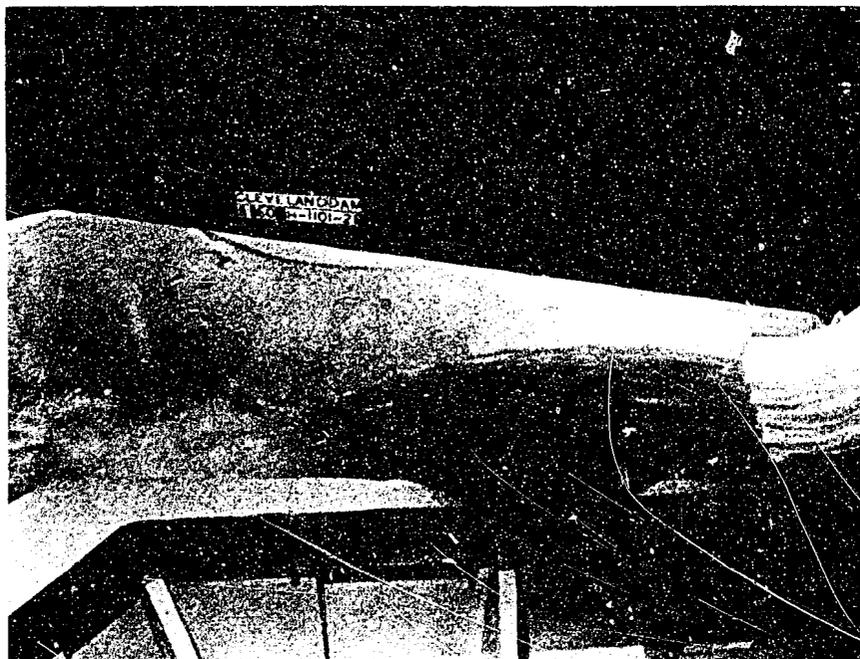
A. 15,000 cfs discharge
Tail water el. 299

B. 25,000 cfs discharge
Tail water el. 307

View of left side in ski-jump area
with flows of 15,000 and 25,000 cfs

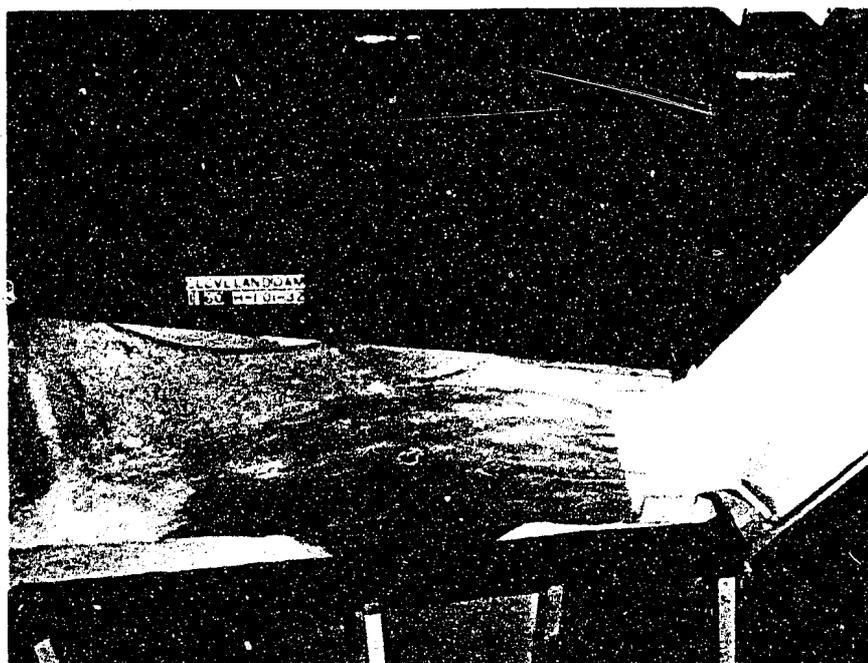
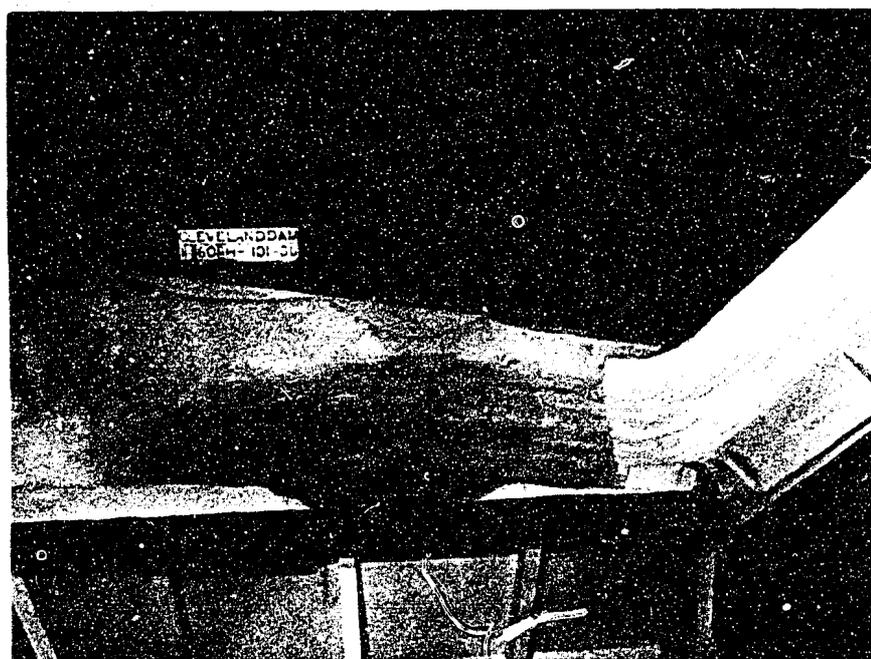
A. 35,000 cfs discharge
Tail water el. 314

B. 43,000 cfs discharge
Tail water el. 319

View of left side in ski-jump area
with flows of 35,000 and 43,000 cfs

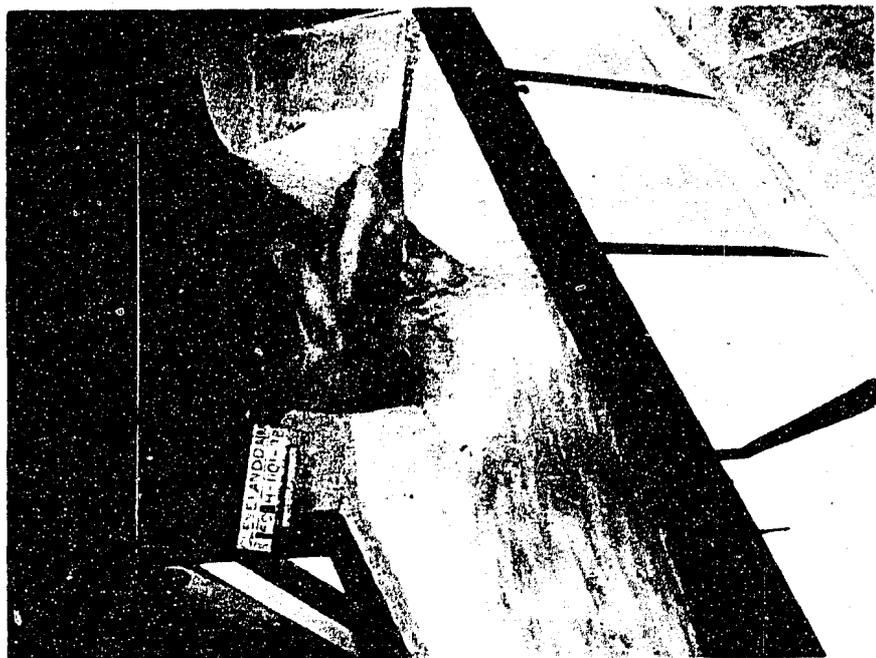
A. 35,000 cfs discharge
Tail water el. 314

B. 43,000 cfs discharge
Tail water el. 319

View of jet impingement and down-
stream river channel with flows of
35,000 and 43,000 cfs.

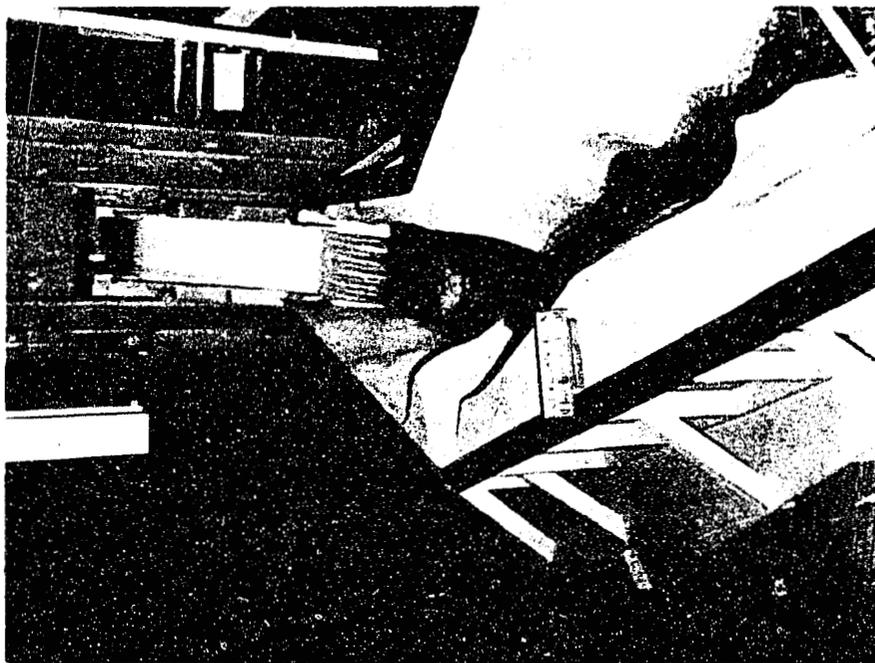
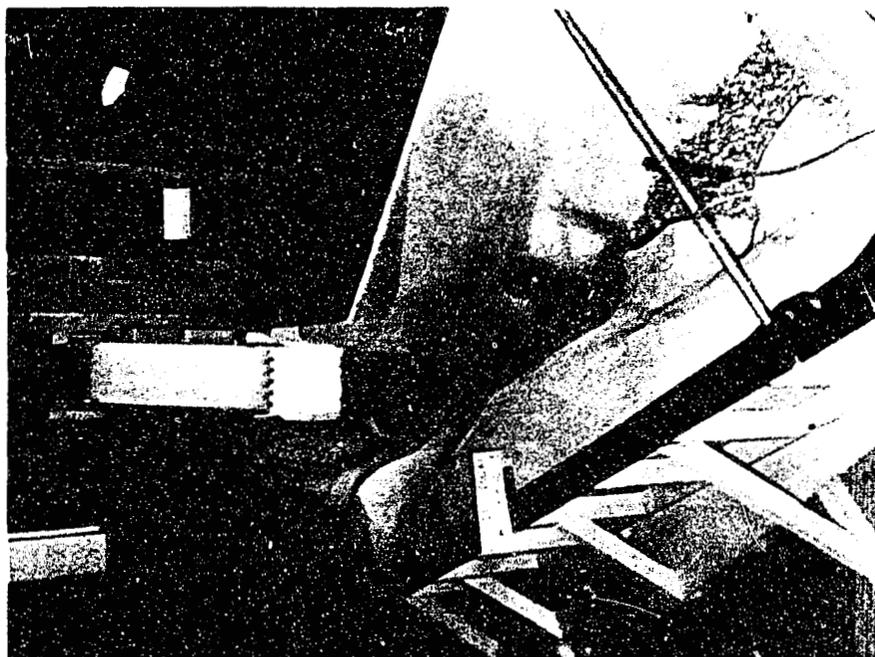
B. 5,000 cfs discharge
Tail water el. 288

A. No discharge

View of river channel and spillway
with flows of 0 and 5,000 cfs

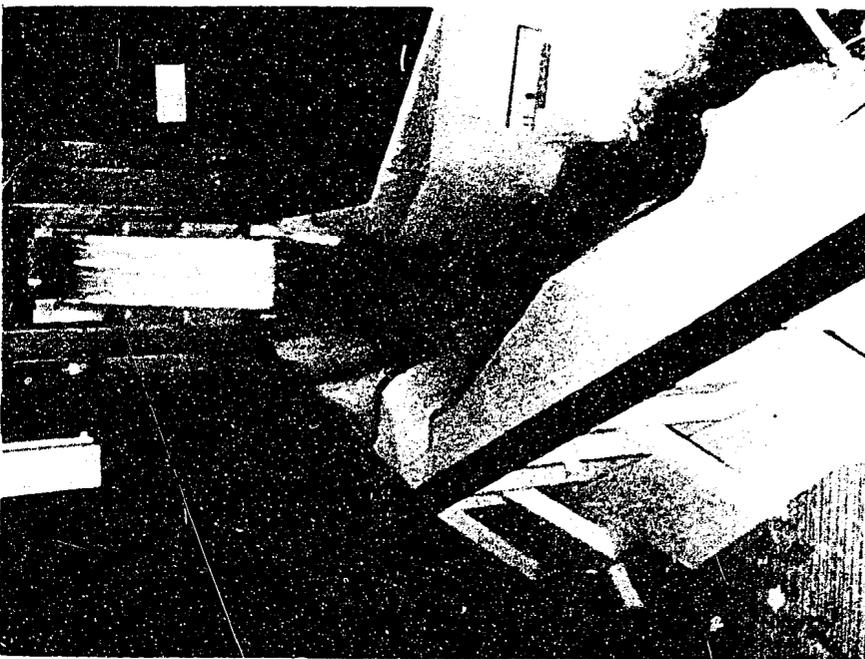
A. 15,000 cfs discharge
Tail water el. 299

B. 25,000 cfs discharge
Tail water el. 307

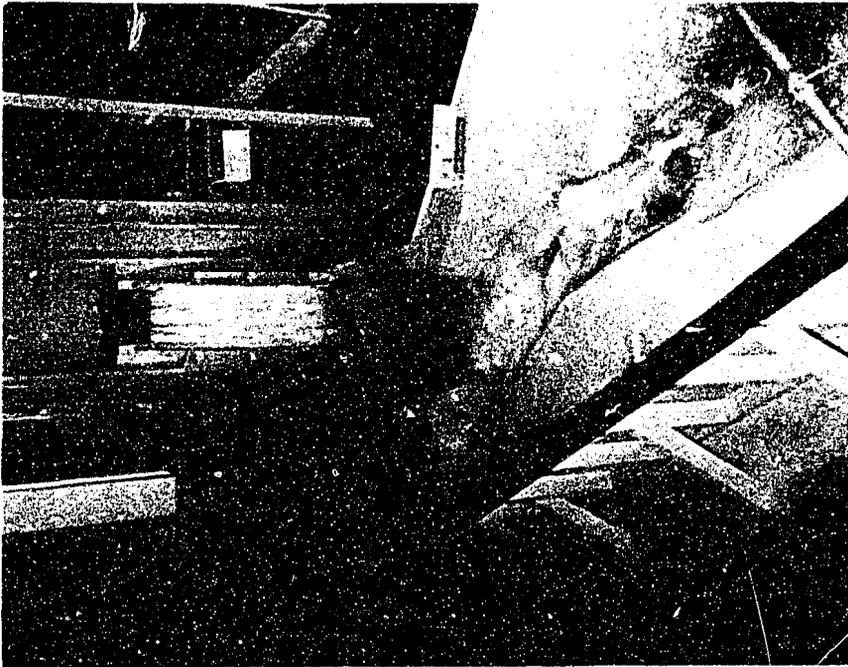
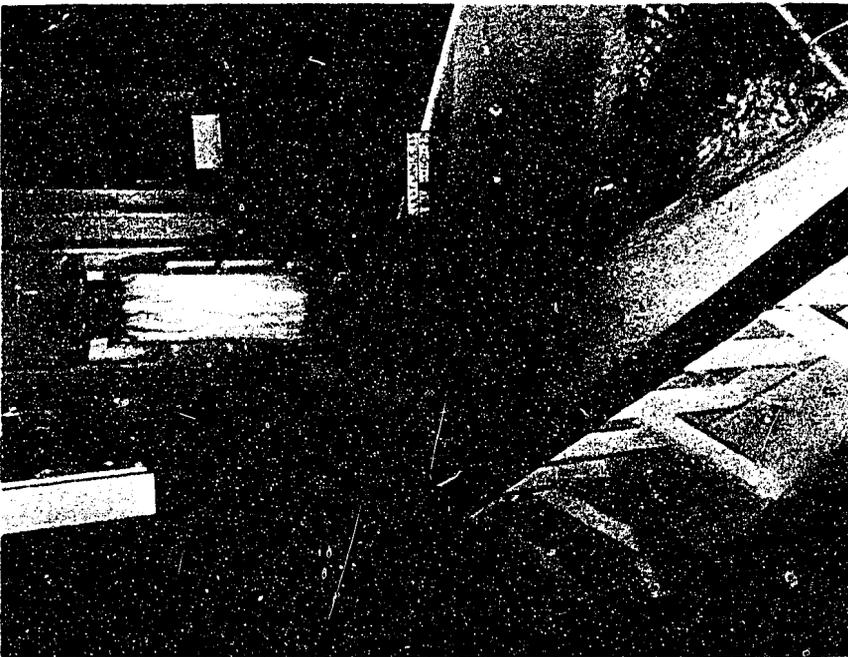
A. 35,000 cfs discharge
Tail water el. 314

B. 43,000 cfs discharge
Tail water el. 319

Greater Vancouver Water District
Vancouver, B.C., Canada
Cleveland Dam ski-jump spillway

View of river channel and spillway
with flows of 35,000 and 43,000 cfs.

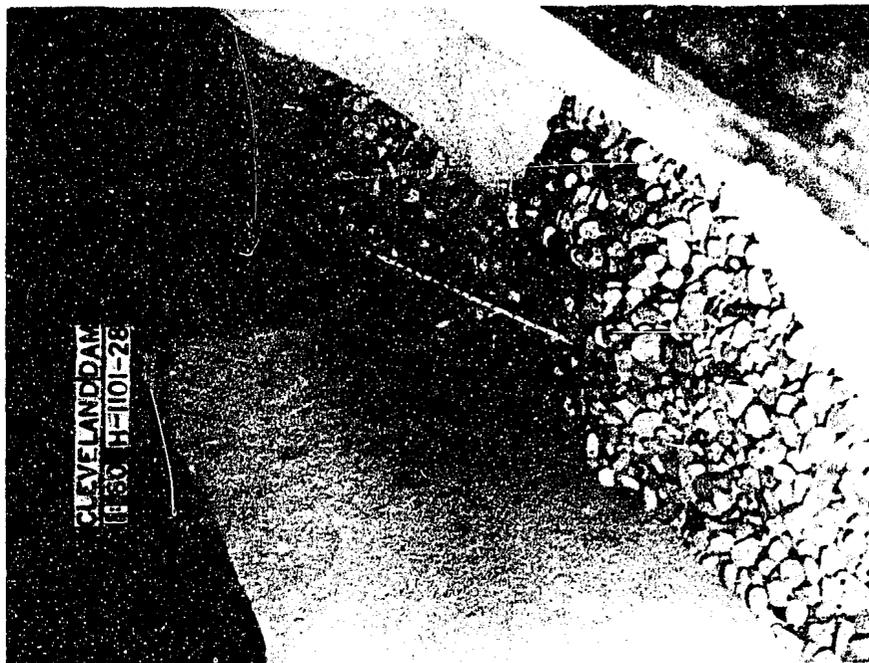
B. Close-up from right side

A. Plan

Greater Vancouver Water District
Vancouver, B.C., Canada
Cleveland Dam ski-jump spillway

Scour in river channel after discharge
of 35,000 cfs

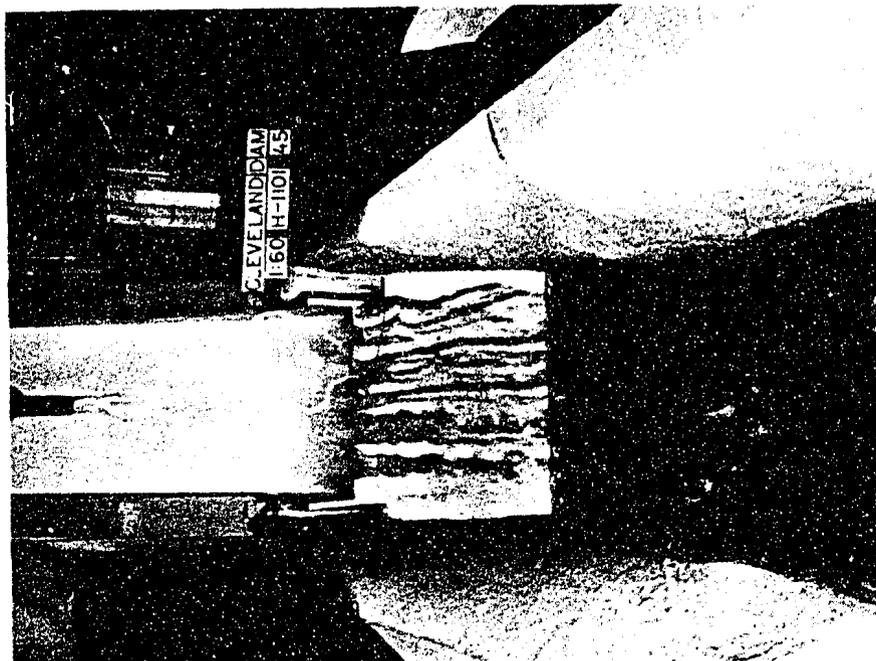
B. 1,750 cfs discharge
Assimilated outlet flow.

A. 22,000 cfs discharge
Gate raised reservoir el. 570

Greater Vancouver Water District
Vancouver, B.C., Canada
Cleveland Dam ski-jump spillway
Flow conditions for spillway and
outlets

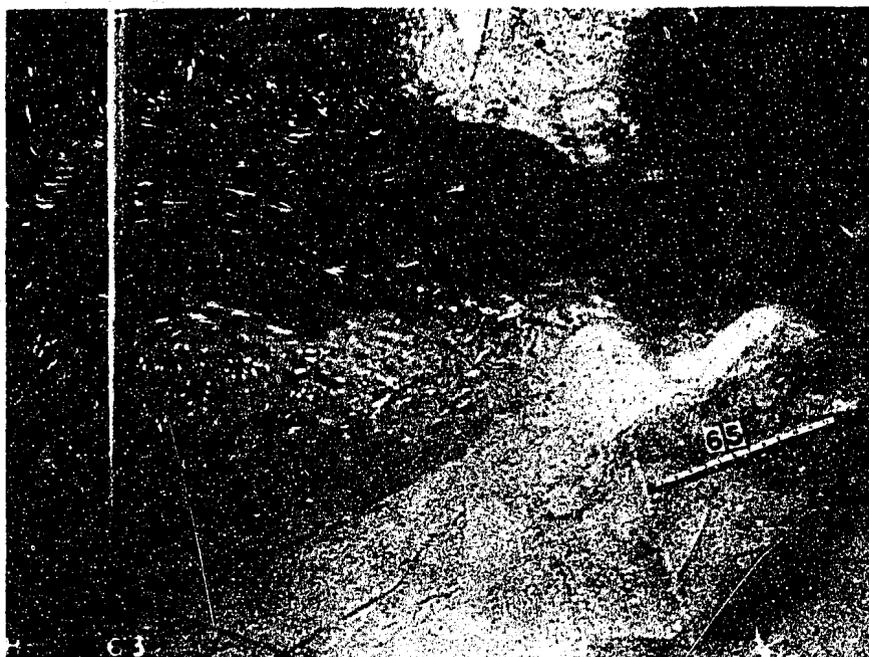
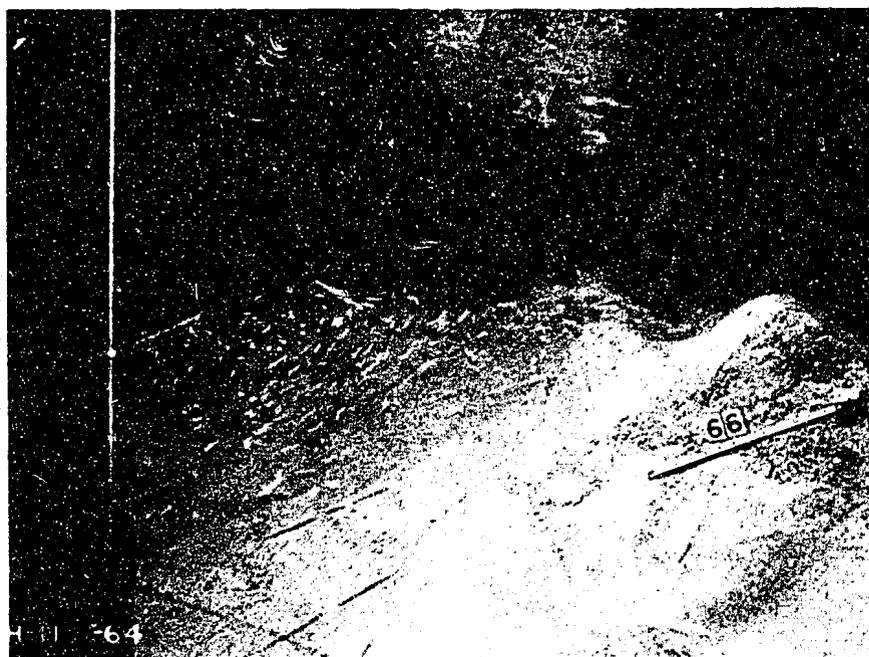
A. 1/10-second exposure

B. 1/5-second exposure

**Greater Vancouver Water District
Vancouver, B. C., Canada
Cleveland Dam ski-jump spillway**

**Flow pattern in pumping plant and
fishway area for 25,000 cfs discharge
as shown by floating confetti.**

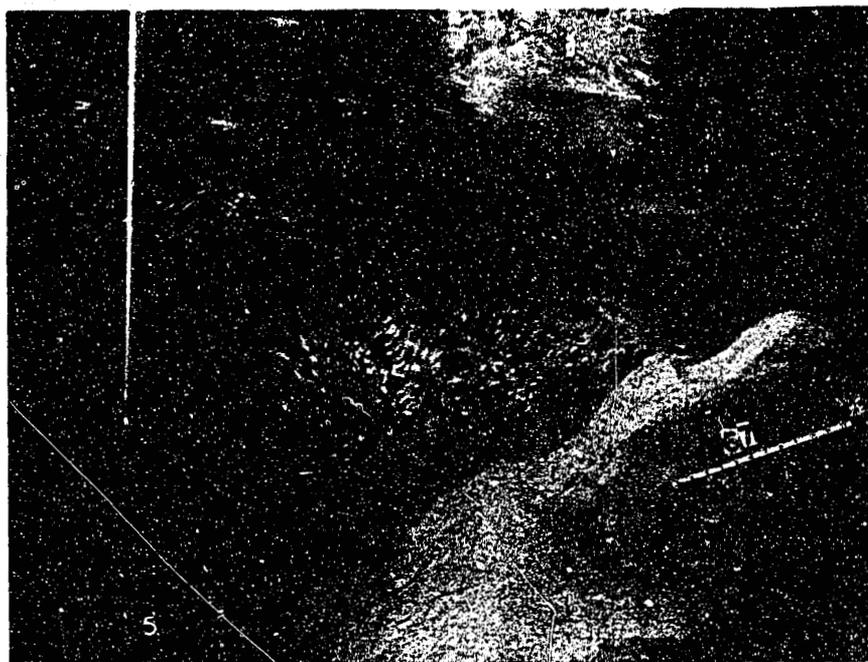
A. 1/10-second exposure

B. 1/5-second exposure

**Greater Vancouver Water District
Vancouver, B.C., Canada
Cleveland Dam ski-jump spillway**

**Flow pattern in pumping plant and
fishway area for 35,000 cfs discharge
as shown by floating confetti.**
