HYDRAULIC STUDIES OF THE SKI-JUMP SPILLWAY
FOR CLEVELAND DAM
GREATER VANCOUVER WATER DISTRICT
VANCOUVER, BRITISH COLUMBIA, CANADA

Hydraulic Laboratory Report No. Hyd-369

May 19, 1953

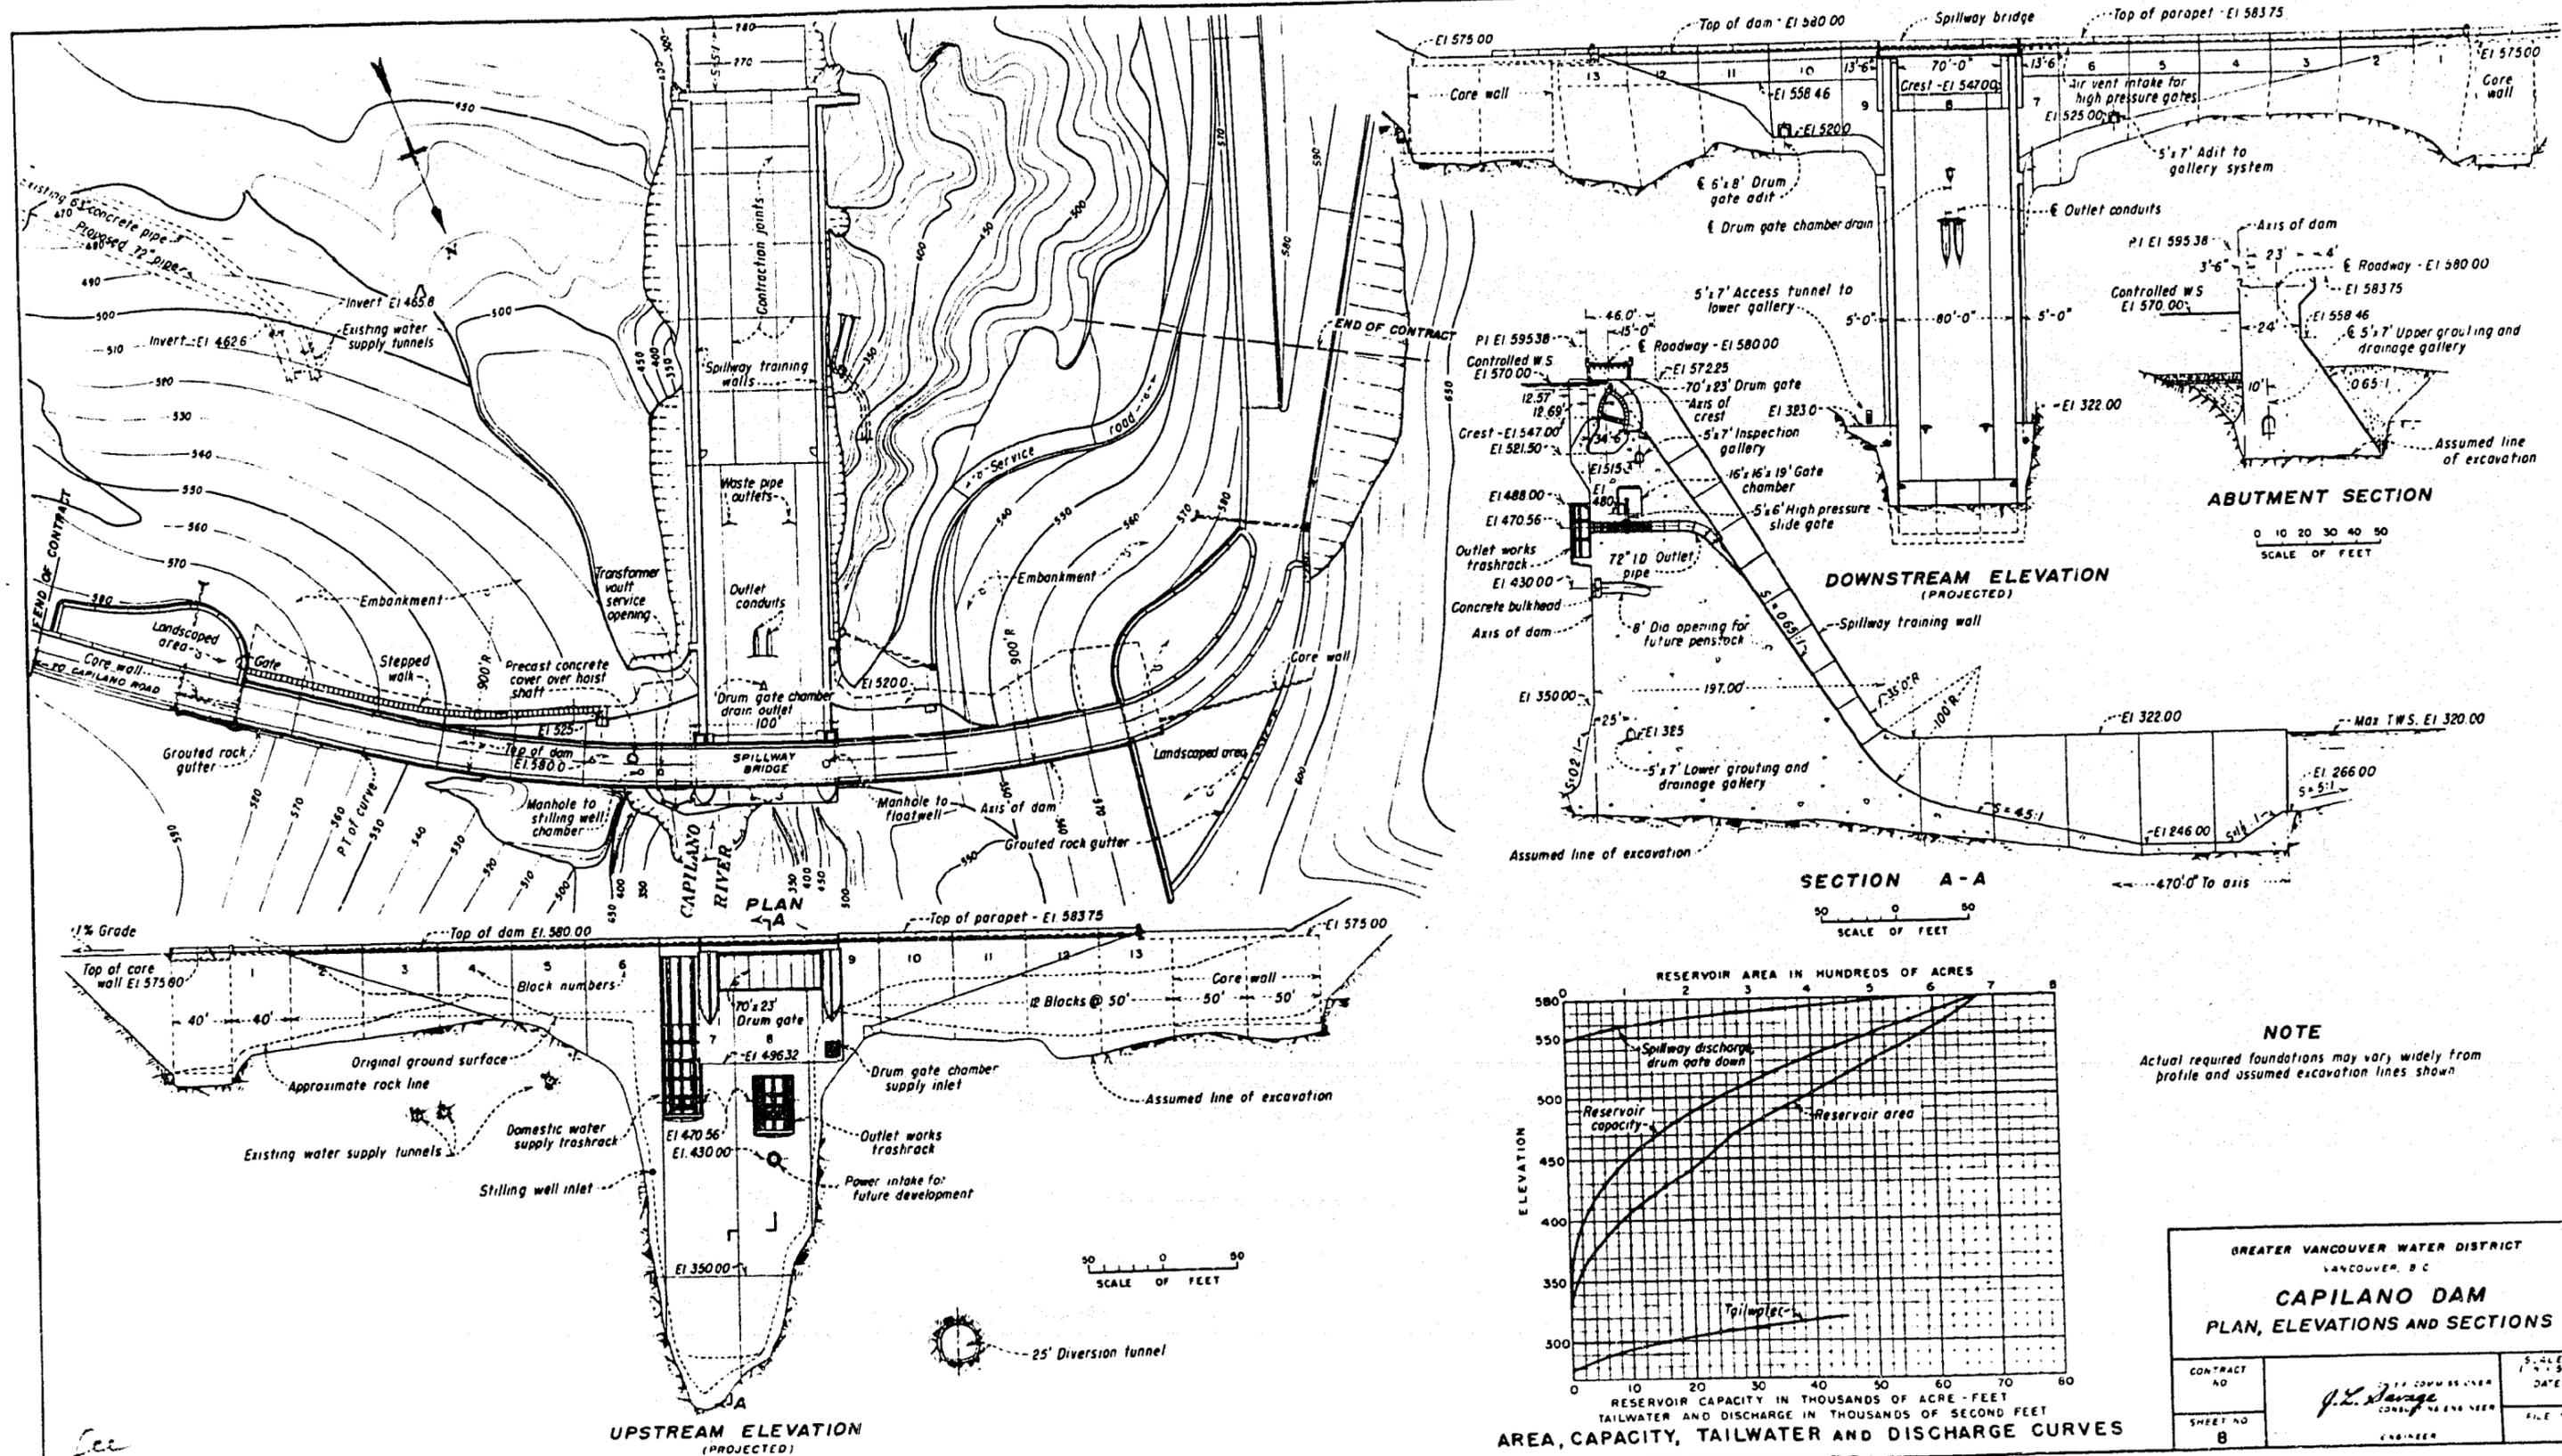
FIGURE 2

NOTE
Actual required foundations may vary widely from profile and assumed excavation lines shown

The Capilano Dam of the Greater Vancouver Water District is located on the Capilano River 2 miles above North Vancouver, British Columbia, Figure 1. This concrete-gravity type structure will rise 300 feet above bedrock, Figure 2. The average hydraulic head will be 260 feet. River flow, past the dam, will be controlled by one 70-by 23-foot drum gate and by two river outlets with 5- by 6-foot

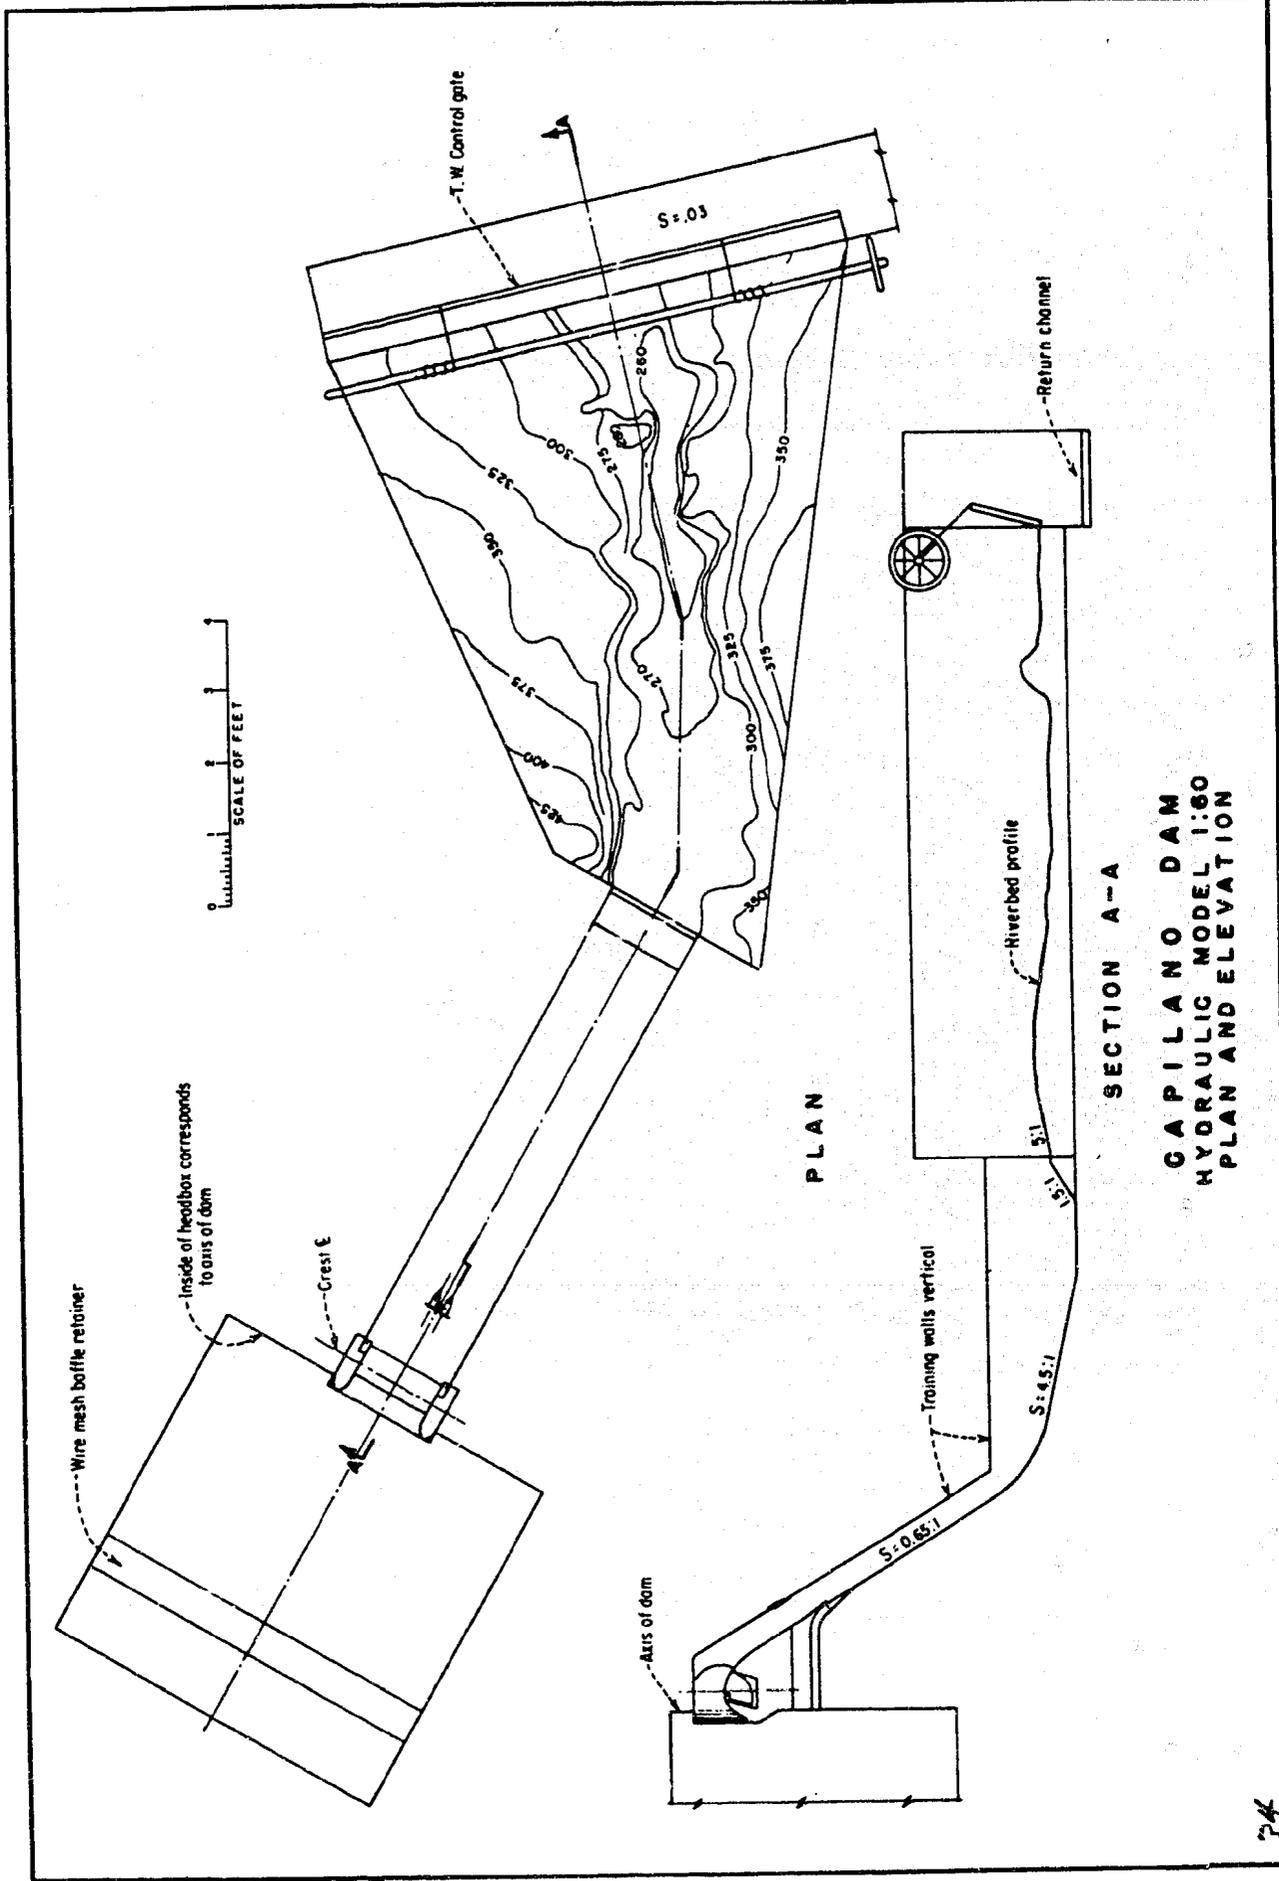
CAPILANO DAM
HYDRAULIC MODEL 1:60
PLAN AND ELEVATION

metal lath frames covered with a thin layer of concrete. The model layout is shown in Figure 3. The model, ready for operation, is shown in Figure 4A.

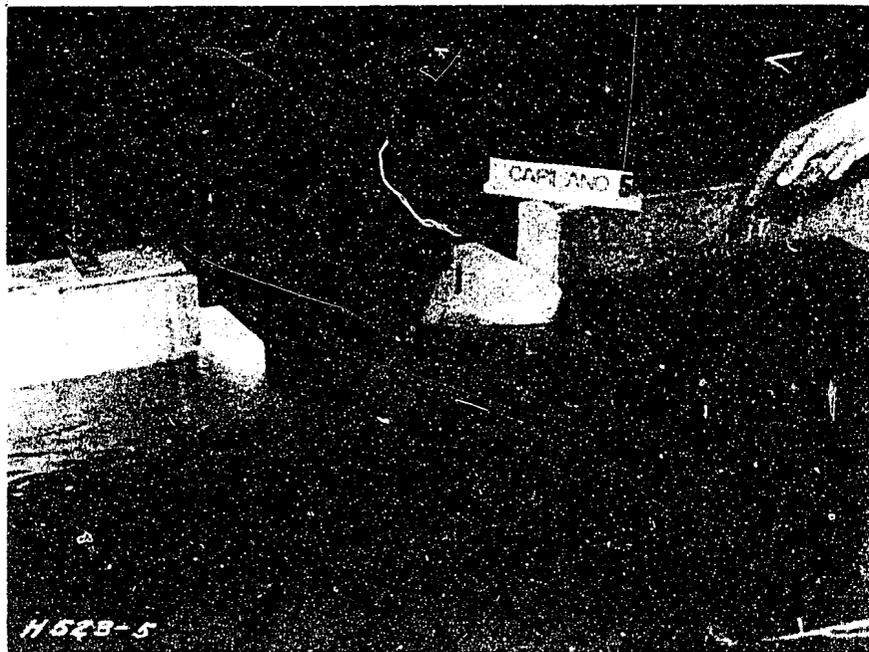
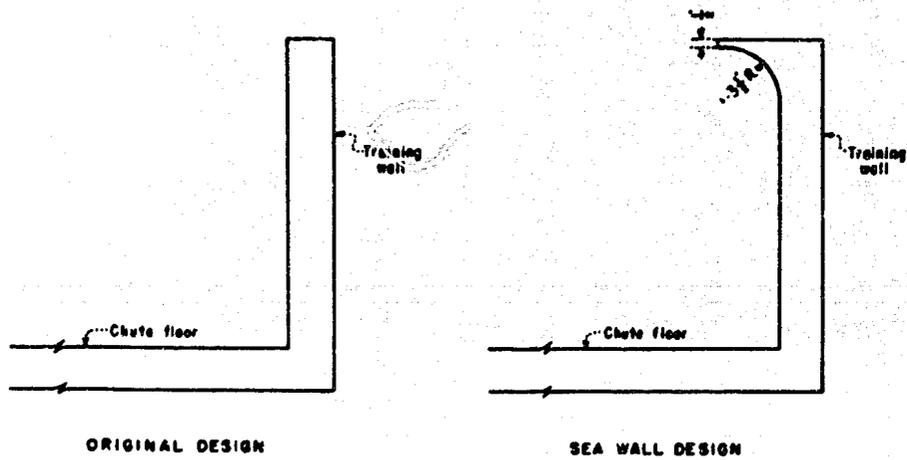
A. Spillway approach
 $Q=43,000$ cfs.

B. Details of chute training-walls.

CAPILANO DAM
1:60 SCALE MODEL

The approach. With the exception of the trashrack for the domestic water supply, the approach to the spillway is straight and symmetrical and, therefore, presents no hydraulic problem. The trashrack is located closer to the spillway than is customary, so model studies were made on the spillway operation and efficiency with and without the trashrack structure. The trashrack structure did not effect the operation or efficiency of the spillway in the model. Figure 5A shows the approach conditions at the maximum discharge of 43,000 second-feet.

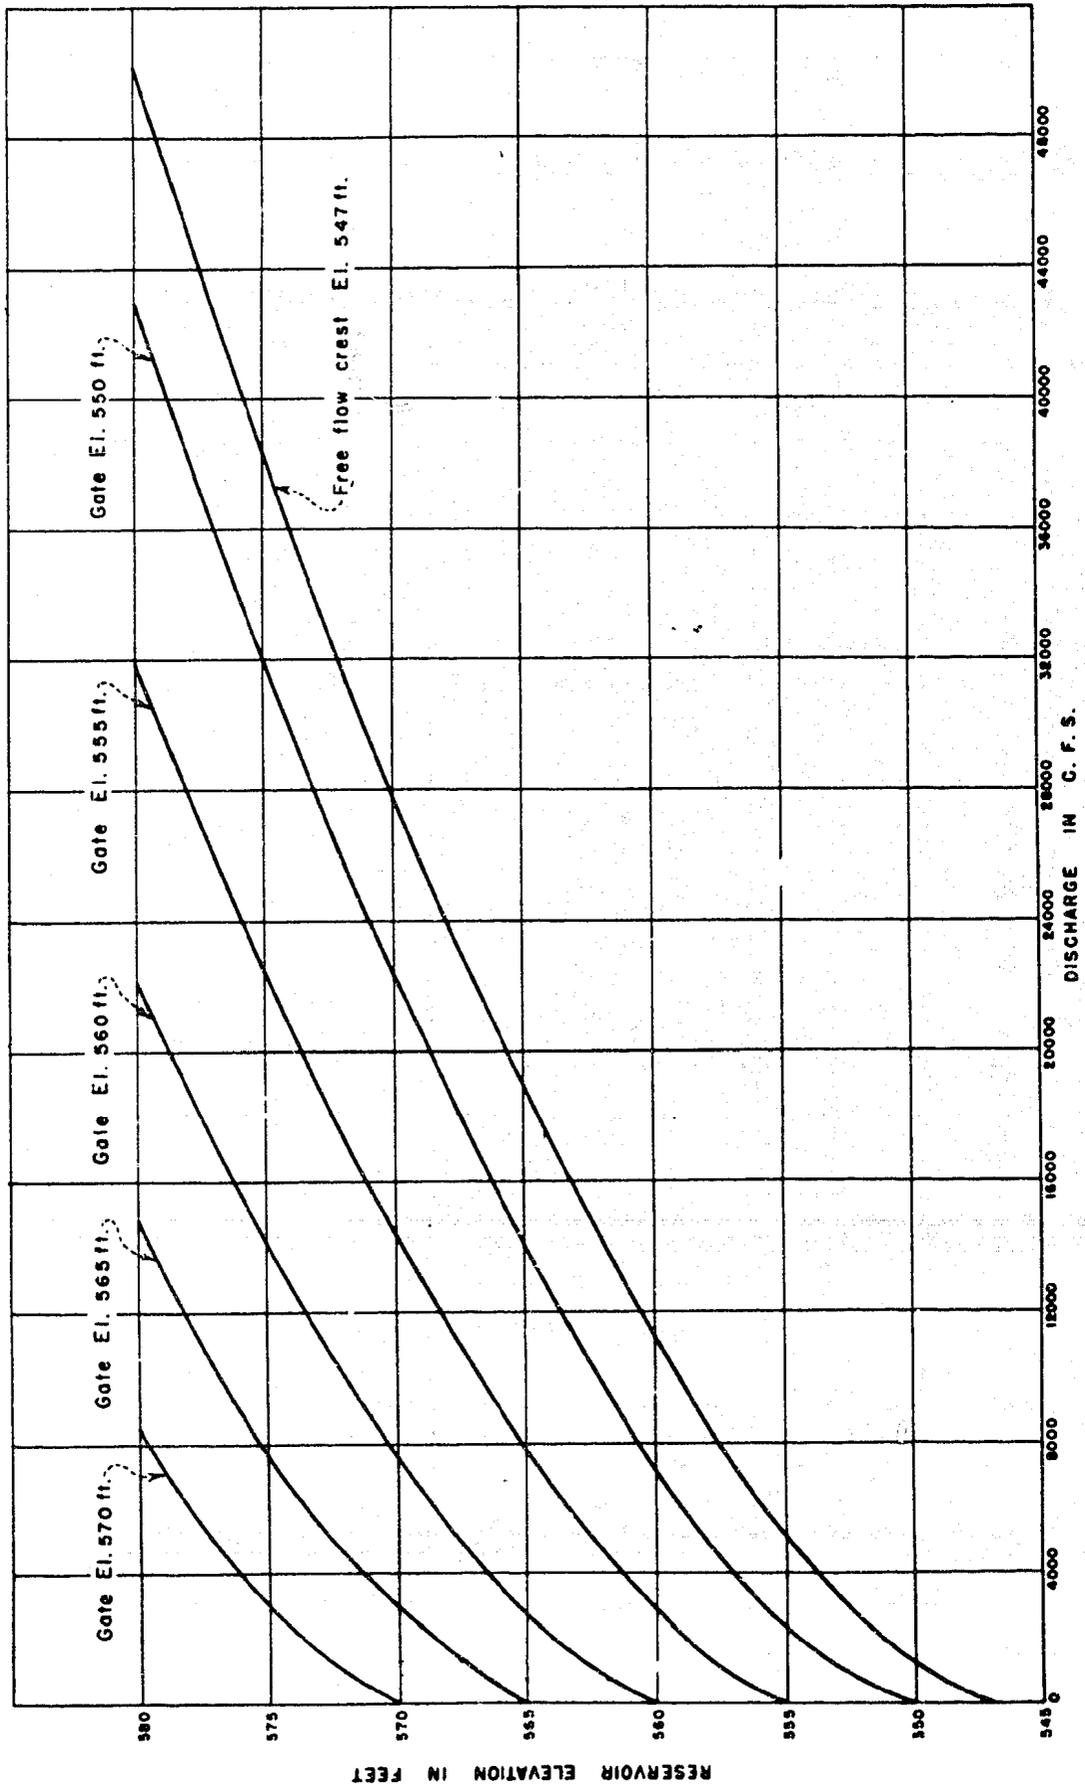
FIGURE 6

CAPILANO DAM
DISCHARGE CURVES FROM CALIBRATION OF 1:60 SCALE MODEL

Test results. The calibration of the free crest (Figure 3) coincided with the calibration of the original model (Figure 6 of the Appendix), so no further calibration was performed. The curves in the Appendix can be used to determine flood quantities.

The overflow crest section. Flow conditions at the crest were satisfactory for the design as submitted. The nappe was completely aerated with the drum gate in raised positions except at very low heads when the sheet of water from the crest did not clear the self-aerating piers. This latter condition, while not serious, may be avoided by using the river outlets instead of the spillway for very small discharges. The coefficient of discharge at maximum reservoir elevation of 575 feet was found to be 3.71, as compared to the design coefficient of approximately 4.14. The difference in coefficients resulted in a maximum free discharge of 38,400 second-feet, as compared to a discharge of 43,000 second-feet for the maximum design head. Due to the nature of the topography of the site, a longer spillway crest was found to be uneconomical. It was therefore decided to increase the maximum reservoir elevation by 2 feet to bring the spillway capacity to the required 43,000 second-feet. The model tests indicated a maximum reservoir water surface of elevation 577.0, as compared to the design water surface of elevation 575.0 feet. Head-discharge curves obtained from the model calibration are shown in Figure 6 for the free crest and several

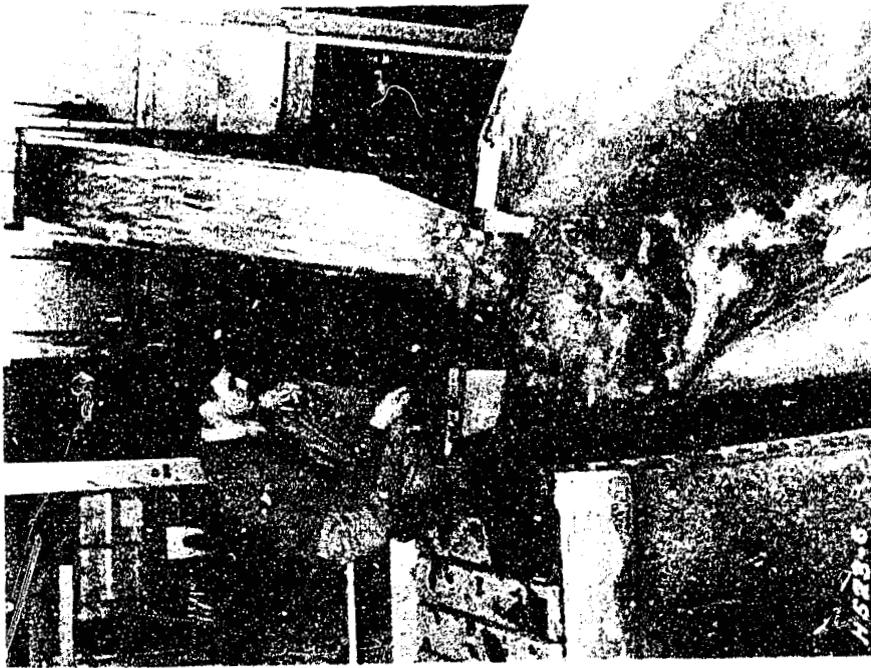
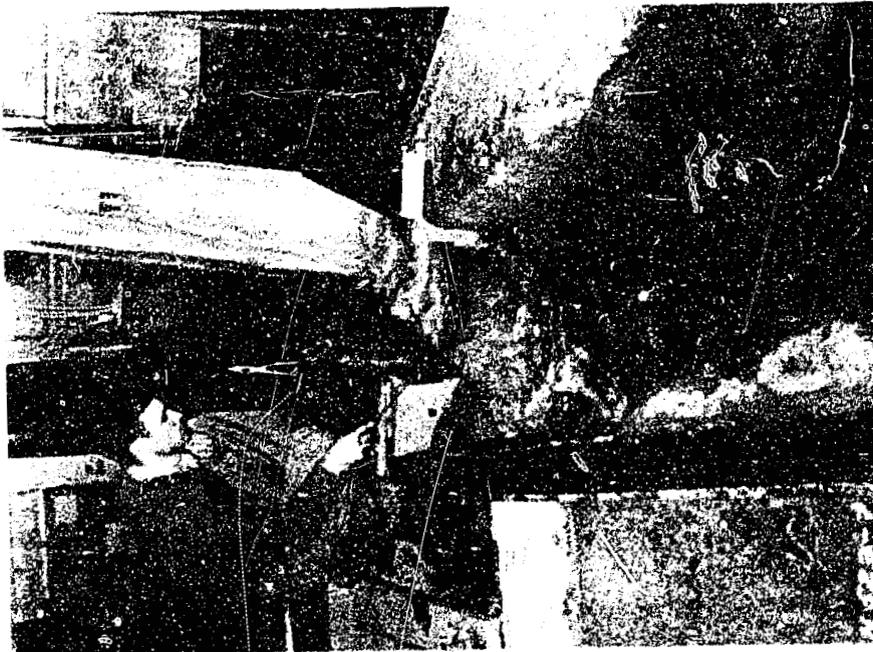
FIGURE 10

q=45,000 cfs.

CAPILANO DAM
1:60 SCALE MODEL
STILLING-PPOOL OPERATION

q=55,000 cfs.

shown for spillway discharges of 15,000, 25,000, 33,000, and 43,000 second-feet in Figures 9 and 10.
