UNITED STATES
DEPARTMENT OF THE INTERIOR
BUREAU OF RECLAMATION

HYDRAULIC MODEL STUDIES OF THE
TRINITY DAM MORNING-GLORY SPILLWAY
TRINITY RIVER DIVISION
CENTRAL VALLEY PROJECT--CALIFORNIA

Hydraulic Laboratory Report No. Hyd-447

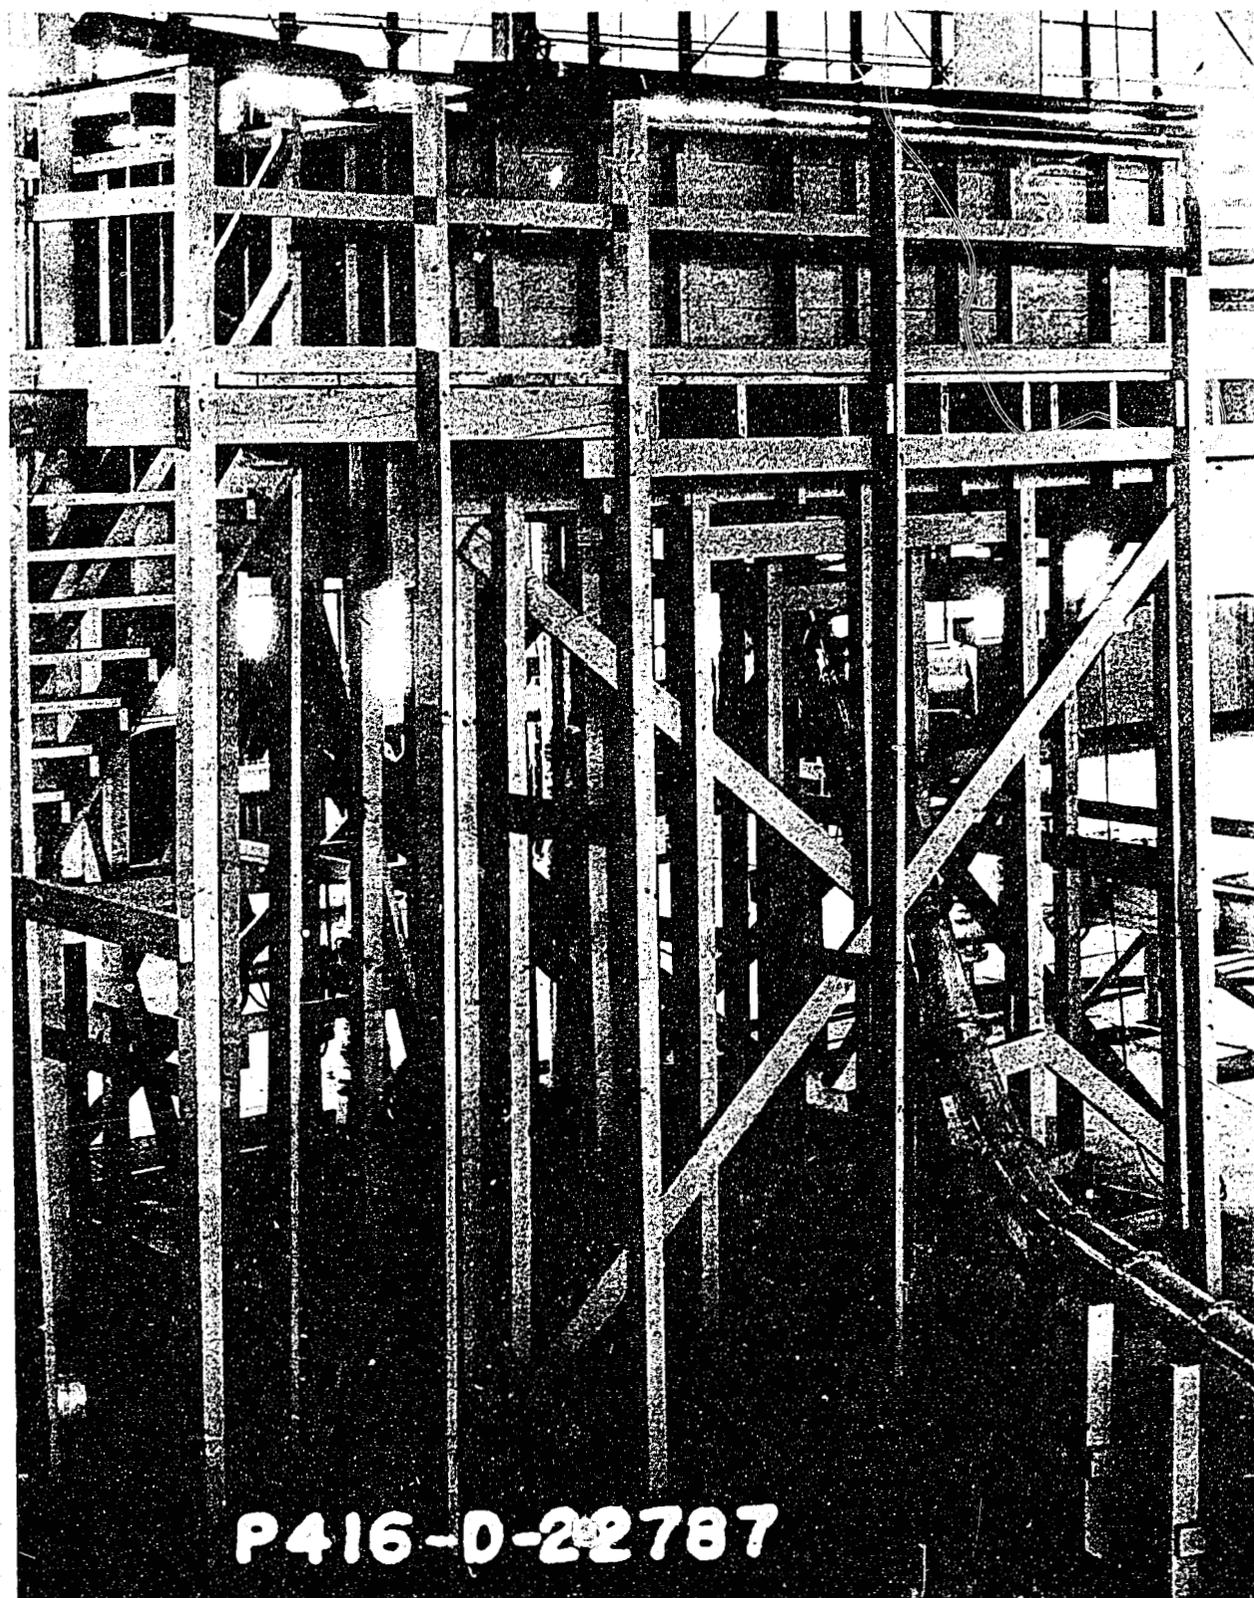
TRINITY MORNING-GLORY SPILLWAY
1:30 MODEL HEADBOX AND TUNNEL

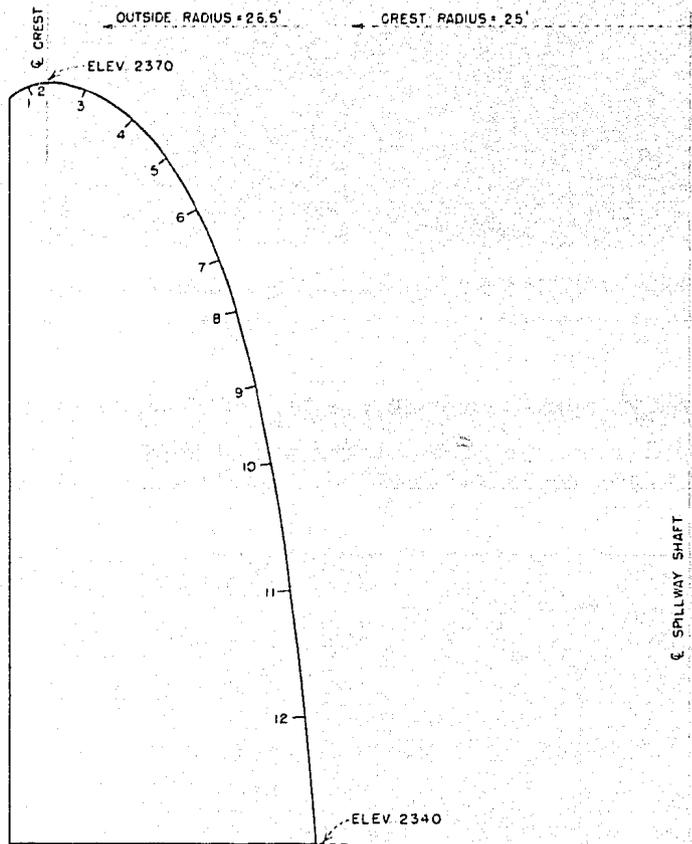
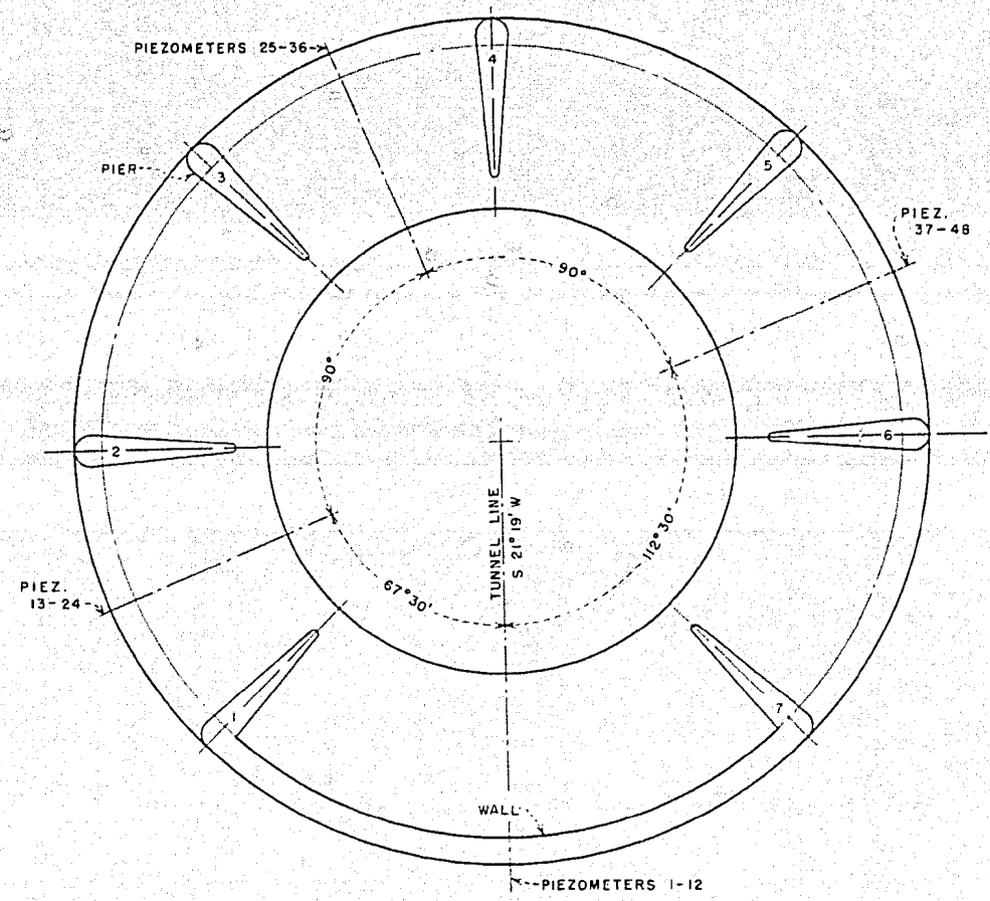
SECTION
SHOWING PIEZOMETER LOCATIONS

PLAN
SHOWING PIEZOMETER SETS

TRINITY MORNING-GLORY SPILLWAY
PRELIMINARY CREST DESIGN
1:30 MODEL

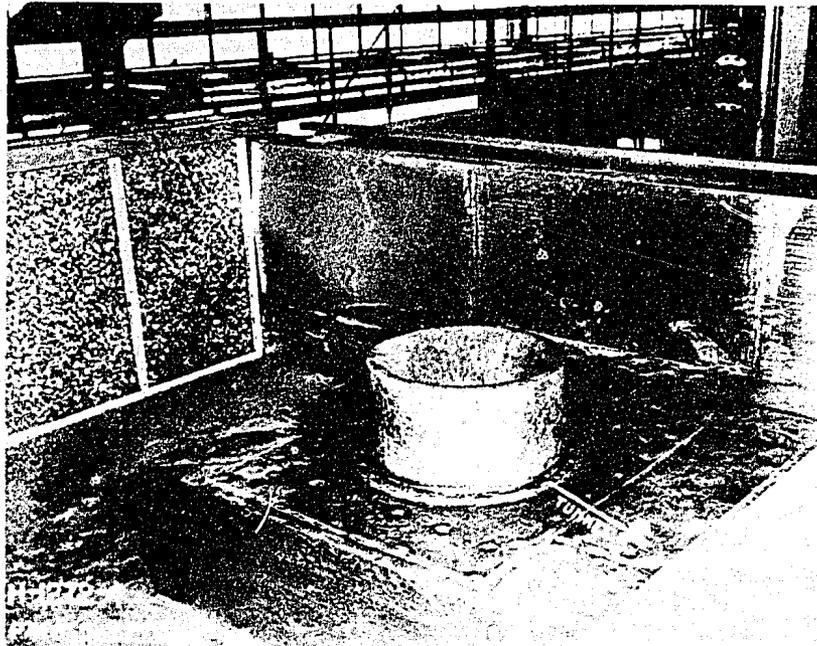
TRINITY MORNING-GLORY SPILLWAY
MORNING-GLORY STRUCTURE BEFORE
INSTALLATION OF TOPOGRAPHY
1:30 MODEL

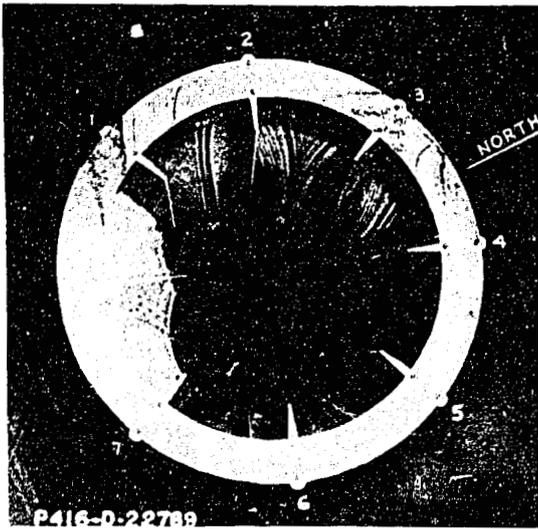
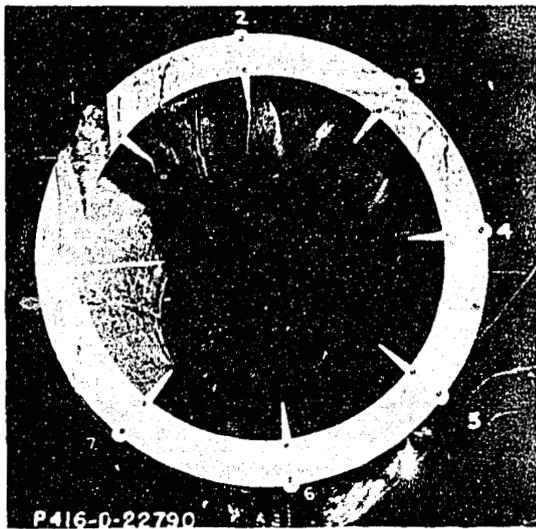
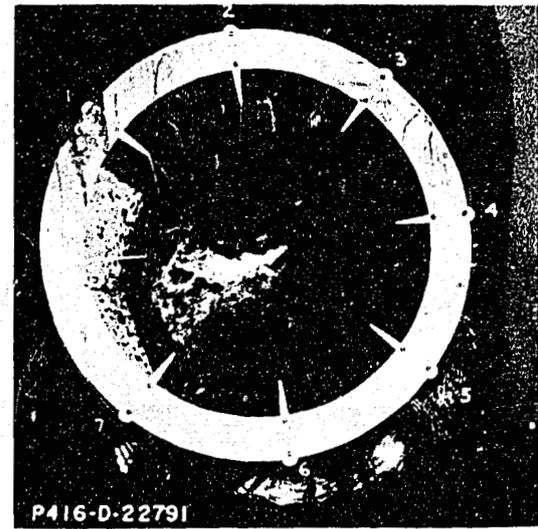
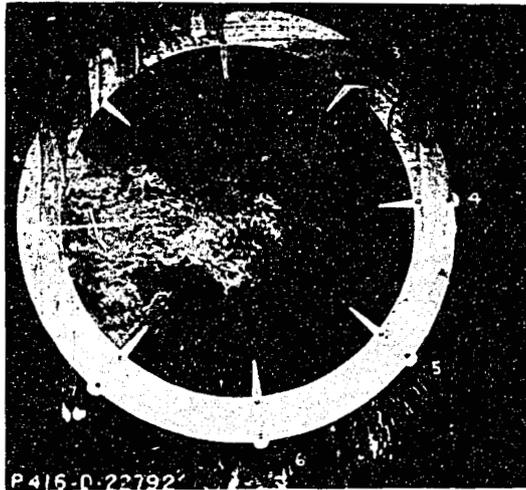
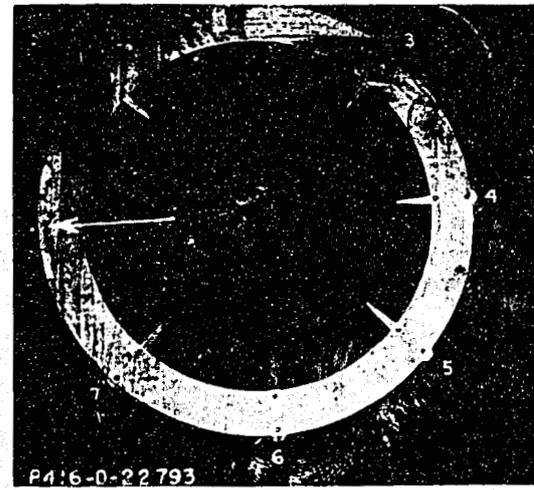
A. Discharge 5,600 cfs

B. Discharge 11,200 cfs

C. Discharge 16,800 cfs

D. Discharge 22,400 cfs

E. Discharge 26,700 cfs

TRINITY MORNING-GLORY SPILLWAY
CREST FLOWS, PRELIMINARY DESIGN, 1:30 MODEL

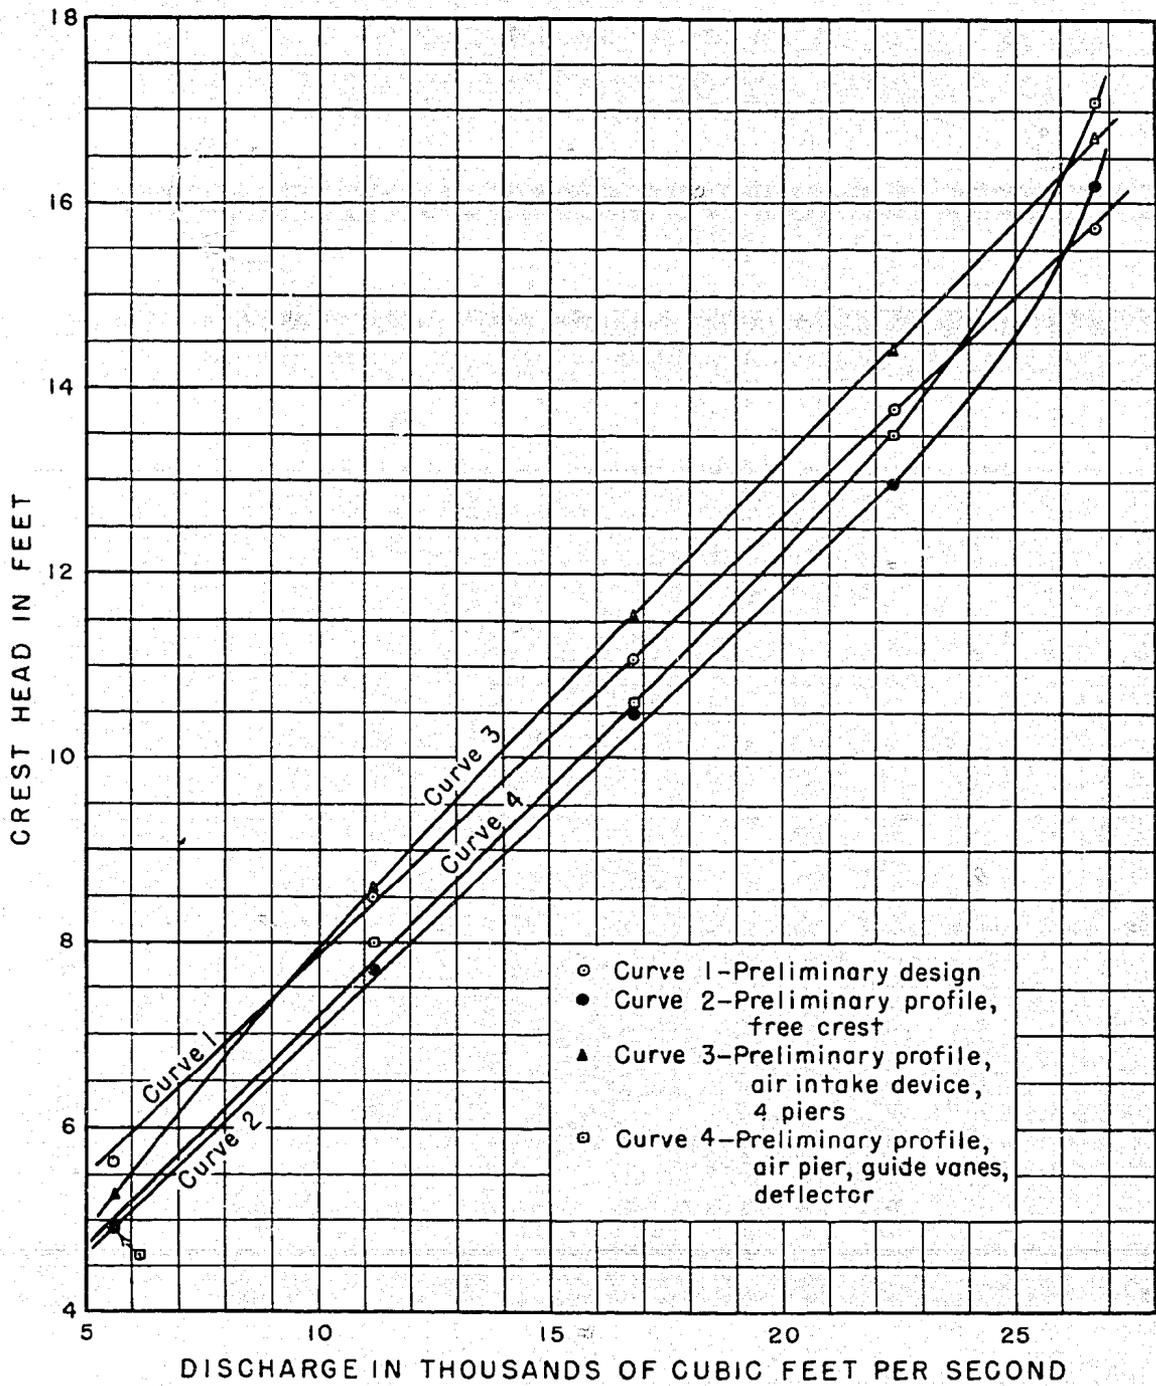
TRINITY MORNING - GLORY SPILLWAY

HEAD - DISCHARGE CURVES
PRELIMINARY PROFILE
1:30 MODEL

Head-discharge relationship. -- For comparative purposes, head-discharge relationships for all preliminary spillway profiles have been plotted in groups on Figure 10, 11, and 12. Figure 13 shows the relationship for the recommended design.

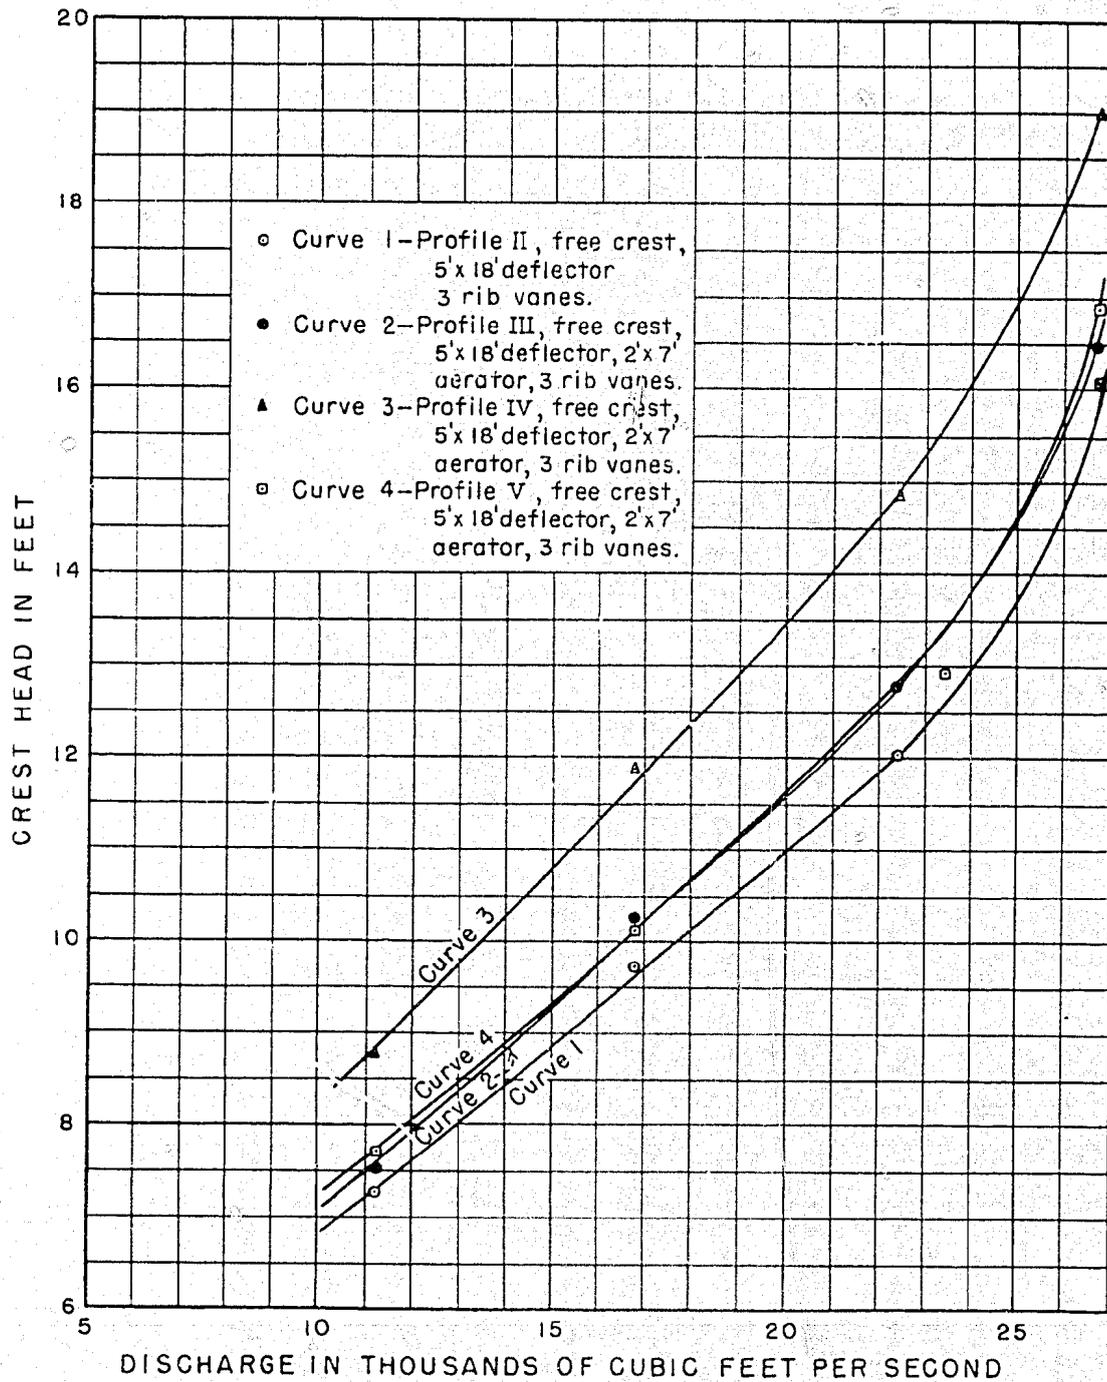
FIGURE 11
REPORT HYD. 447

TRINITY MORNING - GLORY SPILLWAY

HEAD - DISCHARGE CURVES
VARIOUS CREST PROFILES
1:30 MODEL

Head-discharge relationship. --Curve 1 of Figure 11 shows the variation of crest head with discharge for Profile II. Less head was required to pass a given discharge with Profile II than with any scheme using Profile I. The upturn in the rating curve for Profile II showed that the deflector began to decrease the discharge and raise the head on the crest at a point near 24,000 second-feet, but the head at this discharge was over 4 feet lower than desired. The increase in deflector size from 2 by 10 feet to 5 by 18 feet was therefore inadequate to produce the design reservoir head.

Head-discharge relationship. --Curve 2 of Figure 11 shows that more head was required to pass a given discharge than was required with Profile II. Curves 1 and 2 are separated by about 0.5 foot. Though the crest diameter was not changed, flattening the profile in the crest region apparently made the spillway less efficient and produced a rise in operating head. Curve 2 also shows a gradual shift in hydraulic control from crest to the deflector. At 24,000 second-feet, the crest head was 13.5 feet, still about 3.5 feet short of the design head.

Head-discharge relationship. --The head-discharge curve obtained for Profile IV, Curve 3 of Figure 11, was not appreciably different in shape from that derived from tests of Profile III; however, approximately 1-3/4 feet of additional head was required for all discharges. The characteristic upturn of the curve again occurred at 23,000 second-feet. This fact supported the contention that no boil existed at 15,000 second-feet. The operating head was about 1.2 feet below the design value.

Head-discharge relationship. --Curve 4 of Figure 11 shows the variation of crest head with discharge. In comparison with Curve 3 for Profile IV, less head was required to pass a given discharge, and the discharge curve was not appreciably different than the one for Profile III.

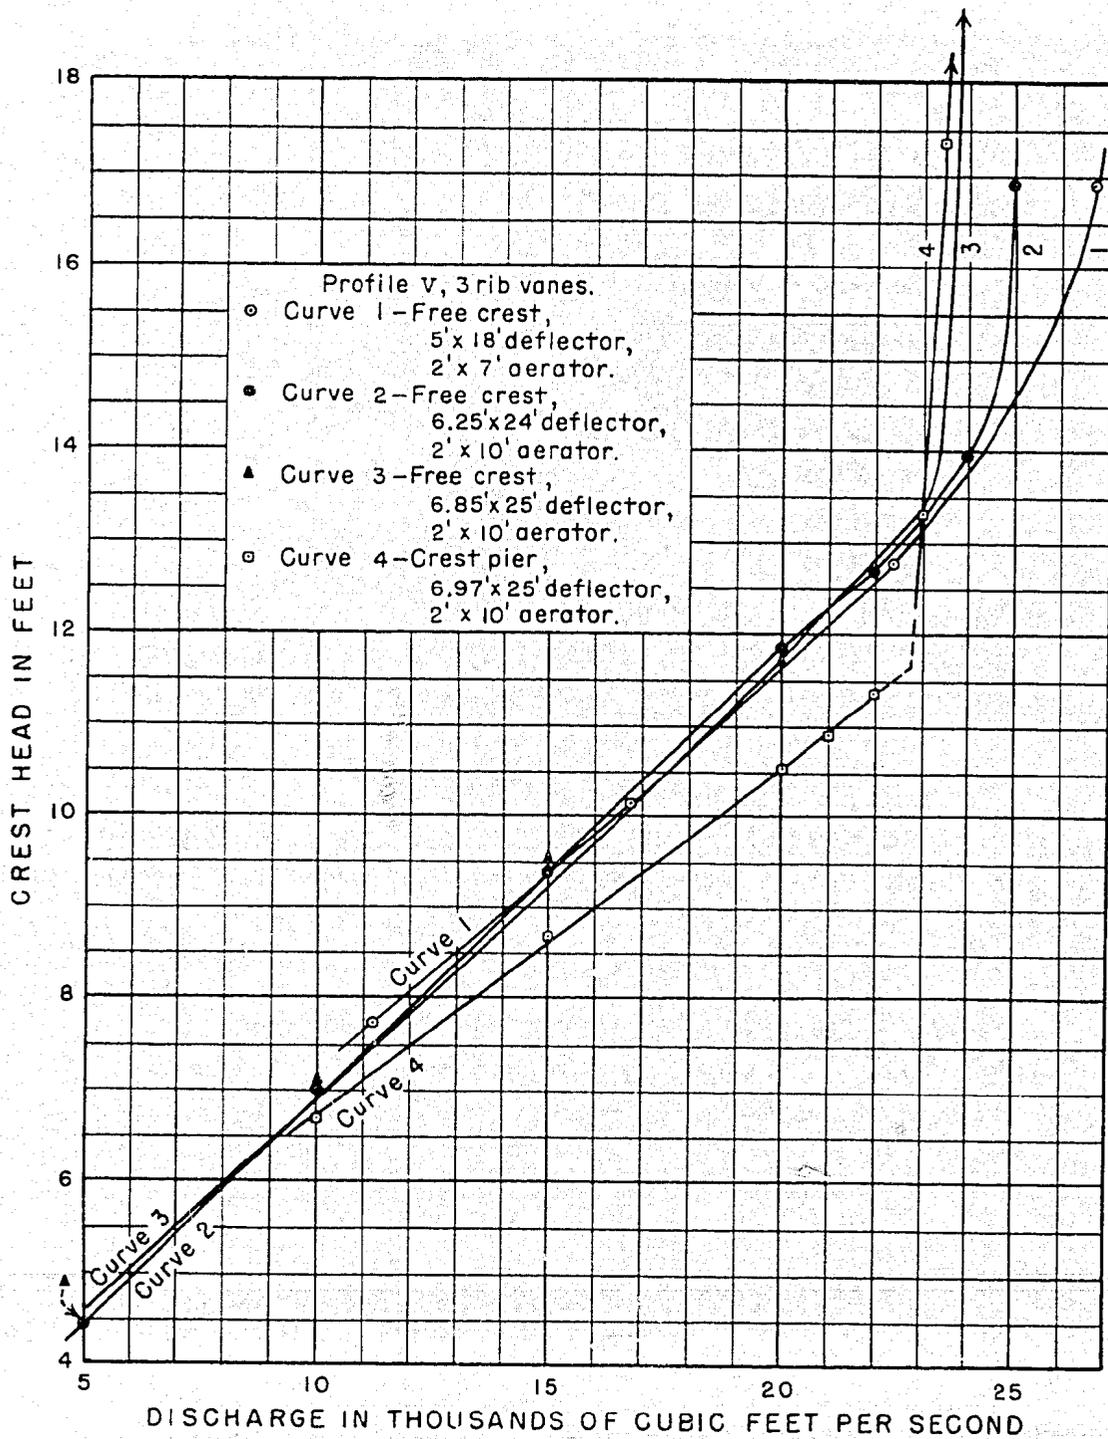
TRINITY MORNING - GLORY SPILLWAY

HEAD - DISCHARGE CURVES

Head-discharge relationship. --Figure 12 illustrates the effect of a shaft deflector on the operating head. Differences in slopes and ordinate position of the curves from 5,000 to about 22,000 second-feet can be charged to various topographic arrangements or to the crest pier. Above 22,000 second-feet differences are caused principally by the sizes of shaft deflector being used. As the deflector size was increased in Curves 1, 2, 3, and 4, the portion of the curve reflecting orifice flow steepened until, in Curve 4, it was difficult to determine the discharge or crest head at which the transition from weir to orifice flow began.

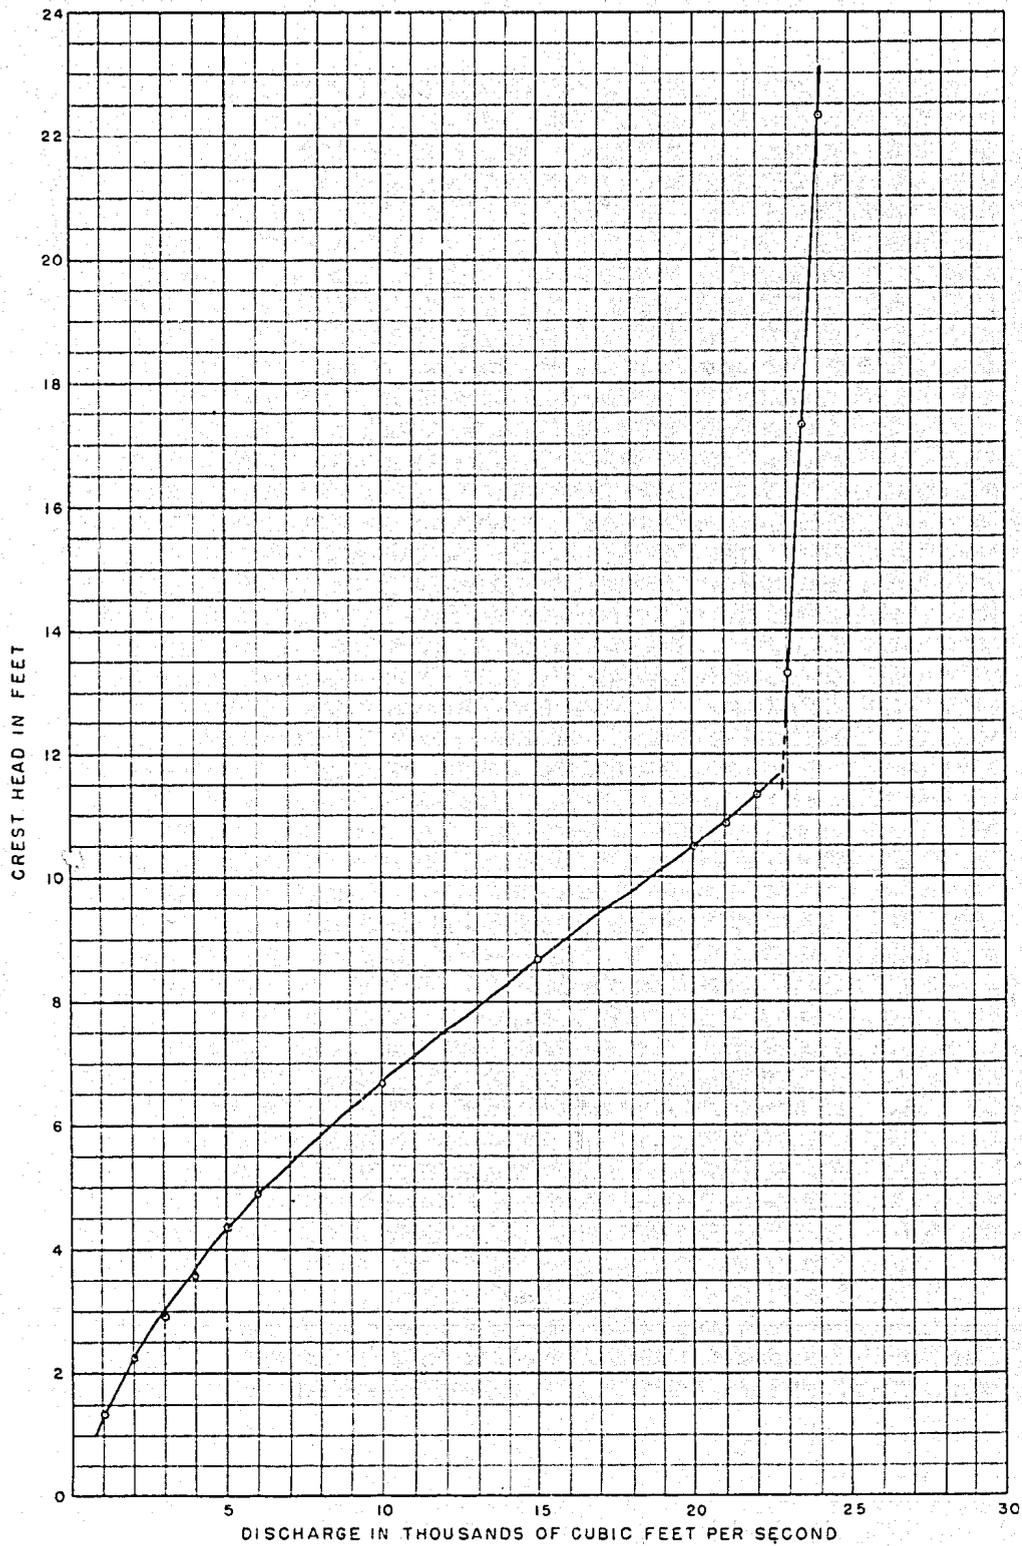
FIGURE 13
REPORT HYD. 447

TRINITY MORNING - GLORY SPILLWAY
HEAD - DISCHARGE CURVE FOR RECOMMENDED DESIGN

The water discharge for which air demand is a maximum does not correspond to that which indicates an impending shift of hydraulic control from crest to deflector, Figure 13. From visual observation of flows above 21,000 second-feet, it did not appear that there was an increase in the intake of air through the water down

Figure 13 shows the head-discharge curve for the recommended profile, deflector pier, rib vanes, shaft deflector, and modified topography.

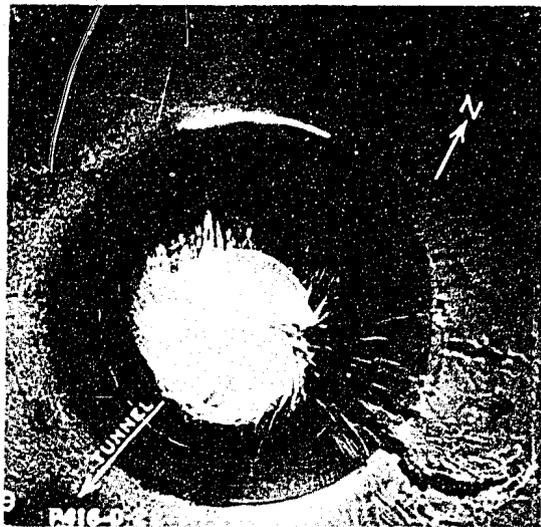
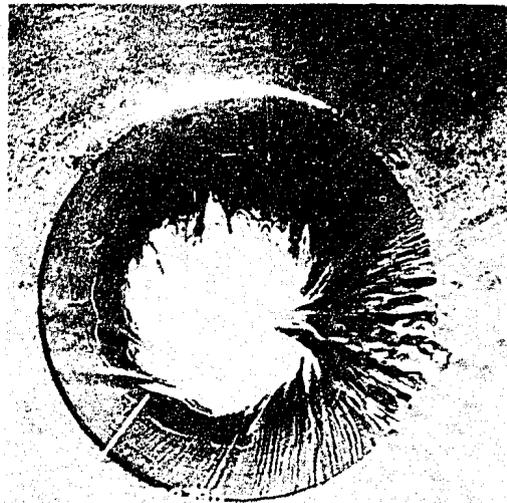
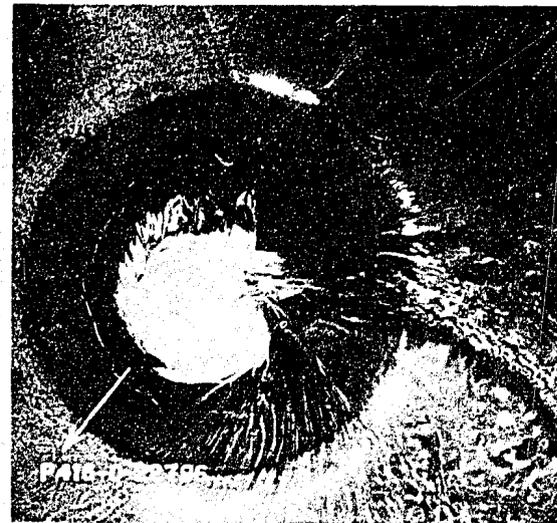
TRINITY MORNING-GLORY SPILLWAY
CREST FLOWS, FREE CREST, PRELIMINARY PROFILE
1:30 MODEL

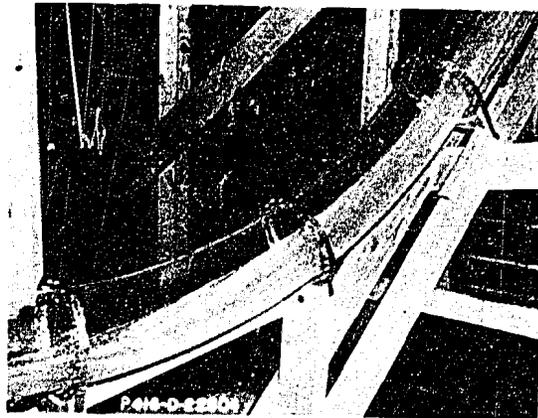
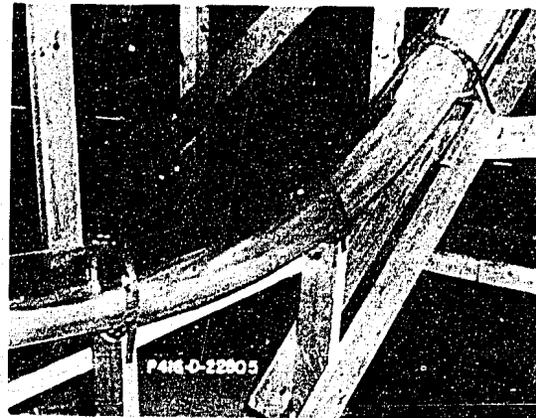
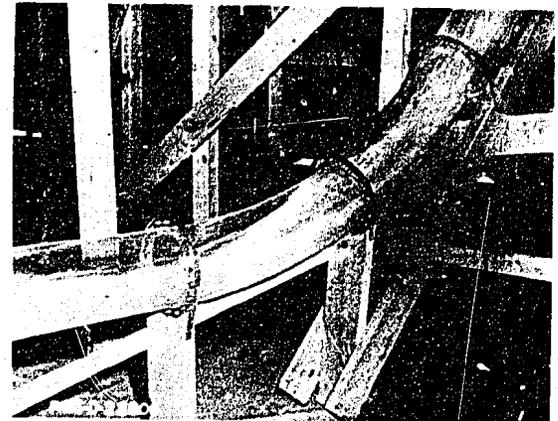
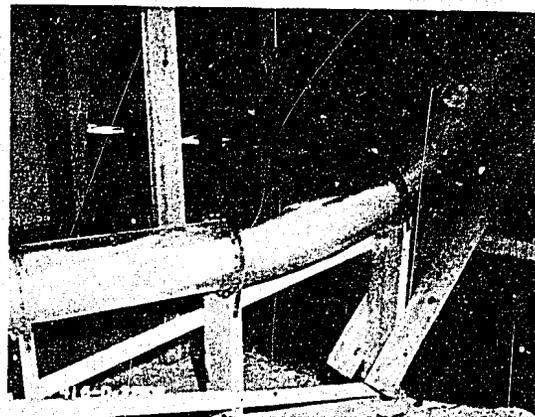
TRINITY MORNING-GLORY SPILLWAY
FLOW IN LOWER BEND
PRELIMINARY SPILLWAY PROFILE
1:30 MODEL

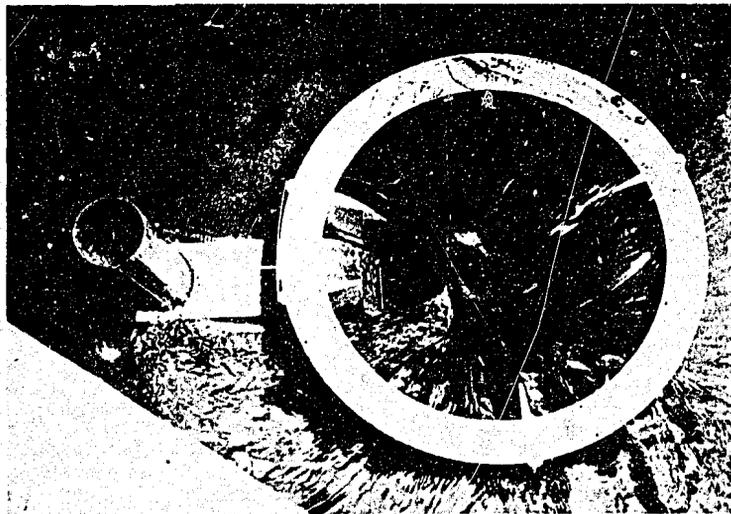
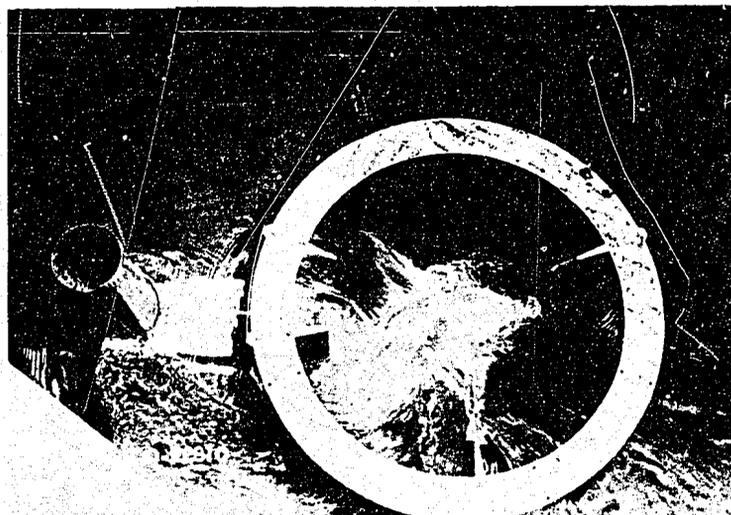
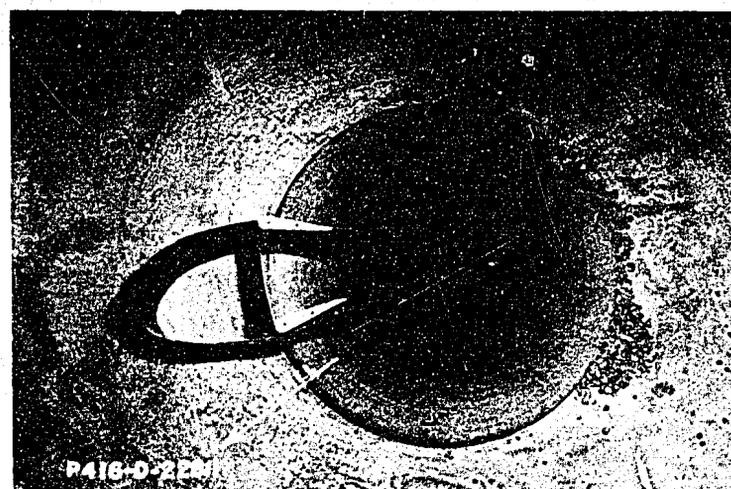
Figure 17
Report HYD - 447

A. Air Intake Device, 4 piers, Discharge 16,800 cfs

B. Air Intake Device, 4 piers, Discharge 26,700 cfs

C. Air Intake Pier, Metal Guide Vanes, No Flow

TRINITY MORNING-GLORY SPILLWAY
PRELIMINARY PROFILE, AIR INTAKE DEVICES
1:30 MODEL

General operation. --Experience in previous tests on other morning-glory spillways pointed the desirability of providing some positive means for supplying air to the vertical shaft. Accordingly, as a first trial to provide a protected air intake which would not close as the discharge increased, a makeshift sheet metal conduit was placed 30° clockwise from the tunnel centerline, as shown in Figure 17A and B. An air intake 3 inches in diameter leads to a rectangular conduit 3/4 by 4 inches, which was formed to fit the spillway profile. The outlet end was about 4 inches below crest level. Four piers were placed on the crest, two adjacent to the air conduit and two others placed for best control of the crest flow.

General operation. --To give a fair trial to the air intake idea, a better proportioned sheet metal pier was provided on the crest, Figure 17C. A large sheet metal pier nose was extended over the berm to produce a more gradual transition in flow direction for water approaching the pier from the west. The pier extended from elevation 2388 to elevation 2343 and was shaped to allow unimpeded introduction of air to the shaft and tunnel. Two sheet metal guide vanes were also installed in the shaft between elevations 2350 and 2325. The guide vanes were added to help straighten the spiral flow in the remainder of the shaft and tunnel.

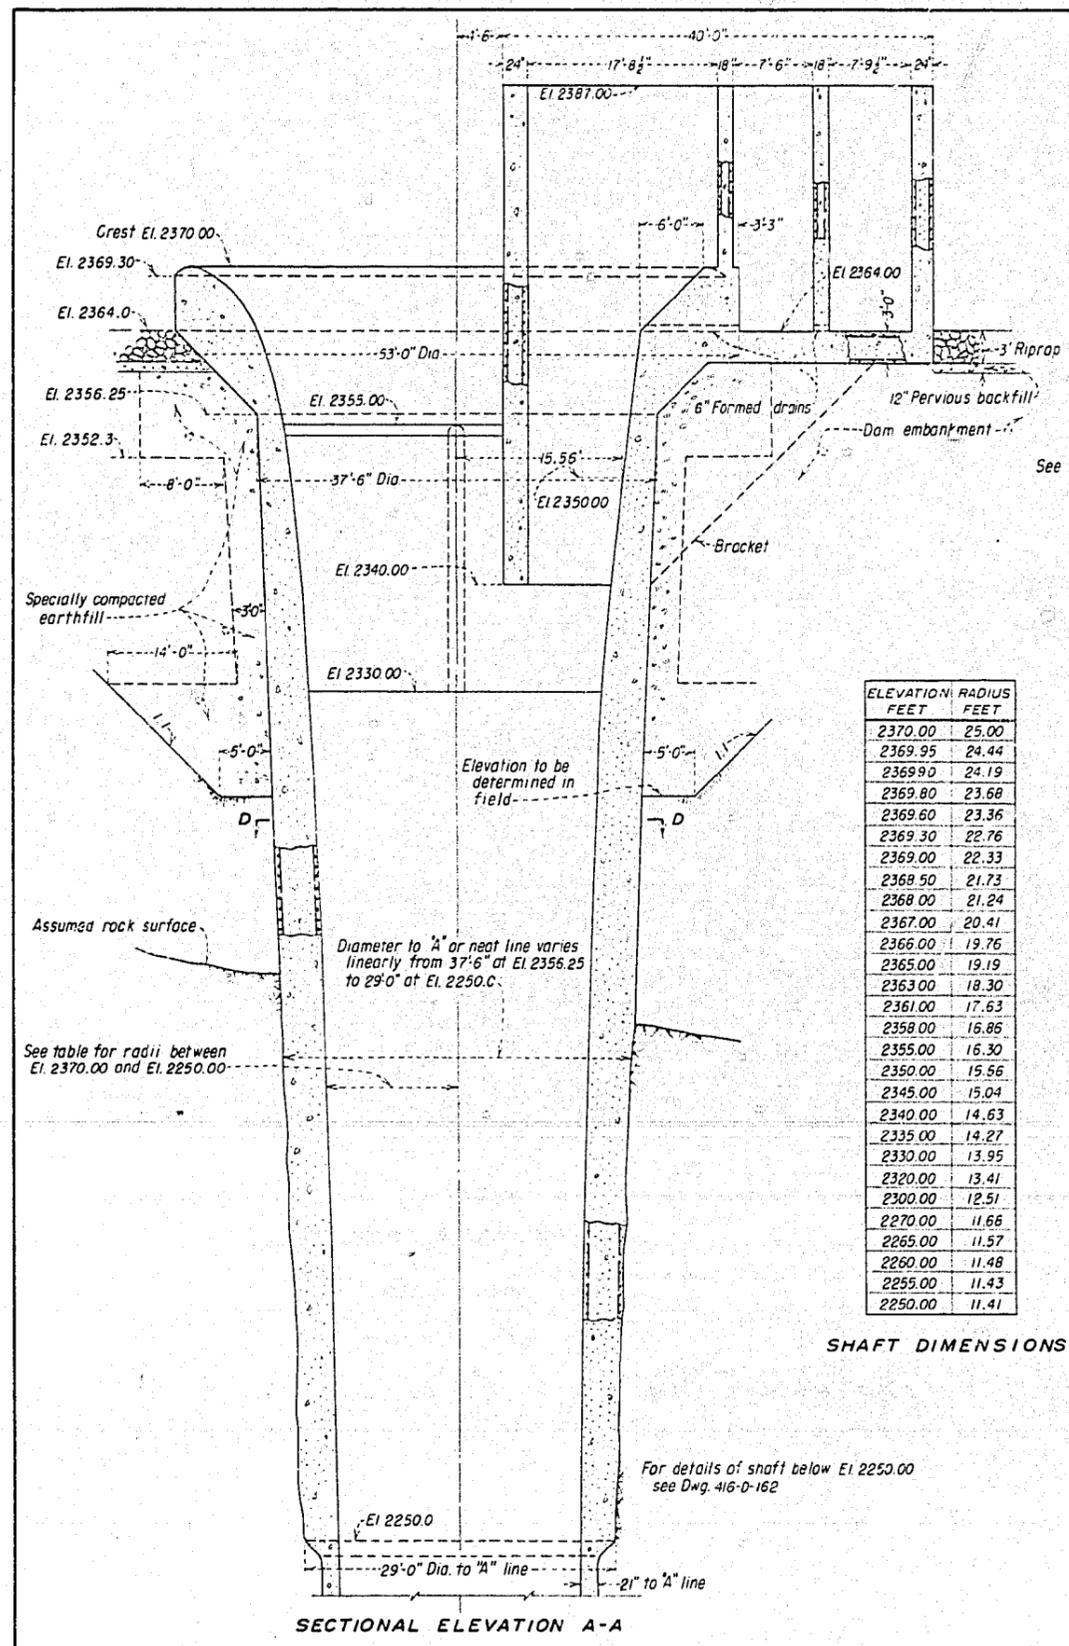
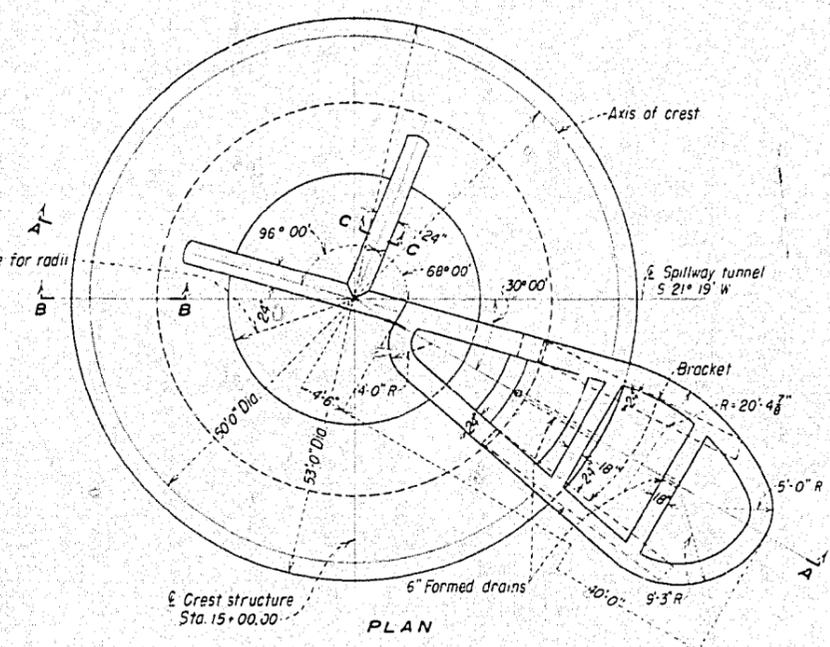
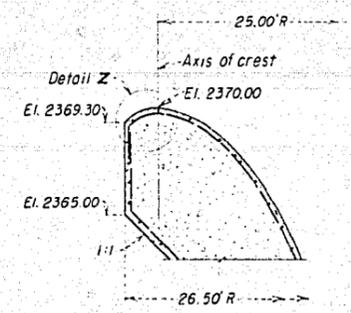
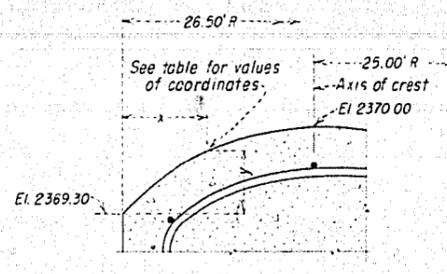
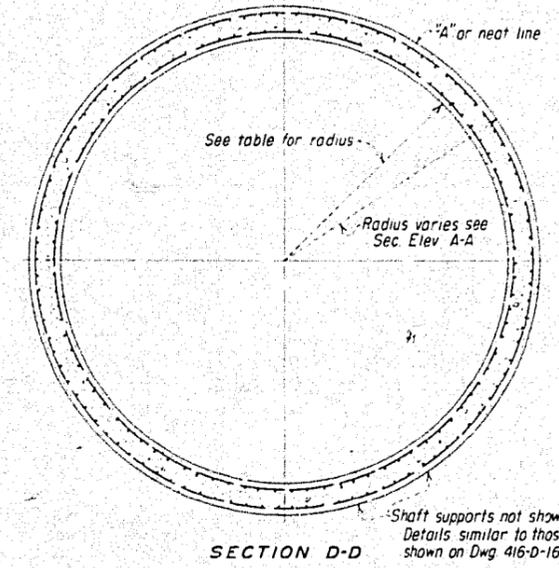
ELEVATION FEET	RADIUS FEET
2370.00	25.00
2369.95	24.44
2369.90	24.19
2369.80	23.68
2369.60	23.36
2369.30	22.76
2369.00	22.33
2368.50	21.73
2368.00	21.24
2367.00	20.41
2366.00	19.76
2365.00	19.19
2363.00	18.30
2361.00	17.63
2358.00	16.86
2355.00	16.30
2350.00	15.56
2345.00	15.04
2340.00	14.63
2335.00	14.27
2330.00	13.95
2320.00	13.41
2300.00	12.51
2270.00	11.66
2265.00	11.57
2260.00	11.48
2255.00	11.43
2250.00	11.41

SHAFT DIMENSIONS

PLAN

SECTION B-B

DETAIL Z

SECTION D-D

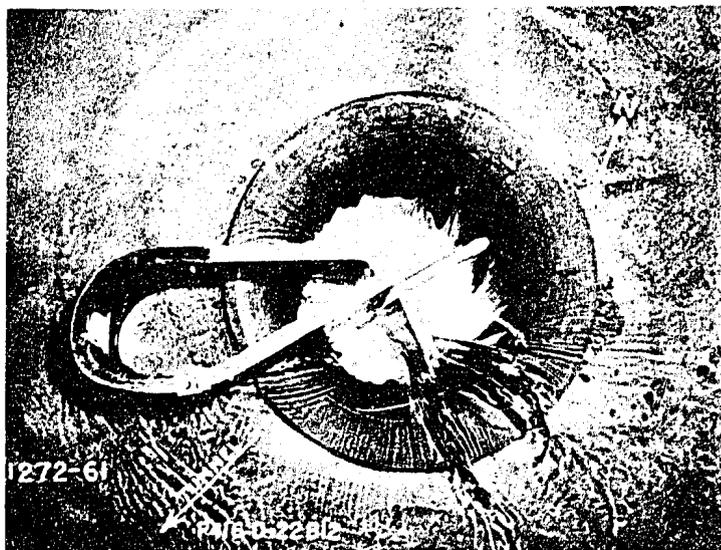
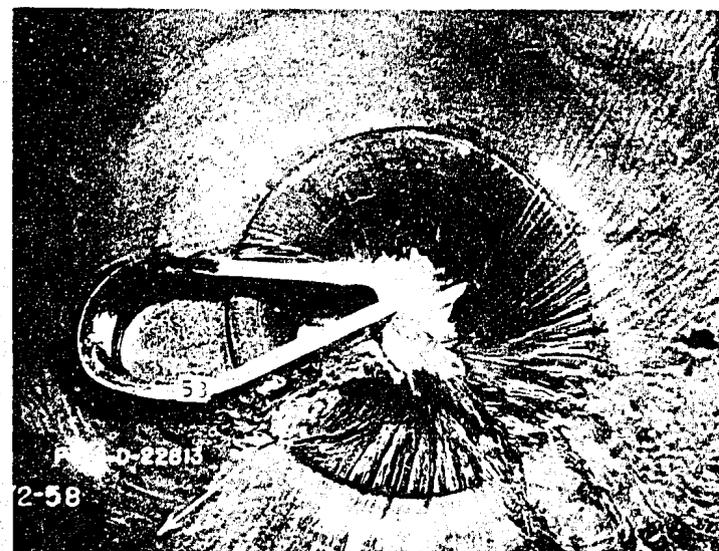
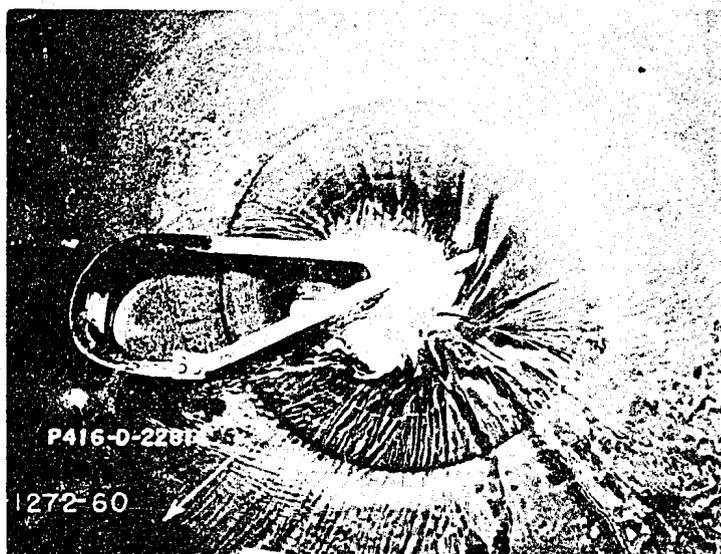
Figure 20
Report HYD - 447

A. Discharge 5,600 cfs

B. Discharge 13,800 cfs

C. Discharge 22,400 cfs

D. Discharge 26,700 cfs

TRINITY MORNING-GLORY SPILLWAY
 PRELIMINARY PROFILE, SCALED AIR INTAKE PIER AND GUIDE VANES
 1:30 MODEL

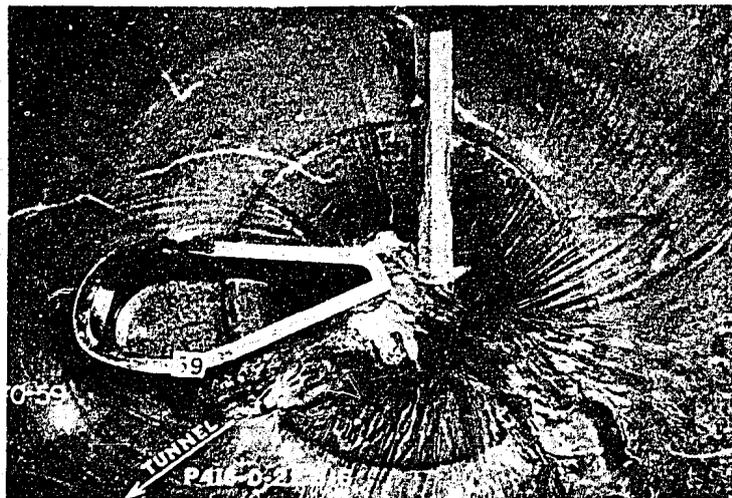
A. Discharge 16,800 cfs

B. Discharge 22,400 cfs

C. Discharge 26,700 cfs

TRINITY MORNING-GLORY SPILLWAY
PRELIMINARY PROFILE, SCALED AIR INTAKE PIER AND GUIDE VANES
LOGS JAMMED IN THROAT OF STRUCTURE
1:30 MODEL

The scale guide vanes performed satisfactorily in minimizing spiral flow in the shaft. However, they offered a serious restriction to the passage of debris which might reach the spillway. To assess the possibilities of plugging, timbers equivalent to 4 feet square in cross-section and 30 feet long were allowed to approach the spillway from all sides and at all discharges. The results are shown in Figure 20. An average of 7 of 10 timbers failed to pass the guide vanes into the throat. Since the timbers used did not have branches, such as fallen trees might have, it is probable that most large trees would fail to pass between the vanes.

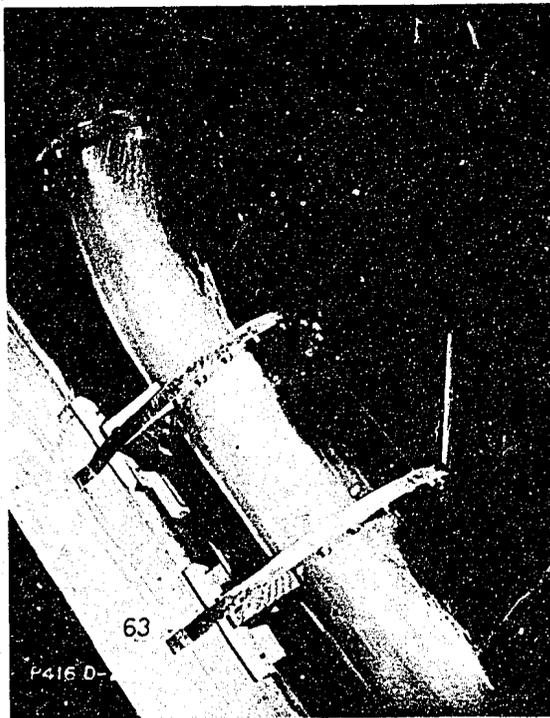
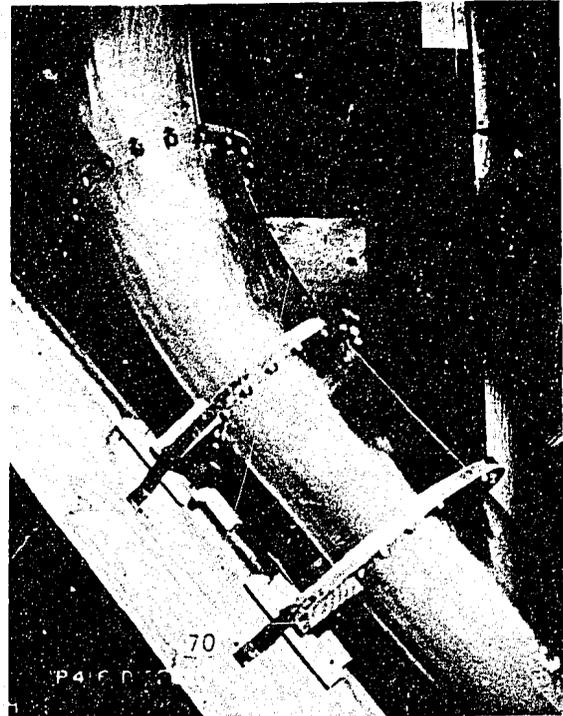
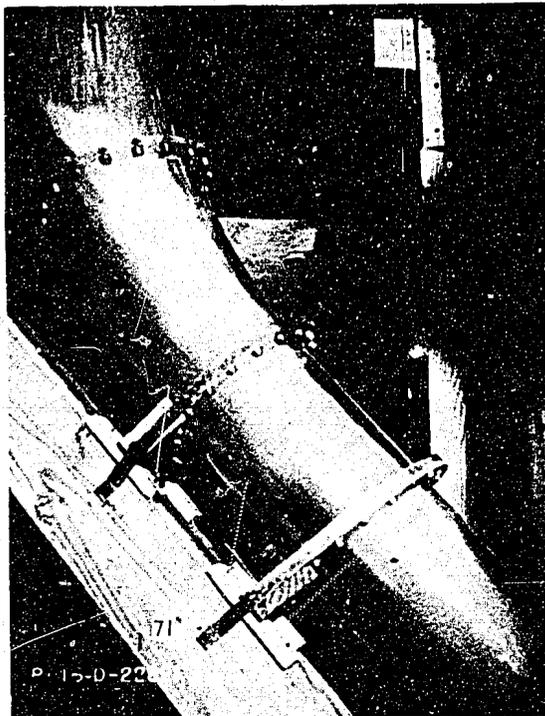
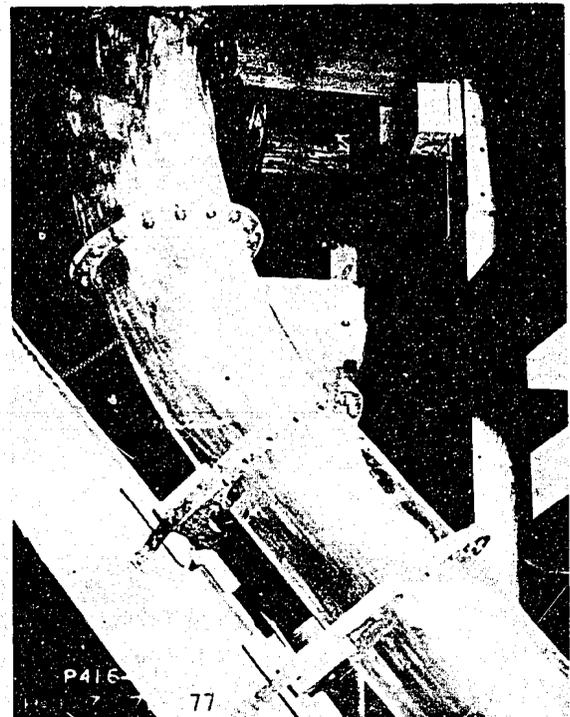
A. Discharge 11,200 cfs

B. Discharge 16,800 cfs

C. Discharge 22,400 cfs

D. Discharge 26,700 cfs

TRINITY MORNING-GLORY SPILLWAY
FLOWS IN UPPER BEND
PRELIMINARY PROFILE, SCALED AIR INTAKE PIER AND GUIDE VANES
1:30 MODEL
