UNITED STATES
DEPARTMENT OF THE INTERIOR
BUREAU OF RECLAMATION

HYDRAULIC MODEL STUDIES OF THE
TRINITY DAM MORNING-GLORY SPILLWAY
TRINITY RIVER DIVISION
CENTRAL VALLEY PROJECT--CALIFORNIA

Hydraulic Laboratory Report No. Hyd-447

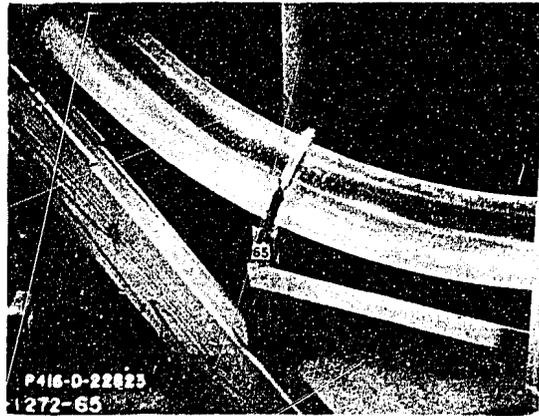
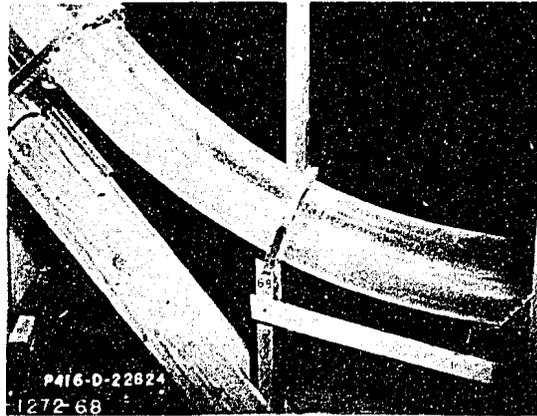
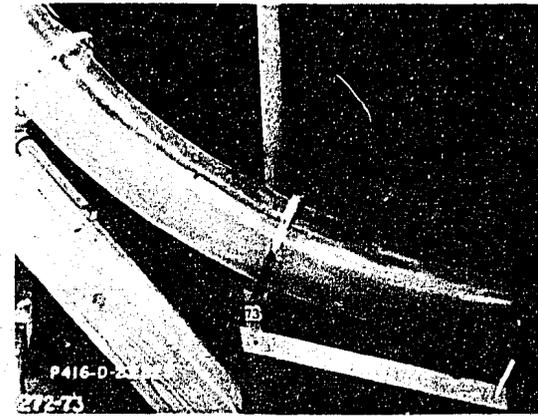
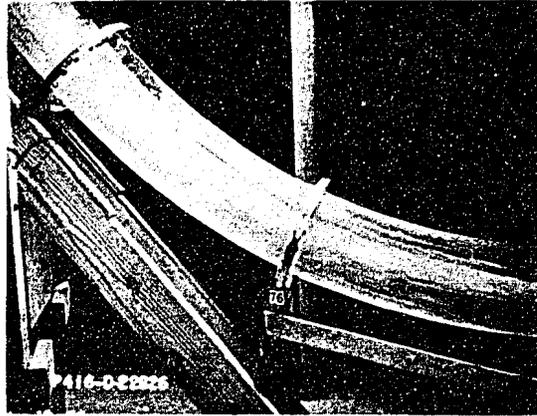
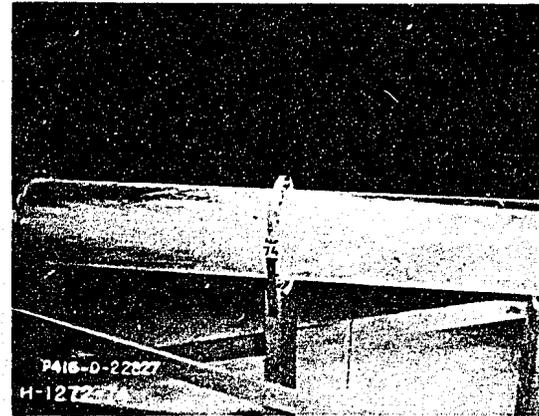
A. Discharge 11,200 cfs

B. Discharge 16,800 cfs

C. Discharge 22,400 cfs

D. Discharge 26,700 cfs

E. Discharge 22,400 cfs

TRINITY MORNING-GLORY SPILLWAY
FLOW IN LOWER BEND AND TUNNEL
PRELIMINARY PROFILE, SCALED AIR INTAKE PIER AND GUIDE VANES
1:30 MODEL

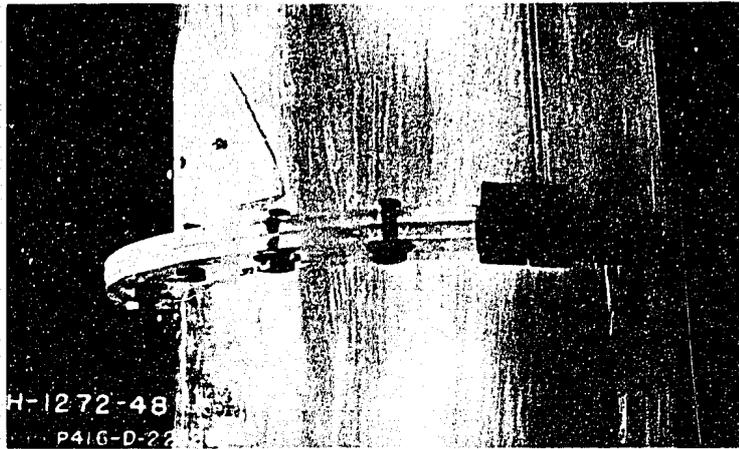
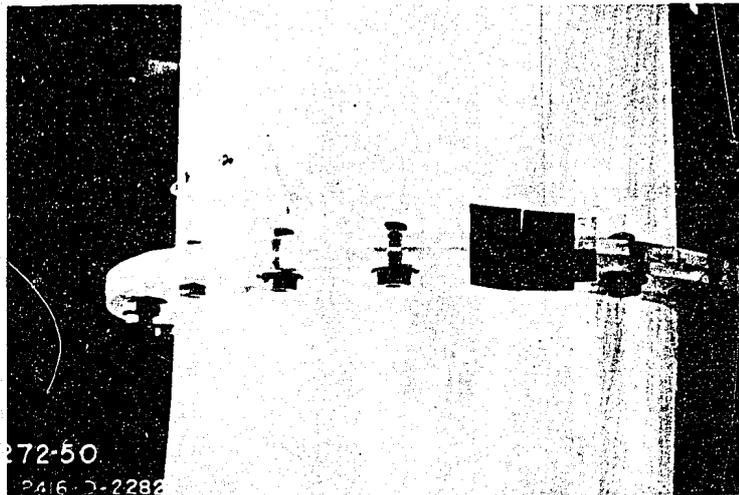
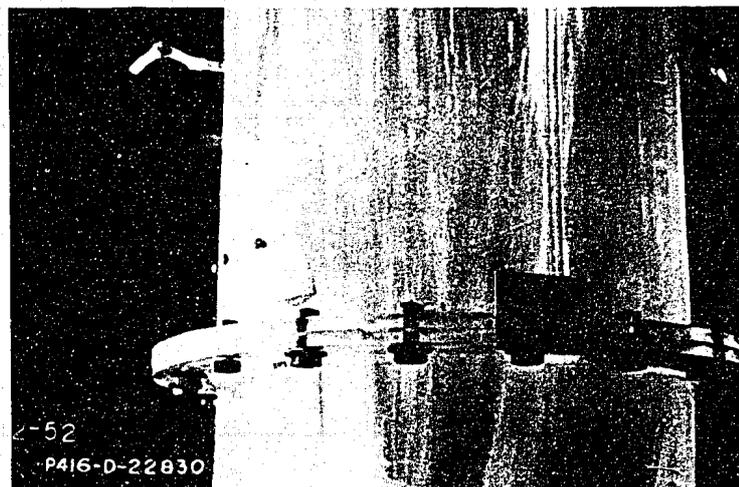
A. Discharge 5,600 cfs

B. Discharge 16,800 cfs

C. Discharge 26,700 cfs

TRINITY MORNING-GLORY SPILLWAY
PRELIMINARY PROFILE, FLOWS AT PRELIMINARY DEFLECTOR
1:30 MODEL

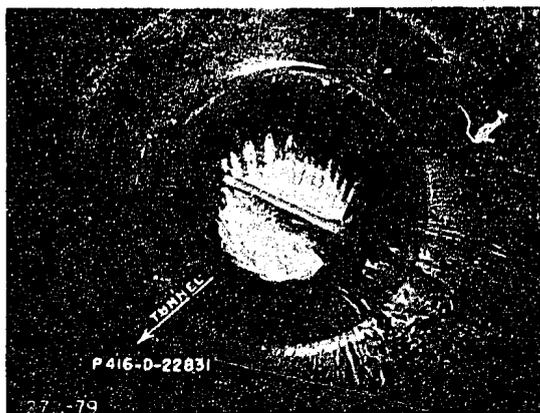
A. Discharge 5,600 cfs

B. Discharge 11,200 cfs

C. Discharge 16,800 cfs

D. Discharge 22,400 cfs

E. Discharge 26,700 cfs

TRINITY MORNING-GLORY SPILLWAY
FLOW WITH SINGLE DIAMMETRICAL GUIDE VANE, PRELIMINARY PROFILE
1:30 MODEL

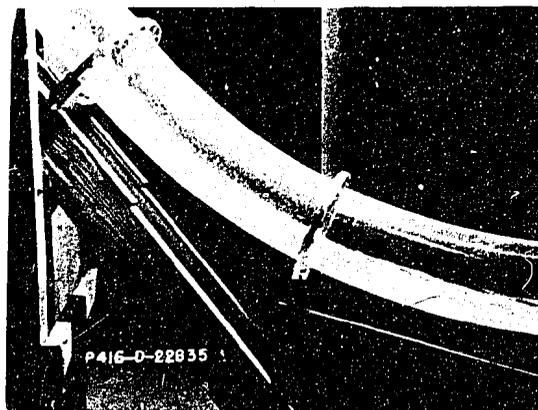
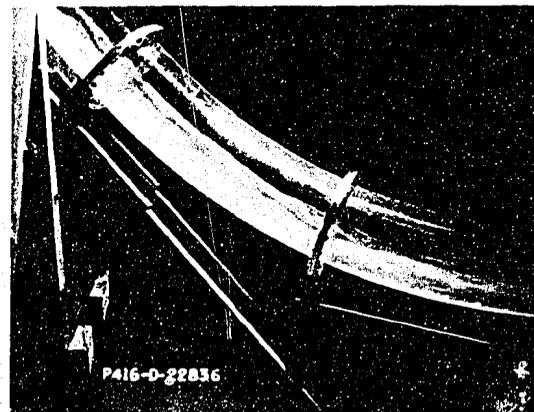
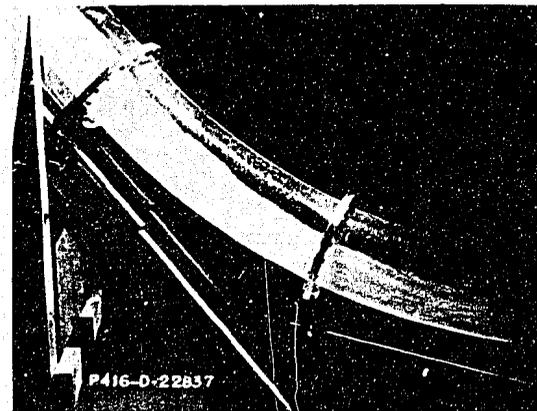
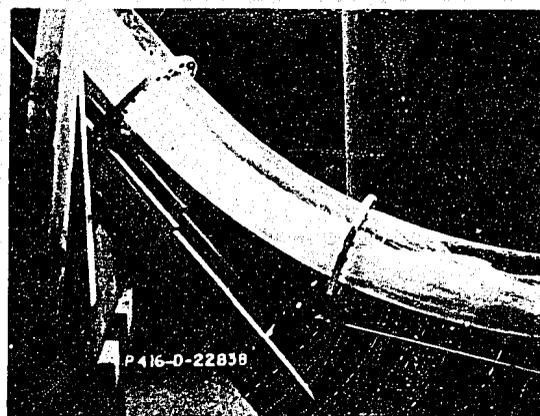
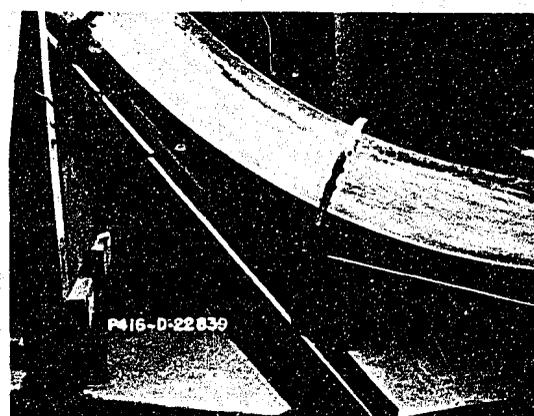
A. Discharge 5,600 cfs

B. Discharge 11,700 cfs

C. Discharge 16,800 cfs

D. Discharge 22,400 cfs

E. Discharge 26,700 cfs

TRINITY MORNING-GLORY SPILLWAY
FLOWS IN LOWER BEND
PRELIMINARY PROFILE, SINGLE DIAMMETRICAL GUIDE VANE
1:30 MODEL

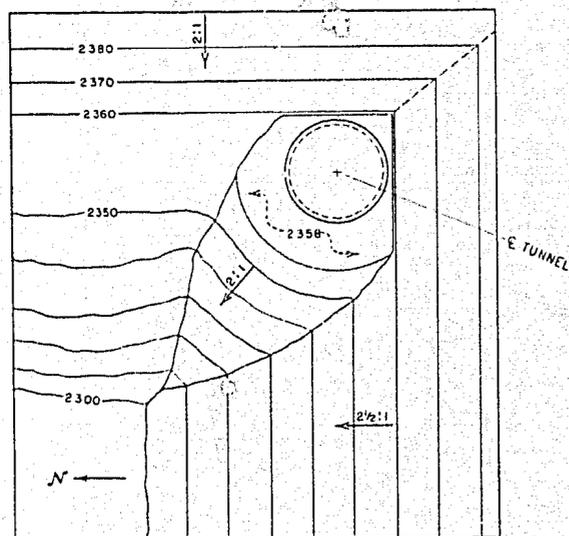
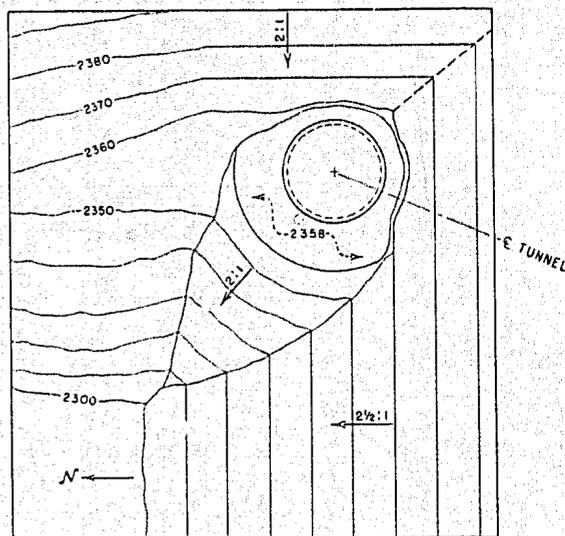
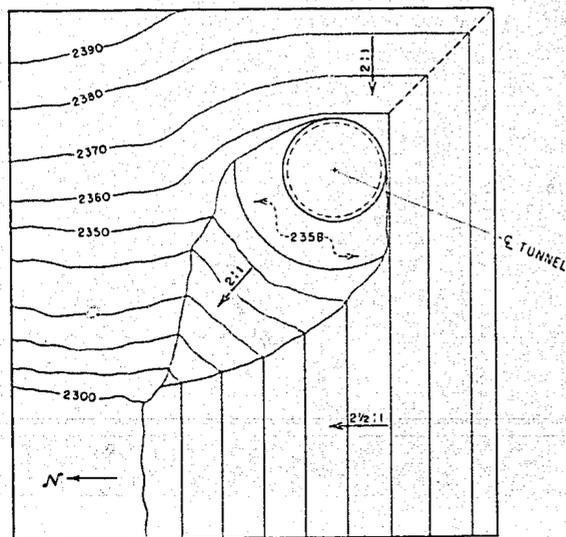
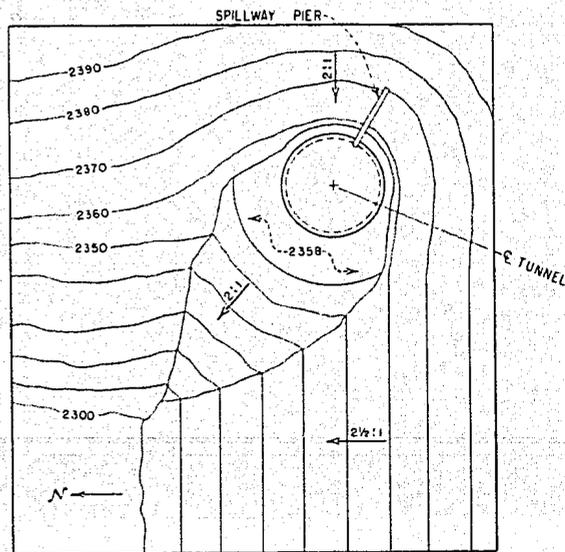
1:30 MODEL

A. - FIRST MODIFICATION

B. - SECOND MODIFICATION

C. - THIRD MODIFICATION

D. - RECOMMENDED CONFIGURATION

TRINITY MORNING - GLORY SPILLWAY
MODIFICATIONS OF TOPOGRAPHIC FEATURES

7. Topographic boundaries in the vicinity of the morning-glory should be formed as indicated in Figure 26D to provide satisfactory entrance flow conditions.

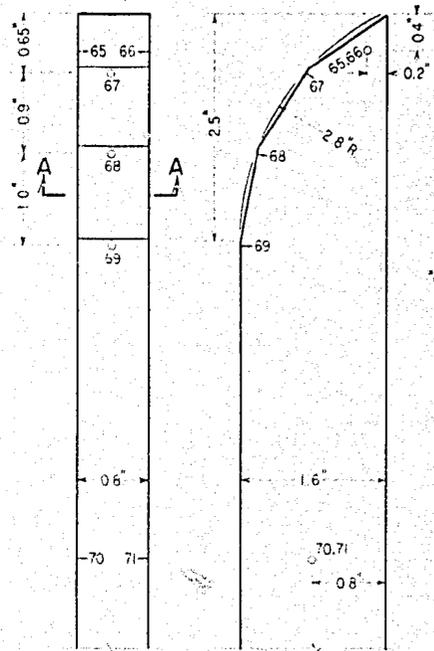
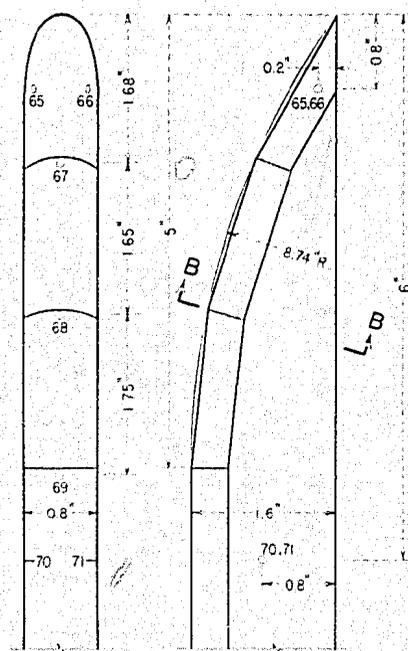
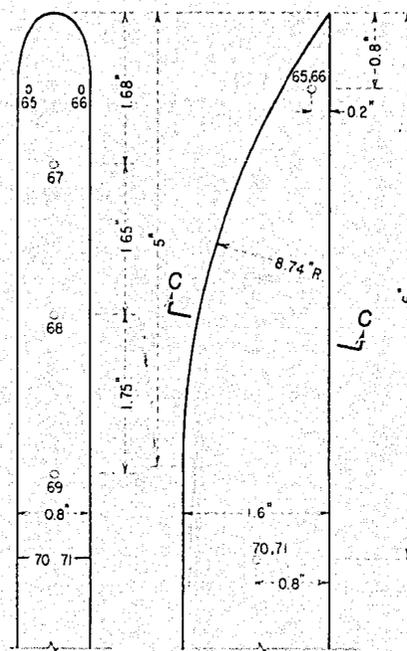
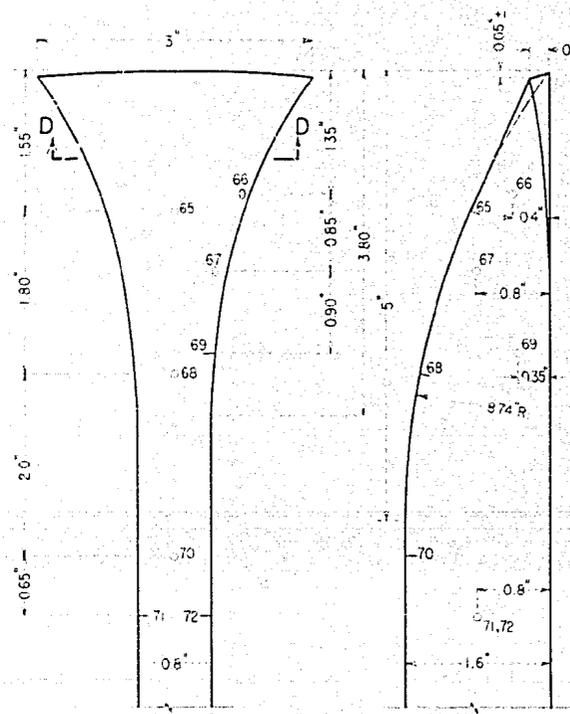
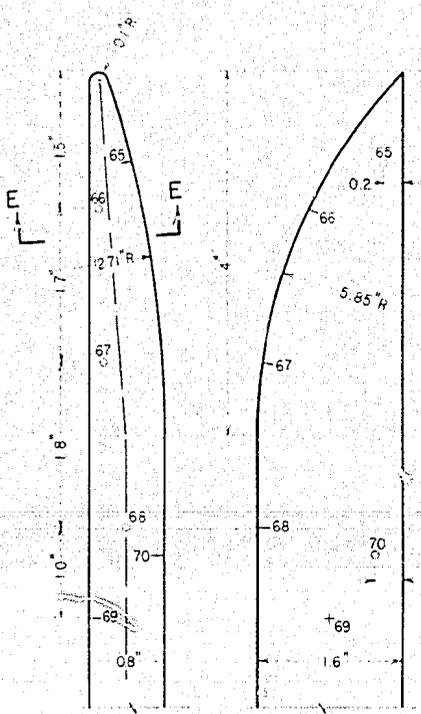
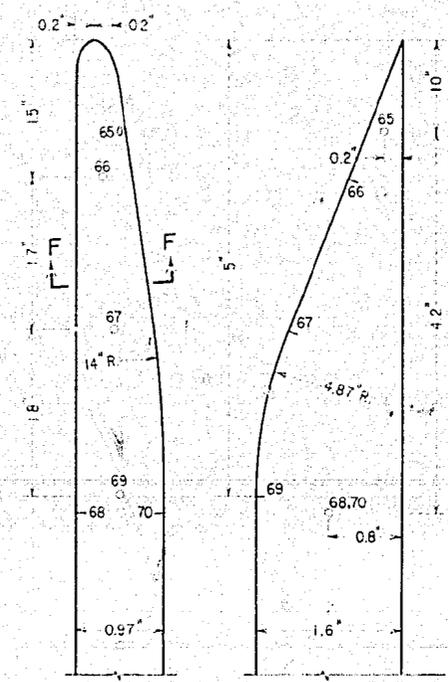
SECTION A-A

SECTION B-B

SECTION C-C

SECTION D-D

SECTION E-E

SECTION F-F

TRINITY MORNING-GLORY SPILLWAY
RIB VANE DESIGNS-TOP DETAILS
1:30 MODEL

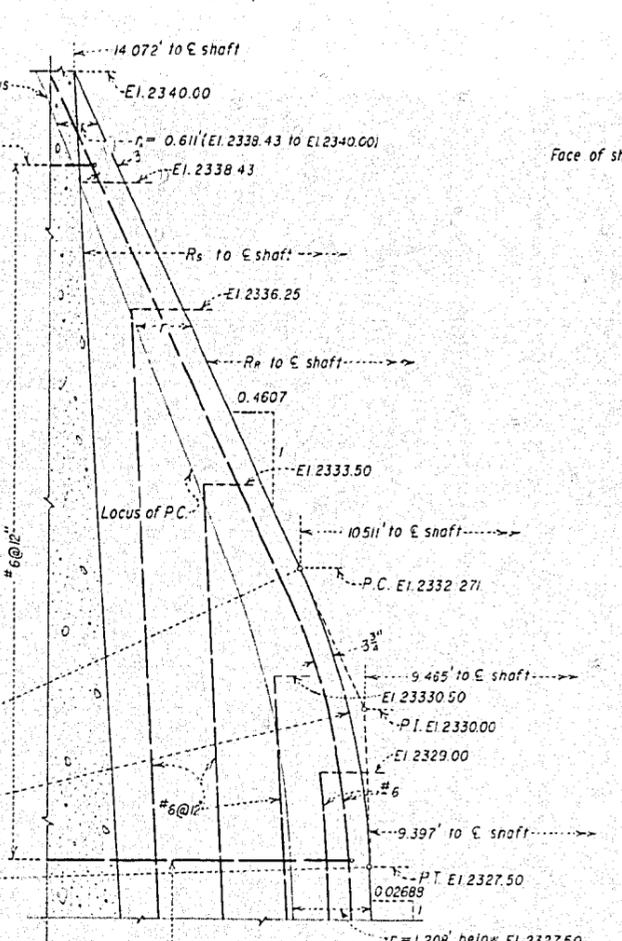
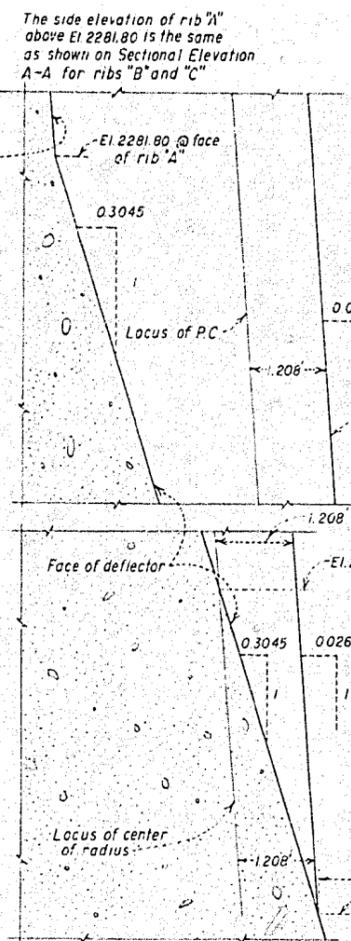
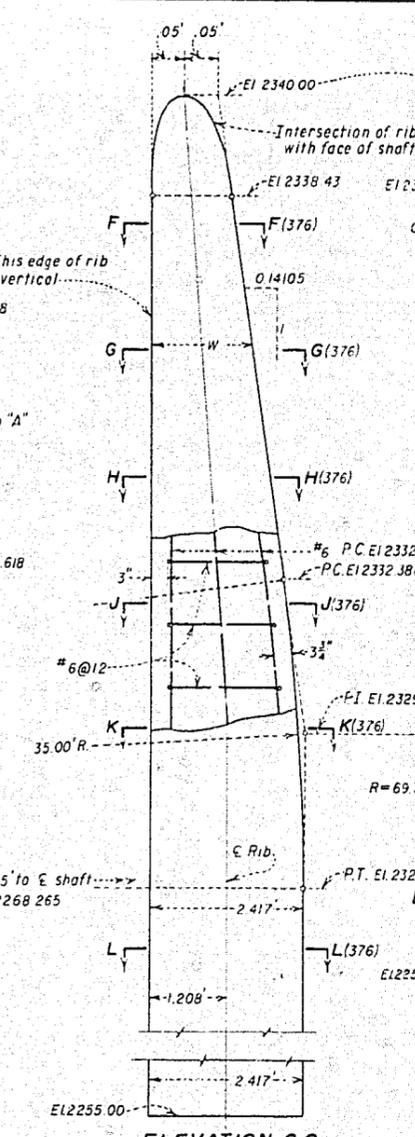
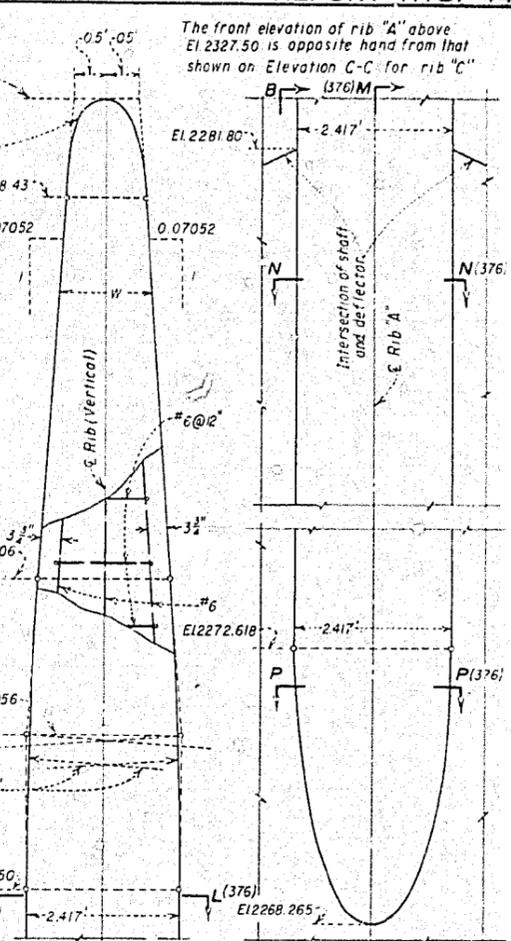
SECTIONAL PLAN
El. 2340.00

SECTIONAL ELEVATION A-A

SECTION B-B
REINFORCEMENT NOT SHOWN

ELEVATION C-C
RIB "C"

ELEVATION D-D
RIB "B" and ELEVATION E-E
RIB "A"

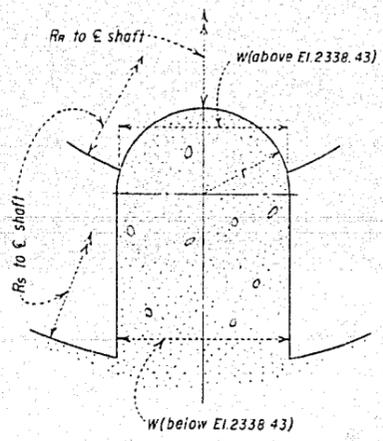
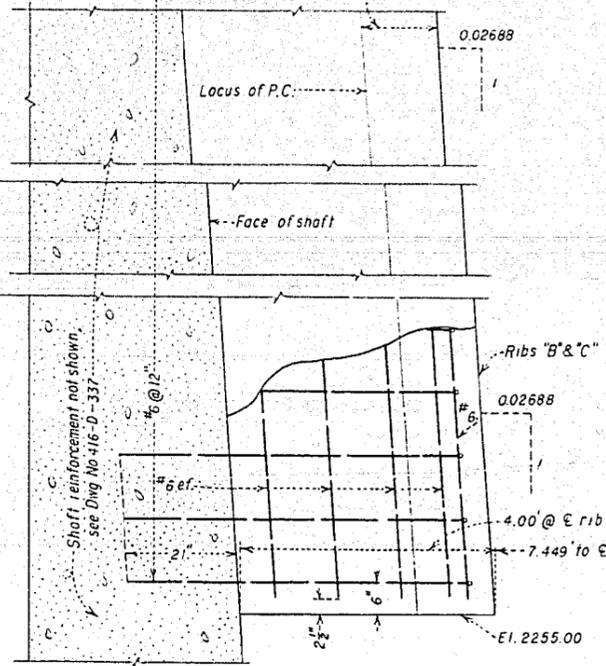
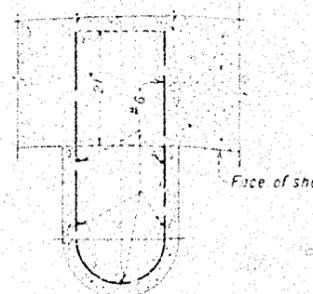
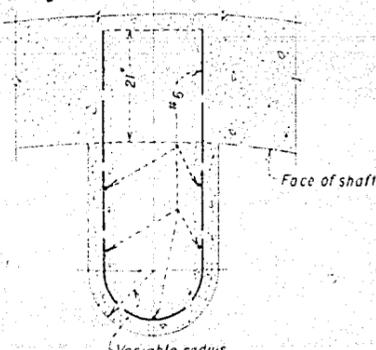
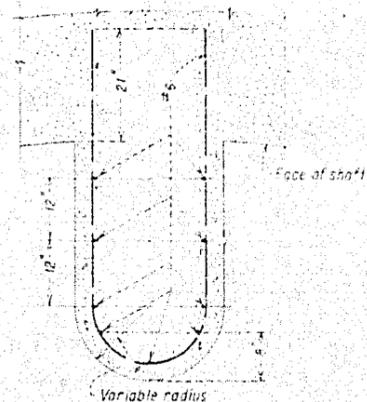
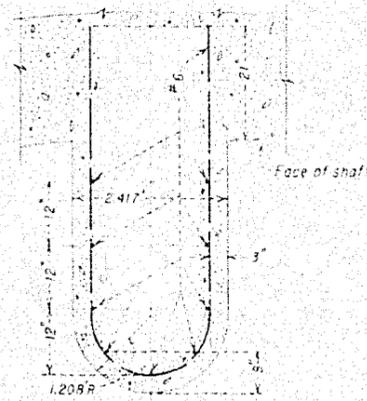
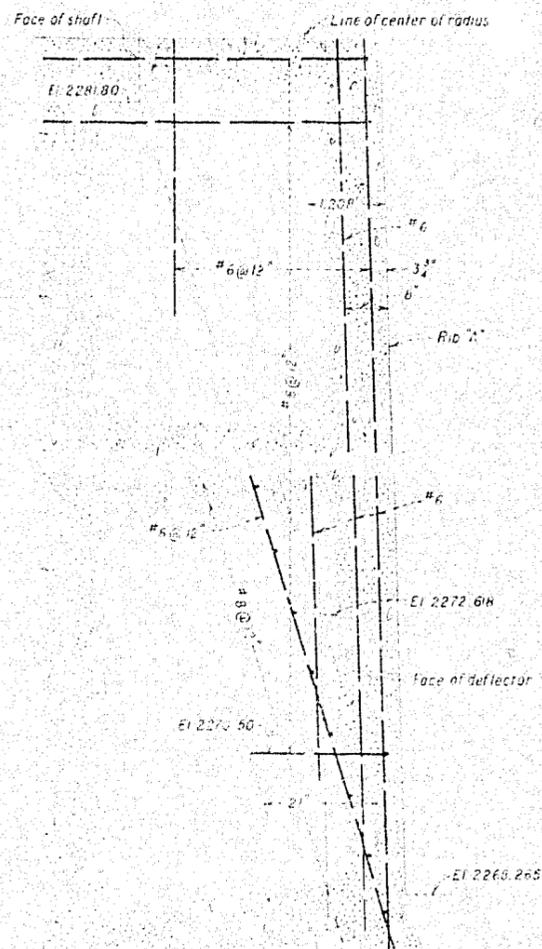
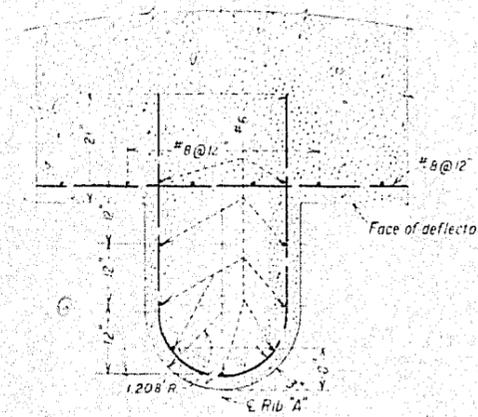
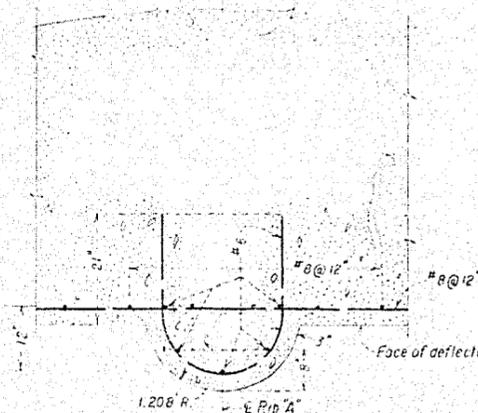
RIB DIMENSIONS

SECTIONAL ELEVATION A-A

SECTION G-G (375)
TYPICAL, ALL RIBS
EL. 2333.50 TO EL. 2336.25

SECTION H-H (375)
TYPICAL, ALL RIBS
EL. 2330.50 TO EL. 2333.50

SECTION J-J (375)

SECTION K-K (375)
TYPICAL, ALL RIBS
EL. 2327.50 TO EL. 2329.00

SECTION L-L (375)
RIBS "B" AND "C", EL. 2255.00 TO EL. 2327.50
RIB "A", EL. 2281.80 TO EL. 2327.50

SECTION M-M (375)

SECTION N-N (375)

SECTION P-P (375)

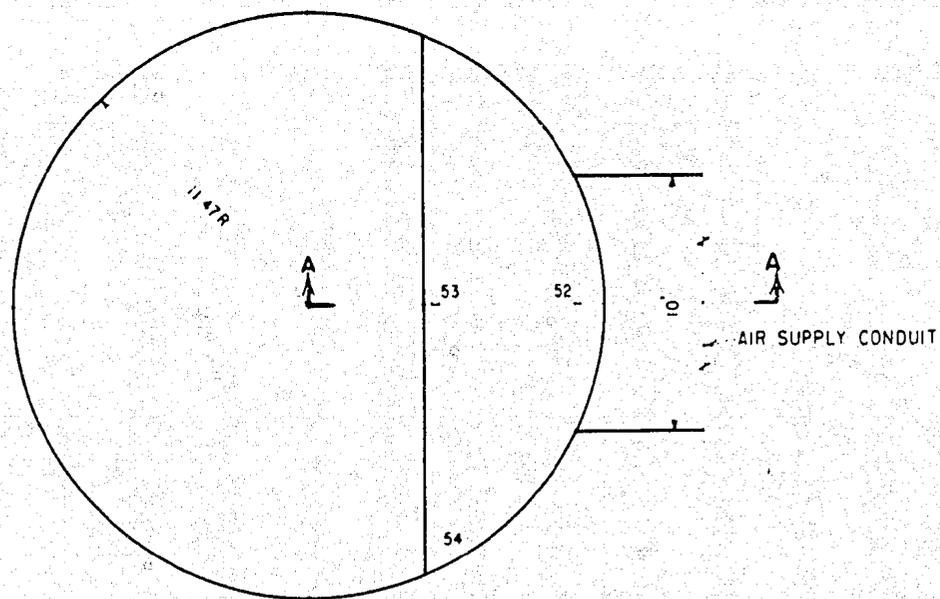
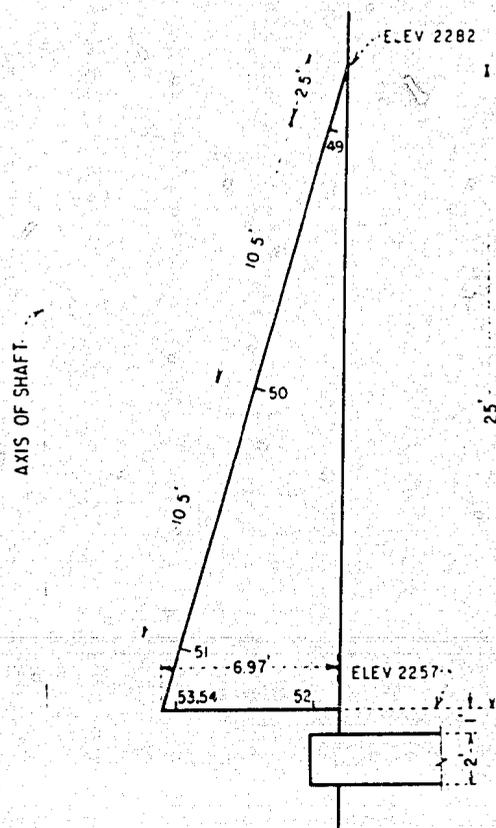
FIGURE 31
REPORT HYD. 447

PLAN
VIEW FROM UNDERSIDE

NOTE
Numbers refer to piezometers

SECTION A-A

TRINITY MORNING-GLORY SPILLWAY
FLOW DEFLECTOR
1:30 MODEL

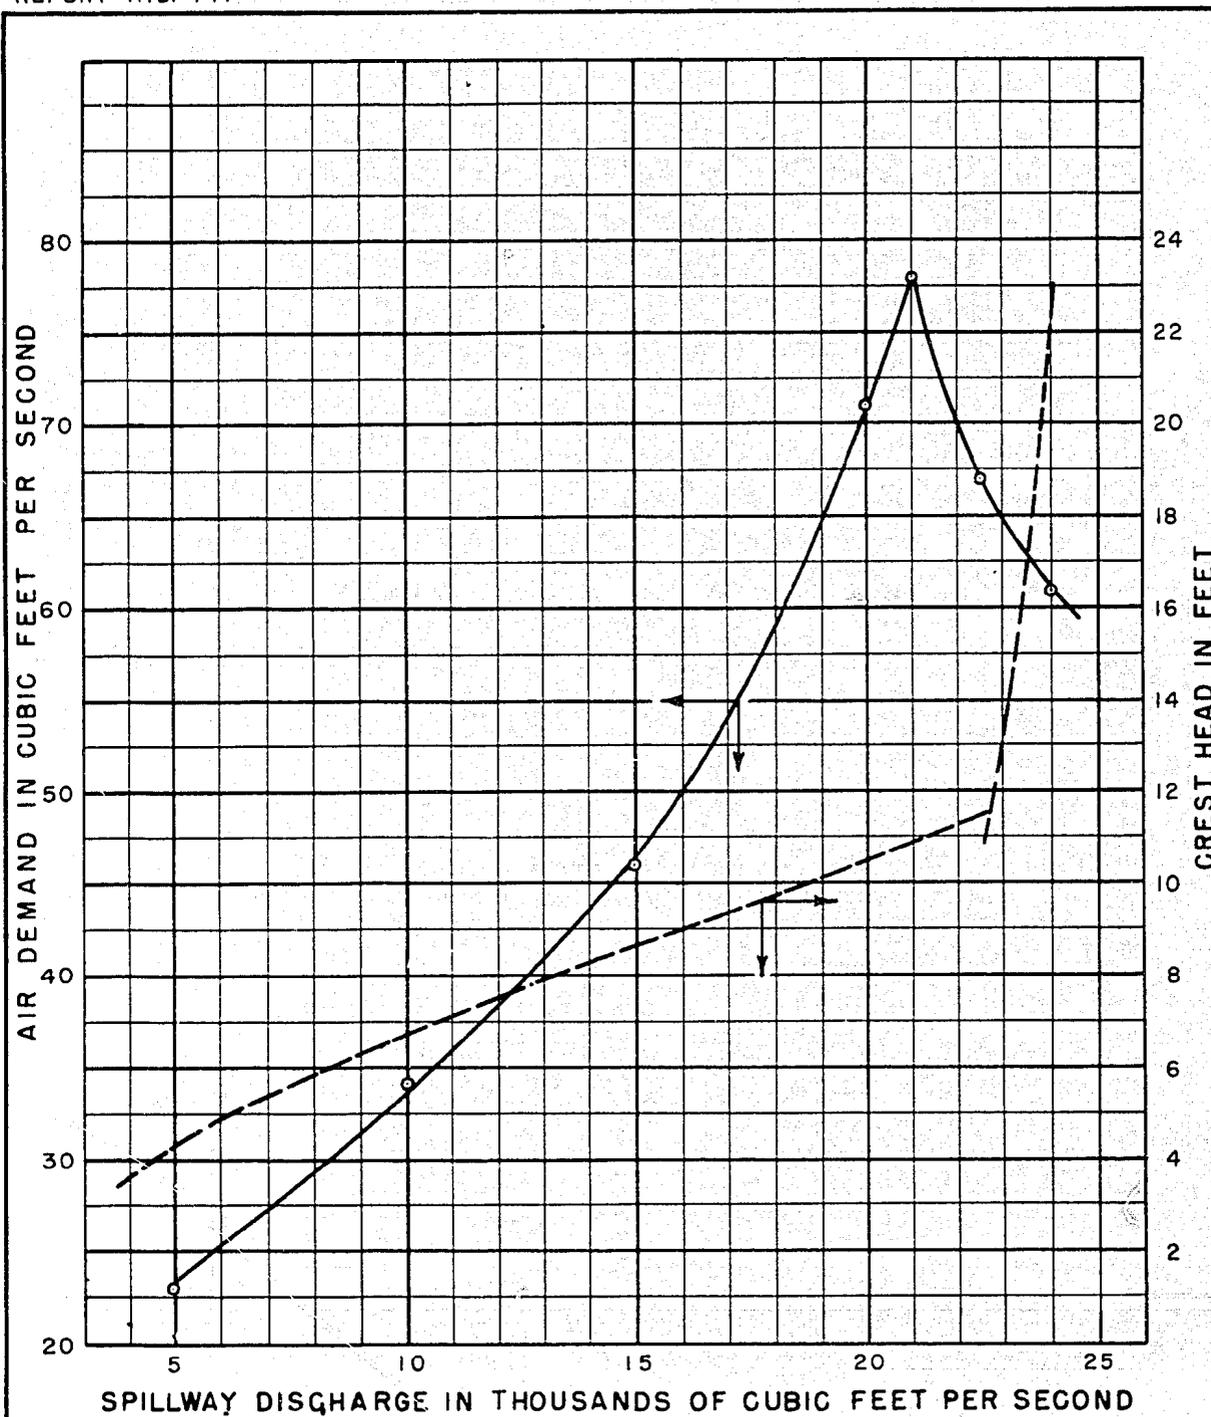
TRINITY MORNING - GLORY SPILLWAY
DEFLECTOR AIR DEMAND VS. SPILLWAY DISCHARGE
RECOMMENDED DEFLECTOR 6.97' x 25'

1:30 MODEL

The air demand of the recommended deflector 6.97 by 25 feet was measured so that comparisons could be made with future prototype measurements. A circular sharp-edged orifice was used to determine the quantity of air required for 7 spillway discharge rates. The coefficient of discharge of the orifice was assumed to be 0.60. Table 5 gives the air quantities in the model. Figure 31 was plotted from Table 5 to show the variation of air demand with spillway discharge. The maximum prototype demand of 78 second-feet is reached at 21,000 second-feet. At 24,000 second-feet, with the spillway submerged, the air demand shows a marked decrease to 60 second-feet. The general shape of the curve conforms well to a similar curve based on air demand measurements made at Shadehill Dam, shown in Figure 52 of Engineering Monograph No. 16.

AIR DEMAND FOR RECOMMENDED FLOW DEFLECTOR
Discharge in cubic feet per second

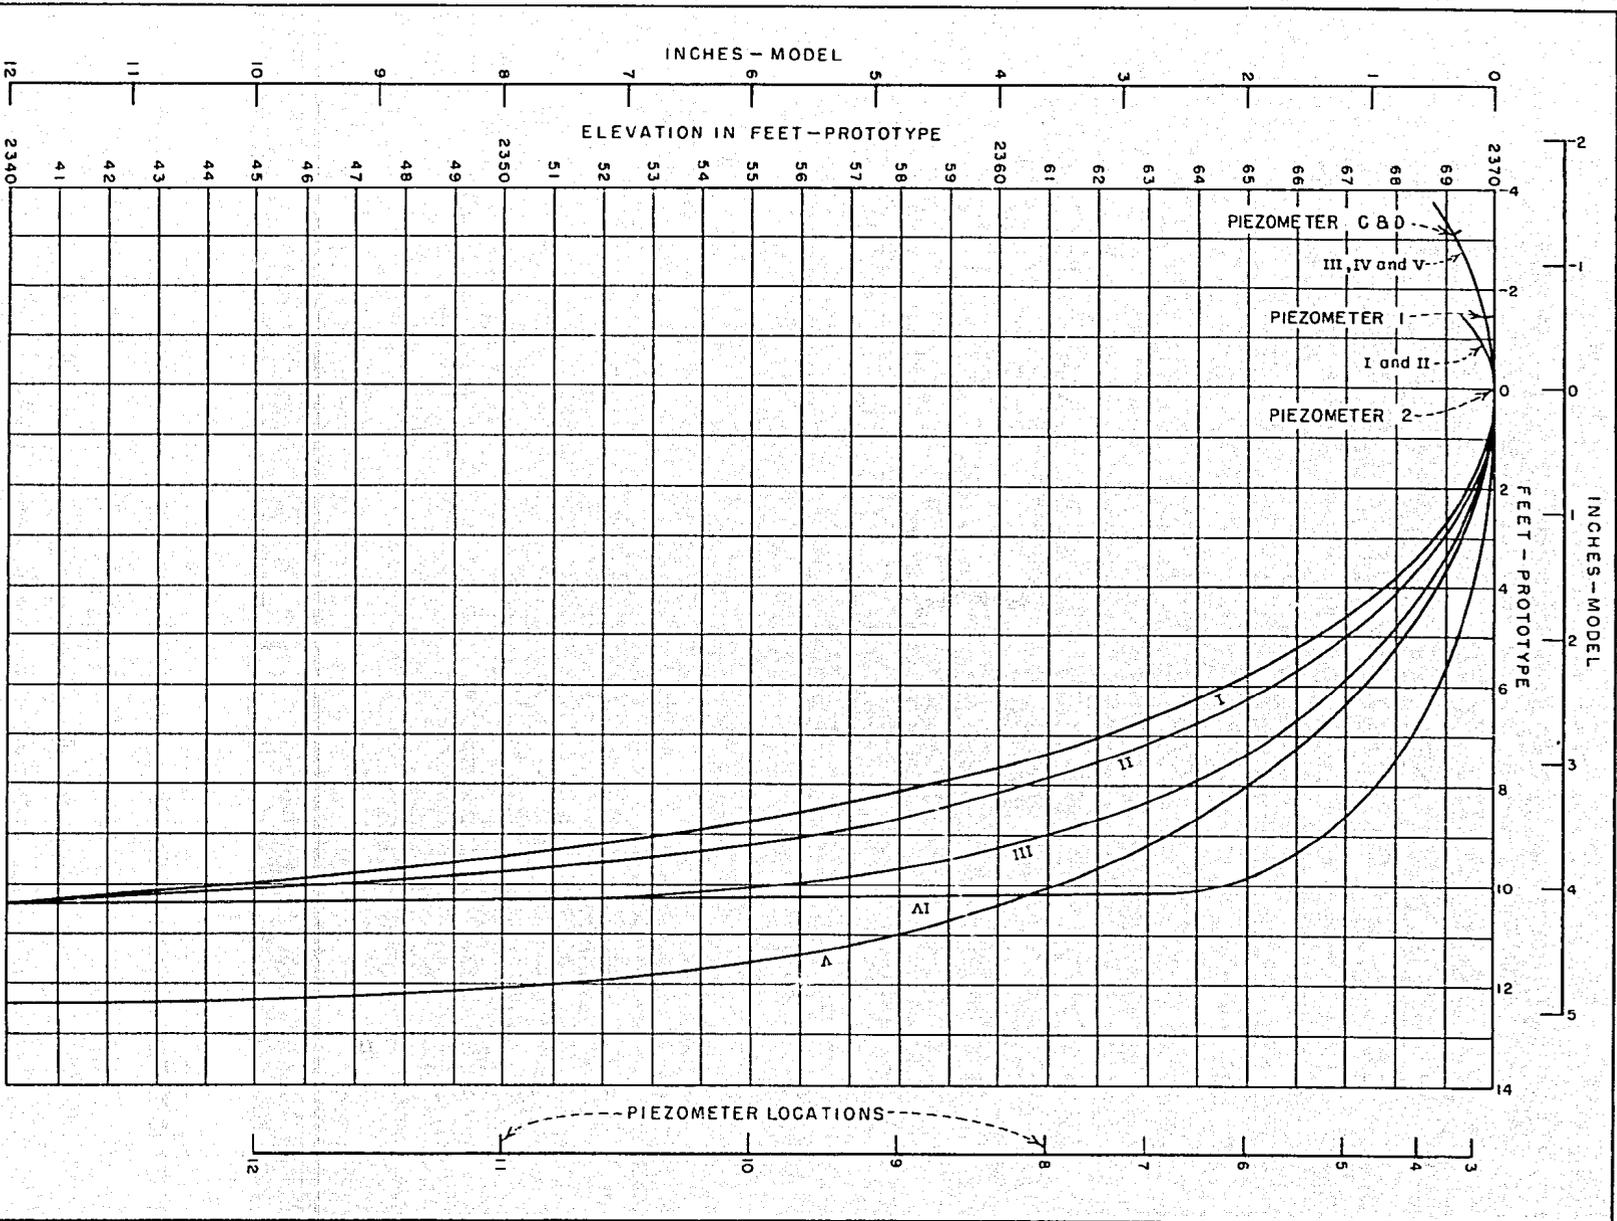
FIGURE 33
REPORT HYD.447

TRINITY MORNING - GLORY SPILLWAY
PROFILES I-V PLOTTED WITH COMMON CREST DIAMETER
1:30 MODEL

Description. --The original spillway diameter and the profile from spring point to crest were retained, but the profile downstream from the crest was revised, Figure 33. Auxiliary features used with Profile II include a deflector 5 by 18 feet, and three rib vanes in the final described positions. The deflector was aerated by a conduit 2 by 7 feet in cross-section. Profile I pressures had indicated that the region of high negative pressures was just downstream from the crest and that there was general improvement toward atmospheric values as the flow passed downstream and approached the upper bend. Therefore, the rate of change in slope downstream from the crest was decreased for the first 10 feet of drop, to elevation 2360, and increased from that point to elevation 2340 so as to use the same shaft diameter from the latter elevation downward. If the changes were of sufficient magnitude, negative pressures between elevations 2370 and 2360 or below could be expected to rise toward atmospheric while pressures near elevation 2340 would be expected to drop below atmospheric. Such changes would be considered as overall improvement.

The coordinates for all spillway profiles tested are contained in Table 1. To facilitate comparisons of them two plots were prepared: (1) profiles plotted from a common crest point without regard to crest diameter, Figure 33, and (2) profiles plotted in proper vertical and horizontal positions, Figure 34.

Description. --Analysis of test results on Profile II gave rise to two conclusions which were applied in defining a new profile. First, the negative pressures on the short curve upstream of the crest, the approach curve, could be interpreted as indicating that flows rising from the berm passed the spillway spring point at an angle much steeper than the angle of a tangent drawn to the spillway surface at the point. It was believed that a milder curve downstream from the spring point would improve the pressures in this region. The first step in modifying Profile II, therefore, was to lengthen the approach curve, Figures 33 and 34.

Profile pressures. --Data Set 10 of Table 2 is a summary of pressures measured on Profile III. Because the crest approach curve was lengthened an additional piezometer was installed in each row to better define the pressure variations upstream of the crest. The piezometers are identified as C and D, located as shown in Figure 33.

Description. --Profile IV is shown in Figures 33 and 34. The crest approach curve was the same as that for Profile III. The portion

Description. --The shape of the Profile V spillway relative to the other profiles is shown in Figure 33. The crest approach curve is identical to that used for Profiles III and IV. Downstream of the crest, however, the new profile lies between Profiles III and IV down to elevation 2361; below this elevation, the rate of change of slope increases to elevation 2340. The use of Profile V would result in a tunnel of reduced diameter at the same elevation; therefore, in order to retain the original tunnel diameter, it was necessary to increase both the crest and outside diameters by 4 feet. Profile V in its true position is shown in Figure 34. The slope of the profile curve is milder at all elevations than the slopes of Profiles I, II, and III. Below elevation 2366, the slope is less severe than that of Profile IV.

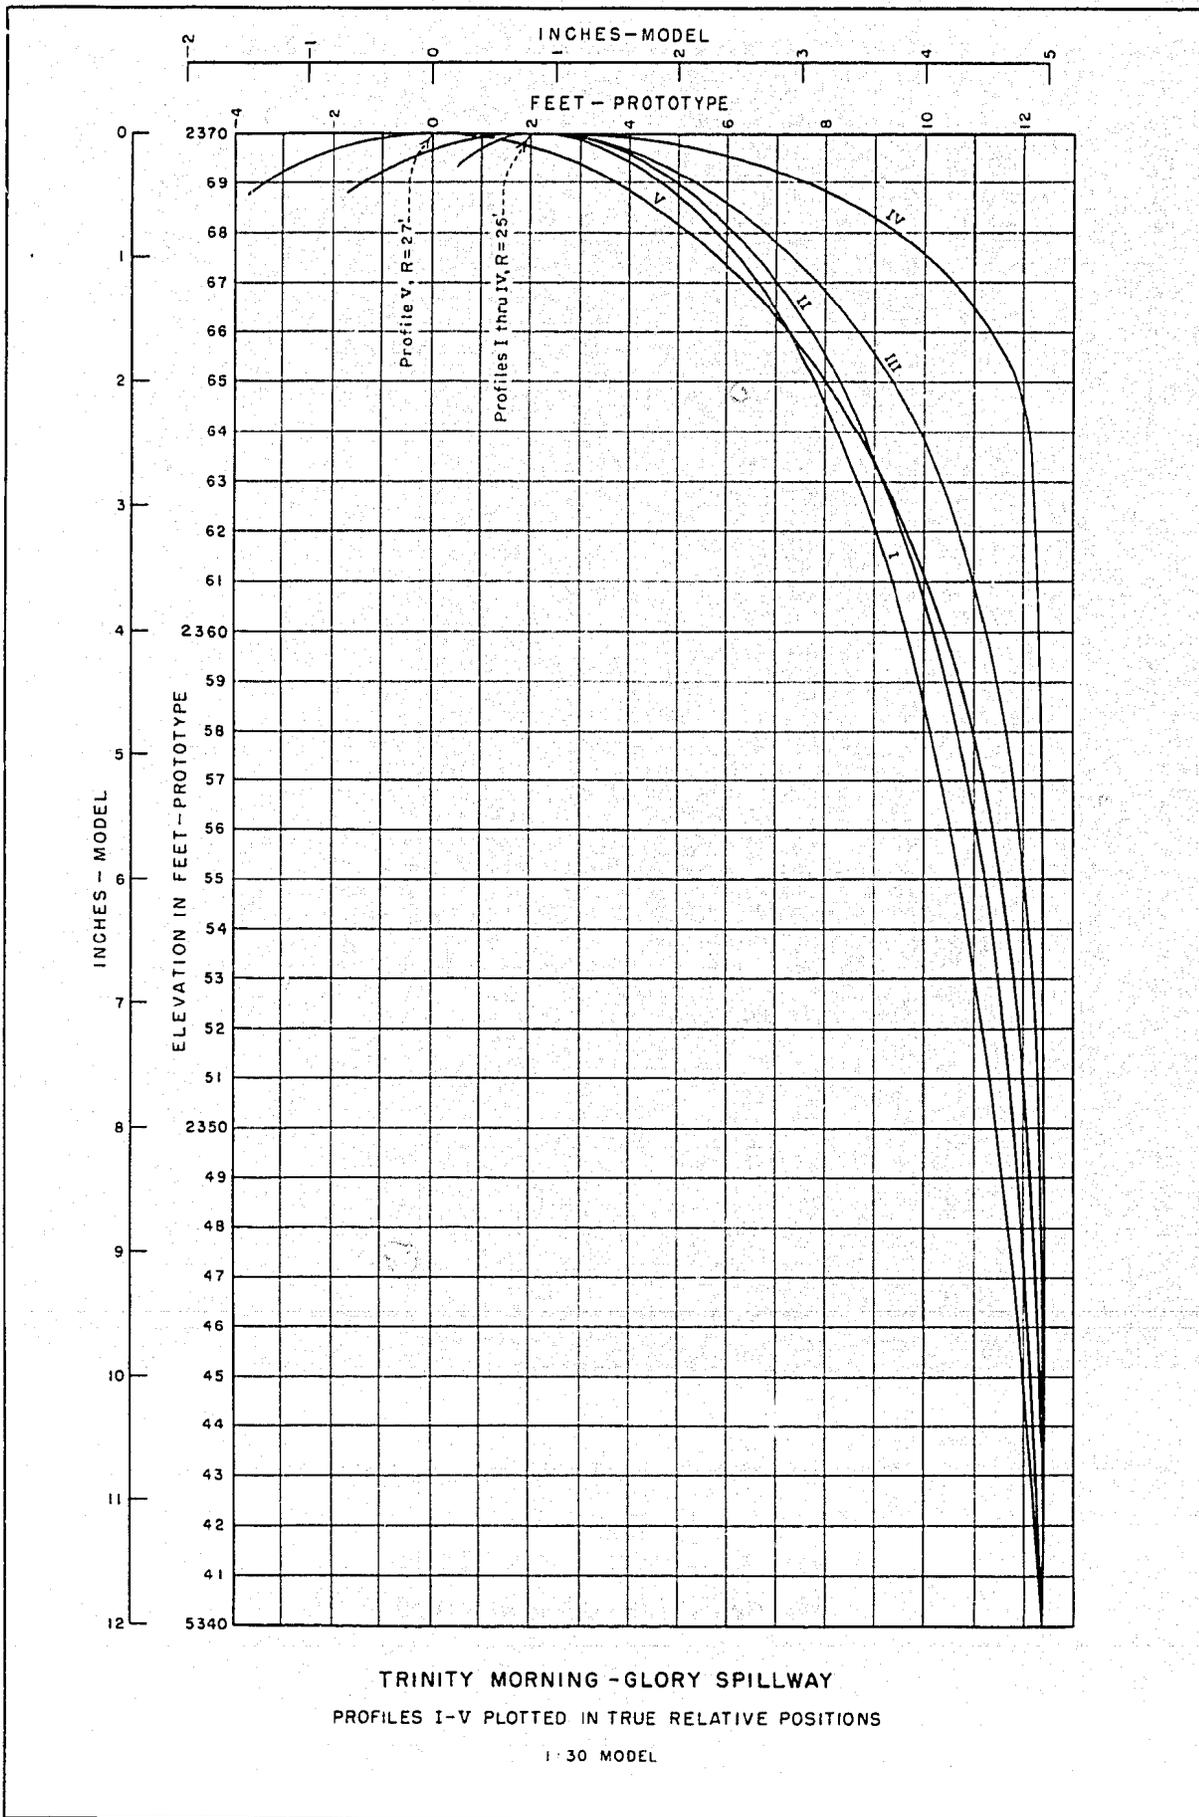
FIGURE 34
 REPORT HYD. 447

TRINITY MORNING - GLORY SPILLWAY
 PROFILES I-V PLOTTED IN TRUE RELATIVE POSITIONS

1:30 MODEL

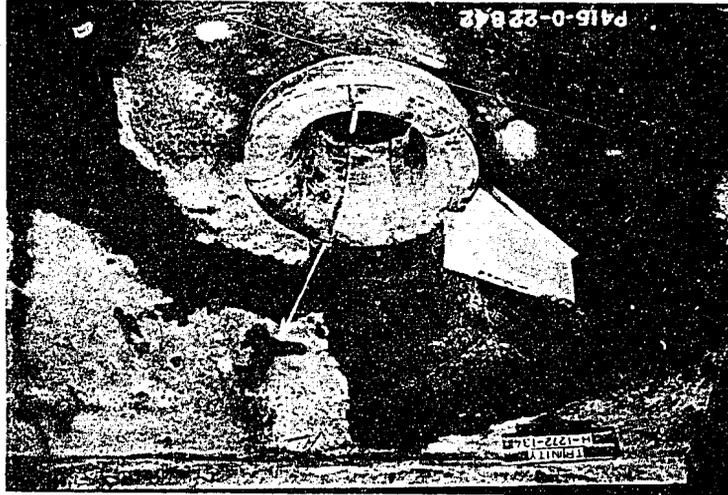
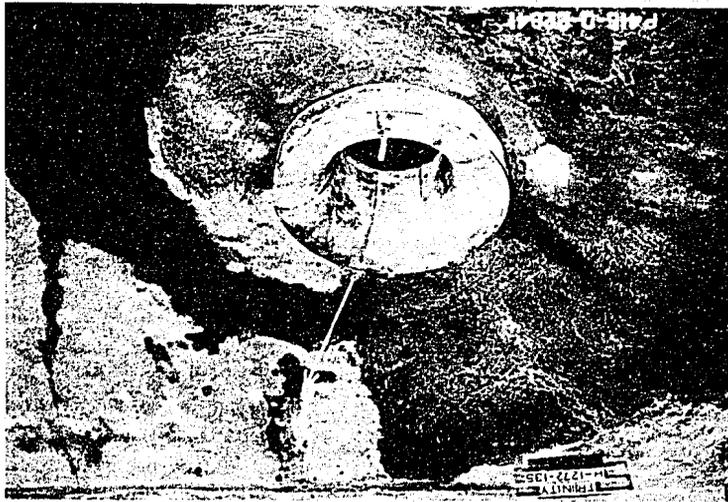
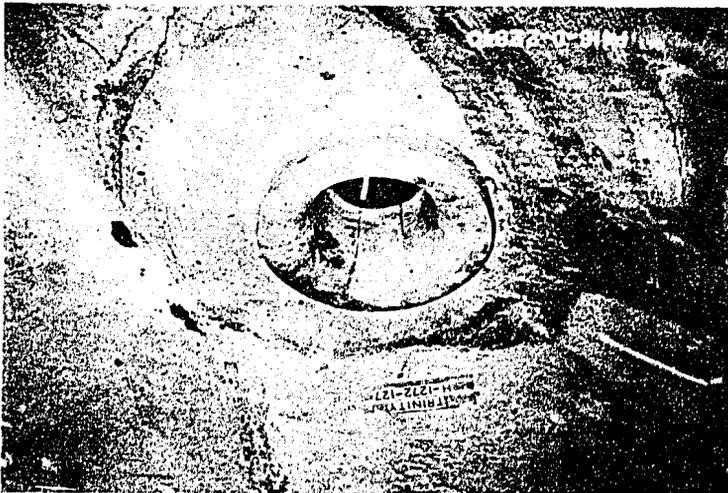
TRINITY MORNING-GLORY SPILLWAY
TOPOGRAPHY CHANGES WITH RECOMMENDED PROFILE
1:30 MODEL

C. Final Topography with Spillway Pier

B. Final Topography

A. Preliminary Topography

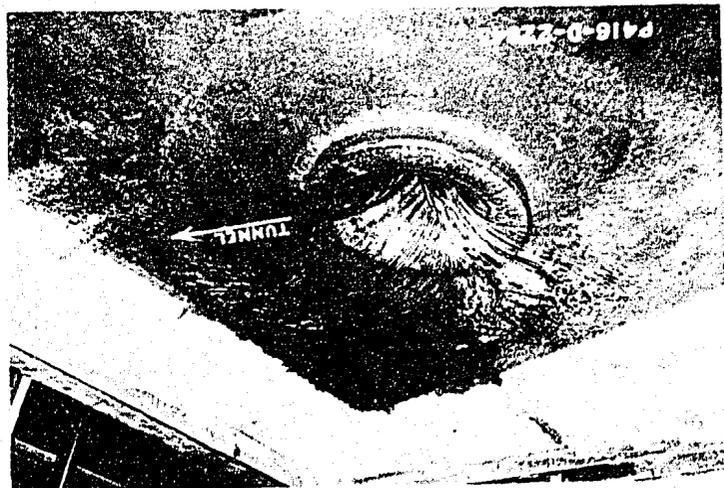
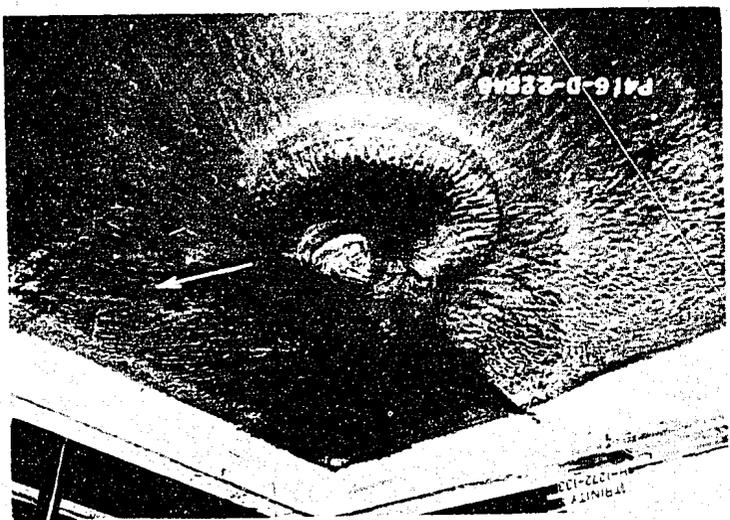
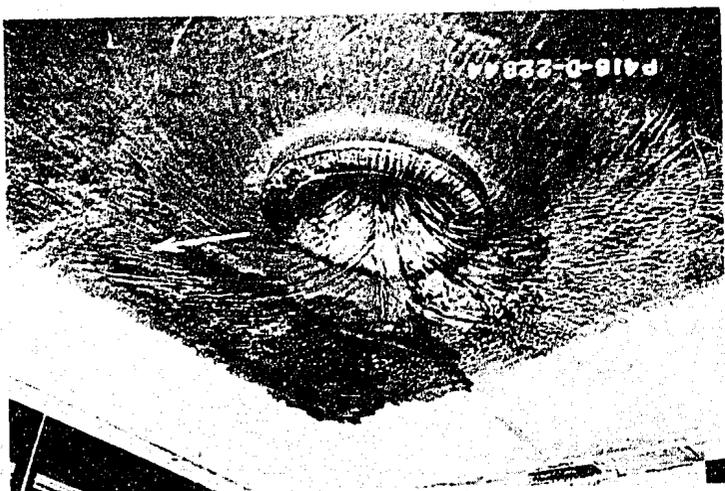
TRINITY MORNING-GLORY SPILLWAY
PERFORMANCE OF RECOMMENDED PROFILE WITH PRELIMINARY TOPOGRAPHY
1:30 MODEL

C. Discharge 22,500 cfs

A. Discharge 15,000 cfs

D. Discharge 24,000 cfs

B. Discharge 20,000 cfs
